Building and Timber Pest Inspection Report

Inspection Date: Tue, 3 Mar 2026

Property Address: 35/5 Broughton Rd, Artarmon NSW 2064,
Australia

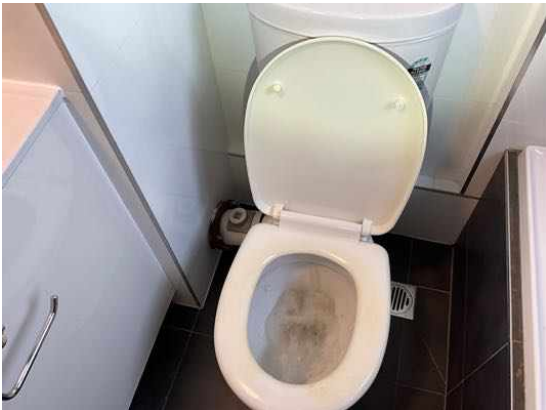
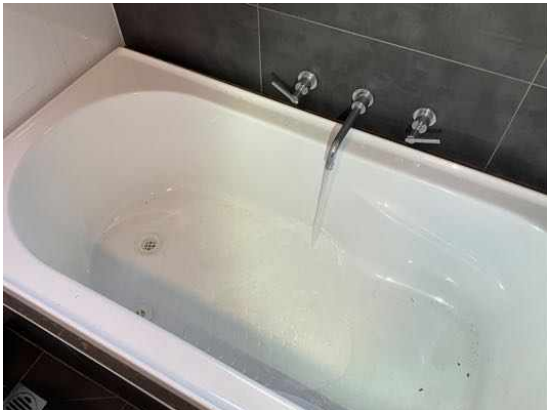
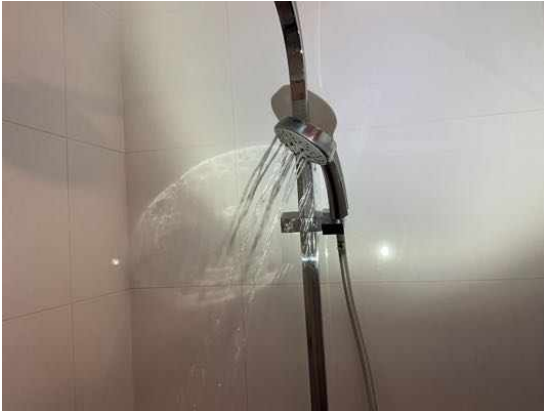
Building: Main Building
 Location: All Wet Areas
 Finding: Waterproofing
 Information: All taps, mixers and toilets were tested for operation, except for those obstructed. The waterproofing to the shower recess was assessed by checking the walls in and around the shower recess for varying moisture content. There were no significant variations across the tested areas. No sign of recent water damage was evident upon a visual inspection of the surrounding walls, where the visual nature of the inspection was possible.

Consequently, there is no conclusive evidence of any current shower recess leakage other than those which may have already been mentioned earlier in this report. It is reasonable to assume the shower waterproofing is sound. Note that if the shower is not used, or has not been used for some time, moisture readings would not vary significantly and this can lead to erroneous results. It is not possible under the visual inspection criteria (under which a prepurchase inspection is carried out) to categorically determine if there are leaks. If a more accurate assessment is required, a special purpose inspection should be requested. Alternatively, the assumption should be made that the shower may leak.

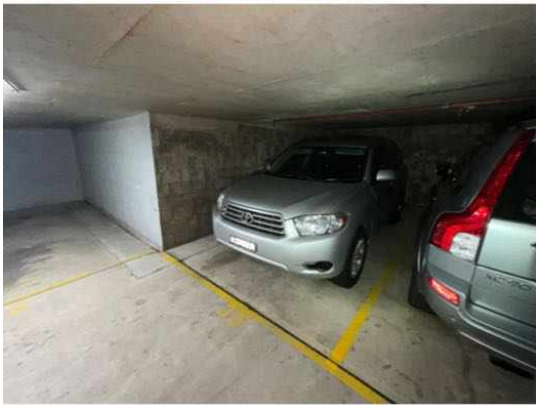
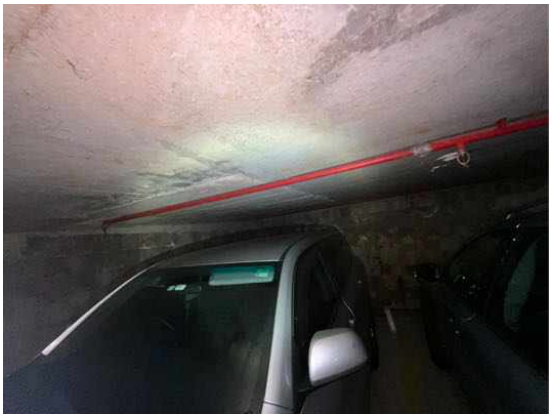
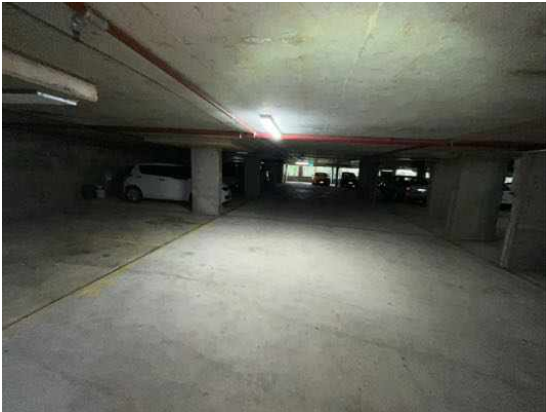
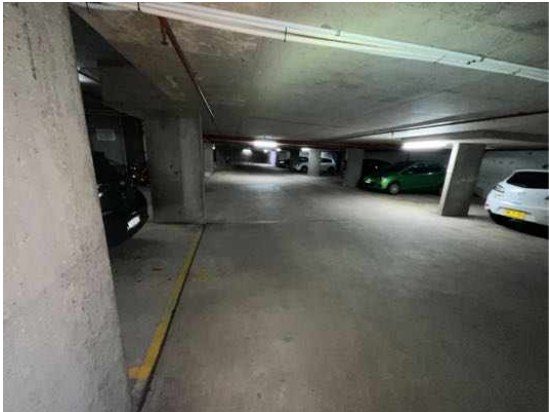
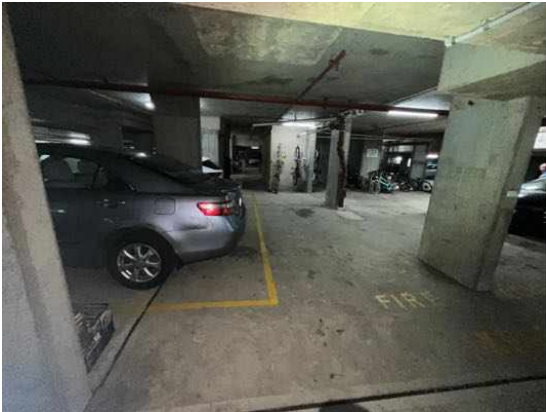
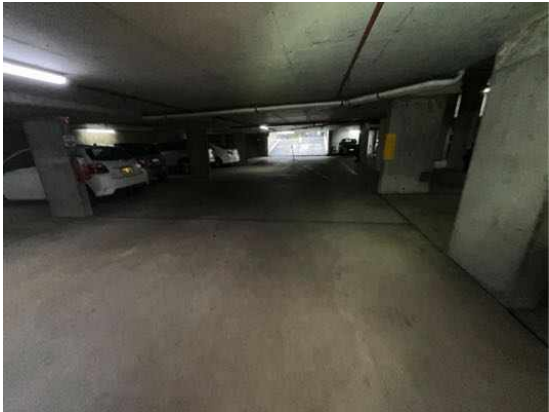
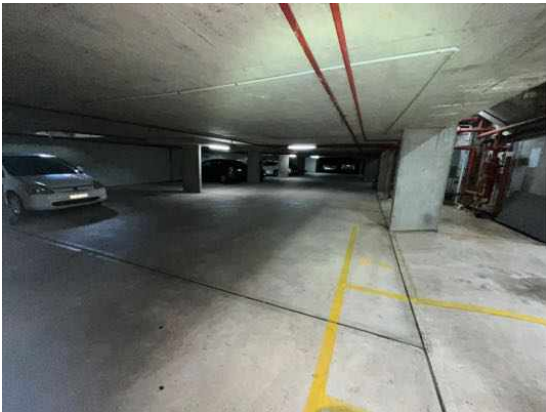
Building:	Main Building
Location:	Garage
Finding:	Additional Photos- Garage
Information:	Additional photos are provided for your general reference. Arrows may have been included to highlight areas of importance. Please discuss these photos with your building consultant for clarification.

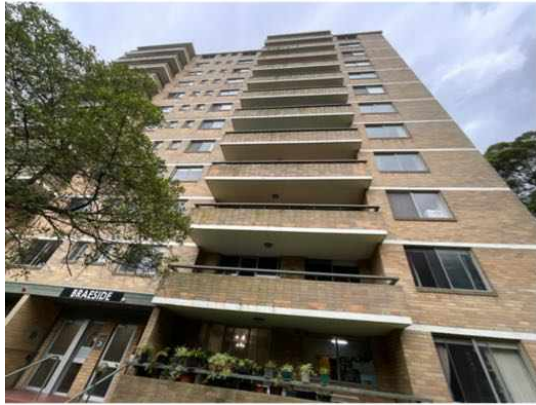
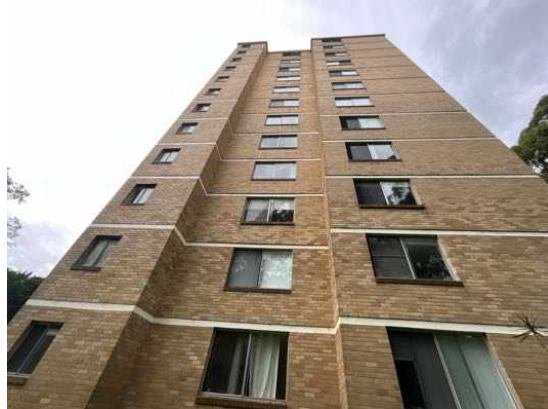
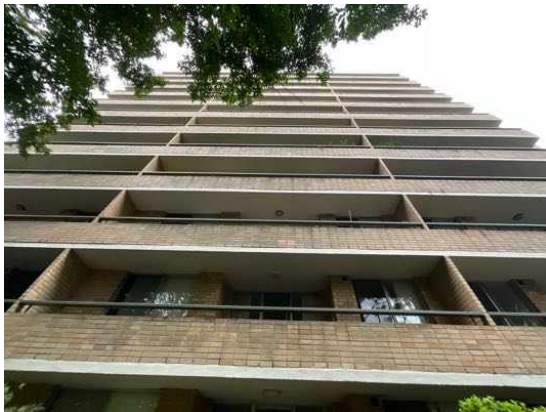
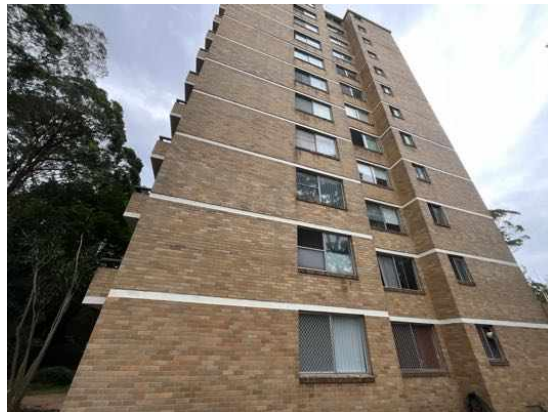
Building: Main Building
Location: Exterior
Finding: Additional Photos
Information:

Additional photos are provided for your general reference.

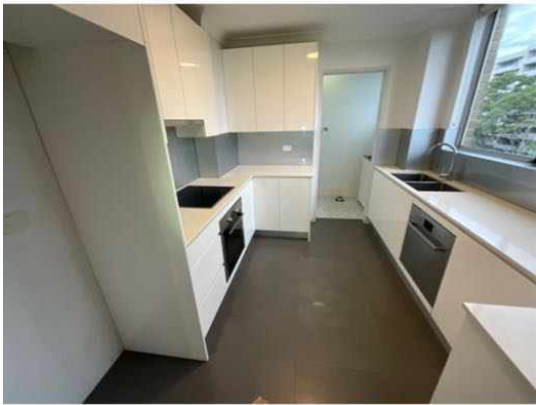
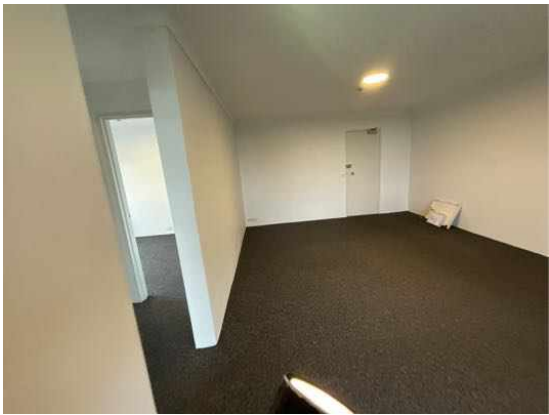
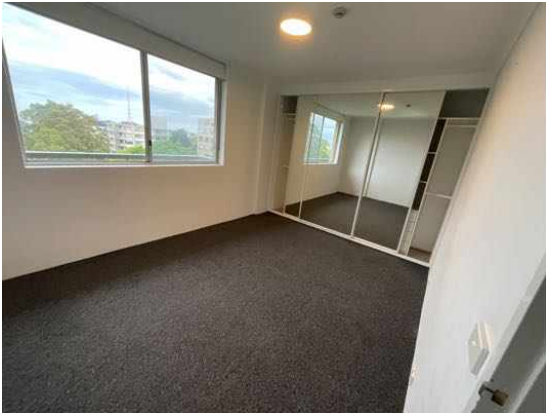
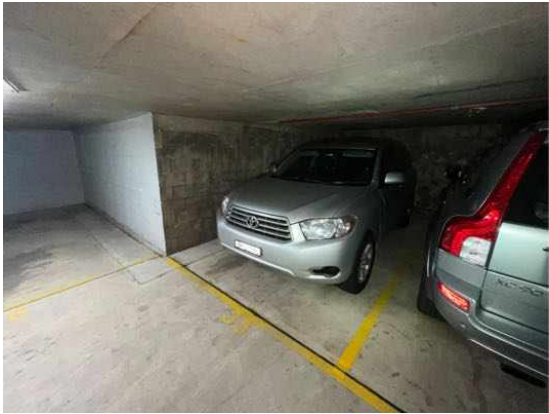
Building: Main Building
Location: All Areas
Finding: Additional Photos - Obstructions and Limitations
Information:

These photographs are an indication of the obstructions and limitations which impeded full inspection of the property at the time of inspection. These obstructions can hide an array of defects and should be removed to allow full inspection to be carried out. A re-inspection is recommended once the areas are made accessible.
