Building Inspection Report

Inspection Date: Sat, 28 Feb 2026

Property Address: 61 Weroona Ave, Park Holme SA 5043,
Australia

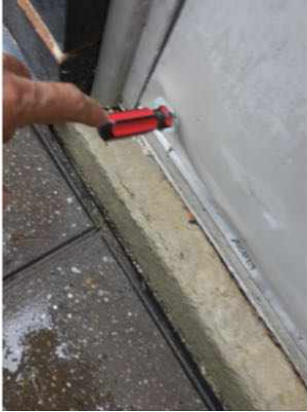
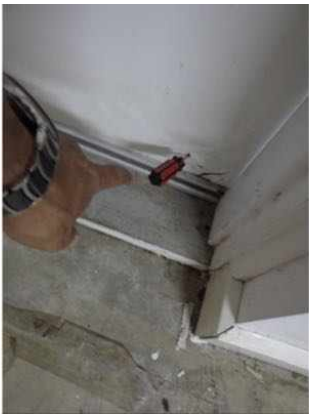
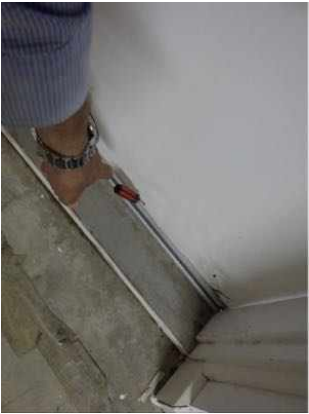
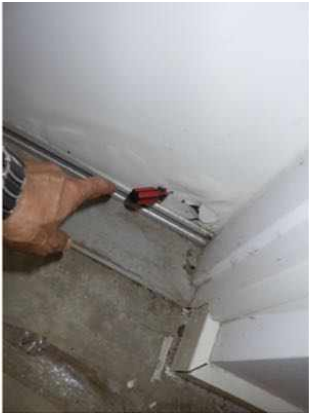
Defects 2.01

Swollen building elements generally indicate that the building materials have been affected by excessive moisture over a prolonged period of time, and have swollen as a result. The formation and development of mould/fungi or mildew is also a likely consequence of excessive moisture, which may pose major respiratory issues for occupants, particularly the elderly, the very young and those with existing illnesses and could be potential health safety hazards. In these cases an appropriately qualified inspector/tester should also be contacted for advice and/or technical assistance.

The structural integrity of swollen building elements can not be guaranteed, and further damage is likely to develop if left unmanaged. Excessive moisture is likely to lead to the development of secondary damage to any associated building elements, which may necessitate major reparation works if prolonged.

Rectification of the cause of the water leak should be addressed prior to any remedial works to the swollen building elements. A licensed plumber should be appointed immediately to identify the cause of the leak and provide advice on remedial works as necessary, Repair and/or replacement of swollen building elements should be conducted as a matter of urgency by a registered builder or qualified carpenter.

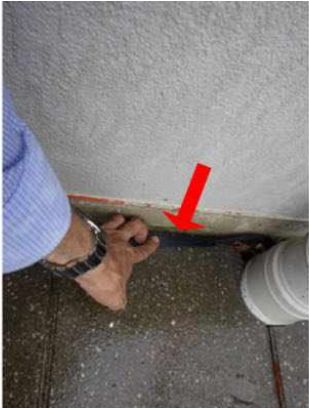
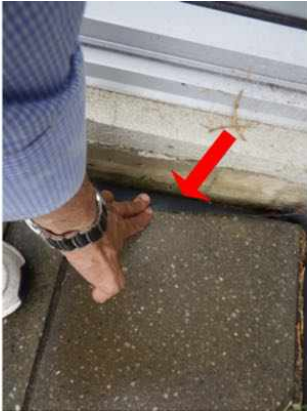
Defects 3.02

Building:	Building 1
Location:	All External Areas
Finding:	Slab Edge - Exposure compromised
Information:	At the time of inspection it was noticed that damp course member has been popping upwards from the external paving in few sections around property and result of that slab edge exposure has been compromised. It's advised to cut the extra popping upwards damp course.

If the slab edge is not properly exposed there is a high risk of termite attack. Sometimes, in order to determine the type of slab, a suitably qualified person such as an architect or builder may be required to consult the construction plans.

Where the slab edge cannot be properly inspected, it is highly recommended that termite or timber pest inspections be carried out every 6-12 months to aid protection of the property against infestation.

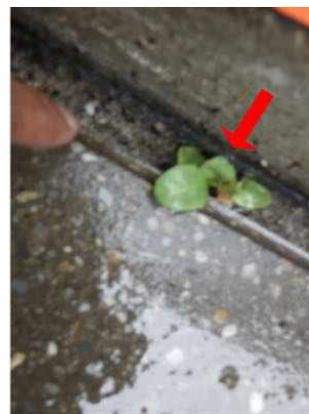
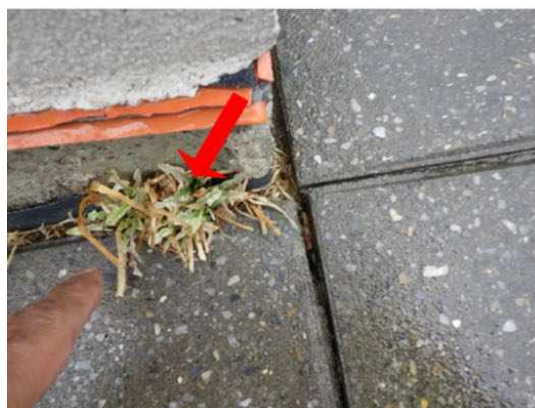
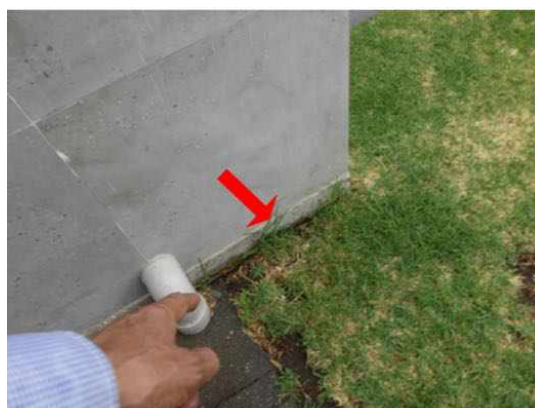
Defects 3.03

Building:	Building 1
Location:	All External Areas
Finding:	Bridging - Vegetation
Information:	Where vegetation obstructs inspection of building elements, also known as bridging as it provides a bridging point for the access of termites, full inspection can not be achieved. Consequently moisture or dampness may be present and the areas becomes conducive to termite activity. Plants against or very close to buildings provide cover, shade and can provide an environment that is attractive to termite infestation.

The removal and replanting of species that do not provide "cover" or cutting back of existing vegetation will assist greatly in preventing Bridging from occurring.

The removal of any such materials that may be conducive to termite activity should be carried out as soon as possible and arrange re inspection to minimize the risk of termite attack.

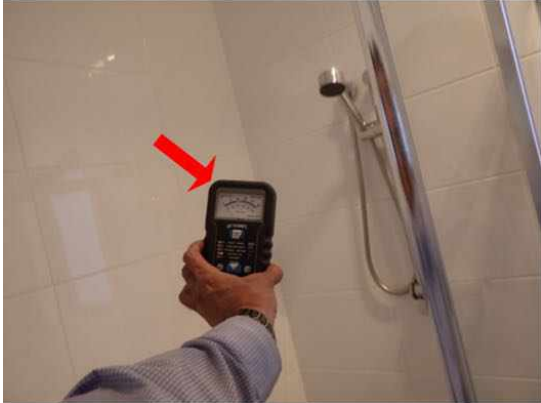
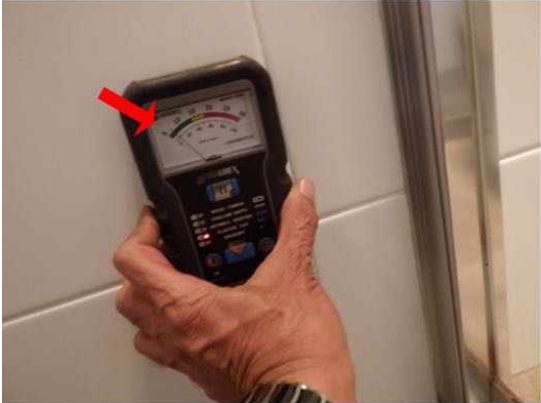
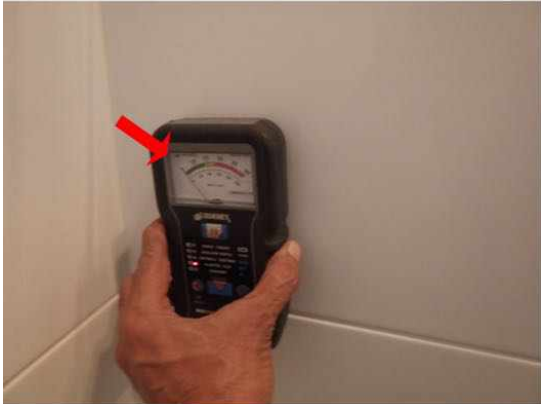
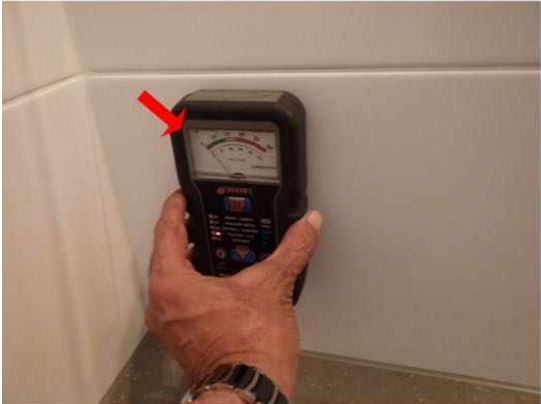
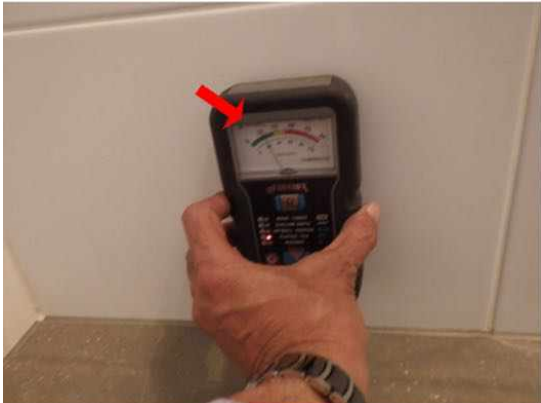
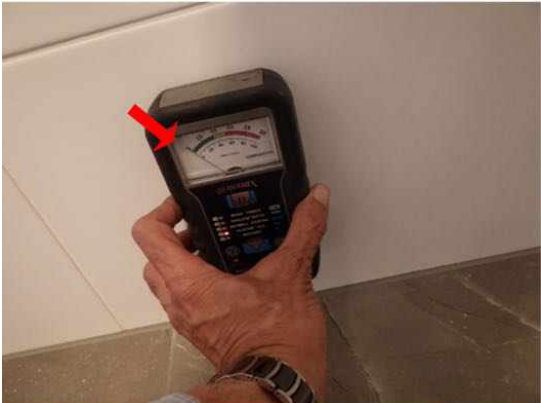
Noted Item

Damp (or structural damp) refers to the presence of unwanted moisture in the structure of a building, either as the result of intrusion from outside, or condensation from within the structure. In the shower area, internal water leaks or other sources of excessive moisture are generally the cause of damp.

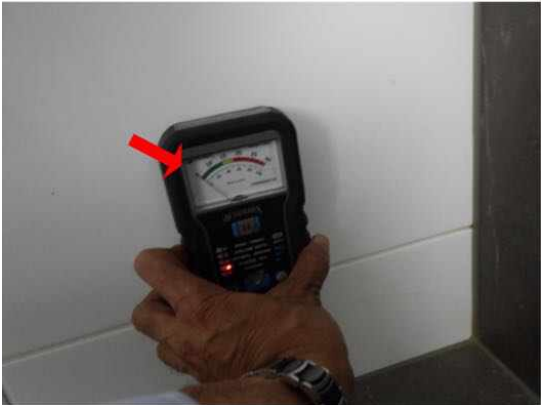
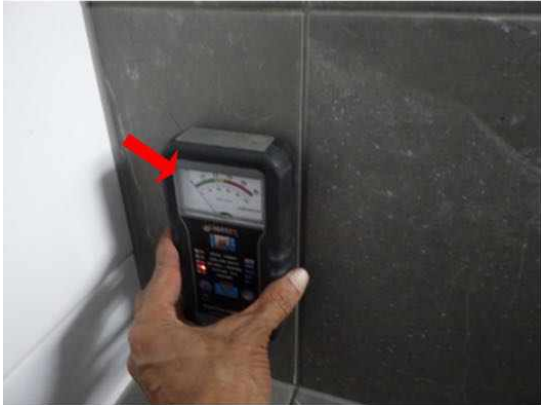
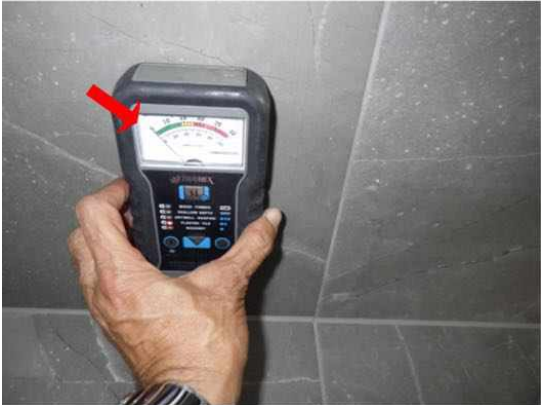
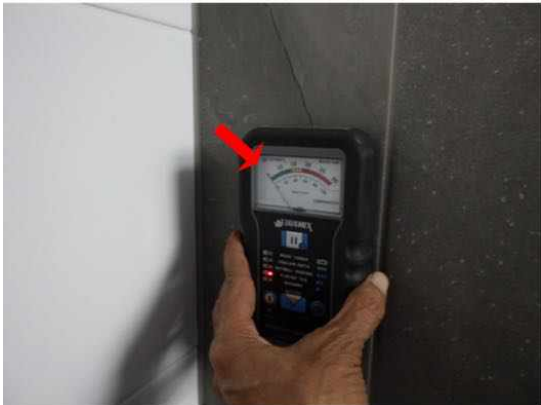
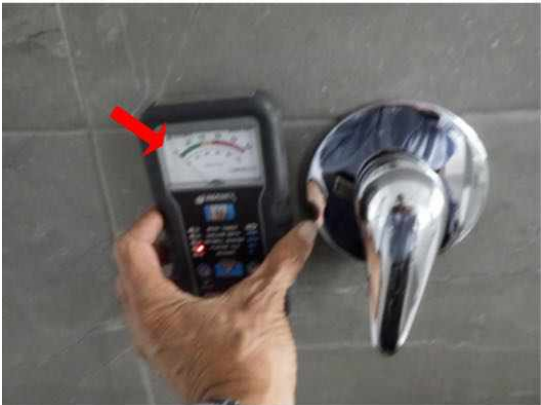
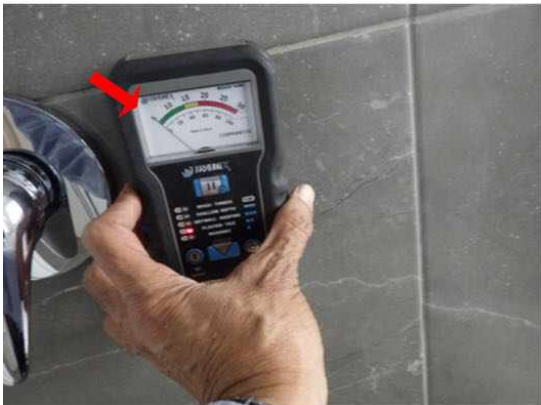
Noted Item

Damp (or structural damp) refers to the presence of unwanted moisture in the structure of a building, either as the result of intrusion from outside, or condensation from within the structure. In the shower area, internal water leaks or other sources of excessive moisture are generally the cause of damp.

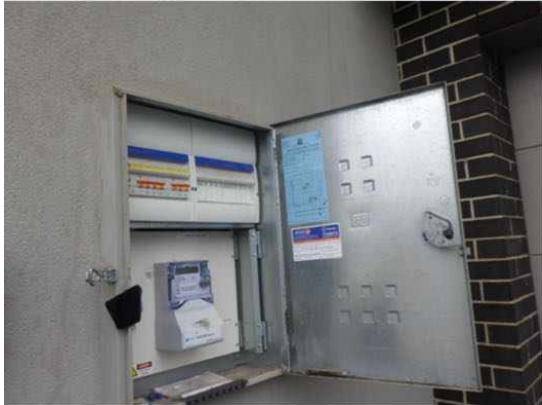
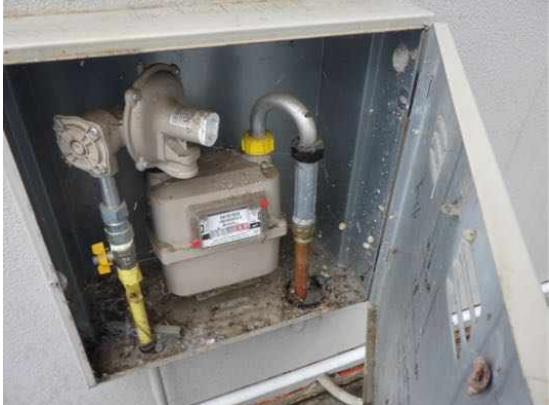
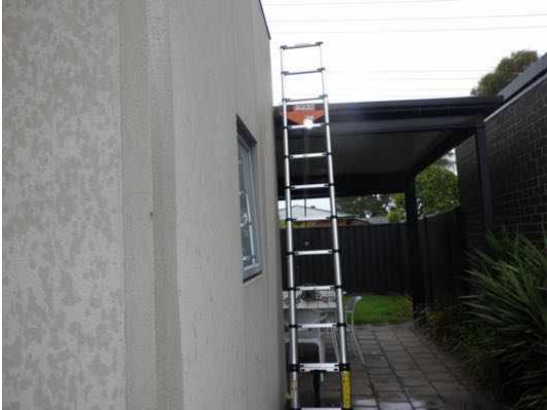
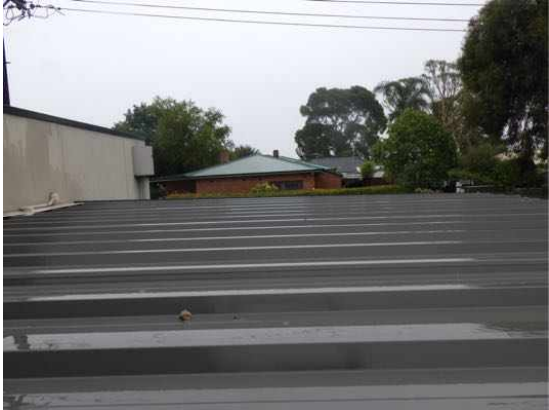
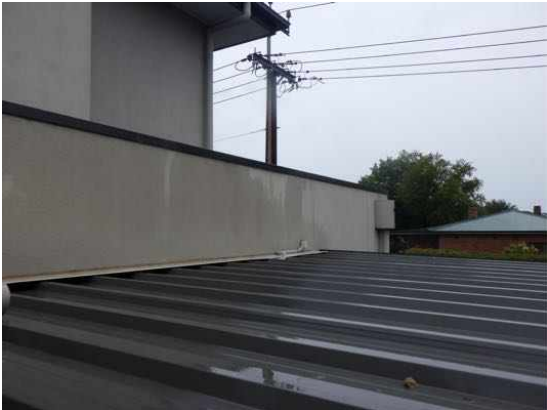
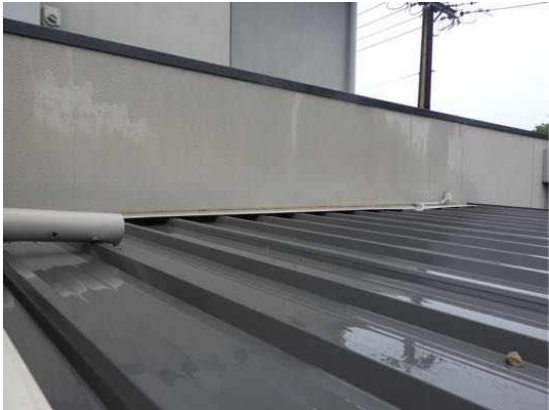
Noted Item

Building: Building 1
Location: All Areas
Finding: Additional Photos
Information: Additional photos are provided for your general reference

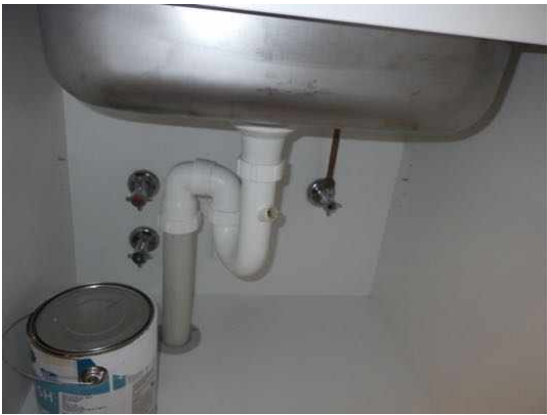
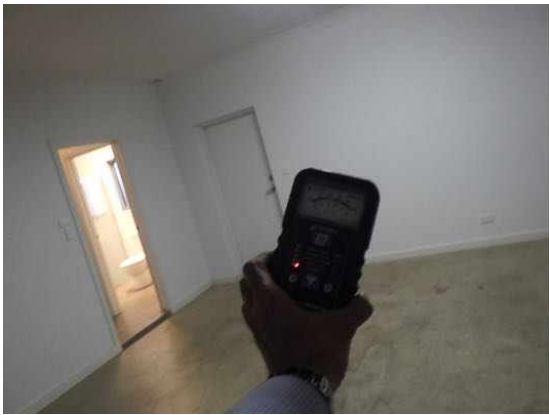
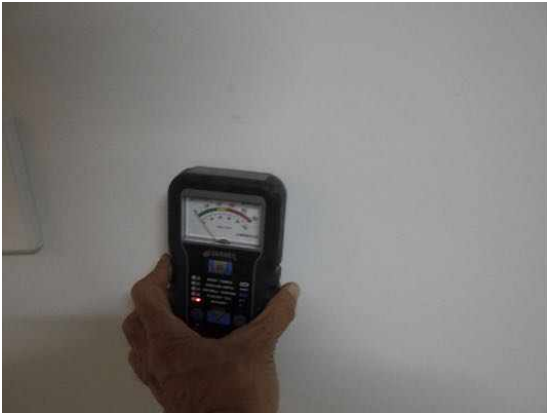
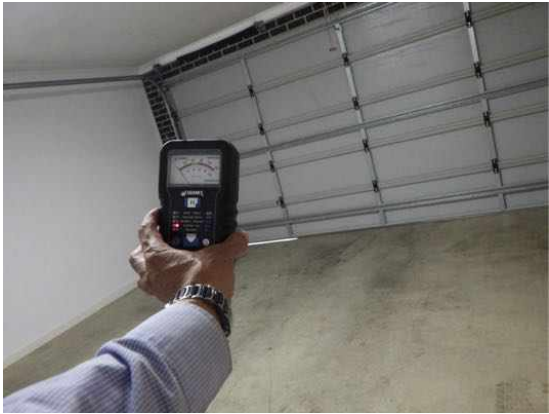
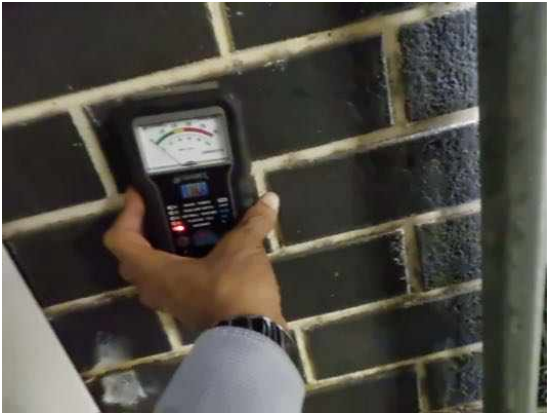
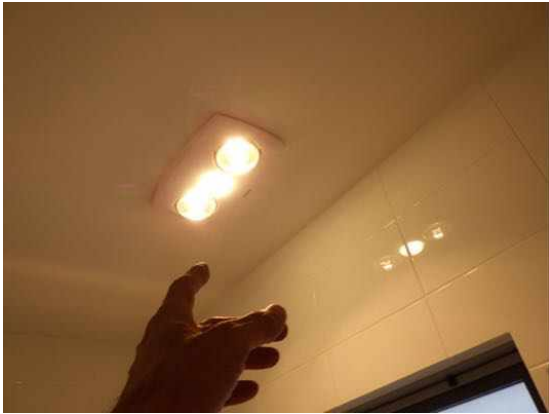
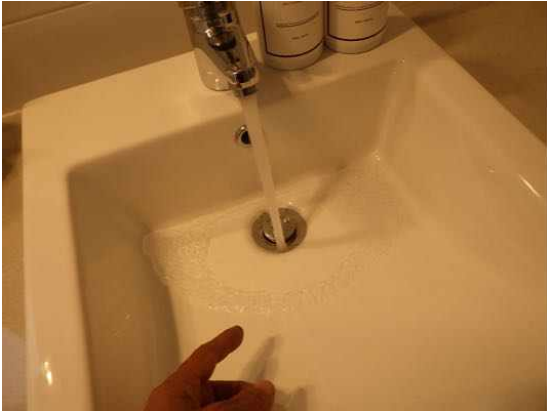
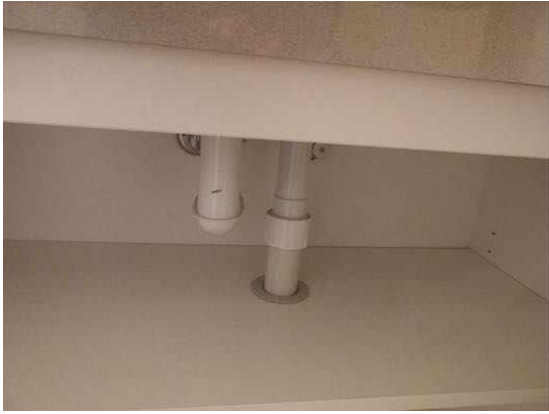
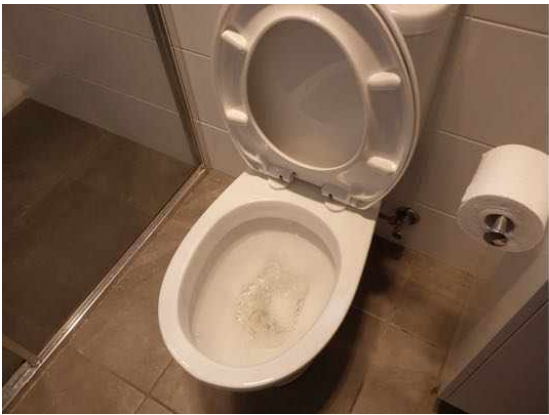
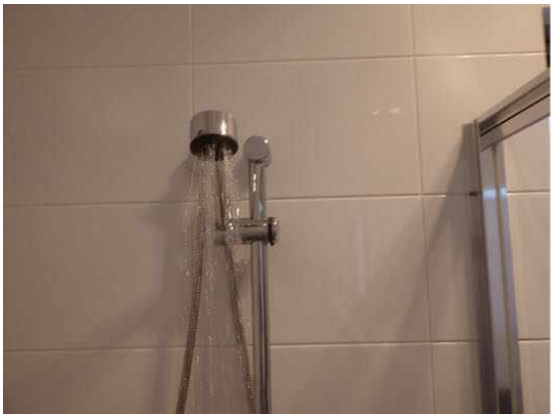
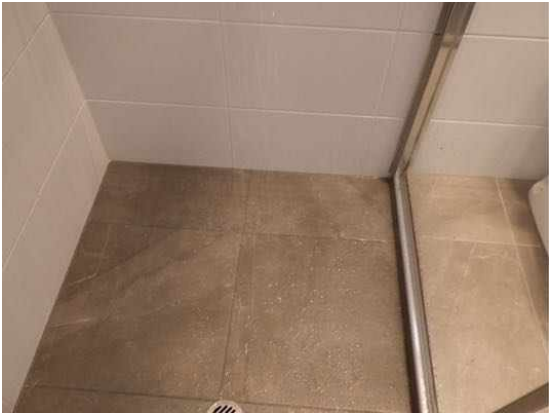
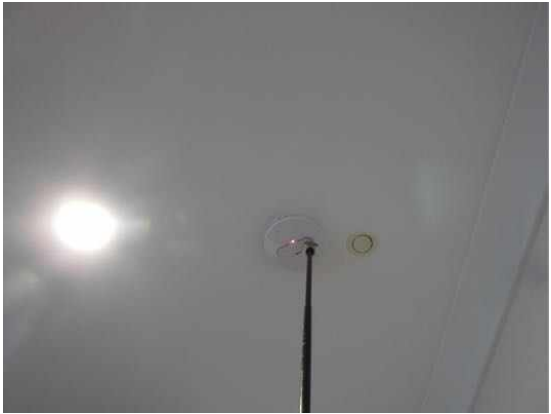
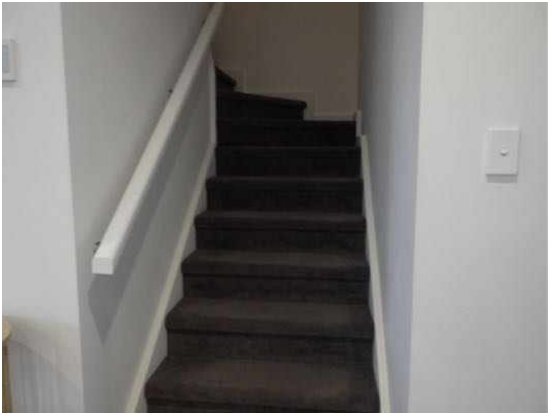
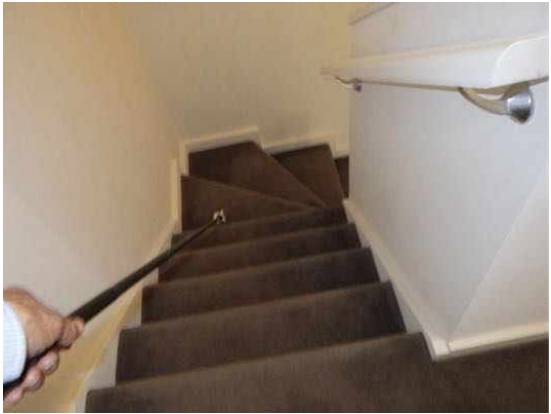
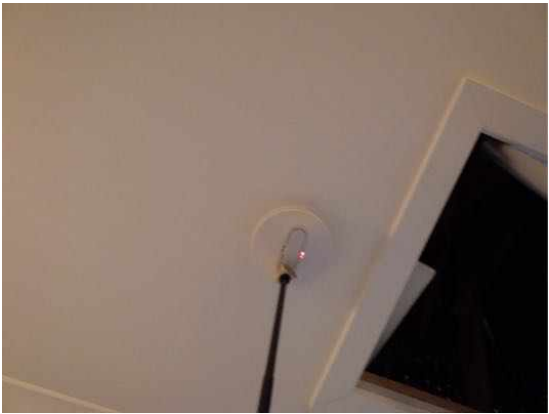
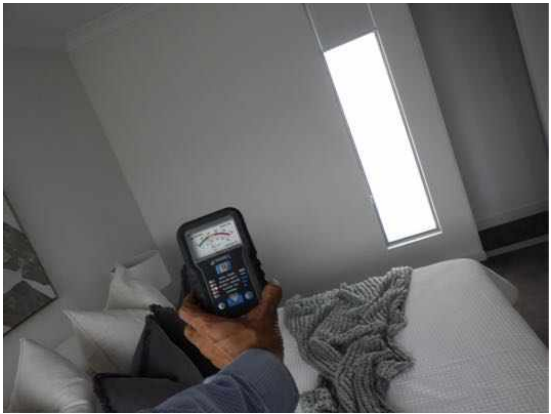
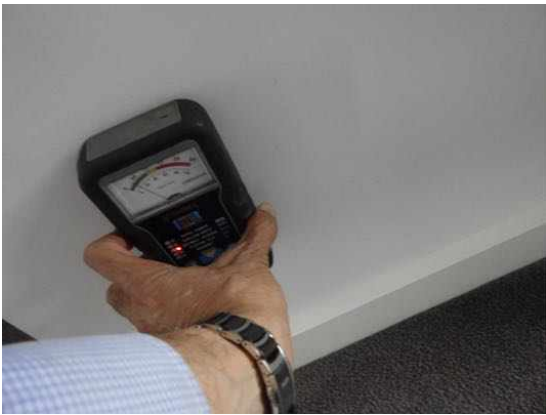
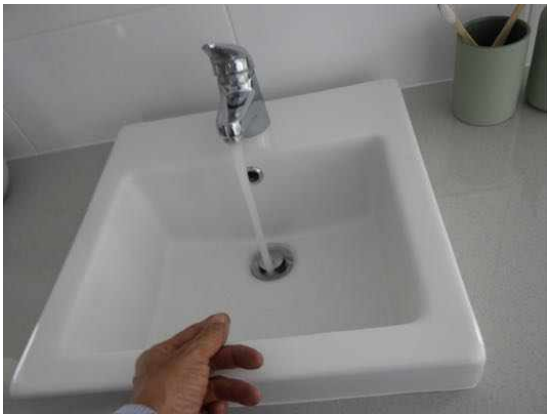
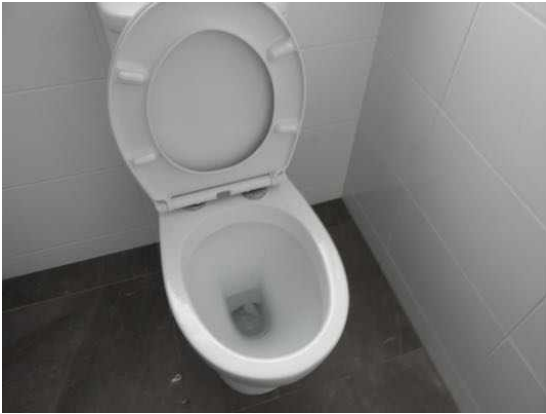
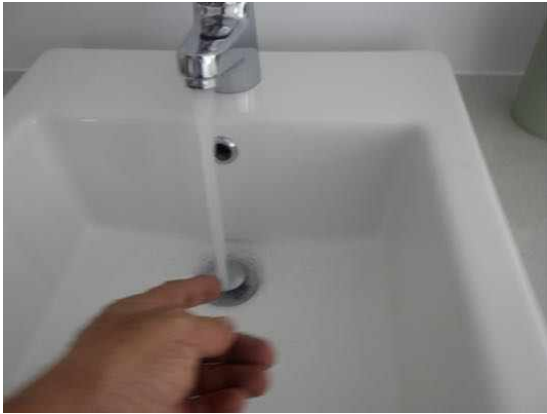
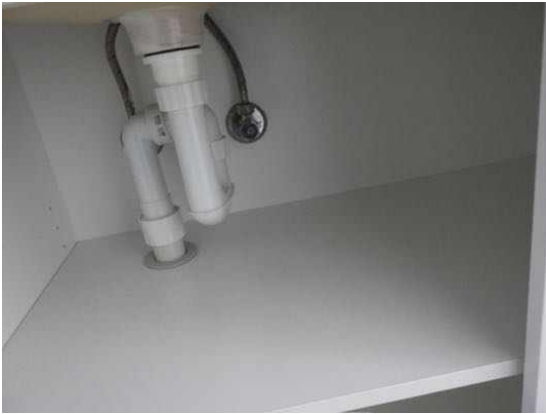
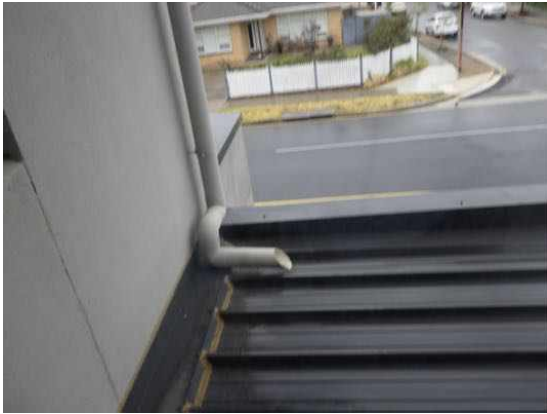
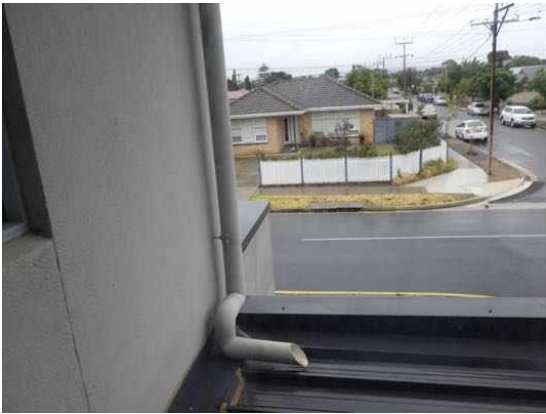
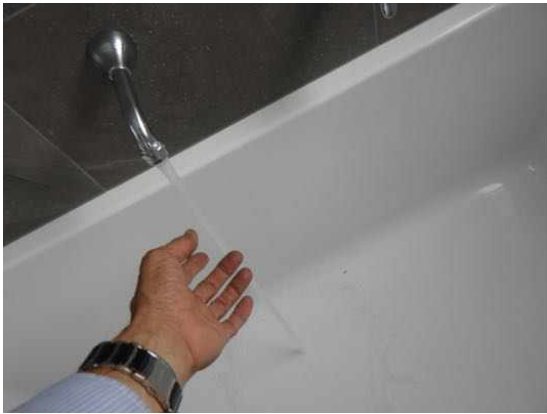
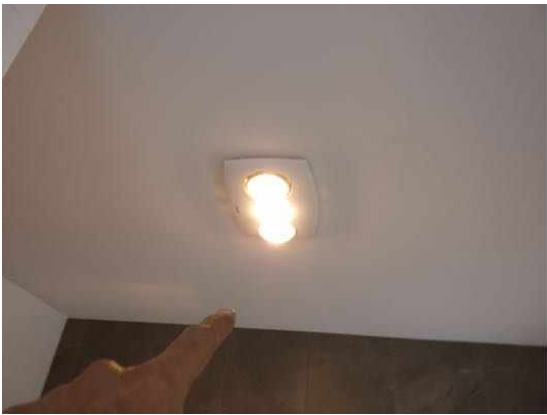
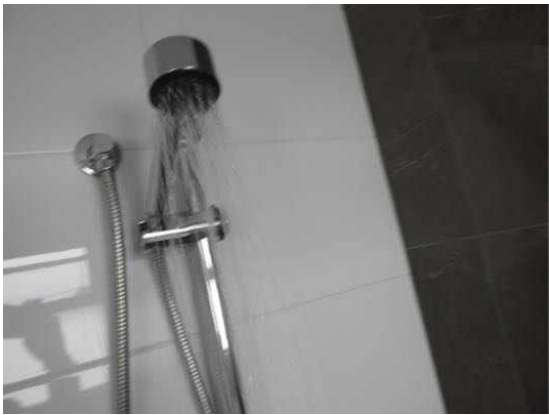
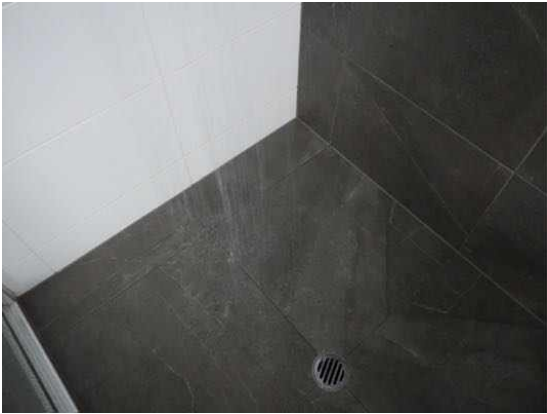
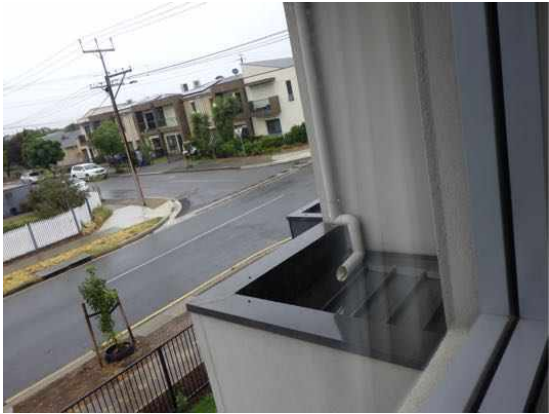
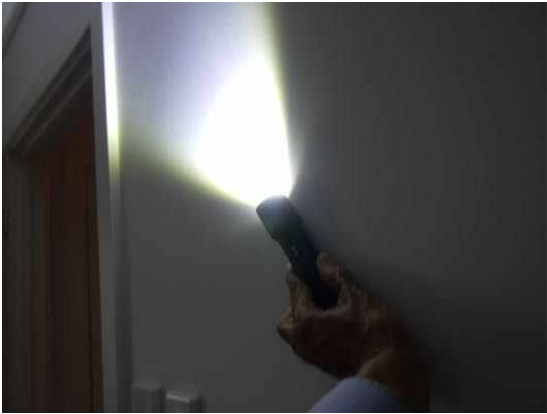
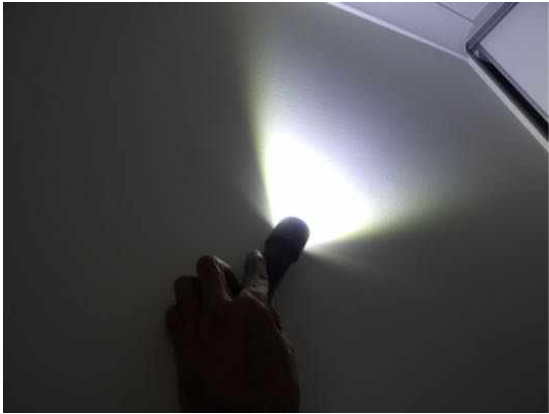
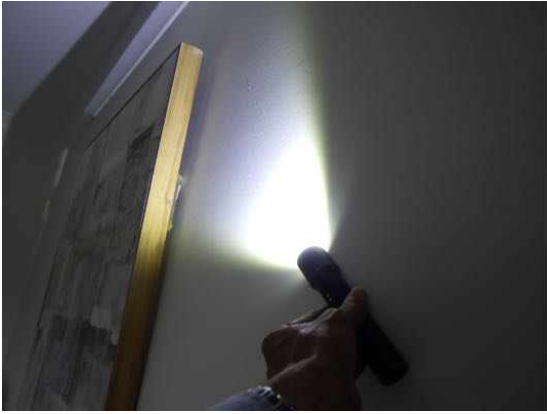
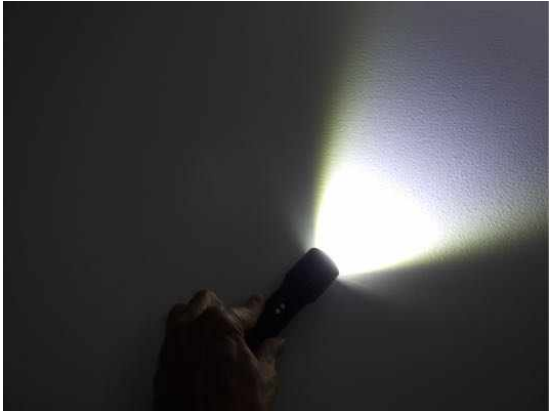
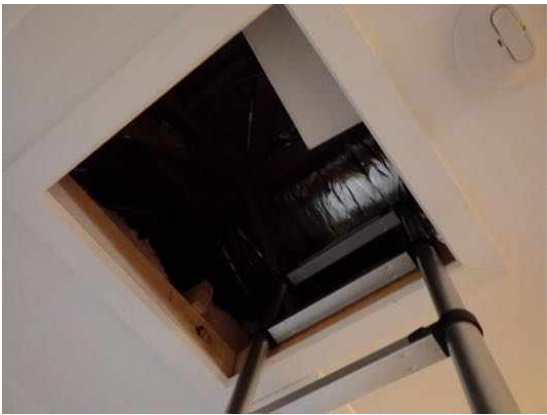
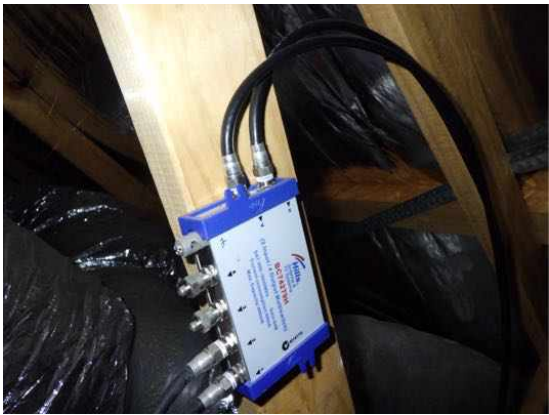
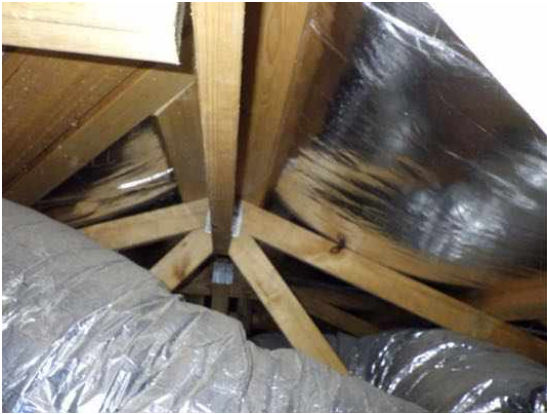
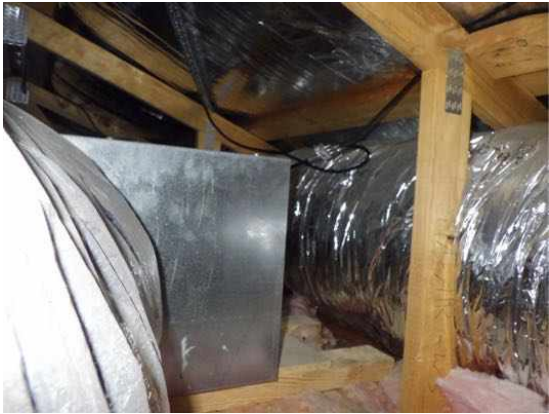
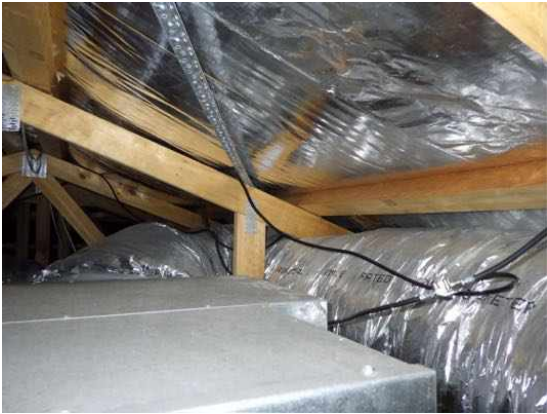
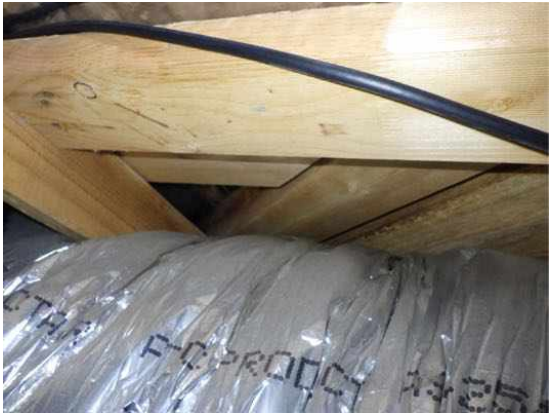
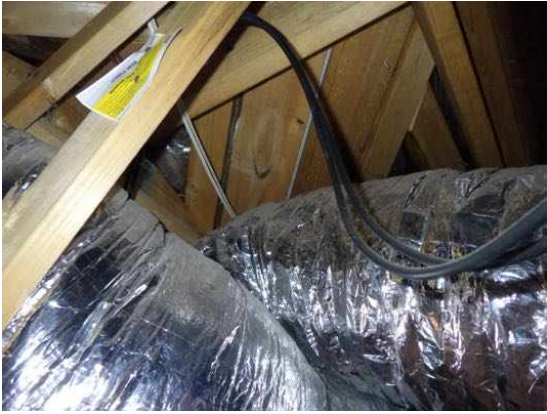
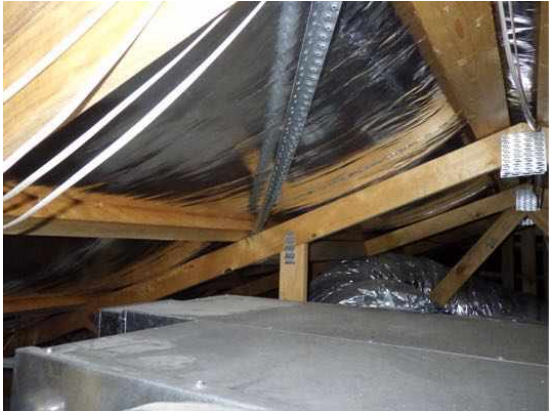
Building: Building 1
 Location: All Areas
 Finding: Additional Photos - Obstructions and Limitations
 Information: These photographs are an indication of the obstructions and limitations which impeded full inspection of the property at the time of inspection. These obstructions can hide an array of defects and should be removed to allow full inspection to be carried out. A re-inspection is recommended once the areas are made accessible.
