Building and Timber Pest Inspection Report VR

Inspection Date: Fri, 27 Mar 2026

Property Address: 2 Kerrani Pl, Coutts Crossing NSW 2460,
Australia

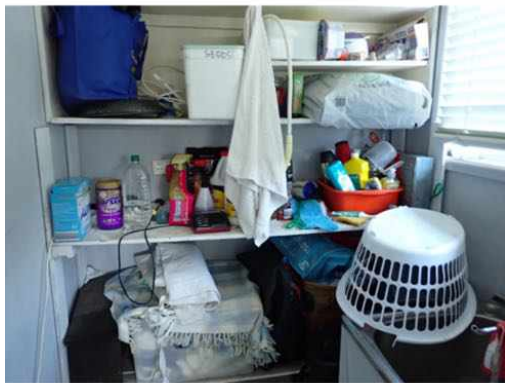
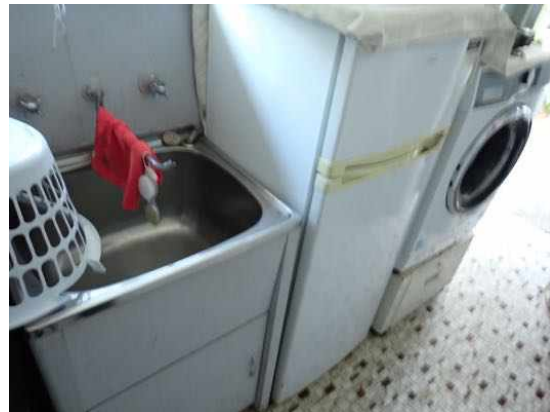
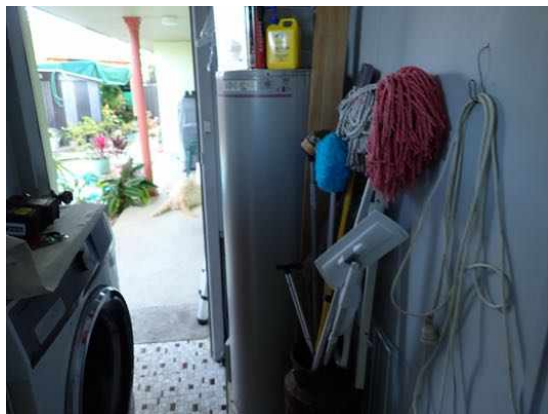
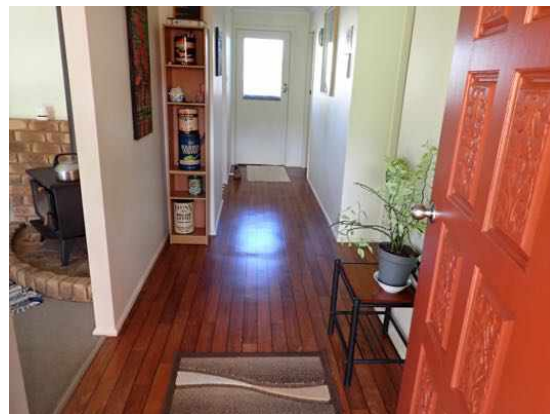
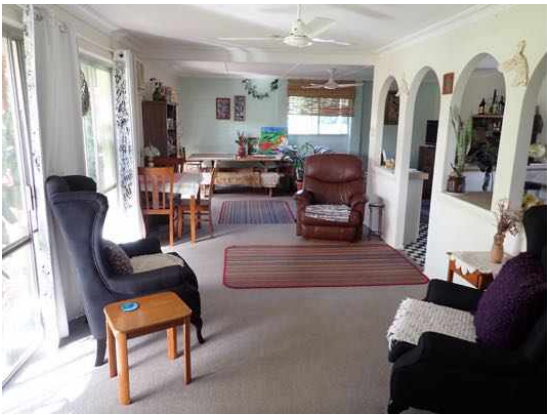
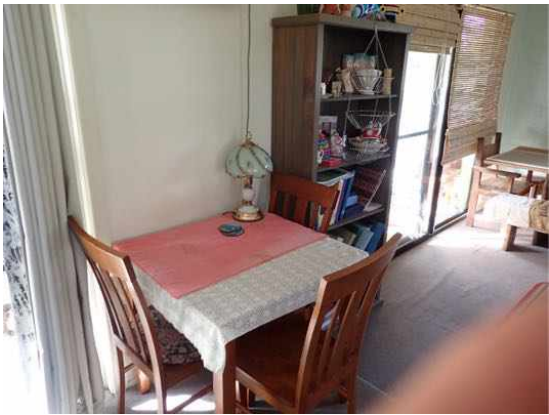
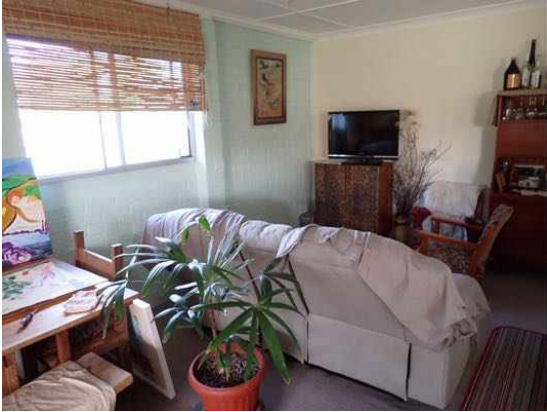
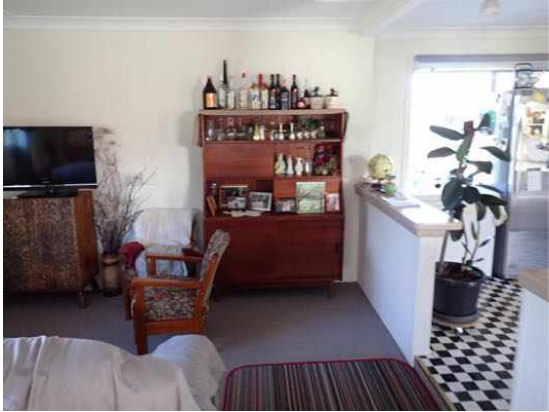
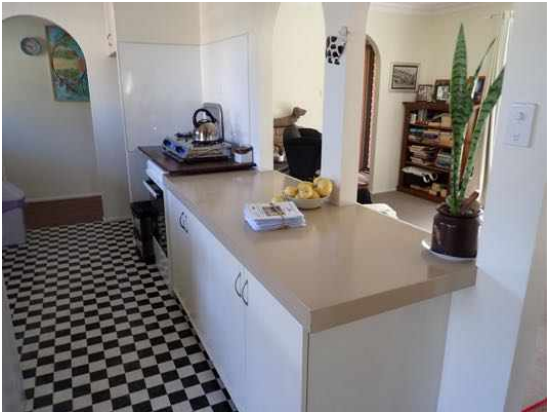
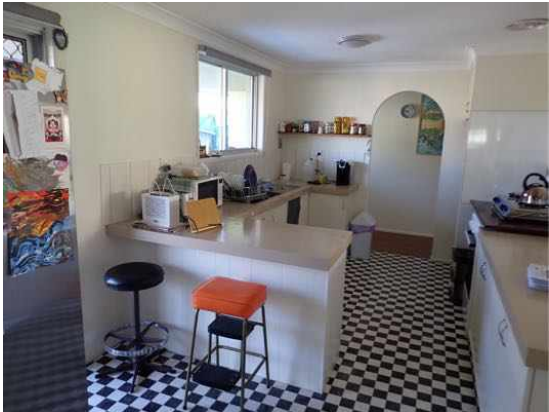
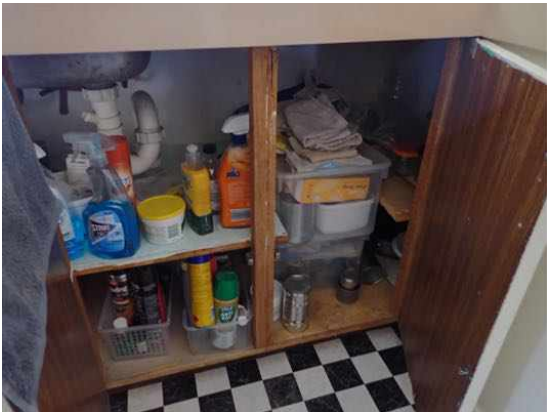
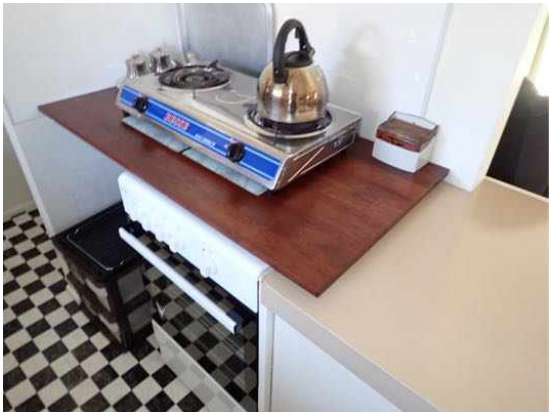
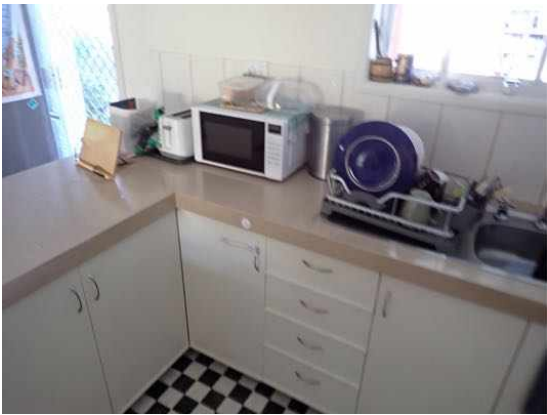
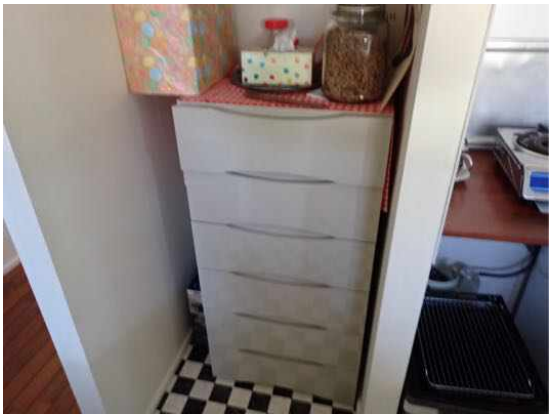
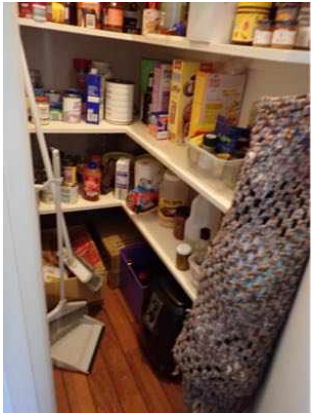
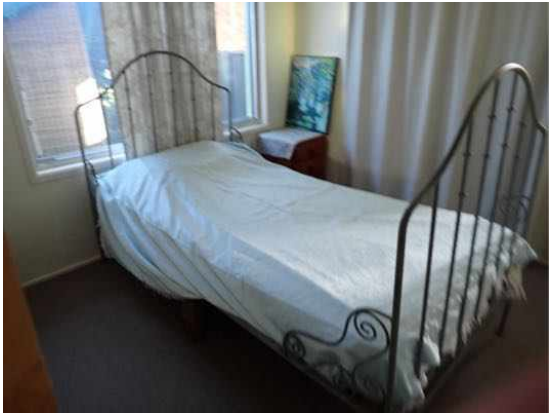
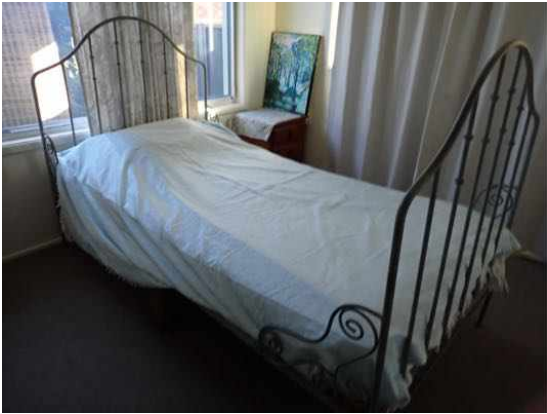
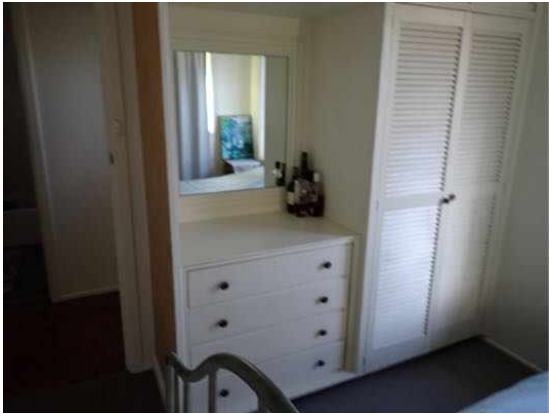
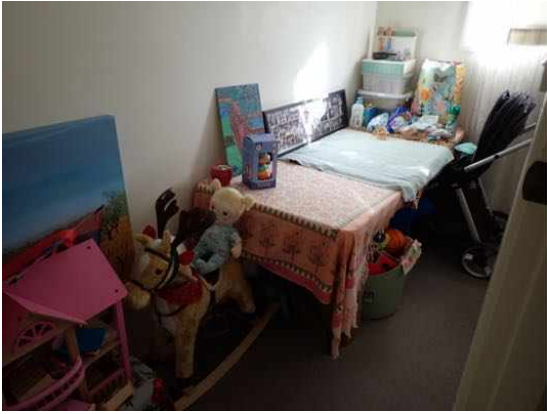
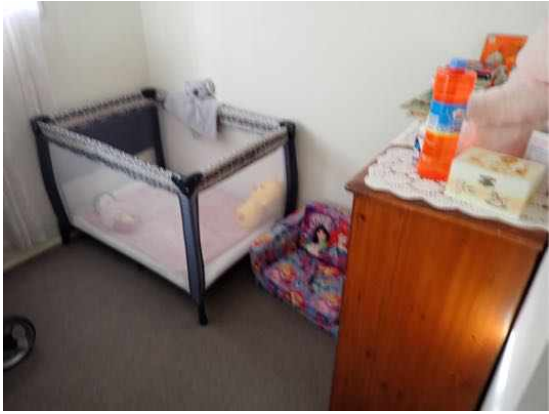
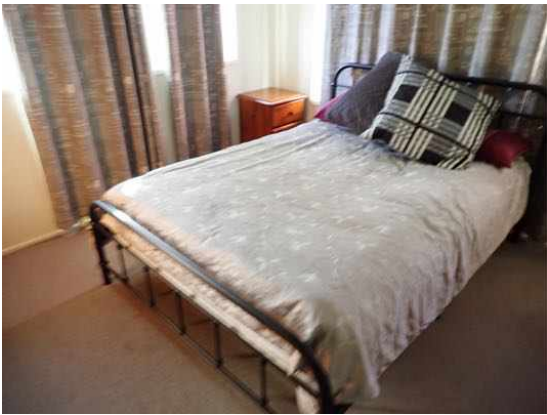
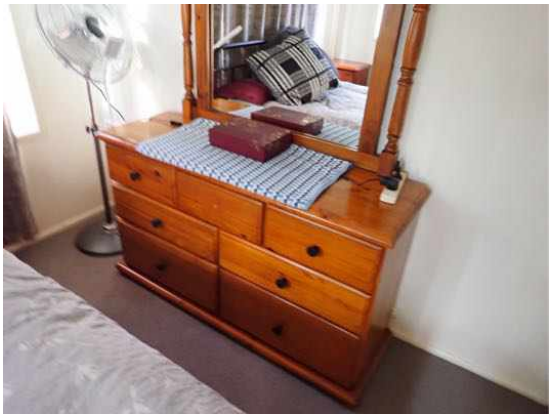
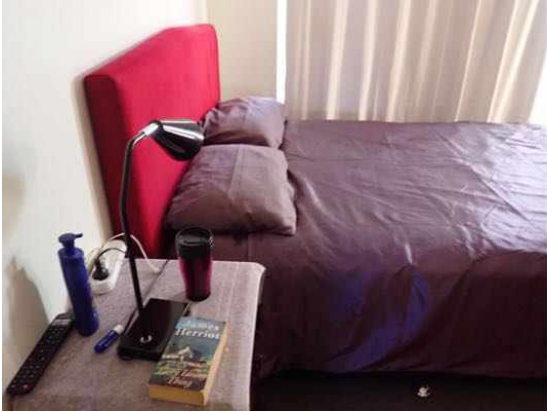
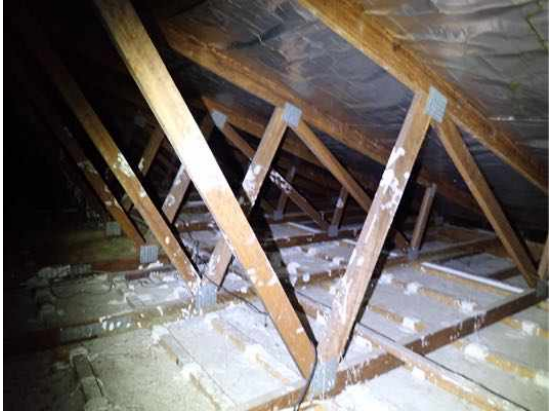
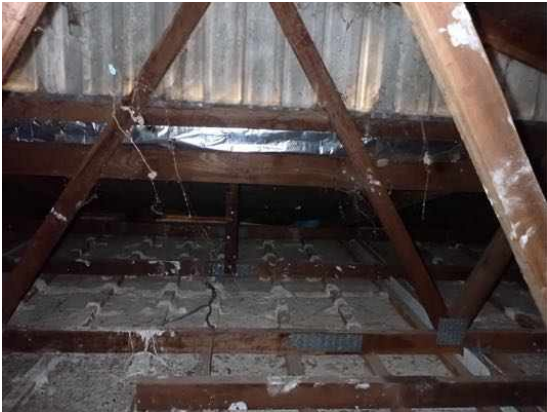
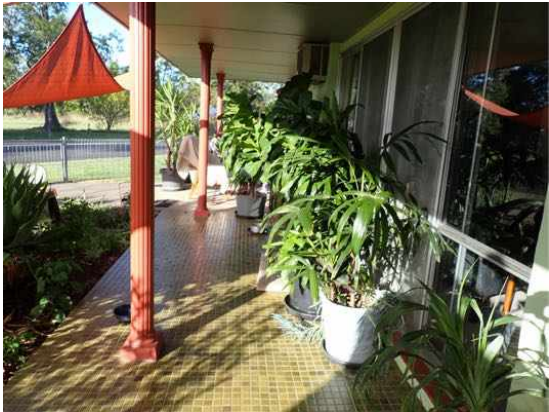
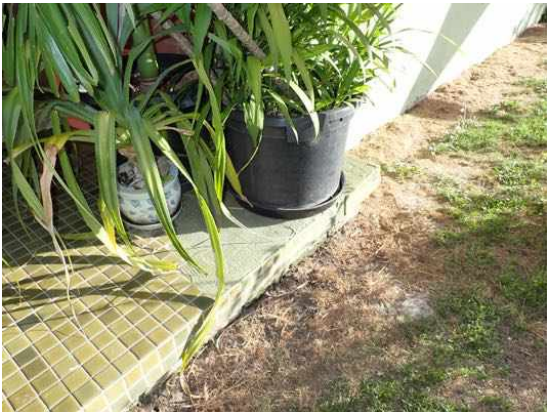
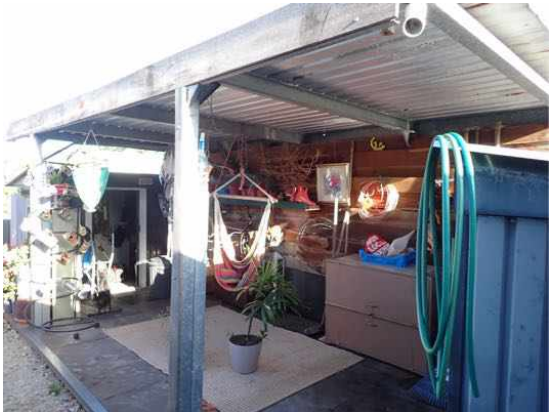
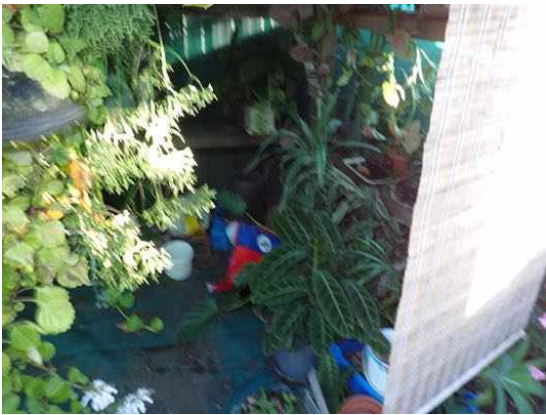
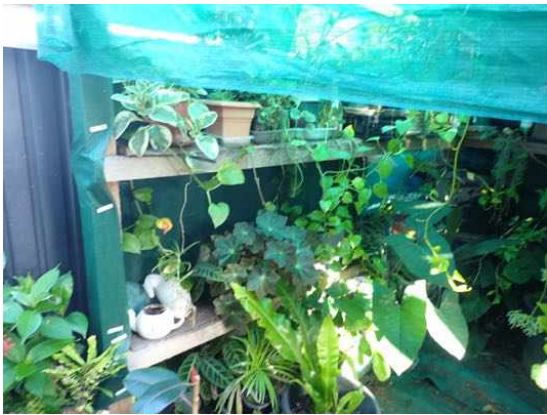
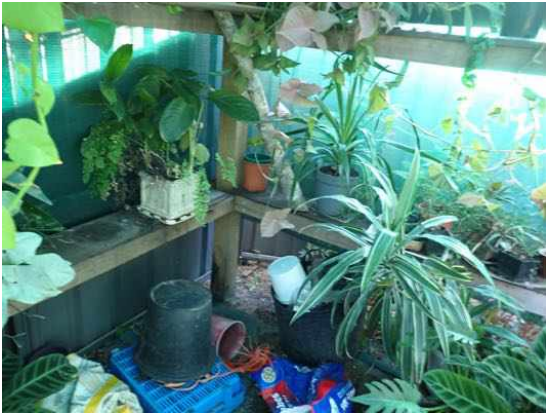
Building: Main Building
Location: All Areas
Finding: Additional Photos - Obstructions and Limitations
Information: These photographs are an indication of the obstructions and limitations which impeded full inspection of the area at the time of inspection. These obstructions can hide an array of defects and should be removed to allow full inspection to be carried out. A re-inspection is recommended once the areas are made accessible.
