Building and Timber Pest Inspection Report

Inspection Date: Wed, 4 Mar 2026

Property Address: 3B George St, Windsor VIC 3181, Australia

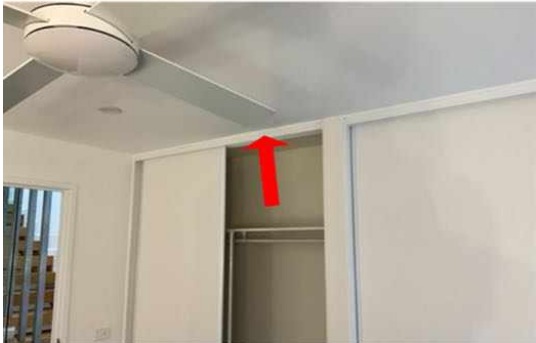
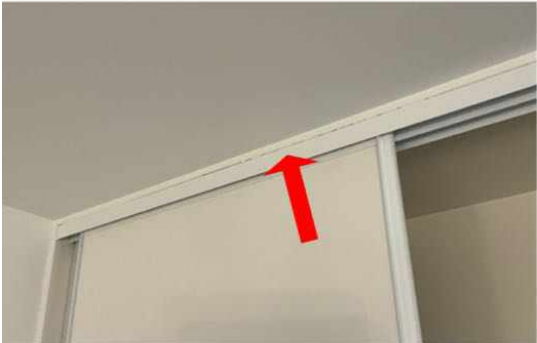
Finding: Cracking - fine

Information: Some fine cracking was noted throughout the property.

Although fine cracks are quite noticeable, they are often only considered to be an appearance defect, and usually do not indicate any structural damage. Generally, the cause of a fine crack is indicative of a separation between building materials and finishes (e.g. paint, plaster, etc.) along joins.

Cracking of this nature can generally be repaired with minor sanding, filling and/or repainting. Such works should be performed by a qualified painter or a general handyman.

Monitoring of all cracking should be conducted frequently. Always contact a building inspector should cracks widen, lengthen, or become more numerous.

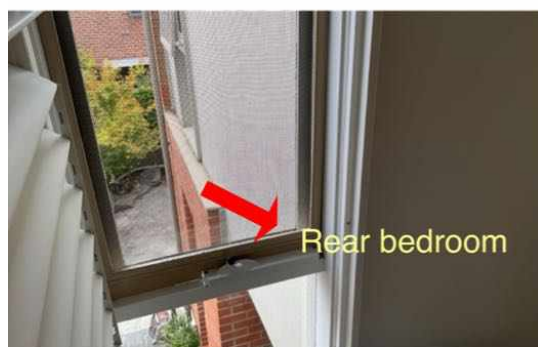
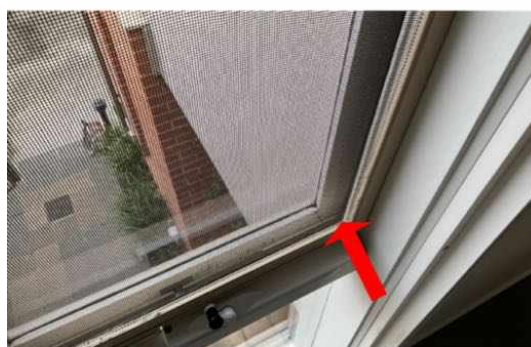
Finding 3.02

Building:
 Location: All Areas
 Finding: Windows - Sticking
 Information: The windows to various areas were sticking and slightly difficult to operate at the time of the inspection. Windows provide ventilation to the adjoining area and should be at a fully operational level to ensure user comfort.

Restricted function of the window may also create potential for secondary defects to the associated building elements, such as damage to the window frames as well as a potential safety hazard if required for emergency egress from the building.

The most usual causes are swelling of timbers due to moisture, bulging or bowing of frames, or general material degeneration. Lack of maintenance can also contribute to the windows sticking.

Easement may be required, which may involve some sanding and repainting. It will almost always include ensuring the areas are cleaned and free of any debris that may be detrimental to their operational state

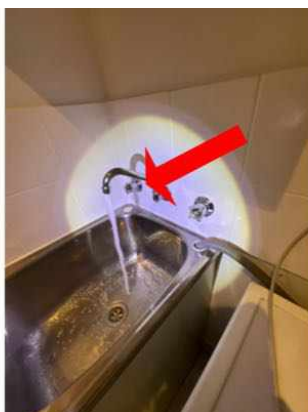
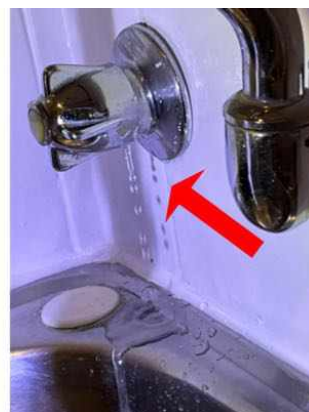
Finding 3.03

Finding: Tap - Leaking

Information: The tap in the laundry was found to be leaking at the time of inspection. This is a common defect that is consistent with general ageing of the building element. However, it may be indicative of substandard plumbing workmanship if the tap is relatively new.

While this defect only seems minor, if left unmanaged, it is likely to result in the development of rust, water damage and/or extensive water usage.

It is advised that a handyman or licensed plumber be appointed to perform remedial works on the affected tap. Such works should be performed prior to the development of secondary defects to ensure adequate functionality of all associated building elements.

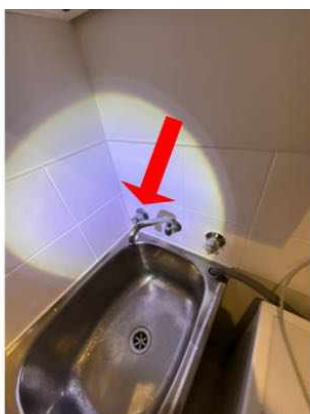
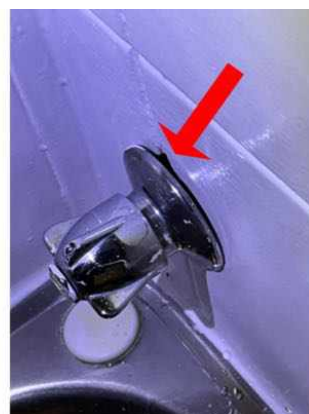
Finding 3.04

Information: At the time of inspection, a gap was noted around the tap of the laundry. This gap may lead to water ingress behind the tiles which in turn can lead to secondary damage to other building materials.

All tap hardware and connections should be tightly fixed and sealed to prevent moisture ingress.

A licensed plumber should be engaged to remove the tap and seal and refit in the appropriate manner.

This should be carried out as a matter of urgency. Failure to do so may result in further damage.

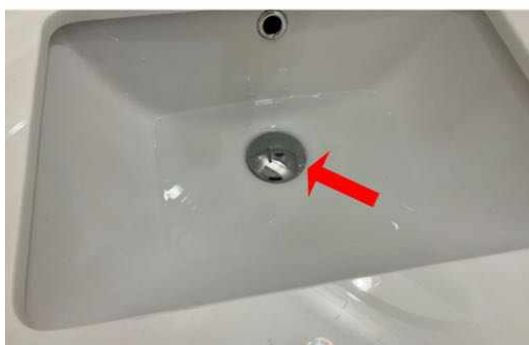
Finding 3.08

Finding: Bathroom vanity pipes - Leaking

Information: The pipe underneath the bathroom vanity sink was found to be leaking at the time of inspection. This is a common defect that is consistent with general ageing of the building element. However, it may also be indicative of substandard plumbing workmanship.

While this defect only seems minor, if left unmanaged, it is likely to result in the

development of water damage.

It is advised that a licensed plumber be appointed to perform remedial works on the area. Such works should be performed prior to the development of secondary defects to other associated building elements.

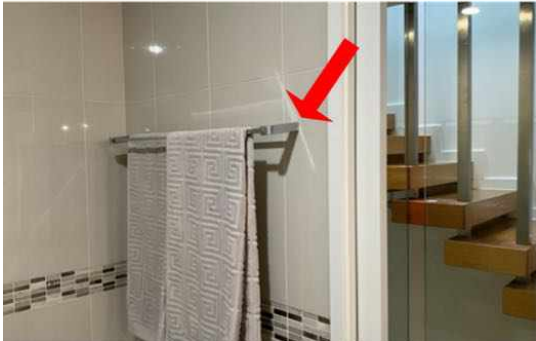
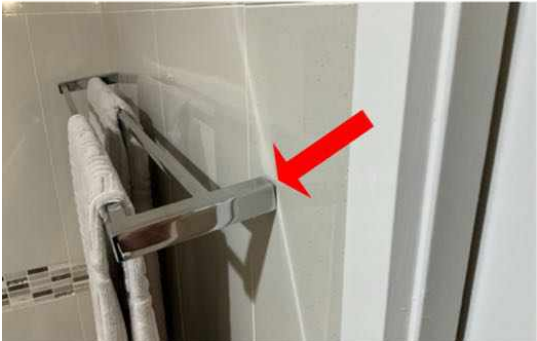
Finding 3.10

Building:
Location: Bathroom
Finding: Towel rail loose
Information: At the time of inspection , the towel rail to the main bathroom was loose and requires tightening.

This may be undertaken by a competent handyman.

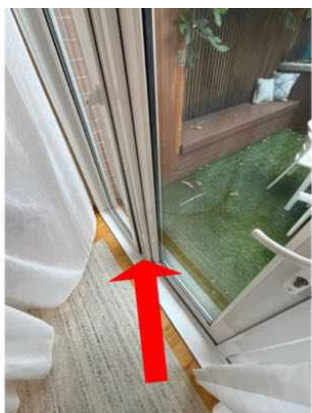
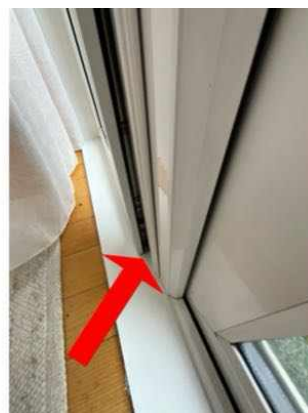
If left, the gap to the door may allow moisture to enter the property..

It is recommended that a door or window specialist be engaged to inspect the door and make the necessary repairs where necessary.

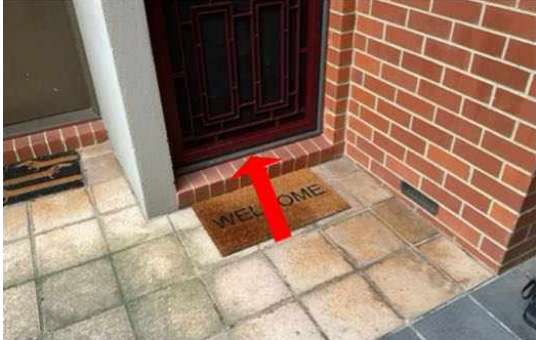
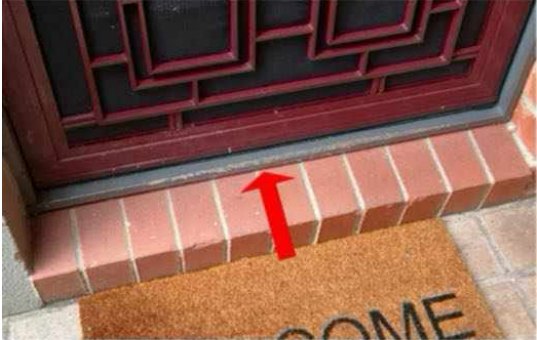
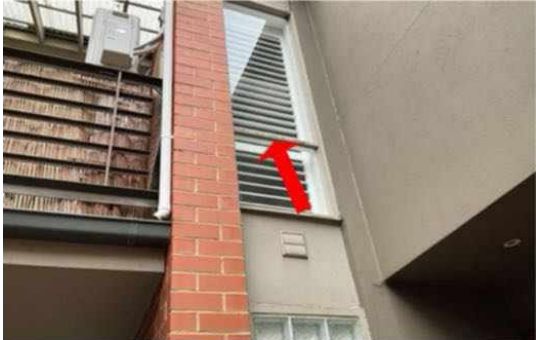
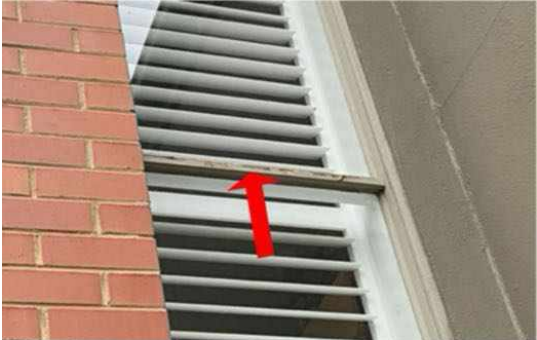
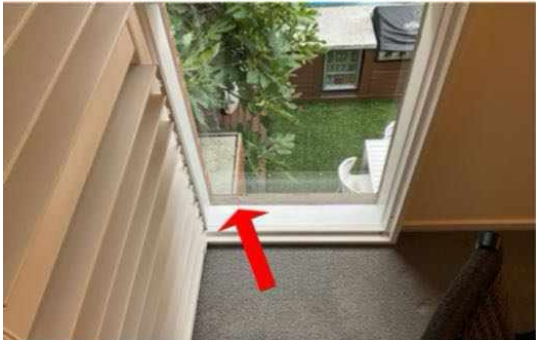
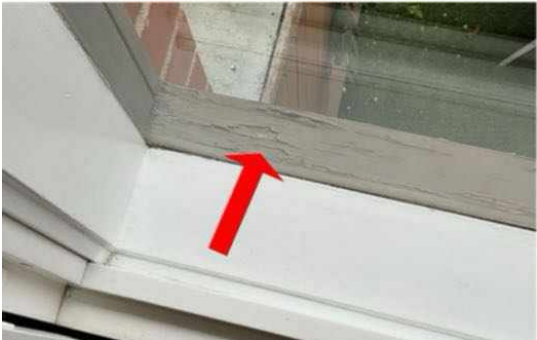
Finding 3.14

Building:
 Location: All External Areas
 Finding: Timber - exposed to weather
 Information: External timbers that are frequently exposed to harsh weather conditions require adequate protection in order to maintain their condition. Where timbers have not been painted or treated adequately, general deterioration is likely to occur at an accelerated rate.

Please note: other timbers around the property may be weathering slightly but not showing here

Adequate treatment of these timbers is required as soon as possible by a painting contractor or general handyman.

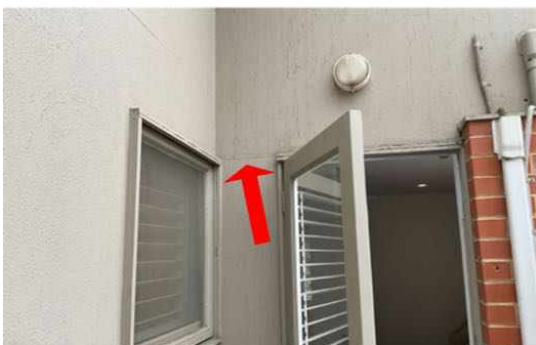
Finding 3.16

Building:
 Location: Exterior walls - left side
 Finding: Window - Wood rot
 Information: Wood rot was found to be affecting this external window. Wood rot, also known as Fungal Decay, occurs when timbers and other cellulose building materials are exposed to damp conditions on an ongoing basis.

It is likely that this wood rot has developed as a result of frequent exposure to rain and other weather conditions. It is suspected that failure to maintain the window frame over a prolonged period has resulted in it deteriorating at an accelerated rate, increasing its susceptibility to the development of wood rot.

Repair of the affected window frame will be necessary to prevent further deterioration.

Remedial works should be performed by a qualified carpenter or registered builder as soon as possible.

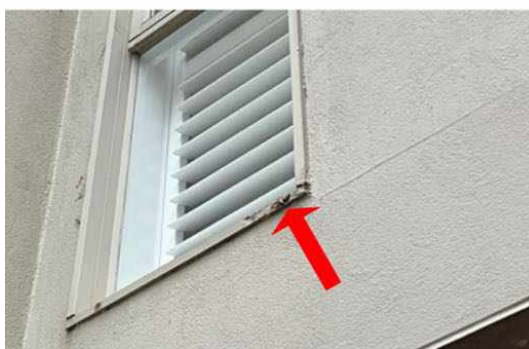
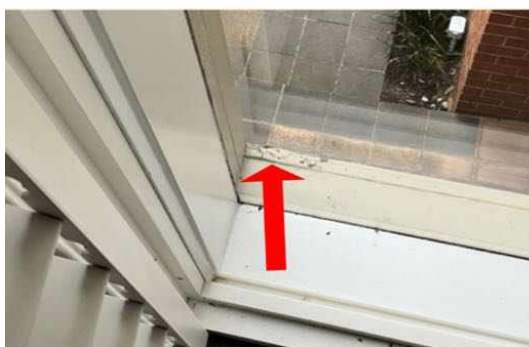
Finding 3.17

Building:
 Location: Exterior walls - left side

Finding: Wood rot to framing timbers of the balcony covered area
Information: The timber framing of the covered area above the balcony shows evidence of wood rot. It is suspected that constant exposure to moisture may have caused the wood rot in the area.

Wood rot, also known as Fungal Decay, occurs when timbers and other cellulose building materials are exposed to damp conditions on an ongoing basis. This could be the result of exposure to weathering over a prolonged period of time, or the attraction of excessive moisture from other abutting building materials.

A qualified plumber may be appointed to assess the cause of excessive moisture and to provide advice on any remedial works as required. A qualified carpenter or registered builder may be engaged to replace affected building materials where necessary.

Failure to act on this defect may result in further deterioration and more significant damage.

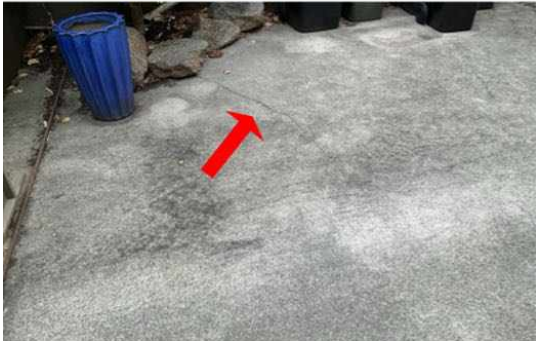
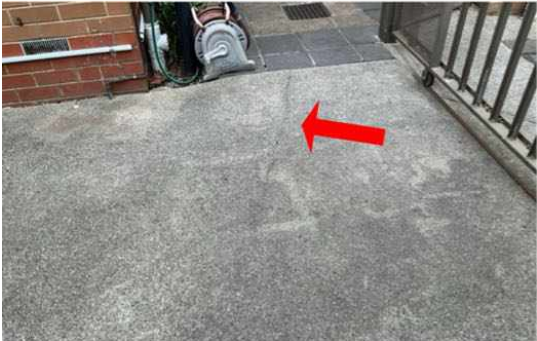
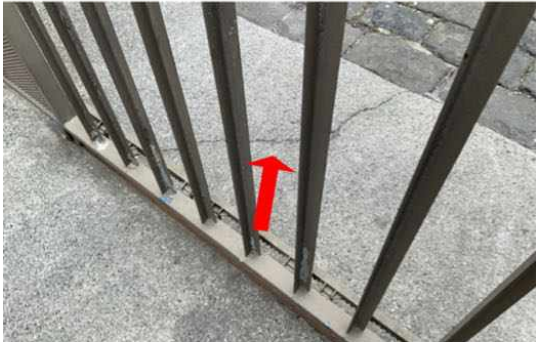
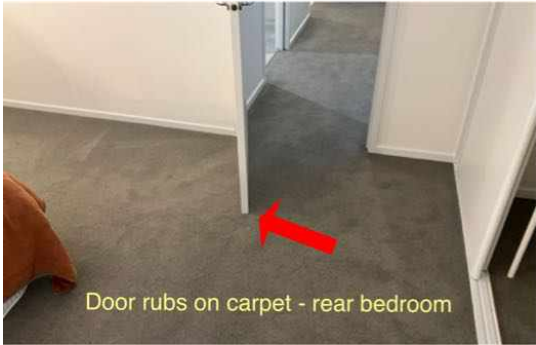
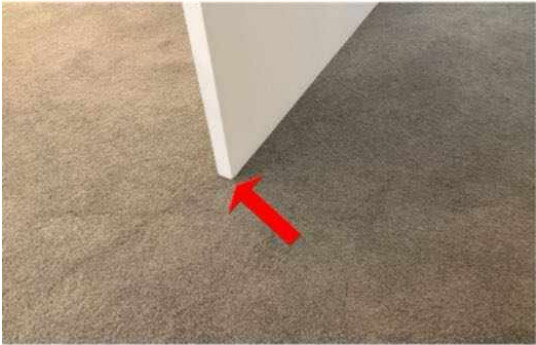
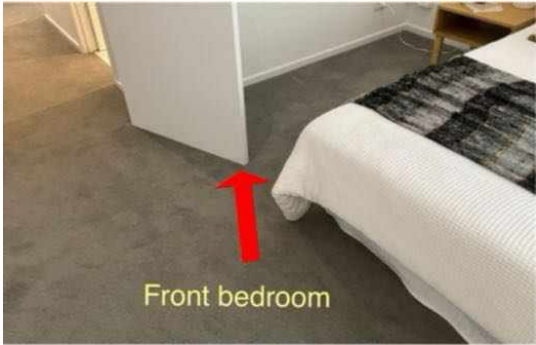
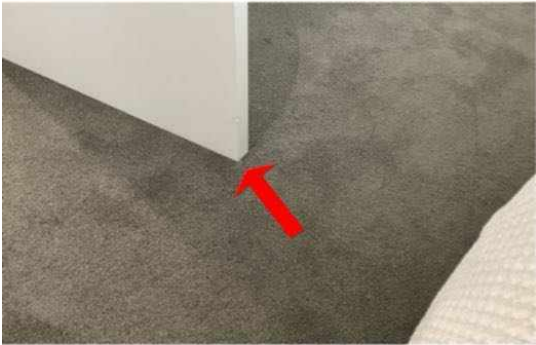
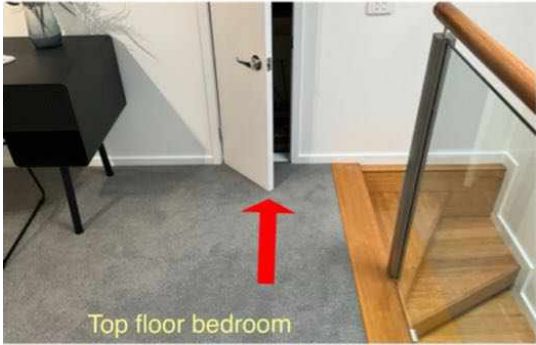
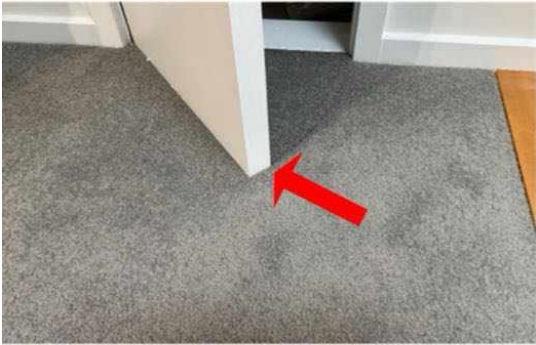
Finding 3.20

Building:
Location: All Areas
Finding: Additional Photos - minor defects
Information: Additional photos are provided for your general reference. Arrows have been included where necessary to highlight areas of importance.

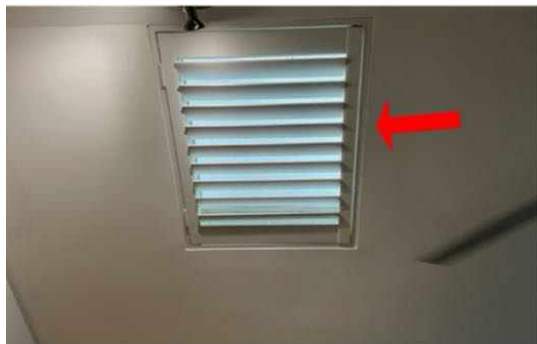
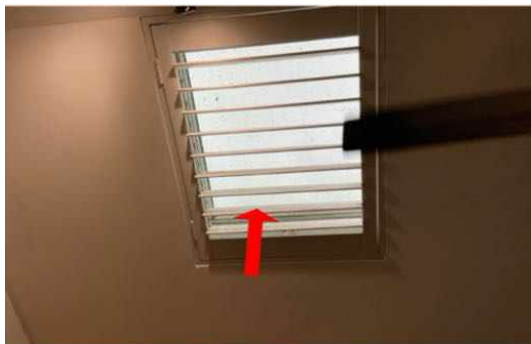
Noted Item

Building:
Location: All Areas
Finding: Additional Photos - for your information
Information: Additional photos are provided for your general reference.

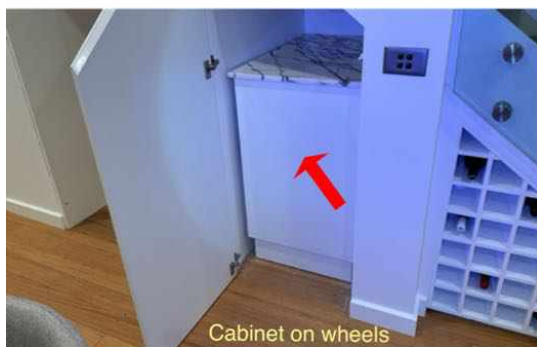
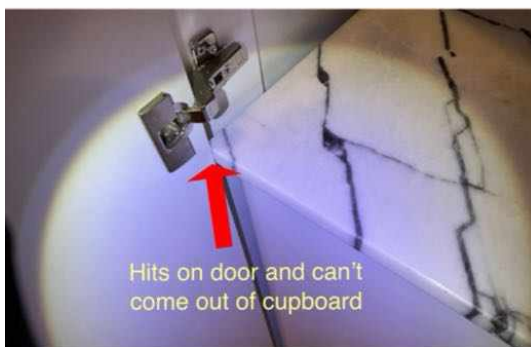
Noted Item

Building:
Location: All Areas
Finding: Additional Photos - Obstructions and Limitations
Information: These photographs are an indication of the obstructions and limitations which impeded full inspection of the property at the time of inspection. These obstructions can hide an array of defects and should be removed to allow full inspection to be carried out. A re-inspection is recommended once the areas are made accessible.
