# Building and Timber Pest Inspection Report VR

Inspection Date: Fri, 20 Feb 2026

Property Address: 4 Mason St, Thirroul NSW 2515, Australia

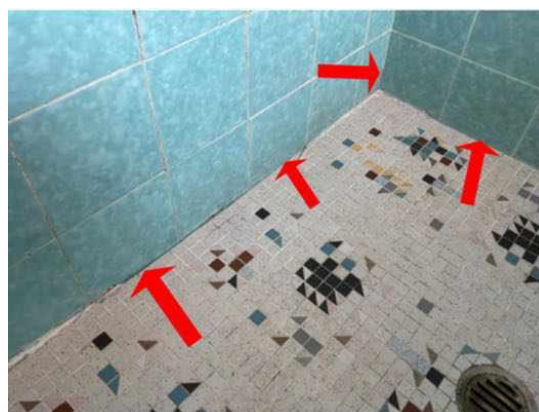
Building: Main Building  
Location: All Wet Areas  
Finding: Sealant and grouting - Missing or damaged  
Information: It was noted on inspection that sealant or grout is degraded to the tiled shower alcove and or other areas of the bathroom.

There appears to be excessive mould to the sealant and grout which will likely require scraping out and replacement.

A sealant specialist or tiling contractor should be appointed to complete these works as soon as possible

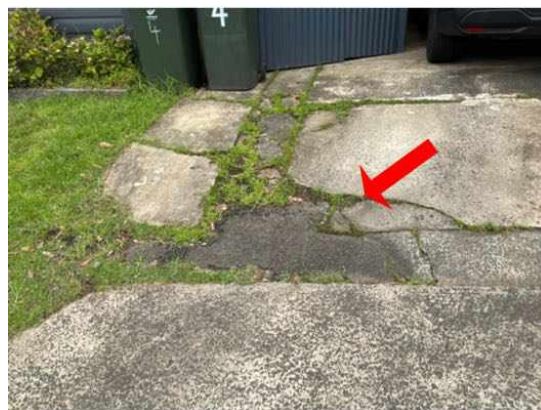
## Finding 2.02

Building:	Main Building
Location:	Driveway
Finding:	Cracking - External Concrete Paving Damage Category 4 - Gaps in Slab (4mm - 10mm +)
Information:	Gaps in the slab were identified in external concrete paving. Gaps in the slab are significant and are likely to lead to the development of safety hazards and secondary defects if left unmanaged, such as the creation of a trip hazard.

Cracking to this degree may also be due to poor original installation of the concrete. Factors such as poor compaction of the sub surface and/or inadequate reinforcing of the slab may create cracking and other secondary defects. Gaps in the concrete paving may also have a more significant structural cause, such as subsidence of soils.

Where gaps in the concrete paving are adjacent to structural elements of the building, the advice of a Structural Engineer is advisable before undertaking repairs. Significant repair and likely replacement of the concrete paving is probable.

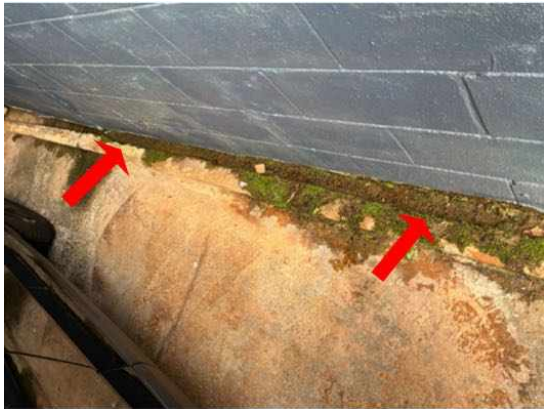
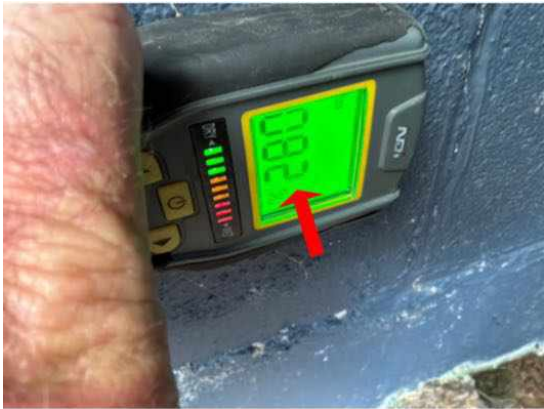
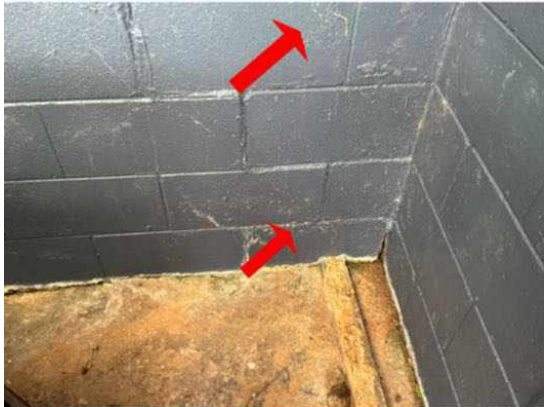
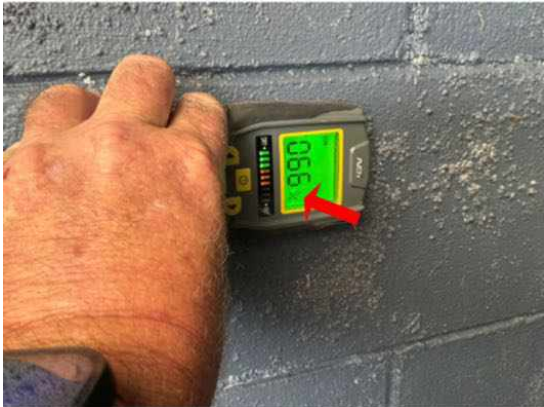
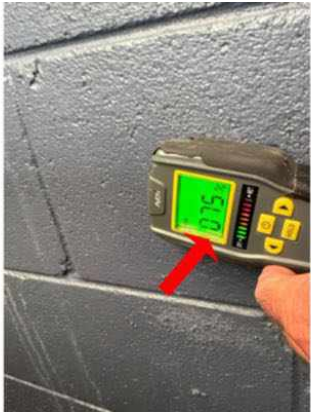
### Finding 2.03

Building:	Carport
Location:	Yard - Front
Finding:	Evidence of excessive moisture was present at the time of inspection
Information:	Excessive moisture can attract termites and produce conditions that promote termite attack, fungal growth and wood decay. Excessive moisture is generally caused by deteriorated, inadequate or missing roof drainage, leaking plumbing pipes or fixtures, poorly plumbed HWS overflows or condenser units and poor site drainage. In the case of excessive moisture being present around wet areas it is highly likely that the waterproofing membrane to these areas is or has failed and allowing water to escape the confines of these areas.

It is highly recommended that all plumbing and drainage fixtures and fittings be maintained regularly in order to prevent excessive moisture being present in the external / internal property.

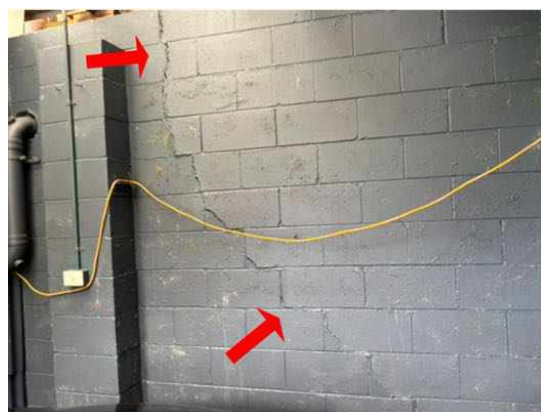
**Finding 2.04**

Finding: Blockwork - Step cracking

Information: Step cracking was identified to the blockwork in this area at the time of inspection. Step cracking, which is similar to other forms of cracking, has a variety of possible causes. However, the most common is the subsidence of adjacent footings.

Where step cracking is extensive or severe, the client is advised to consult a structural engineer. Minor step cracking can be used as a warning sign to address factors causing stress to the wall, which can include the effect of surrounding trees, water leaks, soil erosion, or even the presence of reactive soils in the surrounding area.

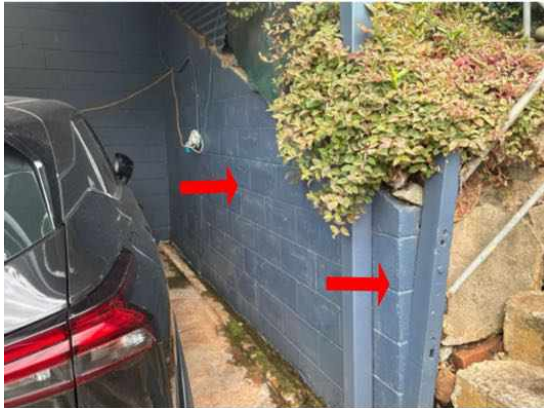
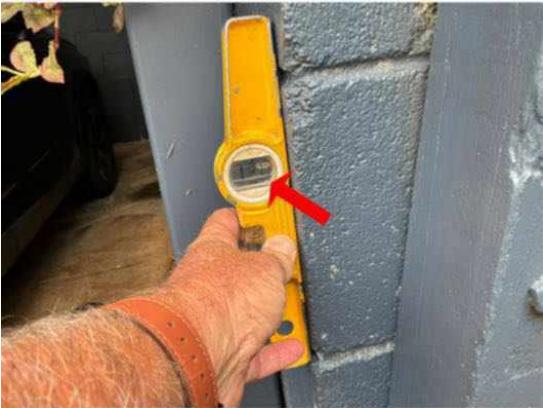
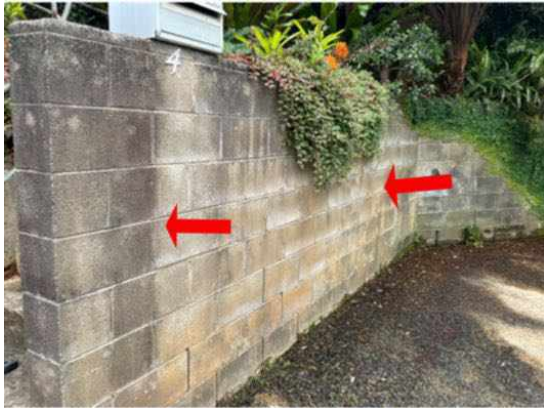
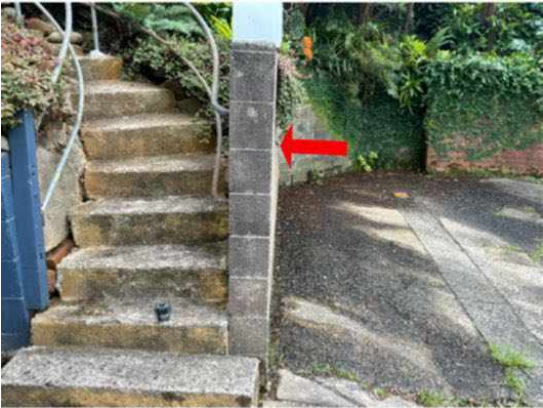
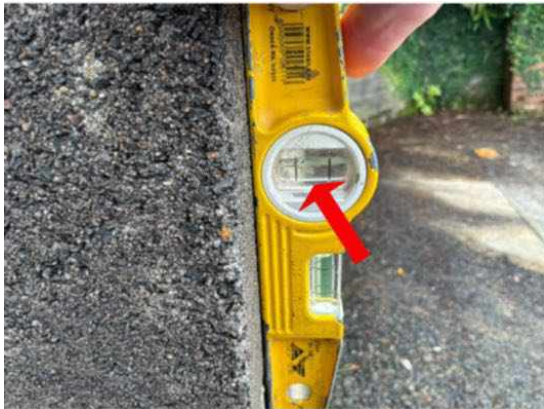
### Finding 2.05

Building:	Carport
Location:	
Finding:	Retaining wall - Defective
Information:	The retaining wall in this area was found to be defective at the time of inspection. Generally, defective retaining walls are caused by poor original design or material use. However, deteriorated retaining walls may also be a result of substandard construction, poor site drainage or unmanaged stormwater flows.

Significant repair and replacement should be expected. Where retaining walls are considered structural walls, a structural engineer / surveyor should be consulted regarding required remedial works. Otherwise, a landscaper or retaining wall installer may be appointed to repair or replace the wall, at the discretion of the client.

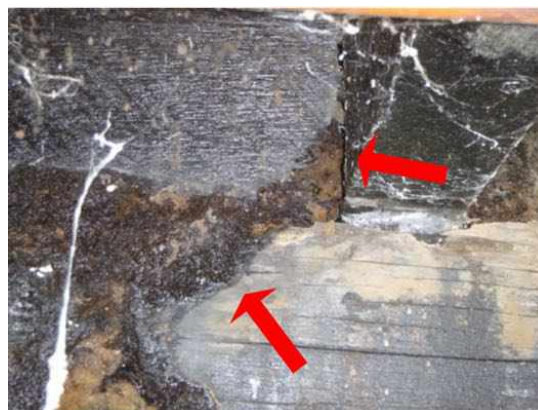
**Finding 2.06**

Building: Main Building  
Location: Subfloor  
Finding: Water Leak Detected to Subfloor Below Bathroom/Shower Area  
Information:

At the time of inspection of the subfloor area, evidence of active water leakage was observed beneath the bathroom shower area. Moisture was present to the subfloor framing and surrounding areas, indicating that water is escaping from the bathroom and entering the subfloor space.

This condition may indicate failure of the shower waterproofing system, leaking plumbing components, or defective seals and does not comply with the performance requirements of the National Construction Code (NCC) and AS 3740 – Waterproofing of Domestic Wet Areas, which require wet area installations to prevent the penetration of water into concealed building elements.

It is recommended that a suitably qualified and licensed plumber and/or waterproofing specialist carry out further investigation to determine the exact source of the leak. Rectification works should be undertaken as required to eliminate the source of moisture and prevent further water ingress. Any moisture-affected structural elements should also be assessed and repaired or replaced as necessary to ensure compliance with NCC requirements and relevant Australian Standards.

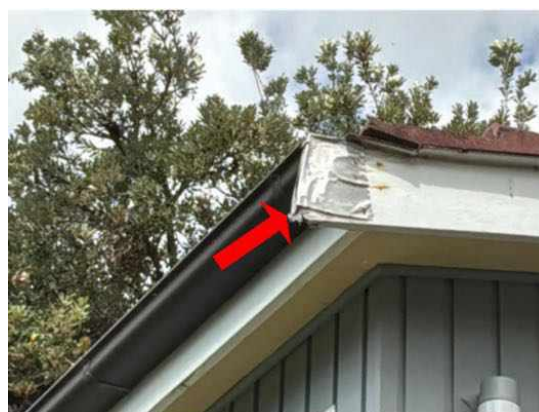
### Finding 3.01

Building:	Main Building
Location:	Exterior walls - front
Finding:	Wood rot
Information:	This building element shows evidence of wood rot. Wood rot, also known as Fungal Decay, occurs when timbers and other cellulose building materials are exposed to damp conditions on an ongoing basis. This could be the result of exposure to weathering over a prolonged period of time, or the attraction of excessive moisture from other abutting building materials. Contributing factors also include poor air ventilation in the area.

A qualified plumber may be appointed to assess the cause of excessive moisture and to provide advice on any remedial works as required. A qualified carpenter or registered builder may also be required to replace affected building materials.

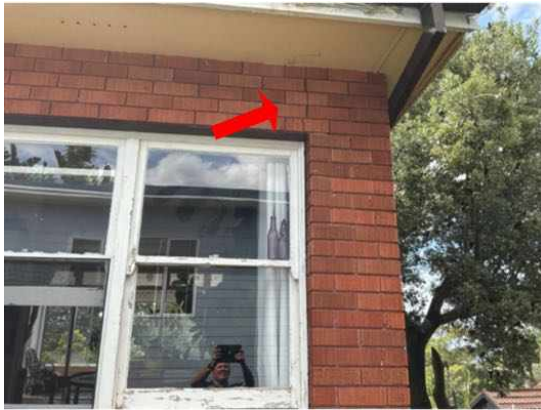
### Finding 3.02

Building:	Main Building
Location:	Exterior walls - rear
Finding:	Brickwork - Cracking noticeable
Information:	There were several cracks and or crack repairs evident to external brickwork.

It is highly advised that a qualified bricklayer be appointed to provide necessary works to cracked brickwork to prevent any further damage. Such works should be conducted as soon as possible.

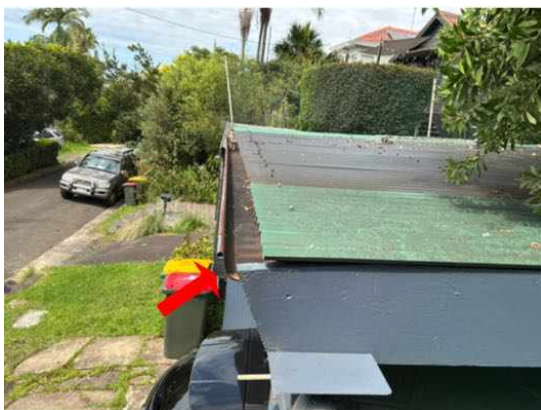
### Finding 3.03

Finding: Gutters Installation incomplete. ( Stop Ends Missing)

Information: It was noted at the time of inspection that the stop ends to the gutter was missing, this allows the water to discharge without being directed into the stormwater drainage system as required.

A licensed Roof Plumber or Builder should be appointed to perform minor rectifications work at the clients discretion.

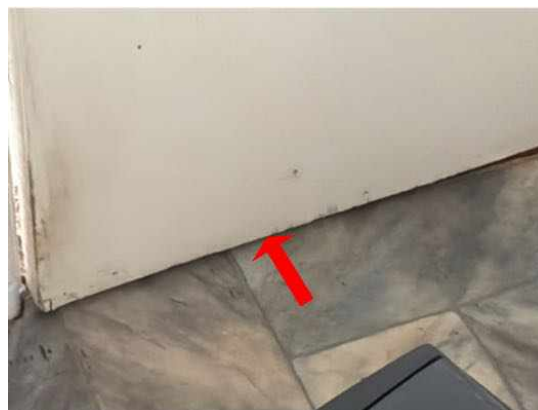
### Finding 3.04

Building:	Main Building
Location:	Kitchen
Finding:	Door - Binding/jamming
Information:	Binding and/or jamming of this door is evident during standard operation. This defect inhibits the functionality of the affected door as well as creating potential for secondary defects to associated building elements, such as damage to the floor covering.

For minor causes, a qualified carpenter or general handyman should be appointed to perform minor rectification works at client discretion.

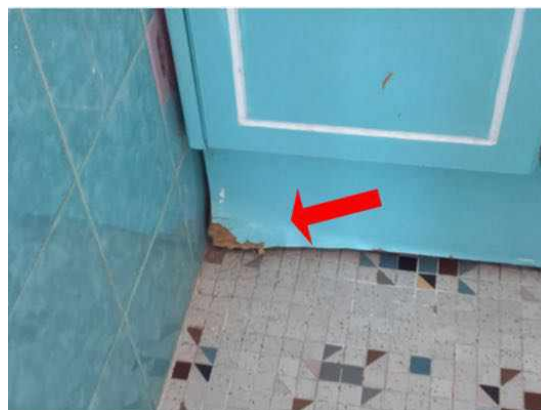
### Finding 3.05

Building:	Main Building
Location:	Bathroom
Finding:	Vanity Cabinet base - Damaged
Information:	Damage occurs generally when the building materials have either aged and decayed, or as a result of damage (accidental or deliberate).

A relevant tradesperson should be appointed to repair or replace the affected building element prior to any subsequent damage being caused.

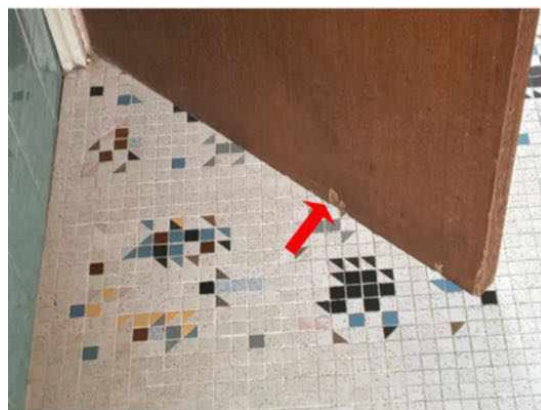
### Finding 3.06

Building:	Main Building
Location:	Bathroom
Finding:	Door - Binding/jamming
Information:	Binding and/or jamming of this door is evident during standard operation. This defect inhibits the functionality of the affected door as well as creating potential for secondary defects to associated building elements, such as damage to the floor covering.

For minor causes, a qualified carpenter or general handyperson should be appointed to perform minor rectification works at client discretion.

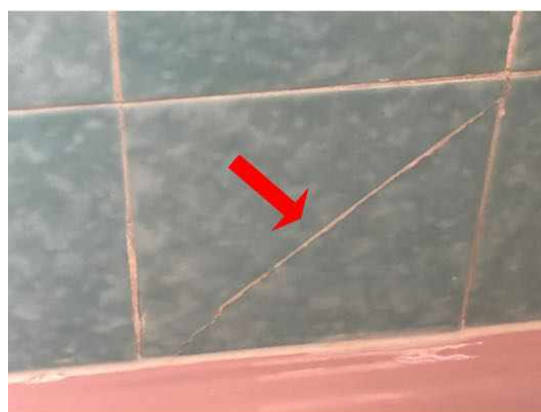
### Finding 3.07

Finding: Cracked tiles

Information: Cracking in the tiles was evident in this area at the time of inspection. It is suspected that this cracking has occurred as a result of minor settlement or shrinkage of the substrate.

While not considered a matter of urgency, replacement of cracked tiles is recommended at the clients discretion. A tiling contractor may be appointed to perform these works. Where cracks become more numerous, contact a licensed building inspector for further investigation.

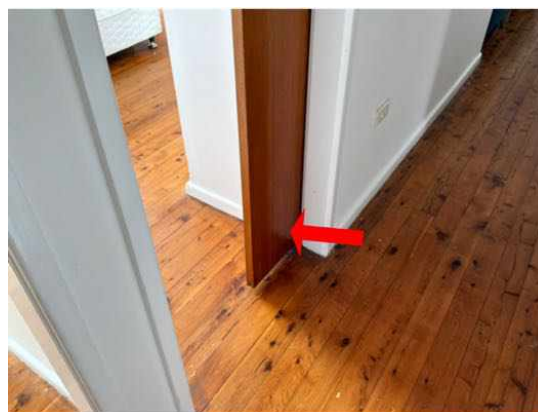
Building:	Main Building
Location:	Bedroom 2
Finding:	Door Binding
Information:	Front door is binding on the door frame at the top right hand side when viewed from internal. Carpenter need to return to ease door from binding and then restrain the

appropriate section to an acceptable finish.

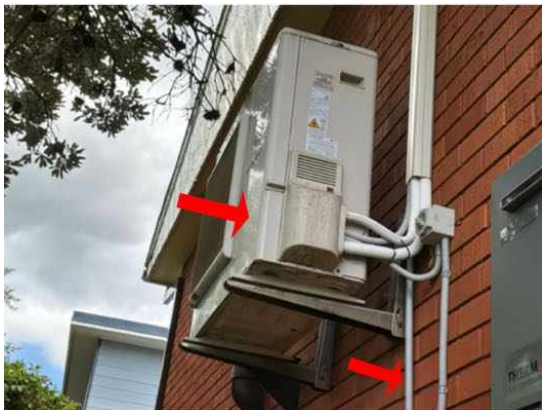
### Finding 6.02

Building:	Main Building
Location:	Exterior wall
Finding:	HWS Overflow - Not Connected
Information:	The Hot Water System (HWS) overflow was found to be disconnected from storm water drainage and is creating excessive moisture in the surrounding area.

It is highly recommended that a licensed plumber be appointed to connect the A/C overflow in order to prevent such an environment from being created. These minor works should be carried out as soon as possible.

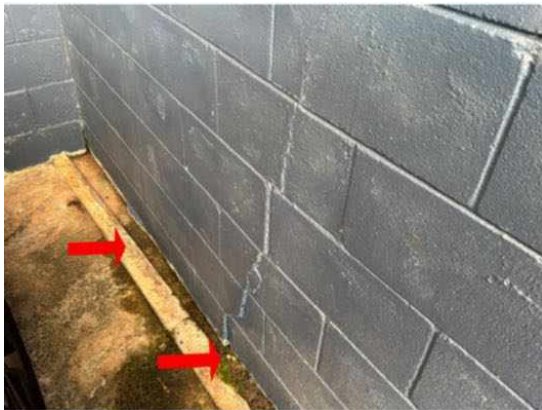
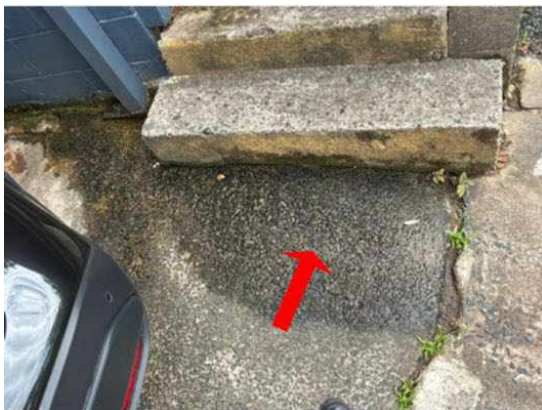
### Finding 6.04

Building:	Main Building
Location:	All Areas
Finding:	Excessive moisture - identified
Information:	Excessive moisture can attract termites and produce conditions that promote fungal growth and wood decay.

Prior to any remedial works being performed a qualified plumber should be appointed to further inspect the property and to identify the cause of the excessive moisture. Works to remove affected building elements may then be necessary and should be performed by an appropriate tradesperson.

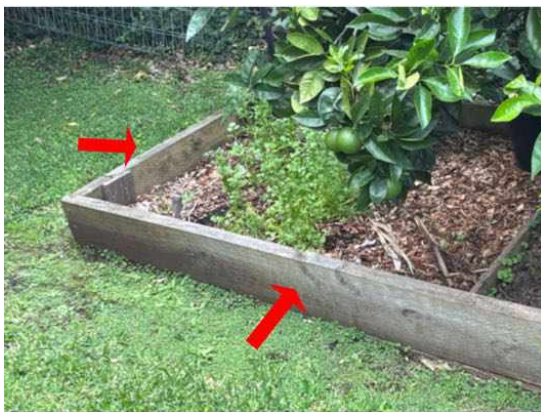
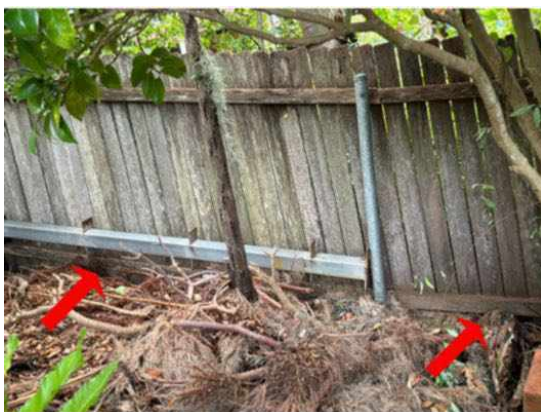
## Finding 6.05

Building:	Main Building
Location:	All Areas
Finding:	Untreated or non-durable timbers in a hazardous environment (Timber in ground contact)
Information:	To reduce the risk of timber pest attack it is essential that timber used in a hazardous environment (e.g. in direct contact with the ground or frequently exposed to damp conditions) is of sufficient durability and/or is adequately preservative treated.

If untreated or non-durable timbers are found to be in a hazardous environment it is highly advised that replacement of these building elements be performed as soon as possible to aid the protection of the property against termite / timber pest attack.

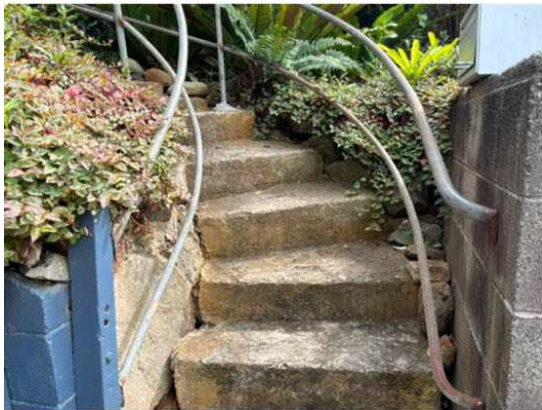
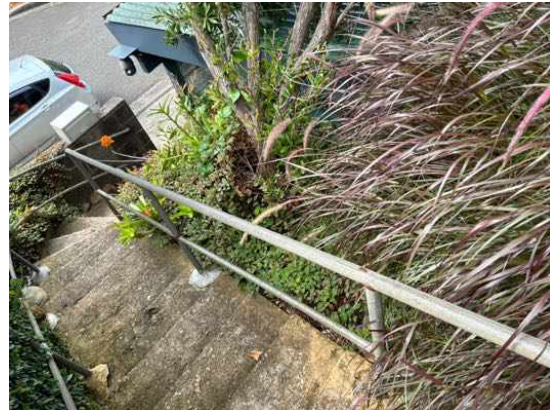
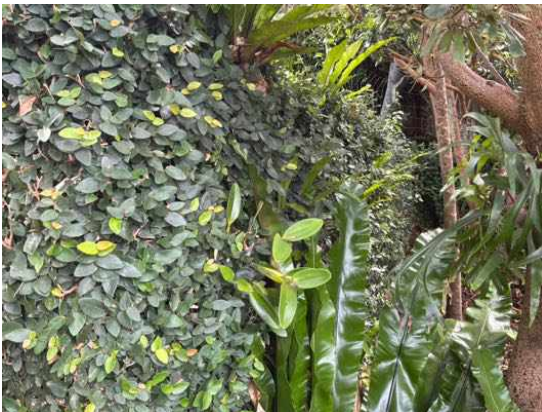
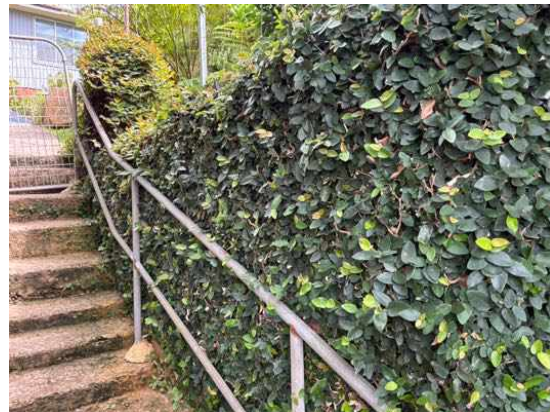
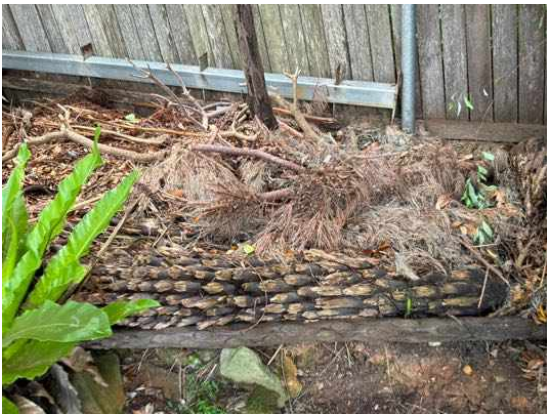
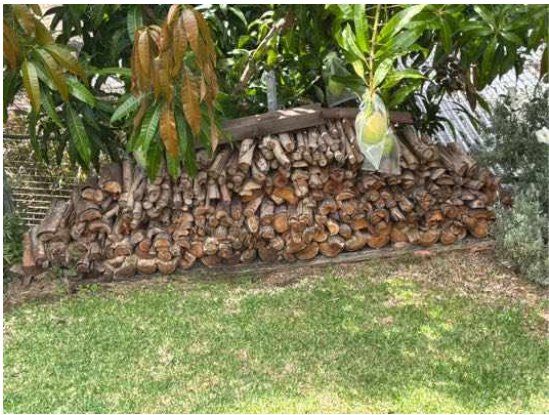
Building: Main Building  
Location: All Areas  
Finding: Additional Photos - Obstructions and Limitations  
Information: These photographs are an indication of the obstructions and limitations which impeded full inspection of the property at the time of inspection. These obstructions can hide an array of defects and should be removed to allow full inspection to be carried out. A re-inspection is recommended once the areas are made accessible.

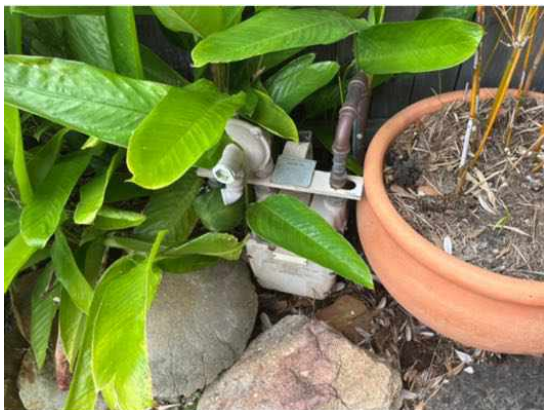
Building:	Main Building
Location:	All Areas
Finding:	Additional Photos
Information:	Additional photos are provided for your general reference. Arrows have been included to highlight areas of importance. Please discuss these photos with your building consultant for clarification.

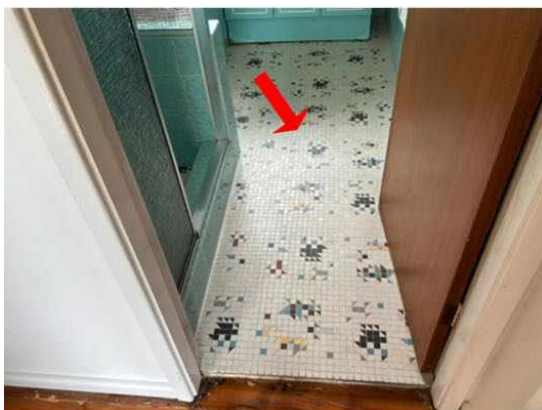
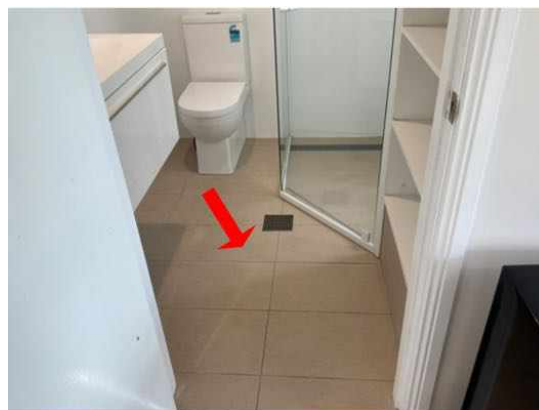
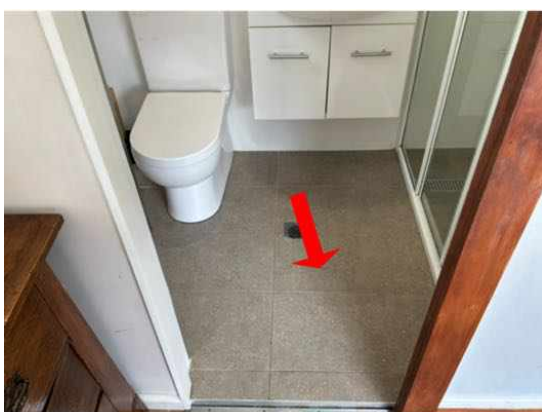
Building:	Main Building
Location:	All Wet Areas
Finding:	Water Proofing Membranes - Information Only
Information:	Internal Water Proofing Membranes, are crucial in preventing water ingress into the property is important to know that the Membrane System used is to Australian Standards and has been installed correctly.

With older property's where this information is unavailable all wet areas should be monitored. Generally waterproofing certificates are only valid for approximately 7-8yrs. If any leaks, water staining, peeling or bubbling of the paint become evident to any adjacent walls or ceilings below a licensed builder or waterproofing specialist is recommended to investigate further.

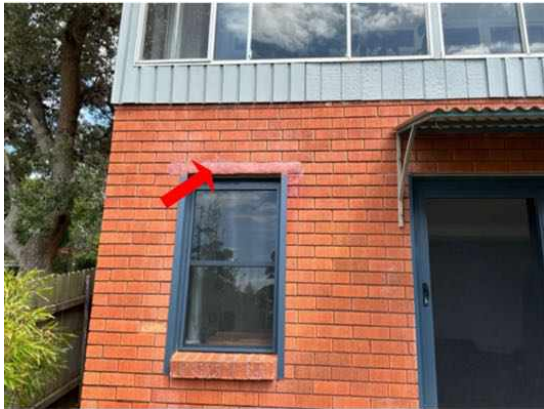
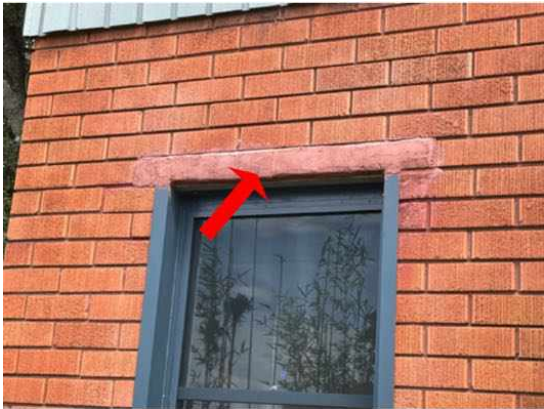
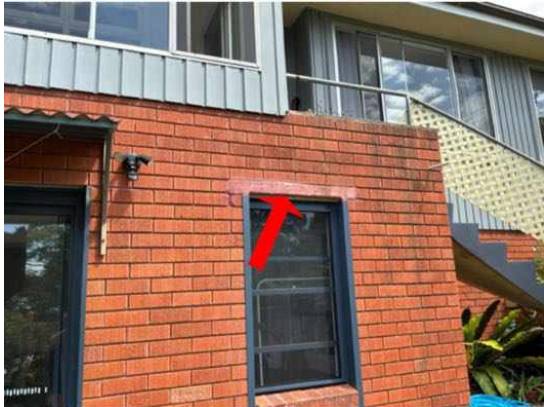
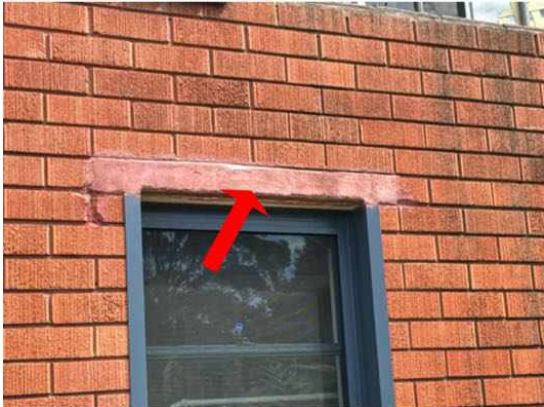
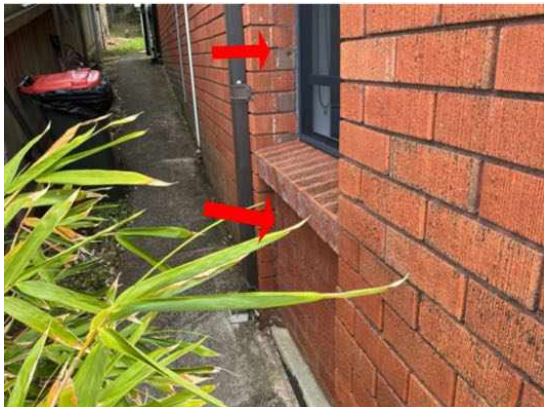
Building: Main Building  
Location: Exterior walls - front  
Finding: Previous remedial works  
Information: At the time of inspection it was identified that there was previous remedial work carried out to this area.

Continual monitoring should be conducted to ensure no further dilapidation occurs to this area.

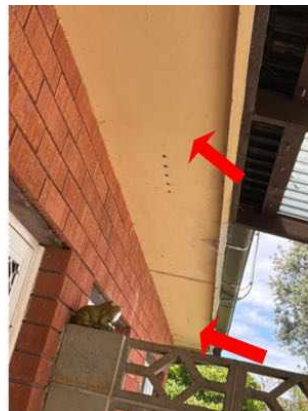
Building: Main Building  
Location: All External Areas  
Finding: Asbestos - Suspected ACM Identified on Site  
Information: Reporting on Asbestos is outside the Scope of this Report. This suspected defect is highlighted as a caution only. We suspect, based on our experience in the building industry, that there is a higher risk of the identified building element containing asbestos.

As Asbestos Reporting is outside the scope of this report, we advise that you consider a separate Asbestos Inspection and Condition Audit, which can include the taking of samples for definitive confirmation of the presence of Asbestos.

In the interim, the client is advised to act with caution, especially when considering any damage to building materials general wear and tear renovations extensions demolition and general maintenance activities due to the suspected presence of Asbestos.

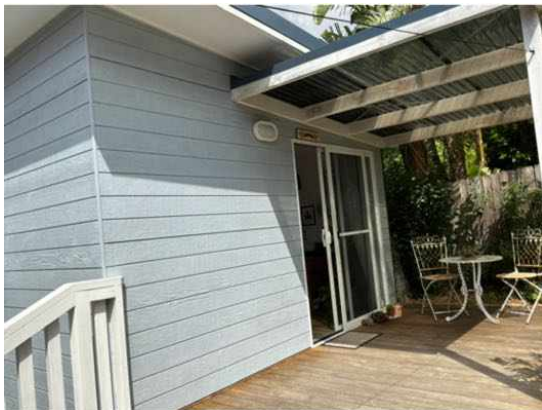
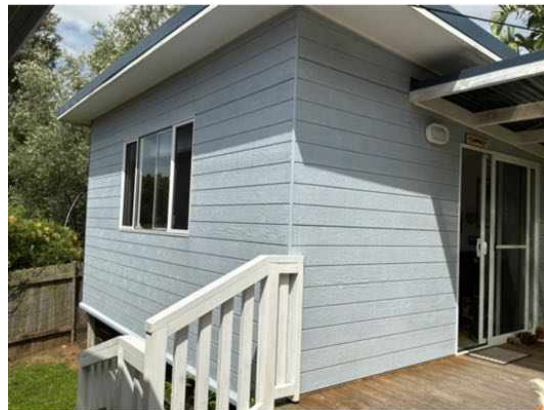
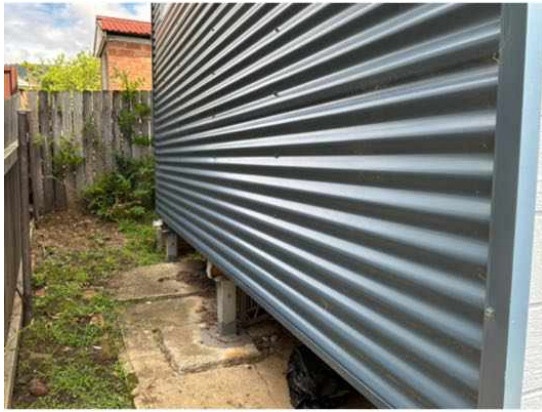
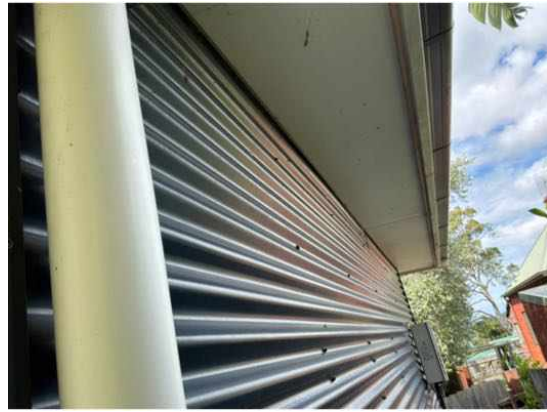
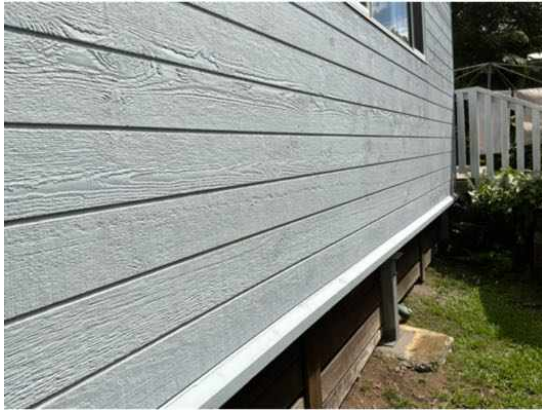
Building: Granny-Flat  
 Location: External Walls  
 Finding: For information only  
 Information: No remedial works are required at the current time.

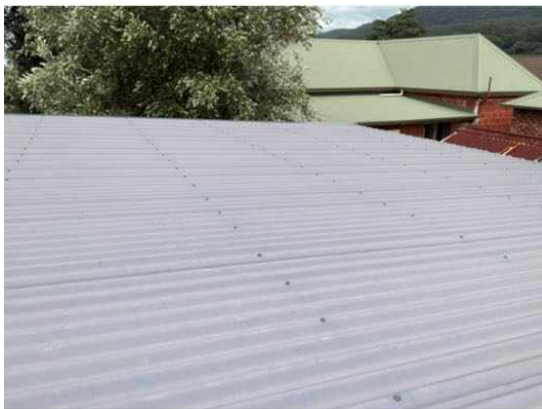
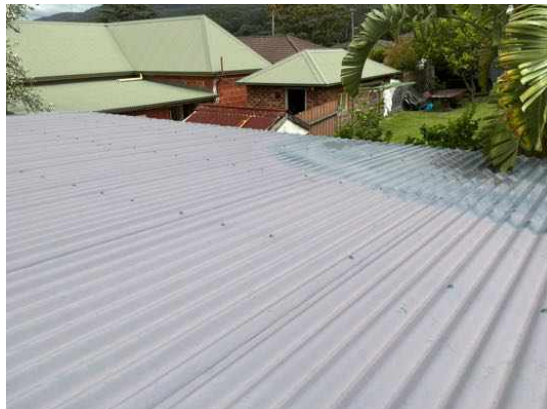
Building: Granny-Flat  
Location: External Roof  
Finding: For information only  
Information: No remedial works are required at the current time.

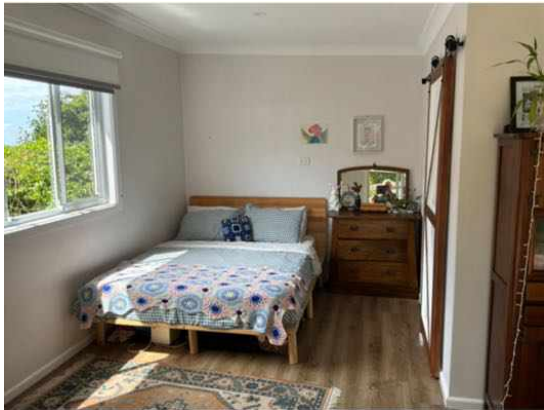
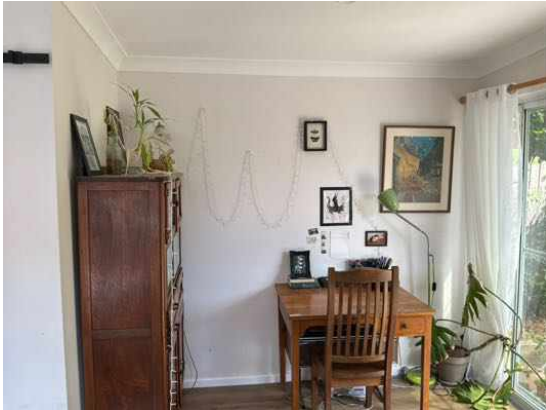
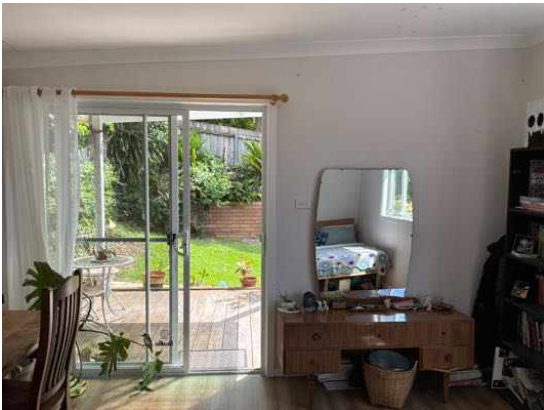
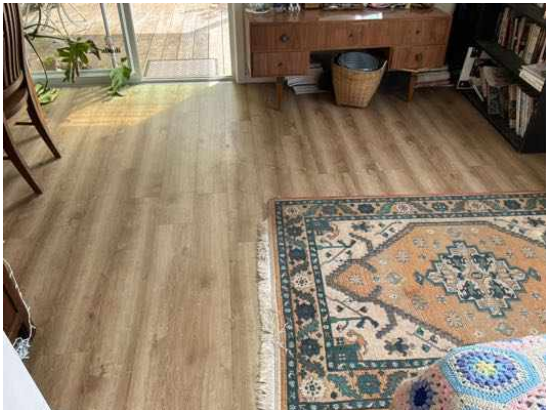
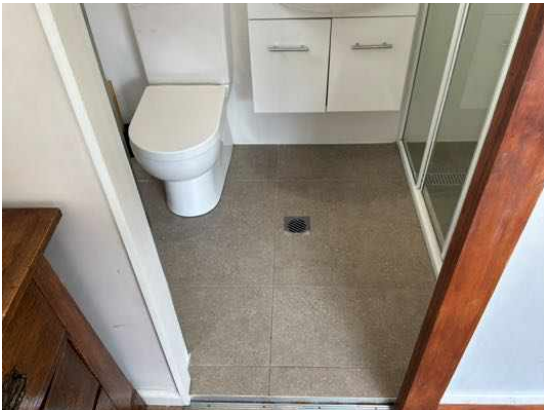
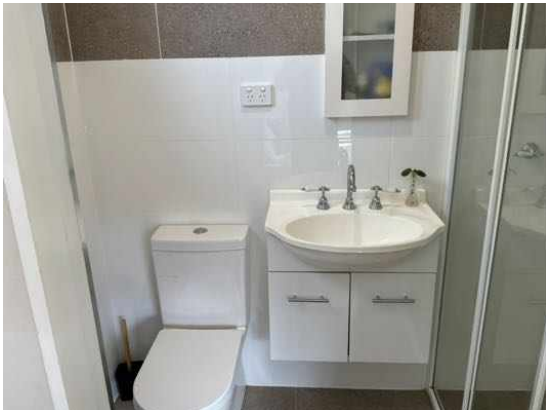
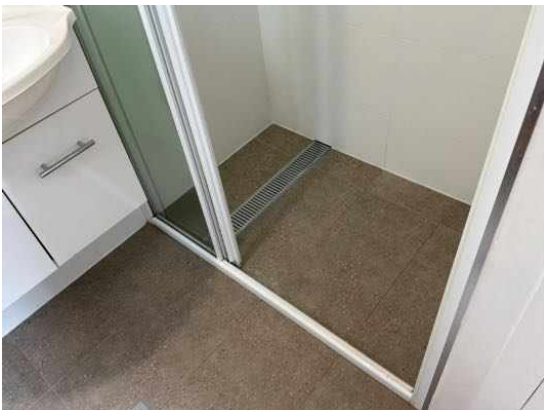
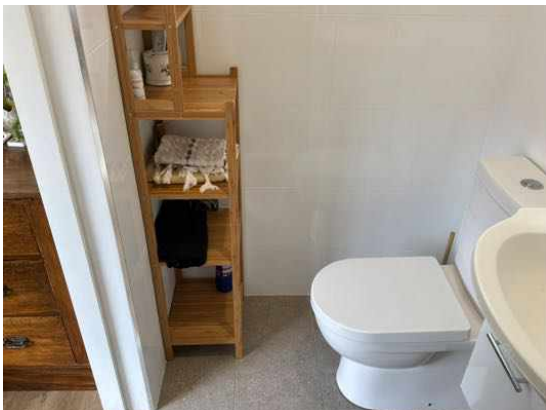
Building: Granny-Flat  
Location: Living Room  
Finding: For information only

Information: No remedial works are required at the current time.

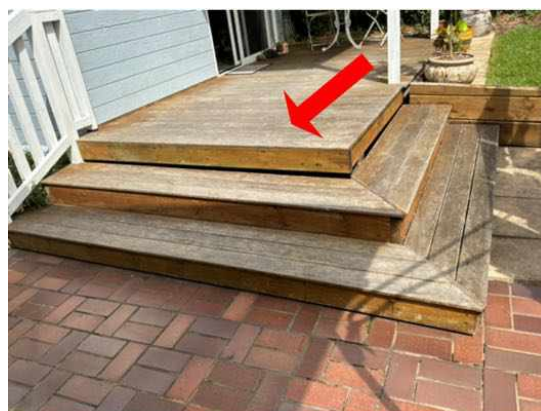
Building:	Main Building
Location:	Balcony
Finding:	Elevated Structures -Balconies or Deck Areas
Information:	Where any elevated Structure (deck, balcony, verandah etc) is present, and this elevated structure is designed to accommodate people, you MUST have this structure checked by an engineer or other suitably qualified person.

You should also arrange annual inspections of the structure by an engineer or other suitably qualified person to ensure any maintenance, that may become necessary, is identified. Care must be taken not to overload the structure.
