Building and Timber Pest Inspection Report

Inspection Date: Fri, 27 Mar 2026

Property Address: 61 Pitfield Cres, Rowville VIC 3178,
Australia

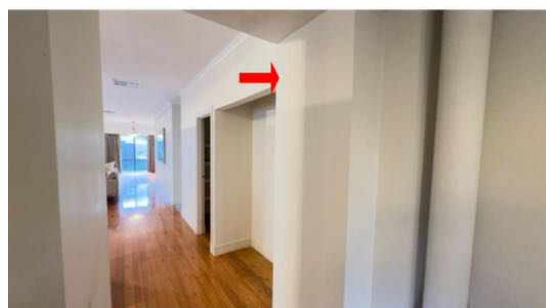
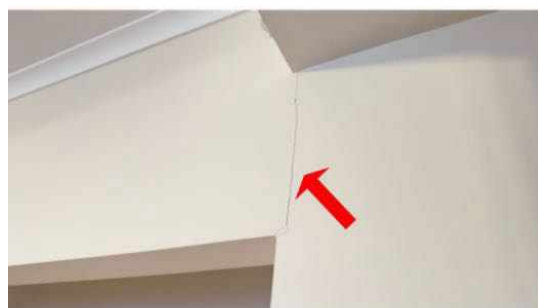
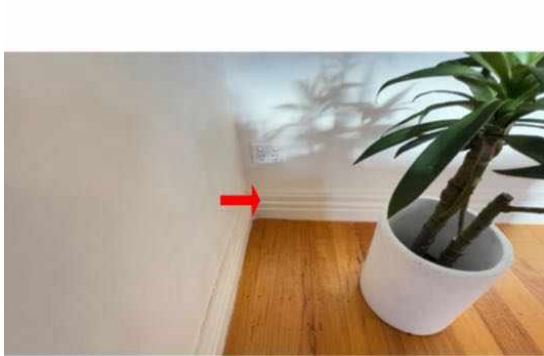
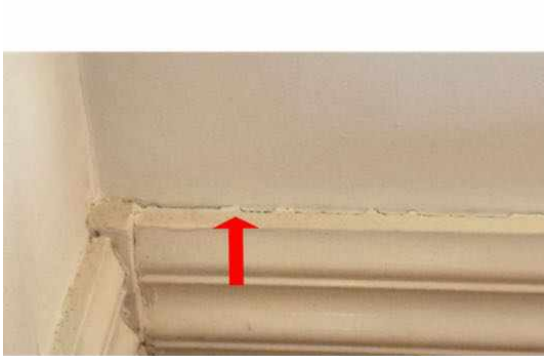
Building: Main Building
Location: All Areas
Finding: Plaster - Minor Plaster Cracking
Information: Cracking was observed to the plaster in this area. While generally cosmetic in nature, plaster cracks can result from minor building movement, seasonal expansion and contraction, or poor jointing and finishing at the time of construction.

Possible causes may include normal building settlement and movement, seasonal expansion and contraction of building materials and or poor installation or finishing of plasterboard joints.

Cracking should be monitored over time to assess whether movement is ongoing. Where cracking is purely cosmetic, patching and repainting may be undertaken as part of routine maintenance by a qualified plasterer.

*If cracks widen, reoccur after repairs, or appear in conjunction with other structural signs, further investigation by a registered builder or structural engineer is recommended immediately.

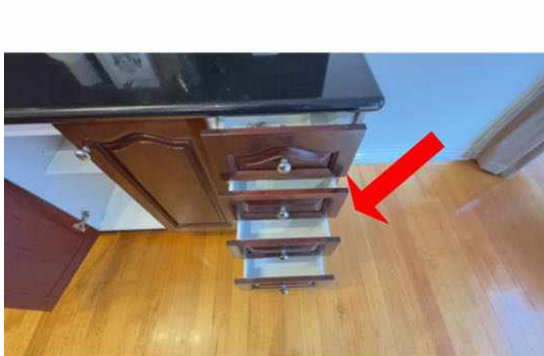
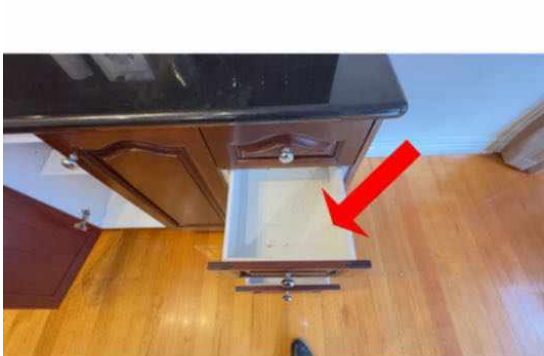
Finding 3.02

Building: Main Building
Location: Kitchen >
Finding: Cabinets - Damaged
Information:

Visible damage was noted to cabinet units, affecting both their appearance and functionality. If left unaddressed, the damage may worsen over time.

This damage may result from impact during installation or use, moisture exposure, poor-quality materials or finishes, or inadequate installation and protection during construction. *No elevated moisture levels were detected at the time of inspection.

When practical, a qualified cabinetmaker should be engaged to repair or replace the damaged components to restore proper function and appearance.

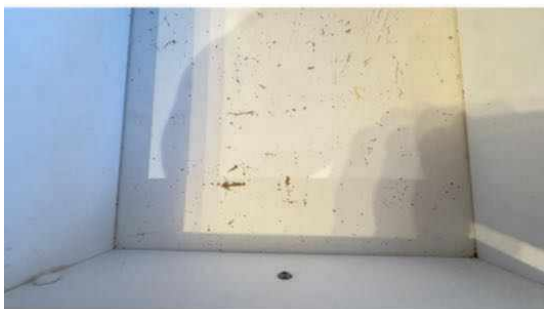
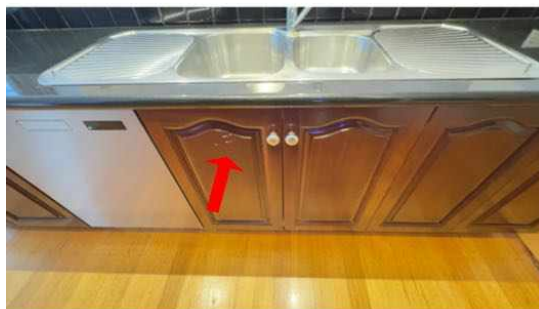
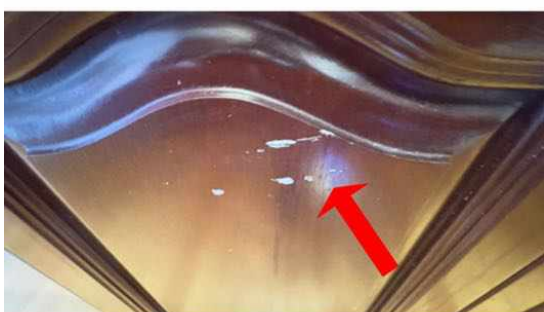
Finding 3.03

Building:	Main Building
Location:	All Areas >
Finding:	Building Element - Deteriated
Information:	Deterioration occurs generally when the building materials have either aged and decayed, or as a result of damage (accidental or deliberate).

Repair and/or replacement of this building element is advised to ensure that additional secondary defects do not arise as a consequence. Such works are necessary, as all building elements play a key role in the operation and function of the overall structure and its performance.

A registered builder should be appointed to repair or replace the affected building element immediately.

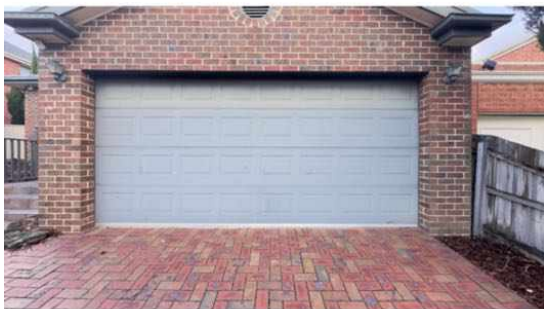
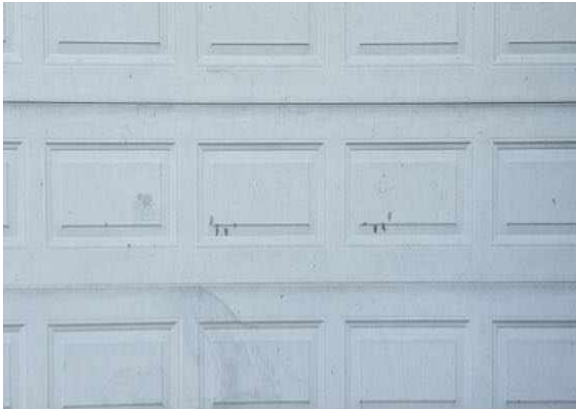
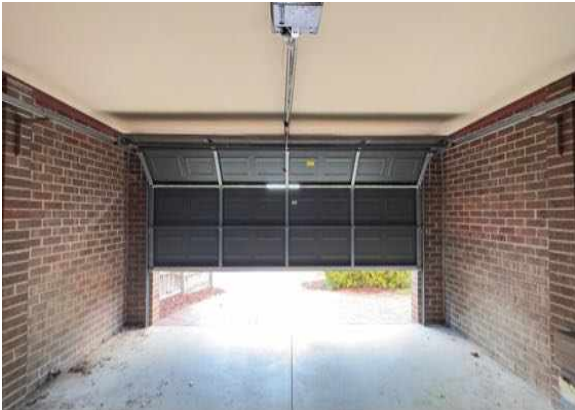
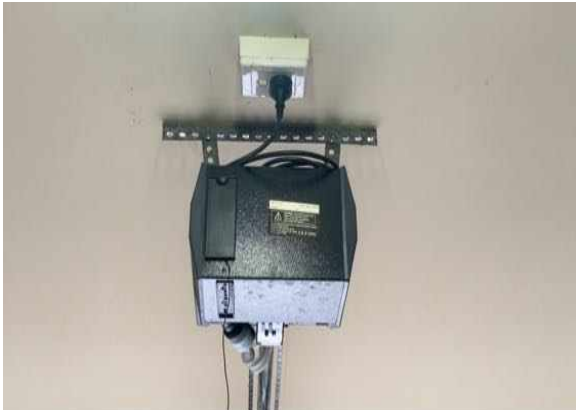
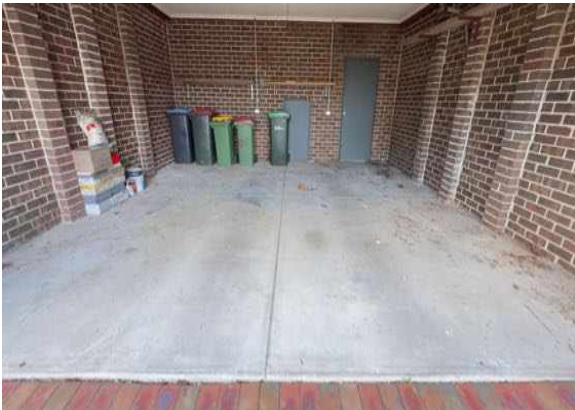
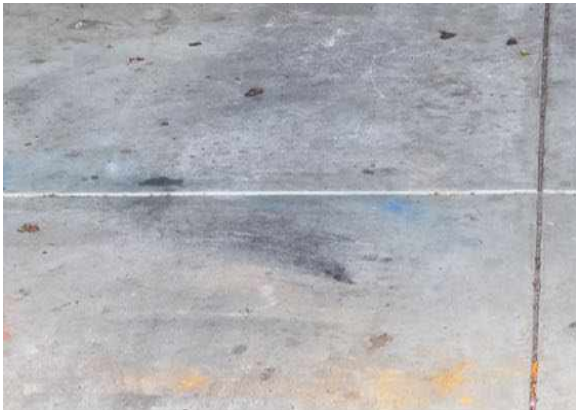
Finding 3.07

Building: Main Building
Location: All External Areas >
Finding: External Walls - Minor Cracking To Wall Claddings
Information: Minor cracking was observed to the external walls in this area. The cracking appeared superficial and did not indicate significant structural movement; however, such cracking can allow moisture ingress if left unaddressed.

The cracking is likely due to building movement or minor settlement.

When practical, a registered builder should assess and repair the cracking, which may include sealing and repainting. The area should be monitored, and any increase in cracking or signs of movement should be further investigated immediately by a Structural Engineer.

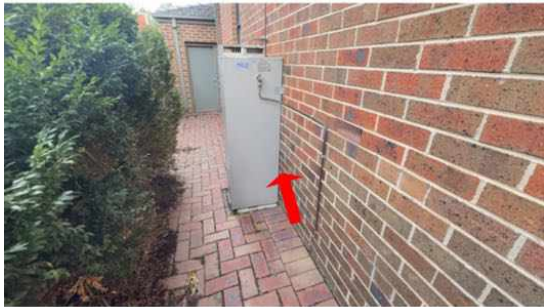
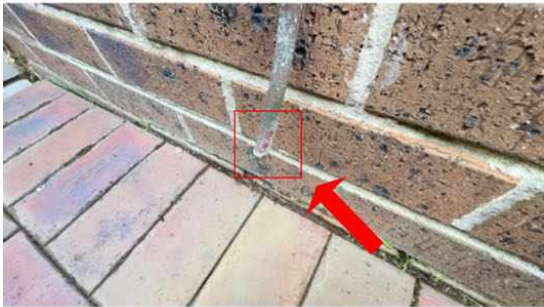
Finding 3.10

Building: Main Building
 Location: All External Areas >
 Finding: HWS - (T&P) Valve Not Connected To Storm Water
 Information: The Hot Water System (HWS) Temperature & Pressure Relief (T&P) valve discharge pipe was observed to be disconnected from stormwater drainage.

When not properly connected, discharged water can create damp conditions around the HWS, potentially leading to secondary defects such as timber rot, corrosion of nearby metal components, mould growth, or slip hazards. Prolonged exposure to moisture in this area may also attract termite activity and contribute to long-term deterioration of surrounding building elements.

A licensed plumber should be engaged immediately to connect the T&P discharge pipe to a suitable stormwater outlet or floor waste. Prompt rectification will ensure safe operation of the HWS, protect surrounding structures, and reduce potential health and safety risks.

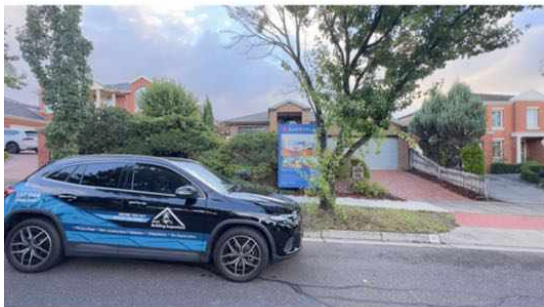
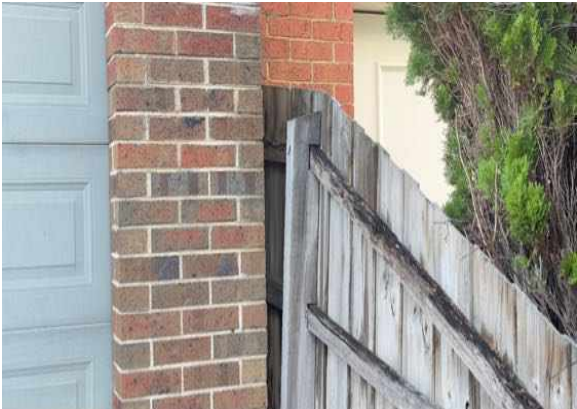
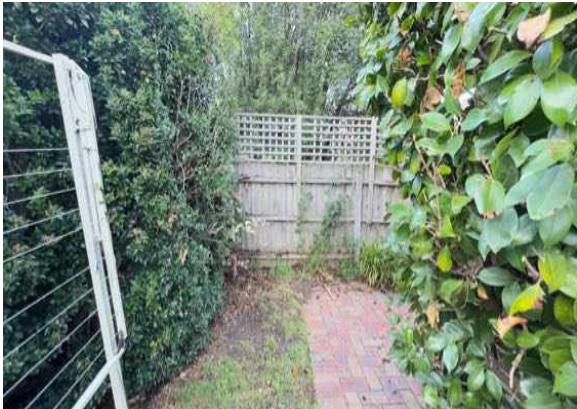
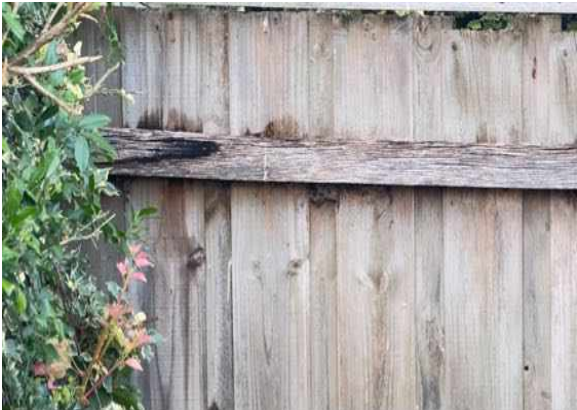
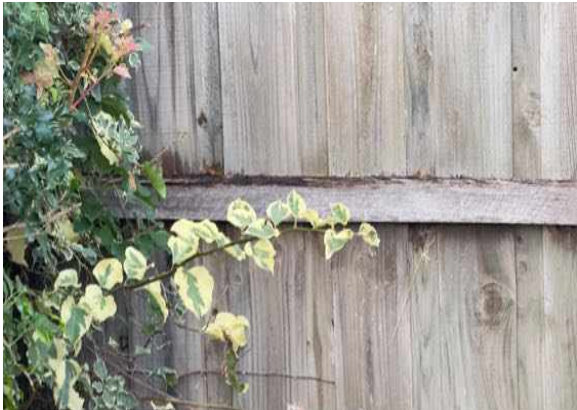
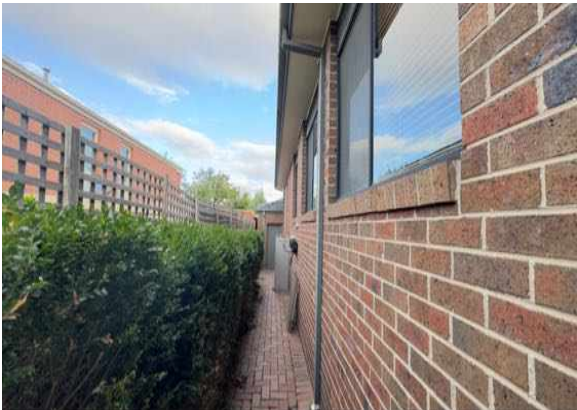
Finding 3.11

Building: Main Building
Location: Fencing All Areas
Finding: Fencing - Deteriated
Information: Timber fencing was inspected and deterioration was observed in this area. Deteriorated fencing can compromise structural stability, reduce privacy, and may allow pest ingress or accelerated decay if left unaddressed.

Possible causes include age-related timber decay, prolonged exposure to moisture or sunlight, poor maintenance, or impact damage.

When practical, a qualified carpenter or fencing specialist should be engaged to repair or replace affected sections, and a qualified painter should be engaged to restore protective finishes. Prompt rectification will maintain structural performance, improve appearance, and extend the lifespan of the fencing.

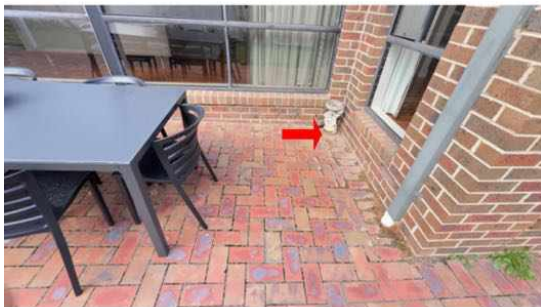
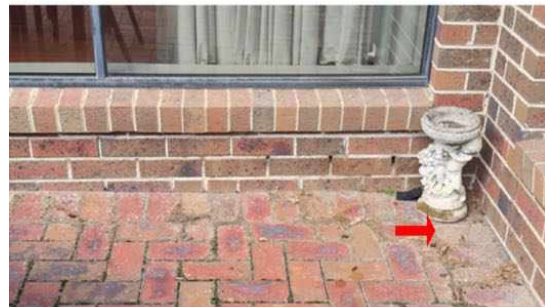
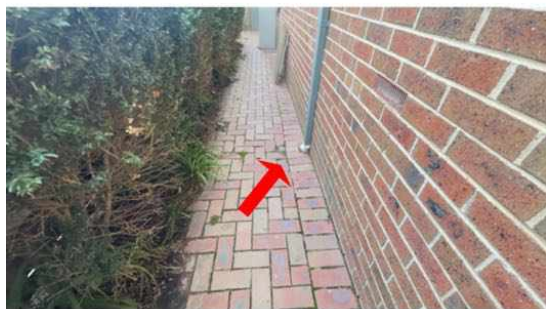
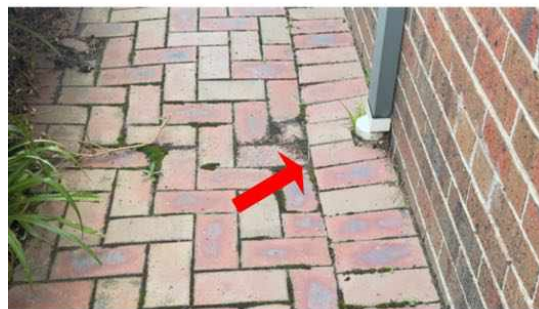
Finding 3.12

Building: Main Building
 Location: All External Areas >
 Finding: Paving - Minor Cracking
 Information: The external paved areas were visually inspected. Minor cracking, uneven surfaces, and general wear were observed in this area. These defects do not currently affect structural safety but may reduce durability, appearance, and safe pedestrian access.

This may be caused by age-related deterioration of concrete, pavers, or other materials, soil movement or settlement beneath paved surfaces, tree root intrusion or erosion, or inadequate original installation or sub-base compaction.

A qualified landscaper should be engaged as soon as possible to repair or resurface sections as required. Rectification will restore even surfaces, reduce trip hazards, and improve the serviceability and appearance of the paved areas.

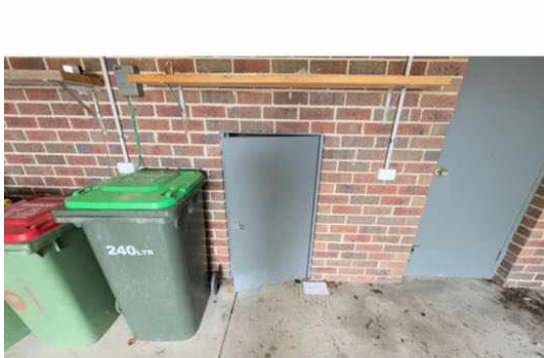
Building: Main Building
Location: Subfloor
Finding: Sub - Floor - Stored Items, Rubbish & Debris
Information: The subfloor was observed to contain stored items, rubbish, and debris. The issue is present where clutter restricts access and covers surfaces beneath the building.

This has likely occurred due to accumulation of materials over time or inadequate cleaning. Excess items can conceal defects, restrict inspections and maintenance, increase pest activity, and create fire or safety hazards.

This observation is provided for information only. When practical, a competent handyman should be engaged to remove all rubbish and clear access to ensure safe inspection, maintenance, and ongoing monitoring of the subfloor.

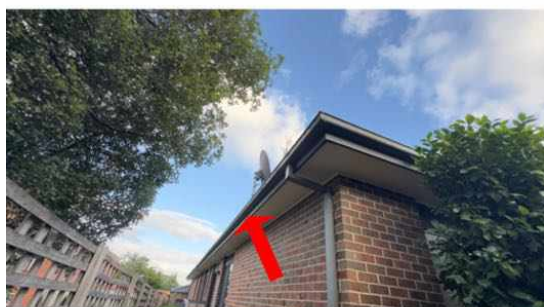
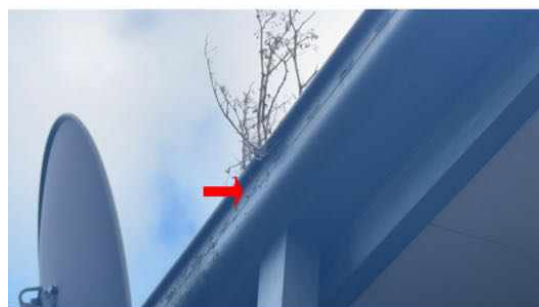
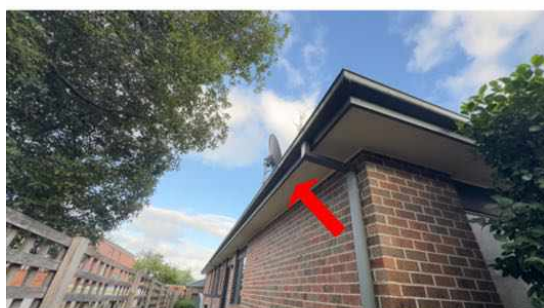
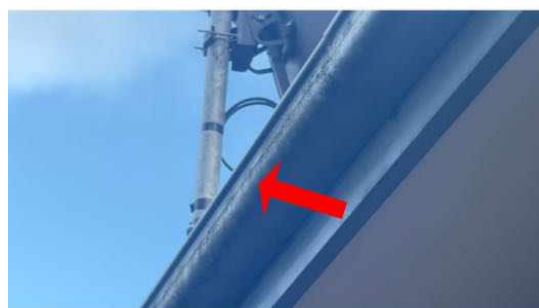
Finding 3.16

Building:	Main Building
Location:	Roof Exterior
Finding:	Roof Plumbing - Rusted & Corroded
Information:	The roof plumbing has areas of rust and corrosion. It is suspected that this has been caused by blockages, resulting in pooling or standing water, that have prematurely rusted elements of the roof plumbing.

Rusted roof plumbing will generally develop holes and leaks that can affect other building elements with poor drainage of storm water. Poorly drained roof areas will also lead to damp conditions surrounding the base perimeter of the building which, if left unmanaged, can lead to a range of secondary building defects.

Repair and/or replacement of rusted roof plumbing is highly required in order to reinstate the roof drainage system to a fully operational level. To further maintain these areas, gutters should be cleaned frequently, allowing the avoidance of any partial blockages.

A licensed plumber or specialist roof restoration company should be appointed to undertake these works. It is advised that such works be completed as soon as possible to prevent any further damage and deterioration.

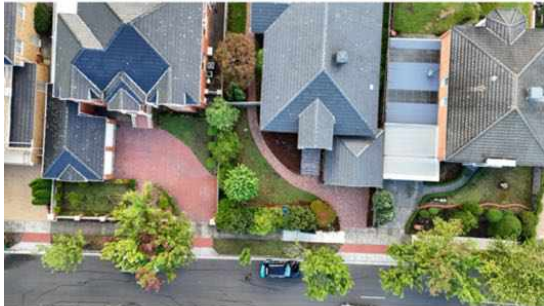
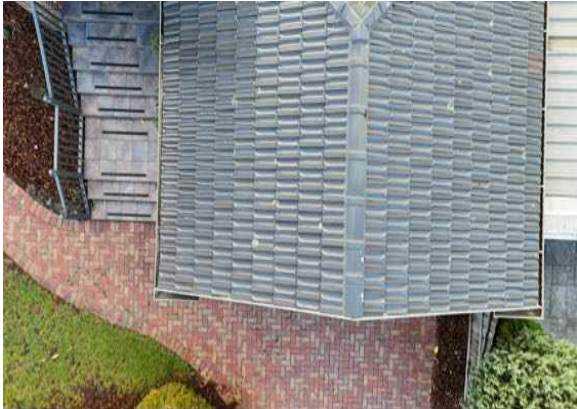
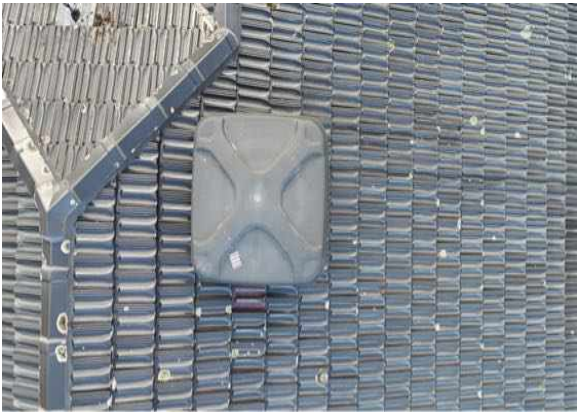
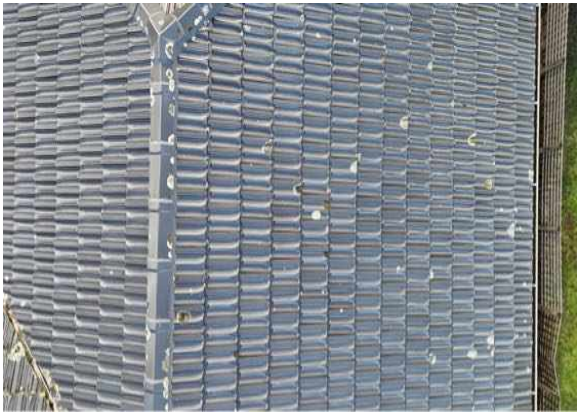
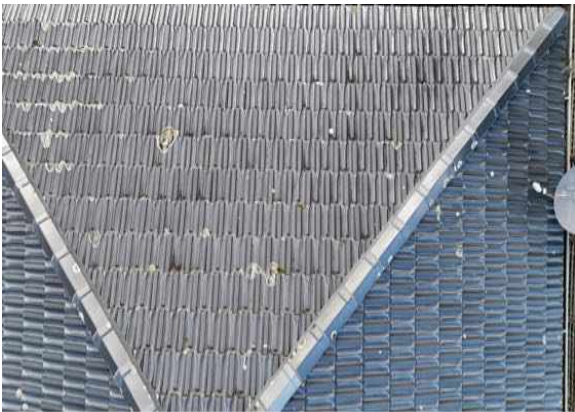
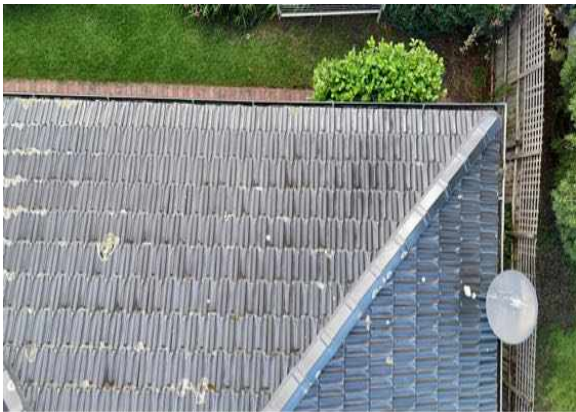
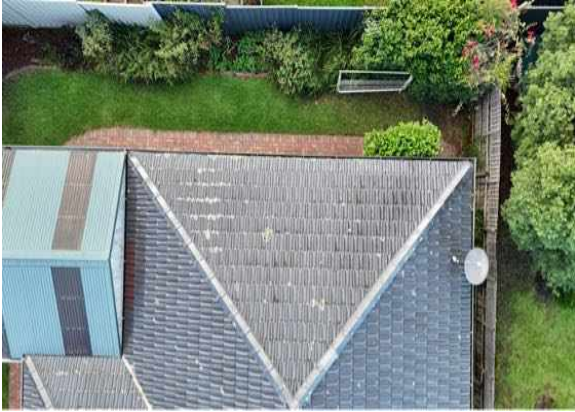
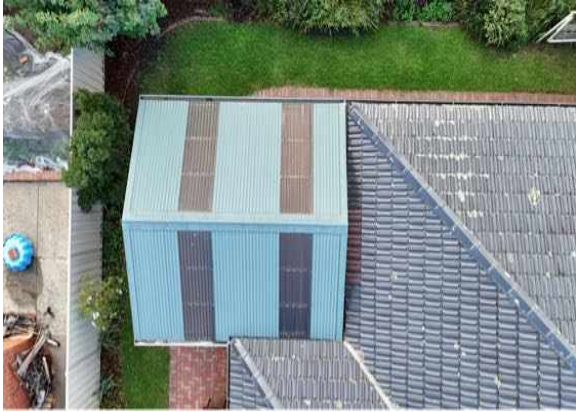
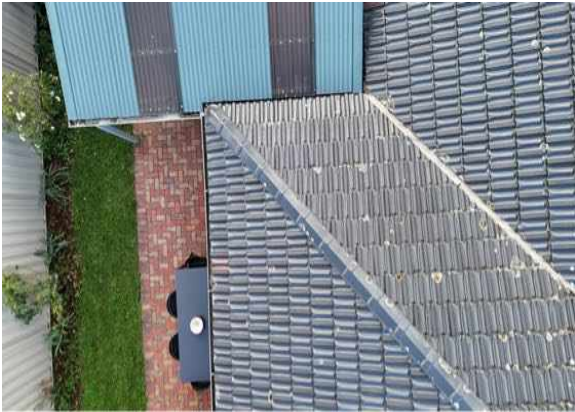
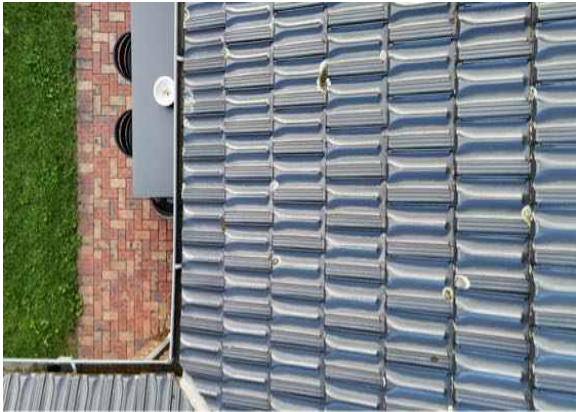
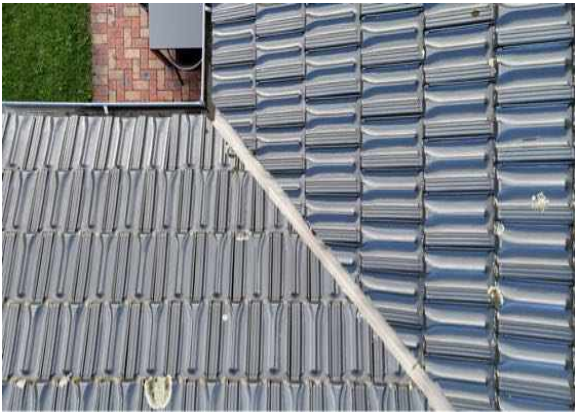
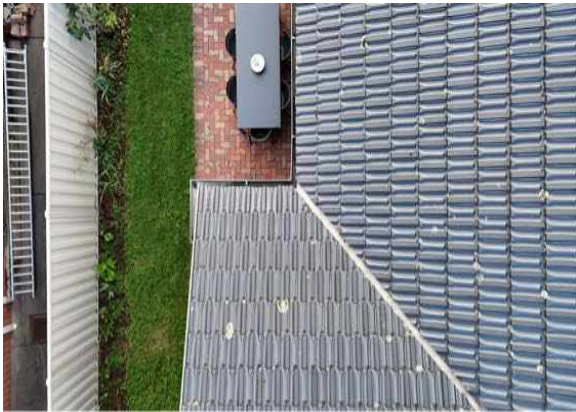
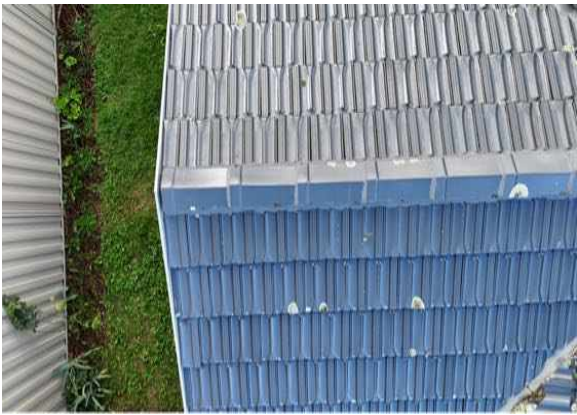
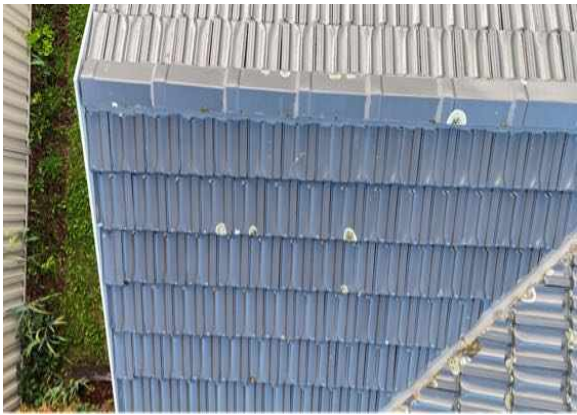
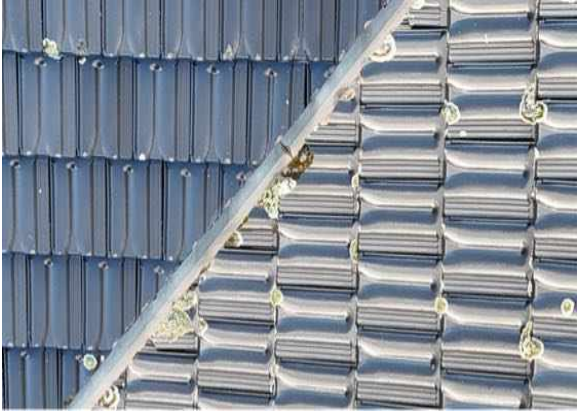
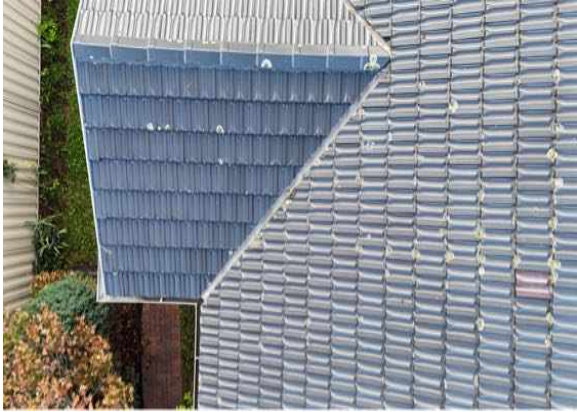
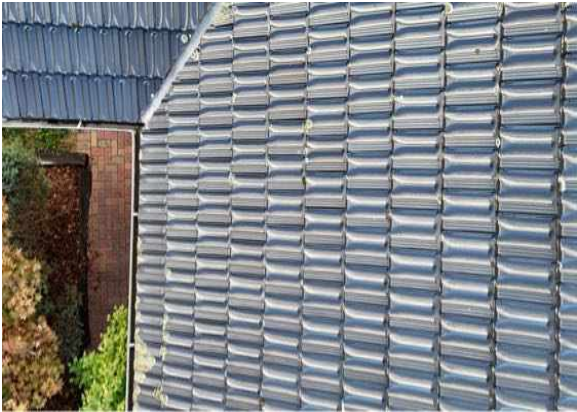
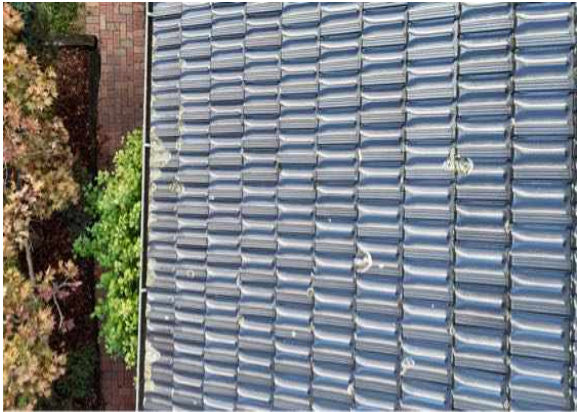
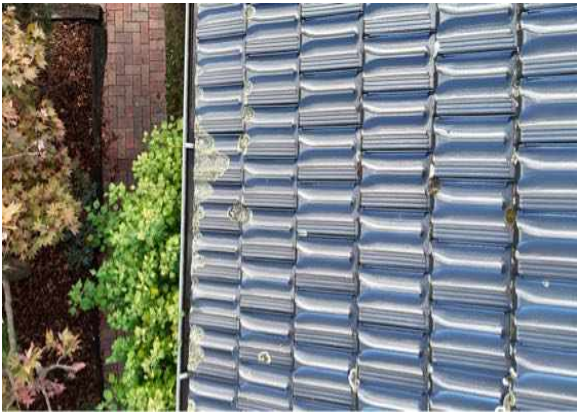
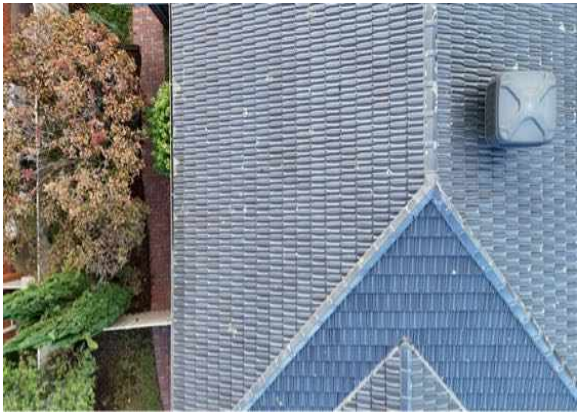
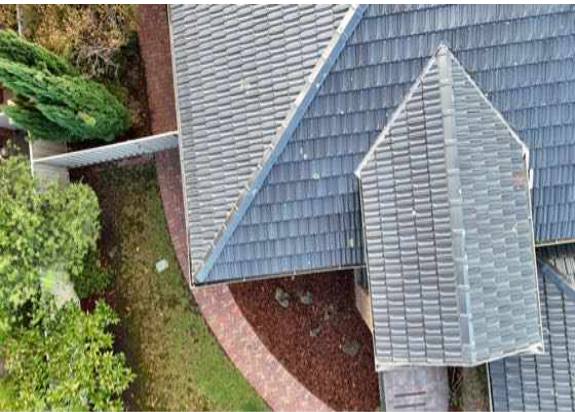
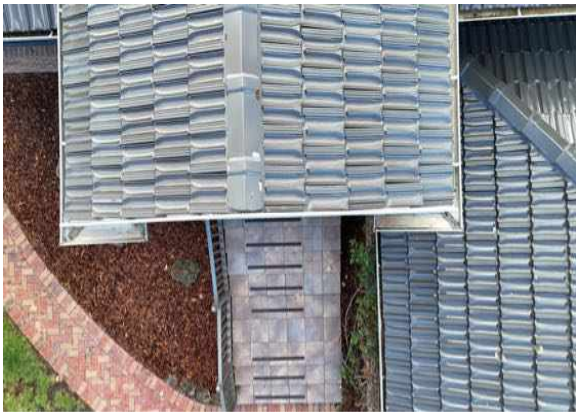
Please note that photographic images may not capture the full extent of site conditions, levels of deterioration, or concealed defects. Roof coverings and components can only be properly assessed through physical inspection, and some areas may be inaccessible due to height, pitch, safety constraints, or limited access at the time of inspection.

If there are any concerns regarding the roof structure, coverings, flashings, drainage, or associated elements, further assessment by a licensed roofing contractor is recommended immediately.

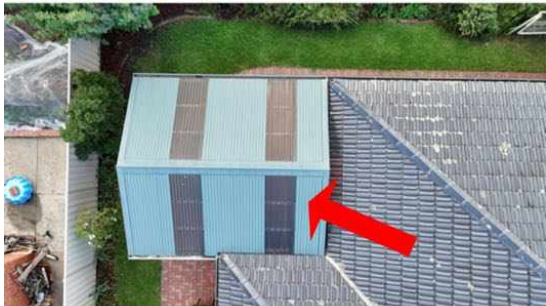
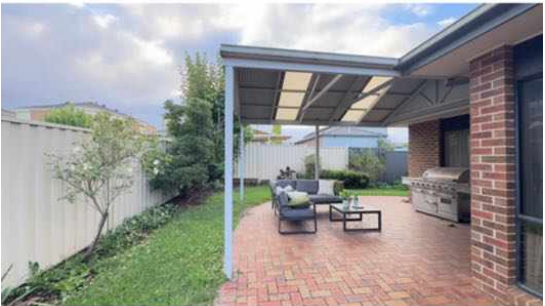
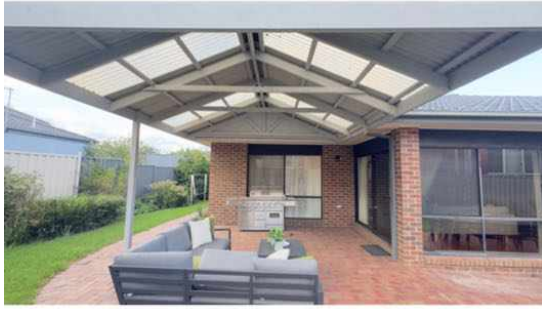
Building: Main Building
Location: All Areas
Finding: Building Approvals – Prior Renovations Advisory
Information: For your information, the dwelling has undergone several renovations over the past years. Evidence of multiple alterations and upgrades was observed at the time of inspection. The inspection did not include verification of council approvals, permits, or compliance documentation for these works.

Unapproved or undocumented renovations may present compliance, safety, insurance, or resale risks if not properly approved or certified.

It is strongly recommended to make enquiries with the relevant local council immediately and engage appropriately qualified professionals, where necessary, to confirm that all historic renovations were carried out with the required permits, approvals, and certifications.

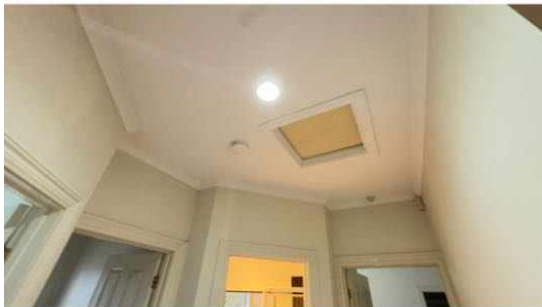
Building: Main Building
 Location: All Internal Areas
 Finding: Smoke Detectors - Advisory
 Information: During the inspection, smoke detectors were noted for advisory purposes only. The operation, age, type, and compliance of smoke detectors could not be fully verified as part of this inspection.

Smoke detectors are critical life-safety devices, and non-compliant, outdated, or non-operational units may not provide adequate warning in the event of a fire.

It is recommended that a licensed electrician be engaged immediately to test, service, and upgrade smoke detectors as required to ensure correct operation and compliance with current safety requirements.

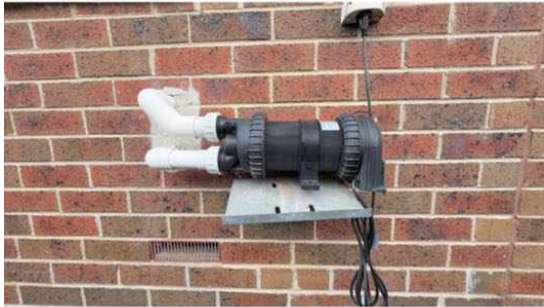
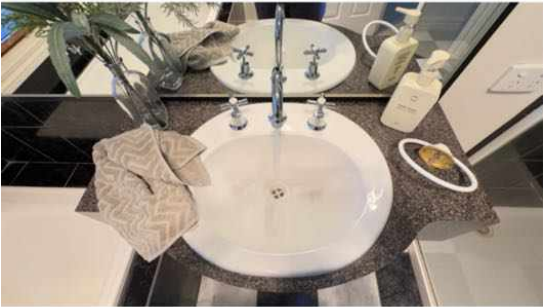
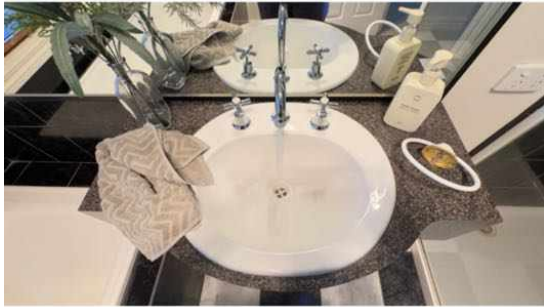
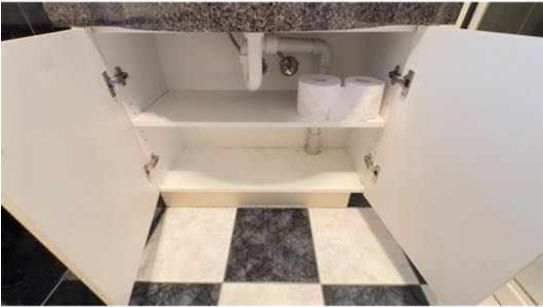
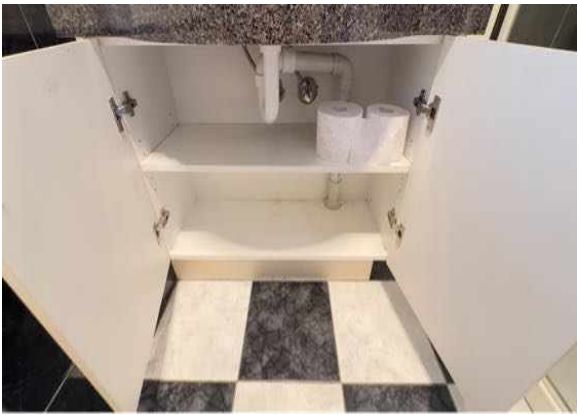
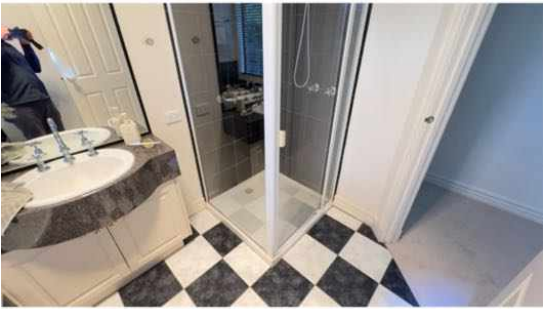
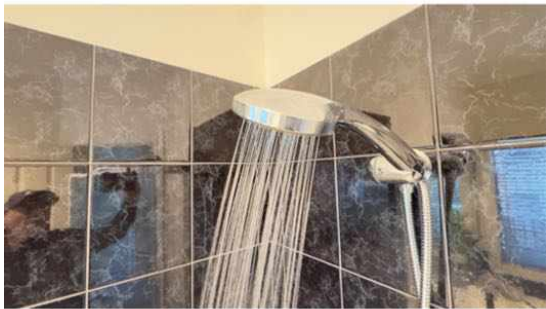
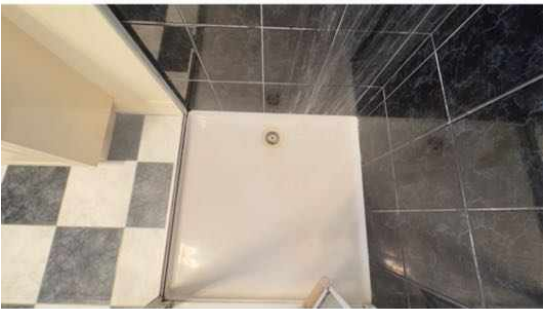
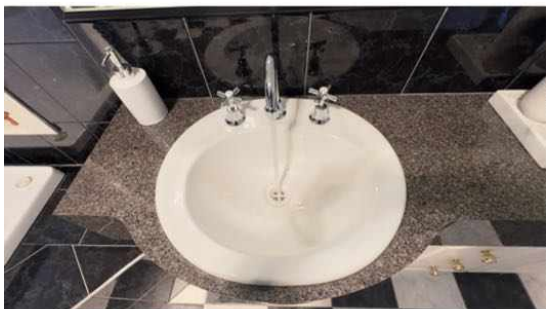
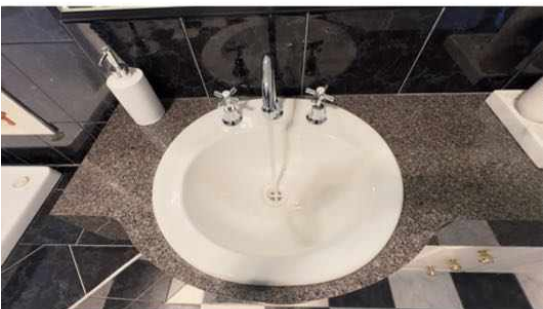
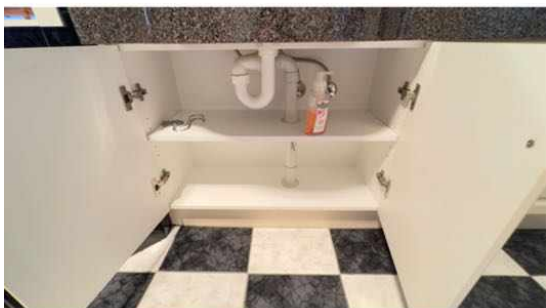
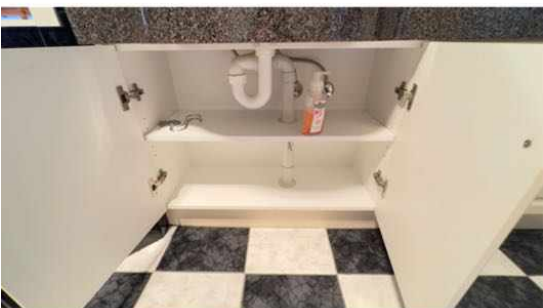
Building: Main Building
 Location: All Internal Areas
 Finding: Water Supply & Drainage - Shower, Basins, Toilets, & Plumbing Fixtures
 Information: The shower recess was tested, and no visible water penetration to surrounding areas was observed at the time of inspection, except where noted as a separate defect

elsewhere in this report. Water appeared to flow freely toward the floor waste. Moisture detected to the shower walls is documented separately in the report. The shower floor waste appeared clear during inspection.

Flushing the toilet revealed no visible leaks, and the fixture appeared to operate normally unless otherwise noted as a separate defect. No water damage was observed to the vanity unit unless specifically stated elsewhere in the report. Basins, bathtubs, laundry tubs, vanities, and sinks were tested and inspected with no evidence of leaks, blockages, or drainage issues at the time of inspection unless otherwise noted. All internal taps and shower heads were tested with no leaks observed, unless documented as a separate defect.

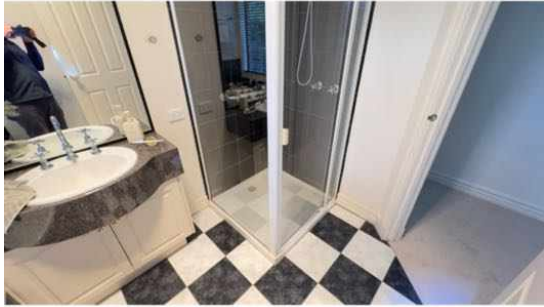
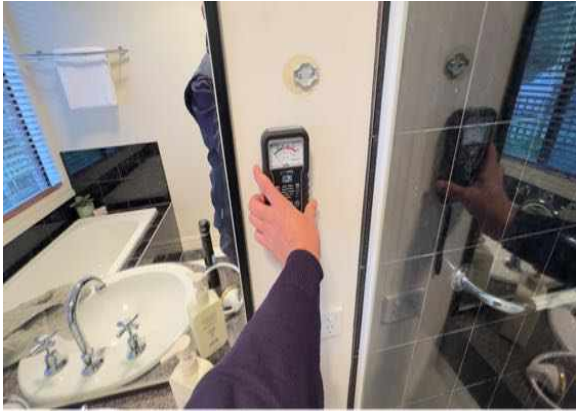
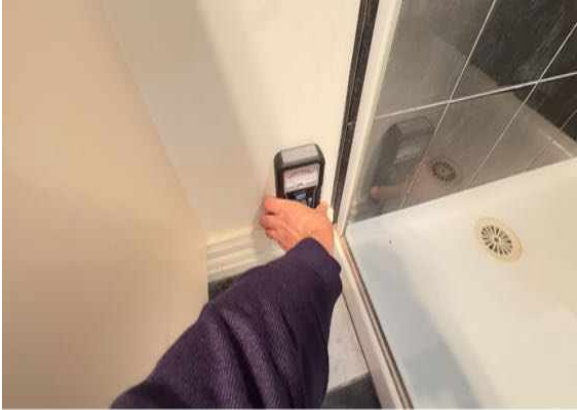
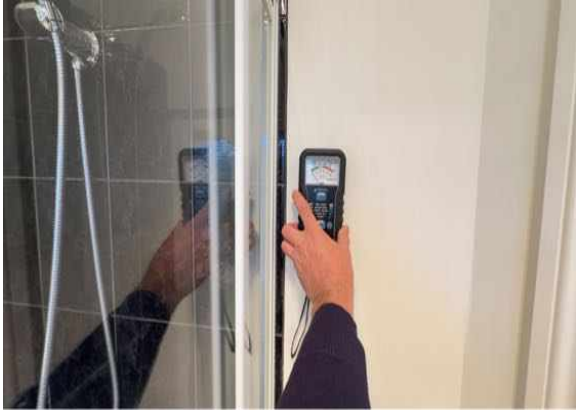
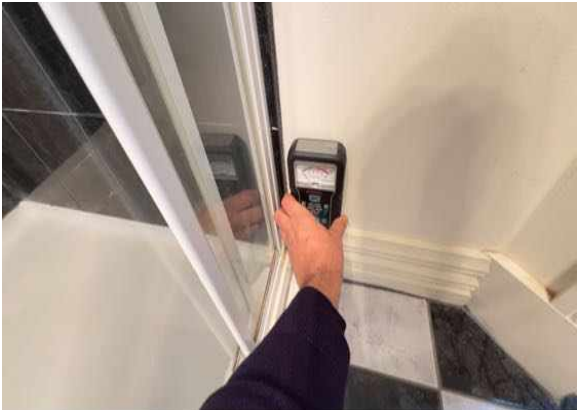
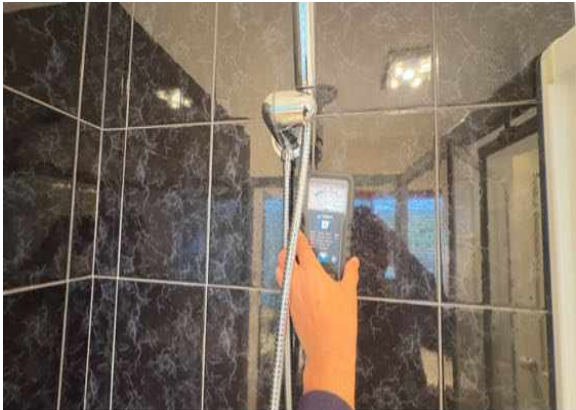
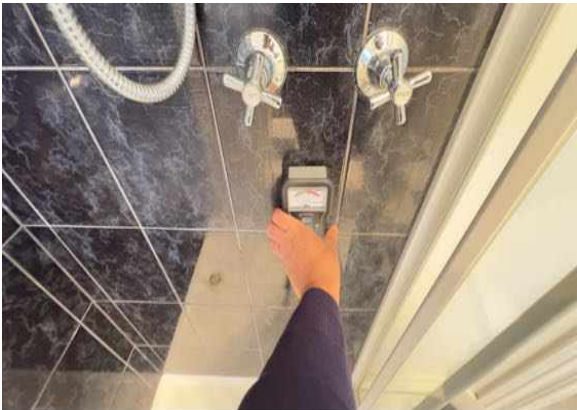
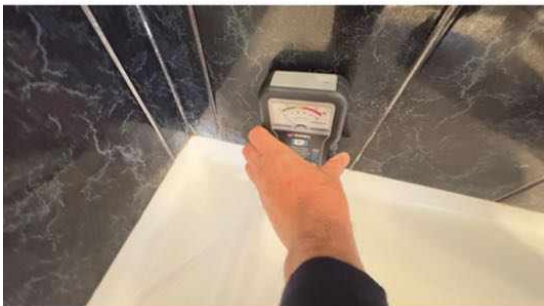
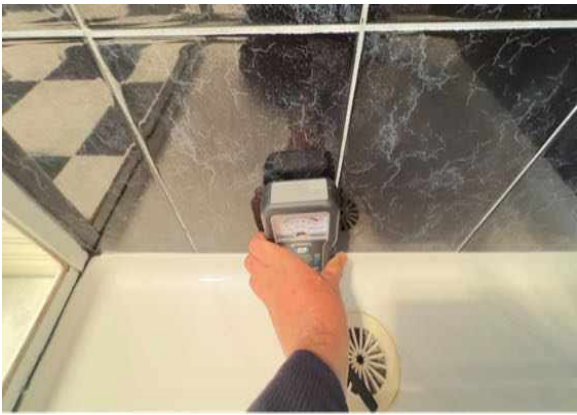
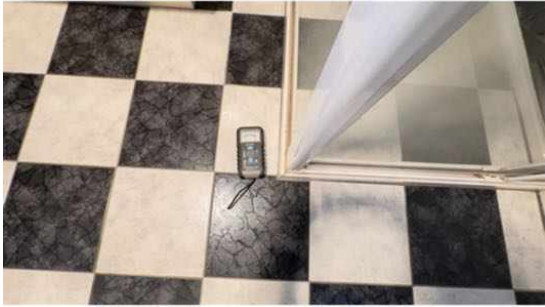
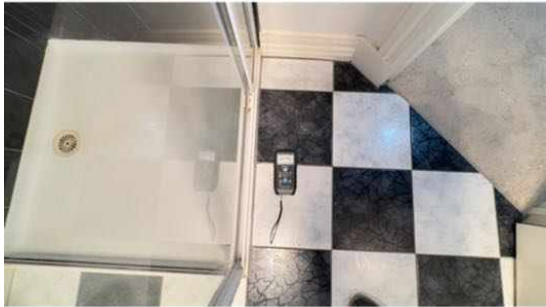
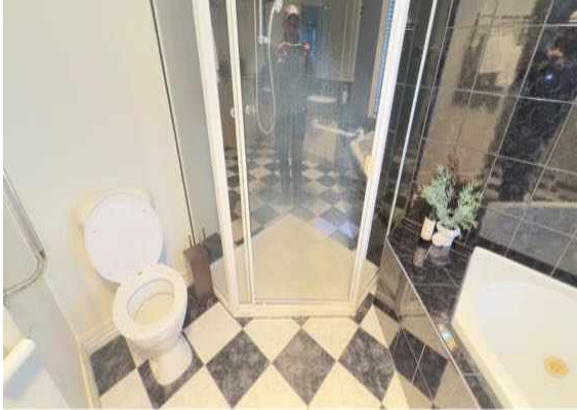
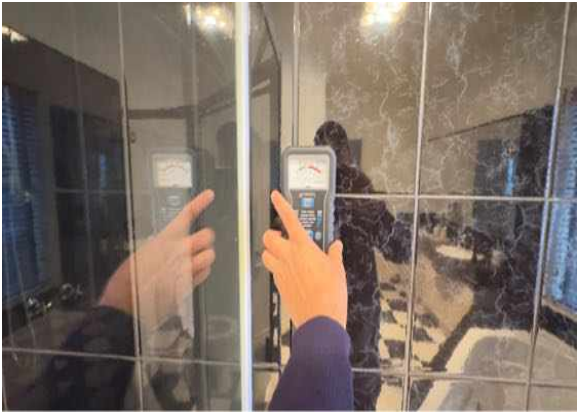
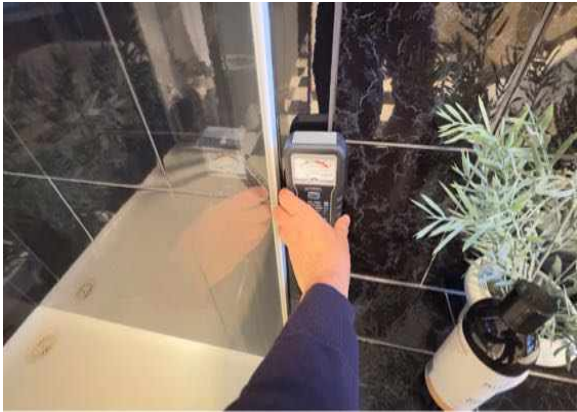
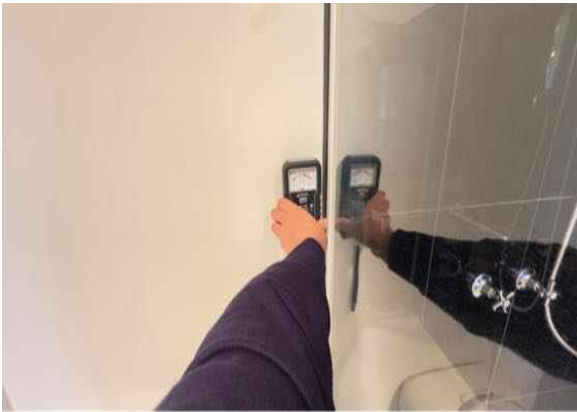
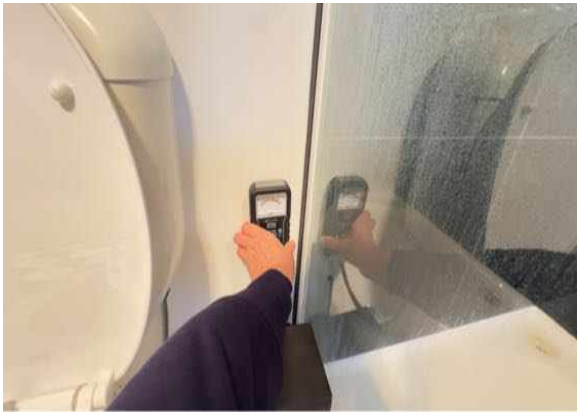
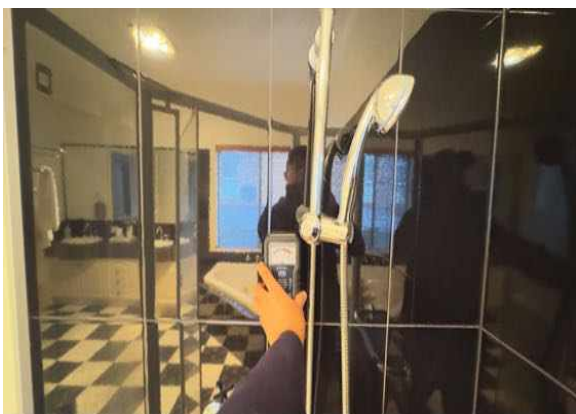
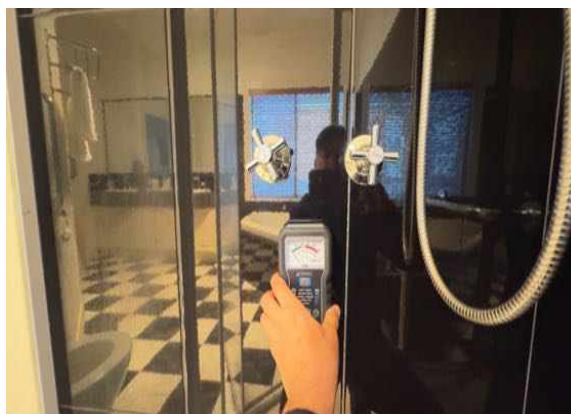
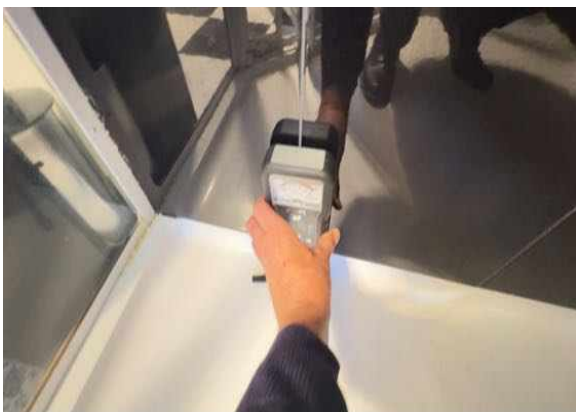
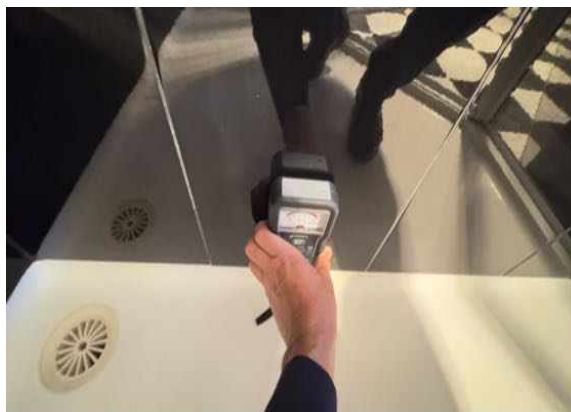
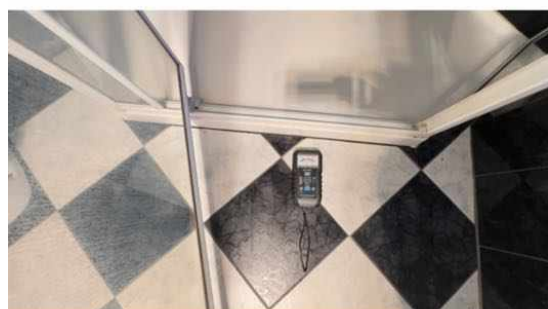
Building: Main Building
 Location: All Areas Interior & Exterior
 Finding: Moisture Levels - Advisory - No Elevated Moisture Levels Present
 Information: At the time of inspection, no elevated moisture levels were detected in these areas. Moisture readings were taken (using a Tramex Moisture Meter) and non-invasive testing methods and reflect conditions present at the time of inspection only. This item is noted for advisory purposes and should not be relied upon as a guarantee that moisture issues are not present elsewhere or may not occur in the future.

It is important to note that moisture levels can fluctuate due to weather conditions, plumbing usage, seasonal changes, or intermittent leaks. Concealed moisture within wall cavities, subfloor areas, or other inaccessible locations may not be detected during a visual or limited moisture assessment.

Ongoing monitoring of the property is recommended, and further investigation by a qualified tradesperson should be considered if signs of water ingress, dampness, staining, mould growth, or material deterioration become apparent.

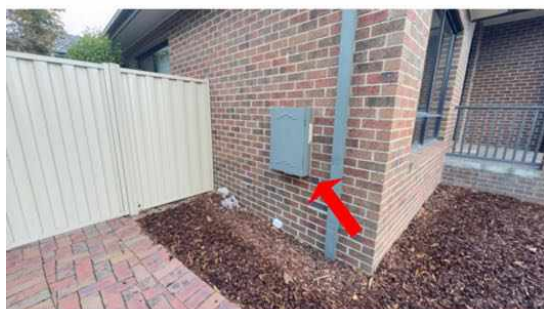
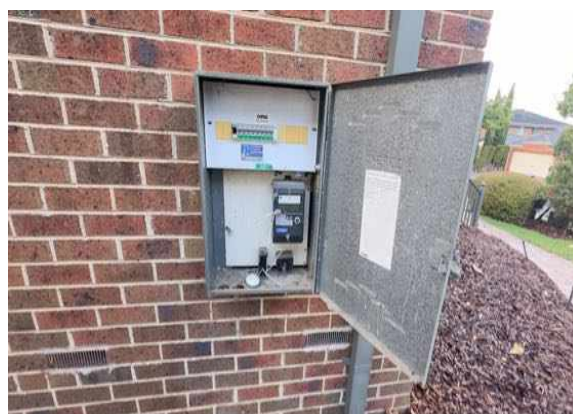
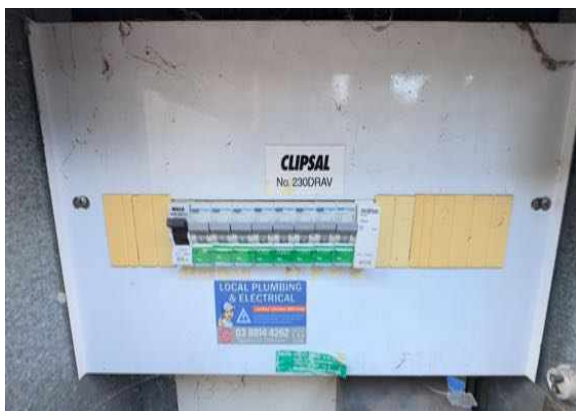
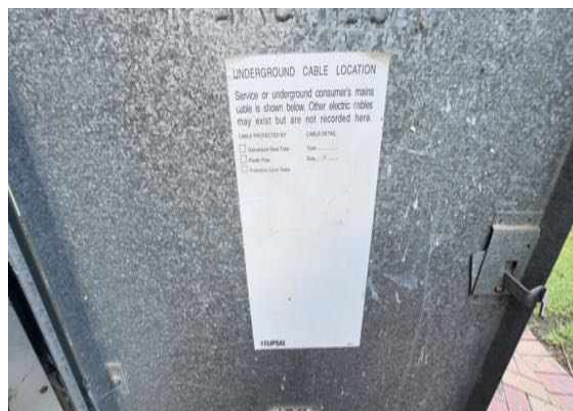
(AS 4349.1-2007: Electrical Switchboard & meter inspections are for your information only, as functional testing is outside the scope of a standard pre-purchase building inspection.)

For full compliance and safety verification, a licensed electrician should be engaged to inspect the switchboard, test all circuits, and ensure all components are functioning correctly. This will help maintain electrical safety and prevent potential hazards.
