Building and Timber Pest Inspection Report

Inspection Date: Fri, 27 Mar 2026

Property Address: 61 Pitfield Cres, Rowville VIC 3178,
Australia

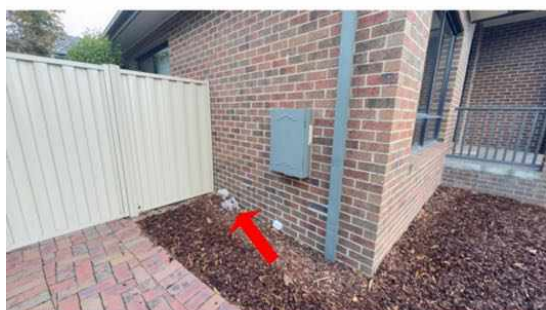
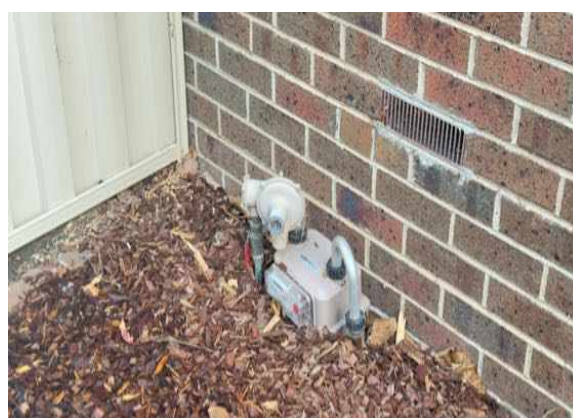
Building: Main Building
 Location: All External Areas
 Finding: Gas Meter - Location For Your Information
 Information: The gas meter was inspected and photographed for reference and location purposes only.

Gas meters can be affected over time by age, environmental exposure, or accidental impact, which may lead to corrosion, physical damage, leakage, or non-compliance with current regulations. Regular checks are recommended to ensure ongoing safe operation.

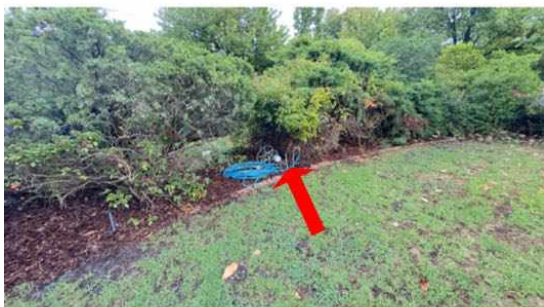
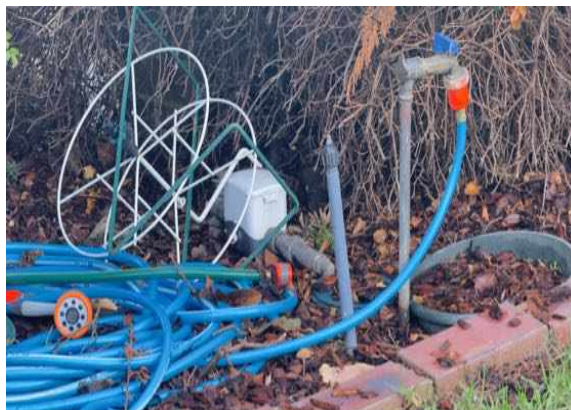
Building:	Main Building
Location:	All External Areas
Finding:	Water Meter - Location For Your Information Only
Information:	The water meter was photographed at the time of the inspection. The meter is included for reference & location purposes only.

Water meters can be affected over time by age, environmental exposure, accidental impact, or poor maintenance. Potential issues could include leaks, corrosion, or malfunction that may impact water supply or cause water damage.

It is recommended that a licensed plumber carry out routine inspections and maintenance to ensure continued safe and compliant operation. Observations are for informational purposes only and do not form part of a full safety or compliance inspection.

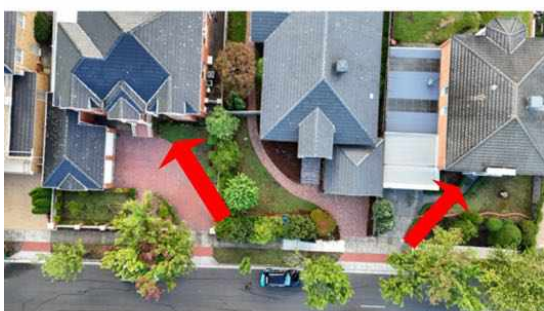
(AS 4349.1–2007: inspection of neighbouring properties is not included in standard pre-purchase building inspections; this statement is for your information only.)

Recommendation: For concerns regarding noise, encroachments, or structural issues affecting neighbouring properties, it is recommended to engage relevant specialists (e.g., acoustic consultant, building surveyor, or a registered builder) and/or contact the local council.

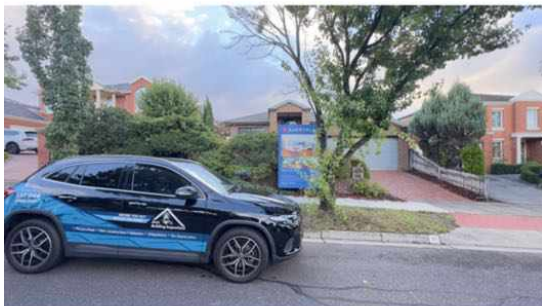
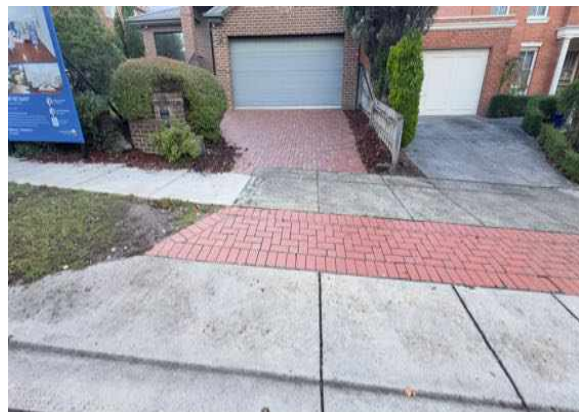
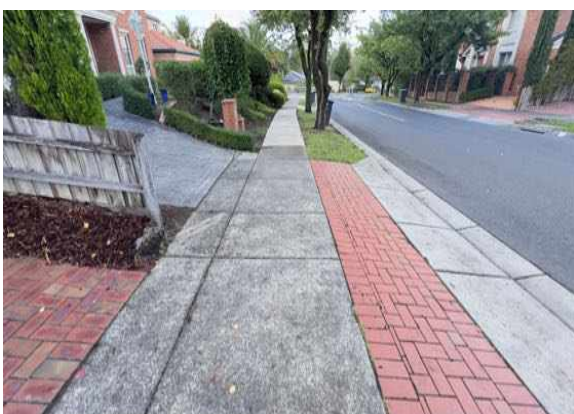
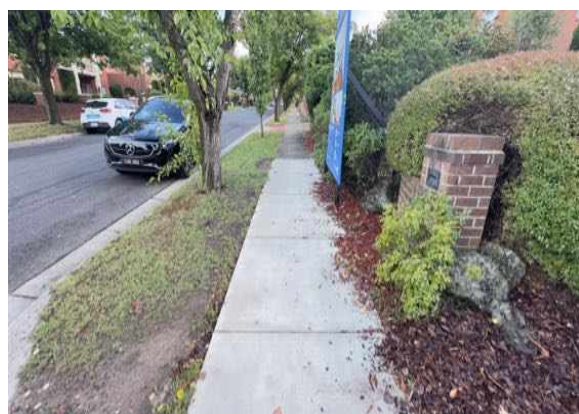
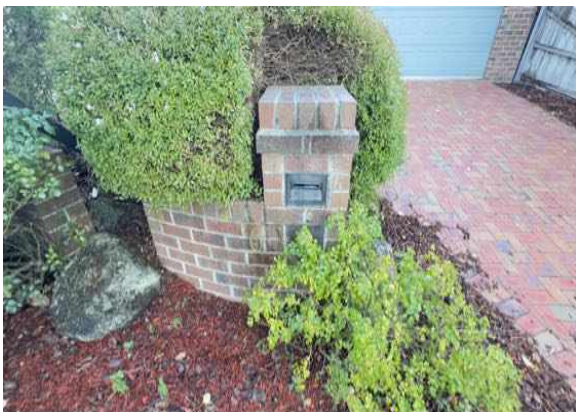
During the inspection, minor cracking, surface wear, or uneven sections were observed on footpaths or crossovers. Some accessible metal components, such as street signage or grates, showed signs of rust or deterioration. Debris accumulation and vegetation encroachment were also noted around council infrastructure. Access or visibility was limited to certain council-owned assets.

These areas should be monitored, and for detailed assessment, maintenance, or compliance verification, the relevant local council authority should be contacted immediately. Regular monitoring of adjacent council assets is recommended to ensure ongoing safety and proper maintenance.
