## Building Inspection Report

Inspection Date: Wed, 1 Apr 2026

Property Address: 46 Sparrow St, Cranbourne VIC 3977,  
Australia

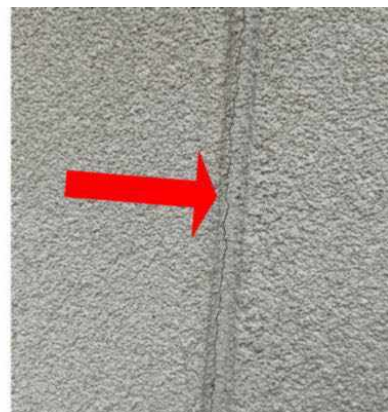
When these joints are covered by rigid finishes such as render, the ability of the structure to move freely is reduced. This can lead to cracking in the render or adjacent building elements over time, and may also contribute to moisture ingress if movement causes gaps or fractures in the render.

It is recommended that the rendered-over section be carefully removed to expose the expansion joint, and the joint reinstated with an appropriate flexible sealant or control joint system to ensure it continues to function as intended.

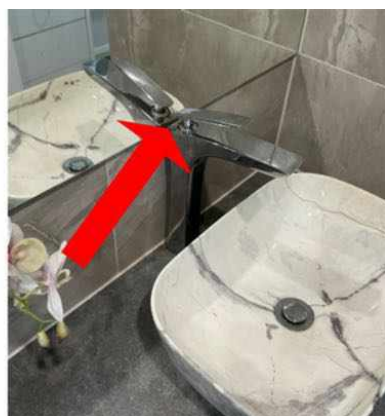
### Defects 3.03

Building: Main Building  
 Location: Ensuite - Master  
 Finding: Ensuite Tap Fixtures Impacting Mirror  
 Information: Both ensuite basin tap fixtures were observed to make contact with the mirror when

This condition may result in repeated impact during normal use, leading to potential damage to the mirror surface and premature deterioration of the tap fixtures. Continued use in this manner increases the likelihood of cracking or breakage of the mirror, posing a safety hazard.

It is recommended that a licensed plumber replace the existing tap fixtures with suitably sized or appropriately designed fittings that provide adequate clearance from the mirror, ensuring safe operation without contact or risk of damage.

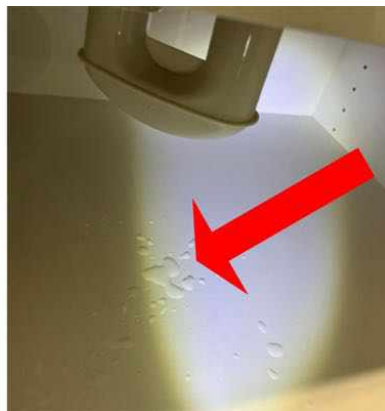
### Defects 3.04

Building:	Main Building
Location:	Bedroom - Master
Finding:	Tap - Leaking
Information:	The RHS tap in the master ensuite was found to be leaking at the time of inspection. This is a common defect that is consistent with general ageing of the building element. However, it may be indicative of substandard plumbing workmanship if the tap is relatively new.

While this defect only seems minor, if left unmanaged, it is likely to result in the

development of rust, water damage and/or extensive water usage.

It is advised that a handyman or licensed plumber be appointed to perform remedial works on the affected tap. Such works should be performed prior to the development of secondary defects to ensure adequate functionality of all associated building elements.

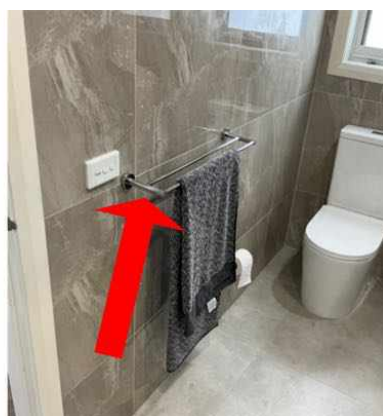
### Defects 3.06

Building:	Main Building
Location:	Ensuite - Master
Finding:	Towel rail - loose
Information:	The towel rail was found to be loose at the time of inspection. While not a major operational defect, function can deteriorate if the problem is left unmanaged.

It is advised that the homeowner performs remedial works to re-attach the towel rail to its original fixing. A general handyperson may be required to perform these works.

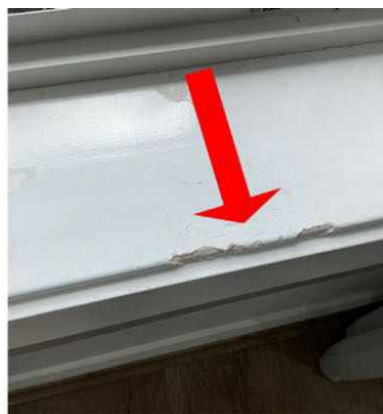
### Defects 3.07

Building:	Main Building
Location:	Ensuite - Master
Finding:	Window frame - Scuffed
Information:	Superficial scuff marks were noted to the window frame of the master bedroom at the time of inspection. Marked and scuffed surfaces, while detracting from the overall appearance of the affected building element, do not indicate any operational or structural damage. This degree of surface damage is consistent with general wear and tear.

Marked surfaces may be left at client discretion, as no repair/replacement is necessarily required. Marked surfaces are unlikely to result in the development of secondary damage; however, the client may wish to seek quotations for the cost to refurbish or replace the affected wall linings.

A general handyperson or professional painter may be appointed to rectify marked or scuffed surfaces at the client's discretion.

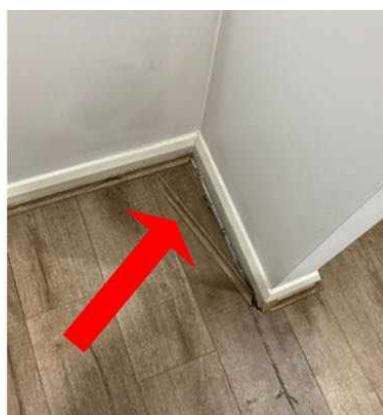
### Defects 3.08

Building:	Main Building
Location:	Pantry - Walk In
Finding:	Floor trim - Detached
Information:	The floor trim in the walk-in pantry has detached, indicating improper installation, wear and tear, or possible movement in the flooring. This defect may pose a trip hazard and affect the overall finish of the flooring. Rectification should involve securely refixing or replacing the trim using appropriate fixing methods to ensure durability and compliance with Australian Standards for flooring installation. A professional handyman can be allocated to completed this task at client's discretion.

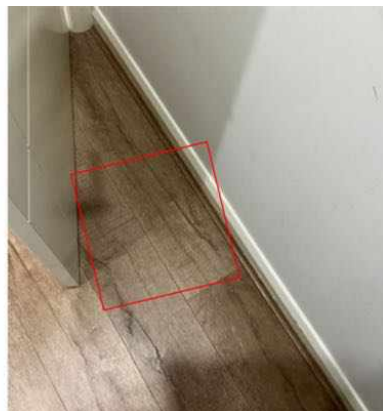
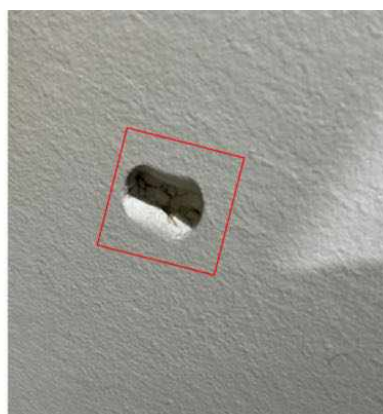
### Defects 3.09

Building:	Main Building
Location:	Pantry - Walk In
Finding:	Missing Door Stop Causing Wall Damage
Information:	No door stop was installed in the walk-in pantry, resulting in the door handle impacting the adjacent plaster wall. Minor damage to the plaster surface was observed behind the door as a result.

This condition allows ongoing contact between the door hardware and wall surface,

which may lead to further deterioration of the plaster and potential damage to the door handle over time.

It is recommended that a suitable door stop be installed by a qualified carpenter or handyman to prevent further impact. The damaged plaster wall can be patched, sanded, and repainted by a qualified plasterer or painter as required.

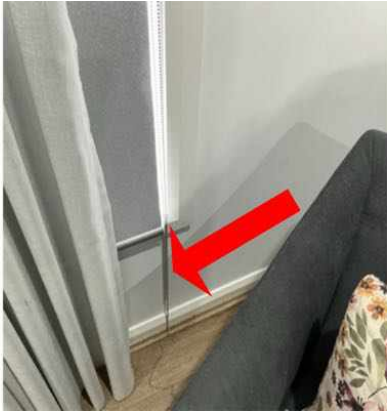
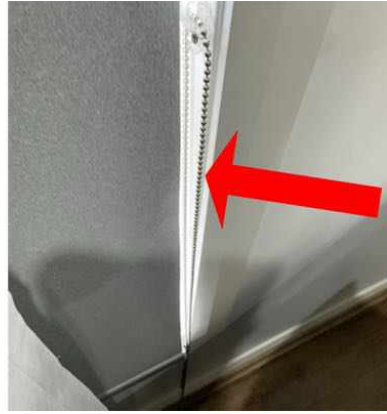
### Defects 3.10

Building: Main Building  
 Location: Lounge Room  
 Finding: Damaged Lounge Room Blind Chain  
 Information:

The blind chain in the lounge room was observed to be detached from the track and appears to be cut, rendering the blind inoperable at the time of inspection.

This condition prevents normal operation of the blind and may lead to further damage to the blind mechanism if force is applied during use.

It is recommended that the blind chain be replaced or the blind assembly repaired by a professional handyman or blind specialist. Replacement can be carried out at the client's discretion depending on functional requirements.

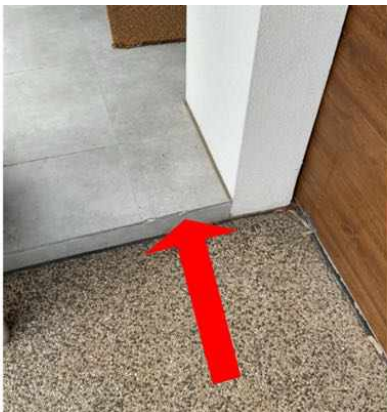
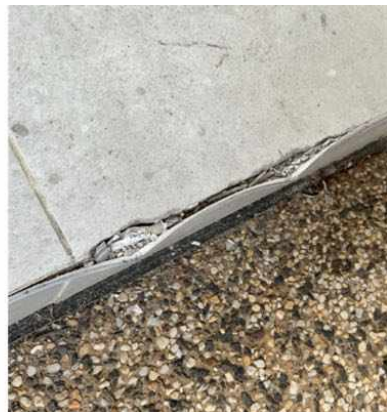
### Defects 3.11

Building: Main Building  
 Location: Porch  
 Finding: Damaged Porch Tile Edge and Trim  
 Information:

Minor damage was observed to the edge of a tile at the front porch entry, where the tile appears scuffed with slight chipping. The adjacent tile edge trim has also been affected.

This condition is cosmetic in nature; however, damaged tile edges may worsen over time and can present a minor trip hazard or lead to further deterioration if left unaddressed.

It is recommended that a qualified tiler carry out repairs or replacement of the affected tile and edge trim as required. Rectification can be undertaken at the client's discretion.

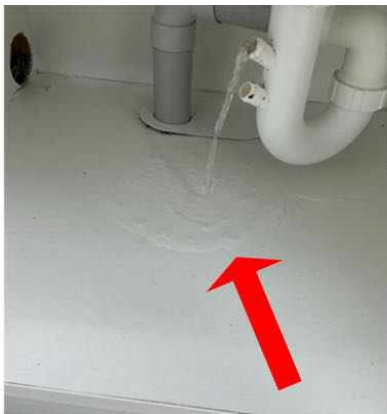
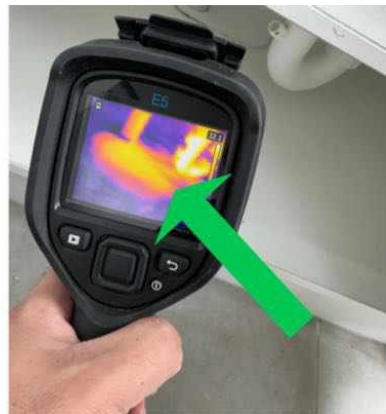
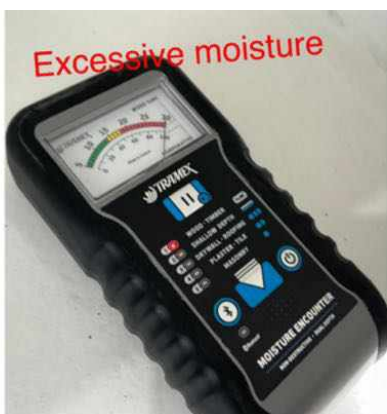
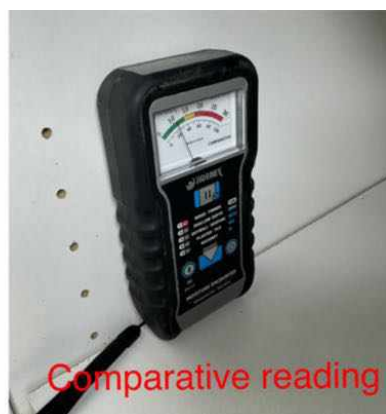
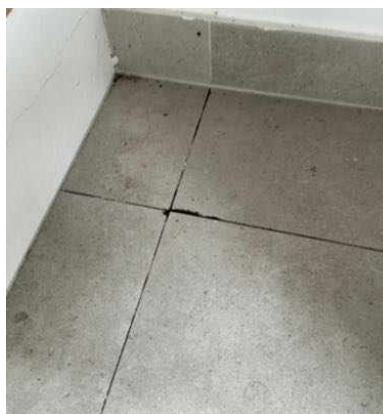
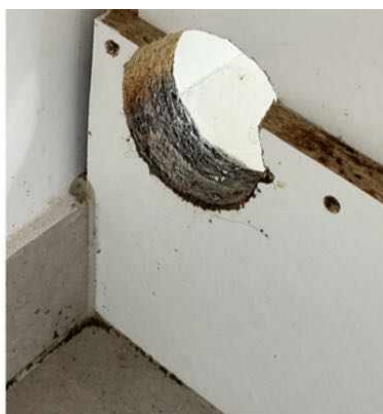
### Defects 3.12

Building: Main Building  
 Location: Laundry  
 Finding: Laundry Tap Leak and Associated Moisture Damage  
 Information: The laundry tap plumbing was observed to be leaking into the cabinetry below, with

visible water damage to the underlying shelving. Signs consistent with mould growth and a musty odour were noted within the cabinet when the tap was in use. Additionally, the adjacent tiled flooring within the washing machine recess shows indications of moisture exposure, with possible mould presence and prior water damage.

This condition indicates an ongoing or previous water ingress issue, which may lead to further deterioration of cabinetry materials, potential mould proliferation, and damage to surrounding building elements if not addressed. Prolonged moisture exposure may also impact indoor air quality and contribute to unhealthy living conditions.

It is recommended that a licensed plumber be engaged without delay to investigate and rectify the source of the leak, and to assess the extent of any concealed moisture damage. Following rectification, a suitable mould remediation specialist and/or qualified trades (such as a cabinet maker or tiler) should be engaged as required to repair or replace affected materials and ensure the area is properly dried and restored.

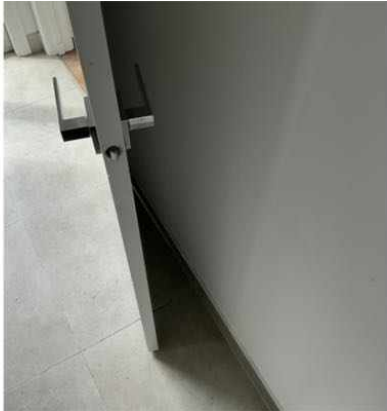
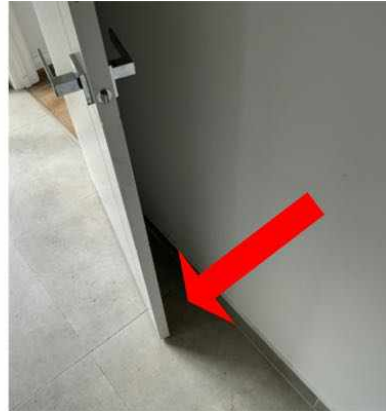
### Defects 3.13

Building:	Main Building
Location:	Laundry
Finding:	Door stop - Missing
Information:	The door stop is missing or is inadequate to stop the door handle from damaging the wall. Although some building elements may seem irrelevant or unnecessary, all building elements play a key role in the operation and function of the overall structure and its performance.

Re-installation or replacement of the door stop is advised as soon as possible to prevent any subsequent damage to the door or associated structures. A general handyman may be appointed to perform these works at client discretion.

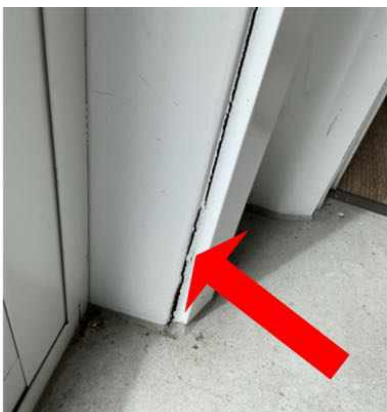
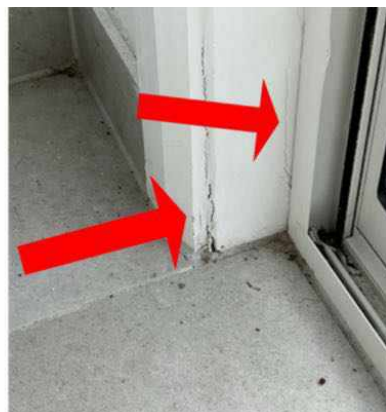
### Defects 3.14

Building: Main Building  
 Location: Laundry  
 Finding: Minor Splitting to Laundry Sliding Door Frame  
 Information:

Minor splitting was observed at the base of the sliding door frame in the laundry. This is likely associated with past moisture exposure or previous water ingress; however, no elevated moisture readings were detected in door frame at the time of inspection.

This condition is currently minor and appears stable; however, if left unattended, the splitting may worsen over time, particularly in a moisture-prone environment such as a laundry.

Repairs can be undertaken at the client's discretion, including filling, sanding, and repainting the affected area. A qualified painter or carpenter can carry out the necessary rectification works as required.

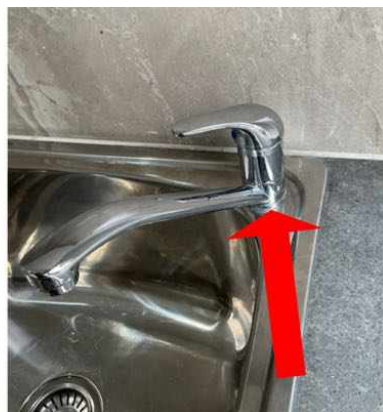
### Defects 3.15

Building: Main Building  
 Location: Kitchen

Finding: Tap - Loose  
 Information: The tap in laundry sink has deteriorated with age, and is consequently loose. This tap being loose creates potential for water leaks and subsequent water damage to the surrounding area.

Where taps or spouts are loose, a qualified plumber should be appointed to re-fix the plumbing fitting.

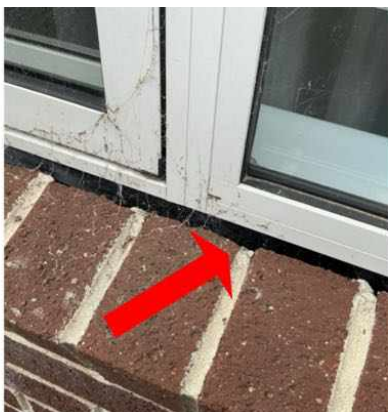
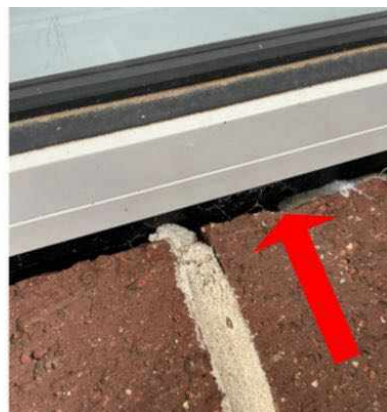
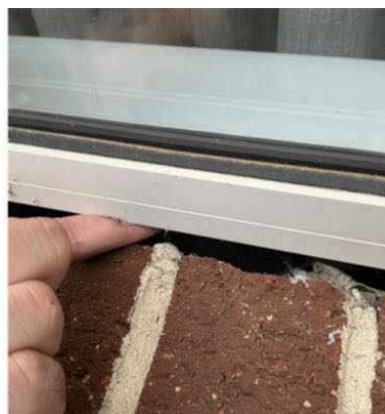
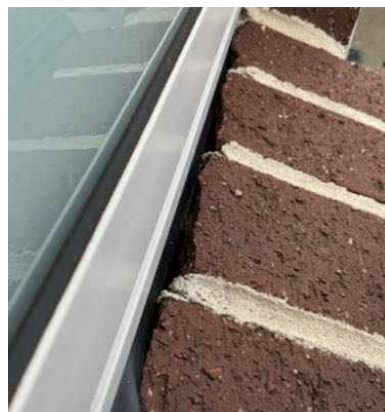
### Defects 3.17

Building: Main Building  
 Location: Exterior walls - right side  
 Finding: Inadequate Sealing to External Window Frames (RHS Elevation)  
 Information:

The two external windows located on the right-hand side of the property (when facing the house) were observed to have the bottom rubber seals tucked into the brickwork, creating a noticeable gap between the window frames and the surrounding masonry.

This condition compromises the watertightness of the window installation and may allow water ingress during rainfall, potentially leading to internal moisture damage, deterioration of building materials, and mould development if left unaddressed.

It is recommended that a qualified caulking specialist be engaged without delay to properly seal around the affected window frames, ensuring all gaps are filled and the installation is made fully watertight in accordance with standard practice.

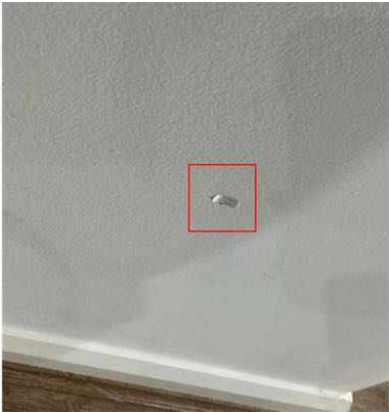
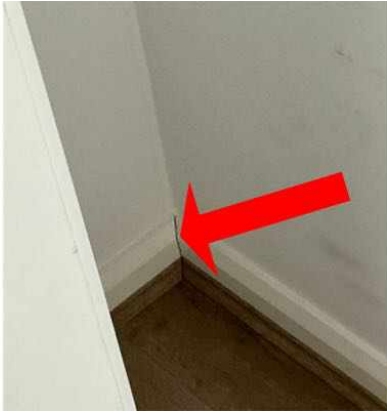
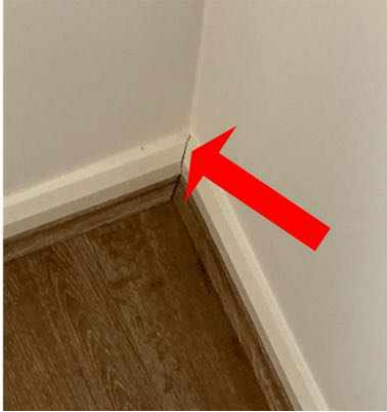
**Defects 3.19**

Building: Main Building  
Location: All Internal Areas  
Finding: General Wear and Tear to Internal Finishes  
Information:

Minor signs of wear and tear were observed at the time of inspection, including small chips to wall surfaces and minor cracking and splitting to sections of skirting boards and door frames.

These conditions are consistent with normal ageing, minor building movement, and day-to-day use, and do not represent significant structural concerns. However, they may affect the overall aesthetic condition of the property.

Repairs can be undertaken at the client’s discretion, including patching, filling, sanding, and repainting by a qualified painter or carpenter as required.

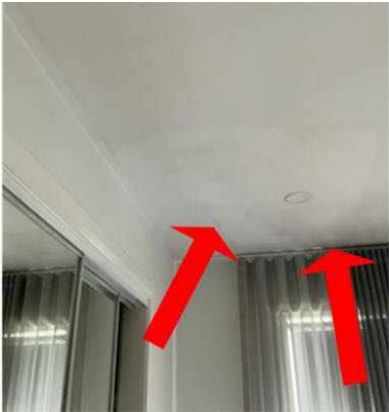
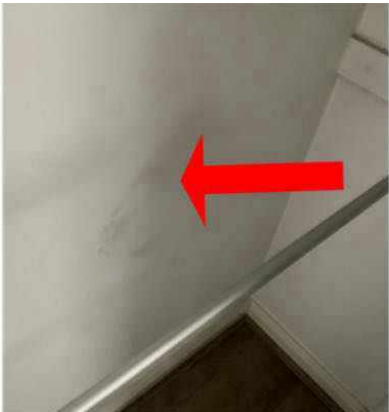
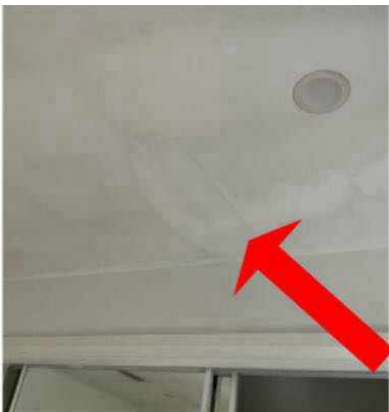
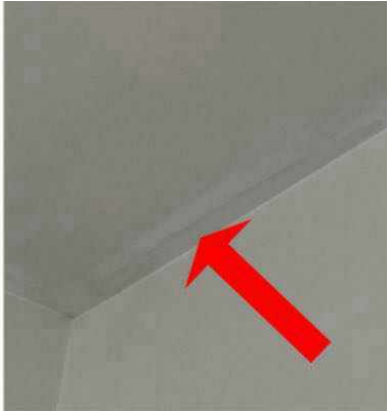
### Defects 3.20

Building: Main Building  
 Location: Bedrooms 3 and 4  
 Finding: Widespread Ceiling and Wall Staining – Bedrooms 3 and 4  
 Information:

Widespread dark staining was observed in Bedroom 3, particularly across the ceiling, within the wardrobe, and to sections of the walls. Similar staining was also noted in Bedroom 4. The exact cause of the staining could not be confirmed at the time of inspection.

This condition is generally consistent with prolonged exposure to airborne contaminants such as smoke, soot, or other environmental factors. While primarily

cosmetic, the staining may be difficult to remove fully and can affect the overall presentation and indoor environment if not addressed.

It is recommended that a professional cleaning service be engaged initially to attempt removal of the staining. If unsuccessful, repainting of the affected surfaces by a qualified painter will likely be required to restore the rooms to an acceptable condition.

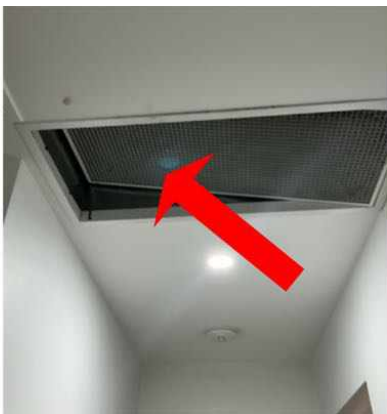
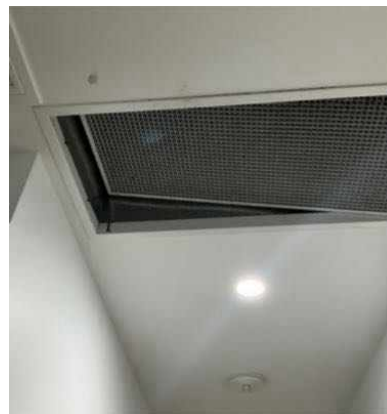
### Defects 3.21

Building: Main Building  
 Location: Hallway 2  
 Finding: Dislodged Ceiling Return Air Grille  
 Information:

This condition may affect the efficiency of the HVAC system, allow dust and debris to enter the ducting, and poses a risk of the grille becoming fully detached over time if not properly secured.

It is recommended that a qualified HVAC technician or handyman refit and securely fix the return air grille, ensuring it is properly aligned, fully seated, and adequately supported within the ceiling opening.

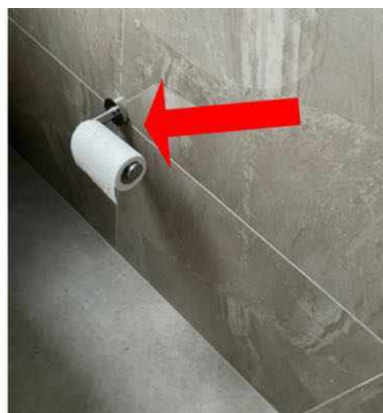
### Defects 3.22

Building: Main Building  
 Location: Toilet (WC)  
 Finding: Toilet roll holder - Loose  
 Information:

The toilet roll holder was found to be loose at the time of inspection. While not a major operational defect, function can deteriorate if the problem is left unmanaged.

It is advised that the homeowner performs remedial works to re-attach the toilet roll holder to its original fixing. A general handyman may be required to perform these works.

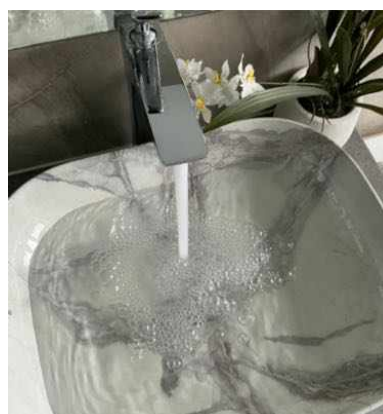
### Defects 3.23

Building:	Main Building
Location:	Bathroom 3
Finding:	Slow Drainage in bathroom 3 Vanity Sink
Information:	Upon inspection, the bathroom 3's vanity sink was found to have very slow drainage, resulting in water pooling within the basin during use. This issue is typically associated with a partial blockage within the sink drain, which may lead to further plumbing complications if left unaddressed. Additionally, prolonged pooling of water can contribute to bacterial growth and potentially cause damage to surrounding cabinetry or surfaces due to excess moisture.

It is recommended that a licensed plumber be engaged to inspect and clear any obstructions within the drainage system as soon as possible to restore proper functionality and prevent further issues. Regular maintenance of sink drains is also advised to ensure efficient water flow.

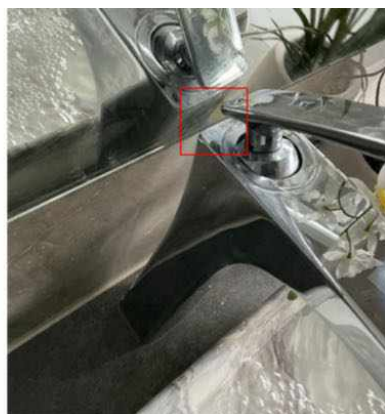
### Defects 3.24

Building:	Main Building
Location:	Bathroom 3
Finding:	Tab fixture affecting mirror
Information:	The basin tap fixtures was observed to make contact with the mirror when operated, indicating insufficient clearance between the tap fitting and the adjacent wall-mounted mirror.

This condition may result in repeated impact during normal use, leading to potential damage to the mirror surface and premature deterioration of the tap fixture. Continued use in this manner increases the likelihood of cracking or breakage of the mirror, posing a safety hazard.

It is recommended that a licensed plumber replace the existing tap fixture with suitably sized or appropriately designed fittings that provide adequate clearance from the mirror, ensuring safe operation without contact or risk of damage.

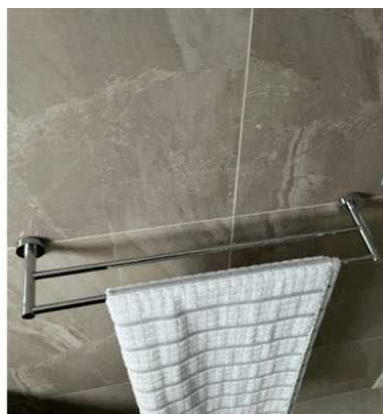
### Defects 3.25

Building:	Main Building
Location:	Bathroom 3
Finding:	Towel rail - loose
Information:	The towel rail was found to be loose at the time of inspection. While not a major operational defect, function can deteriorate if the problem is left unmanaged.

It is advised that the homeowner performs remedial works to re-attach the towel rail to its original fixing. A general handyman may be required to perform these works.

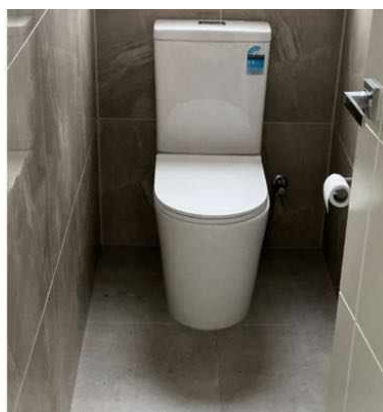
### Defects 3.26

Building: Main Building  
 Location: Toilet (WC)  
 Finding: Continuously Running WC Toilet Cistern  
 Information:

The toilet within the WC was observed to be continuously filling with water at the time of inspection, indicating that the cistern was not shutting off properly. The issue persisted until the water supply was manually isolated.

This condition suggests a fault within the cistern components (such as the inlet valve or float mechanism), which may result in ongoing water wastage, increased utility costs, and potential overflow risk if left unaddressed.

It is recommended that a licensed plumber be engaged without delay to inspect the cistern mechanism, identify the faulty components, and carry out the necessary repairs or replacements to restore proper operation.

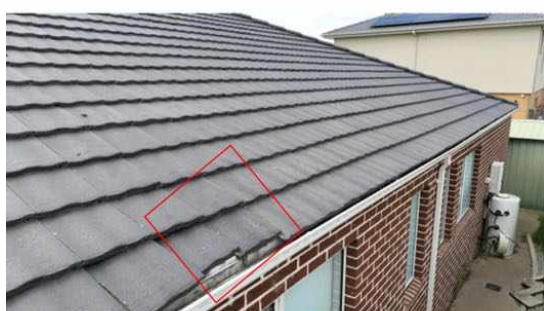
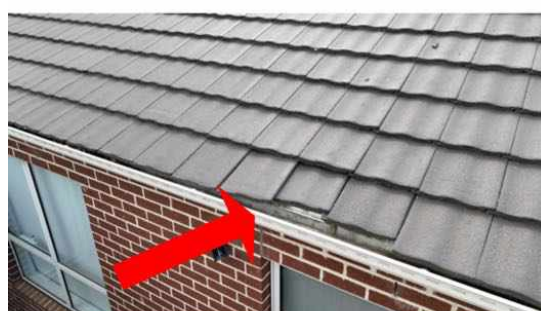
### Defects 3.27

Building: Main Building  
 Location: Roof Exterior  
 Finding: Dislodged and Damaged Roof Tiles  
 Information:

Several roof tiles along the eaves line were observed to be misaligned and slightly displaced, with visible irregular gaps between adjacent tiles. In addition, multiple roof tiles were found to be cracked and broken.

This condition may allow water ingress beneath the tiles during rainfall, potentially affecting the underlying timber structure. Cracked tiles further compromise the integrity of the roof covering and increase the likelihood of leaks and ongoing deterioration if not addressed.

It is recommended that a qualified roof tiler be engaged to realign and properly seat the displaced tiles, and to replace all cracked and damaged tiles. The surrounding roof area should also be checked to ensure all tiles are secure and the roof is watertight.

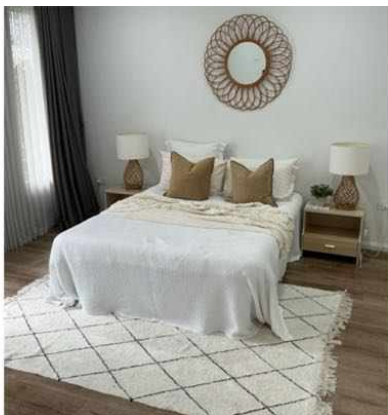
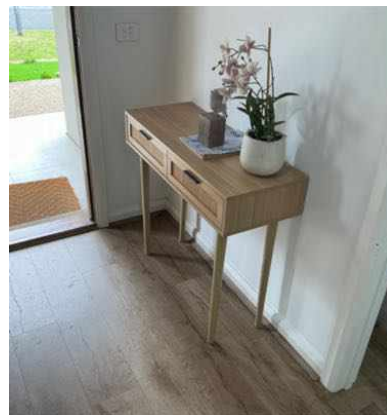
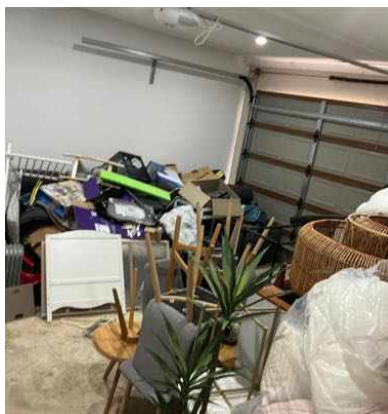
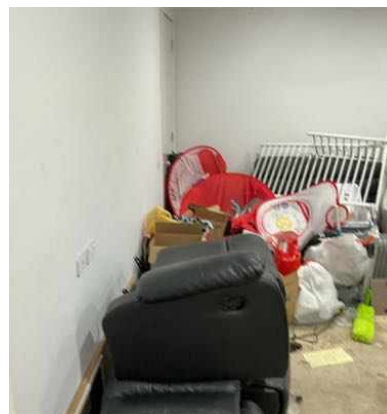
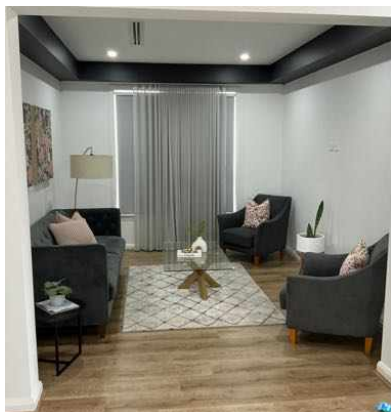
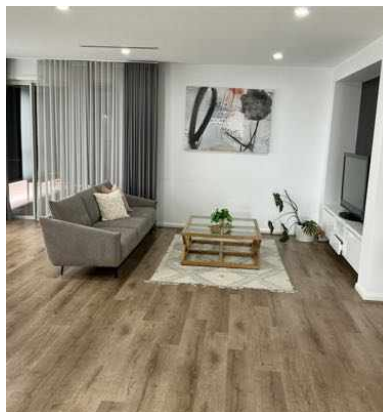
Building: Main Building  
 Location: All Areas  
 Finding: Obstructions and Limitations - Interior  
 Information: These photographs are an indication of the obstructions and limitations which impeded the inspection of the internal areas of the property at the time of inspection. These obstructions can hide an array of defects and should be removed to allow full inspection to be carried out. A re-inspection is recommended once the areas are made accessible.

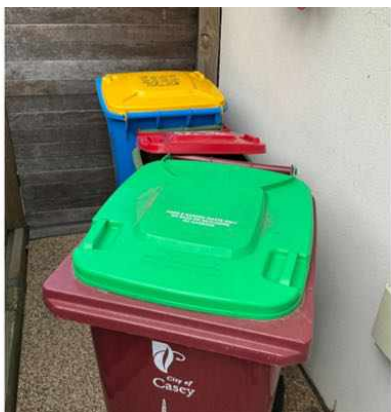
Building: Main Building  
 Location: All External Areas  
 Finding: Obstructions and Limitations - Exterior  
 Information: These photographs are an indication of the obstructions and limitations which impeded the inspection of the external areas of the property at the time of inspection. These obstructions can hide an array of defects and should be removed to allow full inspection to be carried out. A re-inspection is recommended once the areas are made accessible.

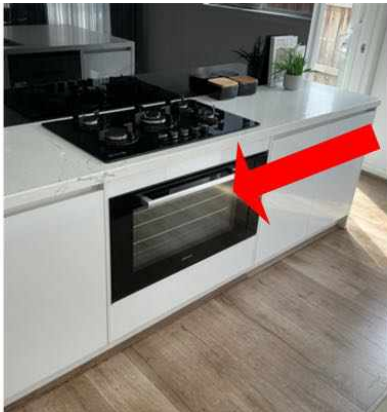
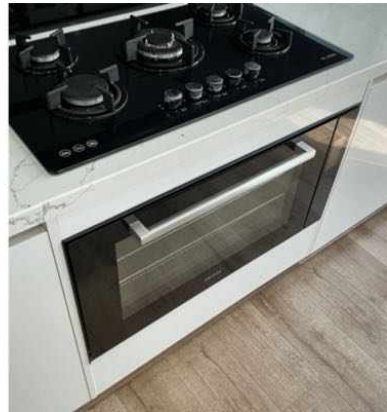
Building: Main Building  
Location: Kitchen  
Finding: Oven Not Tested  
Information:

As a result, the operational condition and functionality of the appliance could not be confirmed, and any existing faults or defects may not have been identified.

It is recommended that the client arrange for testing of the oven prior to settlement, or engage a qualified electrician or appliance technician to assess its functionality if required.
