Building and Timber Pest Inspection Report

Inspection Date: Fri, 27 Feb 2026

Property Address: 13 Lakelands Dr, Dapto NSW 2530, Australia

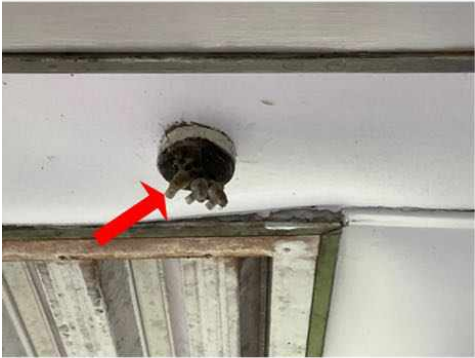
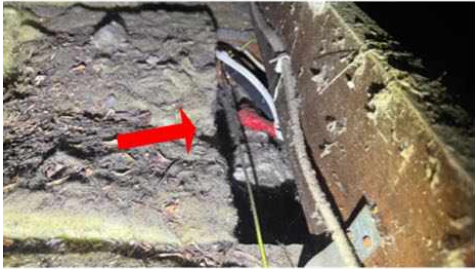
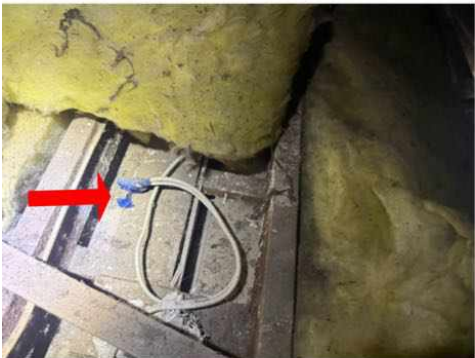
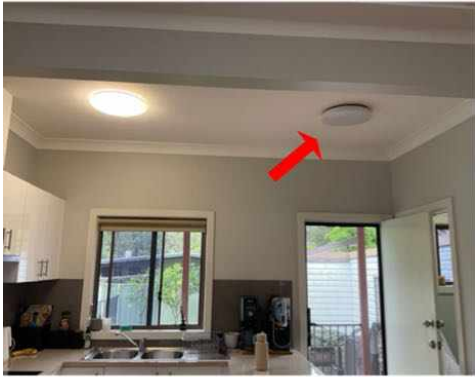
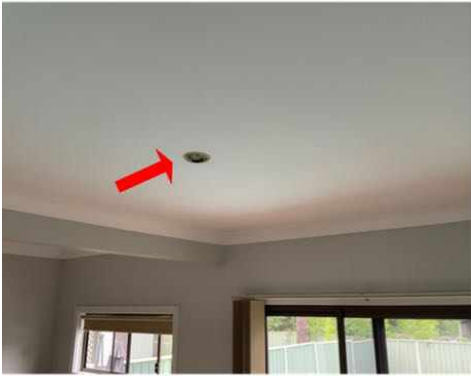
Building: Building 1
Location: Roof Cavity and verandah
Finding: Electrical cables missing a junction box
Information: The electrical fitting in this roof area was found to be missing a junction box at the time of inspection.

This missing fitting and loose cables does expose electrical works, and may create a safety hazard if there is potential contact with persons in the area.

Also the rear bedroom gold light and one kitchen do not work .

A Licensed electrician should be appointed to rectify these areas immediately.

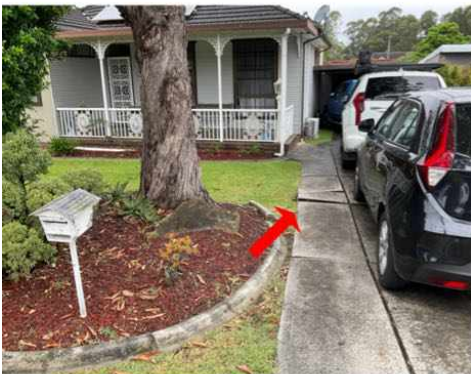
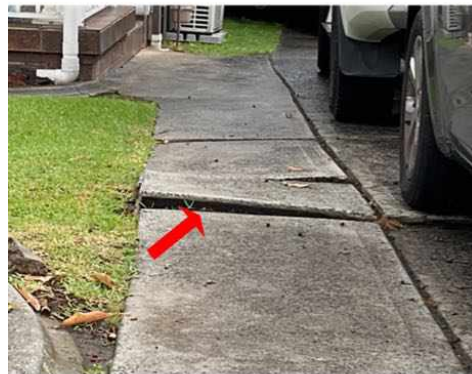
Finding 1.02

Building: Building 1
 Location: Driveway
 Finding: Crack in concrete slab - Category 4
 Information: A crack coded as Category 4 was identified in the driveway slab. A Category 4 crack is described as a crack that appears as a gap in the slab, with disturbing curvature or change in level affecting the slab.

The approximate width of the crack or gap is 4mm-10mm or a change in offset of greater than 25mm when a 3m straight edge is placed over the defect.

Category 4 cracking to slabs exceeds allowable Standards and Tolerances, and are therefore considered as major and safety defects that require rectification.

This is now a trip hazard to all persons.

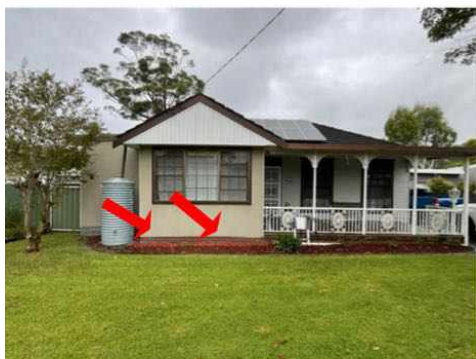
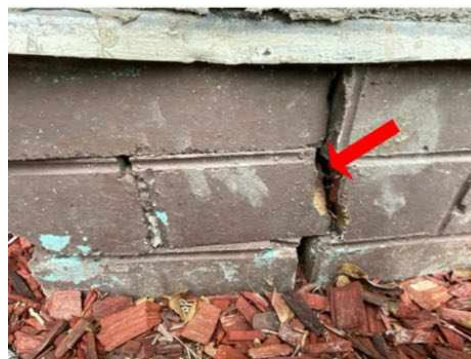
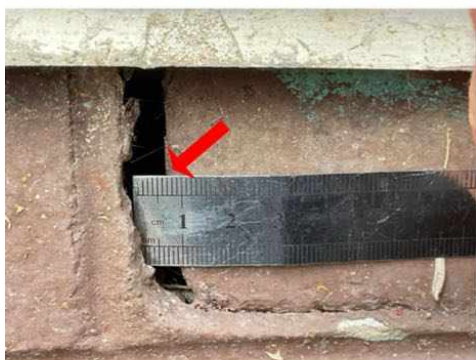
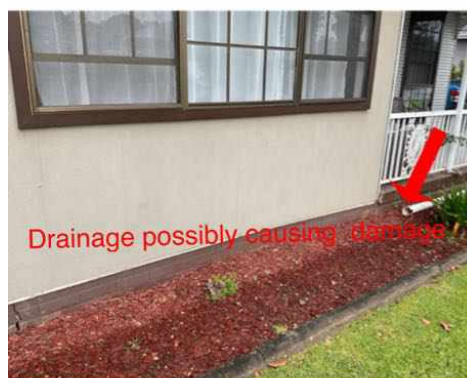
Finding 2.01

Finding: Step cracking to brickwork major
Information: Step cracking was identified to the brickwork in two front external wall areas at the time of inspection.

The NSW Standards and Tolerances 2017 states cracks over 5mm in width are a major defect requiring rectification work. This applies to photo 1 -3 in the subfloor wall.

Other minor step cracking was also found in this wall. The left side of this wall has subsided with an obvious curvature of the brickwork evident. This is likely to be the reason the fibre cement wall cracking above.

Step cracking, which is similar to other forms of cracking, has a variety of possible causes. However, the most common is the subsidence of adjacent footings.

As the downpipe from the right side of the house disgorges water on this area, this may be a contributing factor in this subsidence and cracking.

Where step cracking is extensive or severe here and this subsidence is present, the client is advised to consult a structural engineer before purchase. Minor step cracking can be used as a warning sign to address factors causing stress to the wall, which can include the effect of surrounding trees, water leaks, soil erosion, or even the presence of reactive soils in the surrounding area.

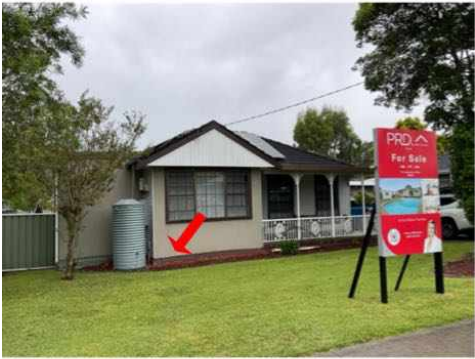
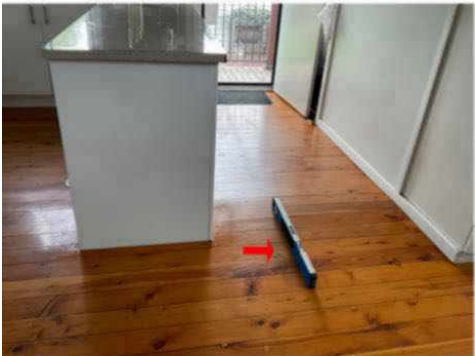
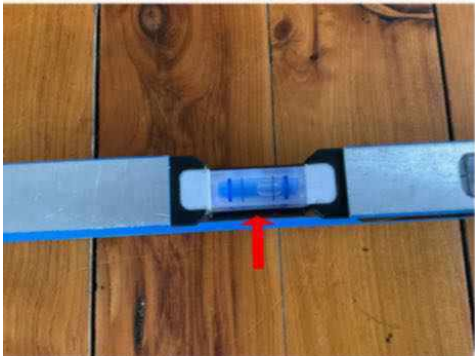
Finding 2.02

Building:	Building 1
Location:	Many areas
Finding:	Subsidence to most north east & south east rooms
Information:	It appears that the house and many other areas has been affected by movement of the foundations, often referred to as sinking or subsidence.

This is evidenced by the curvature front brickwork, very uneven flooring, bedroom wall and ceiling cracks, cracked concrete, cracked verandahs tiles, cracked render etc.

Photos 1-7 show extensive movement and photos 8-10 show minor external paving movement. Whilst a small degree of movement is expected in over time, especially as environmental conditions change and buildings 'settle' after construction, this degree of movement in the left and rear of the house requires attention.

General subsidence is usually initiated by changes in soil moisture content. The most critical factor is identifying the specific cause.

Subsidence can have complex and varying causes, which will influence the required remedial works. It is advised to begin by consulting a structural engineer to determine the required scope of works. This generally includes some form of underpinning, as well as addressing the underlying cause. Consultation with a geotechnical engineer may also be necessary where changes to soil moisture content is apparent.

A Registered Builder would then generally carry out works as advised by an Engineer.

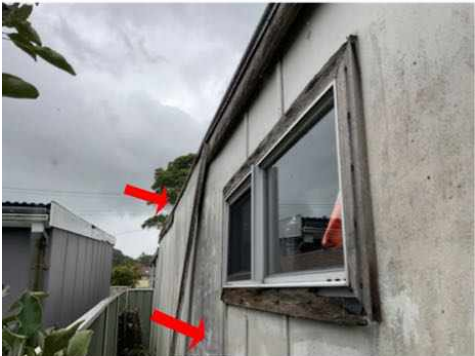
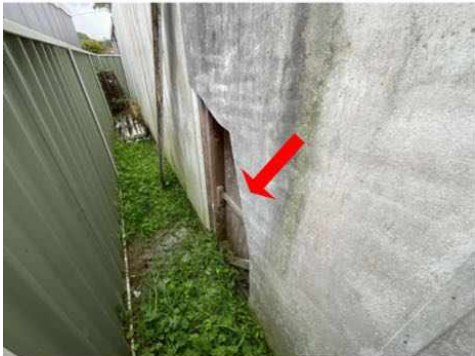
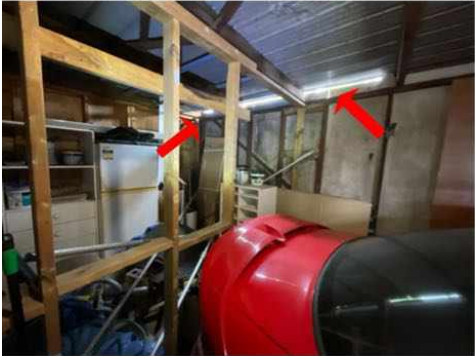
Finding 2.03

Building: Building 1
Location: Pictured external rear right shed area
Finding: Cladding damaged
Information: Evidence of damage was identified to the right rear shed side wall where the cladding has cracking damage and the eave board has exposed the frame.

A carpenter would be the trade responsible for urgently rectification of this wall area to prevent further damage.

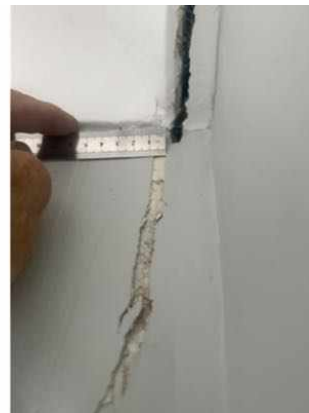
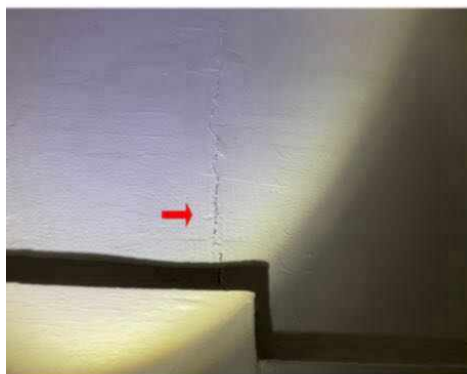
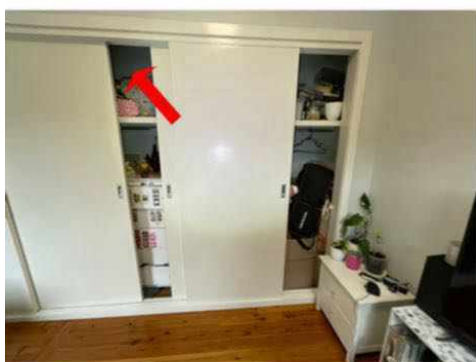
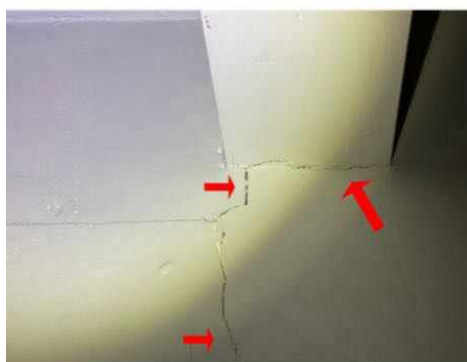
Finding 3.01

Building:	Building 1
Location:	Front bedrooms and other areas
Finding:	Cracking - Damage Category 3 - Repair Required (5mm-15mm or a grouping or cluster of cracks of 3mm or more)
Information:	Cracks of up to 8mm were evident in the front bedrooms. Cracks of this type are likely to have been caused by movement of building elements, but may also have a structural cause that is more significant. Cracking of this degree may result in doors and windows sticking or jamming, but may have more serious implications, such as fracturing service pipes. Weather tightness (the ability to resist rain and wind) is also often impaired, creating potential for the development of secondary defects.

A crack of this size may be repaired. However, these repairs may also include further works, such as easement of associated window and door frames that are jamming, as well as more extensive filling, sanding and/or repainting.

It is highly recommended to gain quotations on repair and restoration works that are required. Always contact your building inspector should cracks widen, lengthen or become more numerous.

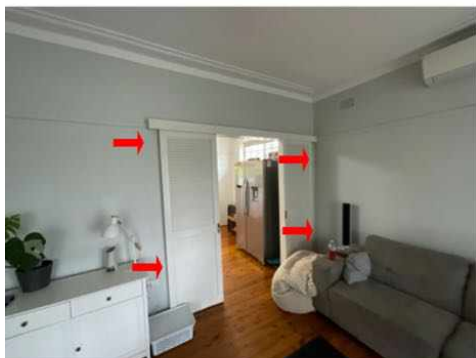
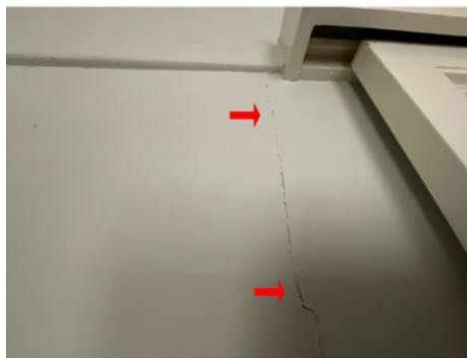
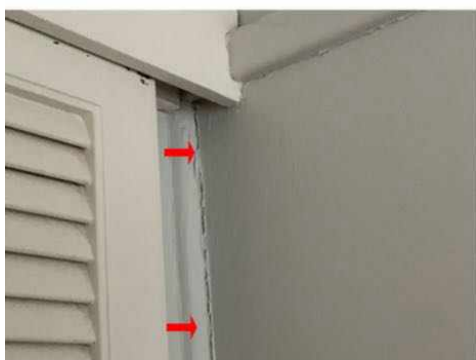
Finding 3.02

Building:	Building 1
Location:	Lounge room
Finding:	Cracking - Damage Category 2 - Noticeable (up to 5mm)
Information:	Noticeable cracks are a common occurrence as a result of many primary defects. Such causes may include age, expected building movement, general expansion/contraction of building materials in different weather conditions, and/or minor failings in the installation or application of building materials. Monitoring of all cracking should be conducted frequently. It is suspected the very wet subfloor under this area is contributing to these cracks.

Relevant tradespeople, such as carpenters, painters and plasterers, should be appointed to perform remedial works, as deemed necessary.

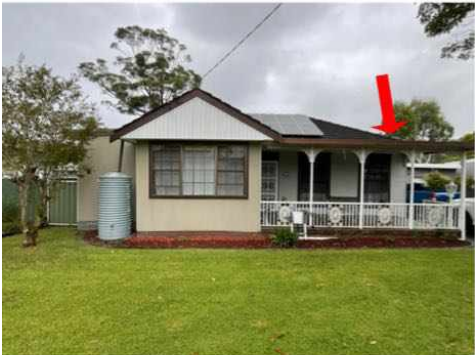
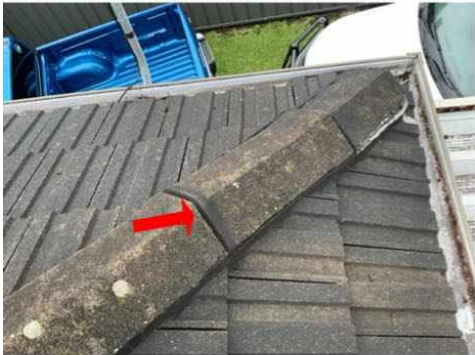
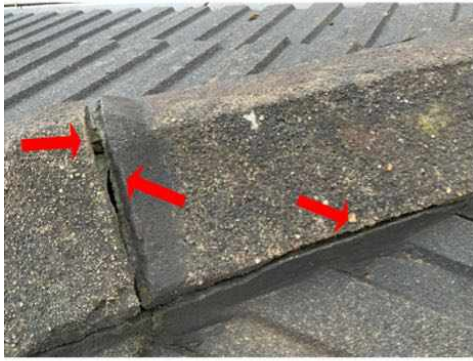
Finding 3.04

Building: Building 1
Location: Roof Exterior - right front
Finding: Roof tiles - Slippage
Information:

Upon inspection of the exterior roof covering, it was noted that some tiles have slipped from their original fixing. Tiles may slip over time due to a number of causes, including breakage of tiles, failings in the adjoining battens, or fixings that may have failed.

Roof tiles that have moved from their original position are very likely to allow water penetration into the roof void, exposing roofing structures to excessive moisture. This creates an environment that is conducive to water damage and accelerated deterioration of all associated building elements.

Replacement of loose or missing roofing tiles is recommended immediately to prevent the development of any secondary defects. A roofing restoration specialist should be appointed to complete such works as necessary.

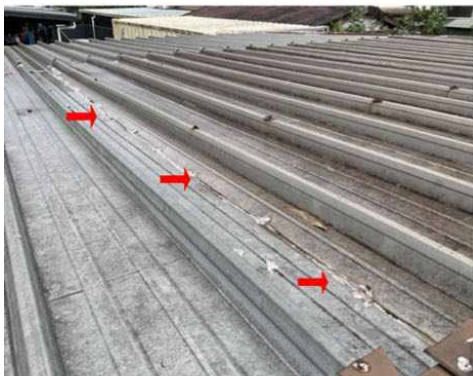
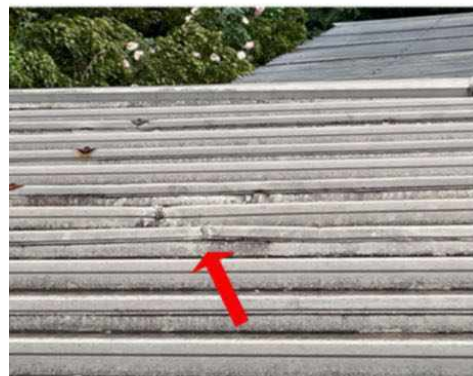
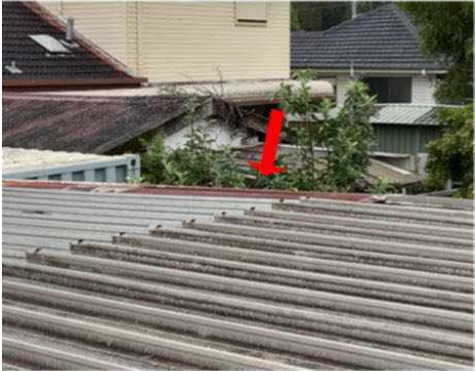
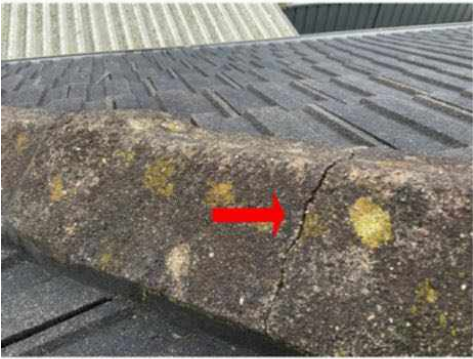
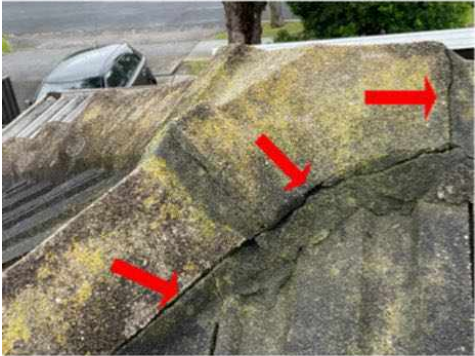
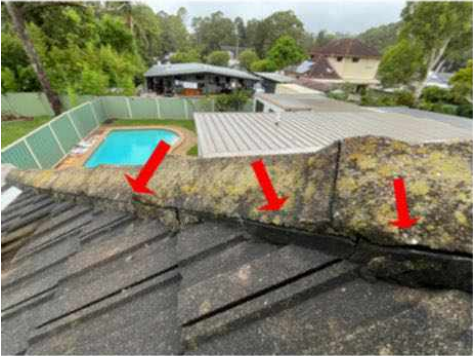
Finding 3.05

Building:	Building 1
Location:	Roof Exterior
Finding:	Roofing areas - Weathered
Information:	Upon inspection of the exterior roofing, the majority of the roof areas were considered to be in a fair condition. While weathering of these pictured areas is consistent with the age of the property, maintenance works are required.

Re-sealing and replacing small areas of gaps, damage or rust the may be considered as an interim solution by the client to help preserve and extend the life span of these roofing areas. Where left unmanaged, deteriorating roofing materials are likely to lead to a number of secondary defects, including minor water leaks and weather exposure to internal roofing structures.

Consultation with a roofing contractor is urgently advised to gain advice on cost of remedial works prior to purchase.

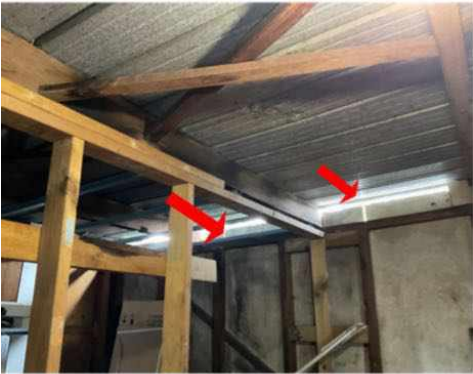
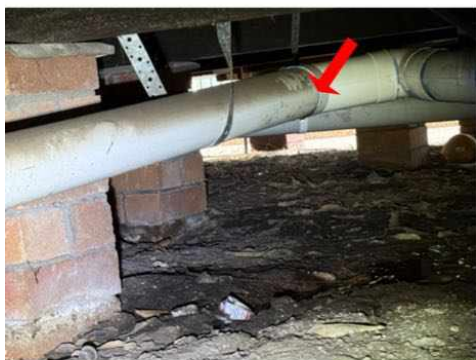
Finding 3.06

Building:	Building 1
Location:	Subfloor - left middle
Finding:	Water leaks - Active
Information:	An active water leak was found in the subfloor, the pipe originating at the front left of the house. Regardless of the location, even minor leaks that are left unmanaged can lead to serious damage of associated building elements and result in the need for replacement of building materials.

It is highly advised that the leak be repaired immediately by a licensed plumber to prevent any further damage.

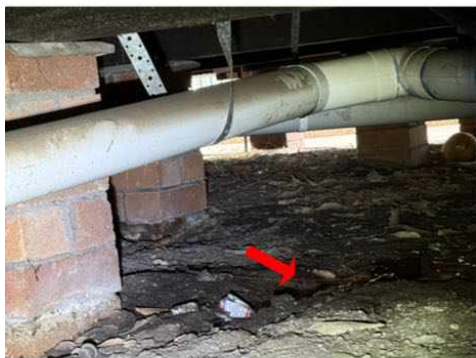
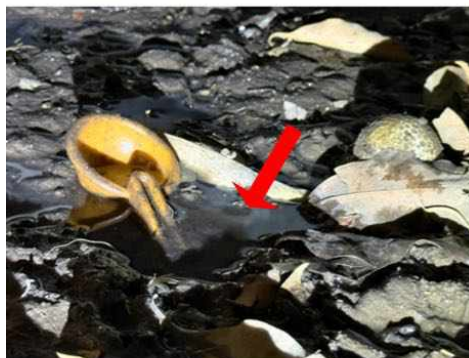
Building:	Building 1
Location:	Subfloor
Finding:	Foundations - adjacent water pooling
Information:	Water pooling near foundations and footings is a serious concern with the potential to adversely impact on the longevity of the dwelling. The Building Code of Australia (BCA) outlines that the soil must be graded away from the dwelling at a minimum of 50mm over 1m (1:50 fall). Any subfloor moisture and rotting wood debris is also attractive to termites.

A qualified plumber should be appointed to further inspect the entire property and perform any remedial works as necessary. Secondary defects are likely to occur if left unmanaged.

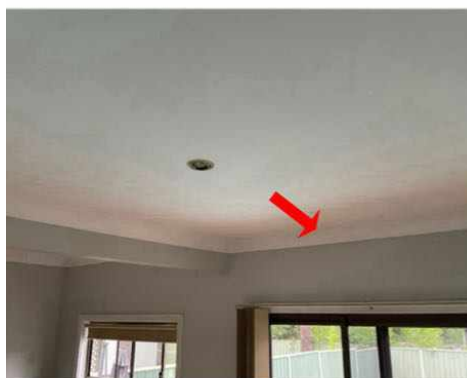
Building:	Building 1
Location:	Front & rear bedrooms
Finding:	Ceilings show minor deflection evident
Information:	Some ceilings were found to show minor deflections at the time of inspection. Where minor sagging of cornice or ceilings is evident, comparatively minor works, such as re-gluing of ceiling sheets, may be required. Such works may be performed by relevant tradespeople, such as plasterers and painters. Where excessive moisture has caused the roofing structure to swell and sag, the source of the water leak should primarily be identified prior to any remedial works being performed.

issues, causing surfaces to warp, twist or sag, or that structural timber elements have been weakened from termite activity. Where sagging appears to be major, appointment of a structural engineer is advised to further inspect the property and identify the cause of the damage and determine the rectification works required.

The appropriate action should be taken by the client as soon as possible to ensure that any potential further damage is limited.

An invasive inspection is required to remove timber/ roof tiles to check the cause of the deflection in these bedrooms.

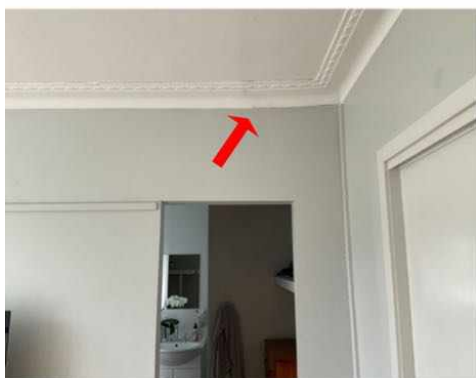
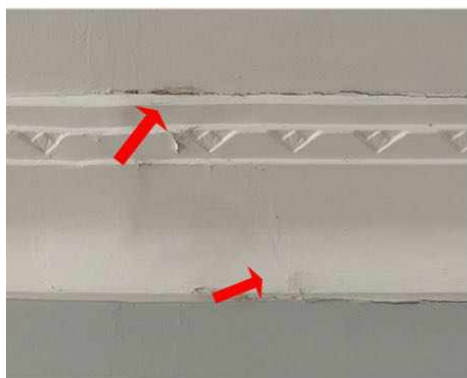
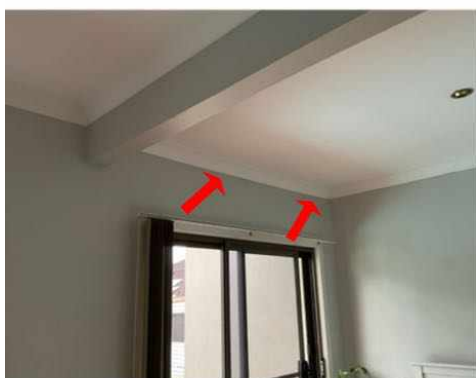
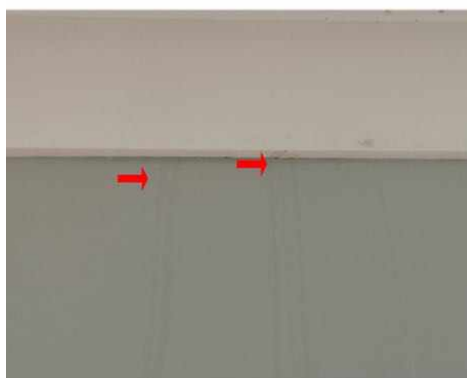
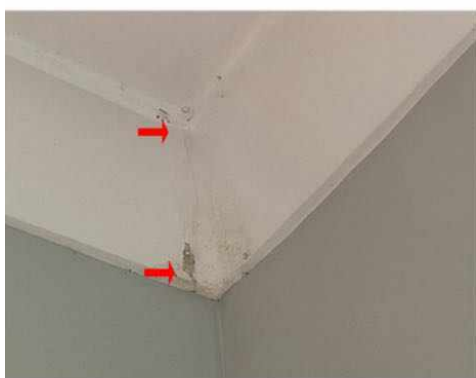
Finding 3.11

Building:	Building 1
Location:	Front & rear bedrooms
Finding:	Ceiling - Water stained
Information:	Water staining to ceiling / wall linings in these areas was evident at the time of inspection. Water staining indicates that surfaces have been exposed to excessive moisture over time. The minerals and other elements in the water lead to staining, which may graduate to corrosion and deterioration if left unmanaged.

While mostly an appearance defect, water staining can be indicative of more serious defects, which may be currently concealed by interior ceilings.

Where water staining is active, a licensed plumber must be consulted to identify the cause of the staining and to provide advice on any reparation works that may be required. Replacement of any damaged structures is advised.

Conversely, where water staining is old and inactive, affected building materials may be repaired or replaced at client discretion.

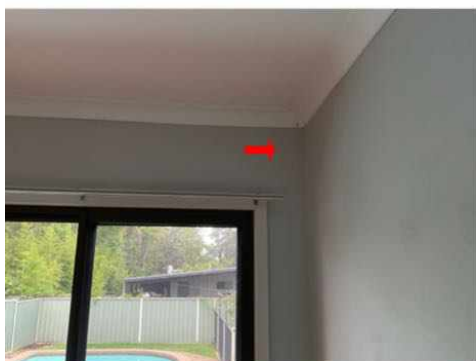
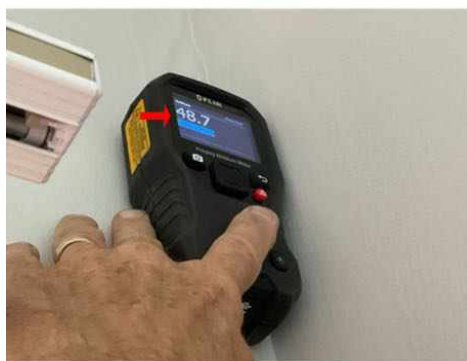
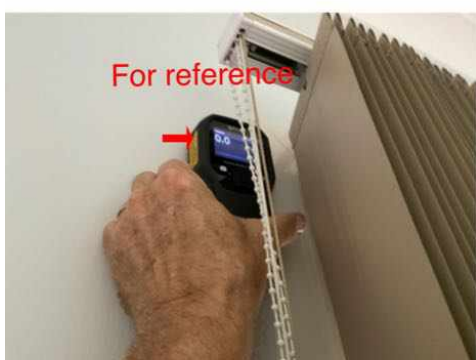
Finding 3.12

Building:	Building 1
Location:	Rear Bedroom
Finding:	Evidence of excessive moisture was present at the time of inspection
Information:	Excessive moisture of 48.7 was recorded in the rear bedroom. Nearby areas showed zero readings for reference. This can attract termites and produce conditions that promote termite attack, fungal growth and wood decay. Excessive moisture is generally caused by deteriorated, inadequate or missing roof drainage, leaking plumbing pipes or fixtures, poorly plumbed HWS overflows or condenser units and poor site drainage. It is highly recommended that all plumbing and drainage fixtures and fittings be maintained regularly in order to prevent excessive moisture being

present in the internal property.

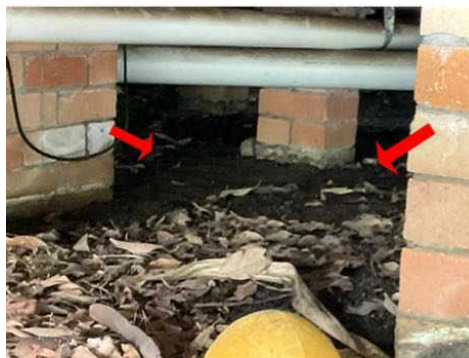
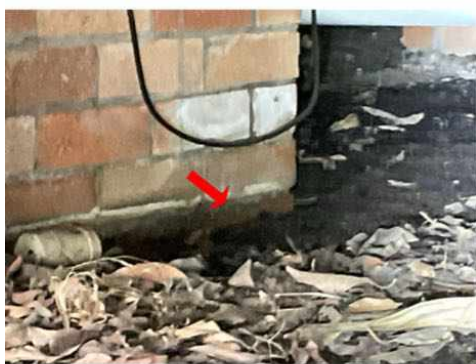
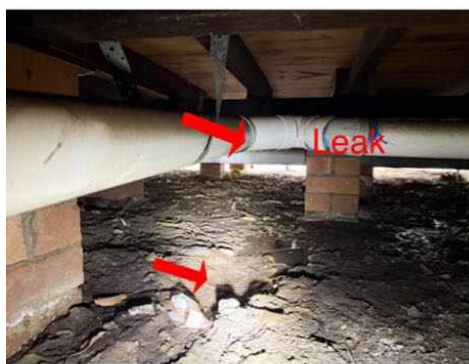
Finding 3.13

Building:	Building 1
Location:	Front wall and subfloor areas
Finding:	Site drainage - Inadequate
Information:	The site drainage many areas was found to be inadequate at the time of inspection, creating potential for subsequent water damage to associated building elements.

Water staining and wet ground in many subfloor areas suggests these areas get runoff in large rain events. An active water leak was found in the middle left subfloor area.

The unplumbed front downpipe would also feed into the subfloor area. The right wall downpipes lying in the ground and some have cracked.

Where site drainage is inadequate, installation of an Agricultural (Aggie) Drain and repairs are required. A qualified plumber should be appointed to further inspect the

entire property and perform any remedial works as necessary. Secondary defects are likely to occur if left unmanaged.

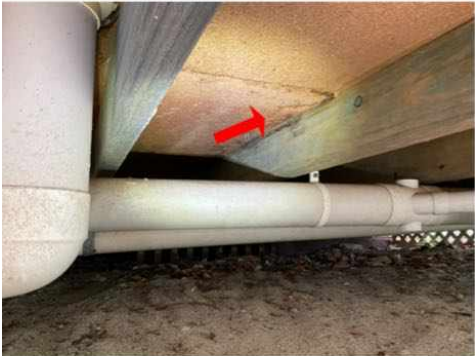
Finding 3.14

Building: Building 1
 Location: Subfloor - right front
 Finding: Water staining
 Information: Water staining was evident in this area at the time of inspection. Water staining indicates that surfaces have been exposed to excessive moisture over time. The minerals and other elements in the water lead to staining, which may graduate to corrosion and deterioration if left unmanaged.

While mostly an appearance defect, water staining can be indicative of more serious defects, which may be currently concealed by other building elements.

Where water staining is active, a licensed plumber must be consulted to identify the cause of the staining and to provide advice on any reparation works that may be required. Replacement of any broken or damaged structures is advised.

Conversely, where water staining is old and inactive, affected building materials may be repaired or replaced at client discretion. A qualified carpenter or registered builder may be appointed to perform these works.

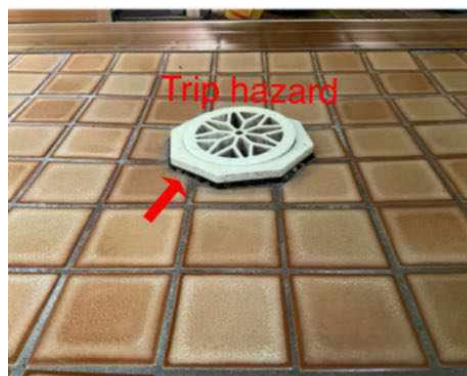
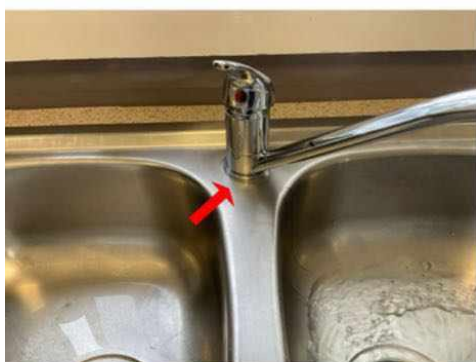
Building: Building 1
Location: Driveway and other areas
Finding: Substandard electrical and plumbing areas
Information: Sub standard and incomplete work are determined by identifying a failure to achieve the minimum requirement set out in the mandated Australian Standard as outlined in the Building Code of Australia and referenced by the Manufacturers Guideline.

The power to the rear buildings is loosely hanging inbetween the buildings with no fixings at either end.

Some plumbing pipes sit on the ground adjacent to the driveway. One pipe has already cracked allowing rainwater to flood the driveway. These pipes should be buried to prevent impact damage. A plumber needs to rectify the defect to stop further damage. This has already cracked allowing rainwater to flood the driveway.

The rear bathroom floor waste protrudes from the tiling preventing water from entering this drain. The kitchen sink tap also leaks into the sink at the base.

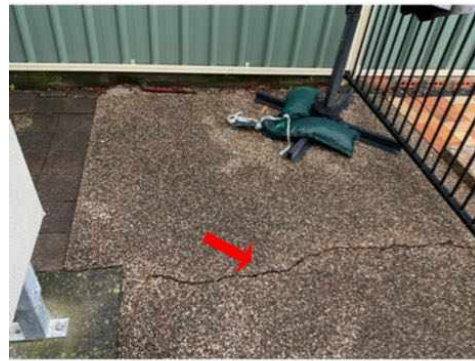
Finding 3.17

Building:	Building 1
Location:	Yard - front and rear
Finding:	Crack in concrete slabs - Category 1
Information:	Cracks coded as Category 1 was identified in front and rear slabs. A Category 1 crack is described as a fine but noticeable crack, with the slab at an otherwise reasonable level. To be considered Category 1, the approximate width of the crack is less than 1.0mm, or a less than 10mm change in offset when a 3m straight edge is placed over the defect.

Category 1 cracks should be monitored for a period of 12 months. At the end of the monitoring period, identified cracks that are rated greater than Category 2 are considered defects, and require rectification.

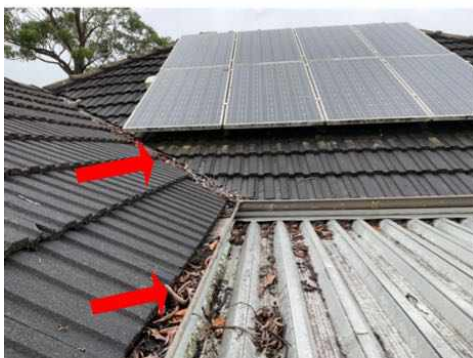
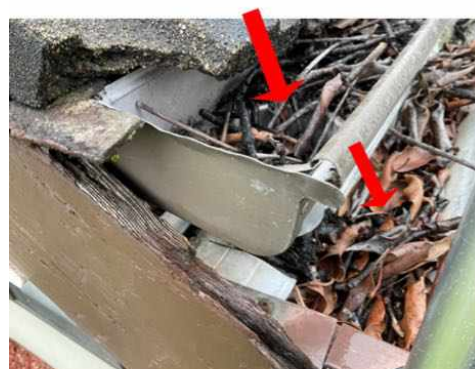
Finding 3.18

Building:	Building 1
Location:	Roof exterior
Finding:	Gutters - Full and blocked
Information:	The guttering on around the roof was found to be blocked at the time of the inspection. Roof plumbing structures, such as guttering and downpipes, should be free of all debris to prevent blockages. Blockages of the guttering and downpipes will lead to pooling and accumulated water overflows, which is likely to subsequently flood eaves and exterior walls.

Blocked gutters are likely to lead to high levels of moisture in the affected areas which can cause rust and decay of the gutters and downpipes and wood rot to adjoining timber areas. Blockages in gutters should therefore be removed immediately to ensure dry conditions are maintained.

It is highly advised that gutters be cleaned by the homeowner or a general handyperson as a matter of urgency.

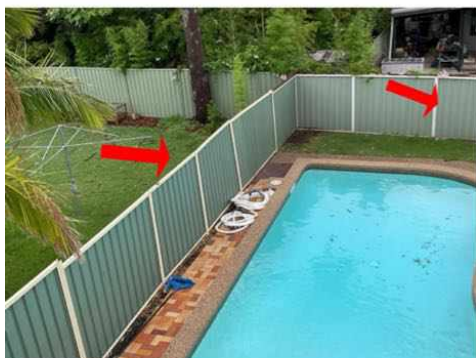
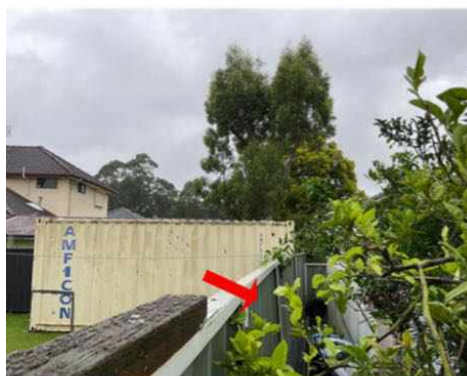
Finding 3.19

Building:	Building 1
Location:	Pictured fences

Finding: Fences damaged - leaning
 Information: Evidence of damage to the pictured fences was identified at the time of the inspection. The likely cause of these fences leaning is not enough concrete used in the post footings. It is suggest a fencing contractor be engaged for rectification when convenient.

The cost of repairing fences is often shared between neighbours.

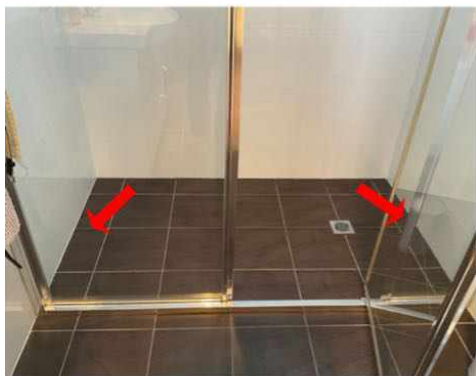
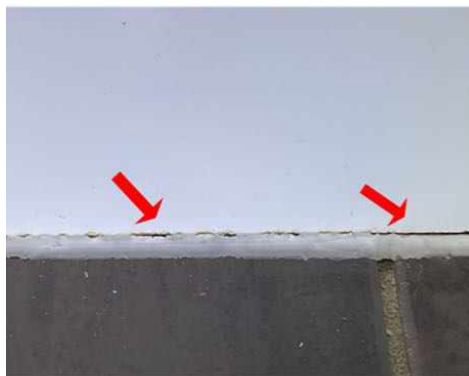
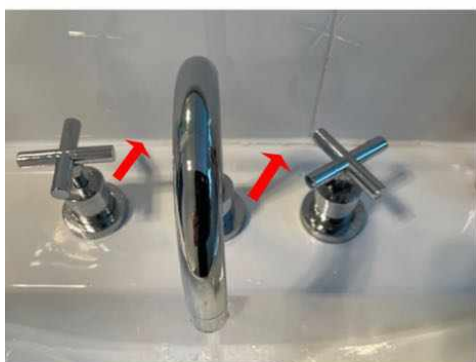
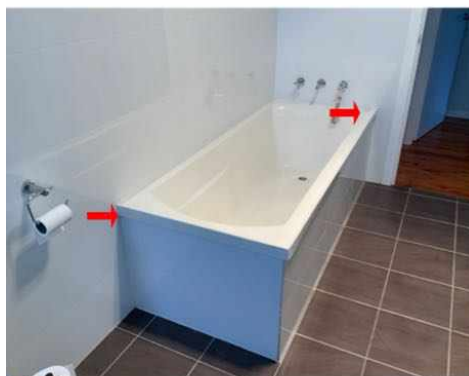
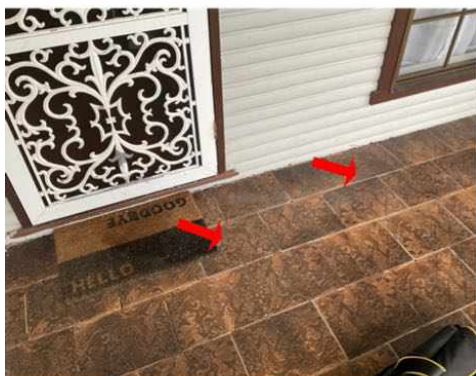
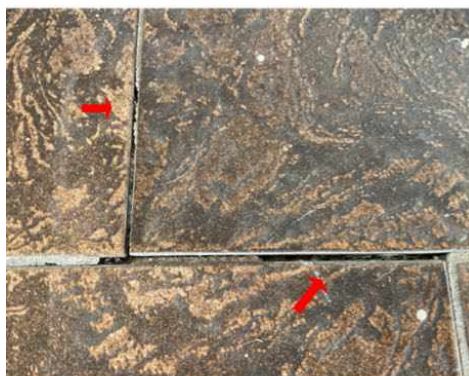
Finding 3.20

Building: Building 1
 Location: bathroom, porch
 Finding: Sealant and grouting - Missing or damaged
 Information: It was noted on inspection that sealant or grout is degraded to these pictured wet areas.

Different materials and floor areas move at different rates, generally causing cracking to grout or sealant at this point. A flexible sealant is required to allow for expected expansion and contraction, while keeping the joint water tight and protective of all associated building materials.

Flexible and mould resistant materials should be applied to affected areas to prevent any subsequent water damage that is likely to occur. Regular maintenance and replacement of damage or missing or damaged sealant and grout is highly recommended to the wet areas, as this is a regular wear and tear defect. Sealant and grouting in areas that come into regular contact with water should be maintained for the long term care of your property.

A sealant specialist or tiling contractor should be appointed to complete these works as soon as possible

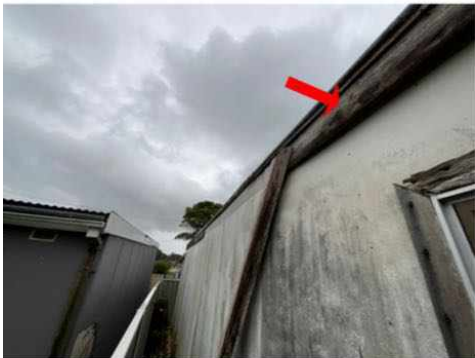
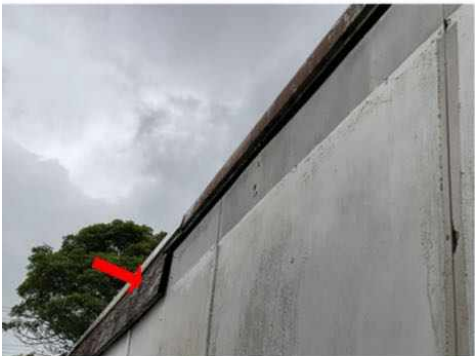
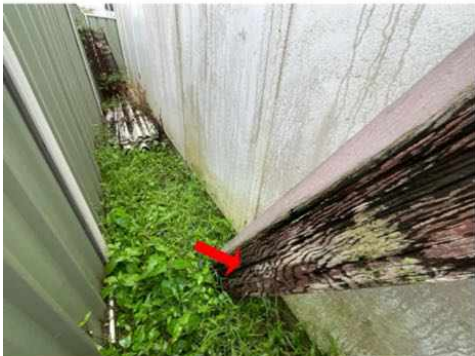
Finding 3.21

Building:	Building 1
Location:	Pictured areas
Finding:	Wood rot
Information:	The buildings shows evidence of wood rot. The rear shed roof timbers have not fallen from requiring replacement. Wood rot, also known as Fungal Decay, occurs when timbers and other cellulose building materials are exposed to damp conditions on an ongoing basis. This could be the result of exposure to weathering over a prolonged period of time, or the attraction of excessive moisture from other abutting building materials.

the useful life of these building elements. Prior to any works being performed, the cause of the moisture that has created the visible wood rot should be identified and addressed in a suitable manner. Replacement of affected timbers may then be a necessary step in protecting surrounding building elements from such deterioration.

A qualified carpenter or registered builder may also be required to replace affected building materials.

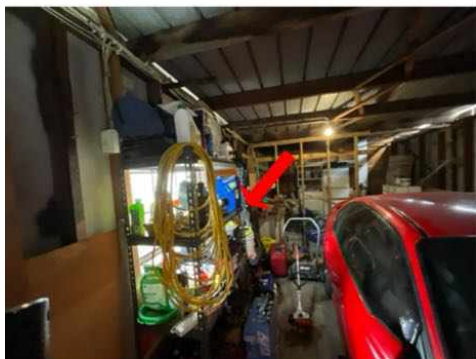
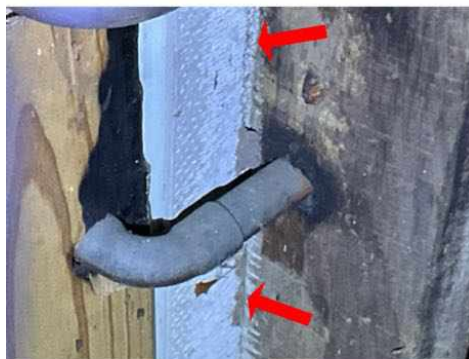
Finding 3.22

Building: Building 1
Location: Shed shower

Finding: Shower screen - Leaking

Information: Leaking was evident to the shower screening at the time of inspection. It is suspected that the leaking has occurred as a result missing sealant. Leaking from the shower , where left unattended, is likely to lead to water damage to adjoining flooring and walls. Such damage can lead to water damage and necessitate extensive remedial works being required. Active water leaks may also create an environment that is susceptible to the formation and development of mould.

Appointment of a sealant expert is required to repair or replace this missing sealant. Such works should be performed as soon as possible to ensure that no further damage occurs.

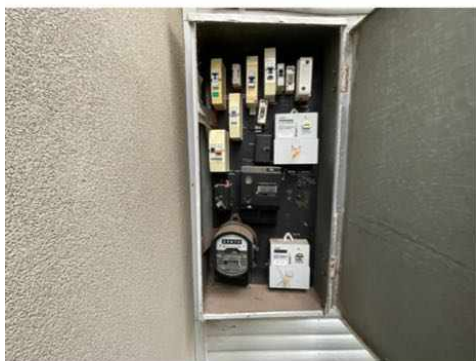
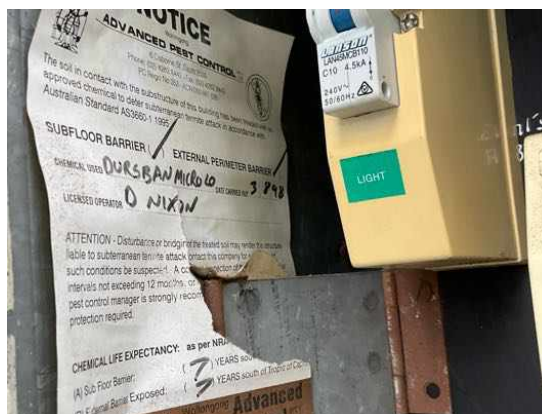
Finding 6.01

Building: Building 1
 Location: Meter Box
 Finding: Termite Management System - no evidence of a chemical installation
 Information: The application of a post-construction chemical termite barrier is highly recommended for all properties. Such barriers are highly effective in preventing termite attack on any timber building elements throughout the property.

A durable notice should be placed in the switchboard unit to indicate current termite barriers. At the time of inspection, the durable notice was evident and it appeared as though no chemical termite management system has been installed, with no evidence to suggest preventative works taking place since 1998.

The client must consider gaining further advice from a pest controller as to the costs and procedures involved with a 'chemical' application. It is recommended that obtaining such advice be a short-term and high priority.

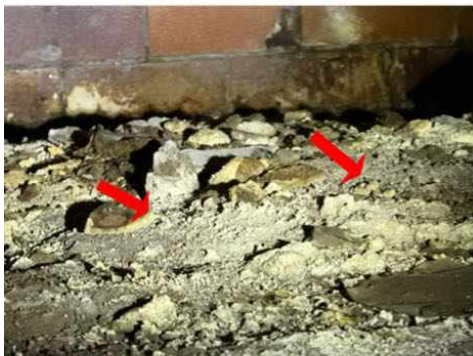
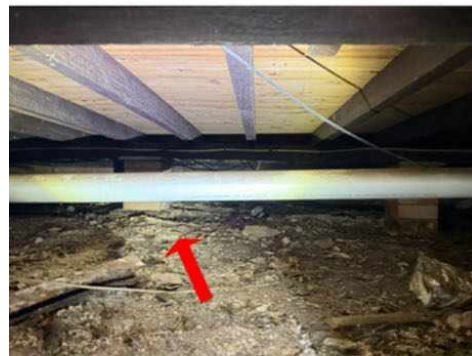
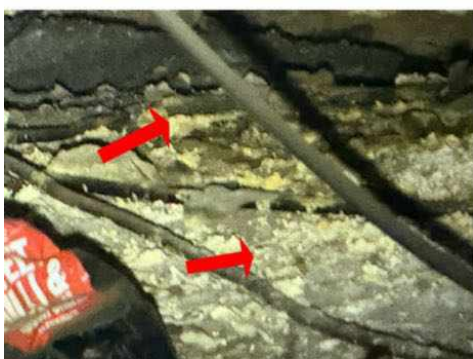
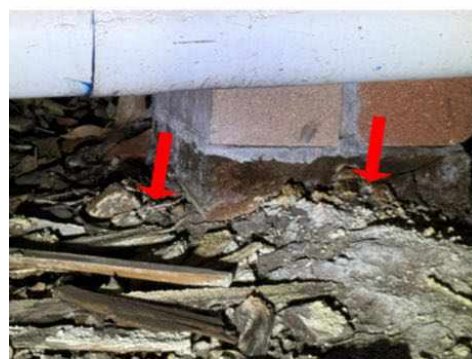
Finding 6.02

Building:	Building 1
Location:	Subfloor
Finding:	Severe Mould - Present in subfloor
Information:	Where evidence of severe mould growth was noted, there may be environmental, biological or health issues associated with the report. A specialist inspection by a suitably qualified environmental health inspector is warranted, where mould is extensive or where any queries regarding air quality spores or other related issues apply.

Subfloor mould is generally caused by moisture ingress, lack of external drainage, lack of adequate ventilation and subfloor debris present. These issues need rectification

Generally, the client is advised to ensure that the general environment is free of moisture and humidity to aid in the prevention of mould formation and development.

to stop mould development. All mould found during the inspection should be cleaned immediately by a cleaning contractor or the homeowner as applicable.

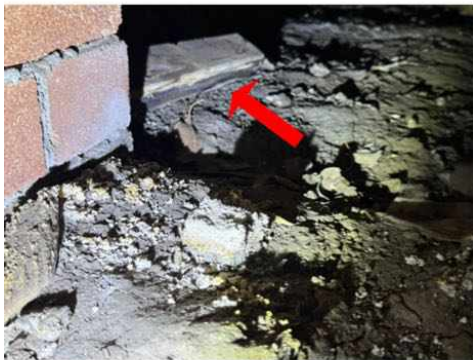
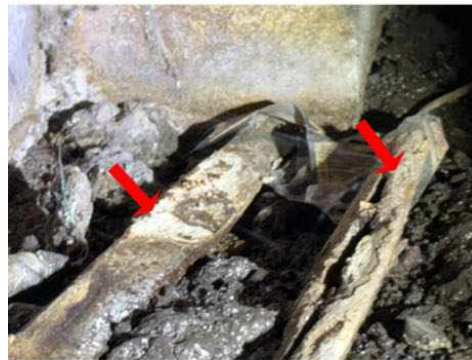
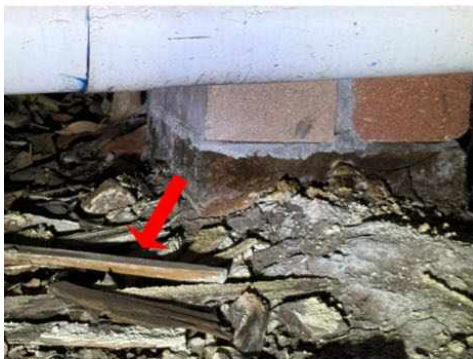
Removal of all waste timber that is in direct contact with ground is highly advised. This timber is promoting mould and wood rot and is very attractive to termites.

Frequent pest inspections are advised to readily identify any termite activity in these areas.

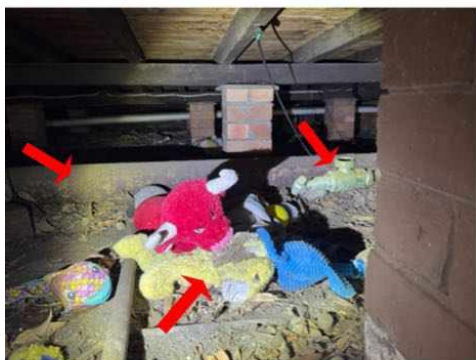
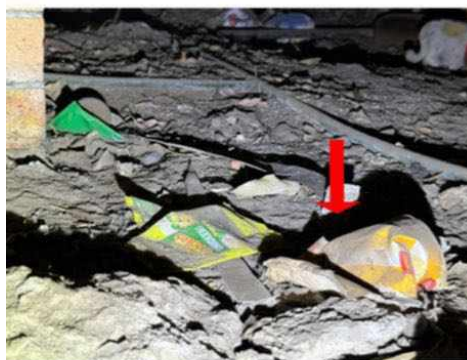
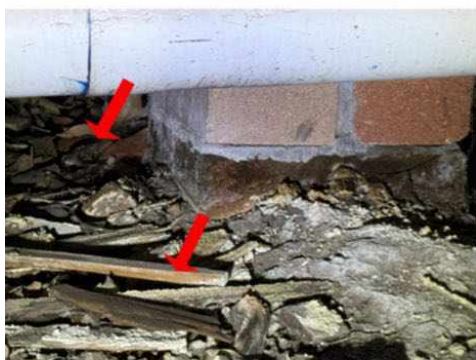
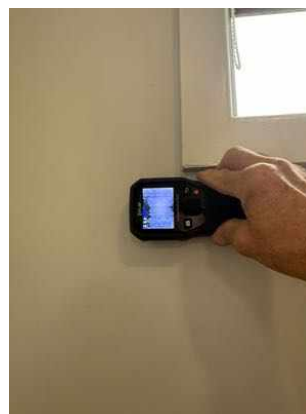
Finding 6.04

Building: Building 1
 Location: Subfloor
 Finding: Subfloor - Debris
 Information: An array of debris was found in the subfloor area at the time of inspection. Debris in this area restricts subfloor ventilation and creates potential for concealed pest entry. Stored timbers and other materials may also make the area susceptible to termite activity and wood rot.

condition. The removal of any timber debris is vital in minimising the risk of termite or wood borer activity.

Debris in the subfloor should be removed as soon as possible. Depending on the location and amount of debris and stored items, the homeowner may elect to undertake this task. Alternatively there are a large number of rubbish removal subcontractors that could undertake these works.

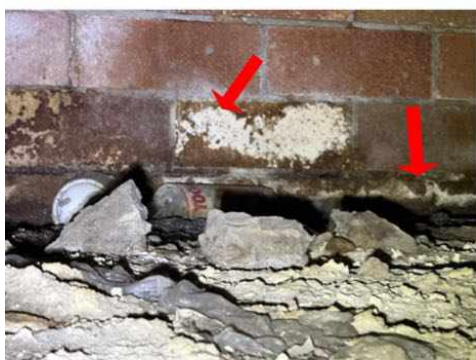
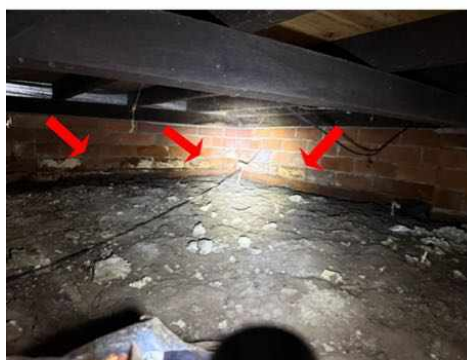
Finding 6.05

Building:	Building 1
Location:	Subfloor
Finding:	Damp - Rising
Information:	Rising damp describes the upward movement of water in low sections of building elements (e.g. walls) by capillary action - the movement of water through porous materials such as bricks, sandstone or mortar.

Rising damp is generally managed by the installation of a damp proof course during construction. A Damp Proof Course (DPC) is an impermeable barrier at the base of the wall above ground level. However, many 19th Century buildings have no damp course installed, or the materials have failed. The DPC may have been omitted as a consequence of poor workmanship, or it may have been bridged where materials built up against the side of the house allow moisture ingress above the DPC level.

The first step in addressing rising damp is to diagnose the cause. The identified cause should be addressed first before addressing the appearance and other defects which have resulted from the rising damp. If the original cause is not resolved, further cases of damp are likely to ensue, resulting in secondary defects.

Consultation with a qualified plumber is advised immediately to identify the cause of the damp and perform remedial works as required.

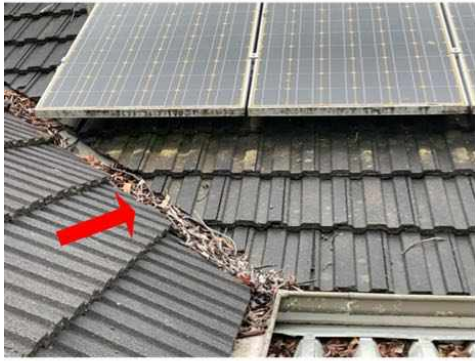
Finding 6.06

Building:	Building 1
Location:	Roof exterior
Finding:	Gutters - Full and blocked
Information:	The guttering on around the roof was found to be blocked at the time of the inspection. Roof plumbing structures, such as guttering and downpipes, should be free of all debris to prevent blockages. Blockages of the guttering and downpipes will lead to pooling and accumulated water overflows, which is likely to subsequently flood eaves and exterior walls.

Blocked gutters are likely to lead to high levels of moisture in the affected areas. Such moisture will not only cause rust and decay of the associated building materials, but can also provide conditions that are conducive to termite and timber pest activity. Blockages in gutters should therefore be removed immediately to ensure dry conditions are maintained.

It is highly advised that gutters be cleaned by the homeowner or a general handyperson as a matter of urgency.

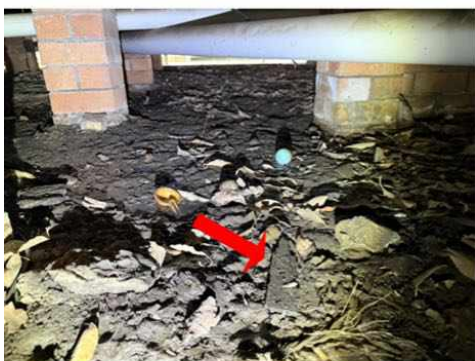
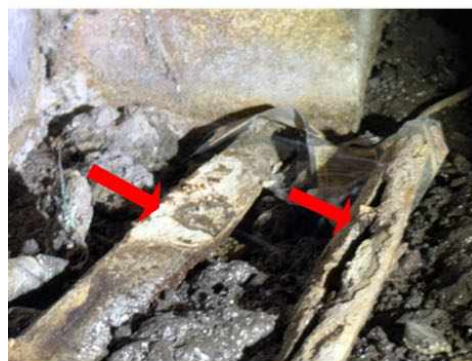
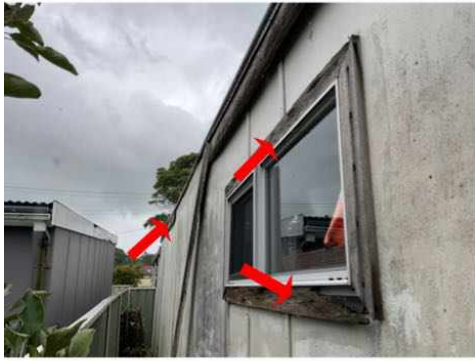
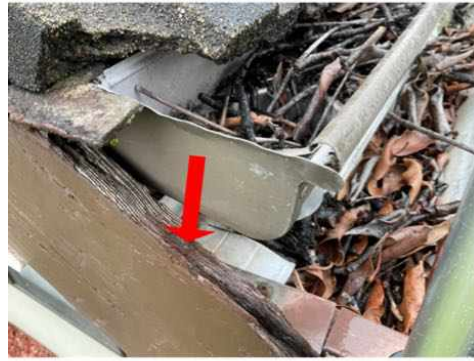
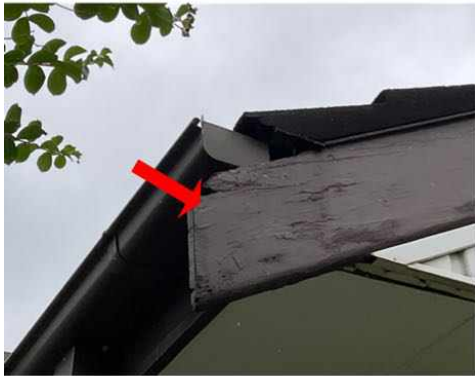
Finding 7.01

Building:	Building 1
Location:	Roof, shed and subfloor areas
Finding:	Fungal decay - present (localised)
Information:	Fungal decay also known as wood decay or wood rot generally refers to the deterioration of timber elements when in contact with excessive levels of moisture for a prolonged period of time.

The development of fungal decay is accelerated by temperatures from 5degreeC to 40degreeC as well as the presence of oxygen. Generally fungal decay develops on timber elements that are in use in an external environment which are exposed to rain penetration.

Note - See ALL wood rot photos, all these show fungal decay.

In this case, the affected timber element is in a decaying state and will need replacement by a carpenter or licensed builder.
