Building and Timber Pest Inspection Report

Inspection Date: Fri, 27 Feb 2026

Property Address: 13 Lakelands Dr, Dapto NSW 2530, Australia

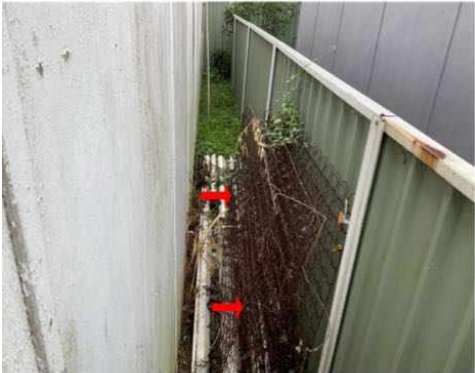
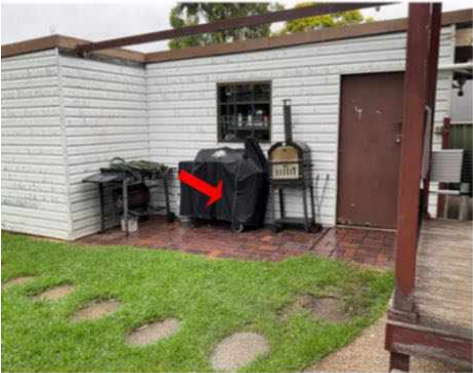
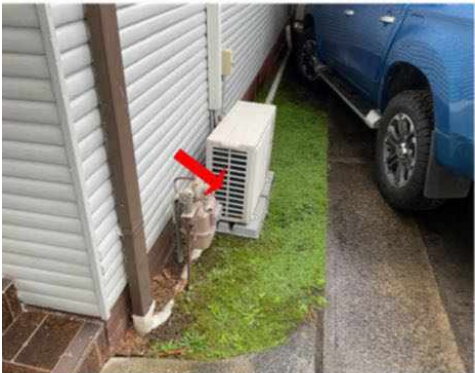
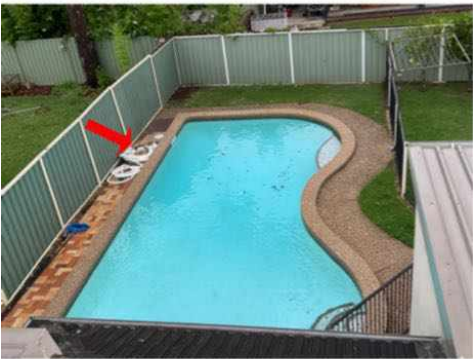
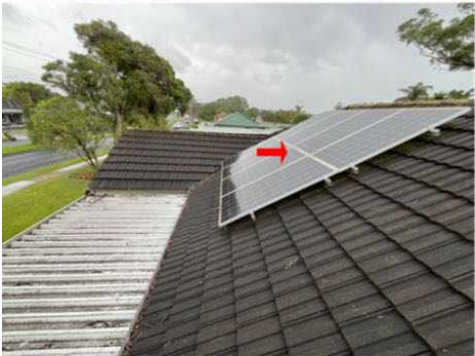
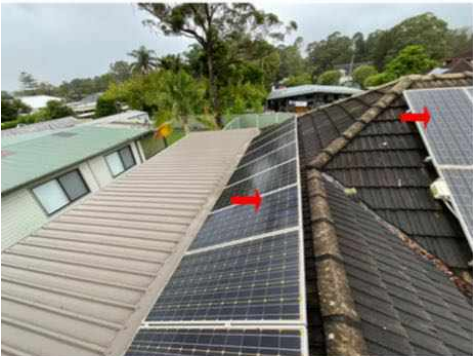
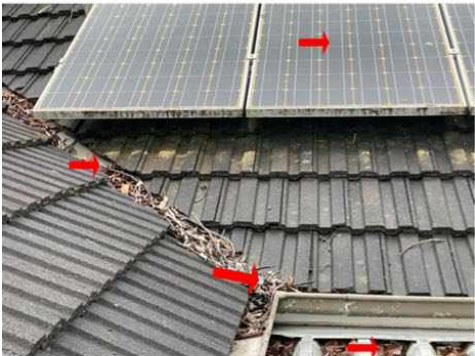
Building: Building 1
 Location: All External Areas
 Finding: Additional Photos - Obstructions and Limitations of EXTERNAL AREAS
 Information: These photographs are an indication of the obstructions and limitations which impeded full inspection of external areas at the time of inspection. These obstructions can hide an array of defects and should be removed to allow full inspection to be carried out. A re-inspection is recommended once the areas are made accessible.

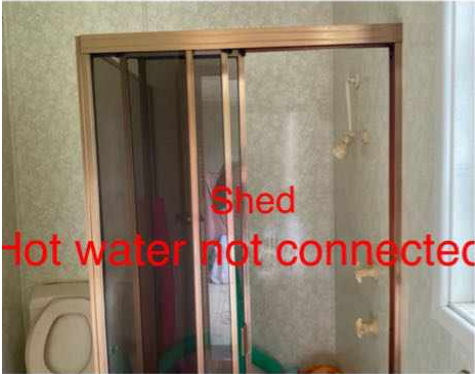
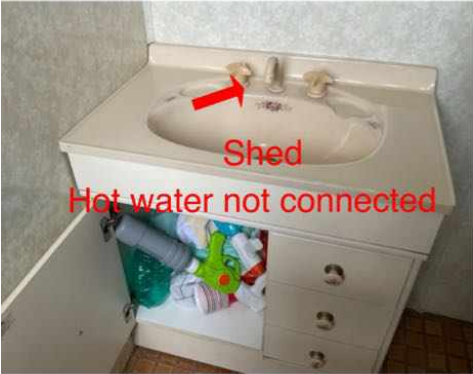
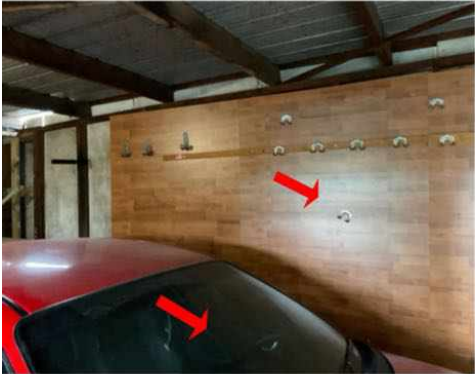
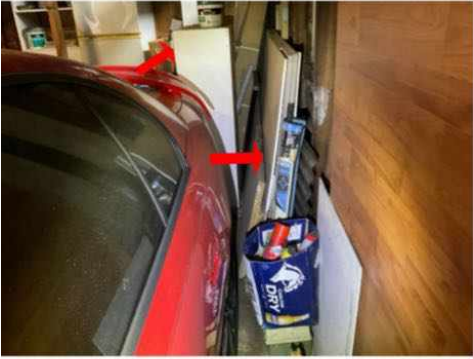
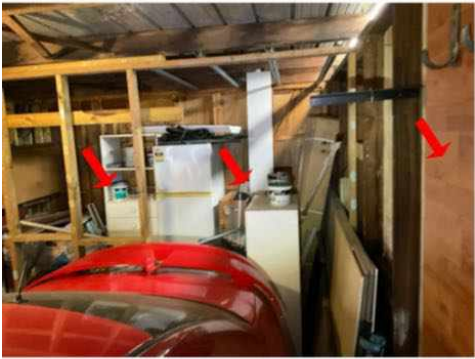
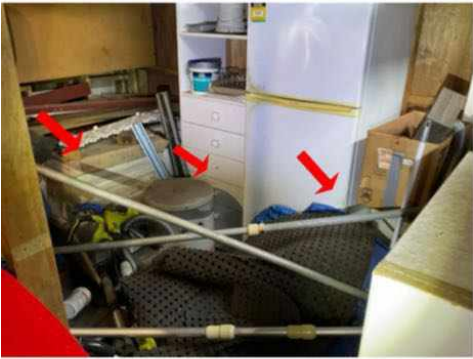
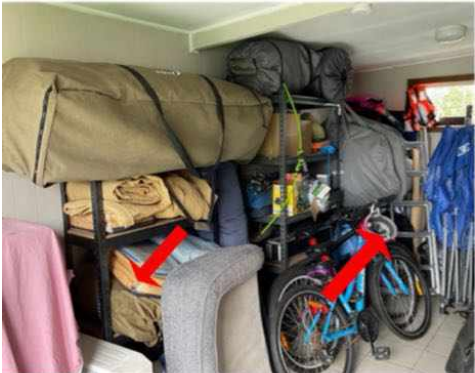
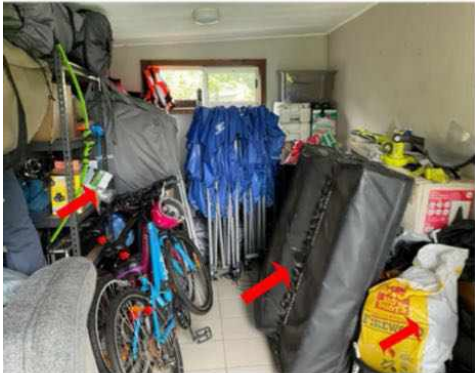
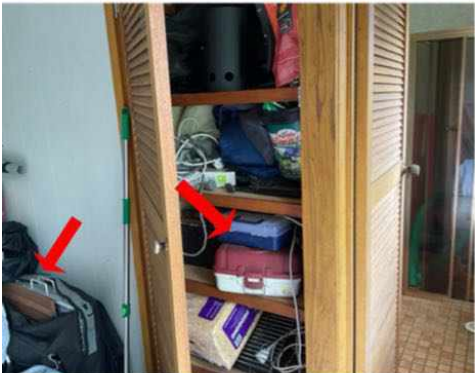
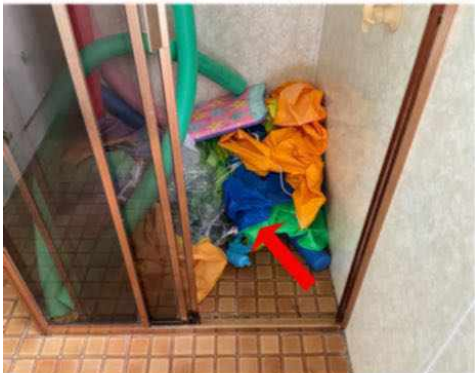
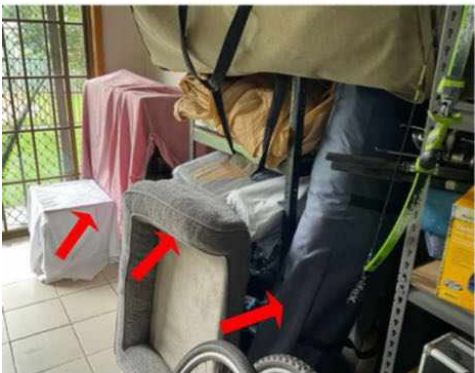
Building: Building 1
Location: All Internal Garage and rear room areas
Finding: Additional Photos - Obstructions and Limitations of INTERNAL AREAS
Information: These photographs are an indication of the obstructions and limitations which impeded full inspection of Internal areas at the time of inspection. These obstructions can hide an array of defects and should be removed to allow full inspection to be carried out. A re-inspection is recommended once the areas are made accessible.

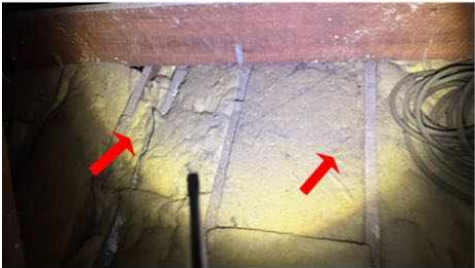
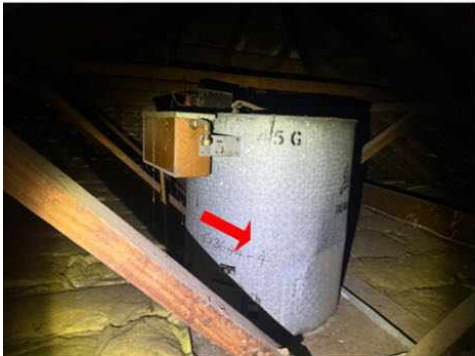
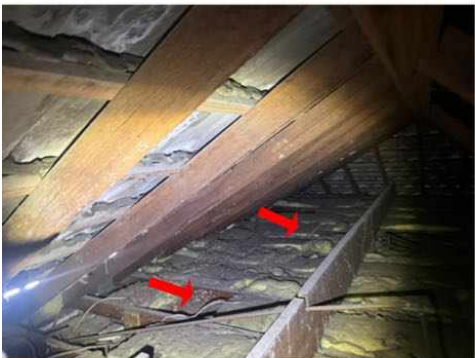
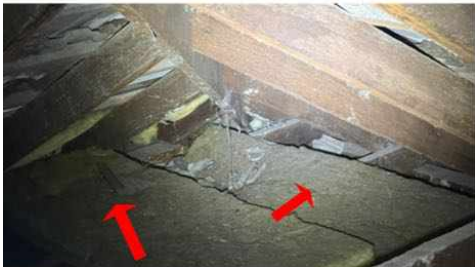
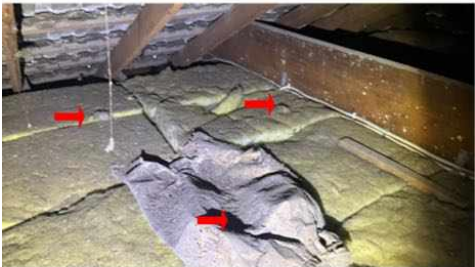
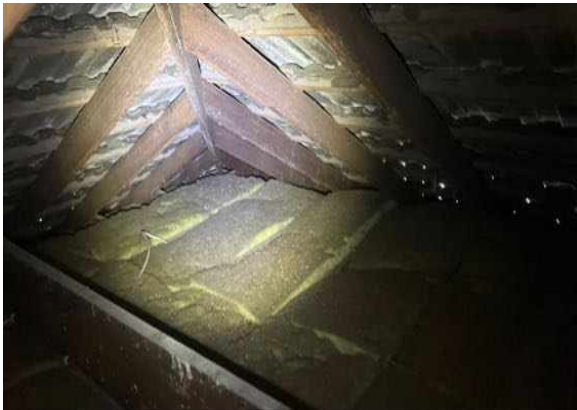
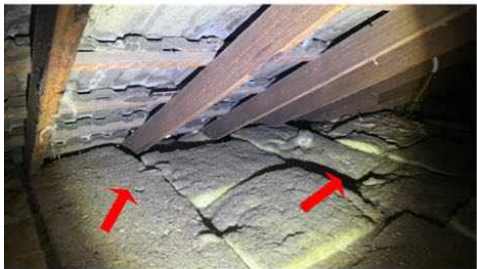
Building: Building 1
 Location: All Roof cavity areas
 Finding: Additional Photos - Obstructions and Limitations of the ROOF CAVITY
 Information: These photographs are an indication of the obstructions and limitations which impeded full inspection of roof cavity areas at the time of inspection. These obstructions can hide an array of defects and should be removed to allow full inspection to be carried out if applicable. A re-inspection is recommended once the areas are made accessible.

The inspection was also limited to areas with an allowable crawl space of 600mm x 600mm, in particular towards the external walls where the roof line diminishes, these

areas were not accessible.

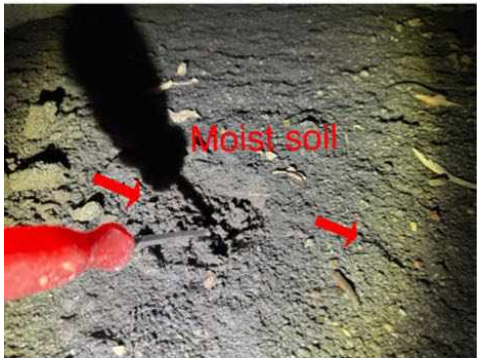
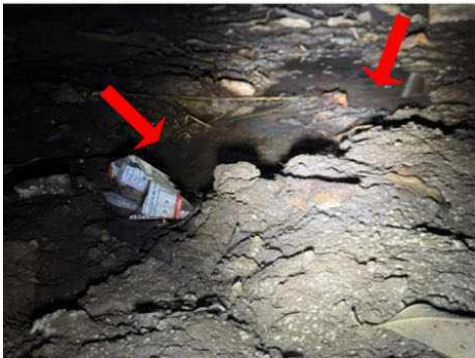
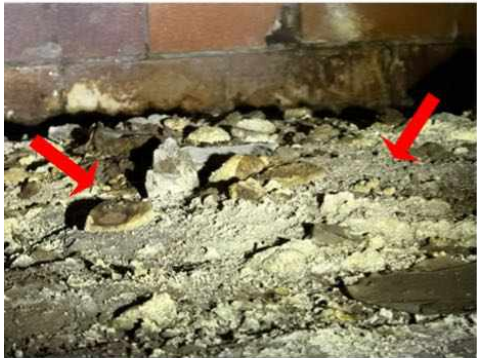
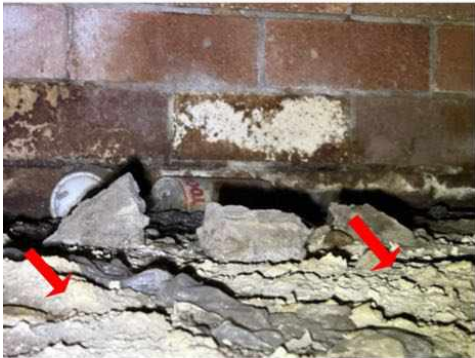
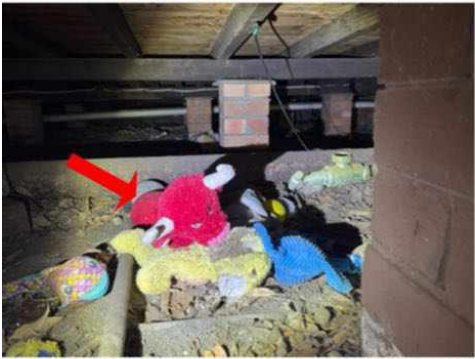
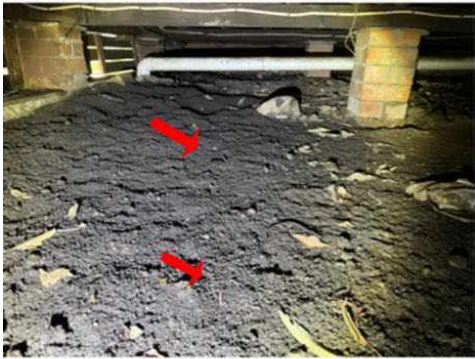
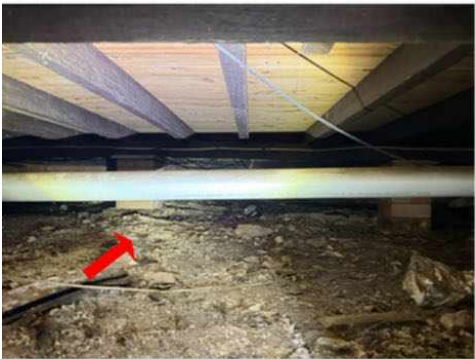
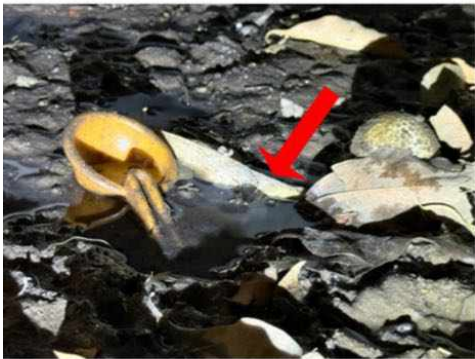
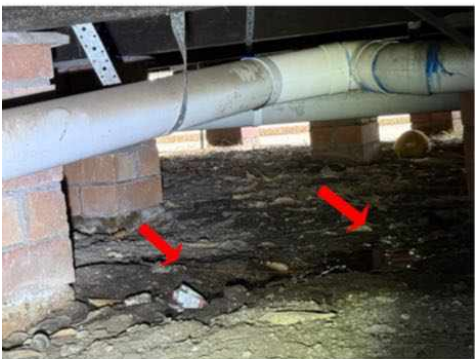
Building: Building 1
Location: All Subfloor Areas
Finding: Additional Photos - Obstructions and Limitations of SUBFLOOR AREAS
Information: These photographs are an indication of the obstructions and limitations which impeded full inspection of subfloor areas at the time of inspection. These obstructions can hide an array of defects and should be removed to allow full inspection to be carried out. This includes areas that could not be accessed due to severe mould, damp sinking soil, pooling water and low clearance. A re-inspection is recommended once the areas are made accessible.

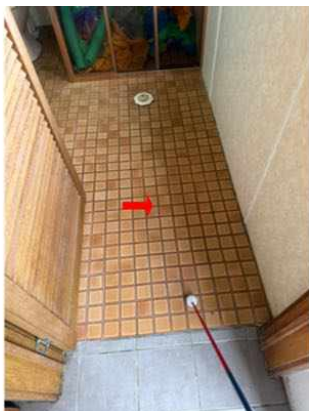
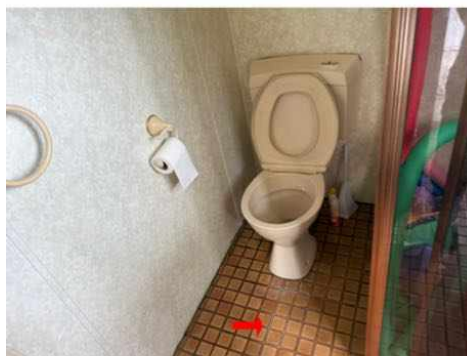
Building: Building 1
 Location: Bathrooms and laundry
 Finding: Waterproofing membranes - Information Only
 Information: Internal Water Proofing Membranes, are crucial in preventing water ingress into the property is important to know that the Membrane System used is to Australian Standards and has been installed correctly.

With older property's where this information is unavailable all wet areas should be monitored. If any leaks, water staining, peeling or bubbling of the paint become evident to any adjacent walls or ceilings below a licensed builder or waterproofing specialist is recommended to investigate further.

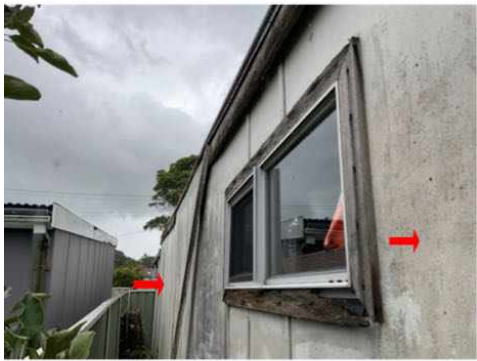
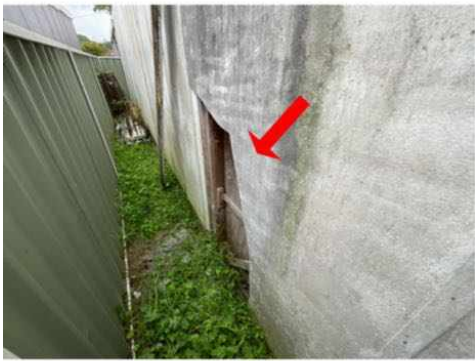
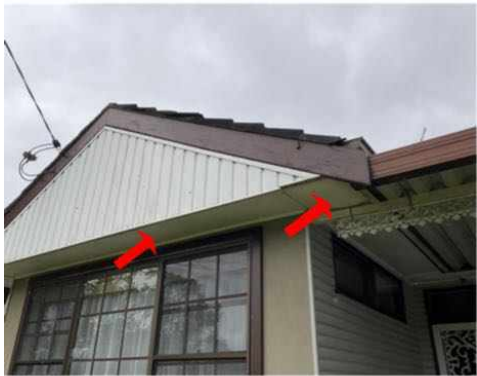
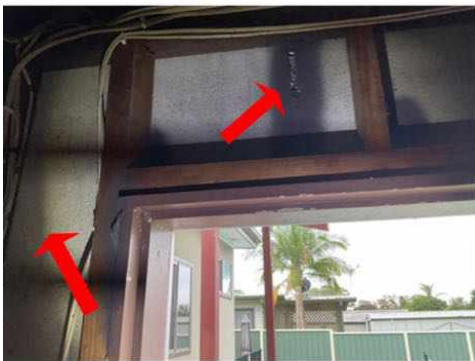
Building:	Building 1
Location:	Pictured areas
Finding:	Asbestos - ACM Identified on Site
Information:	Reporting on Asbestos is outside the Scope of this Report. This defect is highlighted as a caution only. We suspect the house has asbestos present and some areas are damaged.

As Asbestos Reporting is outside the scope of this report, we advise that you consider a separate Asbestos Inspection and Condition Audit, which can include the taking of samples for definitive confirmation of the presence of Asbestos.

In the interim, the client is advised to act with caution, especially when considering any damage to building materials, general wear and tear, renovations, extensions, demolition and general maintenance activities due to the suspected presence of Asbestos.
