Building and Timber Pest Inspection Report

Inspection Date: Tue, 31 Mar 2026

Property Address: 7A McGregor Cl, Adelaide SA 5000,
Australia

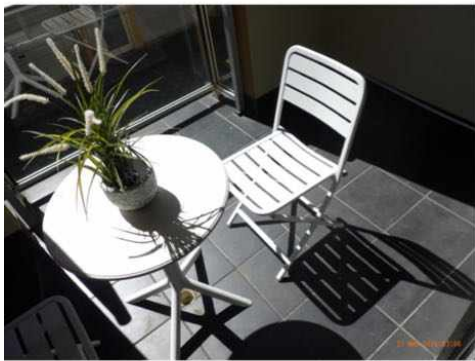
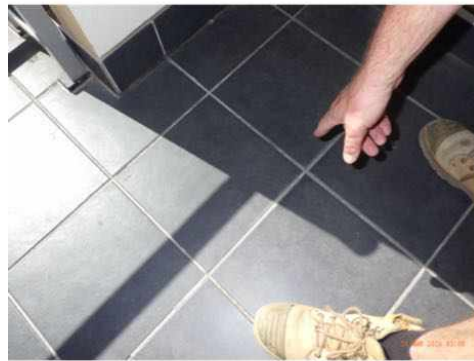
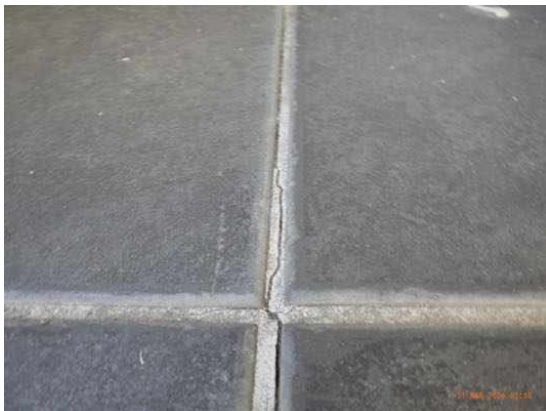
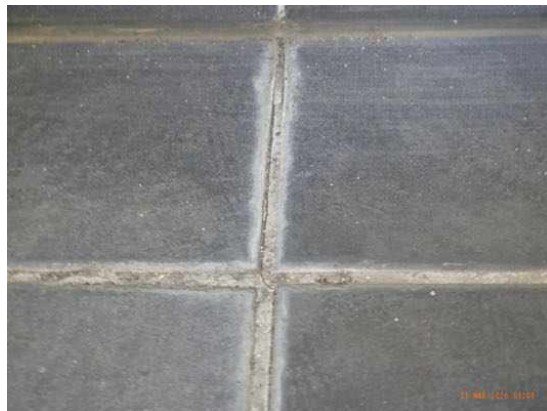
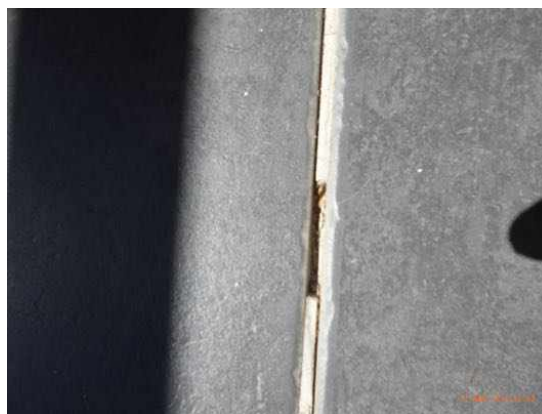
Finding 2.01

Finding: Deteriorated Tiling, sealant and grout

Information: Deterioration was observed to the balcony grout and/or sealant at the time of inspection, with associated damage evident to the ceiling beneath within the garage.

The deterioration is consistent with age-related wear and exposure to weather conditions, resulting in a breakdown of the waterproofing at surface level and allowing water penetration through the balcony structure.

If left unaddressed, continued water ingress may lead to further damage to underlying structural elements, internal finishes to the garage ceiling, and potential long-term deterioration including decay or mould.

A suitably qualified sealant specialist or tiling contractor should be engaged to remove and replace the deteriorated grout and sealant with appropriate flexible, mould-resistant materials. Rectification is recommended in the short term to prevent further water ingress and associated damage.

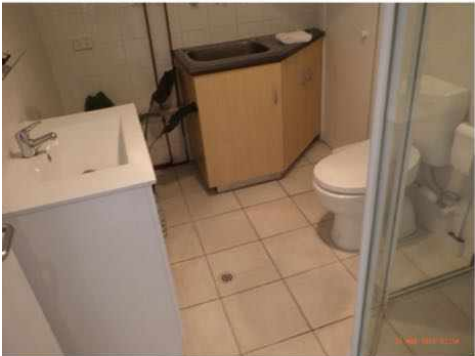
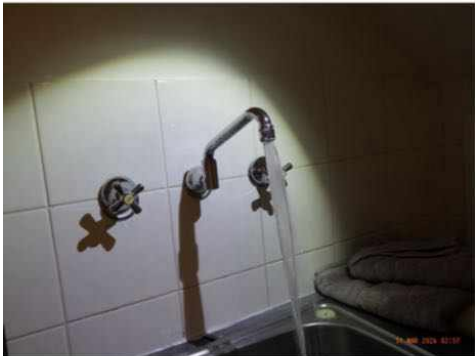
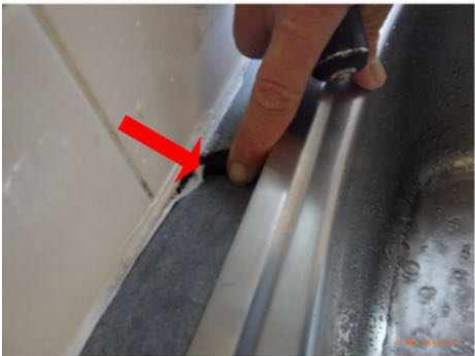
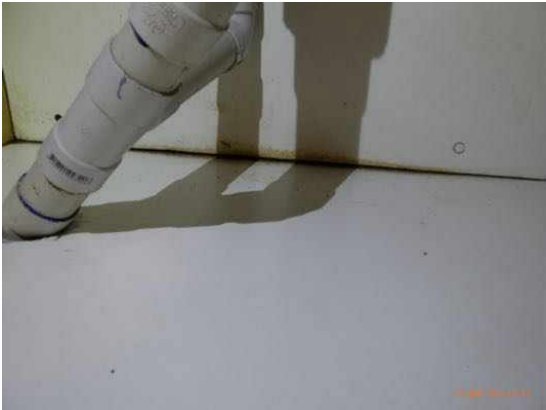
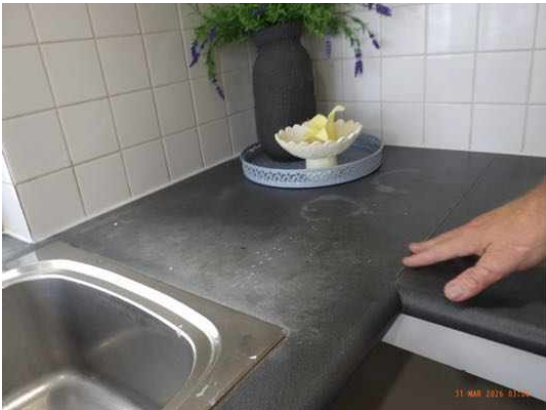
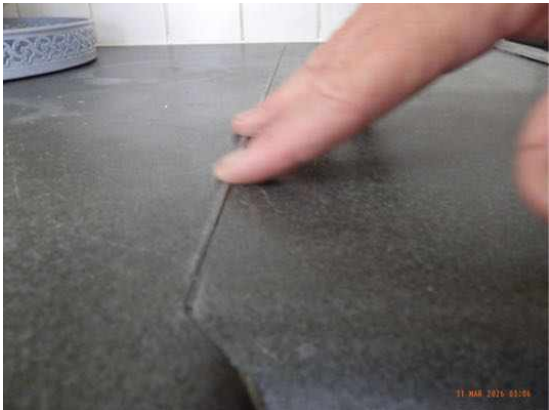
Finding 3.01

Building:	Building 1
Location:	Kitchen and laundry
Finding:	Damage, Benchtops
Information:	Damage was observed to the benchtops throughout the dwelling at the time of inspection, most notably within the laundry and kitchen areas.

In the laundry, the benchtop exhibited extensive moisture-related deterioration with rot evident, along with associated minor damage to the cabinetry below internally.

The kitchen benchtops also showed signs of deterioration including swelling and general wear, indicating they are nearing the end of their serviceable lifespan.

The damage is consistent with prolonged moisture exposure and general age-related deterioration.

If left unaddressed, continued moisture ingress and material breakdown may lead to further deterioration of cabinetry components, potential hygiene concerns, and the need for more extensive replacement works.

Repairs and/or replacement should be carried out by a suitably qualified and licensed builder or cabinetmaker to rectify the affected areas. Rectification is recommended in the short to medium term, with the laundry requiring more immediate attention due to active moisture-related damage.

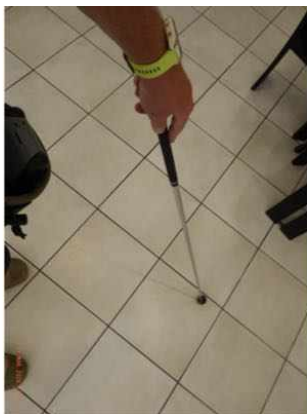
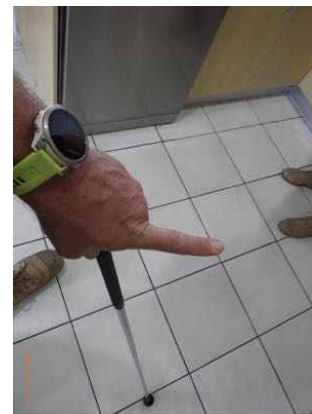
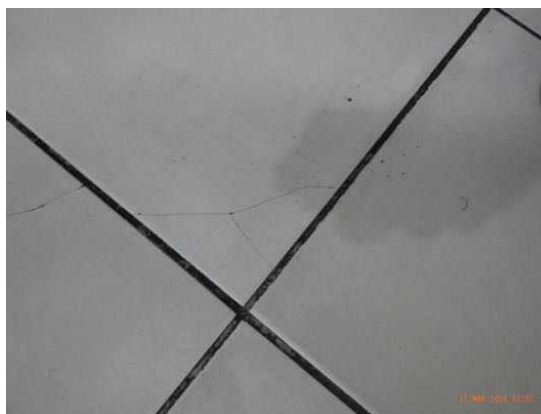
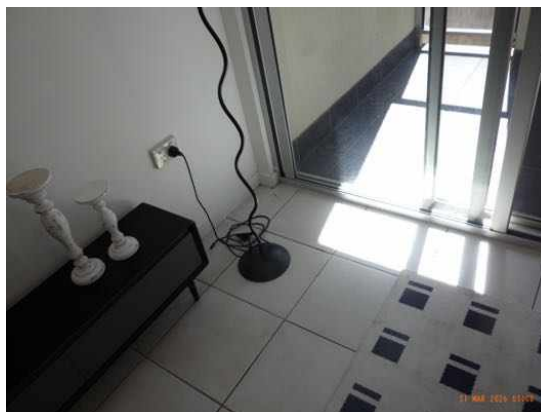
Finding 3.02

Building:	Building 1
Location:	Kitchen/ living
Finding:	Tiles - Cracked or damaged minor
Information:	Cracking was evident to approximately 10 tiles to the kitchen and living area of the home at the time of inspection. It also appears that approximately 10% of the floor tiles sound drummy, meaning they have lost their bond to the floor beneath.

The cracking appears to be minor and is likely due to general movement, settlement of the building.

As the area should not be immersed in water, no secondary defects are likely to be created and as such repairs left to the discretion of the client.

A tiling contractor could be appointed to make repairs to return the ascetics of the property.

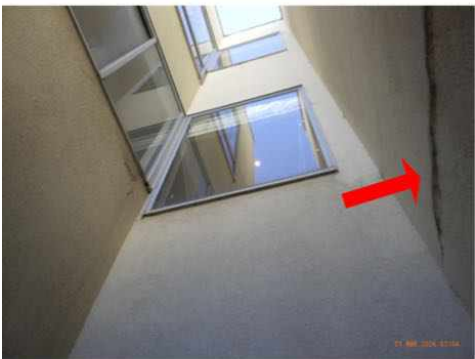
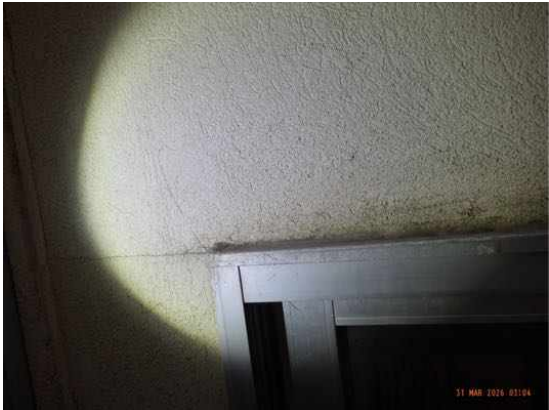
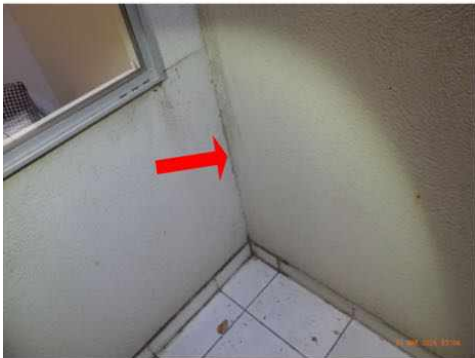
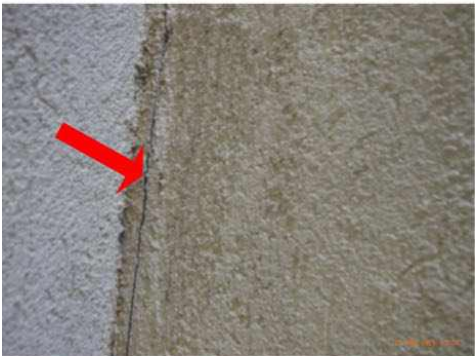
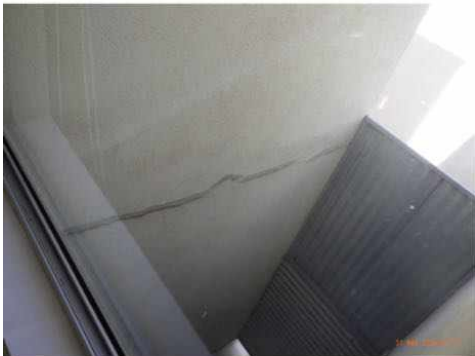
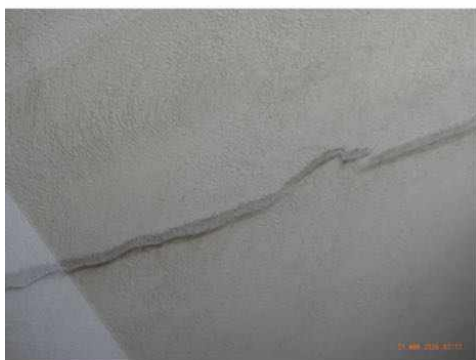
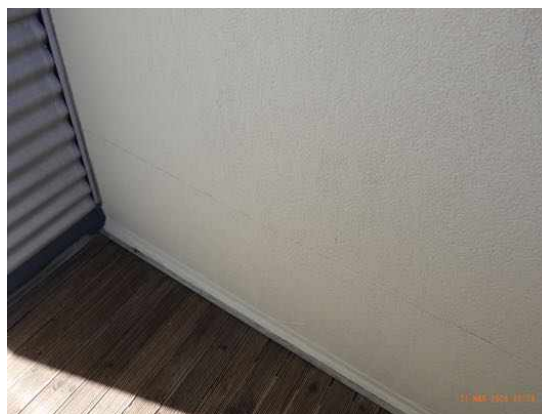
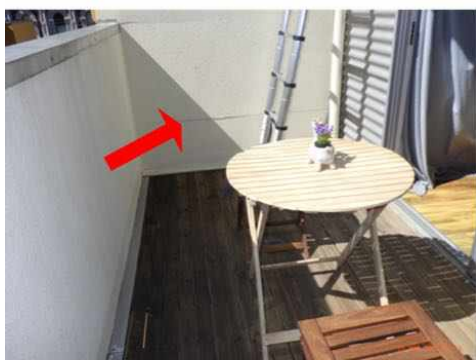
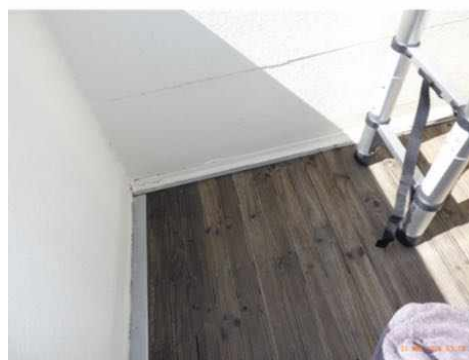
Finding 3.03

Building:	Building 1
Location:	Exterior walls
Finding:	Rendered light weight wall cladding - Hairline Cracking
Information:	Cracking was observed to the lightweight wall panelling at multiple locations throughout the dwelling at the time of inspection.

The cracking appears minor and is generally consistent with movement, shrinkage or installation-related issues.

If left unaddressed, the cracking may allow moisture ingress which can contribute to deterioration of the wall system, potential damage to internal finishes, and an increase in repair scope over time.

Repairs should be carried out by a suitably qualified and licensed builder to assess, seal and rectify the affected areas. Rectification is recommended in the short term as part of routine maintenance to prevent further progression.

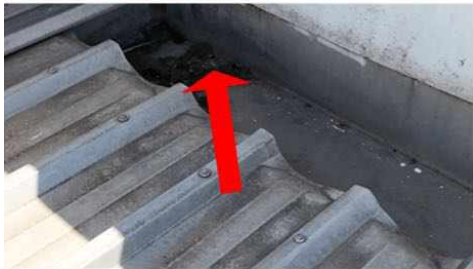
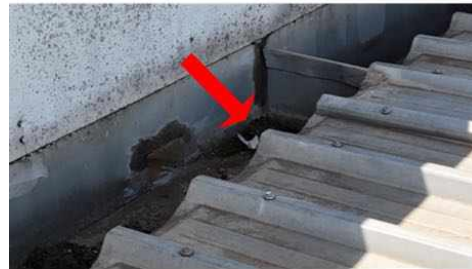
Finding 3.04

Building:	Building 1
Location:	Roof Exterior
Finding:	Gutters - Blocked
Information:	Roof plumbing structures, such as guttering and downpipes, should be free of all debris to prevent blockages. Blockages of the guttering and downpipes will lead to pooling and accumulated water overflows, which is likely to subsequently flood eaves and exterior walls.

Blocked gutters are likely to lead to high levels of moisture in the affected areas. Such

moisture will not only cause rust and decay of the associated building materials, but can also provide conditions that are conducive to termite and timber pest activity. Blockages in gutters should therefore be removed immediately to ensure dry conditions are maintained.

Consult a Licensed Plumber for further specific advice on remedial works that may be required. In the interim, it is highly advised that blocked gutters be removed by the homeowner or a general handyperson as a matter of urgency.

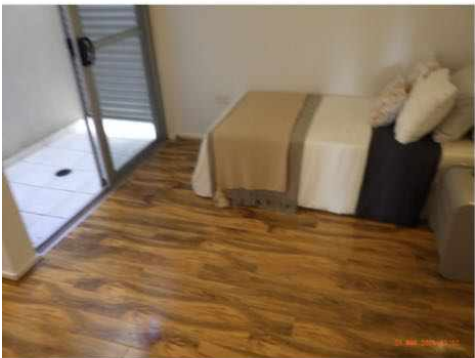
Finding 3.05

Building:	Building 1
Location:	Ensuite and ground floor bedroom
Finding:	Elements - Swollen
Information:	Swelling was observed to the architraves within the ensuite bathroom and adjacent to the sliding door in the lower bedroom at the time of inspection. No abnormal moisture readings were evident.

The swelling of these building elements is typically indicative of moisture exposure. In the ensuite, this is likely associated with the proximity to the shower area or moisture wicking from wet floor surfaces, while in the lower bedroom it is likely attributable to rainwater ingress at or around the sliding door.

If left unaddressed, continued moisture exposure may result in further deterioration of the affected timbers, potential damage to adjoining finishes, and an increased risk of concealed moisture-related issues such as decay or mould.

A suitably qualified and licensed builder should be engaged to investigate the source of moisture ingress and carry out appropriate repairs, including rectification of the moisture source and replacement of affected materials. Rectification is recommended in the short term to prevent further deterioration.

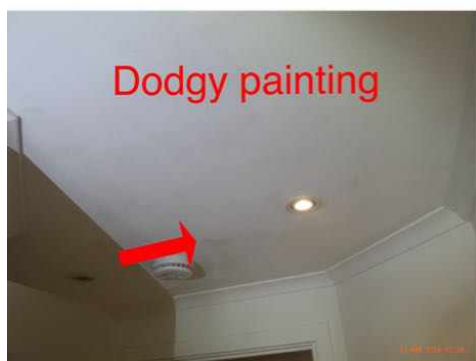
Finding 3.06

Building:	Building 1
Location:	All Areas
Finding:	Minor defects present
Information:	Minor defects were evident throughout the dwelling at the time of inspection, which are consistent with normal wear and tear and considered appropriate for a property of this age.

These defects are typical of ongoing material ageing, settlement, and general use over time, and include, but are not limited to:

- New painting does not appear to have been completed by professionals

While these defects are not considered structurally significant at present, they should be addressed as part of routine and ongoing property maintenance to prevent further deterioration. Repairs and maintenance works should be carried out by appropriately licensed and qualified tradespeople to ensure the continued serviceability and longevity of the dwelling.

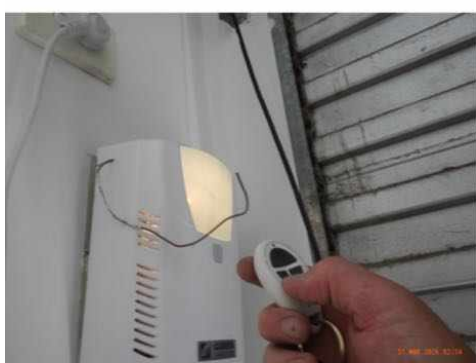
Finding 3.07

Building:	Building 1
Location:	Garage

The issue is likely attributable to mechanical failure, electrical fault, or general wear and tear of the door system or motor components.

If left unaddressed, the defect may result in ongoing inaccessibility to the garage, potential security concerns, and further deterioration of the door system.

A suitably qualified garage door technician should be engaged to assess and carry out the necessary repairs to restore proper operation. It is understood and agreed that the vendor will arrange for this defect to be rectified prior to settlement.

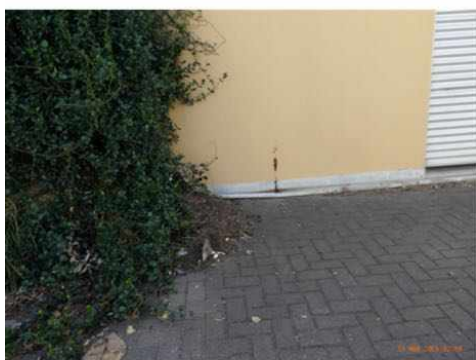
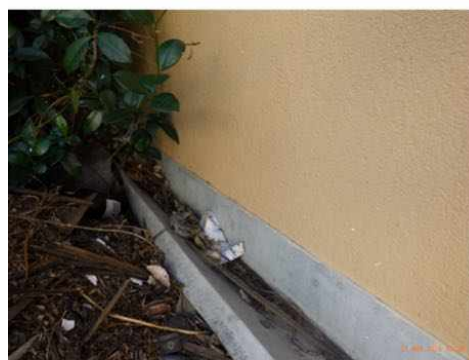
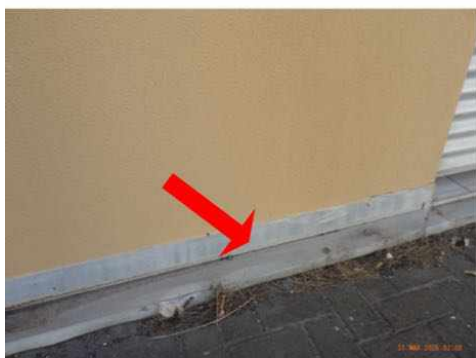
If the slab edge is not properly exposed there is a high risk of concealed termite attack which your inspector will likely not be able to see. Sometimes, in order to determine the type of slab, a suitably qualified person such as an architect or builder may be required to consult construction plans.

Where the slab edge cannot be properly inspected, it is highly recommended that termite or timber pest inspections be carried out every 6-12 months to aid protection of the property against infestation and termite treatment advice is followed closely.

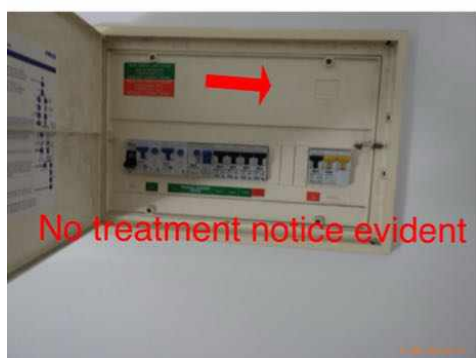
Finding 6.02

Building:	Building 1
Location:	All Areas
Finding:	Termite Management System - no evidence of a chemical installation
Information:	The application of a post-construction chemical termite barrier is highly recommended for all properties, particularly if live termite activity has been found on the site previously. Such barriers are highly effective in preventing termite attack on any timber building elements throughout the property.

At the time of inspection, it appeared as though no termite management system has been installed, with no evidence to suggest preventative works taking place.

The client may consider gaining further advice from a pest controller as to the costs and procedures involved with this application. It is recommended that obtaining such advice be a short-term priority.

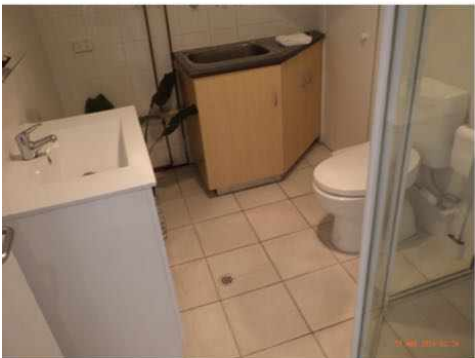
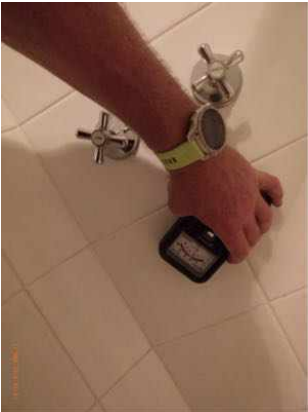
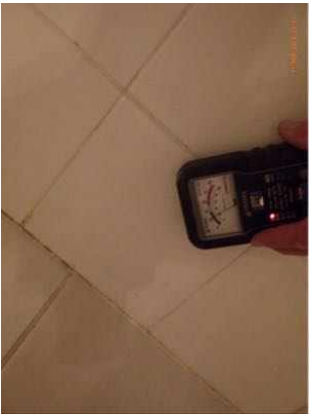
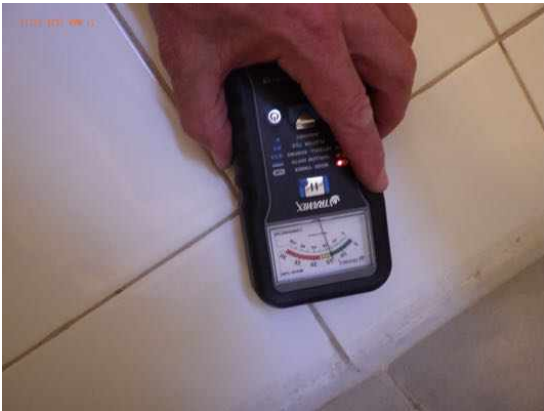
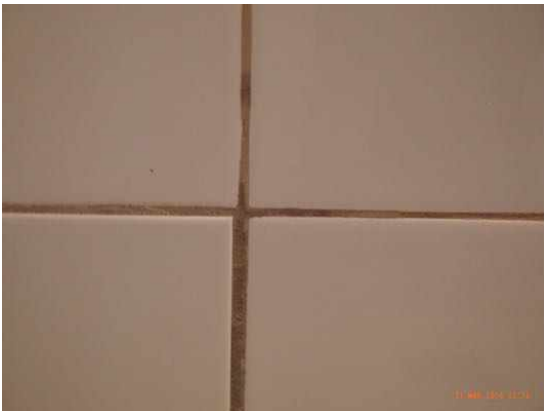
Finding 6.04

Building:	Building 1
Location:	Both bathrooms
Finding:	Sealant and grouting - Regular maintenance
Information:	It was noted on inspection that sealant and grout has small areas of deterioration evident to the shower alcove at the time of inspection.

Silicone and grout generally need repair at least every 5 years and as such close monitoring should be carried out in the future after repairs are carried out.

Different materials and floor areas move at different rates, generally causing cracking to grout or sealant at this point. A flexible sealant is required to allow for expected

Flexible and mould resistant materials should be applied to affected areas to prevent any subsequent water damage that is likely to occur. Regular maintenance and replacement of damage or missing or damaged sealant and grout is highly recommended to the wet areas, as this is a regular wear and tear defect. Sealant and grouting in areas that come into regular contact with water should be maintained for the long term care of your property.

A sealant specialist or tiling contractor should be appointed to complete these works as soon as possible

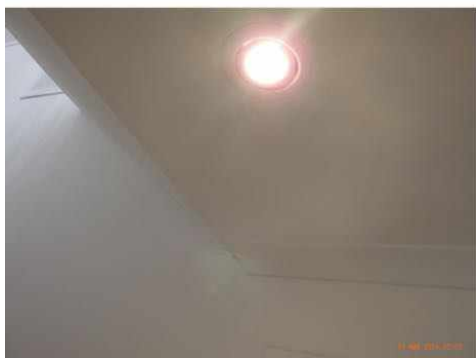
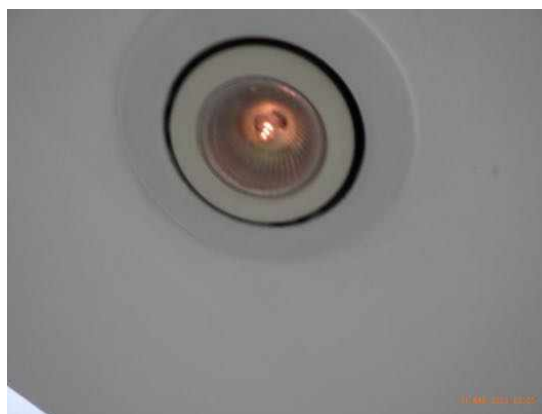
Building: Building 1
 Location: Roof Void
 Finding: Down-lights, Halogen no protective covers
 Information: There were several lights that appear to be halogen down lights noted throughout the property. They may have been replaced with different globes.

Alternatively the lights could be swapped for LED equivalents which burn cooler and use considerably less power.

A qualified electrician should be appointed to provide further advice and quotation for replacement immediately.

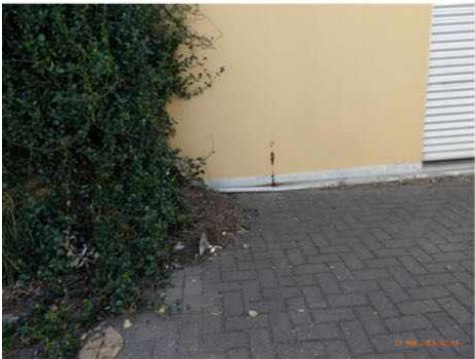
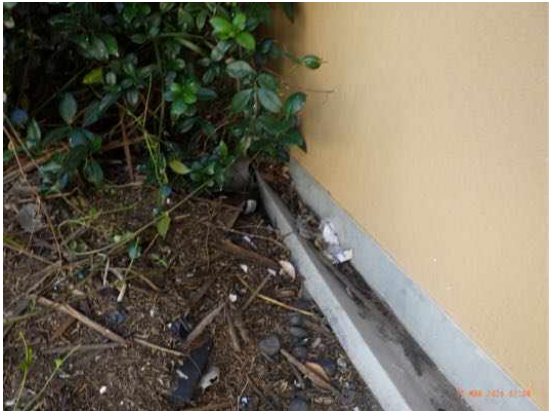
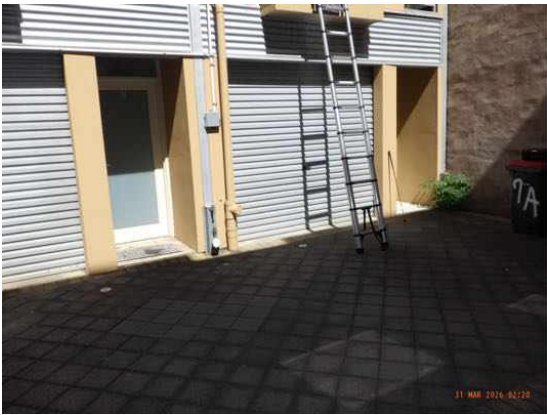
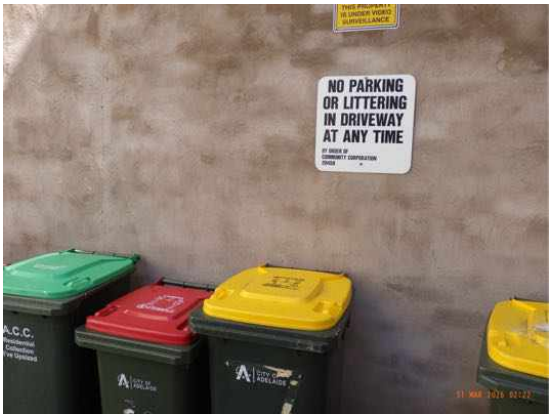
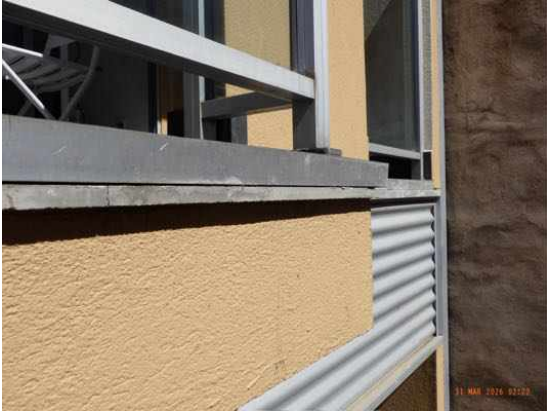
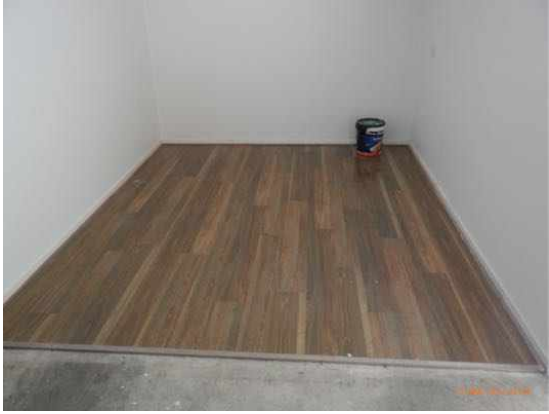
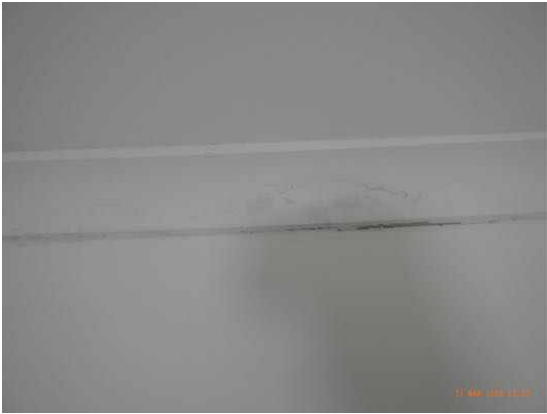
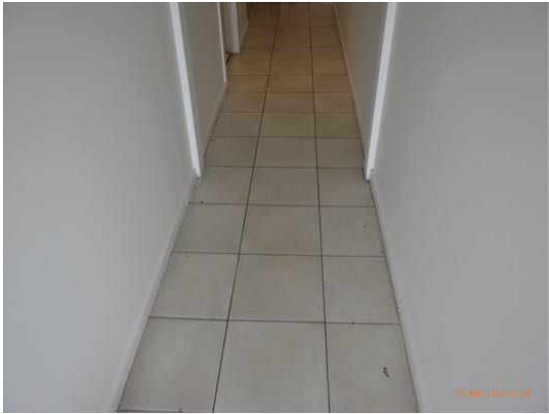
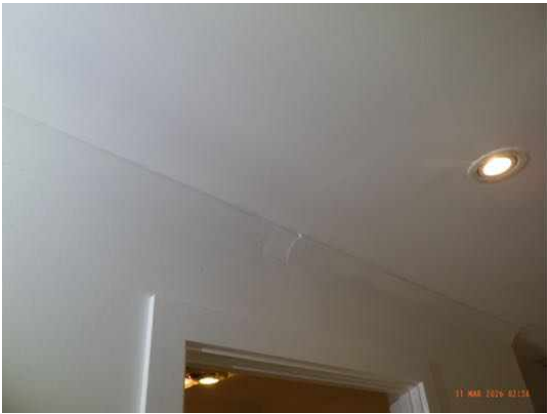
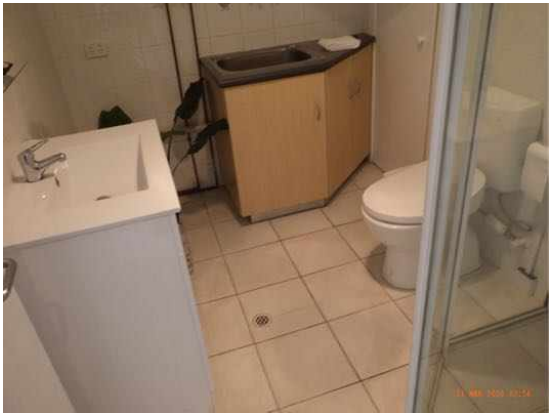
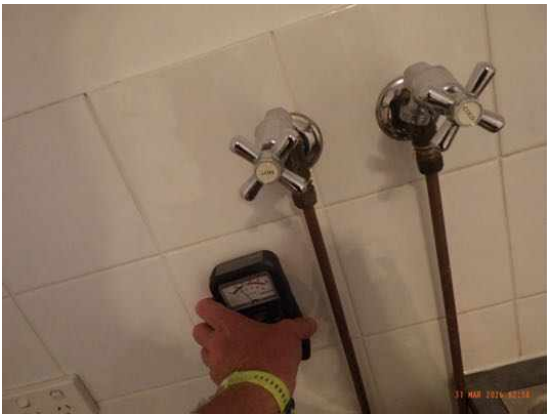
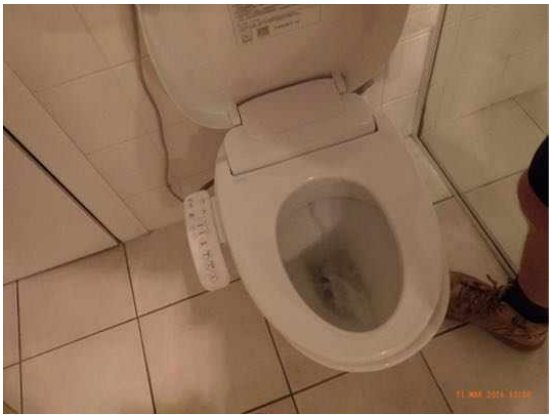
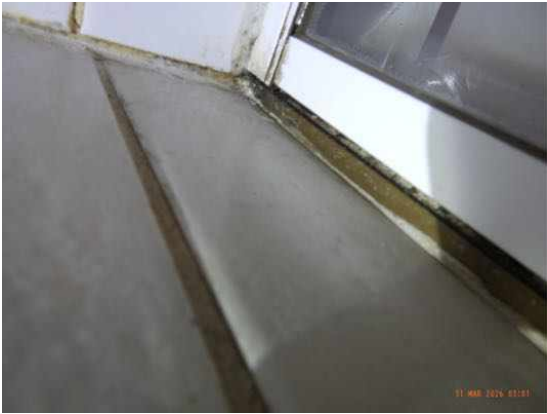
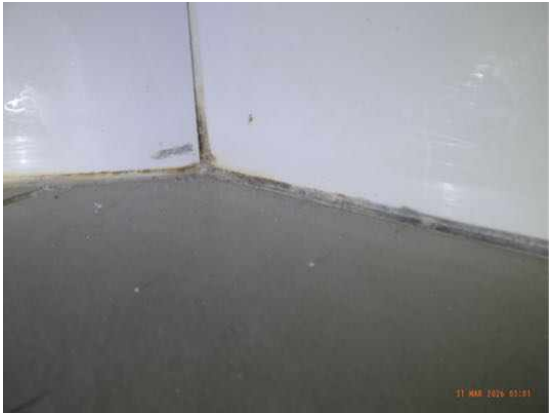
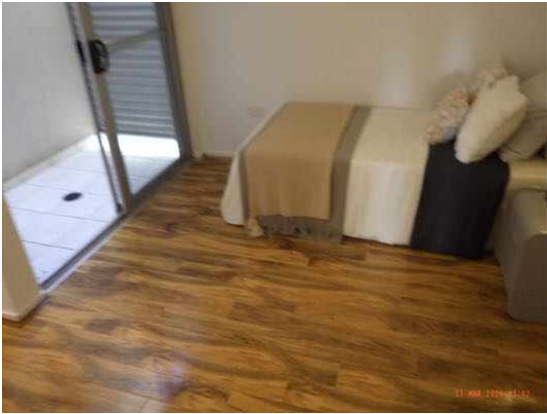
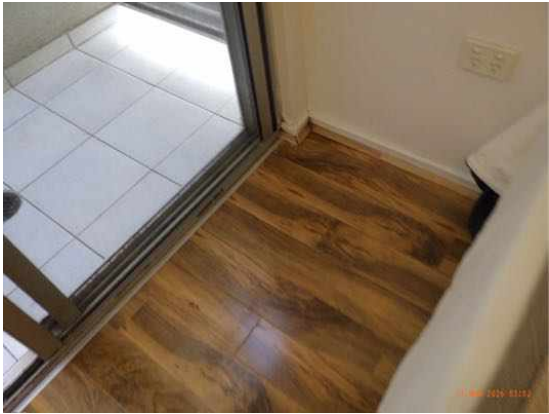
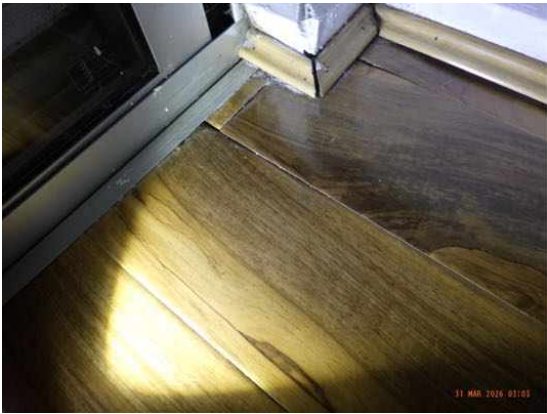
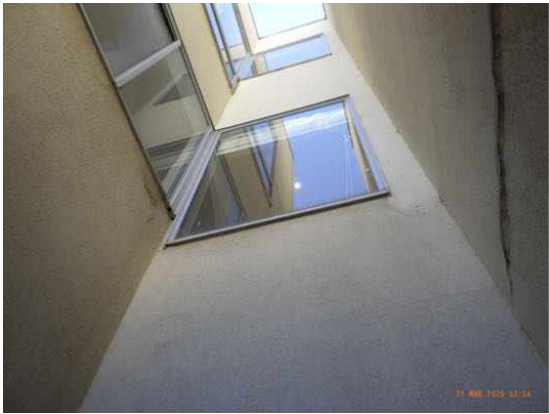
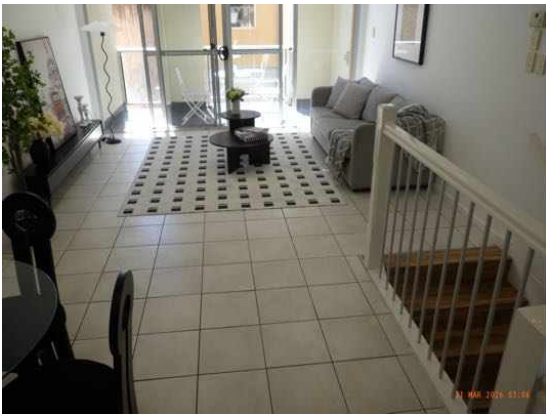
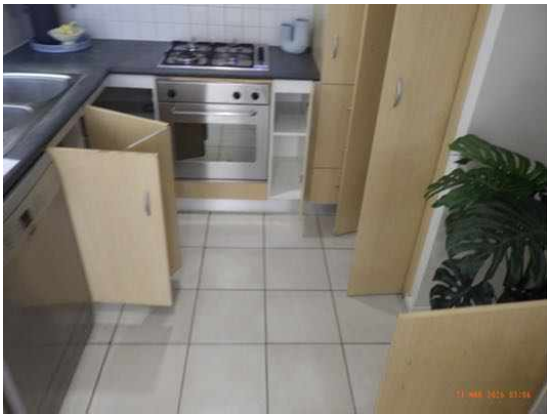
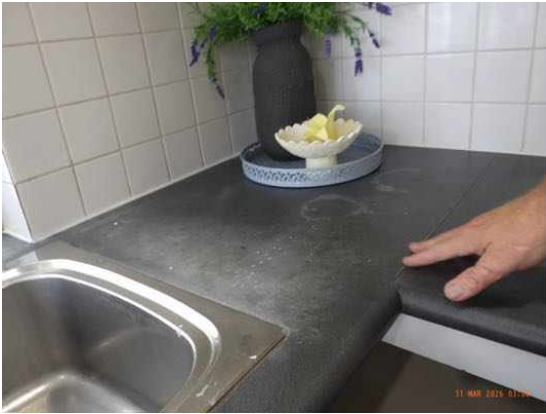
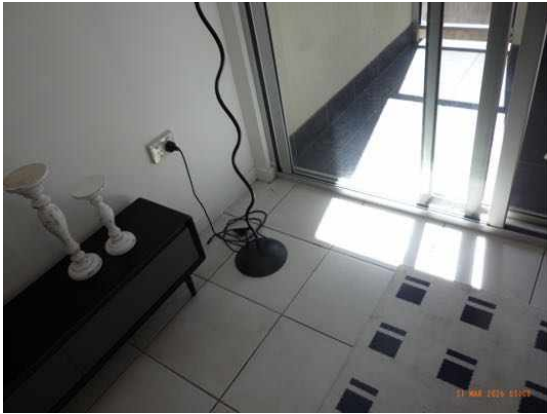
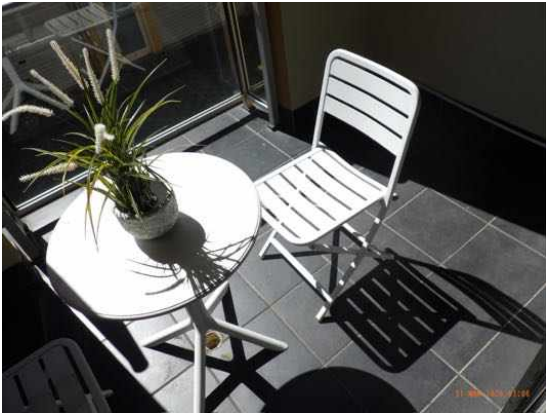
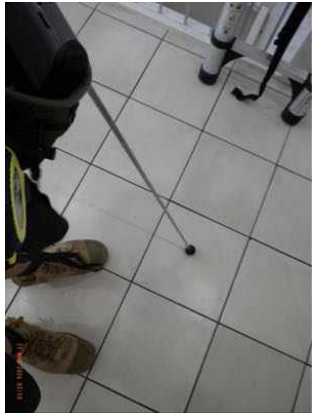
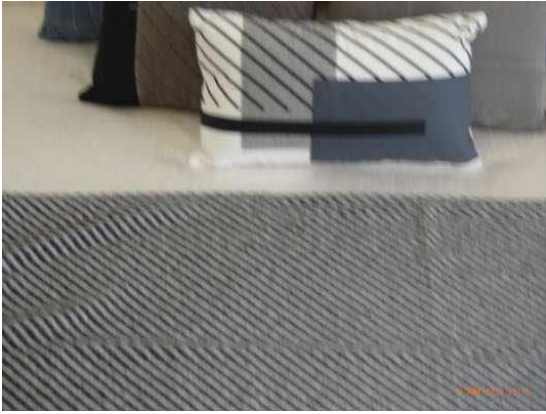
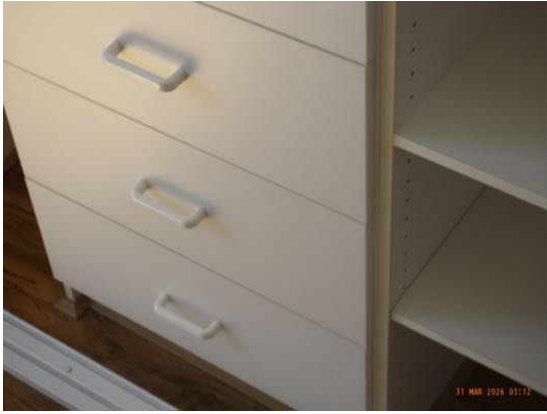
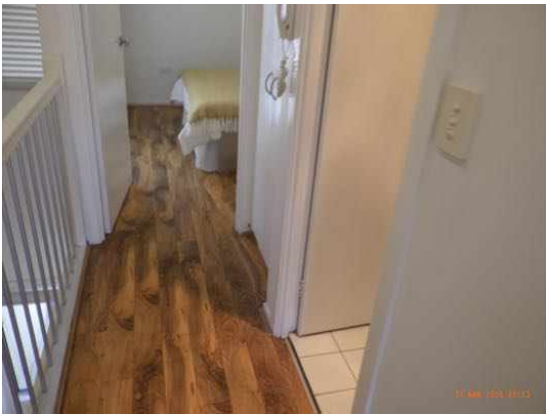
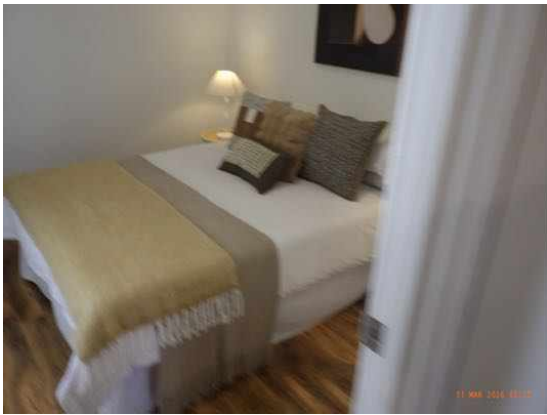
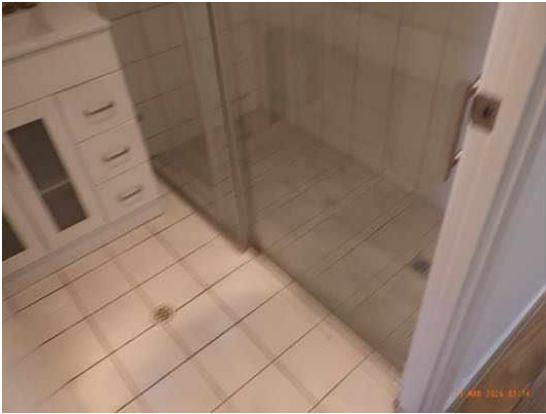
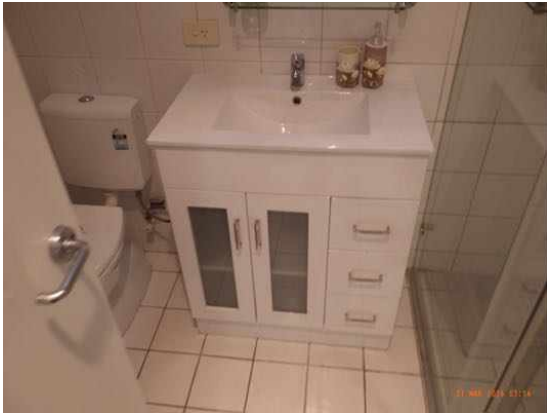
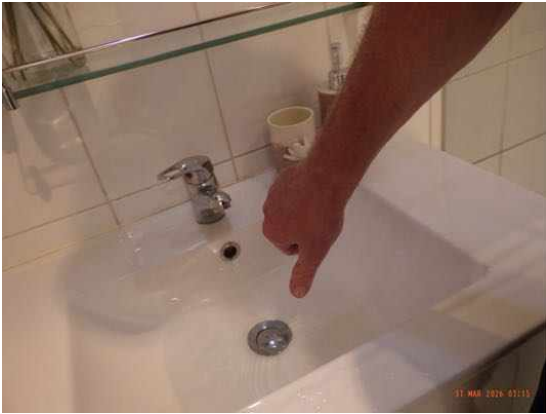
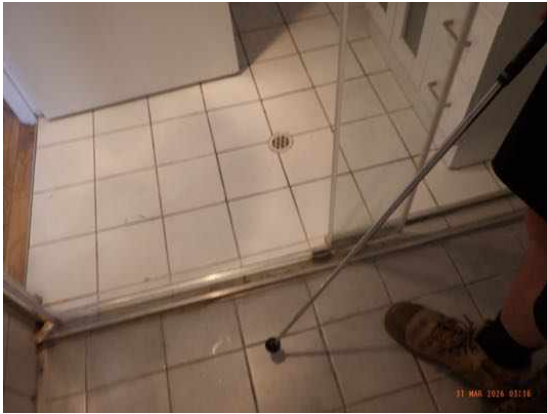
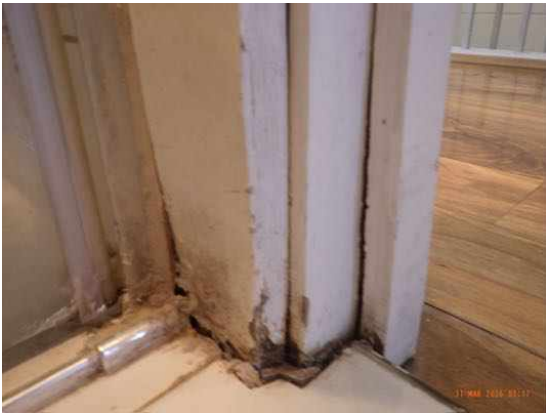
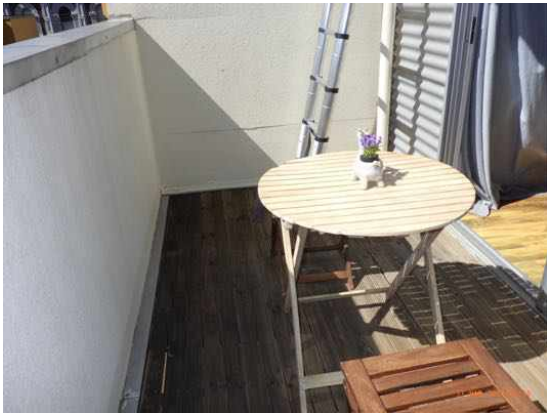
Building: Building 1
Location: All Areas
Finding: Additional Photos - Obstructions and Limitations
Information:

These photographs are an indication of the obstructions and limitations which impeded full inspection of the property at the time of inspection. These obstructions can hide an array of defects and should be removed to allow full inspection to be carried out.

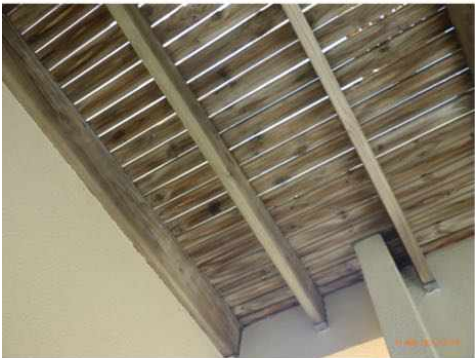
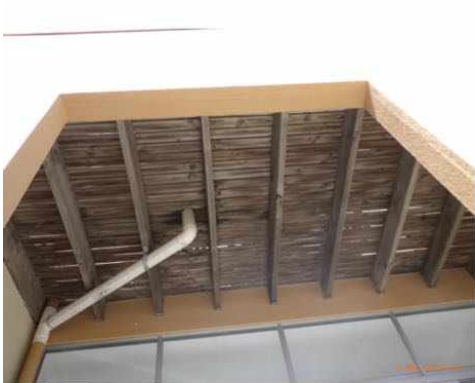
Noted Item

Building: Building 1
 Location: Balcony (Upper)
 Finding: External Timber Balcony or Deck - Structural Stability
 Information: The load capacity of the external balcony or deck could not be verified during the inspection.

External timber structures are also constantly exposed to weather elements and can deteriorate in an accelerated manner, ongoing assessments are required.

It is highly recommended that a Structural Engineer further assess the external timber balcony or deck to inform the client of its load capacity. Regular maintenance

inspections by competent practitioners is needed.
