Building Inspection Report

Inspection Date: Fri, 27 Feb 2026

Property Address: 8 Lemongrove Way, Narre Warren South
VIC 3806, Australia

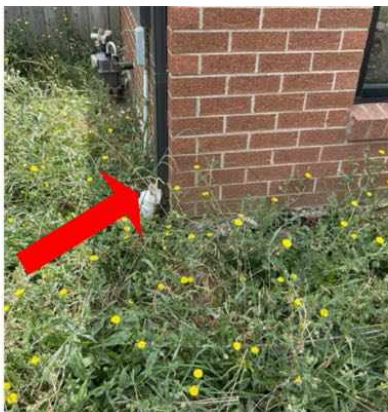
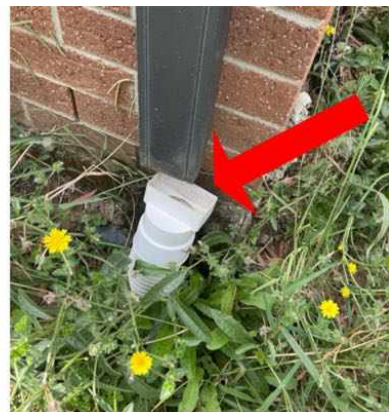
Defects 3.01

The downpipe located at the front elevation was observed to be detached from the stormwater drainage connection at ground level at the time of inspection. This condition is likely attributable to ground movement and/or minor foundation settlement causing displacement at the connection point.

A disconnected downpipe can result in uncontrolled discharge of roof water adjacent to the dwelling, which may contribute to soil saturation, footing movement, moisture ingress, and potential deterioration of adjacent building elements if left unrectified.

It is recommended that a licensed plumber be engaged without delay to reinstate and securely reconnect the downpipe to the stormwater system, ensuring the connection is properly sealed and adequately supported to prevent recurrence.

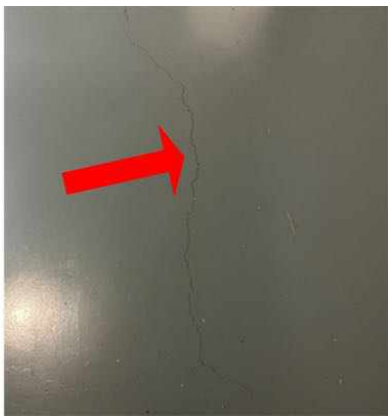
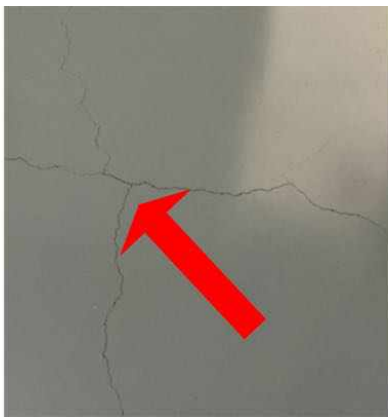
Defects 3.02

Finding: Noticeable cracks in concrete slab of the the garage floor

Information: During the inspection, multiple noticeable cracks were identified in the concrete slab of the garage floor. These cracks vary in size and location, which may indicate underlying movement or stress within the slab. While they do not currently appear to significantly impact the structural integrity, their presence suggests potential early-stage deterioration.

It is recommended that the cracks be monitored closely over the next 12 months. If any of the cracks widen or worsen during this period, it is critical to engage a structural engineer immediately to assess the situation and recommend appropriate rectification measures to prevent further damage and ensure the long-term stability of the structure.

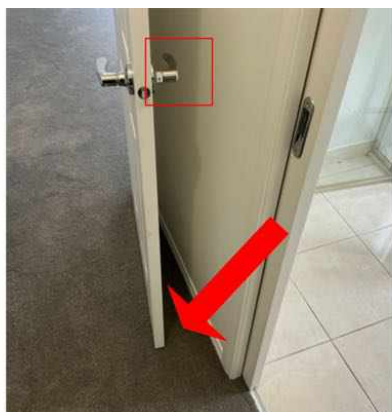
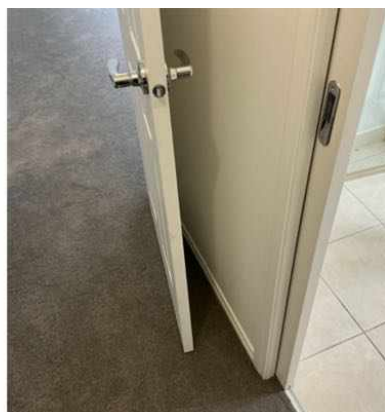
Defects 3.03

Finding: Door stop - Missing

Information: The door stop is missing or is inadequate to stop the door handle from damaging the wall. Although some building elements may seem irrelevant or unnecessary, all building elements play a key role in the operation and function of the overall structure and its performance.

Re-installation or replacement of the door stop is advised as soon as possible to prevent any subsequent damage to the door or associated structures. A general handyman may be appointed to perform these works at client discretion.

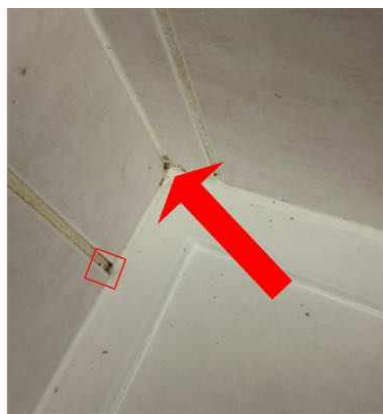
Defects 3.04

Building:	Main Building
Location:	Ensuite - Master
Finding:	Sealant and grouting - Deteriorated
Information:	It was noted on inspection that sealant or grout is degraded to the tiled shower alcove and or other areas of the bathroom.

Different materials and floor areas move at different rates, generally causing cracking to grout or sealant at this point. A flexible sealant is required to allow for expected expansion and contraction, while keeping the joint water tight and protective of all associated building materials.

Flexible and mould resistant materials should be applied to affected areas to prevent any subsequent water damage that is likely to occur. Regular maintenance and replacement of damage or missing or damaged sealant and grout is highly recommended to the wet areas, as this is a regular wear and tear defect. Sealant and grouting in areas that come into regular contact with water should be maintained for the long term care of your property.

A sealant specialist or tiling contractor should be appointed to complete these works as soon as possible

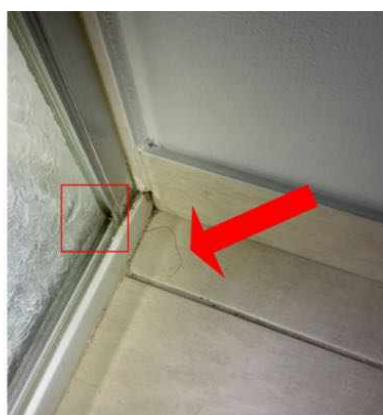
Defects 3.05

Building:	Main Building
Location:	Ensuite - Master
Finding:	Shower screen - Leaking
Information:	Leaking was evident to the ensuite's shower screen at the time of inspection. It is suspected that the leaking has occurred as a result of deteriorated or missing caulking to the shower or general ageing of the building elements.

Leaking from the shower where left unattended, is likely to lead to water damage to adjoining flooring and walls. Such damage can lead to water damage and necessitate extensive remedial works being required. Active water leaks may also create an environment that is susceptible to the formation and development of mould.

Appointment of a caulking contractor is required to repair or replace the caulking to the shower area. Such works should be performed as soon as possible to ensure that no further damage occurs.

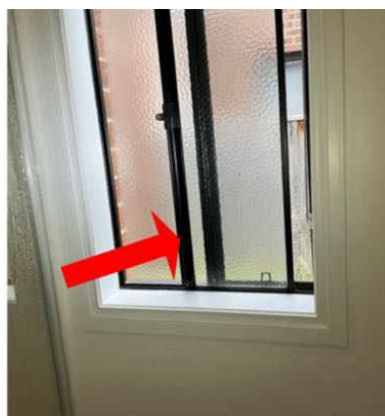
Defects 3.06

Building:	Main Building
Location:	Bathroom 2
Finding:	Window - Stiff to slide

Information: The window in the bathroom was stiff and difficult to operate at the time of the inspection. Windows provide ventilation to the adjoining area and should be at a fully operational level to ensure user comfort. Restricted function of the window may also pose as a potential safety hazard if required for emergency egress from the building.

Generally, factors such as general age of the building element and a lack of maintenance are the usual causes for this type of defect.

Replacement of window hardware or frame may be required, as well as minor repairs and cleaning. A registered builder or general handy person will be required to repair the window.

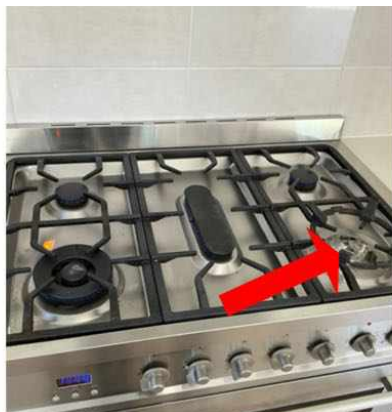
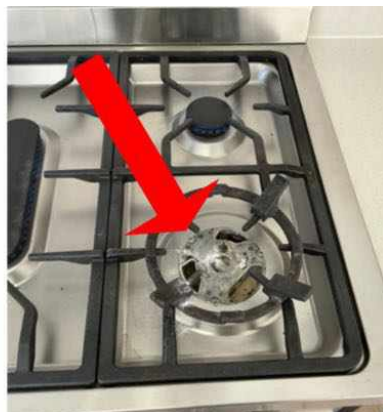
Defects 3.07

Building: Main Building
 Location: Kitchen
 Finding: Missing Stove Burner – Kitchen Area
 Information:

At the time of inspection, the right-hand side stove burner in the kitchen was observed to be missing and not installed. As a result, this specific burner was unable to be tested and was not operational at the time of assessment.

The absence of the burner prevents confirmation of its functionality and may indicate incomplete installation, prior removal, or the need for replacement. An inoperative or incomplete cooking appliance may affect the safe and intended use of the kitchen facilities.

It is recommended that the vendor arrange for the missing burner to be supplied and properly installed by a suitably qualified and licensed gas fitter or electrician (as applicable to the appliance type). The burner should be tested upon installation to confirm safe and correct operation prior to settlement.

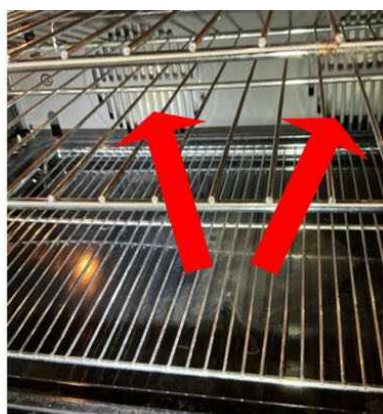
Defects 3.08

Building: Main Building
 Location: Kitchen
 Finding: Noisy Oven Fans
 Information:

At the time of inspection, the oven was tested and observed to be operational. However, both internal oven fans were noted to be loud and producing noticeable noise during operation.

While the oven was functioning, louder-than-expected fan noise may indicate wear to the fan motor, bearings, or internal components. Over time, this condition may affect the appliance's performance or lead to further mechanical deterioration if not addressed.

It is recommended that a suitably qualified appliance technician or oven specialist be engaged to assess the oven, identify the source of the noise, and undertake any necessary servicing or repairs to ensure continued safe and proper operation.

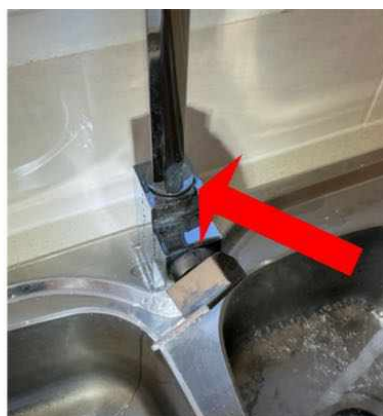
Defects 3.09

Building: Main Building
 Location: Kitchen
 Finding: Tap - Leaking

Information: The kitchen's tap was found to be leaking at the time of inspection. This is a common defect that is consistent with general ageing of the building element. However, it may be indicative of substandard plumbing workmanship if the tap is relatively new.

While this defect only seems minor, if left unmanaged, it is likely to result in the development of rust, water damage and/or extensive water usage.

It is advised that a handyman or licensed plumber be appointed to perform remedial works on the affected tap. Such works should be performed prior to the development of secondary defects to ensure adequate functionality of all associated building elements.

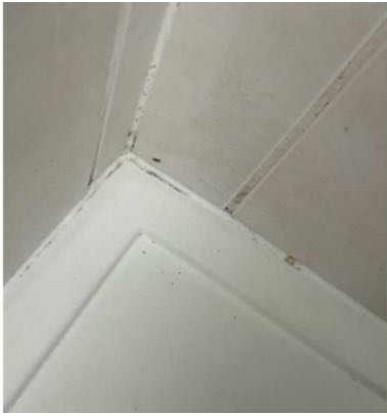
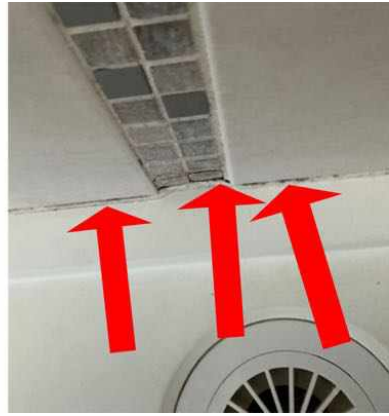
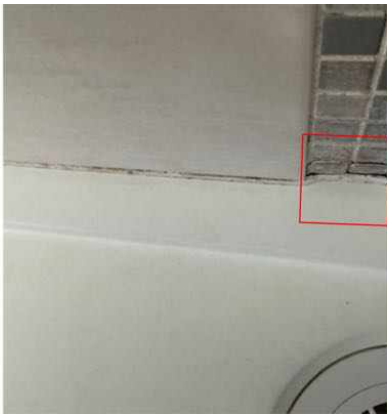
Defects 3.10

Building: Main Building
Location: Bathroom 2
Finding: Sealant and grouting - Deteriorated
Information: It was noted on inspection that sealant or grout is degraded to the tiled shower alcove and or other areas of the bathroom.

Different materials and floor areas move at different rates, generally causing cracking to grout or sealant at this point. A flexible sealant is required to allow for expected expansion and contraction, while keeping the joint water tight and protective of all associated building materials.

Flexible and mould resistant materials should be applied to affected areas to prevent any subsequent water damage that is likely to occur. Regular maintenance and replacement of damage or missing or damaged sealant and grout is highly recommended to the wet areas, as this is a regular wear and tear defect. Sealant and grouting in areas that come into regular contact with water should be maintained for the long term care of your property.

A sealant specialist or tiling contractor should be appointed to complete these works as soon as possible

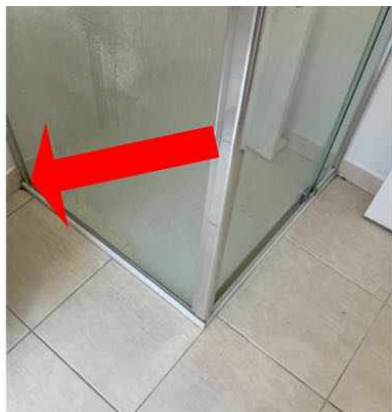
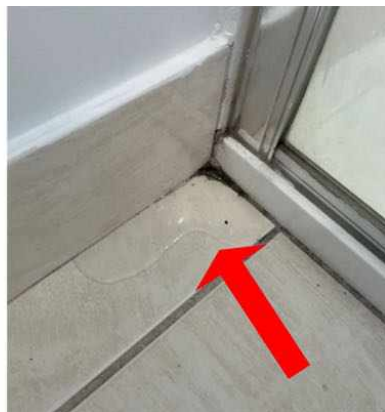
Defects 3.11

Building:	Main Building
Location:	Bathroom 2
Finding:	Shower screen - Leaking
Information:	Leaking was evident to the 2nd bathroom's shower screen at the time of inspection. It is suspected that the leaking has occurred as a result of deteriorated or missing caulking to the shower or general ageing of the building elements.

Leaking from the shower where left unattended, is likely to lead to water damage to adjoining flooring and walls. Such damage can lead to water damage and necessitate extensive remedial works being required. Active water leaks may also create an environment that is susceptible to the formation and development of mould.

Appointment of a caulking contractor is required to repair or replace the caulking to the shower area. Such works should be performed as soon as possible to ensure that no further damage occurs.

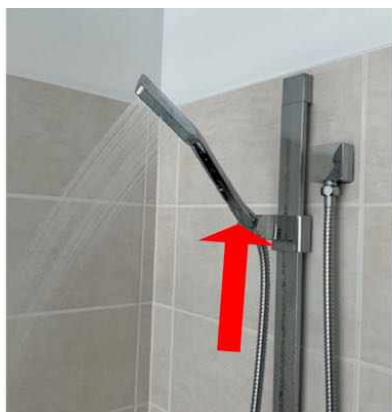
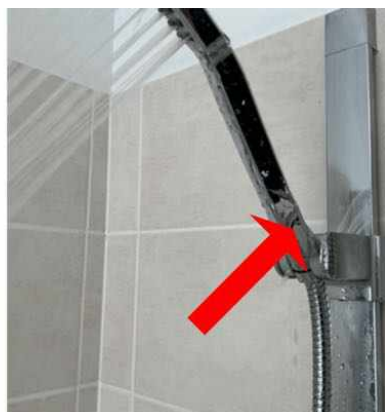
Defects 3.12

Building: Main Building
 Location: Bathroom 2
 Finding: Defective Shower Head in bathroom 2
 Information: Upon visual inspection, it was observed that the shower head in the 2nd bathroom is defective. This prevents the proper operation of the shower, hindering its functionality.

It is recommended that a licensed plumber be engaged as soon as possible to assess and repair or replace the shower head to restore proper use of the shower.

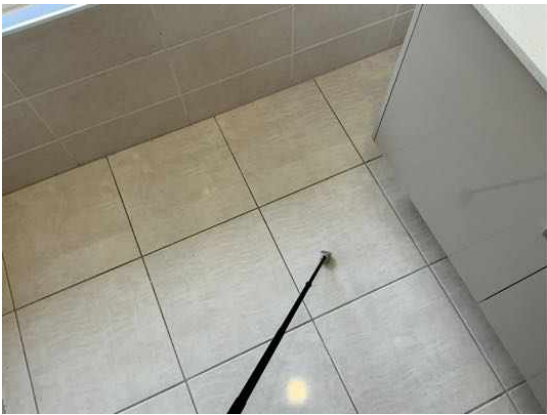
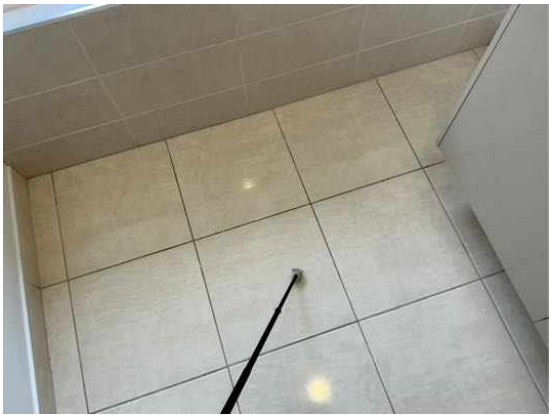
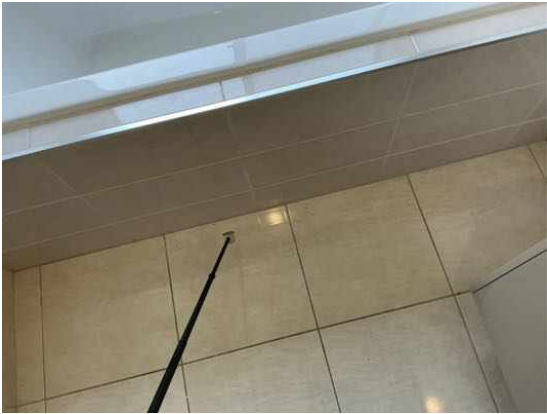
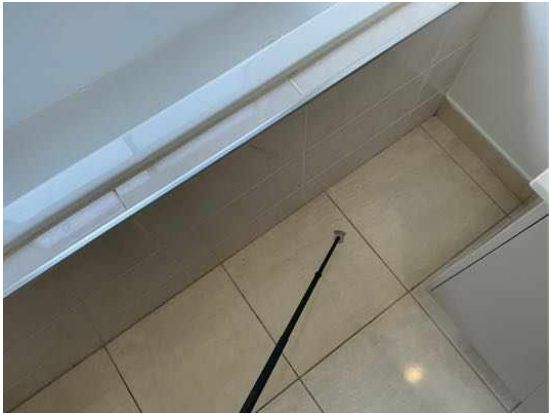
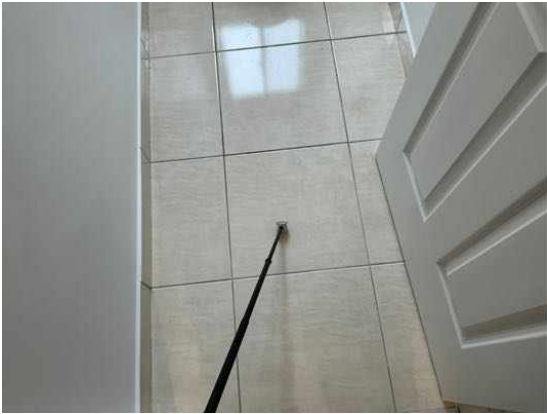
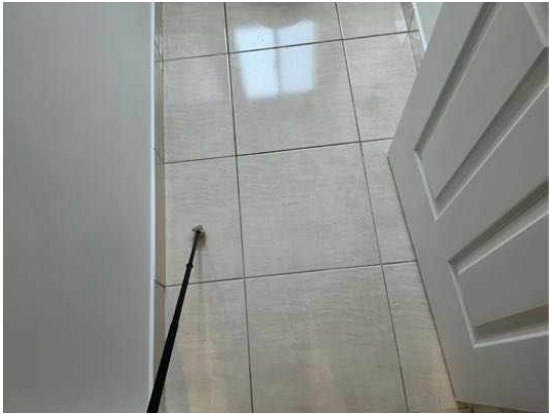
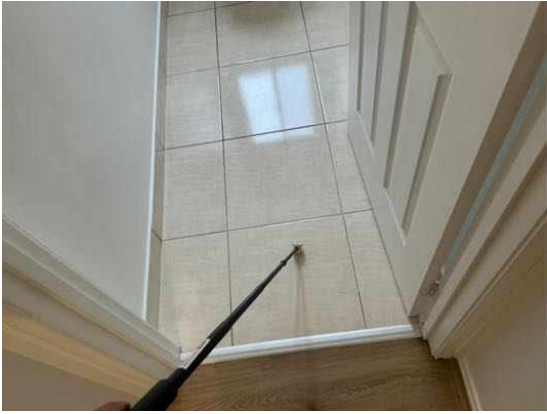
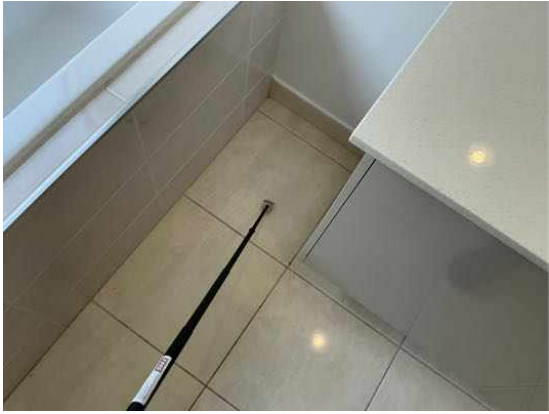
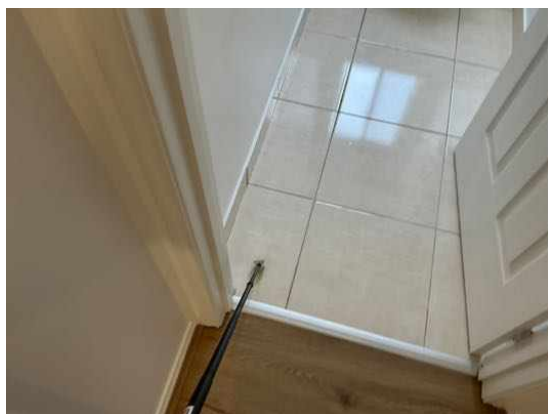
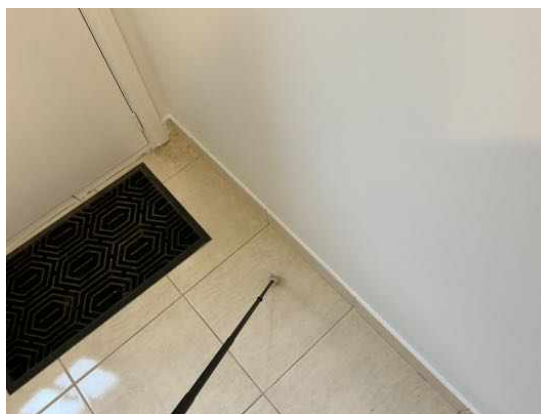
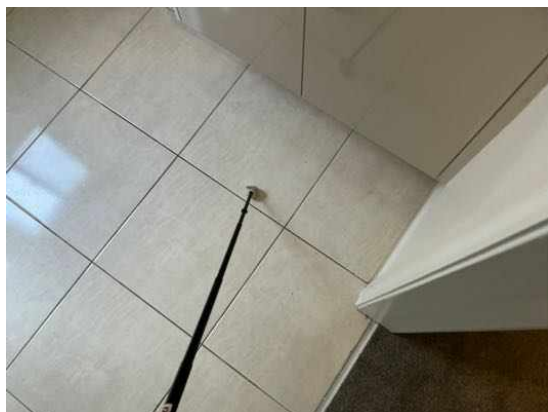
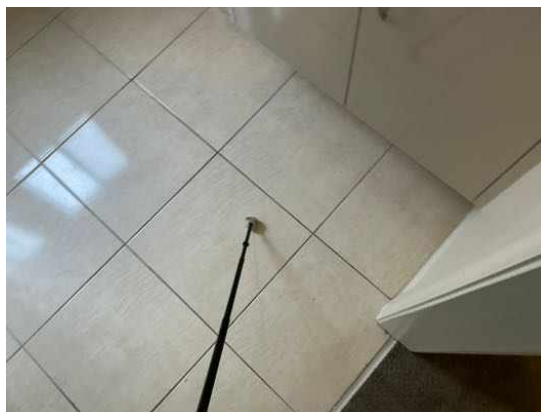
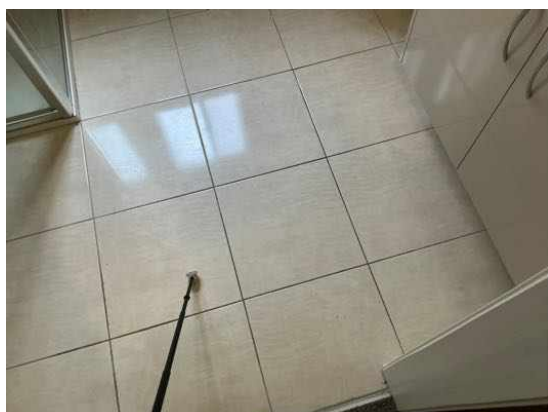
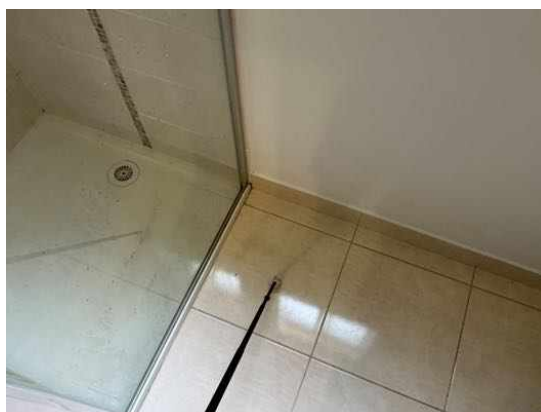
Defects 3.13

Building: Main Building
 Location: All Internal Areas
 Finding: Tiles - Drummy
 Information: Drummy tiled areas were identified at the time of inspection. The term 'drummy' refers to tiles that have become detached from their fixing, despite otherwise being in relatively good condition. Such defects are generally caused by physical or moisture damage to the area. Drummy tiled areas may also be a direct result of poor workmanship during the construction process.

Tiled areas may swell and shrink with changes in air humidity if the area has sustained

moisture damage. Any exposure to moisture is capable of causing tiled areas to become drummy and/or cracked over a prolonged period of time. Drummy tiled areas generally require removal and replacement of affected tiles, with adequate sealant and grouting.

Specialist trades are available for these types of services. A registered builder may be required to undertake works if damage is extensive or if secondary building defects have resulted. Otherwise, it is advised that a tiling contractor be appointed to perform works as necessary. Immediate action is recommended to ensure that no further damage is sustained in the affected area.

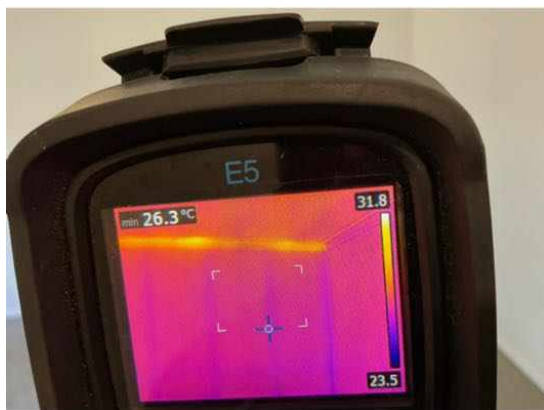
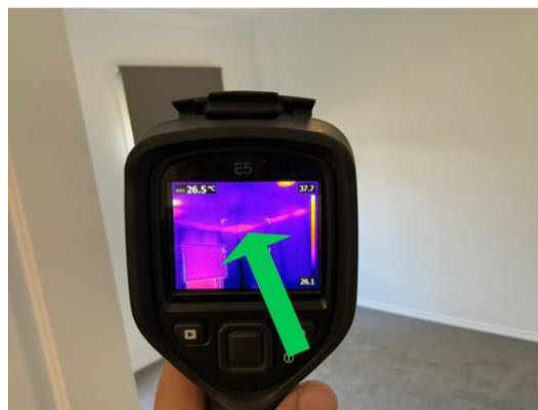
Defects 3.14

Building:	Main Building
Location:	All Internal Areas
Finding:	Inconsistent Thermal Performance to Ceiling Areas – Suspected Insulation Deficiencies
Information:	Thermal imaging conducted to internal ceiling areas at the time of inspection identified inconsistent heat patterns, which are indicative of variations in thermal performance across the roof space. These patterns are commonly associated with areas of missing, displaced, or insufficient insulation above the ceiling linings.

Inadequate or uneven insulation coverage can reduce the energy efficiency of the dwelling, contribute to heat loss in cooler periods and heat gain in warmer conditions,

and may result in reduced occupant comfort and increased heating and cooling costs. Due to the non-invasive nature of the inspection, the exact extent and condition of insulation could not be confirmed visually in all affected areas.

It is recommended that a qualified insulation contractor inspect the roof space, assess insulation coverage and condition, and top up or reinstate insulation where required to achieve consistent thermal performance throughout the property.

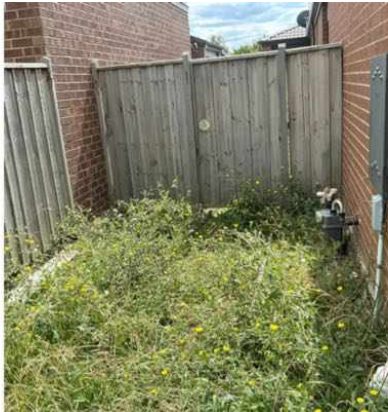
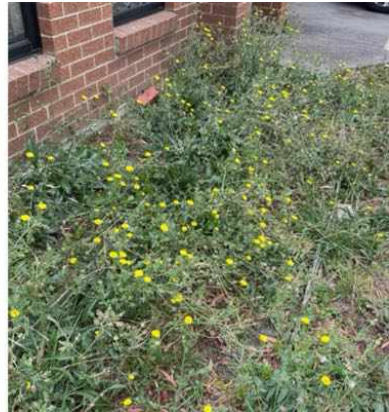
Building: Main Building
 Location: All External Areas
 Finding: Obstructions and Limitations - Exterior
 Information: These photographs are an indication of the obstructions and limitations which impeded the inspection of the external areas of the property at the time of inspection.

These obstructions can hide an array of defects and should be removed to allow full inspection to be carried out. A re-inspection is recommended once the areas are made accessible.

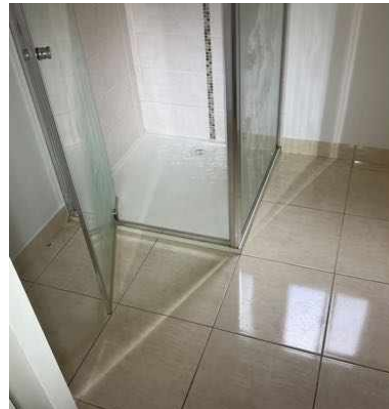
Finding: Obstructions and Limitations - Interior

Information: These photographs are an indication of the obstructions and limitations which impeded the inspection of the internal areas of the property at the time of inspection. These obstructions can hide an array of defects and should be removed to allow full inspection to be carried out. A re-inspection is recommended once the areas are made accessible.
