Building and Timber Pest Inspection Report

Inspection Date: Wed, 1 Apr 2026

Property Address: 3/80c Rathcown Rd, Reservoir VIC 3073, Australia

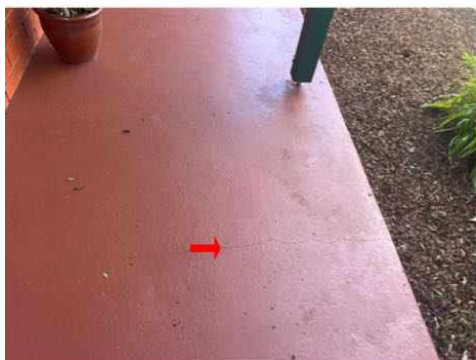
Building: Main Building
Location: Porch > Centre
Finding: Cracking - External Concrete Paving Damage Category 0 - Hairline (less than 1mm)
Information: Hairline cracks were identified in external concrete paving. Hairline cracks are very minor in nature and generally are only ever an appearance defect. To be classified as a Category 0 or hairline crack, the crack width would be less than 0.3mm. While such cracking may be noticeable in some cases, it is common and does not indicate any structural damage.

Generally the cause of a hairline crack in existing concrete paving such as driveways and pathways is indicative of the expansion and contraction of the concrete. Such causes are generally due to environmental factors, such as moisture levels, weather conditions, root systems of nearby trees or the soil types on which they are laid.

Hairline cracks may also be due to poor original installation of the concrete. Factors such as poor compaction of the sub surface and/or inadequate reinforcing of the slab may create cracking and other secondary defects.

Monitoring of all cracking should be conducted frequently. Always contact a building inspector should cracks widen, lengthen, or become more numerous.

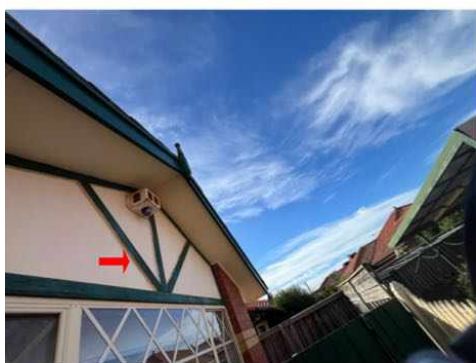
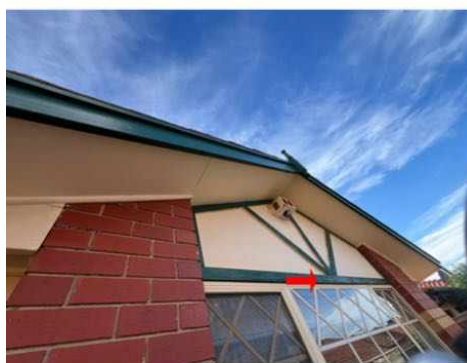
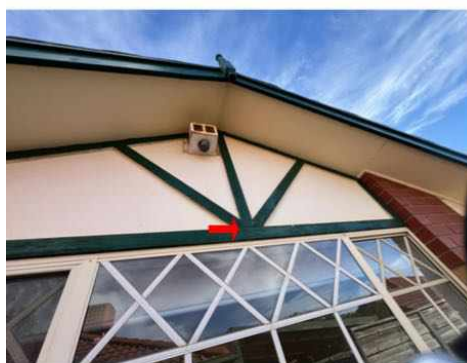
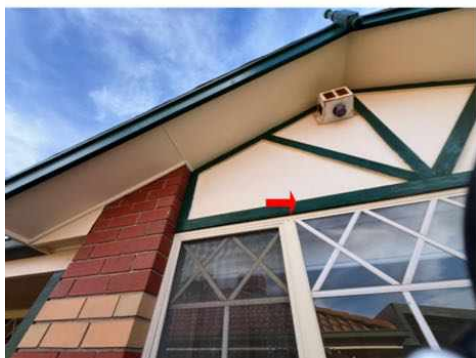
Finding 3.02

Building:	Main Building
Location:	Exterior walls - front > Front Right
Finding:	External painting deteriorated
Information:	Much of the external paintwork including but not limited to windows, fascias, guttering, veranda and other external fitments have been neglected and require attention to prepare and re-paint.

Whilst incomplete or missing paint finish is generally an appearance defect, it can also lead to the development of secondary building defects over time. Incomplete areas of paint finish expose the area to moisture, potentially accelerating the deterioration of underlying building materials.

Degraded paint finishes should be sanded back, filled, leveled and painted, as applicable. Where inadequate or missing paint protection has led to the deterioration of the associated building element, repair and/or replacement of this building element may be required.

A painting contractor should be appointed as soon as possible to perform necessary works to aid the appearance of the affected area and to ensure the area is protected against further deterioration. Alternatively, the homeowner following manufacturer instructions may perform these works.

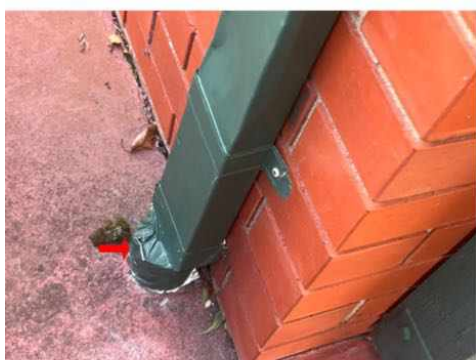
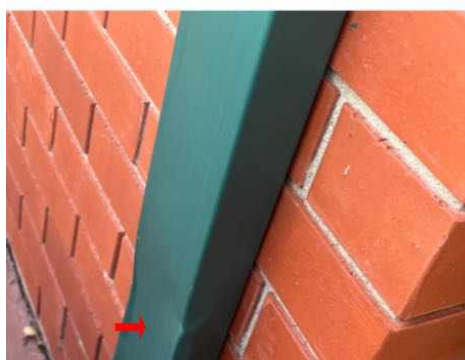
Finding 3.03

Building:	Main Building
Location:	Exterior walls - right side > Front Left
Finding:	Building element - Damaged-down pipe-& drain
Information:	Breakage occurs generally when the building materials have either aged and decayed, or as a result of damage (accidental or deliberate).

Repair and/or replacement of broken elements is advised to ensure that additional secondary defects do not arise as a consequence. Such works are necessary, as all building elements play a key role in the operation and function of the overall structure and its performance.

A relevant tradesperson should be appointed to repair or replace the affected building element prior to any subsequent damage being caused.

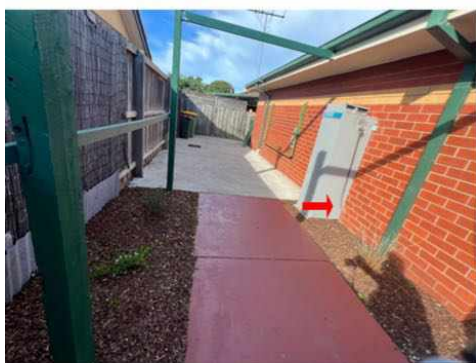
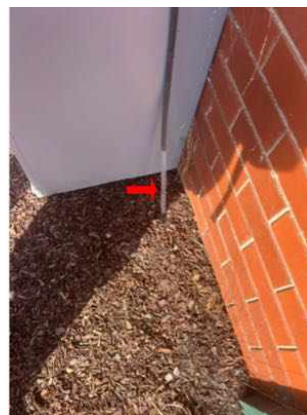
Finding 3.04

Building:	Main Building
Location:	Exterior walls - right side > Centre
Finding:	HWS Overflow - Not Connected
Information:	The Hot Water System (HWS) overflow was found to be disconnected from storm

water drainage and is creating excessive moisture in the surrounding area.

These damp conditions can lead to secondary defects such as rot, rust or corrosion of associated building elements, the formation of fungal decay, or even the creation of potential slip hazards. When coupled with poor site drainage, pooling of water may also attract termite activity to this area.

It is highly recommended that a licensed plumber be appointed to connect the HWS overflow in order to prevent such an environment from being created. These minor works should be carried out as soon as possible.

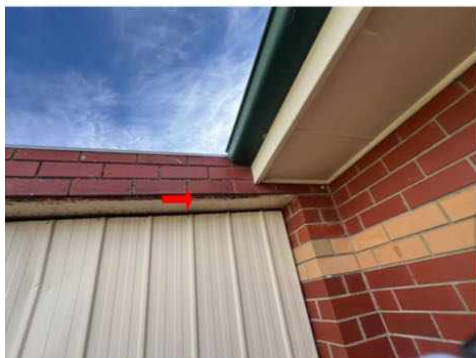
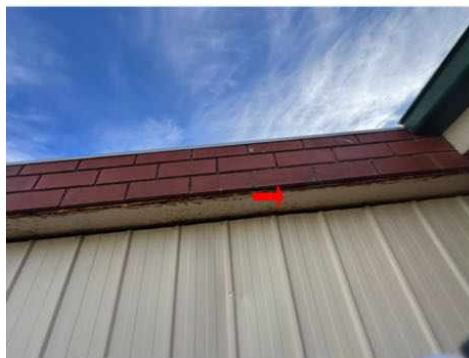
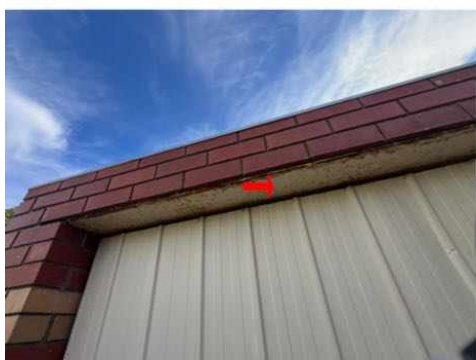
Finding 3.05

Building:	Garage
Location:	Exterior walls - front > All Areas
Finding:	Building element - Rusted or corroded-lentil to garage
Information:	This building element shows evidence of rusting and corrosion, which is likely to have developed as a result of excessive exposure to moisture and or inadequate coatings.

As surface rust provides no protection to the underlying iron, the deteriorating condition is likely to worsen if not addressed in the short-term future.

Where possible, the use of galvanized (treated) metals or aluminium coated metals aid in rust prevention, as does regular general maintenance. Rust formation can be controlled with coatings, such as paint, that isolate the iron from the environment.

Rusting and corrosion should be managed by ideally removing or limiting the affected surface from exposure to moisture. A registered builder may be appointed to replace any building elements that have been severely affected by rust or water damage.

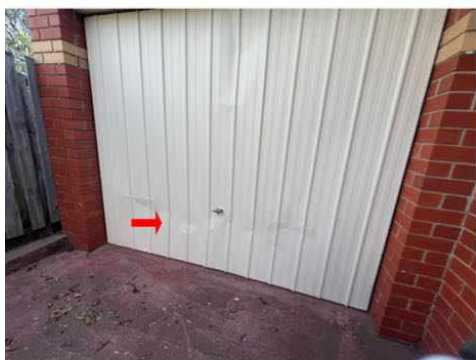
Finding 3.06

Building:	Garage
Location:	Exterior walls - front > Front
Finding:	Garage door - Superficial markings-impact noted
Information:	The garage roller door has a number of marks and dents likely to have resulted from impact damage be it accidental or deliberate impact at sometime.

Garage roller doors can fail when the building materials have aged but may be indicative of impact damage (accidental or deliberate). While superficial markings detract from the aesthetics of the building element, the functionality has not been hindered in any way.

Repair and/or replacement of the two garage doors would improve the condition of the garage but certainly not an urgent item

A qualified roller door installer or supplier should be engaged to check out the operation and overall condition of the doors to determine if repair is an option otherwise replacement may need to be considered.

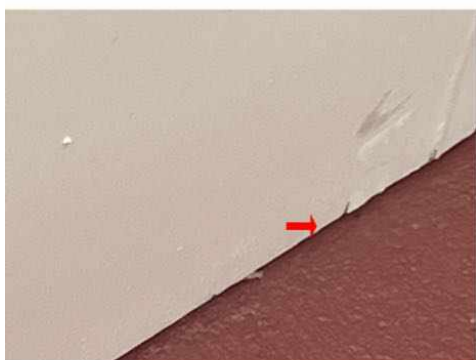
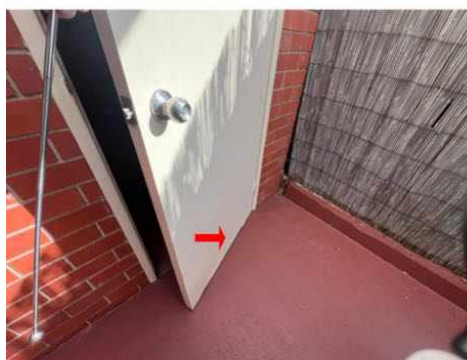
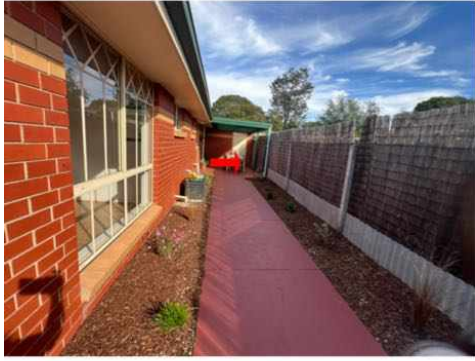
Finding 3.07

Building:	Garage
Location:	Exterior walls - right side > Rear
Finding:	Building element - Swollen-door swollen at base
Information:	Swollen building elements generally indicate that the building materials have been affected by excessive moisture over a prolonged period of time, and have swollen as a result. The formation and development of mould/fungi or mildew is also a likely consequence of excessive moisture, which may pose major respiratory issues for occupants, particularly the elderly, the very young and those with existing illnesses and could be potential health safety hazards. In these cases an appropriately qualified inspector/tester should also be contacted for advice and/or technical assistance.

The structural integrity of swollen building elements can not be guaranteed, and further damage is likely to develop if left unmanaged. Excessive moisture is likely to lead to the development of secondary damage to any associated building elements, which may necessitate major reparation works if prolonged.

Rectification of the cause of the water leak should be addressed prior to any remedial works to the swollen building elements. A licensed plumber should be appointed immediately to identify the cause of the leak and provide advice on remedial works as necessary, Repair and/or replacement of swollen building elements should be conducted as a matter of urgency by a registered builder or qualified carpenter.

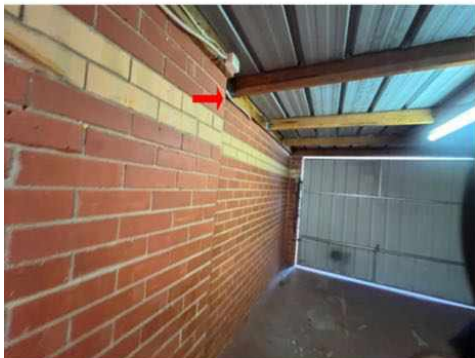
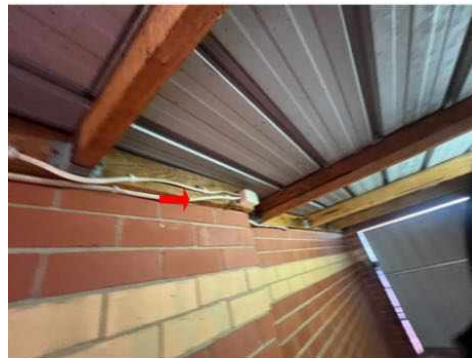
Finding 3.08

Finding: Conduit - Missing

Information: A conduit has not been installed to exterior wires in this area. This is a safety measure that is aimed at protecting the wires and preventing any personal injury that may result if wires are squashed or damaged.

Without a conduit providing adequate protection, external wiring is likely to become damaged and deteriorated over time, creating an electrical safety hazard. Damage to the wiring is also likely to result in the associated elements losing function.

A qualified electrician should be contacted immediately to install a conduit around the wires and provide any further advice on additional works that may be required to increase the safety of the wiring and its surrounding area.

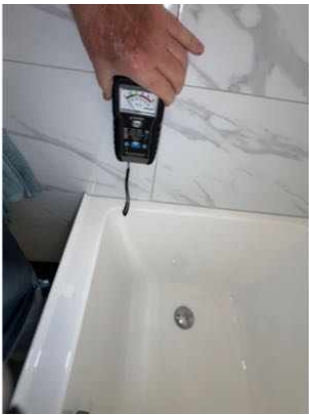
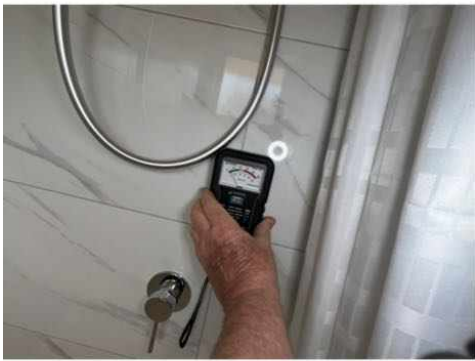
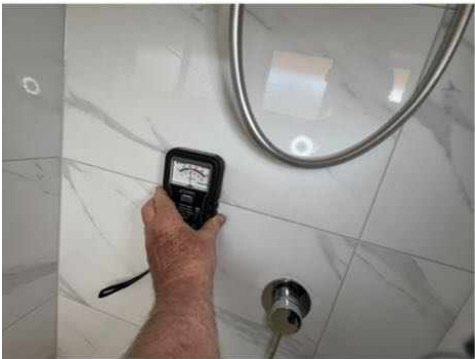
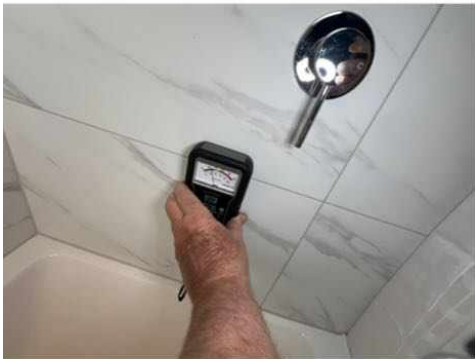
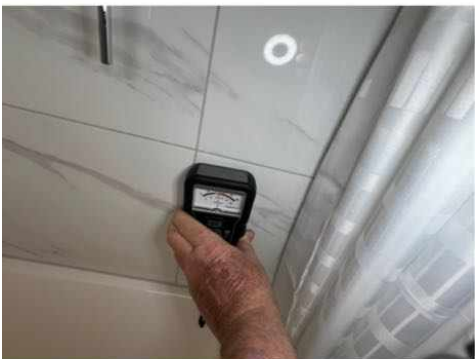
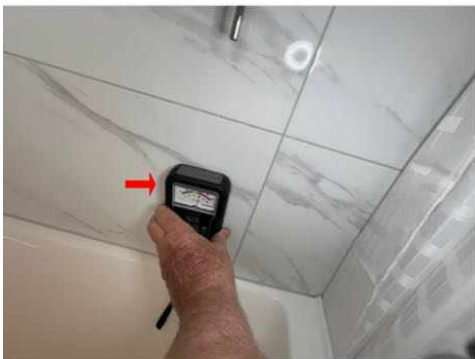
Building: Main Building
 Location: Bathroom > Front Left
 Finding: Shower - Damp
 Information: Damp is evident to the lower 300mm of wall to the shower alcove. This defect is quite common, and is suspected to have been caused by moisture permeating through the

grouting in this area, which shows evidence of deterioration. Leaking pipes within the adjoining wall is also a possible cause.

Unmanaged damp in the shower recess is likely to facilitate the formation and development of mould and fungi growth, decaying associated building materials and compromising their structural integrity. It is important to address damp conditions, as the World Health Organisation notes that excess moisture leads - on almost all indoor materials - to growth of microbes such as moulds, fungi and bacteria, which subsequently emit spores and other matter into the indoor air. Exposure to these contaminants is associated with a wide range of respiratory and other health-related problems.

Consultation with a qualified plumber or bathroom specialist is advised immediately to identify the cause of damp and to perform remedial works as required. Where excessive mould growth is present, further inspection by a specialist environmental health inspector should also be considered.

Always ensure that sealant and grout is in good condition to prevent any moisture issues occurring in the future.

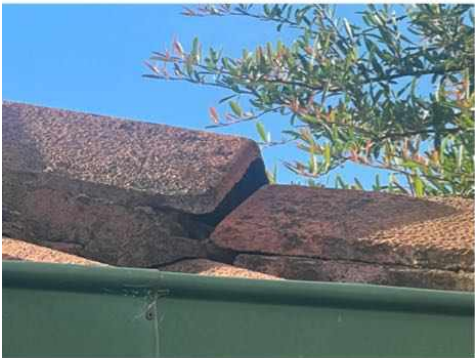
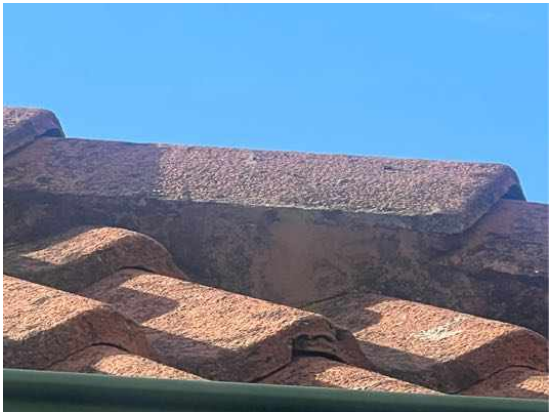
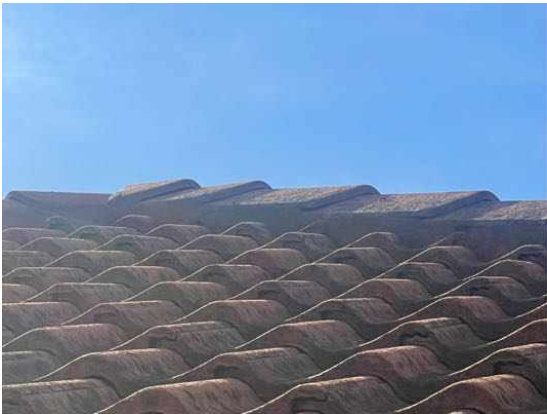
Finding 3.12

Building: Main Building
Location: All Areas > All Areas
Finding: Roof tiles - Weathered
Information: Upon inspection of the exterior roofing, the majority of roof tiles were considered to be in a fair condition. While weathering of the tiles is consistent with the age of the property, maintenance works are required.

Isolated areas of mortar have come loose in the valleys and minor cracking is also present. Re-pointing and re-sealing the may be considered as an interim solution by the client to help preserve and extend the life span of the tiles.

Where left unmanaged, deteriorating roof tiles are likely to lead to a number of secondary defects, including minor water leaks and weather exposure to internal roofing structures.

Consultation with a roofing contractor is highly advised to gain advice on cost of remedial works that may be required in the short to medium term. Remedial works are likely to increase the longevity of the exterior roofing structure.

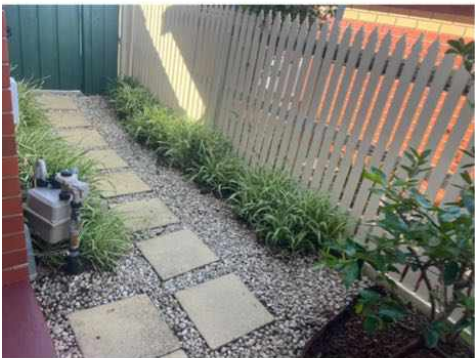
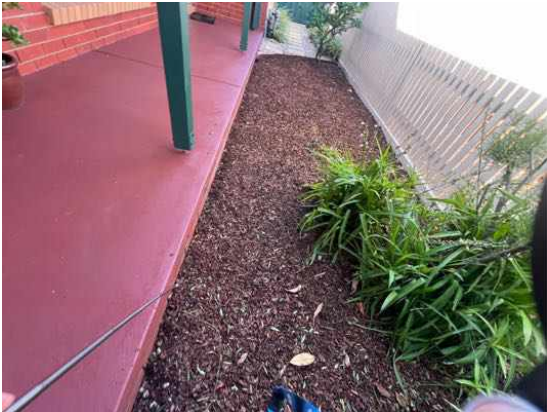
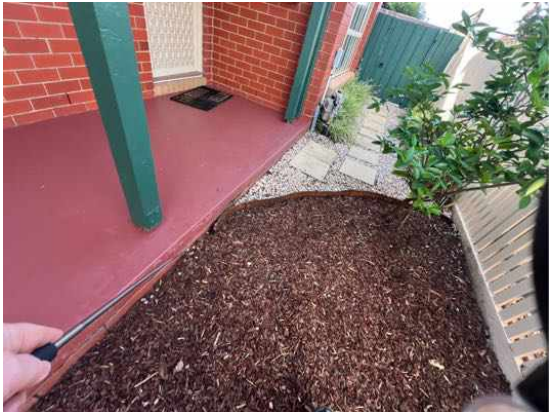
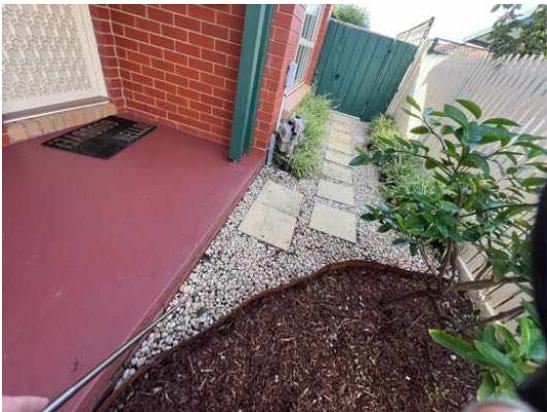
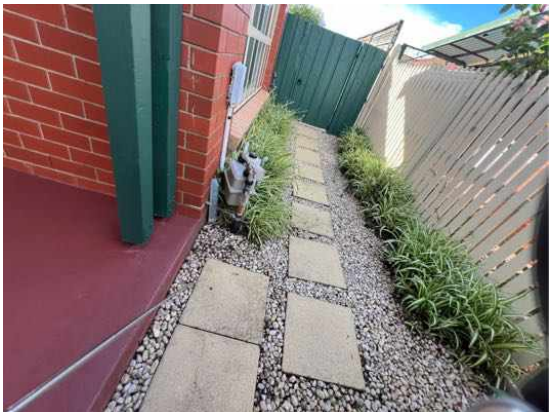
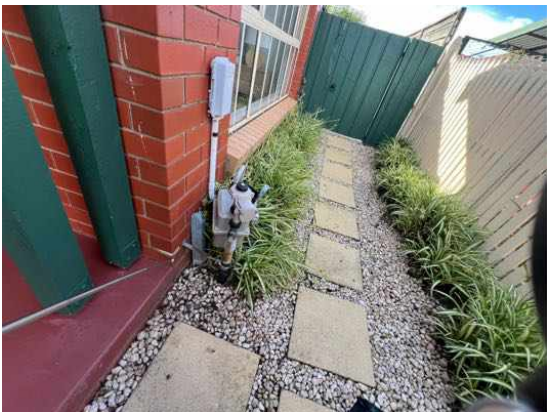
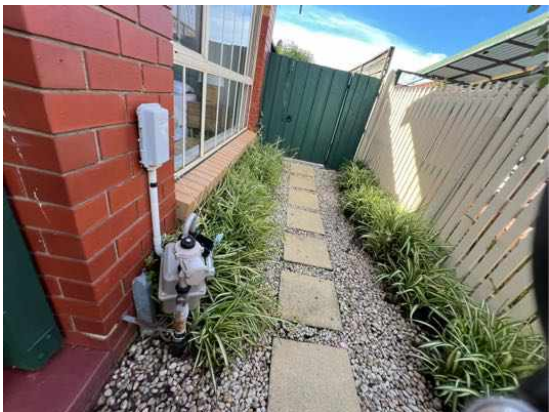
Building:	Yard
Location:	Yard - Front > All Areas
Finding:	Building materials in direct ground contact - conducive to termites
Information:	Where timber elements are in direct contact with the ground and consequently moisture or dampness they become conducive to termite activity. Whether timber is used as a building element part of a fencing structure or stored as an unused item they can provide an environment that is attractive to termite infestation.

When met with excessive moisture timber begins to decay and develop wood rot. Any timbers that are in direct contact with external grounds especially if left untreated or non-durable also provide ingress for subterranean termites into that particular element.

The removal of any such materials that may be conducive to termite activity should be removed as soon as possible to minimise the risk of termite attack.

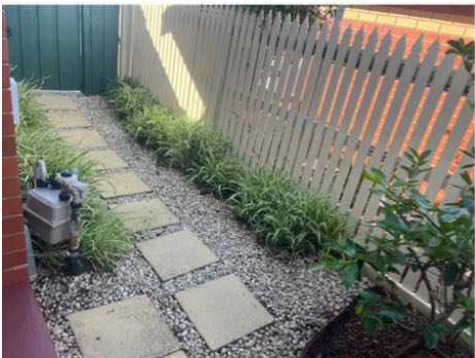
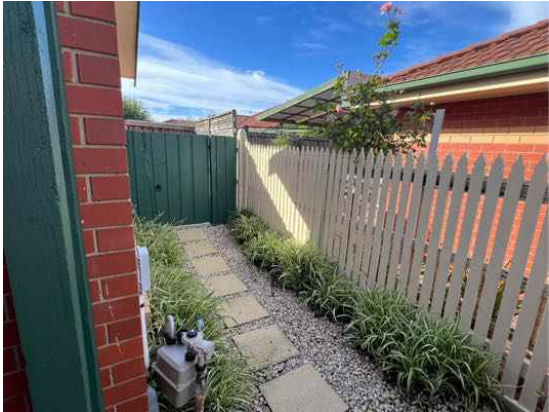
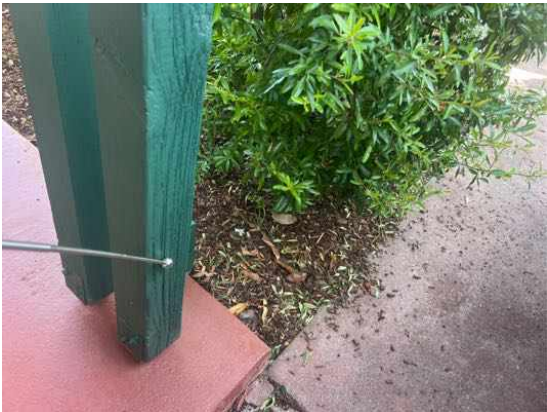
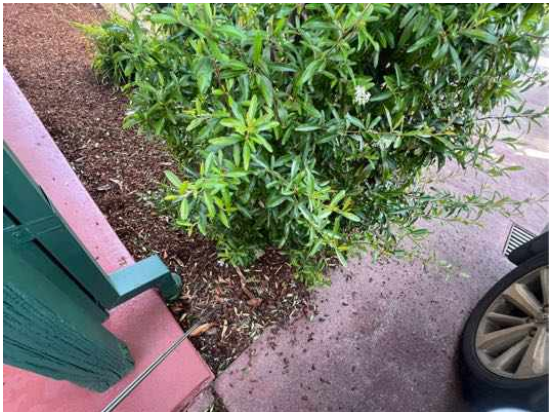
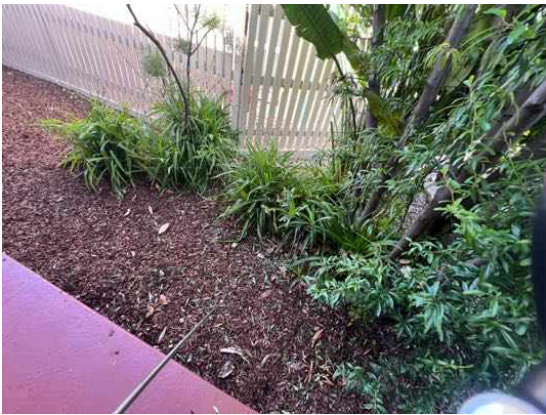
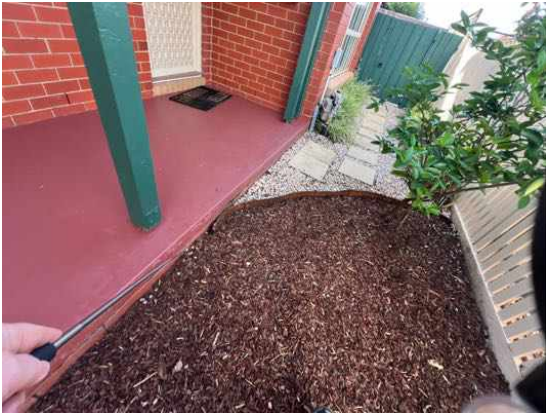
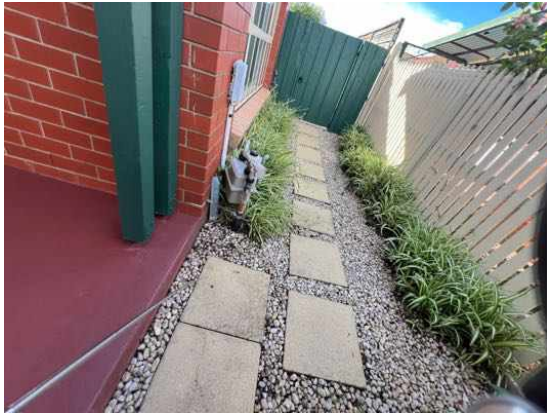
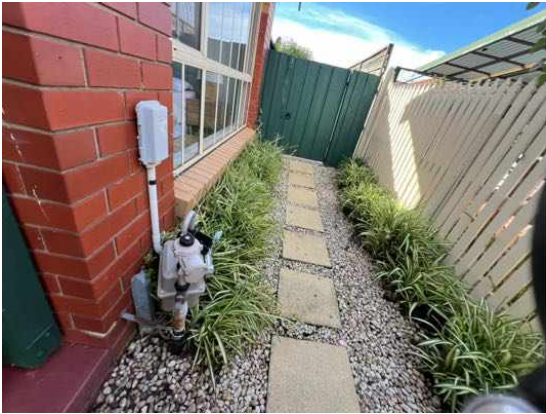
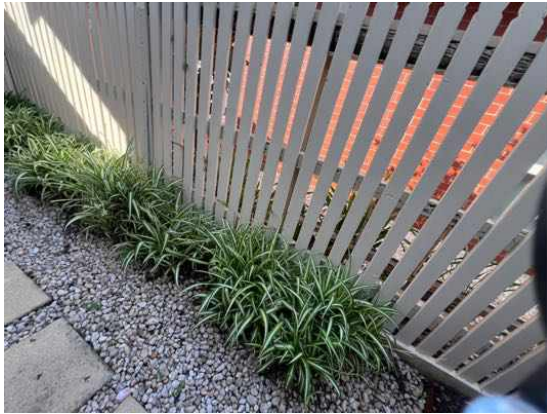
Finding 6.02

Building: Main Building
 Location: Front Elevation > All Areas
 Finding: Garden Beds - Conditions Conducive to Termites
 Information: Garden beds were found to be evident in the garden area. These garden beds can include untreated timber, and with a combination of moisture from watering hosing can make conditions conducive to termite activity and termite ingress.

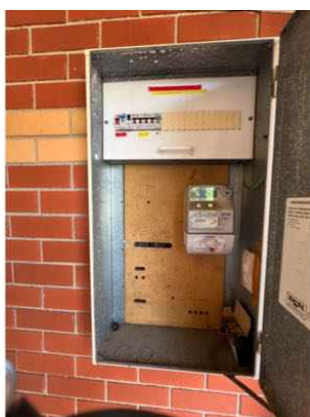
Finding 6.03

Building: Main Building
 Location: Front Elevation > Front Left
 Finding: Timber Pest-meterbox no durable notice-found
 Information: Meter Box

The application of a post-construction chemical termite barrier is highly recommended for all

properties, particularly if live termite activity has been found on the site previously.

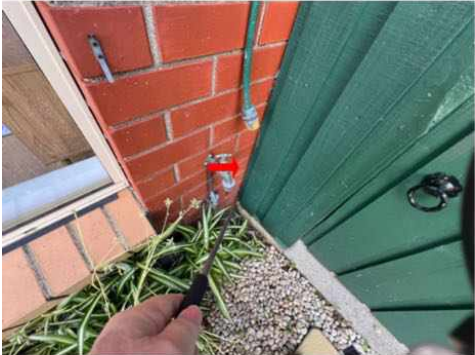
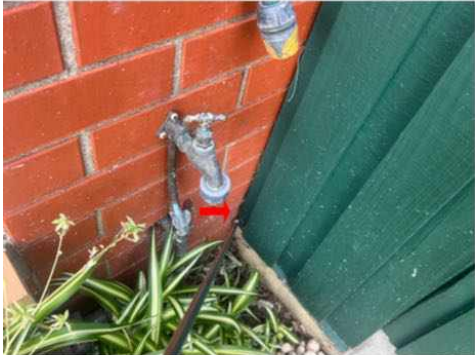
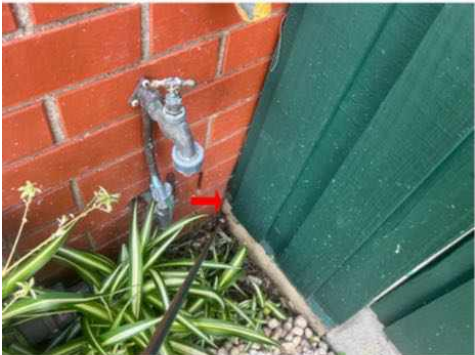
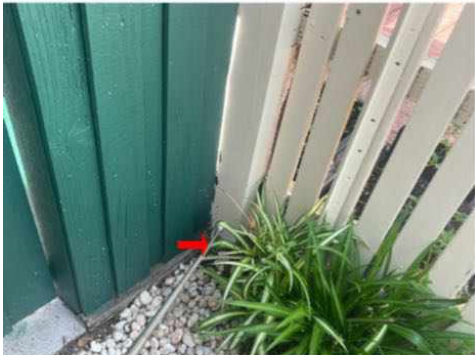
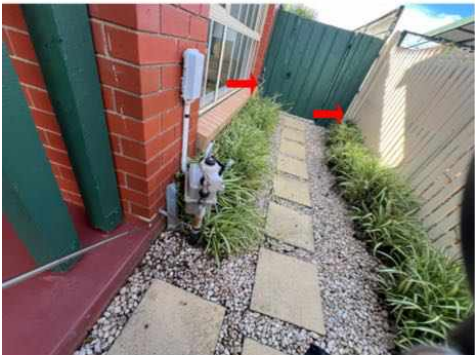
Finding 6.04

Building:	Yard
Location:	Front Elevation > Front Right
Finding:	Pest -Attachments to buildings-structures-EG steps, verandahs, porches, carports, trellises, decks-down pipes-
Information:	5.4.3 Attachments to buildings Attachments to buildings such as downpipes and service pipes mounted on external walls shall have a nominal gap, which provides clear and uninterrupted visual inspection across the inspection zone. Structures such as steps, verandahs, porches, access ramps, carports, trellises, decks, hot- water systems, air-conditioners, or similar, which are not provided with a termite management system in accordance with AS 3660.1, shall be separated from the building by gap of at least 25 mm, to allow clear and uninterrupted visual inspection

across the inspection zone.

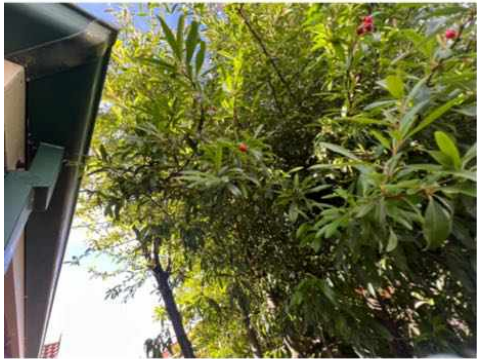
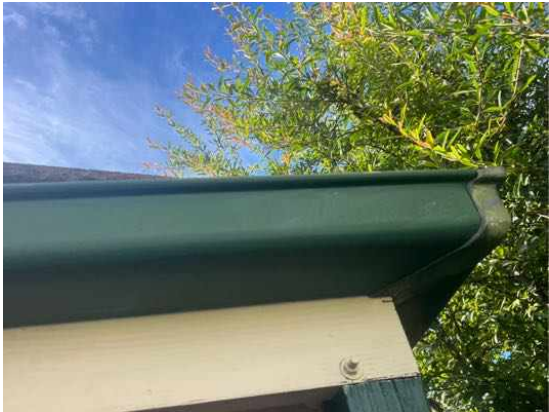
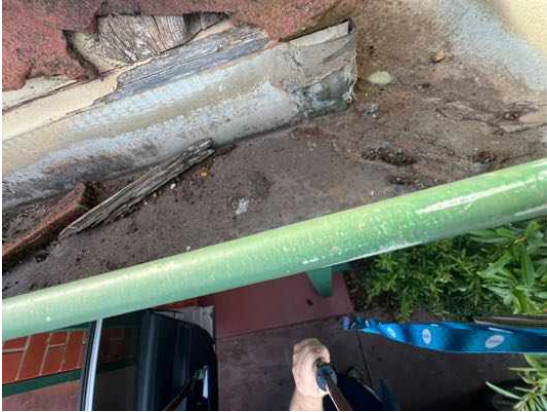
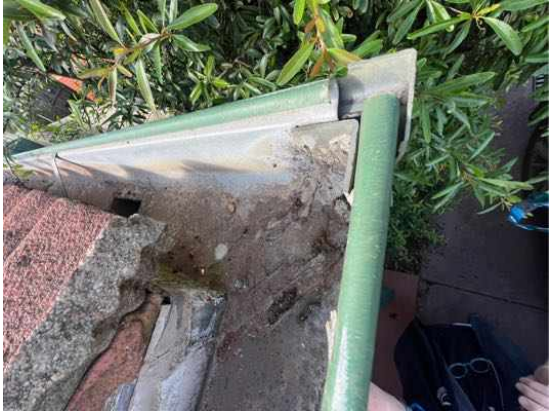
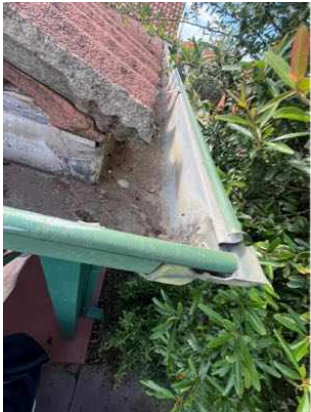
Finding 6.05

Building: Main Building
Location: Porch > Centre, Front Left
Finding: Bridging - Vegetation
Information: Where vegetation obstructs inspection of building elements, also known as bridging

as it provides a bridging point for the access of termites, full inspection can not be achieved. Consequently moisture or dampness may be present and the areas becomes conducive to termite activity. Plants against or very close to buildings provide cover, shade and can provide an environment that is attractive to termite infestation.

The removal and replanting of species that do not provide "cover" or cutting back of existing vegetation will assist greatly in preventing Bridging from occurring.

The removal of any such materials that may be conducive to termite activity should be carried out as soon as possible and arrange re inspection to minimize the risk of termite attack.

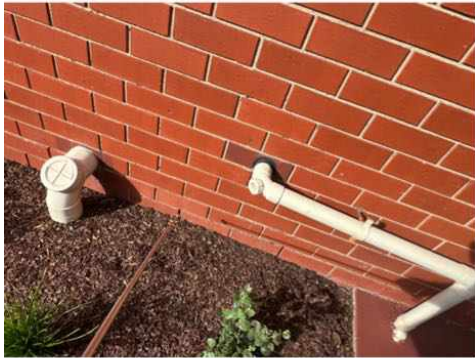
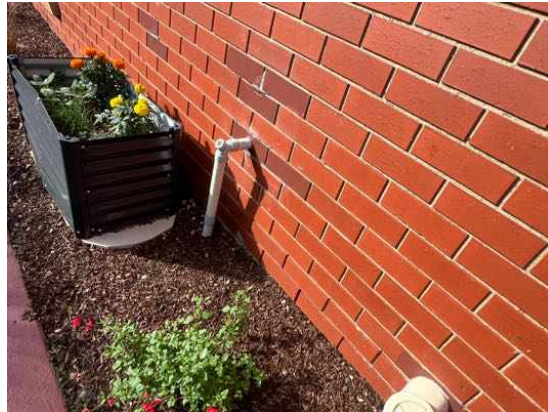
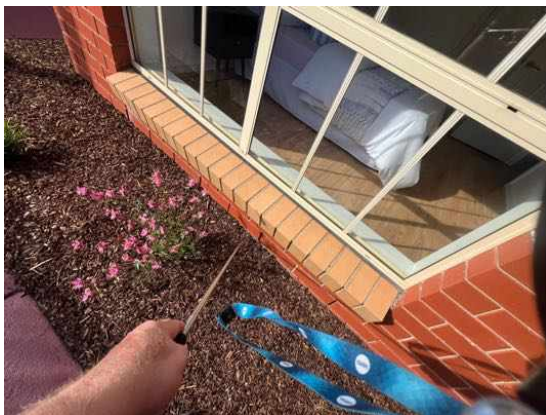
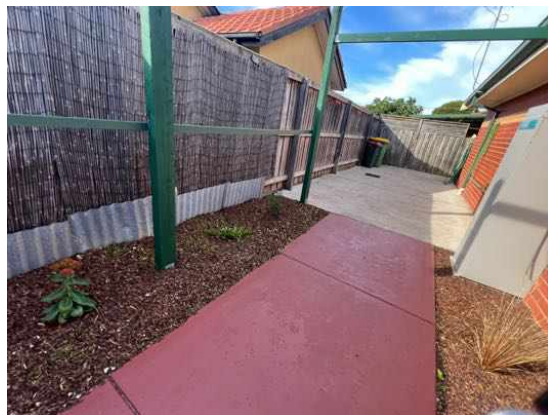
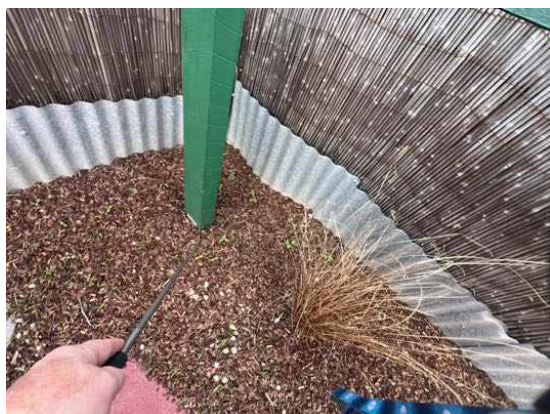
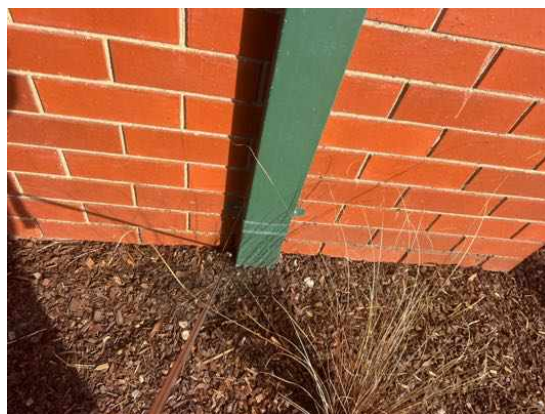
Finding 6.06

Building: Yard
 Location: Yard - Back > All Areas
 Finding: Building materials in direct ground contact - conducive to termites
 Information: Where timber elements are in direct contact with the ground and consequently moisture or dampness they become conducive to termite activity. Whether timber is used as a building element part of a fencing structure or stored as an unused item they can provide an environment that is attractive to termite infestation.

When met with excessive moisture timber begins to decay and develop wood rot. Any timbers that are in direct contact with external grounds especially if left untreated or non-durable also provide ingress for subterranean termites into that particular element.

The removal of any such materials that may be conducive to termite activity should be removed as soon as possible to minimise the risk of termite attack.

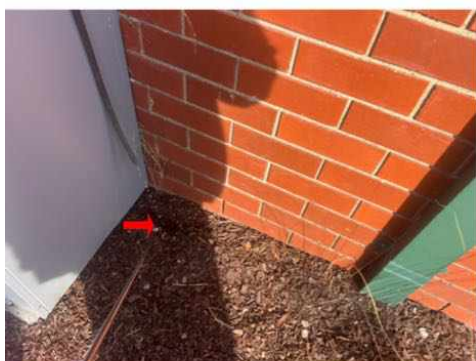
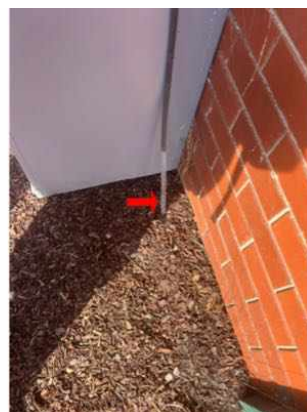
Finding 6.07

Building: Main Building
 Location: Exterior walls - right side > Centre
 Finding: Damp or wet - leak-HWS not plumbed
 Information: Damp or wet conditions are generally a direct result of poor drainage an active leak or poor ventilation (or a combination of the three). Dry conditions should be maintained to prevent secondary building defects from developing.

If left unattended damp or wet conditions may have many consequences including the development of fungal decay and/or wood rot as well as providing an environment that may be conducive to termite or timber pest attack.

A qualified plumber should be appointed immediately to identify the cause of the excessive moisture in order to prevent further damage. The water leak should be resolved prior to any repairs of the damaged area which may require localised replacement of building materials and refinishing..

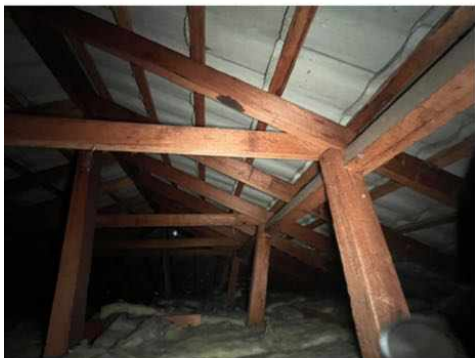
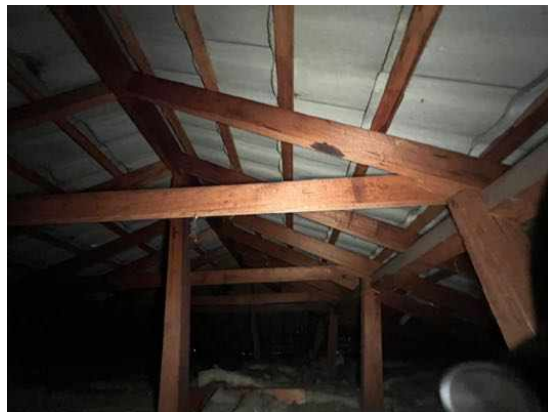
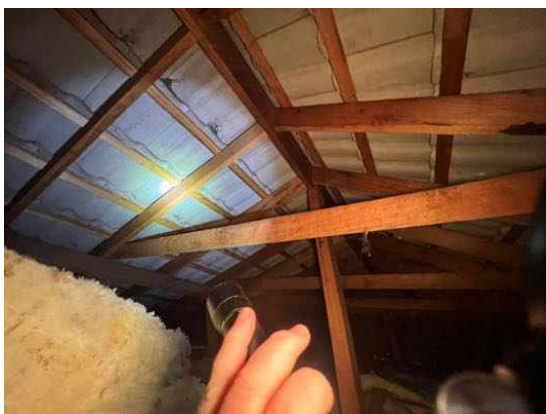
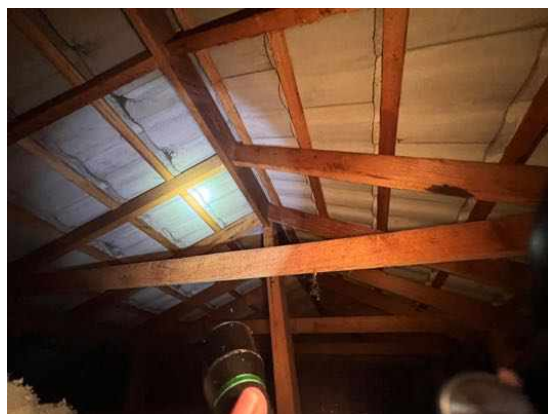
Finding 6.08

Building: Main Building
 Location: All Areas > All Areas
 Finding: Pest -Obstructions & Limitations-roof void-

These photographs are an indication of the obstructions and limitations which impeded full inspection of the property at the time of inspection. These obstructions can hide an array of defects and should be removed to allow full inspection to be carried out. A re-inspection is recommended once the areas are made accessible.

Therefore, It is critical that before proceeding further, an inspection and possibly a treatment or advice regarding a treatment, be sourced form a Licenced Termite Timber Pest Controller.

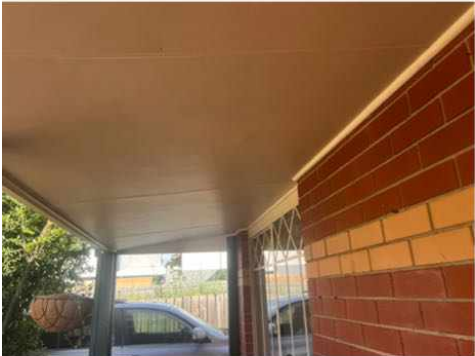
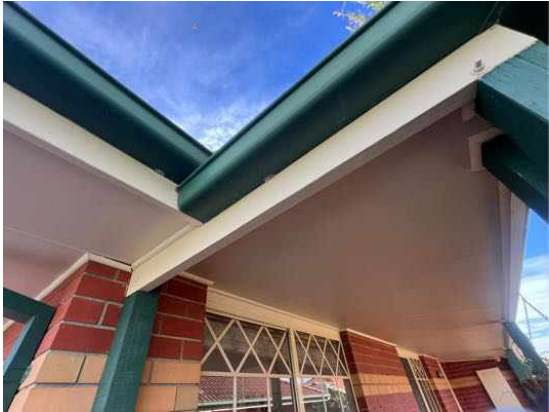
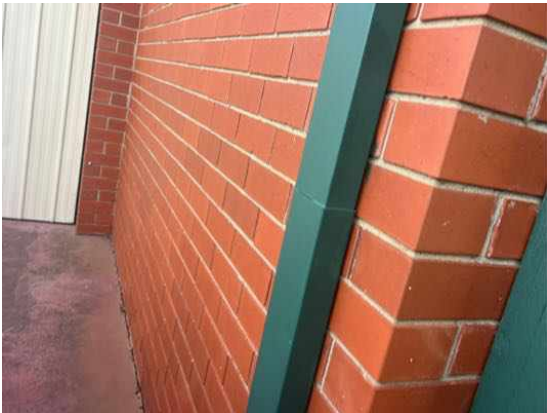
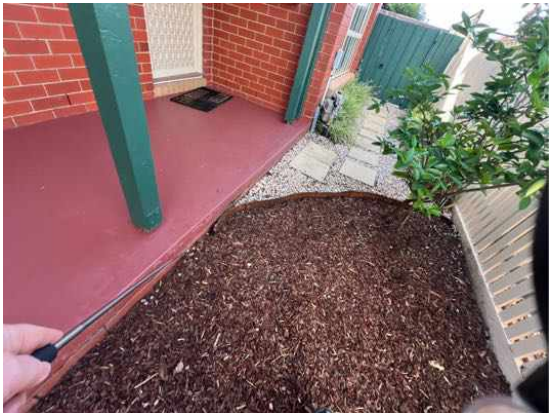
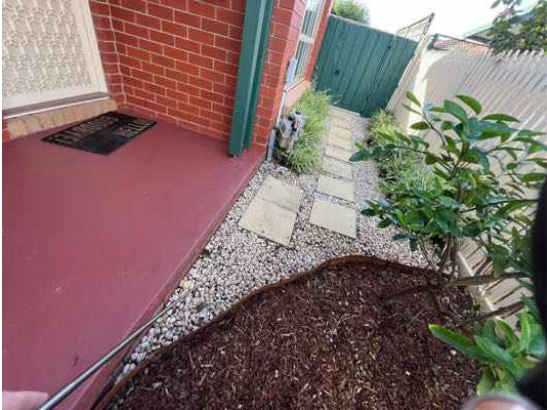
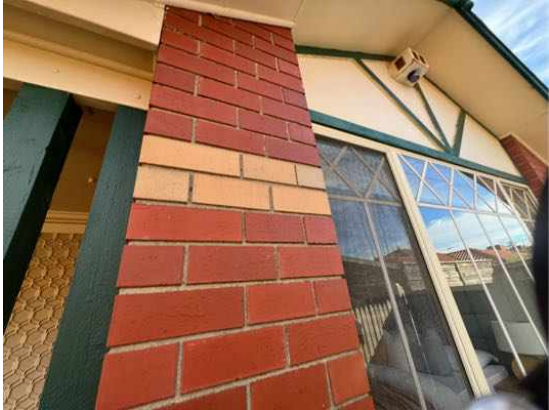
Building: Main Building
Location: Front Elevation > All Areas
Finding: Additional Photos
Information: Additional photos are provided for your general reference

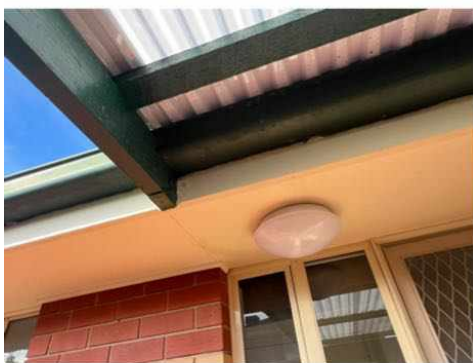
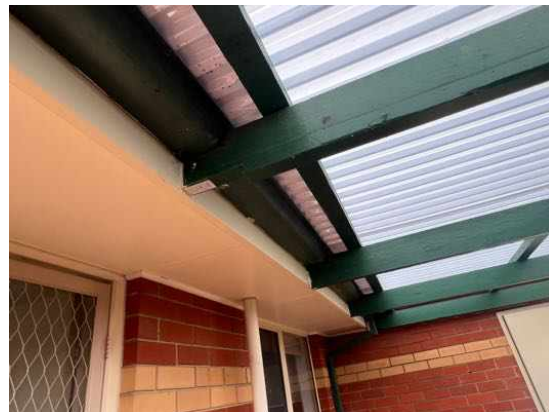
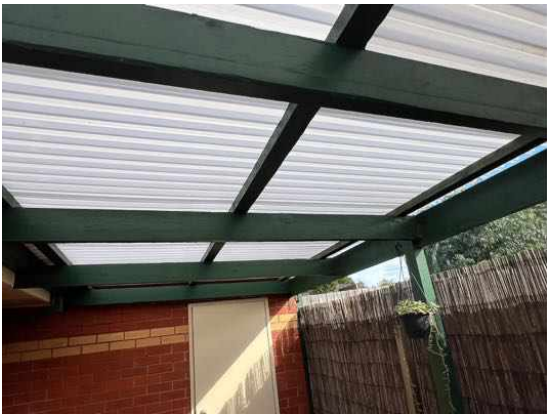
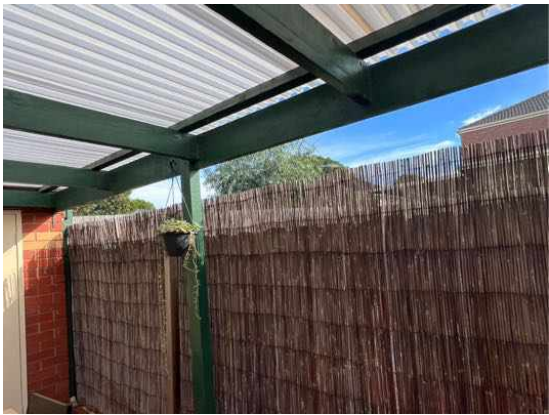
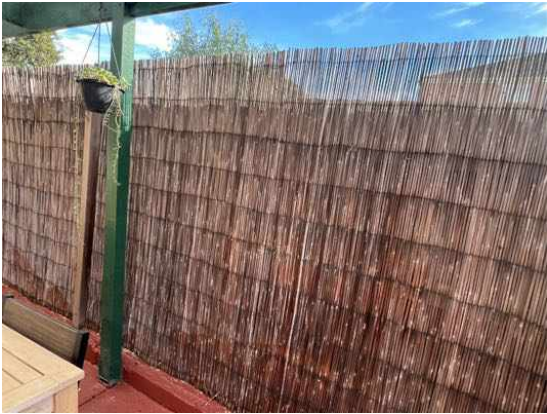
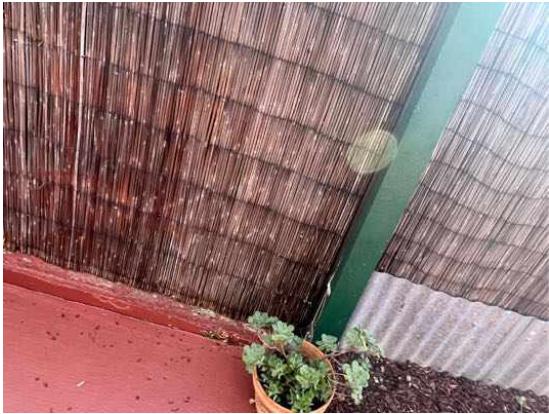
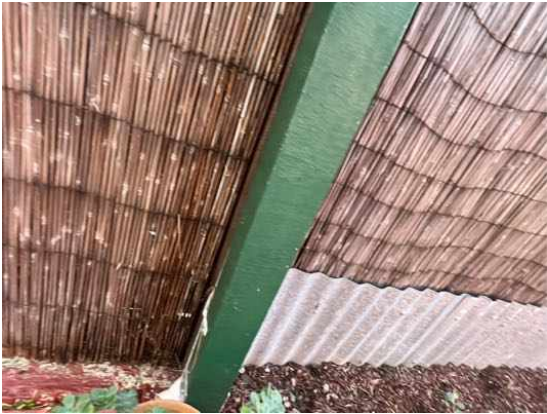
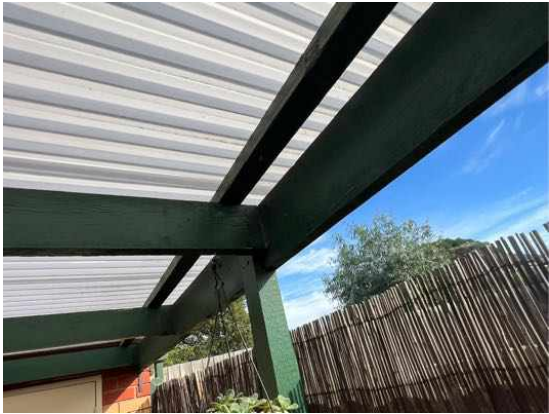
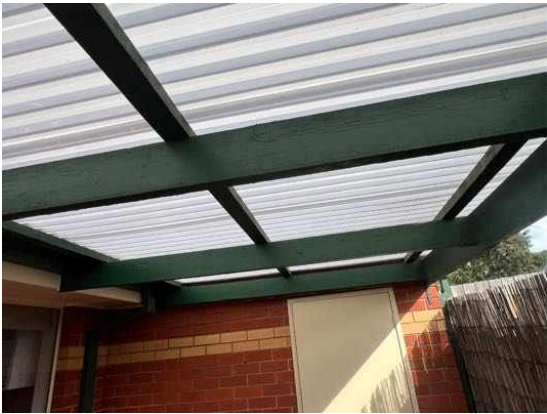
Building: Yard
 Location: Pergola > All Areas
 Finding: Additional Photos - Obstructions and Limitations
 Information: These photographs are an indication of the obstructions and limitations which impeded full inspection of the property at the time of inspection. These obstructions can hide an array of defects and should be removed to allow full inspection to be carried out. A re-inspection is recommended once the areas are made accessible.
