Building and Timber Pest Inspection Report

Inspection Date: Wed, 1 Apr 2026

Property Address: 3/80c Rathcown Rd, Reservoir VIC 3073, Australia

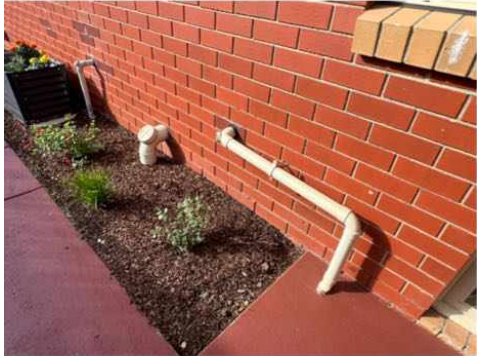
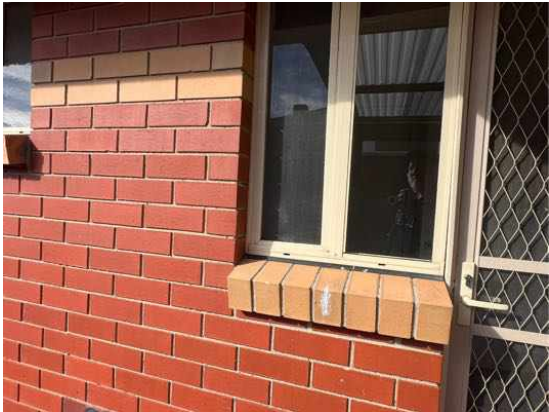
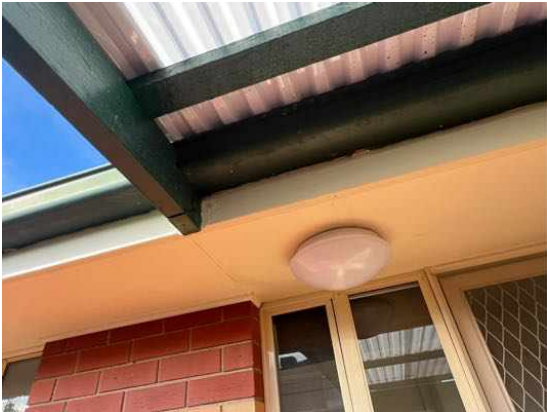
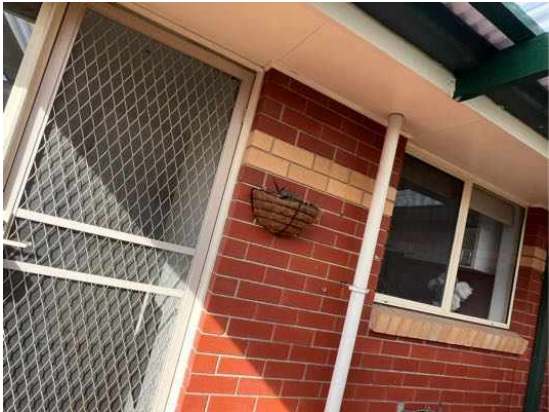
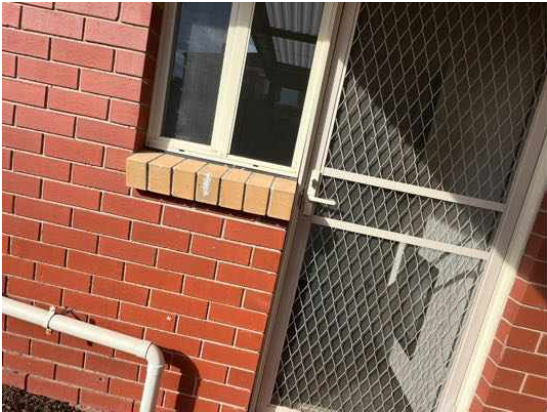
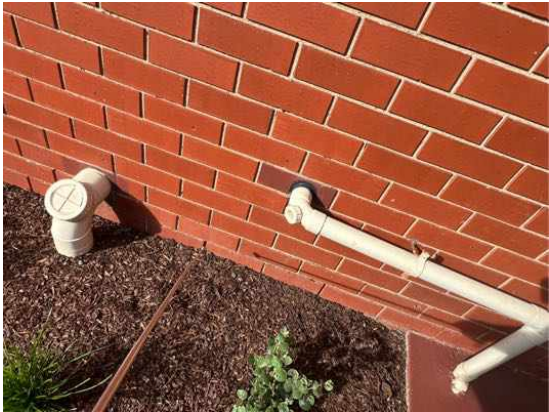
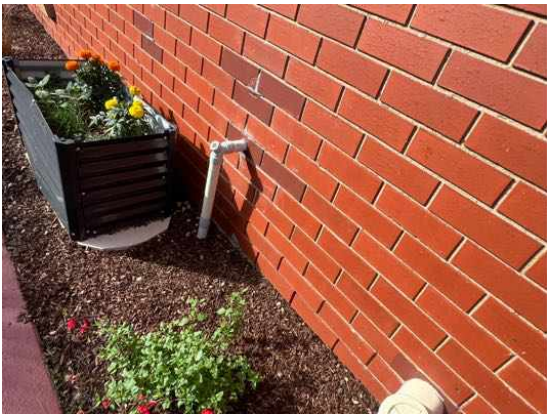
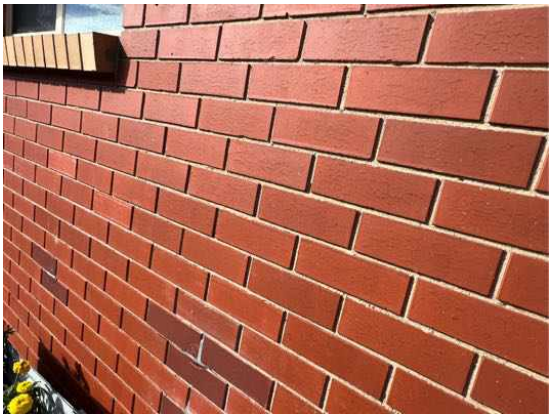
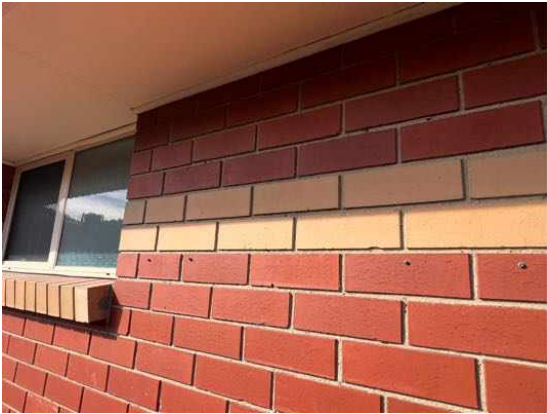
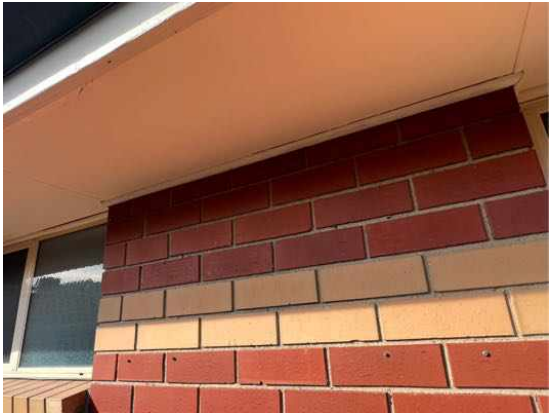
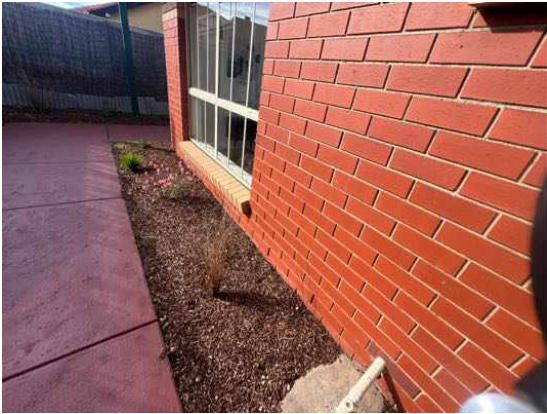
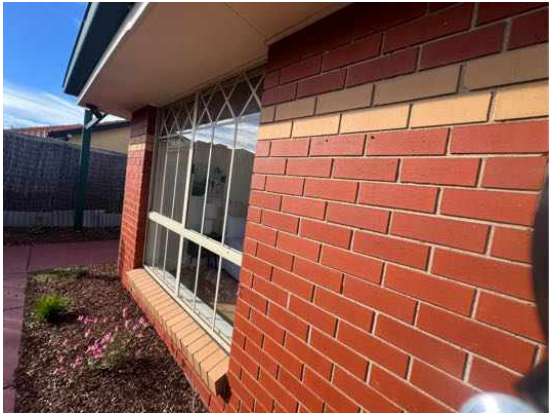
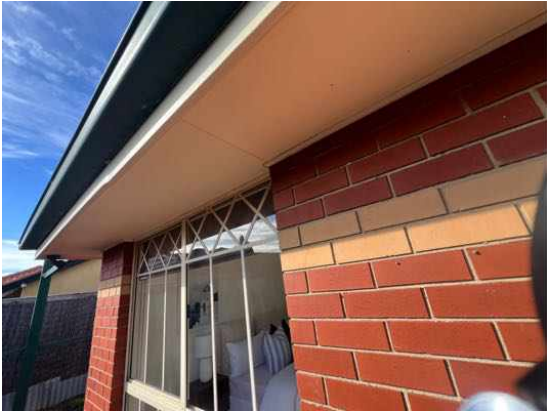
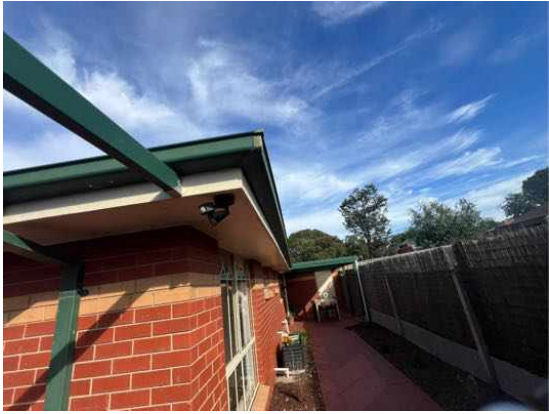
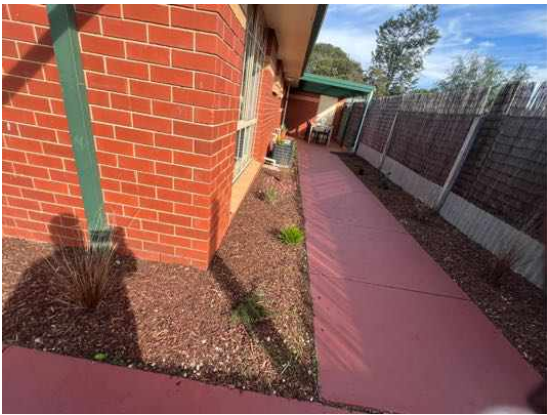
Building: Main Building
Location: Rear Elevation > All Areas
Finding: Additional Photos
Information: Additional photos are provided for your general reference

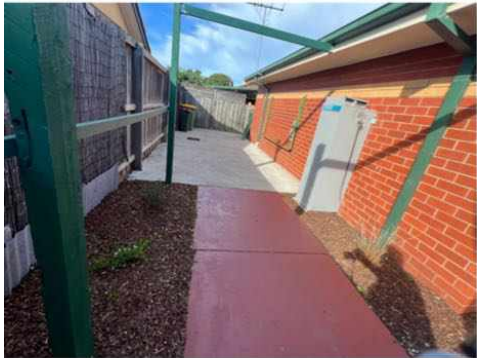
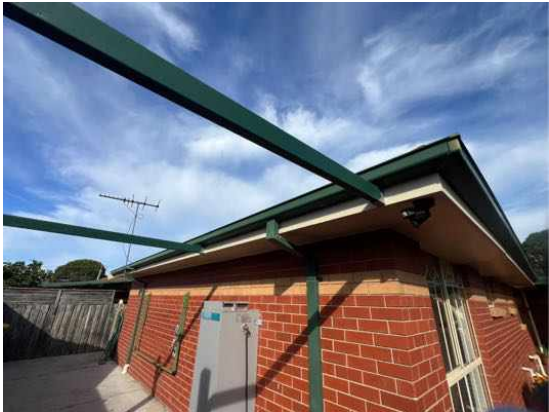
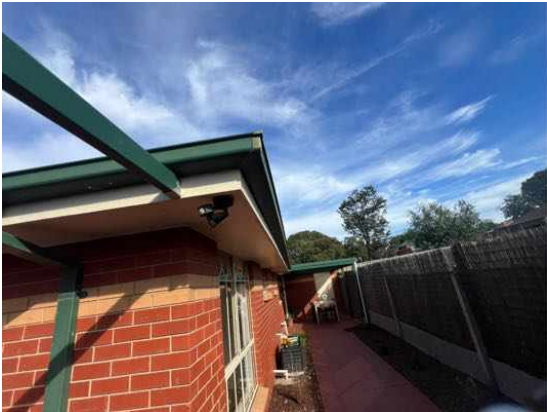
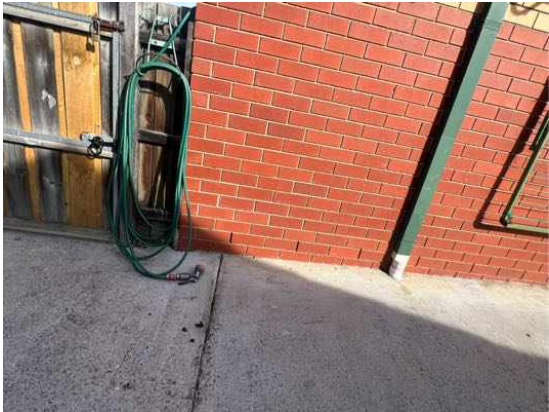
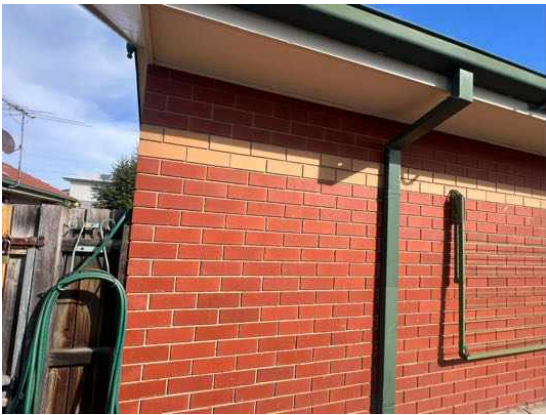
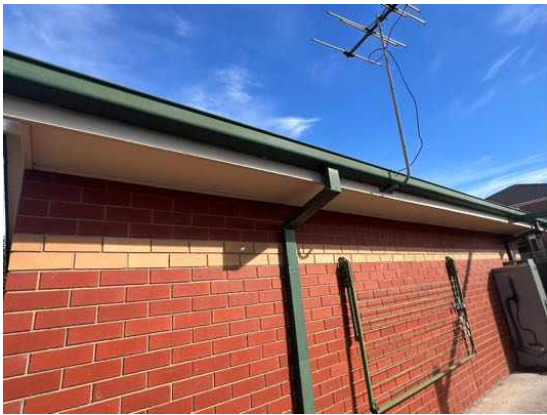
Building: Main Building
Location: Exterior walls - right side > Centre,All Areas
Finding: Additional Photos
Information: Additional photos are provided for your general reference

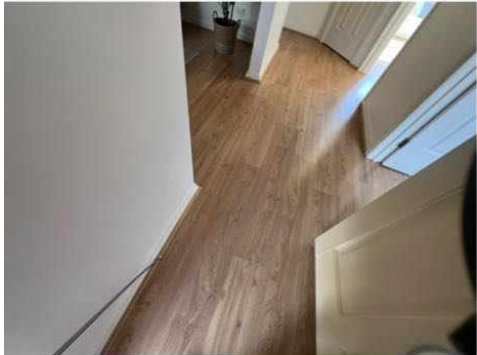
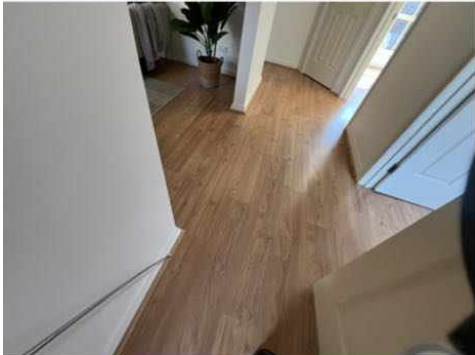
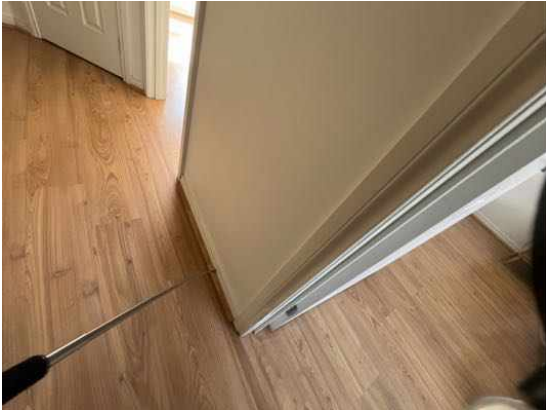
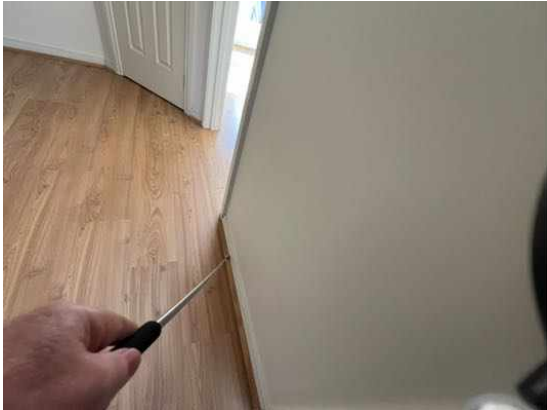
Building: Main Building
Location: All Areas > All Areas
Finding: Pest inspection-FYI-Methodology-and inspection of cabinetry
Information: As part of the course of the Pest Inspection-we /knock on skirting boards and architraves to determine if Pests are present-we also visually examine in and around internal cabinetry-as note in images supplied-

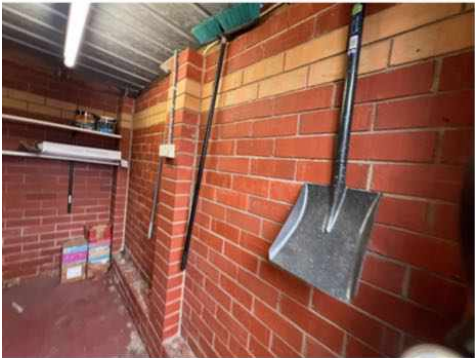
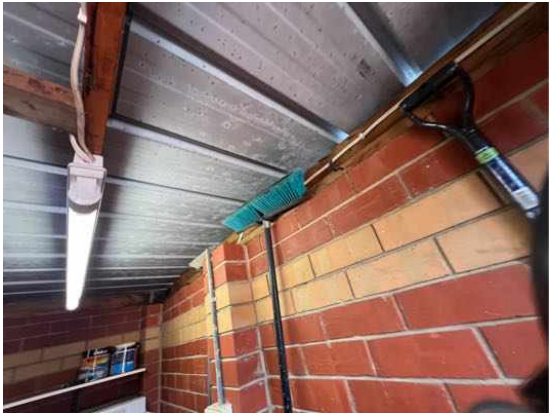
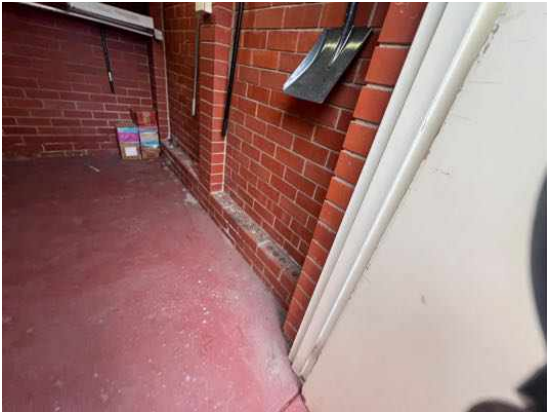
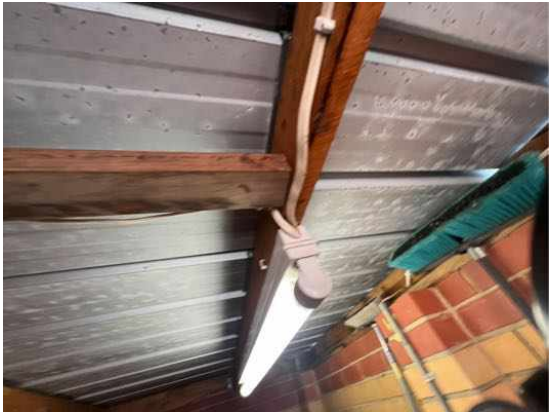
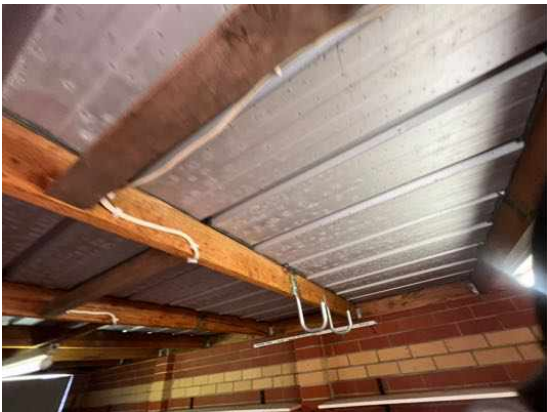
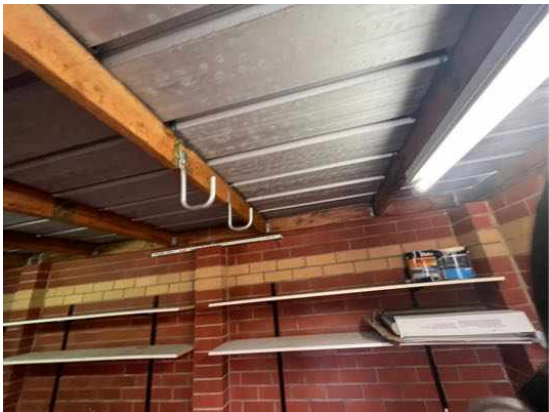
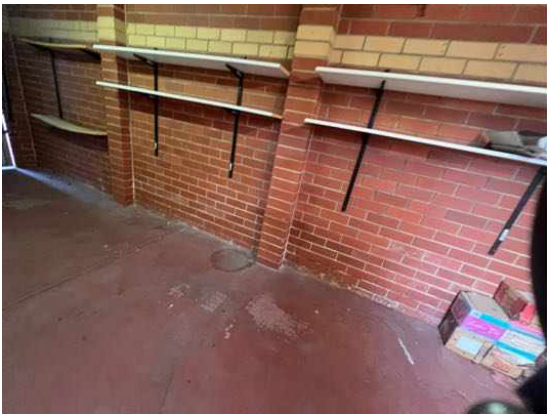
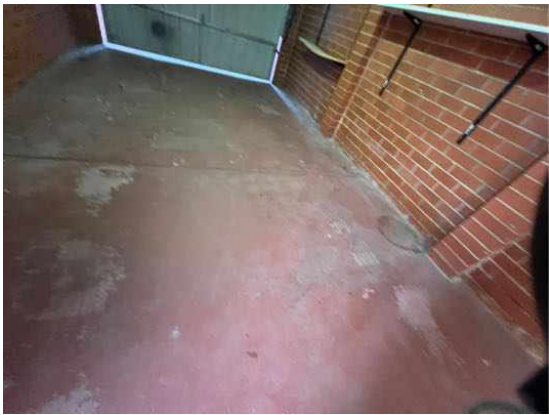
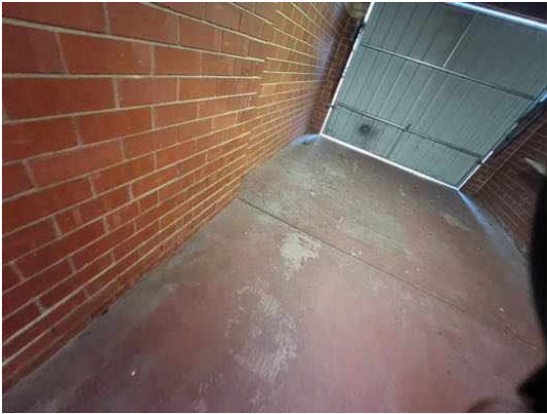
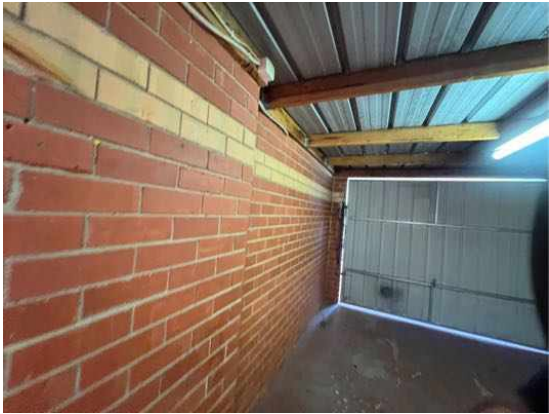
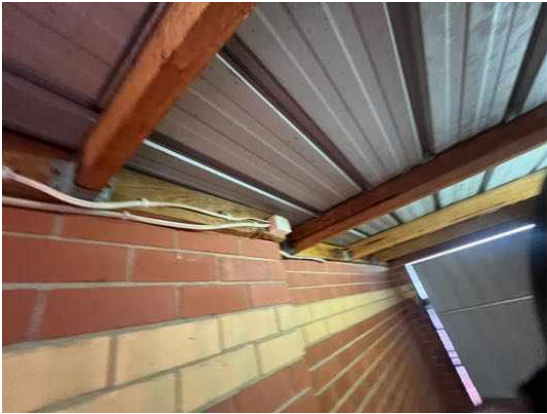
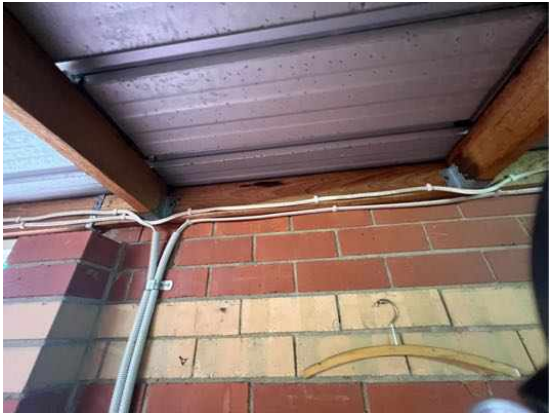
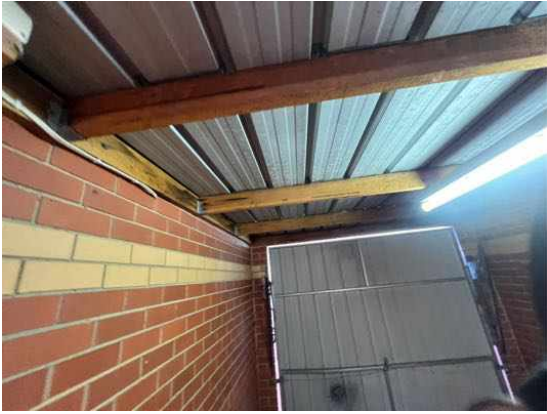
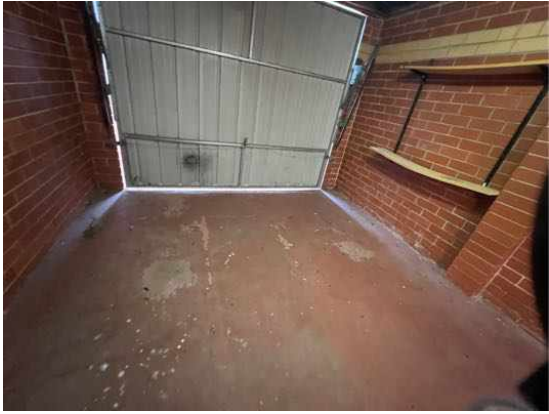
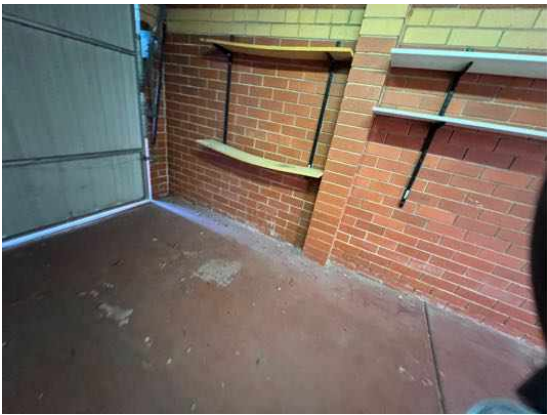
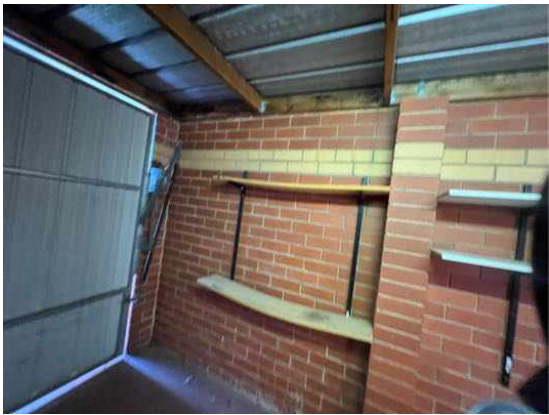
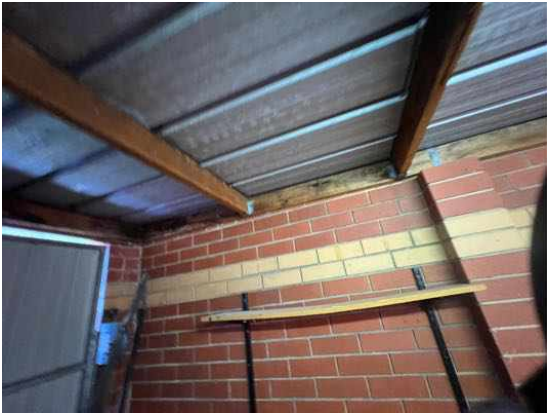
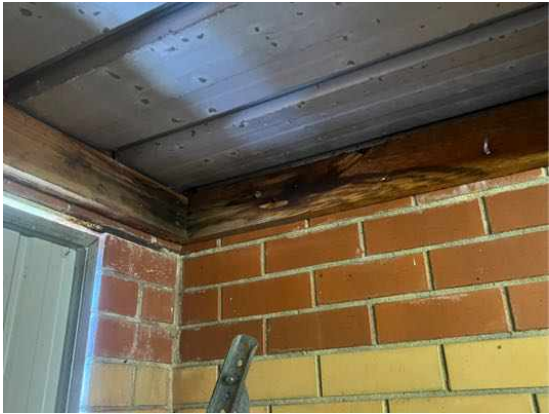
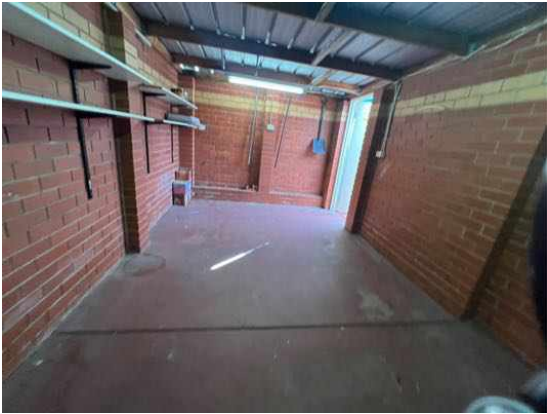
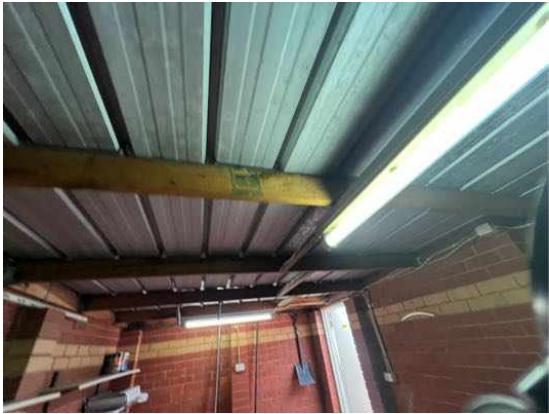
Noted Item

Building: Garage
Location: All Areas > All Areas
Finding: Additional Photos - Obstructions and Limitations
Information: These photographs are an indication of the obstructions and limitations which impeded full inspection of the property at the time of inspection. These obstructions can hide an array of defects and should be removed to allow full inspection to be carried out. A re-inspection is recommended once the areas are made accessible.

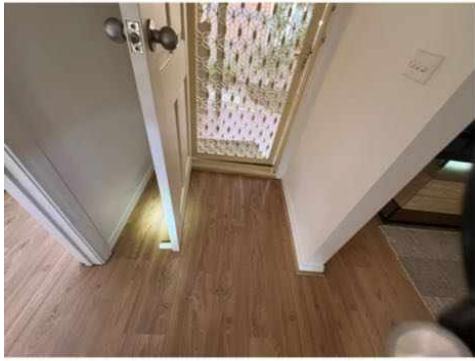
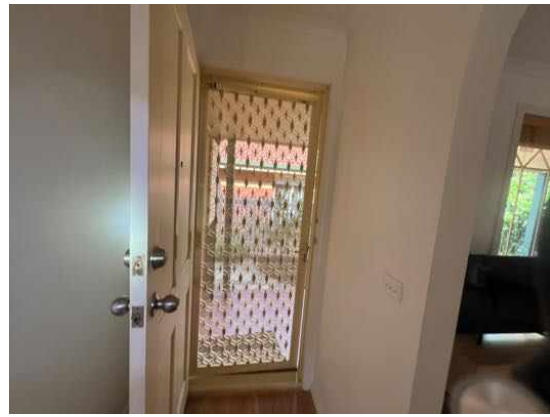
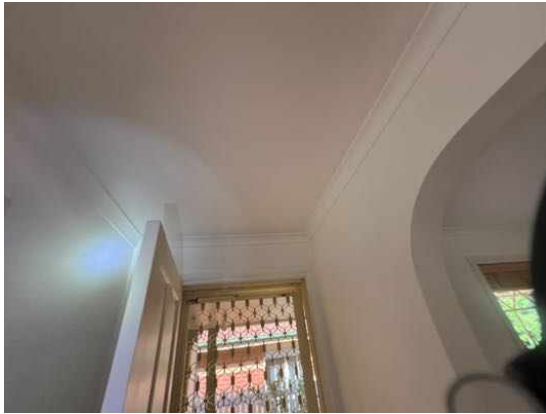
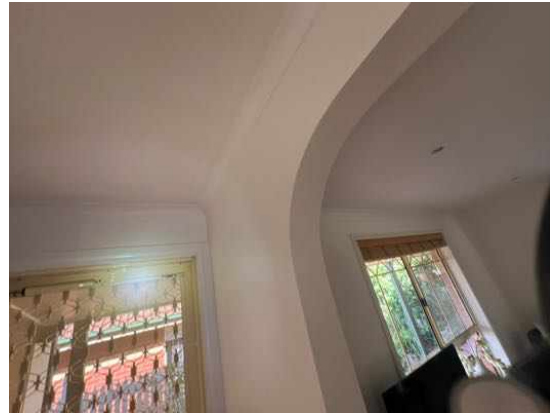
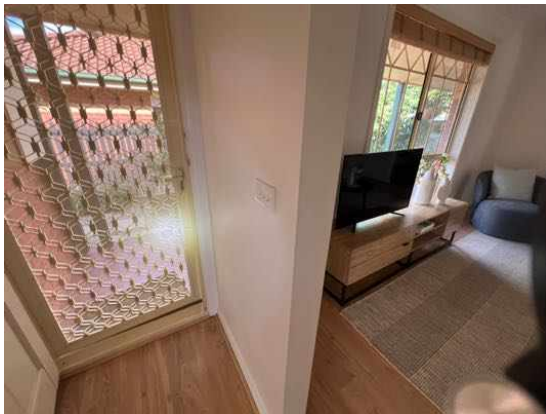
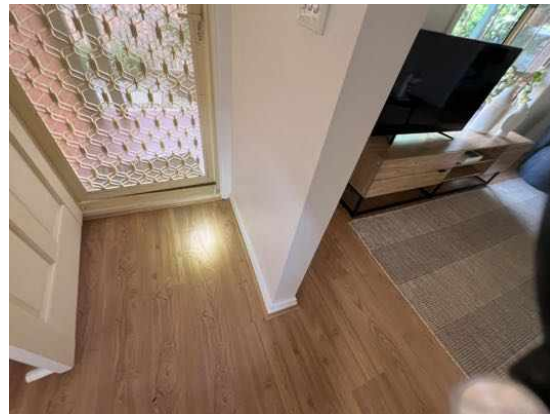
Building: Main Building
Location: Entry > All Areas
Finding: Additional Photos
Information: Additional photos are provided for your general reference

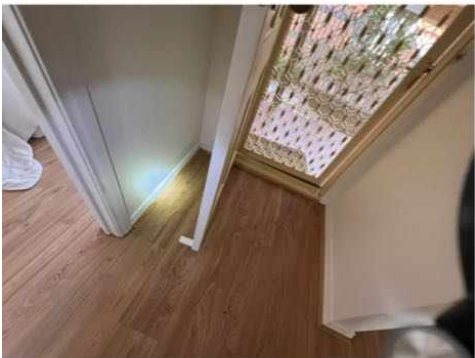
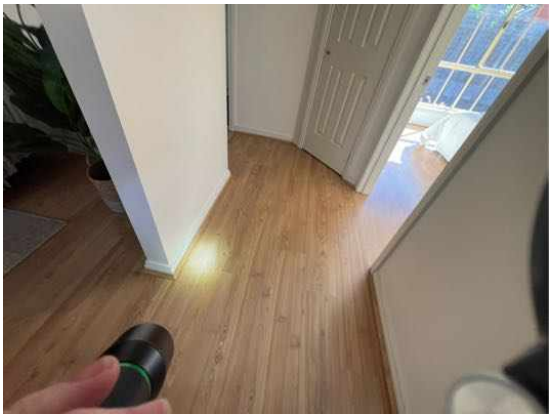
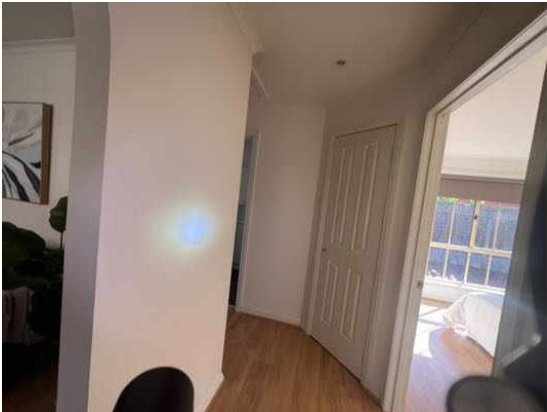
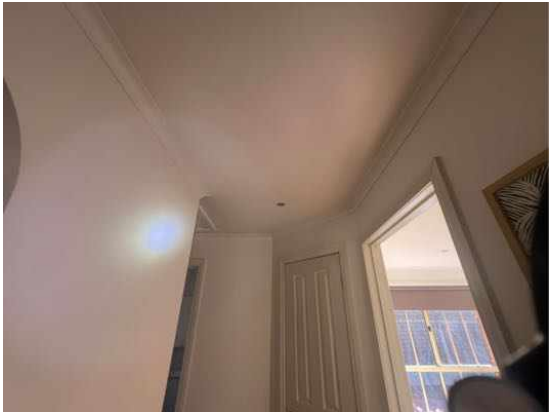
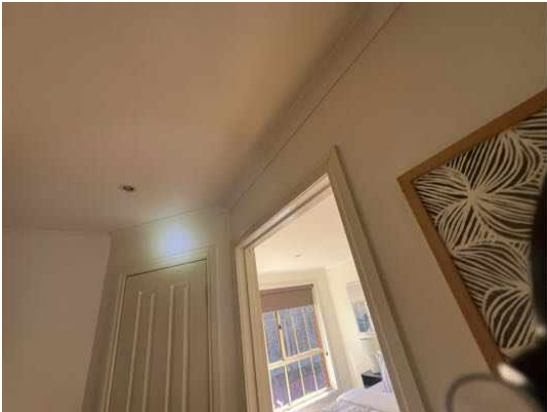
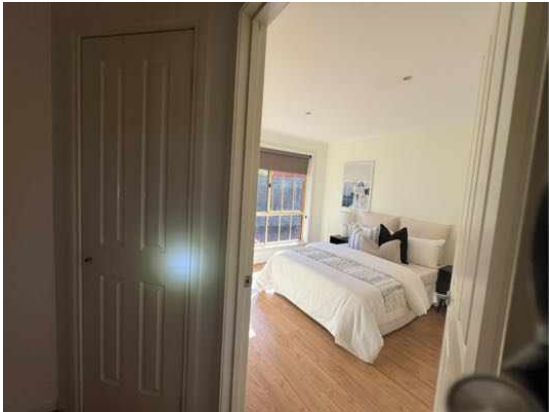
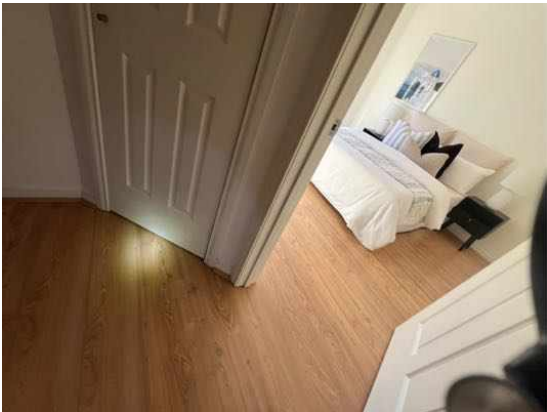
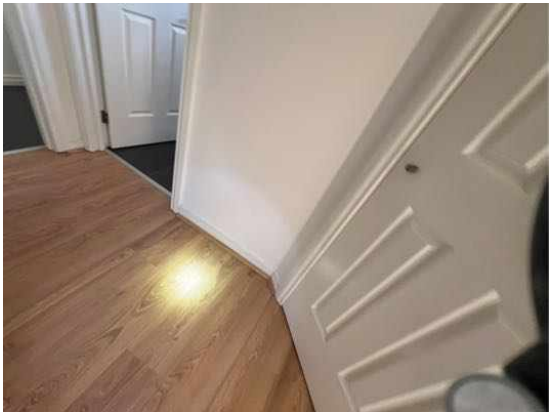
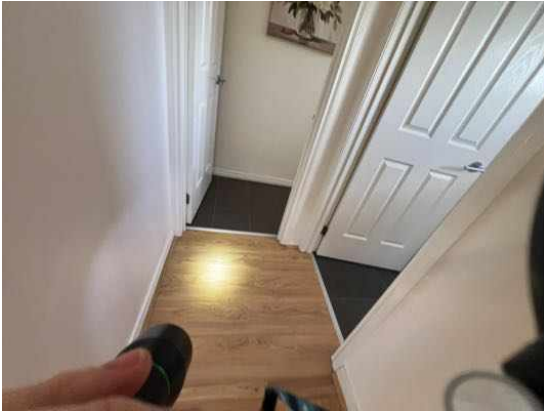
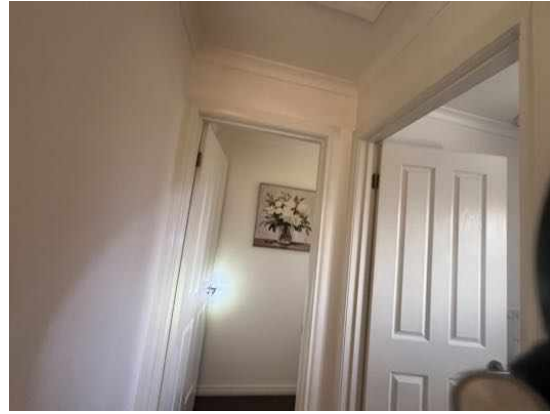
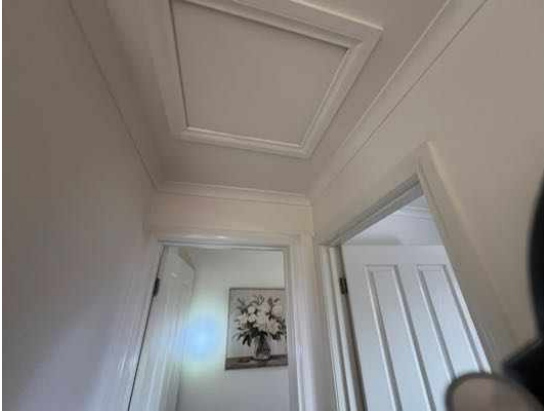
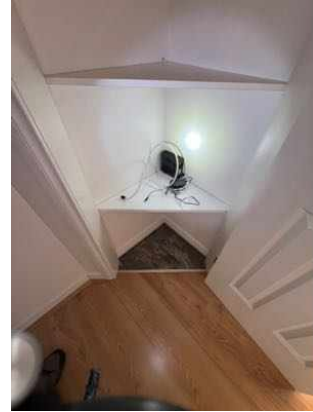
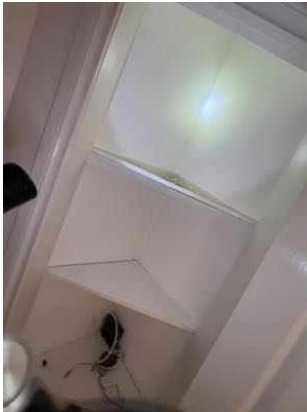
Building: Main Building
 Location: Hallway > All Areas
 Finding: Additional Photos - Obstructions and Limitations
 Information: These photographs are an indication of the obstructions and limitations which impeded full inspection of the property at the time of inspection. These obstructions can hide an array of defects and should be removed to allow full inspection to be carried out. A re-inspection is recommended once the areas are made accessible.

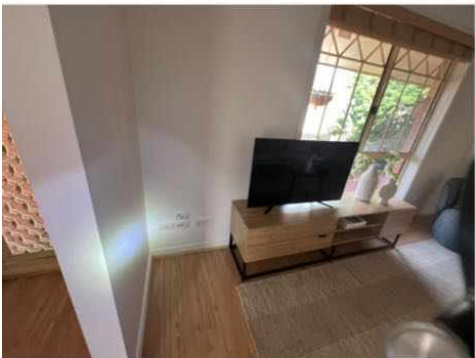
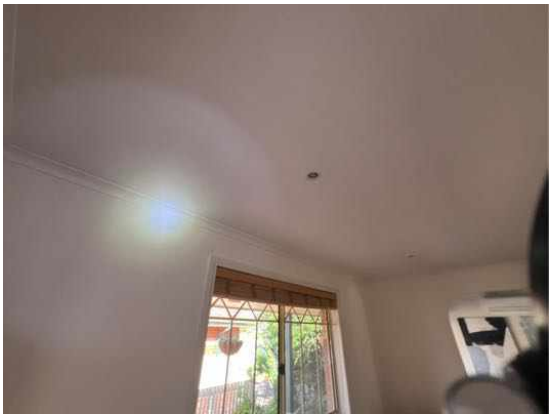
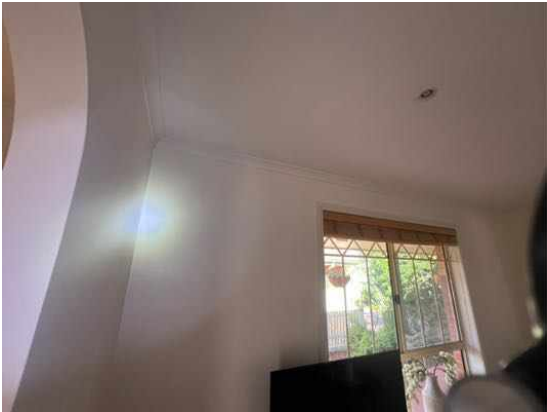
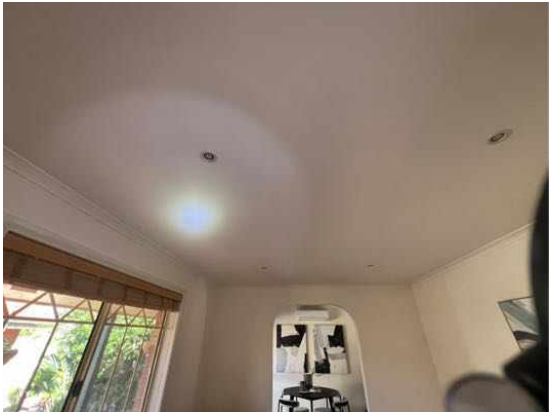
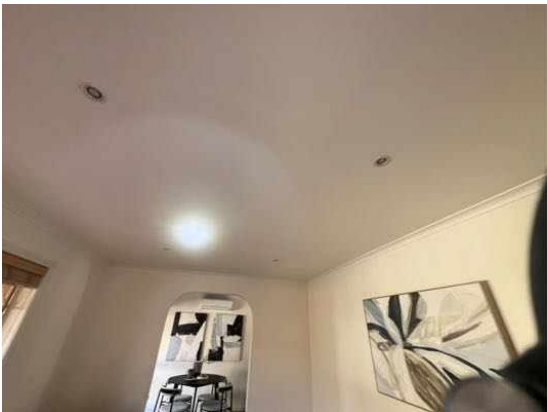
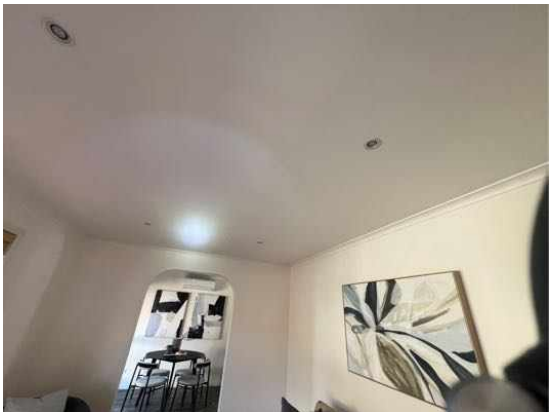
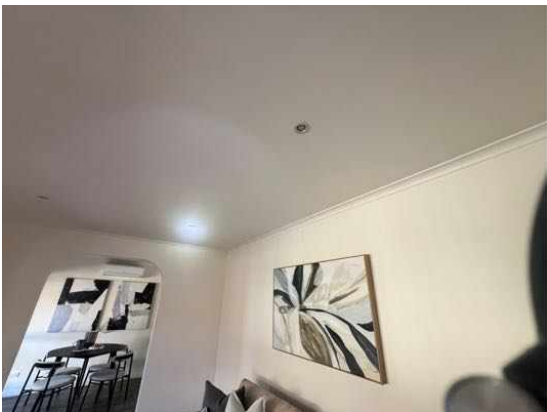
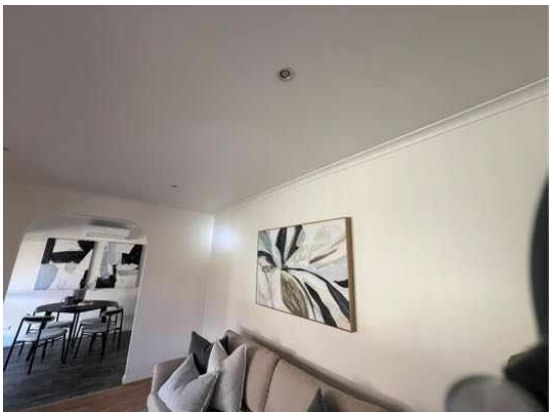
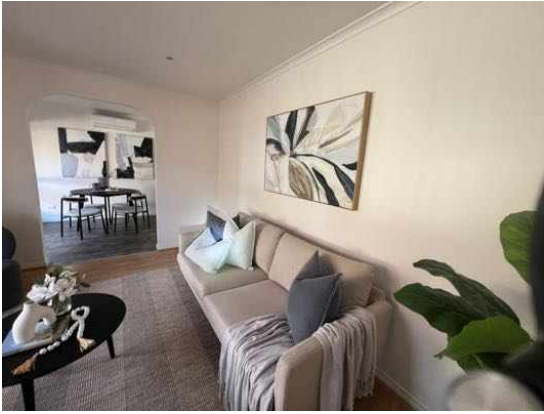
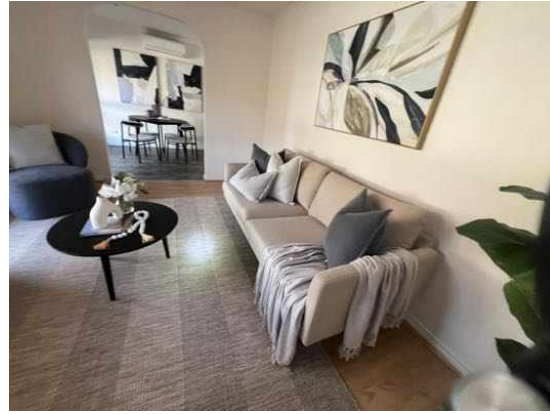
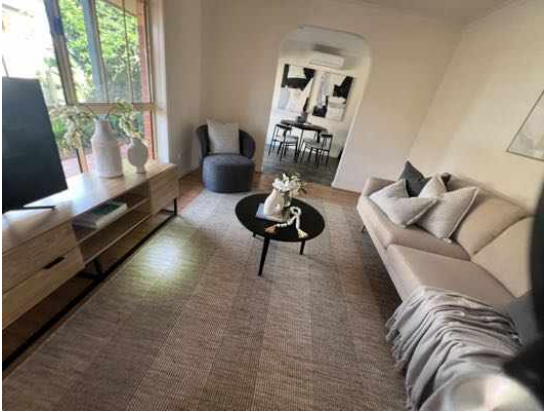
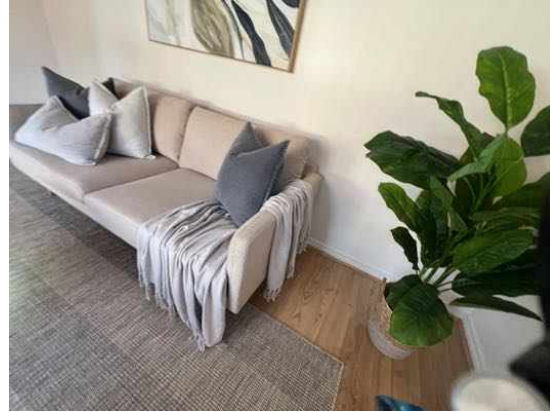
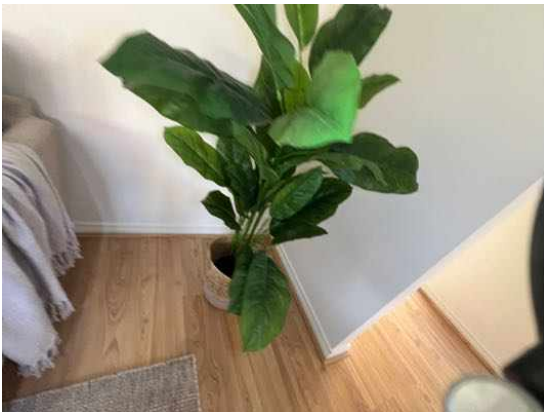
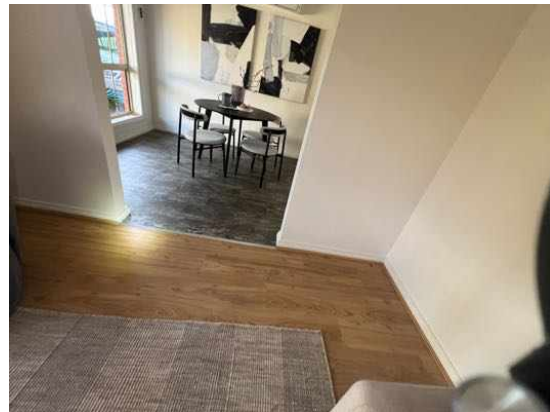
Building: Main Building
 Location: Living Room > All Areas
 Finding: Additional Photos - Obstructions and Limitations
 Information: These photographs are an indication of the obstructions and limitations which impeded full inspection of the property at the time of inspection. These obstructions can hide an array of defects and should be removed to allow full inspection to be carried out. A re-inspection is recommended once the areas are made accessible.

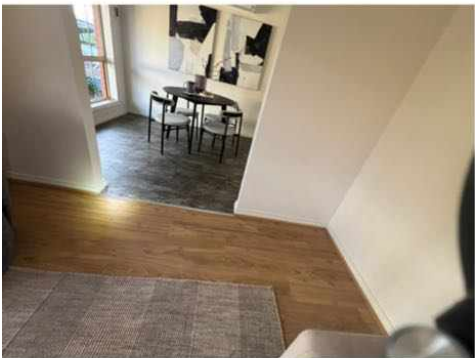
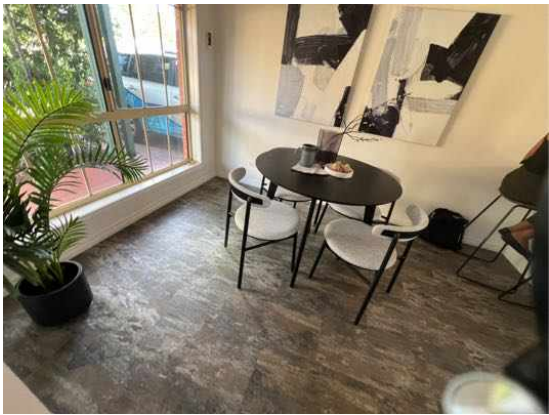
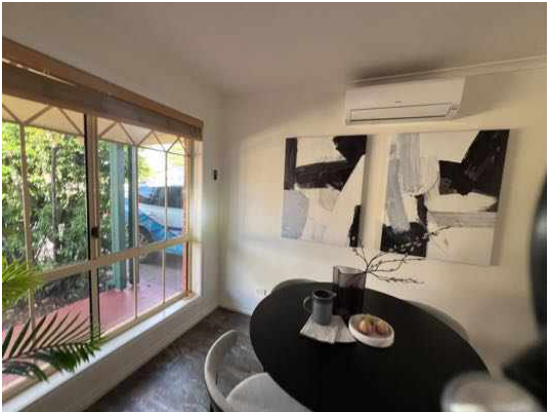
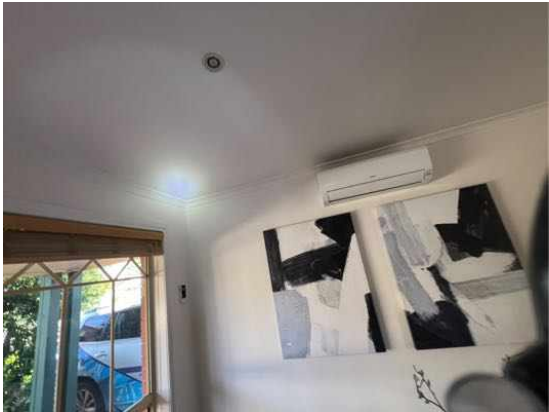
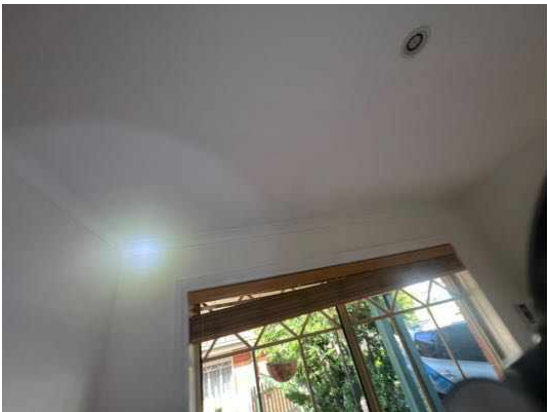
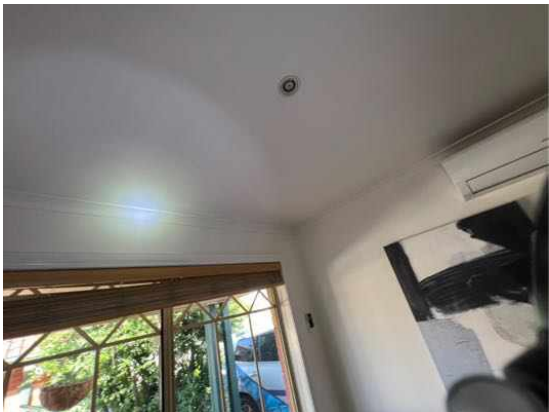
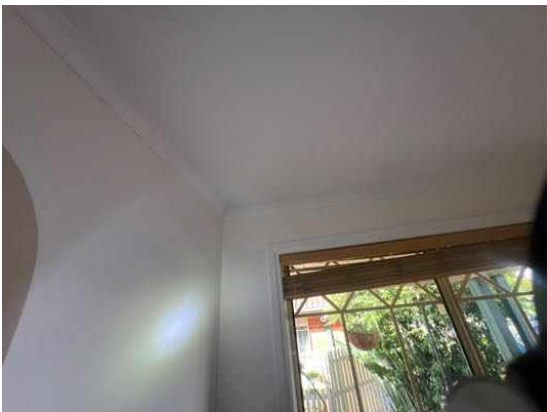
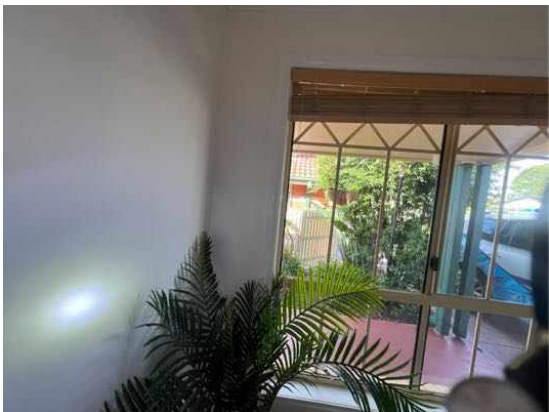
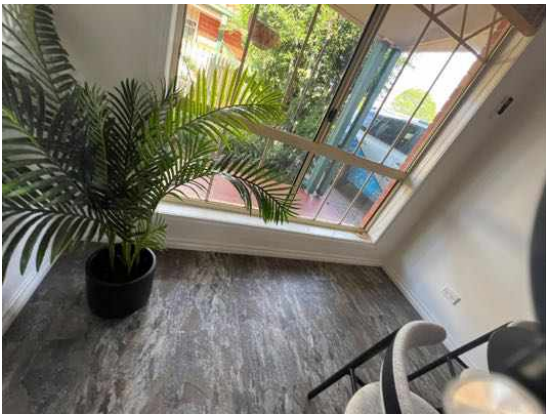
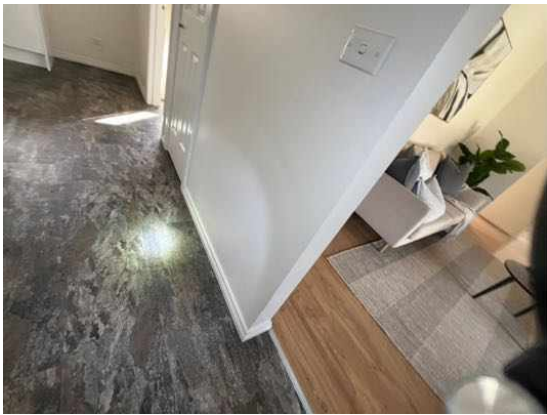
Building: Main Building
 Location: Dining Room > All Areas
 Finding: Additional Photos - Obstructions and Limitations
 Information: These photographs are an indication of the obstructions and limitations which impeded full inspection of the property at the time of inspection. These obstructions can hide an array of defects and should be removed to allow full inspection to be carried out. A re-inspection is recommended once the areas are made accessible.
