Building and Timber Pest Inspection Report

Inspection Date: Wed, 1 Apr 2026

Property Address: 3/80c Rathcown Rd, Reservoir VIC 3073, Australia

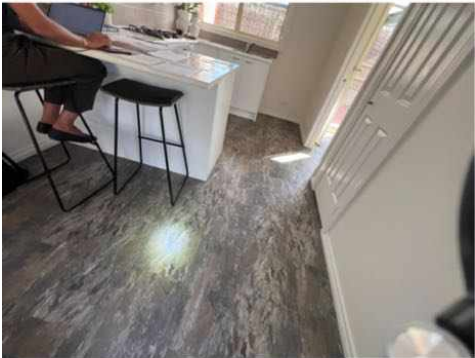
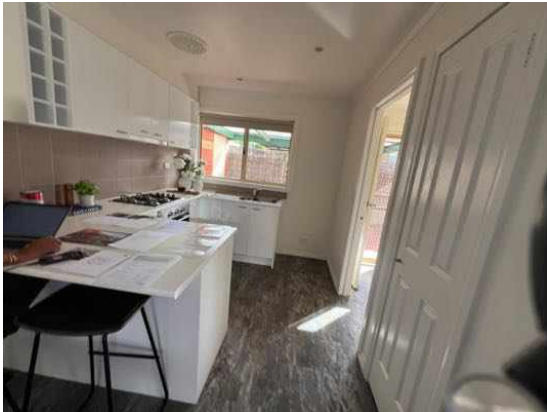
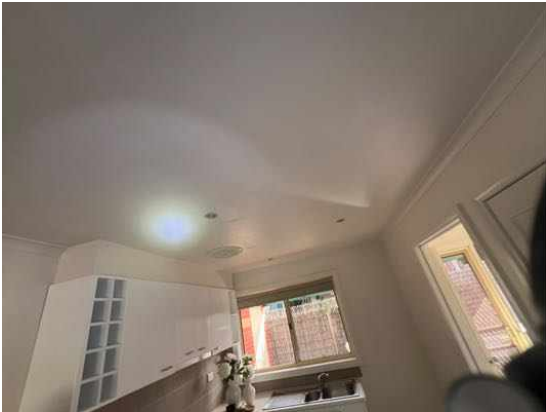
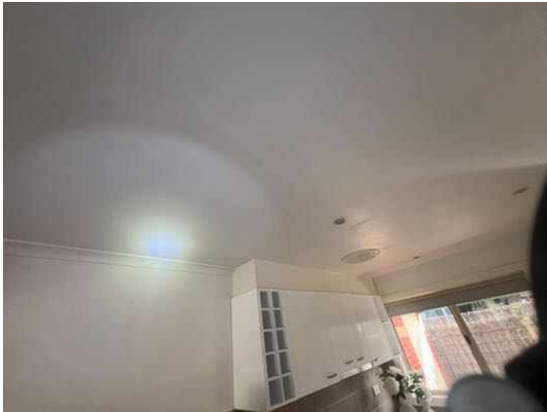
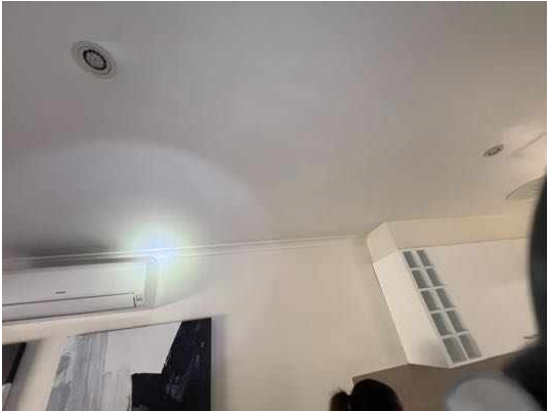
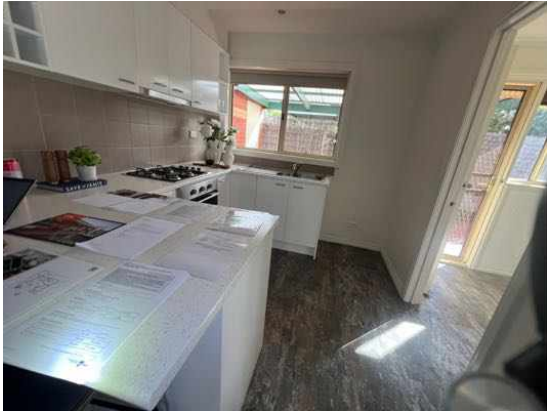
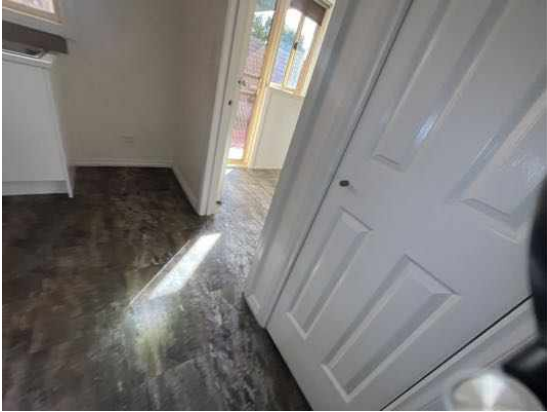
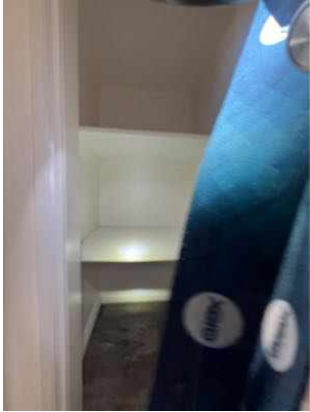
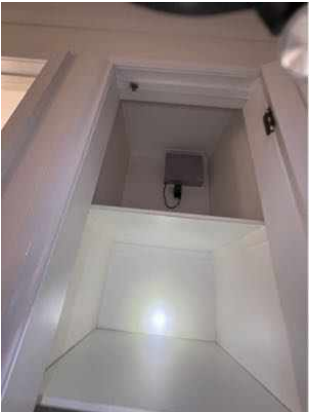
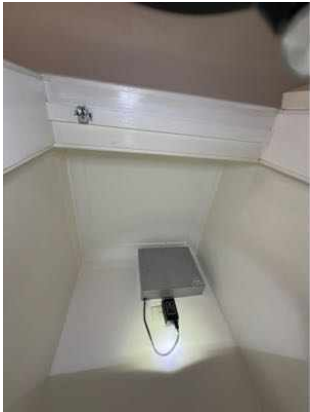
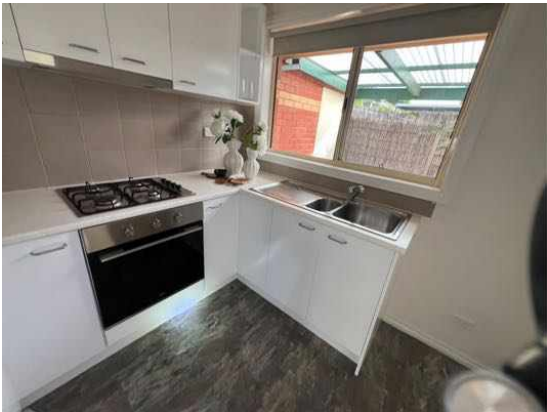
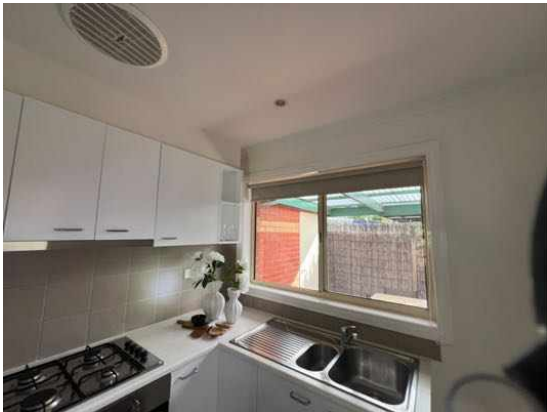
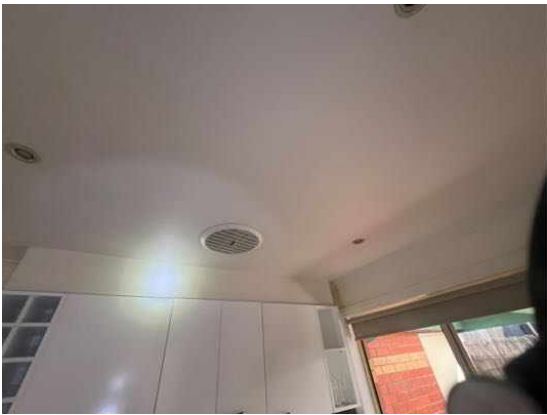
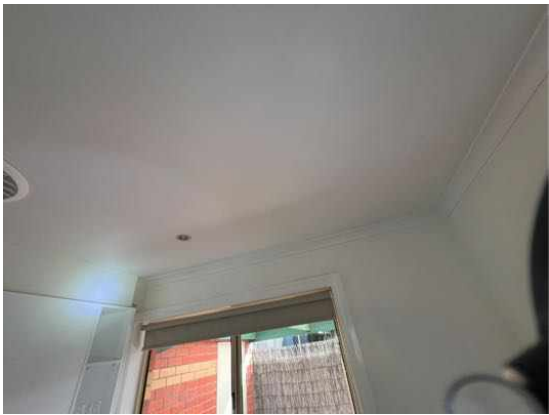
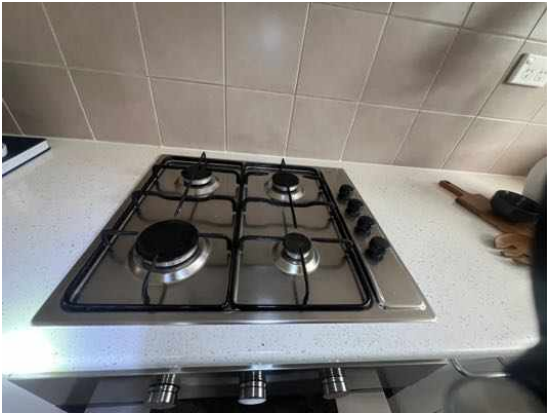
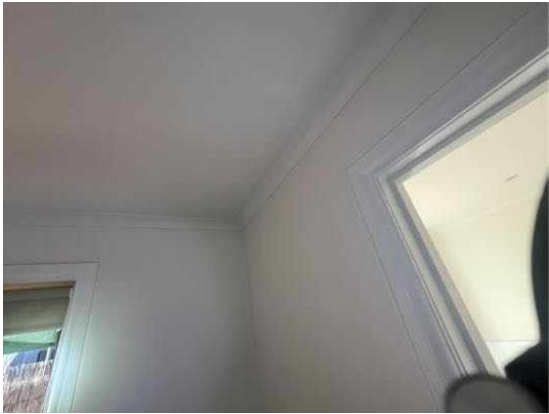
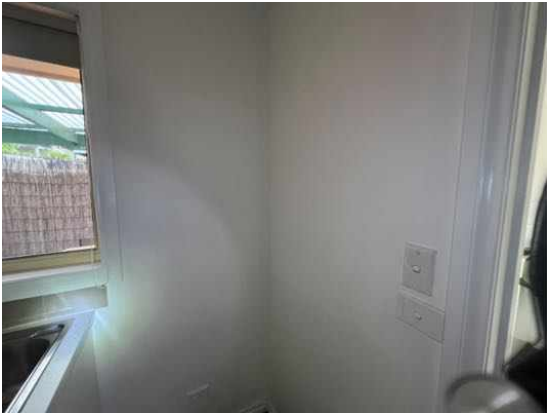
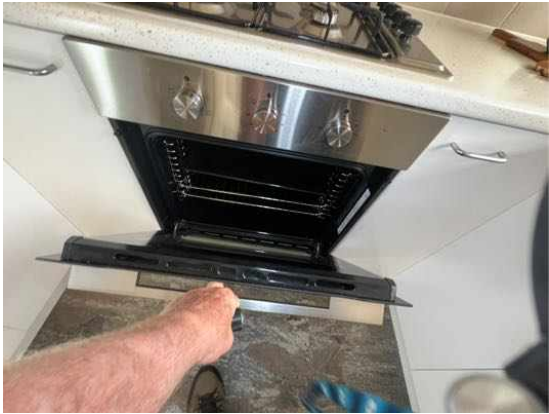
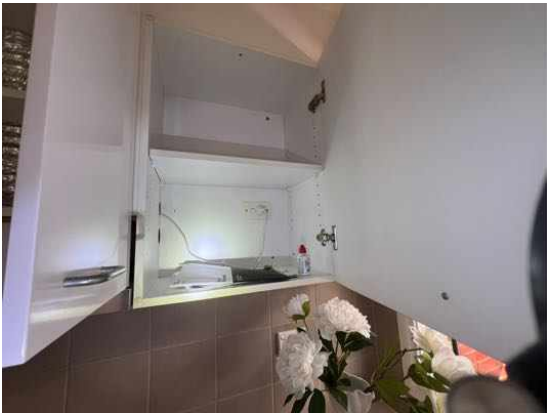
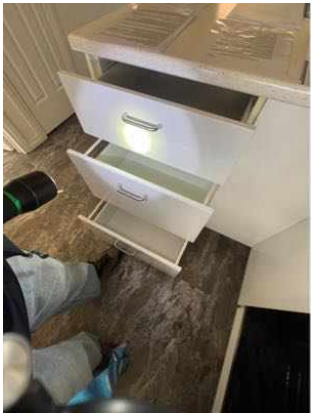
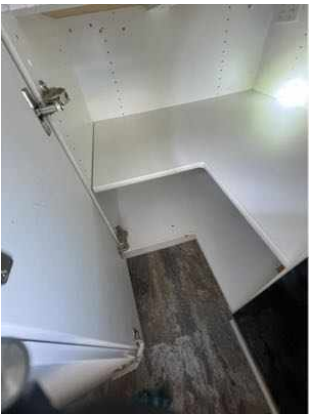
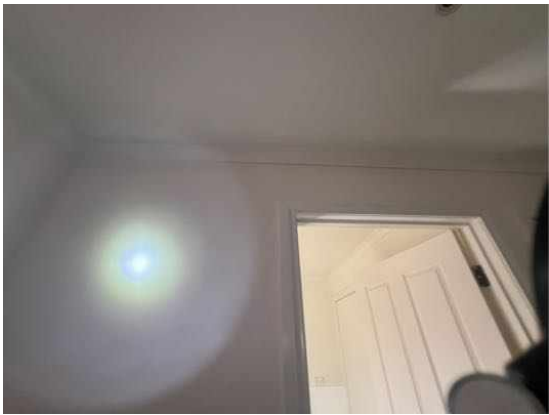
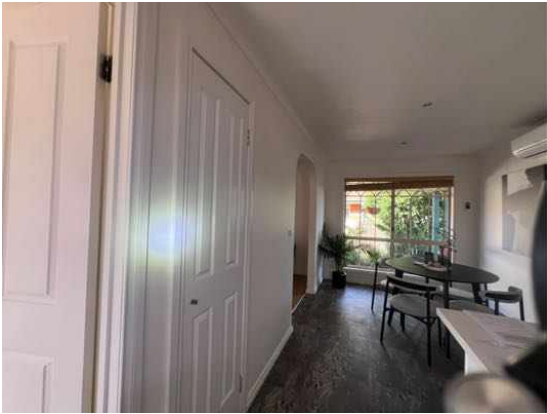
Building: Main Building
Location: Kitchen > All Areas
Finding: Additional Photos
Information: Additional photos are provided for your general reference

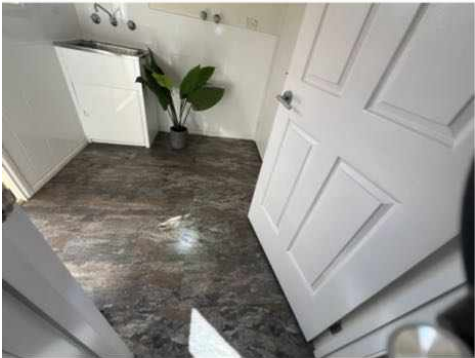
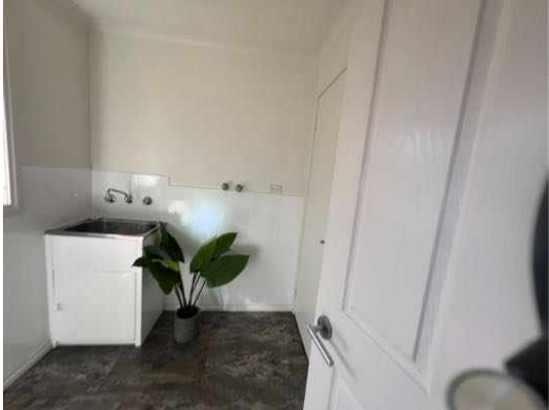
Building: Main Building
Location: Laundry > All Areas
Finding: Additional Photos
Information: Additional photos are provided for your general reference

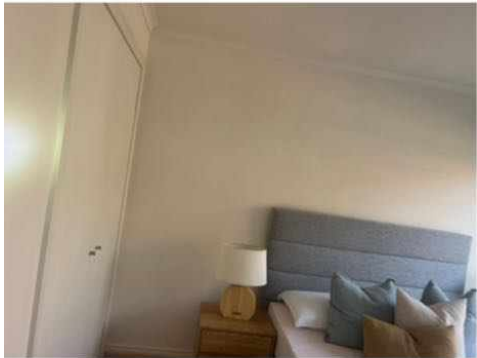
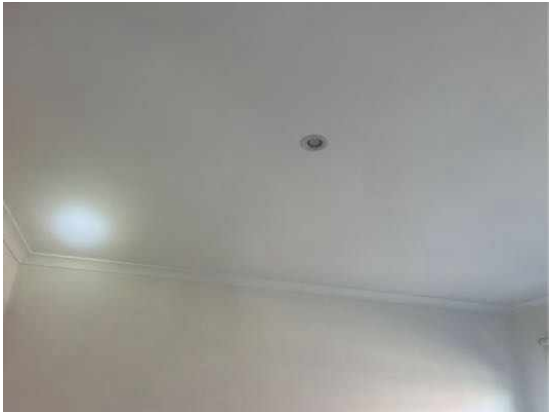
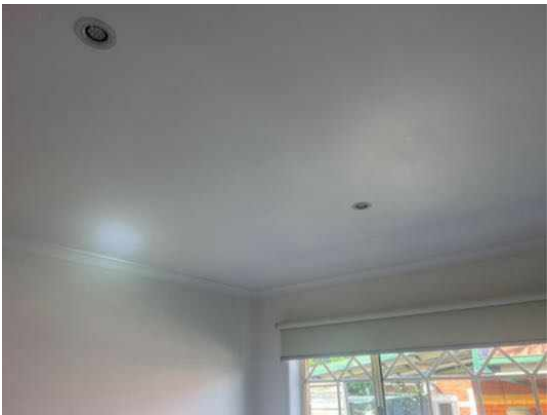
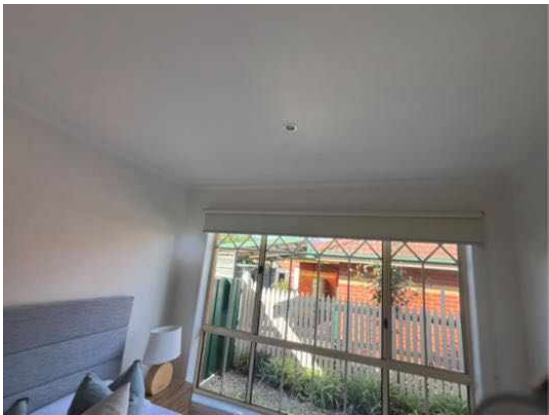
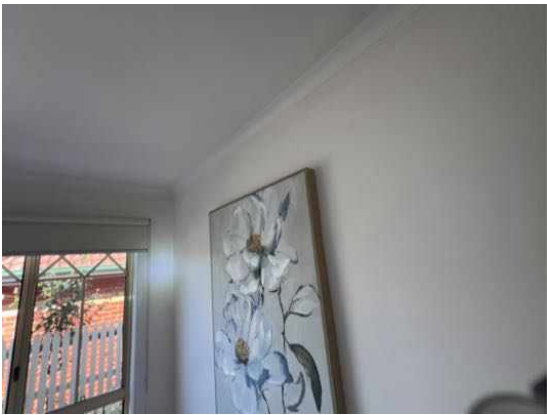
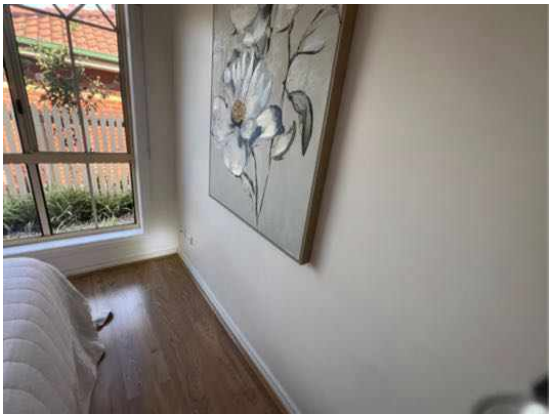
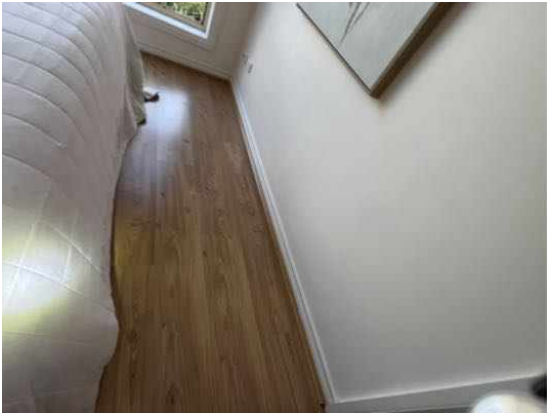
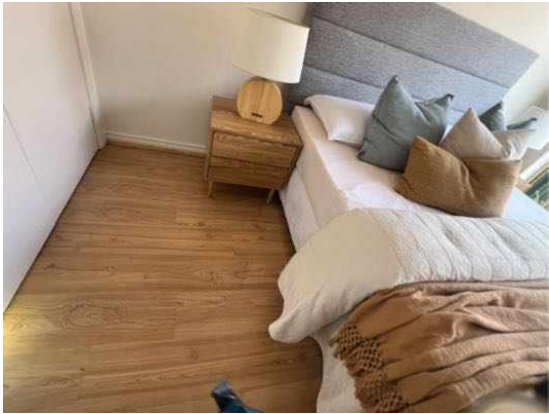
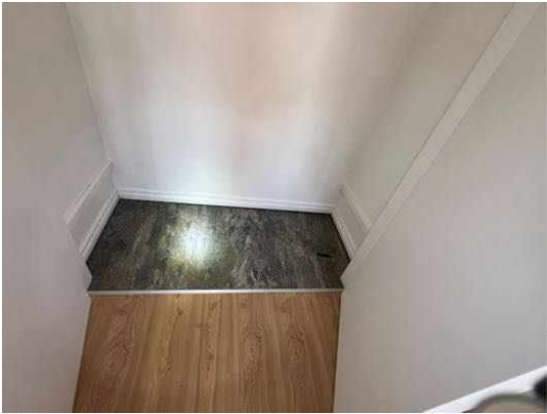
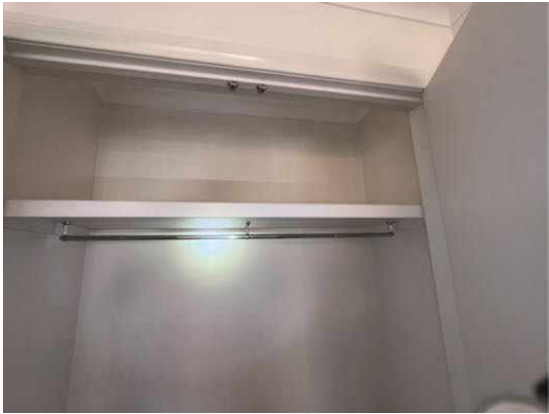
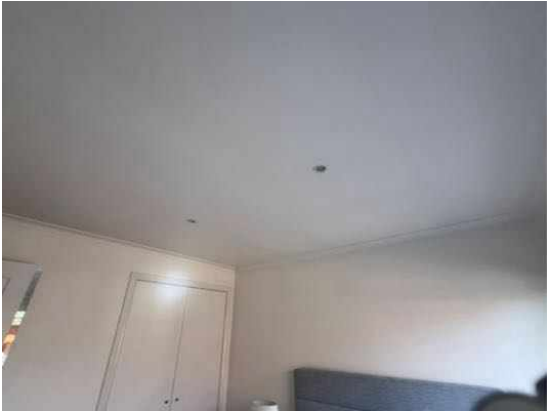
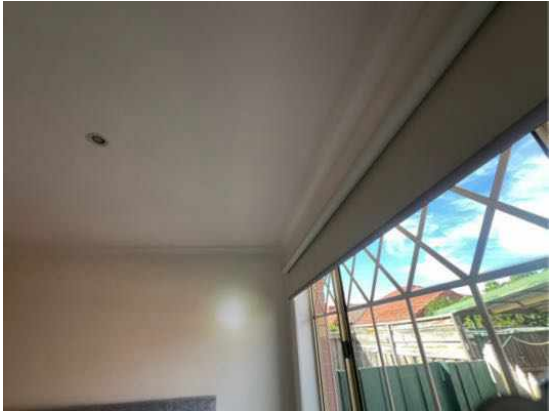
Building: Main Building
Location: Bedroom - Master > All Areas
Finding: Additional Photos - Obstructions and Limitations
Information: These photographs are an indication of the obstructions and limitations which impeded full inspection of the property at the time of inspection. These obstructions can hide an array of defects and should be removed to allow full inspection to be carried out. A re-inspection is recommended once the areas are made accessible.

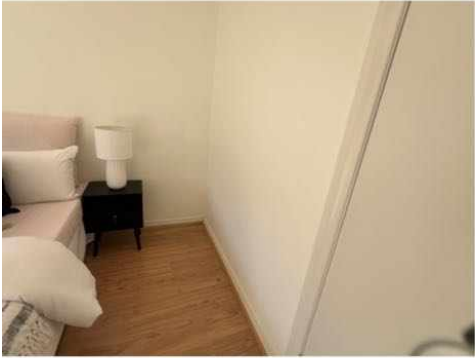
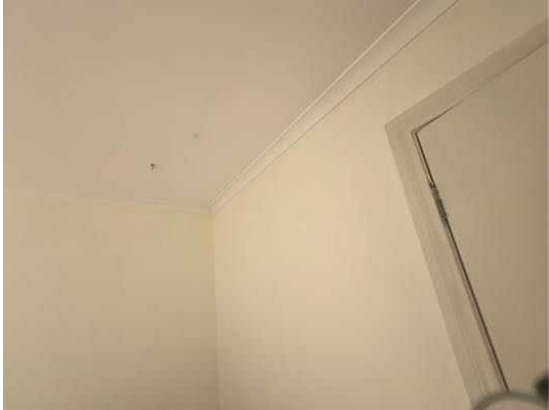
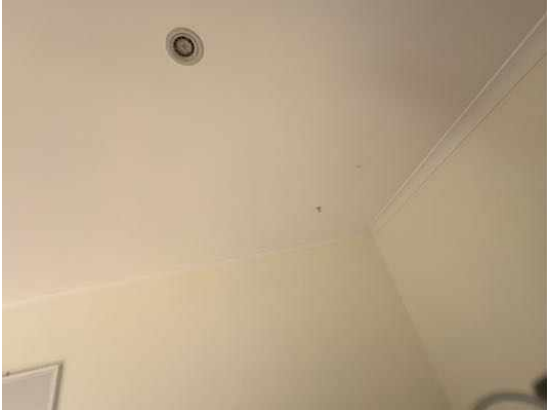
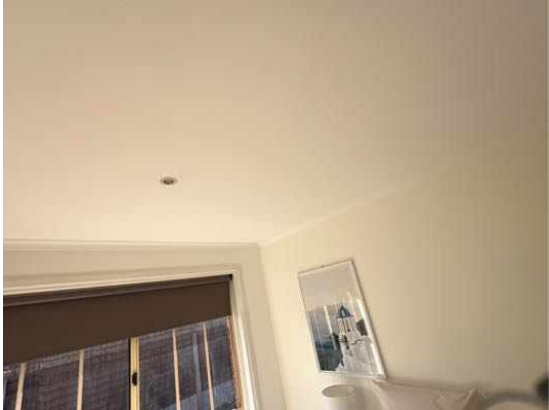
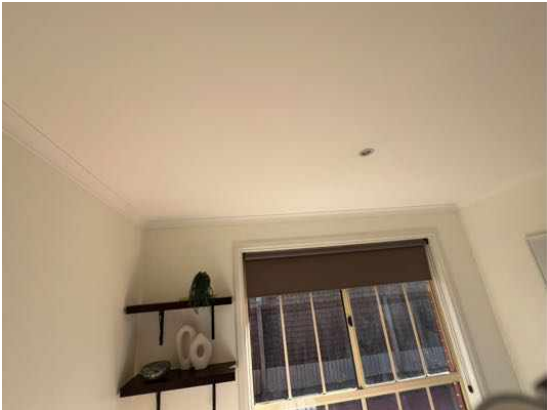
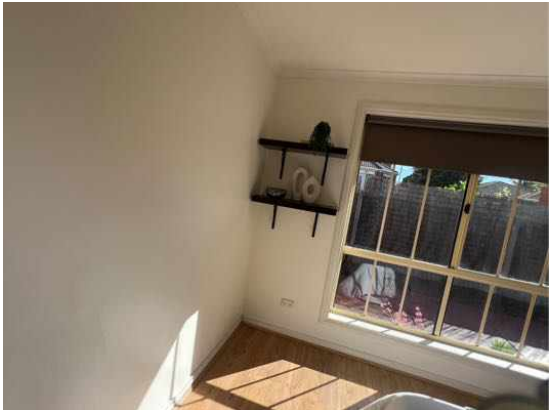
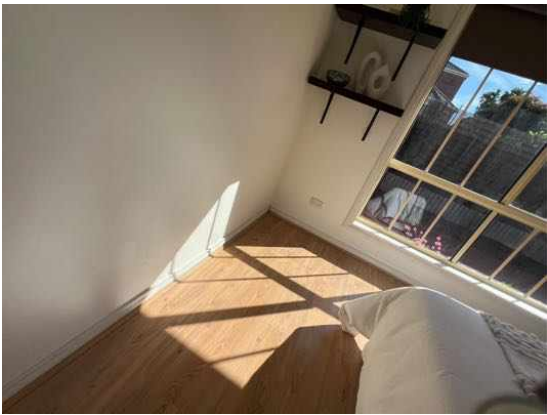
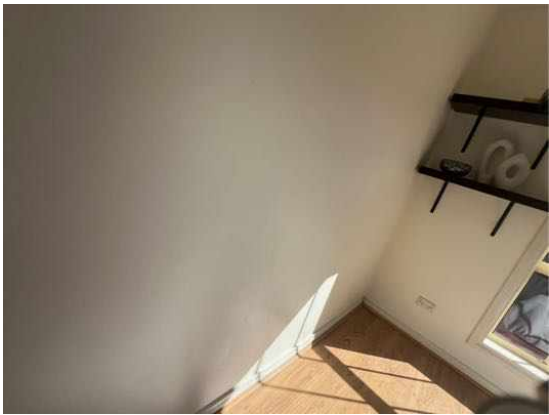
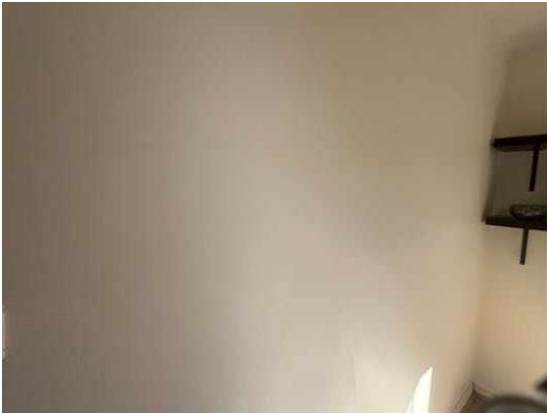
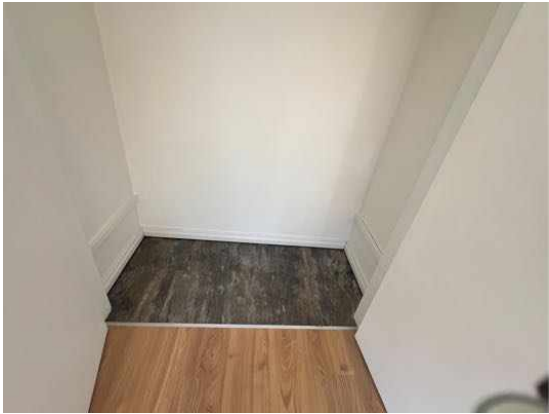
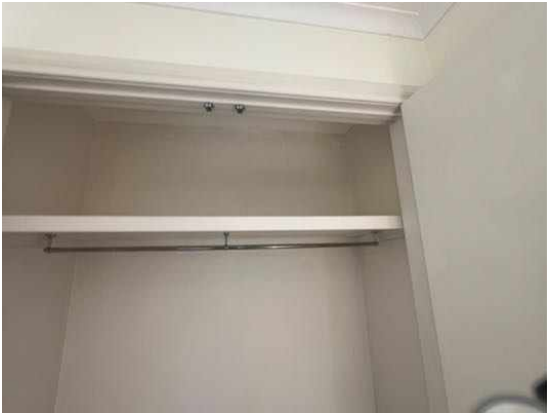
Building: Main Building
Location: Bedroom 2 > All Areas
Finding: Additional Photos
Information: Additional photos are provided for your general reference

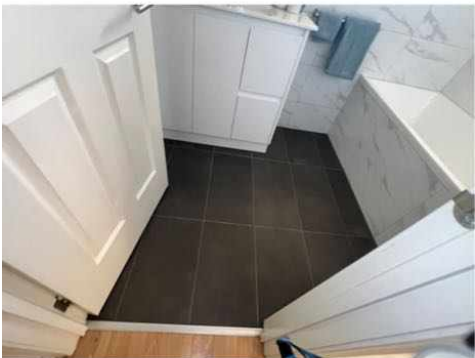
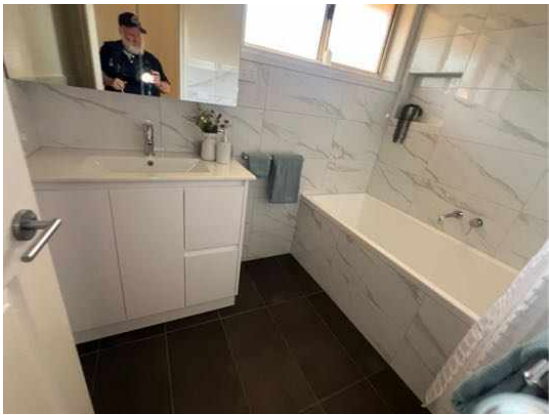
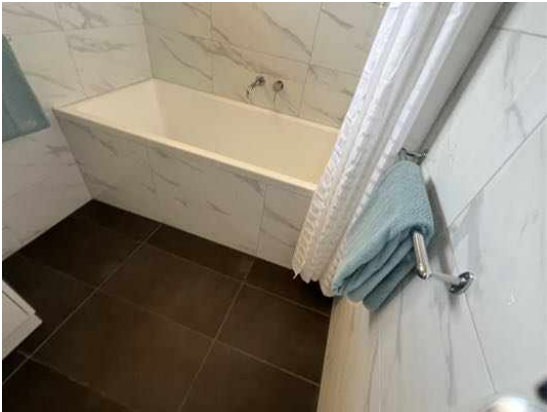
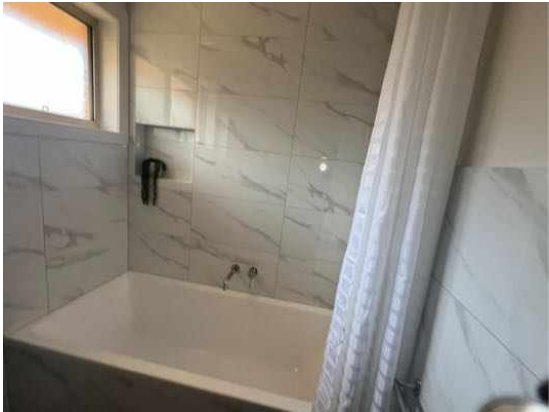
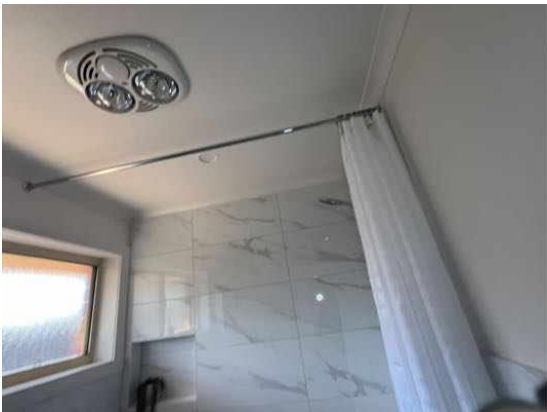
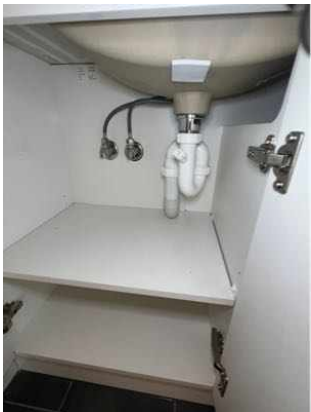
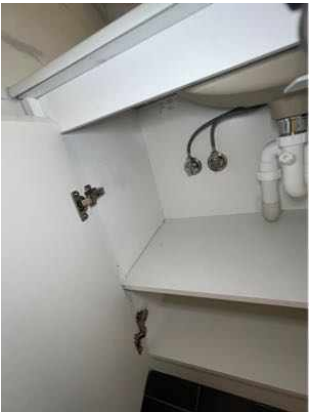
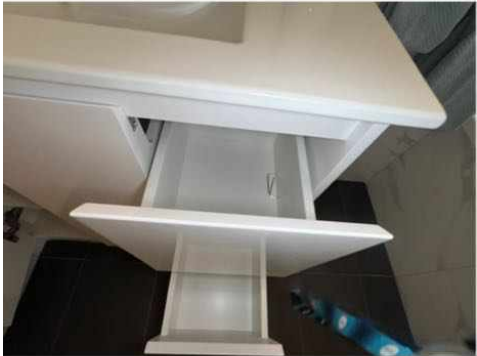
Building: Main Building
Location: Bathroom > All Areas
Finding: Additional Photos
Information: Additional photos are provided for your general reference

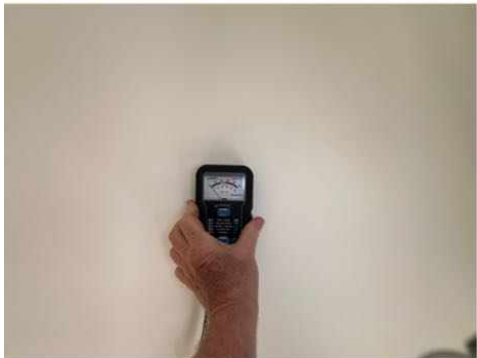
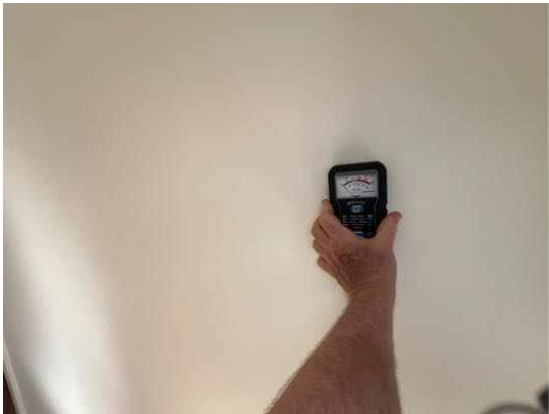
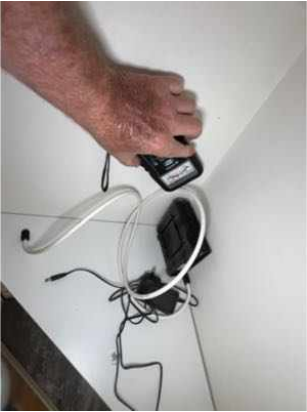
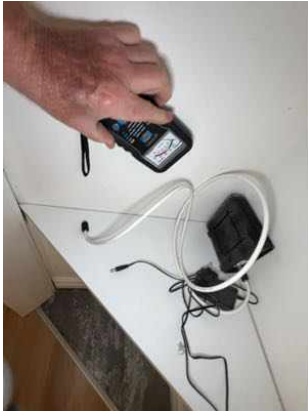
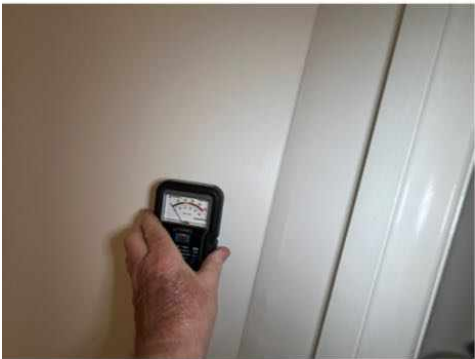
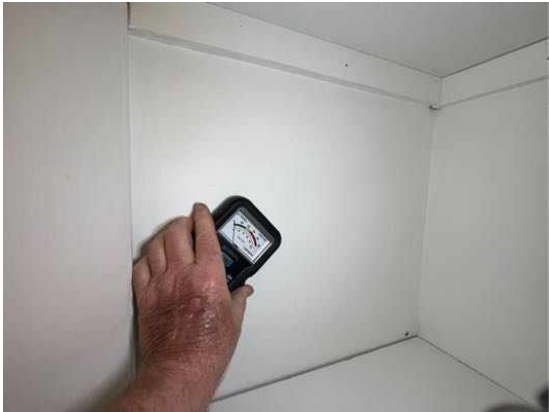
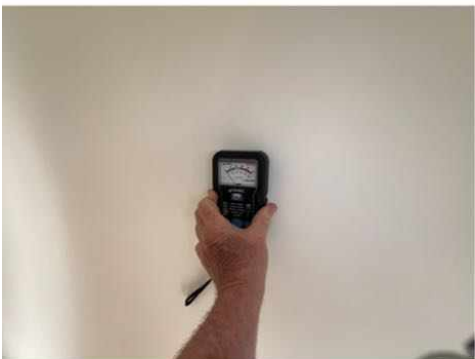
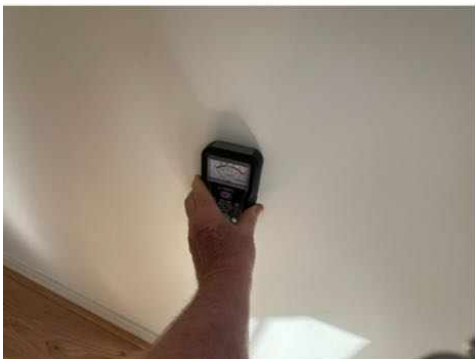
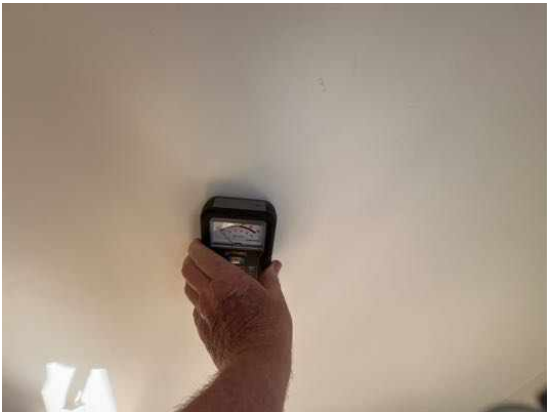
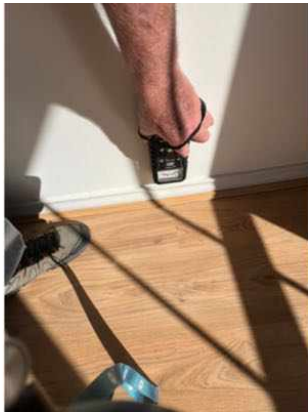
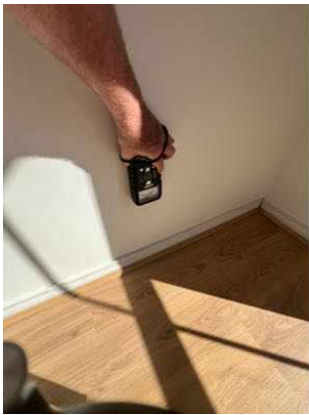
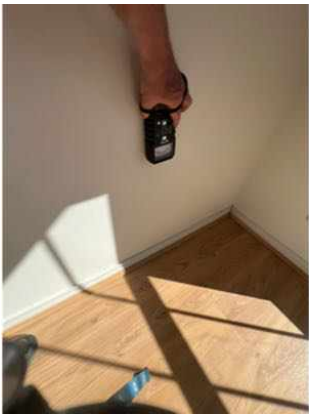
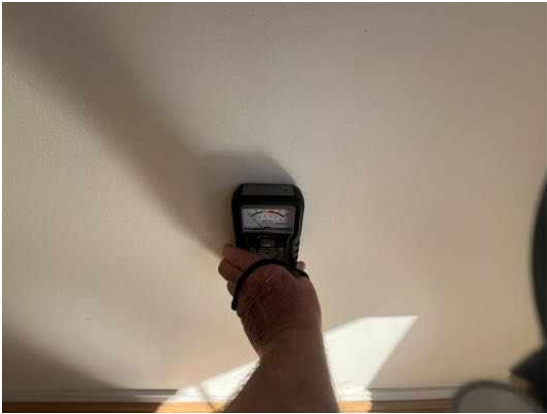
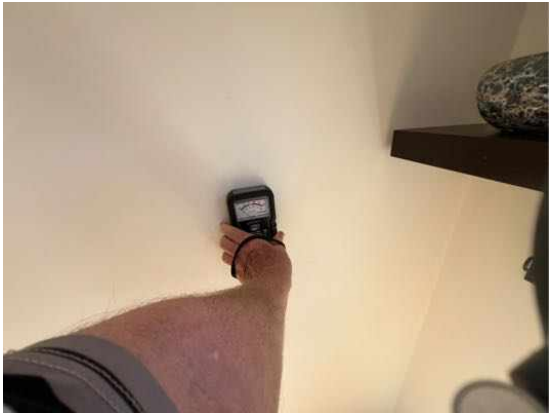
Building: Main Building
Location: Bedroom 2 > Front Left
Finding: Additional Photos-for reference-to identify any excessive moisture to walls adjacent to bathroom -found within tolerance
Information: Additional photos are provided for your general reference

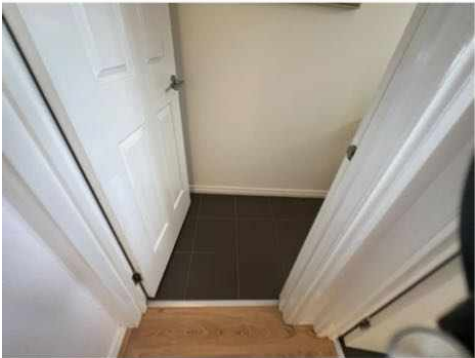
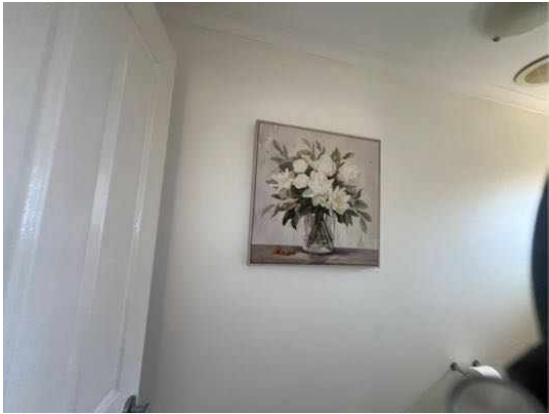
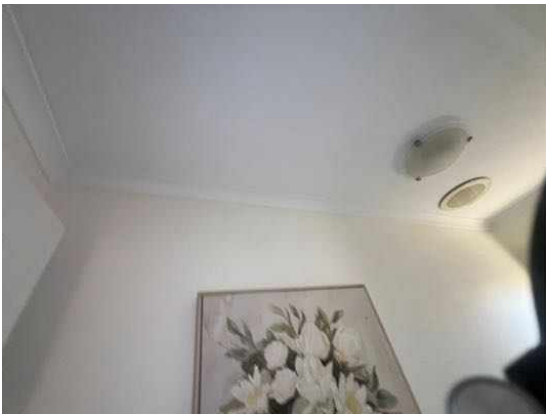
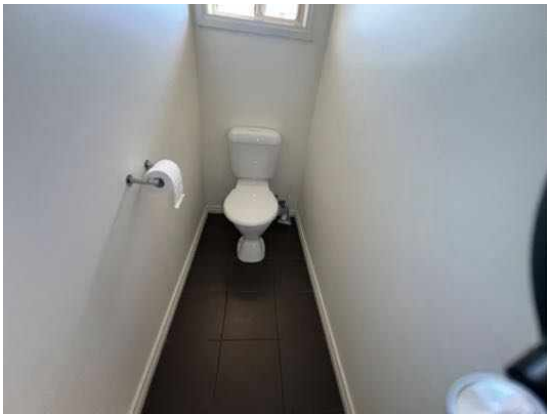
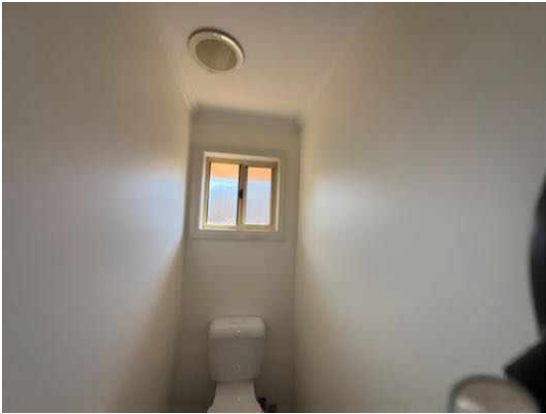
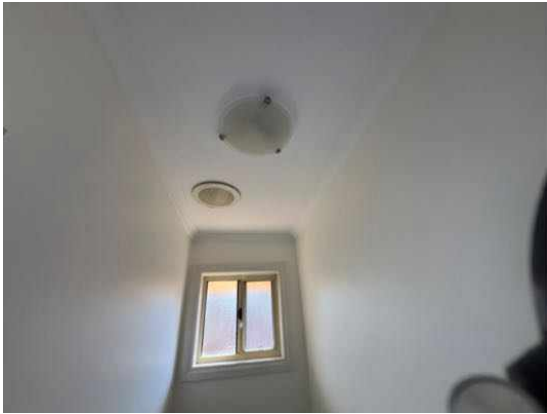
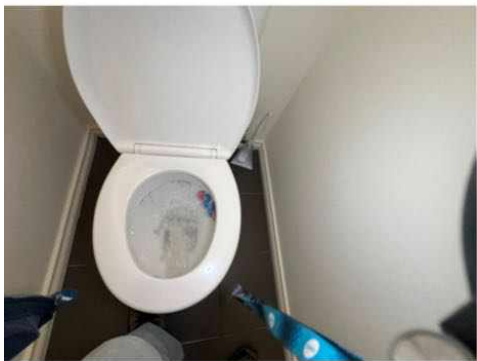
Building: Main Building
Location: Toilet (WC) > All Areas
Finding: Additional Photos
Information: Additional photos are provided for your general reference

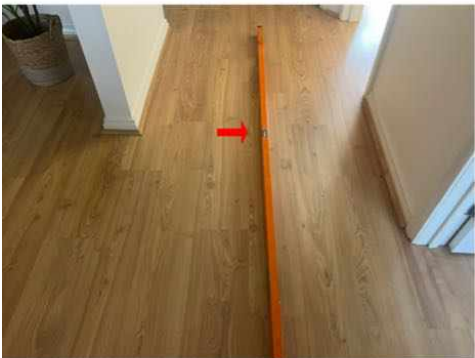
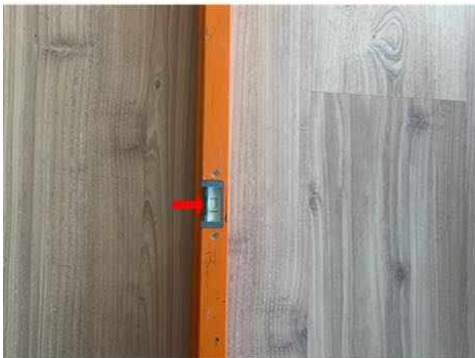
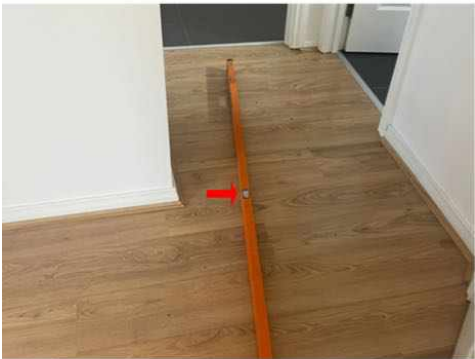
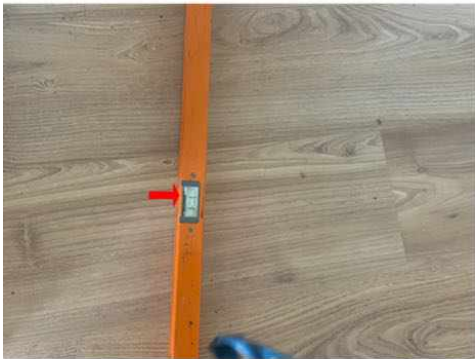
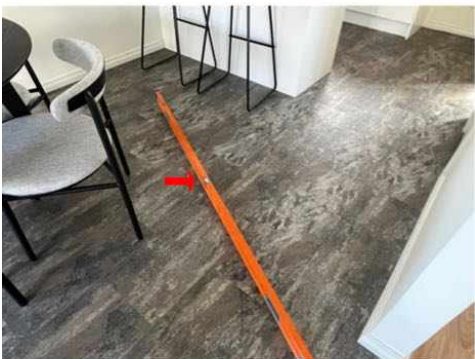
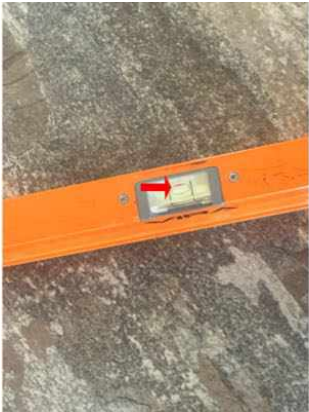
Building: Main Building
Location: All Areas > All Areas
Finding: Additional images of levels taken to floors -found to be within tolerance.
Information: At the time of the inspection it was noted that Additional images of levels taken to floors -found to be within tolerance.

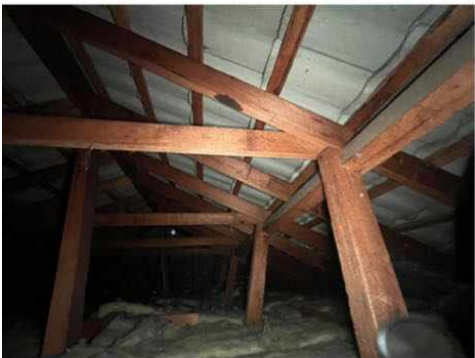
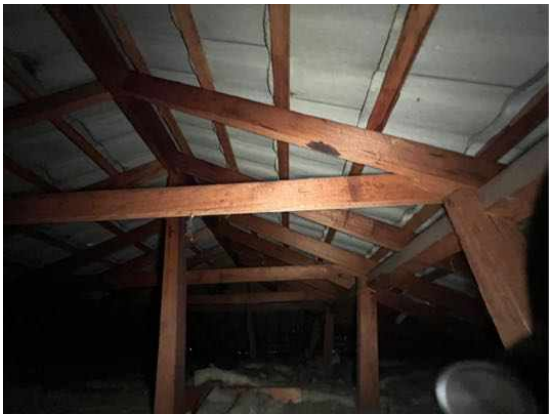
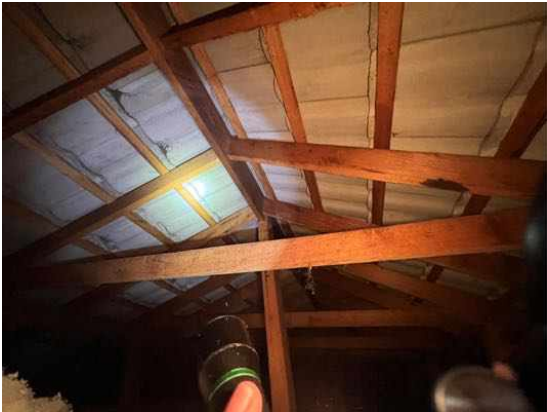
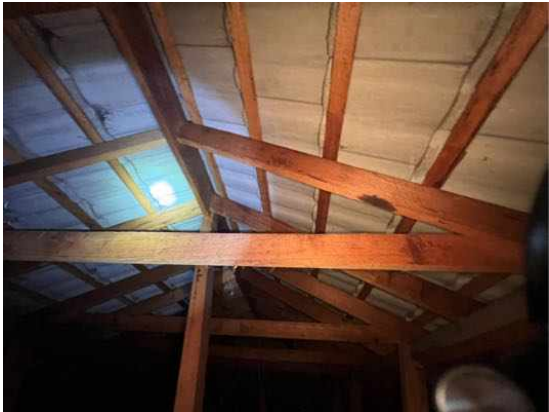
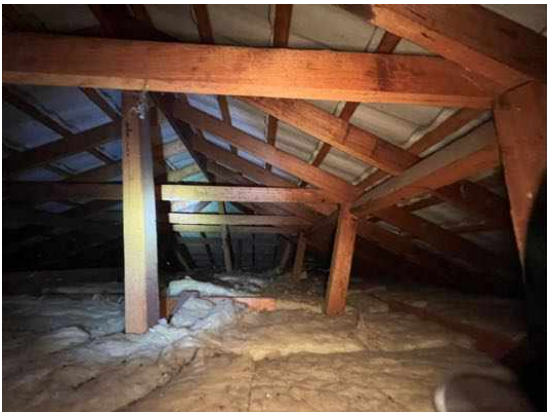
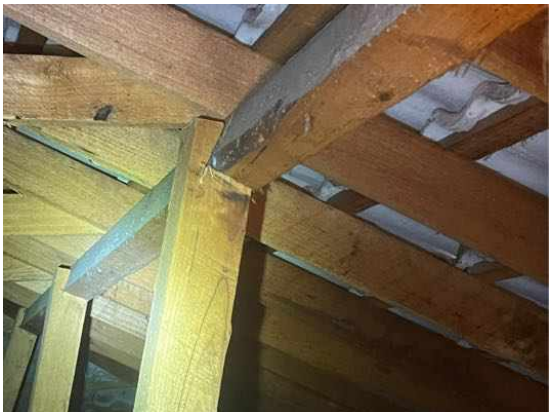
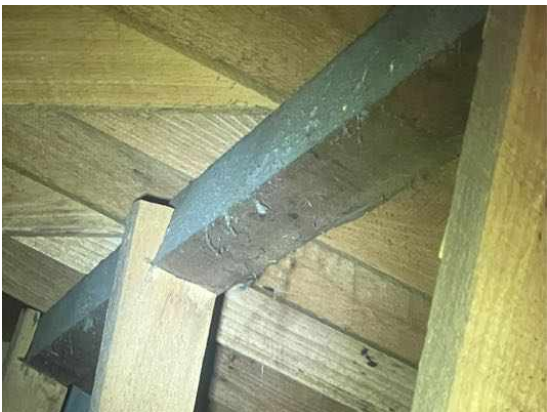
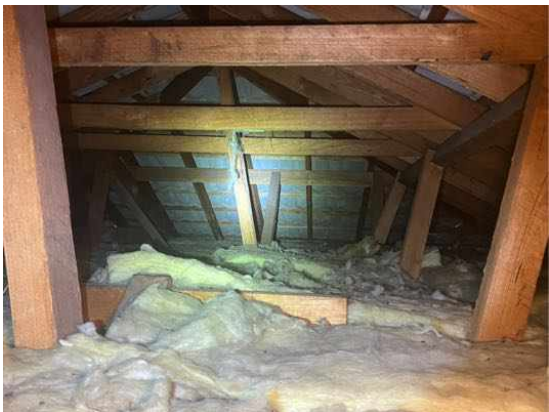
Building: Main Building
Location: All Areas > All Areas
Finding: Additional Photos - Obstructions and Limitations
Information: These photographs are an indication of the obstructions and limitations which impeded full inspection of the property at the time of inspection. These obstructions can hide an array of defects and should be removed to allow full inspection to be carried out. A re-inspection is recommended once the areas are made accessible.
