# Building and Timber Pest Inspection Report

Inspection Date: Mon, 23 Mar 2026

Property Address: 5/37 St Pauls Cres, Liverpool NSW 2170,  
Australia

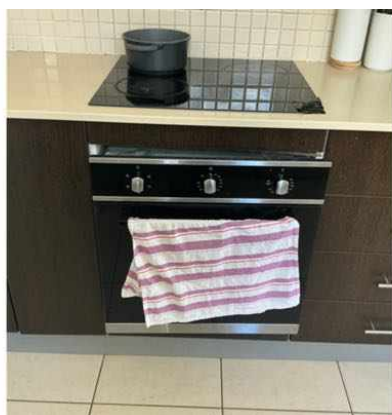
Building:	Main Building
Location:	Kitchen
Finding:	Unsecured Oven Installation
Information:	The electric oven located beneath the gas cooktop in the kitchen island was found to be unsecured.

During a light pull, the oven moved forward freely, presenting a potential safety hazard, especially if weight is applied to the open door. According to AS 4349.1–2007 Appendix C (C2.2 and C2.3), appliances should be properly installed to prevent movement or dislodgement.

This defect is considered a major safety concern due to the risk of injury or damage. Immediate rectification is recommended by a licensed kitchen installer or qualified tradesperson to properly secure the appliance in accordance with manufacturer installation instructions. Rectification should occur within 24–48 hours to eliminate the risk.

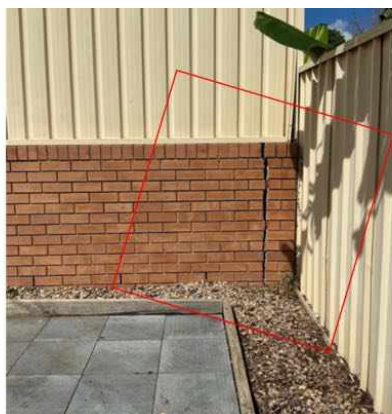
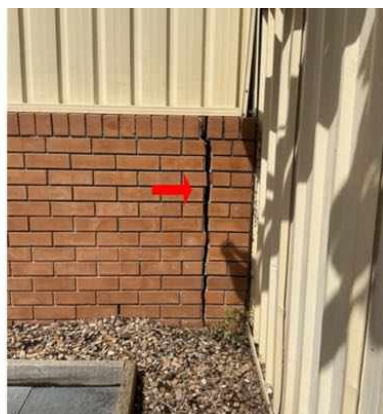
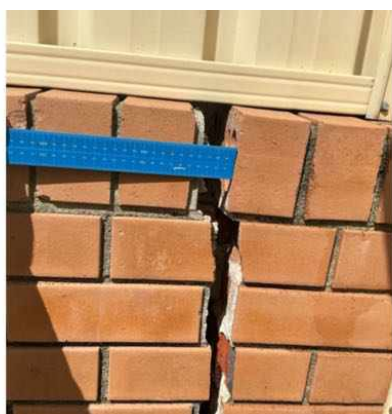
#### Finding 2.01

Building:	Main Building
Location:	All External Areas - Retaining Wall
Finding:	Brickwork - Cracking [Extensive repairs required]
Information:	Major cracking is evident to the brickwork in this area. When managing this degree of cracking, major extensive repair work is generally required. Such work is likely to involve replacement of sections of affected brickwork.

Structural issues are generally the underlying cause of such cracking. It is suspected that this damage has been created due to movement of key structural elements or general subsidence of associated footings.

A structural engineer and bricklayer should be appointed immediately to inspect the structural integrity of the affected brickwork and to assess the safety of the associated structures. The engineer can also nominate a scope of works required for rectification.

Always contact a building inspector or engineer should cracks widen lengthen or become more numerous, even after repair works have been completed.

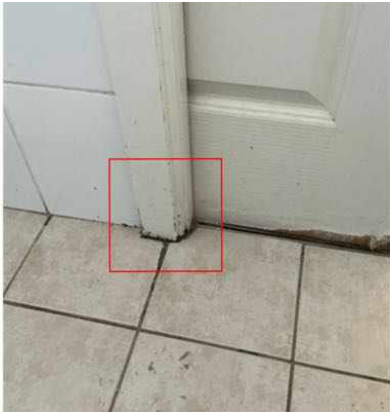
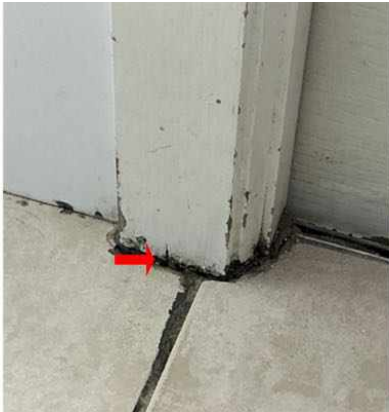
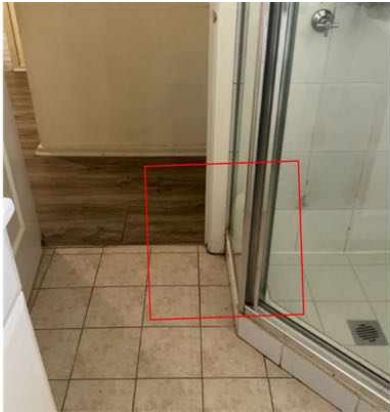
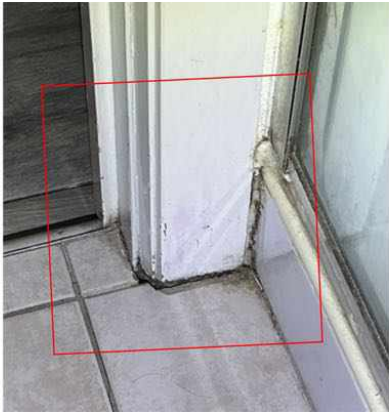
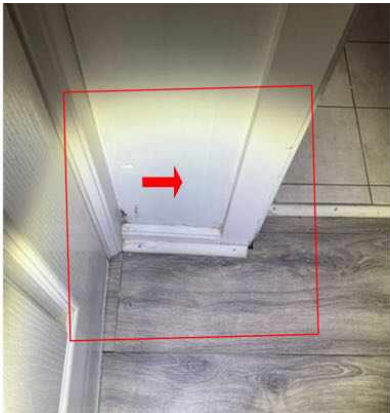
## Finding 2.02

Building:	Main Building
Location:	Ensuite, main bathroom
Finding:	Wet-Area Door Jambs – Moisture Staining / Decay /Elevated Moisture
Information:	moisture staining and deterioration were observed at the base of the wet-area door jamb and architraves. This is commonly due to water splashing or moisture tracking from the bathroom floor into adjacent joinery or inadequate waterproof transition at the bathroom threshold.

Further inspection by a licensed waterproofing contractor is recommended to verify exact cause and remedial measures.

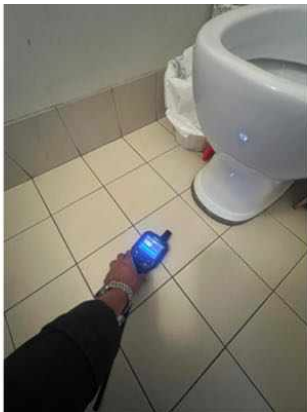
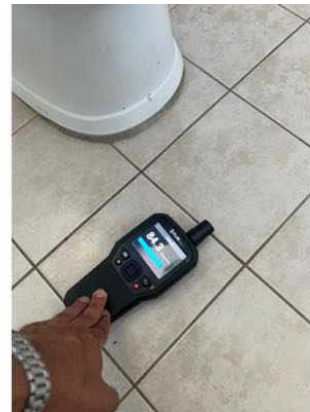
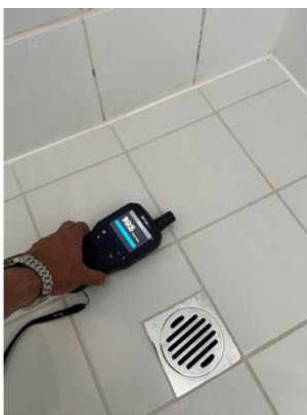
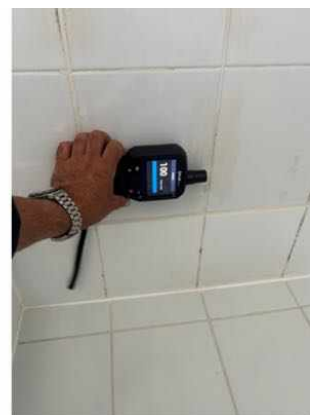
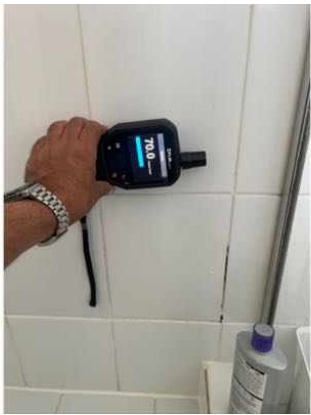
### Finding 3.01

Building:	Main Building
Location:	Bathroom
Finding:	Elevated Moisture Bathrooms - Further investigation Recommended
Information:	Elevated moisture levels were detected to tiled surfaces in bathroom/shower areas. Persistent moisture ingress can lead to concealed damage, including timber rot and mould growth.

Elevated moisture readings in tiled wet areas can occur from normal shower use, age/deterioration of waterproofing membranes, plumbing leaks or moisture absorption through grout lines. While no damage was visible, elevated readings may indicate moisture retention behind tiles, which can be a conducive condition for future deterioration if not monitored.

Monitor the area over time for signs of drumming, efflorescence, tile movement, or grout deterioration. Further inspection by a licensed waterproofing is recommended (e.g., pressure testing, membrane assessment).

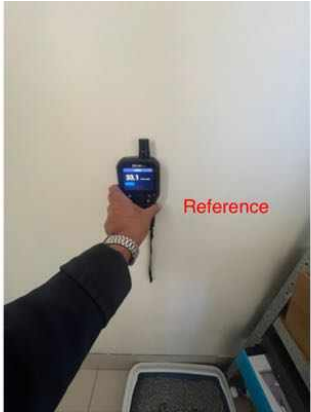
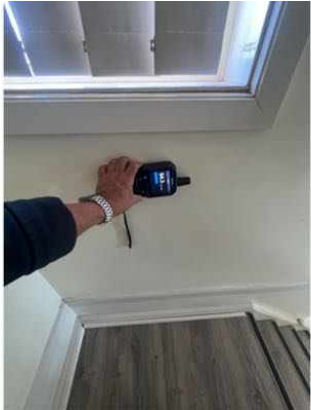
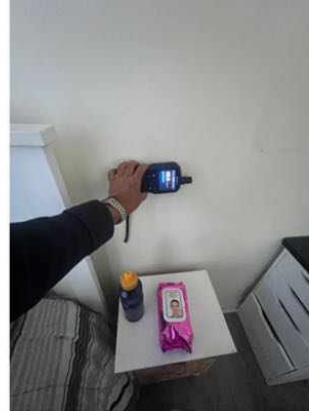
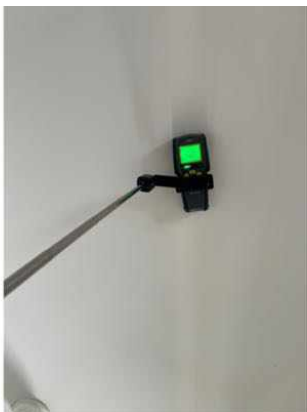
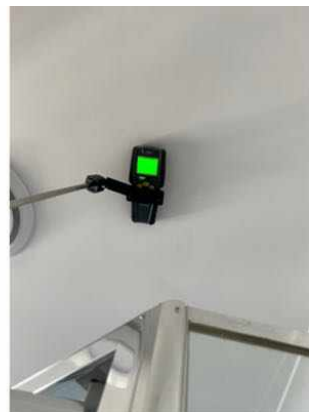
**Finding 3.02**

Building: Main Building  
 Location: All Internal Areas - External parameter walls , main bathroom/ensuite ceiling  
 Finding: Elevated Moisture – Further Investigation Recommended  
 Information: Elevated moisture readings were detected in several locations, with some areas also showing signs of dampness while others did not present visible surface issues, although no significant structural damage was evident at the time of inspection, dampness can contribute to deterioration if left unaddressed. Inspector was not able to inspect the external wall due to space constraints. A further investigation by a licensed plumber or waterproofing specialist is recommended to confirm the source and ensure no concealed issues are developing.

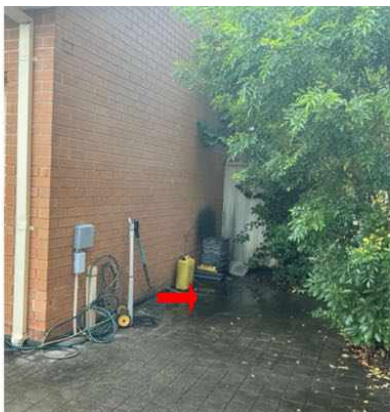
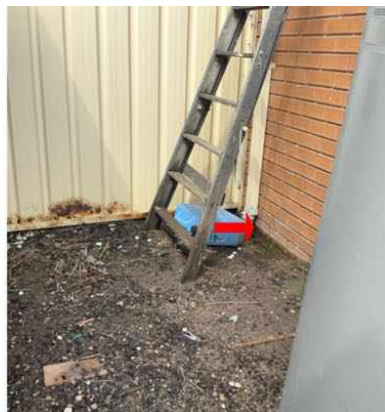
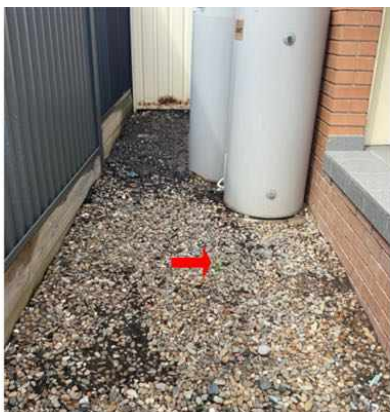
Building:	Main Building
Location:	All External Areas
Finding:	Site drainage - Inadequate
Information:	The site drainage in this area was found to be inadequate at the time of inspection, creating potential for subsequent water damage to associated building elements.

It is important that water does not lie against the base of walls; surrounding paths and ground levels should be sloped to drain water away from walls. Downpipes should not discharge stormwater onto lower walls or plinths. Stormwater should be carried away by large, regularly cleaned drains. Ground levels may need to be lowered to expose a buried DPC.

Where site drainage is inadequate, installation of an Agricultural (Aggie) Drain may be required. A qualified plumber should be appointed to further inspect the property and perform any remedial works as necessary. Water damage and secondary defects are likely to occur if left unmanaged.

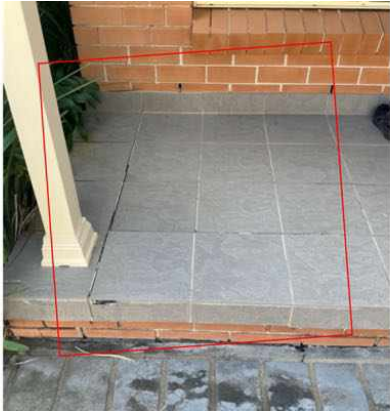
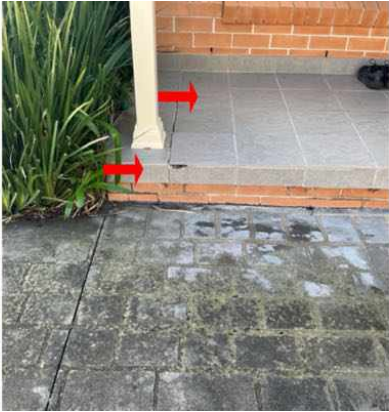
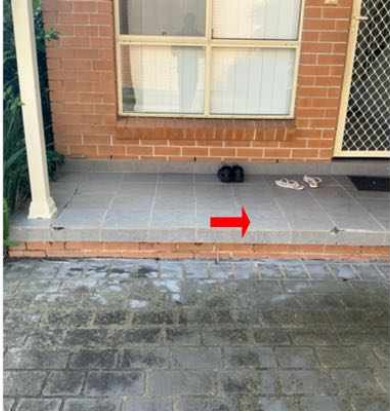
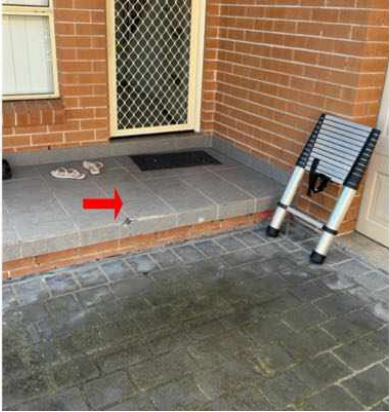
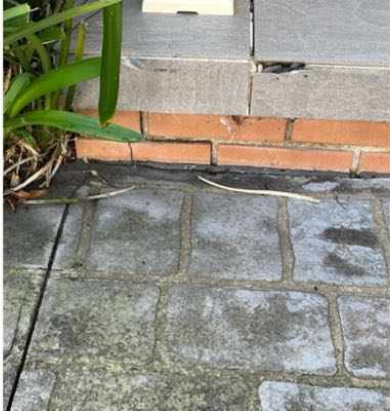
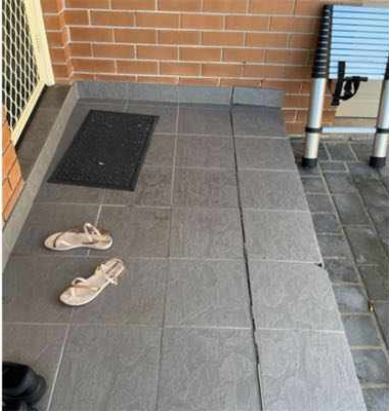
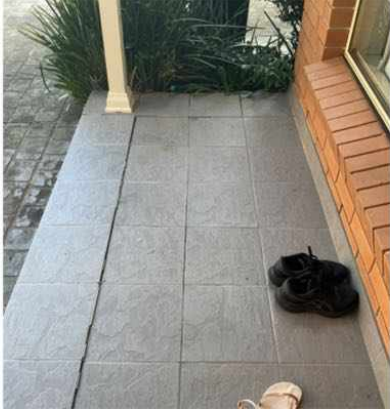
### Finding 3.05

Building:	Main Building
Location:	All External Areas - Front/Rear
Finding:	Tiles - Drummy to some areas
Information:	Drummy tiled areas were identified at the time of inspection. The term 'drummy' refers to tiles that have become detached from their fixing, despite otherwise being in relatively good condition. Such defects are generally caused by physical or moisture damage to the area. Drummy tiled areas may also be a direct result of poor workmanship during the construction process.

Tiled areas may swell and shrink with changes in air humidity if the area has sustained moisture damage. Any exposure to moisture is capable of causing tiled areas to become drummy and/or cracked over a prolonged period of time. Drummy tiled areas generally require removal and replacement of affected tiles, with adequate sealant and grouting.

Specialist trades are available for these types of services. A registered builder may be required to undertake works if damage is extensive or if secondary building defects have resulted. Otherwise, it is advised that a tiling contractor be appointed to perform works as necessary. Immediate action is recommended to ensure that no further damage is sustained in the affected area.

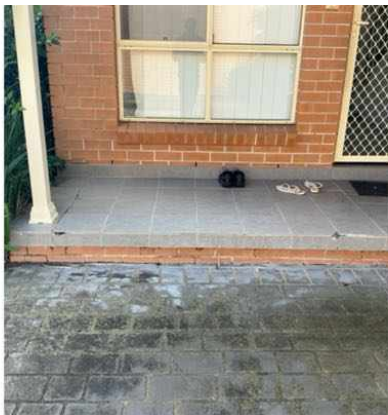
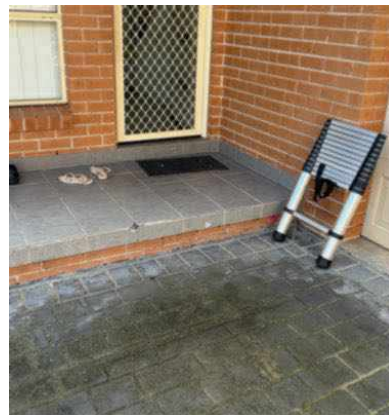
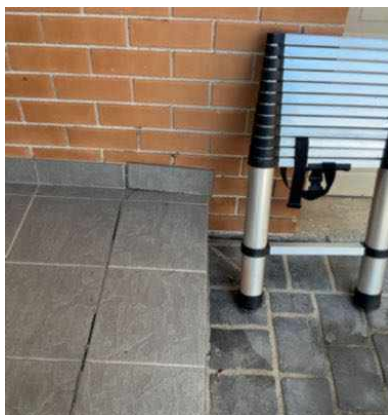
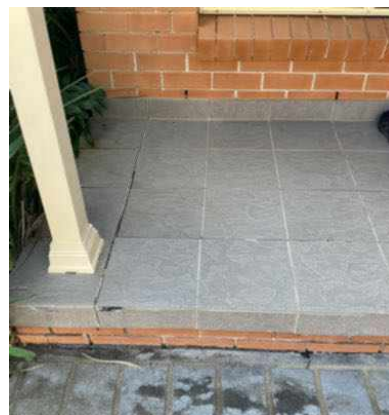
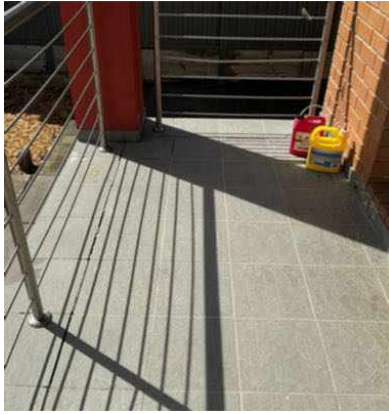
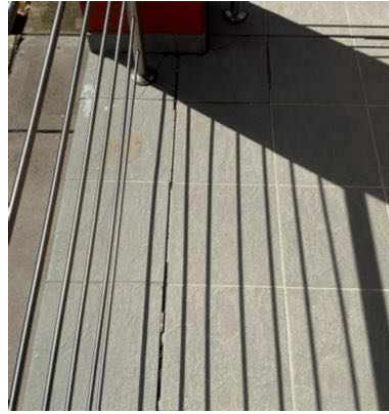
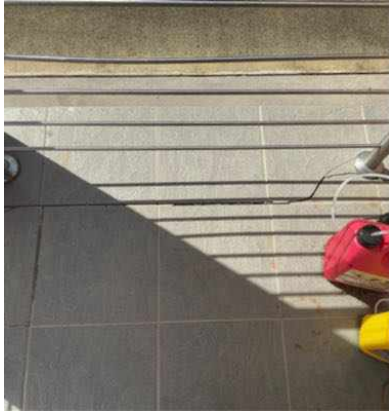
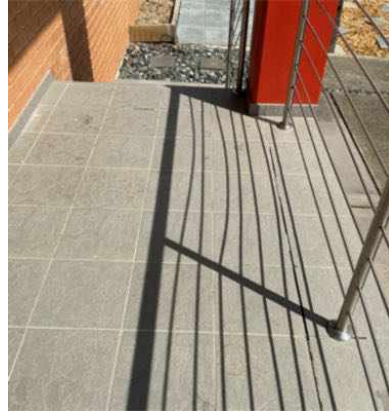
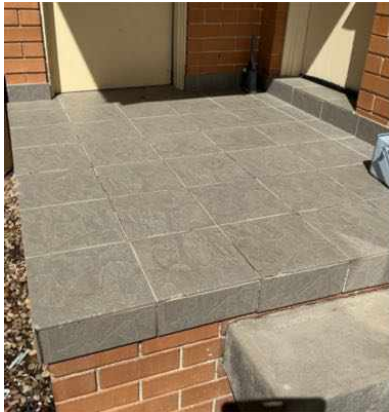
Finding 3.06

Building: Main Building  
Location: All External Areas - Front/Rear/Side  
Finding: Tiles - Cracked or damaged  
Information: Cracking was evident to the tiling in this area at the time of inspection. While the cracking appears to be minor, this area is frequently exposed to water, allowing potential for water penetration into adjoining sections of walls or flooring.

If left unmanaged, water penetration to these areas may lead to subsequent water damage, which is likely necessitate repair work to affected building elements.

A tiling contractor should be appointed to ensure that no further water damage occurs. The re-application of silicone and grouting throughout remaining tile work is also advised, to further protect the area against water penetration.

Where water penetration has led to water damage, appointment of a relevant tradesperson may be required to repair damaged building elements.

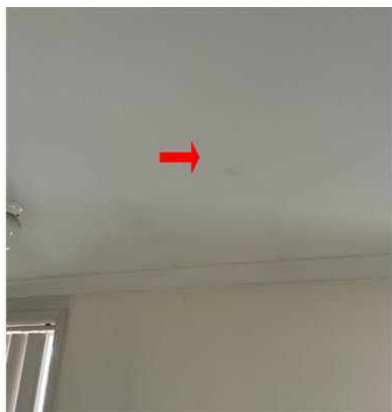
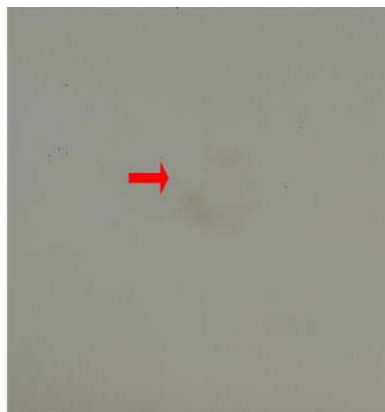
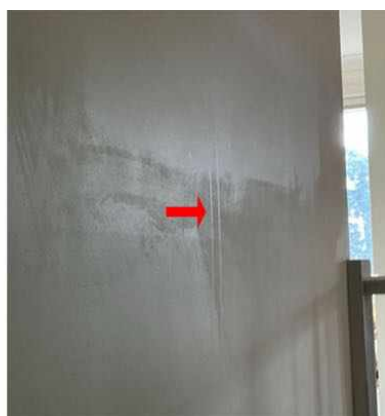
Building:	Main Building
Location:	All Internal Areas - Stair landing, stairs
Finding:	Water staining
Information:	Water staining was evident in this area at the time of inspection. Water staining indicates that surfaces have been exposed to excessive moisture over time. The minerals and other elements in the water lead to staining, which may graduate to corrosion and deterioration if left unmanaged.

While mostly an appearance defect, water staining can be indicative of more serious defects, which may be currently concealed by other building elements.

Where water staining is active, a licensed plumber must be consulted to identify the cause of the staining and to provide advice on any reparation works that may be required. Replacement of any broken or damaged structures is advised.

Conversely, where water staining is old and inactive, affected building materials may be repaired or replaced at client discretion. A qualified carpenter or registered builder may be appointed to perform these works.

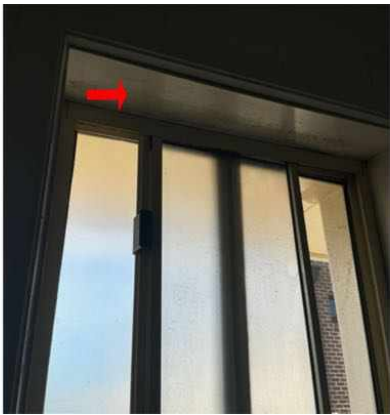
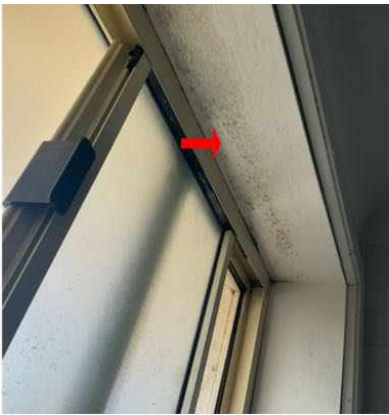
### Finding 3.08

Building:	Main Building
Location:	All Internal Areas
Finding:	Mould Growth – Window Reveal
Information:	mould growth was observed to the internal window reveal and adjacent surface finishes, commonly associated with condensation, limited ventilation or water ingress. No evidence of structural impact was observed at the time of inspection. This condition is classified as a minor defect. Further investigation by a licensed plumber is recommended to understand exact cause of the condition.

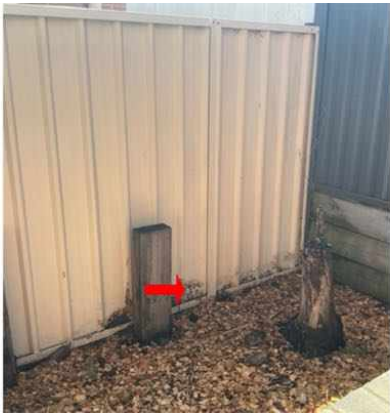
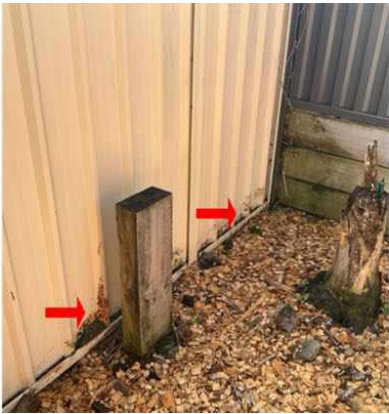
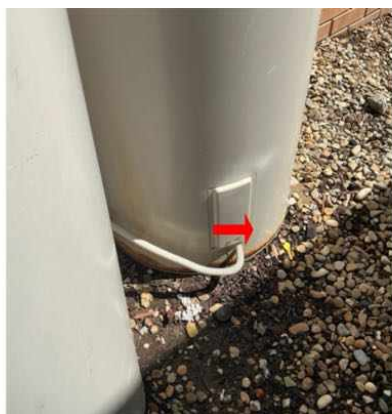
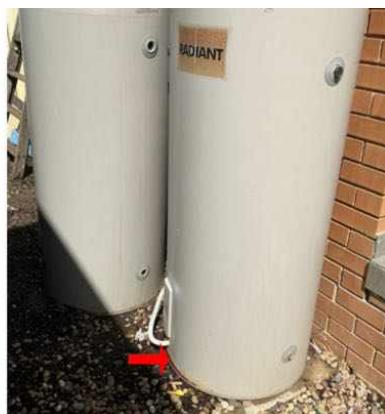
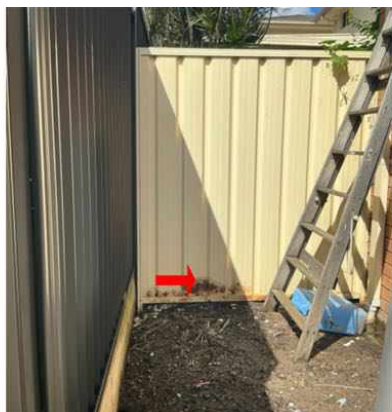
**Finding 3.09**

Building: Main Building  
Location: All External Areas  
Finding: Building element - Rusted or corroded to some areas  
Information: This building element shows evidence of rusting and corrosion, which is likely to have developed as a result of excessive exposure to moisture and or inadequate coatings.

As surface rust provides no protection to the underlying iron, the deteriorating condition is likely to worsen if not addressed in the short-term future.

Where possible, the use of galvanized (treated) metals or aluminium coated metals aid in rust prevention, as does regular general maintenance. Rust formation can be controlled with coatings, such as paint, that isolate the iron from the environment.

Rusting and corrosion should be managed by ideally removing or limiting the affected surface from exposure to moisture. A registered builder may be appointed to replace any building elements that have been severely affected by rust or water damage.

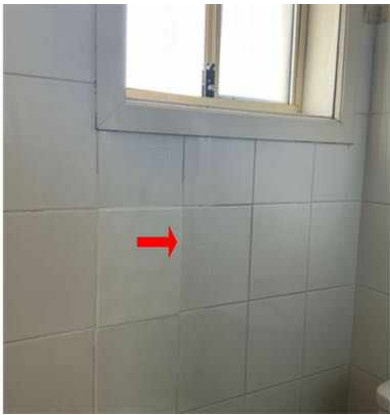
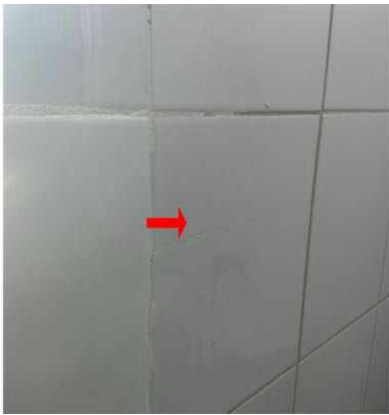
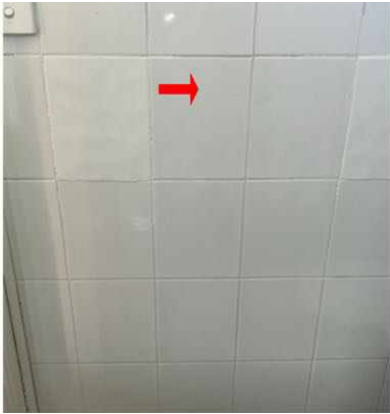
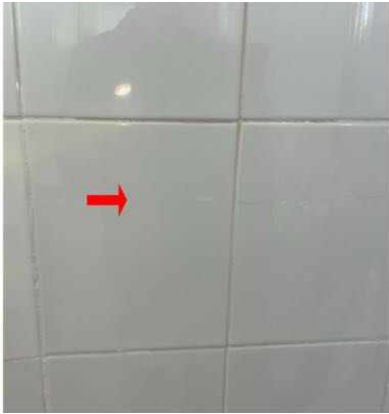
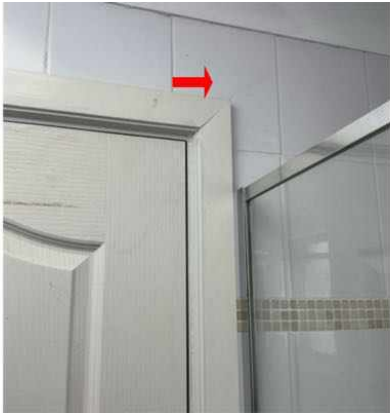
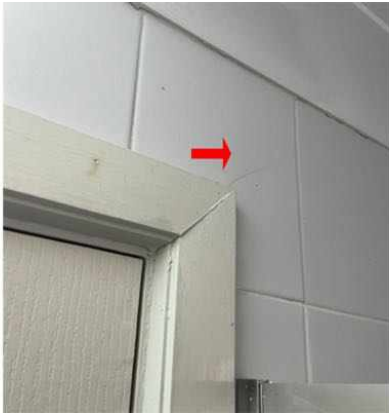
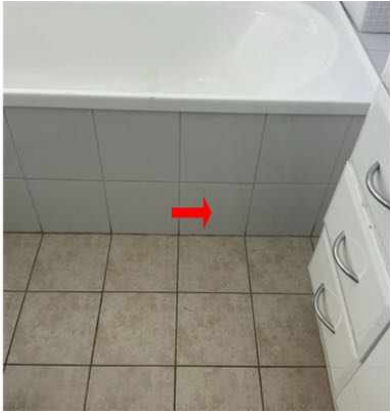
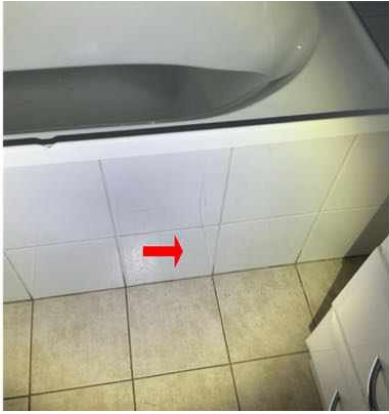
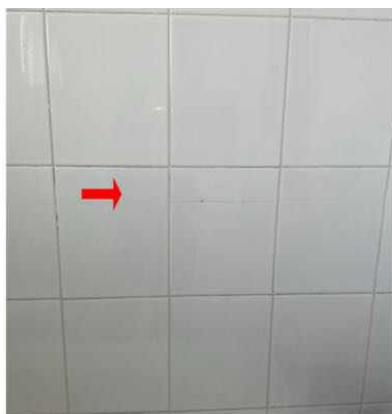
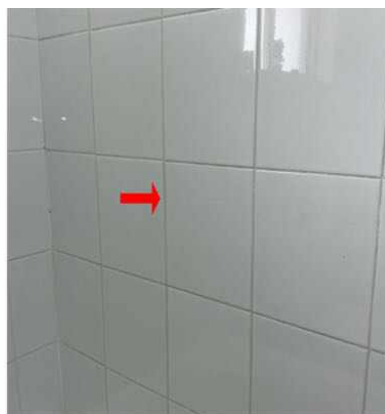
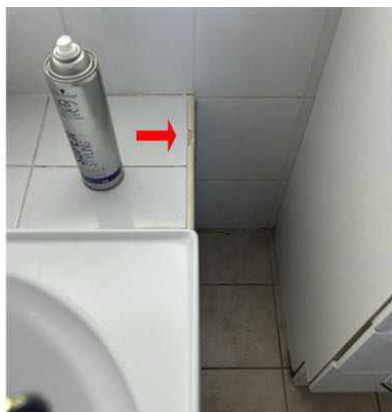
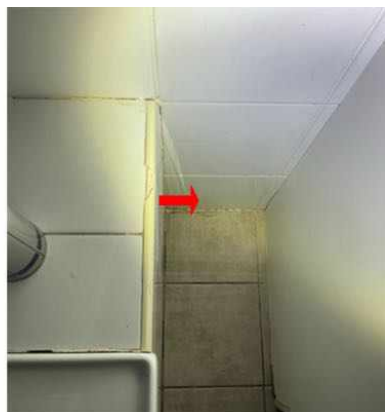
### Finding 3.10

Building:	Main Building
Location:	All Internal Areas - Ensuite , bathroom
Finding:	Tiles - Cracked or damaged
Information:	Cracking was evident to the tiling in this area at the time of inspection. While the cracking appears to be minor, this area is frequently exposed to water, allowing potential for water penetration into adjoining sections of walls or flooring.

If left unmanaged, water penetration to these areas may lead to subsequent water damage, which is likely necessitate repair work to affected building elements.

A tiling contractor should be appointed to ensure that no further water damage occurs. The re-application of silicone and grouting throughout remaining tile work is also advised, to further protect the area against water penetration.

Where water penetration has led to water damage, appointment of a relevant tradesperson may be required to repair damaged building elements.

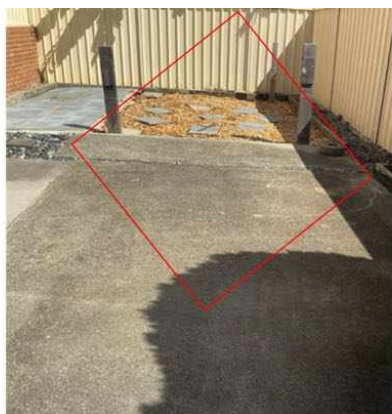
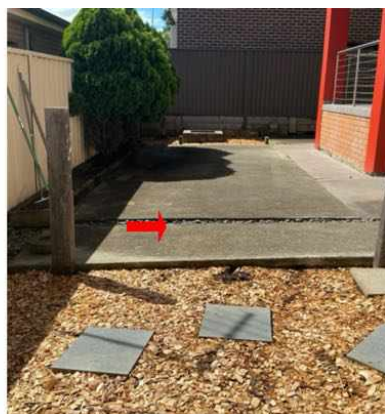
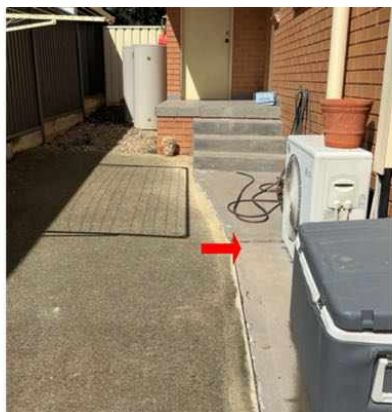
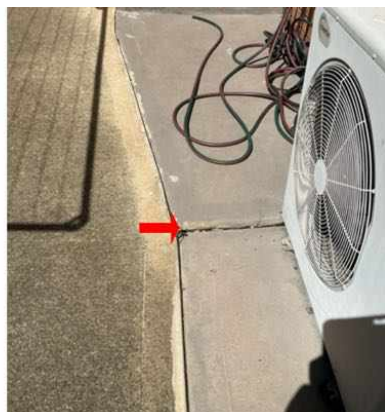
### Finding 3.11

Information: Sections of the external paved area are uneven, creating a potential trip hazard. It appears as though the area has been subject to rough installation, or that paving sections have lifted due to movements in the foundation of the property.

Where paving creates a trip hazard, personal injury may ensue if due caution is not taken by all persons within this area.

Re-paving of the area is required as soon as possible to remedy this situation. Further consultation with a specialist concreter is advised.

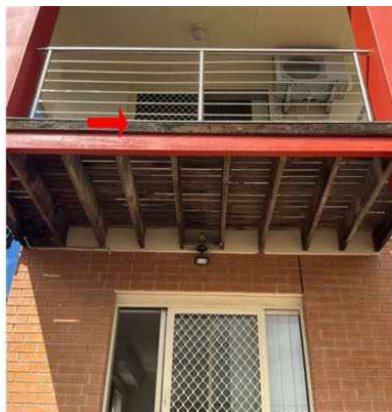
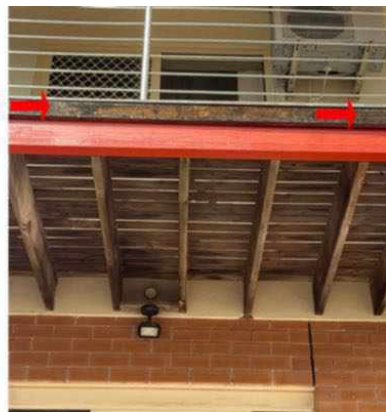
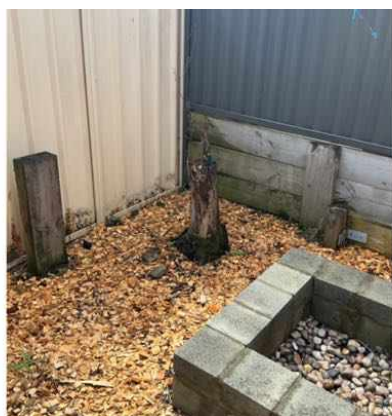
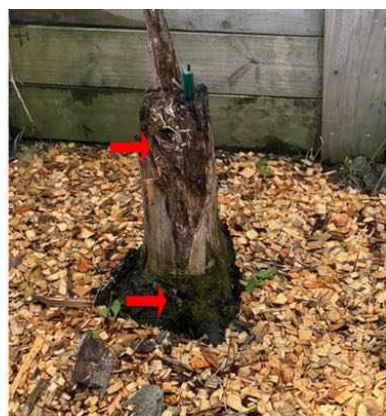
### Finding 3.12

Building:	Main Building
Location:	All External Areas
Finding:	Wood rot to some areas
Information:	This building element shows evidence of wood rot. Wood rot, also known as Fungal Decay, occurs when timbers and other cellulose building materials are exposed to damp conditions on an ongoing basis. This could be the result of exposure to weathering over a prolonged period of time, or the attraction of excessive moisture from other abutting building materials. Contributing factors also include poor air ventilation in the area.

Wood rot is often associated with general damp problems and is evidenced by a 'musty' smell or mould and mildew occurring on surfaces. If left unmanaged, damp conditions can lead to further health problems and the decay of timbers will continue.

Early intervention and regular maintenance, particularly of exterior timbers, will prolong the useful life of these building elements. Prior to any works being performed, the cause of the moisture that has created the visible wood rot should be identified and addressed in a suitable manner. Replacement of affected timbers may then be a necessary step in protecting surrounding building elements from such deterioration.

A qualified plumber may be appointed to assess the cause of excessive moisture and to provide advice on any remedial works as required. A qualified carpenter or

registered builder may also be required to replace affected building materials.

Even though Liverpool termite activity was not visible. A further invasive inspection by a licensed termite technician its also highly recommended to eliminate possibility of potential termite activity.

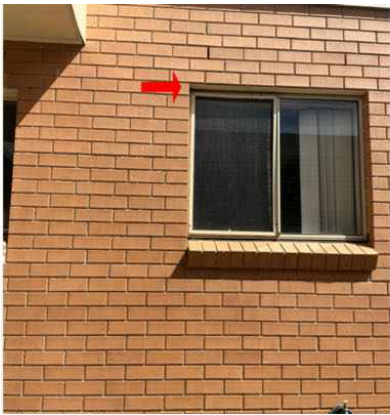
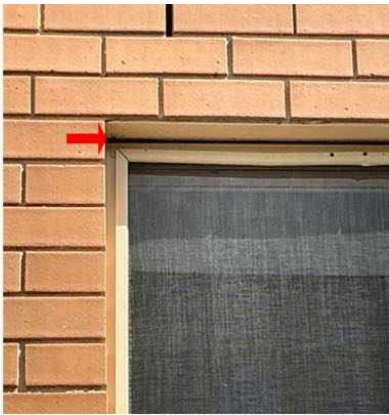
### Finding 3.13

Building:	Main Building
Location:	All External Areas
Finding:	Gap Between Window Frame and Masonry to some areas
Information:	A visible gap is present between the external window frame and the adjacent masonry wall. This gap may allow water ingress, air infiltration, and potential pest entry if not adequately sealed. Over time, such exposure can contribute to frame deterioration, internal water damage, or reduced thermal performance. Sealing or filling the gap with a suitable weatherproof compound is recommended to maintain the integrity of the building envelope, in accordance with good building practice and AS 4349.1

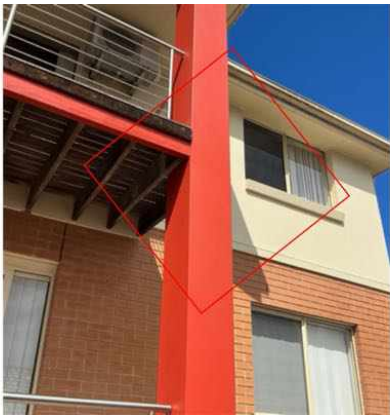
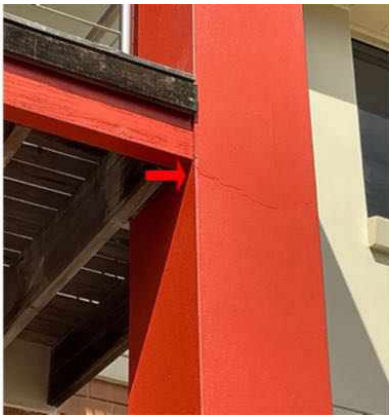
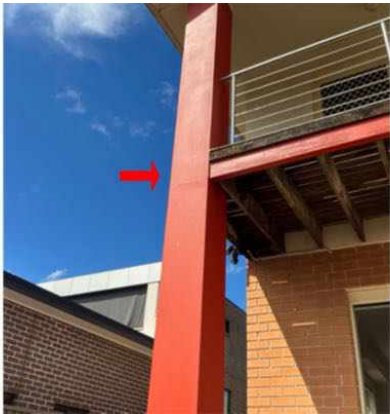
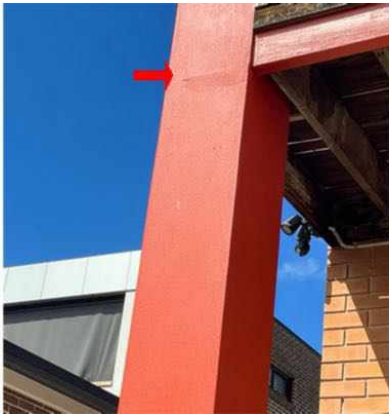
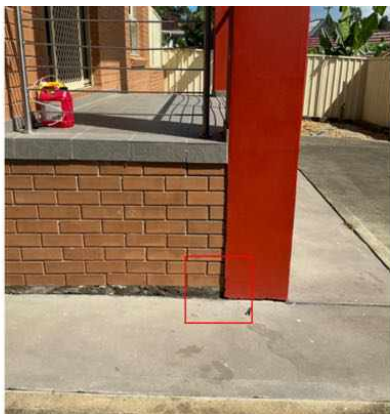
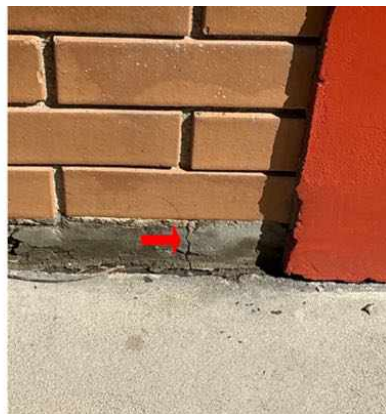
**Finding 3.14**

Building: Main Building  
Location: All External Areas  
Finding: Cracks to render - Category 1 to some areas  
Information: It has been observed that cracking to rendered surfaces has occurred. The degree of damage falls within Category 1, described as fine cracks that do not need repair and which are less than 1.0mm in width limit.

Damage of this category is not considered a defect for rectification. Always contact your building inspector should cracks widen, lengthen, or become more numerous.

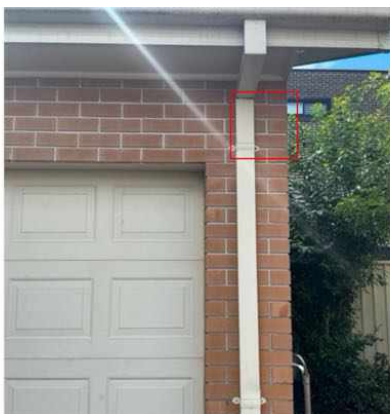
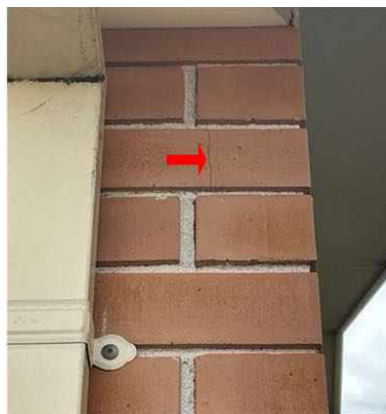
### Finding 3.15

Building:	Main Building
Location:	All External Areas
Finding:	Brickwork - Cracking noticeable
Information:	There were several cracks and or crack repairs evident to external brickwork.

Noticeable cracks are a common occurrence in external brickwork and are a likely result of age expected building movement, general expansion, and/or contraction of building materials in different weather conditions. Noticeable cracks in brickwork may develop if left unattended, with potential for necessitating major remedial works or replacement of the brickwork.

It is highly advised that a qualified bricklayer be appointed to provide necessary works to cracked brickwork to prevent any further damage. Such works should be conducted as soon as possible.

Always monitor these cracks and contact a building inspector should cracks widen, lengthen, or become more numerous.

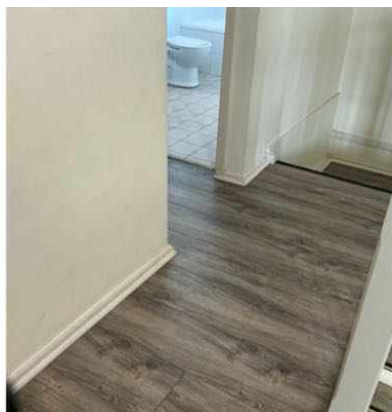
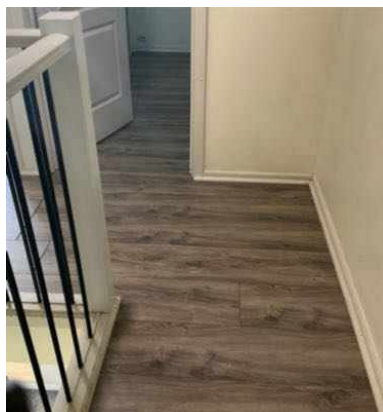
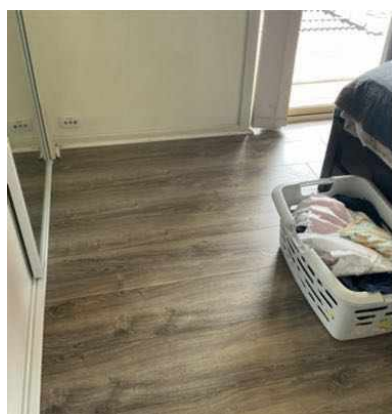
### Finding 3.16

Building:	Main Building
Location:	All Internal Areas
Finding:	Floors - bouncy or creaking
Information:	The internal flooring in this area was identified as being bouncy at the time of inspection. A bouncy floor surface generally presents as a discernible change in level as they are walked across, in noisy or creaking flooring, or in consequent movement of surrounding furniture and fixtures.

Bouncy floors generally indicate that the floorboards or the subfloor structures are coming loose from the joists that they are installed on. Bouncy flooring may also be the result of gaps between flooring and stumps or joist structures, which require packing.

The client is advised to seek quotations for required repairs from an experienced flooring contractor.

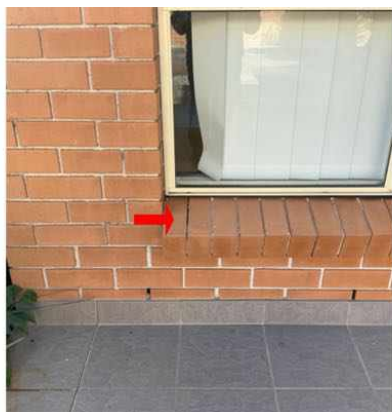
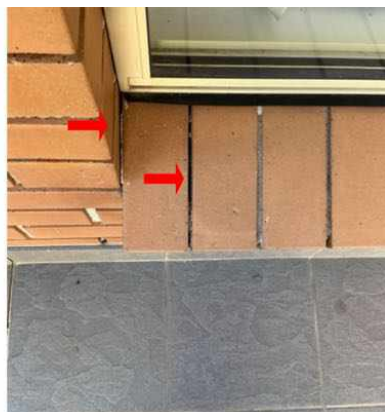
### Finding 3.17

Building:	Main Building
Location:	All External Areas
Finding:	Brickwork - Deteriorated mortar to some areas
Information:	Mortar, or 'bedding', is the material which fills joints and intersections between bricks in masonry walls and structures. Sections of mortar in this brickwork were identified as having deteriorated, which is generally expected for a property of this age and condition.

Mortar may deteriorate as a result of age of building materials, minor movement of bricks, or frequent exposure to weathering. Mortar should be replaced to ensure that bricks remain in their intended location and to prevent gaps, which would allow water or moisture ingress and secondary damage as a result.

Mortar deterioration can be addressed by a bricklayer where areas of deterioration are localised and easily accessible. Alternatively, appointment of a registered builder is advised, to repoint large areas of decaying mortar. Where secondary structural defects have become evident, consultation with a structural engineer may be required.

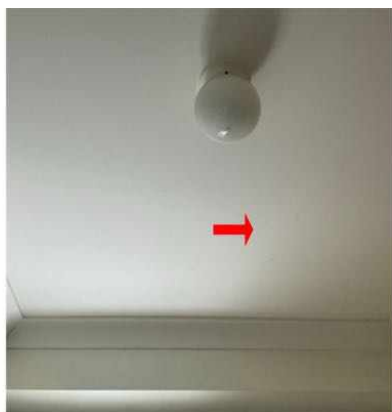
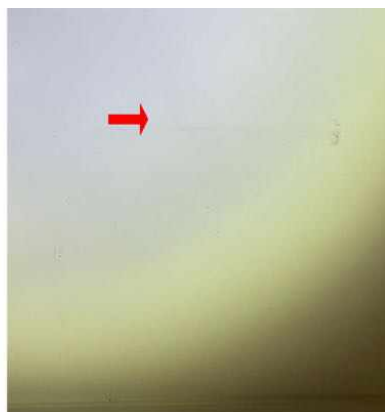
### Finding 3.18

Finding: Water Staining - Humidity or Ventilation

Information: The ceiling surface shows faint darkened spotting or shadowing, commonly consistent with surface mould or humidity-related staining, often found in bathroom or wet area ceilings with insufficient ventilation. While there is no visible sagging or major water damage, the pattern suggests prolonged moisture exposure, possibly due to steam accumulation or minor condensation issues. According to AS 4349.1-2007 (Appendix C), this would be classified as a minor defect unless further deterioration or active leaks are found. Recommend improving mechanical or natural ventilation, cleaning the surface with mould treatment, and monitoring for recurrence.

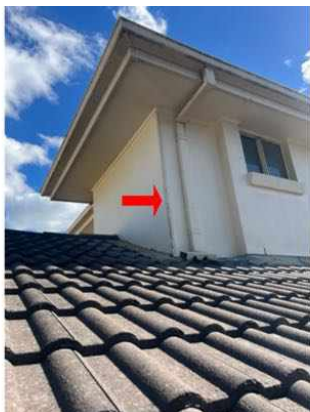
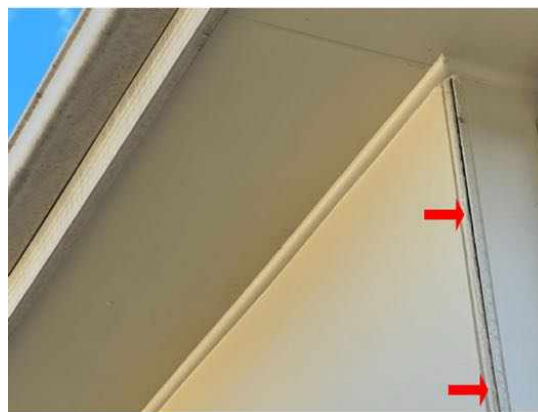
### Finding 3.19

Finding: Installation - substandard or incomplete - Gap at wall junction (Possible moisture ingress)

Information: The installation of this building element appears to have been completed to a substandard level of workmanship or is incomplete. Generally substandard repairs or

installation are related to poor workmanship, the use of inappropriate materials, or a failure to complete installation to a suitable standard.

Where installation is substandard and/or incomplete, the client should contact the responsible trade to undertake rectification. Unfinished and substandard building works are likely to degrade more quickly and may create potential for secondary defects to associated building elements.

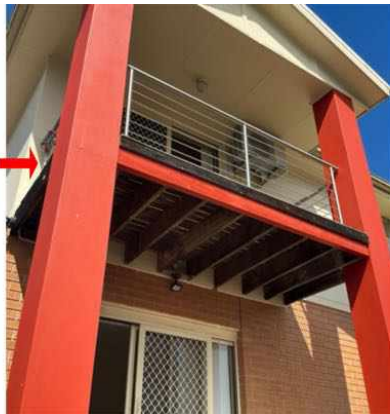
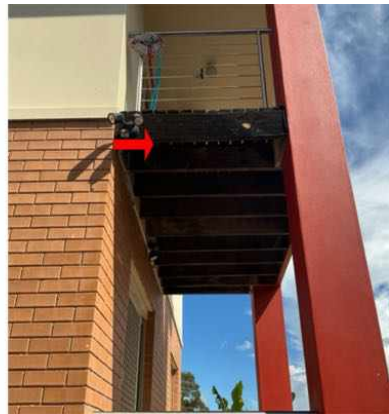
### Finding 3.21

Building:	Main Building
Location:	All External Areas
Finding:	External Timber Balcony or Deck - Structural Stability (Wood rot , cracked timber)
Information:	The load capacity of the external balcony or deck could not be verified during the inspection.

External timber structures are also constantly exposed to weather elements and can deteriorate in an accelerated manner, ongoing assessments are required.

It is highly recommended that a Structural Engineer further assess the external timber balcony or deck to inform the client of its load capacity. Regular maintenance inspections by competent practitioners is needed.

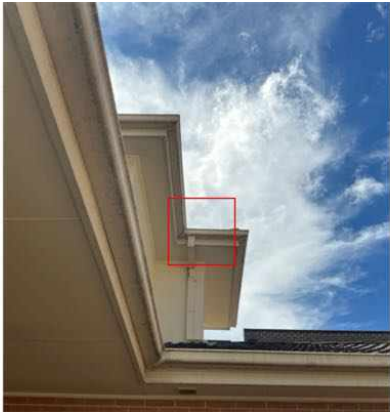
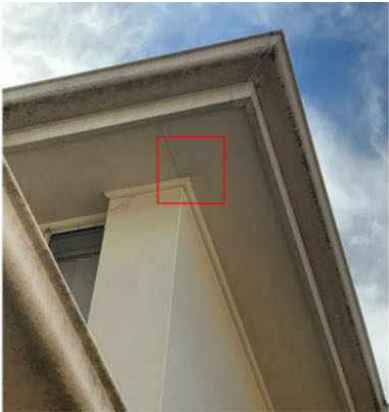
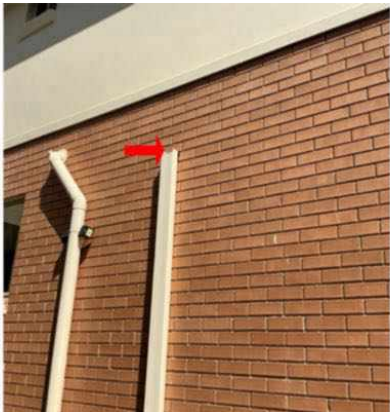
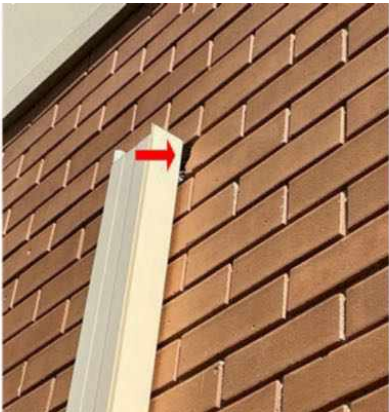
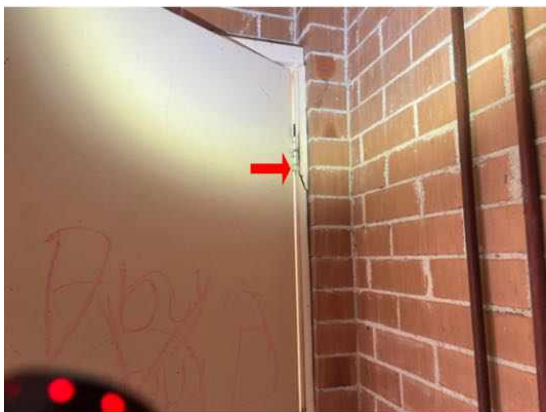
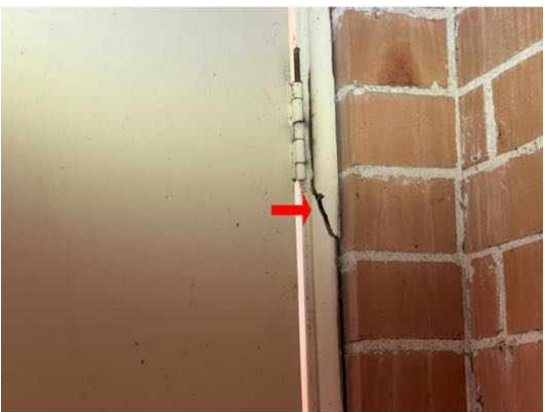
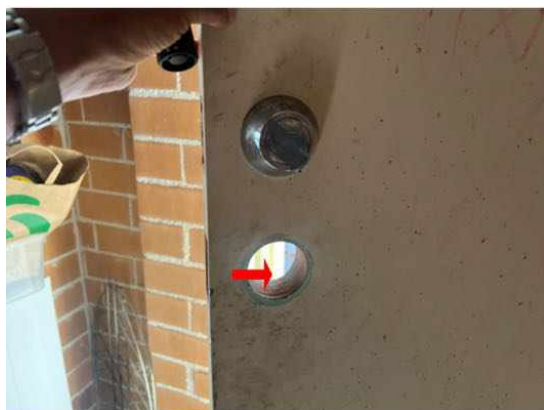
### Finding 3.22

Building:	Main Building
Location:	All External Areas
Finding:	Building element - Damaged - Eaves damaged front , hole not sealed right side , cracked door frame garage , hole in door garage
Information:	Breakage occurs generally when the building materials have either aged and decayed, or as a result of damage (accidental or deliberate).

Repair and/or replacement of broken elements is advised to ensure that additional secondary defects do not arise as a consequence. Such works are necessary, as all building elements play a key role in the operation and function of the overall structure and its performance.

A relevant tradesperson should be appointed to repair or replace the affected building element prior to any subsequent damage being caused.

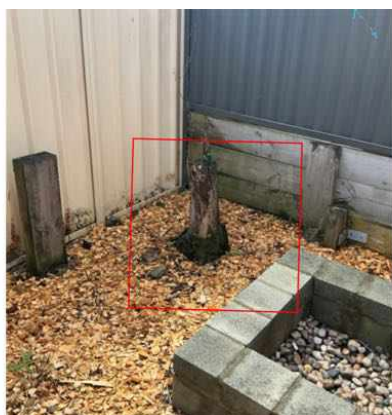
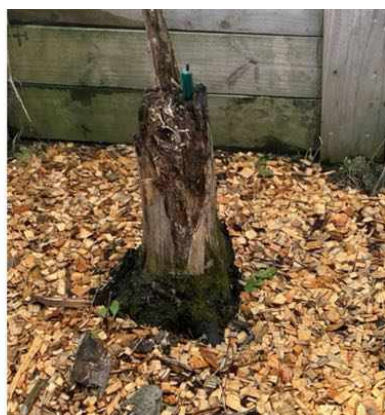
### Finding 3.23

Building:	Main Building
Location:	All External Areas - Rear
Finding:	Tree Stumps - in ground
Information:	Tree stumps left in ground provide opportunity for termite attack as they are likely to be subject to rot and decay providing an attractive food source. Treatment and/or Removal of the stump is highly recommended. A pest controller and tree removalist should be engaged to perform such works.

This also is conducive to termites.

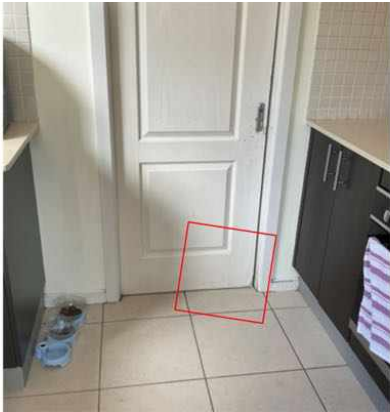
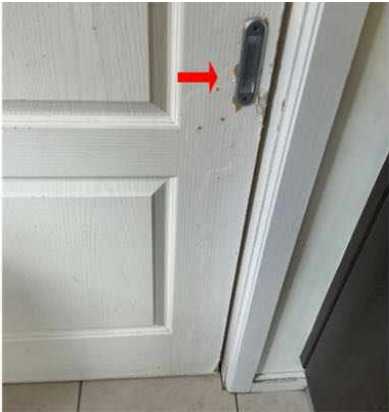
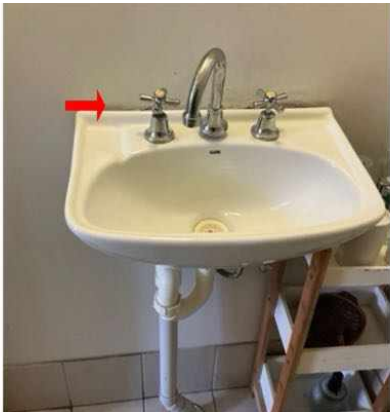
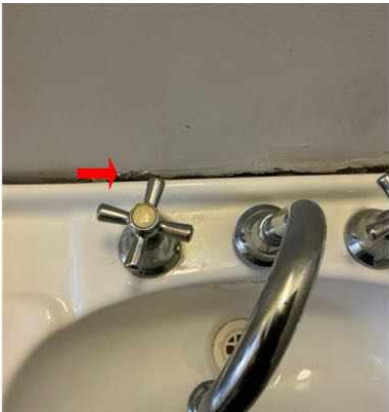
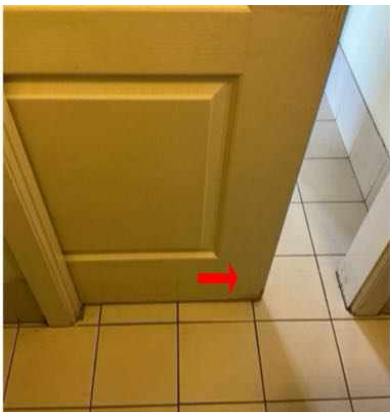
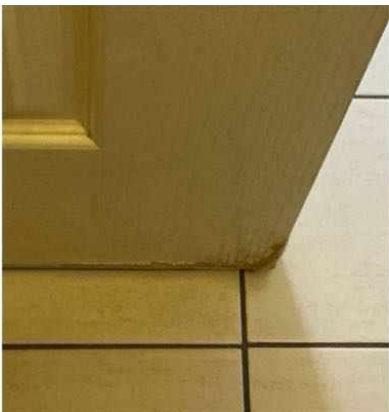
### Finding 3.24

Building:	Main Building
Location:	All Internal Areas
Finding:	Building element - Damaged - Door damaged laundry & WC , toilet basin loose , stove cracked , kitchen cabinet chipped and moisture damaged, blinds damaged , toilet seat damaged ensuite , vanity water damaged ensuite , main bath , bathtub damaged
Information:	Breakage occurs generally when the building materials have either aged and decayed, or as a result of damage (accidental or deliberate).

Repair and/or replacement of broken elements is advised to ensure that additional

secondary defects do not arise as a consequence. Such works are necessary, as all building elements play a key role in the operation and function of the overall structure and its performance.

A relevant tradesperson should be appointed to repair or replace the affected building element prior to any subsequent damage being caused.
