# Building and Timber Pest Inspection Report

Inspection Date: Mon, 23 Mar 2026

Property Address: 5/37 St Pauls Cres, Liverpool NSW 2170,  
Australia

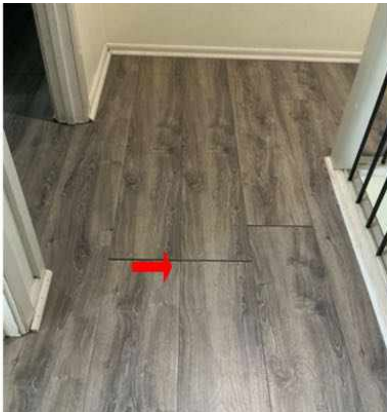
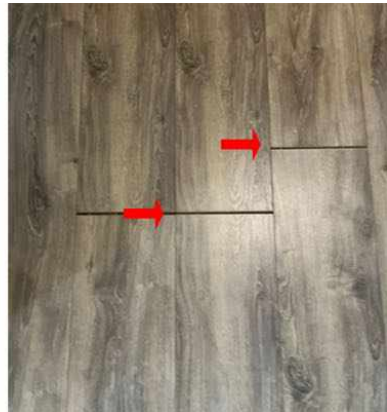
### Finding 3.25

Building:	Main Building
Location:	All Internal Areas
Finding:	Incomplete or substandard works - Gaps in timber flooring
Information:	The works to this area appear to be incomplete or have been completed to a substandard level.

Works that have not been completed to a satisfactory level create potential for the development of building defects and may impede on the safety and integrity of the overall structure.

It is highly recommended that the relevant trades be appointed to complete these works and ensure the safety of the area and the longevity of all associated building elements.

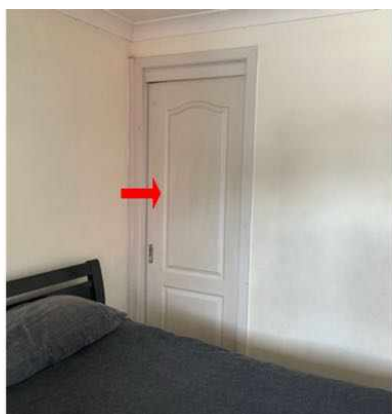
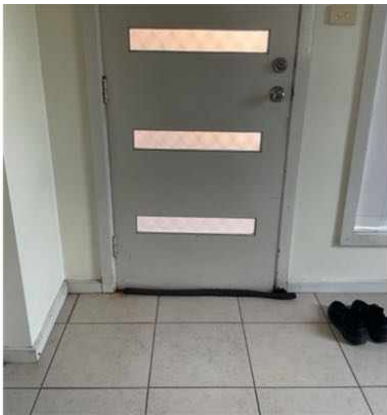
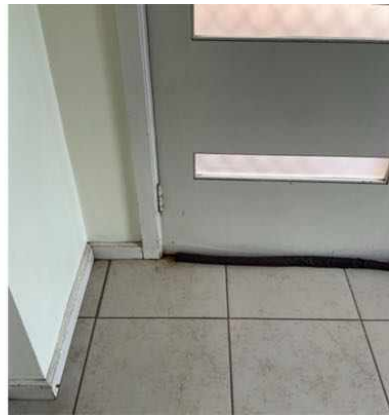
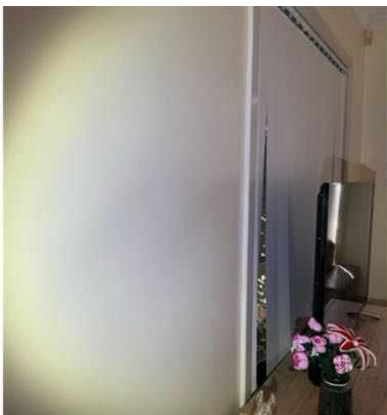
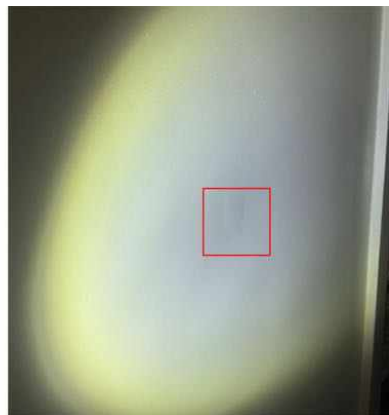
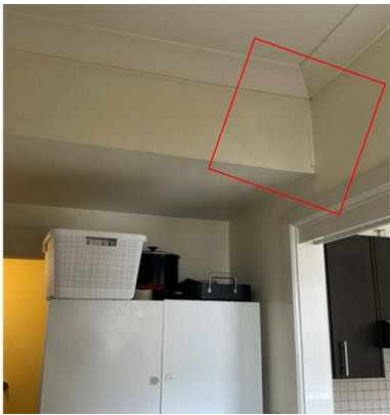
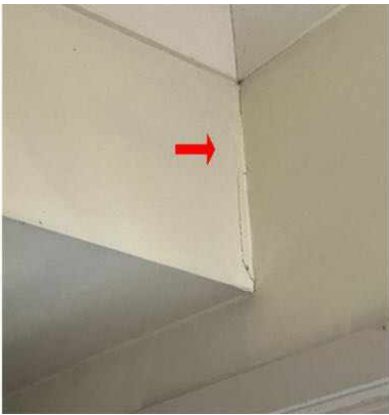
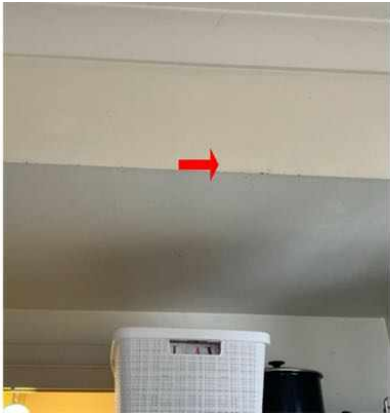
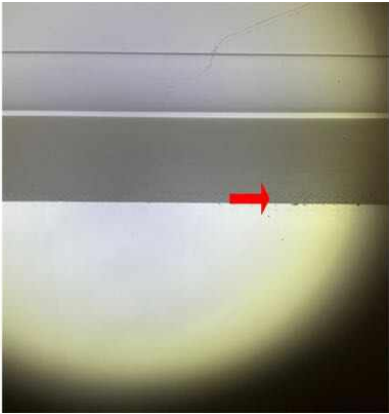
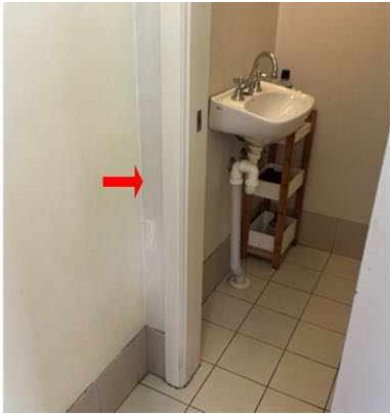
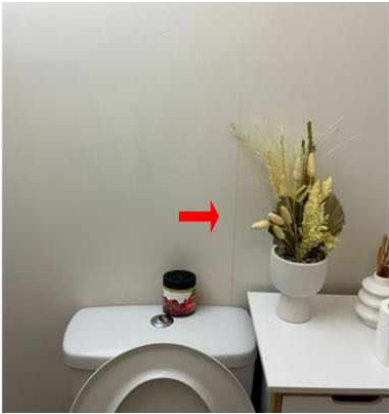
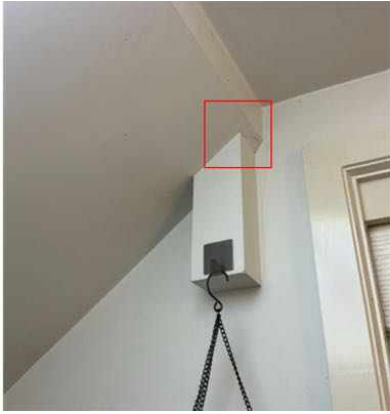
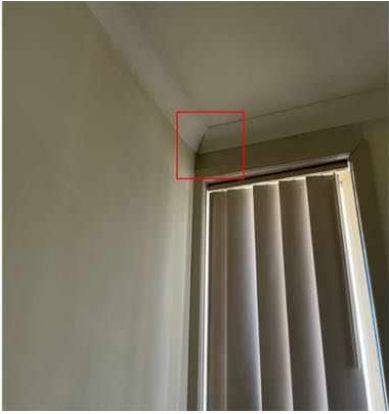
### Finding 3.27

Building:	Main Building
Location:	All Internal Areas
Finding:	Paint Finish & Hairline Cracking - To some areas
Information:	The paint finish in this area was identified as being incomplete at the time of inspection including some hairline minor cracking.

Whilst incomplete or missing paint and minor cracking and imperfections in finish is generally an appearance defect, it can also lead to the development of secondary building defects over time. Incomplete areas of paint finish expose the area to moisture, potentially accelerating the deterioration of underlying building materials.

Incomplete paint finishes should be sanded back, filled, leveled and painted, as applicable. Where inadequate or missing paint protection has led to the deterioration of the associated building element, repair and/or replacement of this building element may be required.

A painting contractor should be appointed as soon as possible to perform necessary works to aid the appearance of the affected area and to ensure the area is protected against further deterioration. Alternatively, the homeowner following manufacturer instructions may perform these works.

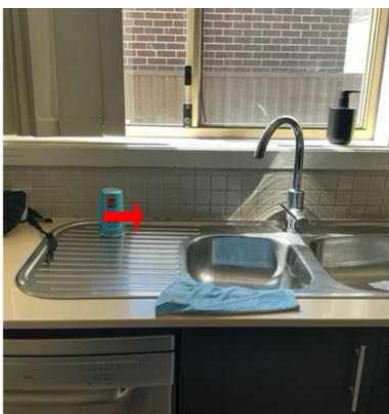
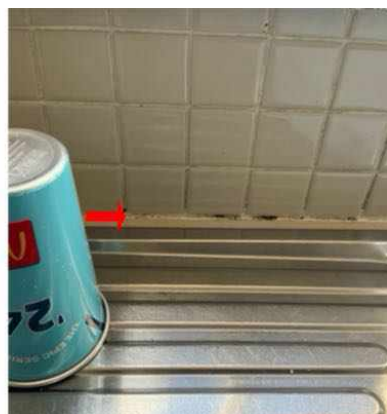
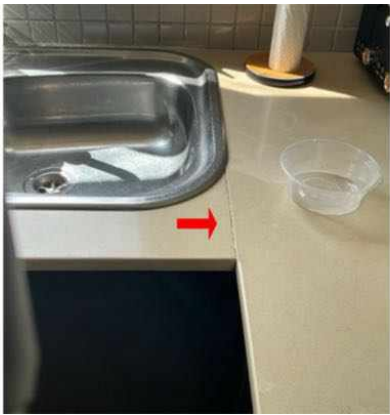
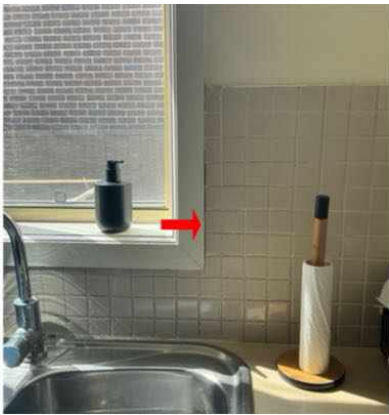
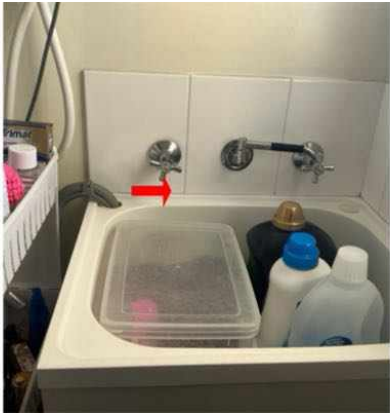
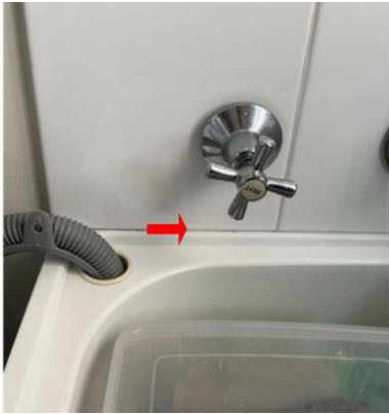
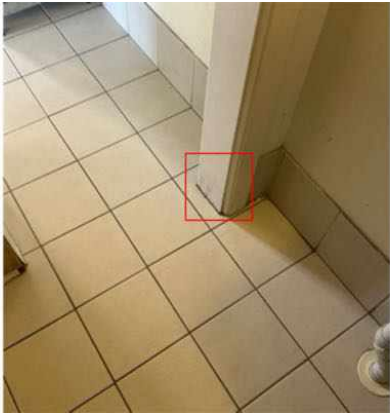
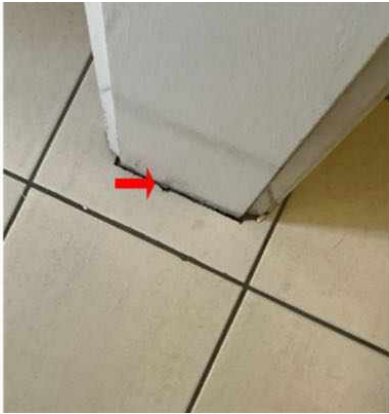
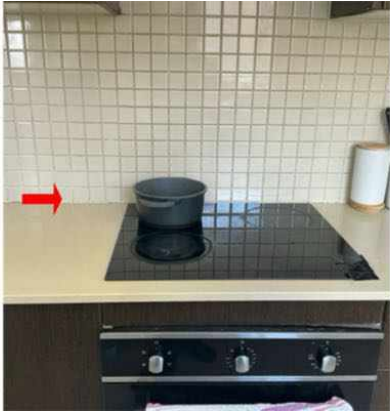
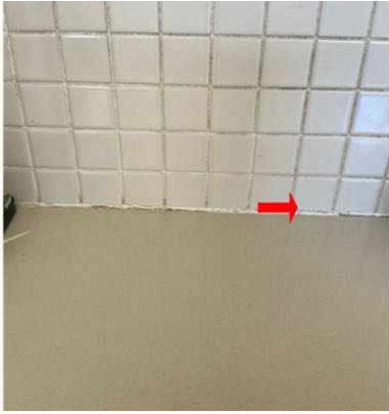
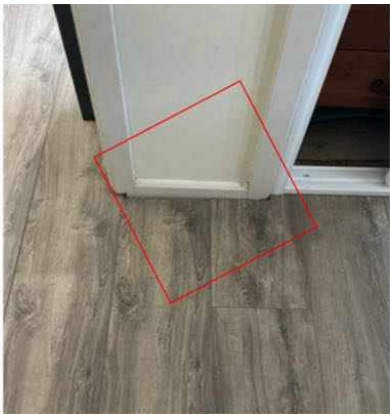
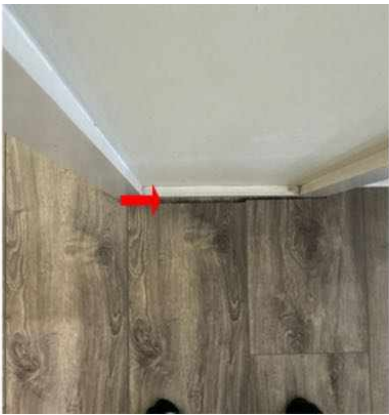
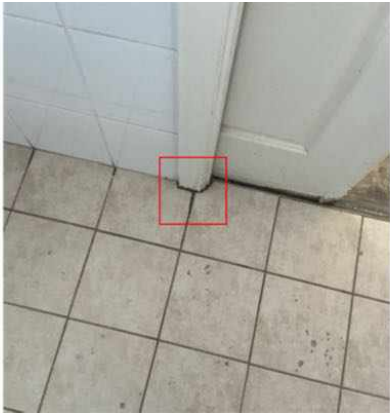
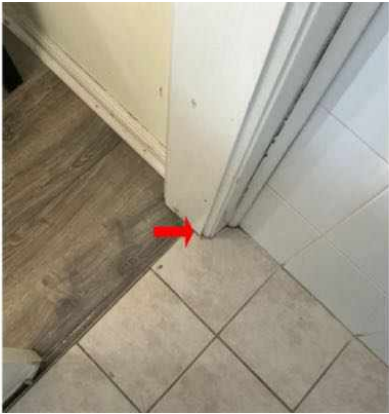
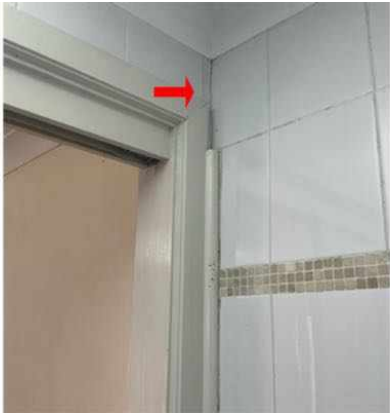
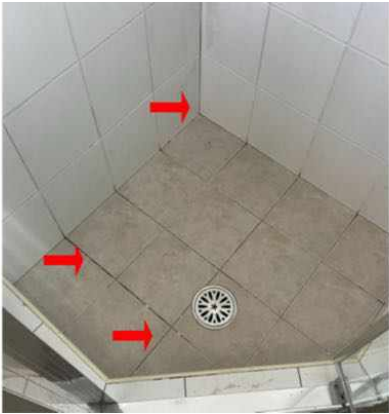
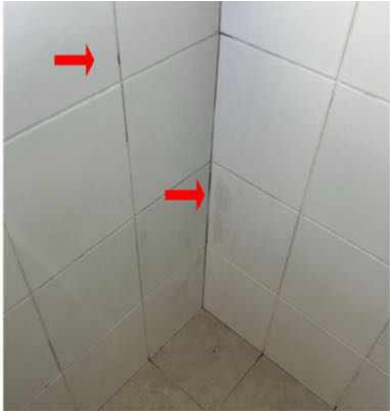
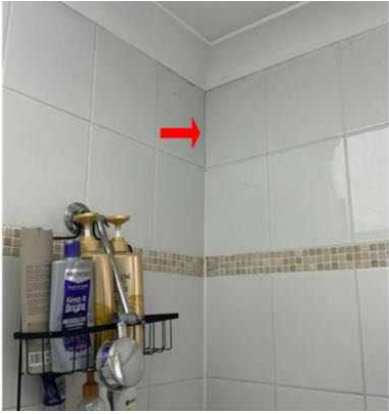
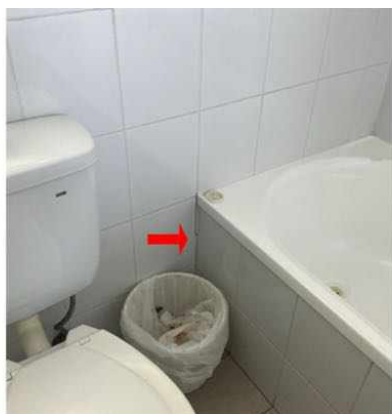
### Finding 3.28

Building:	Main Building
Location:	All Internal Areas
Finding:	Sealant and grouting - Missing or degraded to some areas
Information:	It was noted on inspection that sealant or grout is degraded.

Different materials and floor areas move at different rates, generally causing cracking to grout or sealant at this point. A flexible sealant is required to allow for expected expansion and contraction, while keeping the joint water tight and protective of all associated building materials.

Excessive mould to the sealant and grout may require scraping out and replacement.

Flexible and mould resistant materials should be applied to affected areas to prevent any subsequent water damage that is likely to occur. Regular maintenance and replacement of damage or missing or damaged sealant and grout is highly recommended to the wet areas, as this is a regular wear and tear defect. Sealant and grouting in areas that come into regular contact with water should be maintained for the long term care of your property.

A sealant specialist or tiling contractor should be appointed to complete these works as soon as possible

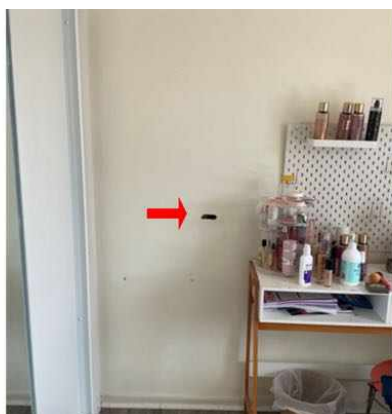
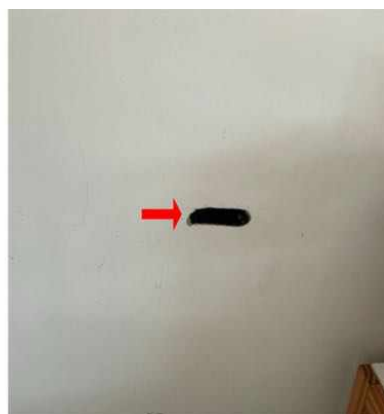
### Finding 3.29

Building:	Main Building
Location:	Bedroom
Finding:	Building element - Damaged - Hole in wall
Information:	Breakage occurs generally when the building materials have either aged and decayed, or as a result of damage (accidental or deliberate).

Repair and/or replacement of broken elements is advised to ensure that additional secondary defects do not arise as a consequence. Such works are necessary, as all building elements play a key role in the operation and function of the overall structure and its performance.

A relevant tradesperson should be appointed to repair or replace the affected building element prior to any subsequent damage being caused.

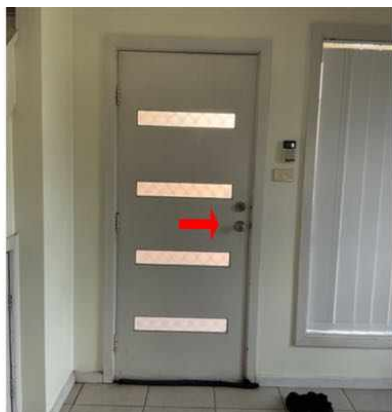
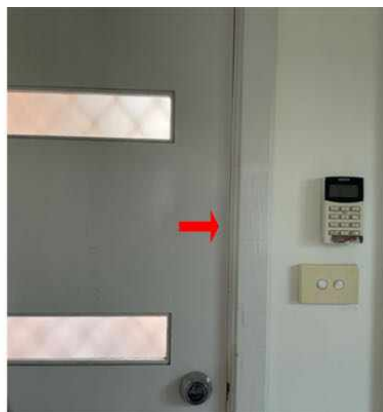
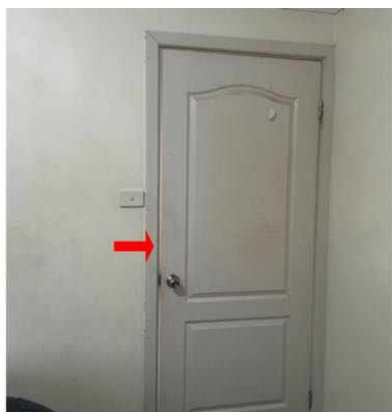
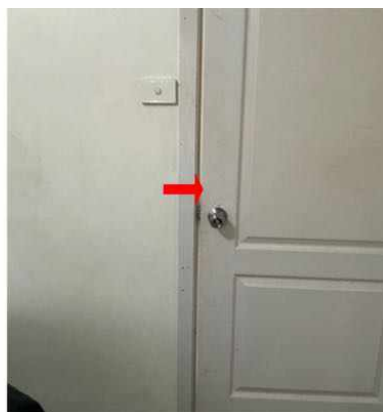
### Finding 3.31

Building:	Main Building
Location:	All Internal Areas - Main , master bedroom
Finding:	Doors - Binding/Jamming
Information:	Binding and/or jamming of several doors throughout the property were evident during standard operation. This defect inhibits the functionality of affected doors as well as creating potential for secondary defects to associated building elements, such as damage to the floor covering.

A door that binds to flooring or to the associated door frame may have several causes, ranging from minor defects, such as poor installation of the door or deteriorated hinges, through to major structural issues, such as damage to subfloor structures.

Where door binding/jamming appears to indicate major structural issues, a registered builder specialising in re-stumping should be appointed to provide an estimate on the cost of rectification.

For minor causes, a qualified carpenter or general handyman should be appointed to perform minor rectification works at client discretion.

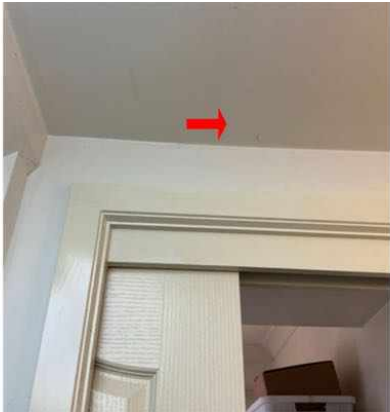
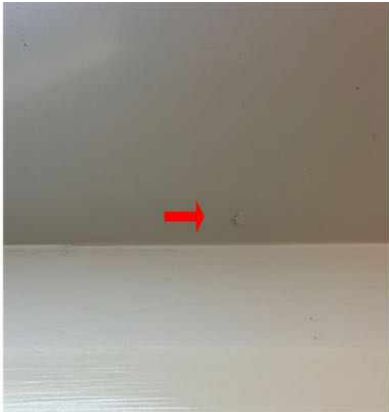
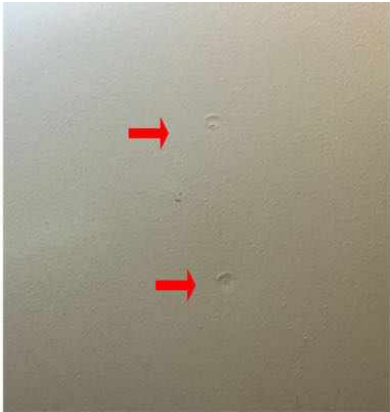
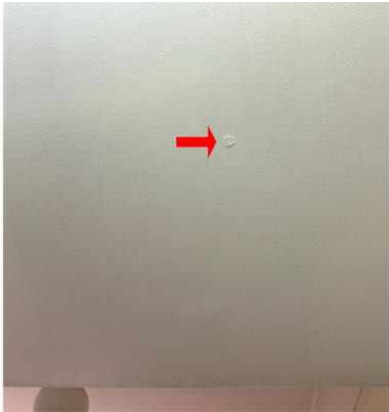
If left unmanaged, the ceiling sheets may become loose and unstable, increasing the rate of deterioration of the internal ceiling and creating potential for the development of secondary defects.

Re-fastening of popped nails will help to maintain the stability of the internal ceiling and associated building elements. Such minor works will also help to improve the appearance of the affected area and secure the ceiling sheets, so as to prevent the onset of ceiling sagging. These works should be performed by a qualified carpenter or plasterer at client discretion.

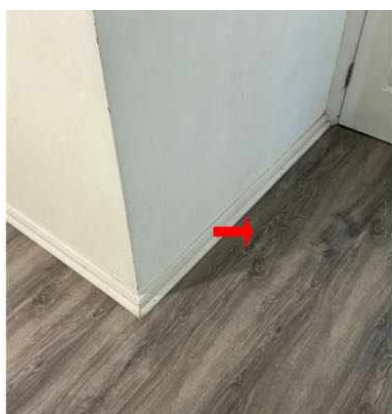
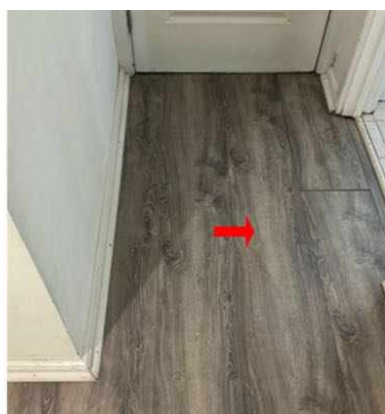
Building: Main Building  
Location: All Internal Areas  
Finding: Flooring - Uneven to some areas  
Information: The internal flooring in this area is out of level and uneven. Uneven flooring is likely to indicate minor defects such as expected movement of the foundations of the property, but may also indicate subsidence of the associated subfloor stumps.

It is advised that the flooring be closely monitored to identify any further movement. Where flooring remains relatively unchanged for an extended period of time (i.e. several months), it is likely that this defect has been caused by expected movement of the foundations of the property.

However, where flooring is uneven further, potentially invasive inspection of the subfloor structures and stumps in this area is required. In this case, works to repair are likely to be required, and would be carried out by a registered builder specialising in re-stumping.

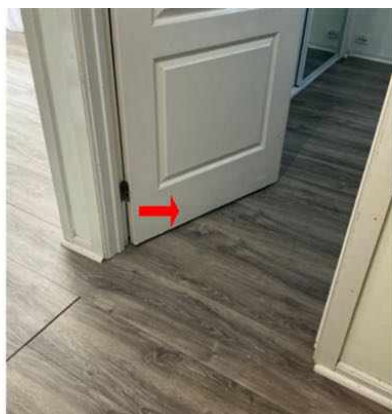
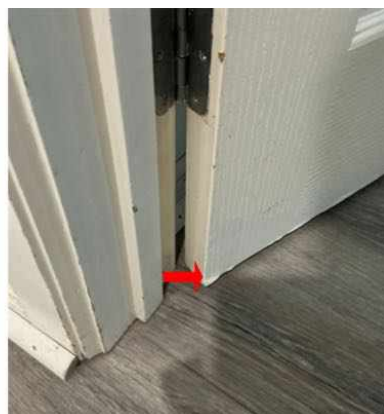
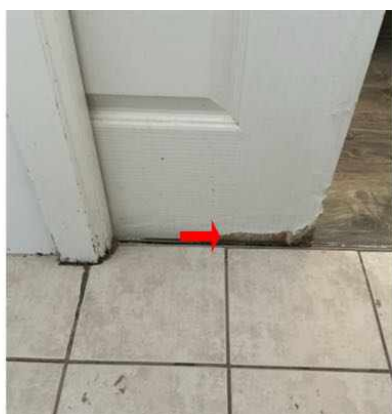
### Finding 3.35

**Finding:** Delamination of timbers to some areas

**Information:** Localised delamination and surface deterioration were observed to sections of laminated joinery panels. This condition commonly occurs where moisture exposure or wear causes separation of laminate finishes from the underlying substrate. The defect is generally cosmetic in nature but may worsen over time if moisture exposure continues. Repair or replacement of affected joinery components may be considered as part of routine maintenance.

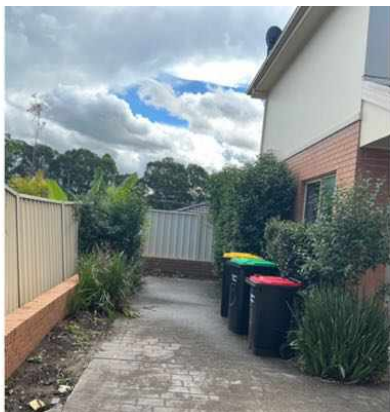
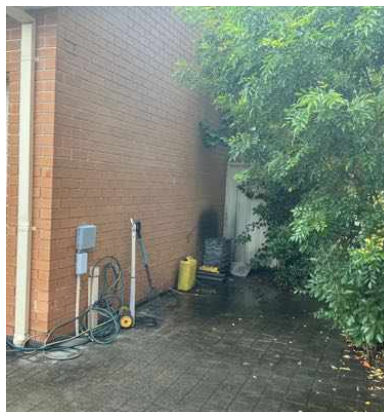
Building:	Main Building
Location:	All External Areas
Finding:	Trees within 50m
Information:	Trees within 50m of the property can be conducive to termite activity. It is

recommended an invasive inspection of all trees with 50m to the property be carried out by a qualified pest control expert.

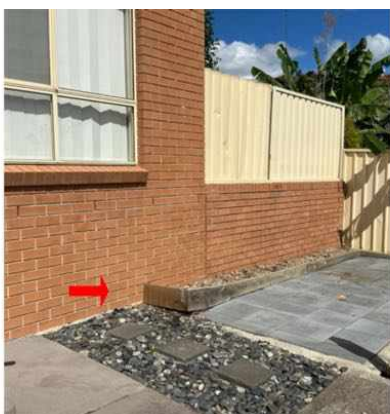
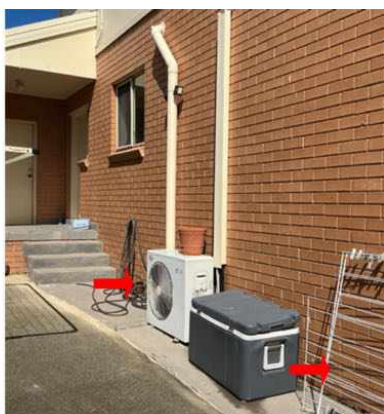
### Finding 6.03

Building: Main Building  
Location: All External Areas  
Finding: Slab Edge - Exposure  
Information: An inspection zone of at least 75mm in relation to the exposed slab edge, between the bottom brick and the perimeter pavement, is required. This inspection zone should be maintained in order to force termites into the open where they can be detected more readily during regular inspections. The slab edge should not be concealed by anything that may prevent inspection of the area, including render, landscaping, soil, turf, paving, concrete cladding or other structures.

If the slab edge is not properly exposed there is a high risk of termite attack. Sometimes, in order to determine the type of slab, a suitably qualified person such as an architect or builder may be required to consult the construction plans.

Where the slab edge cannot be properly inspected, it is highly recommended that termite or timber pest inspections be carried out every 6-12 months to aid protection of the property against infestation.

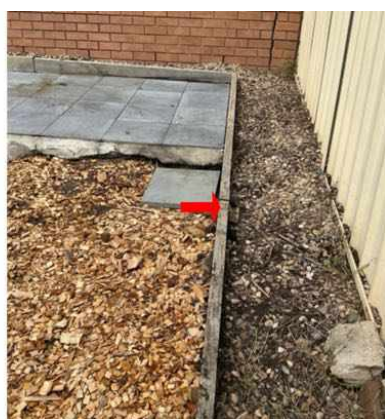
## Finding 6.04

Building:	Main Building
Location:	All External Areas
Finding:	In ground contact - Timber to some areas
Information:	Any timbers in direct ground contact provide opportunity for concealed termite entry and are likely to be subject to premature rot and decay as the soil retains moisture or damp conditions against the timbers.

Remove untreated timber that is in direct contact with external grounds. Consider replacement with more durable materials i.e. treated timber or non timber elements. Frequent pest inspections are advised to readily identify any termite activity in these areas.

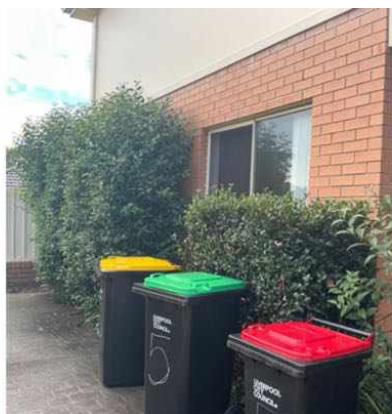
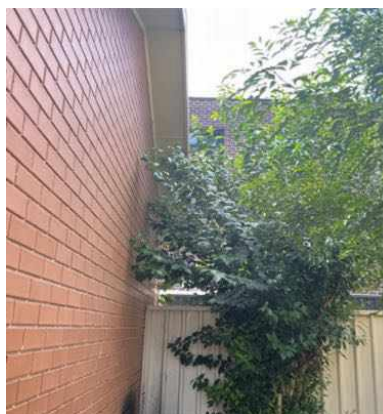
Building:	Main Building
Location:	All External Areas
Finding:	Bridging - Vegetation
Information:	Where vegetation obstructs inspection of building elements, also known as bridging as it provides a bridging point for the access of termites, full inspection can not be achieved. Consequently moisture or dampness may be present and the areas becomes conducive to termite activity. Plants against or very close to buildings provide cover, shade and can provide an environment that is attractive to termite infestation.

The removal and replanting of species that do not provide "cover" or cutting back of existing vegetation will assist greatly in preventing Bridging from occurring.

The removal of any such materials that may be conducive to termite activity should be carried out as soon as possible and arrange re inspection to minimize the risk of termite attack.

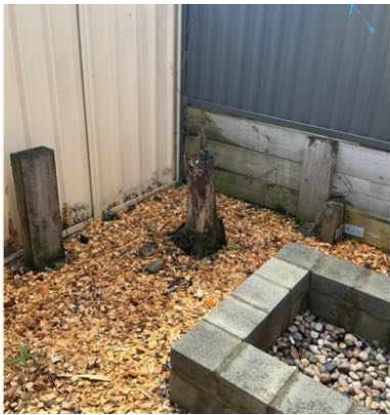
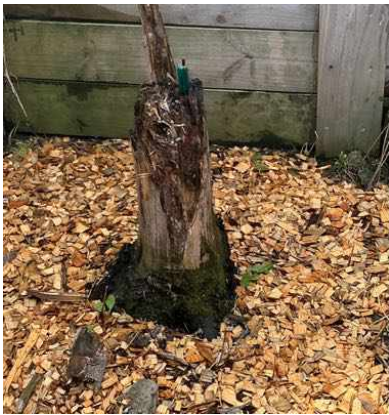
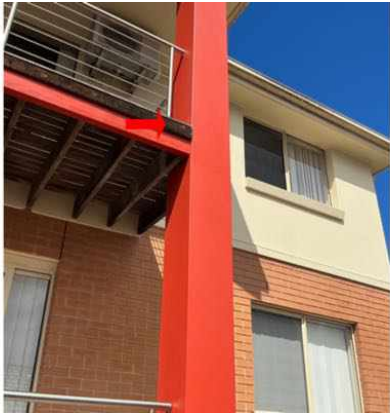
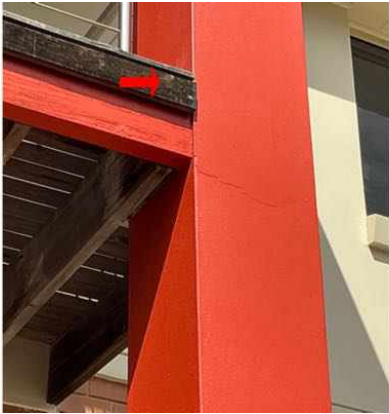
### Finding 7.01

Building:	Main Building
Location:	All External Areas
Finding:	Fungal decay - present to some areas
Information:	Fungal decay also known as wood decay or wood rot generally refers to the deterioration of timber elements when in contact with excessive levels of moisture for a prolonged period of time.

The development of fungal decay is accelerated by temperatures in the range of 5degreeC to 40degreeC as well as the presence of oxygen. Generally fungal decay develops on timber elements that are in use in an external environment which are exposed to rain penetration.

In this case although the affected timber element is in a decaying state the extent of any visible damage appears to be localised to a specific area and is yet to spread to other parts of the building element or affect adjoining structures. The fungal decay is therefore likely to be of a relatively superficial nature with minimal impact on the structural integrity or tensile strength of the timber element.

A further invasive inspection by a licensed timber pest technician is highly recommended to check for concealed activity.

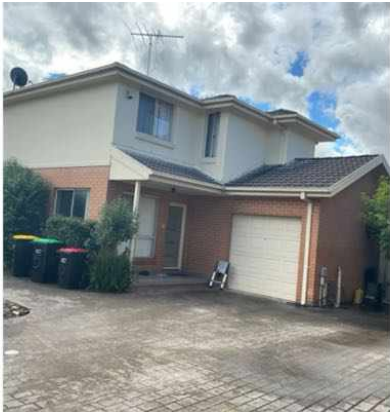
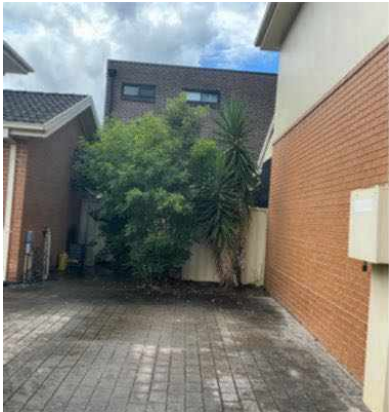
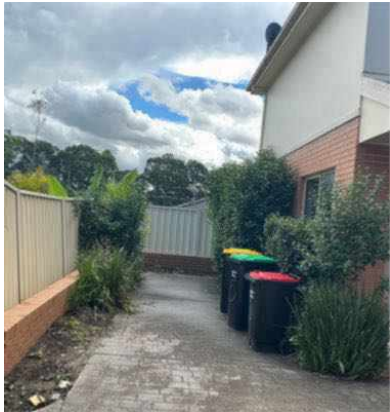
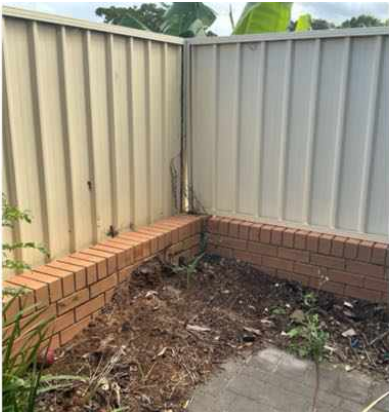
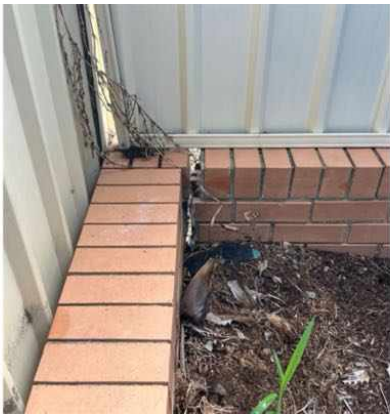
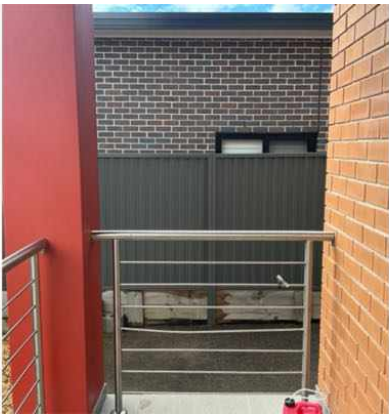
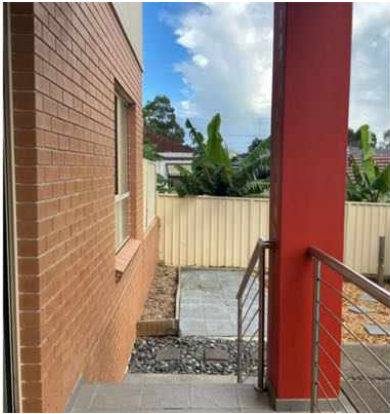
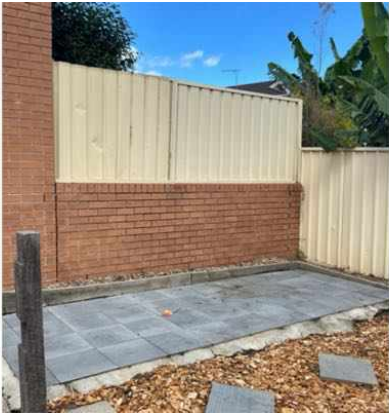
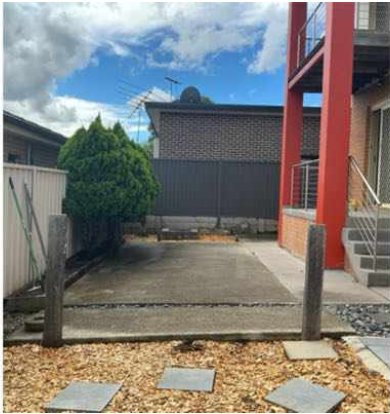
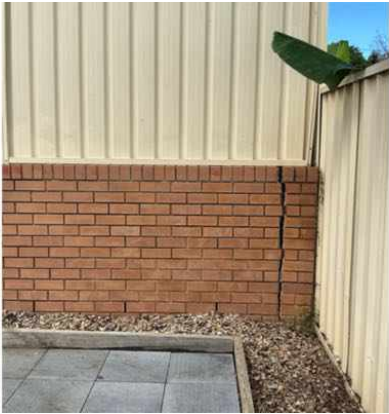
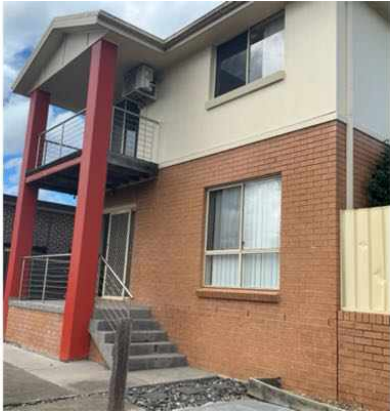
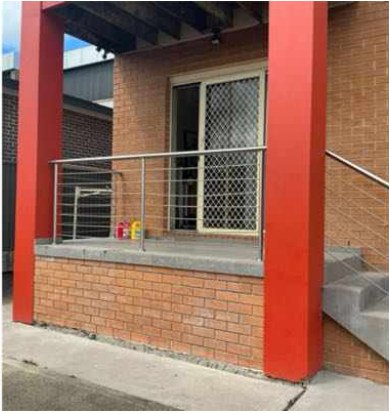
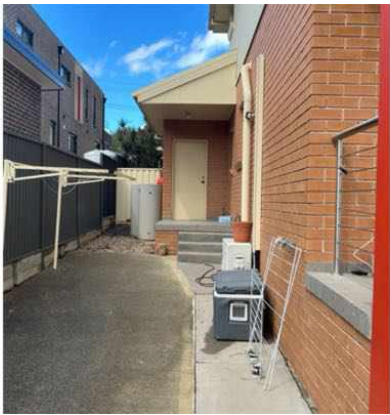
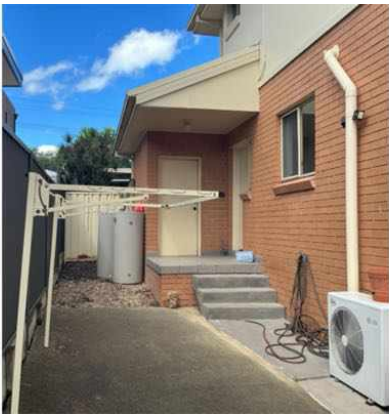
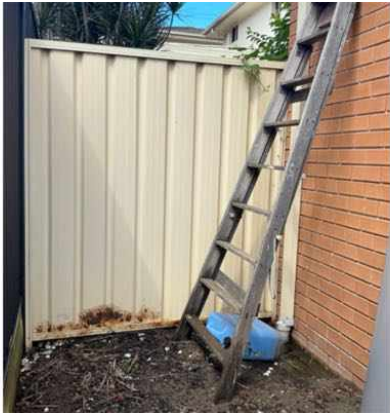
Building: Main Building  
Location: All External Areas  
Finding: Additional Photos - Obstructions and Limitations  
Information: These photographs are an indication of the obstructions and limitations which impeded full inspection of the property at the time of inspection. These obstructions can hide an array of defects and should be removed to allow full inspection to be carried out. A re-inspection is recommended once the areas are made accessible.

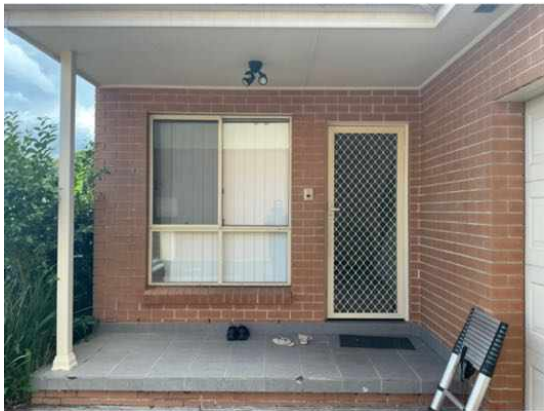
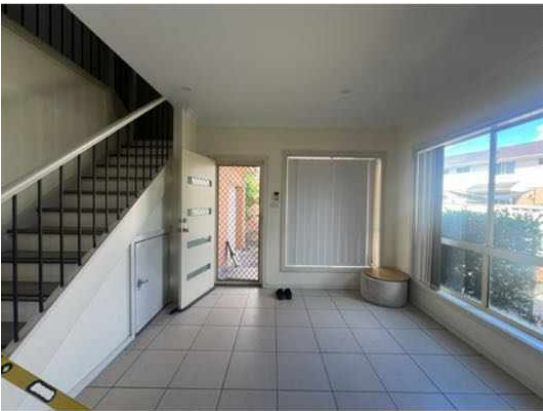
Building: Main Building  
Location: All Internal Areas  
Finding: Additional Photos - Obstructions and Limitations  
Information: These photographs are an indication of the obstructions and limitations which impeded full inspection of the property at the time of inspection. These obstructions can hide an array of defects and should be removed to allow full inspection to be carried out. A re-inspection is recommended once the areas are made accessible.

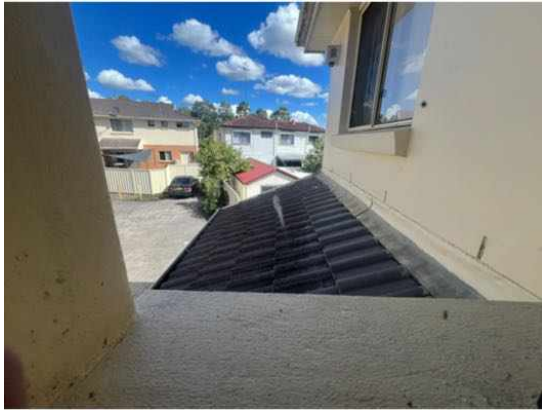
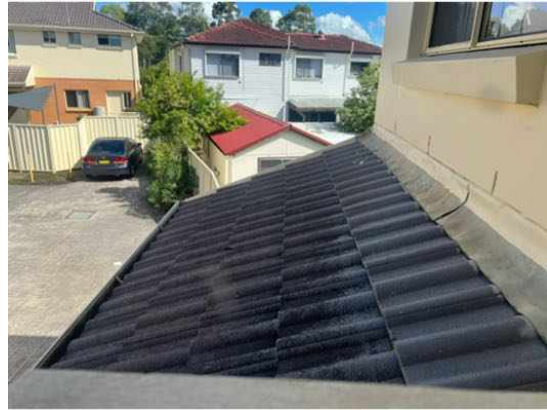
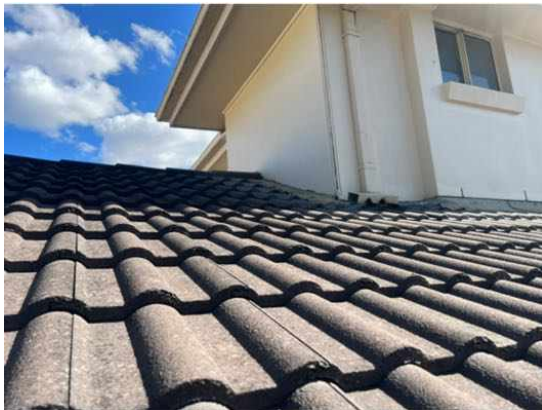
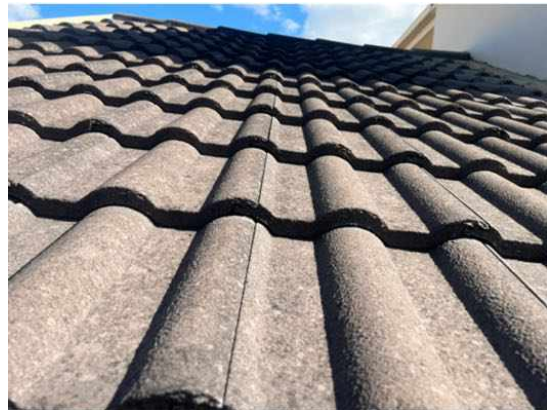
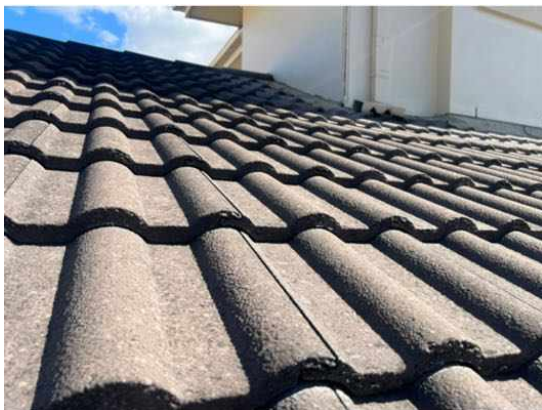
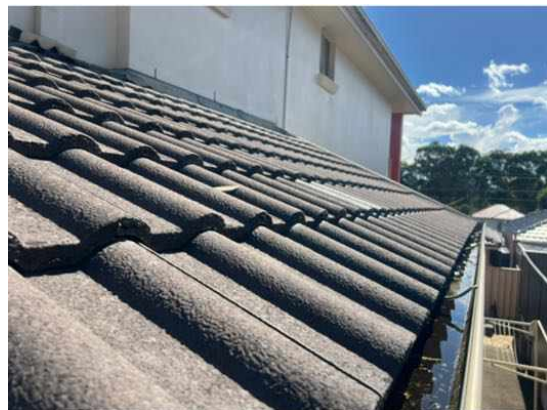
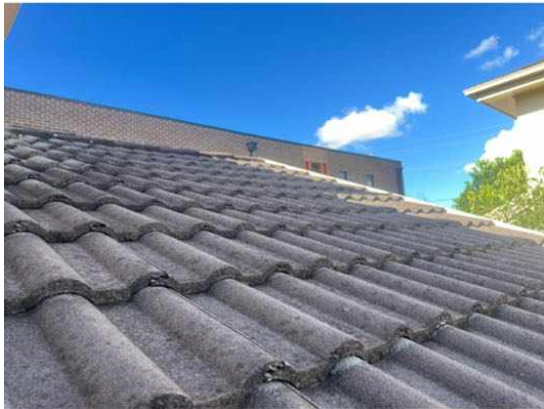
Finding: Additional Photos - Obstructions and Limitations

Information: These photographs are an indication of the obstructions and limitations which impeded full inspection of the property at the time of inspection. These obstructions can hide an array of defects and should be removed to allow full inspection to be carried out. A re-inspection is recommended once the areas are made accessible.

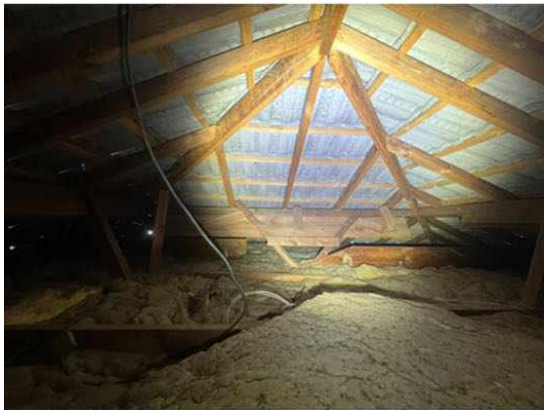
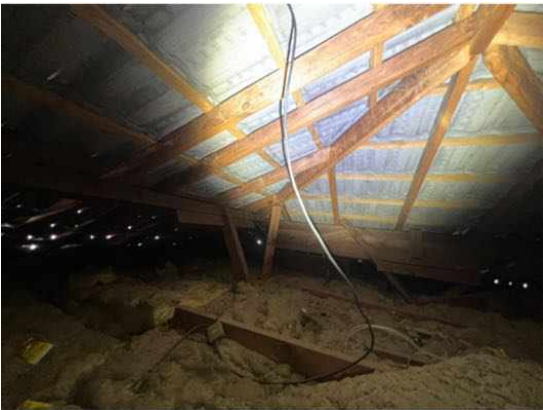
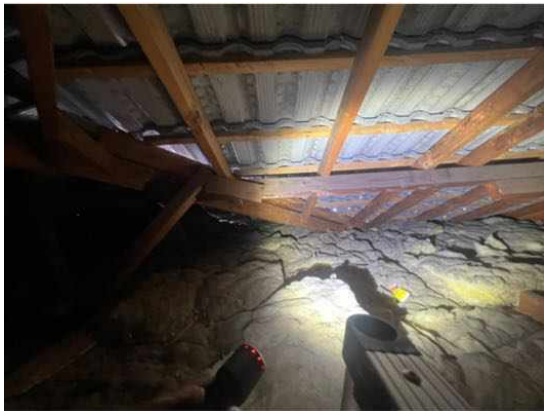
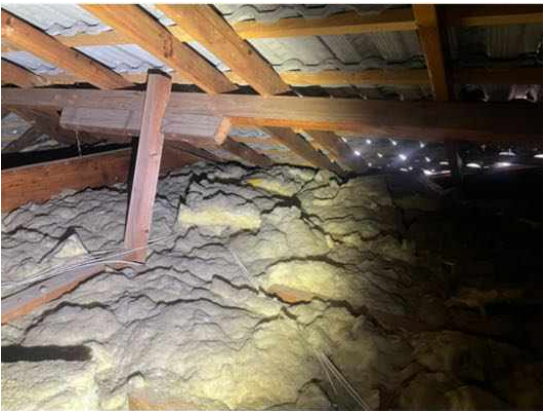
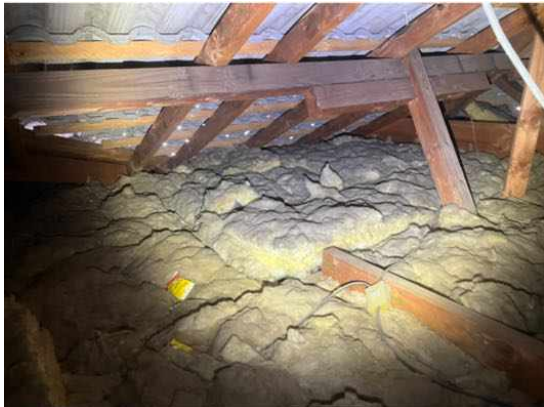
Building: Main Building  
Location: Roof Void  
Finding: Additional Photos - Obstructions and Limitations  
Information: These photographs are an indication of the obstructions and limitations which impeded full inspection of the property at the time of inspection. These obstructions can hide an array of defects and should be removed to allow full inspection to be carried out. A re-inspection is recommended once the areas are made accessible.
