# Building and Timber Pest Inspection Report

Inspection Date: Fri, 6 Mar 2026

Property Address: 9 Stirbeck St, Holbrook NSW 2644,  
Australia

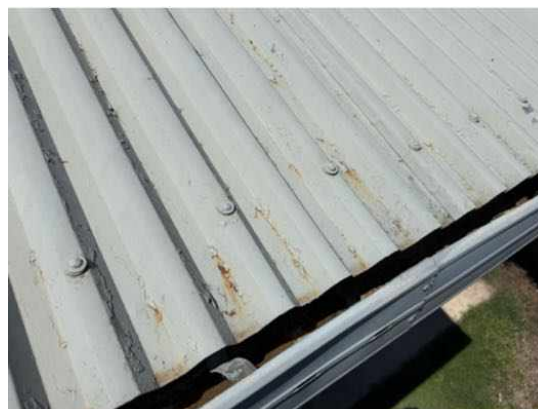
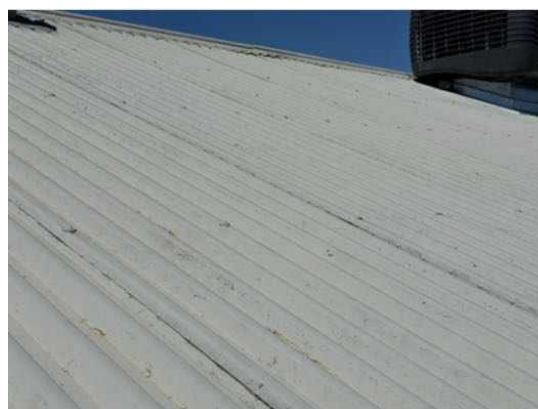
Building:	Main Building
Location:	Roof Exterior
Finding:	Roof Exterior - Weathered, Rust
Information:	Areas of rust and deterioration were noted to the roof exterior. While weathering of the roof exterior is consistent with the age of the property, maintenance works are advised. Where left unmanaged, deteriorating and damaged roof sheeting and plumbing is likely to lead to secondary defects.

It is advised that the client consult with a licensed roofing contractor in the short term, to provide further advice on maintenance works that may be required.

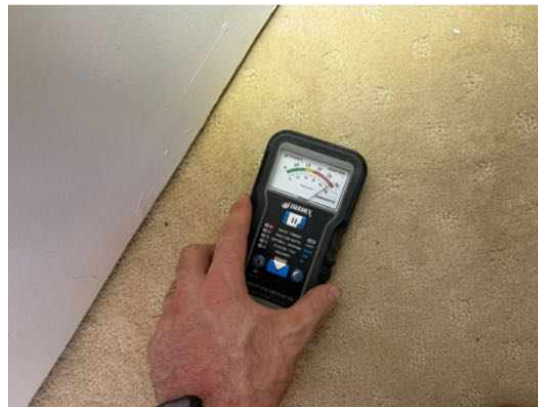
### Finding 6.02

Building:	Main Building
Location:	Dining Room Floor, Bedroom Carpet
Finding:	Floorboards & Carpet - High Moisture Reading
Information:	It appears high moisture readings were present at, but not limited to the dining room floorboards, and the rear bedroom carpet. This creates an environment conducive to termite activity. Recommend engaging a licensed plumber promptly, to identify the cause of the moisture and provide remedial works where necessary.

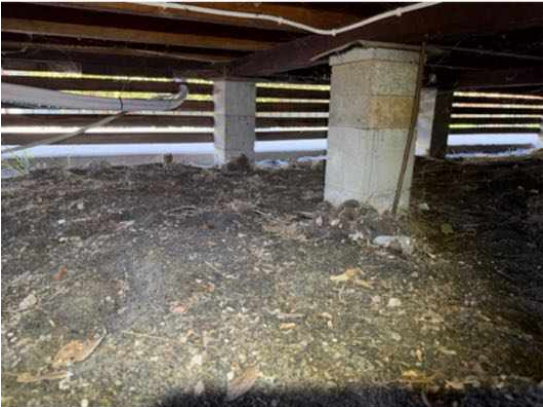
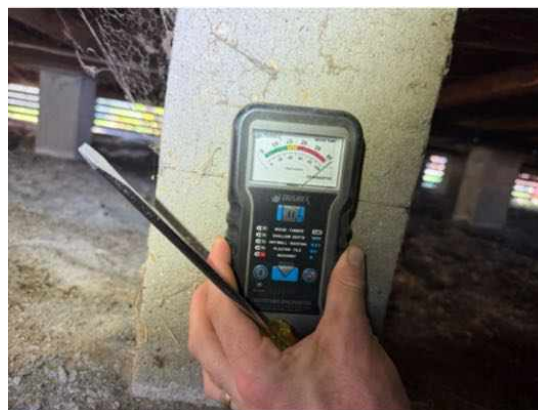
### Finding 6.03

Building:	Main Building
Location:	All external areas, Subfloor
Finding:	Potential Water pooling against property & Moist Conditions in Subfloor & Piers
Information:	It appears that there are potential areas around the perimeter of the property that could be susceptible to water pooling. Areas of high moisture & water pooling were also identified throughout the subfloor and piers, creating an environment conducive to termite activity.

Where insufficient site drainage, leaking down-pipes, and insufficient drainage of taps

& aircon overflows are present, water pooling is likely to occur, and can create areas conducive to timber pests and potential damage to the subfloor structure overtime, if neglected.

Recommend consulting with a licensed plumber in the short term to provide further advice & remedial works, to ensure sufficient drainage is achieved.

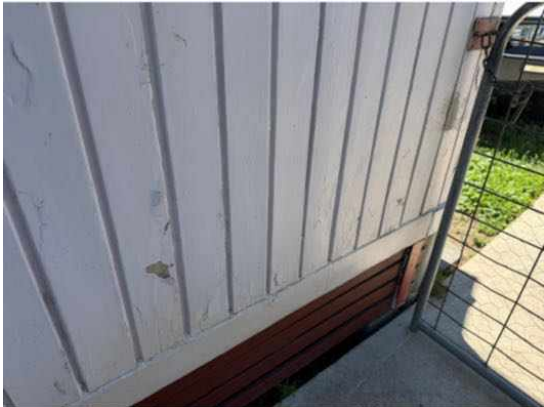
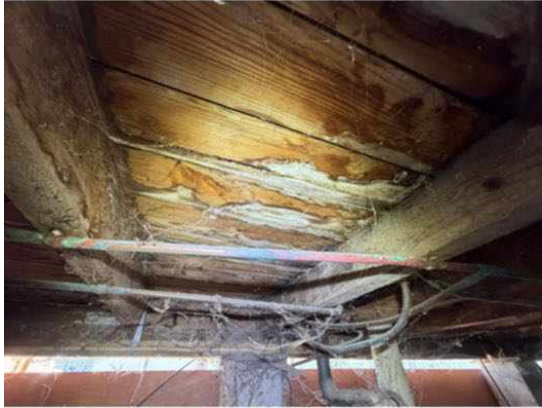
areas of the cladding, some window frames, floorboards, subfloor timbers, fascias and external trims.

For areas of fungal decay, the client can engage a licensed carpenter at their discretion to replace affected materials. For areas of general weathering, it is advised the client engage a licensed painter to apply protective sealant or coating to areas of weathered external timbers.

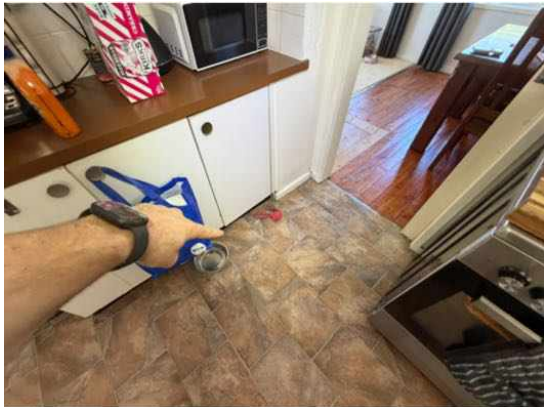
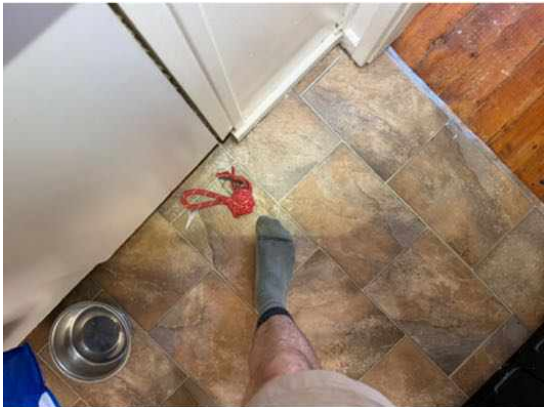
Building: Main Building  
Location: Kitchen  
Finding: Flooring - Slightly Uneven  
Information: Some areas, of the flooring at, but not limited to the kitchen appears to be slightly uneven. It is advised that the client monitor the flooring to identify any further movement. Where flooring remains relatively unchanged for an extended period of time, it is likely that this has been caused by expected movement of the property.

However, where further movement and unevenness occurs, a structural engineer should be engaged promptly for further evaluation.
