Building and Timber Pest Inspection Report

Inspection Date: Thu, 5 Mar 2026

Property Address: 1 Gino Cl, Flagstaff Hill SA 5159, Australia

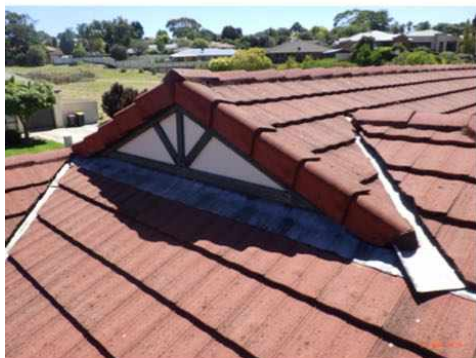
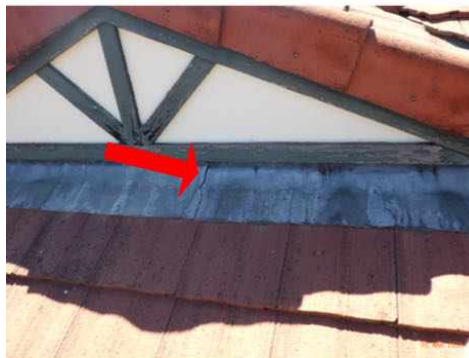
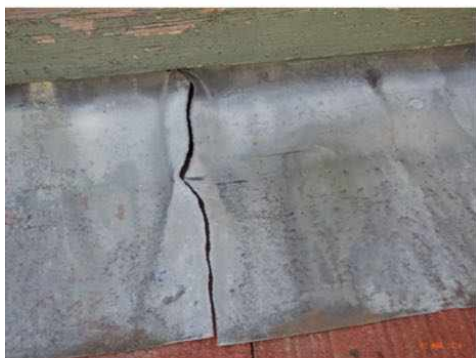
Finding 2.01

Building:	Building 1
Location:	Roof Exterior
Finding:	Roof plumbing - Flashing cracked
Information:	Water leaks generally occur when a particular area of the property is not weather or

water tight. Cracks were evident to the lead roof flashings at the time of inspection.

Regardless of the location, if left unmanaged, even minor leaks can lead to serious damage of associated building elements, potentially resulting in the need for replacement of building materials. Damage to ceilings, wood rot, mould and other hazards, such as electrical hazards, may also arise if left unmanaged.

The cause of the water leak should be identified and addressed immediately to prevent further damage. The water leak should be resolved prior to any repairs of the damaged area, which may require localised replacement of building materials and refinishing.

Further inspection by a qualified carpenter or licensed plumber is advised to adequately rectify the potential leak.

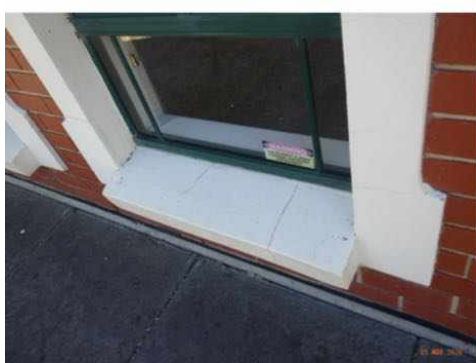
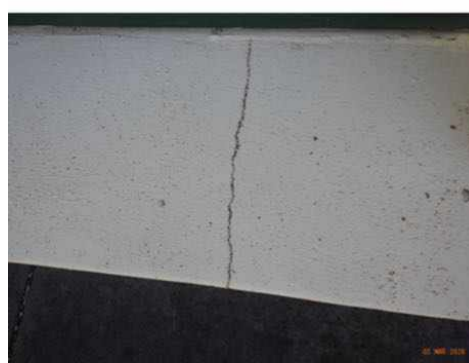
Finding 3.01

Building: Building 1
Location: Front Elevation
Finding: Render - Cracking

Information: There were several cracks evident to the render around the property at the time of inspection likely due to general expansion and contraction and or general old age. Most cracks were found to be less than 1 mm wide.

Moisture can penetrate the cracks and as such regular maintenance is required in these older properties.

A licensed painting contractor can be appointed to repair minor cracking and repaint the walls however a plasterer would be required if cracks were found to be in excess of 2 mm.

Always contact a building inspector should cracks widen lengthen or become more numerous.

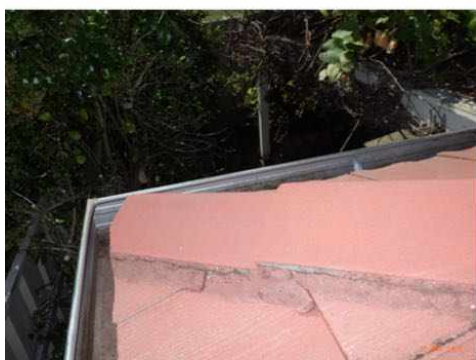
Finding 3.02

Finding: Mortar - Deterioration

Information: Mortar, or 'bedding', is the material which fills joins and intersections between tiles and other building elements on the exterior roof covering, such as gable ends, hip capping and valleys. Upon inspection of the exterior roof, it was noted that sections of the mortar show low levels of deterioration.

Mortar generally deteriorates as a result of frequent exposure to weather conditions over a prolonged period of time. Mortar that is deteriorating may allow water ingress into the roof void, putting associated building elements and roofing structures at risk of water damage.

Deteriorated mortar also detracts from the functionality of roof tiles and other roofing elements, potentially decreasing weather tightness and roof drainage.

Mortar deterioration can be attended to by a handyperson where areas of deterioration are localised and easily accessible. Otherwise, consultation with a roofing contractor is advised where greater works are required.

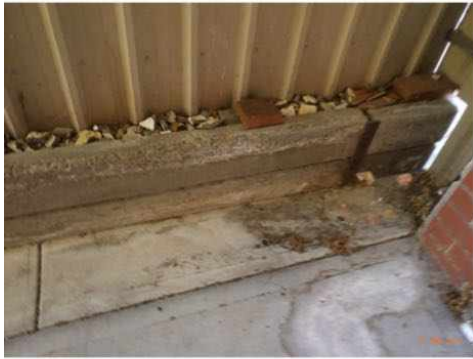
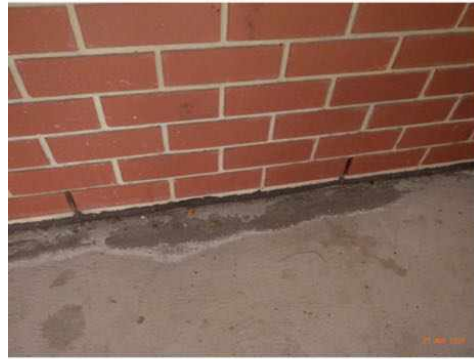
Finding 3.03

Building:	Building 1
Location:	Garage
Finding:	Slab edge - Efflorescence
Information:	Efflorescence appears to be affecting the concrete around the side of the garage.

It is typically seen as white salt deposits on the surfaces of concrete pavement and spalling on the face of the concrete.

Generally, soluble salt deposits can be removed by dry brushing with a stiff-bristled brush. Repeated dry brushing is an ideal treatment for eliminating this forming of efflorescence. A cleaning contractor or general handyperson may be appointed to perform these works at the discretion of the client.

Always contact a building inspector should efflorescence get significantly worse.

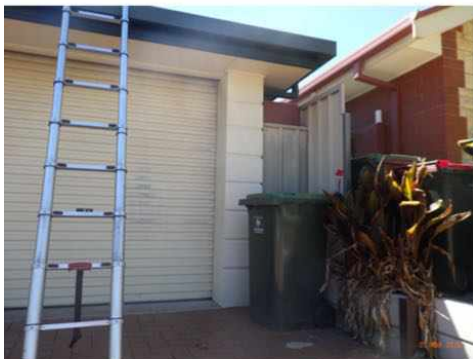
Finding 3.04

Building: Building 1
 Location: Carport
 Finding: Ceiling - Garage
 Information:

A very common defect found in garages is that the ceiling can sag over time, due to their lack of insulation and or their susceptibility to moisture. Condensation builds up in the roof and rests on the plasterboard softening it somewhat which makes it more likely to sag and release from its fixing points. Moisture evaporating from cars can also contribute to this issue.

Therefore we recommend that you insulate your garage and also apply a good coat of washable paint to the ceiling of the garage to prevent any moisture entering the plasterboard and creating issues in the future. A licensed building insulation installer and licensed painting contractor could be appointed to carry out these works at the discretion of the client.

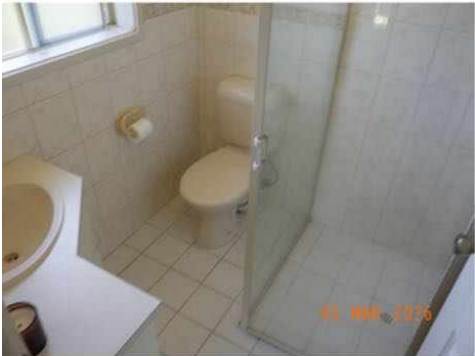
Finding 3.05

Building:	Building 1
Location:	All Internal Areas
Finding:	Cracking - Damage Category 1 - Fine (up to 1mm)
Information:	There were fine cracks evident to the walls and ceilings throughout the dwelling at the time of inspection.

Although fine cracks are quite noticeable, they are often only considered to be an appearance defect, and usually do not indicate any structural damage. Generally, the cause of a fine crack is indicative of a separation between building materials and finishes (e.g. paint, plaster, etc.) along joins.

Cracking of this nature can generally be repaired with minor sanding, filling and/or repainting. Such works should be performed by a qualified painter or a general handyman.

Monitoring of all cracking should be conducted frequently. Always contact a building inspector should cracks widen, lengthen, or become more numerous.

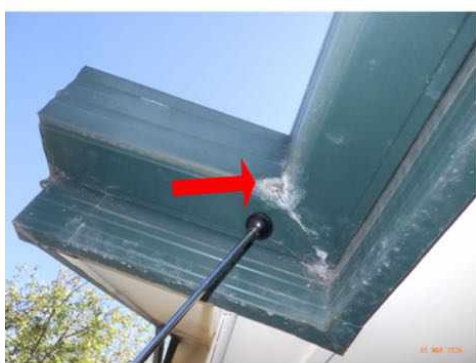
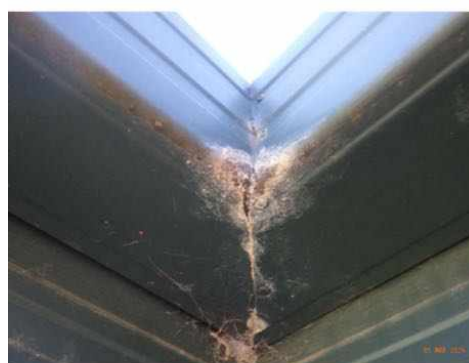
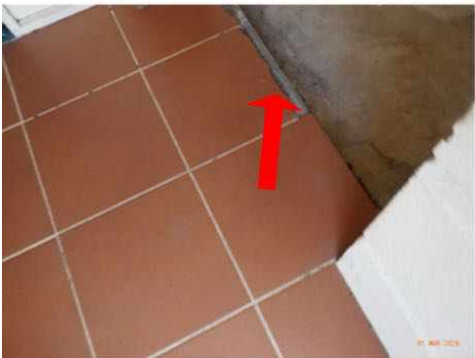
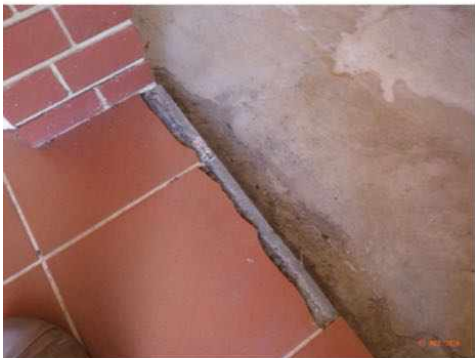
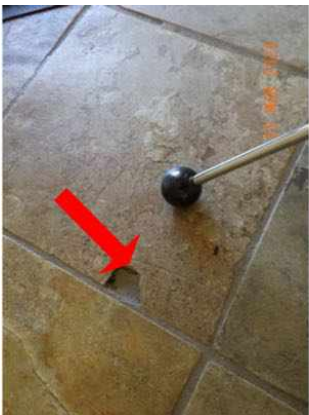
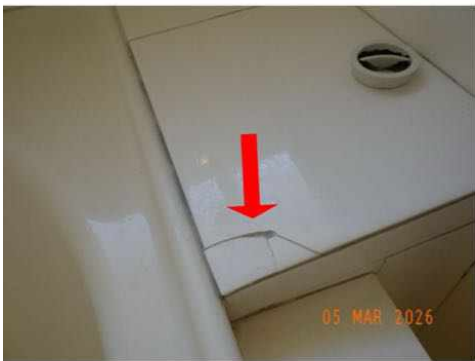
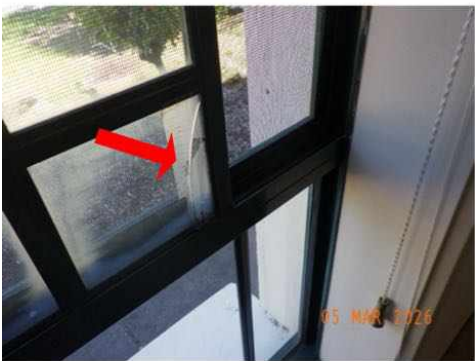
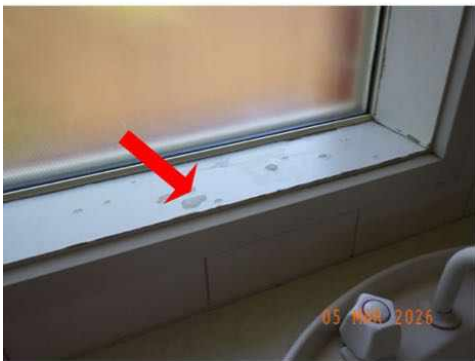
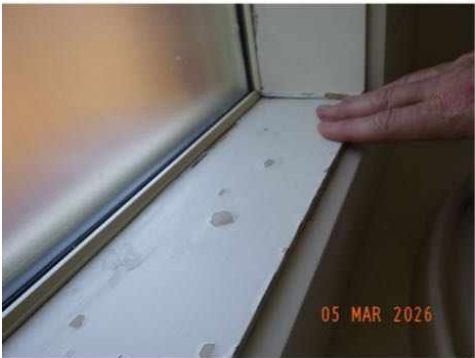
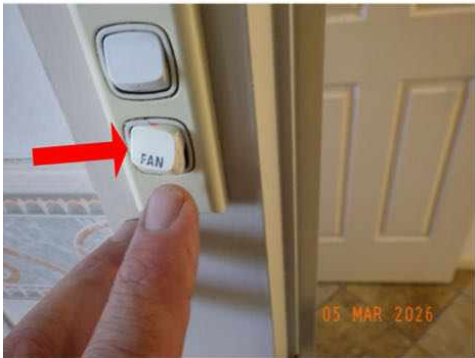
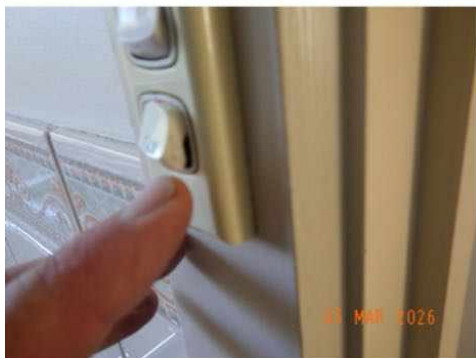
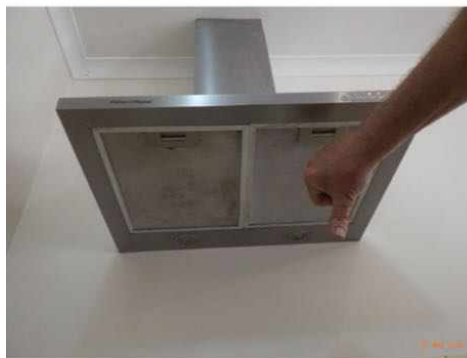
Finding 3.06

Building:	Building 1
Location:	All Areas
Finding:	Minor defects present
Information:	Minor defects were evident throughout the dwelling at the time of inspection, which are consistent with normal wear and tear and considered appropriate for a property of this age.

These defects are typical of ongoing material ageing, settlement, and general use over time, and include, but are not limited to:

- Minor Corrosion to guttering
- Tiles damaged to front porch
- Cracks to slate tile and adjacent to bath,
- Crack to bedroom 1 window
- Sealant damage at base of vanity
- Bathroom fan switch damaged
- range hood light not operating

While these defects are not considered structurally significant at present, they should be addressed as part of routine and ongoing property maintenance to prevent further deterioration. Repairs and maintenance works should be carried out by appropriately licensed and qualified tradespeople to ensure the continued serviceability and longevity of the dwelling.

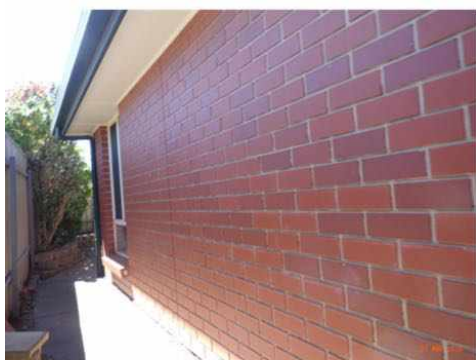
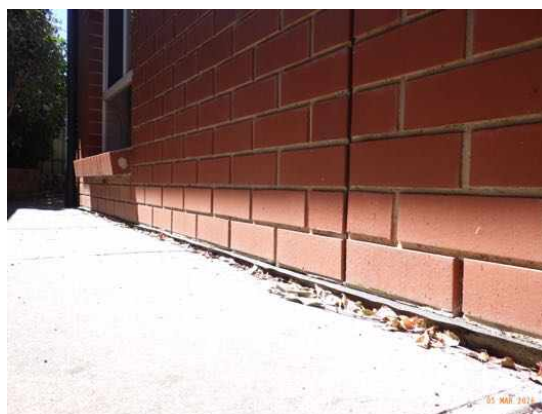
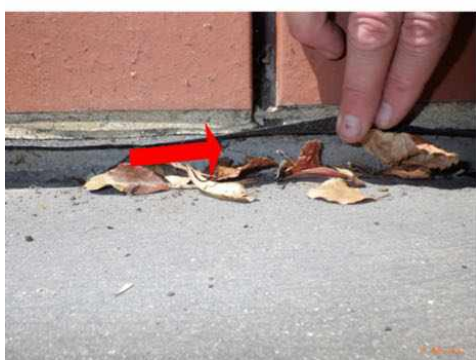
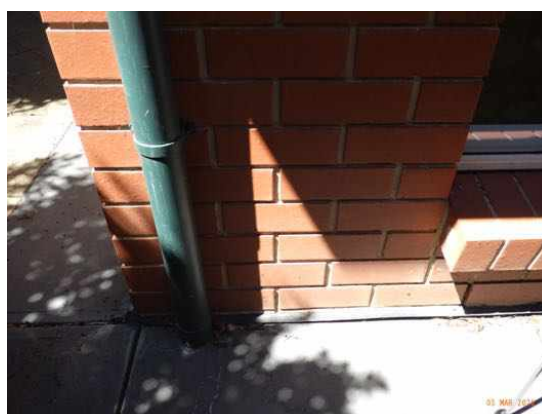
If the slab edge is not properly exposed there is a high risk of concealed termite attack which your inspector will likely not be able to see. Sometimes, in order to determine the type of slab, a suitably qualified person such as an architect or builder may be required to consult construction plans.

Where the slab edge cannot be properly inspected, it is highly recommended that termite or timber pest inspections be carried out every 6-12 months to aid protection of the property against infestation and termite treatment advice is followed closely.

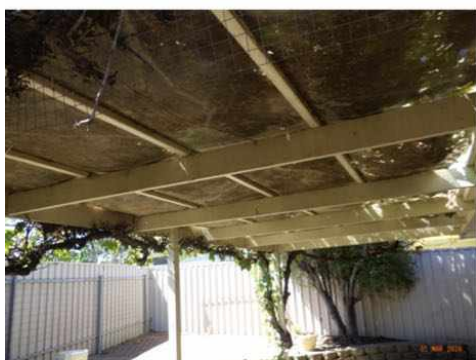
Finding 6.02

Building: Building 1
 Location: All External Areas

Finding: Untreated or non-durable timbers in a hazardous environment
Information: To reduce the risk of timber pest attack it is essential that timber used in a hazardous environment (e.g. in direct contact with the ground or frequently exposed to damp conditions) is of sufficient durability and/or is adequately preservative treated. Additionally any timber lying around or timber stumps should be removed.

Untreated timbers in direct contact with the ground are likely to develop severe wood rot and/or fungal decay if left unattended creating attraction for subterranean termites to infest the timbers from surrounding areas.

If untreated or non-durable timbers are found to be in a hazardous environment it is highly advised that replacement of these building elements be performed as soon as possible to aid the protection of the property against termite / timber pest attack. Failing this close monitoring is recommended in an attempt to identify termite infestation at an early stage.

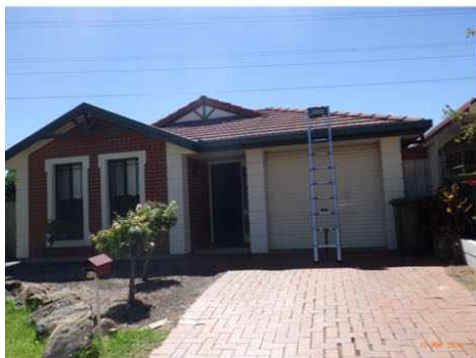
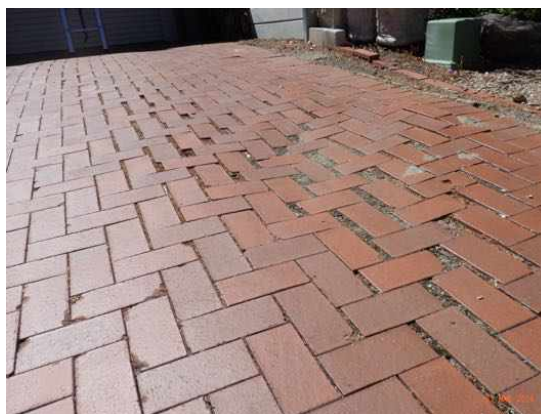
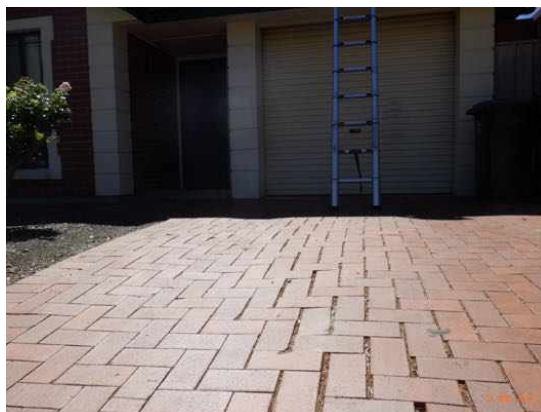
Finding 6.03

Building: Building 1
Location: Driveway
Finding: Paving - Uneven
Information: Sections of the external paved area at the front of the building are uneven, creating a potential trip hazard.

Where paving creates a trip hazard, personal injury may ensue if due caution is not taken by persons within this area.

Movement paving is likely due to heavy traffic from vehicles and potentially inadequate installation.

Re-paving of the area is required as soon as possible to remedy this situation. Further consultation with a specialist paving contractor is advised.

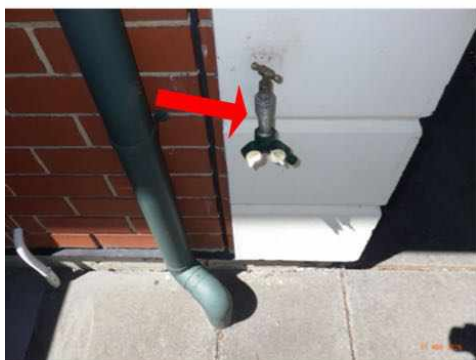
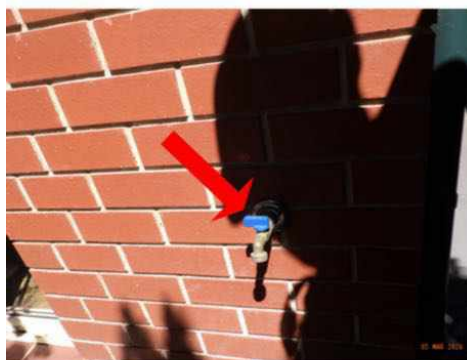
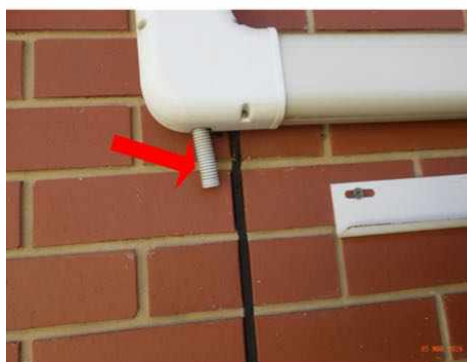
Finding 6.04

Building:	Building 1
Location:	All External Areas
Finding:	Air conditioner and or external tap - No drainage
Information:	Moisture around the perimeter of the building should be minimised to ensure that the area is kept dry and stable which in turn reduces the risk of water damage and termite infestation.

There appears to be no drainage points set up to the air conditioning unit, and or the external tap. While this is not a legal requirement it is recommended to reduce the risk of moisture related issues and the creation of an environment conducive to termite activity.

It is recommended that a licensed plumber be appointed to set up drainage in order to prevent such an environment from being created.

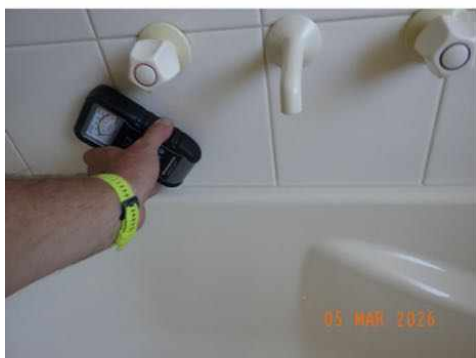
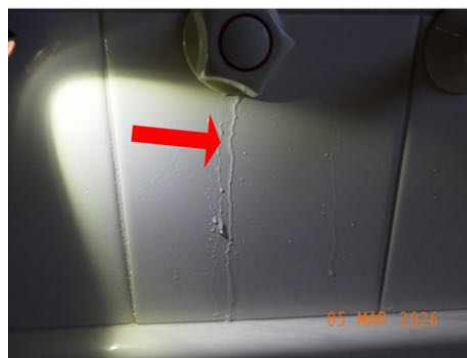
Building:	Building 1
Location:	Bathroom
Finding:	Tap - Leaking
Information:	The bath tap was found to be leaking at the time of inspection. There is no high moisture evident in the area surrounding the leak.

This is a common defect that is consistent with general ageing of the building element. However, it may be indicative of substandard plumbing workmanship if the tap is relatively new.

While this defect only seems minor, if left unmanaged, it is likely to result in the development of rust, water damage and/or extensive water usage.

It is advised that a licensed plumber be appointed immediately to perform remedial works on the affected fitting.

Such works should be performed prior to the development of secondary defects to ensure adequate functionality of all associated building elements.

Repair Bath tap leak

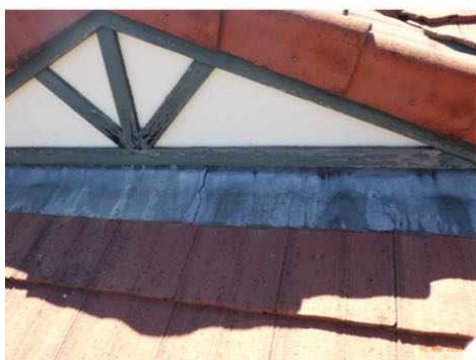
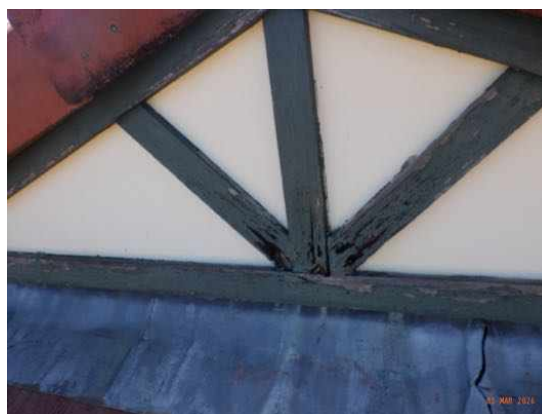
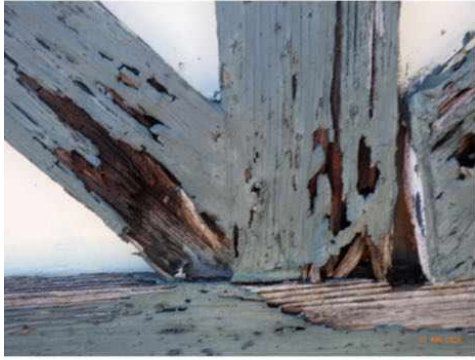
Finding 7.01

Evidence of fungal decay activity and/or damage

Building:	Building 1
Location:	Roof Exterior
Finding:	External painting deteriorated
Information:	The external paintwork including but not limited to the front upper level gable, have been neglected and require attention to replace the rotten timbers and re-paint.

Whilst incomplete or missing paint finish is generally an appearance defect, it can also lead to the development of secondary building defects over time. Incomplete areas of paint finish expose the area to moisture, potentially accelerating the deterioration of underlying building materials.

Degraded paint finishes should be sanded back, filled, leveled and painted, as applicable. Rust to steel beams should be ground out and treated.

A licensed carpenter followed by a painting contractor should be appointed as soon as possible to perform necessary works to aid the appearance of the affected area and to ensure the area is protected against further deterioration. Alternatively, the homeowner following manufacturer instructions may perform these works.

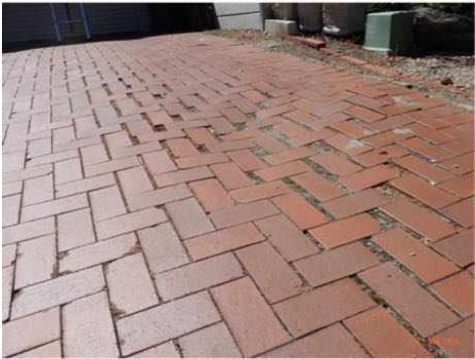
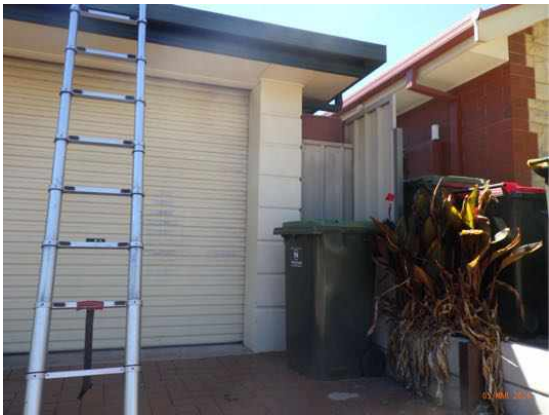
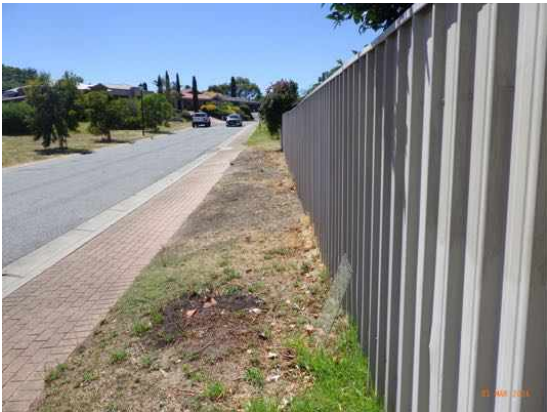
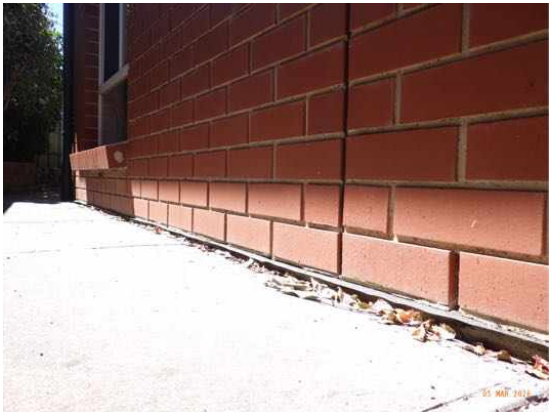
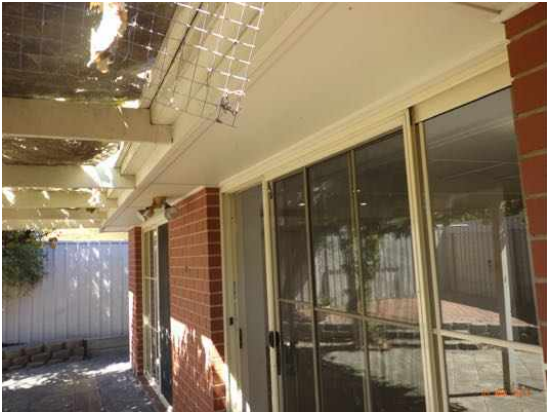
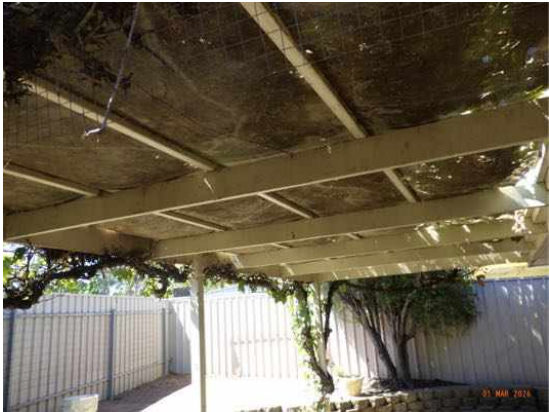
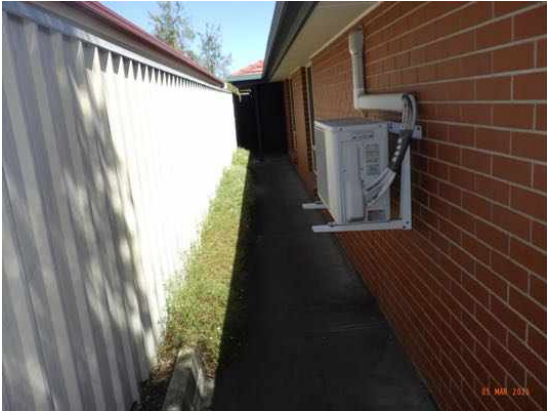
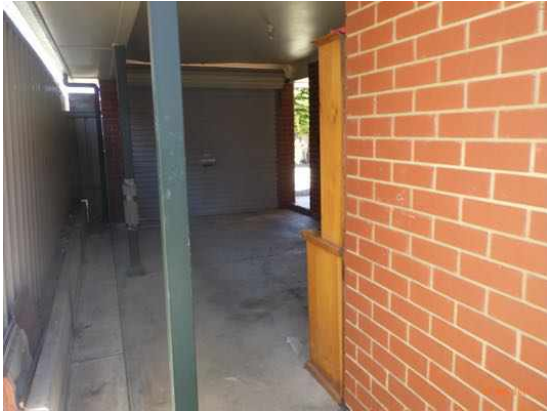
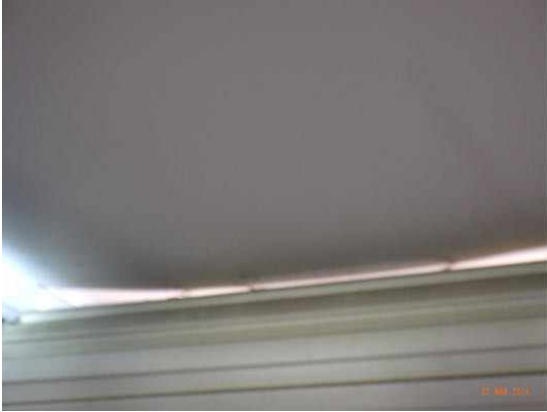
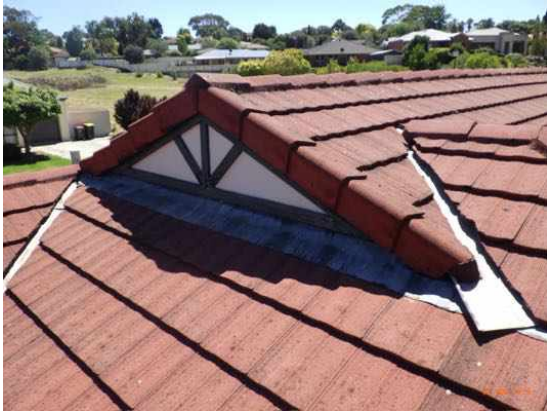
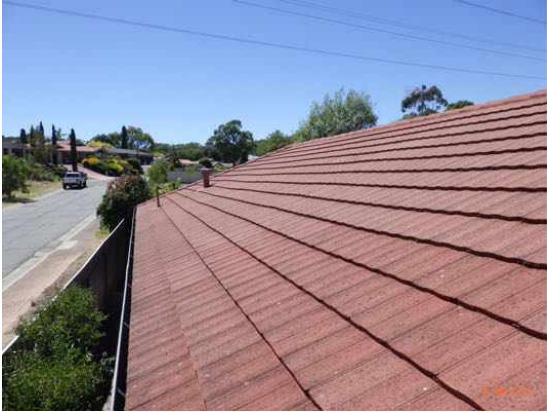
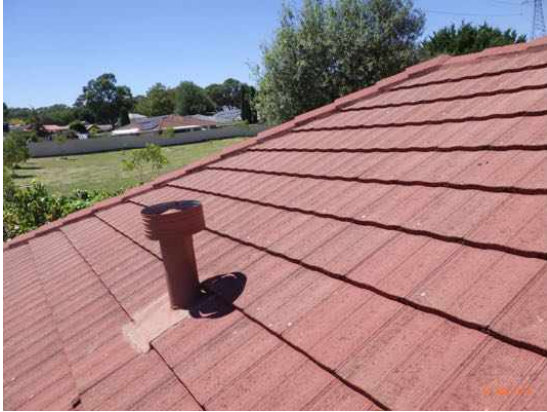
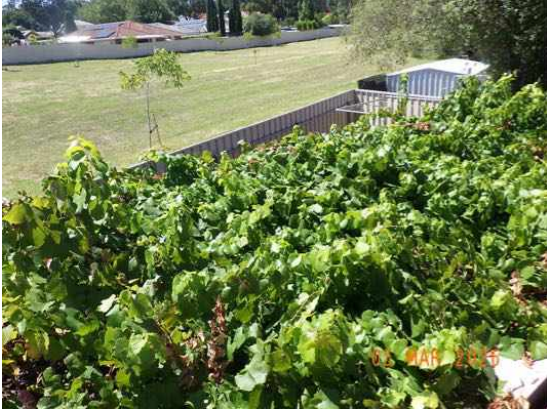
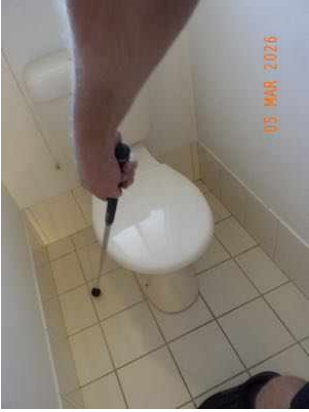
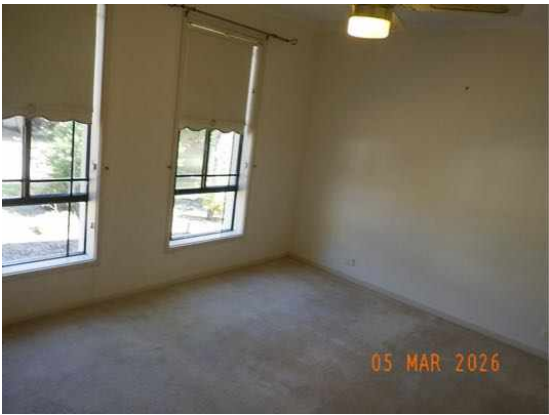
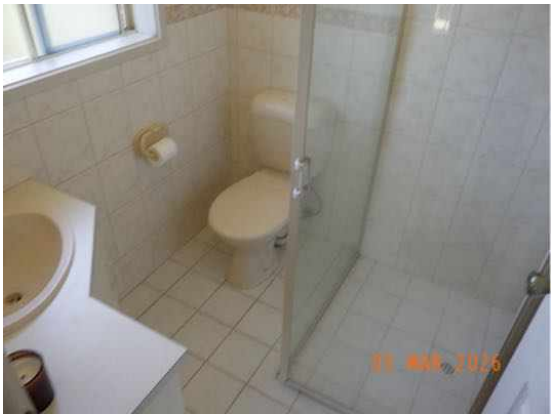
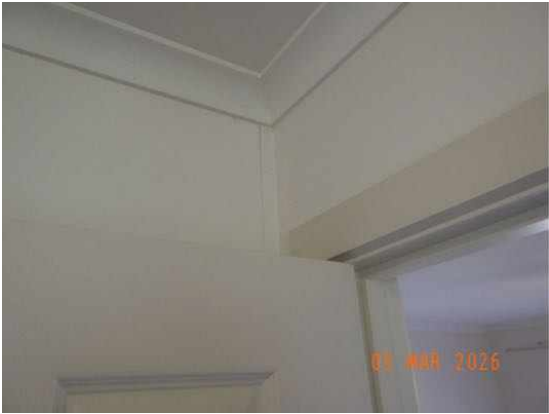
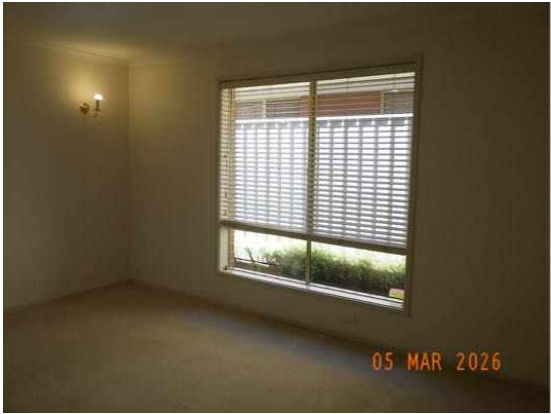
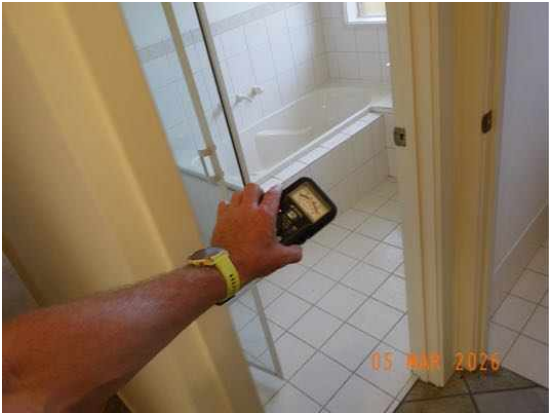
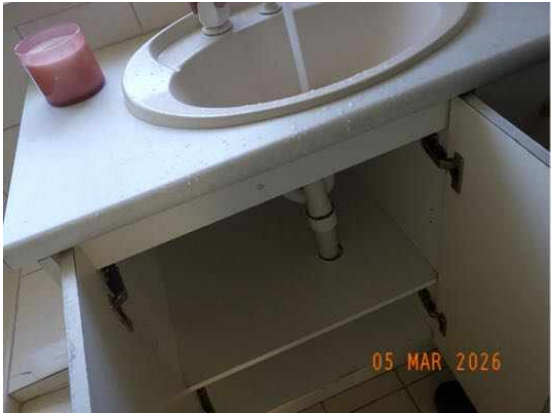
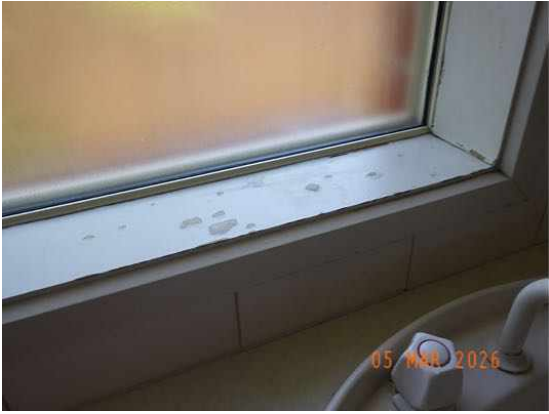
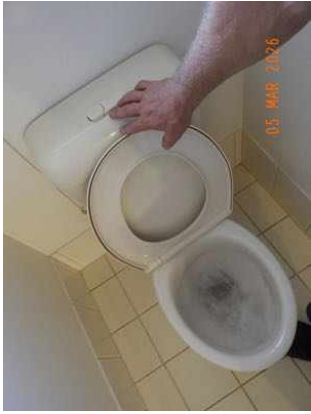
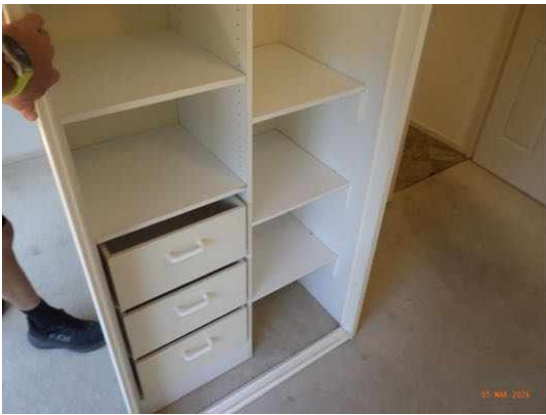
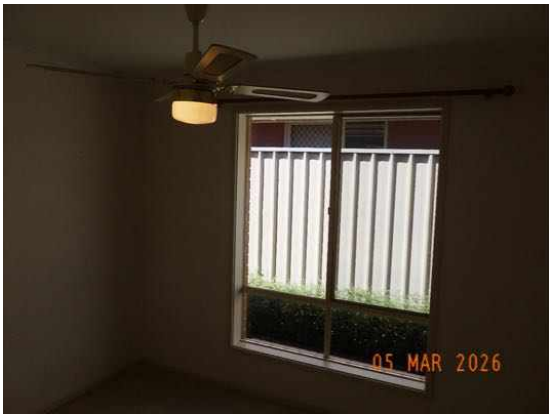
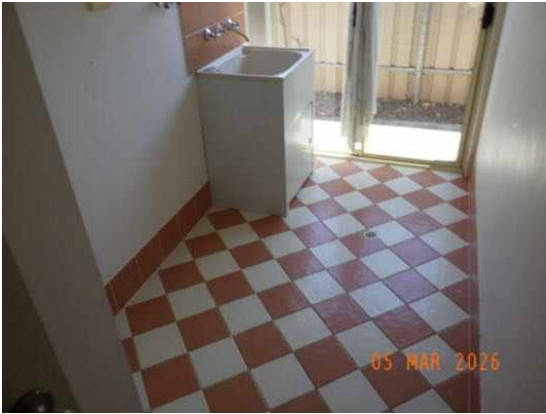
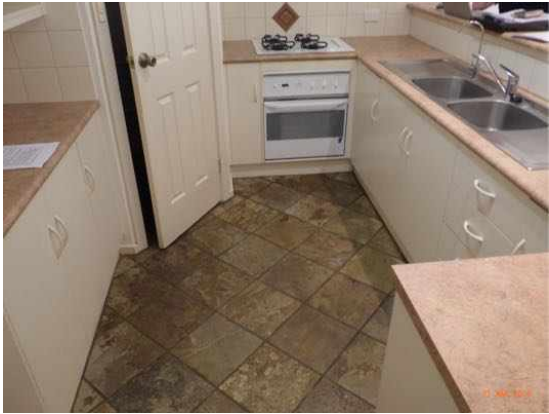
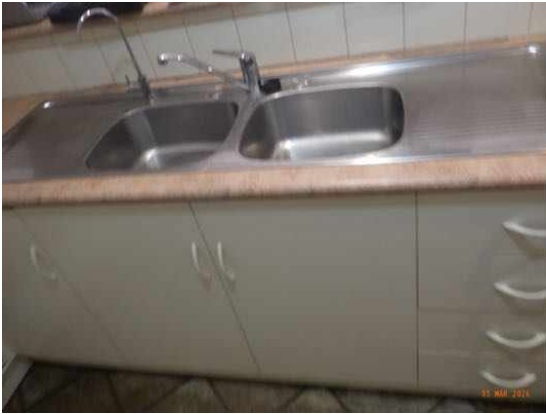
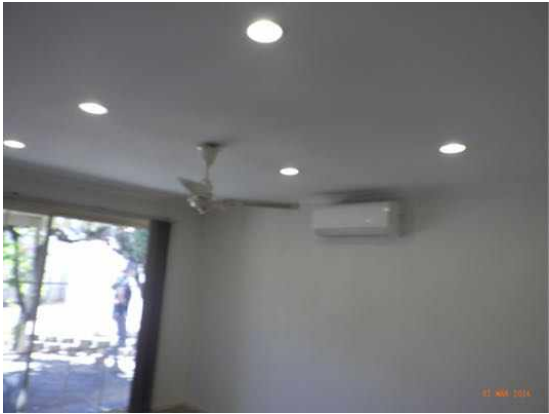
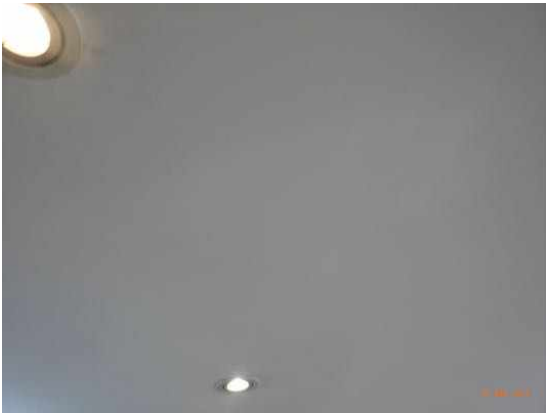
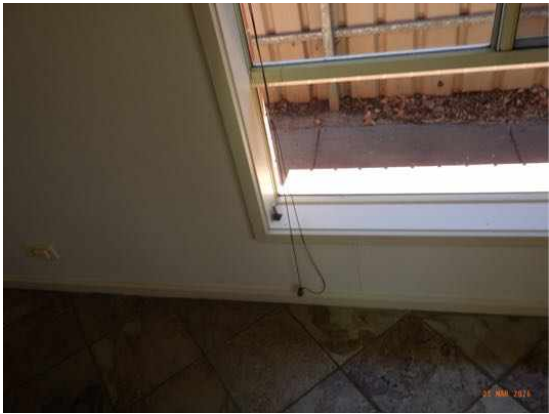
Building: Building 1
Location: All Areas
Finding: Additional Photos - Obstructions and Limitations
Information:

These photographs are an indication of the obstructions and limitations which impeded full inspection of the property at the time of inspection. These obstructions can hide an array of defects and should be removed to allow full inspection to be carried out.

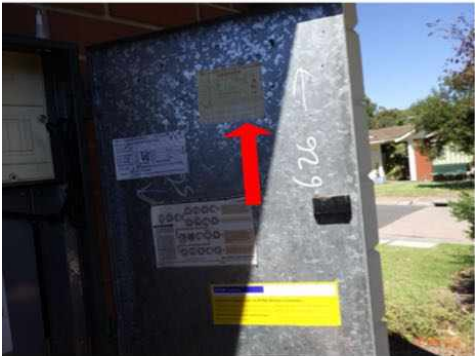
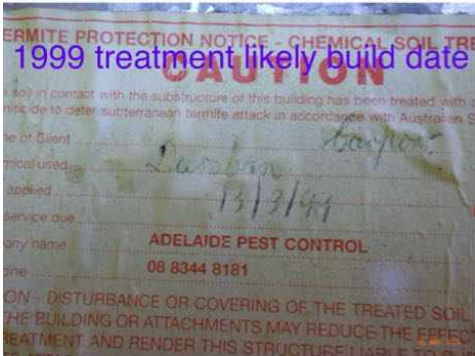
Noted Item

The following items were noted as - Evidence of a previous termite management program

Where a Termite Management System has been identified you should refer to the type of barrier date of installation warranty conditions and any documentation provided by a builder or past owner.

Consult the company who installed the barrier to confirm whether the system is still under warranty.

Most chemical termite management systems expire and require replenishment and all physical systems are primarily designed to prevent concealed entry.
