Building and Timber Pest Inspection Report

Inspection Date: Wed, 11 Mar 2026

Property Address: 20 Bunyip walkway, Melonba NSW 2765,
Australia

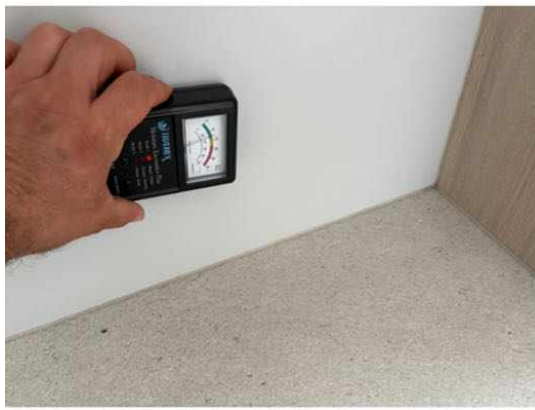
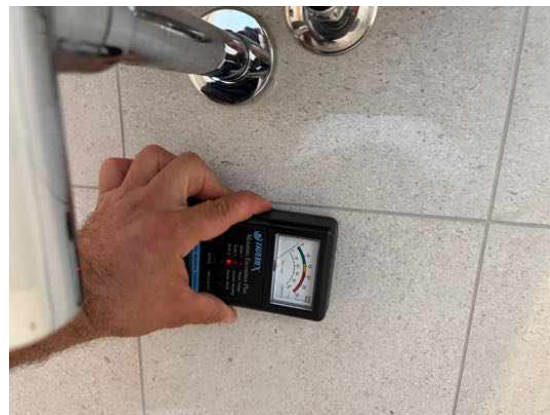
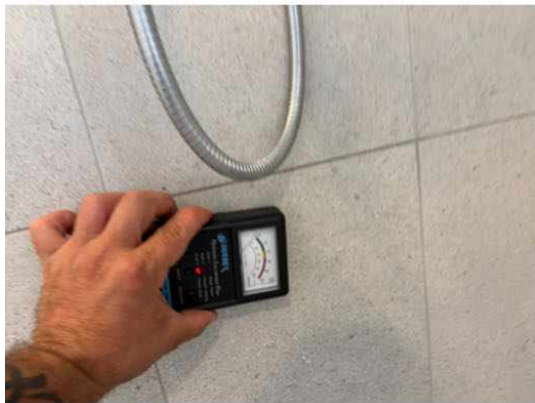
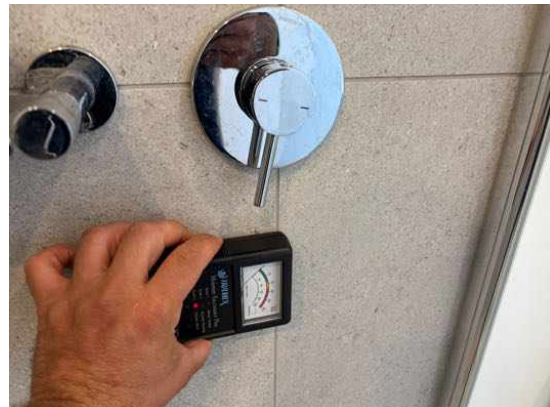
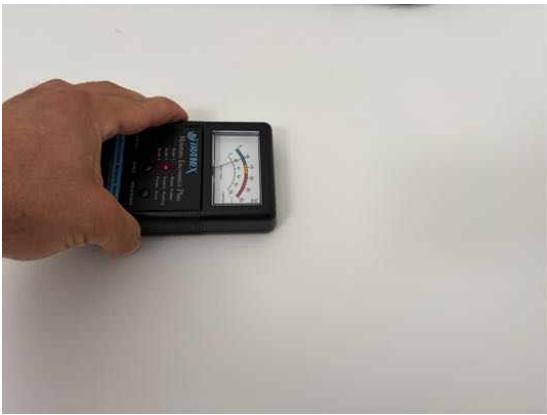
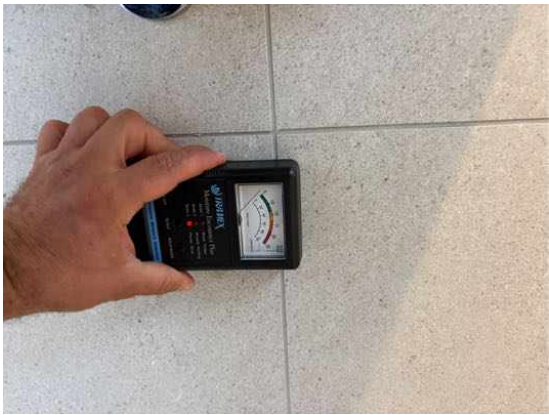
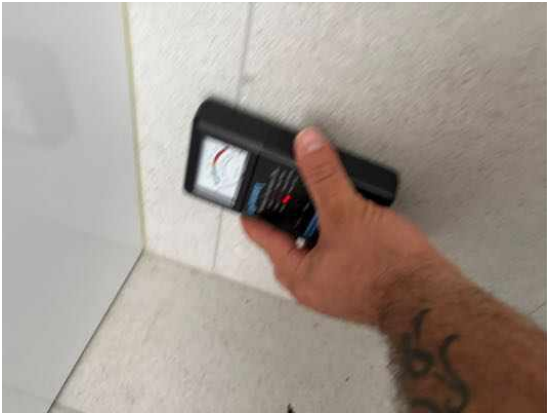
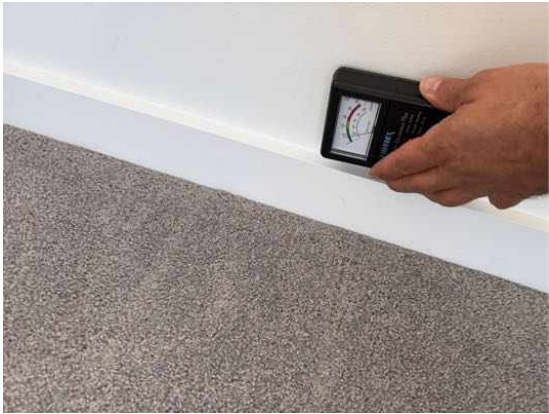
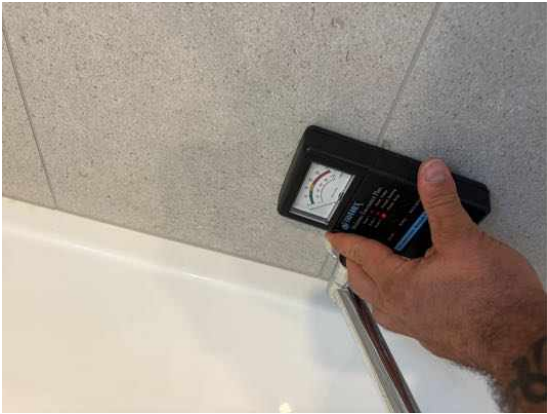
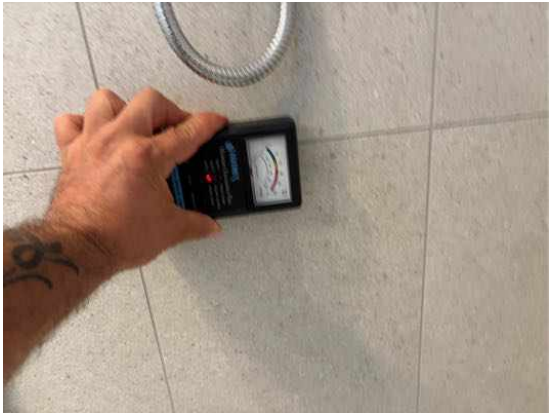
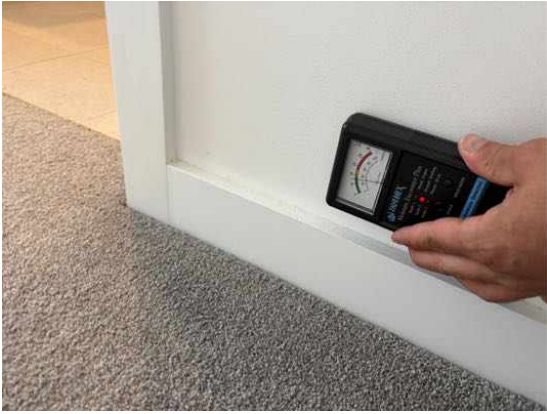
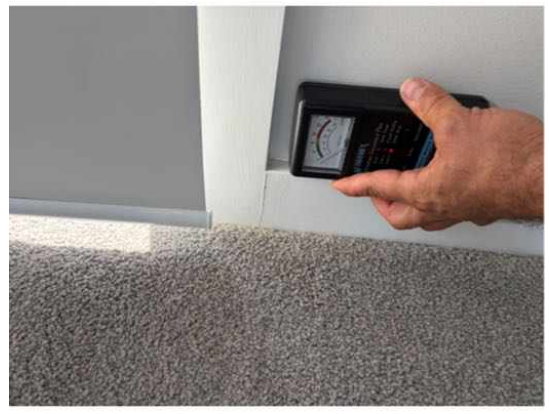
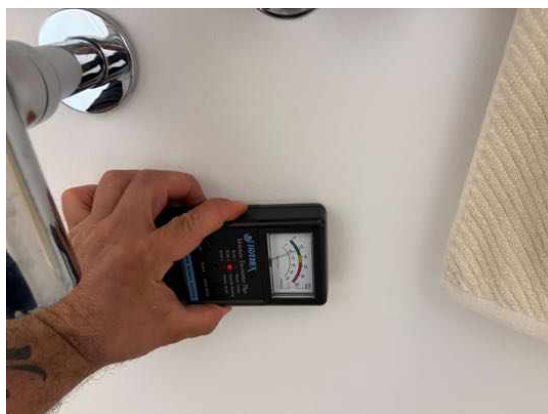
Building: Main Building
Location: All Areas
Finding: Moisture metre
Information: During the inspection the property was checked for moisture using a moisture metre.

This is for information only.
