Building and Timber Pest Inspection Report

Inspection Date: Thu, 19 Mar 2026

Property Address: 9 Flametree Dr, Melonba NSW 2765, Australia

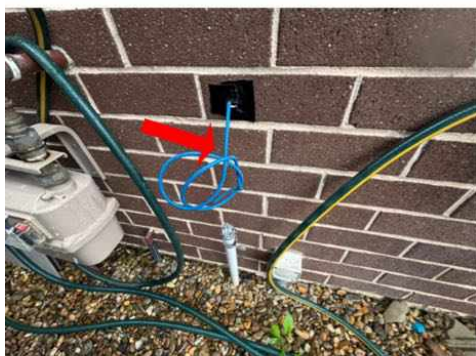
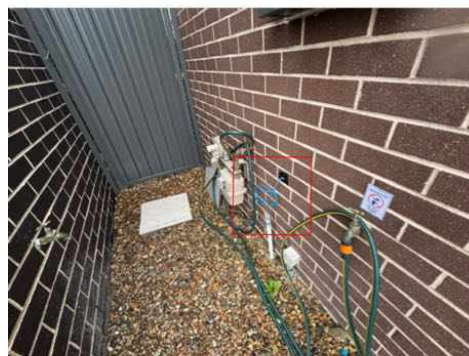
Building:	Main Building
Location:	Exterior walls - left side
Finding:	Exposed Wiring
Information:	At the time of inspection, wiring was observed to be exposed and not properly concealed. Exposed wiring presents a safety hazard, as it may be susceptible to damage, accidental contact, and potential electrical risks.

It is recommended that all wiring, whether electrical or communication/cable wiring, be properly enclosed and secured to ensure safety and compliance with acceptable standards. Where the wiring is electrical in nature, a licensed electrician should be engaged to assess and rectify the installation. For non-electrical wiring, a suitably qualified handyman may be engaged to neatly conceal and secure the wiring in a professional manner.

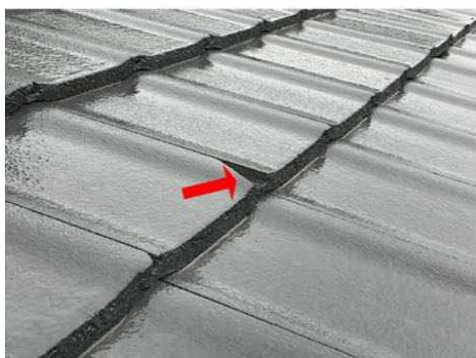
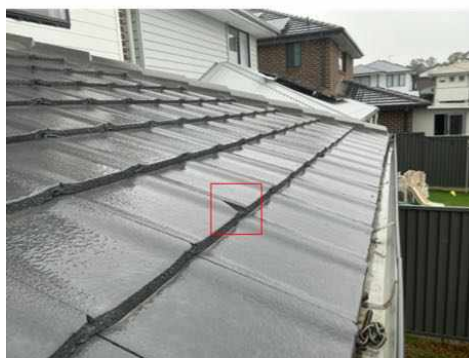
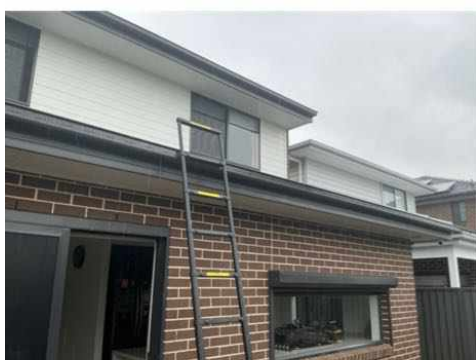
Building:	Main Building
Location:	Rear Side
Finding:	Roof tiles - Broken
Information:	Upon inspection of the exterior roof covering, broken roofing tiles were identified. Broken and friable roof tiles are generally the result of ageing and weathering of what

If left to further deteriorate, broken and brittle roof tiles are likely to lead to water penetration via the roof into the ceiling space, causing secondary damage to ceiling linings, insulation and roof structures. Broken roof tiles are also likely to detract from the effectiveness of the roof drainage system, creating potential for secondary damage to the exterior roof covering and roof plumbing.

Replacement of broken tiles is required and should be performed by a roofing contractor.

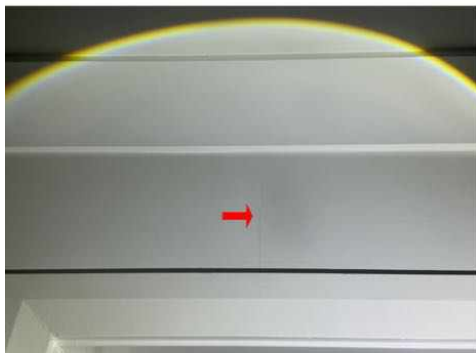
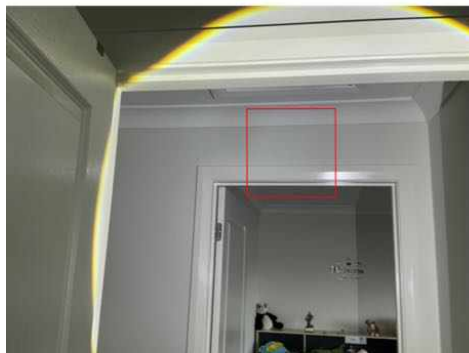
Finding 3.02

Building:	Main Building
Location:	Upstairs Hallway
Finding:	Cracking - Damage Category 1 - Fine (up to 1mm)
Information:	Although fine cracks are quite noticeable, they are often only considered to be an appearance defect, and usually do not indicate any structural damage. Generally, the cause of a fine crack is indicative of a separation between building materials and finishes (e.g. paint, plaster, etc.) along joins.

Cracking of this nature can generally be repaired with minor sanding, filling and/or repainting. Such works should be performed by a qualified painter or a general

handyman.

Monitoring of all cracking should be conducted frequently. Always contact a building inspector should cracks widen, lengthen, or become more numerous.

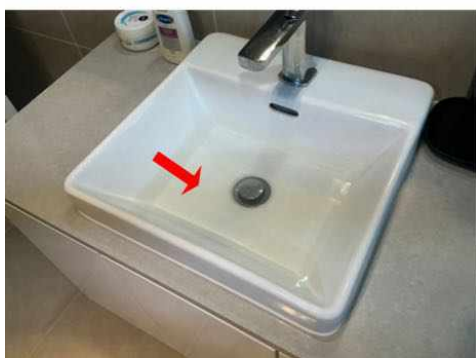
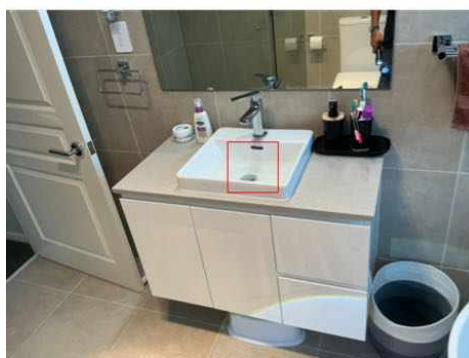
Finding 3.03

Building:	Main Building
Location:	Upstairs Bathroom
Finding:	Sink - Slow Draining
Information:	The sink drain appeared to be slow draining at the time of inspection.

Blockages prevent building elements from operating as intended. If left unmanaged, a lack of general maintenance may lead to the development of more significant defects, such as water damage to surrounding building materials. It is advised that the blockage be removed as soon as possible.

If blockage remains, a licensed plumber should be appointed as soon as possible to perform any remedial works where required.

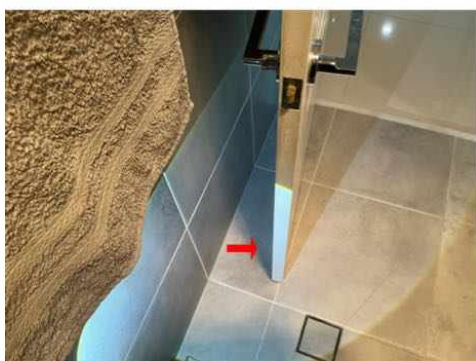
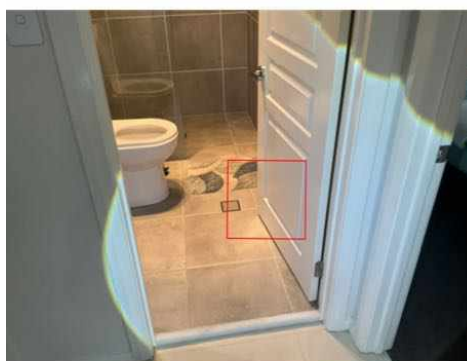
Finding 3.04

Location: Downstairs Bathroom
 Finding: Door Stopper(s) - Missing
 Information: At the time of inspection, it was noted that a door stopper was missing in this area.

The absence of a door stopper can lead to potential damage to the door, wall, or surrounding finishes, as the door may swing open too far and impact the wall or adjacent objects. Over time, this can cause dents, scuffs, or even structural damage to the wall or door. It is recommended that a door stopper be installed to prevent further damage and ensure the protection of both the door and the surrounding area.

The client is advised to engage services of a handyman to install the door stopper.

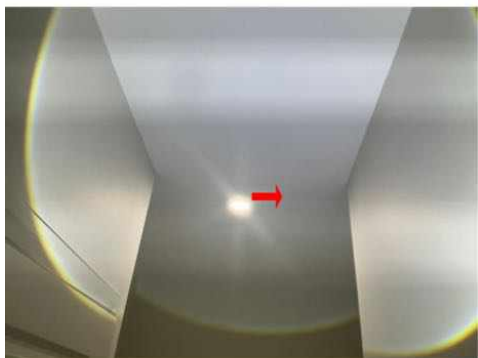
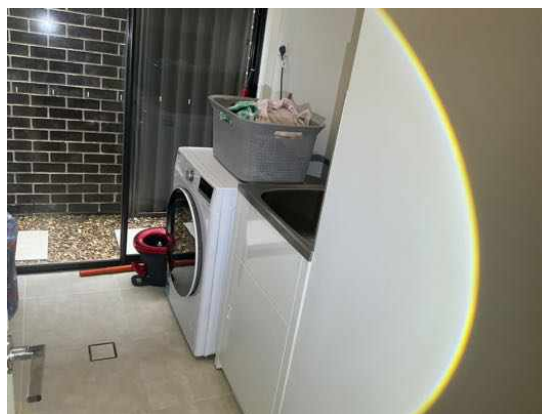
Finding 3.05

Building: Main Building
 Location: Laundry
 Finding: Laundry - No Exhaust Fan Installed
 Information: At the time of inspection, it was noted that the laundry area is not equipped with an exhaust fan.

The absence of mechanical ventilation in a confined space such as a laundry can lead to the accumulation of excess moisture and humidity, particularly during the use of washing machines and dryers. Over time, this can result in condensation build-up on walls and ceilings, increasing the risk of mould and mildew growth, which may cause health issues such as respiratory irritation and allergies. Additionally, persistent damp conditions can contribute to the deterioration of paint, plaster, and other building materials, potentially leading to more extensive and costly repairs.

A licensed electrician should be appointed to carry out this work to ensure the fan is installed safely and in accordance with Australian electrical standards at clients own discretion.

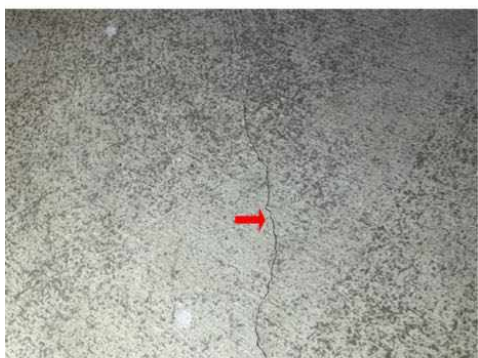
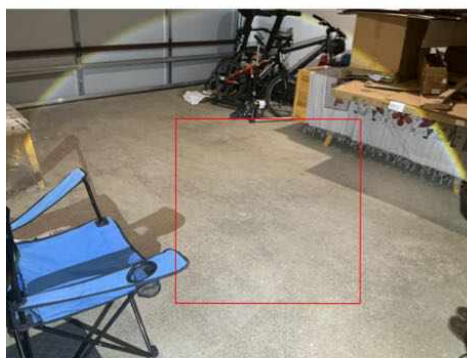
Finding 3.06

Building: Main Building
 Location: Garage
 Finding: Crack in concrete slab - Category 2
 Information: A crack coded as Category 2 was identified in the slab. A Category 2 crack is described as a distinct crack, with the slab being noticeably curved or changed in level.

To be considered Category 2, the approximate width of the crack is less than 2.0mm, or a change in offset of less than 15mm when a 3m straight edge is placed over the defect.

Category 2 crack in the garage concrete slab (distinct but under 2 mm wide or 15 mm offset), which must be monitored for 12 months before determining if rectification is needed. No major defects were found. Conditions conducive to timber pest activity were present, including inadequate slab-edge exposure (less than 75 mm inspection zone) at the front entrance & deck, bridging of termite barriers by adjacent internal flooring levels on the deck, bridging via attached appliances on the right-side exterior walls, and timber fencing materials in direct ground contact in the yard, all increasing termite entry risk and necessitating a new termite treatment. No live timber pest activity, timber pest damage, fungal decay, or wood borer activity was detected, though evidence of a previous termite management program exists; the building is otherwise in good overall condition relative to similar properties.

Category 2 cracks to slabs should be monitored for a period of 12 months. At the end of the monitoring period, cracks rated greater than Category 2 are considered defects that require rectification.

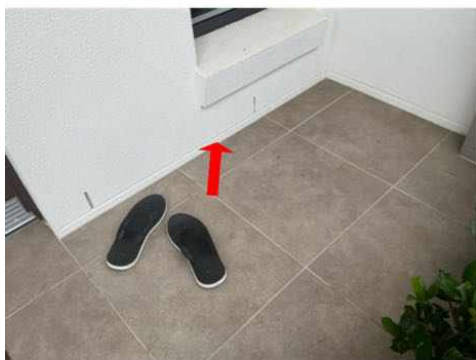
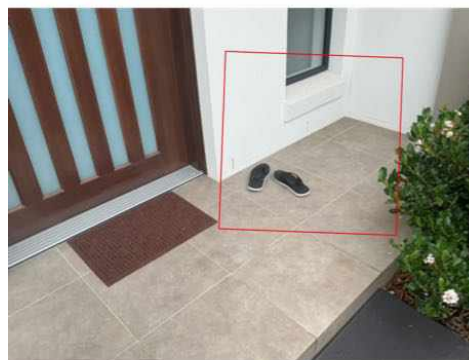
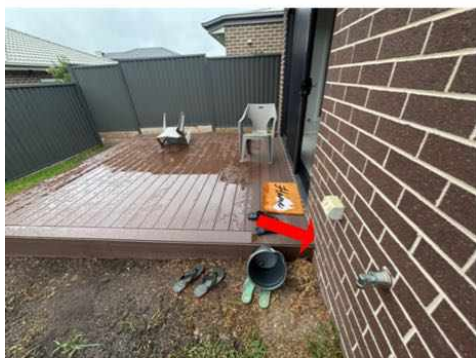
If the slab edge is not properly exposed there is a high risk of termite attack. Sometimes, in order to determine the type of slab, a suitably qualified person such as an architect or builder may be required to consult the construction plans.

Where the slab edge cannot be properly inspected, it is highly recommended that termite or timber pest inspections be carried out every 6-12 months to aid protection of the property against infestation.

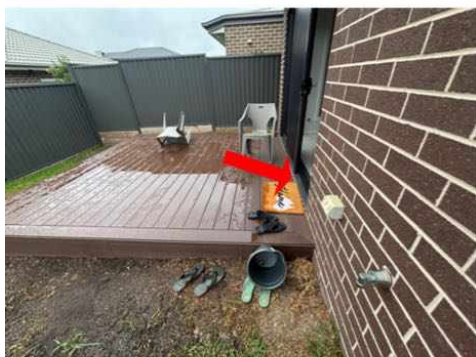
Finding 6.02

Building:	Main Building
Location:	Deck
Finding:	Bridging or Breaching of Termite Barriers - Adjacent Internal Flooring
Information:	Bridging is the spanning of a termite barrier or inspection zone so that subterranean termites are provided with passage over or around that barrier.

It is important for internal flooring to be raised above adjacent external ground levels. Where external ground levels are above or same level as internal flooring, water pooling and subsequent internal flooding is likely to occur which may attract termite activity to the internal area.

It is highly advised that a landscaper or relevant tradesperson be appointed to lower external grounds that are raised above or same as adjacent internal flooring. Alternatively if external grounds and internal flooring is level installation of a raised door sill may be appropriate in preventing any water pooling in the area. If the client wishes not to make any changes, then a qualified pest controller is recommended for termite treatment around the perimeter of the house and subfloor (if any) as soon as possible.

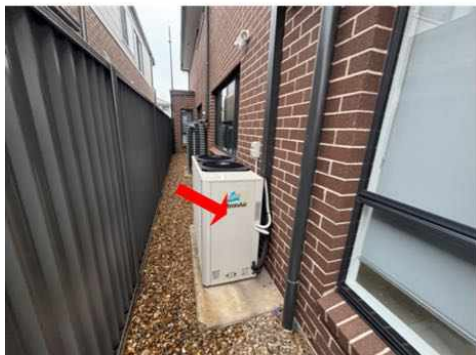
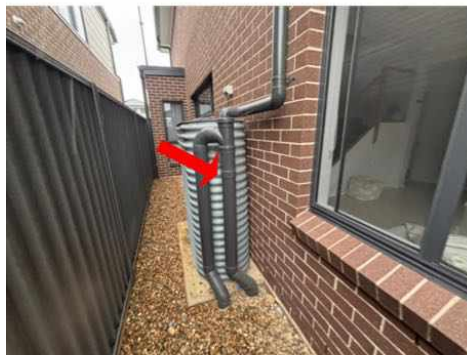
Finding 6.03

Building:	Main Building
Location:	Exterior walls - right side
Finding:	Bridging Appliances - Attachment to Buildings
Information:	Bridging occurs when items against a building provide a concealed entry point for termites into the building or by passing around a termite management system.

service conduits and the like provide the opportunity for concealed entry.

Building attachments of this nature need to be frequently inspected for termite activity by a qualified inspector.

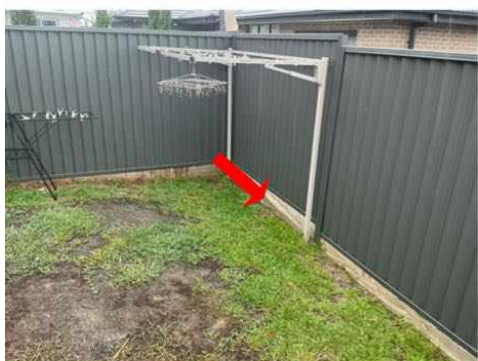
Finding 6.04

Building:	Yard
Location:	Fencing
Finding:	Building Materials in Direct Ground Contact - Conducive to Termites
Information:	Timber elements that are in direct contact with the ground and exposed to moisture or damp conditions are highly conducive to termite activity. This susceptibility arises because timber, when in contact with soil and dampness, creates an environment that is particularly attractive to termites, encouraging infestation and potential structural compromise. Whether the timber is used as a part of the building's construction or incorporated into fencing, its presence near or on the ground can become a pathway for termites to access and damage the property.

When exposed to excessive moisture, timber begins to deteriorate, developing conditions such as wood decay and rot. These compromised areas of timber are even more appealing to termites, as they are easier to infest and consume. This is especially true for untreated or non-durable timber, which lacks the protective treatments that can deter or withstand termite attacks. Termites can use these weakened, moisture-laden elements as a bridge into other parts of the structure, creating an entry point for potential infestations that can spread and cause extensive damage if left unchecked.

For any timber in direct contact with the external ground, special attention is required. The combination of moisture, untreated wood, and direct ground contact not only accelerates the decay process but also provides subterranean termites with a straightforward means of ingress into the structure. This entry can lead to termites moving undetected into other vulnerable areas, resulting in potentially significant structural issues and costly repairs.

elements be appropriately treated or removed as soon as possible. Timbers that are necessary for use should be made durable through appropriate treatments and maintained to ensure they do not create conditions conducive to termites. Additionally, the client is advised to schedule regular termite treatments to maintain an effective barrier against infestations and ensure ongoing protection.

The client is strongly advised to assess the property for any timber elements that may be in direct contact with the ground and ensure prompt action is taken to remove or treat them effectively. Regular inspections, proactive maintenance, and consistent termite treatment are essential steps in minimising the risk of termite attack and protecting the structural integrity of the property. Taking these preventive measures is crucial for maintaining a termite-free environment and avoiding potentially costly damage and future repairs.

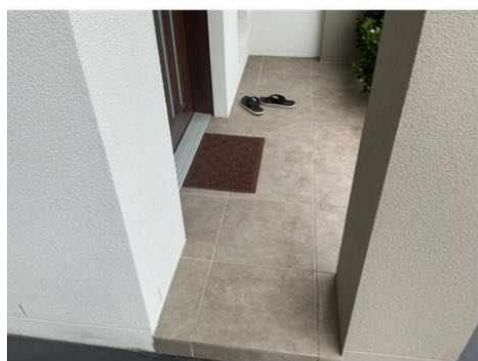
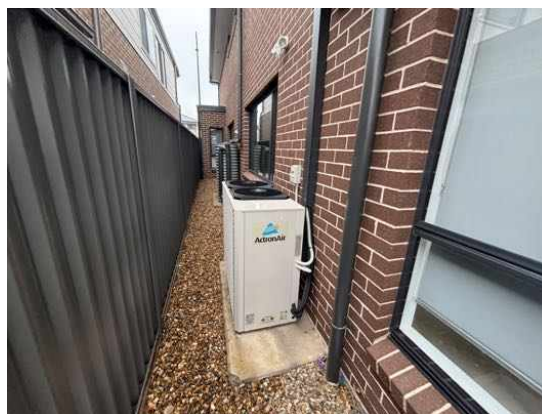
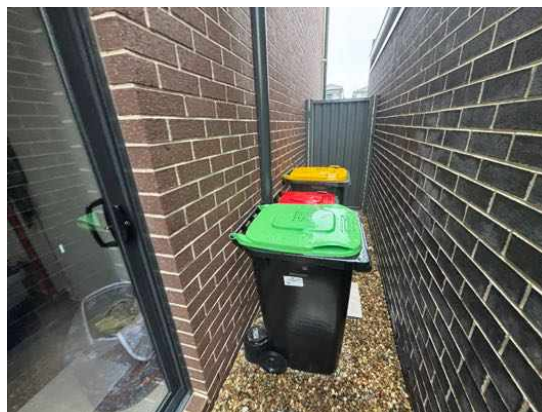
Building: Main Building
Location: All External Areas
Finding: Obstructions and Limitations - External Areas
Information: The attached photographs provide a visual representation of the obstructions and limitations that impeded a full inspection of the external areas of the property at the time of assessment. These obstructions, which may include vegetation, stored items, debris, or other physical barriers, can obscure potential defects and prevent a thorough evaluation of the property's condition. Obstructions of this nature can conceal a wide range of issues, such as structural damage, water ingress, pest infestations, or deteriorating building materials, which may not be visible during the initial inspection.

It is essential that these obstructions be cleared to allow for a comprehensive inspection of the external areas. Removing these barriers will enable a more accurate assessment of the property's condition and allow any hidden defects to be identified and addressed promptly. Failure to do so could result in undetected issues worsening over time, potentially leading to more costly repairs in the future.

Therefore, it is strongly recommended that the obstructions be removed and a re-inspection be scheduled once the affected areas are made fully accessible. This will ensure a complete evaluation of the property's exterior and provide the client with a clear understanding of any potential issues that may have been concealed during the initial inspection.

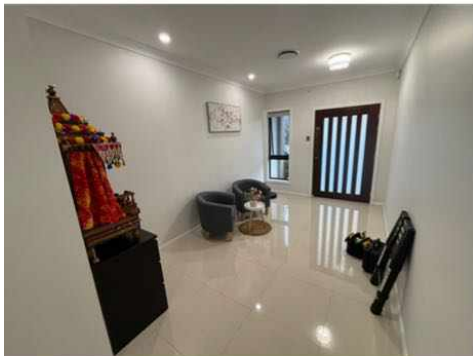
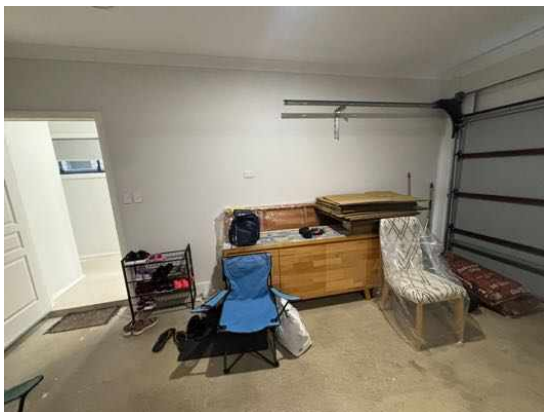
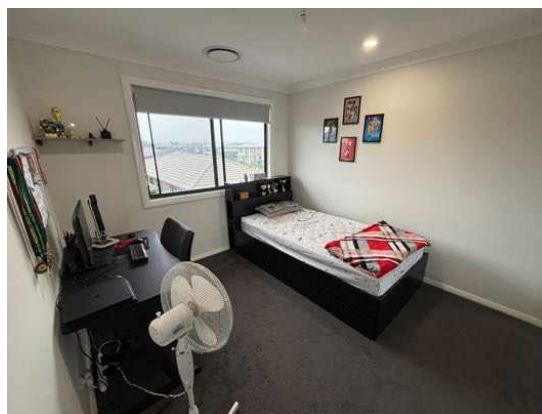
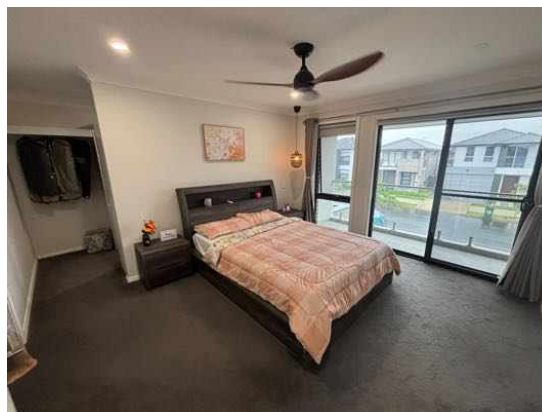
Building:	Main Building
Location:	All Internal Areas
Finding:	Obstructions and Limitations - Internal Areas
Information:	The accompanying photographs provide clear evidence of the obstructions and limitations that restricted a comprehensive inspection of the internal areas of the property at the time of assessment. These obstructions, which may include furniture, personal belongings, stored items, or structural elements such as wall coverings and built-ins, significantly hindered the ability to thoroughly evaluate these areas. It is important to note that such obstructions can potentially conceal a wide array of defects, ranging from hidden structural damage, water leaks, pest infestations, or

electrical issues, to deteriorating materials that may not be visible during the initial inspection.

The presence of these impediments means that critical areas of the property were not accessible, and therefore, any underlying defects that may affect the integrity and safety of the property could remain undetected. These hidden defects, if left unaddressed, could worsen over time and may result in costly repairs or pose potential safety hazards to the occupants.

It is highly recommended that all obstructions be cleared to facilitate a complete and thorough inspection of the internal areas. Once the obstructions have been removed and full access is available, a re-inspection should be carried out to ensure that any previously concealed issues can be properly identified and rectified. This follow-up inspection will provide a more accurate assessment of the property's internal condition and help the client make informed decisions about any necessary repairs or maintenance.

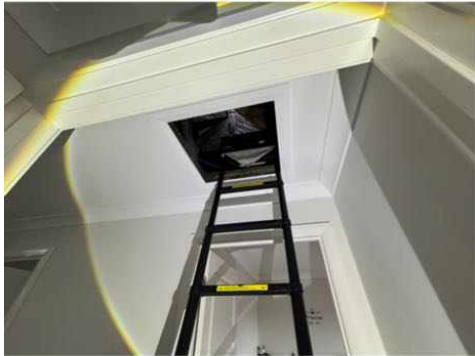
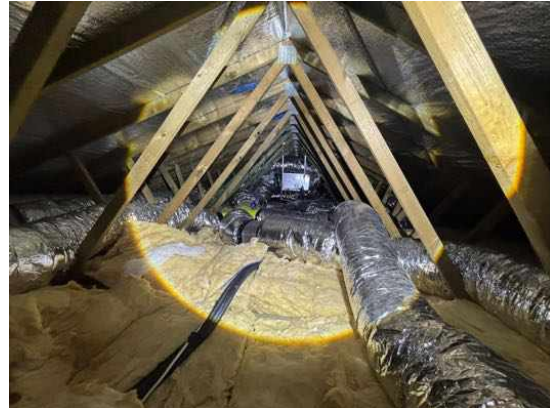
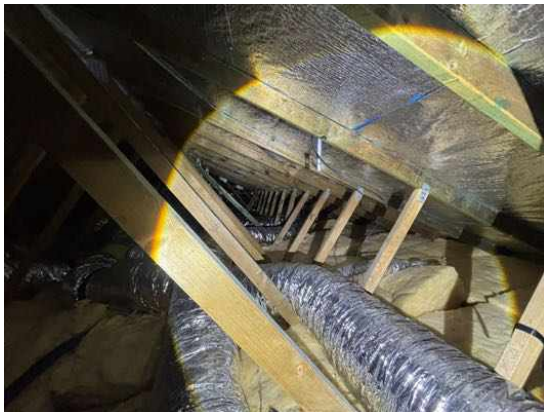
Building: Main Building
 Location: Roof Void
 Finding: Obstructions, Limitations, and General Roof Space Condition
 Information: The photographs provided document both the general condition and the obstructions and limitations that were present in the roof cavity of the main building at the time of inspection. These obstructions—such as insulation materials, stored items, structural elements, or electrical wiring—restricted safe and adequate access to key areas within the roof space. As a result, a comprehensive inspection of all components could not be completed.

Obstructions of this nature may conceal a variety of potential defects, including

damaged framing, compromised insulation, evidence of moisture ingress, pest activity, or electrical hazards. While no major issues were observed in the visible areas, the presence of these limitations means that some defects may remain undetected.

It is recommended that these barriers be removed or repositioned to facilitate full and safe access to the roof space. Once clear, a follow-up inspection should be conducted to allow for a thorough assessment of all concealed areas. This will help ensure that the condition of the roof cavity is accurately evaluated and any hidden issues are appropriately identified and addressed.

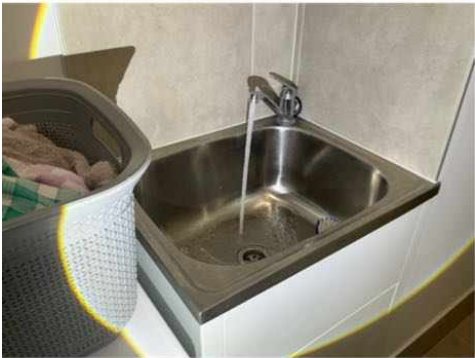
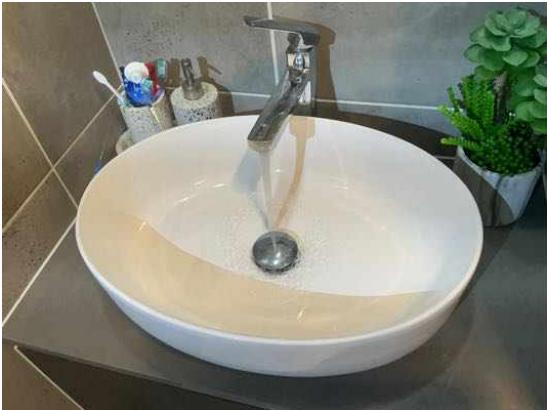
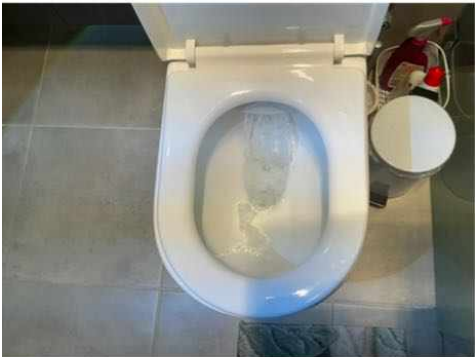
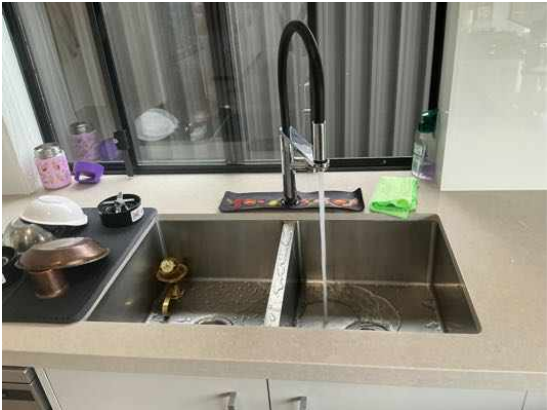
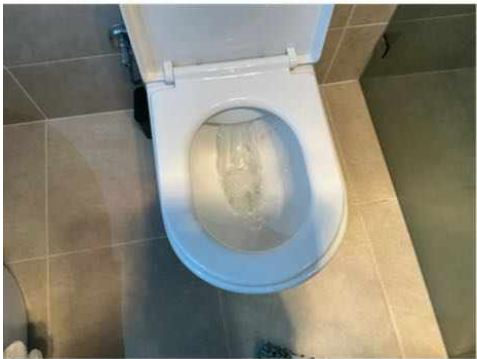
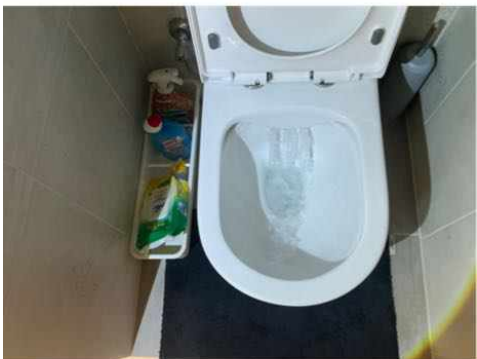
It is important to note that while a visual inspection of cupboards and cabinetry beneath sinks and vanities was undertaken, stored personal items and fixtures presented obstructions that limited full visibility of the internal areas. As per standard inspection practices, inspectors are not permitted to move or disturb personal belongings during the inspection process. Therefore, only visible and accessible sections were inspected, and concealed water damage or plumbing defects may not have been detected.

Given this, a re-inspection is recommended after all obstructions have been cleared to allow for a comprehensive assessment of these areas. Regular maintenance and monitoring of plumbing and drainage systems is also advised to ensure ongoing functionality and early detection of potential issues.

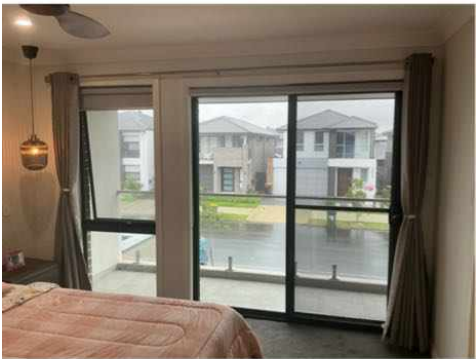
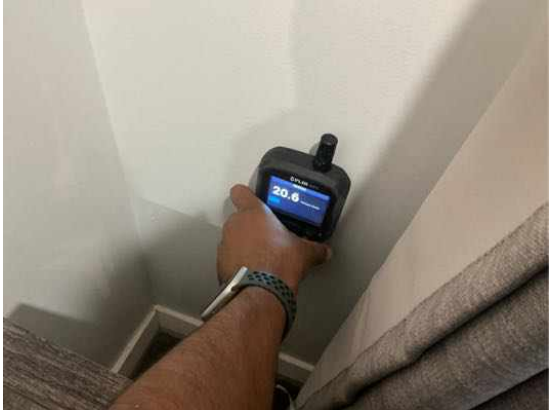
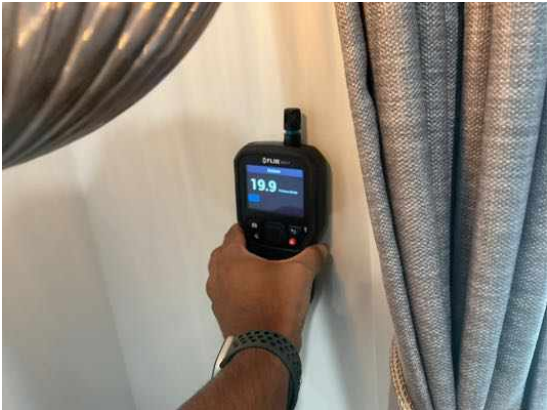
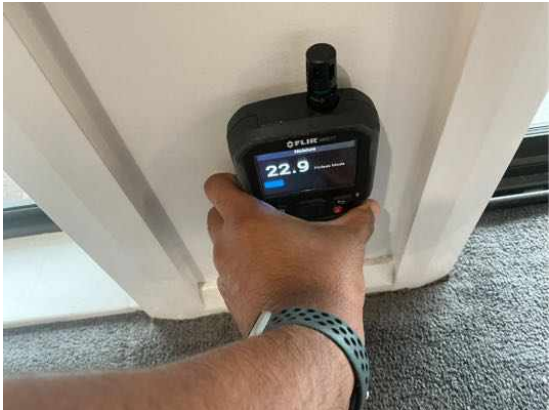
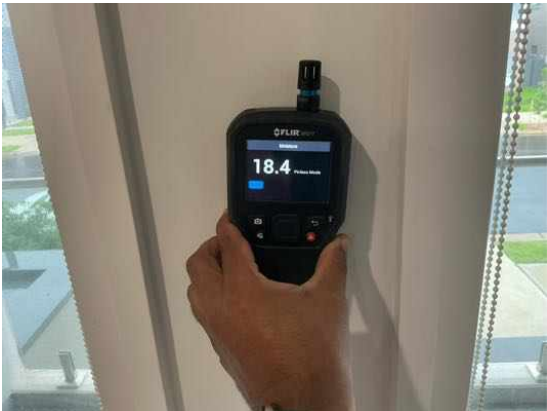
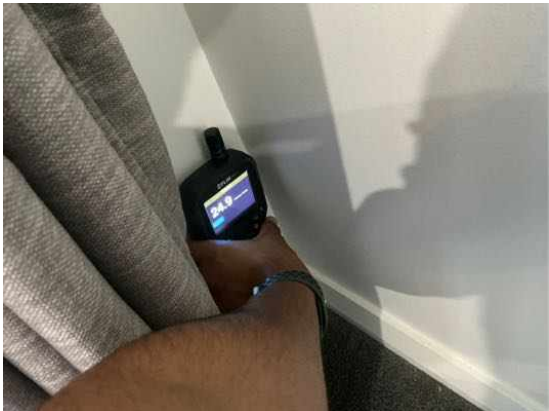
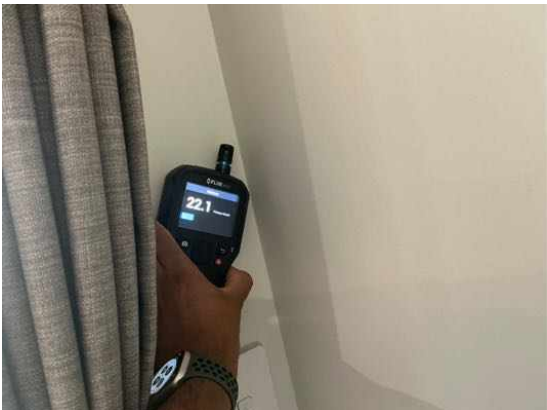
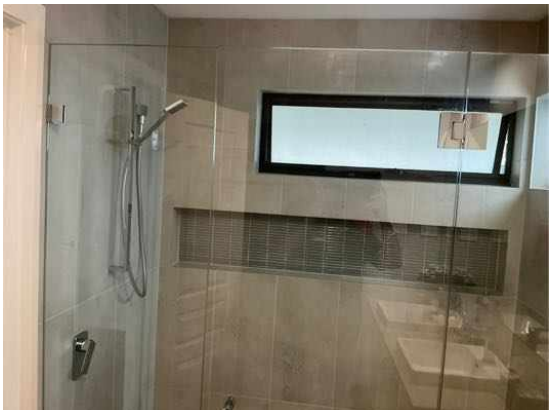
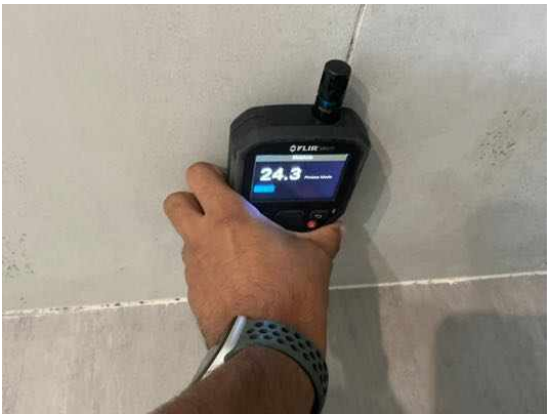
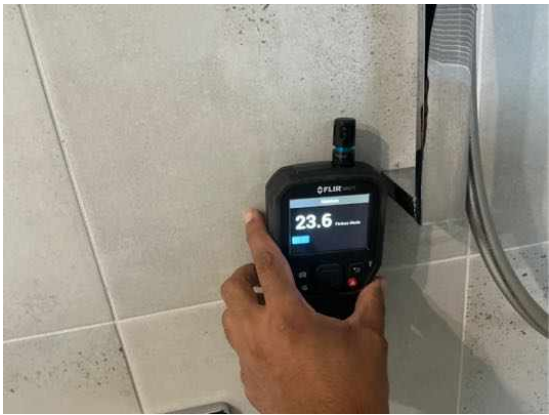
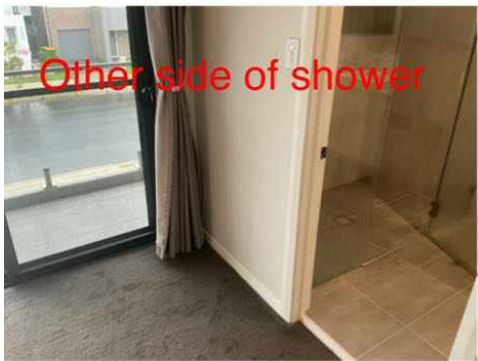
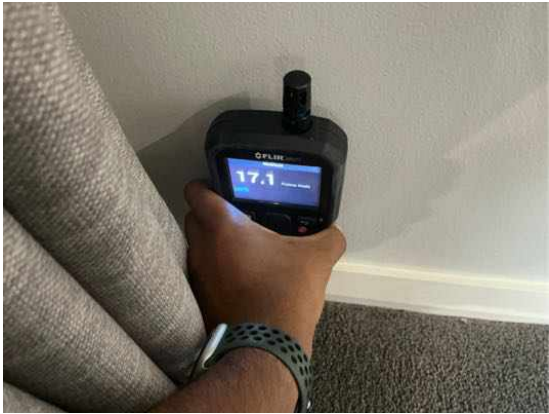
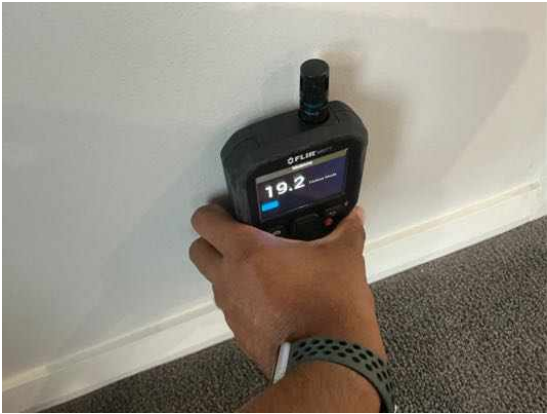
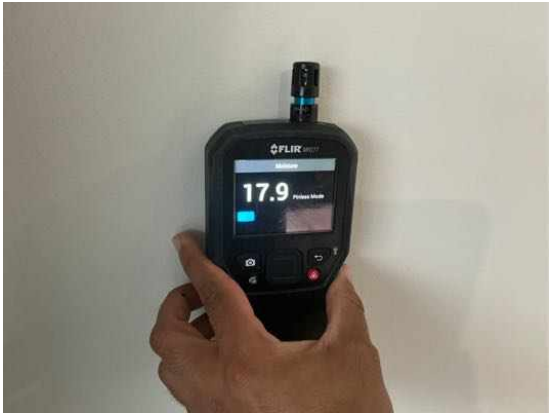
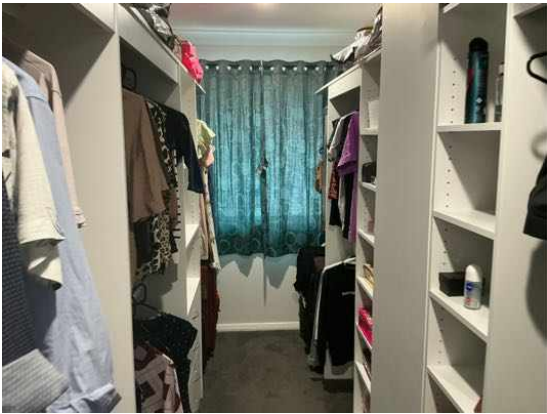
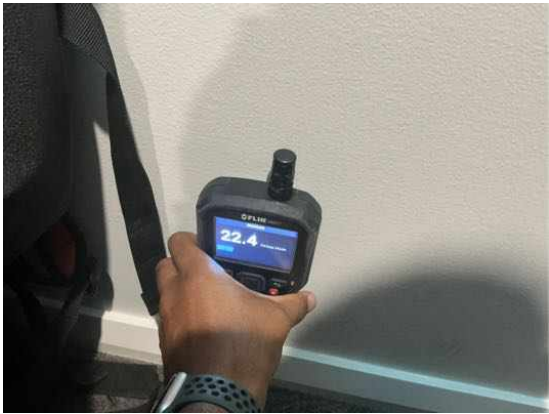
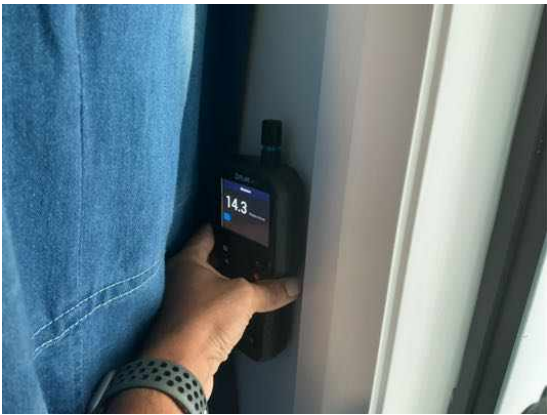
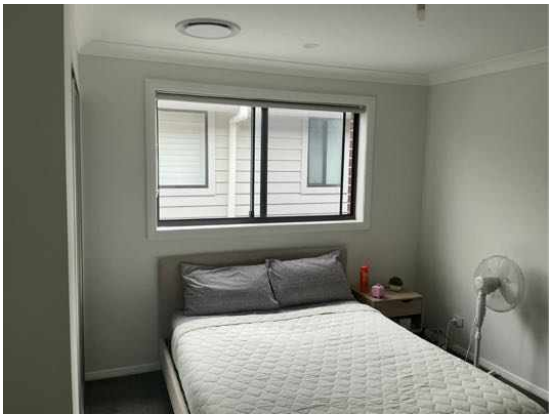
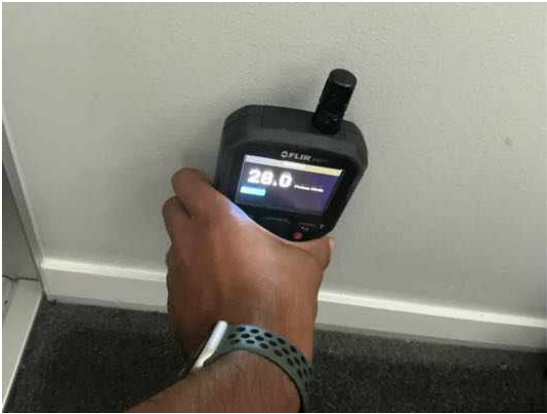
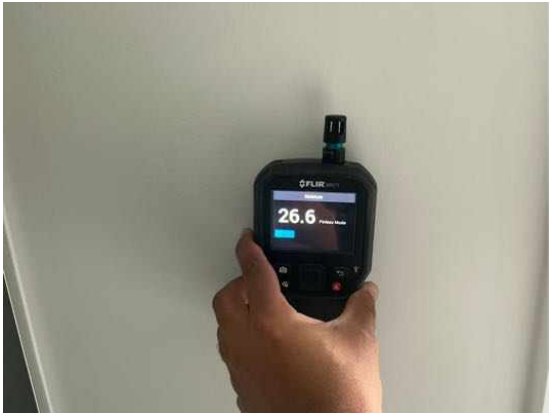
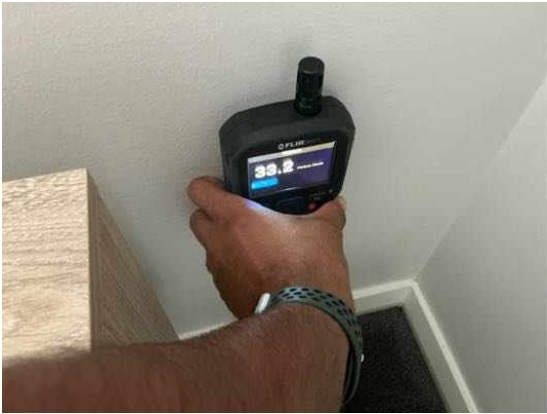
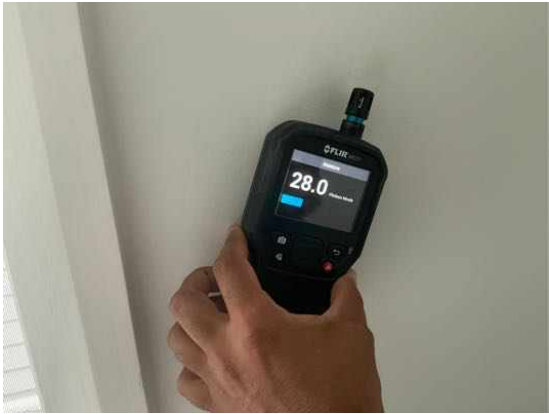
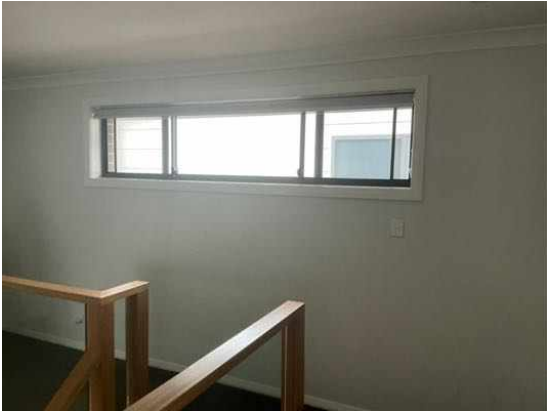
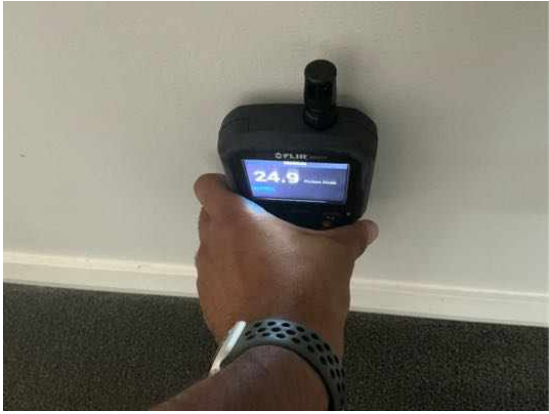
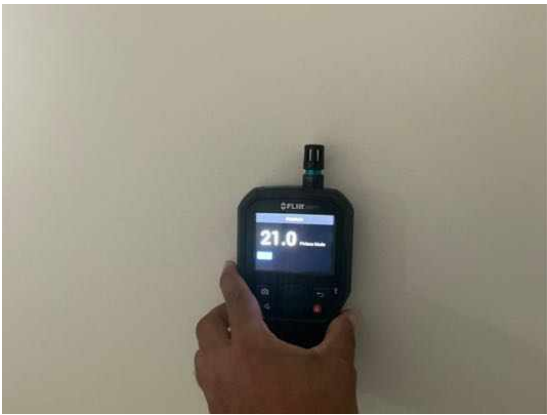
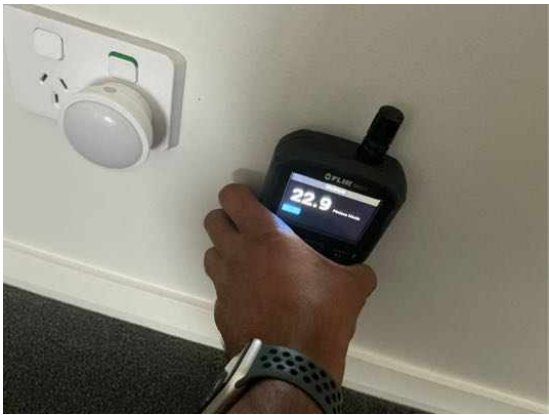
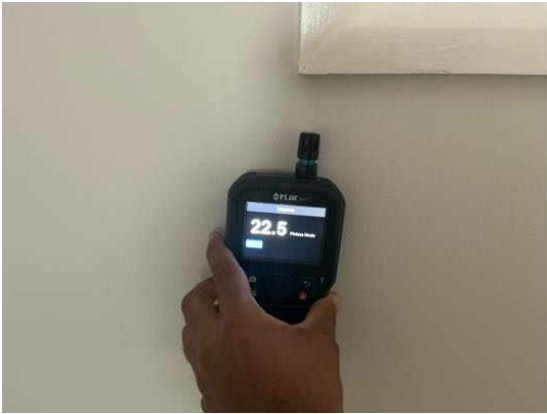
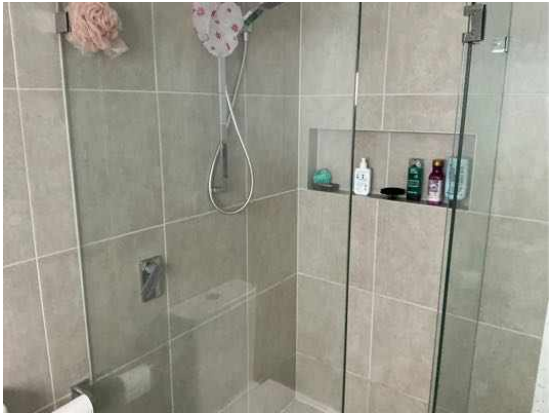
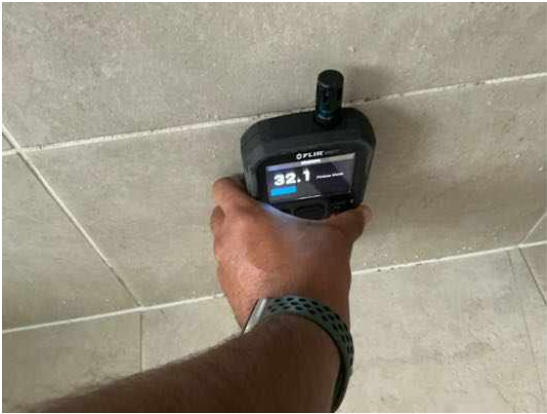
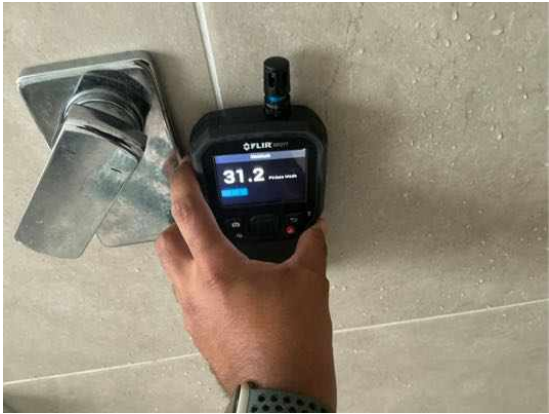
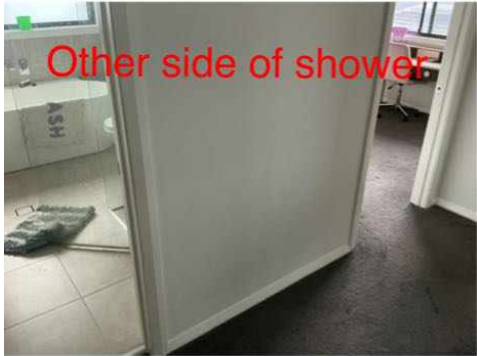
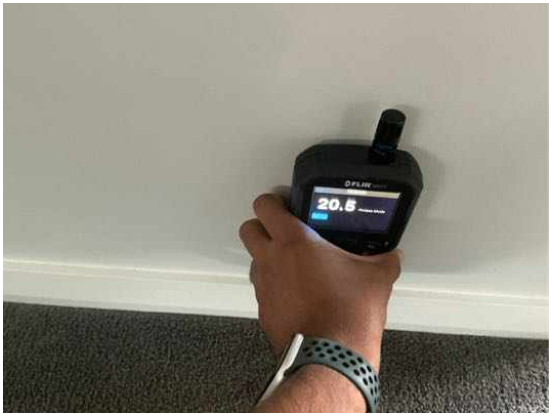
Building:	Main Building
Location:	All Areas
Finding:	Additional Photos - Moisture Meter Readings
Information:	Additional moisture meter reading photos have been provided for the property to offer further clarity on areas tested during the inspection. These photos are intended to give a visual reference for the specific locations where moisture levels were measured. These readings were taken at the time of the inspection to assess any potential moisture-related issues within the property. Any defects related to moisture that were identified during the inspection have been separately mentioned in the defect statements within the report.
