Building and Timber Pest Inspection Report

Inspection Date: Thu, 19 Mar 2026

Property Address: 9 Flametree Dr, Melonba NSW 2765, Australia

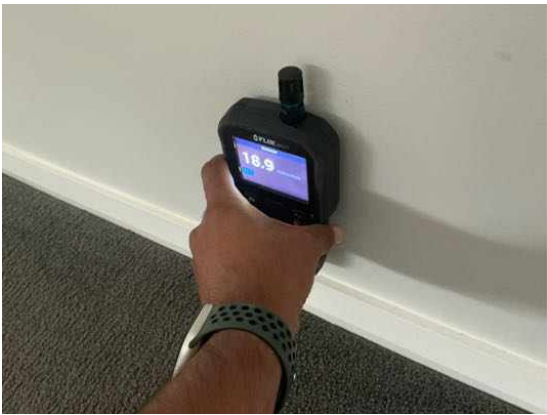
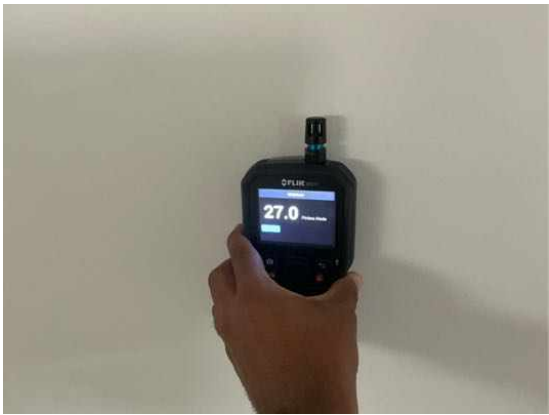
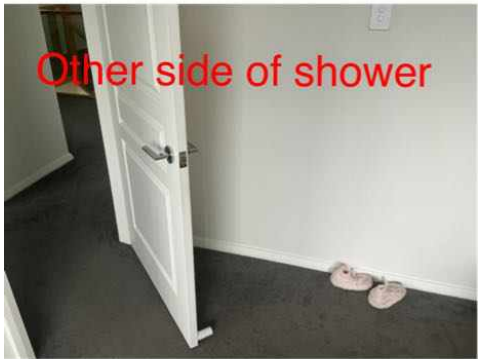
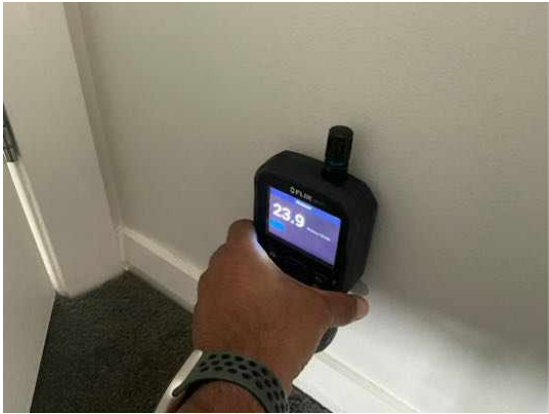
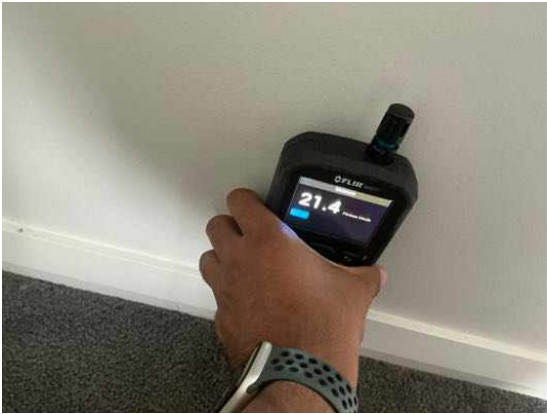
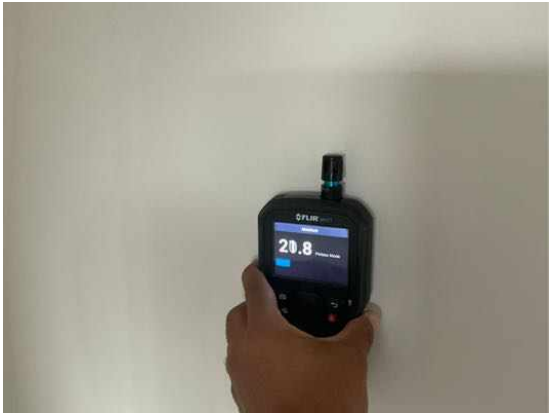
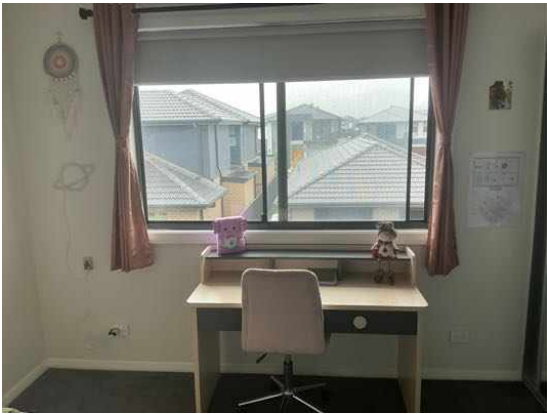
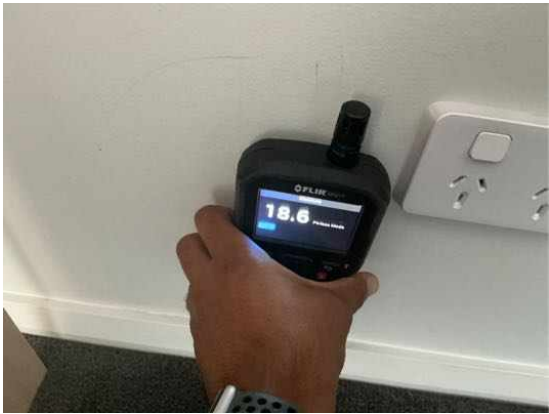
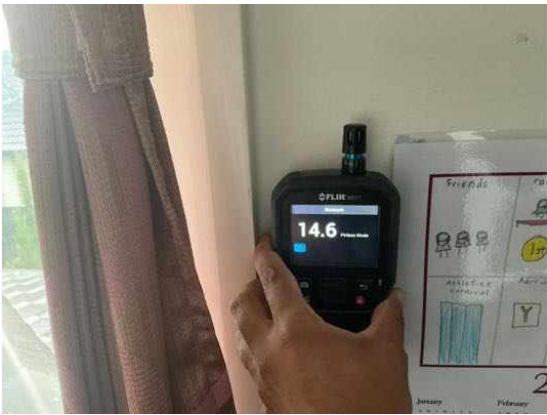
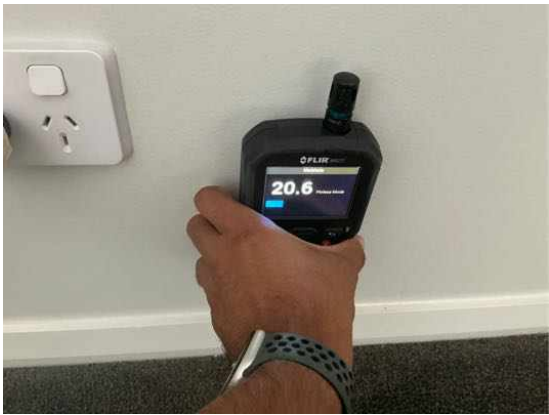
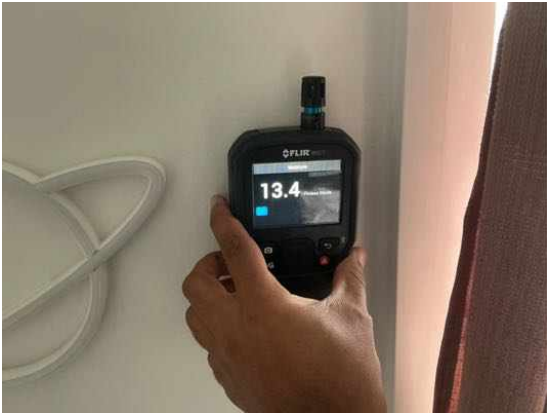
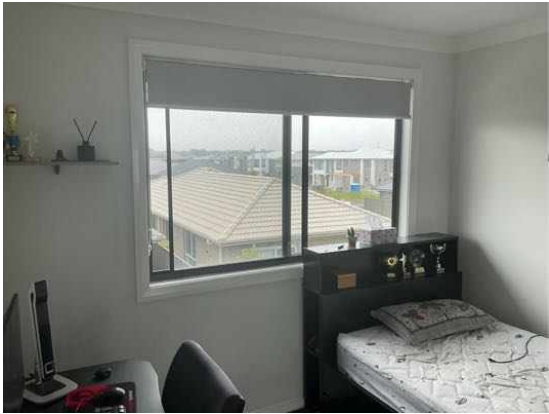
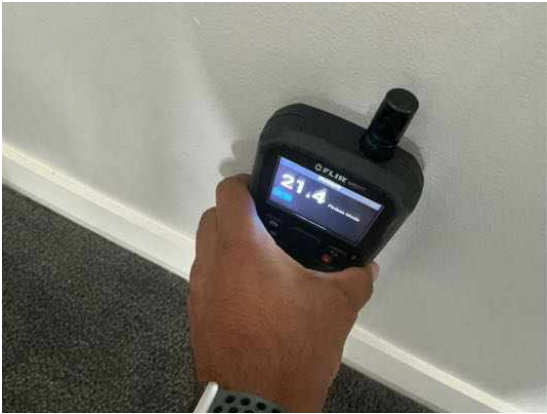
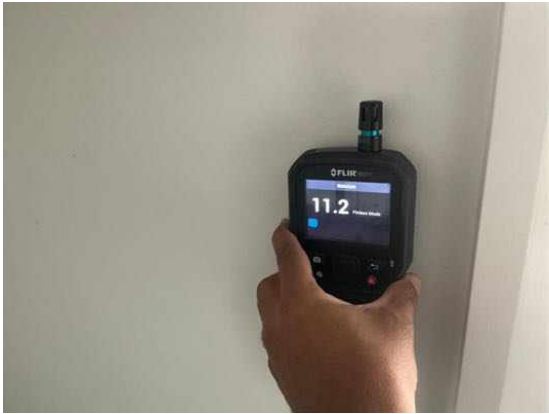
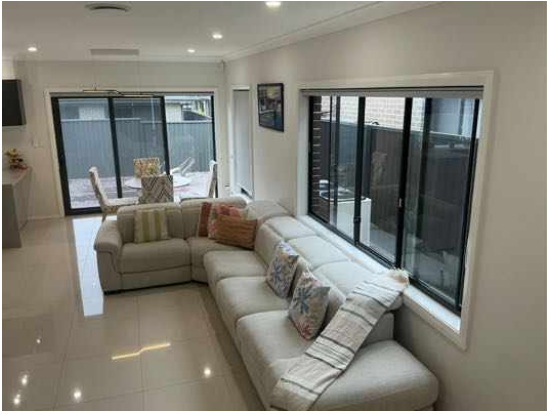
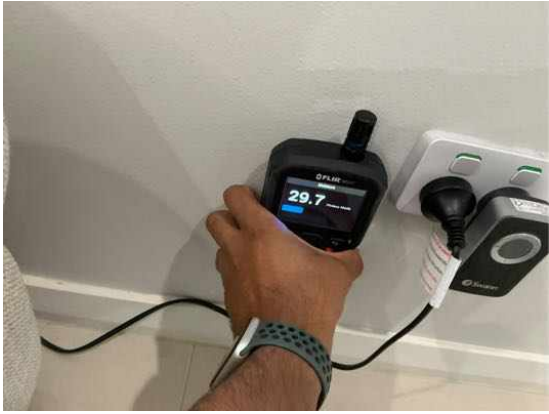
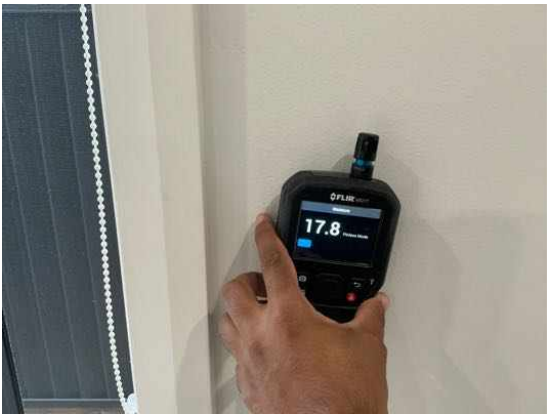
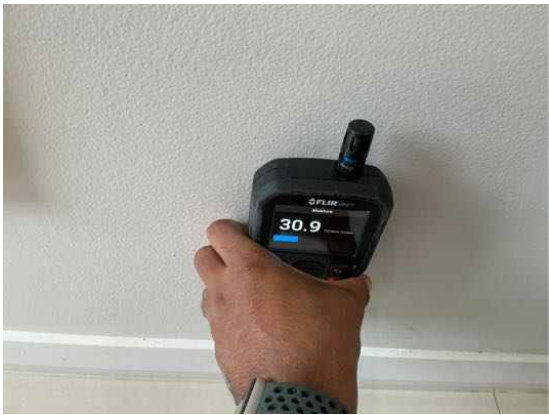
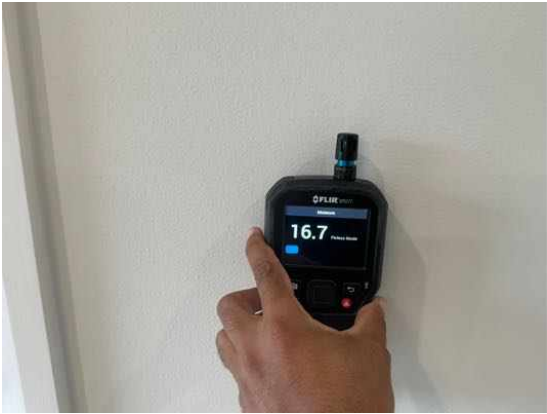
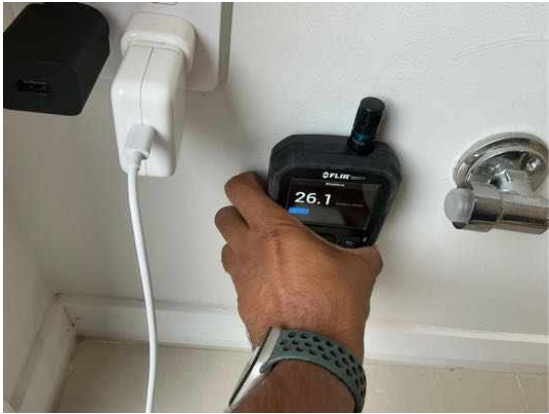
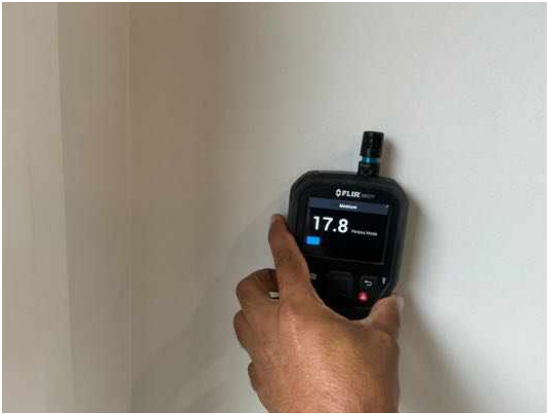
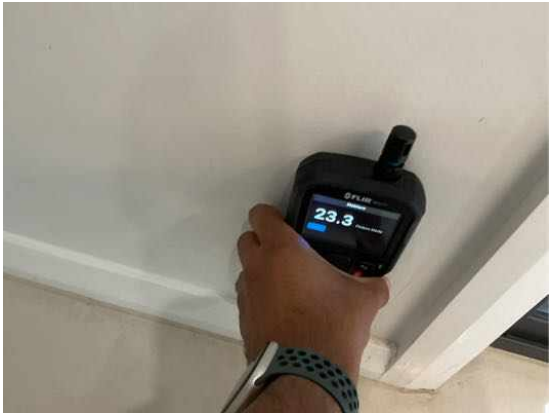
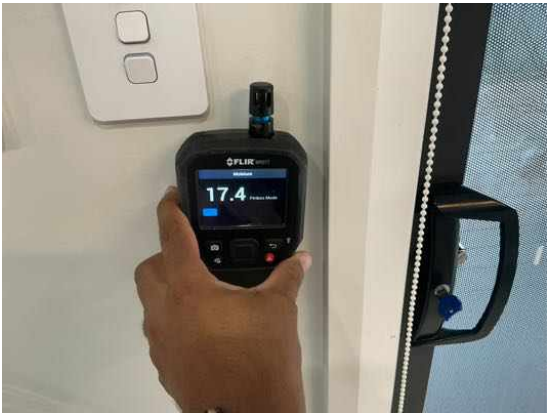
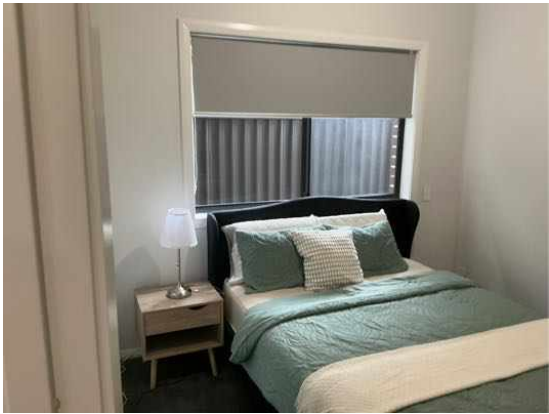
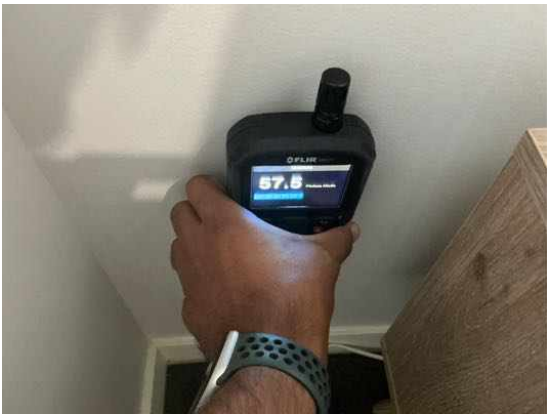
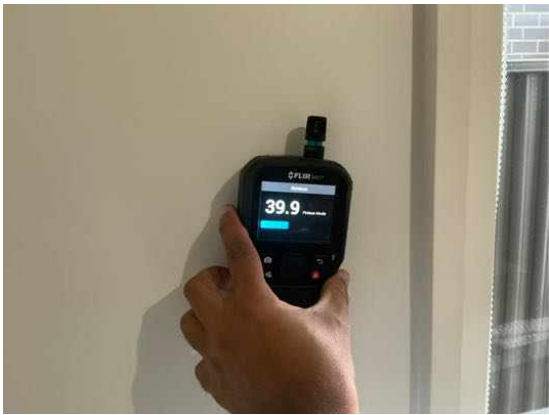
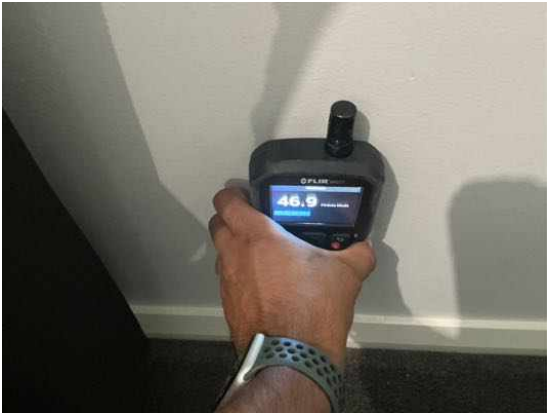
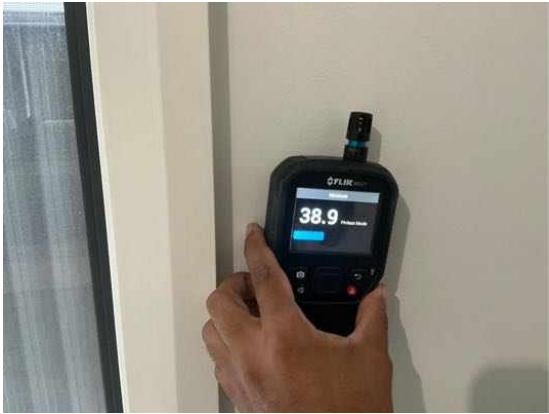
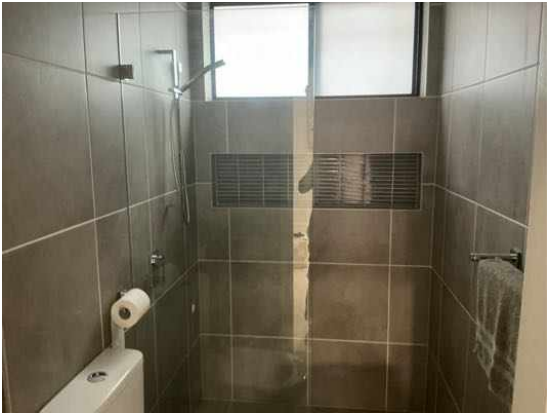
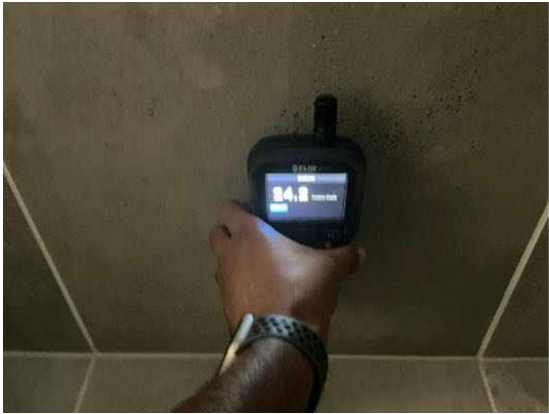
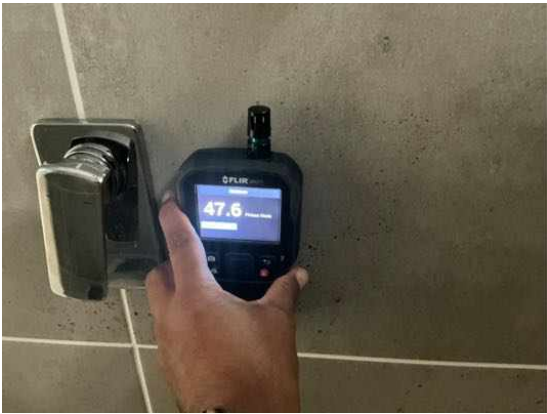
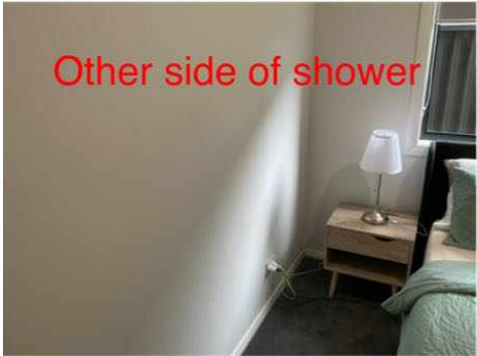
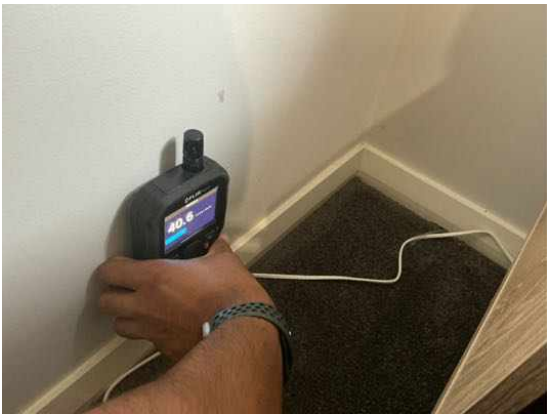
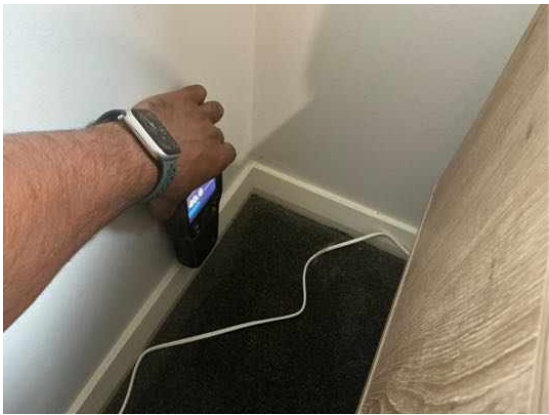
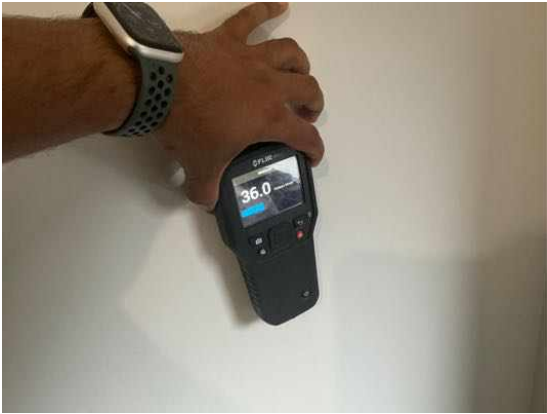
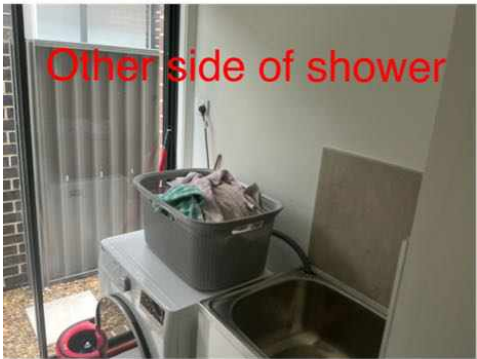
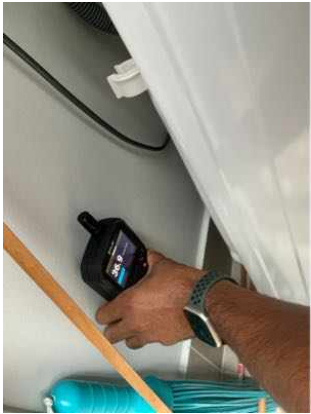
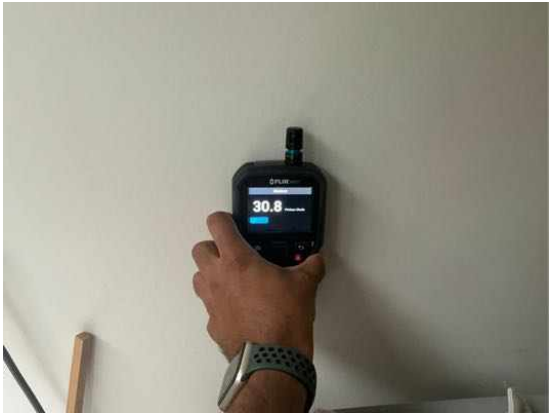
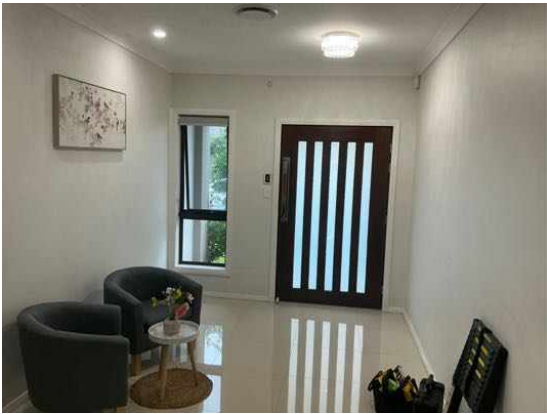
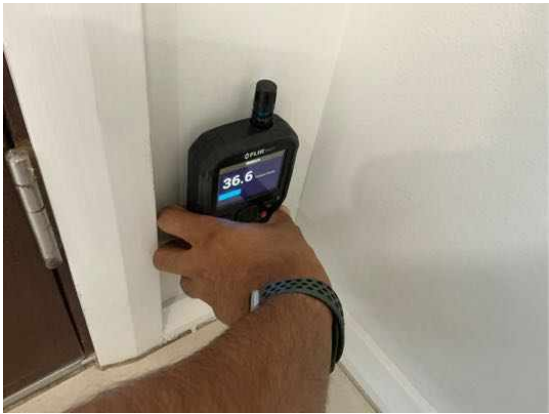
Building:	Main Building
Location:	All Areas
Finding:	Additional Photos - Moisture Meter Readings
Information:	Additional moisture meter reading photos have been provided for the property to offer further clarity on areas tested during the inspection. These photos are intended to give a visual reference for the specific locations where moisture levels were measured. These readings were taken at the time of the inspection to assess any potential moisture-related issues within the property. Any defects related to moisture that were identified during the inspection have been separately mentioned in the defect statements within the report.

It is important for the client to understand that moisture levels can fluctuate over time due to various factors, including changes in weather, humidity, and environmental conditions. While the readings reflect the property's moisture levels during the inspection, they may not represent future conditions, and increased moisture could lead to issues such as dampness, mould growth, or deterioration of building materials if left unmonitored.

For further clarification or additional information regarding the moisture readings, the client is encouraged to contact the building inspector directly. Regular monitoring of moisture-prone areas is recommended to ensure any emerging concerns are addressed promptly, particularly during wetter seasons or in high-humidity conditions.

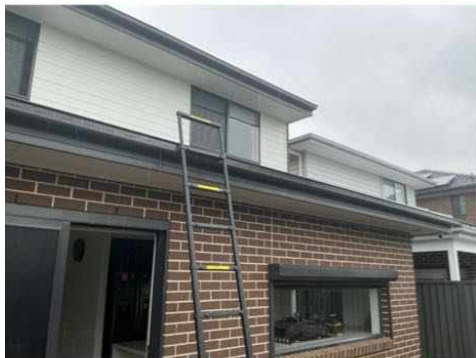
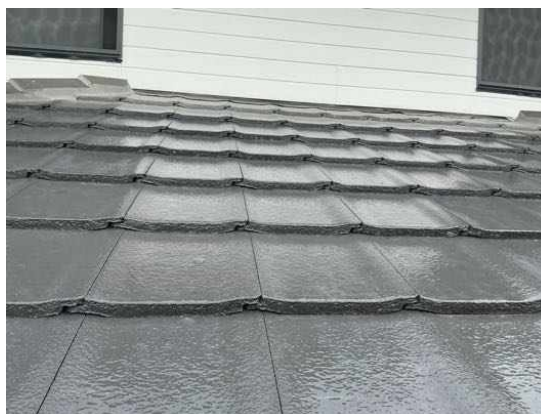
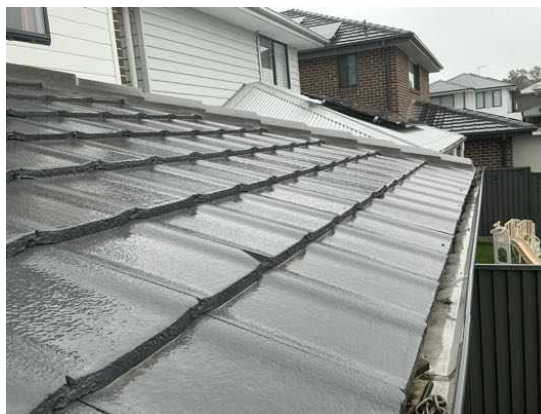
Building: Main Building
Location: Roof Exterior
Finding: Additional Roof Photos
Information:

As part of the information provided, please note that the attached roof photos represent the condition of the roof at the time of inspection. These photos are for visual reference only and do not constitute a detailed roofing assessment. Any defects or issues identified with the roof are mentioned separately in the defect statements. It is strongly recommended that the client engage a qualified roofer to conduct a thorough inspection of the roof, ensuring that any potential issues, such as leaks, structural integrity, or wear and tear, are properly identified and addressed.

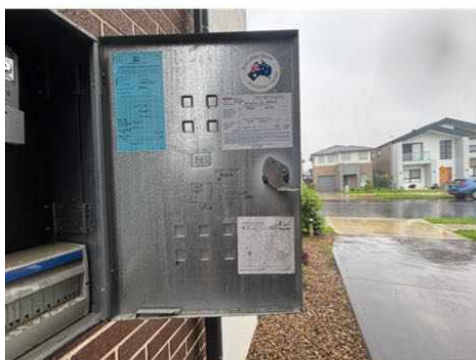
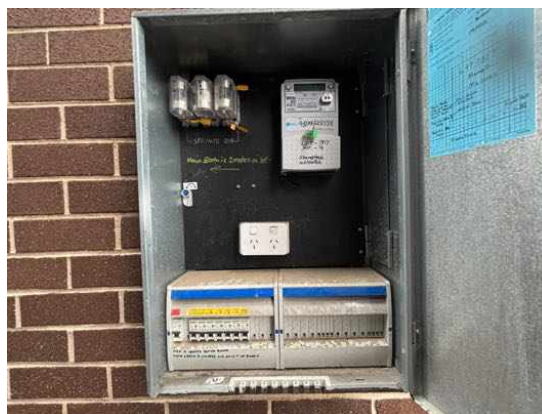
Building: Main Building
 Location: Meter Box
 Finding: Termite Management Recommendation – No Evidence of Chemical Installation
 Information: At the time of inspection, there was no visible evidence of a chemical termite management system installed around the property. Chemical barriers are a key component of termite protection and are particularly important in preventing concealed termite entry into timber elements of the structure.

In accordance with standard requirements, a durable notice should be located within the electrical switchboard to detail any termite protection systems applied, including chemical treatments. No such notice was observed during the inspection.

It is recommended that the client engage a licensed pest controller to assess the suitability of installing a chemical barrier, and to provide advice on associated costs and procedures. This should be considered a short-term priority, particularly if the property has any history of termite activity or is located in a high-risk area.

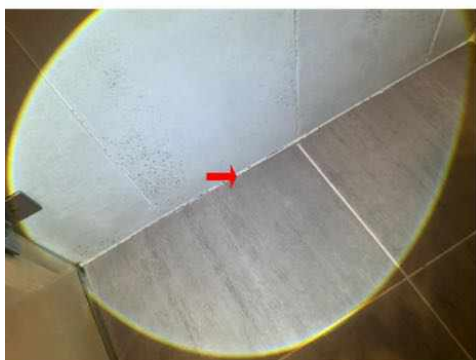
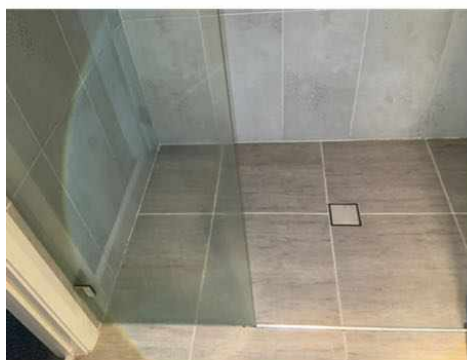
Building:	Main Building
Location:	Ensuite - Master
Finding:	Suspected Mould - Sealant
Information:	At the time of inspection, mould growth was observed on the sealant within the wet areas, indicating prolonged moisture exposure and inadequate ventilation. Mould can deteriorate the integrity of the sealant over time and pose hygiene concerns.

The affected sealant should be removed and replaced with a high-quality mould-resistant silicone, and the area should be thoroughly cleaned and treated to remove existing mould. Adequate ventilation should be maintained to prevent recurrence.

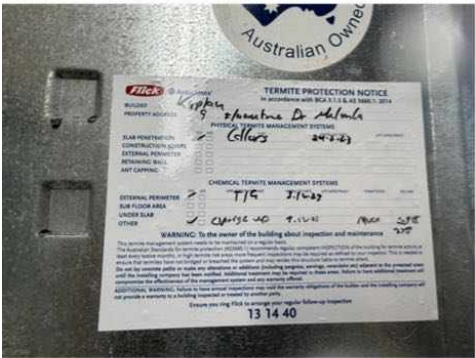
The following items were noted as - Evidence of a previous termite management program

Where a Termite Management System has been identified you should refer to the type of barrier date of installation warranty conditions and any documentation provided by a builder or past owner. Consult the company who installed the barrier to confirm whether the system is still under warranty.

Most chemical termite management systems expire and require replenishment and all physical systems are primarily designed to prevent concealed entry.
