Building and Timber Pest Inspection Report

Inspection Date: Tue, 7 Apr 2026

Property Address: 26/293 Alison Rd, Coogee NSW 2034,
Australia

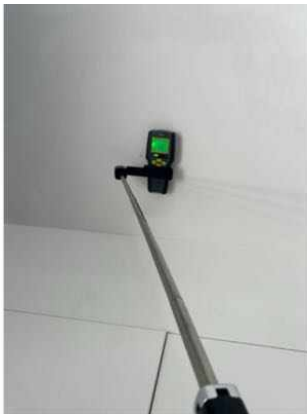
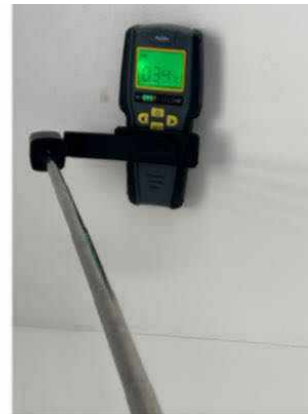
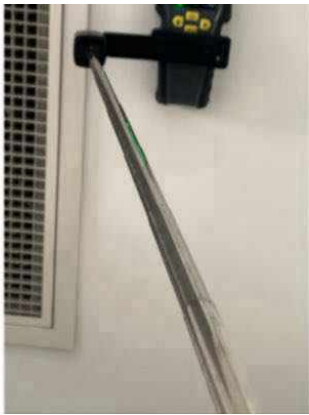
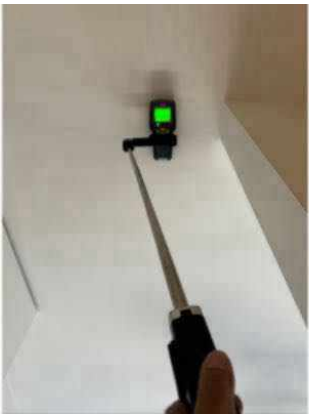
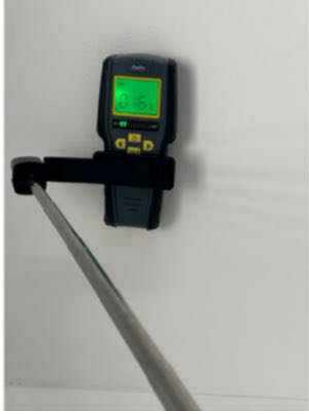
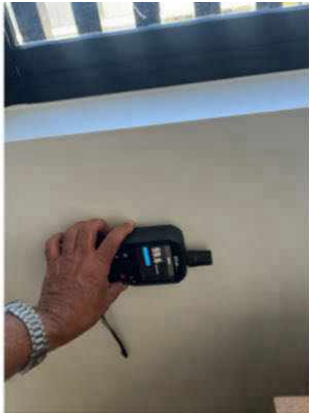
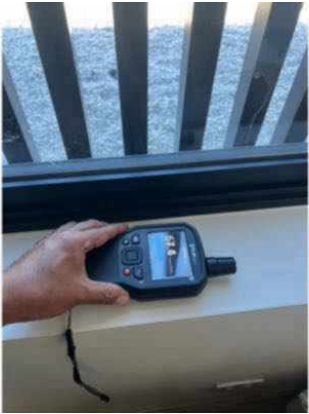
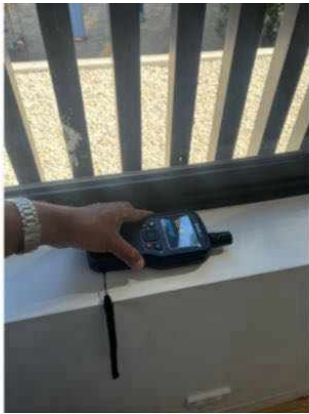
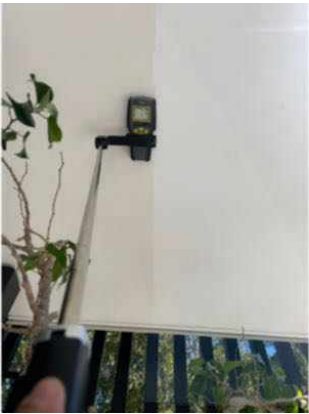
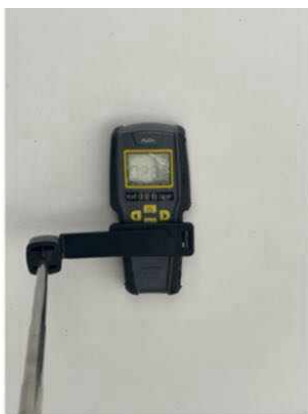
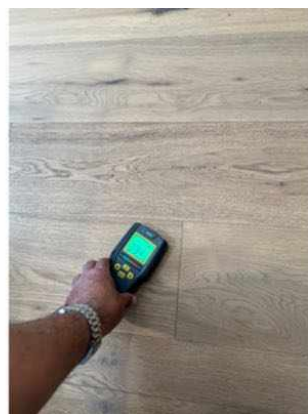
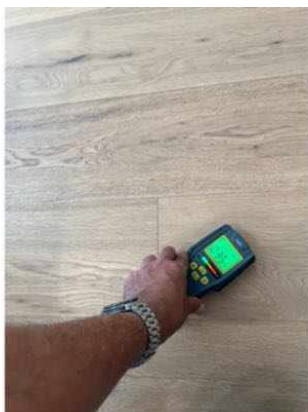
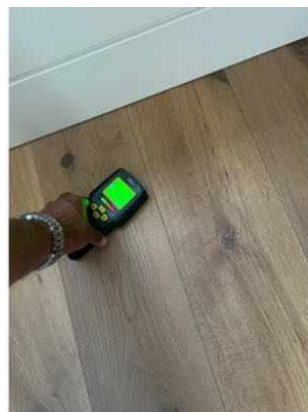
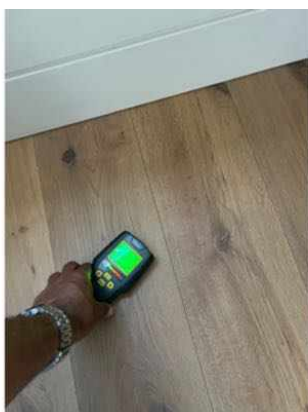
Finding 3.01

Building:	Main Building
Location:	All Internal Areas - Hallway ceiling and master bedroom ceiling , master Bedroom rear wall , external awning, Floor near kitchen area
Finding:	Elevated Moisture – Further Investigation Recommended
Information:	Elevated moisture readings were detected in several locations, although no significant structural damage was evident at the time of inspection, dampness can contribute to deterioration if left unaddressed. A further investigation by a licensed plumber/licensed waterproofing contractor is recommended to confirm the source and ensure no concealed issues are developing. Given the walls are adjacent to the shaded structure , it also increases the likelihood of moisture ingress to the dwelling.

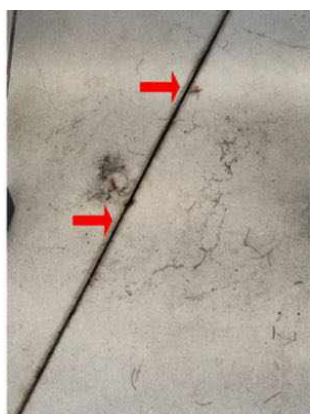
Building: Main Building
Location: Balcony
Finding: Balcony Elevated Moisture - Strata
Information: Slightly elevated moisture was recorded at the base of the balcony tiles, with associated dark staining within the grout consistent with water exposure.

The readings were relatively consistent across the tested areas. While no internal damage was visible at the time of inspection, balconies in multi-unit dwellings are high-risk areas for waterproofing failure, which can lead to leaks into adjoining units and significant rectification costs. Further investigation by a licensed waterproofing contractor is strongly recommended.

Depending on the strata plan, this area may form part of the common property, in which case remedial responsibility may rest with the owners corporation (strata). Purchasers should seek clarification from the strata manager and legal adviser prior to purchase.

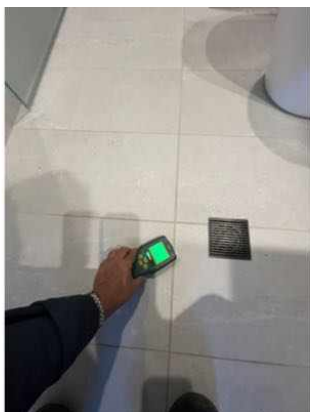
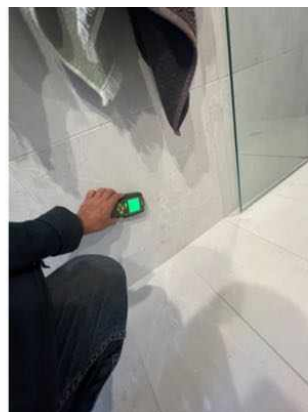
Finding 3.04

Building:	Main Building
Location:	All Internal Areas
Finding:	Elevated Moisture Bathroom (No visible deterioration noted)
Information:	Slightly elevated moisture levels were detected to tiled surfaces in bathroom/shower areas. Persistent moisture ingress can lead to concealed damage, including timber rot and mould growth.

Elevated moisture readings in tiled wet areas can occur from normal shower use, age/deterioration of waterproofing membranes, plumbing leaks or moisture absorption through grout lines. While no damage was visible, elevated readings may indicate

moisture retention behind tiles, which can be a conducive condition for future deterioration if not monitored.

Monitor the area over time for signs of drumming, efflorescence, tile movement, or grout deterioration. A further inspection by a licensed waterproofing specialist is recommended to determine cause of elevated moisture (e.g., pressure testing, membrane assessment).

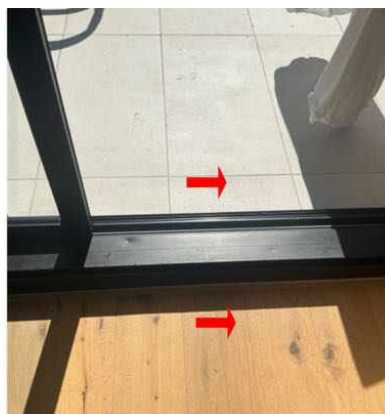
Finding 3.05

Building:	Main Building
Location:	All Internal Areas
Finding:	Balcony Floor Level Differential
Information:	The balcony finished surface appears to be close to, or at the same level as, the internal floor. Standard construction practice requires a step-down of approximately 50 mm unless a fully engineered threshold drainage system is provided. No such drainage features were visible during inspection. This configuration increases the risk of water ingress, and confirmation of the balcony waterproofing detail through strata/building management is recommended.

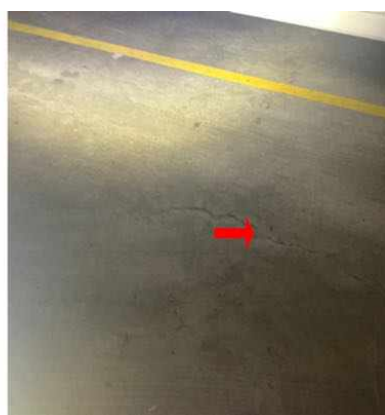
Finding 3.06

Building:	Main Building
Location:	All Internal Areas
Finding:	Cracking - External Concrete Paving Damage Category 1 - Fine (less than 2mm)
Information:	Fine cracks were identified in external concrete paving. Although fine cracks are quite noticeable, they are often only considered to be an appearance defect, and usually do not indicate any structural damage. To be considered a Category 1 or fine crack, the crack is found to be less than 2mm in width.

Generally the cause of a hairline crack in existing concrete paving such as driveways and pathways is indicative of the expansion and contraction of the concrete. Such causes are generally due to environmental factors, such as moisture levels, weather conditions, root systems of nearby trees or the soil types on which they are laid.

Fine cracks may also be due to poor original installation of the concrete. Factors such as poor compaction of the sub surface and/or inadequate reinforcing of the slab may create cracking and other secondary defects.

Monitoring of all cracking should be conducted frequently. Always contact a building inspector should cracks widen, lengthen, or become more numerous.

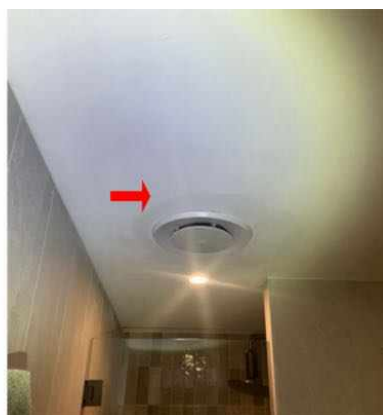
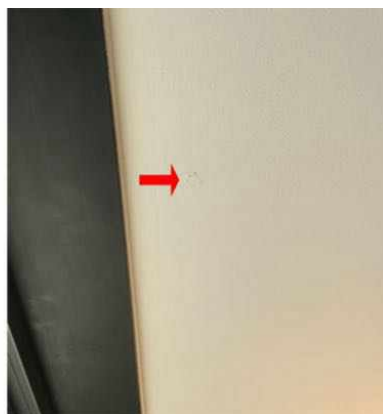
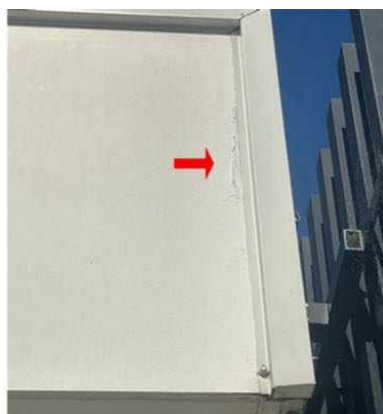
Finding 3.07

Building:	Main Building
Location:	All Internal Areas
Finding:	Paint finish and hairline cracking
Information:	The paint finish in this area was identified as being incomplete at the time of inspection including some hairline minor cracking.

Whilst incomplete or missing paint and minor cracking and imperfections in finish is generally an appearance defect, it can also lead to the development of secondary building defects over time. Incomplete areas of paint finish expose the area to moisture, potentially accelerating the deterioration of underlying building materials.

Incomplete paint finishes should be sanded back, filled, leveled and painted, as applicable. Where inadequate or missing paint protection has led to the deterioration of the associated building element, repair and/or replacement of this building element may be required.

A painting contractor should be appointed as soon as possible to perform necessary works to aid the appearance of the affected area and to ensure the area is protected against further deterioration. Alternatively, the homeowner following manufacturer instructions may perform these works.

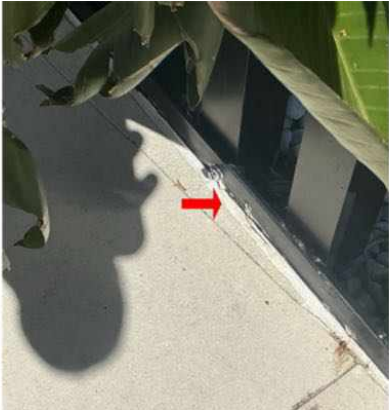
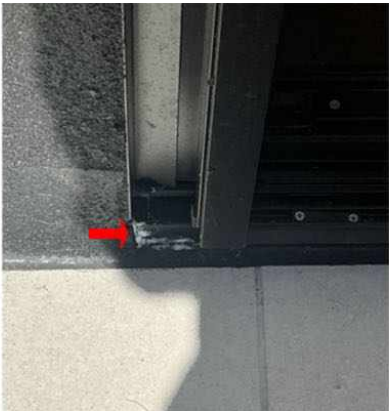
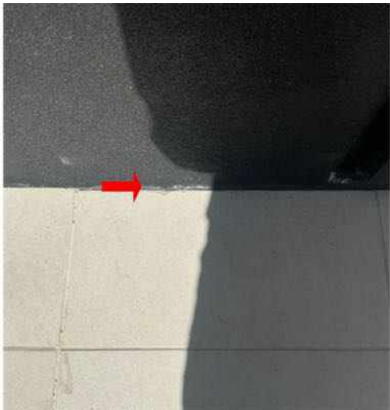
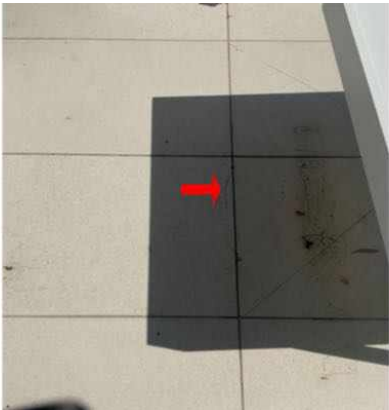
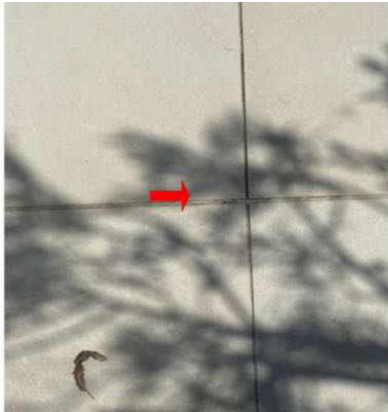
Finding 3.08

Building:	Main Building
Location:	All Internal Areas
Finding:	Sealant and grouting - Missing or degraded
Information:	It was noted on inspection that sealant or grout is degraded. There is also evidence of poor workmanship and excessive use of sealant. Silicone should never be used as a first line of defence against waterproofing. Further inspection by a licensed waterproofing contractor is highly recommend

Different materials and floor areas move at different rates, generally causing cracking to grout or sealant at this point. A flexible sealant is required to allow for expected expansion and contraction, while keeping the joint water tight and protective of all associated building materials.

There appears to be excessive mould to the sealant and grout which will likely require scraping out and replacement.

Flexible and mould resistant materials should be applied to affected areas to prevent any subsequent water damage that is likely to occur. Regular maintenance and replacement of damage or missing or damaged sealant and grout is highly recommended to the wet areas, as this is a regular wear and tear defect. Sealant and grouting in areas that come into regular contact with water should be maintained for the long term care of your property.

A sealant specialist or tiling contractor should be appointed to complete these works as soon as possible

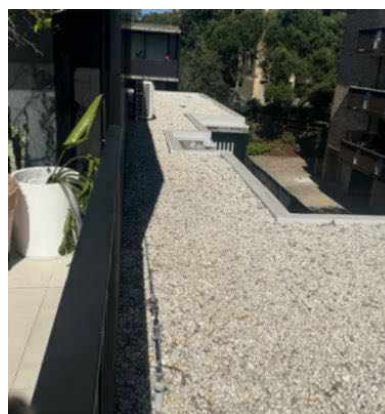
Building:	Main Building
Location:	All Internal Areas
Finding:	Pebbles on Roof Structure
Information:	The flat roof area is finished with loose pebble ballast, which is commonly used to protect waterproofing membranes from UV exposure and mechanical damage, the loose stones may conceal roof drainage points, increasing the risk of water pooling or blocked outlets if not regularly maintained. The use of pebble ballast also introduces significant dead load—typically between 80–100 kg/m ² —which must be accounted for in the structural design in accordance with AS/NZS 1170.1, the waterproofing detail can't be verified during a visual inspection.

it is recommended that the adequacy of structural support for this loading be verified if not already certified.

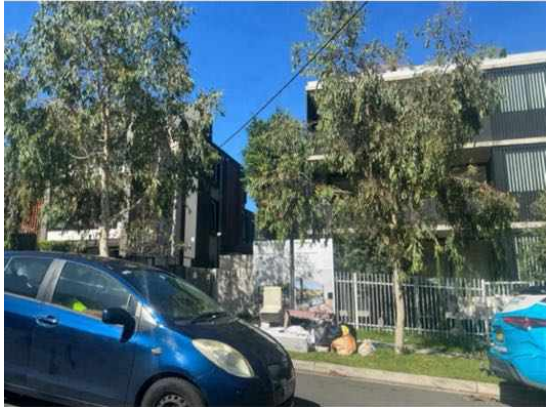
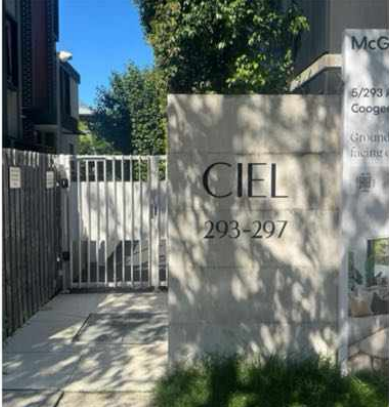
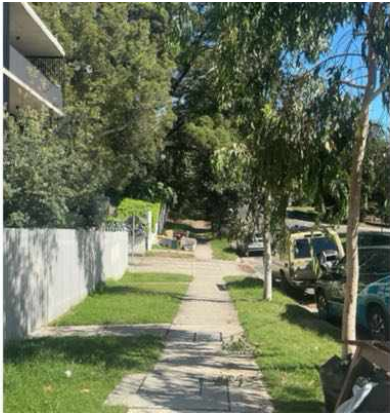
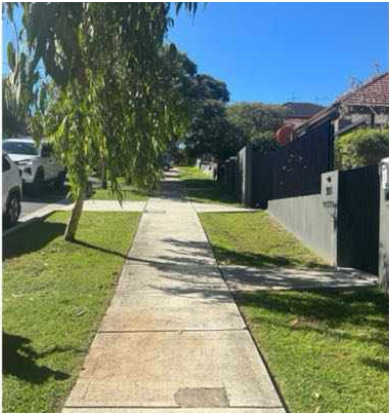
Building: Main Building
 Location: All External Areas
 Finding: Additional Photos - Obstructions and Limitations
 Information: These photographs are an indication of the obstructions and limitations which impeded full inspection of the property at the time of inspection. These obstructions can hide an array of defects and should be removed to allow full inspection to be carried out. A re-inspection is recommended once the areas are made accessible.

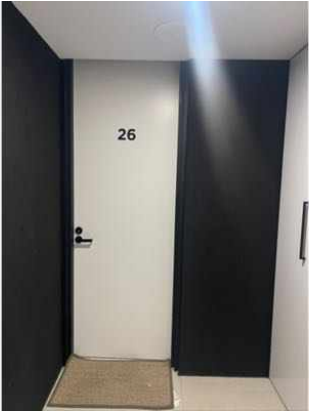
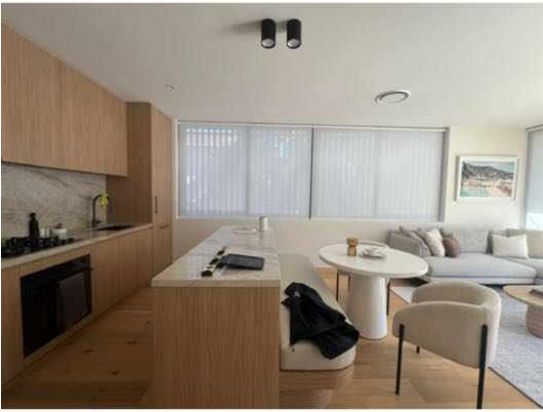
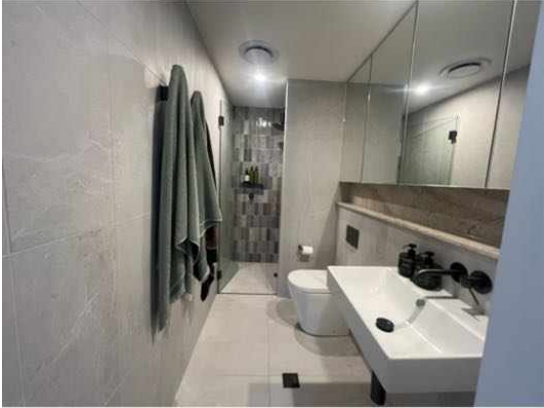
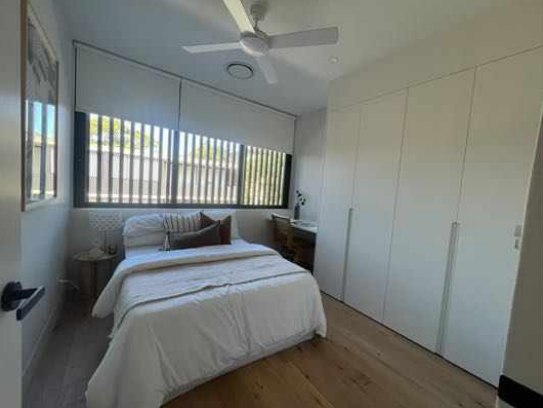
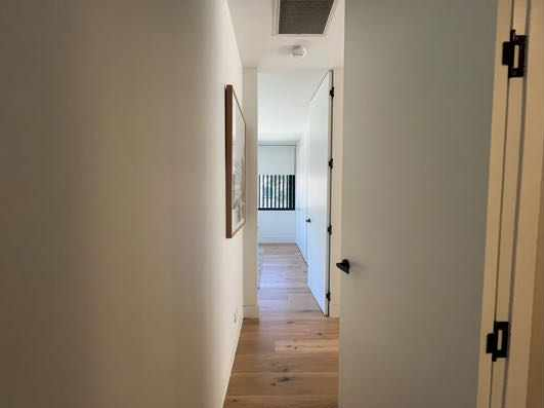
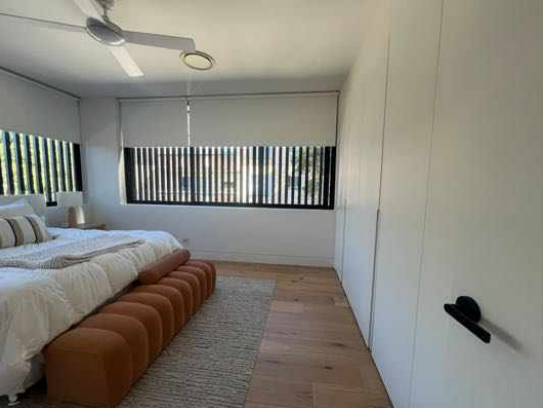
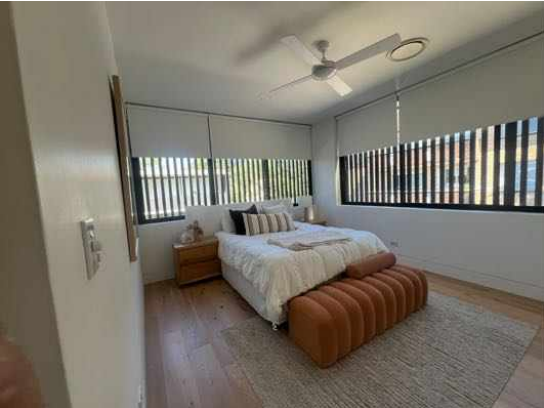
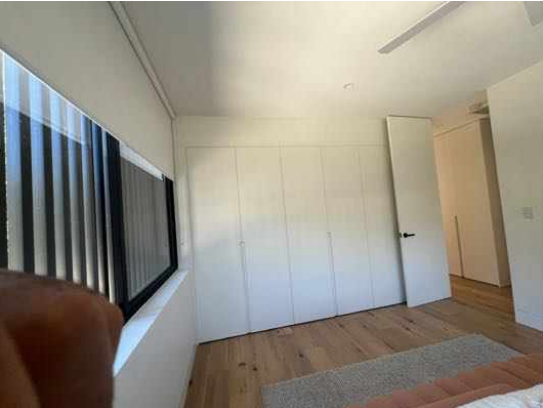
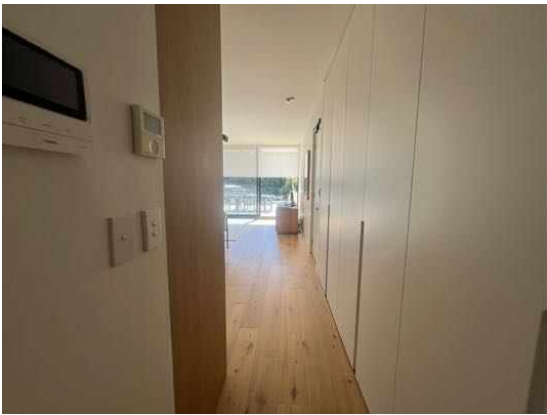
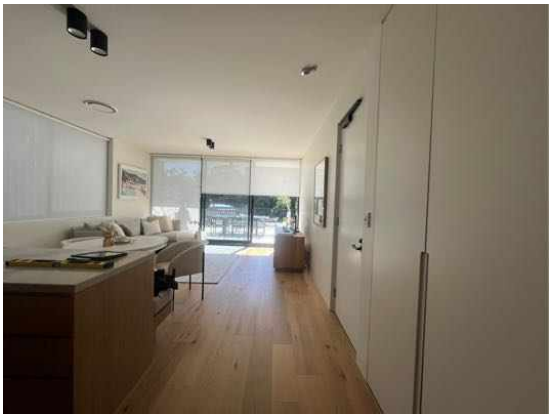
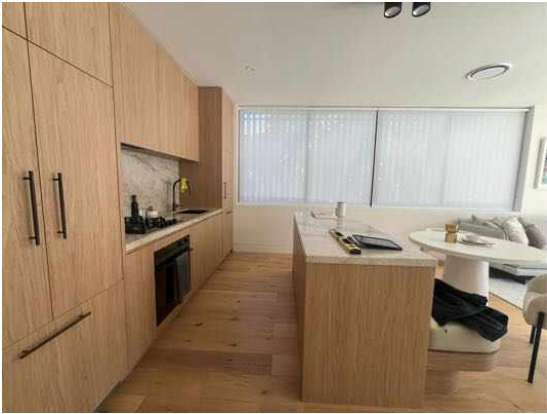
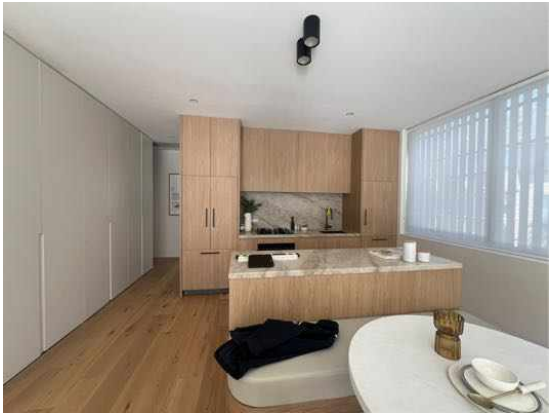
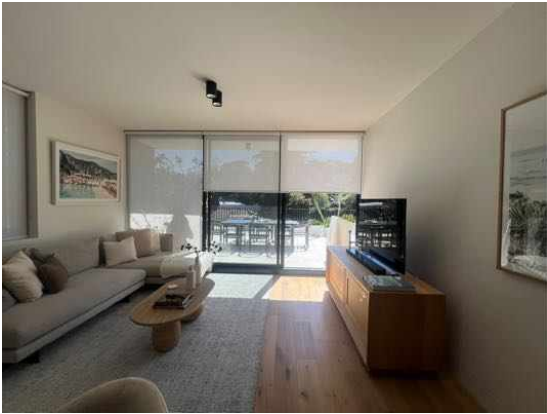
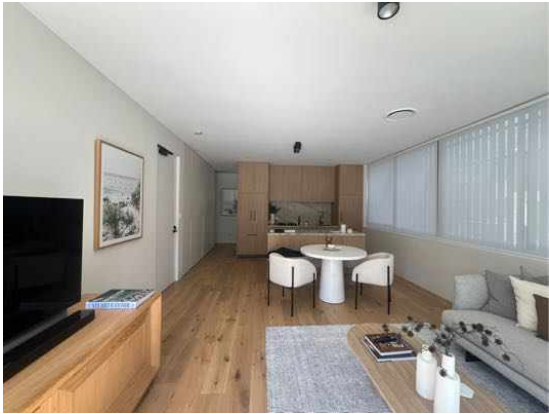
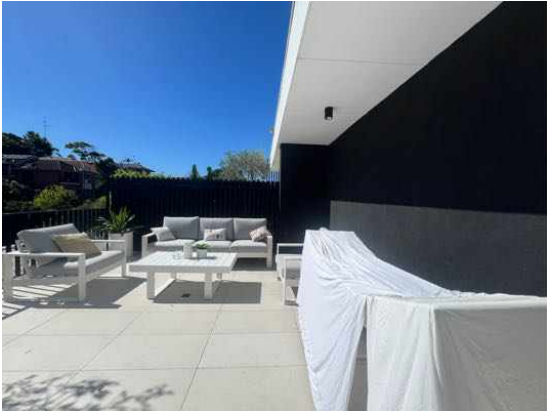
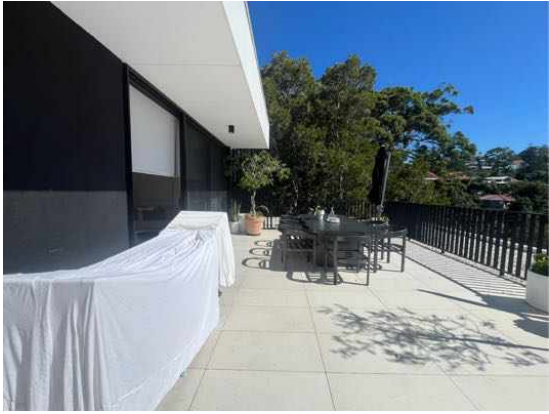
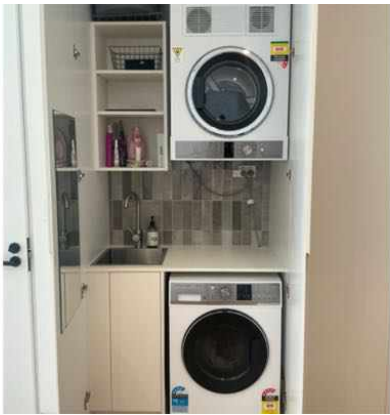
Building: Main Building
Location: All Internal Areas
Finding: Additional Photos - Obstructions and Limitations
Information: These photographs are an indication of the obstructions and limitations which impeded full inspection of the property at the time of inspection. These obstructions can hide an array of defects and should be removed to allow full inspection to be carried out. A re-inspection is recommended once the areas are made accessible.
