Building and Timber Pest Inspection Report

Inspection Date: Thu, 12 Feb 2026

Property Address: 19 Robert Rd, Cherrybrook NSW 2126,
Australia

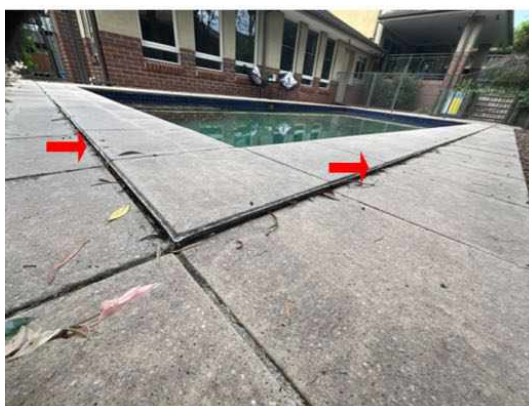
Building:	Main Building
Location:	Pool area
Finding:	Paving -- Uneven (Safety hazard)
Information:	Sections of the external paved area are uneven, creating a potential trip hazard. It appears as though the area has been subject to rough installation, or that paving sections have lifted due to movements in the foundation.

Where paving creates a trip hazard, personal injury may ensue if due caution is not taken by all persons within this area.

Re-paving of the area is required urgently by a landscaper to remedy this situation.

The pavers around the pool were found to be uneven, creating a safety hazard. Immediate repair must be carried out by a landscaper.

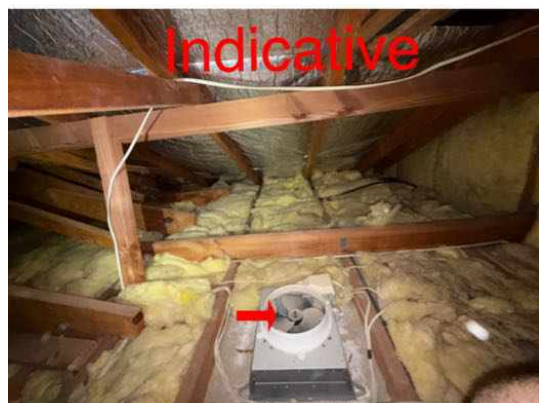
Finding 1.02

Building:	Main Building
Location:	Roof Void
Finding:	Roof void ventilation
Information:	Exhaust fans have not been connected to the outside through ducts. In further inspection, there was also no whirlybird installed to the roof surface for ventilation purposes.

(ii) the roof is clad in roofing tiles without sarking or similar materials which would prevent venting through gaps between tiles.

As the roof is fully sarked the vents are recommended to be ducted to the eave or a whirlybird be installed.

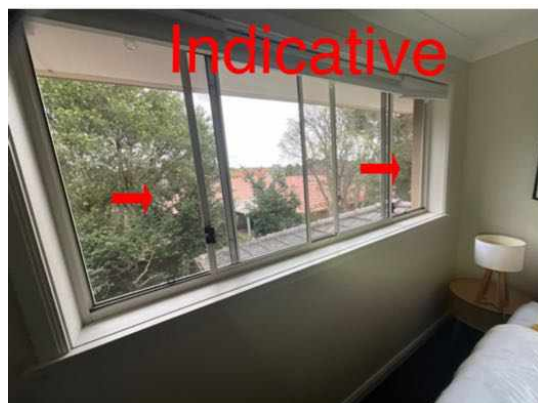
Finding 1.03

Building:	Main Building
Location:	Upstairs Windows
Finding:	Window restrictions - Missing
Information:	Window restrictors were found to be missing.

The National Construction Code (NCC) requirements apply to all openable bedroom windows in residential buildings, including hotels, motels and for all windows in early childhood centres.

Windows need to be locked at 12.5cm when the devices are engaged. The safety devices must be robust and child proof. The alternative is security screens such as bars or grills on the windows so long as they have gaps no bigger than 12.5cm. Flyscreens do not comply unless they are the reinforced security type and capable of resisting the very strong outward pressure which would prevent a child falling through. The laws apply to openable windows in a building within 1700mm of the internal floor and if the internal floor is more than 2m above the ground floor outside.

Windows upstairs lack appropriate child locks, creating a safety hazard. Window restrictors must be installed on these Windows immediately for added safety.

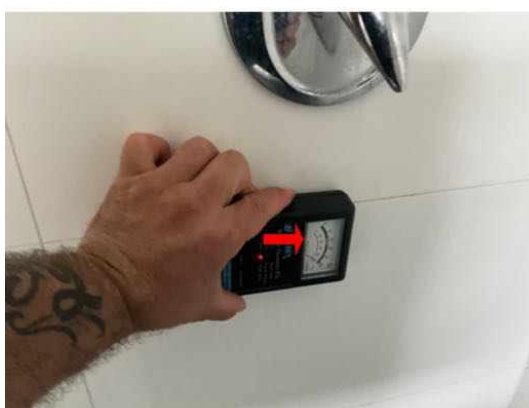
Finding 2.01

Building:	Main Building
Location:	Bathroom
Finding:	Water leak - Suspected
Information:	A water leak is suspected in this area as excessive moisture was detected at the time of inspection. Another potential cause maybe moisture ingress behind the tiles from around the wall fittings and penetrations.

Internal water leaks can be detrimental to surrounding building elements; their potential causes include damage to plumbing fittings and fixtures, through to water damage and deterioration of associated building elements.

Attracting termites, corrosion, mould, decay and water damage are potential outcomes where a minor water leak is left unattended. More serious defects may also result, such as electrical hazards, or water damage to structural building elements.

In extreme cases, structural damage may develop due to a prolonged water leak. It is highly advised that internal water leaks be addressed by a licensed plumber as a matter of relative urgency.

Excessive moisture was identified to the walls in the bathroom shower. There maybe a water leak OR otherwise moisture maybe penetrating around the fittings. A licensed plumber must be appointed urgently for further assessment and repairs.

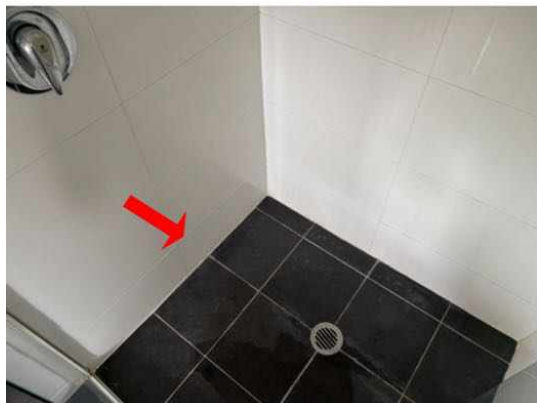
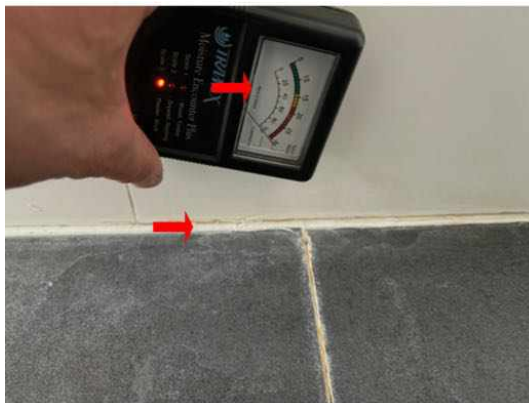
Finding 3.01

Building:	Main Building
Location:	Ensuite
Finding:	Shower damp - Sealant and grout
Information:	Damp is evident to the lower 400mm of wall to the shower alcove. This defect is quite common, and is suspected to have been caused by moisture permeating or leaching through the grouting and sealant in this area, which shows evidence of deterioration. Leaking pipes within the wall is also a possible cause however this seems unlikely in this instance as there is no moisture build up around the taps or transferring to the other side of the wall. There appears to be no sealant around the tap spindles which may be a small contributing factor.

Damp (or structural damp) refers to the presence of unwanted moisture in the structure of a building, either as the result of intrusion from outside, or condensation from within the structure. In the shower area, internal water leaks, degraded materials or other sources of excessive moisture are generally the cause of damp.

Unmanaged damp in the shower recess is likely to facilitate the formation and development of mould and fungi growth, decaying associated building materials and compromising their structural integrity of associated elements. It is important to address damp conditions, as the World Health Organisation notes that excess moisture leads - on almost all indoor materials - to growth of microbes such as moulds, fungi and bacteria, which subsequently emit spores and other matter into the indoor air. Exposure to these contaminants is associated with a wide range of respiratory and other health-related problems. Damp conditions also create a conducive environment for termite infestation.

Consultation with a bathroom sealant specialist is advised immediately to identify the cause of damp and to perform remedial works as required.

Always ensure that sealant and grout is in good condition to prevent any moisture issues occurring in the future.

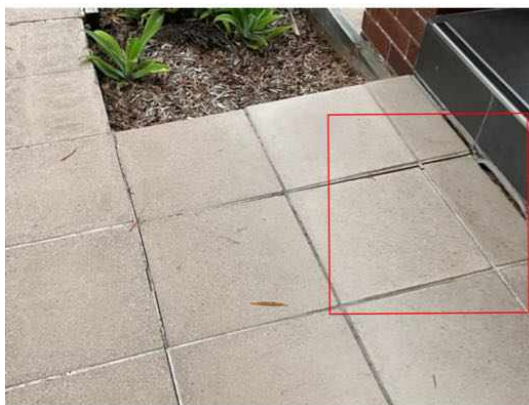
Finding 3.02

Building: Main Building
 Location: Backyard
 Finding: Paving — Uneven
 Information:

Sections of the external paved area are uneven, which may develop into a trip hazard. It appears as though the area has been subject to rough installation, or that paving sections have lifted due to movements in the foundation.

Left unmanaged, the May develop into a safety hazard due to trip and fall.

Re-paving of the area is required to remedy this situation. Further consultation with a specialist concreter is advised.

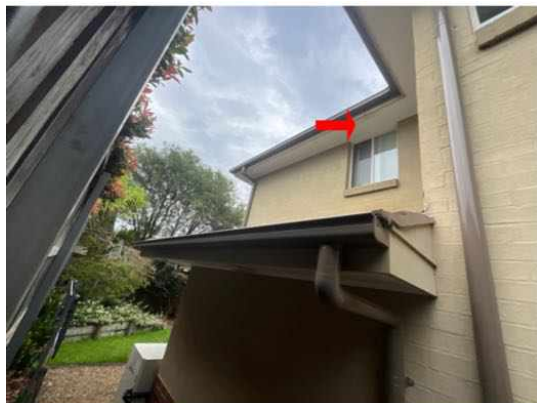
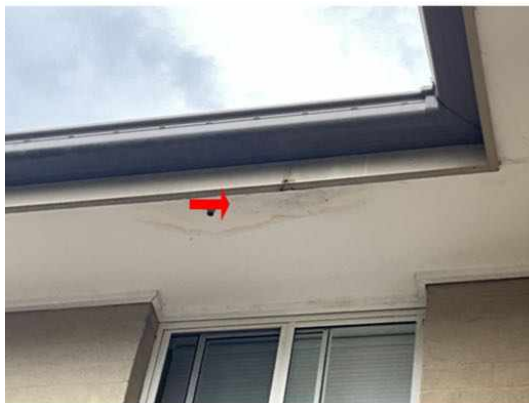
Finding 3.03

Building: Main Building
 Location: Eaves - RHS
 Finding: Eaves/Roof plumbing -- water damages
 Information:

Water damage is generally an indication of excessive moisture being present, usually via a leak. It is suspected that gutter blockages causing stormwater to backflow into the eaves causing water damages. This is additionally conducive to termite activity due to the damp conditions.

Where water damage is evident, the primary requirement is to identify and rectify the source of the leak. Gutters must be kept clear of any blockages moving forward. A roofing plumber should be appointed for further assessment if the problem persists.

Once the leak is repaired, consultation with relevant tradespeople, including carpenters, plasterers and painters, is advised.

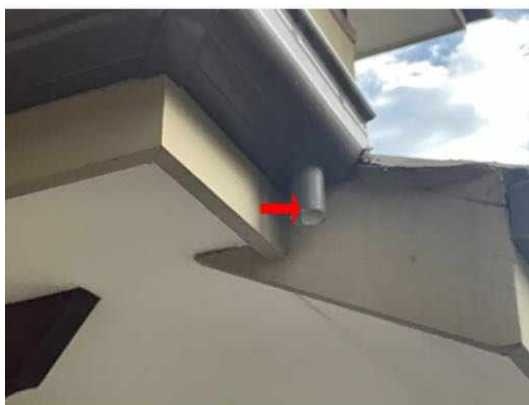
Finding 3.04

Building:	Main Building
Location:	Multiple areas
Finding:	Stormwater drain - Not connected
Information:	The roof plumbing is not adequately connected to stormwater drainage on the site. This disconnection negatively impacts the functional capacity of the roof plumbing.

Where roof plumbing doesn't drain adequately, the area at the base perimeter can become excessively damp, potentially creating an environment that is susceptible to rust and corrosion of surrounding building elements, as well as attracting termites and other pests.

It is highly recommended that a plumber be appointed to further inspect the area and to install adequate drainage equipment where necessary.

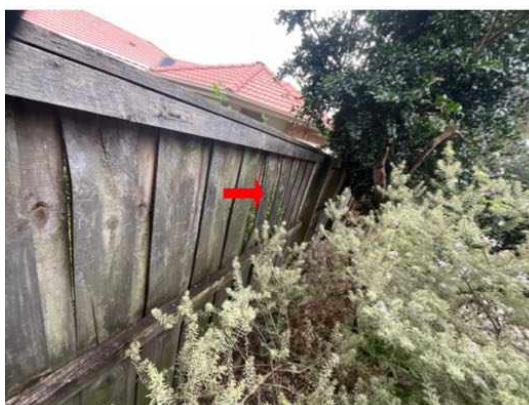
Finding 3.05

Finding: Fencing - Deteriorated

Information: It was noted at the time of inspection that sections of the fencing in this area has deteriorated. Typically fencing deteriorates due to age and or wear, rot and or rust which is generally expected for a structure of this age, due to prolonged exposure to weather conditions. Sometimes inadequate installation or maintenance can be to blame.

If left unattended, it is likely that further damage will occur. It is suspected that repair of several elements of the fencing may be required however replacement may be a consideration of the client also.

A licensed fencing contractor should be appointed to provide further advice and perform rectification works as necessary.

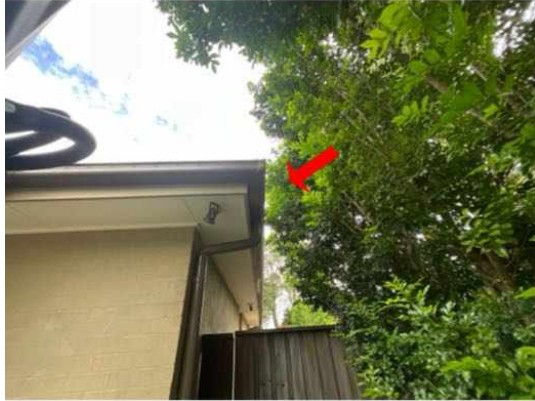
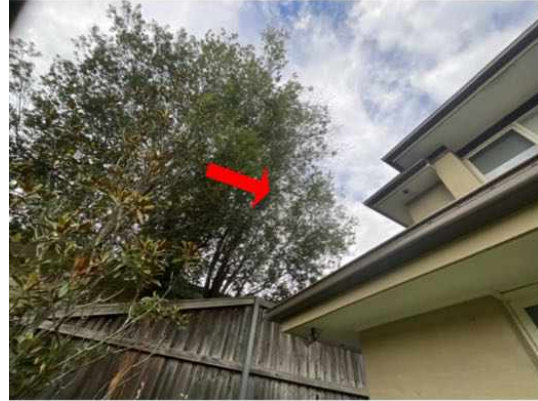
Finding 3.06

Gutters are a critical part of the building's management of storm water and rain. It is therefore important that they be kept clear to prevent secondary damage to associated building elements, including exterior and interior walls, ceiling linings and any adjoining building elements. Where gutters are blocked, pooling of rainwater is likely to occur, fast-tracking rust and corrosion of the roof plumbing elements.

It is highly advised that all overhanging tree branches be removed as soon as possible to prevent any further damage. Repair and/or replacement of sections of damaged

guttering may also be required where the extent of the damage necessitates.

Such works should be performed by the homeowner; however, appointment of a landscape contractor or an arborist may be required. Consultation with a licensed roof plumber is required where guttering has been damaged.

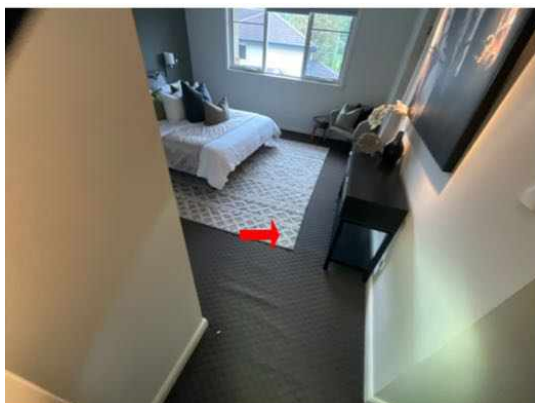
Finding 3.07

Building:	Main Building
Location:	Bedroom - Master
Finding:	Floors - Squeaky
Information:	The internal flooring in this area was identified as being squeaky at the time of inspection. This generally presents as a discernible change in level as they are walked across.

Although structural defects such as settlement could also be possible, however squeaky floors generally indicate that nails are coming loose from the joists that they are installed on, which is generally cosmetic rather than structural.

The client should appoint a licensed carpenter to undertake repairs.

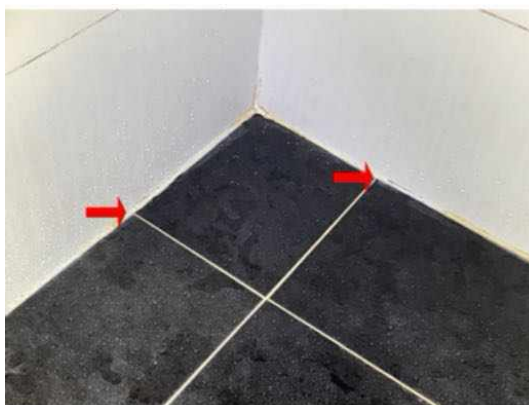
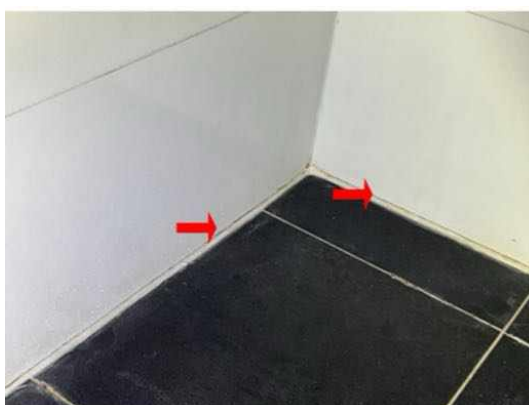
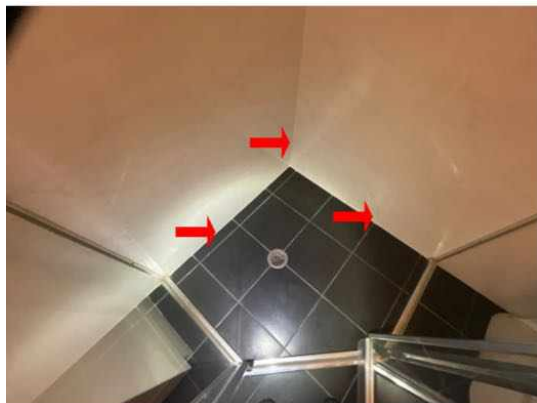
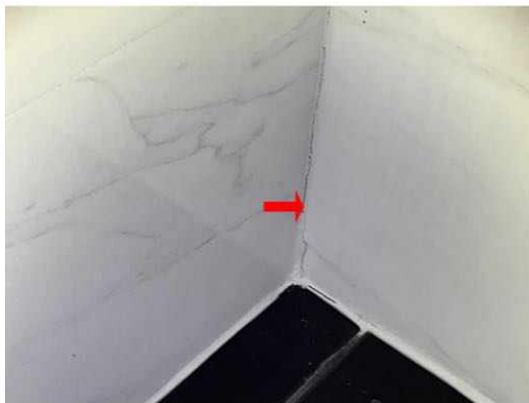
Finding 3.08

Building: Main Building
Location: All Wet Areas
Finding: Sealant and grouting - Missing or damaged
Information:

It was noted on inspection that sealant or grout is degraded to this area.

Different materials and floor areas move at different rates, generally causing cracking to grout or sealant at this point. A flexible sealant is required to allow for expected expansion and contraction, while keeping the joint water tight and protective of all associated building materials.

Flexible and mould resistant materials should be applied to affected areas to prevent any subsequent water damage that is likely to occur. Regular maintenance and replacement of damage or missing or damaged sealant and grout is highly recommended to the wet areas, as this is a regular wear and tear defect. Sealant and grouting in areas that come into regular contact with water should be maintained for the long term care of your property.

A sealant specialist should be appointed to complete these works as soon as possible.

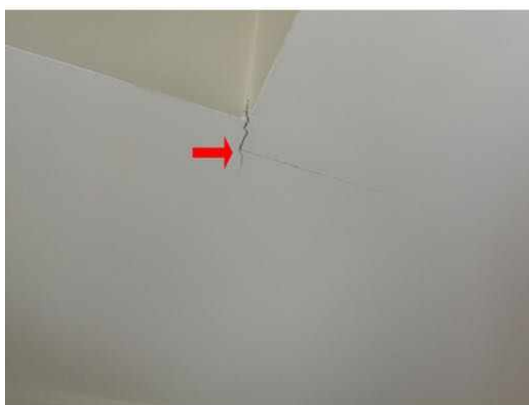
Finding 3.09

Building:	Main Building
Location:	Bedroom - Master
Finding:	Cracking - Damage Category 1 - Fine (up to 1mm)
Information:	Although fine cracks are quite noticeable, they are often only considered to be an appearance defect, and usually do not indicate any structural damage. Generally, the cause of a fine crack is indicative of a separation between building materials and finishes (e.g. paint, plaster, etc.) along joins.

Cracking of this nature can generally be repaired with minor sanding, filling and/or repainting. Such works should be performed by a qualified painter or a general handyman.

Monitoring of all cracking should be conducted frequently. Always contact a building inspector should cracks widen, lengthen, or become more numerous.

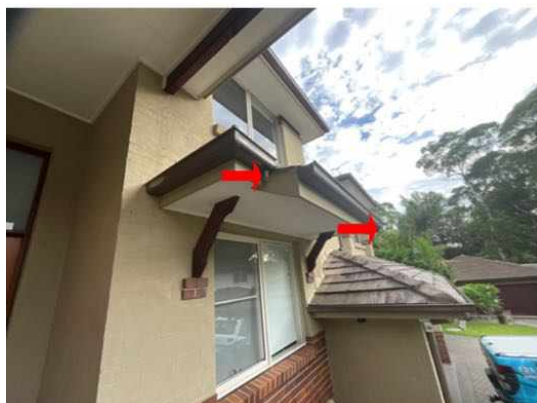
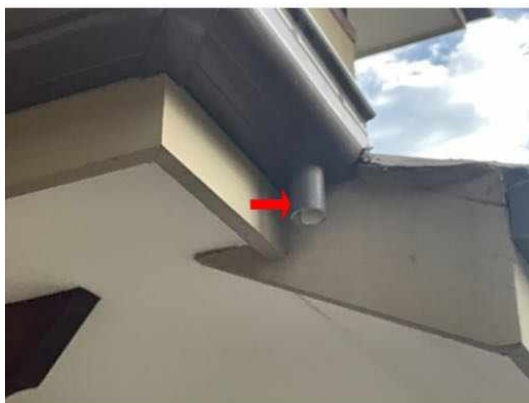
Where roof plumbing doesn't drain adequately, the area at the base perimeter can become excessively damp, potentially creating an environment that is susceptible to rust and corrosion of surrounding building elements, as well as attracting termites and other pests.

It is highly recommended that a plumber be appointed to further inspect the area and to install adequate drainage equipment where necessary.

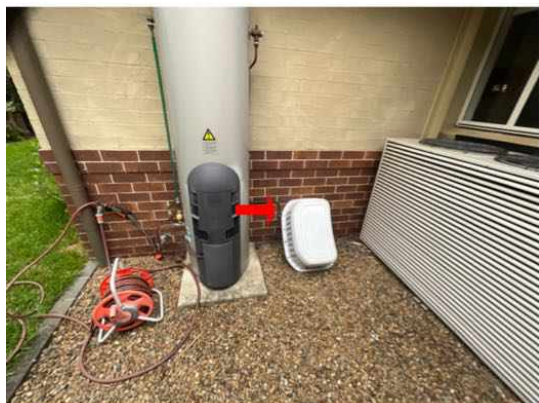
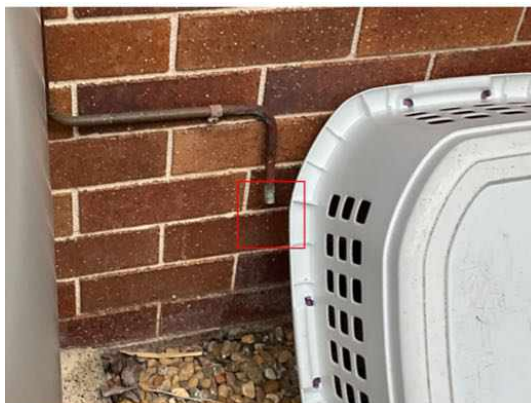
Finding 6.02

Building:	Main Building
Location:	Yard - Side
Finding:	Overflow - Not plumbed for drainage
Information:	The overflow is not plumbed or connected to suitable drainage, which can result in the surrounding area becoming excessively damp.

These damp conditions can lead to secondary defects such as rot, rust or corrosion of associated building elements, the formation of fungal decay, or even the creation of potential slip hazards. When coupled with poor site drainage, pooling of water may also attract termite activity to this area.

It is highly recommended that a licensed plumber be appointed to install adequate

drainage to the overflow. These works will ensure that the area remains dry and free of any secondary defects.

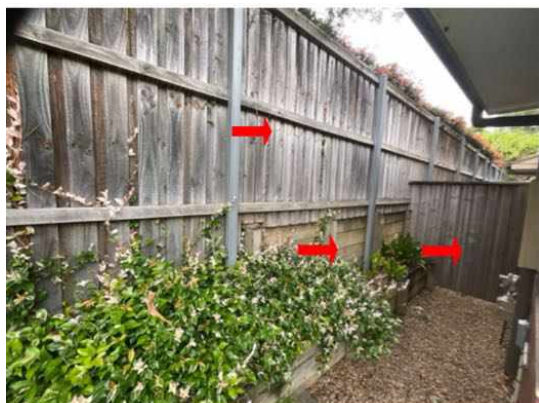
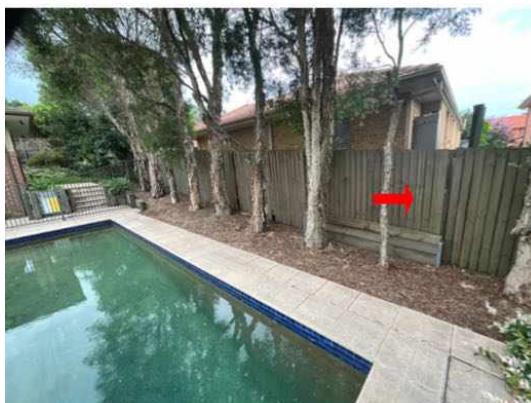
Finding 6.03

Building: Main Building
 Location: Fencing & Landscaping
 Finding: Building materials in direct ground contact - conducive to termites
 Information: Where timber elements are in direct contact with the ground and consequently moisture or dampness they become conducive to termite activity. Whether timber is used as a building element part of a fencing structure or stored as an unused item they can provide an environment that is attractive to termite infestation.

When met with excessive moisture timber begins to decay and develop wood rot. Any timbers that are in direct contact with external grounds especially if left untreated or non-durable also provide ingress for subterranean termites into that particular element.

The removal of any such materials that may be conducive to termite activity should be removed as soon as possible to minimise the risk of termite attack.

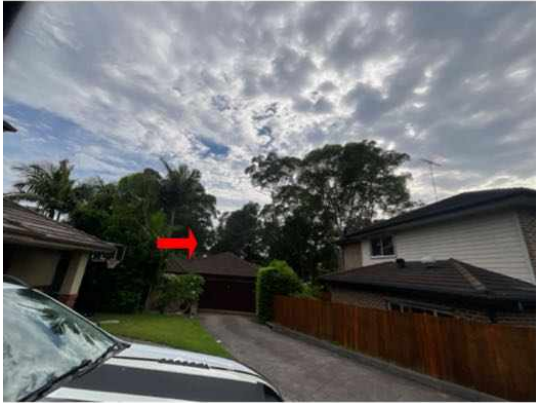
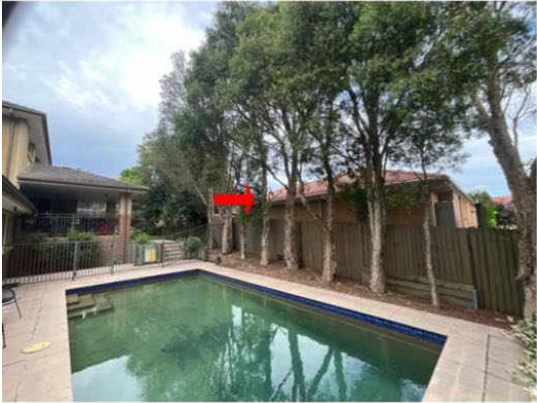
Finding 6.04

Location:
Finding: Surrounding bushland - Conducive
Information: Home and or building is situated in a high risk area for termite activity, due to close proximity to surrounding bushland.

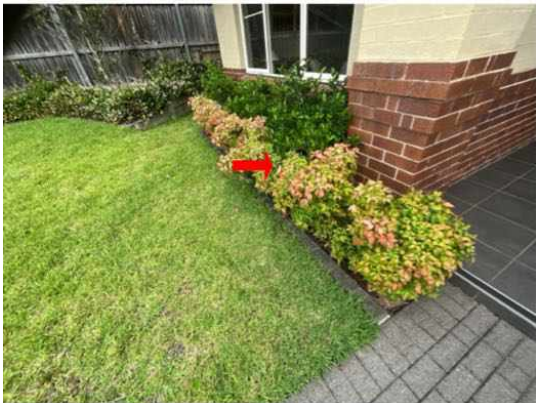
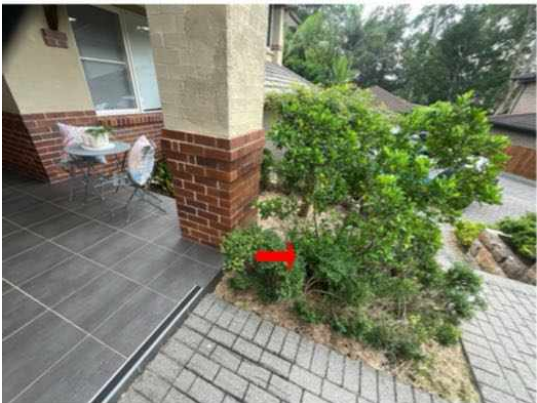
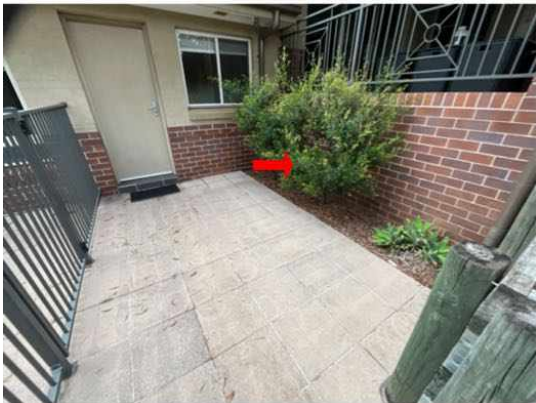
Finding 6.05

Building: Main Building
Location: Vegetation
Finding: Vegetation - Abutting property
Information: Vegetation against external wall may have an invasive root system. If there are weak points in the brick work or concrete slab, it is possible for the roots to gain entry into these areas. Once the roots have gained entry, it is possible for termites to gain concealed entry via these roots. It is recommended to remove the vegetation and root system where possible.

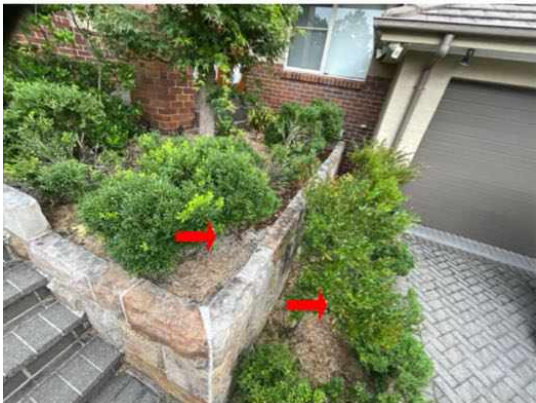
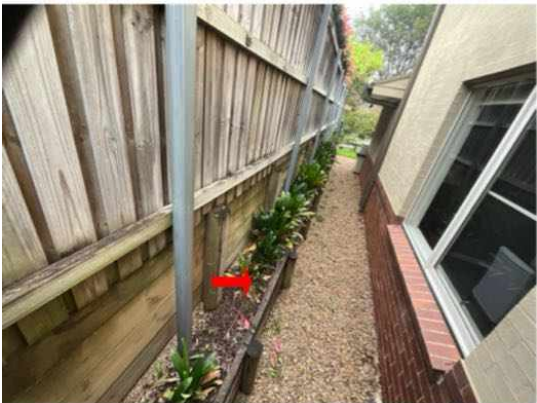
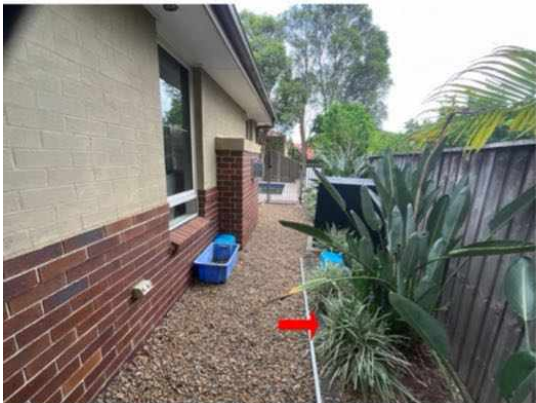
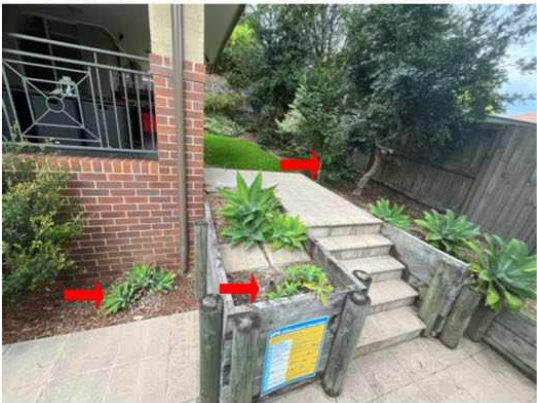
Finding 6.06

Building: Main Building
Location: Garden beds
Finding: Garden Beds
Information: Garden beds were found to be evident in the garden area. These garden beds can include untreated timber, and with a combination of moisture from watering hosing can make conditions conducive to termite activity and termite ingress.

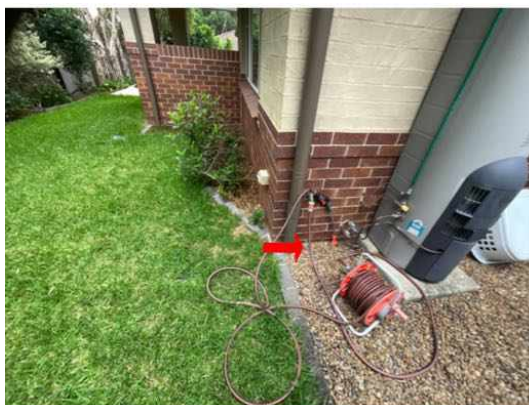
Finding 6.07

Location: External tap
 Finding: Tap - No drain
 Information: The external tap in this area was noted to have no drain at the time of inspection.

This keeps the surrounding surfaces damp while using the tap, which becomes conducive to termite activity.

A licensed plumber must be appointed to ensure an appropriate drain is installed.

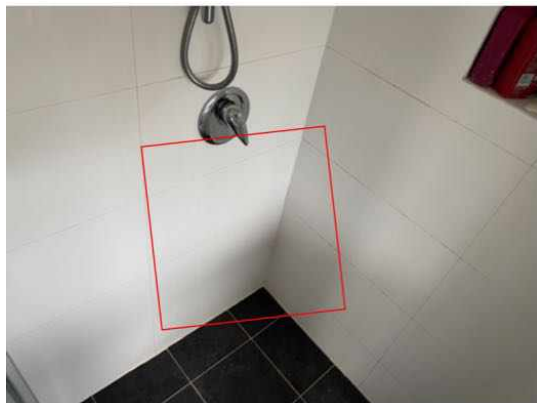
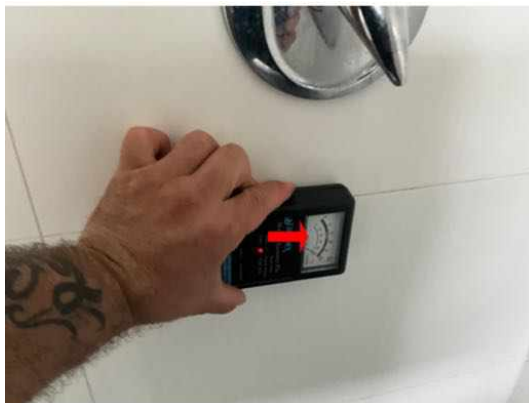
Finding 6.08

Building: Main Building
 Location: Bathroom
 Finding: Water leak - Suspected
 Information: A water leak is suspected in this area as excessive moisture was detected at the time of inspection. Another potential cause maybe moisture ingress behind the tiles from around the wall fittings and penetrations.

Internal water leaks can be detrimental to surrounding building elements; their potential causes include damage to plumbing fittings and fixtures, through to water damage and deterioration of associated building elements.

Attracting termites, corrosion, mould, decay and water damage are potential outcomes where a minor water leak is left unattended. More serious defects may also result, such as electrical hazards, or water damage to structural building elements.

In extreme cases, structural damage may develop due to a prolonged water leak. It is highly advised that internal water leaks be addressed by a licensed plumber as a matter of relative urgency.

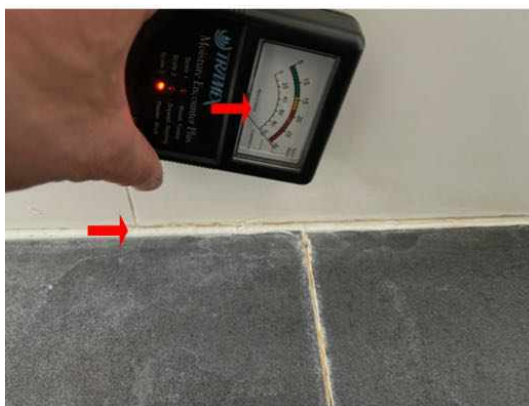
Finding 6.09

Building:	Main Building
Location:	Ensuite
Finding:	Shower damp - Sealant and grout
Information:	Damp is evident to the lower 400mm of wall to the shower alcove. This defect is quite common, and is suspected to have been caused by moisture permeating or leaching through the grouting and sealant in this area, which shows evidence of deterioration. Leaking pipes within the wall is also a possible cause however this seems unlikely in this instance as there is no moisture build up around the taps or transferring to the other side of the wall. There appears to be no sealant around the tap spindles which may be a small contributing factor.

Damp (or structural damp) refers to the presence of unwanted moisture in the structure of a building, either as the result of intrusion from outside, or condensation from within the structure. In the shower area, internal water leaks, degraded materials or other sources of excessive moisture are generally the cause of damp.

Unmanaged damp in the shower recess is likely to facilitate the formation and development of mould and fungi growth, decaying associated building materials and compromising their structural integrity of associated elements. It is important to address damp conditions, as the World Health Organisation notes that excess moisture leads - on almost all indoor materials - to growth of microbes such as moulds, fungi and bacteria, which subsequently emit spores and other matter into the indoor air. Exposure to these contaminants is associated with a wide range of respiratory and other health-related problems. Damp conditions also create a conducive environment for termite infestation.

Consultation with a bathroom sealant specialist is advised immediately to identify the cause of damp and to perform remedial works as required.

Always ensure that sealant and grout is in good condition to prevent any moisture issues occurring in the future.

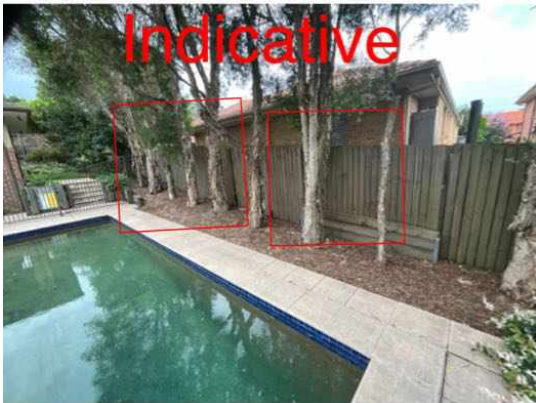
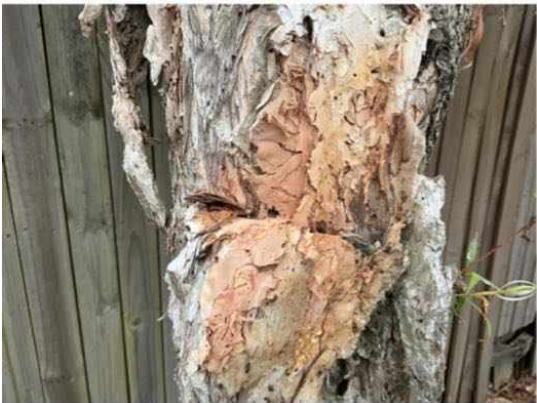
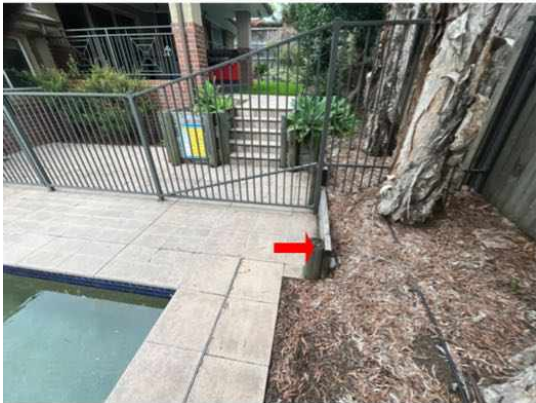
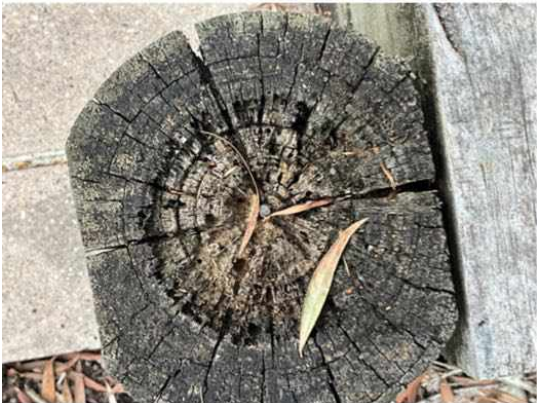
Building:	Main Building
Location:	Trees & landscaping
Finding:	Evidence of wood borer activity identified
Information:	Wood borers small beetles that colonise in exposed timber elements are a common timber pest that are regularly mistaken for termites. Although wood borer activity is generally not detrimental to the affected timber they may lead to serious damage and necessitate replacement of certain building elements if left unattended.

The other commonly known borer the Anobium borer is more likely to attack floorboards and may cause severe structural damage to flooring areas.

As no live wood borer activity was identified treatment is not required at this time. Replacement of affected timbers may be considered by the client for superficial reasons.

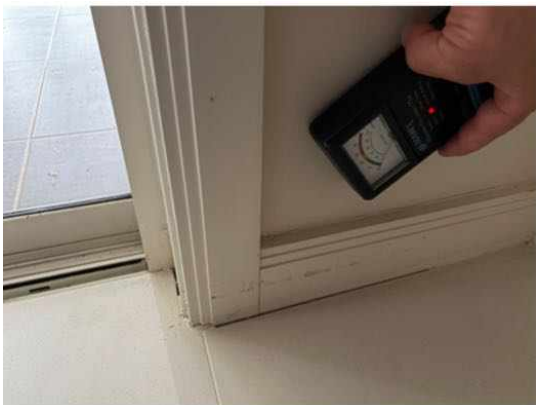
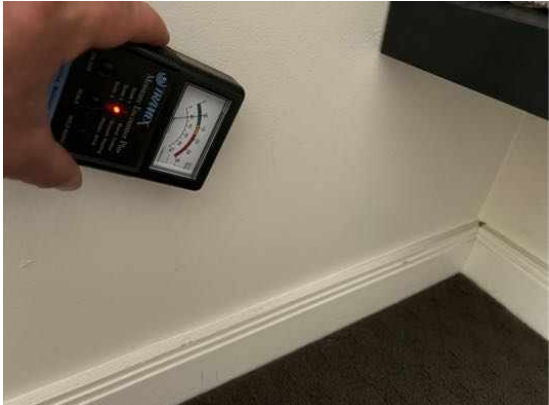
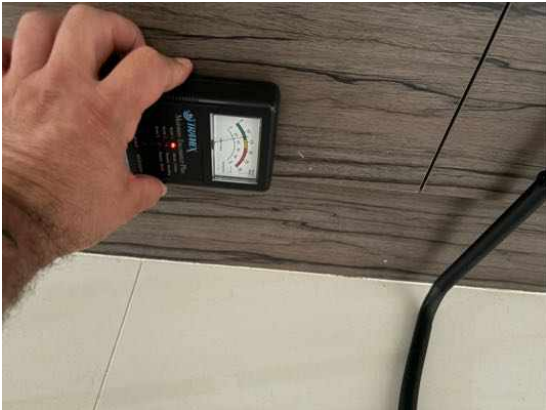
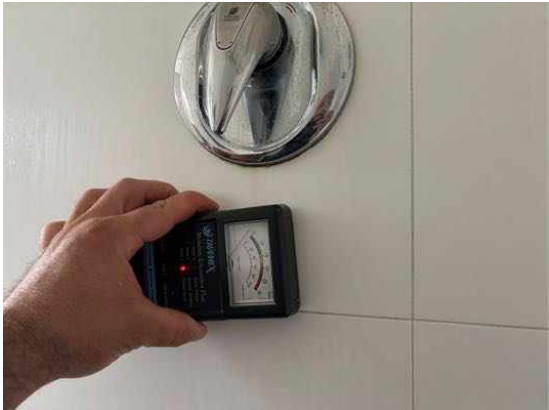
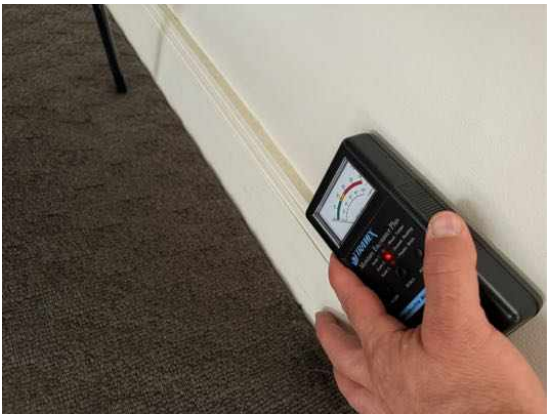
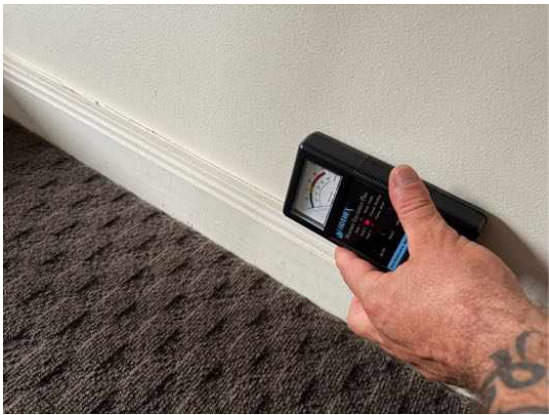
Building: Main Building
Location: All Areas
Finding: Moisture metre
Information: During the inspection the property was checked for moisture using a moisture metre.

This is for information only.

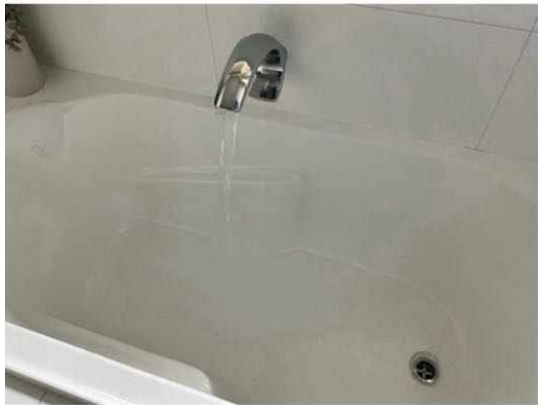
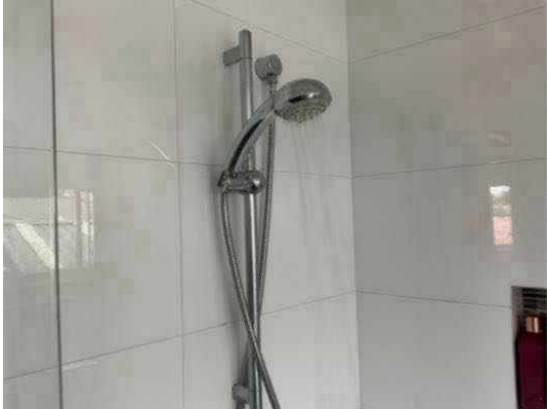
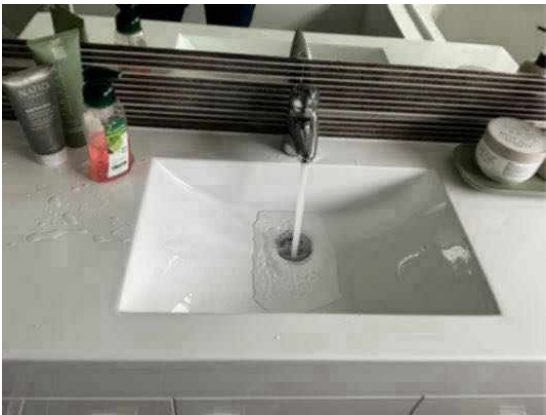
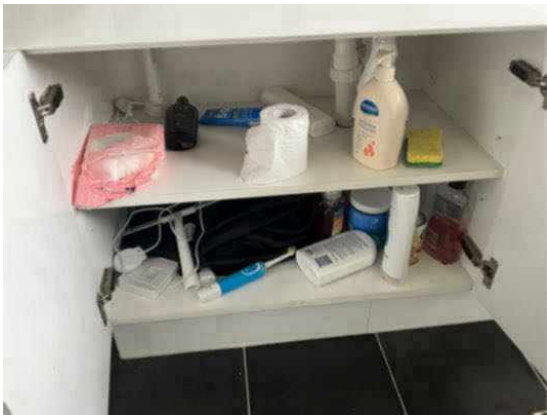
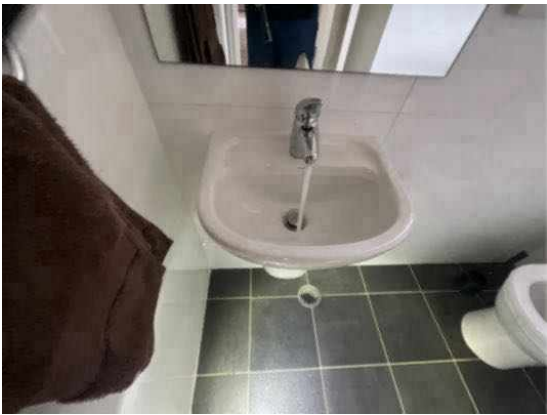
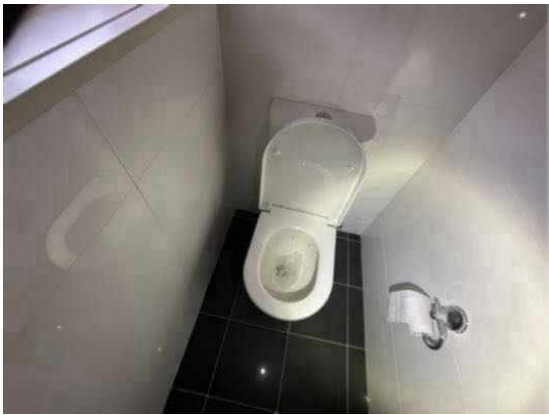
Building: Main Building
Location: All Wet Areas
Finding: Additional Photos
Information:

Additional photos are provided for your general reference.

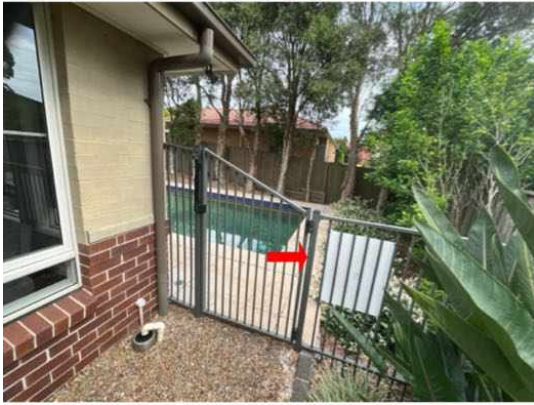
Building:	Main Building
Location:	Pool area
Finding:	Pool inspection
Information:	This inspection specifically excludes any inspection of the pool, associated pool equipment and pool surrounds. An inspection should be made by a specialist pool inspector to determine the condition of the pool, pool equipment and surrounds. A pool safety inspection is not included as part of a standard building inspection and must be commissioned separately as a specialist report.

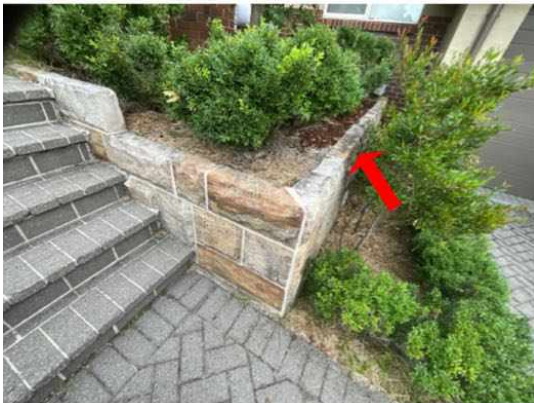
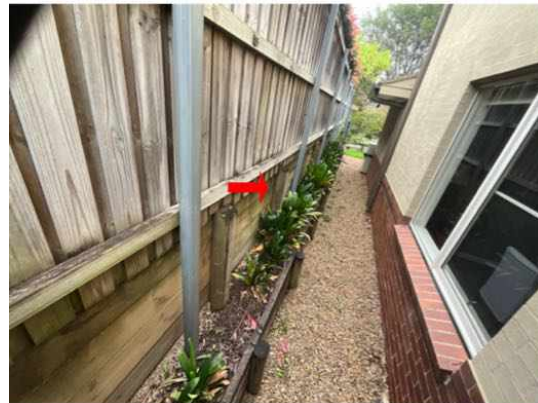
Information: At the time of inspection the retaining walls were checked and no defects were observed other than those which May have been mentioned earlier in this report.

AS4349.1-2007 requires all retaining walls in excess of 700mm to be inspected by a licensed and practicing structural engineer.

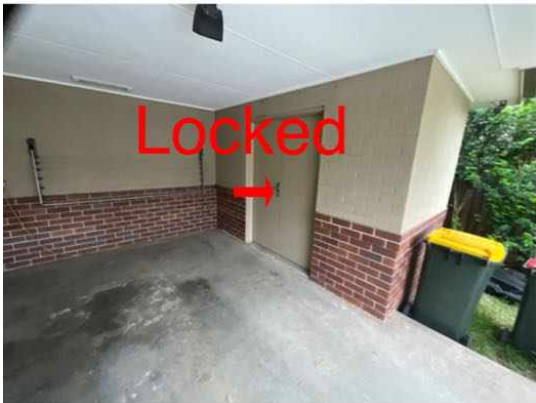
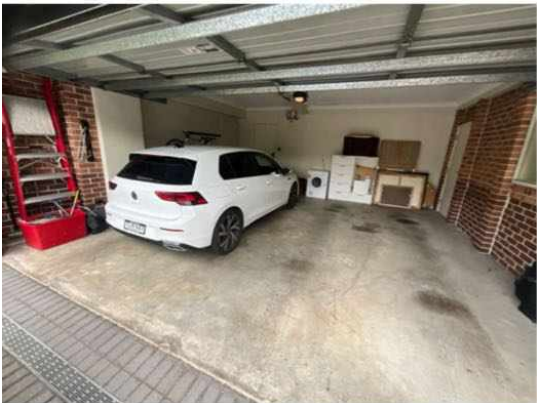
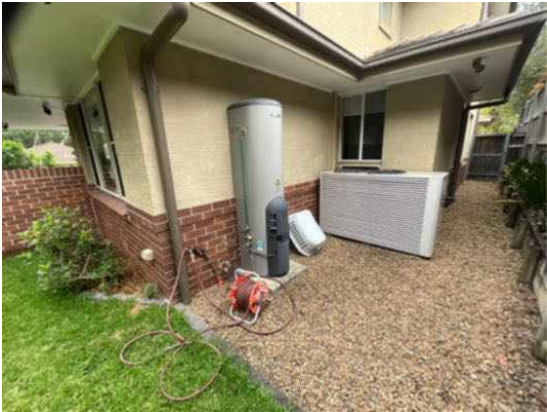
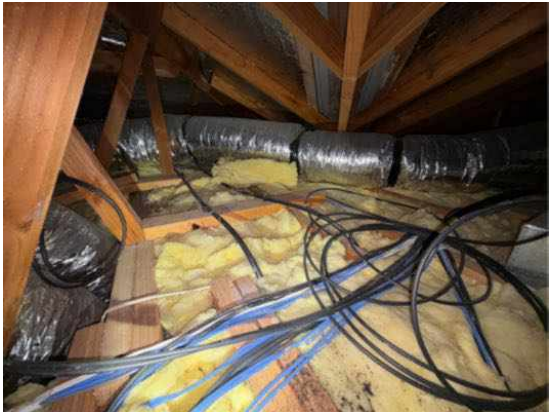
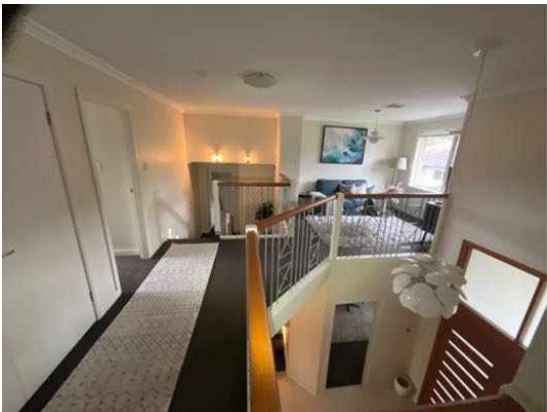
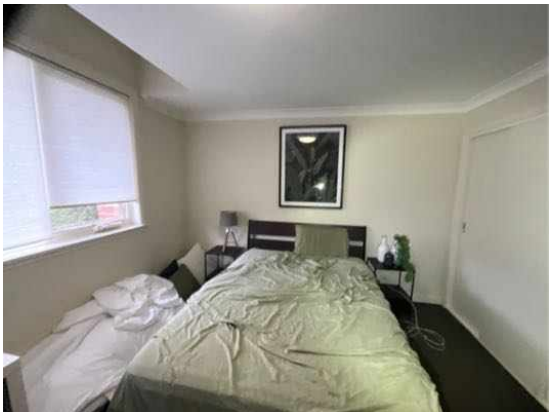
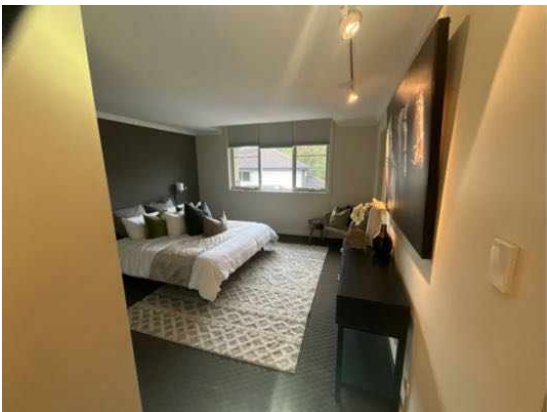
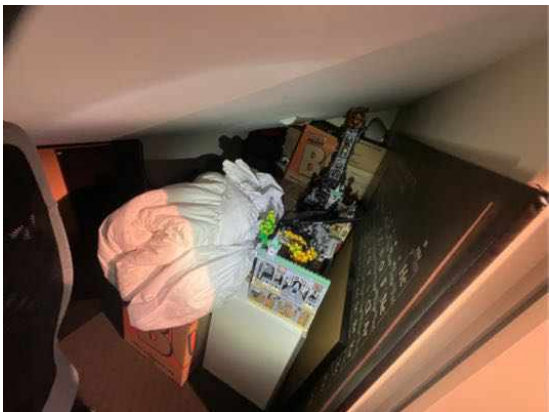
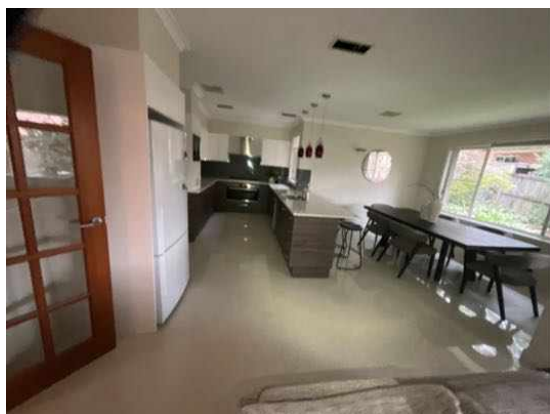
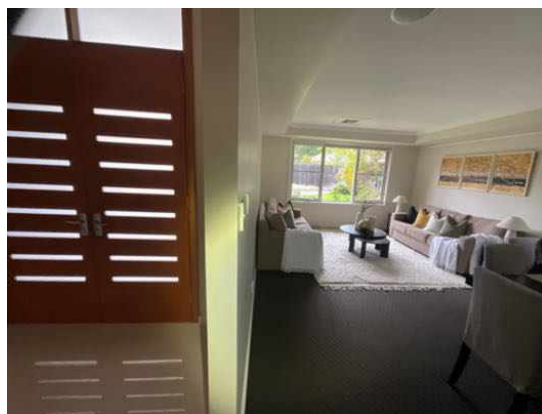
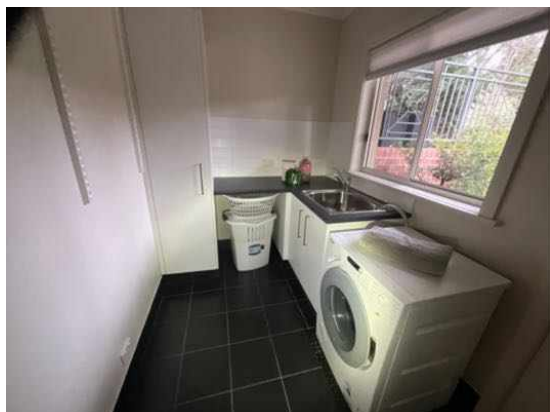
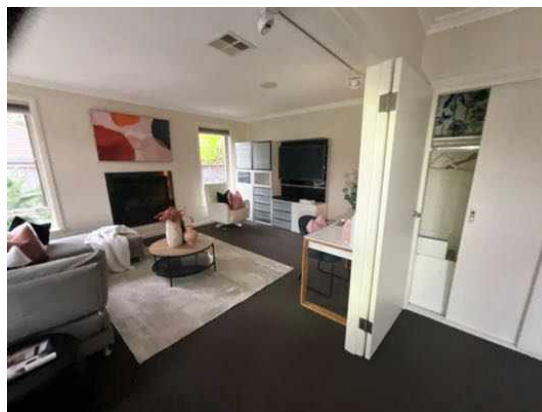
These photographs are an indication of the obstructions and limitations which impeded full inspection of the property at the time of inspection. These obstructions can hide an array of defects and should be removed to allow full inspection to be carried out. A re-inspection is recommended once the areas are made accessible.

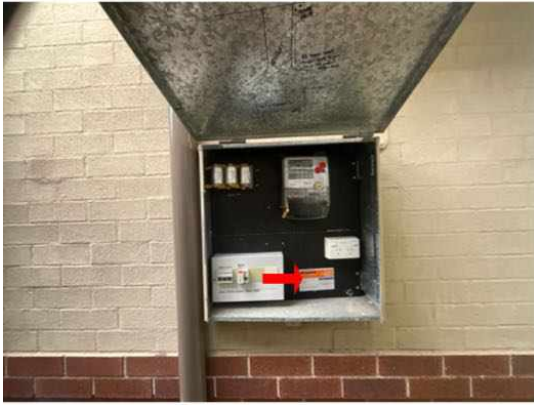
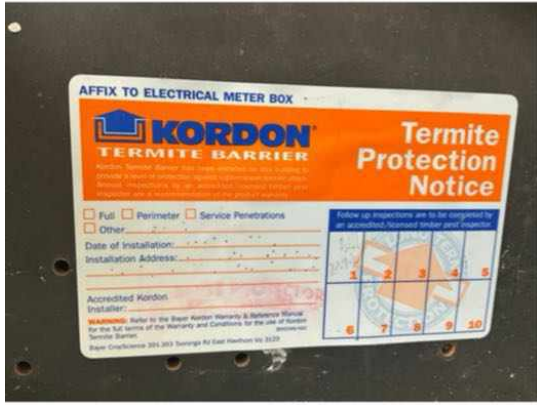
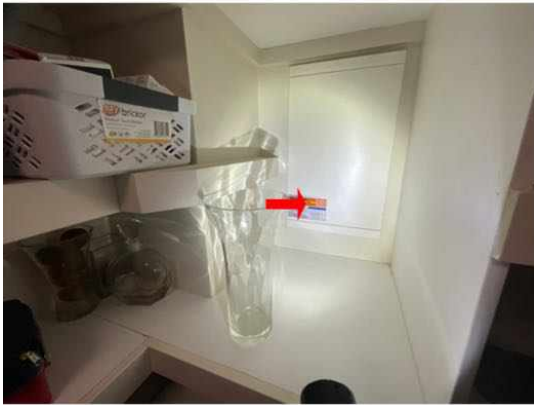
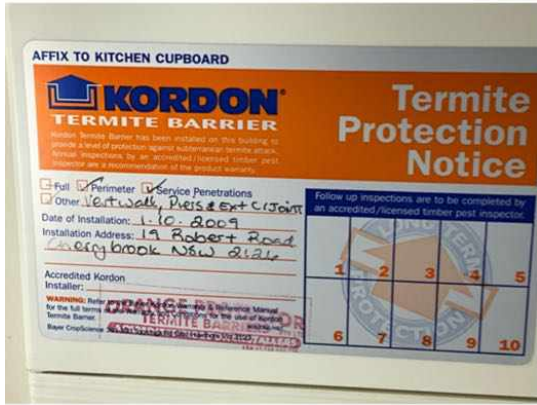
The following items were noted as - Evidence of a previous termite management program

Where a Termite Management System has been identified you should refer to the type of barrier date of installation warranty conditions and any documentation provided by a builder or past owner. Consult the company who installed the barrier to confirm whether the system is still under warranty.

Most chemical termite management systems expire and require replenishment and all physical systems are primarily designed to prevent concealed entry.
