Building and Timber Pest Inspection Report

Inspection Date: Mon, 16 Feb 2026

Property Address: 57 Lady Jamison Drive, Glenmore Park
NSW 2745

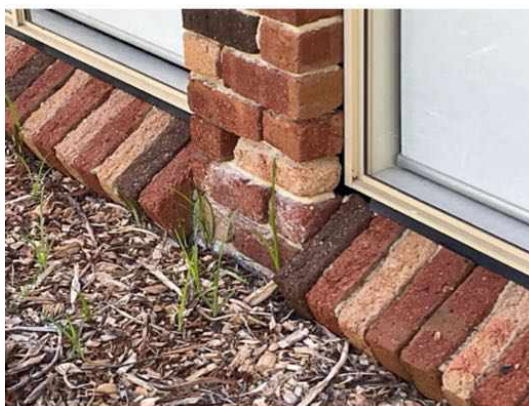
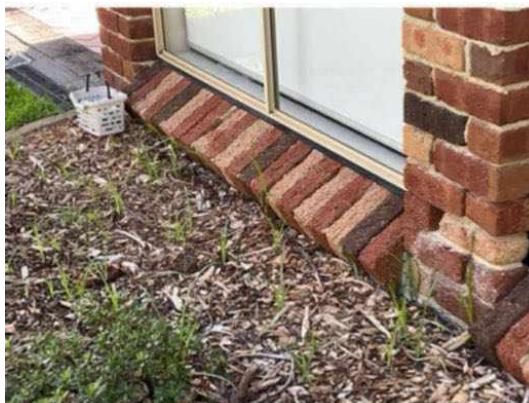
Building: Main Building
 Location: Exterior walls - rear
 Finding: Deterioration to Lower Brickwork
 Information: Location: Lower sections of rear external brickwork

Deterioration consistent with brick fretting was observed to sections of the lower external masonry walls at the time of inspection. The affected areas exhibited surface erosion, flaking and loss of face material to individual bricks. Mortar joints in isolated locations were brittle and powdery, indicating moisture-related degradation.

This condition is typically associated with prolonged exposure to ground moisture and salt crystallisation within the masonry. As moisture rises through porous brickwork, soluble salts are transported to the surface. When moisture evaporates, salt crystals expand within the brick matrix, resulting in progressive breakdown of the brick face and mortar joints.

The deterioration was most evident at the base of the walls, which is consistent with rising damp and/or inadequate site drainage.

Although presently localised and assessed as minor, brick fretting is a progressive condition. If moisture sources are not addressed, continued salt attack and saturation may result in:

- Reduction in compressive strength of affected masonry units
- Increased risk of rising damp affecting internal finishes
- Secondary deterioration to adjacent materials, including render, paint systems and internal wall linings

Over time, untreated fretting can transition from a cosmetic defect to a structural concern requiring partial wall reconstruction.

While the observed fretting is currently moderate and localised, the underlying moisture mechanism presents a risk of continued degradation. Early intervention is recommended to prevent escalation into a major structural masonry defect.

Engage a licensed drainage plumber to assess site drainage conditions and implement corrective measures where required. This may include improving surface water runoff, ensuring ground levels are appropriately graded away from the dwelling, and confirming that damp-proof courses are not bridged.

Where brick and mortar deterioration is advanced, affected bricks should be carefully removed and replaced, and mortar joints re-pointed by a licensed bricklayer experienced in salt-damage remediation.

The affected areas should be monitored, particularly following periods of heavy rainfall, to assess whether deterioration is accelerating.

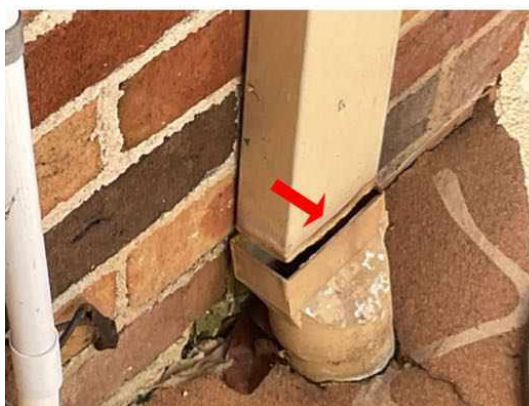
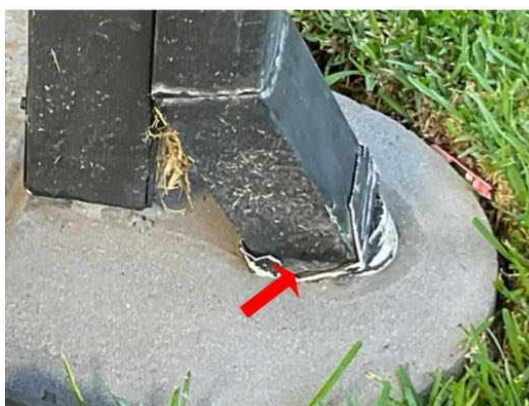
Finding 3.01

Building:	Main Building
Location:	Exterior walls - left side
Finding:	Downpipe - Damaged
Information:	Damaged Downpipe connection – Stormwater Drainage Concern

- The roof plumbing (downpipe) in this location has been damaged and/or is not fully sealed at the connection point.
- This may suggest impact damage and soil subsidence.

- Rectification is recommended.
- A licensed plumber may be appointed to:
 - Inspect the area thoroughly and repair, replace or properly connect all downpipes to ensure compliant and effective drainage

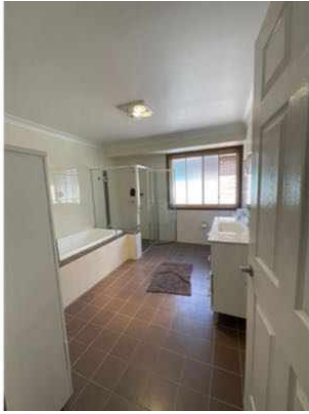
Finding 3.02

Building: Main Building
 Location: Bathroom
 Finding: Floor tiles - Cracked
 Information: Location: Upstairs Bathroom – Shower Area and Entrance

A licensed builder should be engaged to assess the substrate for movement or deflection issues. Rectification works should be carried out by a qualified tiling contractor or bathroom renovation specialist to ensure compliance with current waterproofing and tiling standards.

Ongoing monitoring for additional cracking is advised, as further movement may indicate underlying structural or substrate concerns requiring more extensive remediation.

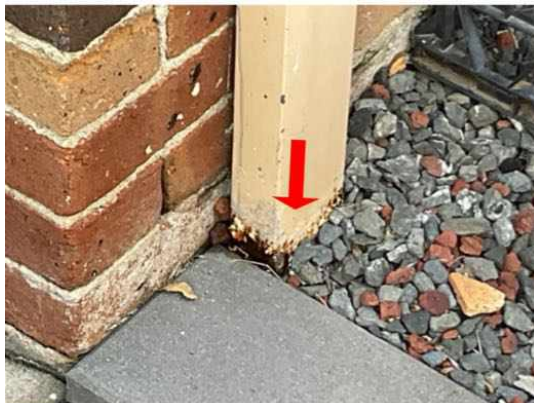
Finding 3.03

Building: Main Building
Location: All Areas
Finding: Photographic Reference Note.
Information: Additional photos have been provided for your general reference.

Arrows have been included in the images to highlight areas where minor defects or general wear and tear are present.

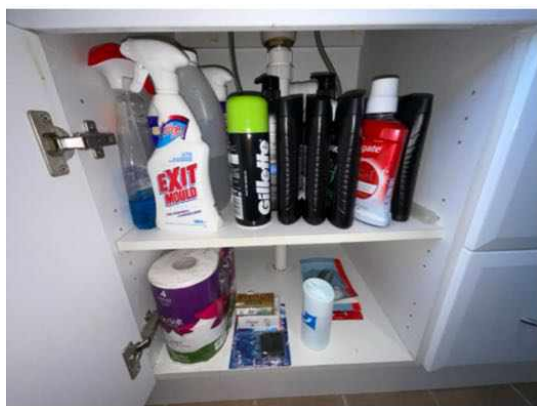
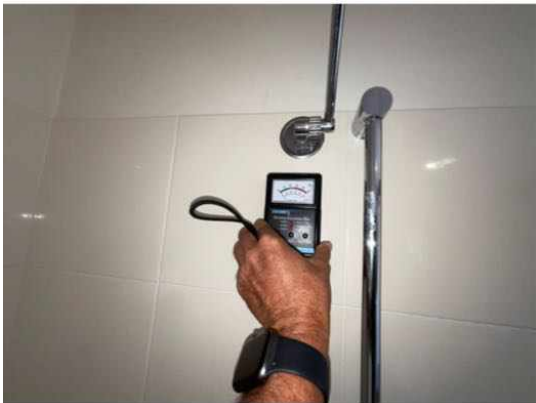
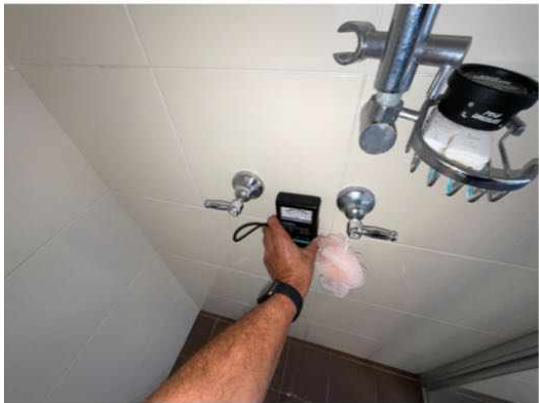
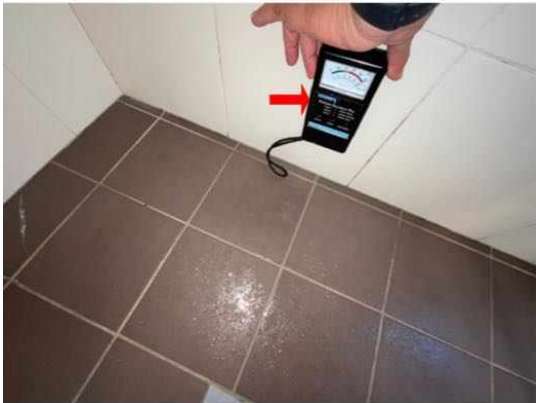
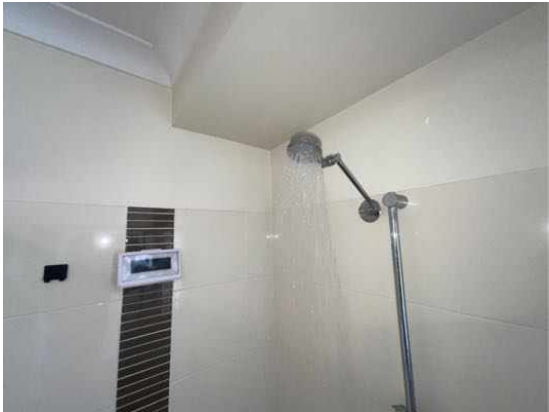
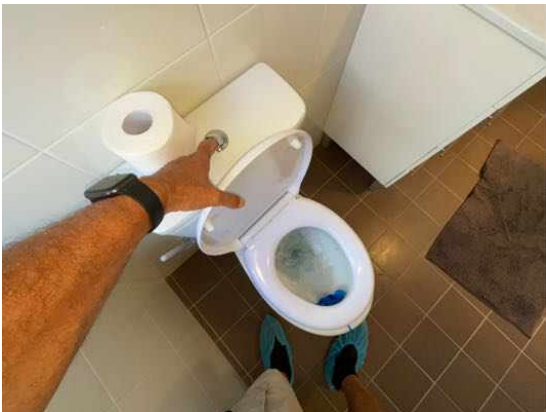
Building: Main Building
 Location: Bathroom
 Finding: Wet Areas - Bathroom(s) - Overall Condition & Recommendations.
 Information: Overall Condition & Recommendations

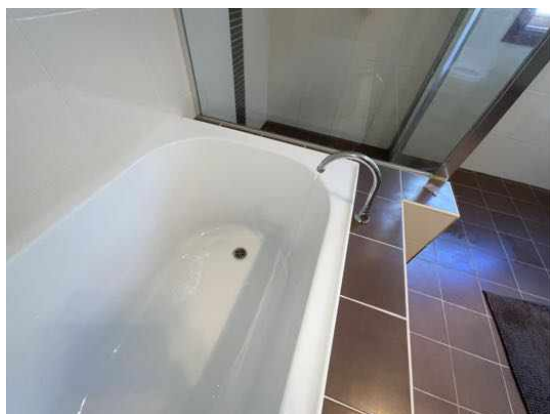
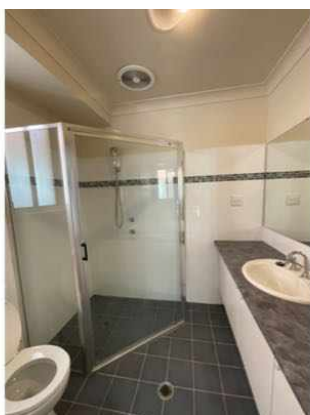
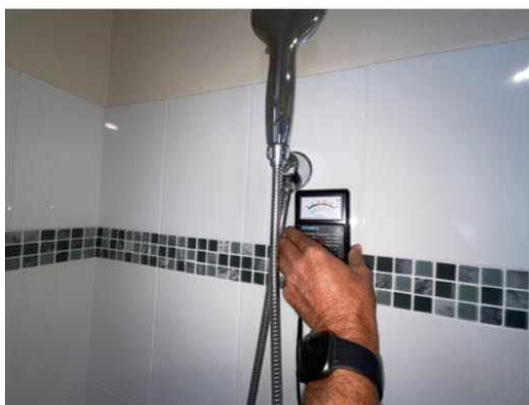
Building: Main Building
 Location: Ensuite > Ground Level
 Finding: Wet Areas - Bathroom(s) - Overall Condition & Recommendations.
 Information: Overall Condition & Recommendations

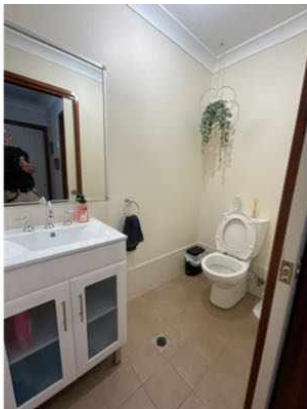
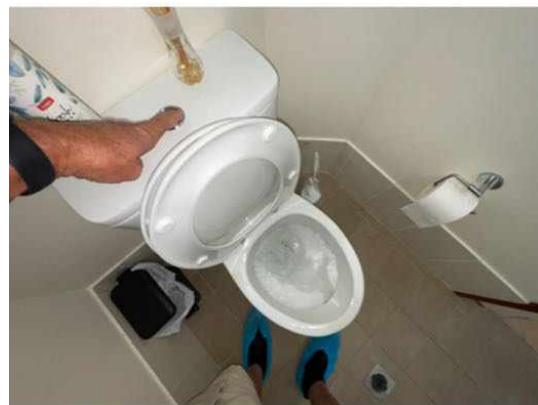
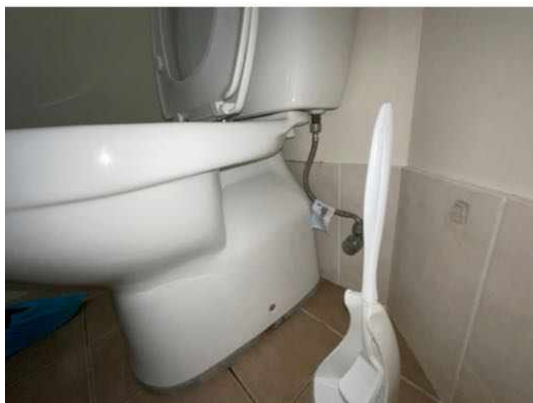
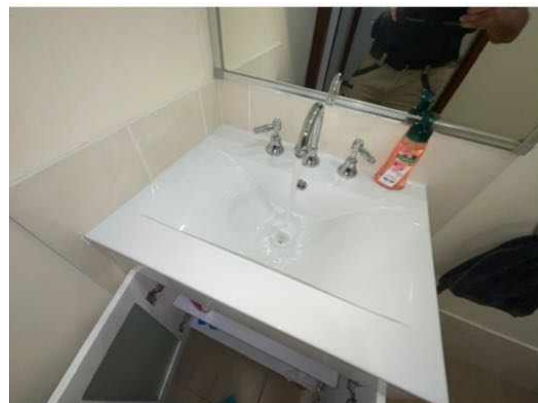
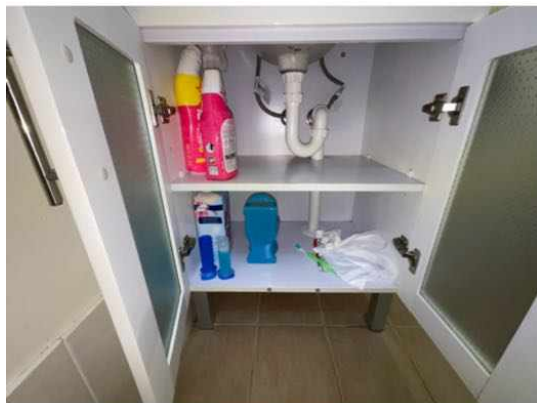
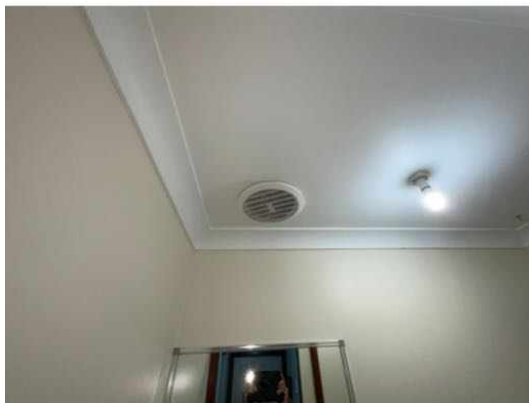
Building: Main Building
 Location: All Areas
 Finding: Water Pressure – Observation Only.
 Information: During the inspection, water pressure appeared to be within a normal operating range based on a basic functional check. However, this observation was made without the use of pressure testing equipment and does not constitute an assessment by a licensed plumber.

It is strongly recommended that a Licensed Plumber be engaged to conduct a comprehensive assessment of the plumbing system to verify its functionality, check for any underlying issues, and confirm compliance with current regulations and standards.

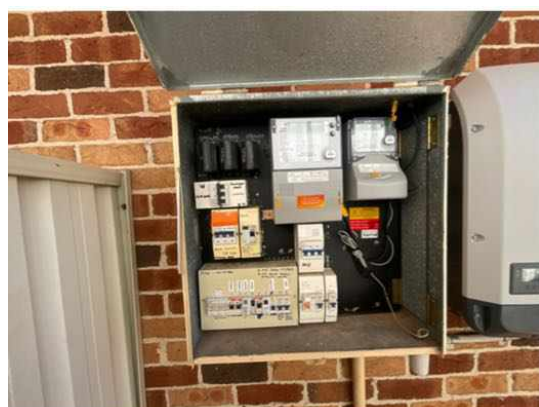
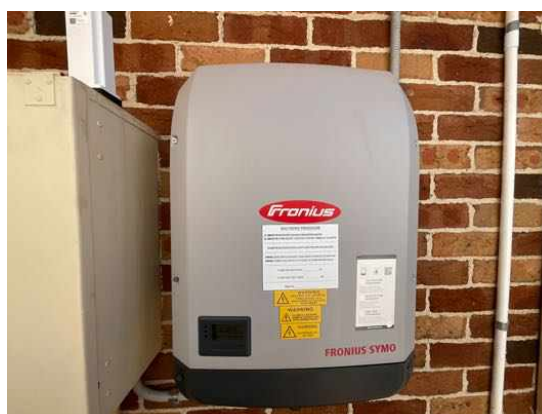
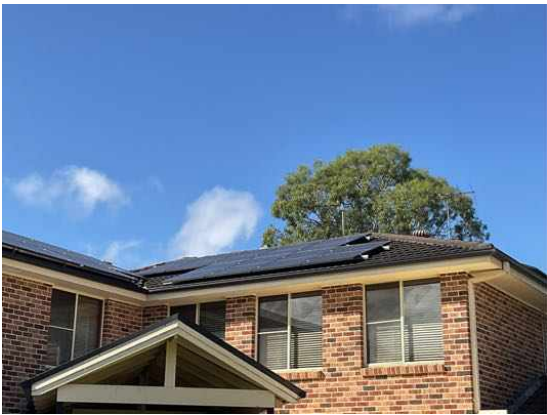
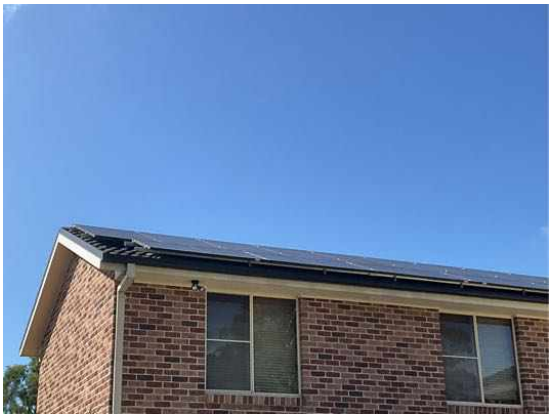
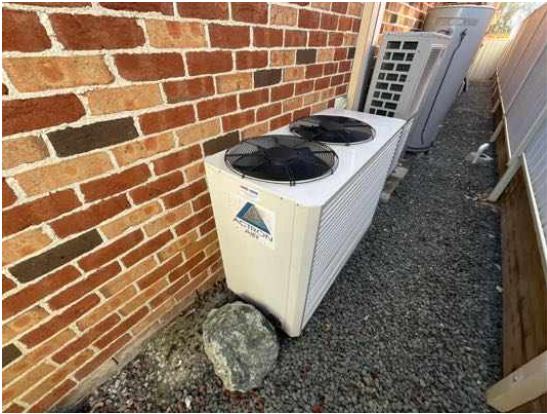
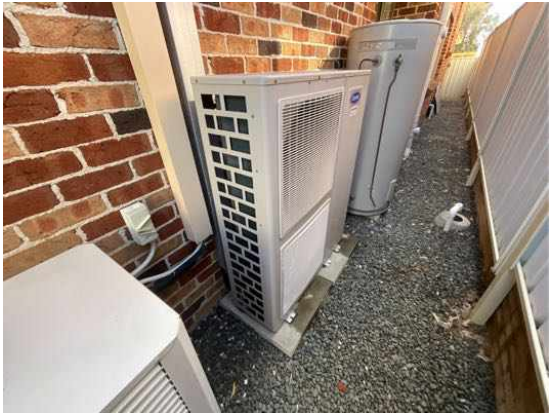
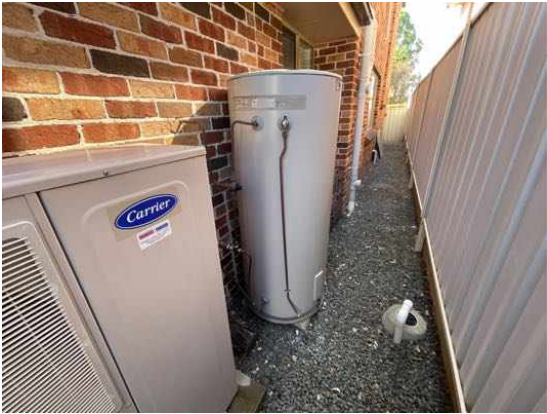
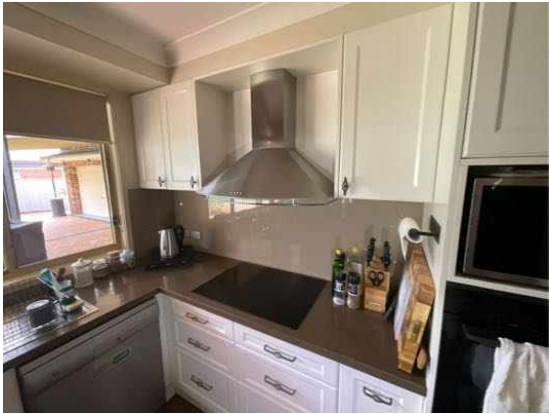
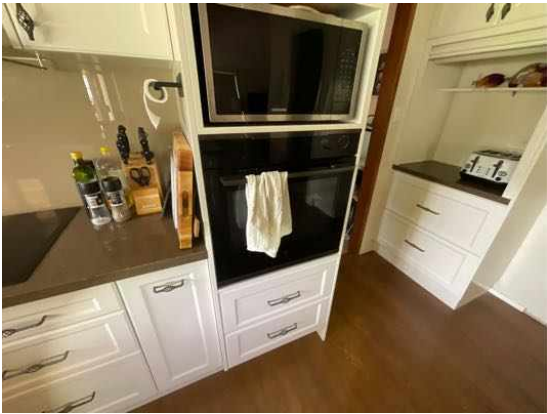
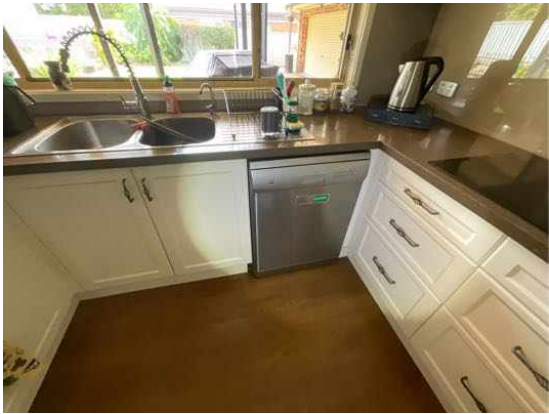
Building: Main Building
 Location: All Areas
 Finding: Plumbing, Electrical & Gas Installations – Scope and Recommendations.
 Information: Plumbing and electrical inspections fall outside the scope of this building inspection and must be carried out by appropriately licensed and registered tradespersons.

- Any gas appliances (if applicable) must be inspected by a licensed gas plumber to confirm they are operating safely and efficiently.
- We also recommend that all other plumbing and electrical installations be thoroughly checked by qualified professionals to ensure they are functioning correctly and meet current safety and compliance standards.

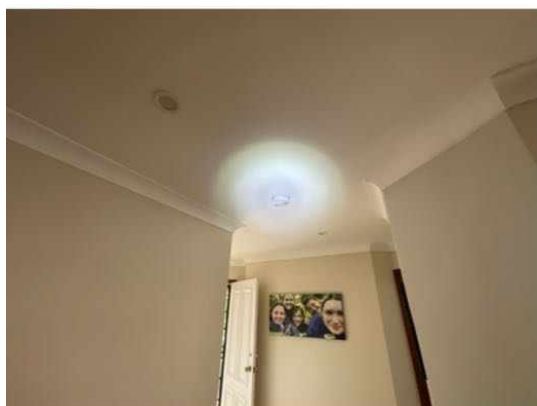
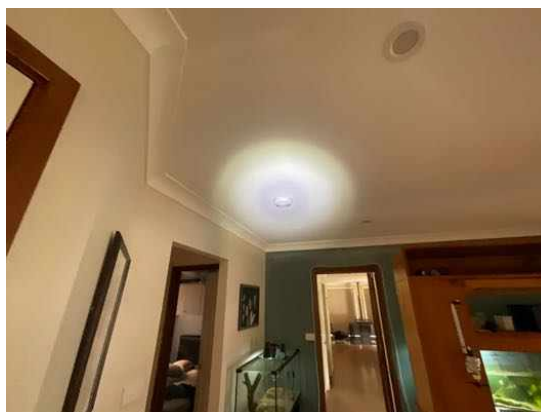
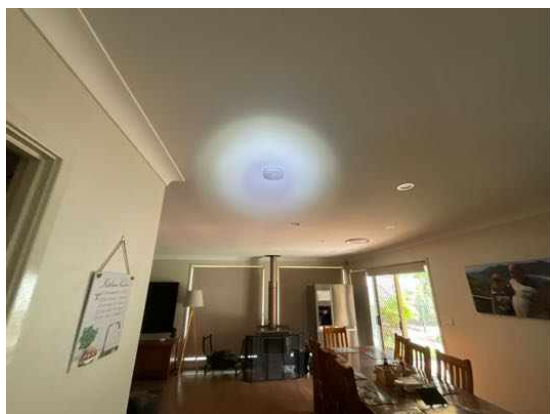
Building: Main Building
Location: All Areas
Finding: Smoke Detectors / Alarms.
Information: Reporting on the presence, type, location, or compliance of smoke detectors or alarms, including hard-wired smoke detection systems and their legislative requirements, is outside the scope of this inspection report.

To ensure compliance and safety, further inspection and/or advisory services from a qualified specialist are recommended. These services can confirm the sufficiency, type, location, and functionality of all smoke detection devices within the property.

- All smoke detectors be tested monthly by the homeowner.
- All systems comply with the requirements of AS 3786 and any applicable state-based legislation.
