Building Inspection Report

Inspection Date: Mon, 12 Jan 2026

Property Address: 13/125 Lake Entrance Rd, Barrack Heights
NSW 2528, Australia

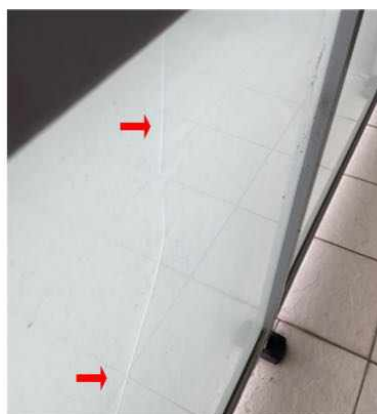
Defects 1.01

Building:	Building 1
Location:	Balcony railing
Finding:	Railing glass - Cracked
Information:	Cracks were identified in the balcony glass. Cracking in glass is generally the result of impact damage, and is likely to develop further when left unmanaged.

The likelihood of further cracking and shattering is increased exponentially, providing a safety hazard in the area.

A qualified glazier is required to repair the glass. Please be advised that any persons coming into contact with the cracked glass should do so with due caution.

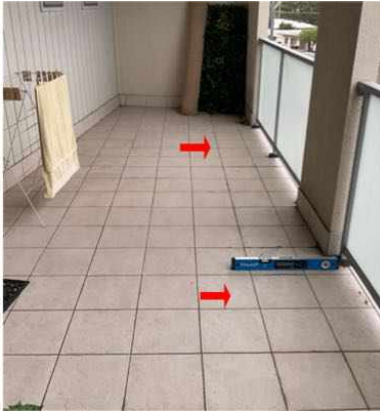
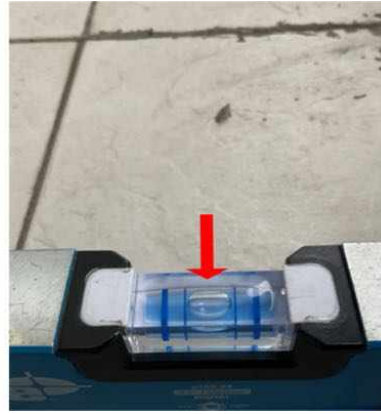
Defects 3.04

Building: Building 1
 Location: Balcony areas
 Finding: Fall to balcony tiling insufficient
 Information: There is an insufficient fall in the balcony tiling, which means that the angle of the tiling is inadequate for rainwater to drain away. This may result in pooling of water in the area, creating the potential for water damage to nearby areas. This is likely to lead to further defects if not repaired and may be the cause or contributed to the front verandah damage. Adjustment by a tiling contractor is required as soon as possible to prevent any further damage to the area.

AS 4654.2 – Waterproofing membranes (2012) sets the Australian Standard for the design and installation of external waterproofing membranes for above-ground use, covering roofs, balconies, decks, and planter boxes, ensuring UV stability, proper drainage (min 1:100 fall), adequate upstands, correct substrate prep, and detailed junction/penetration sealing, working alongside AS 4654.1 (Materials) for reliable waterproofing.

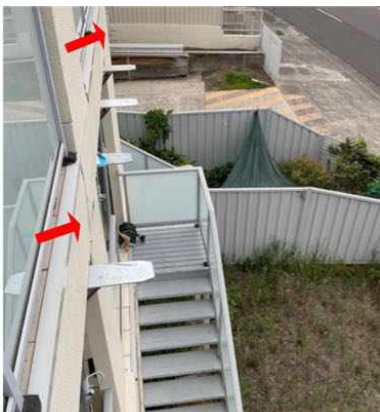
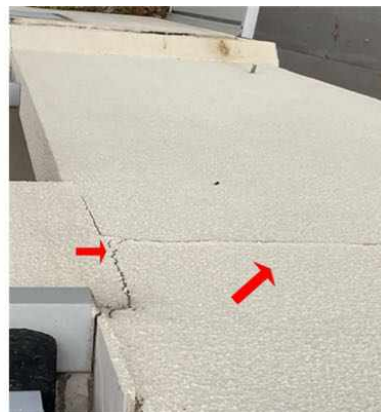
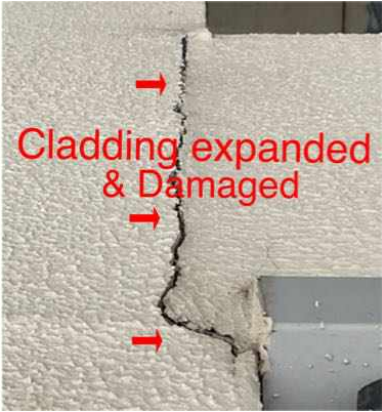
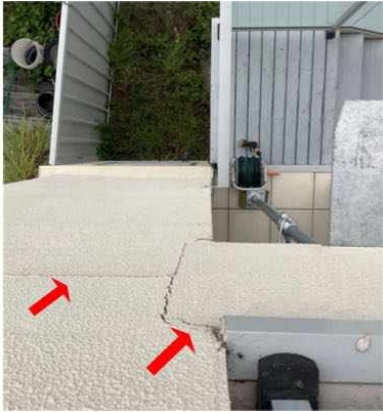
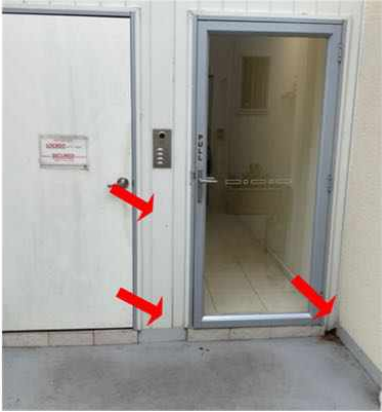
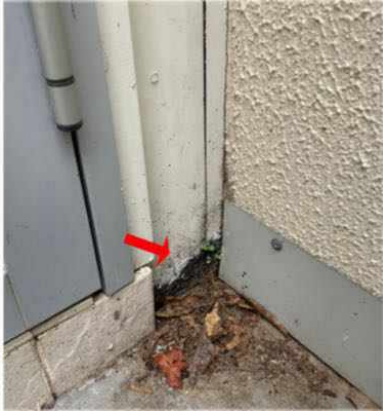
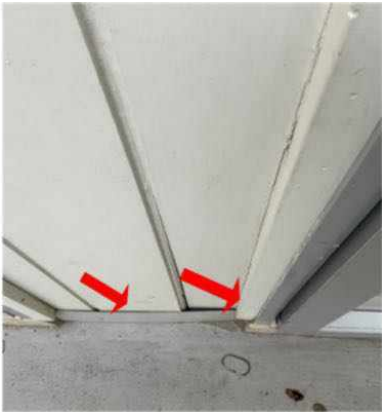
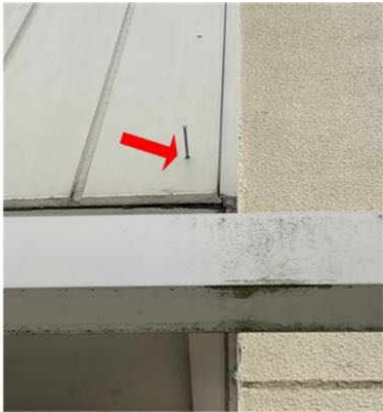
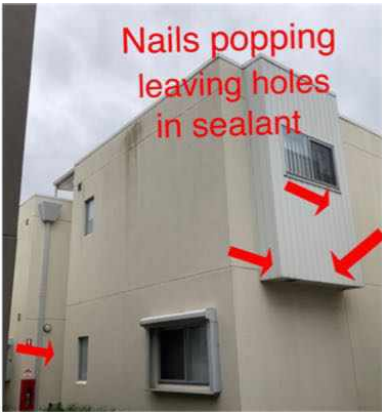
Defects 3.05

Building:	Main Building
Location:	Front and rear wall areas
Finding:	Sealant (external) - Missing and damaged
Information:	It was noted on inspection that areas of external sealant and render was damaged many external walls. The front wall cladding appears to have had water ingress from the damaged areas of sealant. The front middle pillar cladding has now expanded and is likely to further expand and crack in the future. This cladding may conceal larger defects in the units timber framing. It is unclear if the repairs underway include repairing this cladding. The rear walls have popped nails creating holes in the render, movement in the cladding opening gaps for rainwater as well as peeling cladding, upper mould, and moisture damage.

Flexible sealants should be applied to these affected areas to prevent any subsequent water damage that is likely to occur.

A sealant specialist or licensed builder should be appointed to complete these works as soon as possible

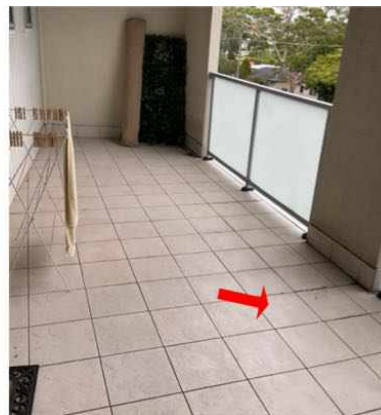
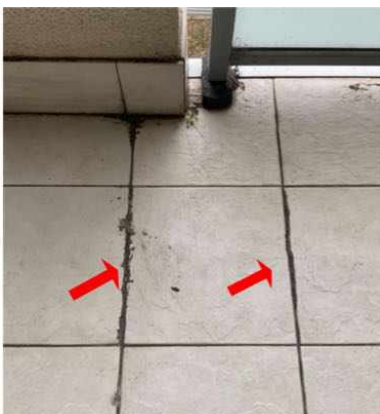
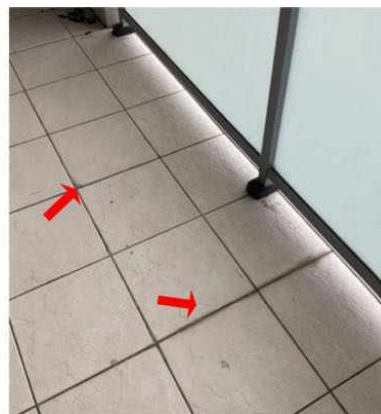
Defects 3.06

Building: Building 1
Location: Pictured kitchen, balcony, bathroom areas
Finding: Sealant and grouting - Missing, damaged, substandard balcony repairs
Information: It was noted on inspection that sealant or grout is missing to these pictured areas of the building. Some verandah grout repairs appears to be of a substandard nature.

Flexible and mould resistant materials should be applied to affected areas to prevent any subsequent water damage that is likely to occur.

A tiling contractor or sealant expert is required to repair these tiled areas.

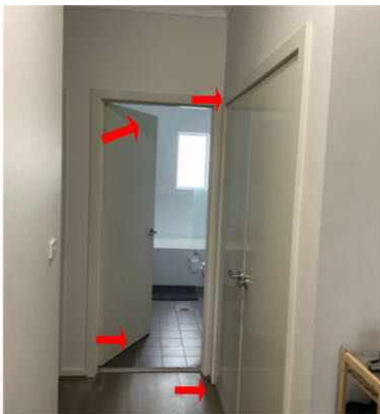
Defects 3.08

NSW Guide to Standards and Tolerances 9.6 states that “door leaves are defective if they do not have all sides, top and bottom edges sealed/painted

Whilst incomplete or missing paint finish is generally an appearance defect, it can also lead to the development of secondary building defects over time. Incomplete areas of paint finish expose the area to moisture, potentially accelerating the deterioration of underlying building materials. The laundry doors now require replacement to to swelling damage.

A painting contractor should be appointed as soon as possible to perform necessary works to aid the appearance of the affected area and to ensure the area is protected against further deterioration. Alternatively, the homeowner following manufacturer instructions may perform these works.

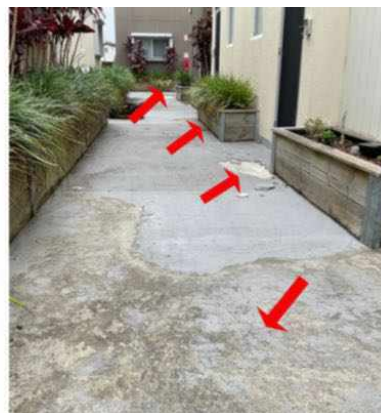
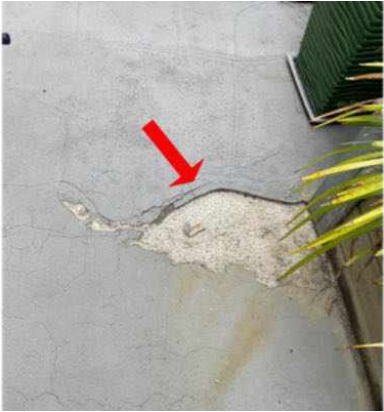
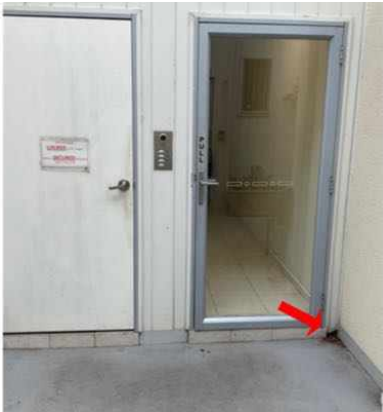
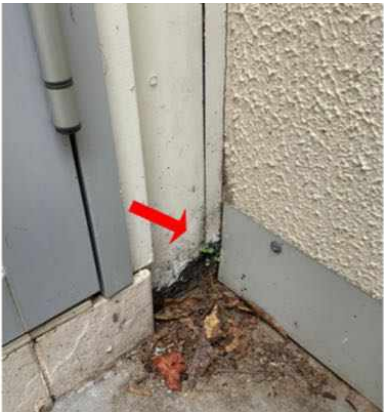
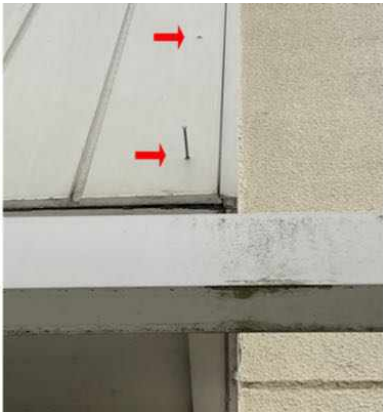
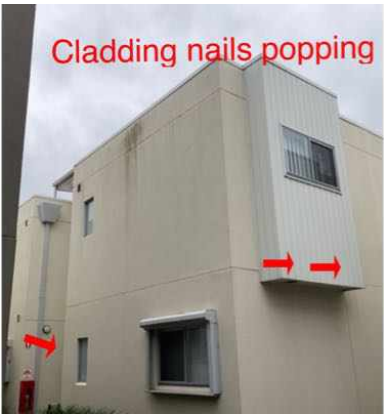
Defects 3.09

1. The front door remote lock did not work meaning it needed to be opened internally for visitors
2. The rear path concrete has numerous cracks evident despite being repaired in the past, this is thought to be due to no fall to allow rainwater to drain away.
3. Other units have cladding damage under repair.
4. The driveway wall has minor step cracking and damaged fencing.
5. Rear wall areas have popped nails requiring repair then repainting.
6. The rear entry had moisture damage in the bottom right wall.

Various trades are required to repair these areas in the future.

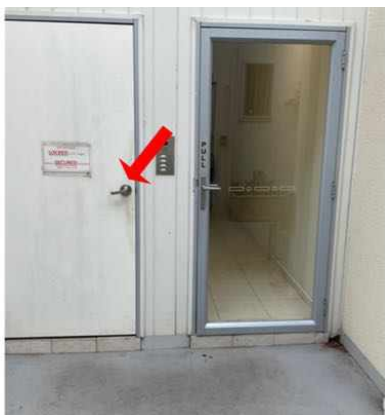
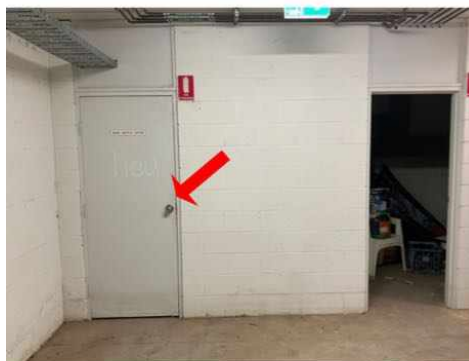
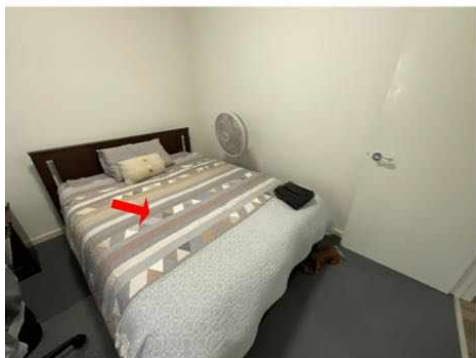
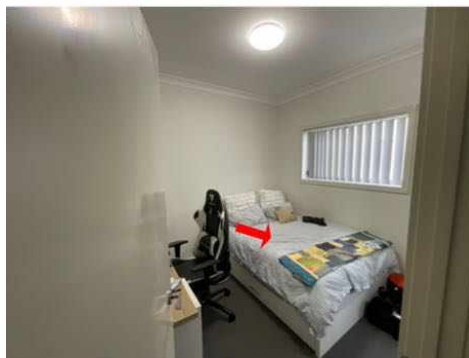
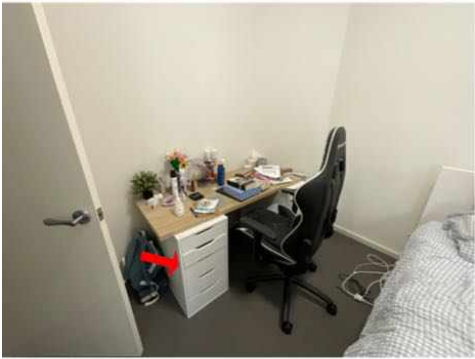
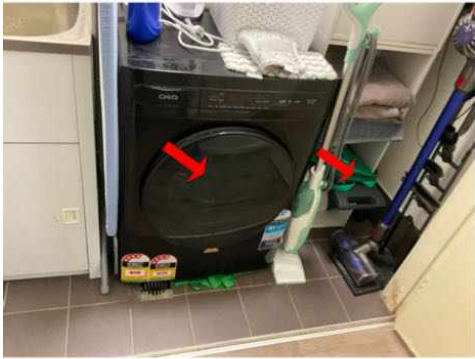
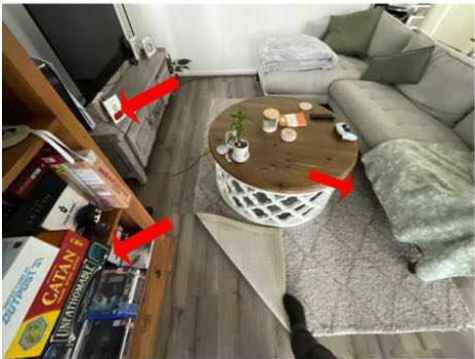
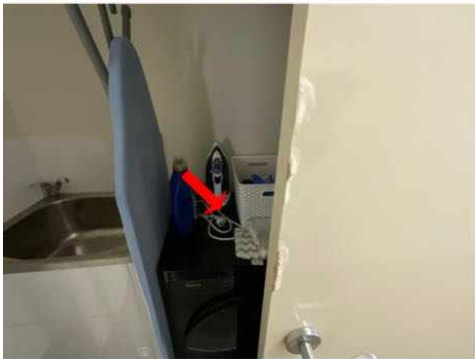
Building: Main Building
Location: All Internal Areas
Finding: Additional Photos - Obstructions and Limitations of Internal areas
Information: These photographs are an indication of the obstructions and limitations which impeded full inspection of Internal areas at the time of inspection. These obstructions can hide an array of defects and should be removed to allow full inspection to be carried out. A re-inspection is recommended once the areas are made accessible.

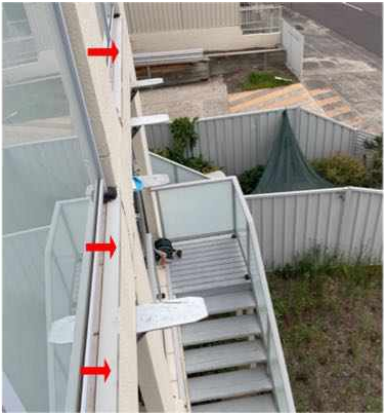
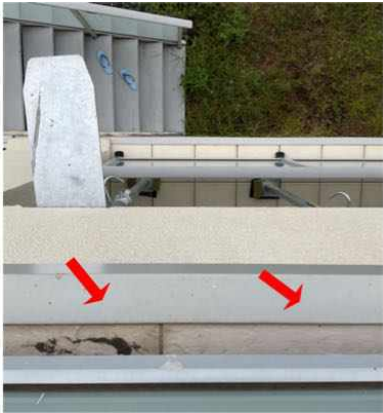
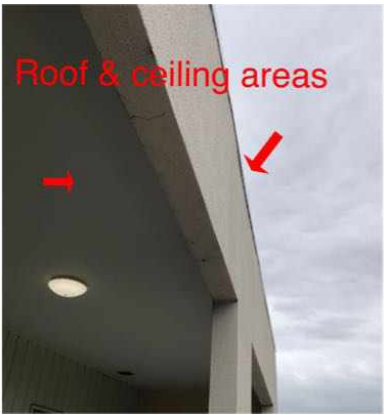
Building: Yard
Location: All External Areas
Finding: Additional Photos - Obstructions and Limitations of External areas
Information: These photographs are an indication of the obstructions and limitations which impeded full inspection of external areas at the time of inspection. These obstructions can hide an array of defects and should be removed to allow full inspection to be carried out. A re-inspection is recommended once the areas are made accessible.

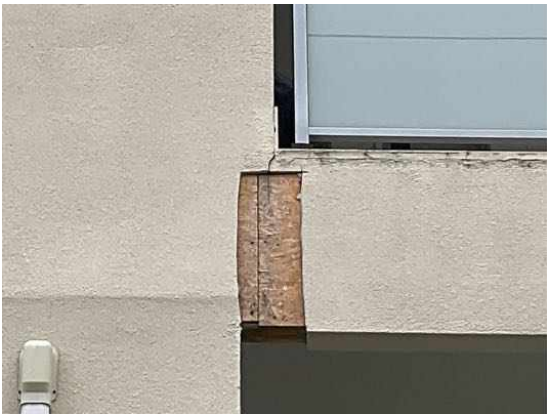
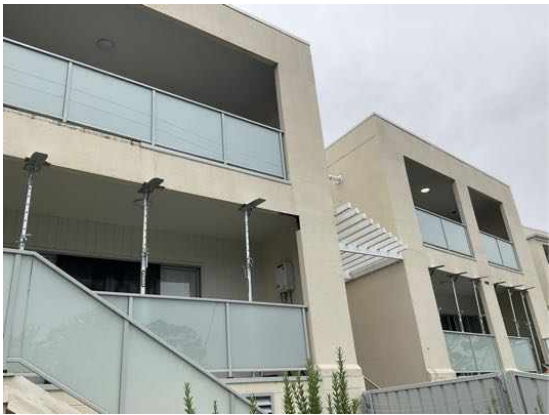
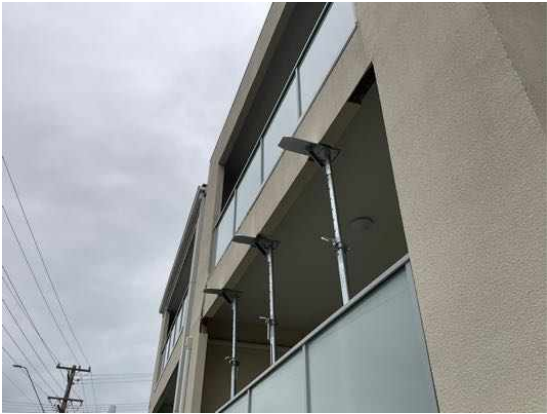
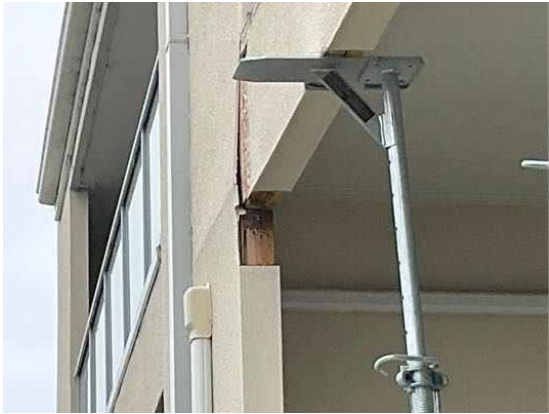
Building: Building 1
Location: Unit
Finding: Additional Photos
Information: Additional photos are provided for your general reference

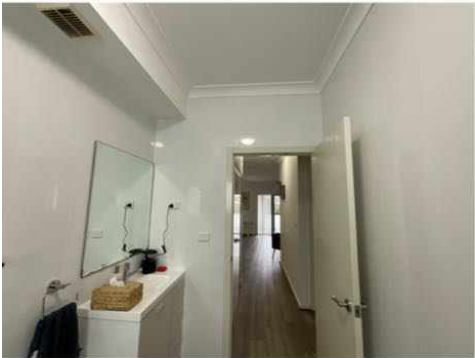
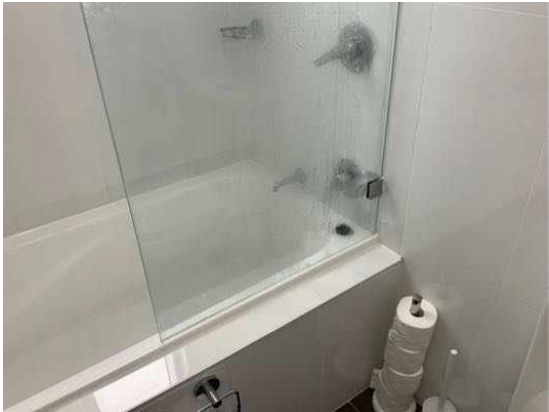
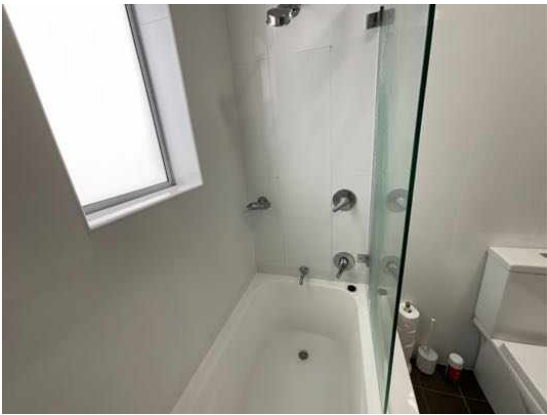
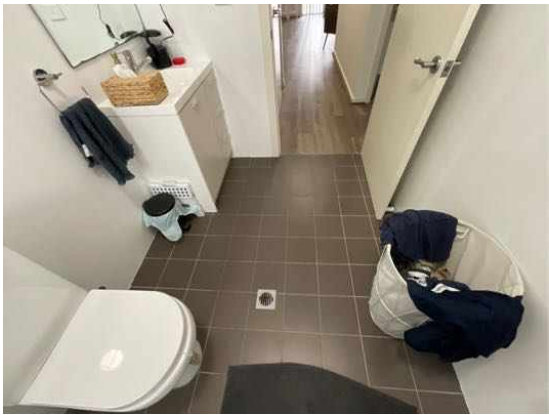
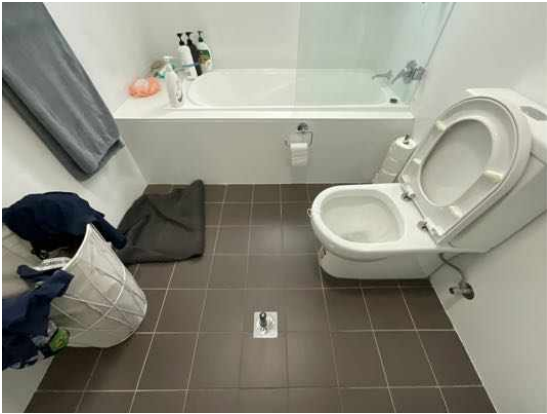
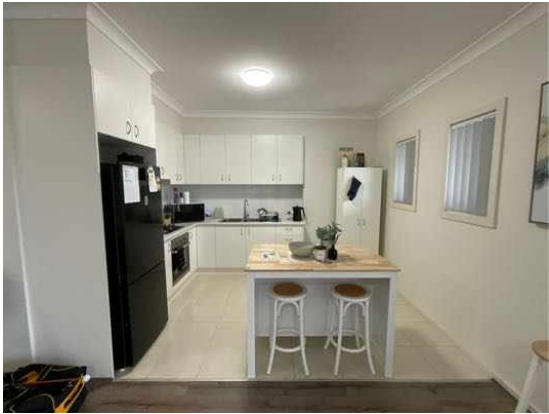
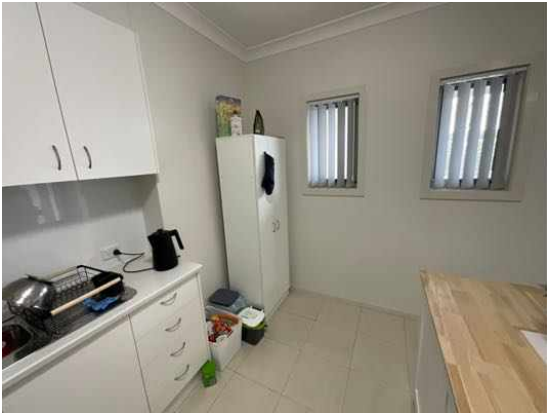
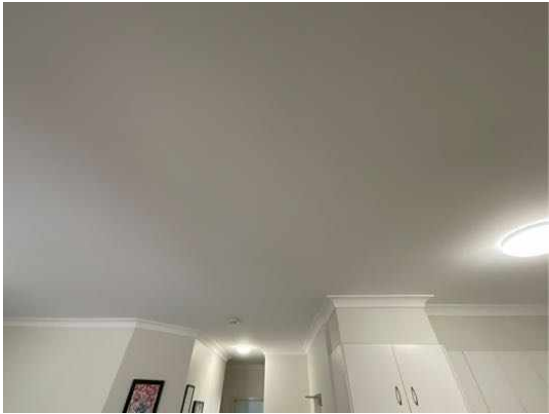
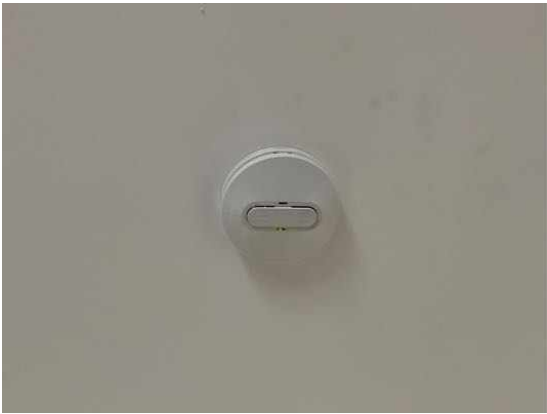
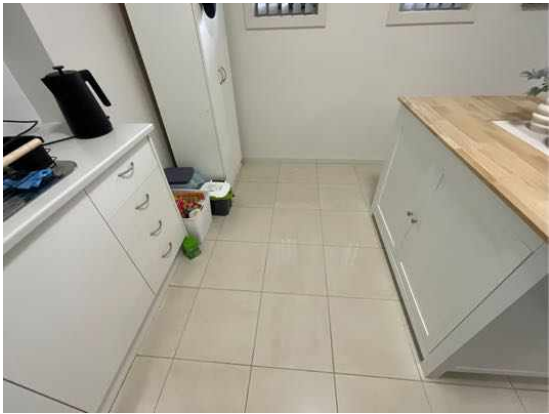
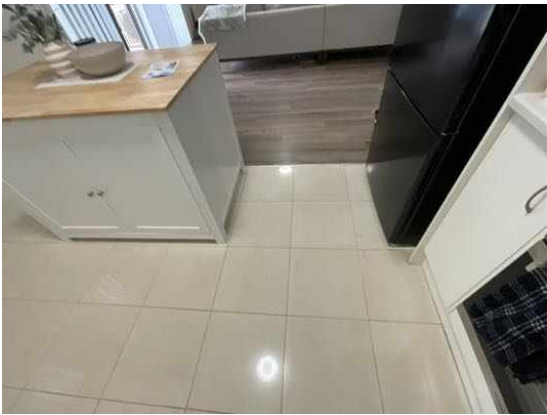
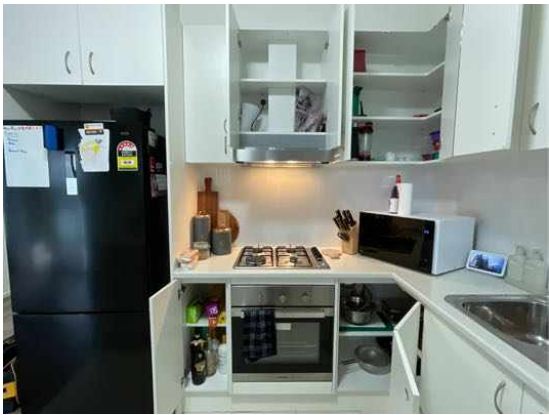
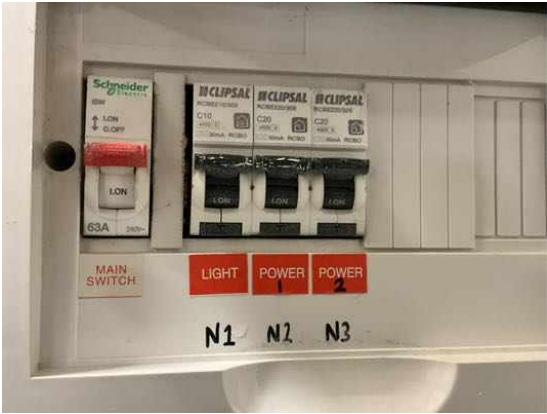
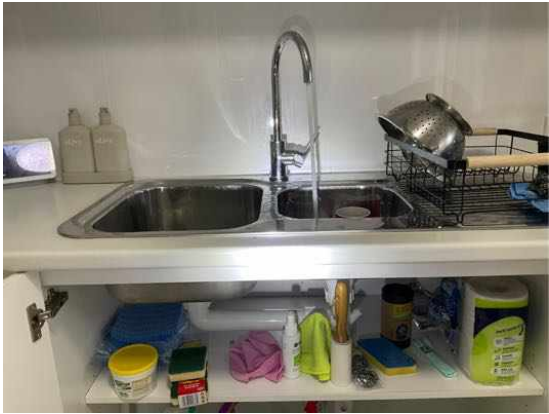
Building: Building 1
Location: Kitchen & Bathrooms
Finding: Additional Photos
Information: Additional photos are provided for your information

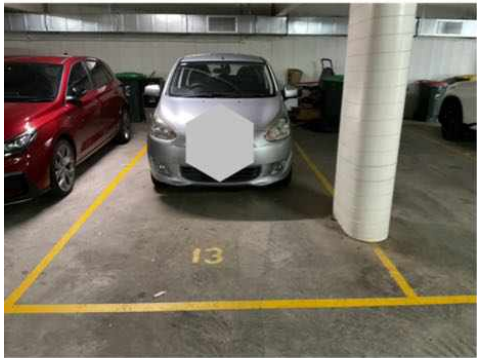
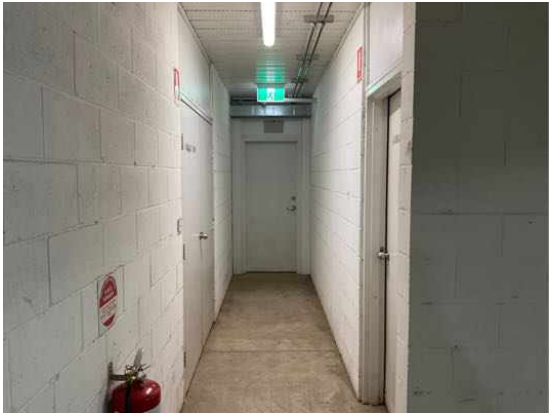
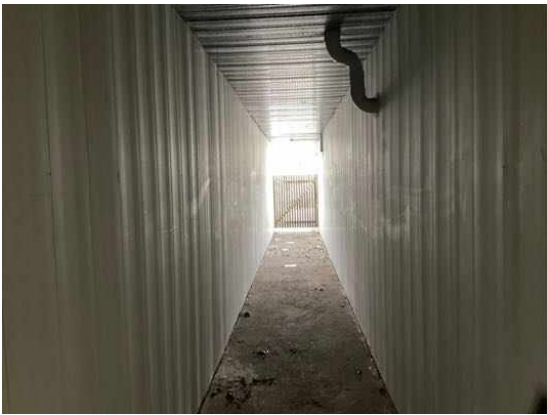
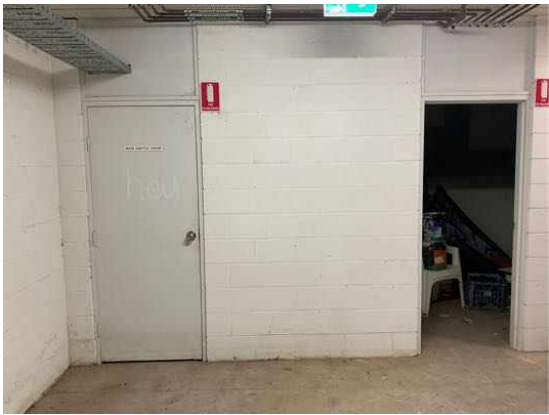
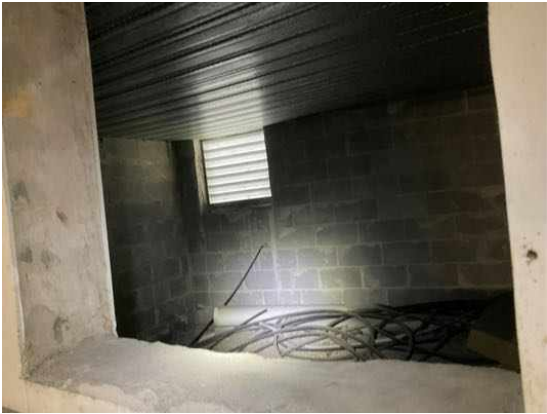
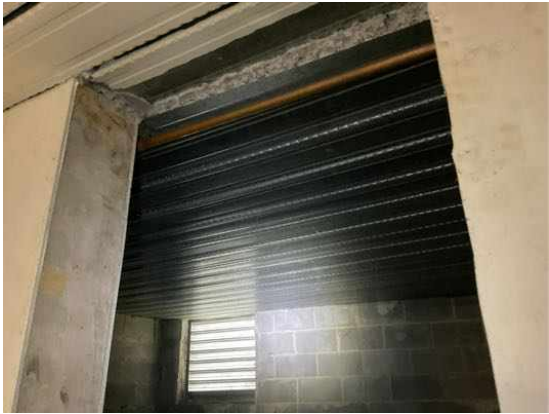
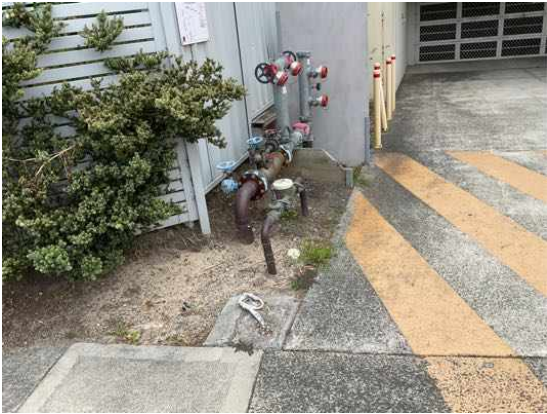
Building: Building 1
 Location: Garage areas
 Finding: Additional Photos
 Information: Additional photos are provided for your general reference
