Building and Timber Pest Inspection Report

Inspection Date: Fri, 30 Jan 2026

Property Address: 20 Dundee Dr, West Wodonga VIC 3690,
Australia

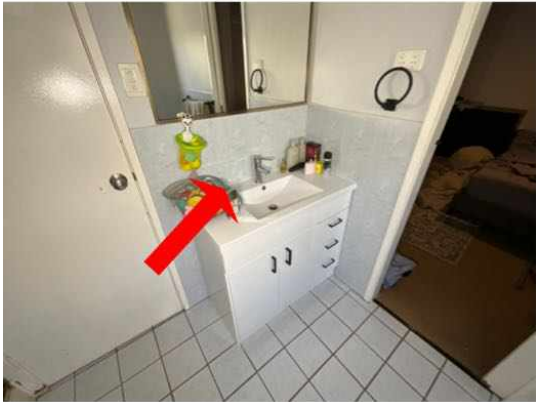
areas, as well as creating potential for water penetration to adjoining building elements. If left unmanaged, water damage may occur as a result of constant water penetration over a prolonged period of time.

While not considered a matter of urgency, replacement of tiles is advised as a solution. A Tiling Contractor may be appointed to perform these works at client discretion.

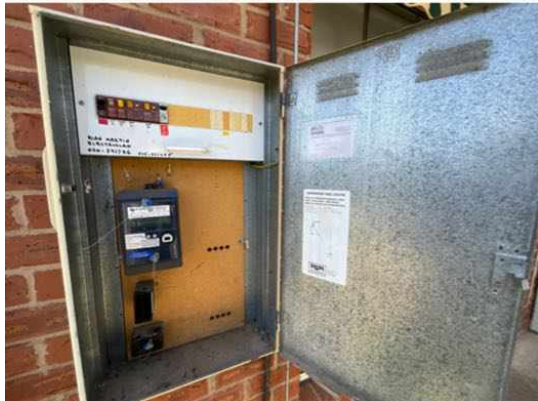
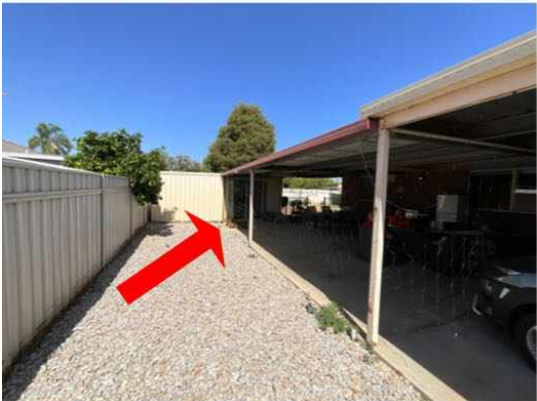
A durable notice should be placed in the switchboard unit to indicate current termite barriers. At the time of inspection, it appeared as though no termite management system has been installed, with no evidence to suggest preventative works taking place.

The client may consider gaining further advice from a pest controller as to the costs and procedures involved with this application. It is recommended that obtaining such advice be a short-term priority.

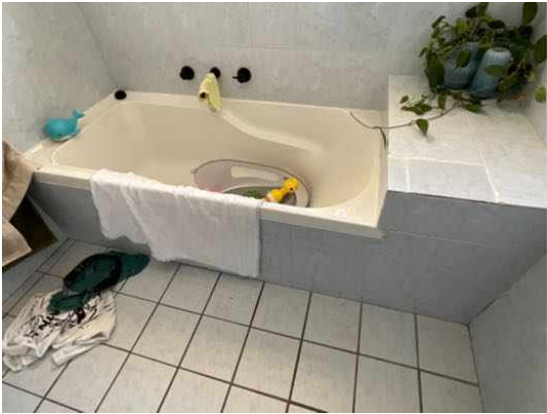
Building: Building 1
 Location: All Areas
 Finding: Additional Photos - Obstructions and Limitations
 Information: These photographs are an indication of the obstructions and limitations which impeded full inspection of the property at the time of inspection. These obstructions can hide an array of defects and should be removed to allow full inspection to be carried out. A re-inspection is recommended once the areas are made accessible.
