Building and Timber Pest Inspection Report VR

Inspection Date: Tue, 17 Feb 2026

Property Address: 8/12-16 Blaxcell St, Granville NSW 2142,
Australia

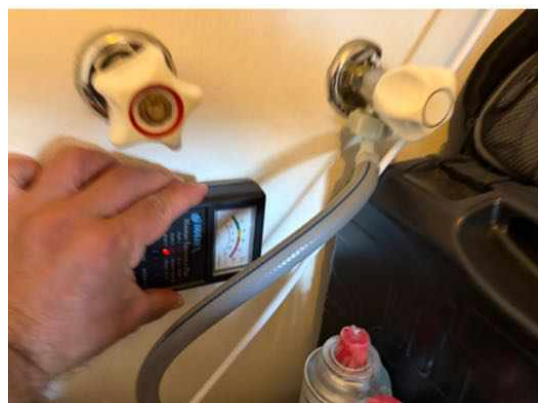
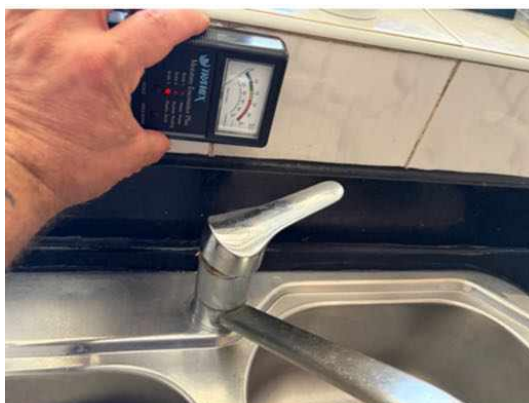
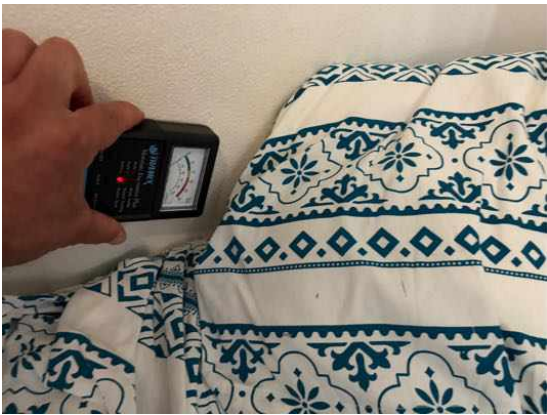
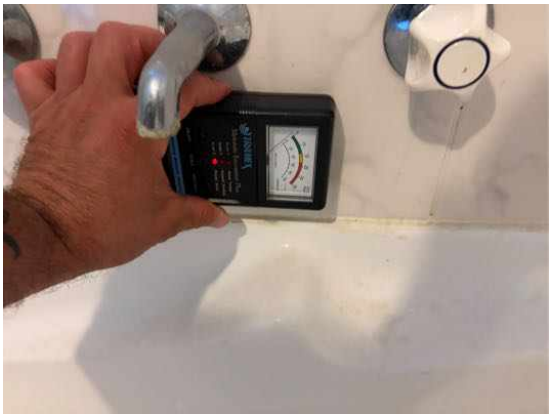
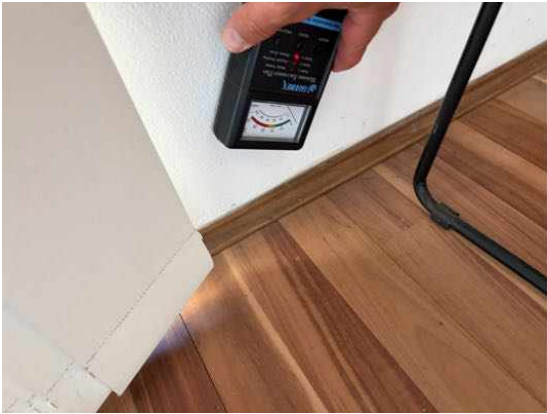
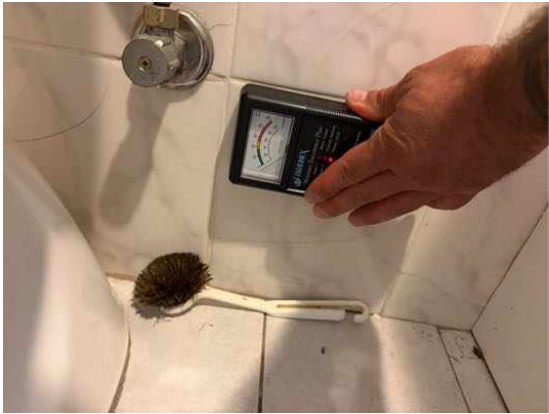
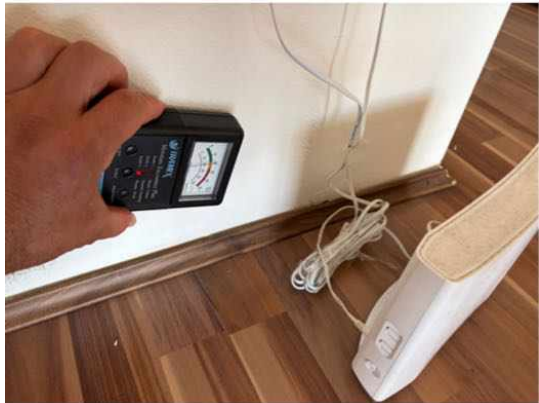
Building: Main Building
 Location: All Areas
 Finding: Moisture metre
 Information: During the inspection the property was checked for moisture using a moisture metre.

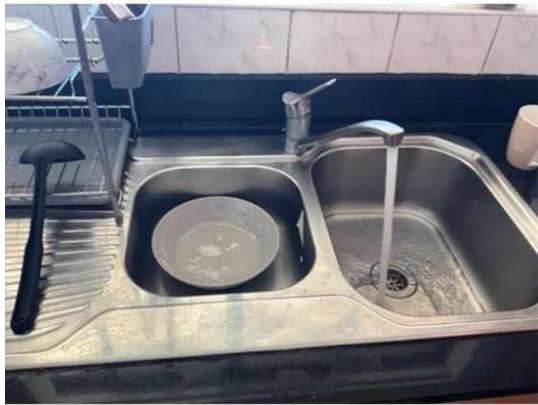
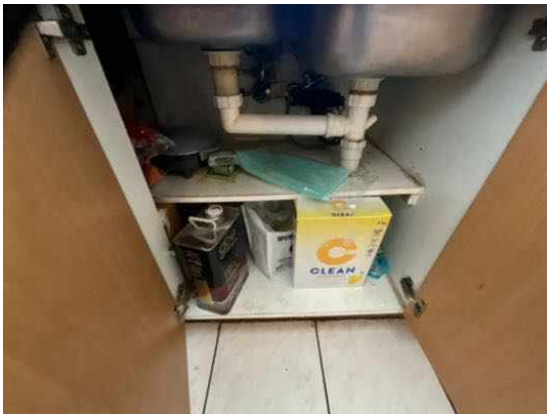
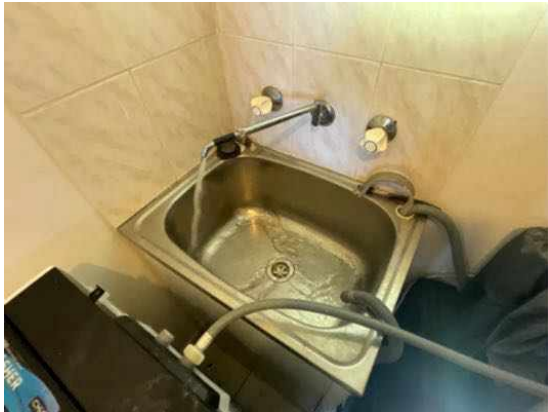
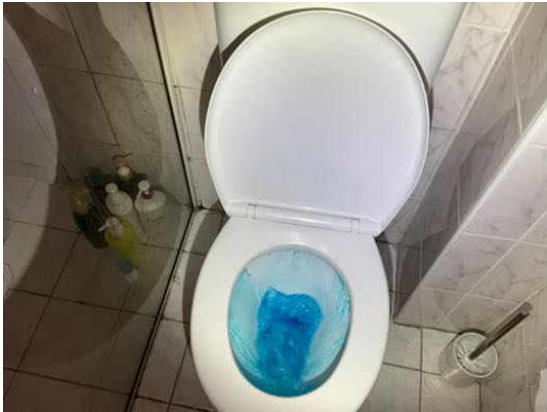
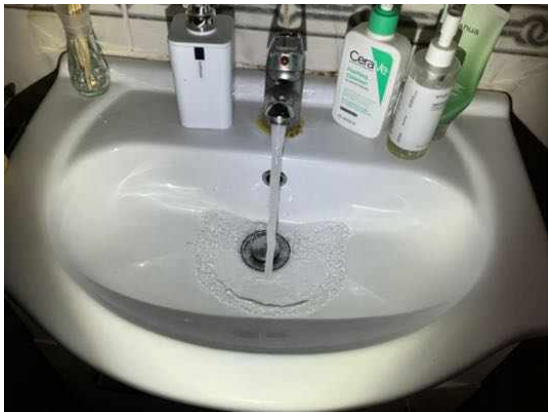
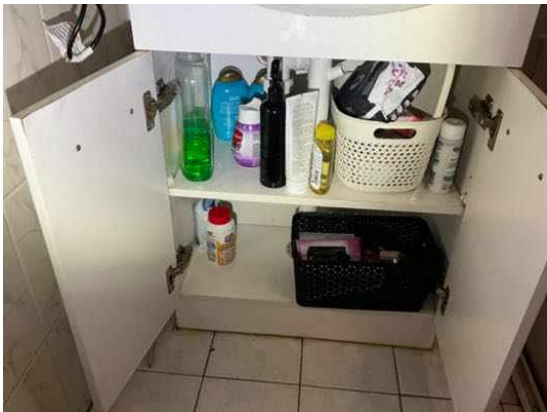
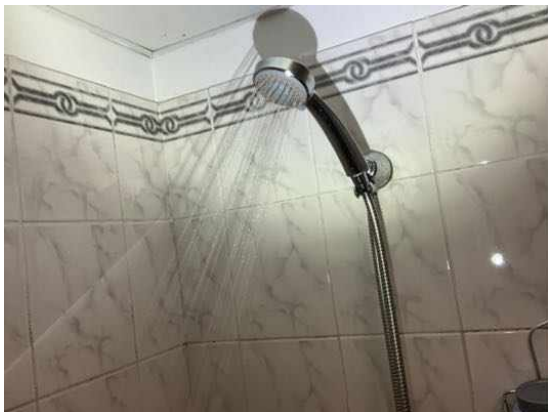
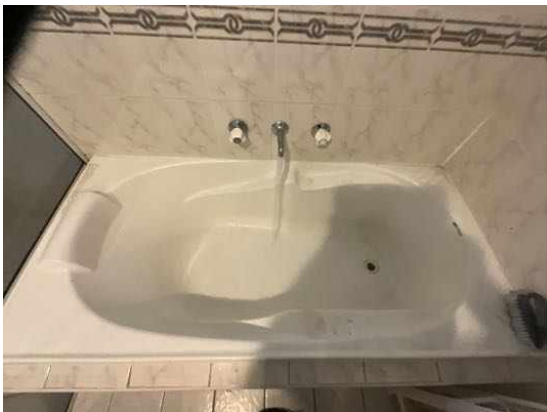
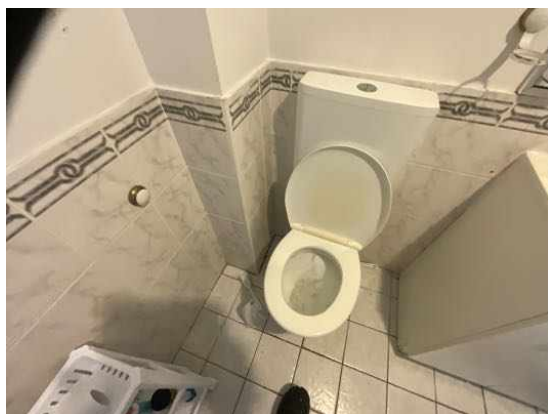
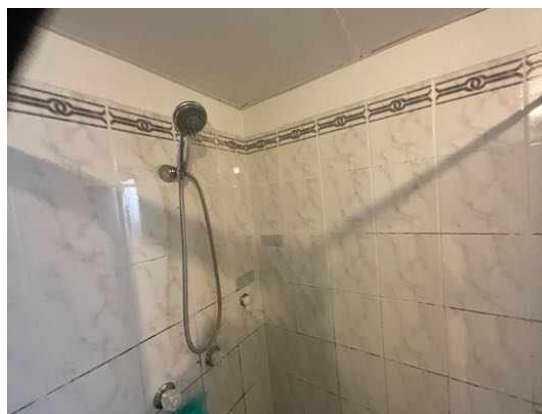
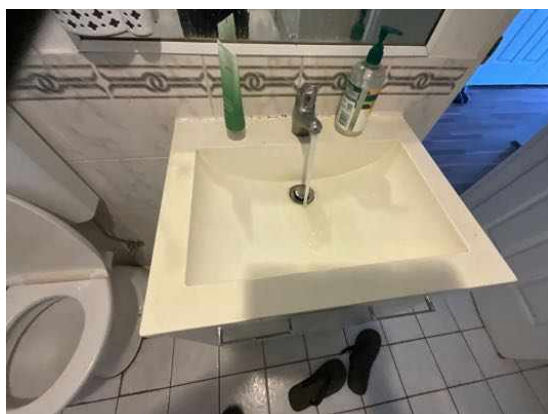
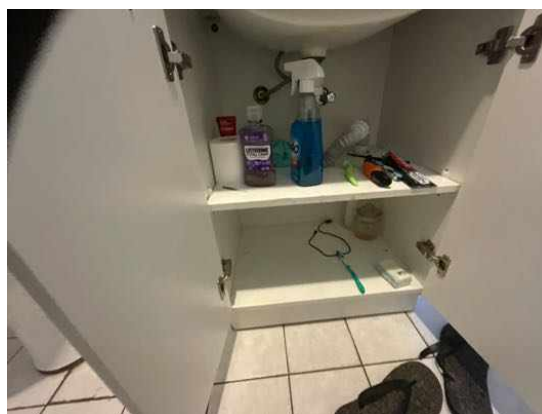
Building: Main Building
Location: All Wet Areas
Finding: Additional Photos
Information:

Additional photos are provided for your general reference.

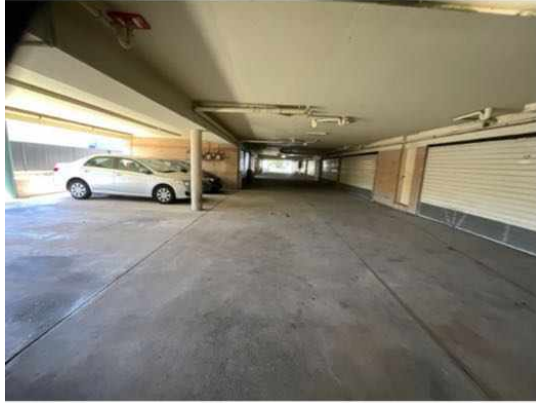
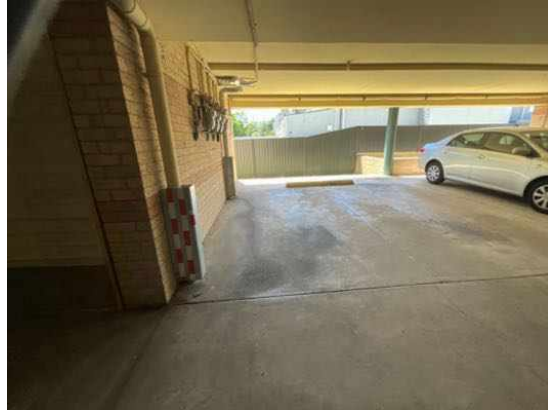
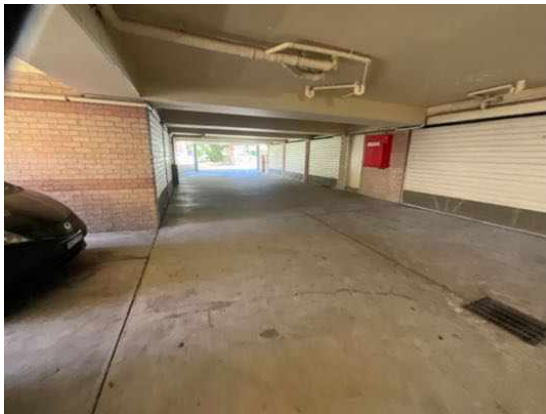
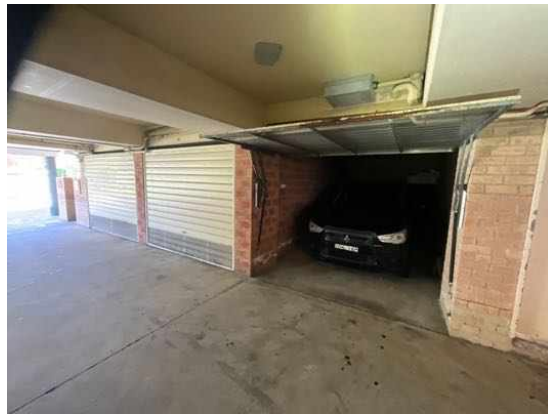
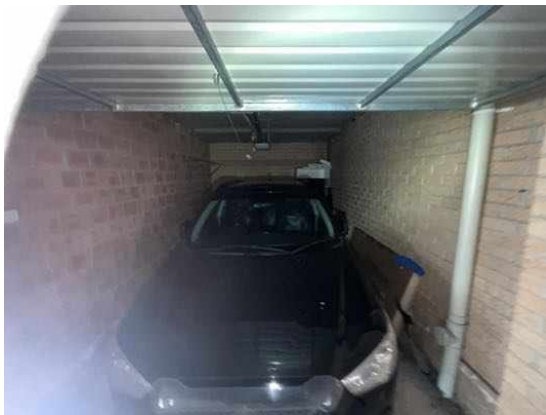
Building:	Main Building
Location:	Garage
Finding:	Additional Photos- Garage
Information:	Additional photos are provided for your general reference. Arrows may have been included to highlight areas of importance. Please discuss these photos with your building consultant for clarification.

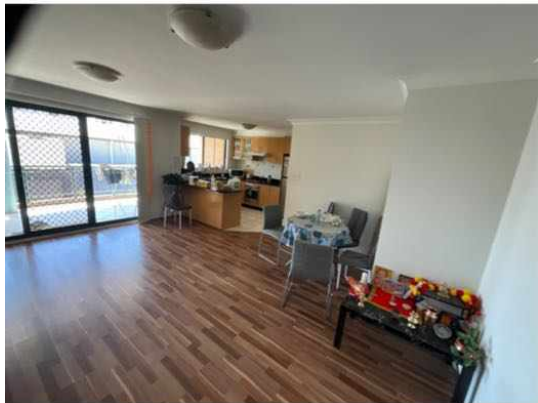
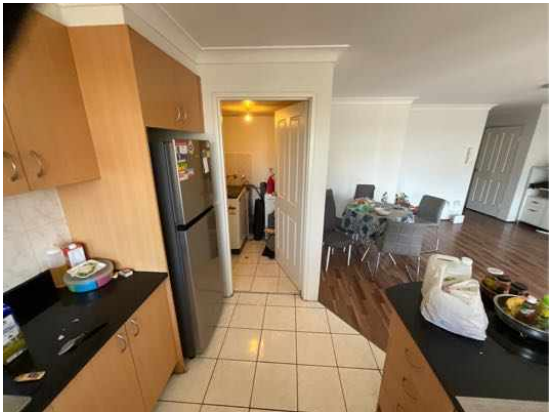
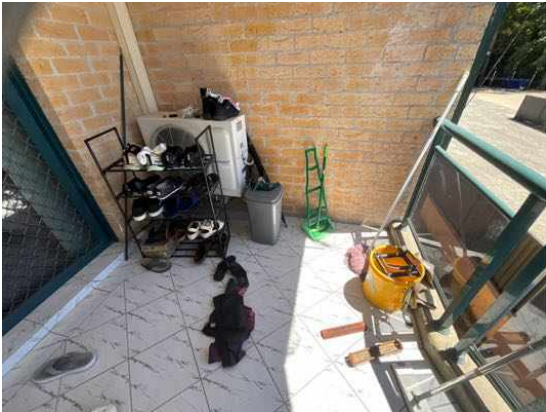
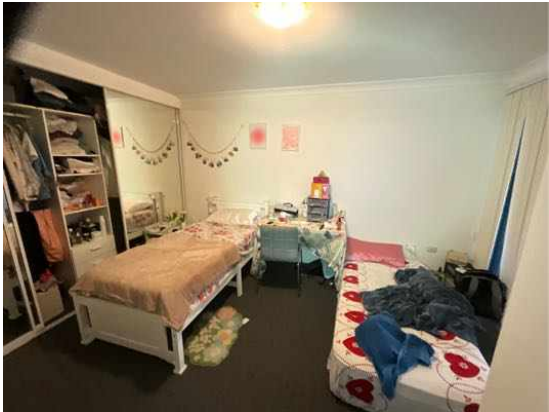
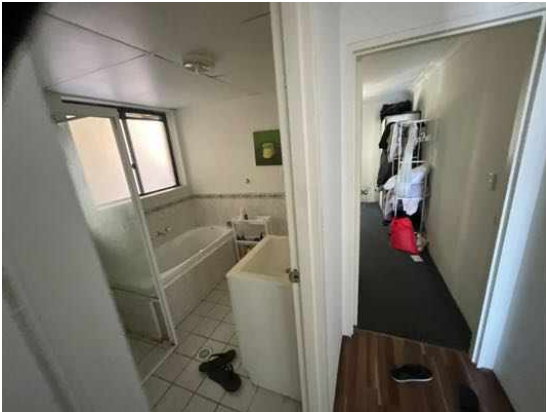
Building: Main Building
Location: All Areas
Finding: Additional Photos - Obstructions and Limitations
Information:

These photographs are an indication of the obstructions and limitations which impeded full inspection of the property at the time of inspection. These obstructions can hide an array of defects and should be removed to allow full inspection to be carried out. A re-inspection is recommended once the areas are made accessible.
