Building and Timber Pest Inspection Report

Inspection Date: Mon, 8 Dec 2025

Property Address: 19 Mariana Ave, Croydon South VIC 3136,
Australia

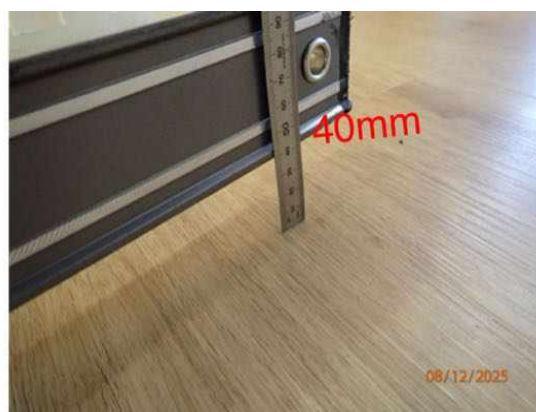
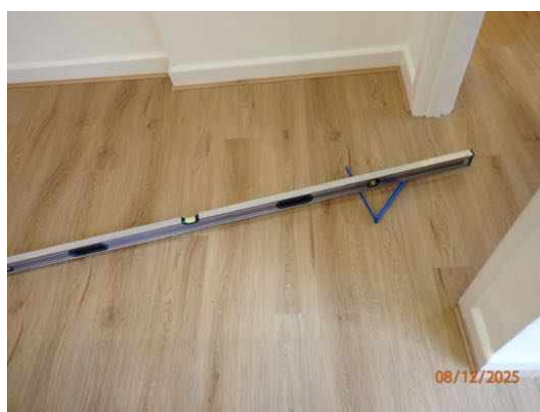
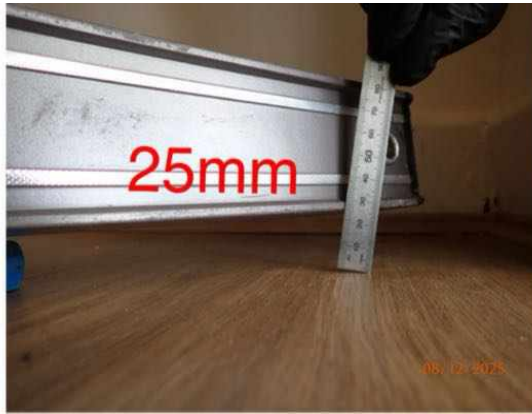
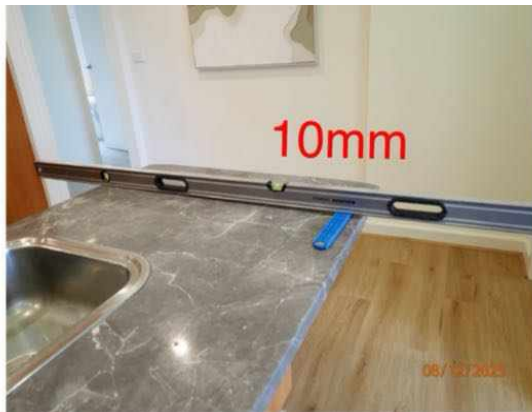
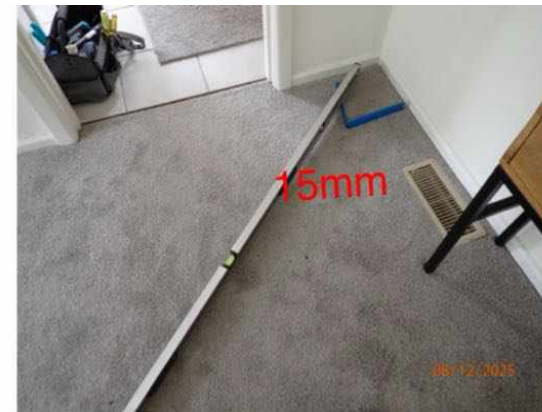
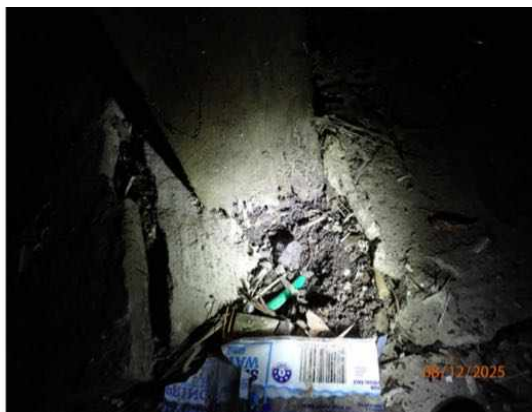
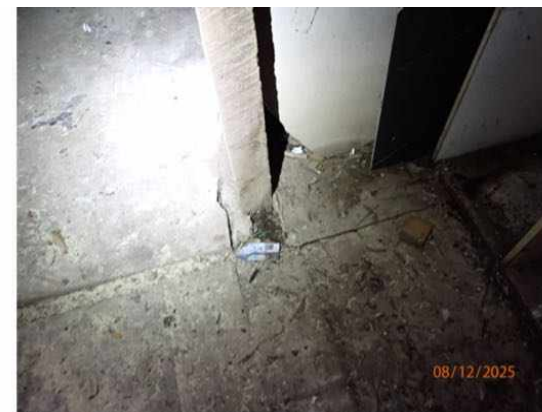
Building: Main Building
Location: Kitchen and dining
Finding: Subsidence - stumps
Information: Significant subfloor movement was noted during the inspection, consistent with foundation movement such as sinking or subsidence. While some settlement over time is expected, the degree of movement observed in this property requires attention and is classified as a major defect.

The property is supported on timber stumps, and the condition of these stumps below ground cannot be assessed within the scope of this inspection. However, deterioration of some stumps is suspected due to secondary signs such as uneven flooring and observable settlement. Even in the absence of visible secondary defects, deteriorated timber stumps may still be present, as timber is prone to decay and long-term breakdown.

Ongoing subfloor movement or failing stumps can lead to structural instability, further subsidence, and damage to other building elements if left unmanaged.

It is recommended to engage a structural engineer to assess the extent of movement and determine the required rectification works. A registered builder specialising in re-stumping should also be appointed to conduct a more invasive inspection of the stumps and soil conditions and provide quotations for required repairs based on the engineer's advice.

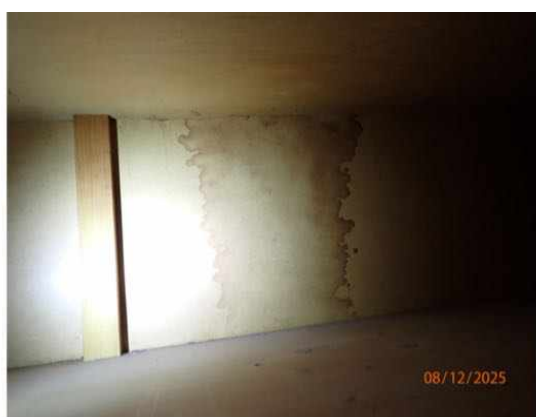
Finding 3.01

Building: Main Building
Location: Bedroom 1
Finding: Wardrobe - Water staining
Information: Water staining was evident in this area at the time of inspection. No moisture ducted during inspection.

Water staining indicates that surfaces have been exposed to excessive moisture over

time. The minerals and other elements in the water lead to staining, which may graduate to corrosion and deterioration if left unmanaged.

While mostly an appearance defect, water staining can be indicative of more serious defects, which may be currently concealed by other building elements.

Where water staining is active, a licensed plumber must be consulted to identify the cause of the staining and to provide advice on any reparation works that may be required. Replacement of any broken or damaged structures is advised.

Conversely, where water staining is old and inactive, affected building materials may be repaired or replaced at client discretion. A qualified carpenter or registered builder may be appointed to perform these works.

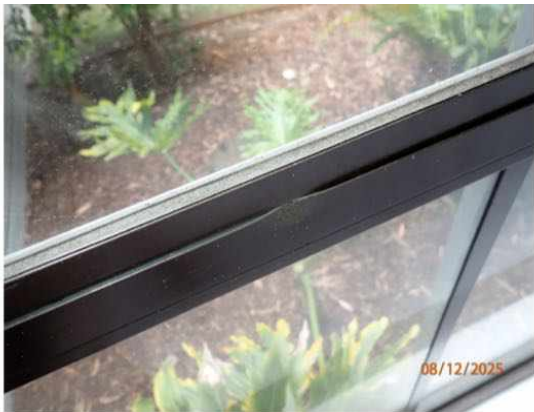
Finding 3.02

Building:	Main Building
Location:	All Internal Areas
Finding:	Window - jammed
Information:	The window in this area was jammed and difficult to operate at the time of the inspection. Windows provide ventilation to the adjoining area and should be at a fully operational level to ensure user comfort. Restricted function of the window may also pose as a potential safety hazard if required for emergency egress from the building.

Generally, factors such as general age of the building element and a lack of maintenance are the usual causes for this type of defect.

Replacement of window hardware or frame may be required, as well as minor repairs and cleaning. A registered builder or general handy person will be required to repair the window.

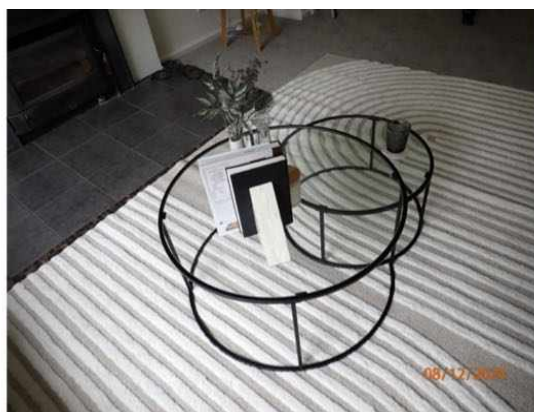
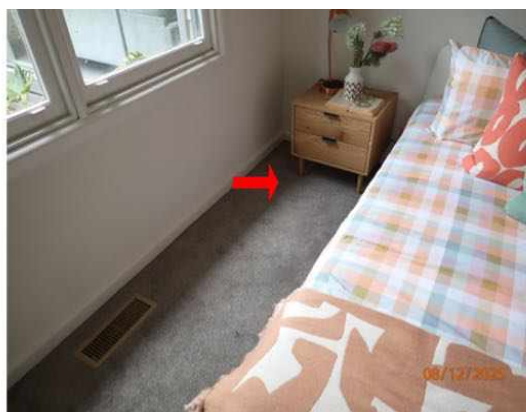
Finding 3.03

Building:	Main Building
Location:	Living Room and Bedroom 3
Finding:	Floors - bouncy
Information:	During inspection, the internal flooring in this area was noted to be bouncy, exhibiting discernible movement and noise when walked upon.

Bouncy floors typically indicate that floorboards or subfloor structures are becoming loose from the underlying joists or there is movement in the subfloor structures causing. This may also result from gaps between flooring and stumps or joist structures, requiring attention to ensure stability and safety.

It is advisable for the client to obtain quotations for necessary repairs from a Registered Builder specializing in re-stumping. The potential resolution may involve packing gaps in subfloor structures or replacement of subfloor stumps, along with refixing of flooring as needed. Prompt action can prevent further deterioration and ensure the structural integrity of the flooring.

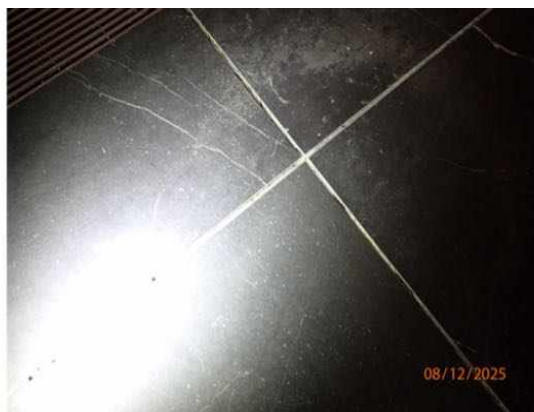
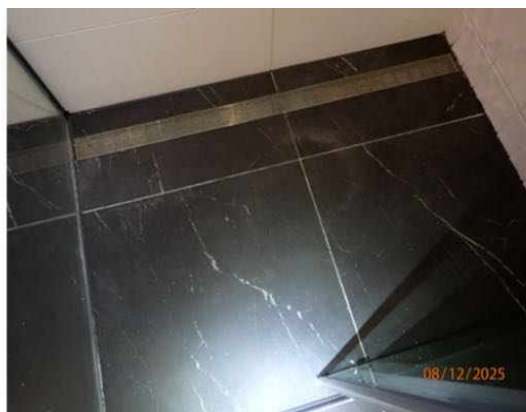
Finding 3.04

Building:	Main Building
Location:	Bathroom
Finding:	Sealant and grouting - Missing or damaged
Information:	During inspection, degradation of the sealant or grout was noted in the tiled shower alcove.

Differential movement between materials and floor areas can lead to cracking of grout or sealant, compromising the water tightness of the joint. This deterioration increases the risk of water penetration and subsequent damage to associated building materials.

To prevent further water damage, flexible and mould-resistant materials should be applied to the affected areas. Regular maintenance and replacement of damaged sealant and grout are essential to ensure long-term protection of wet areas. Prompt engagement of a sealant specialist or tiling contractor is advised to address this defect

and prevent potential structural issues in the future.

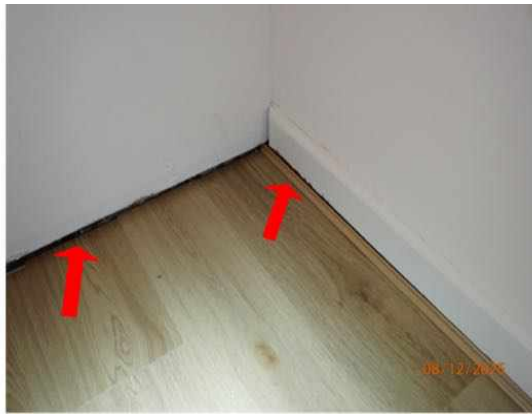
Finding 3.05

Building:	Main Building
Location:	Laundry
Finding:	Floor Skirting - Gaps to edges
Information:	Considerable gaps were noted around the edges of the flooring in this area. Beading is typically used to cover such gaps and provide a finished appearance while preventing drafts.

These gaps are suspected to have developed due to foundation movement or subsidence affecting the flooring over time. It is recommended that the gaps be filled with coloured caulking or covered with beading to restore appearance and maintain a draft-free environment.

A qualified carpenter or general handyperson should carry out the remedial works at the client's discretion. Prompt attention will help maintain both the functionality and visual appeal of the flooring. ealing.

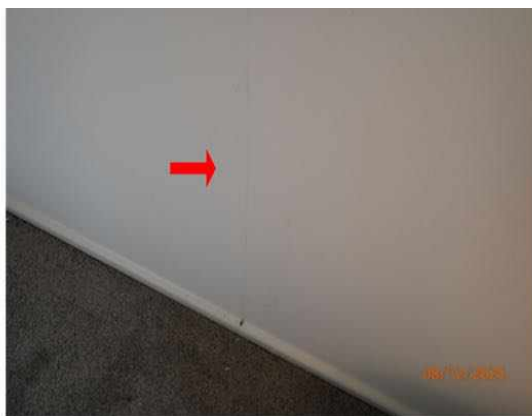
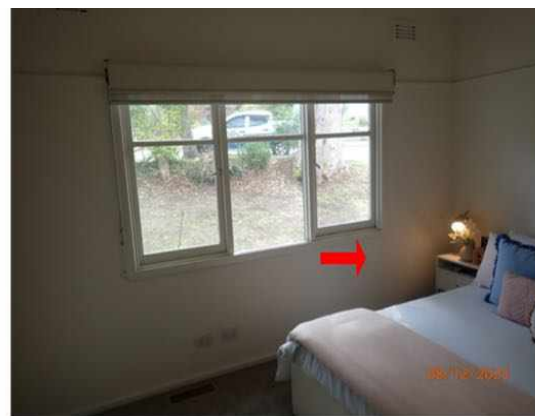
Finding 3.06

Building:	Main Building
Location:	Bedroom 4
Finding:	Wall - Water stained
Information:	Water staining to wall linings in this area was evident at the time of inspection. No moisture detected during inspection.

Water staining indicates that surfaces have been exposed to excessive moisture over time. The minerals and other elements in the water lead to staining, which may graduate to corrosion and deterioration if left unmanaged.

While mostly an appearance defect, water staining can be indicative of more serious defects, which may be currently concealed by wall lining.

Where water staining is active, a licensed plumber must be consulted to identify the cause of the staining and to provide advice on any reparation works that may be required. Replacement of any damaged structures is advised.

Conversely, where water staining is old and inactive, affected building materials may be repaired or replaced at client discretion.

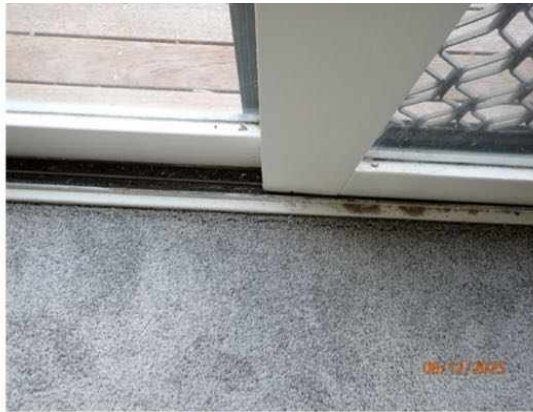
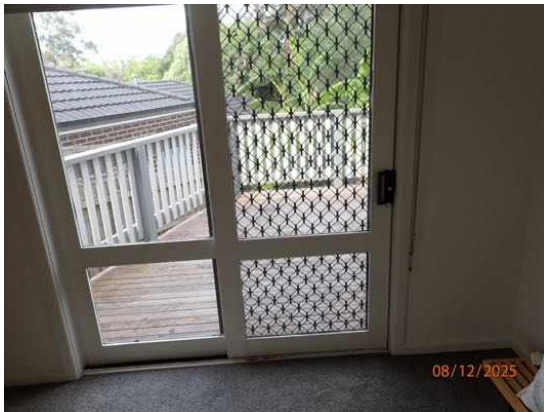
Finding 3.07

Building: Main Building
 Location: Rumpus Room
 Finding: Door need maintenance
 Information: The external sliding door to the backyard was noted difficult to slide during the inspection, and the door handle was found to be loosely attached. This affects the proper operation of the door and may result in further damage to the door frame or handle if left unattended.

It is recommended to engage a qualified carpenter or handyperson to adjust the sliding mechanism and securely fix the handle to restore smooth and safe operation.

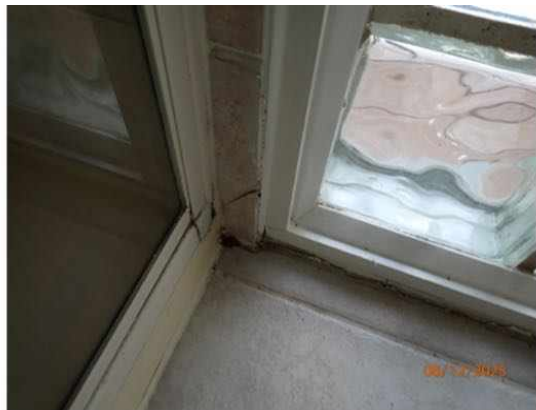
Finding 3.08

Building: Main Building
 Location: Bathroom 2
 Finding: Bathroom tiles - Cracked
 Information: Cracking was evident in the tiles in this area during the inspection.

Cracked tiles not only affect the visual appeal but also pose a risk of water penetration to adjacent building elements. Prolonged exposure to water may lead to potential water damage over time, compromising the integrity of the affected areas.

Replacing the cracked tiles is advised to prevent water penetration and potential

damage. Clients have the option to engage a tiling contractor or a general handyman for the replacement works. If the number of cracks increases significantly, consulting with a registered builder specializing in re-stumping may be necessary to address underlying structural issues. Timely action is recommended to mitigate the risk of further damage.

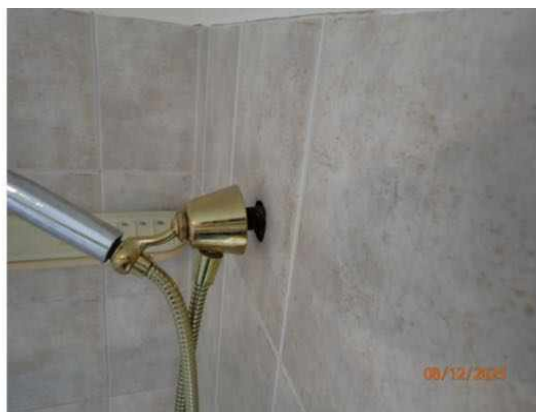
Finding 3.09

Information: This handyman work appears to have been completed to a substandard level and does not comply with regular building practices. Where handyman work is not completed satisfactorily, accelerated deterioration of the associated building elements is likely to occur and secondary defects to surrounding structures may develop.

It is highly recommended that the substandard work be rectified by licensed plumber. Works to improve this area are likely to increase the safety and the operation of the associated building elements.

Rectification works are advised as soon as possible by the licensed plumber.

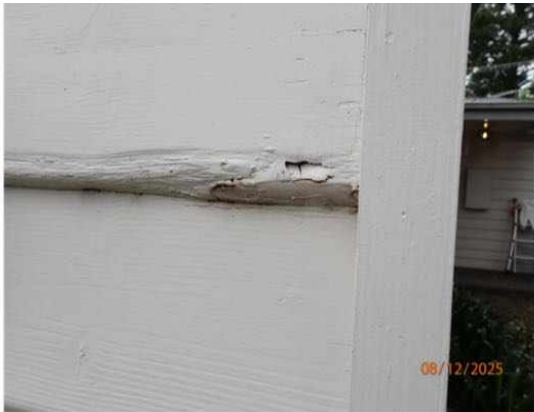
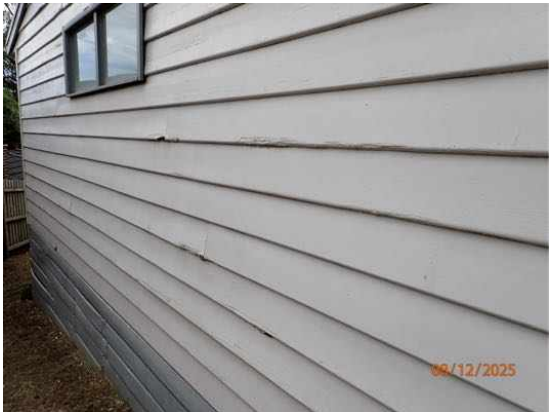
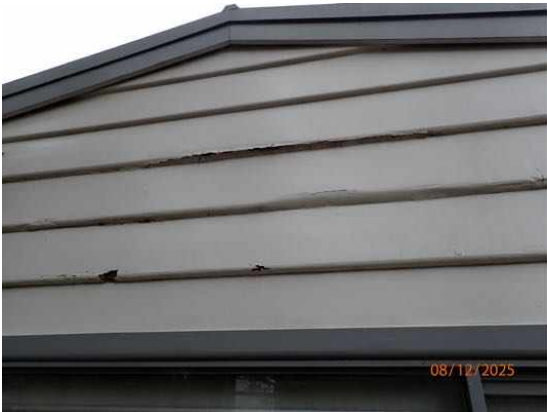
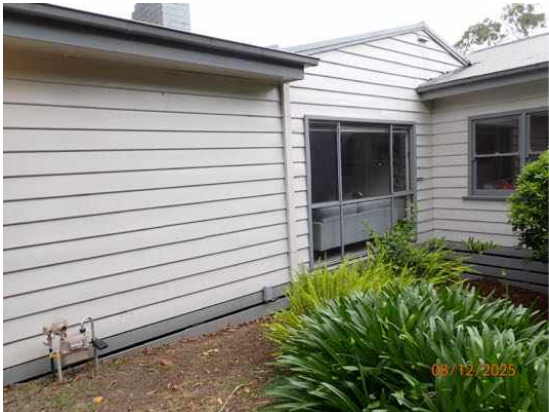
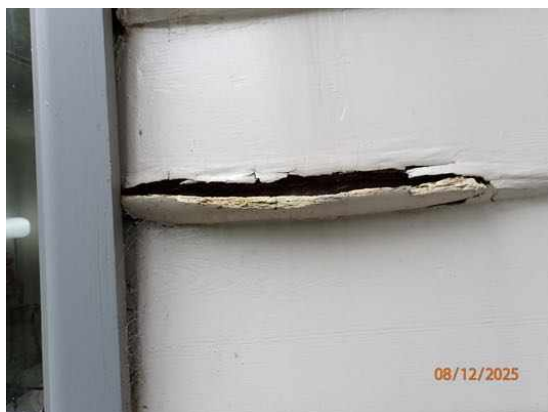
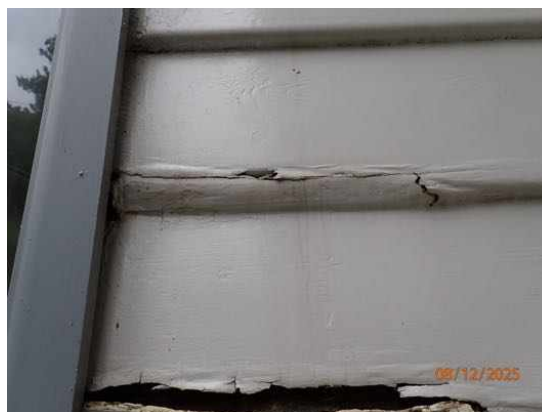
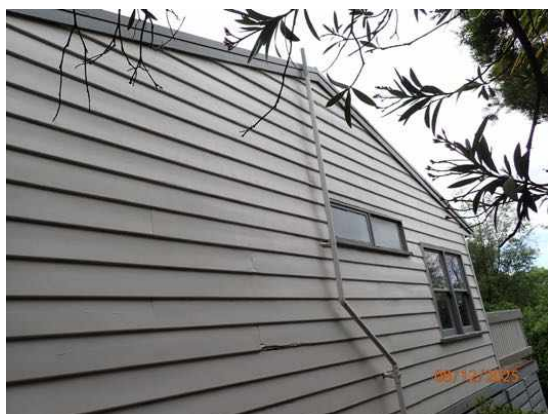
Finding 3.10

Building: Main Building
Location: All External Areas
Finding: Wood rot - Weatherboard
Information: This weatherboard shows evidence of wood rot. Wood rot, also known as Fungal Decay, occurs when timbers and other cellulose building materials are exposed to damp conditions on an ongoing basis. This could be the result of exposure to weathering over a prolonged period of time, or the attraction of excessive moisture from other abutting building materials. Contributing factors also include poor air ventilation in the area.

Early intervention and regular maintenance, particularly of exterior timbers, will prolong the useful life of these building elements. Prior to any works being performed, the cause of the moisture that has created the visible wood rot should be identified and addressed in a suitable manner. Replacement of affected timbers may then be a necessary step in protecting surrounding building elements from such deterioration.

A qualified plumber may be appointed to assess the cause of excessive moisture and to provide advice on any remedial works as required. A qualified carpenter or registered builder may also be required to replace affected building materials.

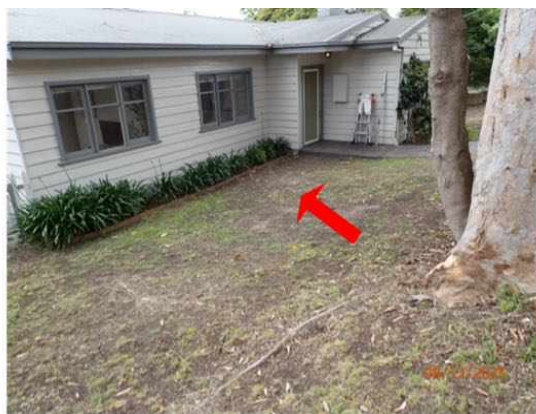
Finding 3.11

Building:	Main Building
Location:	Exterior walls - front
Finding:	Site drainage - Inadequate
Information:	The site drainage in this area was found to be inadequate at the time of inspection, creating potential for subsequent water damage to associated building elements.

It is important that water does not lie against the base of walls; surrounding paths and ground levels should be sloped to drain water away from walls. Downpipes should not discharge stormwater onto lower walls or plinths. Stormwater should be carried away by large, regularly cleaned drains. Ground levels may need to be lowered to expose a buried DPC.

Where site drainage is inadequate, installation of an Agricultural (Aggie) Drain may be required. A qualified plumber should be appointed to further inspect the property and perform any remedial works as necessary. Water damage and secondary defects are likely to occur if left unmanaged.

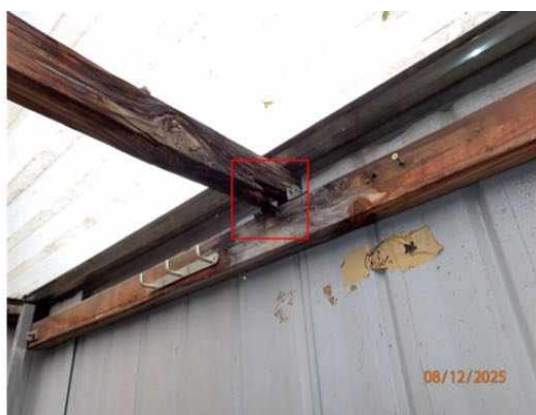
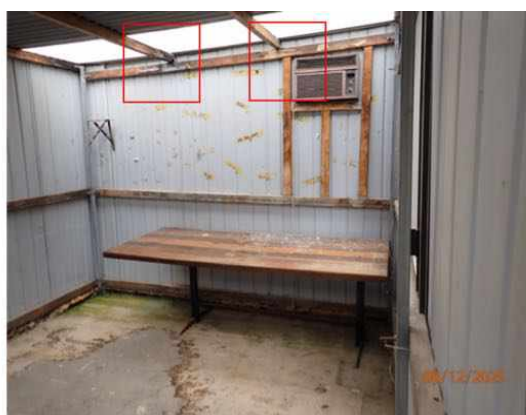
Finding 3.12

Building:	Main Building
Location:	Exterior walls - rear
Finding:	Timber wood rot
Information:	The timber supporting the roof in the shed was noted to be rotted during inspection, likely due to prolonged moisture exposure. Continued deterioration may compromise the stability of the roof structure.

It is recommended to engage a qualified carpenter to assess the extent of the damage and repair or replace the affected timber to ensure the shed remains structurally safe.

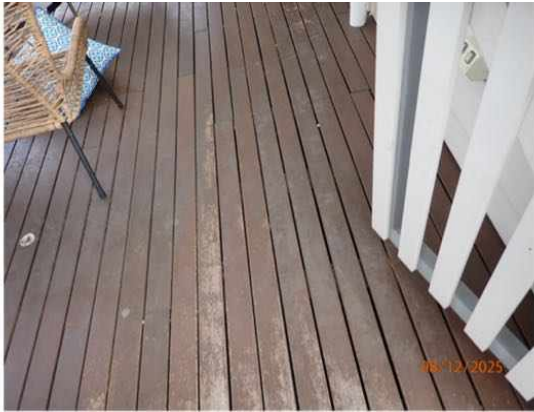
Finding 3.13

Building:	Main Building
Location:	Exterior walls - rear
Finding:	Deck - bouncy
Information:	The decking in this area was identified as being bouncy at the time of inspection. A bouncy floor surface generally presents as a discernible change in level as they are walked across, in noisy or creaking flooring, or in consequent movement of surrounding furniture and fixtures.

coming loose from the joists that they are installed on. Bouncy flooring may also be the result of gaps between flooring and stumps or joist structures, which require packing.

The client is advised to seek quotations for required repairs from a qualified carpenter. The potential resolution may range from packing gaps in subfloor structures through to replacement of subfloors structure and refixing of flooring.

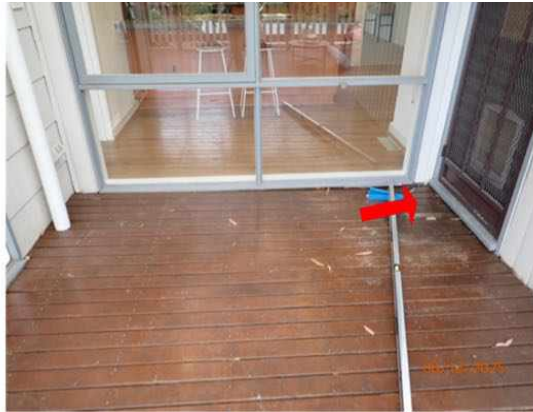
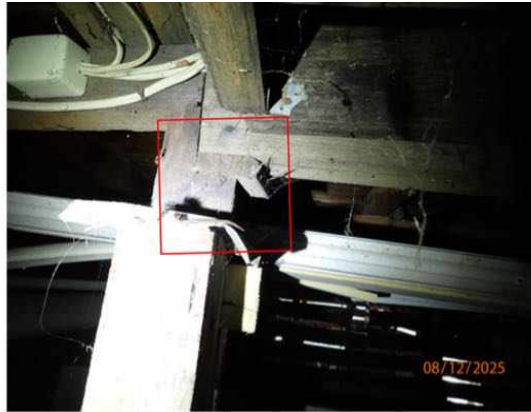
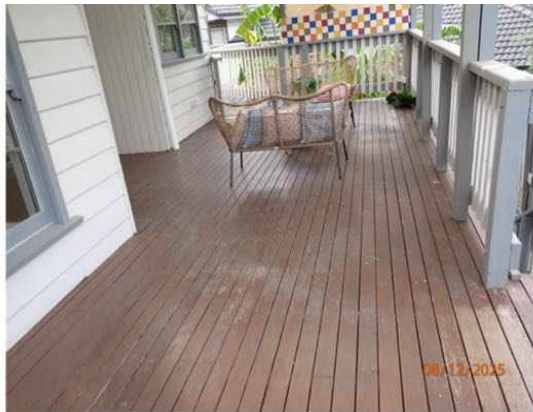
Finding 3.14

Building: Main Building
Location: Exterior walls - rear
Finding: Deck uneven and Un supported

Information: The decking support frame in this corner was noted to be unsupported, resulting in a bouncy and uneven deck surface during inspection.

This indicates substandard construction and may affect the safety and stability of the deck. This is noted as a minor defect with major implications if not rectified immediately

It is highly recommended to engage a registered builder to assess the structure and carry out necessary rectification works to ensure the deck is properly supported and compliant with current building standards.

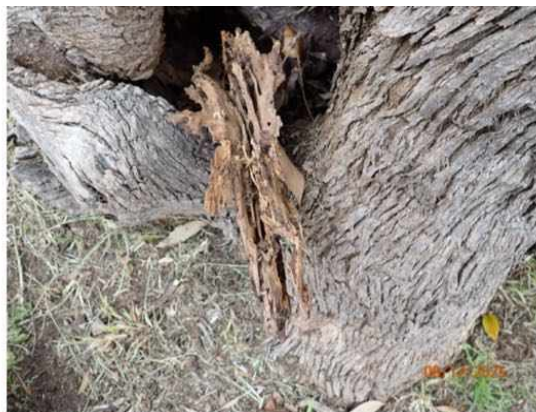
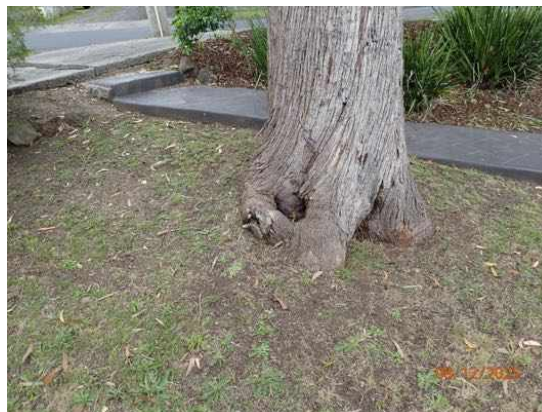
Building: Main Building
 Location: Exterior walls - front
 Finding: Evidence of termite damage - minor

Information: Despite no live termite or timber pest activity being indicated, previous termite damage was found to have affected this area. This damage is considered to be inactive and is minor in nature.

It is advised that the area be visually inspected frequently to ensure that the condition of affected materials does not worsen. At the time of inspection, damage is not structural and is only considered to be superficial.

A timber pest technician should be appointed immediately to provide a further invasive inspection to determine if they are active.

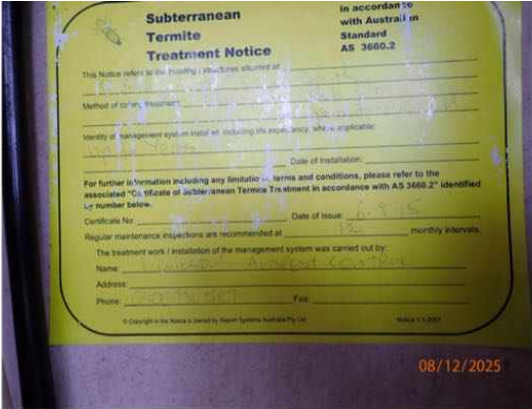
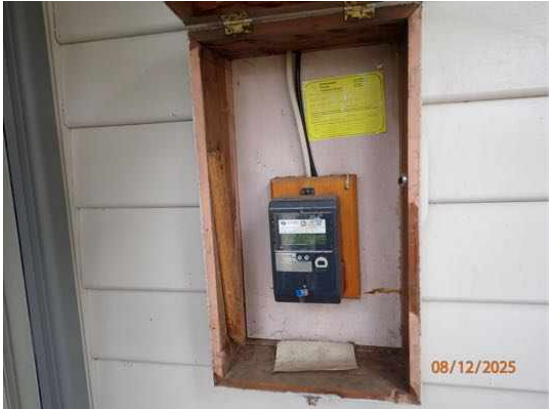
Finding 6.01

Information: The application of a post-construction chemical termite barrier is highly recommended for all properties, particularly if live termite activity has been found on the site previously. Such barriers are highly effective in preventing termite attack on any timber building elements throughout the property.

A durable notice should be placed in the switchboard unit to indicate current termite barriers. At the time of inspection, it appeared as though no termite management system has been installed, with no evidence to suggest preventative works taking place.

The client may consider gaining further advice from a pest controller as to the costs and procedures involved with this application. It is recommended that obtaining such advice be a short-term priority.

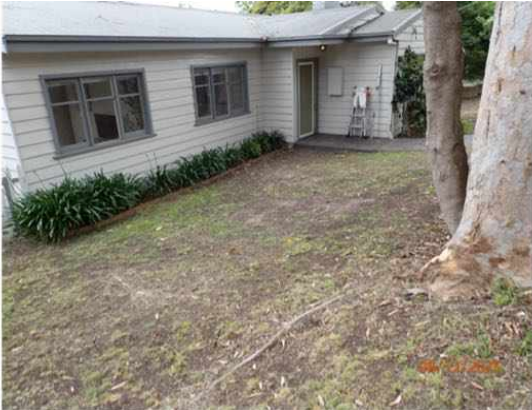
Building: Main Building
 Location: All External Areas
 Finding: Garden Beds - Conditions Conducive to Termites
 Information: Garden beds were found to be evident abutting the external walls of the property. These garden beds can include untreated timber, and with a combination of moisture from watering hosing can make conditions conducive to termite activity and termite ingress.

It is recommended that the property owner be vigilant in reducing conducive conditions around the property where possible. If conducive conditions are present and not removable periodically inspections should be conducted by a licensed pest controller.

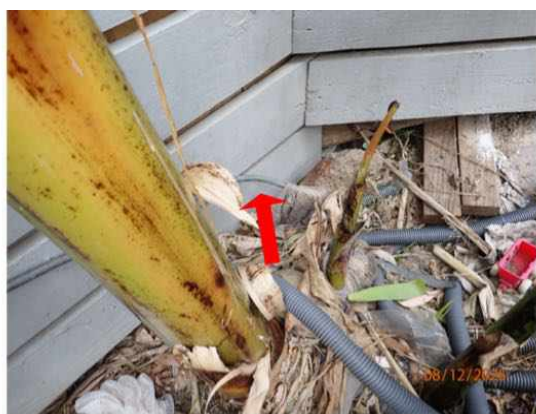
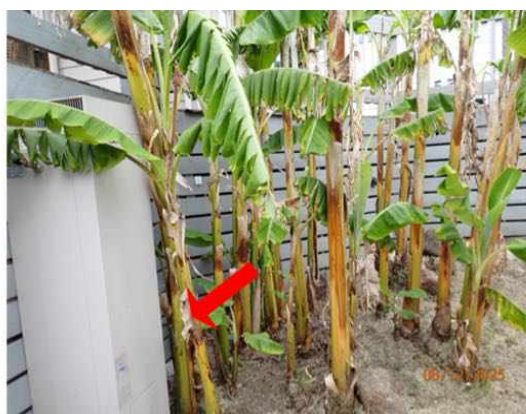
Finding 6.03

Building:	Main Building
Location:	All External Areas
Finding:	HWS Overflow - Not Connected
Information:	The Hot Water System (HWS) overflow was found to be disconnected from storm water drainage and is creating excessive moisture in the surrounding area.

These damp conditions can lead to secondary defects such as rot, rust or corrosion of associated building elements, the formation of fungal decay, or even the creation of potential slip hazards. When coupled with poor site drainage, pooling of water may also attract termite activity to this area.

It is highly recommended that a licensed plumber be appointed to connect the HWS overflow in order to prevent such an environment from being created. These minor works should be carried out as soon as possible.

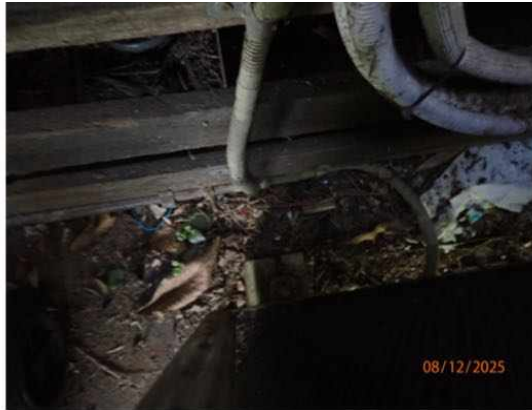
Finding 6.04

Building:	Main Building
Location:	All External Areas
Finding:	Air condition discharge - Not plumbed for drainage
Information:	The Air condition discharge is not plumbed or connected to suitable drainage, which

has resulted in the surrounding area becoming excessively damp. These damp conditions can lead to secondary defects such as rot, rust or corrosion of associated building elements, the formation of fungal decay, or even the creation of potential slip hazards. When coupled with poor site drainage, pooling of water may also attract termite activity to this area. It is highly recommended that a qualified plumber be appointed to install adequate drainage to the overflow. These works will ensure that the area remains dry and free of any secondary defects.

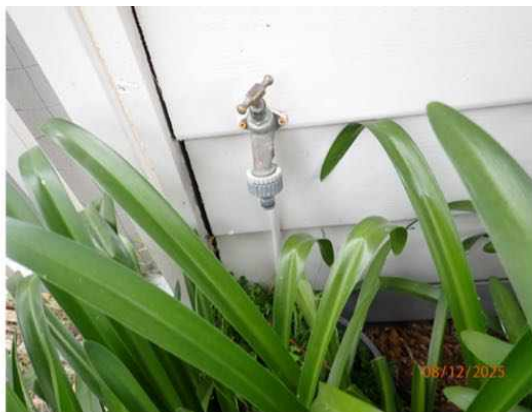
Finding 6.05

Building: Main Building
 Location: All External Areas
 Finding: Tap - No Drain
 Information: It was found at the time of inspection the tap at this section of the property have no drain or basin below them. This can cause excess water next to the foundation of the property and can also attract termites.

A licensed plumber should be engaged for rectification as soon as possible.

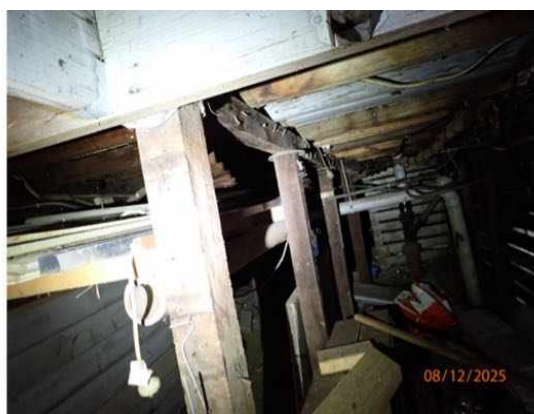
Finding 6.06

Building: Main Building
 Location: Subfloor

Finding: Timber Stumps in direct ground contact - conducive to termites
Information: During inspection, it was noted that the property has timber stumps and access to this area of subfloor was not available, preventing a full inspection of the stumps and subfloor. This puts the property at high risk for timber pest activity.

Timber elements, such as the stumps, in direct contact with the ground are susceptible to termite activity, especially in the absence of regular inspections and maintenance. Excessive moisture can lead to decay and wood rot, further attracting termites and compromising the structural integrity of the property.

Immediate action is necessary to mitigate the risk of termite infestation and structural damage. The property owner should be proactive in reducing conducive conditions by removing any timber materials in direct contact with the ground and addressing moisture issues. Periodic inspections by a licensed pest controller are essential to monitor and address any potential termite activity. Treatment should be administered promptly to protect the property from further damage. Engaging a registered builder or pest control expert specializing in timber pest management is advised to assess the extent of the risk and implement necessary preventive measures. Timely intervention is crucial to safeguard the property against termite infestation and preserve its structural integrity.

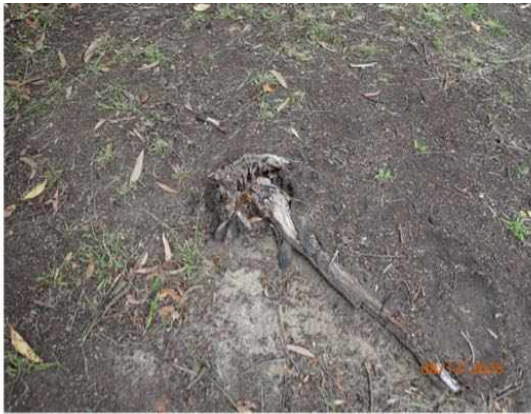
Finding 6.07

Building: Main Building
Location: All External Areas
Finding: Dead tree stumps
Information: The storing of timbers and dead tree stumps around the external property increases the risk of termite activity being present. As they are likely to come into contact with weather conditions or excessive moisture wood rot is likely to develop on timbers that are not treated.

It is highly recommended that any stored timbers be immediately removed from areas and dead tree stumps taken out in which they may attract any termite / timber pest attack. Minimisation of risk / prevention of termite attack is far more adequate than

dealing with the presence of termite activity.

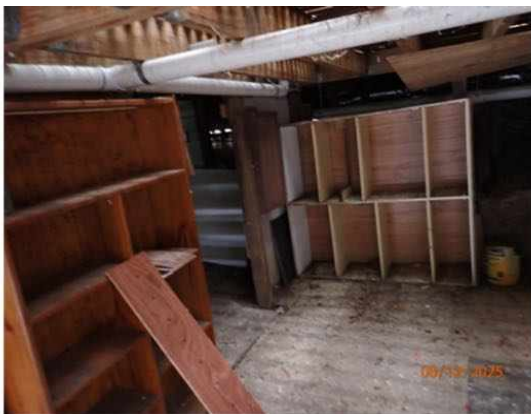
Finding 6.08

Building:	Main Building
Location:	Subfloor
Finding:	Stored timbers - subfloor space or external area
Information:	The storing of timbers in the subfloor space increases the risk of termite activity being present. As they are likely to come into contact with weather conditions or excessive moisture wood rot is likely to develop on timbers that are not treated.

It is highly recommended that any stored timbers be immediately removed from areas in which they may attract any termite / timber pest attack. Minimisation of risk / prevention of termite attack is far more adequate than dealing with the presence of termite activity.

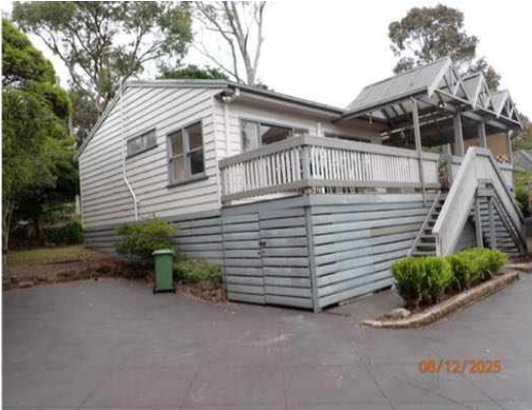
Finding 7.01

Building: Main Building
 Location: All External Areas
 Finding: Windows - Wood rot
 Information: Wood rot was identified in the external windows during the inspection.

Wood rot, also known as Fungal Decay, poses a significant threat to the structural integrity of the windows. It occurs due to prolonged exposure to damp conditions,

which accelerates the deterioration of timber materials. In this case, frequent exposure to rain and inadequate maintenance of the window frames have contributed to the development of wood rot. Additionally, leaks in roof plumbing or associated pipework may have further exacerbated the issue.

Immediate action is required to address the wood rot and prevent further deterioration of the windows. This may involve repairing or replacing the affected window frames and addressing any underlying causes of moisture ingress, such as roof leaks or poor drainage. Engaging a qualified carpenter or window specialist to assess the extent of the damage and perform necessary repairs is advised. Additionally, implementing a regular maintenance schedule to inspect and maintain external windows can help prevent future occurrences of wood rot.

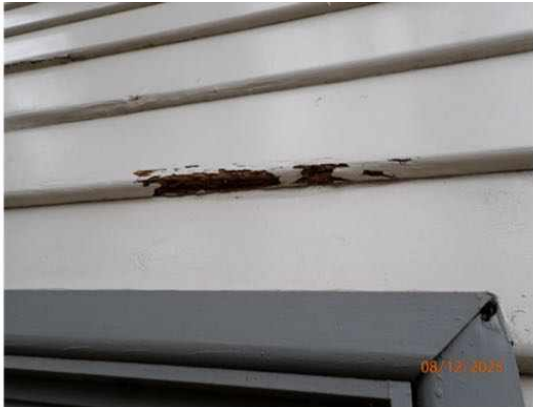
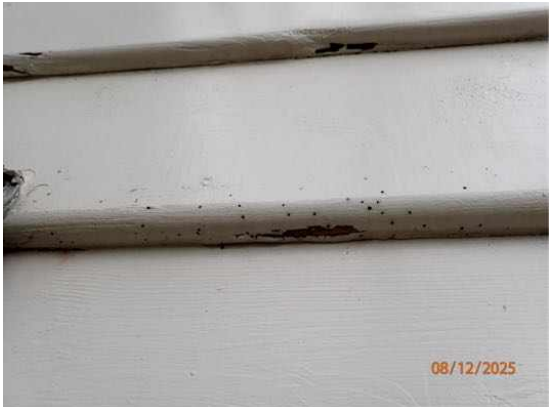
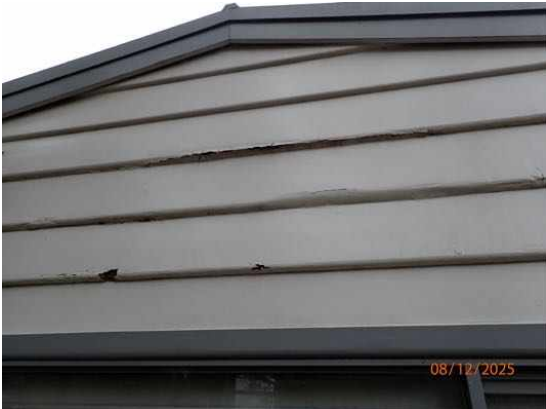
Finding 8.01

Building: Main Building
Location: Exterior walls - front
Finding: Evidence of Wood Borer.
Information: Wood borers small beetles that colonise in exposed timber elements are a common timber pest that are regularly mistaken for termites. Although wood borer activity is generally not detrimental to the affected timber they may lead to serious damage and necessitate replacement of certain building elements if left unattended.

The Lyctid borer which generally attacks hardwoods such as subfloor and roofing structures is generally identified by a fine dust surrounding the affected timbers. The other commonly known borer the Anobium borer is more likely to attack floorboards and may cause severe structural damage to flooring areas.

While the treatment of wood borers is generally not required remedial cleaning of affected timbers may aid the protection of the wood alternatively the injection of insecticides into heavily affected areas may be suggested by a pest controller.

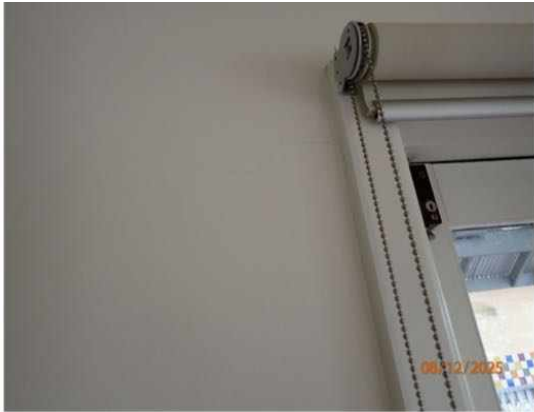
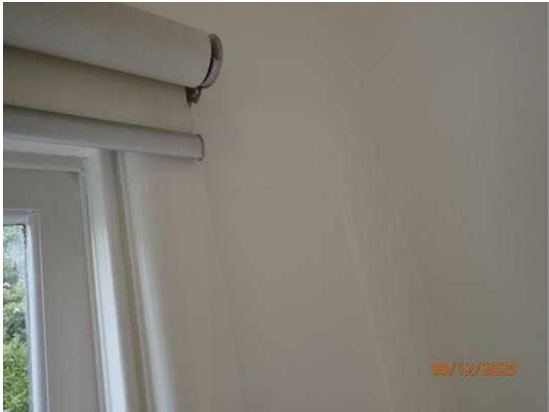
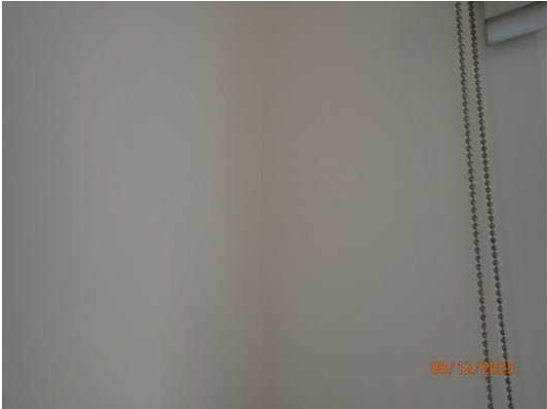
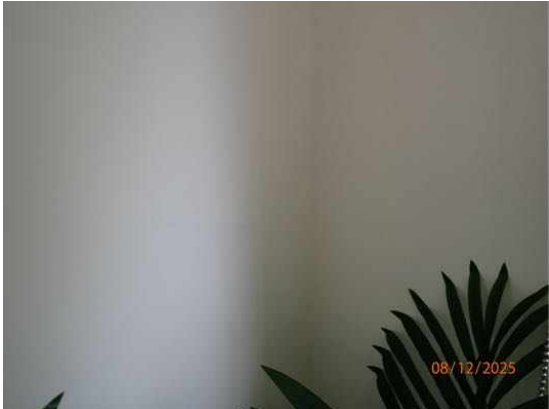
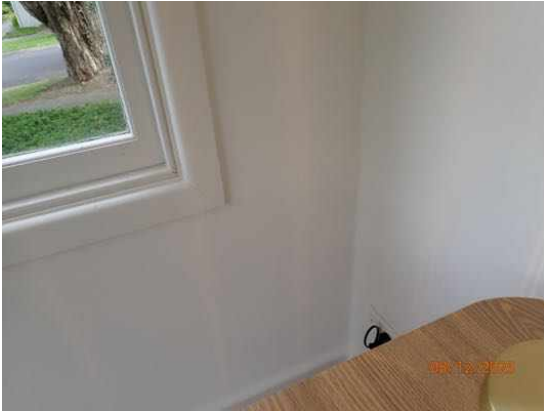
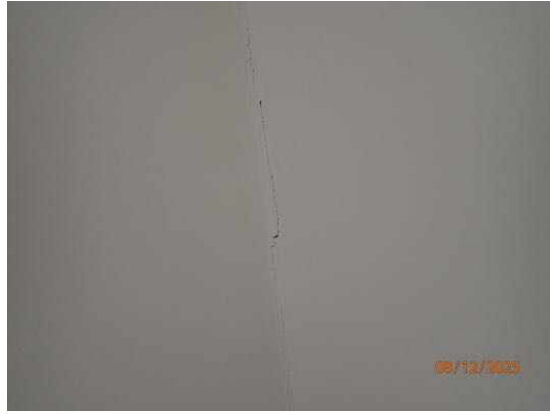
Building: Main Building
Location: All Internal Areas
Finding: Cracking Plaster - Hairline
Information: During inspection, hairline cracks on the plasterboard were noted in this area. These cracks are very minor in nature and typically only affect the appearance of the surface. They do not indicate any structural damage.

Hairline cracks are common and do not pose a significant threat to the integrity of the structure. However, they should be monitored regularly to ensure they do not worsen over time.

Cracks of this nature can generally be repaired with minor sanding, filling, and/or repainting. It is advisable to hire a qualified painter or general handyman for such works. Regular monitoring of all cracking is recommended, and if cracks widen, lengthen, or become more numerous, it is important to contact a building inspector or a structural engineer for further assessment.

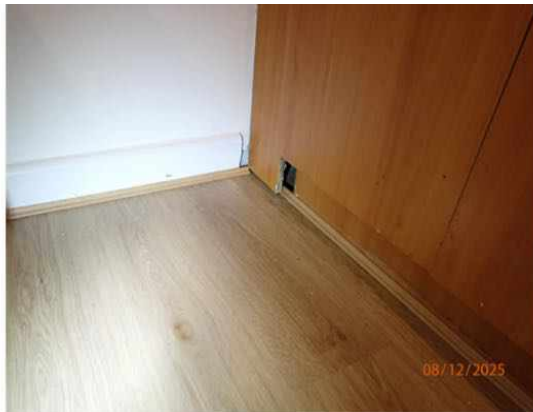
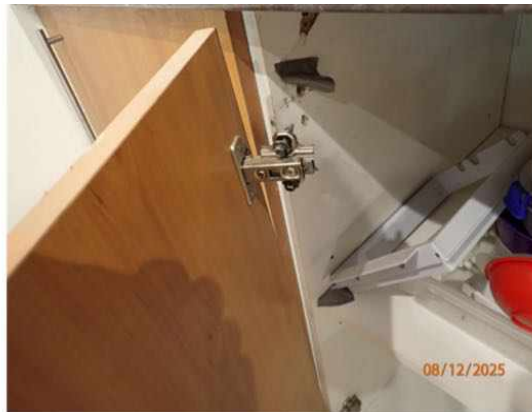
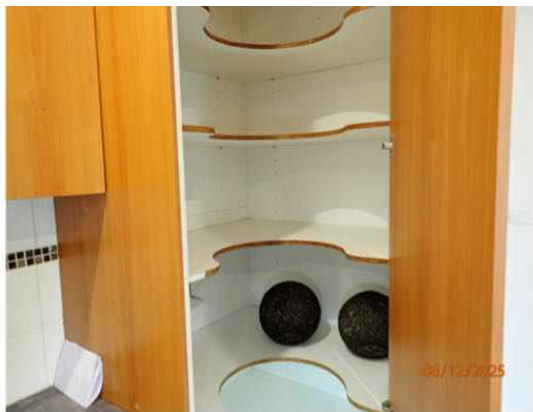
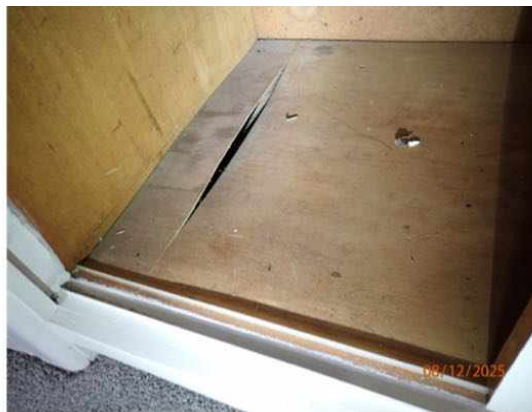
Building: Main Building
Location: Kitchen and bedroom 2
Finding: Cabinet - Damaged wear and tear
Information: The kitchen cabinet was noted to be damaged during the inspection. This damage appears to be consistent with the general wear and tear expected for a property of this age.

It is advised that a qualified carpenter or cabinet maker be engaged to repair or replace the damaged cabinet as deemed necessary. This will help restore the functionality and appearance of the kitchen.

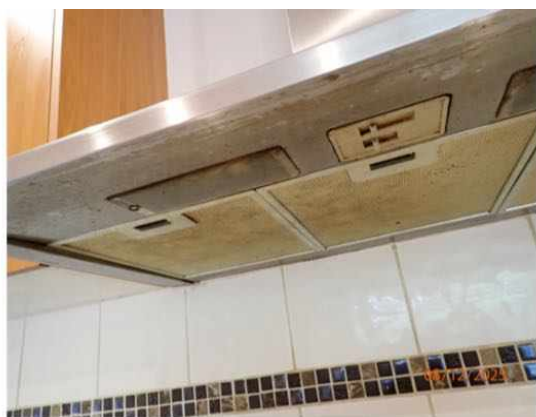
Building: Main Building
 Location: Kitchen
 Finding: Range hood Light - Not working
 Information: The range hood light was not operational during the inspection.

While checking appliances is not part of the inspection, it is noted here for your reference. It is recommended to replace the light bulb or consult a licensed electrician if further issues are suspected.

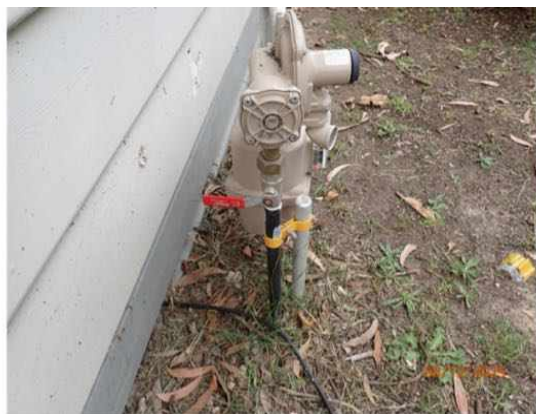
Building: Main Building
 Location: All Internal Areas
 Finding: Gas turned off
 Information: The gas connection to the house was turned off at the time of inspection. As a result, the hot water system could not be tested for operation. It is recommended that the gas supply be restored and the system checked by a licensed plumber or gas fitter to confirm proper functionality and safety.

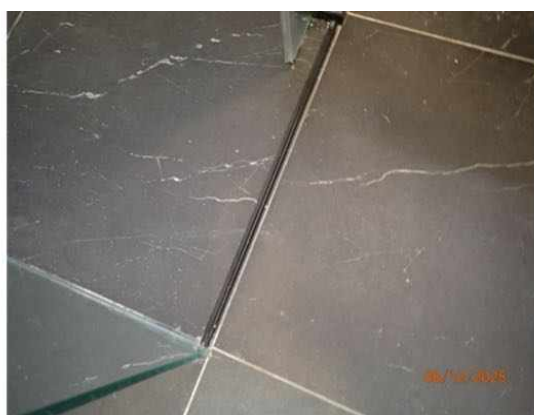
Building:	Main Building
Location:	Bathroom
Finding:	Water stop not visible in shower
Information:	During the inspection in the bathrooms, the water stop to the shower area was not visible. Water stops are essential components of waterproofing systems designed to prevent water or moisture from escaping the wet area and causing damage to other materials and structural building elements.

The absence of visible water stops suggests potential issues with the waterproofing of the shower areas. Without proper waterproofing, water leakage can occur, leading to damage to surrounding materials and compromising the structural integrity of the building.

This observation is noted for your reference. Depending on the time the house was built, current regulations may not have been applicable. However, it is recommended to further investigate the waterproofing system of the shower areas to ensure they meet appropriate standards and to address any deficiencies promptly to prevent water damage issues in the future. If necessary, consulting a qualified building inspector or waterproofing specialist for an assessment and potential remediation is advised.

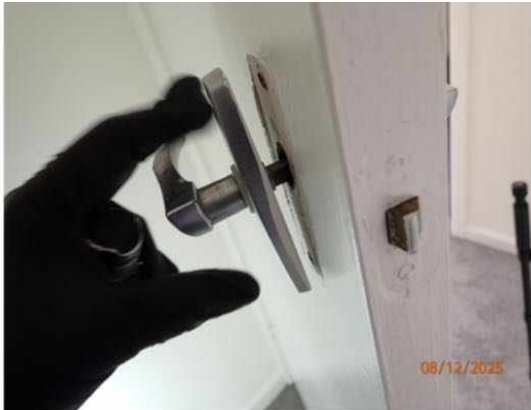
Building:	Main Building
Location:	Bedroom 3
Finding:	Door Handle - loose
Information:	During inspection, the door handle in this area was found to be loose, indicating potential age-related decay or impact damage.

A loose door handle compromises the operational efficiency and security of the associated door, potentially leading to further functional issues or safety concerns.

To address this issue, it is advised to repair or replace the loose door handle promptly. Engaging a qualified carpenter or general handyman to perform the necessary repairs

or replacements ensures the restoration of the door's operational state. Timely intervention is essential to maintain the functionality and security of the door.

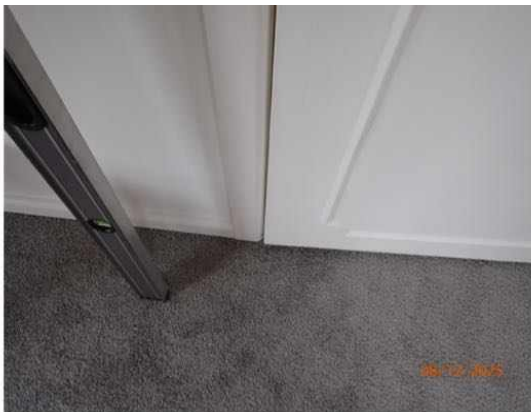
Building: Main Building
Location: Rumpus Room and bedroom 4
Finding: Door - Binding/jamming
Information: Binding and/or jamming of the door was noted during inspection.

This issue affects the door's functionality and may cause damage to the flooring or door frame if left unaddressed.

It is recommended to engage a qualified carpenter or general handyperson to perform repairs and restore proper operation, preventing further damage.

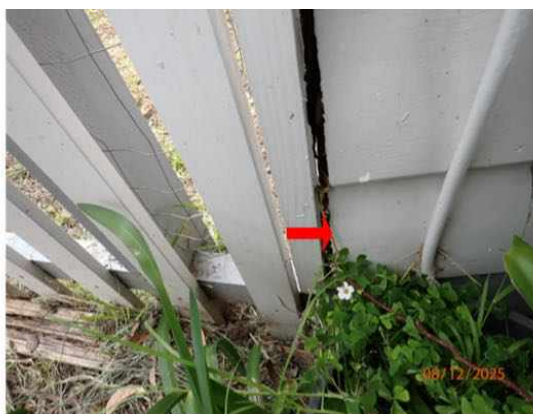
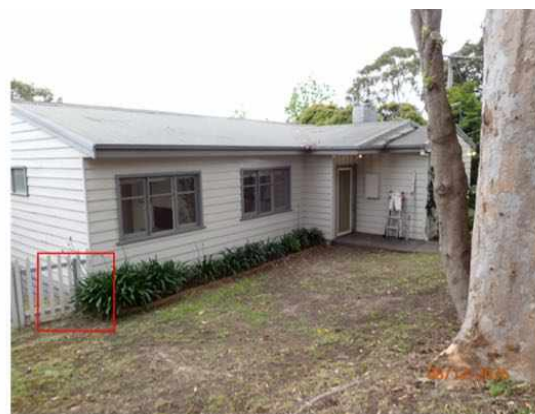
Building: Main Building
 Location: Exterior walls - front
 Finding: External wall - Gaps
 Information: Considerable gaps were noticeable in the weatherboard installation in this part of the house, allowing water to enter the cavity. These gaps make the adjoining building elements prone to water penetration, creating potential for the development of secondary damage.

Over time, water penetration through these gaps can lead to more severe problems such as wood rot, mold growth, and structural damage. The long-term integrity of the affected building elements is at risk if not properly repaired.

It is recommended to engage a qualified carpenter or general handyperson to properly seal these gaps using sealant or other appropriate materials. These works should be performed as soon as possible to prevent any water damage and ensure the durability and safety of the property.
