Building and Timber Pest Inspection Report

Inspection Date: Mon, 8 Dec 2025

Property Address: 19 Mariana Ave, Croydon South VIC 3136,
Australia

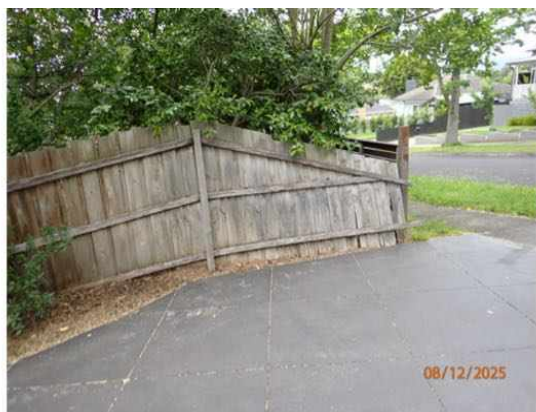
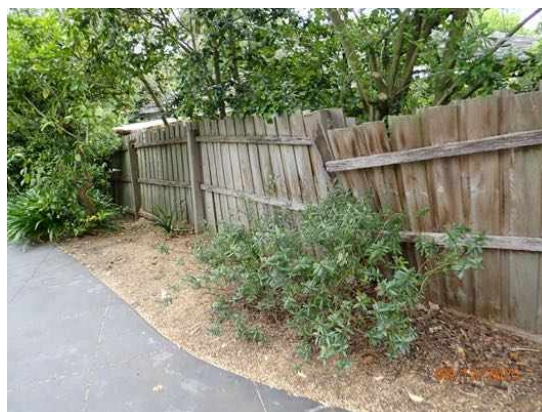
Building: Main Building
 Location: Exterior walls - rear
 Finding: Fence - Deteriorated
 Information: During the inspection, it was noted that this section of the fencing has deteriorated, likely due to age, weather exposure, or possible inadequate installation or maintenance.

If not addressed, further deterioration is expected, and repairs may be needed. In some cases, replacement might be a better option depending on the extent of the damage.

Engaging a licensed fencing contractor is recommended to assess the condition and carry out the necessary repairs or replacement.

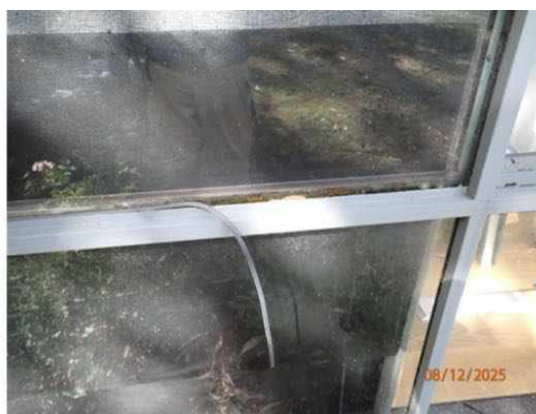
Building: Main Building
 Location: Exterior walls - front
 Finding: Window seals - deteriorated
 Information: The window seals have deteriorated. Due to frequent exposure to weather conditions and subsequent moisture, deterioration of window seals is expected in a property of this condition and age.

Where window seals have deteriorated, the window is no longer weather-tight; rain penetration and subsequent water damage is therefore likely to ensue. Insulation of the area against external weather conditions will also be compromised.

It is recommended that all deteriorated window seals be replaced by a general handyman or sealant expert to prevent any further damage and to restore the window to a fully functional level.

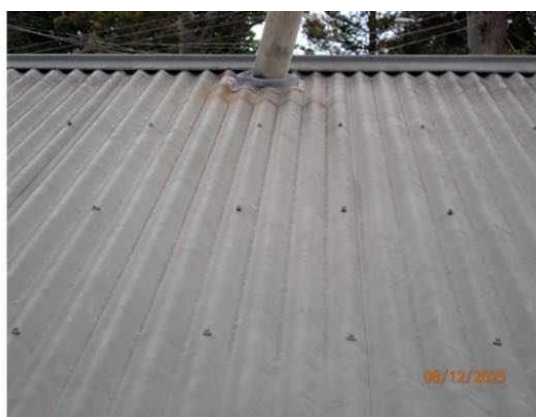
Building: Main Building
 Location: Roof Exterior
 Finding: Flue install substandard
 Information: The installation of the flue through the roof in this section was noted to be

The flashing between the flue and the roof sheeting was not installed correctly, which may lead to premature deterioration of the flashing and potential water ingress over time.

There was no access to the roof void, so the internal condition of the roof structure around the flue could not be inspected.

It is recommended to engage a licensed roof plumber to assess the installation and carry out necessary rectification works to ensure the flue and flashing are weatherproof and compliant.

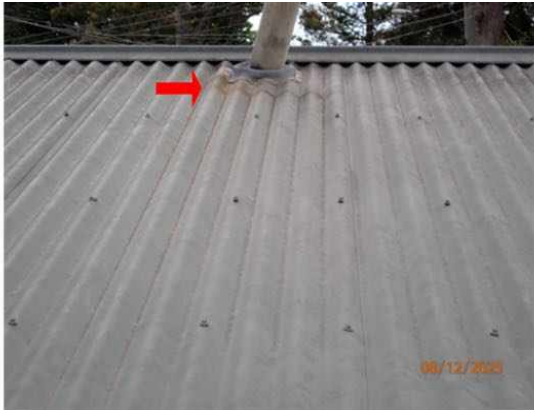
Building:	Main Building
Location:	Roof Exterior
Finding:	Roof sheets - Rusted
Information:	Rust on the roofing sheet was noted during the inspection. It is suspected that accumulation of debris and leaves, along with improper maintenance, may have caused water pooling, leading to the rusting of the sheeting.

This is a minor defect with major implications if not addressed immediately. If left unmanaged, the rust will continue to progress, potentially allowing water ingress into the internal roofing structures. This could lead to secondary damage of building elements and accelerate the deterioration of the roofing sheets and any associated components.

A licensed roof plumber or a roof restoration company should be engaged immediately to assess the condition of the sheets and perform any necessary rectification works. Remedial actions may include replacing severely affected roofing sheets or applying rust-retardant surface protectors to mitigate further rust development. Immediate attention is required to prevent further damage and ensure the longevity of the roofing structure.

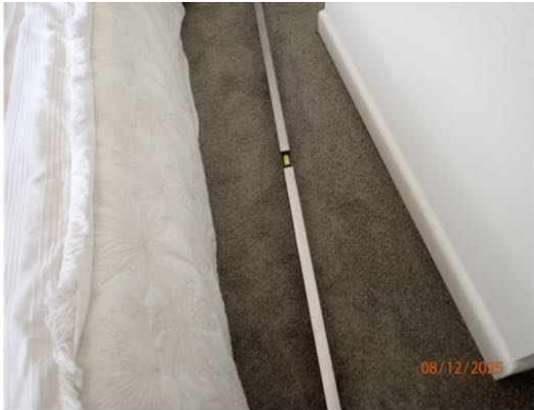
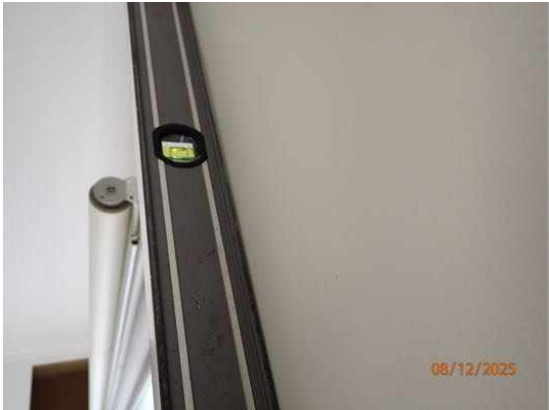
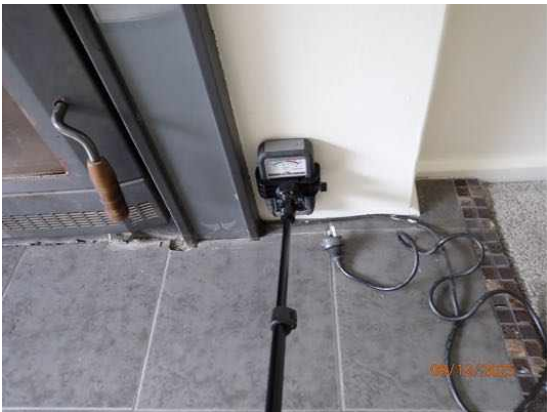
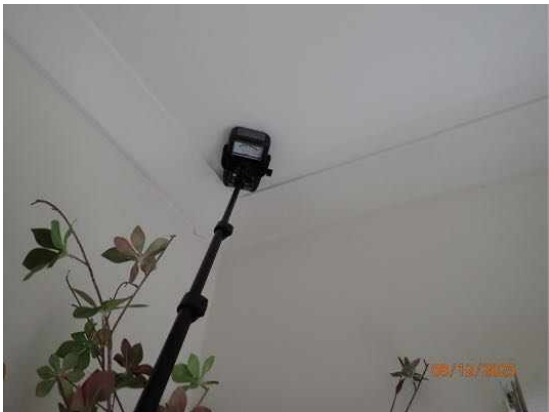
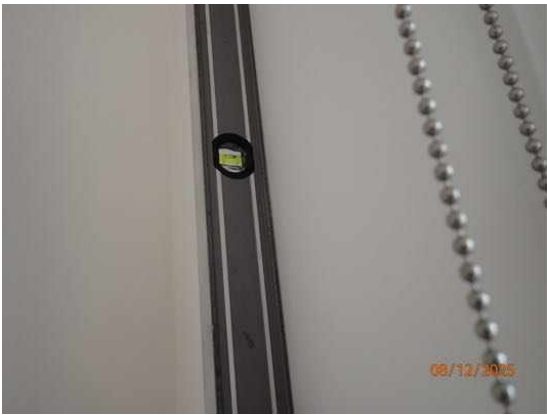
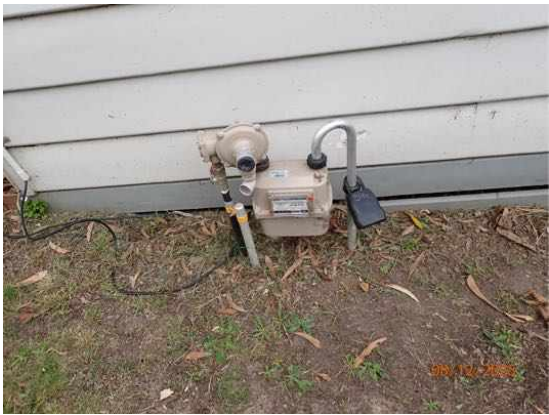
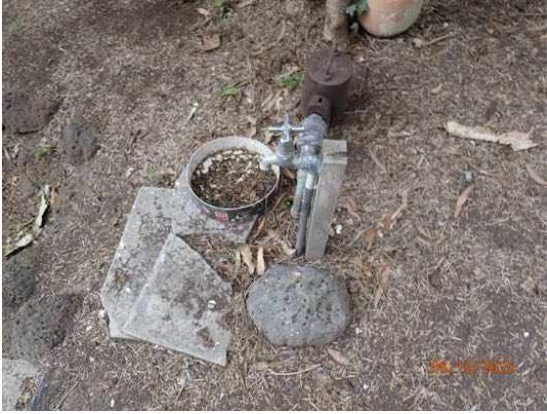
Building: Main Building
Location: All Areas
Finding: Additional Photos
Information: Additional photos are provided for your general reference

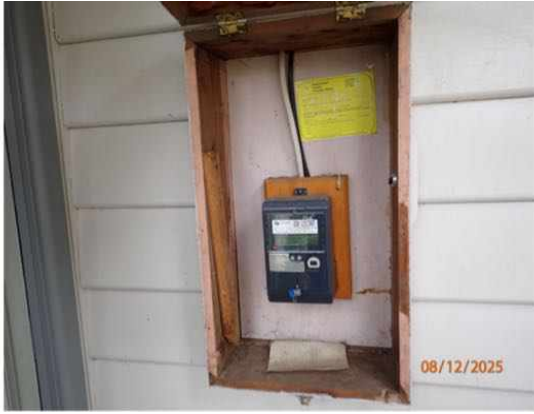
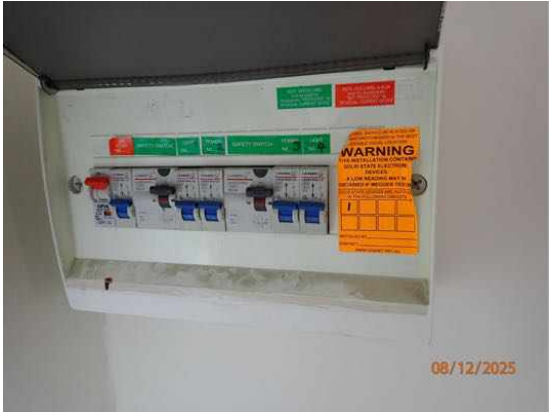
Building: Main Building
Location: Meter Box
Finding: Electrical Switch Box
Information: All electric wiring, meter boxes and appliances need to be checked by a licensed Electrician ensuring any work completed as part of a renovation or extension has been issued with a Certificate of electrical Safety (CES). The checking of any electrical items is out side the scope of this inspection.

Photos are added here for your information.

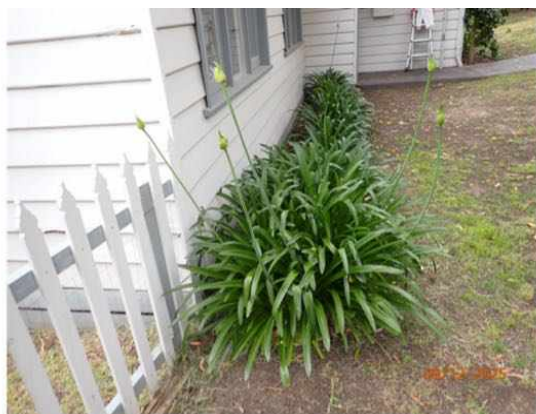
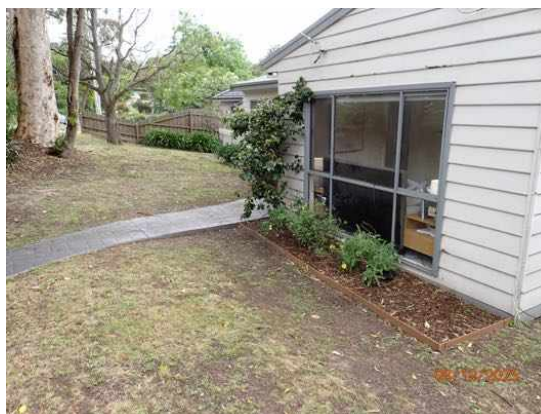
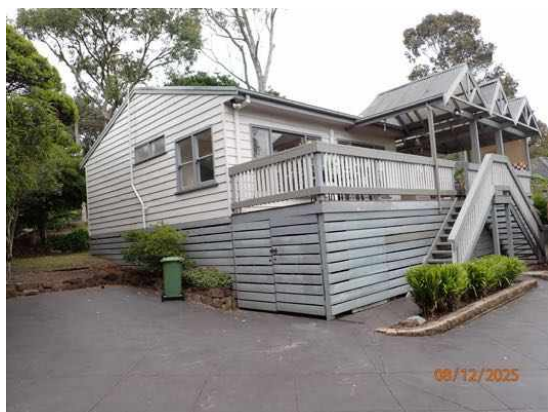
Building: Main Building
 Location: All External Areas
 Finding: Additional Photos - Obstructions and Limitations External Areas
 Information: These photographs are an indication of the obstructions and limitations which impeded full inspection of the External areas of the property at the time of inspection. These obstructions can hide an array of defects and should be removed to allow full inspection to be carried out. A re-inspection is recommended once the areas are made accessible.

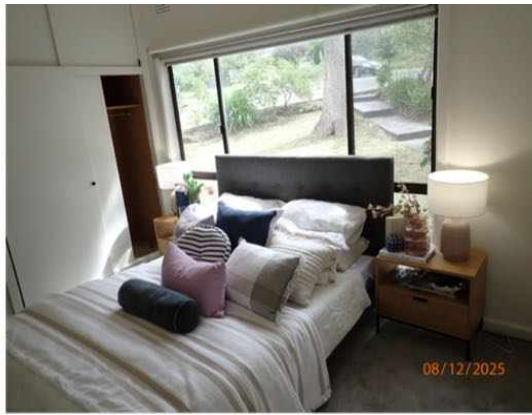
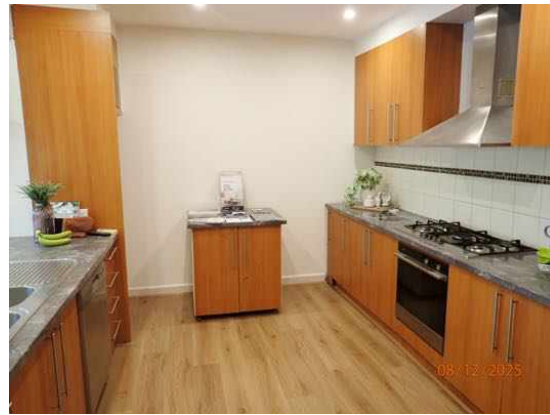
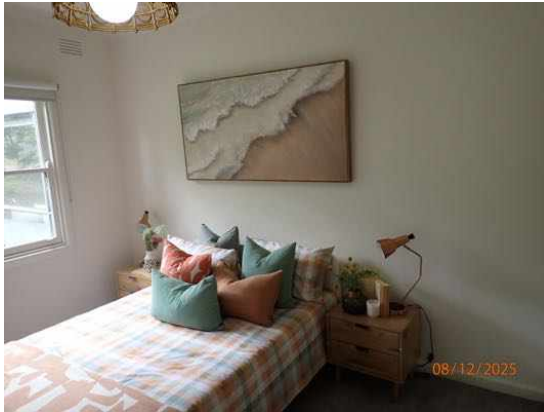
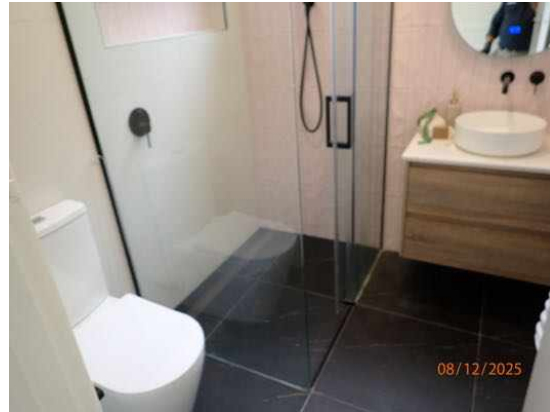
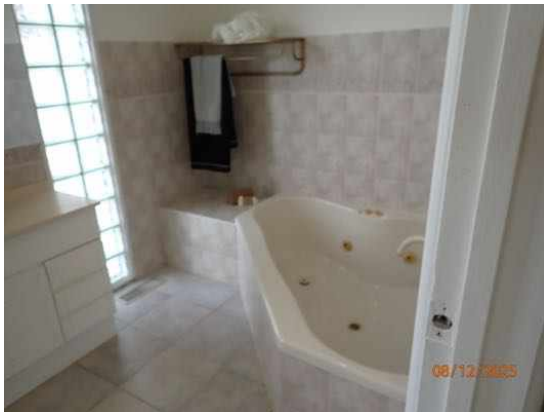
Building: Main Building
 Location: All Internal Areas
 Finding: Additional Photos - Obstructions and Limitations internal Areas
 Information: These photographs are an indication of the obstructions and limitations which impeded full inspection of the internal areas of the property at the time of inspection. These obstructions can hide an array of defects and should be removed to allow full inspection to be carried out. A re-inspection is recommended once the areas are made accessible.

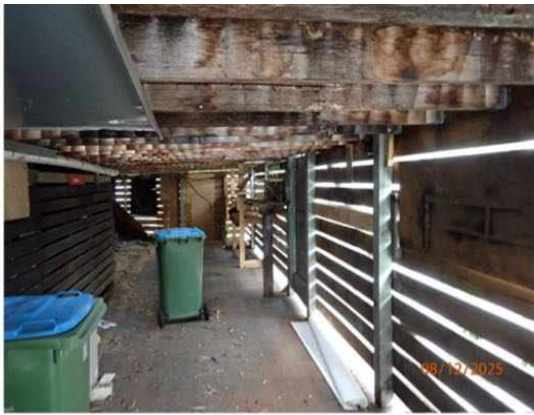
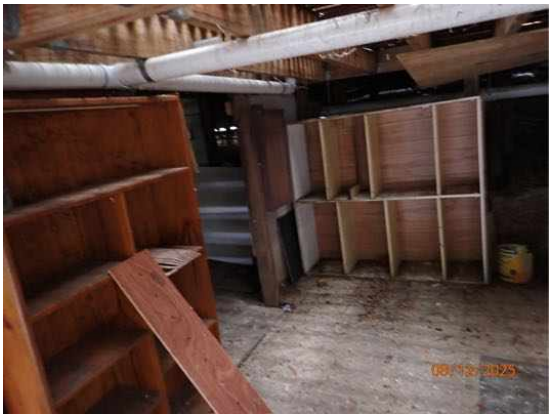
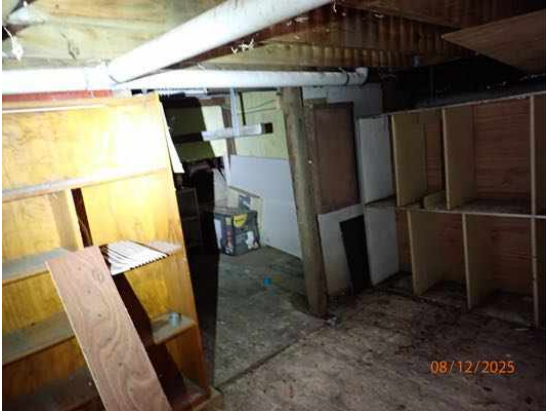
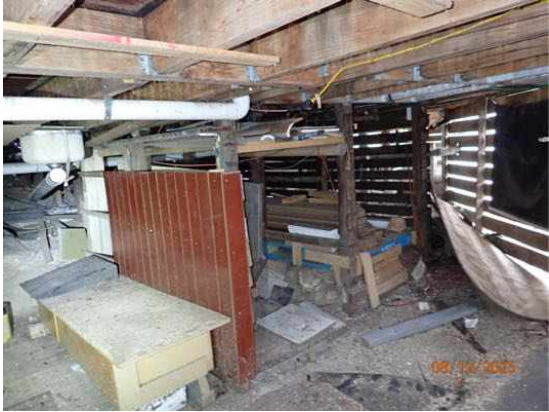
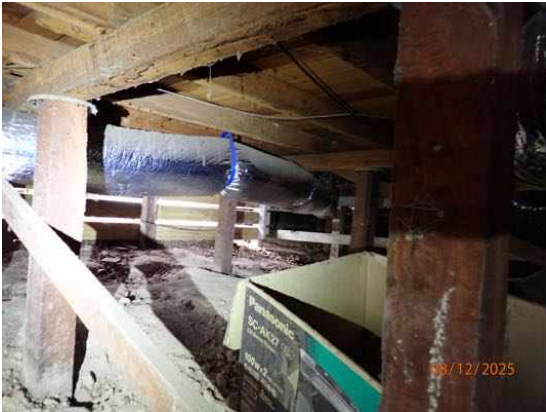
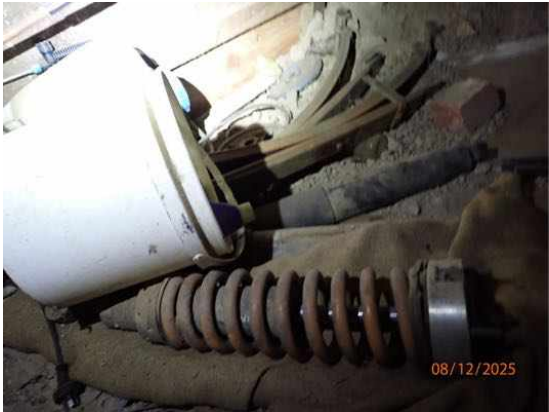
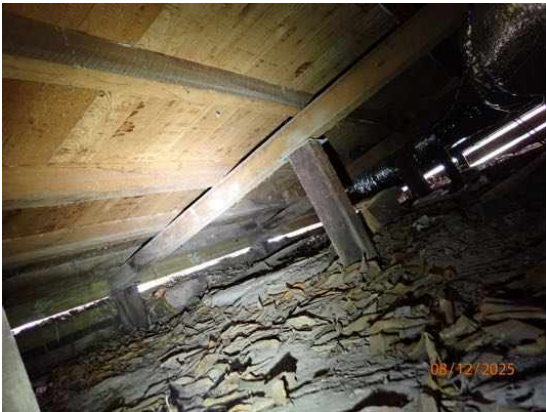
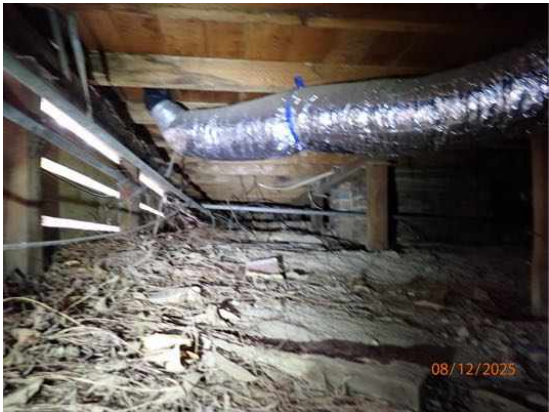
Building: Main Building
 Location: Subfloor
 Finding: Additional Photos - Obstructions and Limitations Subfloor Areas
 Information: These photographs are an indication of the obstructions and limitations which impeded full inspection of the subfloor areas of the property at the time of inspection. These obstructions can hide an array of defects and should be removed to allow full inspection to be carried out. A re-inspection is recommended once the areas are made accessible.

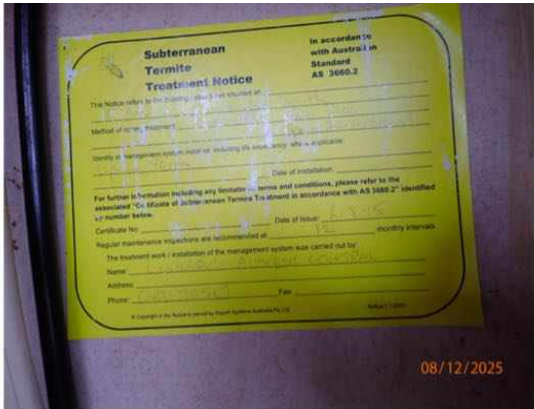
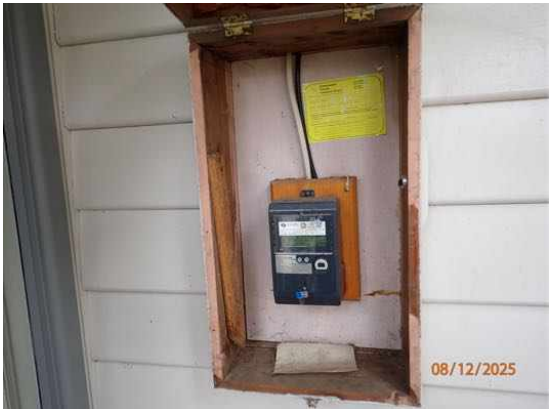
The following items were noted as - Evidence of a previous termite management program

Where a Termite Management System has been identified you should refer to the type of barrier date of installation warranty conditions and any documentation provided by a builder or past owner. Consult the company who installed the barrier to confirm whether the system is still under warranty.

Most chemical termite management systems expire and require replenishment and all physical systems are primarily designed to prevent concealed entry.
