Building and Timber Pest Inspection Report

Inspection Date: Wed, 28 Jan 2026

Property Address: 188 Bernhardt St, East Albury NSW 2640,
Australia

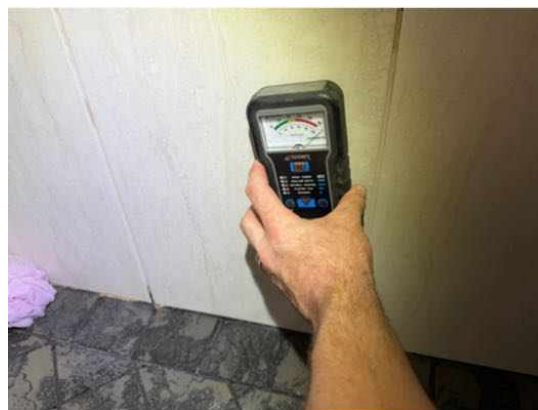
Building: Main Building
Location: Ensuite Shower & Main Shower
Finding: Showers - High Moisture
Information: It appears that high moisture is present at but not limited to, below the ensuite shower taps, & at the base of the shower walls. Potential causes of leaking include but are not limited to loose or damaged plumbing fittings and fixtures, and/or deteriorated seals or waterproofing.

Areas of leaking and high moisture create an environment conducive to termite activity & water damage to surrounding materials.

Recommend engaging a licensed plumber and/or tiling contractor promptly, to provide remedial works, to avoid further damage.

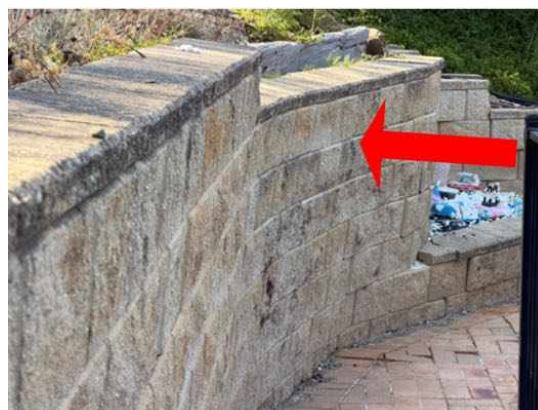
Finding 3.02

Building:	Main Building
Location:	Rear of property
Finding:	Retaining Wall - Leaning
Information:	It appears that the rear retaining wall was leaning at the time of inspection. It is recommended that the client monitor the retaining wall. Should further movement occur, a structural engineer should be engaged promptly, to provide further advice & remedial works.

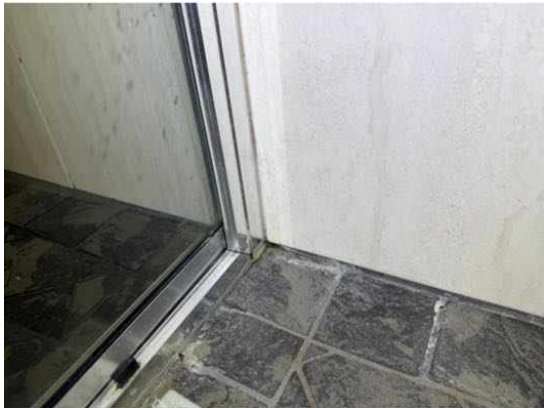
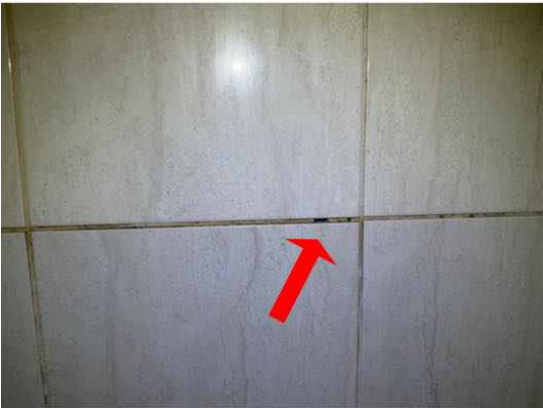
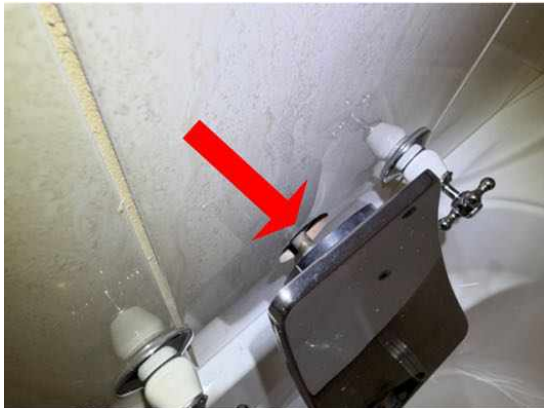
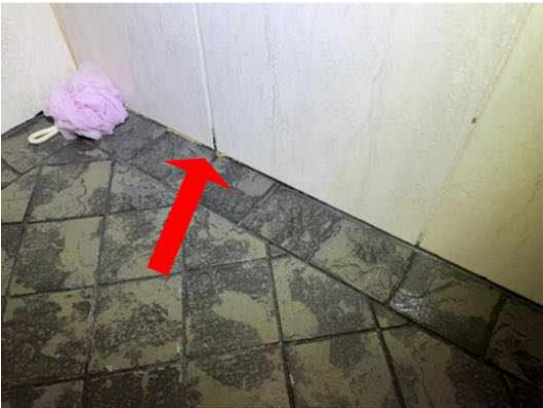
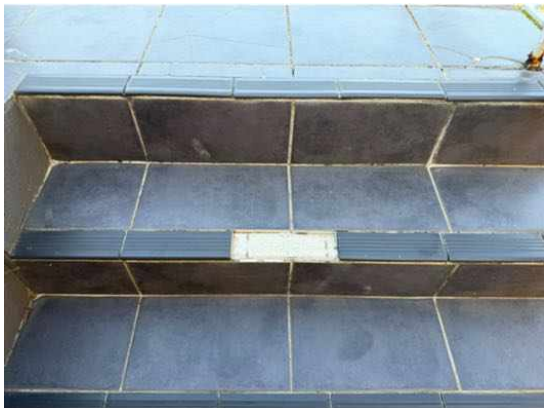
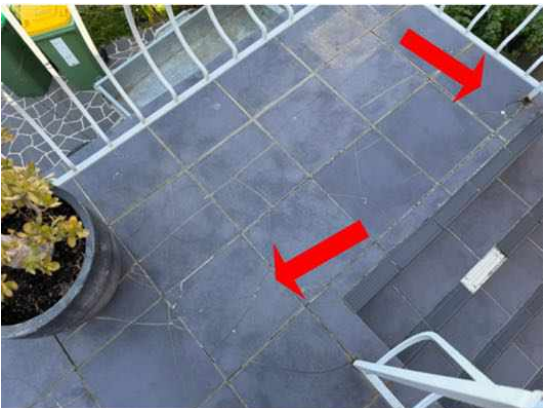
Building: Main Building
Location: Tiled Areas, Balcony
Finding: Sealant / grouting - deteriorated or missing & Cracked Balcony Tiles
Information: It appears that the sealant and grout has deteriorated in some tiled areas, a common defect in buildings of a similar age. Areas of cracked & loose tiles were also noted to the balcony.

Sealant and grouting in areas that come into regular contact with water should be maintained for the long term care of your property.

Recommend engaging a licensed tiling contractor promptly, to provide maintenance works where necessary.

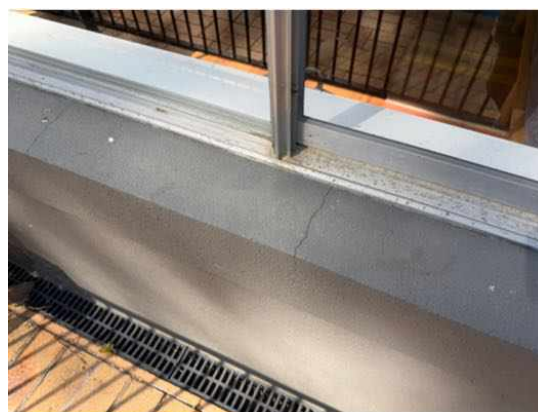
Finding 3.08

Building:	Main Building
Location:	All Areas
Finding:	Cracking - External & Internal
Information:	Cracking was identified to areas of the brickwork & internal linings. The most common cause is general movement of adjacent footings and/or expansion / contraction of building materials. Cracking is a relatively common defect.

The client should monitor the cracking. Should the cracking lengthen, widen or become more numerous, the client should consult with a structural engineer to provide further advice.

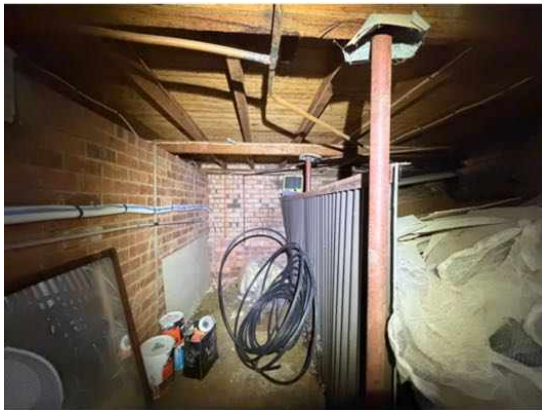
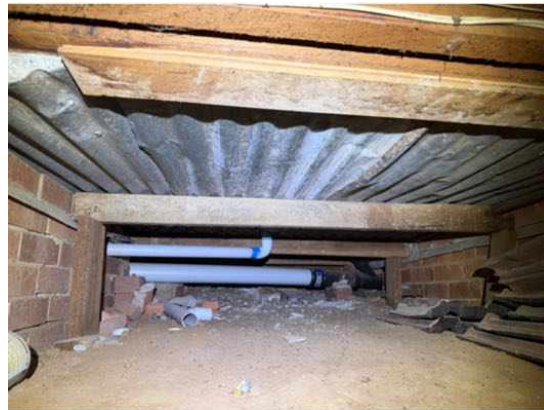
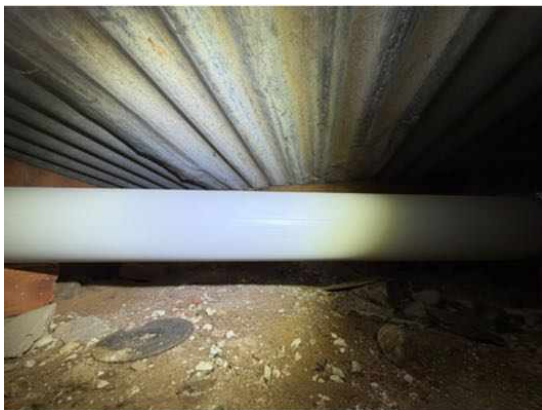
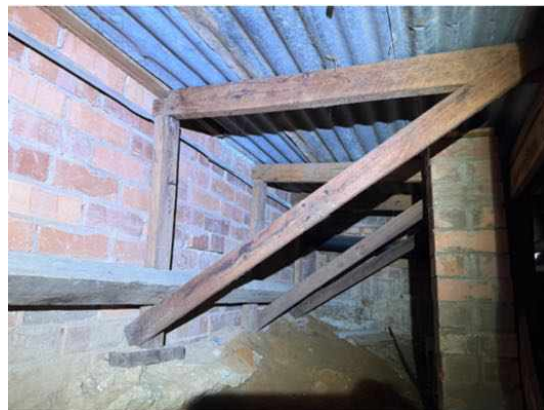
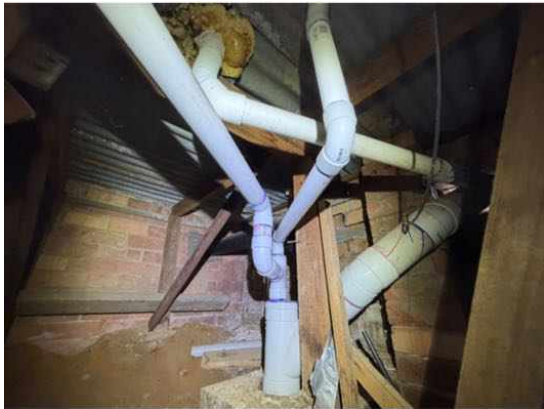
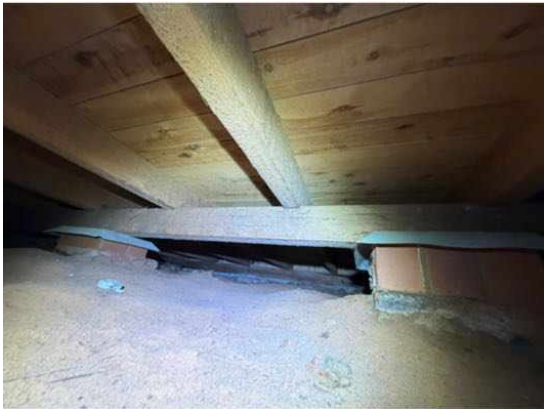
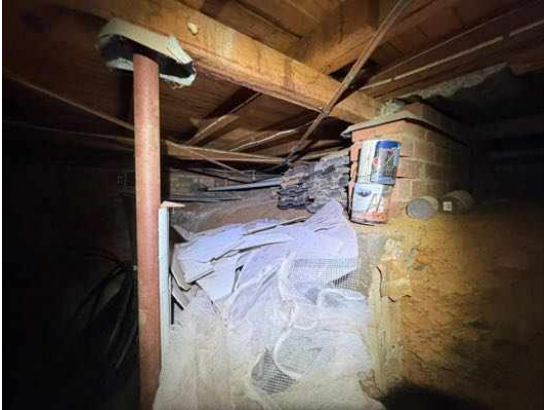
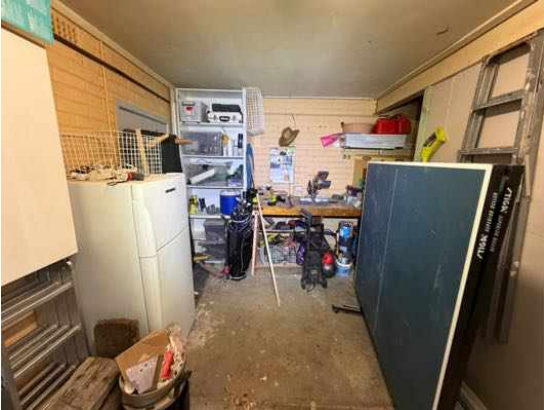
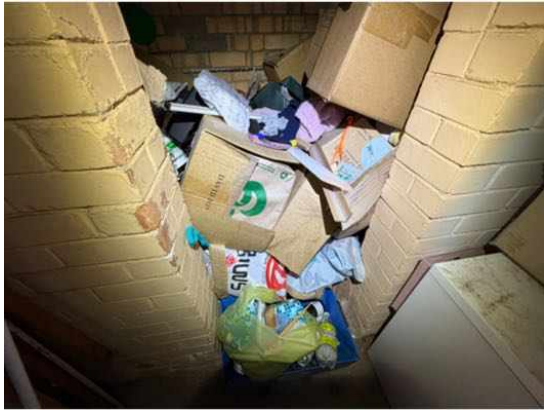
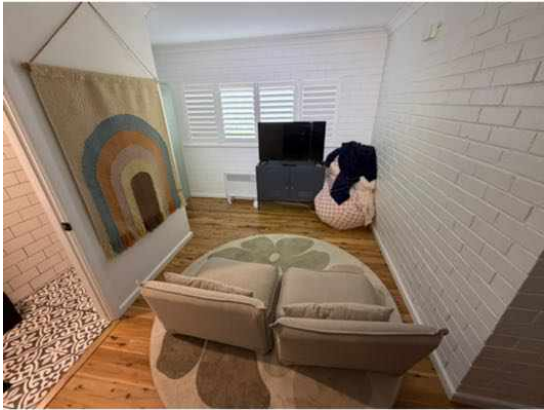
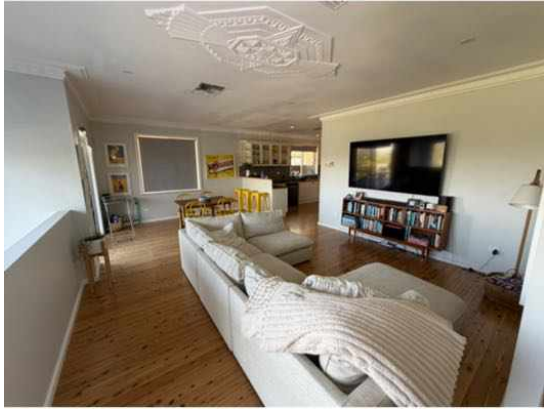
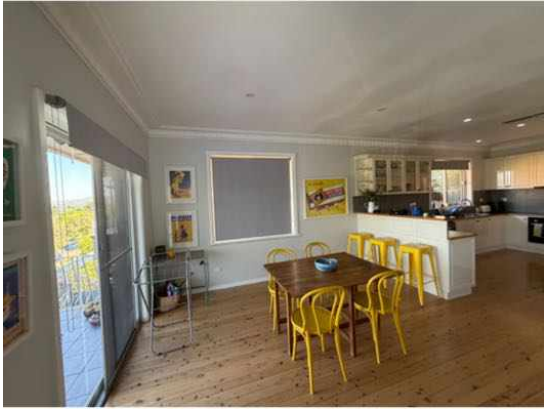
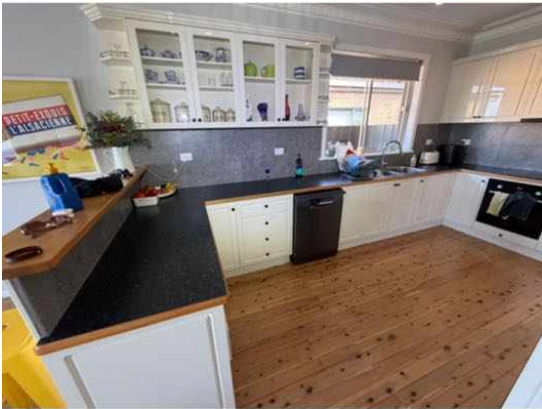
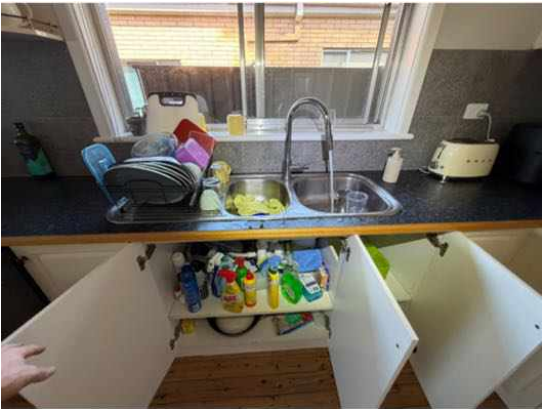
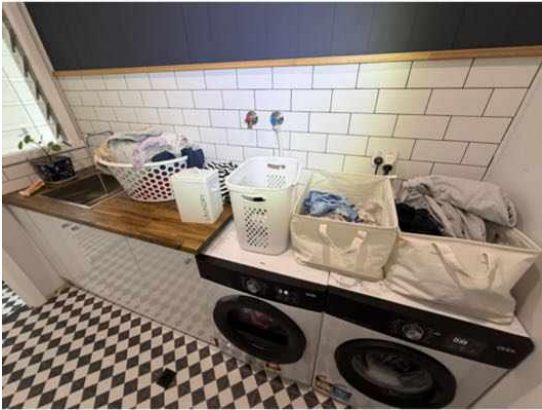
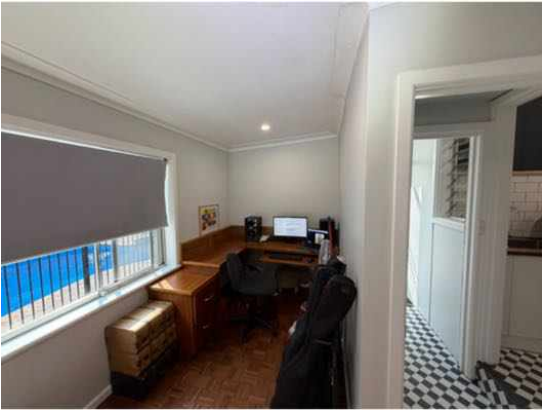
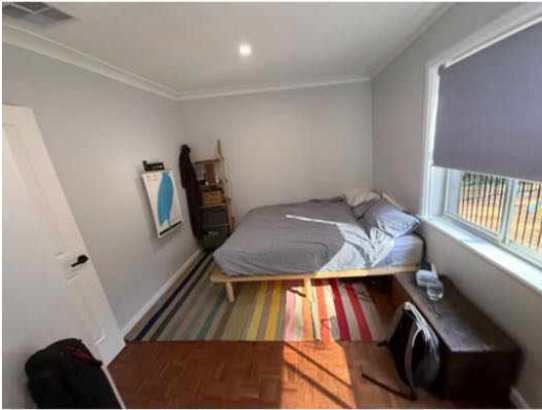
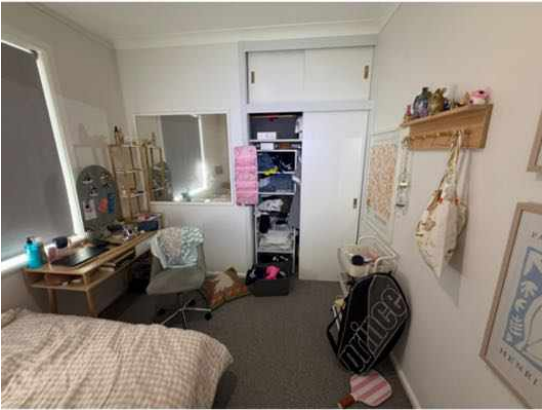
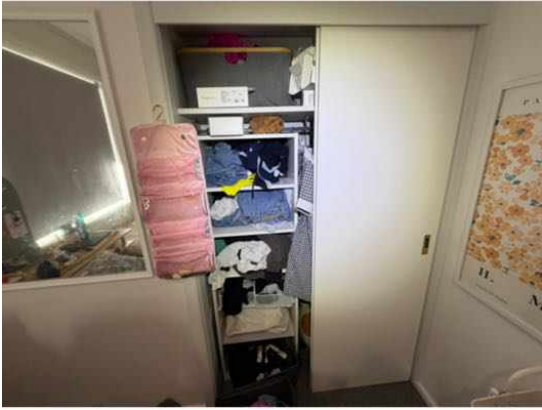
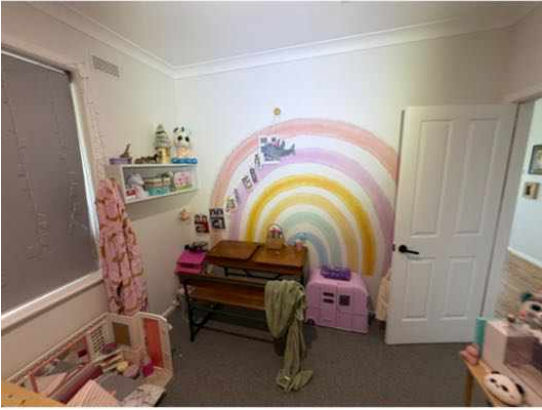
Building: Main Building
Location: All Areas
Finding: Additional Photos - Obstructions and Limitations
Information: These photographs are an indication of the obstructions and limitations which impeded full inspection of the property at the time of inspection. These obstructions can hide an array of defects and should be removed to allow full inspection to be carried out. A re-inspection is recommended once the areas are made accessible.

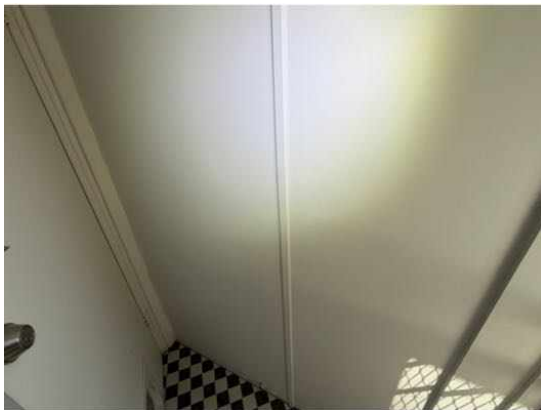
Building: Main Building
 Location: Eaves, Toilet, Laundry, Rear Entry
 Finding: Asbestos - Suspected ACM Identified on Site
 Information: This suspected defect is highlighted as a caution only as reporting on asbestos is outside the scope of this report. It is suspected that the materials including but not limited to the eave sheets, laundry, toilet & rear entry sheeting may be an ACM (Asbestos containing material)

It is advised that the client consider a separate Asbestos Inspection and Condition Audit, which can include the taking of samples for definitive confirmation of the presence of Asbestos, carried out by a licensed Asbestos Inspector. In the interim, no works should be conducted to these areas without further specialist advice.

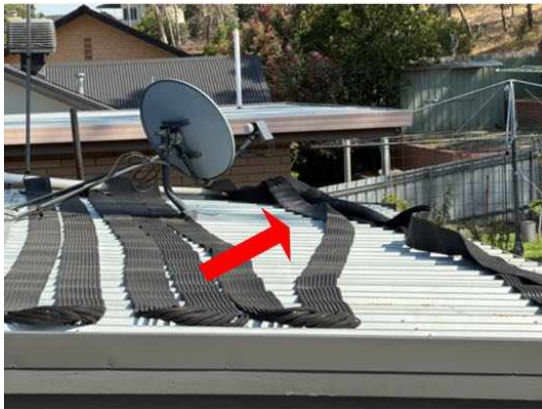
Finding: Solar Heating

Information: It appears that the solar heating is not operational. The client can engage a licensed solar plumber at their discretion to provide remedial works where necessary.
