# Building and Timber Pest Inspection Report

Inspection Date: Mon, 23 Mar 2026

Property Address: 9/1 Virginia St, Springvale VIC 3171,  
Australia

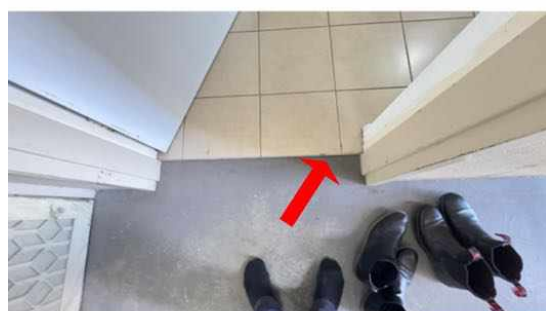
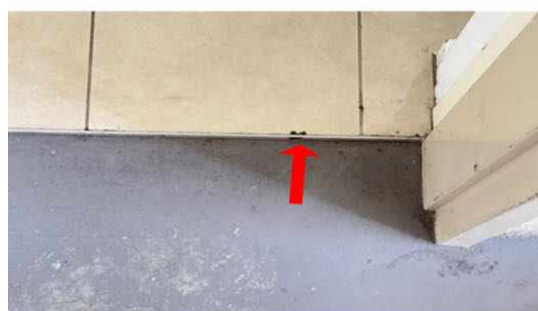
Building: Main Building  
Location: Entry  
Finding: Floor tiles - Cracked  
Information: Cracking in the floor tiles was evident in this area at the time of inspection. It is suspected that this cracking has occurred as a result of the floor being uneven and lacking a solid or suitable foundation for the tiles to be laid on. Settlement in the floor foundations may also have caused movement and resulted in the cracking of tiles in this area.

Cracked tiles throughout the household detract from the overall appearance of the affected areas, as well as creating potential for water penetration to adjoining building elements. If left unmanaged, water damage may occur as a result of constant water penetration over a prolonged period of time.

While not considered a matter of urgency, replacement of cracked floor tiles is advised as a solution. A tiling contractor or general handyperson may be appointed to perform these works at client discretion. Where cracks become more numerous, consultation with a registered builder specialising in re-stumping may be required.

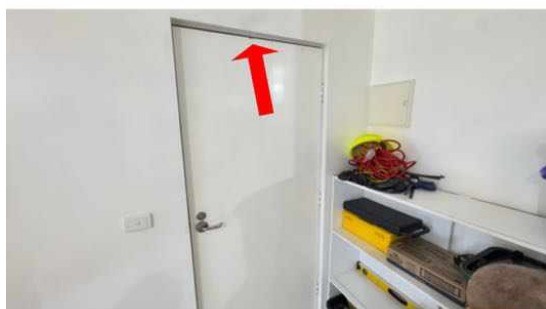
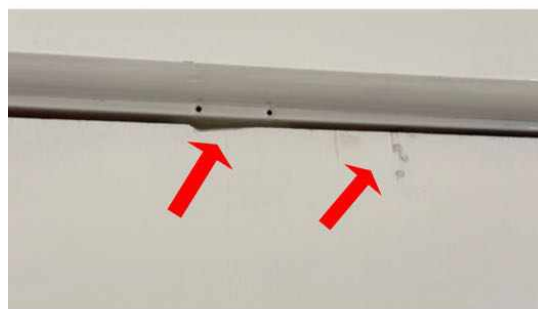
#### Finding 3.02

Building: Main Building  
 Location: Entry >  
 Finding: Doors - Damaged Doors  
 Information: The inspection identified doors with visible damage, including cracks, dents and splits. The damaged doors may affect operation, convenience, security, weatherproofing, and appearance.

The damage appears to be caused by age-related wear, poor maintenance such as inadequate painting or sealing, and minor structural movement affecting door alignment.

When practical, a qualified carpenter or door specialist should be engaged to repair, replace, or refinish the damaged doors. Prompt rectification will ensure safe operation, maintain security, and protect weatherproofing.

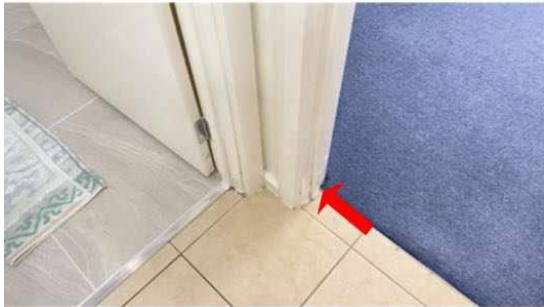
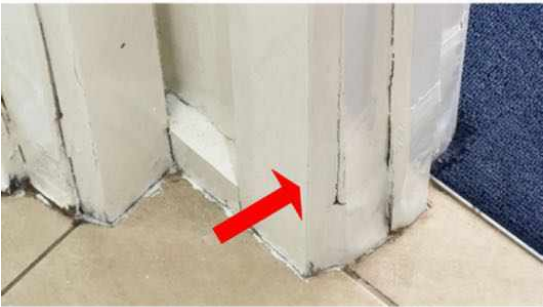
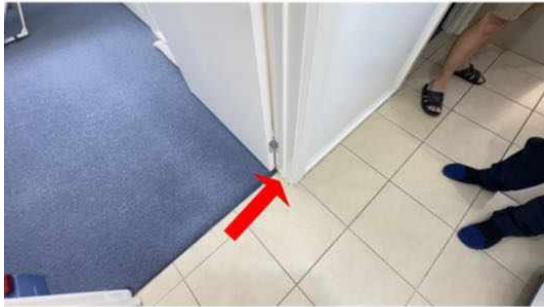
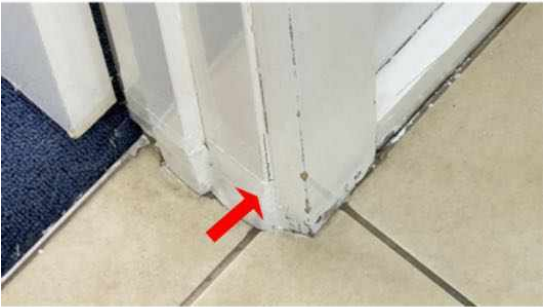
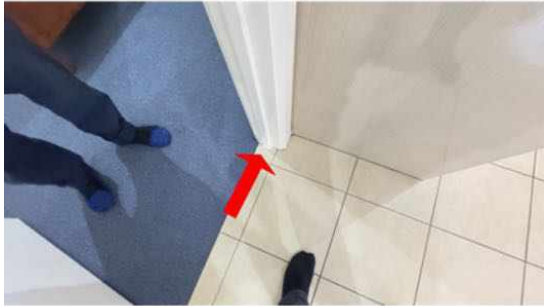
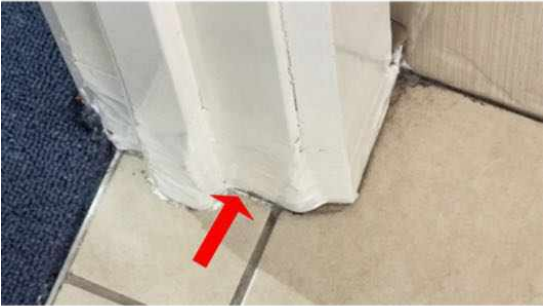
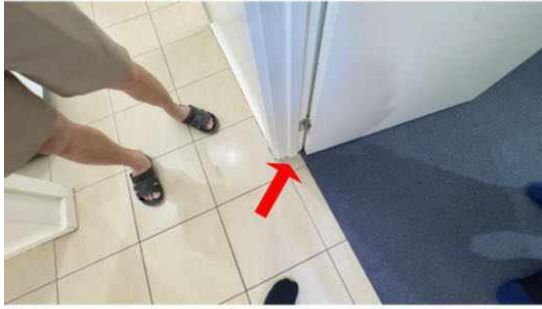
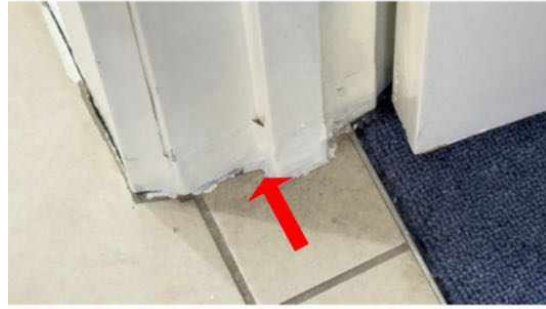
### Finding 3.03

Building: Main Building  
 Location: Bedroom 1 & Bedroom 2 >  
 Finding: Building Element - Swollen - Skirting  
 Information: Swollen building elements generally indicate that the building materials have been affected by excessive moisture over a prolonged period of time, and have swollen as a result.

The formation and development of mould/fungi or mildew is also a likely consequence of excessive moisture if left unattended. Excessive moisture is likely to lead to the development of secondary damage to any associated building elements.

Rectification of the cause of the water leak should be addressed prior to any remedial works to the swollen building elements. It is also likely given the reading were at an acceptable level the previous fridge leaks and damaged the surrounding building elements.

appointed to identify the cause of the leak and provide advice on remedial works as necessary.

Repair and/or replacement of swollen building elements may then be conducted by a qualified carpenter or general handyman at the clients discretion.

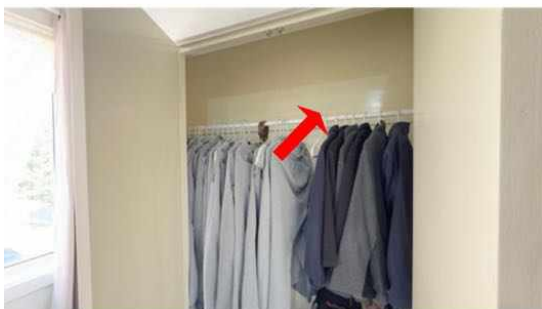
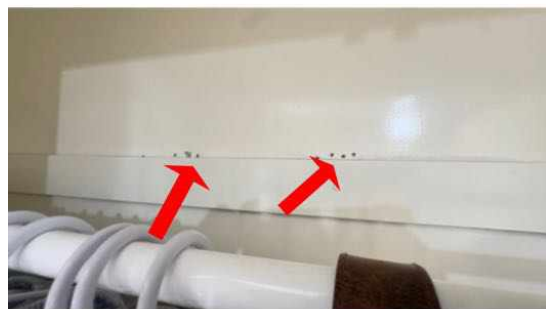
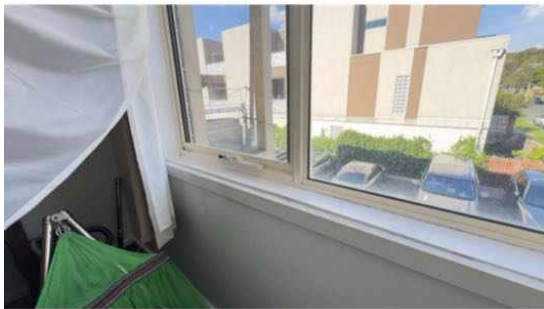
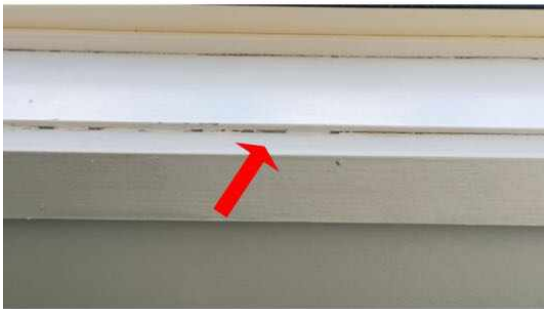
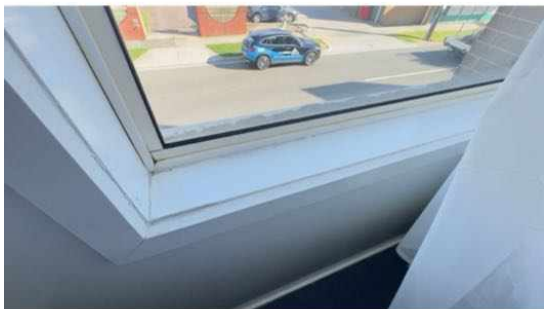
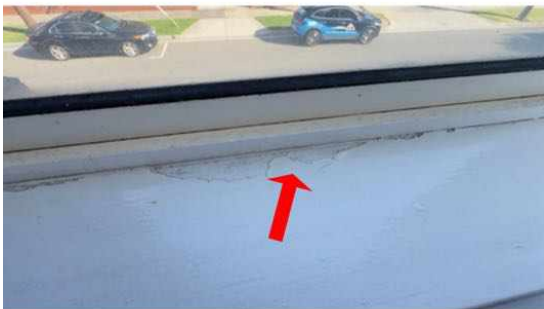
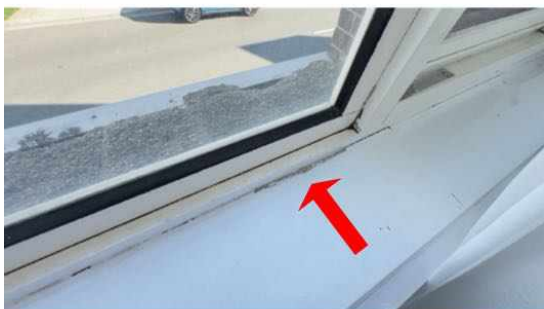
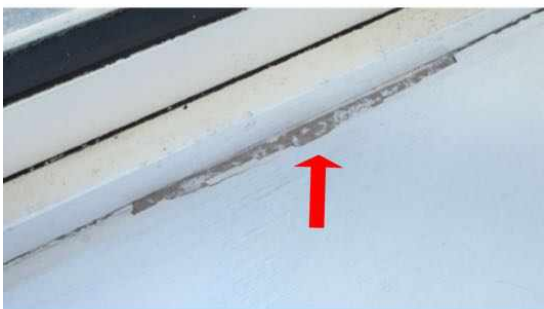
### Finding 3.04

Information: Poor paint finishes were observed in this area. The defects include uneven coverage, brush and roller marks and drips in areas, which affect the visual appearance of the surface.

Poor paint finish can result from inadequate surface preparation, application over damp or unprimed surfaces, use of low-quality paint, or environmental conditions during painting. While primarily cosmetic, these issues may reduce the durability of the painted surfaces if left unaddressed.

A qualified painter should be engaged as soon as possible to prepare and repaint the affected areas. Rectification will restore an even, visually appealing finish and help protect the underlying surfaces from premature deterioration.

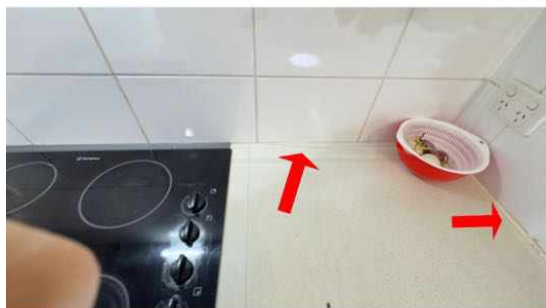
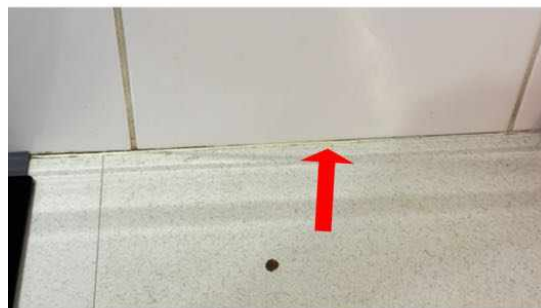
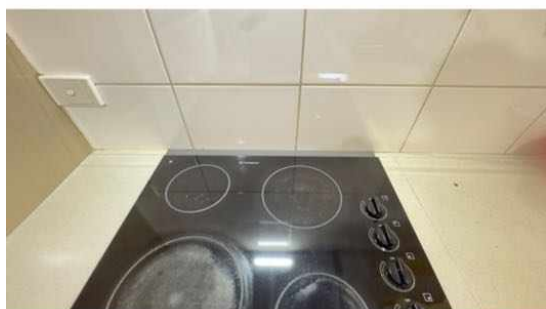
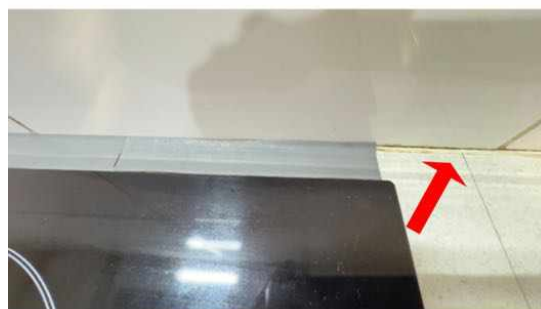
**Finding 3.05**

Building: Main Building  
Location: Kitchen  
Finding: Caulking - Inadequate Sealant At Junctions  
Information: The junctions in this area were inspected, and inadequate and deteriorated sealant was observed. Missing or compromised sealant can allow moisture ingress, promote mould growth, and reduce the durability of tiled surfaces and underlying substrates.

This condition may be due to age-related wear, poor initial application, or lack of maintenance.

A licensed tiler or competent caulking specialist should be engaged immediately to

remove old sealant and apply new, compliant materials. Prompt rectification will protect the building elements, maintain hygiene, and prevent possible water-related damage.

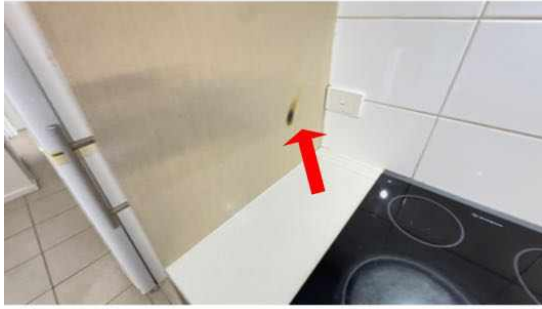
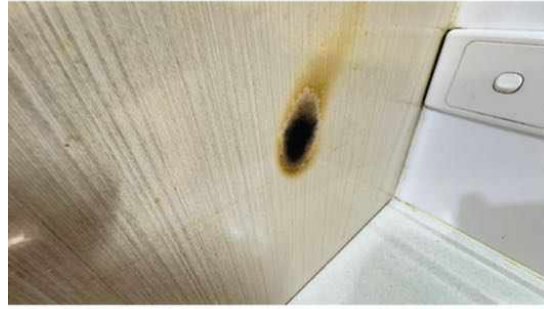
### Finding 3.06

| Finding: | Cabinets - Damaged |
| Information: | The inspection identified cabinets with visible damage. Defective cabinets can compromise usability, hygiene, and, over time, may deteriorate further if exposed to moisture. |

The issue may be caused by age-related material deterioration, poor installation practices or impact damage from daily use.

A licensed carpenter, joiner, or kitchen specialist should be engaged immediately to assess, repair, or replace the affected cabinets. Remedial works may include re-gluing, re-sealing, replacing damaged sections, or full replacement if structural integrity is compromised. Prompt rectification will restore functionality, prevent further deterioration, and maintain hygiene and appearance.

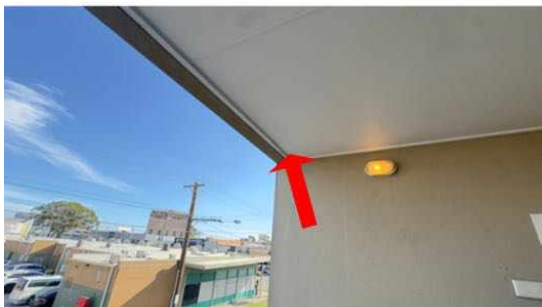
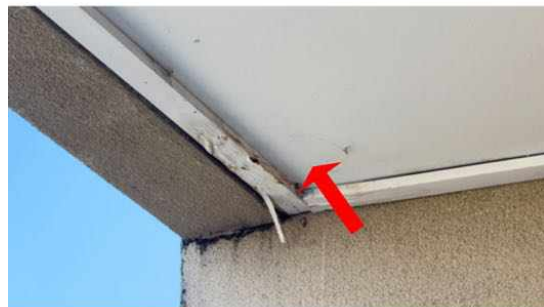
### Finding 3.07

Finding: Eaves - Deteriorated

Information: The eaves were inspected and paint deterioration, minor timber decay, and gaps at joints were observed in this area. Defective eaves can reduce weatherproofing, allow moisture ingress, and, in more severe cases, affect the structural integrity of roofing edges.

Possible causes include age-related timber decay from prolonged moisture exposure, UV and weathering damage, poor maintenance or lack of repainting, improper installation, and blocked or inadequate gutters causing water overflow onto timber components.

When practical, a qualified carpenter or registered builder should be engaged to repair or replace affected timber, seal gaps, and repaint as required. Timely attention will protect the underlying structure, maintain weatherproofing, and prevent further decay.

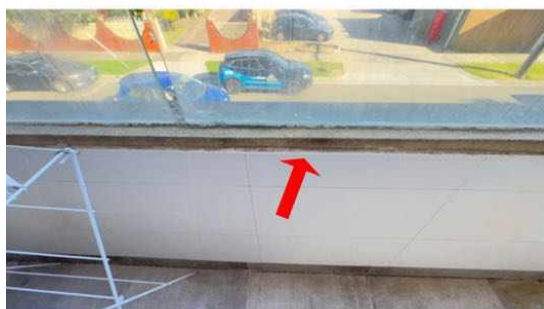
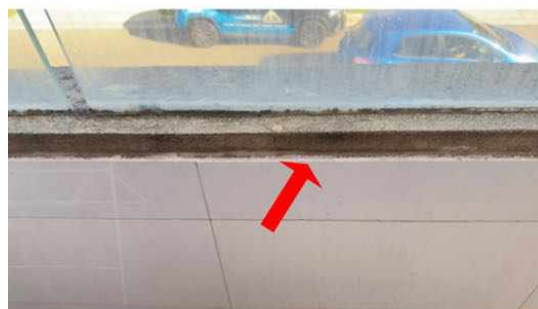
### Finding 3.08

**Finding:** Tiles - Inadequate Sealant  
**Information:** Tiles were inspected, and inadequate and deteriorated sealant was observed in this area. Missing or compromised sealant can allow moisture ingress, promote mould growth, and reduce the durability of tiled surfaces and underlying substrates.

This condition may be due to age-related wear, poor initial application, or lack of maintenance.

A qualified tiler or competent caulking specialist should be engaged immediately to remove old sealant and apply new, compliant materials. Prompt rectification will protect the flooring, maintain hygiene, and prevent possible water-related damage.

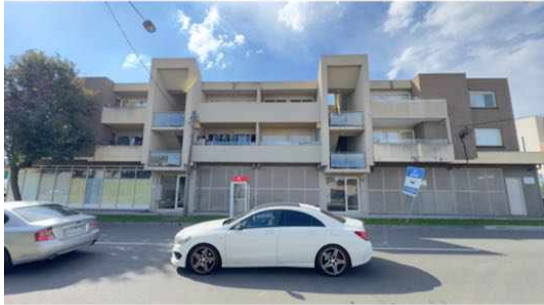
### Finding 3.09

**Building:** Main Building  
**Location:** All External Areas >  
**Finding:** External Walls - Minor Cracking To Wall Claddings  
**Information:** Minor cracking was observed to the external walls in this area. The cracking appeared superficial and did not indicate significant structural movement; however, such cracking can allow moisture ingress if left unaddressed.

The cracking is likely due to building movement or minor settlement.

When practical, a registered builder should assess and repair the cracking, which may include sealing and repainting. The area should be monitored, and any increase in cracking or signs of movement should be further investigated immediately by a Structural Engineer.

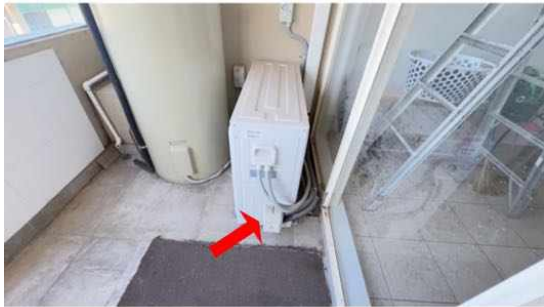
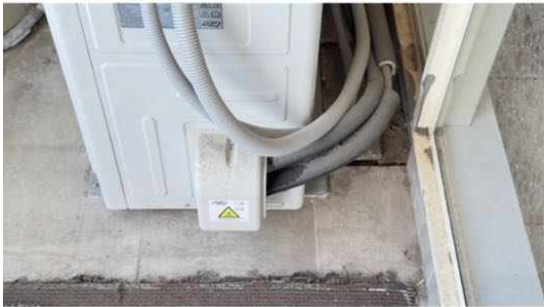
### Finding 3.10

| Information: | The air conditioning condensate drain in this area was observed to be disconnected from stormwater drainage. |

When condensate is not properly directed to a stormwater outlet, water can accumulate around the building or air conditioning unit, creating damp conditions that may lead to secondary defects such as timber rot, corrosion of nearby metal components, mould growth, or slippery surfaces. Prolonged pooling of water may also attract termites and contribute to long-term deterioration of surrounding building elements.

A qualified HVAC technician or licensed plumber should be engaged immediately to connect the condensate drain to a suitable stormwater outlet. Prompt rectification will ensure proper drainage, protect the building fabric, and reduce potential health and safety risks.

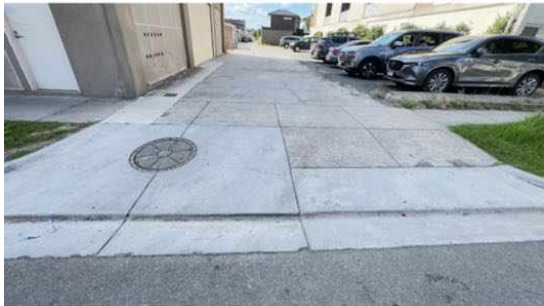
**Finding 3.11**

Building: Main Building  
Location: Driveway >  
Finding: Driveway - Minor Cracking & Surface Imperfections  
Information: The external driveway was visually inspected. Minor cracking, surface settlement, and minor unevenness was observed in this area. While these defects do not currently compromise structural safety, they may affect long-term durability, appearance, and vehicle access.

These issues may be caused by age-related wear, soil movement or settlement beneath the driveway, possible tree root intrusion, or inadequate original construction or reinforcement.

A qualified concreter should be engaged when practical to repair or resurface affected areas. Prompt rectification will restore a smooth surface, improve appearance, and prevent further deterioration.

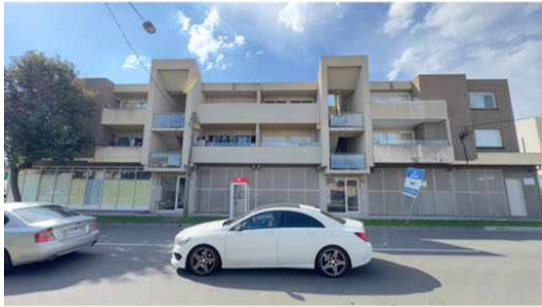
| Information: | During the inspection, no durable notice relating to a termite management system was observed on the property. A durable notice is required to identify the type of termite management system installed, the date of installation, and any ongoing maintenance or inspection requirements. The absence of this notice makes it difficult to confirm the presence, effectiveness, or maintenance status of any termite protection measures. |

Without a durable notice, there is an increased risk that termite management systems may not be adequately maintained or may have expired, particularly in the case of chemical barriers that require periodic replenishment. This uncertainty increases the likelihood of undetected termite activity and potential damage to timber elements within the building.

The lack of a durable notice may be due to removal during renovations, age of the property, or the absence of a compliant termite management system at the time of construction. Regardless of the cause, this represents a gap in termite risk management and ongoing building protection.

It is recommended that a licensed pest management technician be engaged immediately to assess whether a termite management system is present and functioning. Where a system exists, the technician should confirm its type, condition,

and maintenance requirements and install a compliant durable notice in accordance with current standards.

If no termite management system is identified, it is strongly recommended that an appropriate termite protection system be installed and documented. Regular inspections and maintenance should then be undertaken to reduce the risk of future termite infestation and associated structural damage.

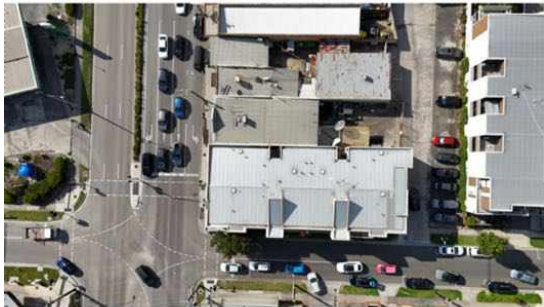
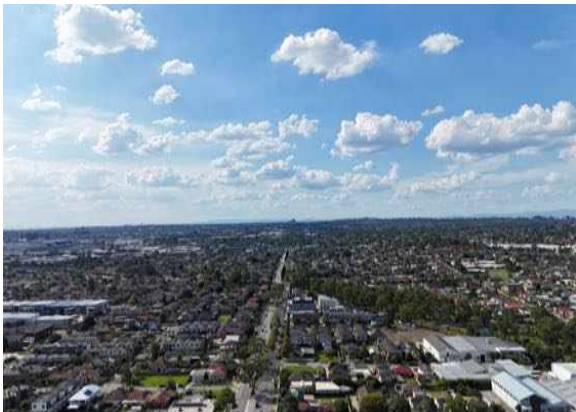
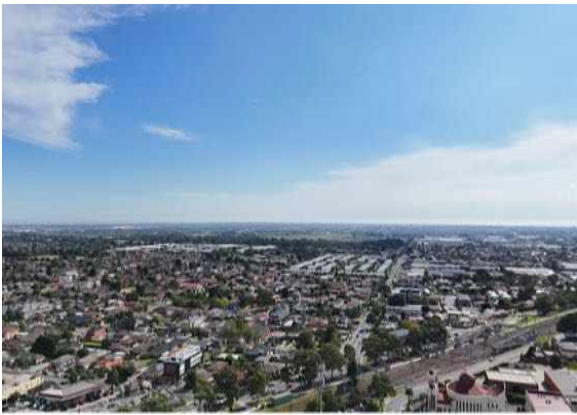
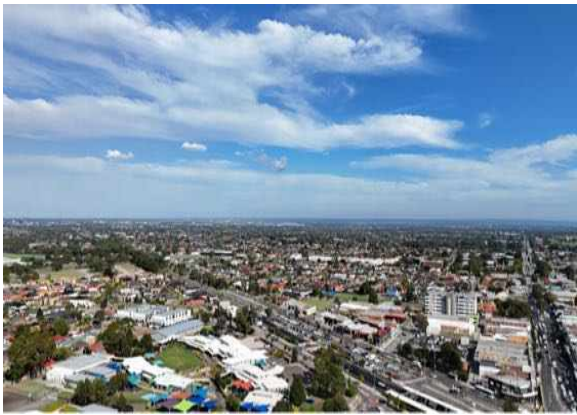
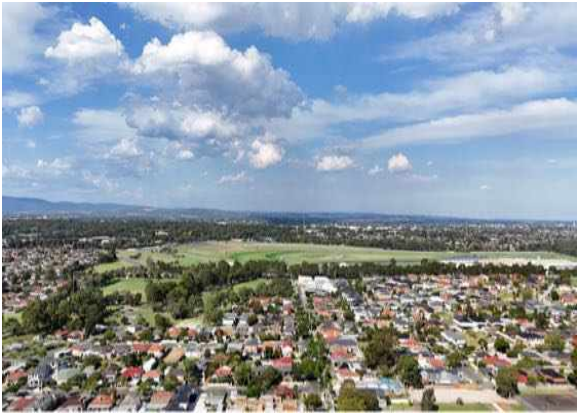
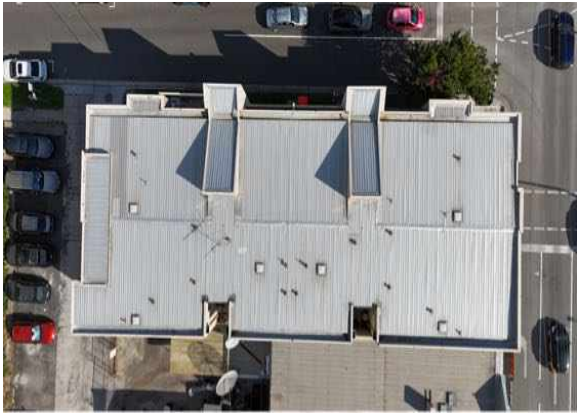
Please note that photographic images may not capture the full extent of site conditions, levels of deterioration, or concealed defects. Roof coverings and components can only be properly assessed through physical inspection, and some areas may be inaccessible due to height, pitch, safety constraints, or limited access at the time of inspection.

If there are any concerns regarding the roof structure, coverings, flashings, drainage, or associated elements, further assessment by a licensed roofing contractor is recommended immediately.

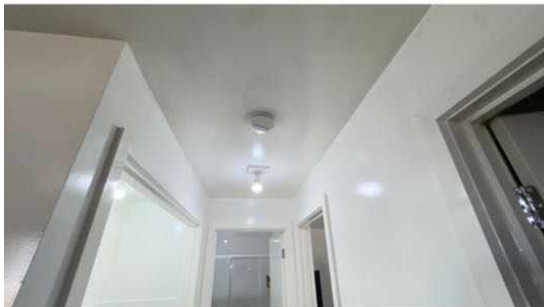
**Noted Item**

Building: Main Building  
 Location: All Internal Areas  
 Finding: Smoke Detectors - Advisory  
 Information: During the inspection, smoke detectors were noted for advisory purposes only. The operation, age, type, and compliance of smoke detectors could not be fully verified as part of this inspection.

Smoke detectors are critical life-safety devices, and non-compliant, outdated, or non-operational units may not provide adequate warning in the event of a fire.

It is recommended that a licensed electrician be engaged immediately to test, service, and upgrade smoke detectors as required to ensure correct operation and compliance with current safety requirements.

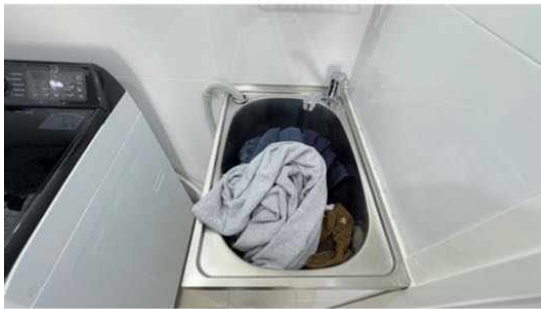
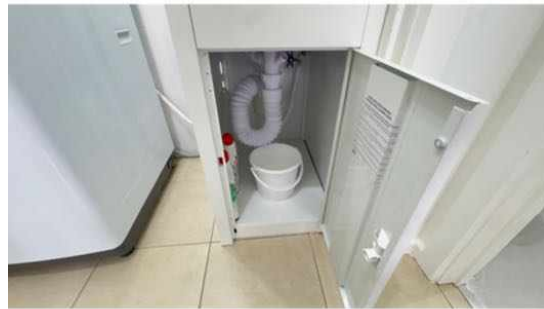
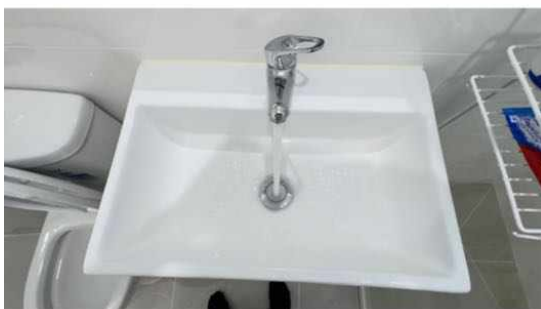
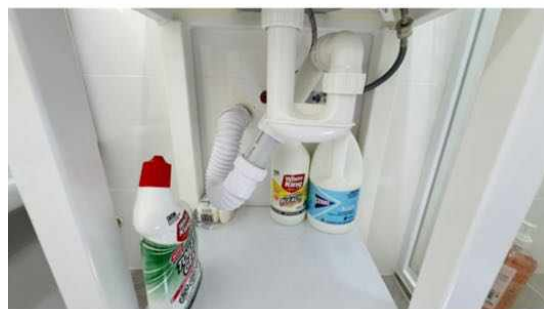
**Noted Item**

Building: Main Building  
 Location: All Internal Areas  
 Finding: Water Supply & Drainage - Shower, Basins, Toilets, & Plumbing Fixtures  
 Information: The shower recess was tested, and no visible water penetration to surrounding areas was observed at the time of inspection, except where noted as a separate defect

elsewhere in this report. Water appeared to flow freely toward the floor waste. Moisture detected to the shower walls is documented separately in the report. The shower floor waste appeared clear during inspection.

Flushing the toilet revealed no visible leaks, and the fixture appeared to operate normally unless otherwise noted as a separate defect. No water damage was observed to the vanity unit unless specifically stated elsewhere in the report. Basins, bathtubs, laundry tubs, vanities, and sinks were tested and inspected with no evidence of leaks, blockages, or drainage issues at the time of inspection unless otherwise noted. All internal taps and shower heads were tested with no leaks observed, unless documented as a separate defect.

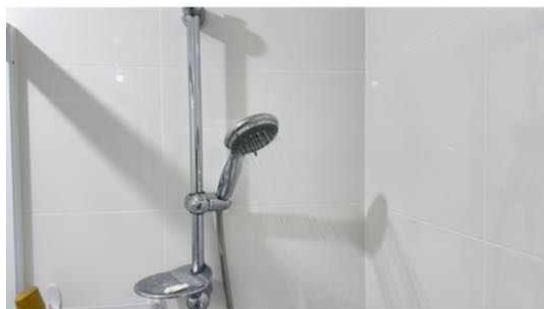
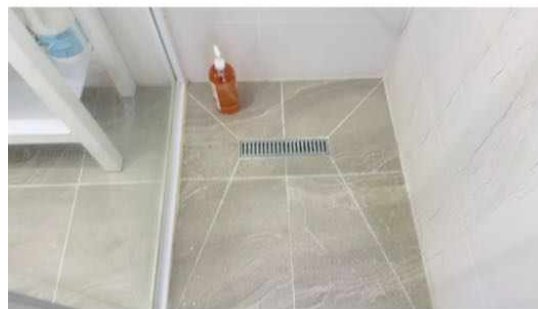
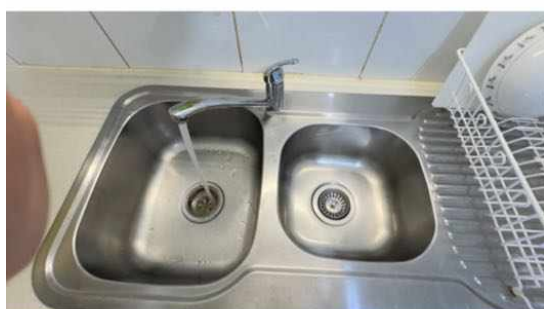
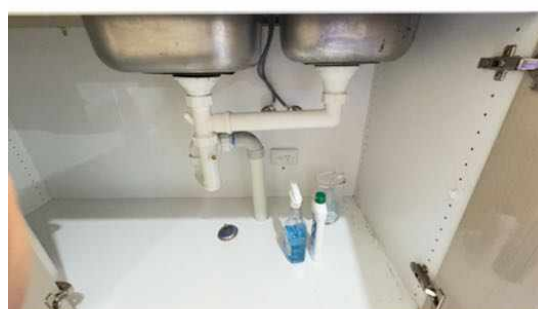
Building: Main Building  
 Location: All Areas Interior & Exterior  
 Finding: Moisture Levels - Advisory - No Elevated Moisture Levels Present  
 Information: At the time of inspection, no elevated moisture levels were detected in these areas. Moisture readings were taken (using a Tramex Moisture Meter) and non-invasive testing methods and reflect conditions present at the time of inspection only. This item is noted for advisory purposes and should not be relied upon as a guarantee that moisture issues are not present elsewhere or may not occur in the future.

Ongoing monitoring of the property is recommended, and further investigation by a qualified tradesperson should be considered if signs of water ingress, dampness, staining, mould growth, or material deterioration become apparent.

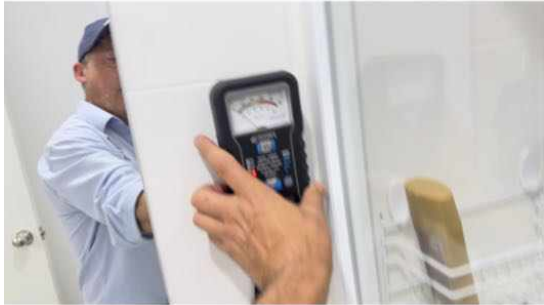
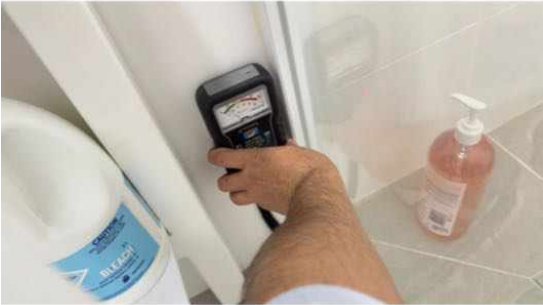
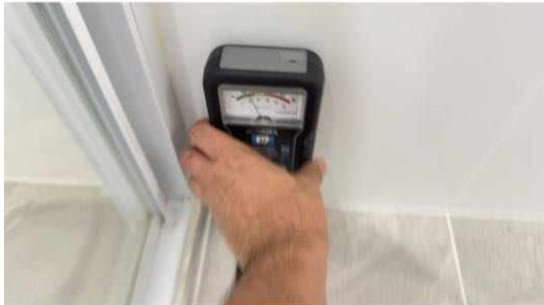
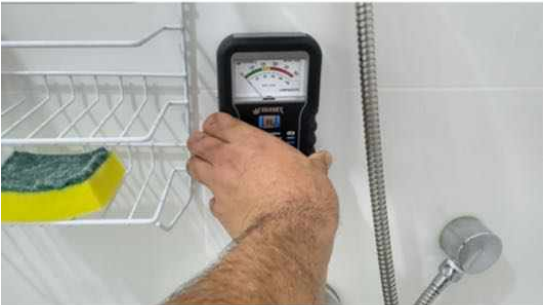
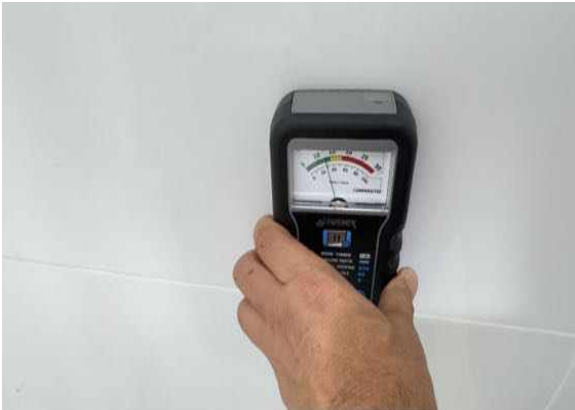
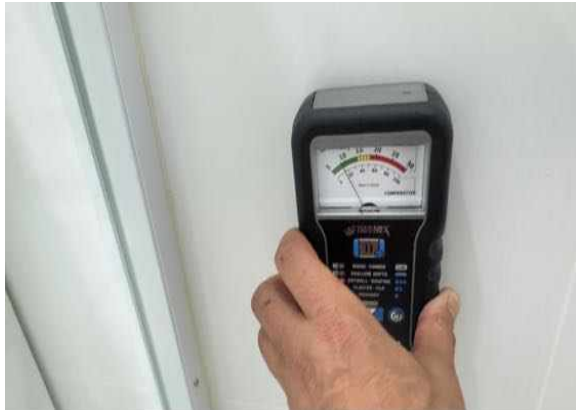
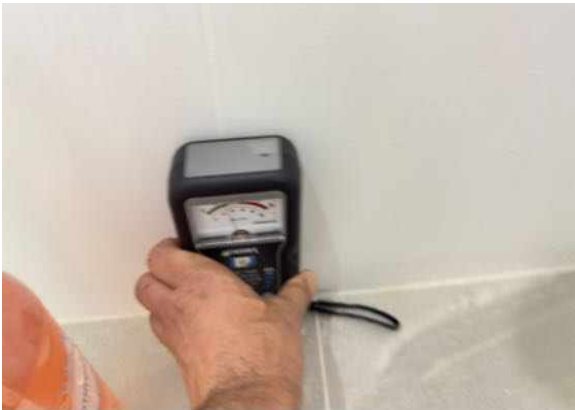
Building: Main Building  
 Location: All Areas Interior & Exterior  
 Finding: Thermal Scanning & Diagnostic - Advisory - No Elevated Moisture Levels Present  
 Information: During the inspection, a thermal imaging camera was utilised as a non-invasive diagnostic tool to assist in identifying potential irregularities associated with moisture ingress, heat loss, insulation deficiencies, or concealed building defects. Thermal imaging detects surface temperature variations that may indicate abnormal conditions within building elements.

Any thermal anomalies identified during the inspection were further assessed where accessible using visual inspection methods and moisture testing. It is noted that thermal imaging is an indicative tool only and does not confirm the presence of defects or moisture without supporting evidence.

Due to the concealed nature of building construction and the limitations inherent in non-invasive inspection methods, the absence of significant thermal anomalies at the time of inspection does not guarantee that concealed defects or moisture issues are not present. Ongoing monitoring and further investigation are recommended should concerns arise.

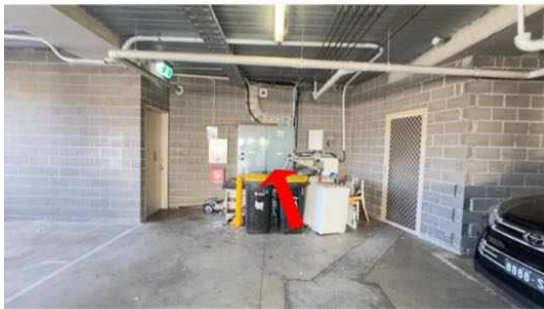
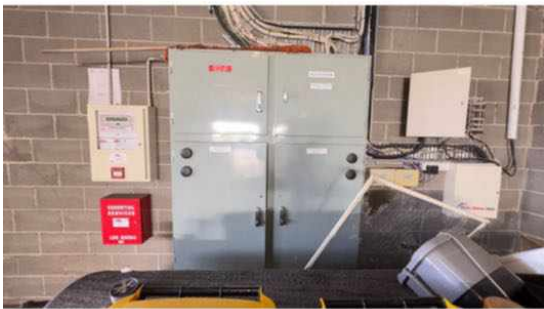
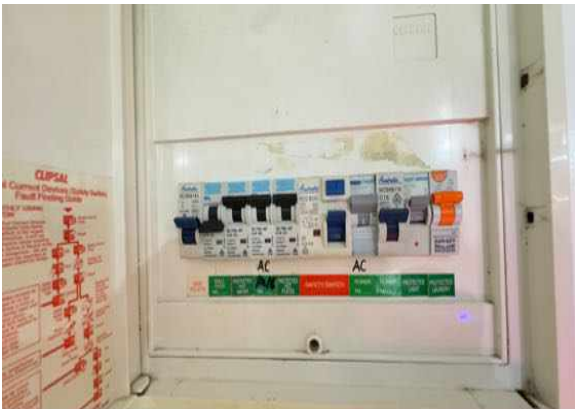
Building: Main Building  
 Location: All External Areas  
 Finding: Water Meter - Location For Your Information Only  
 Information: The water meter was photographed at the time of the inspection. The meter is included for reference & location purposes only.

Water meters can be affected over time by age, environmental exposure, accidental impact, or poor maintenance. Potential issues could include leaks, corrosion, or malfunction that may impact water supply or cause water damage.

It is recommended that a licensed plumber carry out routine inspections and maintenance to ensure continued safe and compliant operation. Observations are for informational purposes only and do not form part of a full safety or compliance inspection.

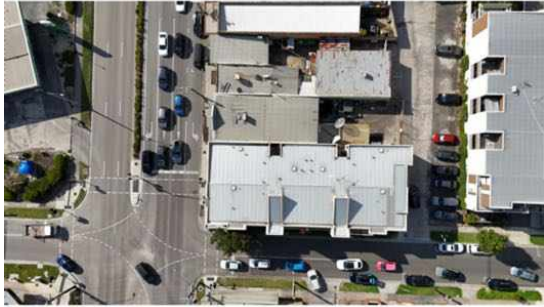
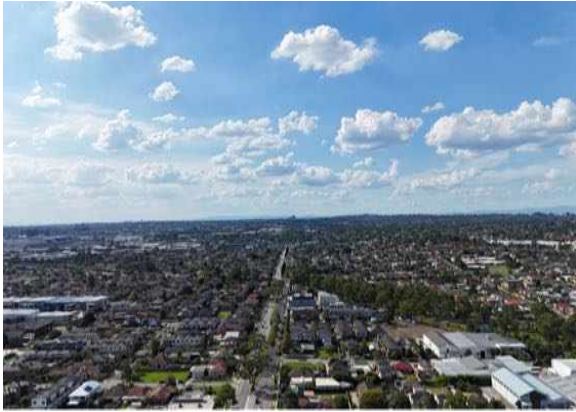
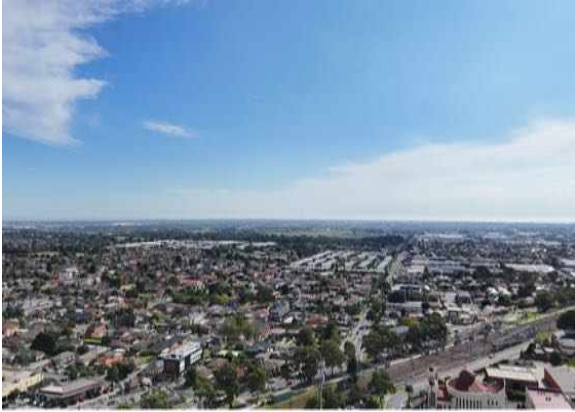
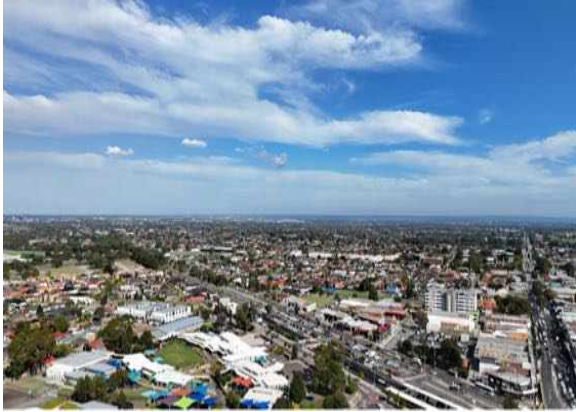
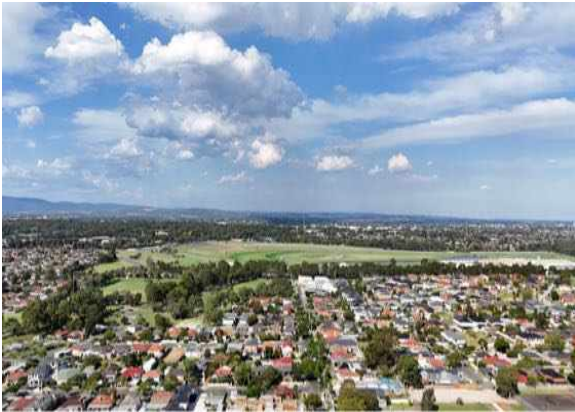
During the inspection, minor cracking, surface wear, or uneven sections were observed on footpaths or crossovers. Some accessible metal components, such as street signage or grates, showed signs of rust or deterioration. Debris accumulation and vegetation encroachment were also noted around council infrastructure. Access

These areas should be monitored, and for detailed assessment, maintenance, or compliance verification, the relevant local council authority should be contacted immediately. Regular monitoring of adjacent council assets is recommended to ensure ongoing safety and proper maintenance.
