# Building and Timber Pest Inspection Report

Inspection Date: Mon, 23 Mar 2026

Property Address: 9/1 Virginia St, Springvale VIC 3171,  
Australia

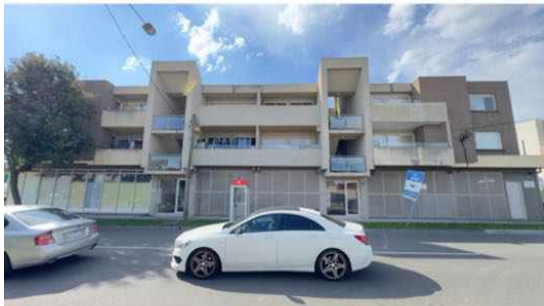
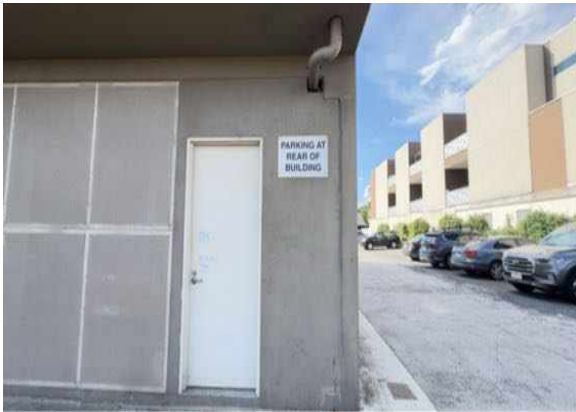
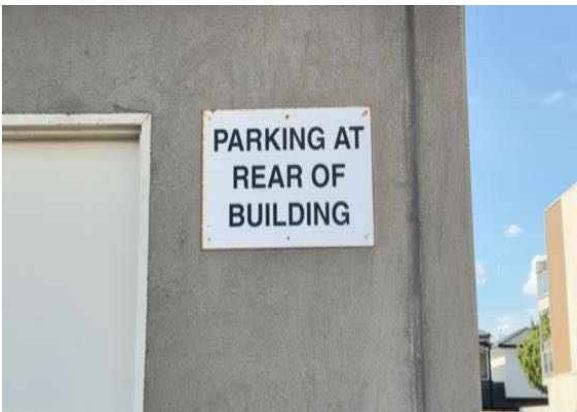
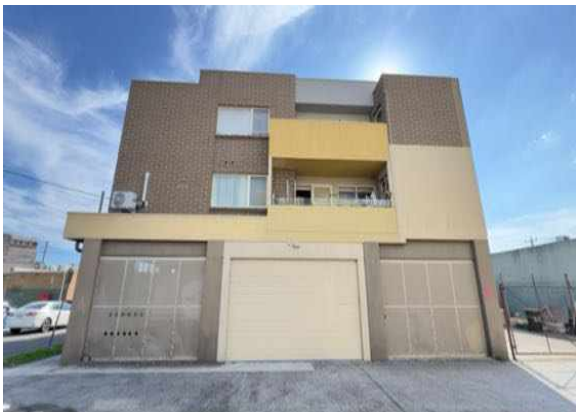
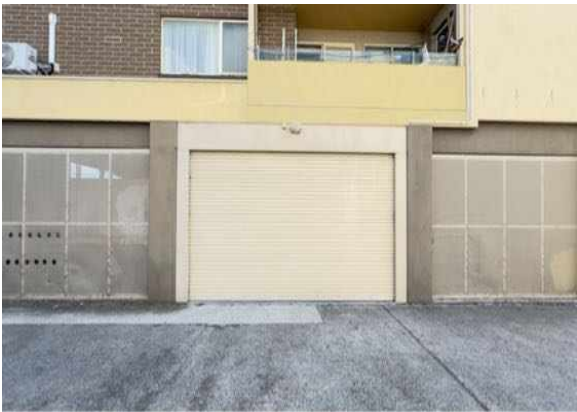
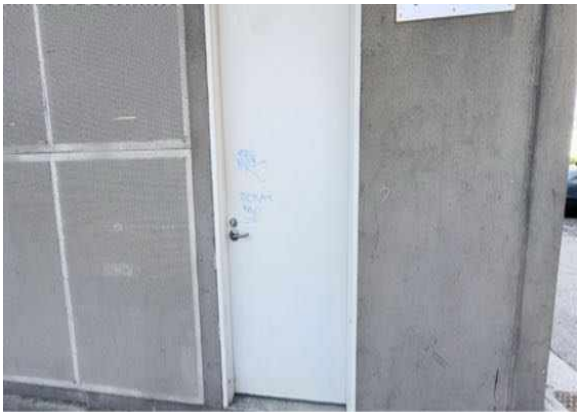
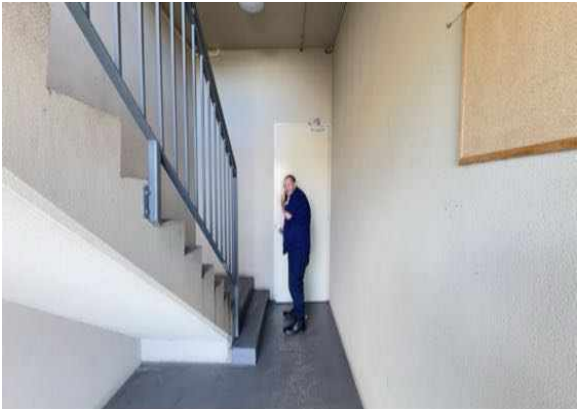
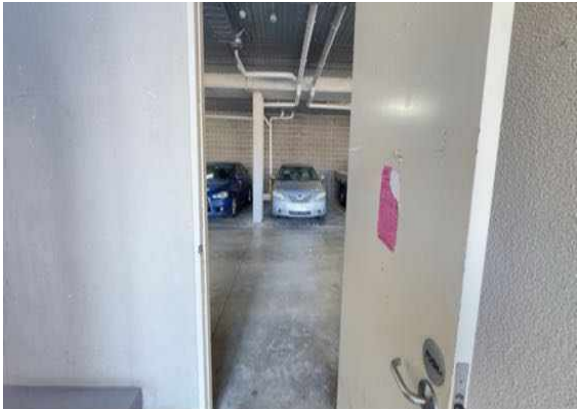
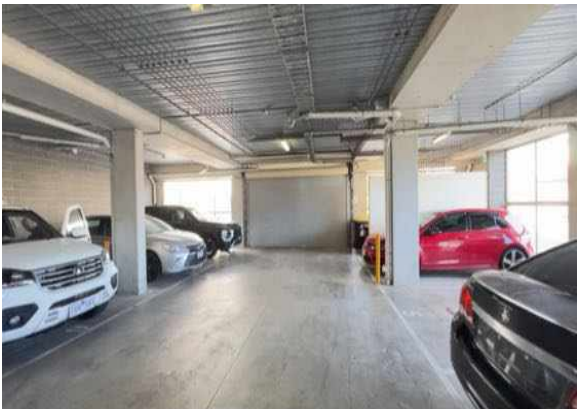
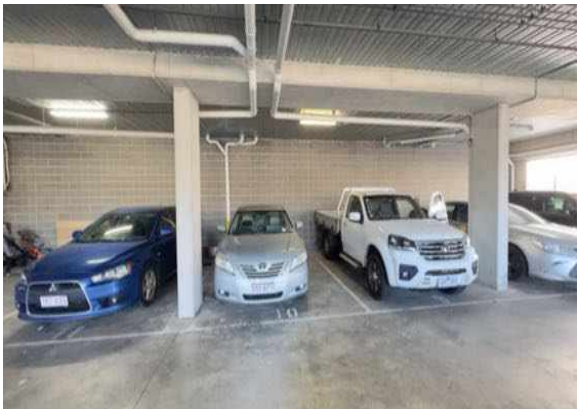
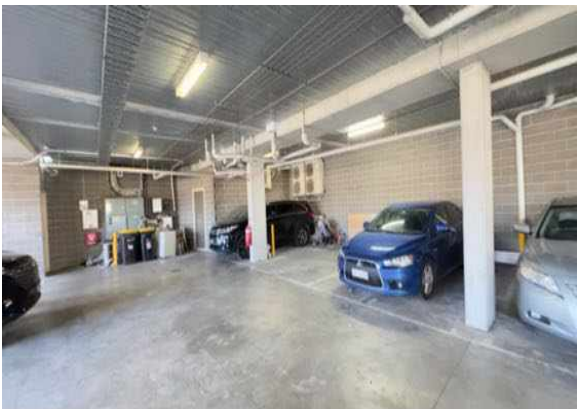
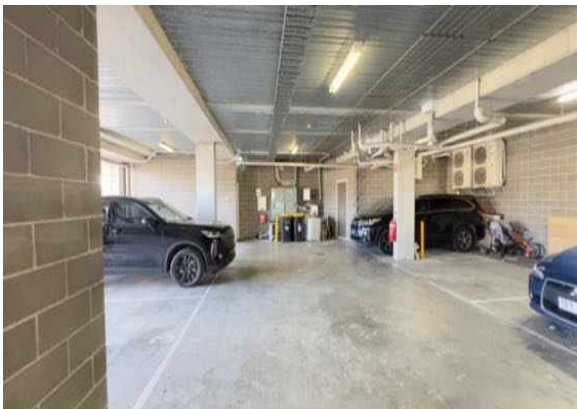
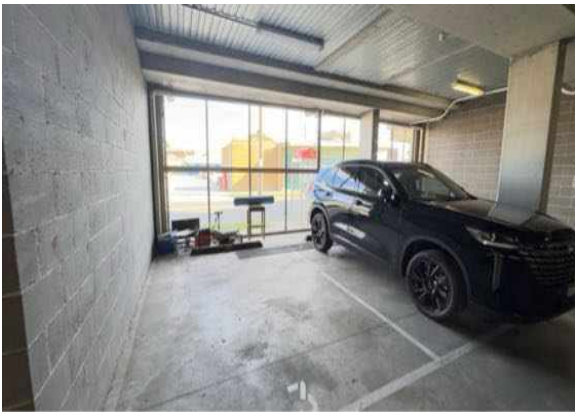
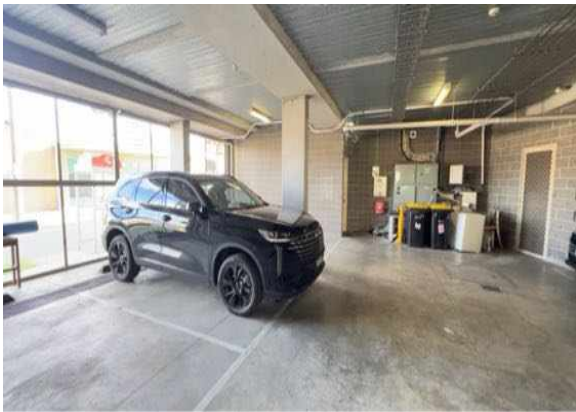
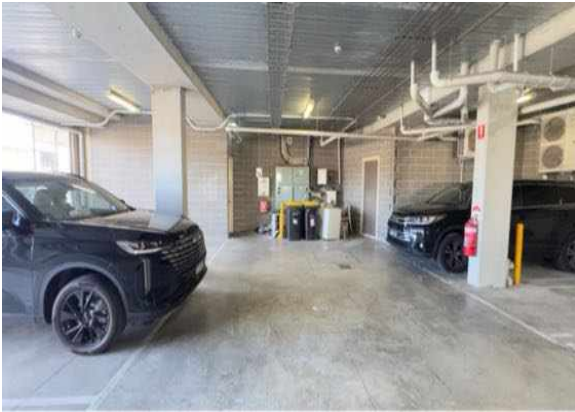
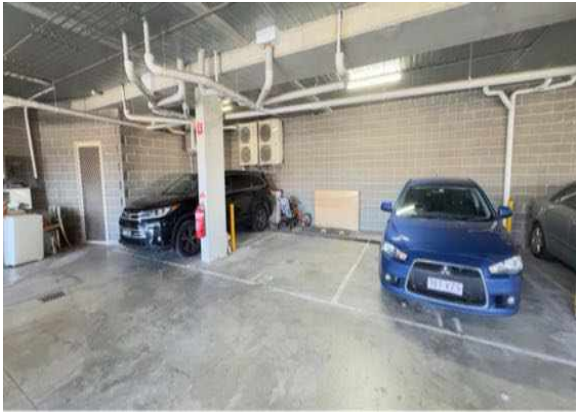
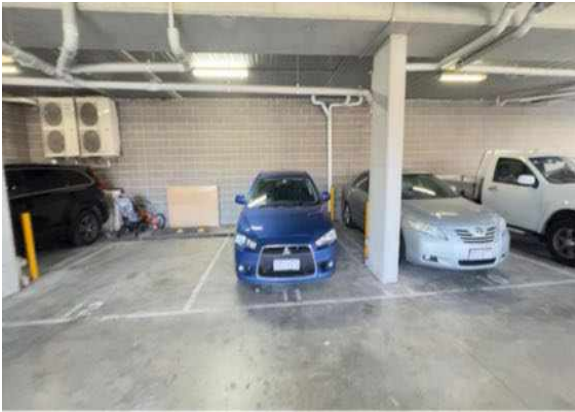
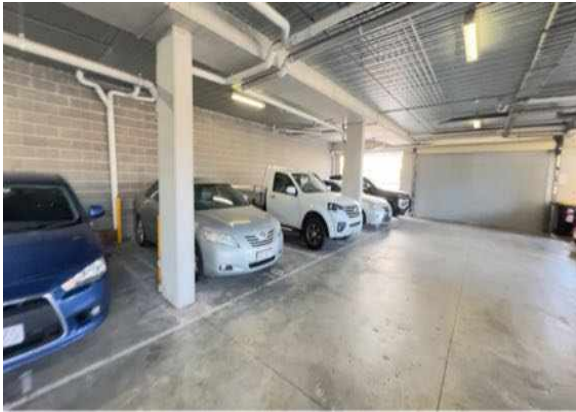
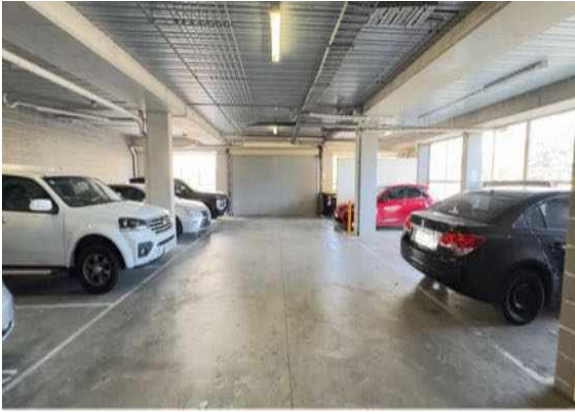
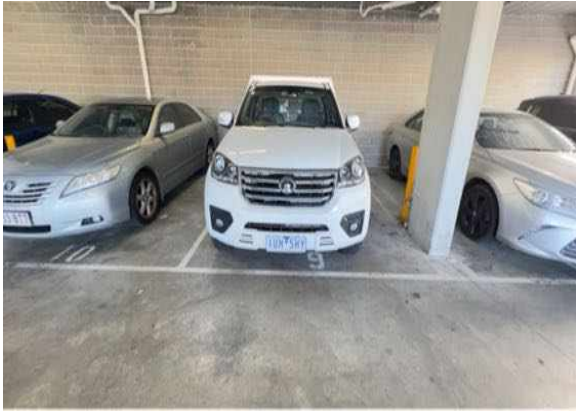
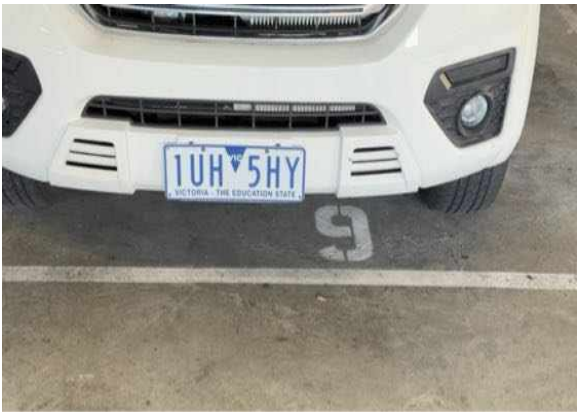
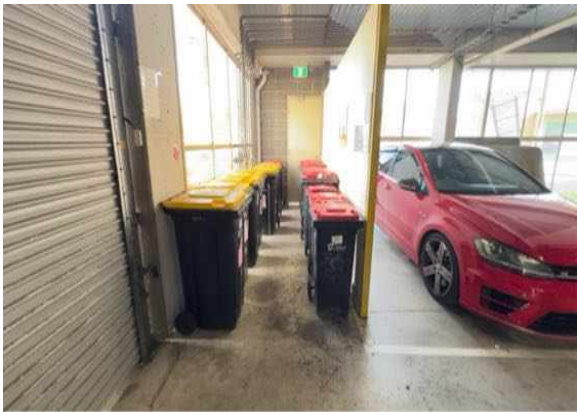
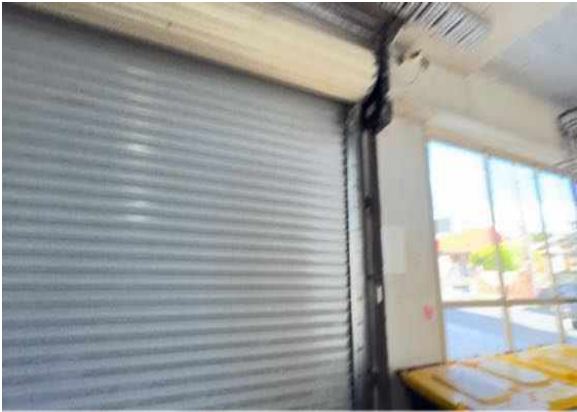
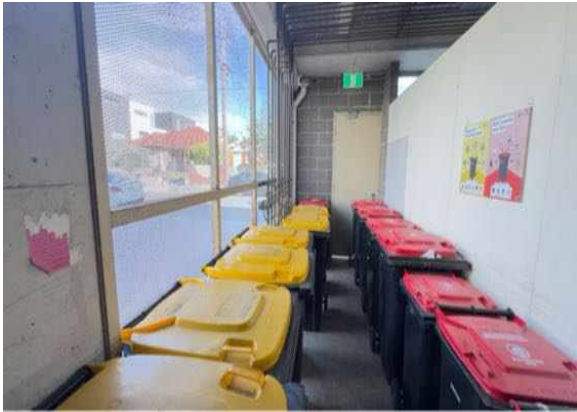
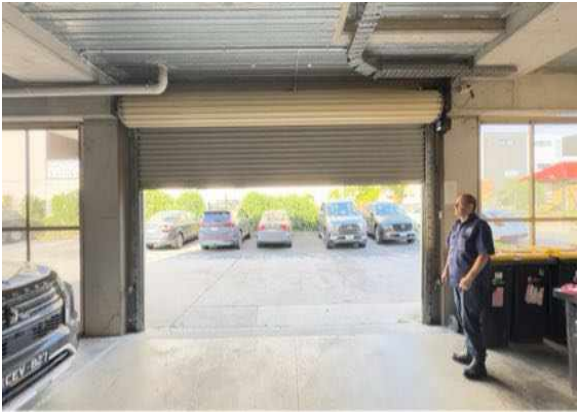
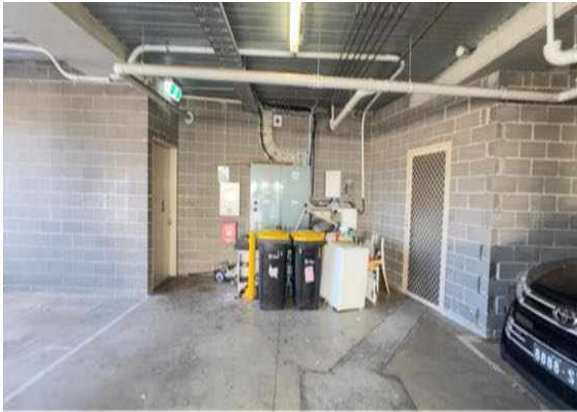
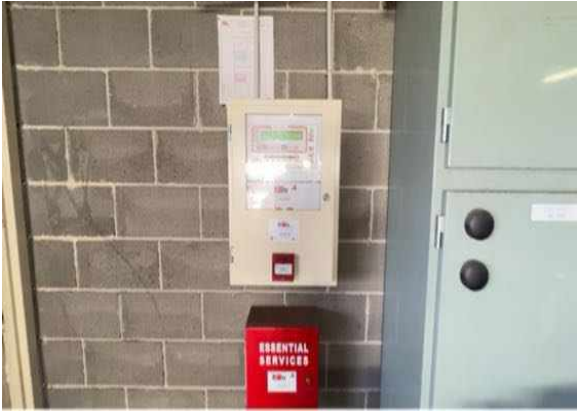
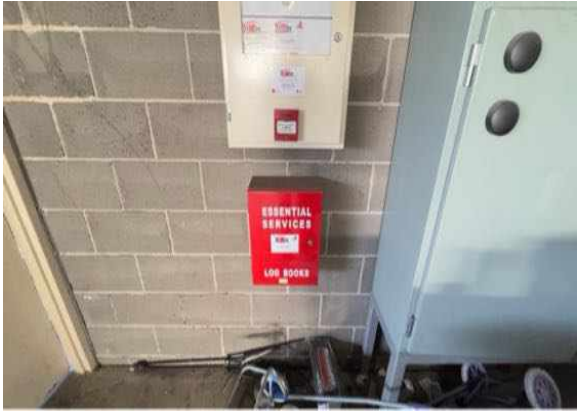
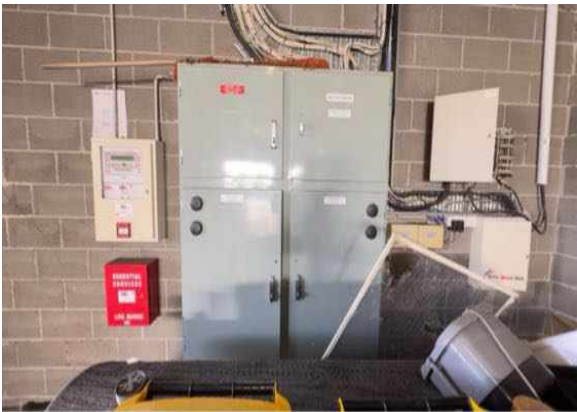
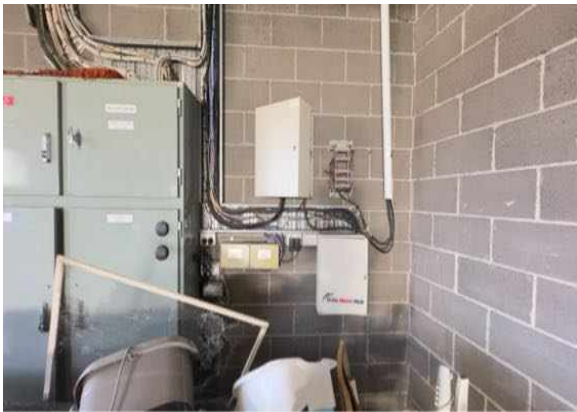
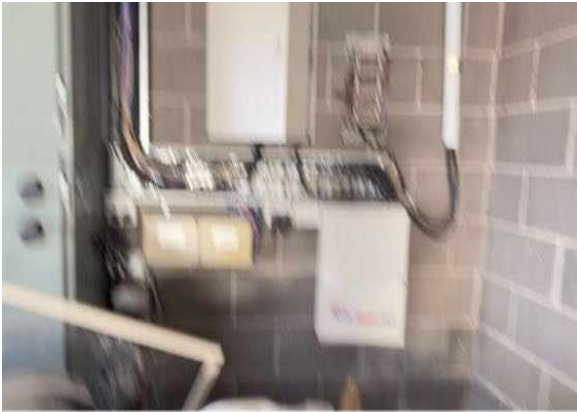
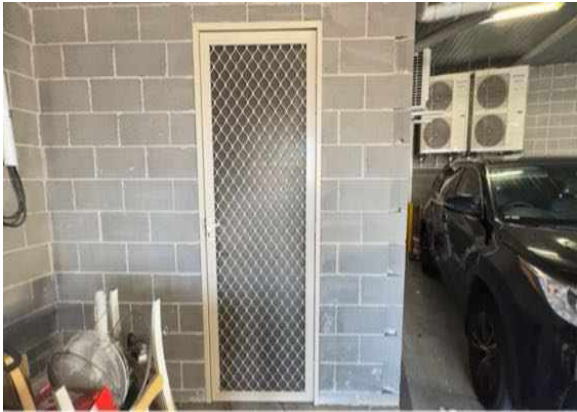
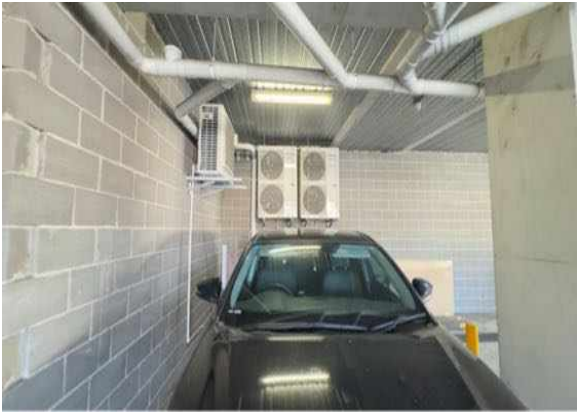
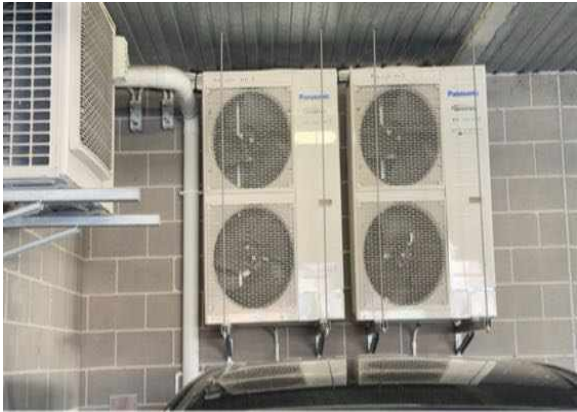
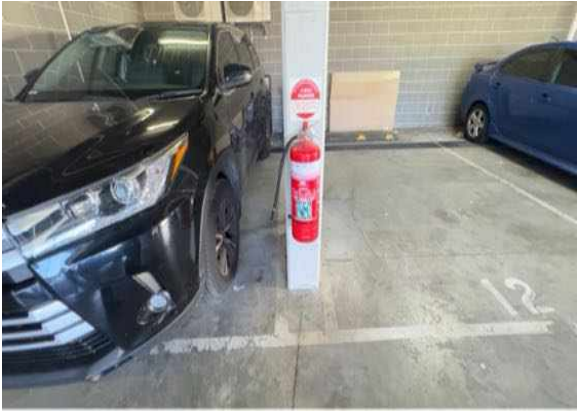
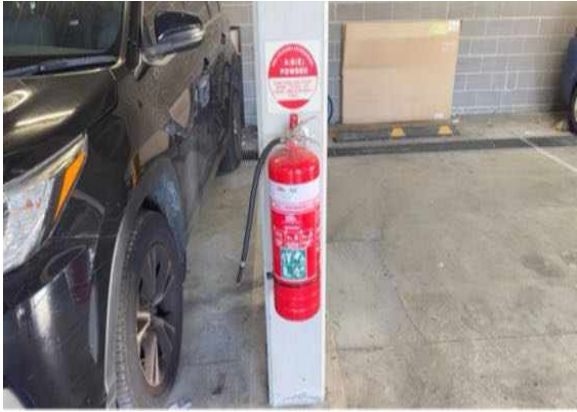
Building:  
Location: Limited Areas  
Finding: Additional Photos - Common Property  
Information: Additional photos are provided for your general reference and are to be discussed with your building inspector.
