## Building Inspection Report

Inspection Date: Thu, 15 Jan 2026

Property Address: 65 Maraket Ave, Blaxland NSW 2774,  
Australia

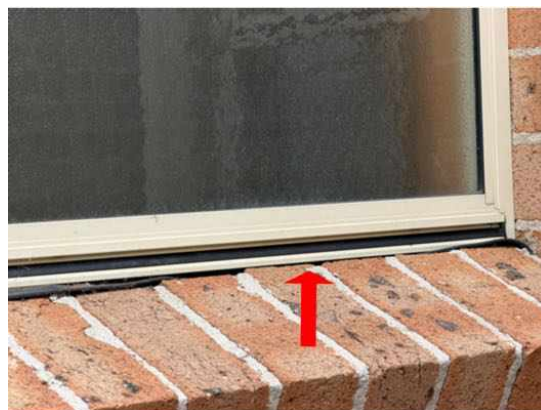
This can lead to water ingress potentially causing further damage to other building elements.

I recommend a general handy man be appointed rectify this at the owners discretion.

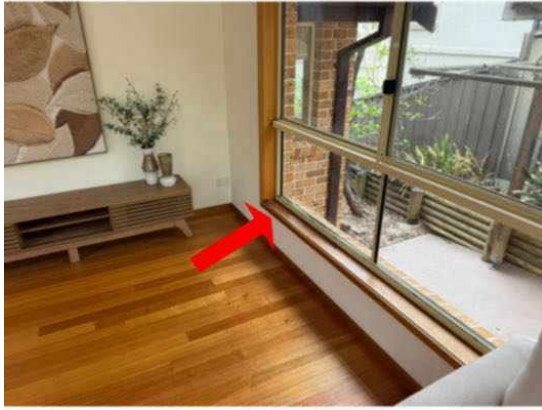
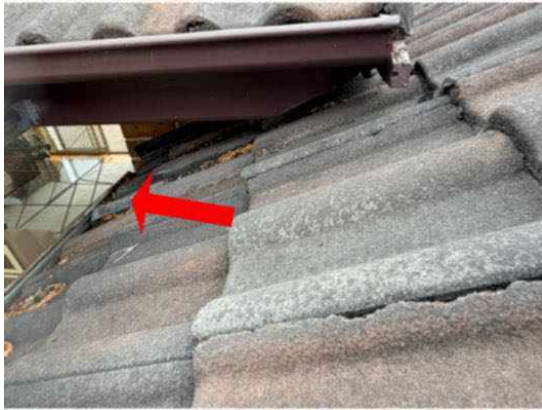
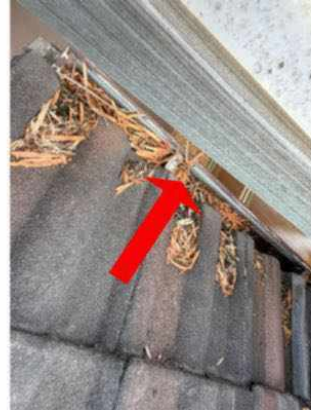
### Defects 3.04

Building:	Main Building
Location:	All Areas
Finding:	Gutters - Blocked
Information:	At the time of inspection it was found that this gutter was completely blocked with debris, leaves and silt.

It does look as though this has caused water ingress to the window previously.

The area was checked for high readings of moisture in the area and no high levels were recorded.

Blocked gutters are likely to lead to high levels of moisture in the affected areas. Such moisture will not only cause rust and decay of the associated building materials, but can also provide conditions that are conducive to termite and timber pest activity.

Blockages in gutters should therefore be removed immediately to ensure dry conditions are maintained.

Consult a Licensed Plumber for further specific advice on remedial works that may be required. In the interim, it is highly advised that blocked gutters be removed by the homeowner or a general handyperson as a matter of urgency.

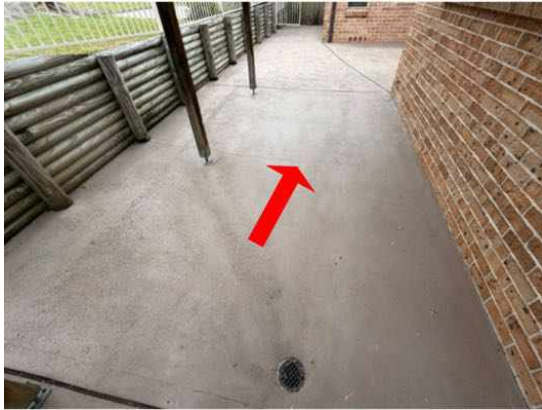
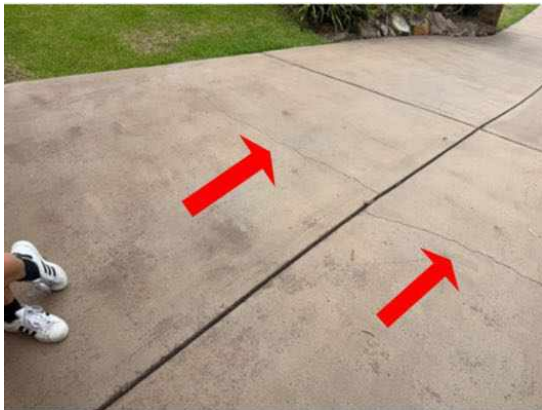
### Defects 3.05

Building:	Main Building
Location:	All External Areas
Finding:	Crack in concrete slab - Category 1
Information:	A crack coded as Category 1 was identified in the slab. A Category 1 crack is described as a fine but noticeable crack, with the slab at an otherwise reasonable level.

To be considered Category 1, the approximate width of the crack is less than 1.0mm, or a less than 10mm change in offset when a 3m straight edge is placed over the defect.

Category 1 cracks should be monitored for a period of 12 months. At the end of the monitoring period, identified cracks that are rated greater than Category 2 are considered defects, and require rectification.

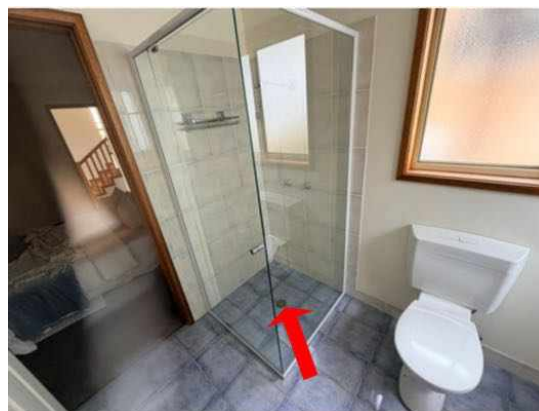
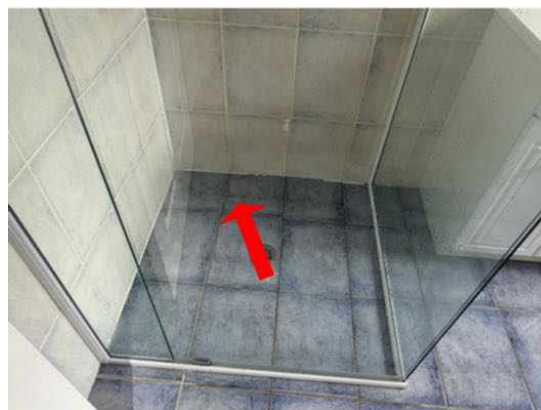
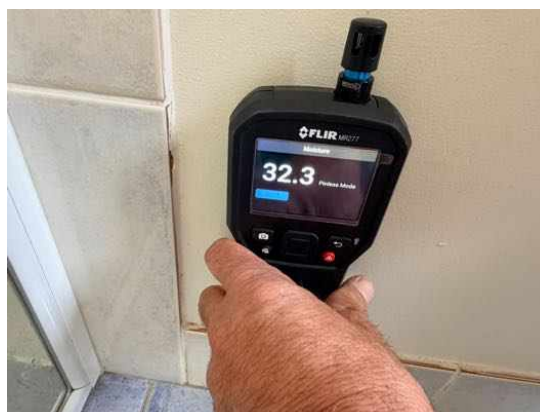
### Defects 3.06

Building: Main Building  
 Location: Showers  
 Finding: Shower seal repairs required  
 Information: The shower recess was flood tested and no visible leaks were noted at time of inspection.

However grout and silicone is missing from wall to floor tiled junctions. These areas of missing grout should be re-instated and silicone applied to all internal corners to maintain a good overall seal and to prevent water from penetrating under the tiled surface.

High moisture readings in adjacent walls was noted. Past water damage to nearby timber building elements was also present. Water is pooling around the floor-waste indicating inadequate fall.

Further inspection is recommended.

If a more accurate assessment is required, a special purpose inspection should be requested. Alternatively, the assumption should be made that the shower may leak.

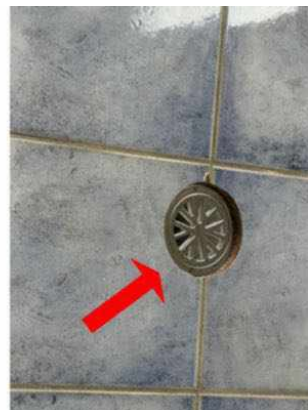
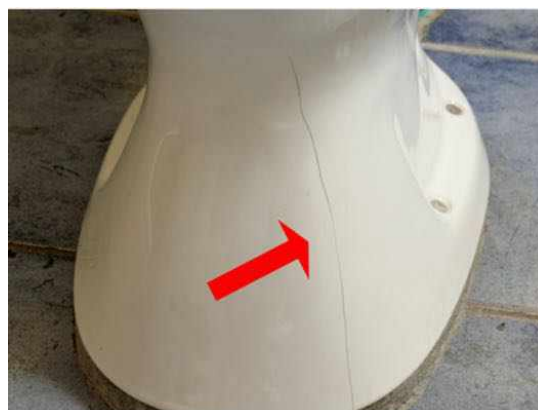
### Defects 3.07

Building:	Main Building
Location:	Bathroom
Finding:	Bathroom defects
Information:	Some minor defects were found in this area at the time of inspection.

The toilet pan has a crack in it. Again this does not cause any functional issues it is cosmetic but does deter from the general appearance of the bathroom. The toilet was checked for leaks and none were noted at the time of inspection.

A plumber could be appointed to replace the toilet at the owners discretion and a tiler be appointed to reinstall the floor waste at the owners discretion.

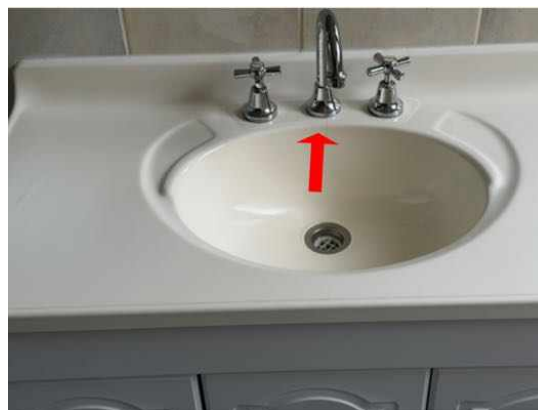
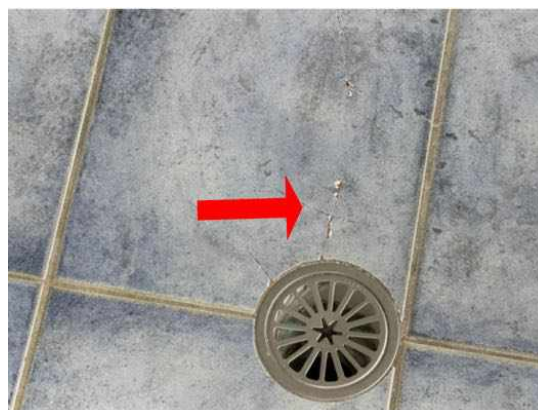
### Defects 3.08

The vanity basin has a small crack in it. Whilst this is cosmetic it does deter from the general appearance of the area.

Floor tiles in this area are cracked. Again they function as intended but do deter from the general appearance of the bathroom and could eventually lead to water ingress into the substrate which can lead to secondary defects.

A plumber could be appointed to replace the vanity basin at the owners discretion and a tiler be appointed to replace the cracked floor tiles at the owners discretion.

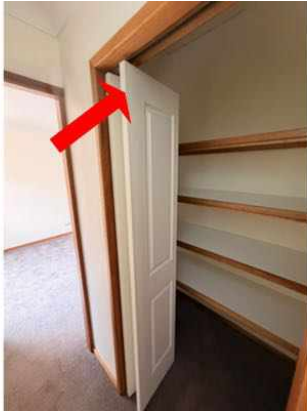
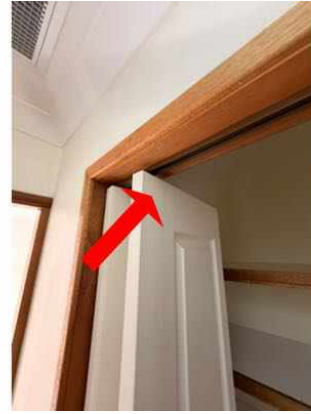
### Defects 3.10

Building:	Main Building
Location:	Linen Cupboard
Finding:	Door - Binding/jamming
Information:	Binding and/or jamming of this door is evident during standard operation. This defect inhibits the functionality of the affected door as well as creating potential for secondary defects to associated building elements, such as damage to the door and jamb.

A door that binds to flooring or to the associated door frame may have several causes, ranging from minor defects, such as poor installation of the door or deteriorated hinges, through to minor building movement.

For minor causes, a qualified carpenter or general handyperson should be appointed to perform minor rectification works at client discretion.

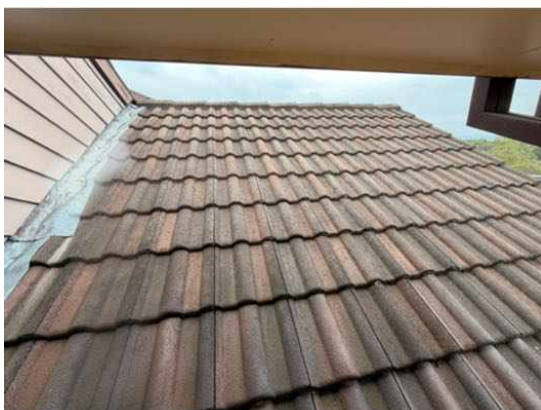
### Defects 3.11

Building:	Main Building
Location:	Roof Exterior
Finding:	Roof tiles - Weathered
Information:	Upon inspection of the exterior roofing, the majority of roof tiles were considered to be in a fair condition. While weathering of the tiles is consistent with the age of the property, maintenance works are required.

Isolated areas of mortar have come loose and minor cracking is also present. Repointing and re-sealing these areas may be considered as an interim solution by the client to help preserve and extend the life span of the tiles.

Where left unmanaged, deteriorating roof tiles are likely to lead to a number of secondary defects, including minor water leaks and weather exposure to internal roofing structures.

Consultation with a roofing contractor is highly advised to gain advice on cost of remedial works that may be required in the short to medium term. Remedial works are likely to increase the longevity of the exterior roofing structure.

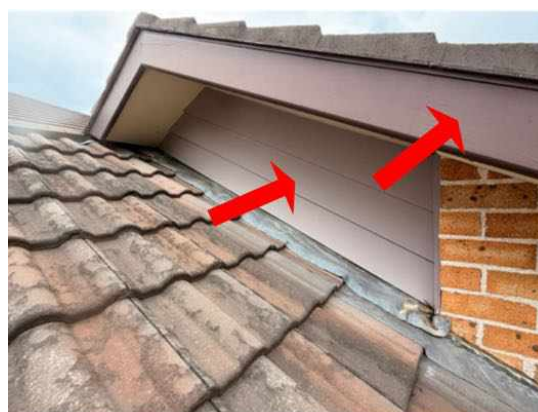
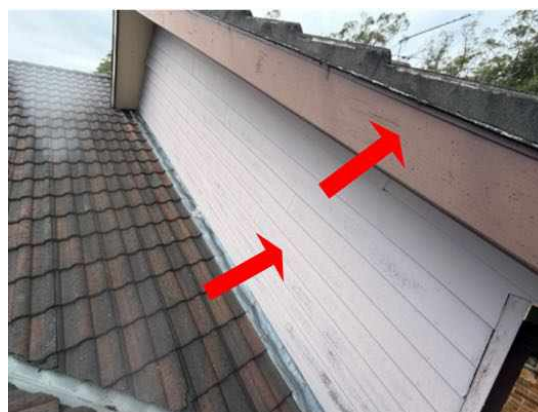
### Defects 3.13

Location:	All External Areas
Finding:	External painting deteriorated/weathered
Information:	Much of the external paintwork including but not limited to eaves, fascias and cladding have been neglected and require attention to prepare and re-paint.

Whilst incomplete or missing paint finish is generally an appearance defect, it can also lead to the development of secondary building defects over time. Incomplete areas of paint finish expose the area to moisture, potentially accelerating the deterioration of underlying building materials.

Degraded paint finishes should be sanded back, filled, leveled and painted, as applicable. Where inadequate or missing paint protection has led to the deterioration of the associated building element, repair and/or replacement of this building element may be required.

A painting contractor should be appointed as soon as possible to perform necessary works to aid the appearance of the affected area and to ensure the area is protected against further deterioration. Alternatively, the homeowner following manufacturer instructions may perform these works.

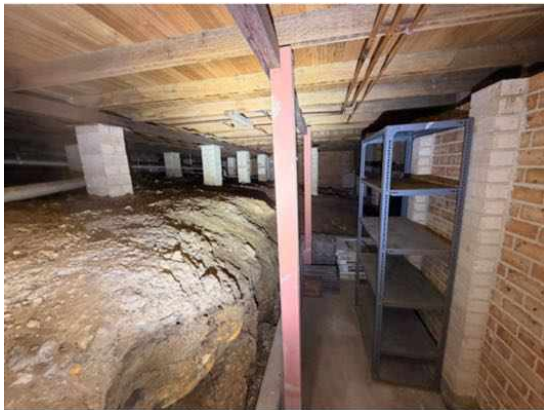
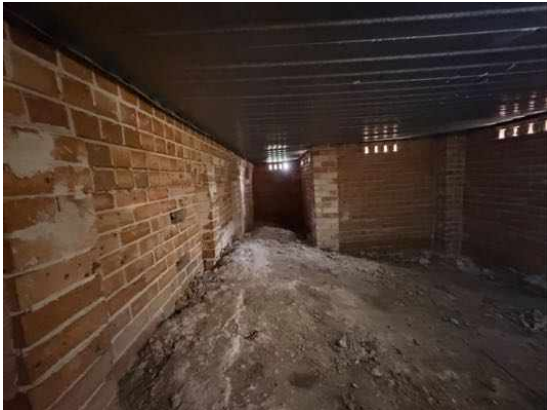
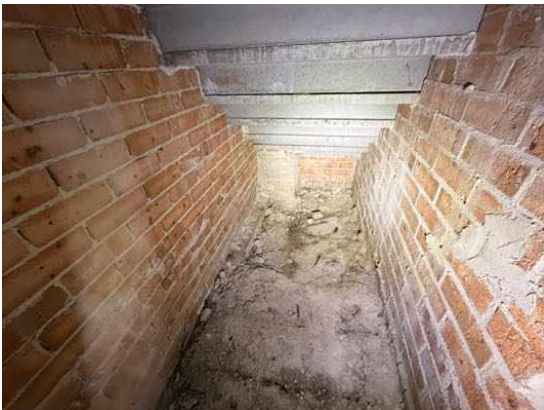
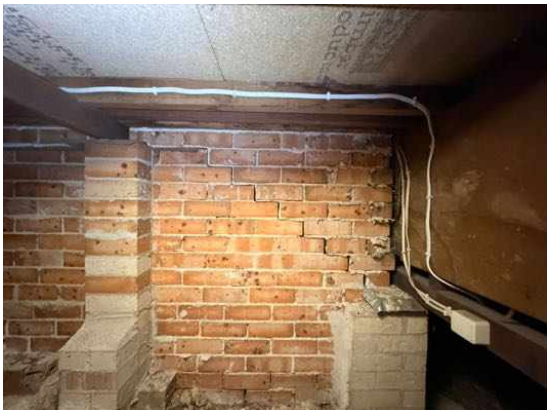
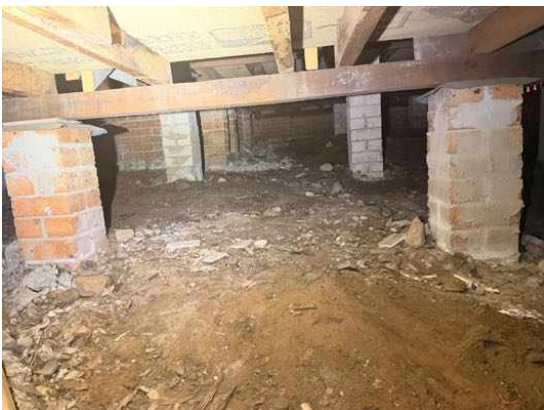
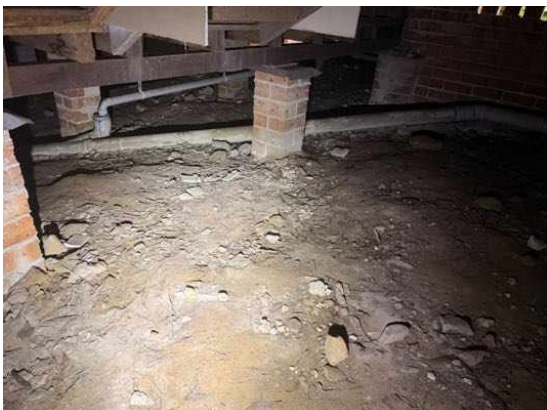
**Noted Item**

Building: Main Building  
Location: All Areas  
Finding: Additional Photos - Obstructions and Limitations  
Information: These photographs are an indication of the obstructions and limitations which impeded full inspection of the property at the time of inspection. These obstructions can hide an array of defects and should be removed to allow full inspection to be carried out. A re-inspection is recommended once the areas are made accessible.
