Building and Timber Pest Inspection Report

Inspection Date: Tue, 3 Feb 2026

Property Address: 33 Ringrose Ave, Greystanes NSW 2145,
Australia

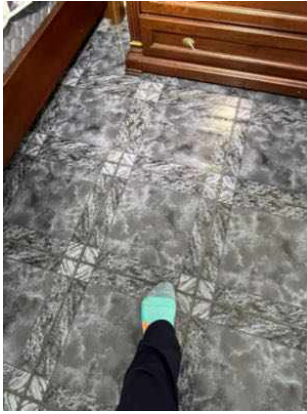
Building:	Main Building
Location:	All Areas
Finding:	Crackling or creaking sound on the tiles floor
Information:	Small but noticeable crackling or creaking sound was detected when walked on the tiles in the area. The cause of the crackling sound can be from number of the reasons including inadequately bonded tiles to the the substrate base for the tiled area, degraded or deflected plywood under the tile or inadequately installed control joint for expanded tiles. Further monitoring to the area is recommended and if the crackling sounds intensifies or the area being further deteriorates, licensed builder should be appointed to inspect further and repair the areas.

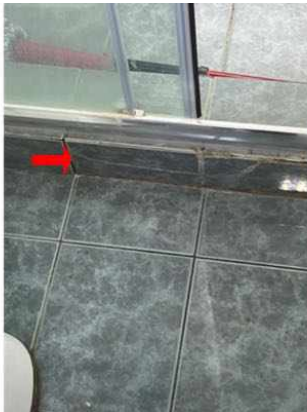
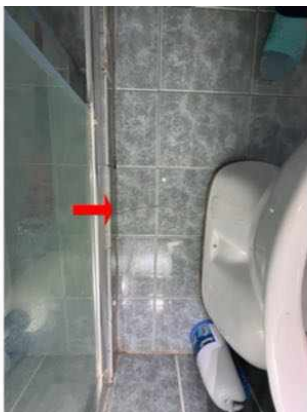
Finding 3.02

Finding: Tiles - Cracked

Information: During the inspection, it was observed that the tiles in this area had visible cracks. Typically, cracked tiles are a result of underlying issues such as incorrect installation, temperature changes, cracks in the substrate, excessive weight on the tiles, or accidental impact. Since the cracked tiles detract from the overall appearance of the area, it is advisable to hire a professional tiling contractor to address the issue.

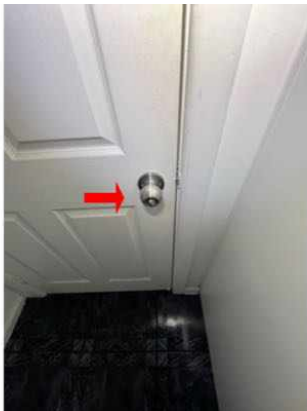
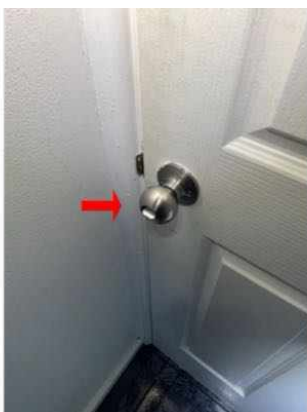
Finding 3.03

Building: Main Building
Location: All Areas
Finding: Deterioration caused by Fair and Wear and Tear
Information: Certain forms of deterioration commonly associated with fair wear and tear may not be specifically itemised within this report. At the time of inspection, minor hairline cracking was observed to plaster linings and junctions consistent with normal building movement over time, together with a bathroom door that exhibited a slight rattle when operated, indicative of minor hardware or alignment adjustment being required rather than a structural defect. Deterioration to some areas of sealant, particularly around wet area junctions and joinery interfaces, was also noted as being aged and serviceable but nearing the end of its effective life, which is typical for a property of this type and age. A small superficial crack was further observed on the surface of the bathroom benchtop; this appeared cosmetic in nature and did not show signs of active movement, displacement, or moisture-related failure.

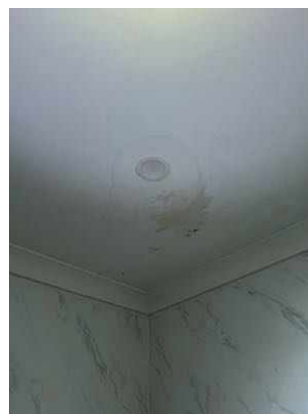
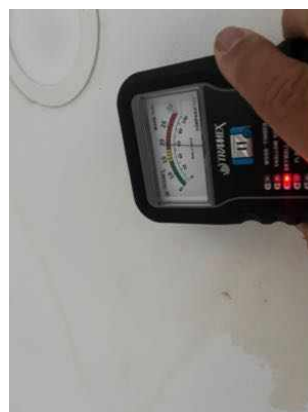
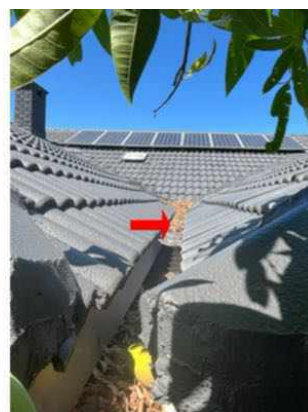
Finding 3.04

Finding: Ceiling - Water Stained

Information: At the time of inspection, water staining and associated surface deterioration were clearly evident to the ceiling linings in this area, consistent with ongoing or recent water ingress. The pattern, extent, and distribution of staining indicate that moisture has migrated through the ceiling substrate rather than being a superficial or historic blemish. Thermal imaging assessment and moisture meter testing confirmed the presence of elevated moisture levels in the affected area, supporting the conclusion that the defect is active rather than solely residual from a past event.

Given the location of the staining directly beneath a box gutter, it is reasonably suspected that the source of water ingress is associated with the box gutter system above, likely due to blocked drainage, defective flashing, membrane failure, or compromised waterproofing detailing. Continued exposure to moisture in this manner has the potential to degrade ceiling linings, promote mould growth, and, if left unaddressed, may lead to damage of concealed structural elements such as ceiling battens or framing.

It is therefore recommended that a licensed plumber or appropriately qualified roofing contractor be engaged to inspect the box gutter, associated flashings, and drainage components to identify the precise source of leakage and carry out necessary remedial works. Following rectification of the leak, damaged ceiling linings should be repaired or replaced as required to restore the integrity and appearance of the affected area.

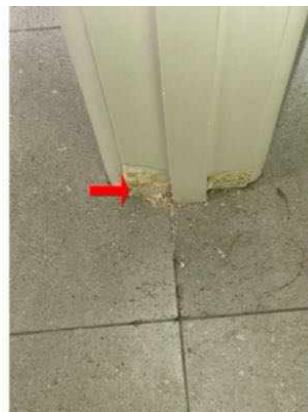
Finding 3.05

Building:	Main Building
Location:	Bathroom 2
Finding:	High Moisture Metre Readings - inadequate waterproofing is suspected
Information:	High moisture metre readings were identified in the area at the time of the inspection. The high moisture metre readings may implies that water proofing to the wet area/s may not comply with Australian Standards. Incorrect application of waterproofing materials and poor or substandard application of water proofing methods are common minor defects, but can have serious implications if left unattended.

resistant buildings materials. Failure to prevent excessive moisture in these areas may lead to the development of water damage and other secondary defects to associated building elements.

Although there was no noticeable water damages found around the area, it is recommended to assume that the area leaks and repair the waterproofing or carry out an invasive inspection.

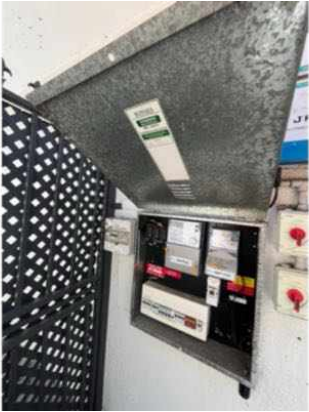
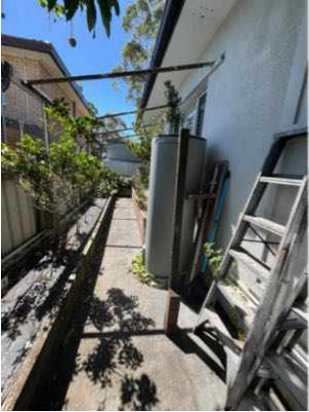
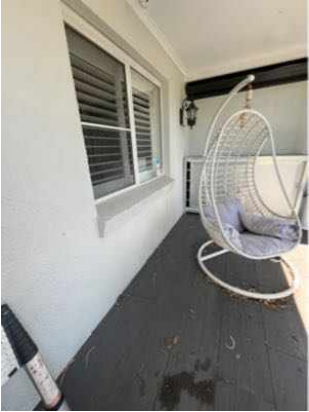
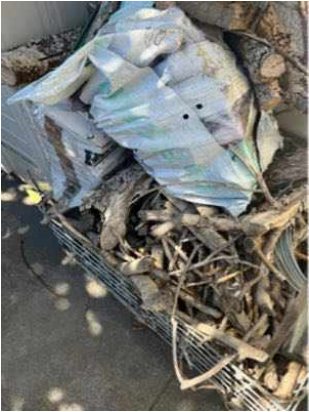
Finding: Conditions Conducive to Termite Activity

Information: The following areas and environmental conditions were identified as conducive to termite activity. These conditions increase the risk of concealed termite entry and should be addressed through appropriate maintenance, repairs, improved drainage, additional monitoring, or the installation of a compliant termite management system.

The HWS overflow discharges directly to ground, resulting in constant moisture at the building perimeter. Excess moisture provides conditions favourable to termite activity.

Air conditioner condensation lines discharging near walls can cause damp soil conditions, attracting termites.

External taps without drainage provisions allow pooling at the base of walls, increasing moisture levels.

Blocked gutters were noted to cause overflow, directing water onto walls and foundations. Excess moisture increases termite attractivity.

Stumps and garden beds near the dwelling provide both moisture and cellulose, creating ideal termite feeding sites.

Higher-than-normal moisture readings in wall or timber elements indicate hidden moisture sources and increased susceptibility.

Recommendation: Connect the overflow to suitable stormwater drainage to divert water away from all structural elements.

Recommendation: Ensure AC overflow pipes are connected to appropriate stormwater drainage.

Recommendation: Install a drainage system or concrete plinth that directs runoff away from the structure.

Recommendation: Clean and maintain gutters and downpipes regularly.

Recommendation: Remove decaying stumps and avoid positioning garden beds directly against walls.

Recommendation: Investigate all sources of moisture and undertake immediate rectification.

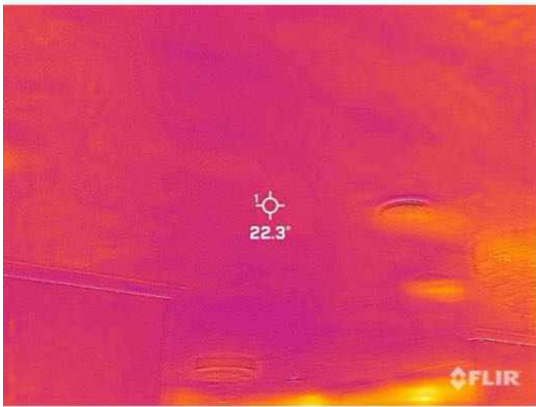
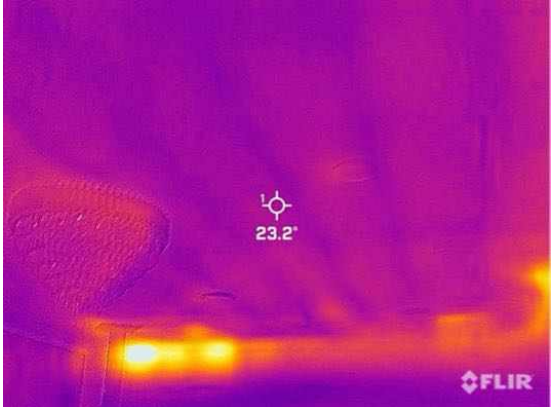
Building: Main Building
Location: All Areas
Finding: Additional Photos
Information: Thermal imaging camera was used to detect any active water leaks or/ and termite activities in the property. No water leaks or termite activities were found from inspection by thermal imaging camera. Additional photos are attached for general reference.
