Building and Timber Pest Inspection Report

Inspection Date: Tue, 7 Apr 2026

Property Address: 98 Baanya St, Wurtulla QLD 4575, Australia

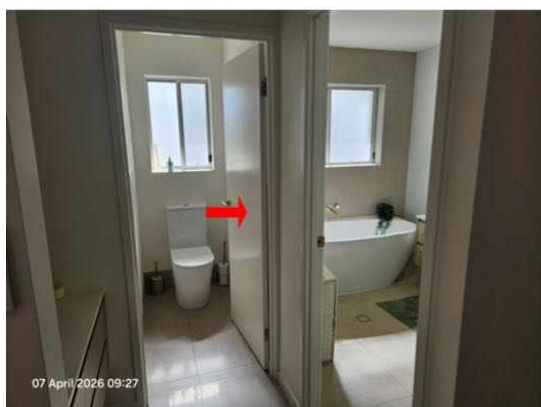
The BCA requires that the door to a fully enclosed sanitary compartment (WC or toilet) must either open outwards slide or be readily removable from the outside of the compartment. This requirement applies unless there is clear space of at least 1.2 m between the closet pan within the sanitary compartment and the nearest doorway.

The client could employ a licensed carpenter or suitably qualified handy person to replaced the hinges its compliant hardware.

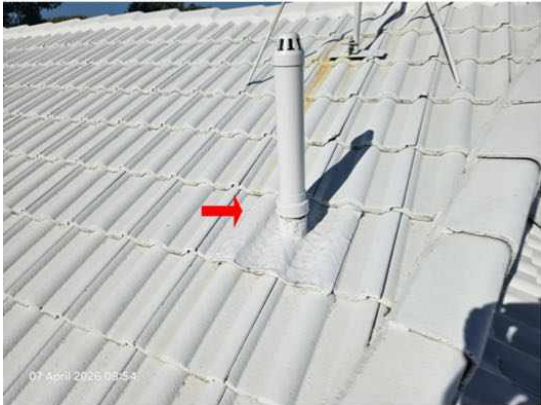
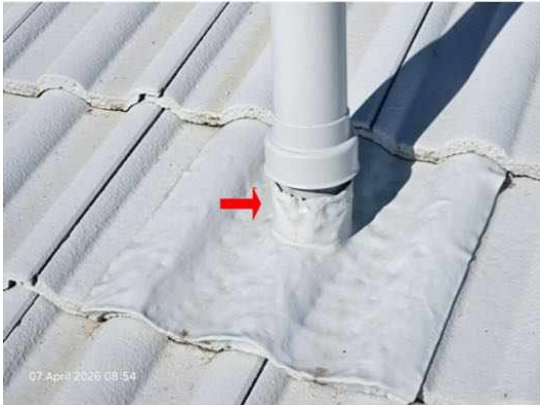
Finding 3.01

Building: Main Building
Location: As shown
Finding: Roof plumbing - vent pipe cap not sealed
Information: The flashing cap to the vent pipe was stuck above the lead flashing, exposing the opening of the lead against the pipe. This requires pushing down over the lead to provide an adequate seal for the pipe penetration.

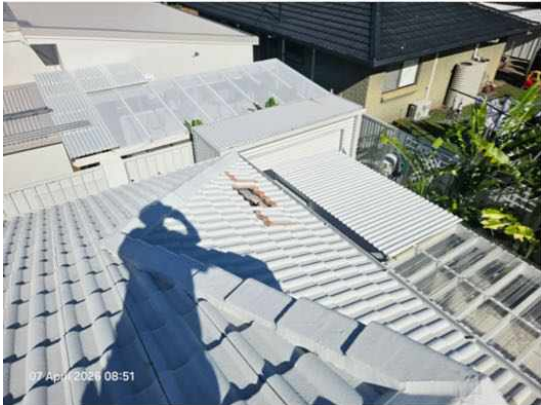
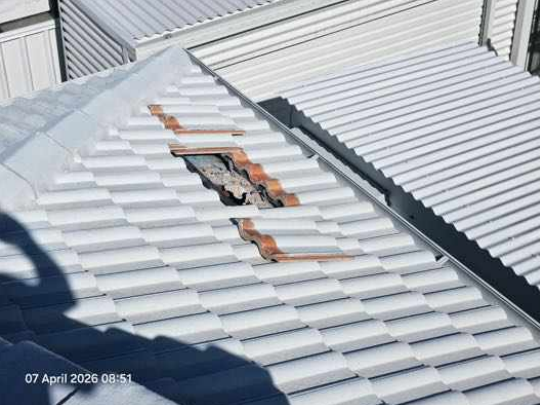
Finding 3.02

Building: Main Building
Location: As shown
Finding: Roof, opening in tiles
Information: During the inspection of the roof surface, it was noted that the roof had been opened to carry out work and was exposed on the day.

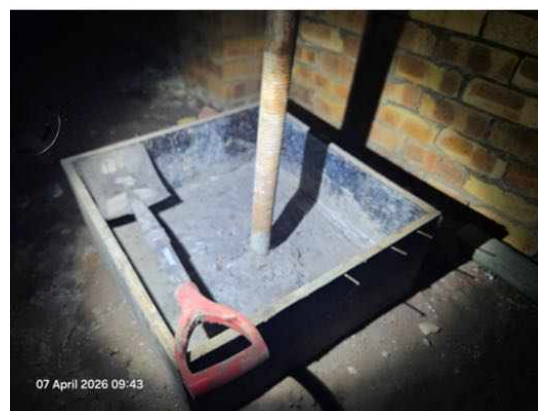
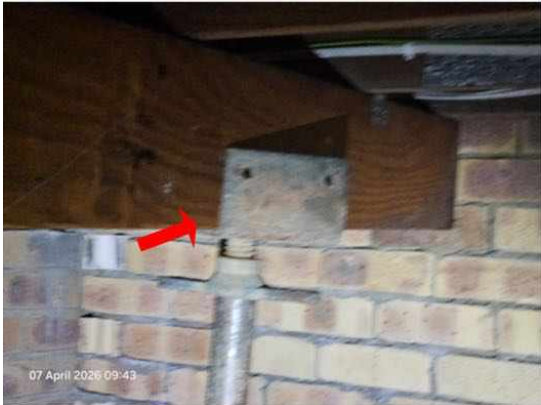
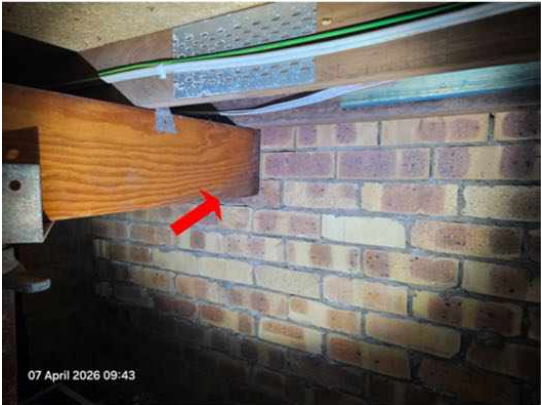
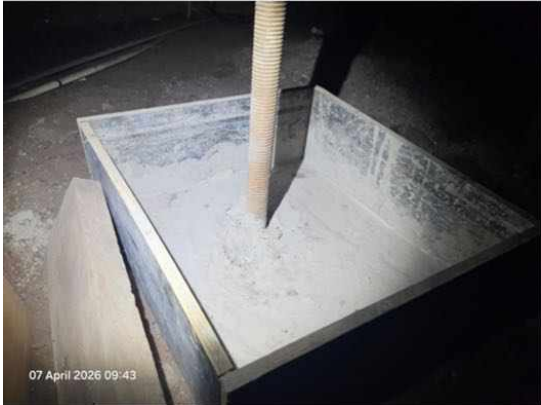
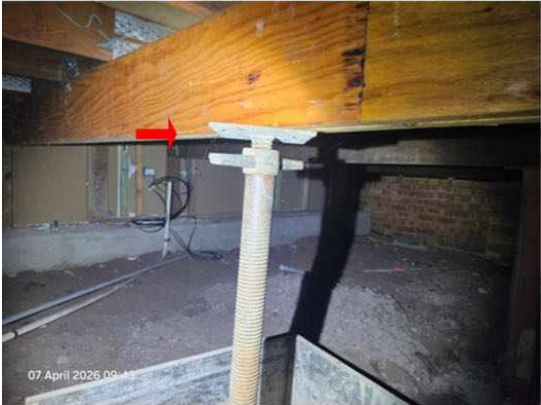
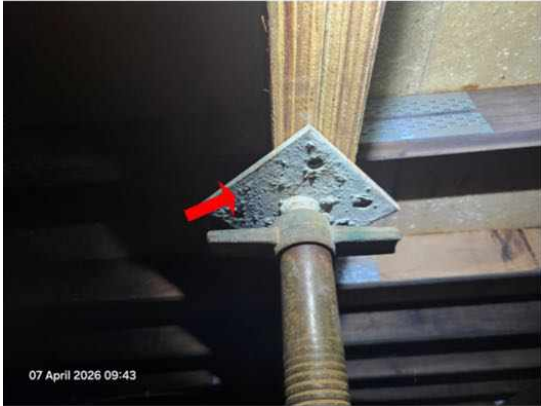
Finding 3.03

Building:	Main Building
Location:	As shown
Finding:	Subfloor, incomplete work, stumps / piers
Information:	During the inspection of the subfloor it was noted that two temporary props (acro props) and two insufficient timber props have been used during the construction of the subfloor structural framing.

As shown in the photos, it appears that the two temporary steel props are set up ready for the stumps / columns to be installed and the formwork is in place for the foundation pads. Two of the bearers are supported by undersized timbers, it is assumed that these are awaiting the stumps / columns to be fitted, and should be replaced by compliant sized timbers or steel columns.

A minor defect rating has been applied at this time; however, this has the potential to become a major defect if not rectified.

At the time of inspection the structure appears to sound and no movement was noted or observed. These works should be completed by a licensed carpenter or builder in the short term.

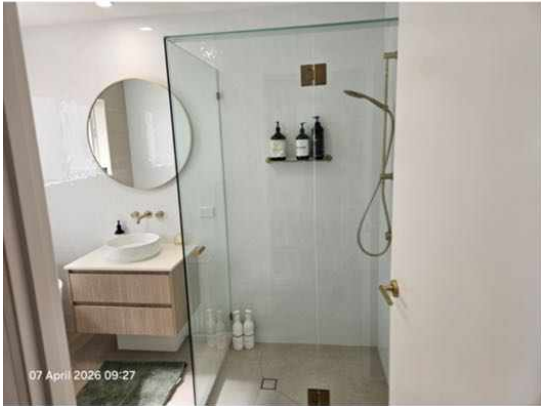
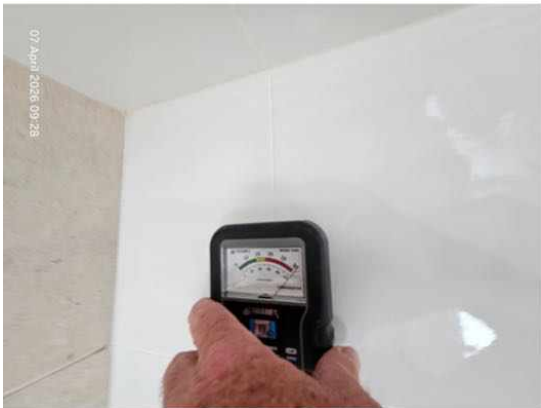
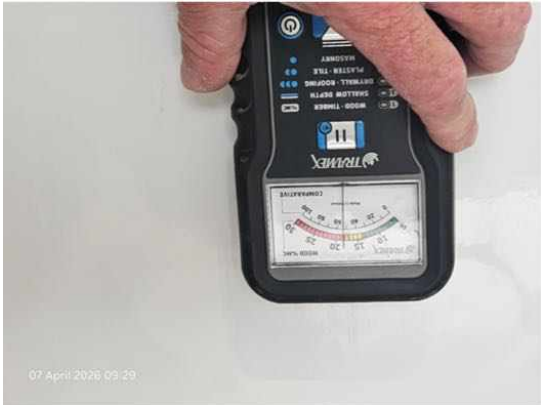
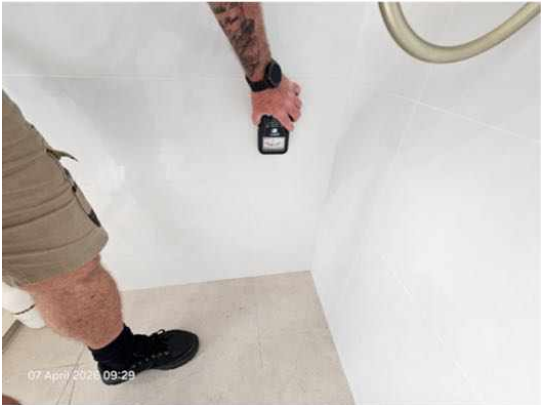
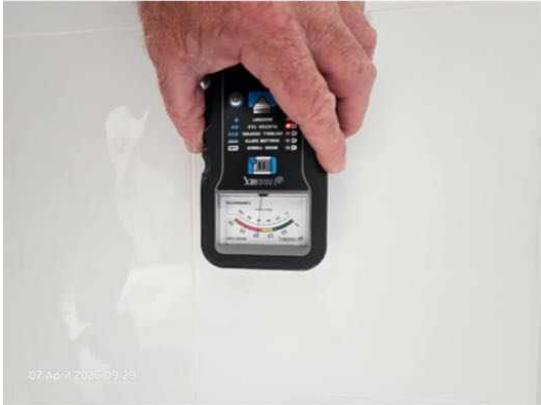
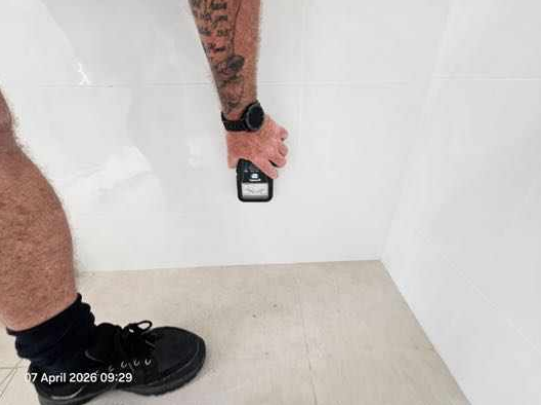
Finding 3.04

Building:	Main Building
Location:	Bathroom, house
Finding:	Elevated moisture present at the time of inspection - bathroom
Information:	Elevated moisture was noted in the lower tiled wall surfaces of the bathroom shower.

The levels varied at differing points throughout the recess. This could possibly be due to deteriorated grout and silicone sealants and / or plumbing fittings and fixtures. The grouts and sealants can break down over time and become porous, allowing moisture to enter the wall sheet surface behind the tiles. Although no obvious grout defects could be seen careful monitoring of the tile surface and checking of the fittings for adequate sealing is strongly advised.

Plumbing, and shower fittings and fixtures, can be areas of water penetration if not installed correctly and sealed completely. Whenever a fitting is screwed / fitted to the tiled shower walls , the holes and fittings should be sealed with an appropriate sealant to prevent water from entering the wall cavity. This is a common fault. A moisture reading was noted directly beneath the cold tap, checking the silicone seal at the penetration is recommended.

Elevated moisture can attract timber pests and vermin, and produce conditions that promote timber pest attack, fungal growth and wood decay.

It is recommended that the moisture levels in these areas be monitored over time and the grout and silicone could be renewed, if visible signs of elevated moisture are noted, to possibly eliminate any further moisture penetration.

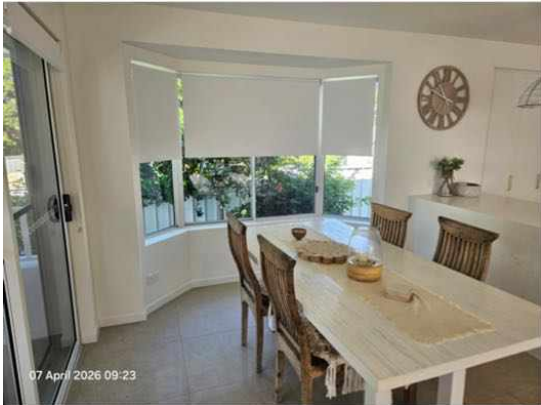
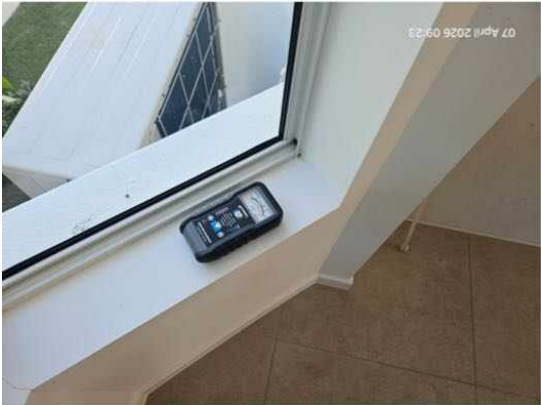
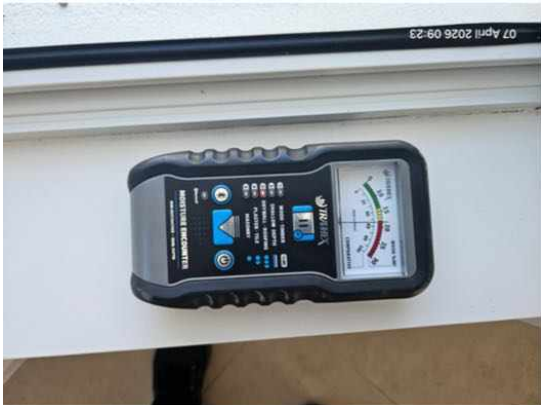
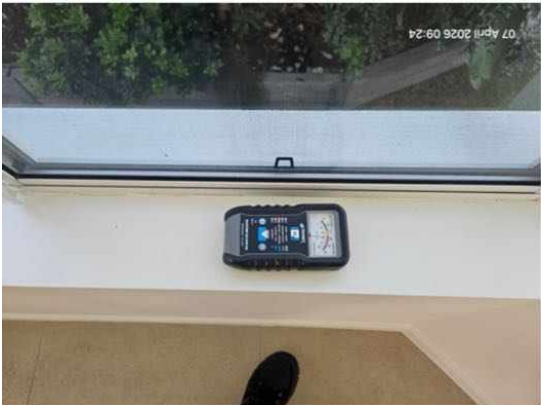
Finding 3.05

Building: Main Building
Location: Bedroom 2, dining
Finding: Window sill / reveal moisture
Information: During the inspection minor moisture readings were noted in the plastered reveals of the windows shown.

Damage is isolated to the bottom sills and internal corners, which would indicate that moisture may be entering through the joint between the bottom aluminium profile and the rendered sill. Alternatively, it may be due to the windows being left open for extended periods and sea air and rain moisture having an effect. Bay windows do experience this issue more often than standard windows, possibly due to the increased exposure of the window surface externally.

This should be monitored and there is a change in the reveal appearance, a licensed plasterer or painter should be engaged to carry out the necessary repairs.

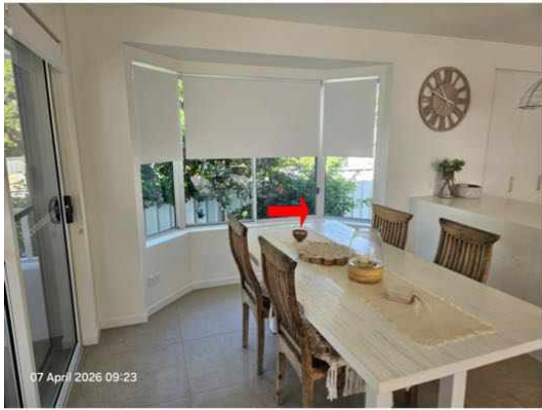
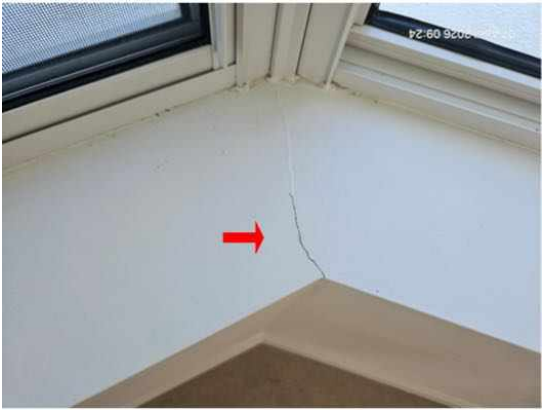
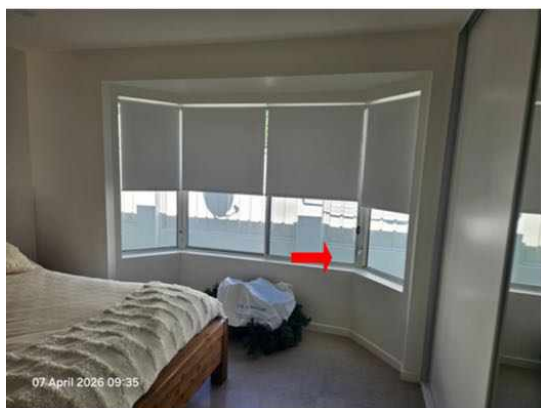
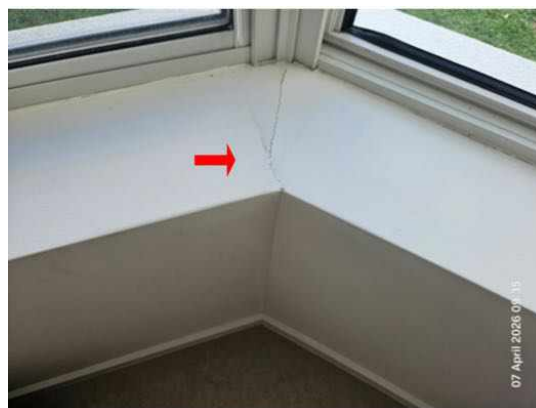
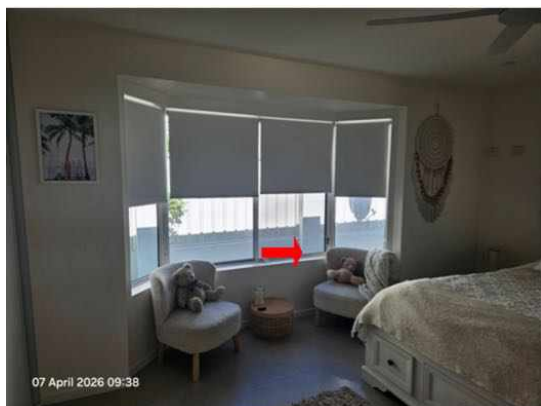
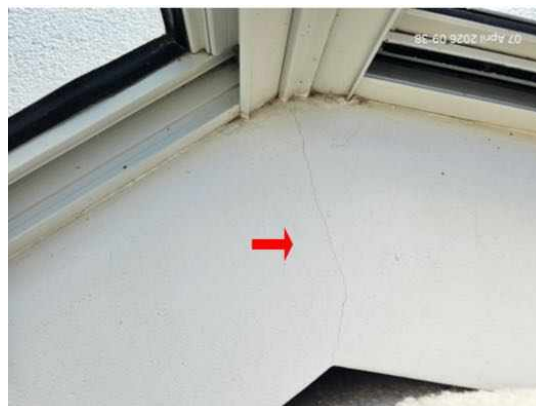
Building: Main Building
 Location: As shown
 Finding: Minor movement cracking
 Information: Minor movement cracking to the window reveals shown was observed at the time of the inspection.

Cracking of this nature is expected in this type of building and it appears to be associated with movement of the building elements. Should there be further greater movement, always contact a structural engineer or a licensed builder.

The fine but visible cracks can be patched and painted over by an experienced painter or handyman at the clients discretion.

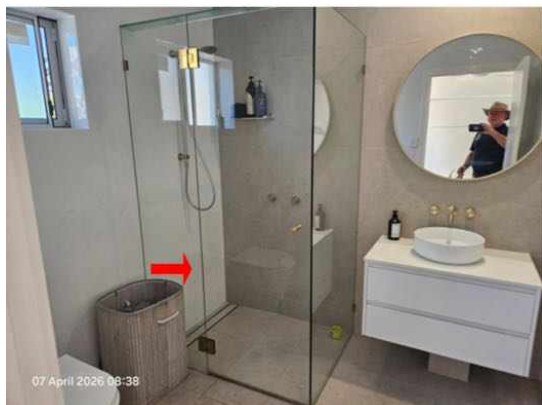
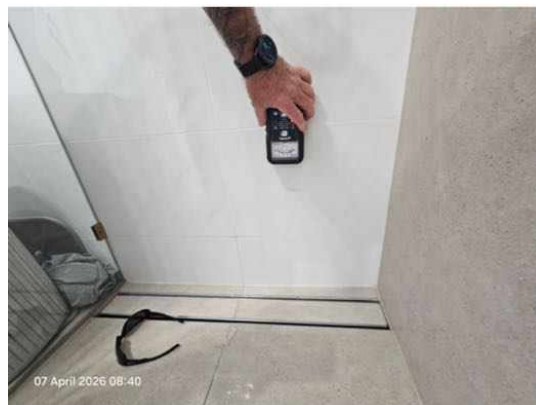
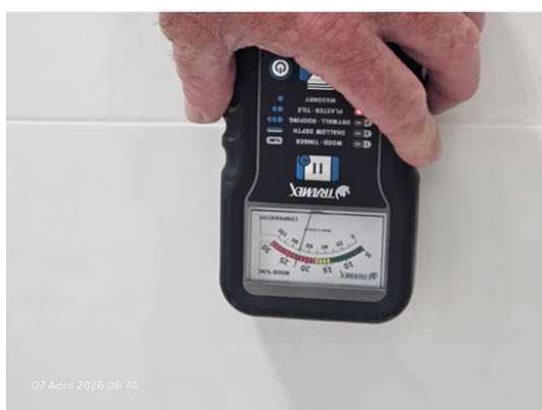
Finding 3.07

Building:	Out Building
Location:	Granny Flat, ensuite
Finding:	Elevated moisture present - granny flat ensuite shower
Information:	Elevated moisture was noted in a small area of the tiled wall surface of the granny flat ensuite shower.

This could possibly be due to deteriorated grout and silicone sealants and / or plumbing fittings and fixtures. The grouts and sealants can break down over time and become porous, allowing moisture to enter the wall sheet surface behind the tiles.

Elevated moisture can attract timber pests and vermin, and produce conditions that promote timber pest attack, fungal growth and wood decay.

It is recommended that the moisture levels in these areas be monitored over time and the grout and silicone could be renewed to possibly eliminate any further moisture penetration.

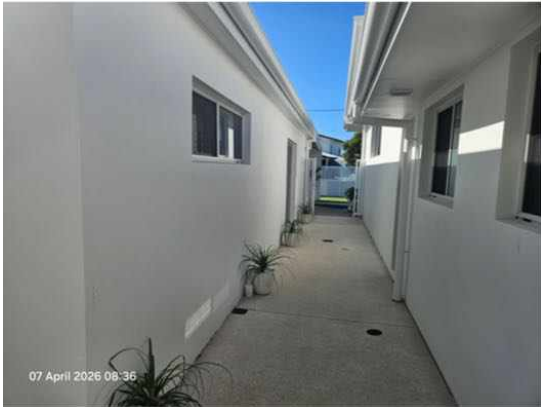
Where a Termite Management System has been identified you should refer to the type of barrier date of installation warranty conditions and any documentation provided by a builder or past owner. Consult the company who installed the barrier to confirm whether the system is still under warranty.

It is recommended that a licensed pest controller be consulted and a system proposal sought.

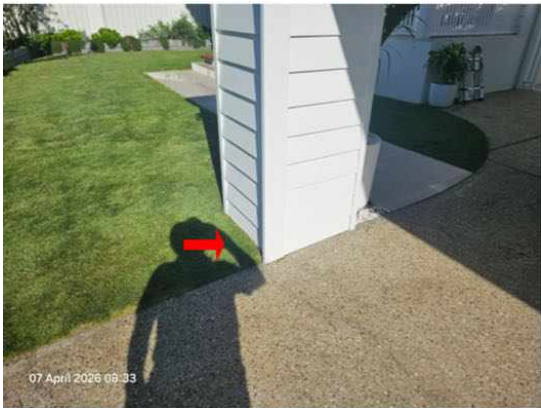
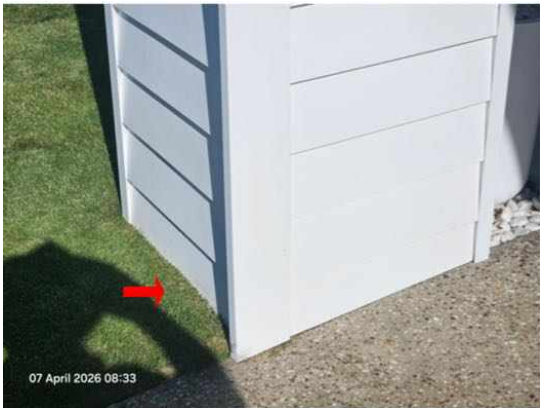
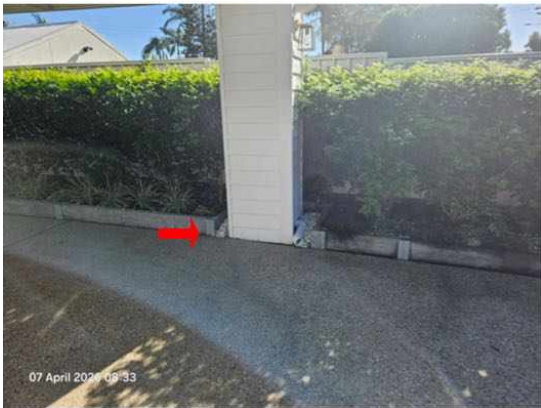
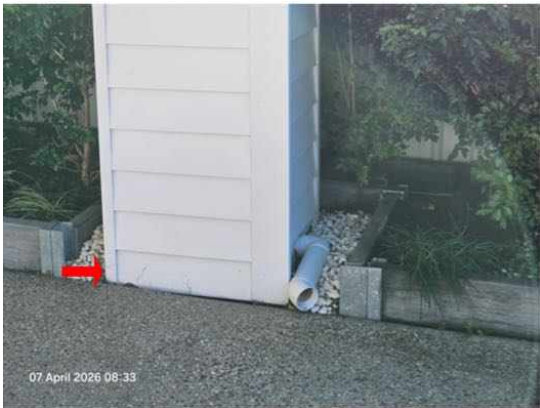
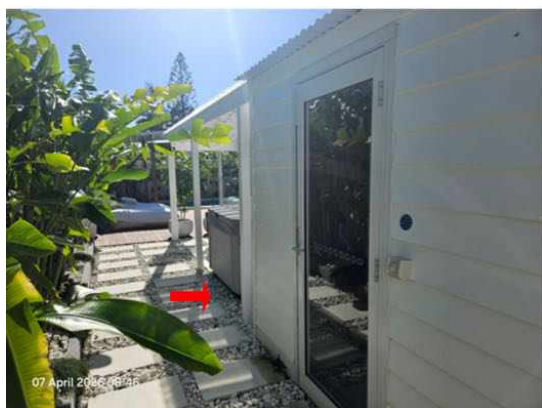
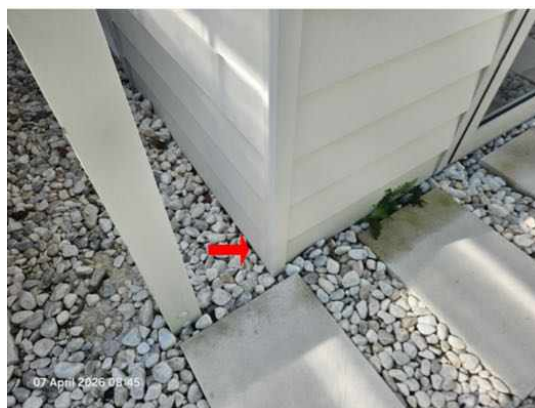
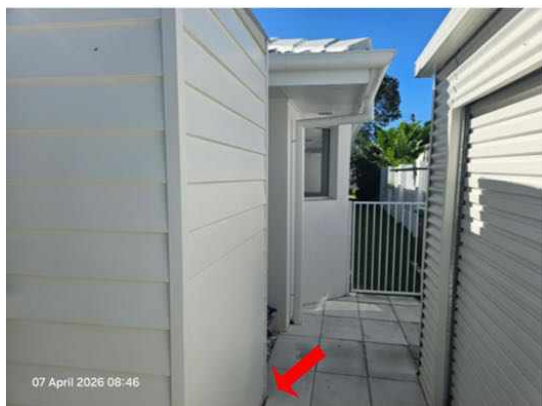
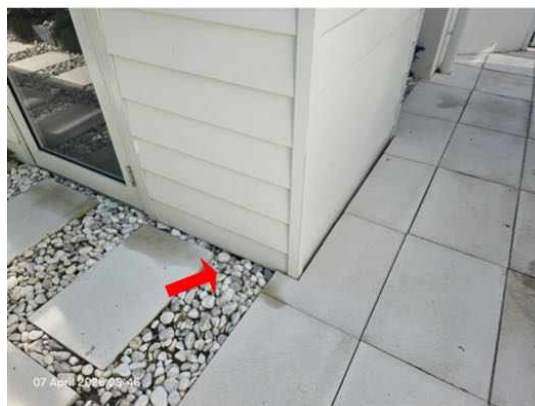
Finding 6.02

Shown in the photos are the weather boards in contact with the ground. The pest barrier system plan was not available for viewing on the day of inspection and; therefore the a system type, if used, was not able to be noted.

Where bridging has occurred full inspection is prevented and termites may enter a property in a concealed or undetectable manner.

It is recommend that the client consult with the builder and the pest controller to ascertain the type and installation of the system to ensure coverage.

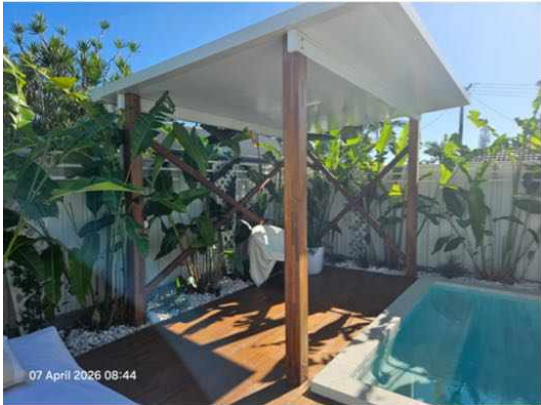
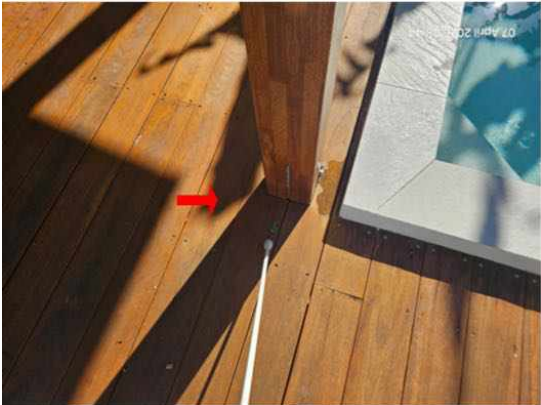
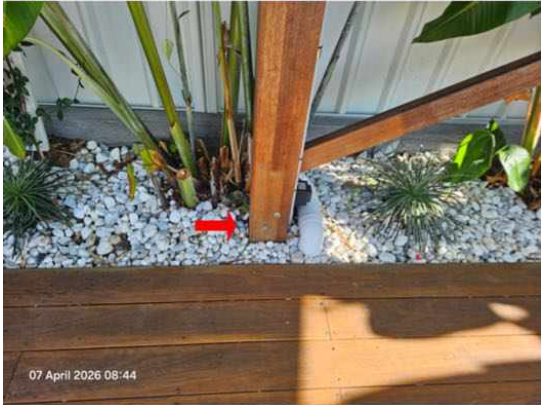
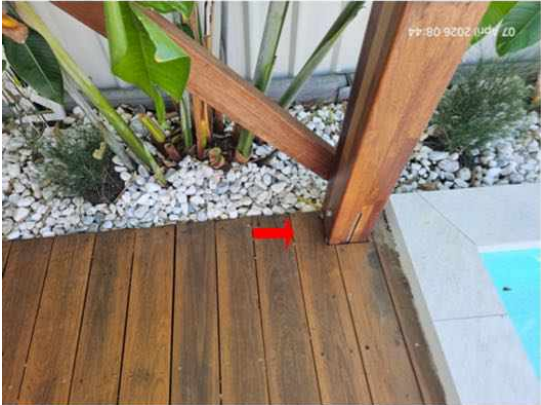
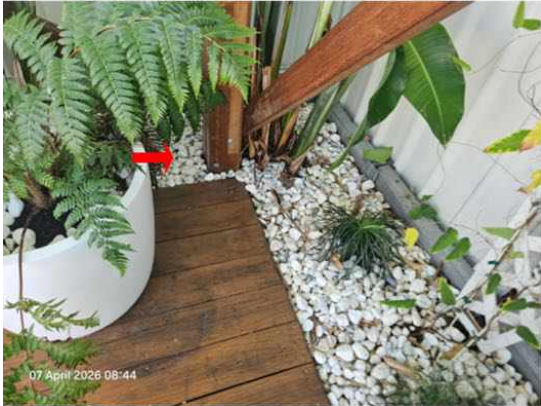
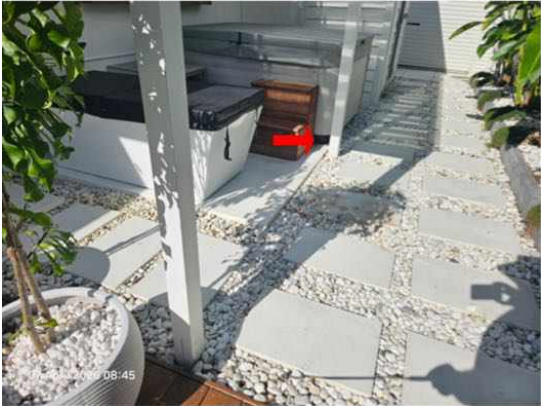
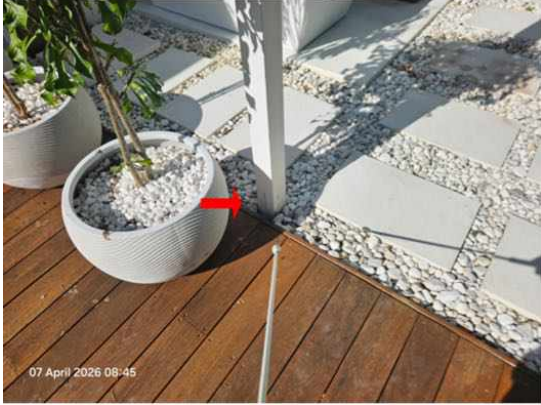
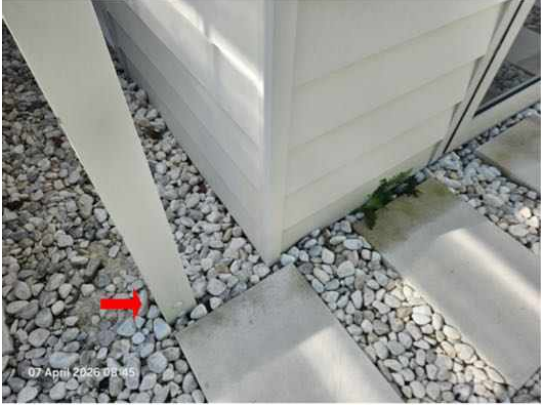
Finding 6.03

Building:	Main Building
Location:	Gazebo, pergola
Finding:	Timber contact with ground - posts
Information:	It was noted during inspection, that the timber post supports of the pool gazebo and the spa area pergola are in contact with the ground and do not have sufficient clearance to provide and adequate inspection zone.

These could be a possible entry point for timber pests.

The soil and debris should be cleared away from the base of all timber structural members to provide clear visible access to view the post bases. Alternatively, these areas would require regular inspections.

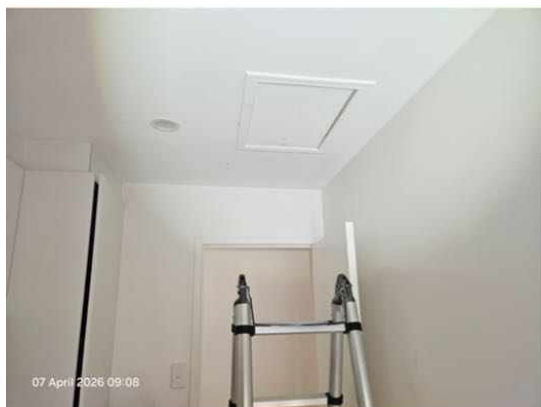
Normally accessing a roof space via diminishing truss roof framing can be challenging; however, when services such as air conditioning ducting are run near the available opening, it can make it unsafe or impractical to attempt to traffic the framing.

Only a visual inspection from the garage ceiling and the immediate area of the house ceiling space was possible. Should a full inspection be desired, an alternative ceiling access may have to be installed to provide unhindered access to the balance of the roof void.

Please rebook an inspection if desired when access is clear. No issues were observed at the time of inspection.

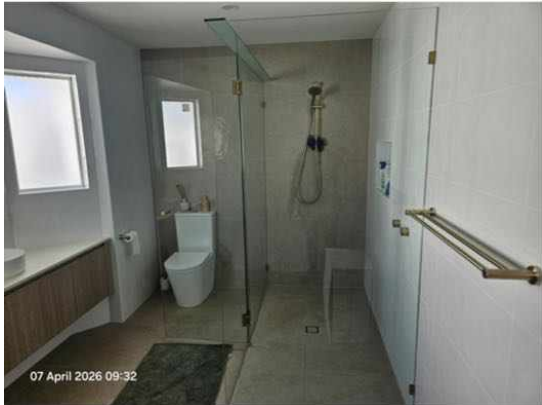
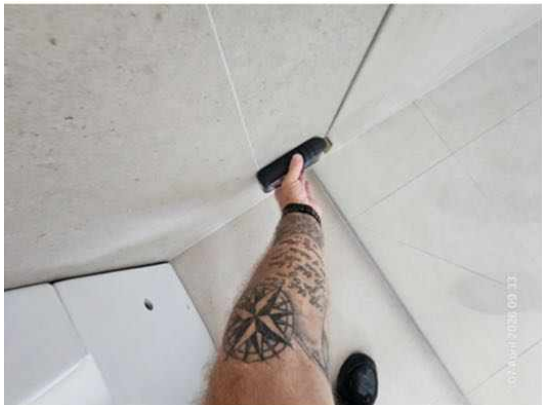
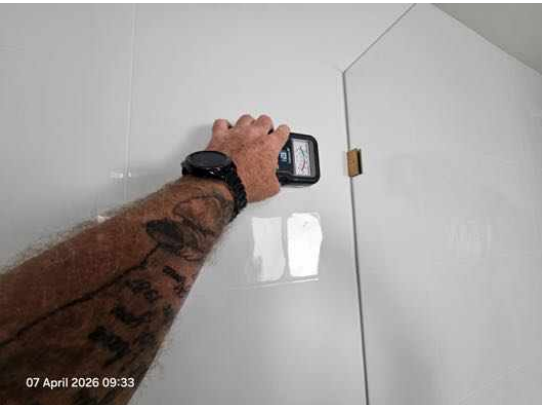
Building: Main Building
Location: Ensuite - Master
Finding: No moisture detected in ensuite
Information: On the day of inspection the shower in the ensuite was measured for moisture using a "Tramex" moisture meter. During this inspection no moisture was detected in these areas and the tiled / sheeted surfaces appear to be in good order.

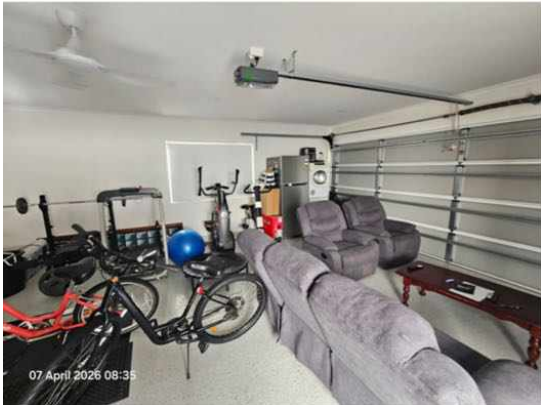
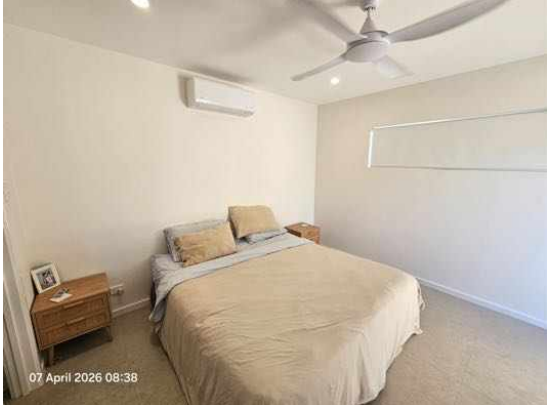
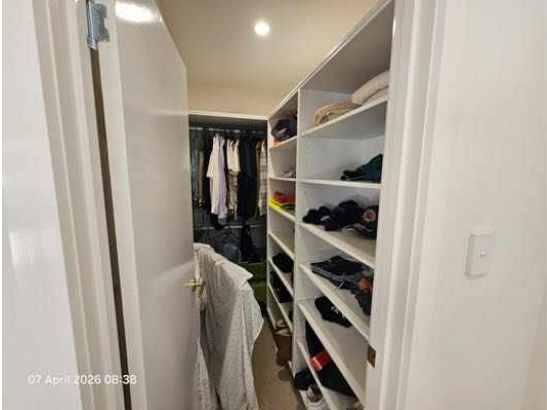
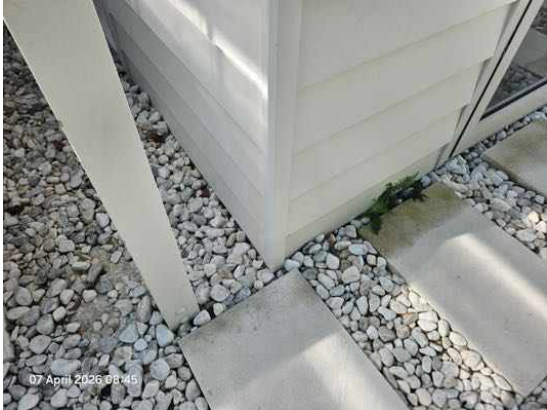
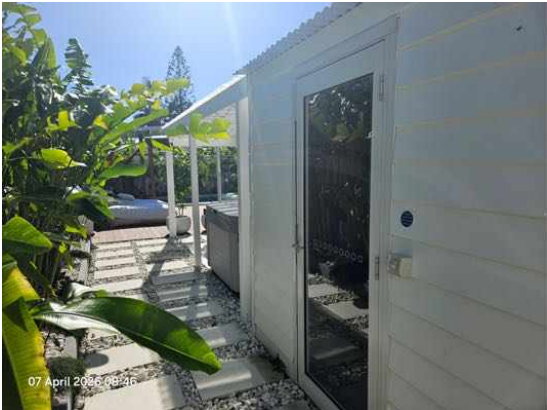
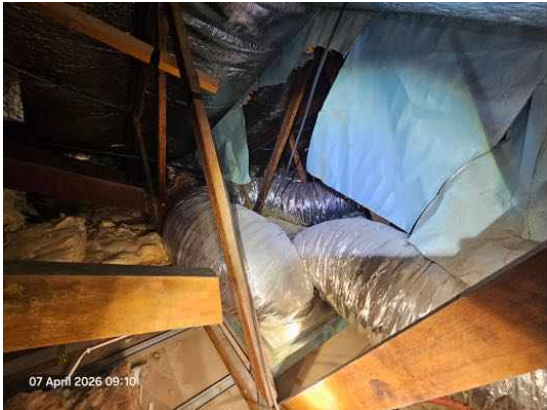
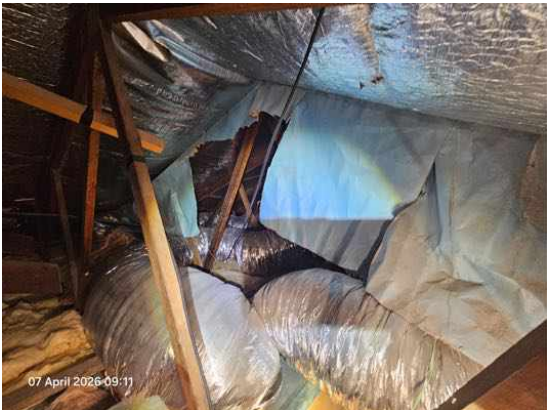
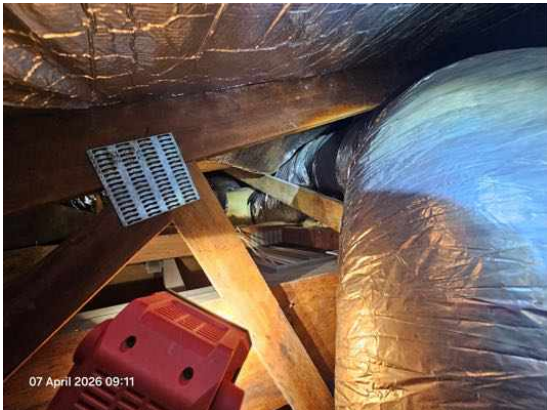
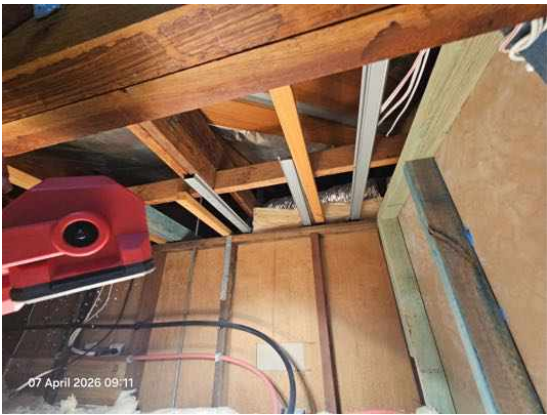
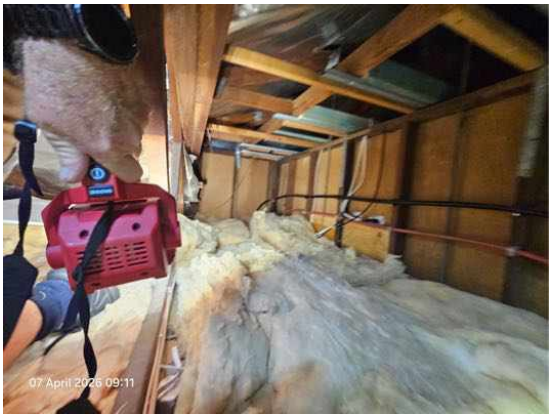
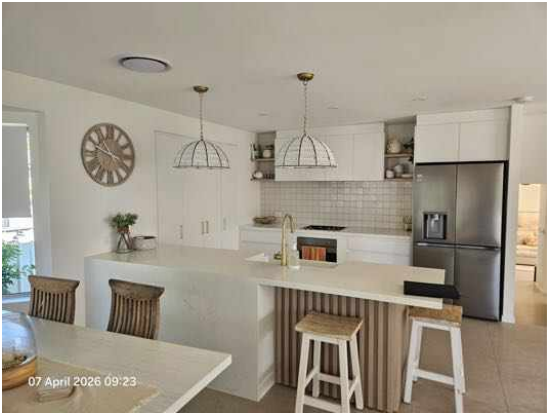
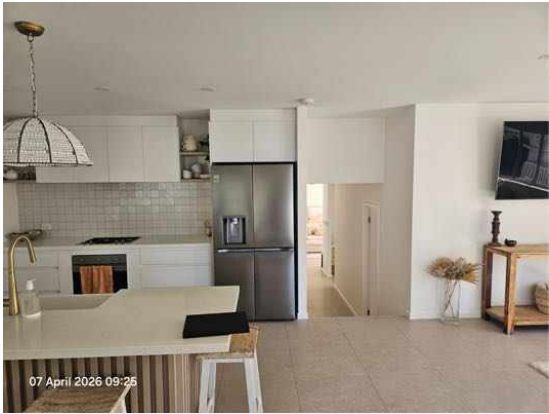
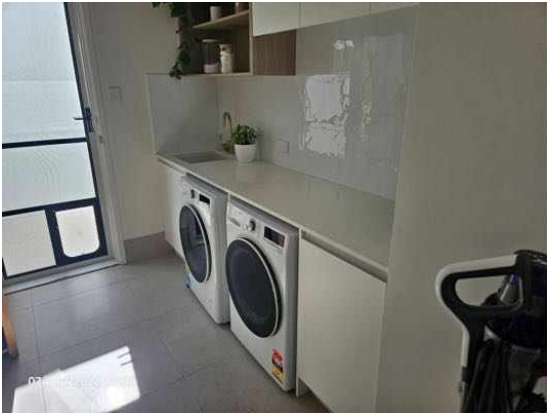
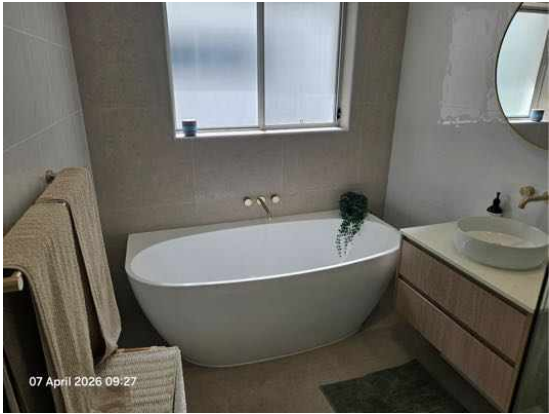
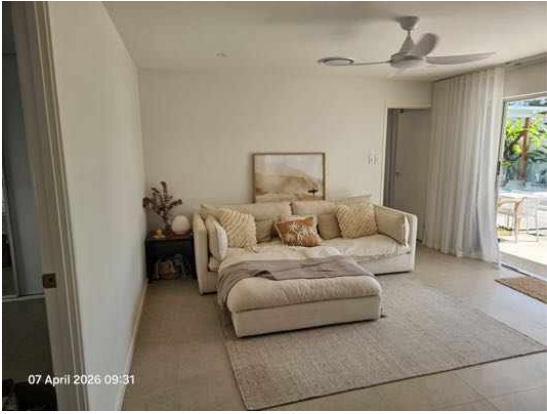
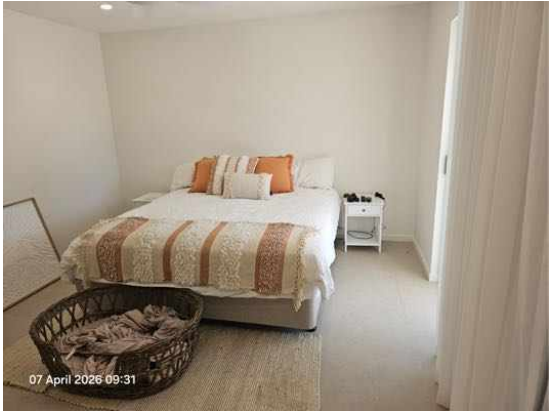
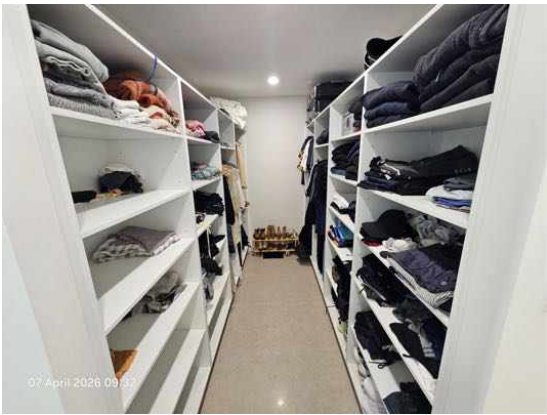
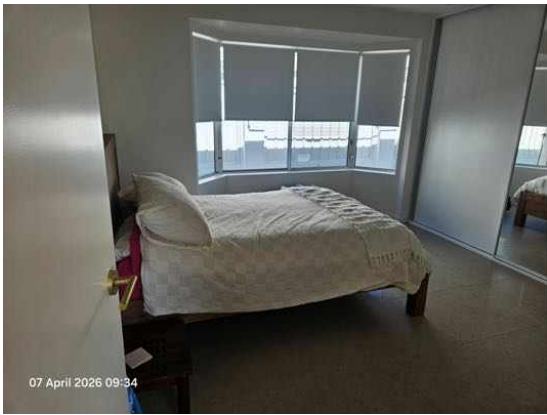
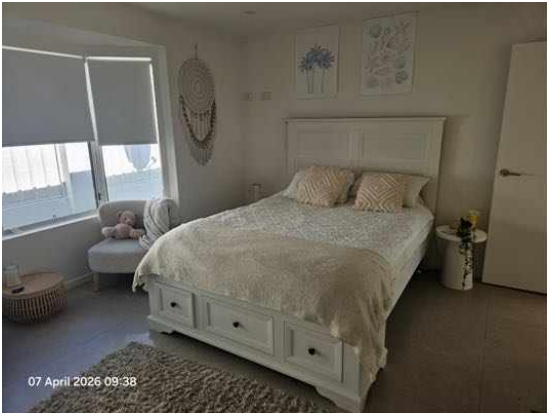
Building: Main Building
 Location: All Areas
 Finding: Additional Photos - Obstructions and Limitations
 Information: These photographs are an indication of the obstructions and limitations which impeded full inspection of the property at the time of inspection. These obstructions can prevent full inspections of the areas shown.
