Building and Timber Pest Inspection Report

Inspection Date: Tue, 7 Apr 2026

Property Address: 98 Baanya St, Wurtulla QLD 4575, Australia

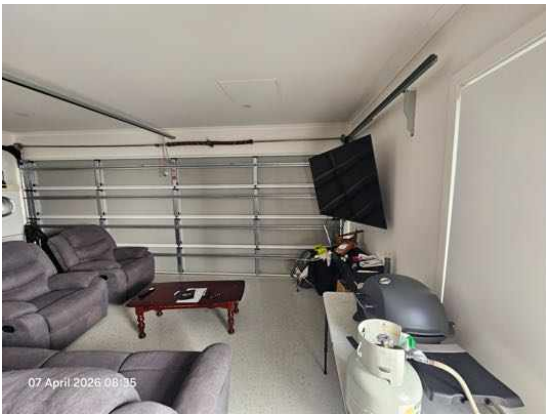
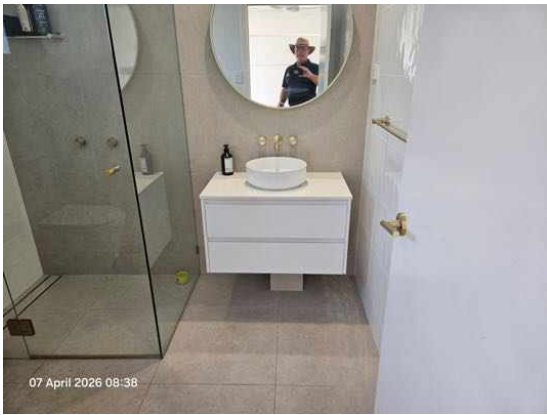
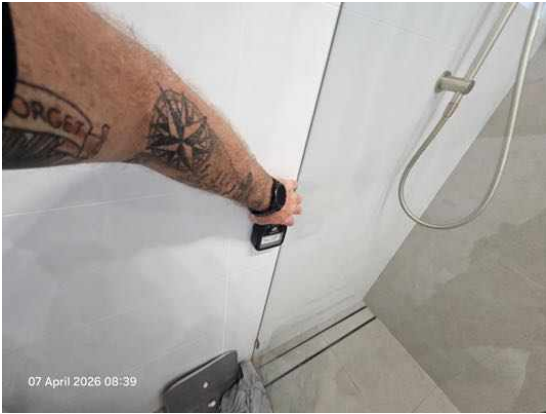
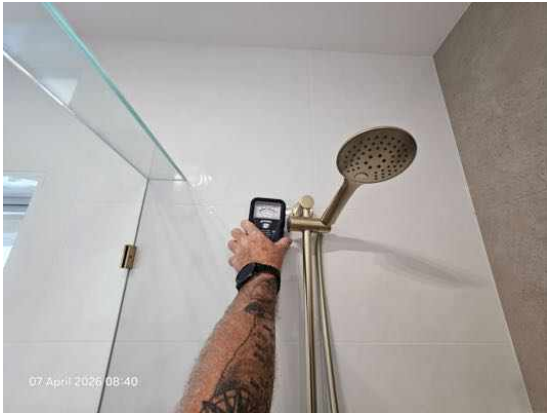
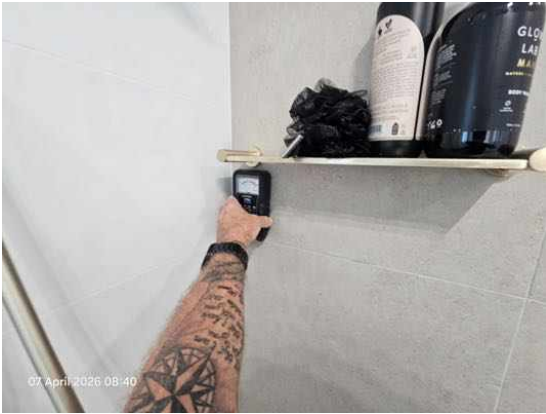
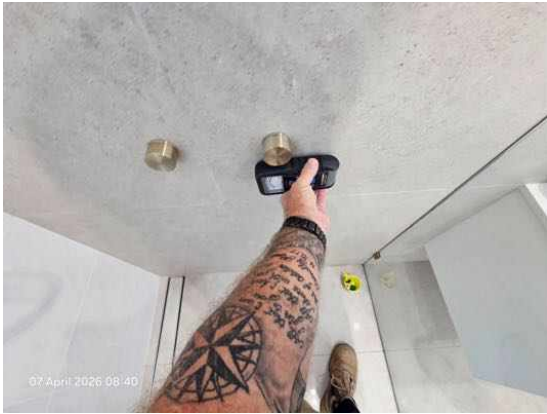
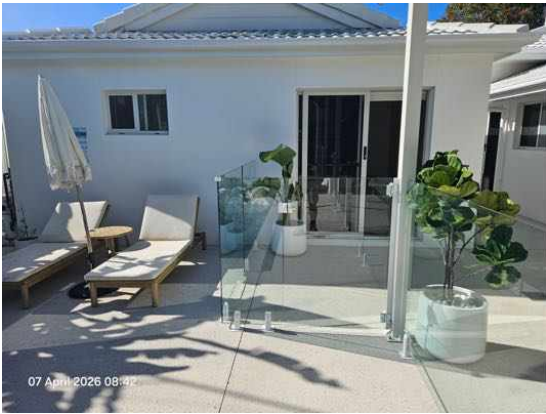
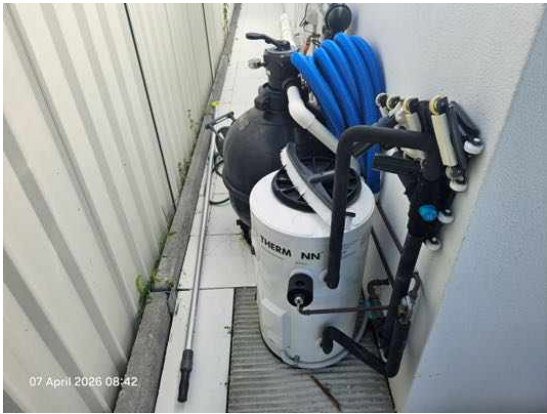
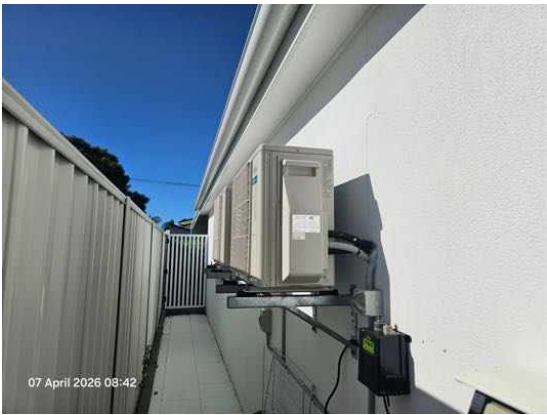
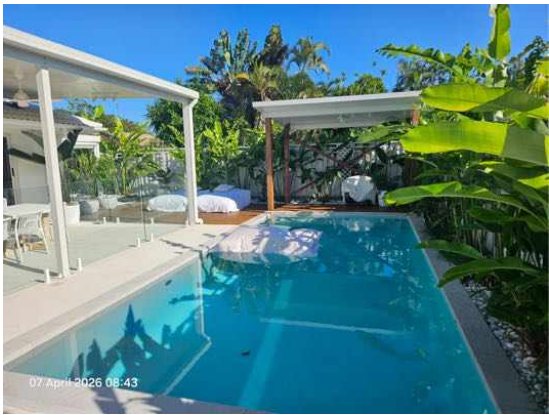
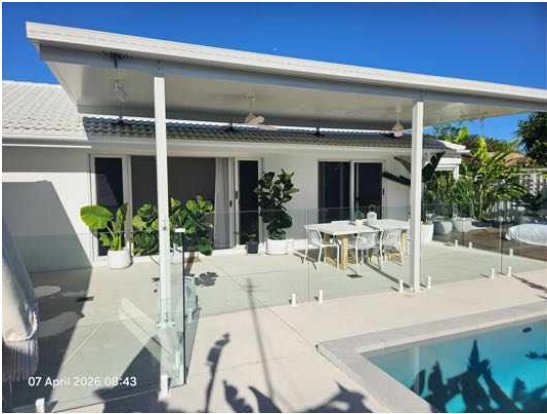
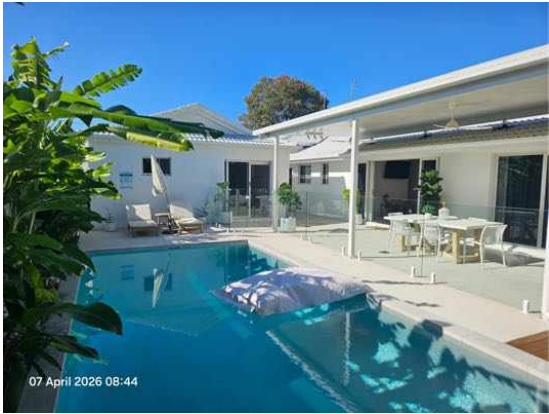
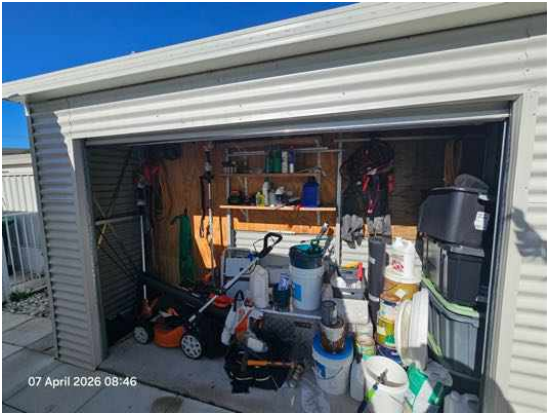
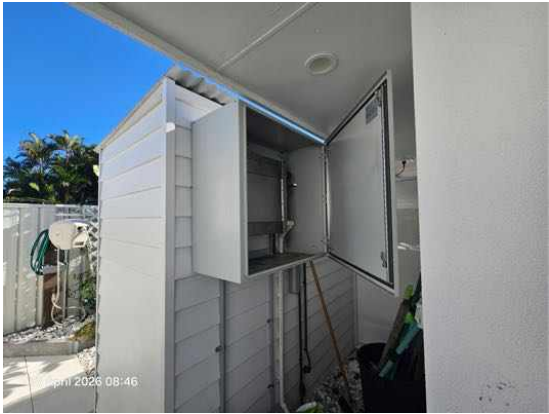
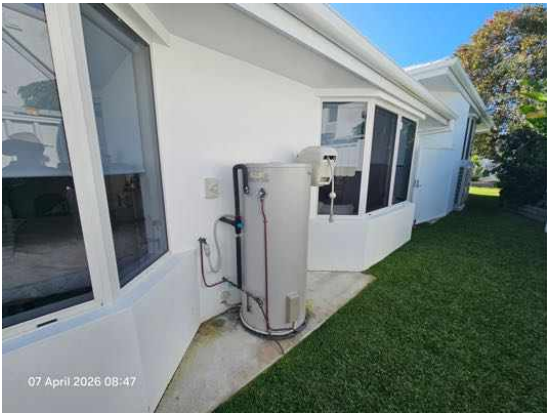
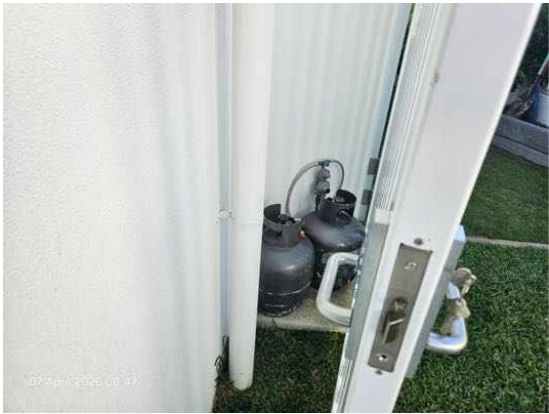
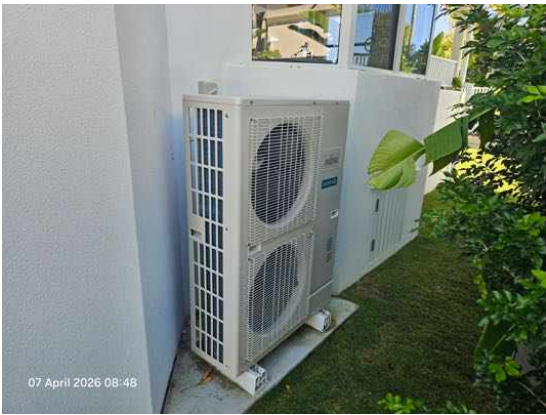
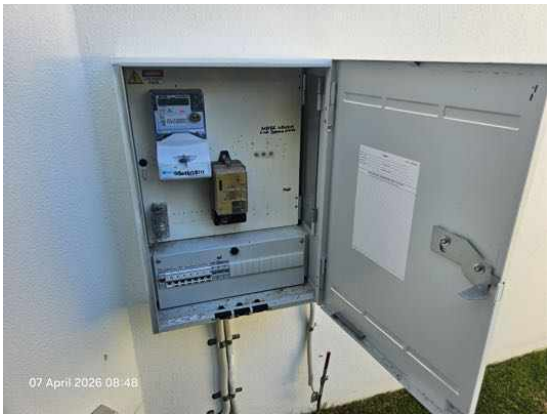
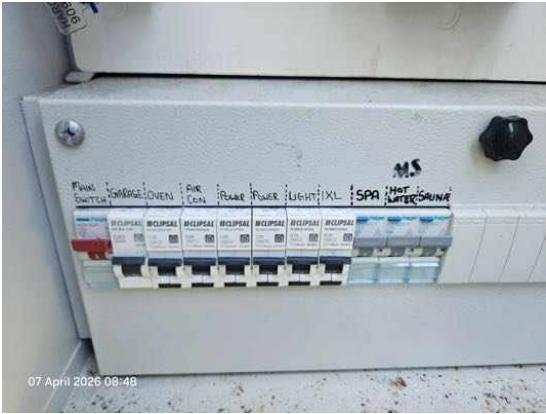
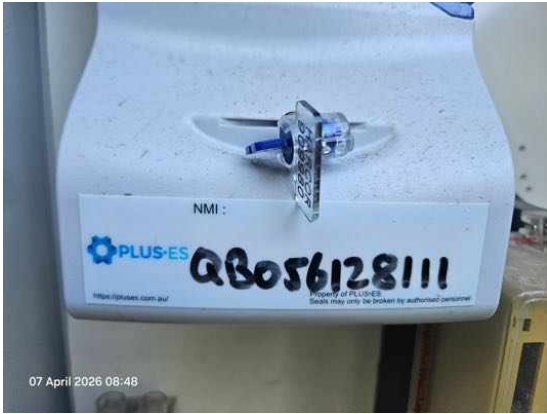
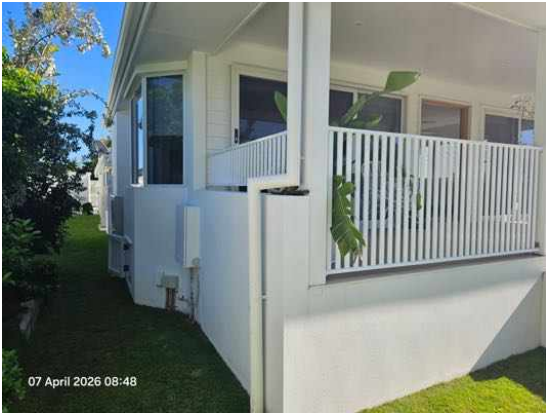
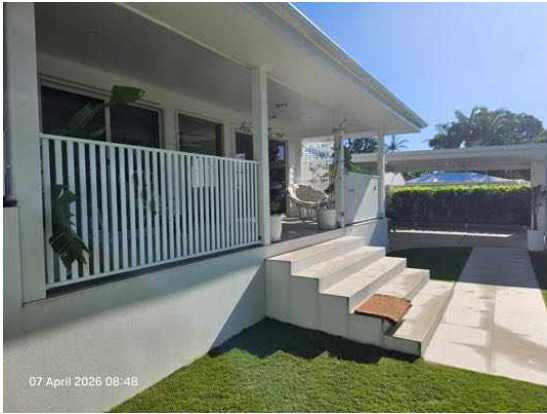
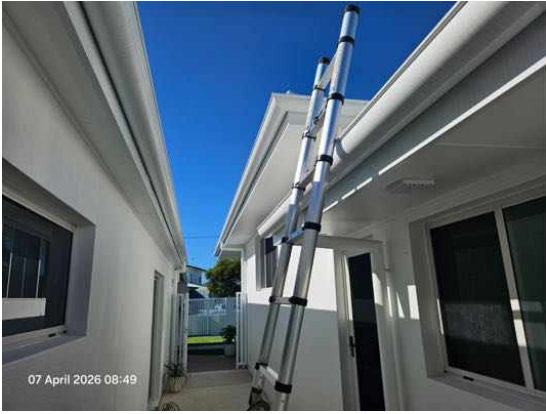
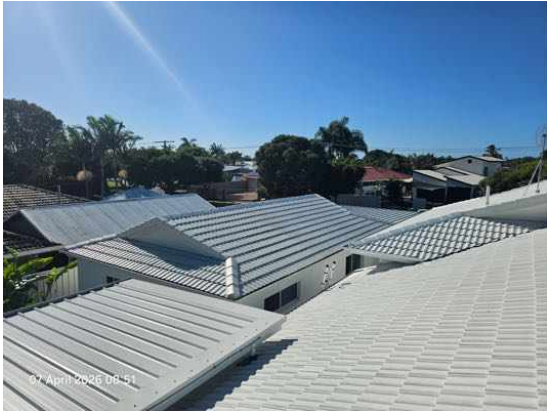
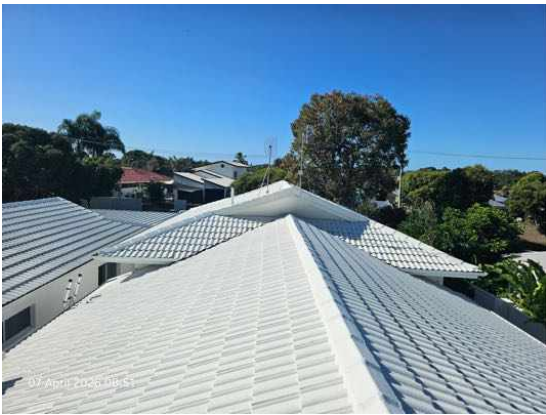
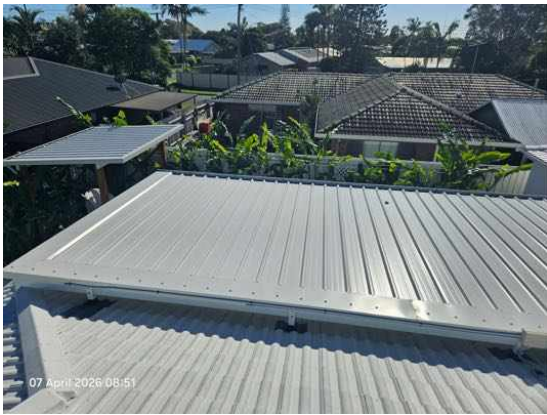
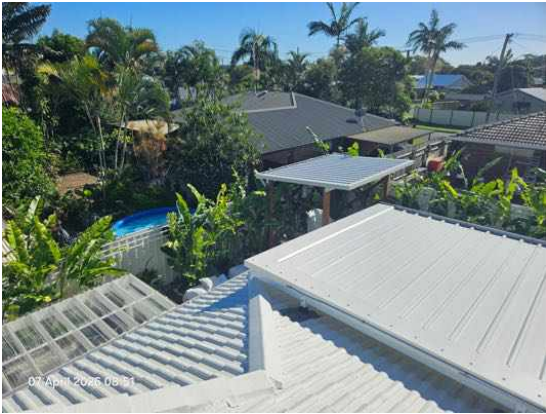
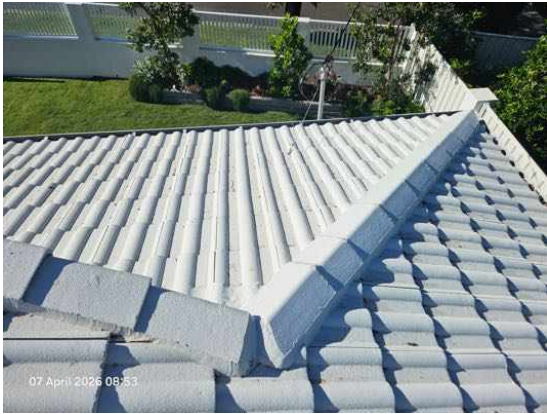
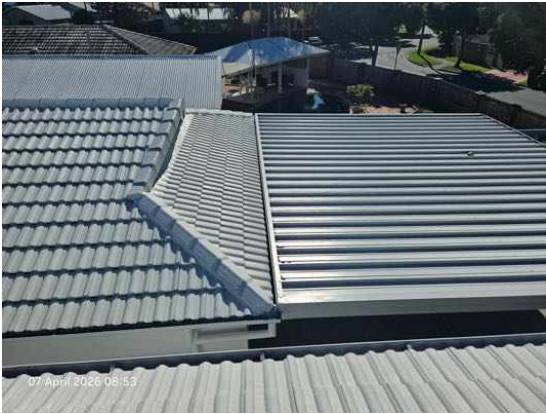
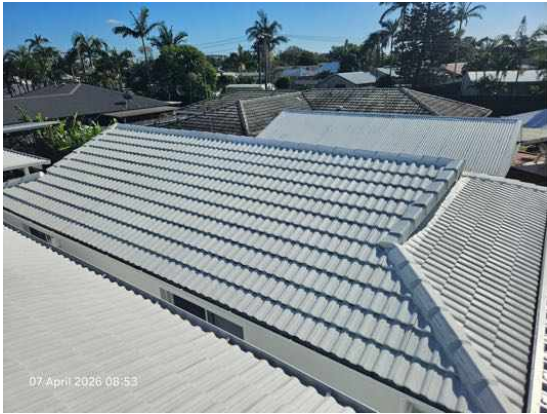
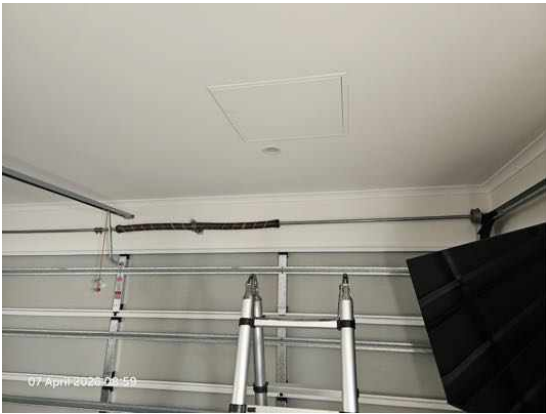
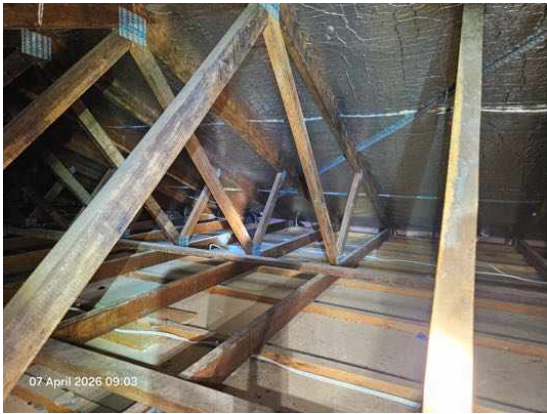
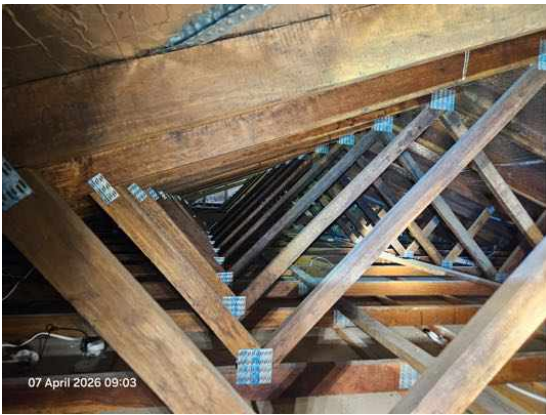
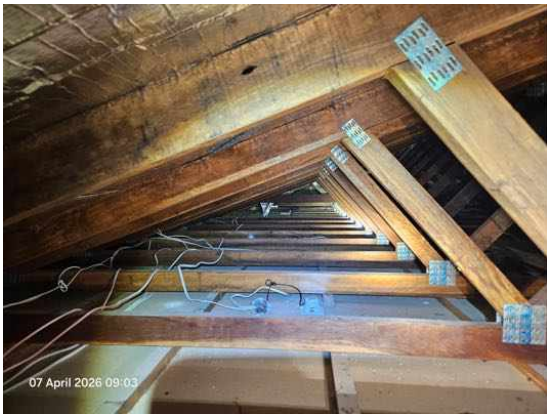
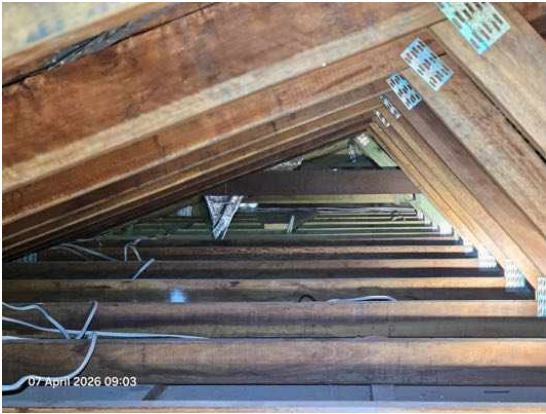
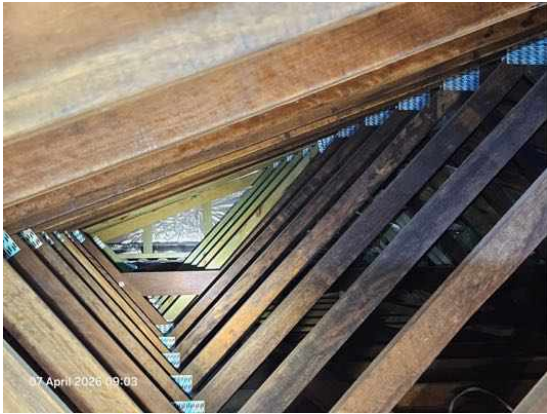
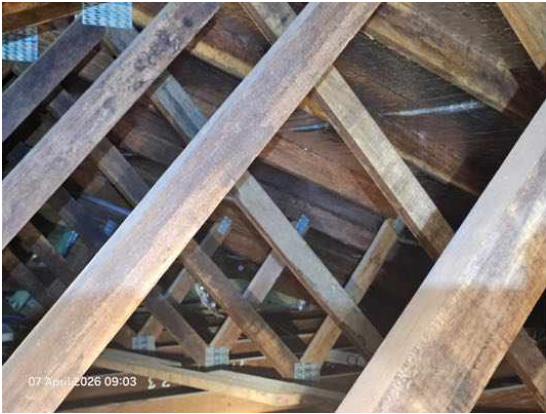
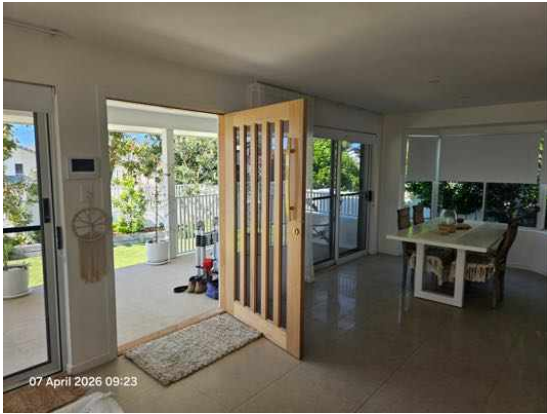
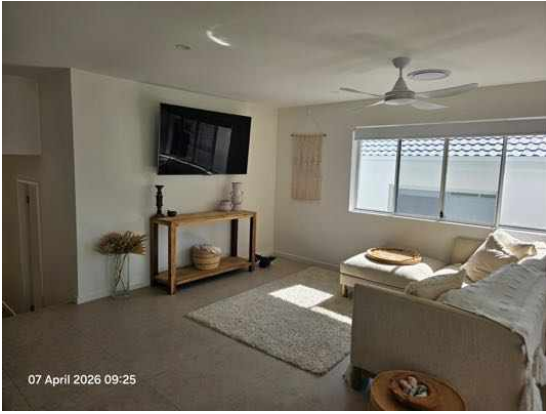
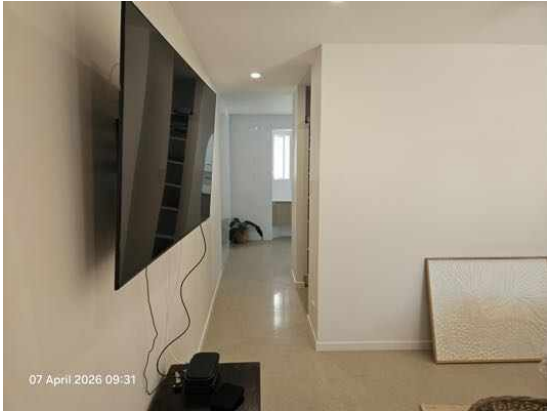
Building: Main Building
Location: All Areas
Finding: Additional Photos for client reference
Information: Additional photos are provided for your general reference.

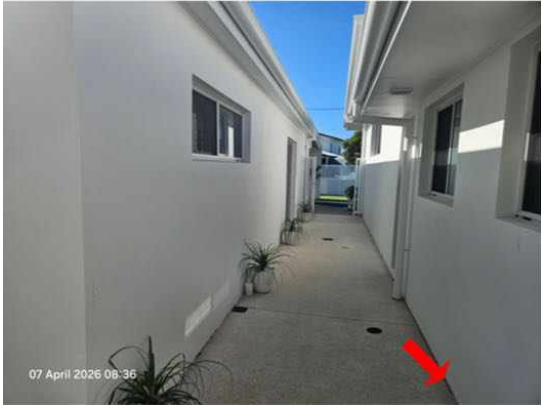
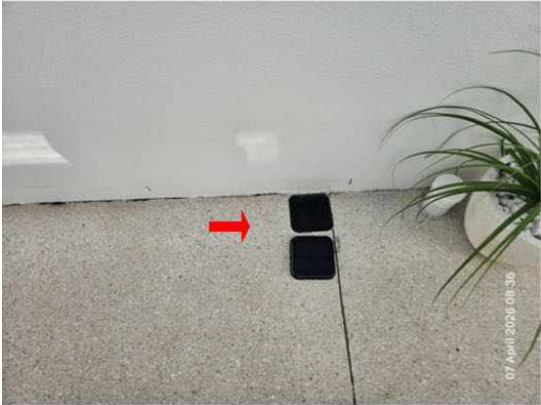
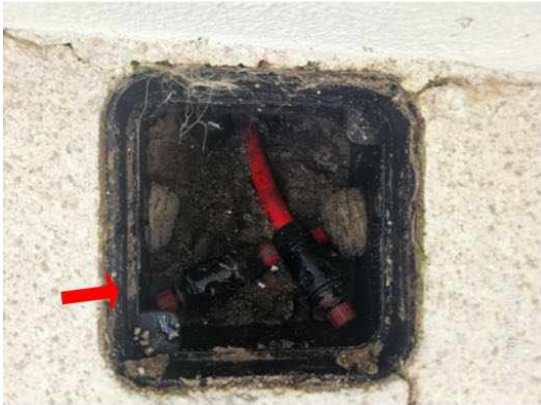
Noted Item

The building employs a physical barrier system to the perimeter and slab penetrations. In order for a barrier system to be effective, the property must have regular inspections at intervals of not greater than 12 months. Depending on the risk profile attributed to the property, these inspections may be recommended at lesser time periods.

programme is strongly advised.
