# Building and Timber Pest Inspection Report

Inspection Date: Wed, 14 Jan 2026

Property Address: 54B Hillier Rd, Evanston SA 5116, Australia

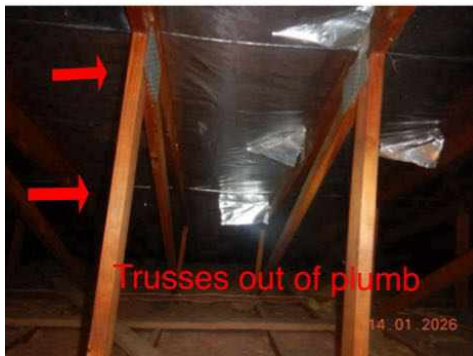
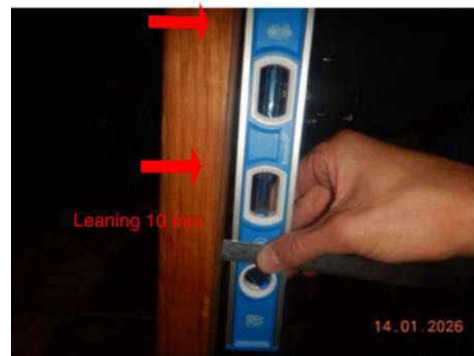
Building: Main Building  
Location: Roof Void  
Finding: Roof Trusses - Leaning  
Information: Roof trusses were observed to be leaning out of their intended vertical alignment.

This condition is indicative of inadequate temporary or permanent bracing, restraint, or fixing, either from original build date or that conditions have changed and movement has occurred which may compromise the structural performance and stability of the roof system.

Leaning trusses can result in uneven load distribution and increase the risk of further movement under wind or service loads.

The roof trusses should be assessed by a structural engineer and should repairs be required they should be carried out by licensed trades people.

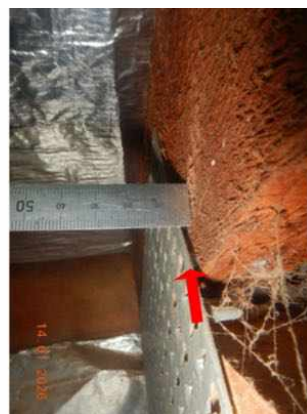
## Finding 2.02

This could be due to one or more of several reasons including faulty, nail plates, varying moisture levels, and slight movement of timber elements. Secondary defects can be created, ranging from damage to ceiling linings through to structural failure.

The back out appears to be minimal to the majority of plates and as such, repair is certainly possible.

A structural engineer would be required to provide recommendations to be carried out by a licensed builder ASAP to prevent any further deterioration and to prevent a hazard being created.

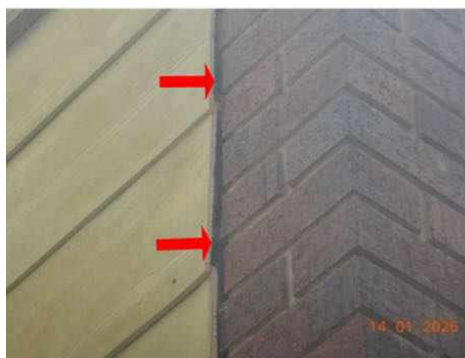
Building:	Main Building
Location:	Roof Exterior
Finding:	Timber Cladding Not Weather-Sealed
Information:	It was found at the time of inspection that the timber cladding to the rear of the dwelling has not been adequately weather-sealed.

The absence of appropriate sealing increases the risk of moisture or pest ingress, which may lead to timber deterioration, mould growth, and damage to the underlying wall framing and building fabric.

A qualified carpenter or cladding contractor should assess the affected areas and apply appropriate weather-sealing measures

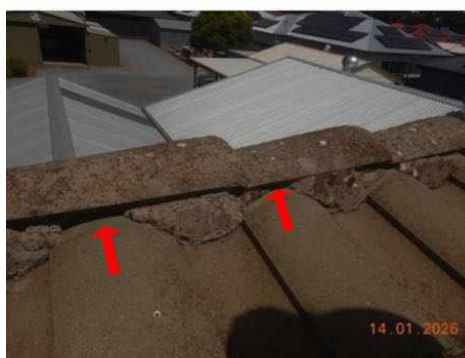
### Finding 3.02

Building:	Main Building
Location:	Roof Exterior
Finding:	Mortar - Deterioration
Information:	Mortar, or 'bedding', is the material which fills joints and intersections between tiles and other building elements on the exterior roof covering, such as gable ends, hip capping and valleys. Upon inspection of the exterior roof, it was noted that sections of the mortar show varying levels of deterioration.

Mortar generally deteriorates as a result of frequent exposure to weather conditions over a prolonged period of time. Mortar that is deteriorating may allow water ingress into the roof void, putting associated building elements and roofing structures at risk of water damage. Deteriorated mortar also detracts from the functionality of roof tiles and other roofing elements, potentially decreasing weather tightness and roof drainage.

Mortar deterioration can be attended to by a handyperson where areas of deterioration are localised and easily accessible. Otherwise, consultation with a roofing contractor is advised where greater works are required.

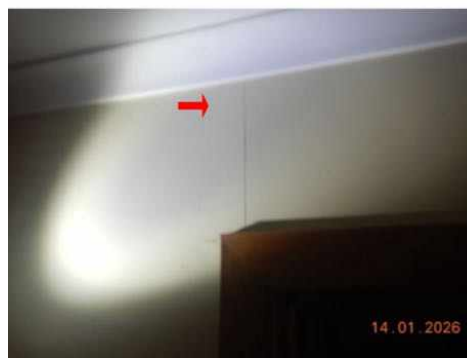
### Finding 3.03

Building:	Main Building
Location:	All Internal Areas

Finding: Cracking - Minor  
 Information: Various minor cracks were found throughout the interior of the dwelling at the time of inspection. Although minor cracks are noticeable, they are often only considered to be an appearance defect, and usually do not indicate any structural damage.

Generally, the cause of a fine crack is indicative of a separation between building materials and finishes (e.g. paint, plaster, etc.) along joints.

Cracking of this nature can generally be repaired with minor sanding, filling and/or repainting. Such works should be performed by a qualified painter or a general handyman.

Monitoring of all cracking should be conducted frequently. Always contact a building inspector should cracks widen, lengthen, or become more numerous.

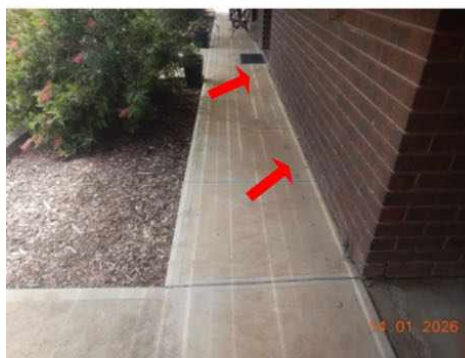
Building:	Main Building
Location:	All External Areas >
Finding:	Slab Edge - Exposure
Information:	It can be seen that at the time of inspection multiple areas throughout the slab edge of the dwelling failed to adhere to the minimum requirements of 75MM exposure.

If the slab edge is not properly exposed there is a high risk of termite attack. Sometimes, in order to determine the type of slab, a suitably qualified person such as an architect or builder may be required to consult the construction plans.

Where the slab edge cannot be properly inspected, it is highly recommended that termite or timber pest inspections be carried out every 6-12 months to aid protection of the property against infestation.

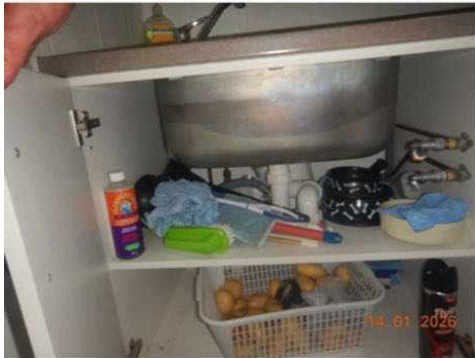
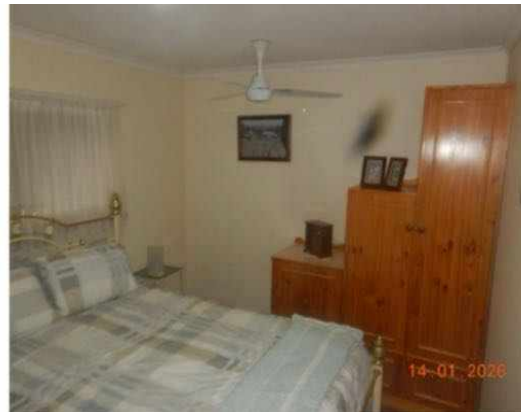
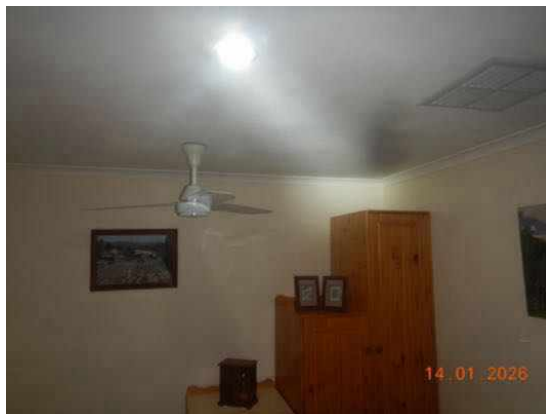
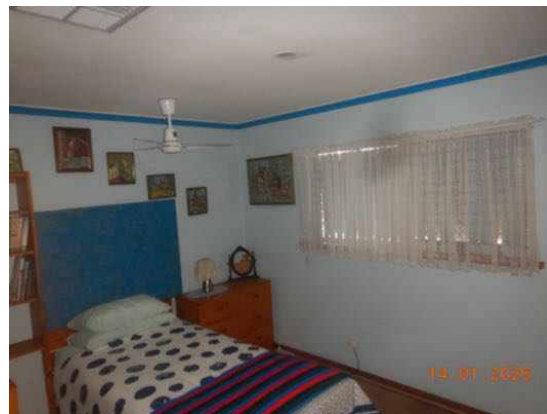
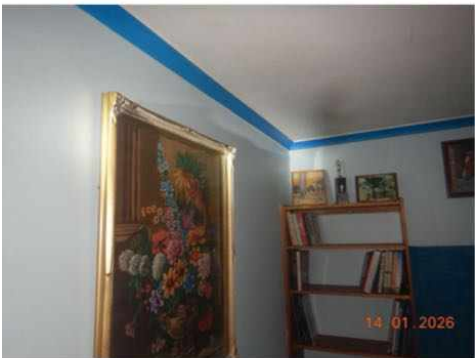
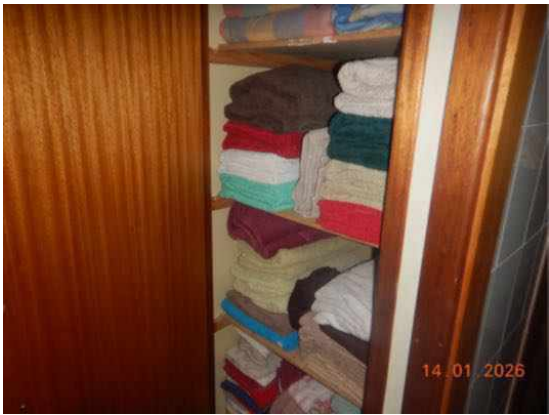
Building: Main Building  
Location: All Areas  
Finding: Additional Photos - Obstructions and Limitations  
Information: These photographs are an indication of the obstructions and limitations which impeded full inspection of the property at the time of inspection. These obstructions can hide an array of defects and should be removed to allow full inspection to be carried out. A re-inspection is recommended once the areas are made accessible.

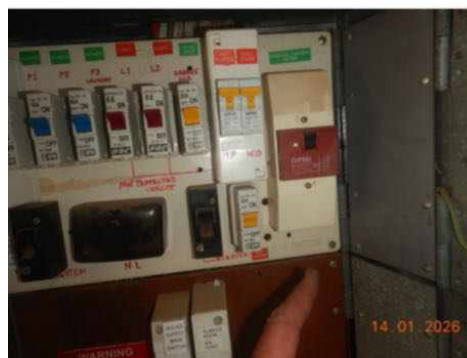
Building:	Main Building
Location:	Electrical Switchboard
Finding:	Electrical switchboard - Old ceramic fuses
Information:	The electrical switchboard while appearing to have adequate safety switches installed has old ceramic fuses in place.

While this on its own on is not considered a defect it is noted for the clients consideration that a switchboard upgrade may be required in the short to mid term to improve the functionality of the electrical system.

A licensed electrician could be appointed to provide quotation for the works at the client's discretion which may in turn expose other required works to bring the system up to a compliant state.
