# Building and Timber Pest Inspection Report

Inspection Date: Fri, 9 Jan 2026

Property Address: 21 Calida Cres, Hassall Grove NSW 2761, Australia

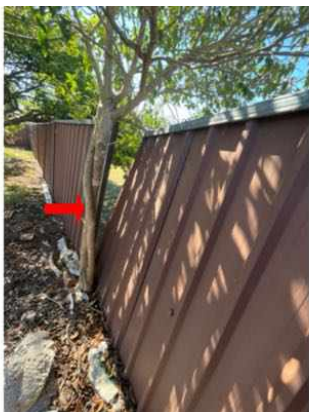
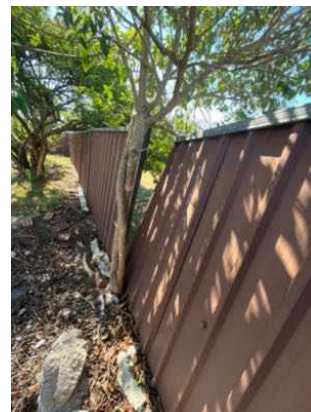
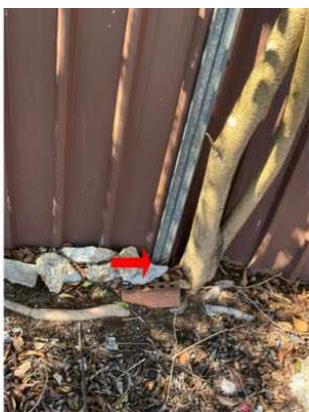
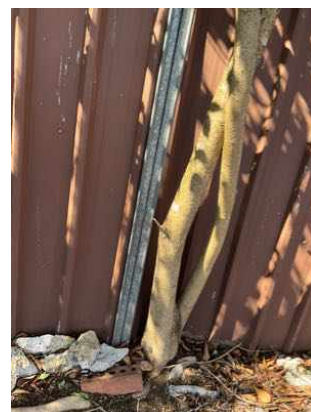
#### Finding 2.01

Building: Main Building  
Location: Fencing  
Finding: Tree roots have uplifted & damaged fence  
Information: Tree roots and trunk growth have damage to the boundary fence. This presents a trip hazard, creates movement to adjacent structures, and indicates ongoing root activity. Visual inspection only in accordance with AS 4349.1. Recommend further evaluation by a qualified arborist and rectification of fencing and paving by appropriate contractors.

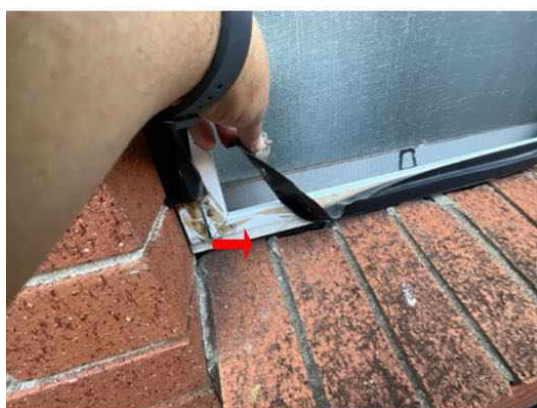
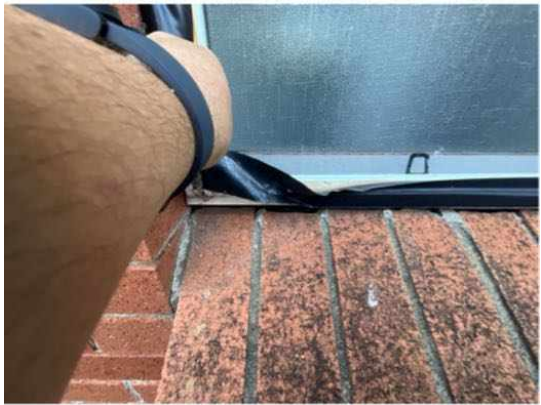
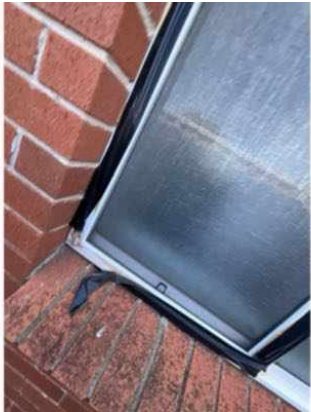
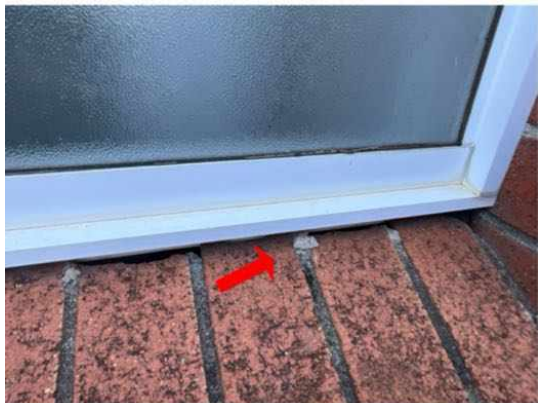
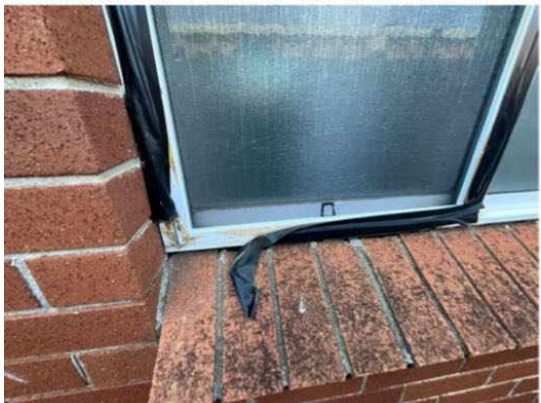
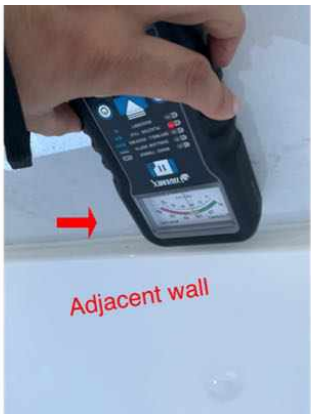
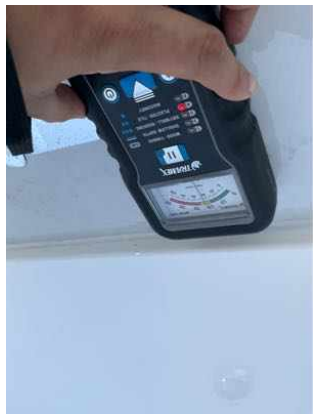
#### Finding 2.02

Building: Main Building  
Location: Exterior walls - right side

Finding: Window sill gaps are observed  
Information: Gaps are observed between the brick sill and the base of the window frame. Mortar joints are incomplete in multiple areas, and there is no visible weather sealant applied between the window frame and the adjacent bricks.

- Potential for moisture ingress during rainfall events, which may result in internal water damage, mould growth, and deterioration of building materials.
- Gaps may allow pest intrusion and compromise thermal insulation.
- The condition may lead to non-compliance with the National Construction Code (NCC) and relevant Australian Standards (e.g., AS 2047 – Windows and external glazing, and AS 3700 – Masonry structures).

- Repoint all affected mortar joints to close visible gaps.
- Apply a suitable, flexible weatherproof sealant between the brick sill and window frame.
- Inspect and, if necessary, adjust or install flashing to ensure appropriate water diversion and drainage.

Priority: Remediation is recommended to prevent long-term damage, especially before the next major weather event.

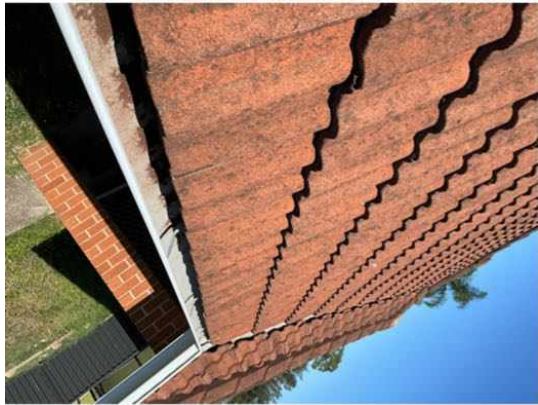
Information: Inspection of the roof revealed widespread weathering to the tiled roof surface. The tiles show loss of surface finish, colour fading, and age-related deterioration typical of older roof coverings. Although no significant cracking was noted, weathering can lead to increased porosity, reduced water-shedding capability, and a higher risk of future cracking or displacement during adverse weather conditions.

A licensed roofer should be engaged to undertake a closer inspection, carry out routine maintenance, and replace any tiles that may be compromised. Ongoing monitoring is recommended due to the age and condition of the roof covering.

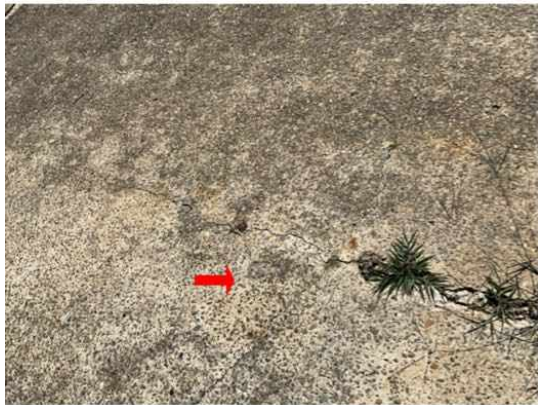
Building: Main Building  
Location: Driveway  
Finding: Crack in concrete slab - Category 0  
Information: A crack coded as Category 0 was identified in the slab. A Category 0 crack is described as a hairline crack, representing insignificant movement of slab from level.

The approximate width of the crack to be considered Category 0 is 0.3mm, or change in offset of less than 8mm when a 3m straight edge is placed over the defect.

No rectification is required at this time. However, all cracking should be monitored over a 12 month period to identify any further damage in the area.

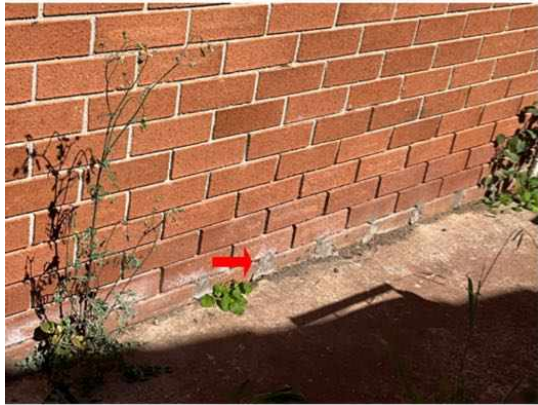
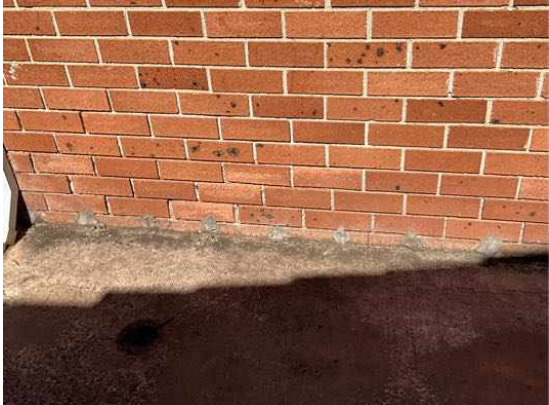
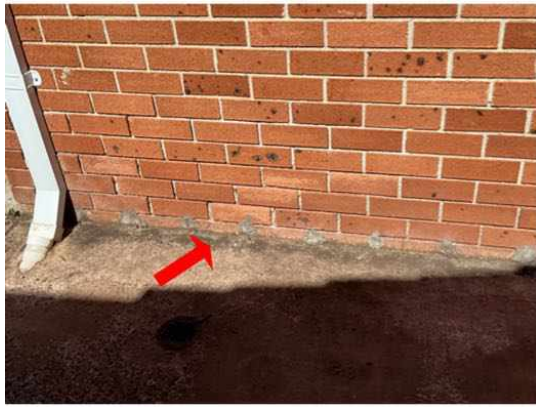
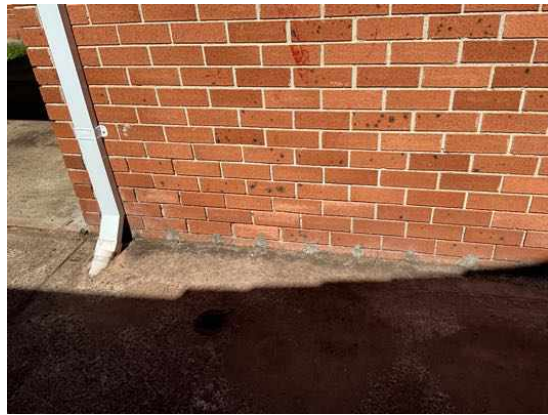
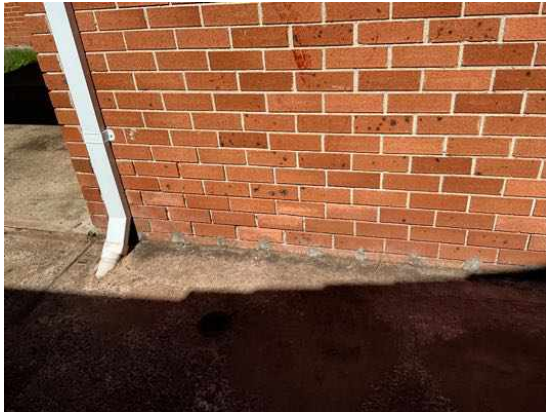
**Finding 3.03**

Risk: Poor workmanship poses a range of risks, including compromised structural integrity, potential safety hazards, and a decreased lifespan of the structure. It may also lead to aesthetic and functional issues.

Resolution: A qualified contractor or construction professional should be consulted to assess and address the poor workmanship. They can implement corrective measures to ensure structural soundness, safety, and overall quality of the construction.

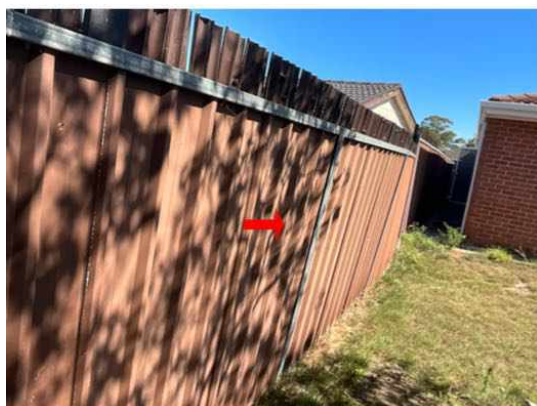
### Finding 3.04

Building:	Main Building
Location:	Fencing
Finding:	Leaning fence
Information:	The fence is leaning, deviating from its vertical position, compromising its stability and aesthetic appeal.

The leaning fence poses a risk of collapse, potential property damage, and a security breach, diminishing its effectiveness as a barrier.

A skilled fencing contractor or handyman is needed to assess and rectify the leaning fence. Timely repair is crucial to restore the fence's stability and prevent further damage or safety hazards.

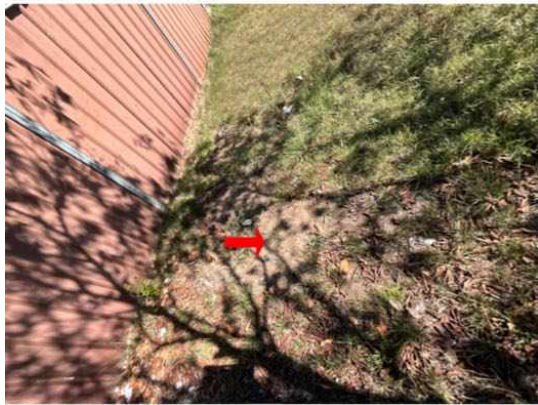
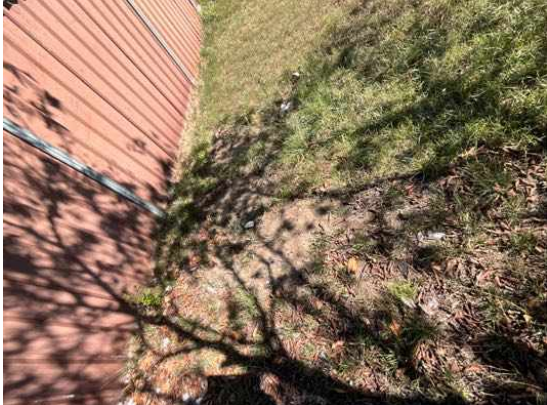
### Finding 3.05

Building:	Main Building
Location:	Yard - Back
Finding:	Water pooling - poor surface drainage
Information:	Surface drainage

Surface water drainage is defective if it is not in accordance with the requirements of the Building Code of Australia.

Such water pooling also increases the risk of termite activity and the development of fungal decay in the area.

Consult a Licensed Plumber regarding the cost of potential site drainage rectification works.

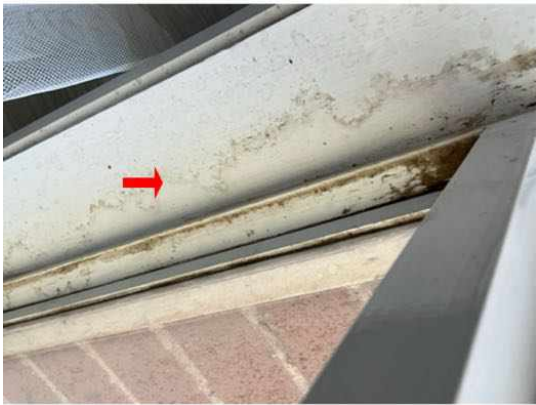
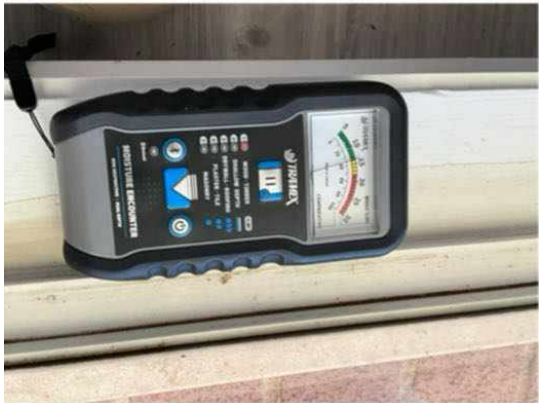
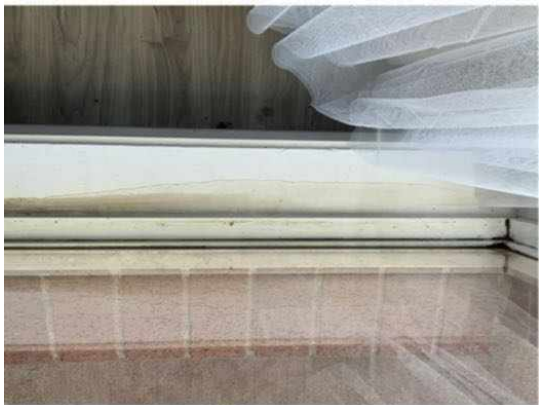
Finding: Water staining

Information: Water staining was evident in this area at the time of inspection. Water staining indicates that surfaces have been exposed to excessive moisture over time. The minerals and other elements in the water lead to staining, which may graduate to corrosion and deterioration if left unmanaged.

While mostly an appearance defect, water staining can be indicative of more serious defects, which may be currently concealed by other building elements.

Where water staining is active, a licensed plumber must be consulted to identify the cause of the staining and to provide advice on any reparation works that may be required. Replacement of any broken or damaged structures is advised.

Conversely, where water staining is old and inactive, affected building materials may be repaired or replaced at client discretion. A qualified carpenter or registered builder may be appointed to perform these works.

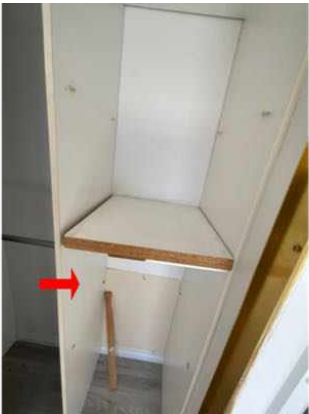
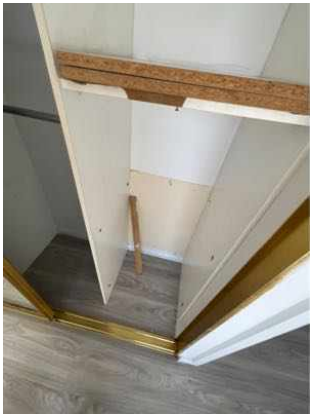
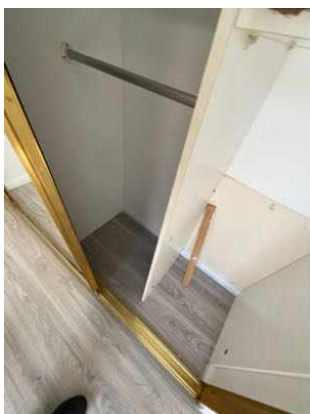
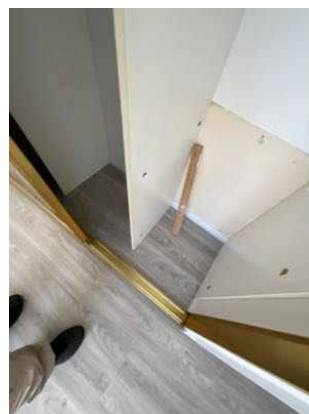
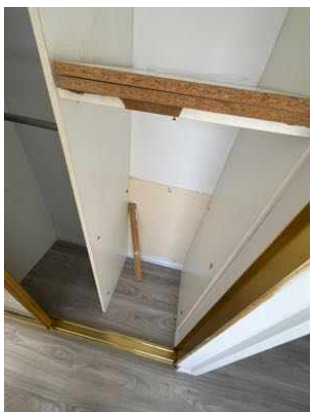
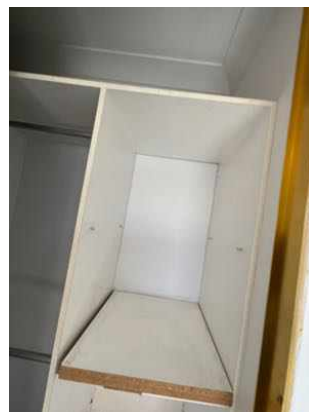
**Finding 3.08**

Building: Main Building  
Location: Bedroom  
Finding: Fixed cabinetry damage  
Information: Fixed cabinetry was observed damaged at the time of inspection, compromising the structural integrity.

Damage on cabinetry pose a risk of further deterioration, potentially leading to structural issues and decreased aesthetic appeal.

Engaging the services of a professional carpenter is recommended to assess and address the damage, ensuring proper repairs and preventing future damage.

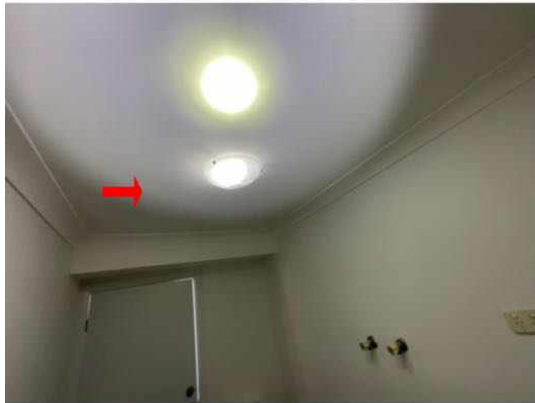
### Finding 3.09

Building:	Main Building
Location:	Laundry / Toilet
Finding:	No exhaust fan in laundry / toilet
Information:	The laundry / toilet lacks an exhaust fan, leading to inadequate ventilation and potential issues with moisture buildup.

1. Mold and mildew growth: Without proper ventilation, moisture accumulates in the bathroom, creating an environment conducive to mold and mildew growth, which can pose health risks and damage surfaces.
2. Odor retention: The absence of an exhaust fan can lead to lingering odors in the bathroom, causing discomfort for occupants and potential embarrassment.
3. Damage to building materials: Excessive moisture can damage paint, wallpaper, and even structural elements like drywall and wood, leading to costly repairs and renovations.

A licensed electrician or general contractor can install an exhaust fan in the bathroom. Additionally, a building inspector or HVAC technician may be consulted to ensure

proper ventilation requirements are met and to recommend the appropriate fan size and placement.

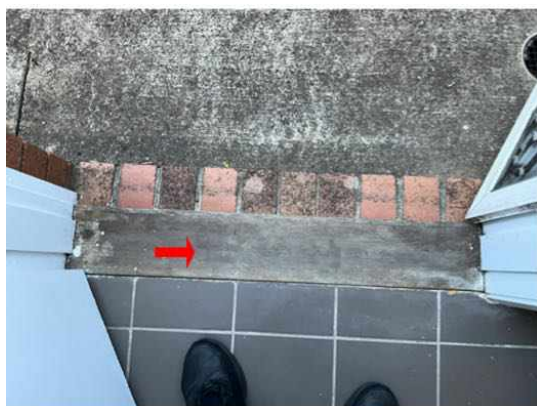
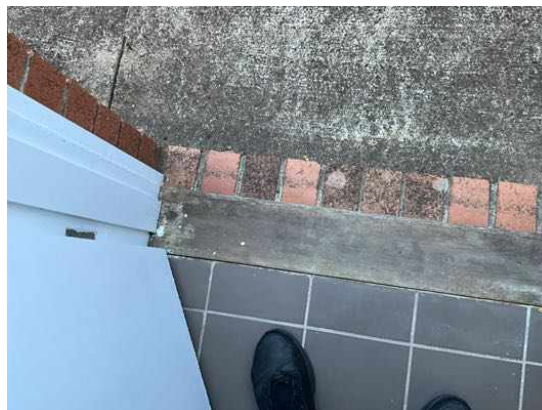
### Finding 3.10

Building:	Main Building
Location:	Laundry / Toilet
Finding:	Timber - exposed to weather
Information:	External timbers that are frequently exposed to harsh weather conditions require adequate protection in order to maintain their condition. Where timbers have not been painted or treated adequately, general deterioration is likely to occur at an accelerated rate.

If left unattended, replacement of these timbers is likely to be necessary in the short-term future. Adequate treatment of these timbers is required as soon as possible by a painting contractor or general handyman.

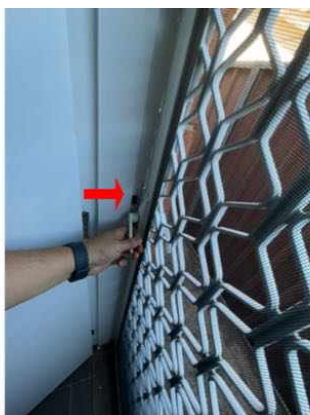
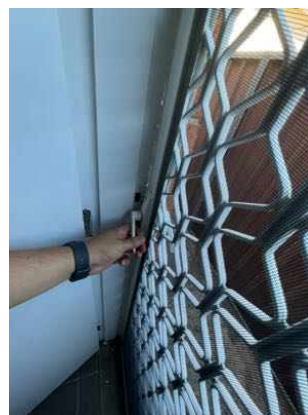
### Finding 3.11

Building:	Main Building
Location:	Laundry / Toilet
Finding:	Door - Binding/jamming
Information:	Binding and/or jamming of this door is evident during standard operation. This defect inhibits the functionality of the affected door as well as creating potential for secondary defects to associated building elements.

A door that binds to flooring or to the associated door frame may have several causes, ranging from minor defects, such as poor installation of the door or deteriorated hinges, through to major structural issues. For minor causes, a qualified carpenter or general handyperson should be appointed to perform minor rectification works at client discretion.

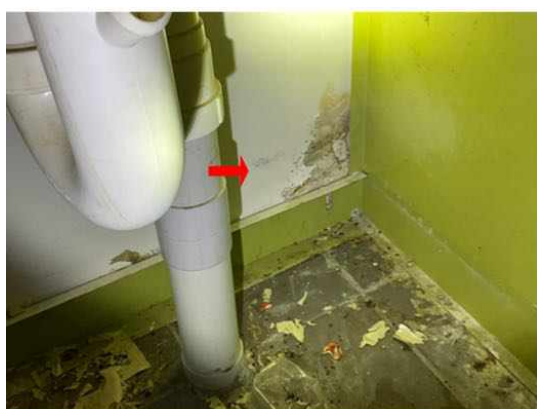
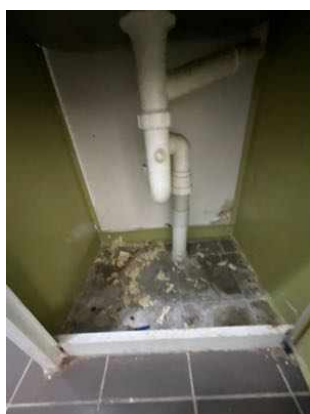
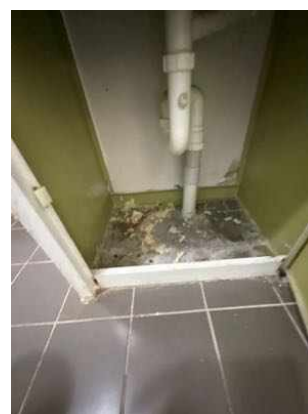
### Finding 3.12

Building:	Main Building
Location:	Laundry / Toilet
Finding:	Water damage / Vanity
Information:	"The vanity in the shower area has sustained water damage, resulting in swelling and discoloration of the wood, as well as potential structural issues. This damage compromises both the aesthetic and functional aspects of the vanity."

1. **Carpenter or Woodworker:** They can assess and repair the damage to the vanity, potentially replacing any irreparable parts.
2. **Plumber:** If the water damage is due to plumbing issues, a plumber can fix leaks and ensure there are no further water-related problems.
3. **General Contractor:** If the damage is extensive and affects the surrounding area, a general contractor can coordinate the repair work, including both the vanity and any related structural or cosmetic repairs.

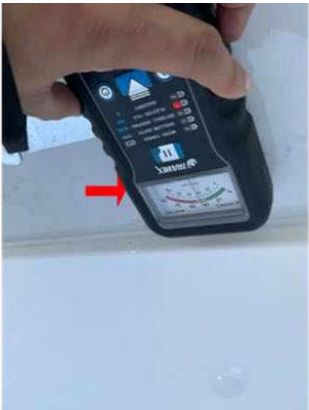
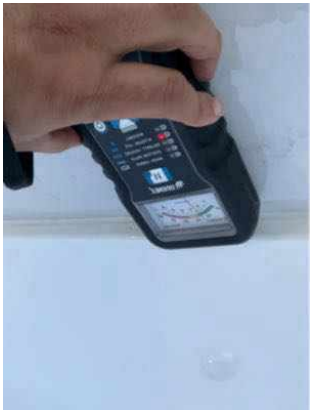
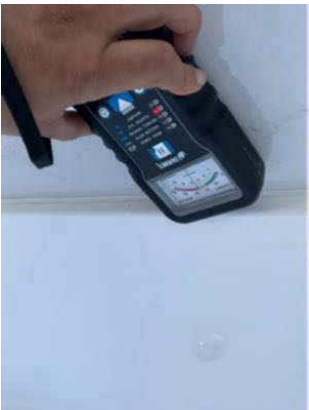
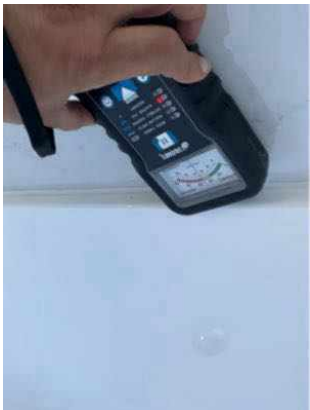
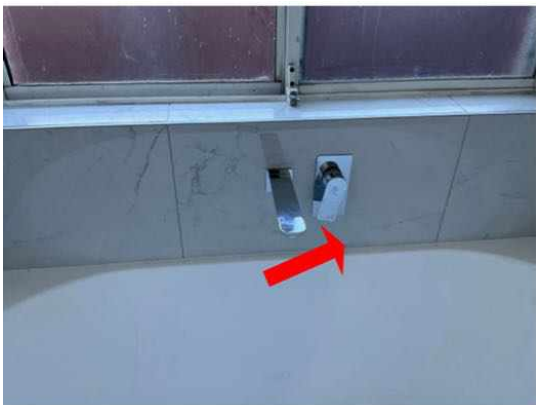
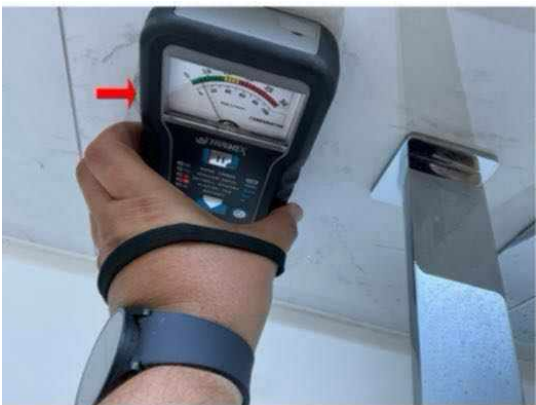
Building:	Main Building
Location:	Bathroom
Finding:	Evidence of excessive moisture was present at the time of inspection
Information:	Excessive moisture is present behind the bathroom tiles, indicating a potential water leakage issue within the wall.

The prolonged presence of moisture can lead to mold growth, deteriorate the

structure, and create an environment conducive to health hazards. Additionally, it may compromise the adhesive holding the tiles, leading to their detachment.

A licensed plumber or a qualified contractor specializing in water damage remediation should investigate the source of the moisture, fix any leaks, and address the damage. Additionally, replacing affected tiles and ensuring proper waterproofing are crucial to preventing future issues.

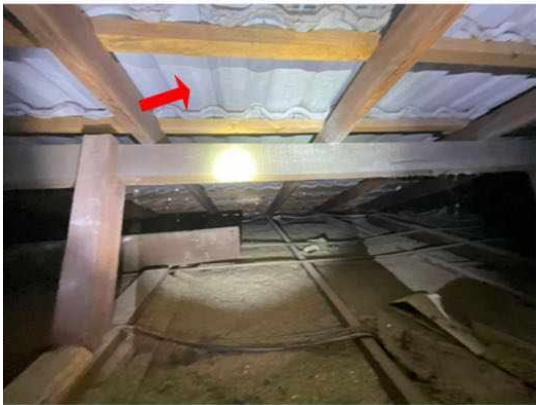
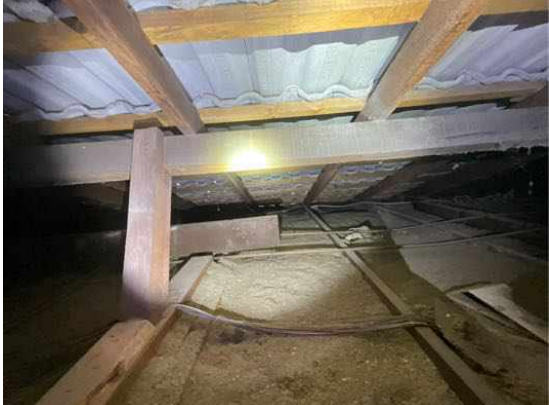
**Finding 3.14**

Building: Main Building  
Location: Roof Void

Finding: Sarking - Missing  
Information: Sarking is missing under the roof sheeting. Sarking acts as an insulator that helps with noise reduction and protects against water penetration. Sarking plays a key role in the operation and function of the overall roofing structure and its performance.

Although not a requirement at the time of construction, replacement of any missing building element is advisable (although this can be quite expensive to do after the time of construction). Where sarking is missing, regular inspections of the roof tiles for cracking and potential moisture penetration is required.

Sarking may be retrospectively fitted by a registered builder at the discretion of the client.

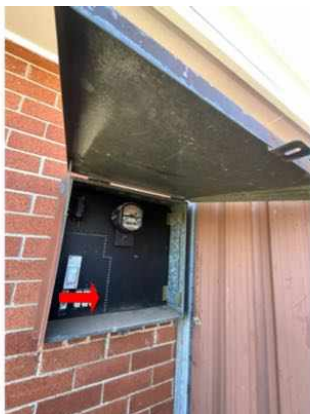
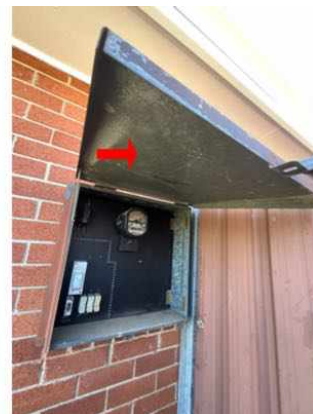
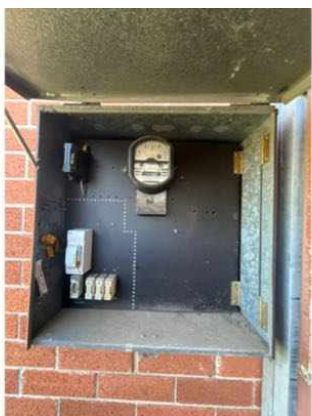
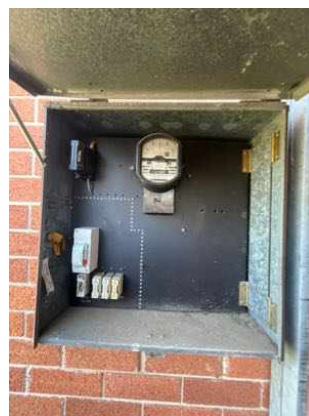
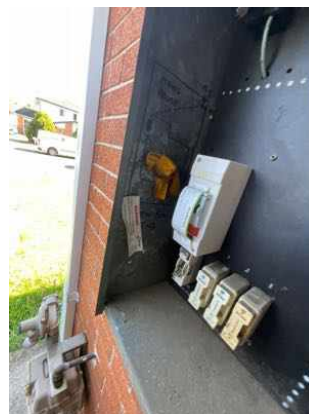
Building: Main Building  
Location: Exterior walls - right side  
Finding: No Evidence of Termite Management System - Durable notice / Legible Sticker  
Information: The application of a pre & post-construction chemical termite barrier is highly recommended for all properties. Such barriers are highly effective in preventing termite attack on any timber building elements throughout the property.

A durable notice was not placed in the switchboard unit to indicate current termite barriers is legible at the time of inspection.

Client must seek further information from the vendor or real estate agent if the conditions of termite management systems were maintained.

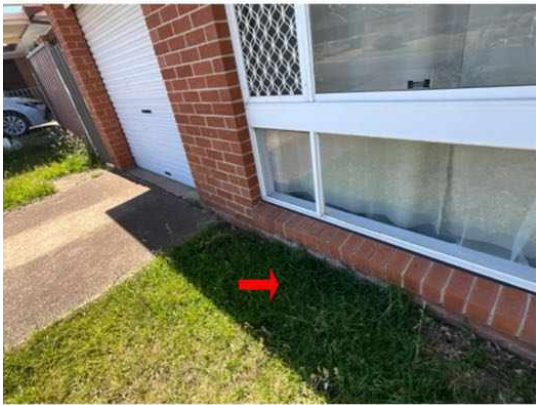
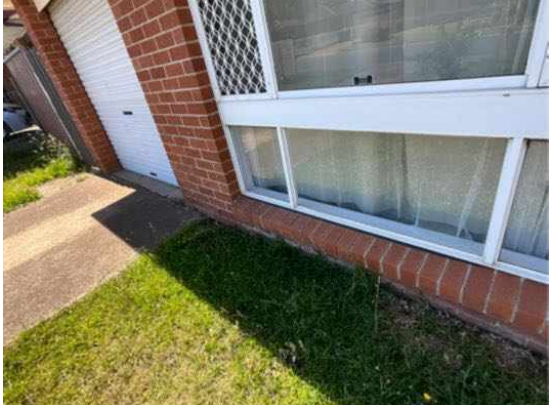
### Finding 6.02

Building:	Main Building
Location:	All Areas
Finding:	Slab Edge - Exposure
Information:	An inspection zone of at least 75mm in relation to the exposed slab edge, between the bottom brick and the perimeter pavement, is required. This inspection zone should be maintained in order to force termites into the open where they can be detected more readily during regular inspections. The slab edge should not be concealed by anything that may prevent inspection of the area, including render, landscaping, soil, turf, paving, concrete cladding or other structures.

If the slab edge is not properly exposed there is a high risk of termite attack. Sometimes, in order to determine the type of slab, a suitably qualified person such as an architect or builder may be required to consult the construction plans.

Where the slab edge cannot be properly inspected, it is highly recommended that termite or timber pest inspections be carried out every 6-12 months to aid protection of the property against infestation.

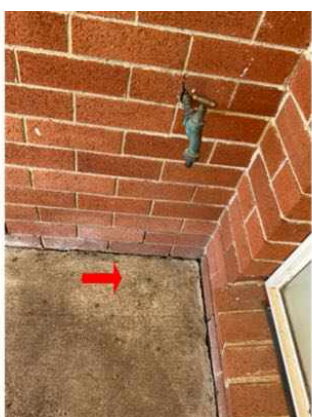
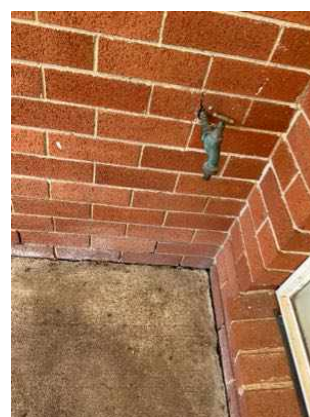
### Finding 6.03

Building: Main Building  
 Location: All Areas  
 Finding: No Drain under tap  
 Information: There is no drain installed under the tap, leading to water accumulation and creating conducive conditions for timber pests. This defect needs immediate attention to prevent potential damage and pest infestation.

2. Timber Pest Infestation: The damp environment created by standing water is highly conducive to timber pests, such as termites and wood borers, which thrive in moist conditions and can cause significant damage to wooden structures.

3. Structural Damage: Prolonged exposure to moisture can lead to wood rot and deterioration of structural timber, compromising the integrity of the building.

A licensed plumber or a qualified building contractor can address this defect by:

3. Repair and Prevention: Inspecting and repairing any existing water damage and implementing measures to prevent future water accumulation and pest infestations.

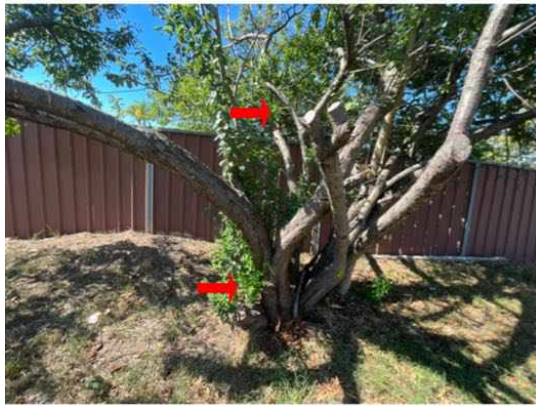
### Finding 6.04

Building:	Main Building
Location:	Yard - Back
Finding:	Cut and Exposed tree Stumps
Information:	The tree stump, which has been cut and exposed, poses a potential risk of termite

infestation due to its increased vulnerability to termite attacks.

Please contact Licenced pest controller for further advice. Pictures attached for your reference.

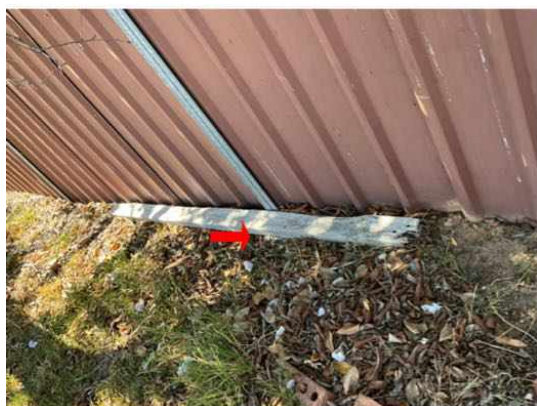
### Finding 6.05

Building:	Main Building
Location:	Yard - Back
Finding:	Timber on ground / conducive conditions to termite damage
Information:	Timber on the ground is indeed conducive to termite damage. Termites are known to thrive in moist environments, and wood in contact with soil or moisture is more susceptible to infestation.

To prevent this, it's important to keep timber elevated and away from direct ground contact. Regular inspections and proper termite control measures are also essential to protect your wooden structures from termite damage.

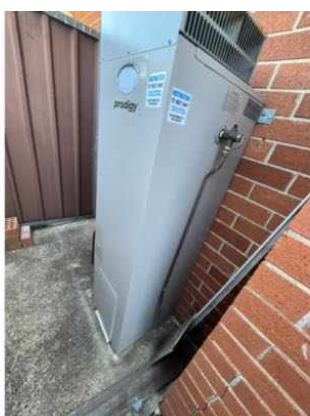
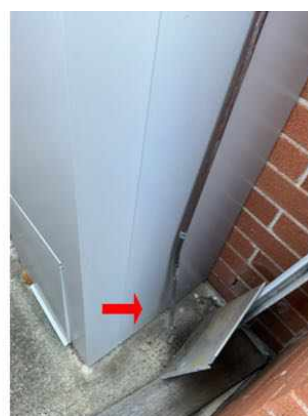
### Finding 6.06

Building:	Main Building
Location:	Exterior walls - right side
Finding:	HWS not connected - conducive conditions for timber pest attacks
Information:	The hot water system (HWS) is not connected, leaving exposed pipes and creating conducive conditions for timber pest attacks.

**Risk of Timber Pest Attack:** The risk of timber pest attack is heightened when the hot water system is not connected. Exposed pipes provide easy access points for timber pests like termites and ants to infiltrate the building structure. These pests are attracted to moisture, and the absence of flowing water through the system can lead to moisture buildup, creating an ideal environment for pests to thrive and cause damage to timber components within the building.

A licensed plumber or qualified plumbing technician should be engaged to reconnect the hot water system. They will assess the existing plumbing infrastructure, determine the appropriate connection points, and ensure proper installation and functionality of the HWS. Additionally, they may inspect for any signs of timber pest activity and recommend preventive measures, such as installing physical barriers or implementing moisture control measures, to deter pest infestations and protect the building from damage. Regular maintenance and inspections by homeowners or property managers are also essential to detect and address potential issues before they escalate.

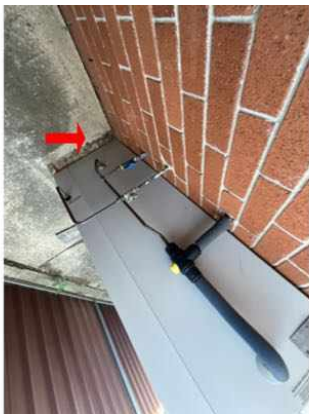
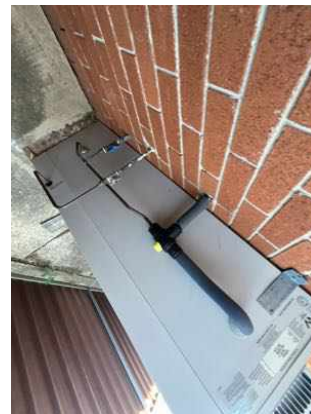
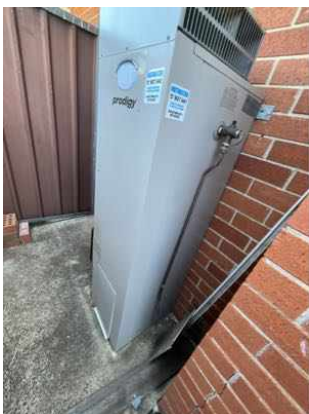
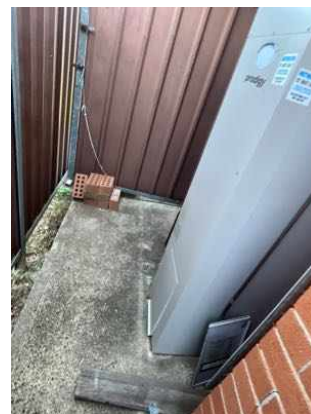
## Finding 6.07

Building: Main Building  
 Location: Exterior walls - right side  
 Finding: Bridging or Obstruction Conducive environment for Termites  
 Information: Bridging of termite barriers occurs when termites bridge (usually by building a mud tunnel) a termite barrier or inspection inspection zone or where termites have a passage, allowing them to bridge the barrier.

Where bridging has occurred full inspection is prevented and termites may enter a property in a concealed or undetected manner.

Recommended moving obstructions away from the external walls for further and future inspections.

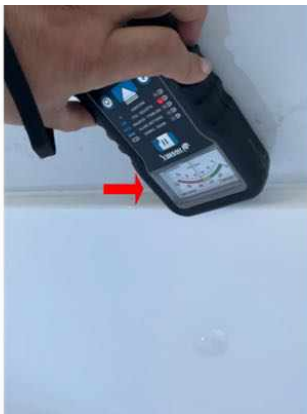
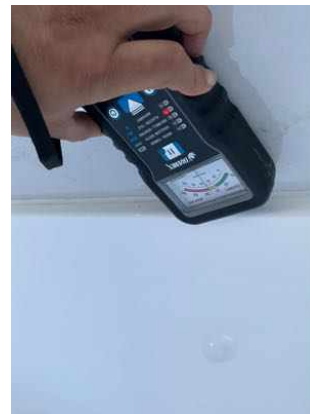
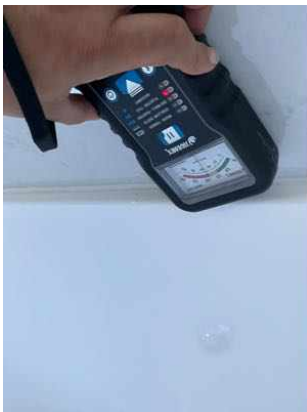
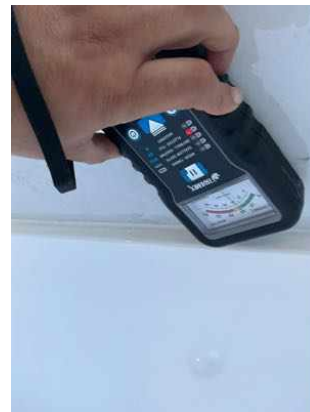
## Finding 6.08

Building: Main Building  
 Location: Bathroom  
 Finding: Excessive moisture - Conducive to Timber pest

Information: Excessive moisture can attract termites and produce conditions that promote fungal growth and wood decay.

Excessive moisture is generally caused by deteriorated inadequate or missing roof drainage leaking plumbing pipes or fixtures poorly plumbed HWS overflows or condenser units and poor site drainage.

Prior to any remedial works being performed a qualified plumber should be appointed to further inspect the property and to identify the cause of the excessive moisture. Works to remove affected building elements may then be necessary and should be performed by an appropriate tradesperson.

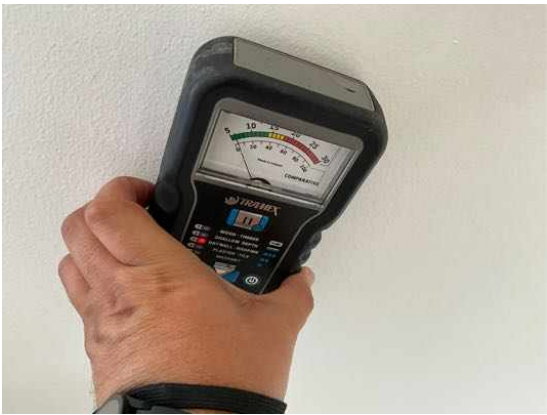
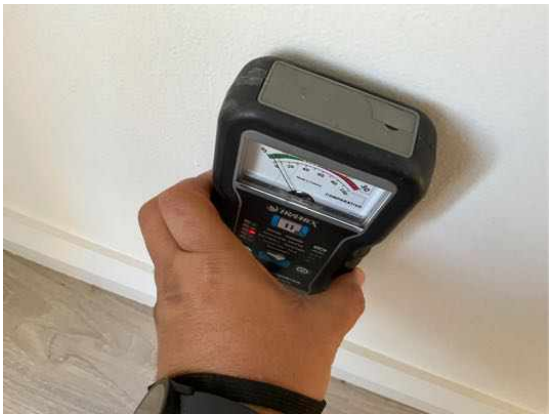
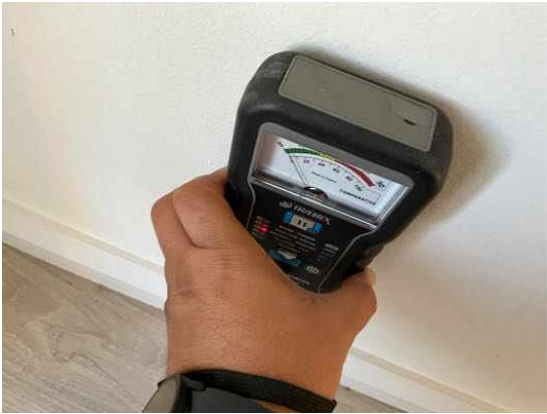
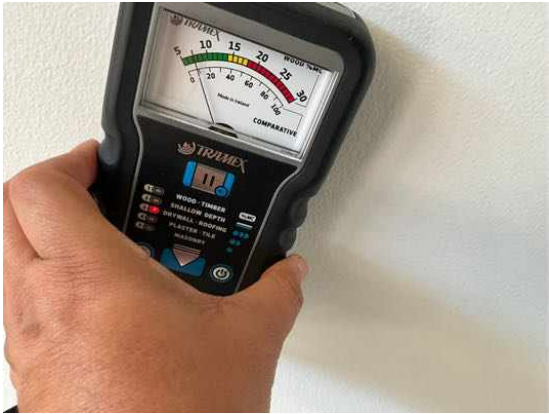
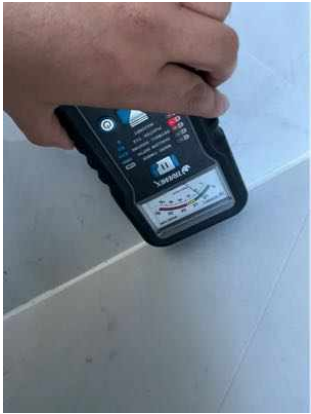
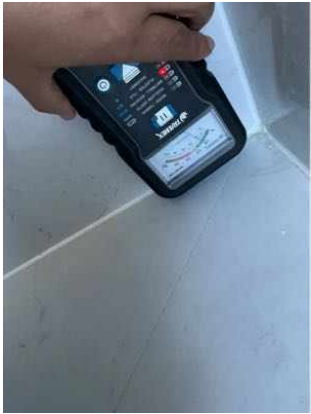
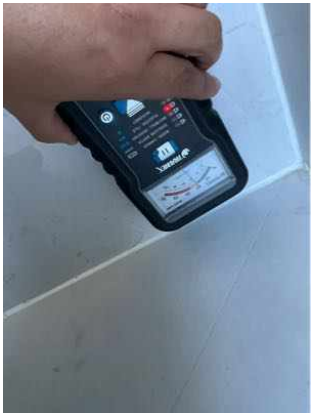
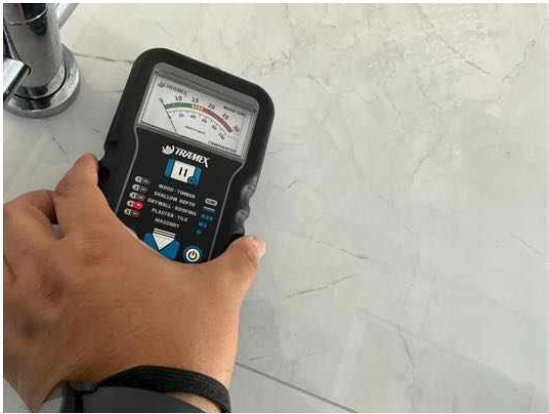
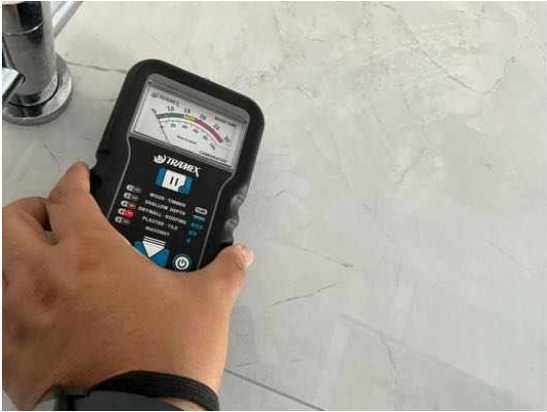
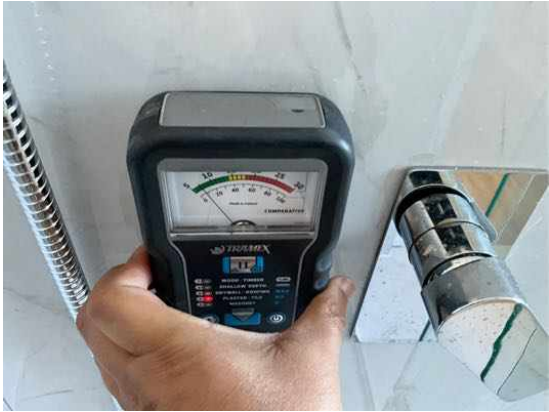
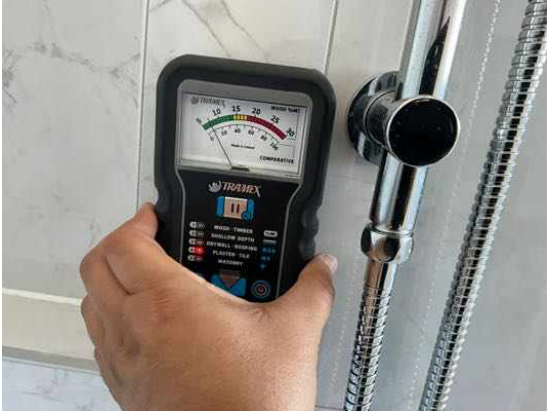
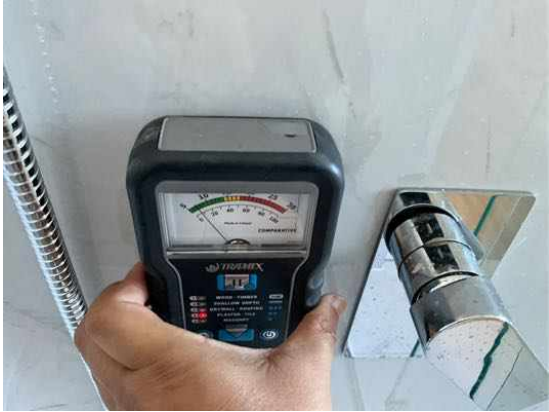
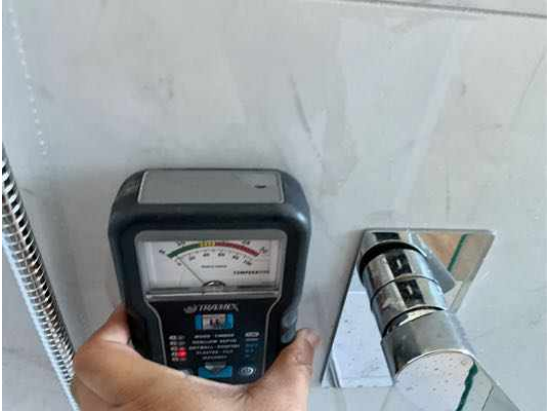
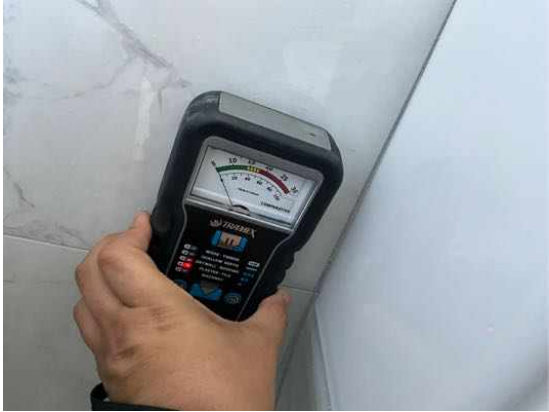
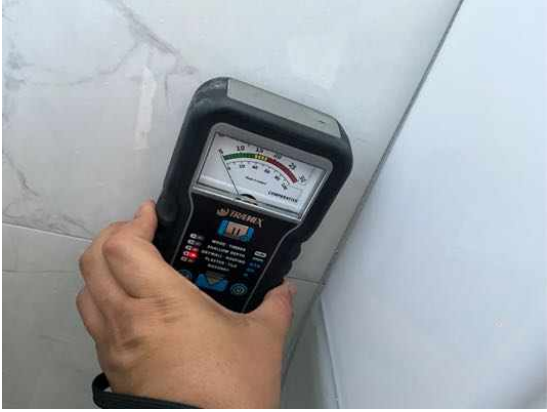
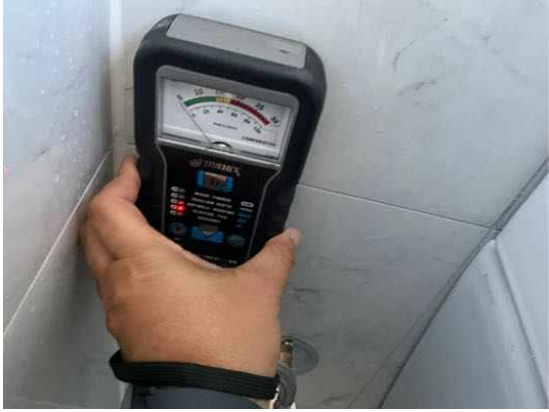
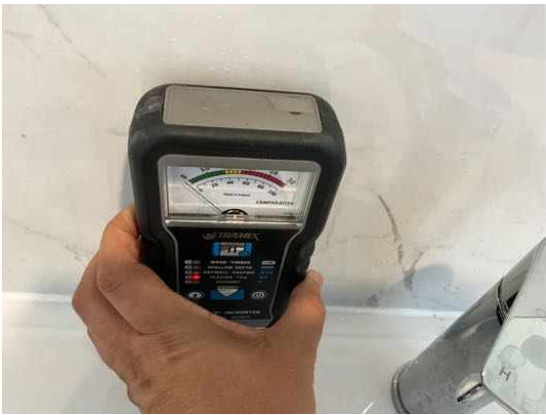
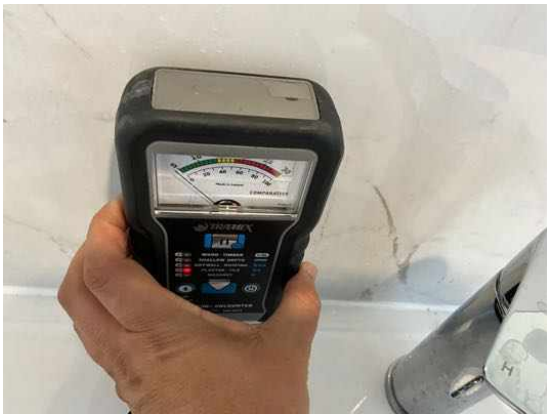
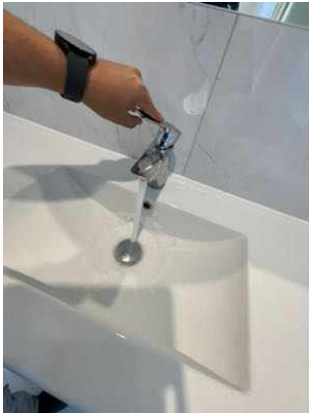
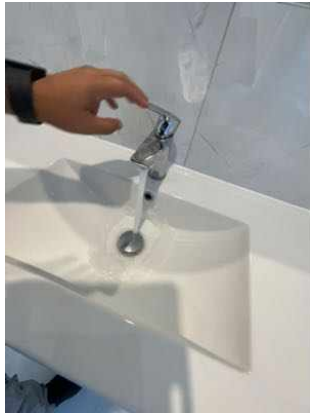
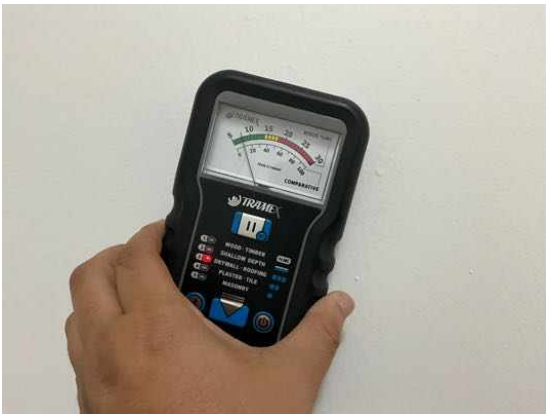
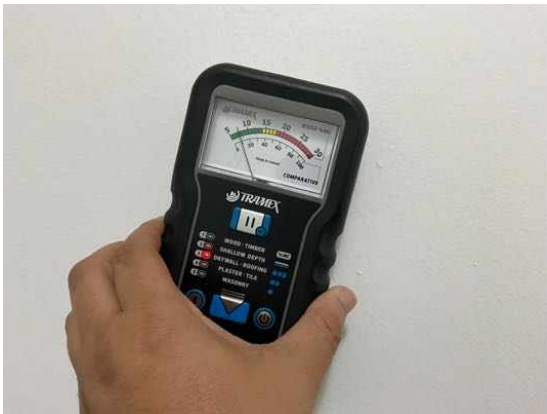
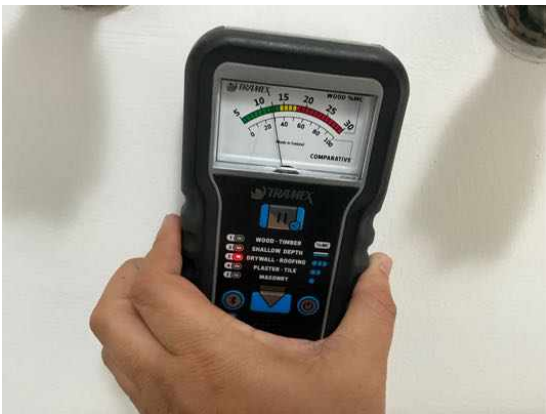
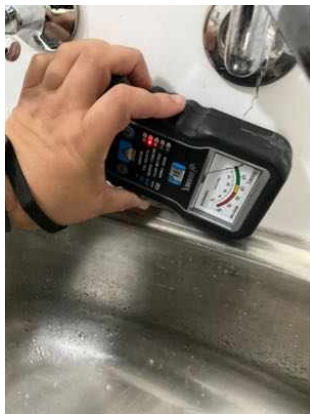
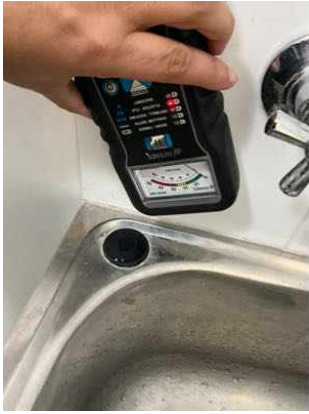
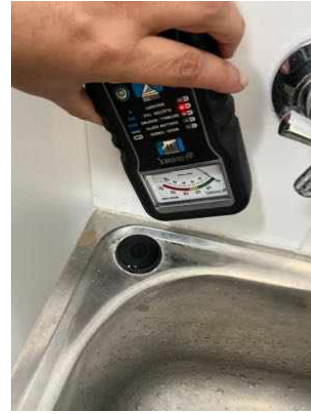
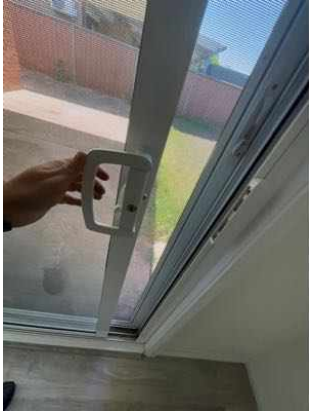
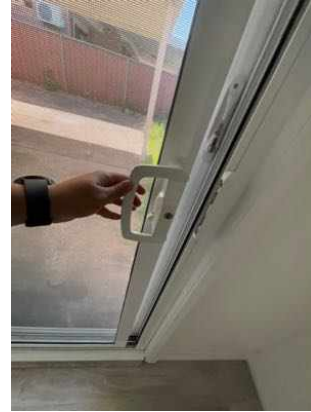
Building: Main Building  
Location:  
Finding: Additional Photos  
Information: Additional photos are provided for your general reference
