# Building and Timber Pest Inspection Report

Inspection Date: Fri, 9 Jan 2026

Property Address: 21 Calida Cres, Hassall Grove NSW 2761, Australia

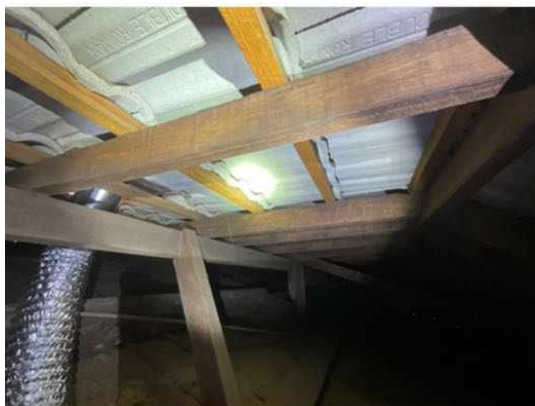
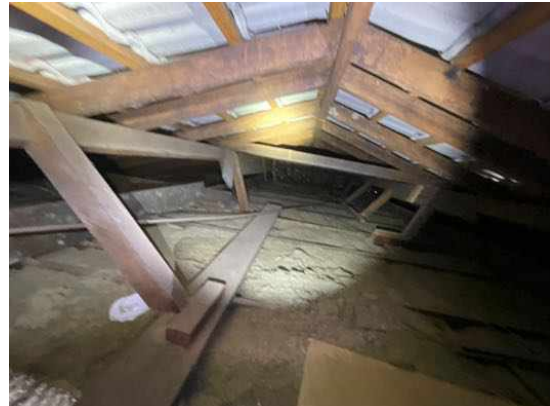
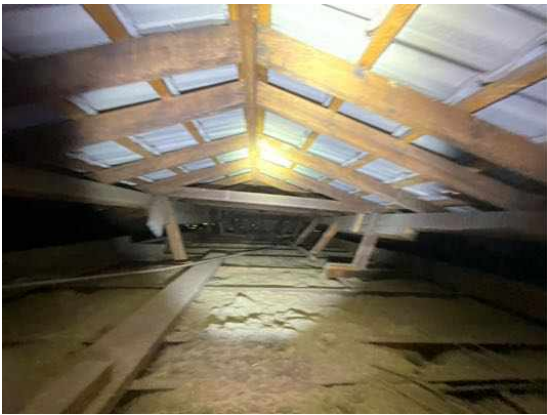
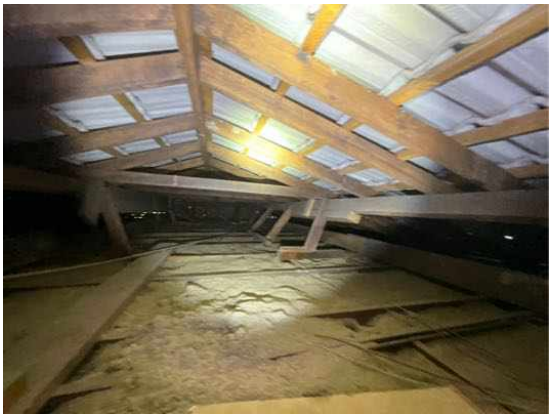
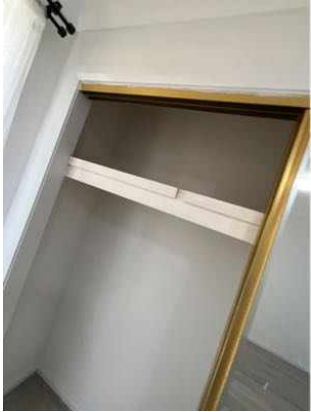
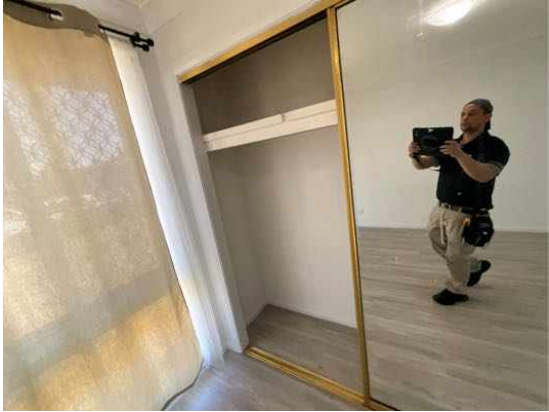
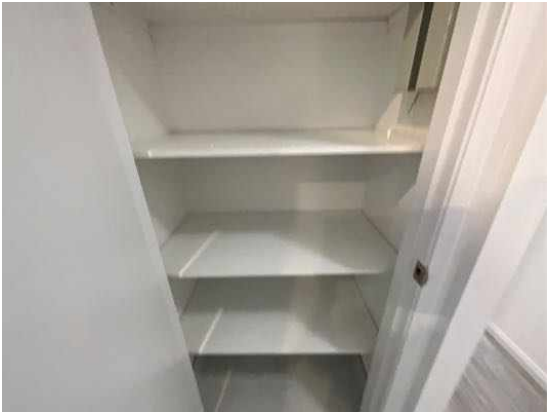
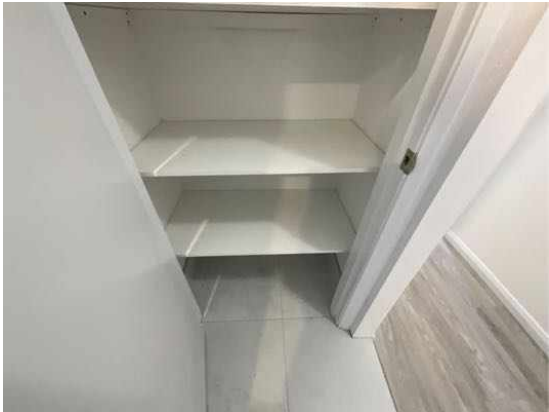
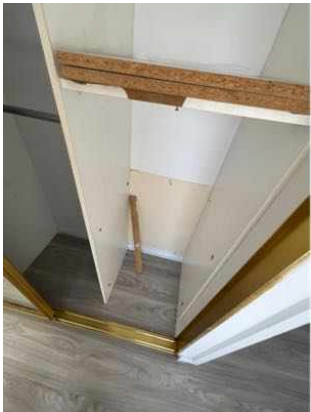
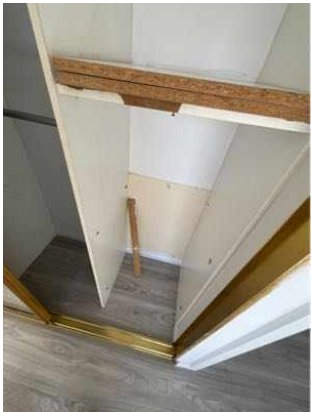
Finding: Additional Photos - Obstructions and Limitations

Information: These photographs are an indication of the obstructions and limitations which impeded full inspection of the property at the time of inspection. These obstructions can hide an array of defects and should be removed to allow full inspection to be carried out. A re-inspection is recommended once the areas are made accessible.
