## Building Inspection Report

Inspection Date: Tue, 17 Mar 2026

Property Address: 6 Wyperfeld Ave, Taylors Lakes VIC 3038,  
Australia

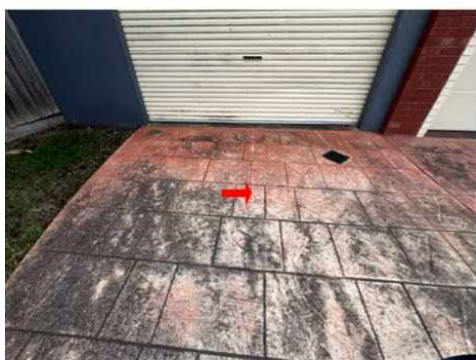
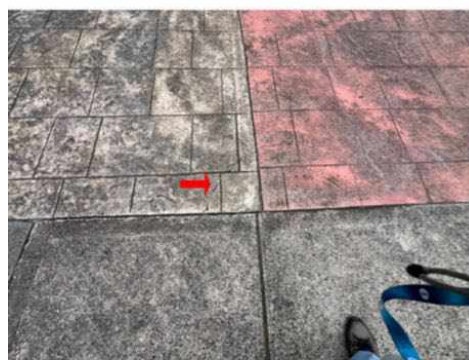
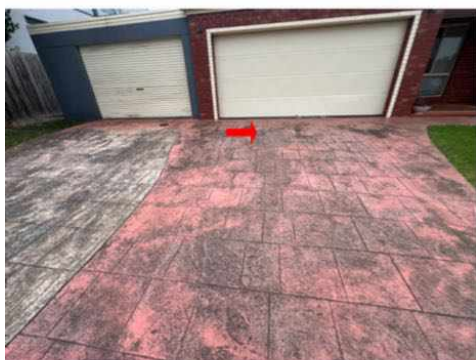
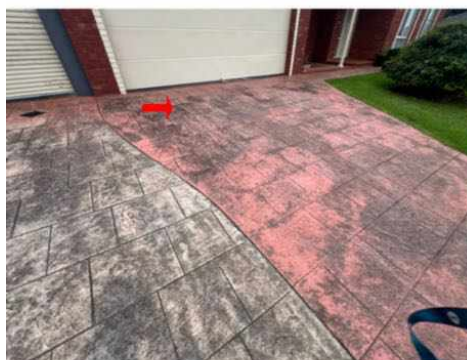
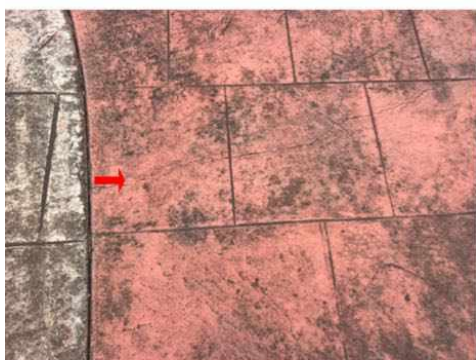
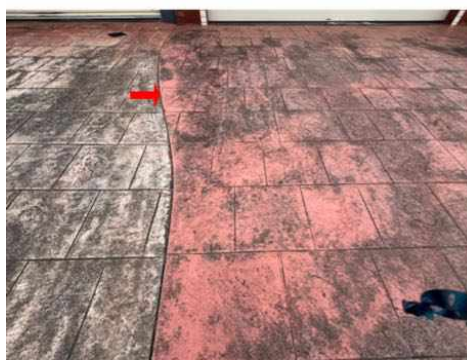
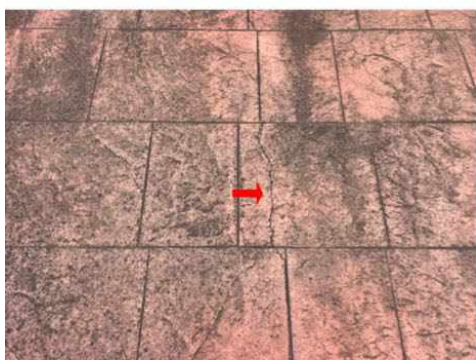
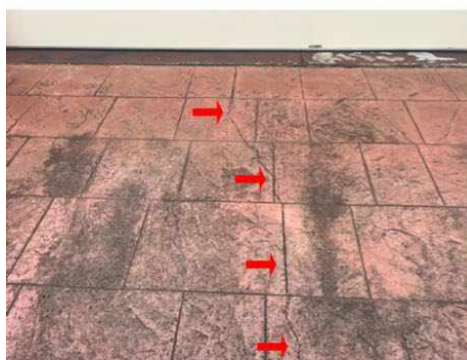
#### Defects 3.01

Building: Yard  
 Location: Driveway > All Areas  
 Finding: Cracking - External Concrete Paving Damage Category 1 - Fine (less than 2mm)  
 Information: Fine cracks were identified in external concrete paving. Although fine cracks are quite noticeable, they are often only considered to be an appearance defect, and usually do not indicate any structural damage. To be considered a Category 1 or fine crack, the crack is found to be less than 2mm in width.

Generally the cause of a hairline crack in existing concrete paving such as driveways and pathways is indicative of the expansion and contraction of the concrete. Such causes are generally due to environmental factors, such as moisture levels, weather conditions, root systems of nearby trees or the soil types on which they are laid.

Fine cracks may also be due to poor original installation of the concrete. Factors such as poor compaction of the sub surface and/or inadequate reinforcing of the slab may create cracking and other secondary defects.

Monitoring of all cracking should be conducted frequently. Always contact a building inspector should cracks widen, lengthen, or become more numerous.

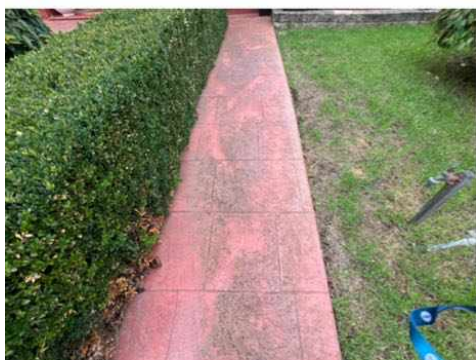
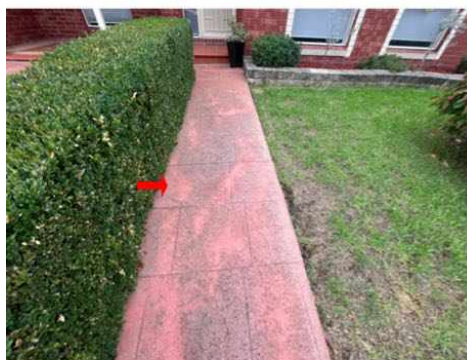
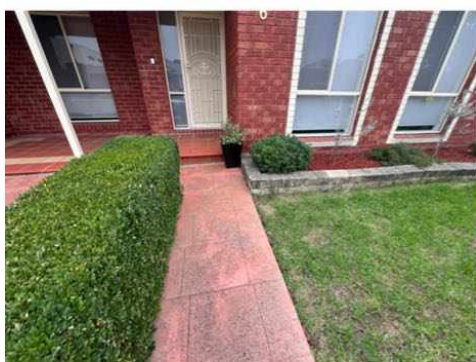
### Defects 3.02

Building:	Yard
Location:	All Areas > Centre
Finding:	Cracking - External Concrete Paving Damage Category 0 - Hairline (less than 1mm) to path
Information:	Hairline cracks were identified in external concrete paving. Hairline cracks are very minor in nature and generally are only ever an appearance defect. To be classified as a Category 0 or hairline crack, the crack width would be less than 0.3mm. While such cracking may be noticeable in some cases, it is common and does not indicate any structural damage.

Generally the cause of a hairline crack in existing concrete paving such as driveways

and pathways is indicative of the expansion and contraction of the concrete. Such causes are generally due to environmental factors, such as moisture levels, weather conditions, root systems of nearby trees or the soil types on which they are laid.

Hairline cracks may also be due to poor original installation of the concrete. Factors such as poor compaction of the sub surface and/or inadequate reinforcing of the slab may create cracking and other secondary defects.

Monitoring of all cracking should be conducted frequently. Always contact a building inspector should cracks widen, lengthen, or become more numerous.

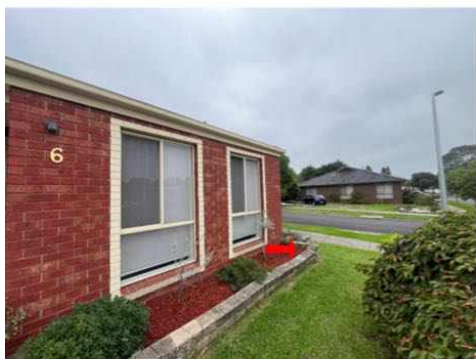
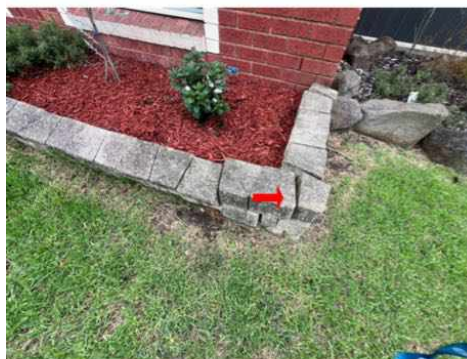
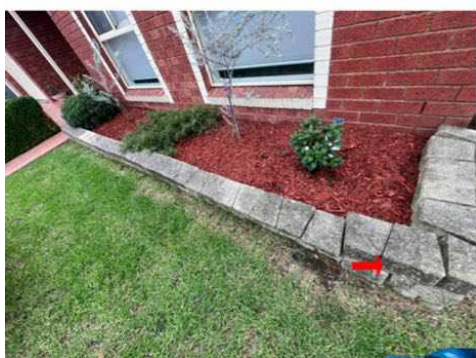
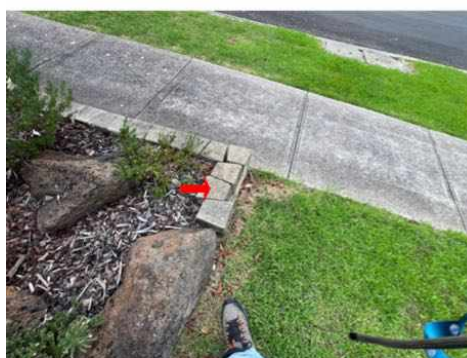
### Defects 3.03

Building:	Yard
Location:	All Areas > Front Left
Finding:	Retaining wall - Defective-to garden bed
Information:	The retaining wall in this area was found to be defective at the time of inspection. Generally, defective retaining walls are caused by poor original design or material use. However, deteriorated retaining walls may also be a result of substandard construction, poor site drainage or unmanaged stormwater flows.

If left unmanaged, the retaining wall may become a safety hazard if it continues to destabilise. Where retaining walls further rot and decay, an environment is created that

is conducive to termite and pest infestation.

Significant repair and replacement should be expected. Where retaining walls are considered structural walls, a structural engineer / surveyor should be consulted regarding required remedial works. Otherwise, a landscaper or retaining wall installer may be appointed to repair or replace the wall, at the discretion of the client.

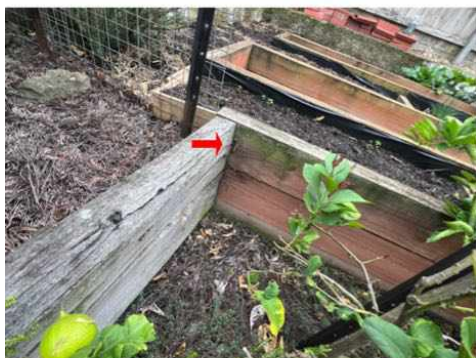
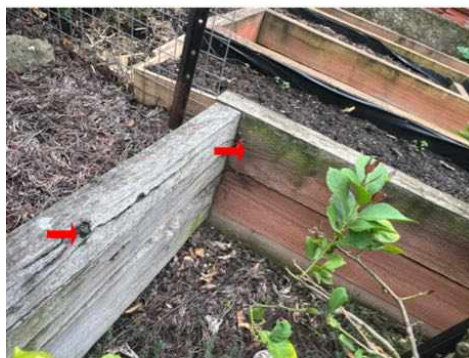
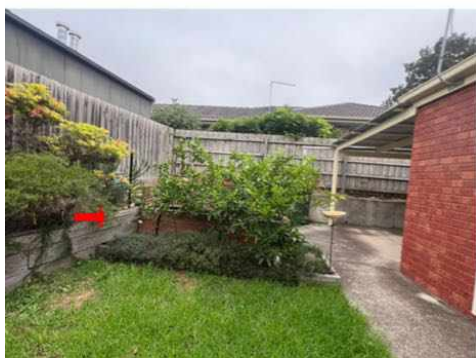
### Defects 3.04

Building:	Yard
Location:	Yard - Side > Rear
Finding:	Wood rot-to timber retaining walls
Information:	This building element shows evidence of wood rot. Wood rot, also known as Fungal Decay, occurs when timbers and other cellulose building materials are exposed to damp conditions on an ongoing basis. This could be the result of exposure to weathering over a prolonged period of time, or the attraction of excessive moisture from other abutting building materials. Contributing factors also include poor air ventilation in the area.

Wood rot is often associated with general damp problems and is evidenced by a 'musty' smell or mould and mildew occurring on surfaces. If left unmanaged, damp conditions can lead to further health problems and the decay of timbers will continue.

the useful life of these building elements. Prior to any works being performed, the cause of the moisture that has created the visible wood rot should be identified and addressed in a suitable manner. Replacement of affected timbers may then be a necessary step in protecting surrounding building elements from such deterioration.

A qualified plumber may be appointed to assess the cause of excessive moisture and to provide advice on any remedial works as required. A qualified carpenter or registered builder may also be required to replace affected building materials.

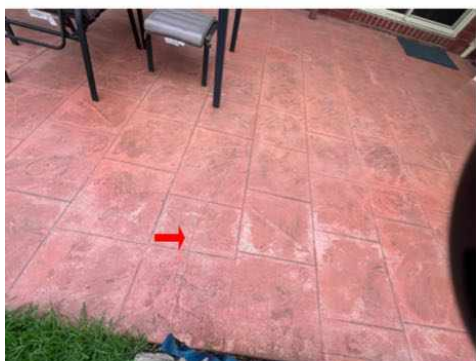
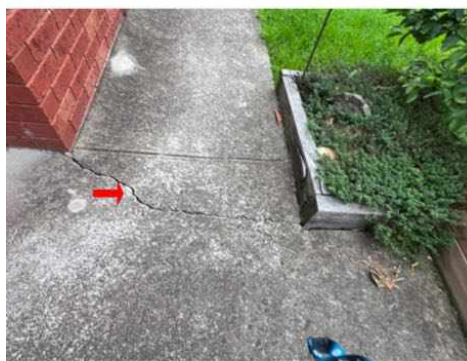
### Defects 3.05

Building:	Yard
Location:	Rear Elevation > Centre, Rear Left
Finding:	Cracking - External Concrete Paving Damage Category 1 - Fine (less than 2mm) & noted 'heaving' to some areas - expected due to site drainage-
Information:	Fine cracks were identified in external concrete paving. Although fine cracks are quite noticeable, they are often only considered to be an appearance defect, and usually do not indicate any structural damage. To be considered a Category 1 or fine crack, the crack is found to be less than 2mm in width.

Generally the cause of a hairline crack in existing concrete paving such as driveways and pathways is indicative of the expansion and contraction of the concrete. Such causes are generally due to environmental factors, such as moisture levels, weather

conditions, root systems of nearby trees or the soil types on which they are laid.

Fine cracks may also be due to poor original installation of the concrete. Factors such as poor compaction of the sub surface and/or inadequate reinforcing of the slab may create cracking and other secondary defects.

Monitoring of all cracking should be conducted frequently. Always contact a building inspector should cracks widen, lengthen, or become more numerous.

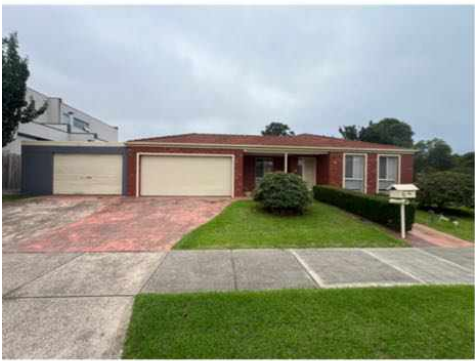
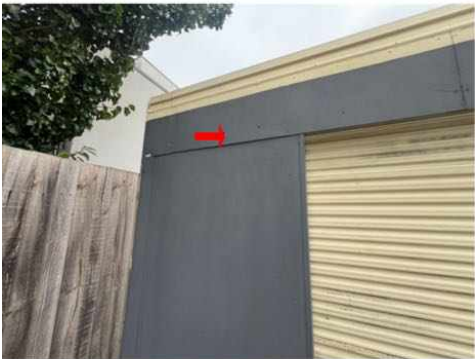
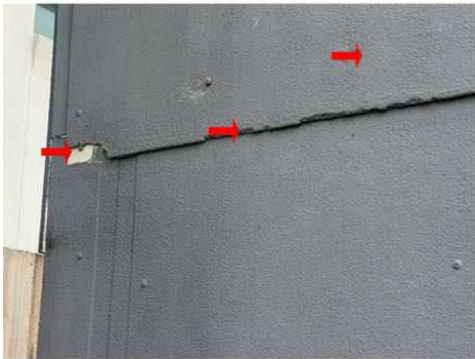
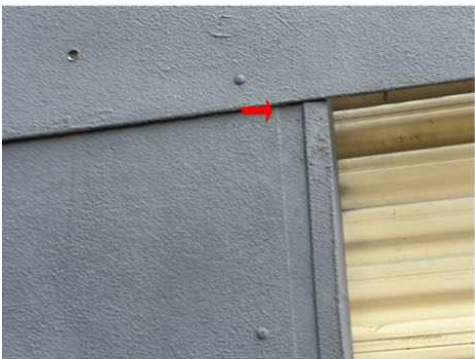
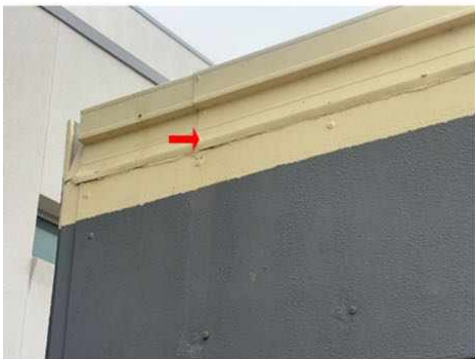
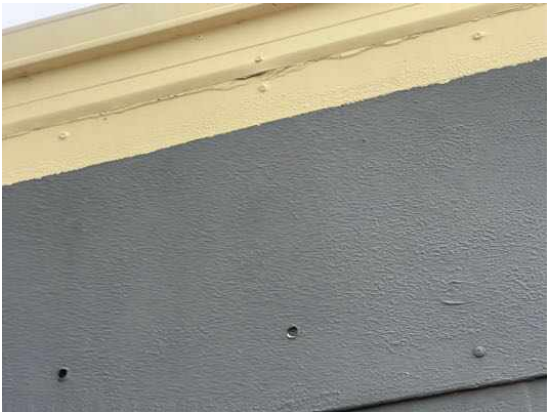
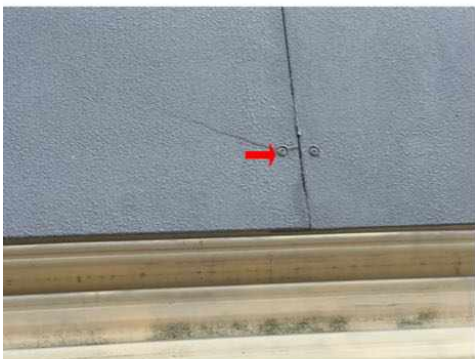
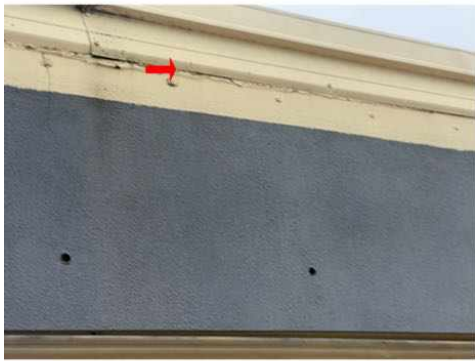
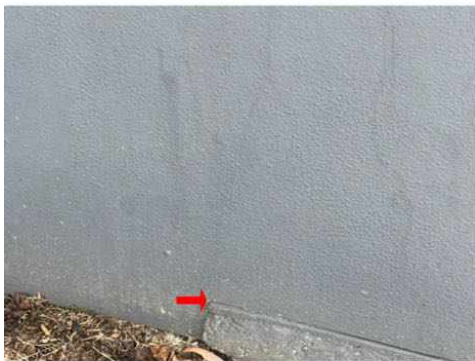
### Defects 3.06

Building:	Main Building
Location:	Front Elevation > Centre Left
Finding:	Unconventional handyman work-poorly constructed fascia to roller door-
Information:	This handyman work appears to have been completed to a substandard level and does not comply with regular building practices. Where handyman work is not completed satisfactorily, accelerated deterioration of the associated building elements is likely to occur and secondary defects to surrounding structures may develop.

It is highly recommended that the substandard work be rectified by professional services. Works to improve this area are likely to increase the safety and the operation of the associated building elements.

The client should exercise care when coming into the immediate vicinity of the substandard works. Rectification works are advised as soon as possible by the appropriate trades.

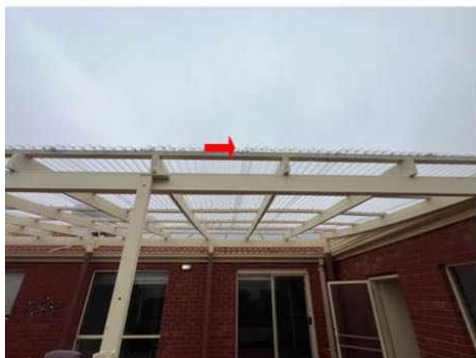
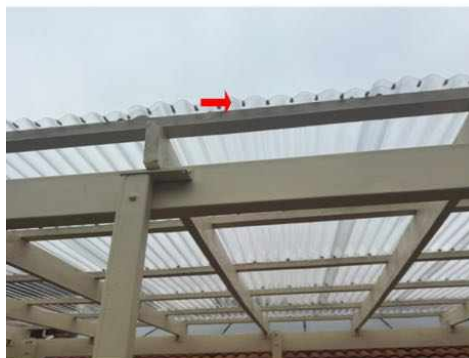
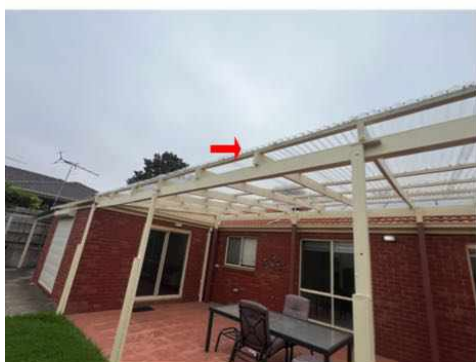
### Defects 3.07

Building: Main Building  
 Location: Pergola > All Areas  
 Finding: Building element - Missing-no roof plumbing installed-eg gutters -& down pipes-  
 Information: Although some building elements may seem irrelevant or unnecessary, all building elements play a key role in the operation and function of the overall structure and its performance.

Replacement of any missing building element should be conducted as soon as possible to ensure that no damage or functional issues occur to associated building materials.

The appropriate tradesperson should be appointed as soon as possible to replace the missing building element.

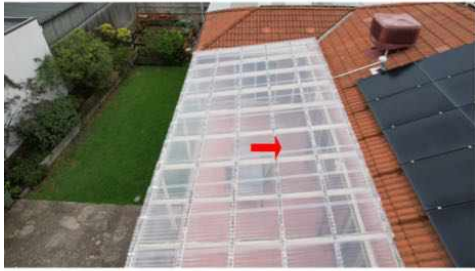
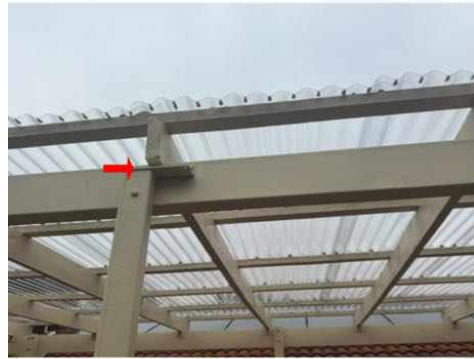
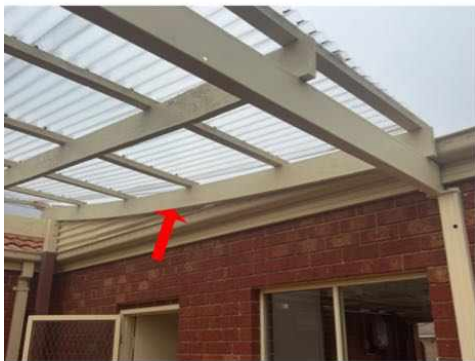
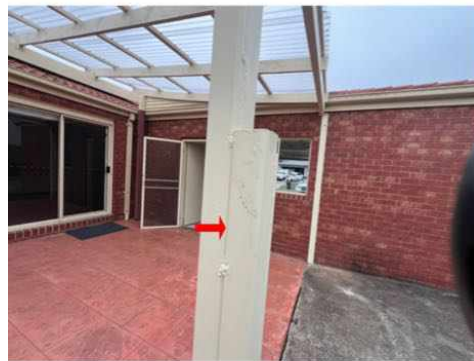
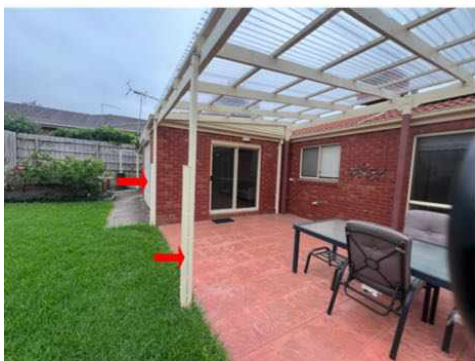
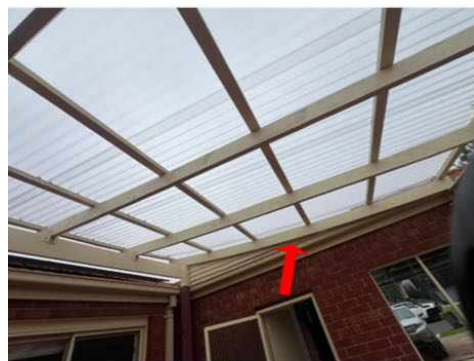
### Defects 3.08

Building:	Main Building
Location:	Pergola > All Areas
Finding:	Unconventional handyman work-throughout the pergola structure
Information:	This handyman work appears to have been completed to a substandard level and does not comply with regular building practices. Where handyman work is not completed satisfactorily, accelerated deterioration of the associated building elements is likely to occur and secondary defects to surrounding structures may develop.

It is highly recommended that the substandard work be rectified by professional services. Works to improve this area are likely to increase the safety and the operation of the associated building elements.

The client should exercise care when coming into the immediate vicinity of the substandard works. Rectification works are advised as soon as possible by the appropriate trades.

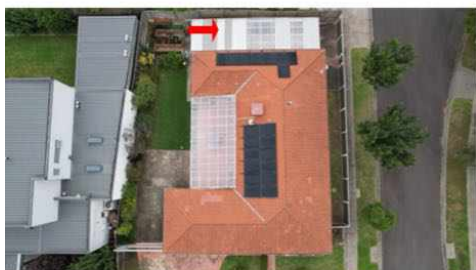
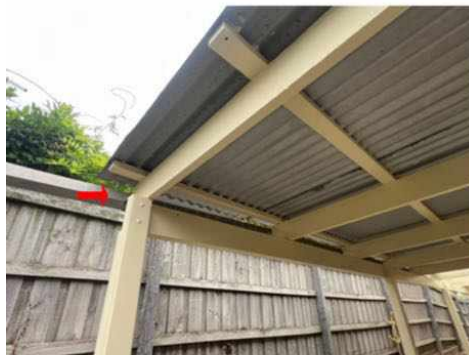
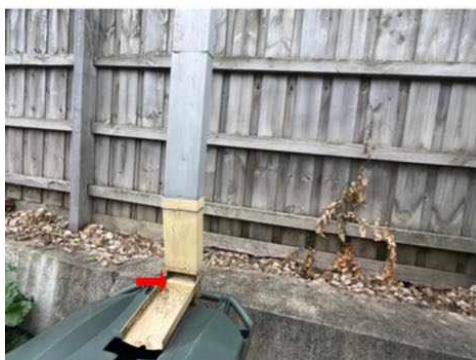
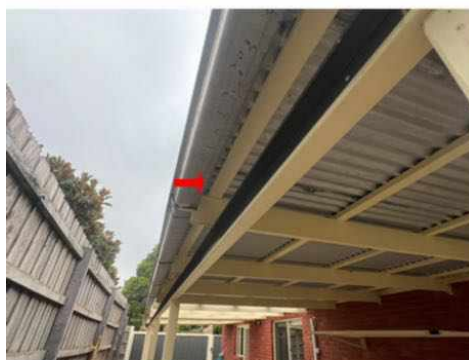
### Defects 3.09

Building: Main Building  
 Location: Pergola > Rear  
 Finding: Plumbing - Point of connection non-compliant  
 Information: At the time of inspection it was noted that connections between above ground pipe work and below ground sewer/storm water systems were incomplete.

connections which can pose a serious health risk.

Engagement of a certified plumber is strongly recommended to ensure all connection points are sealed in accordance with the plumbing construction guidelines.

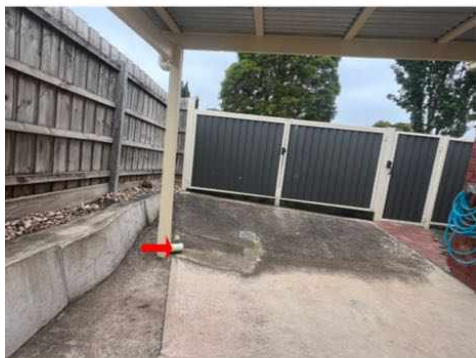
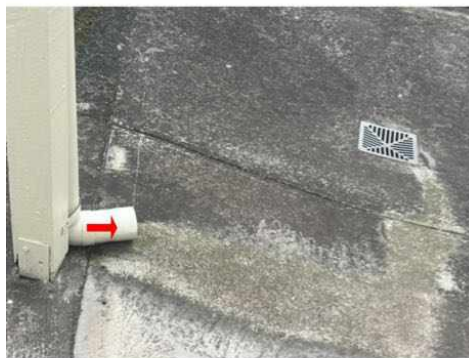
### Defects 3.10

Building:	Main Building
Location:	Pergola > Rear Right
Finding:	Plumbing - Point of connection non-compliant
Information:	At the time of inspection it was noted that connections between above ground pipe work and below ground sewer/storm water systems were incomplete.

Additionally, where sewer pipes are concerned, gases can escape from unsealed connections which can pose a serious health risk.

Engagement of a certified plumber is strongly recommended to ensure all connection points are sealed in accordance with the plumbing construction guidelines.

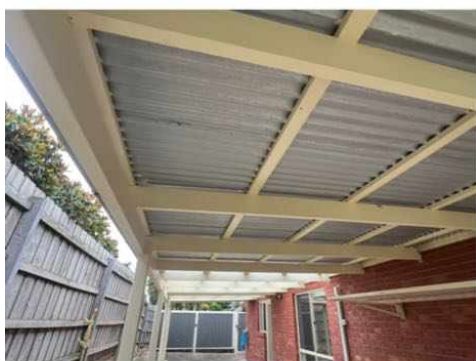
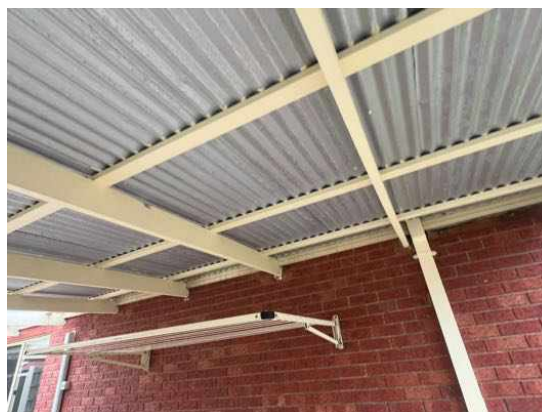
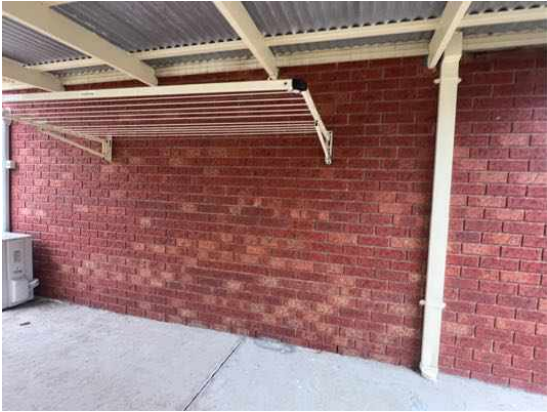
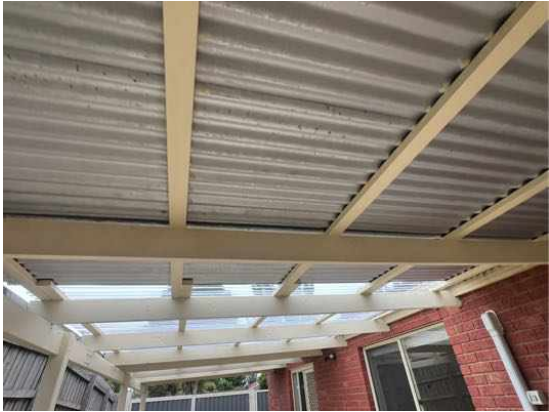
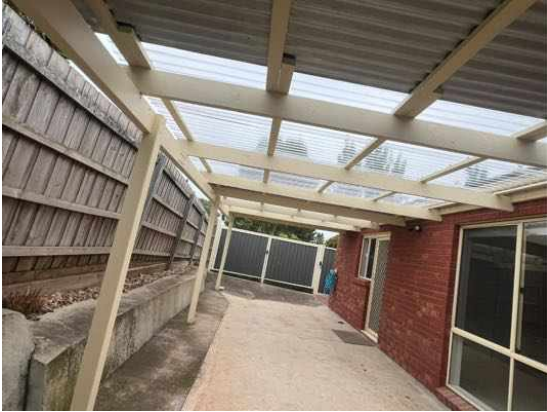
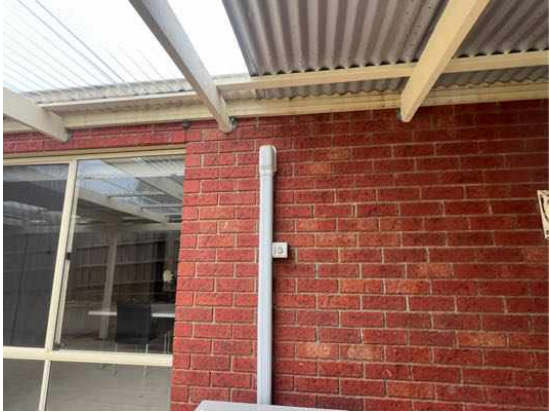
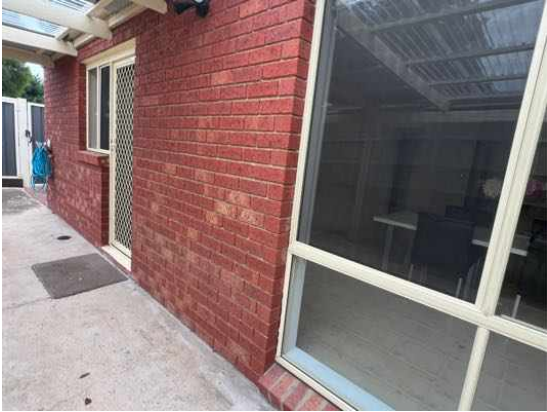
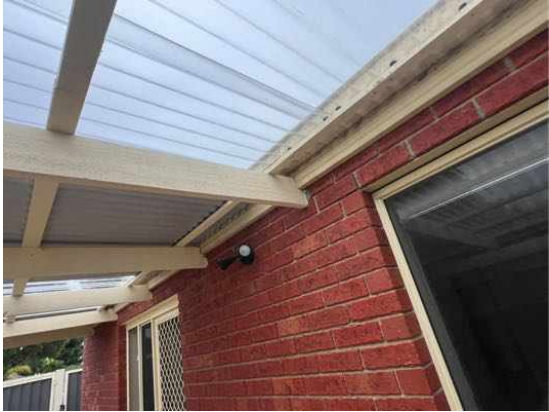
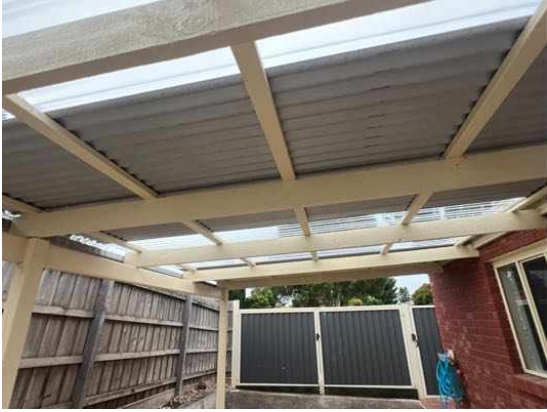
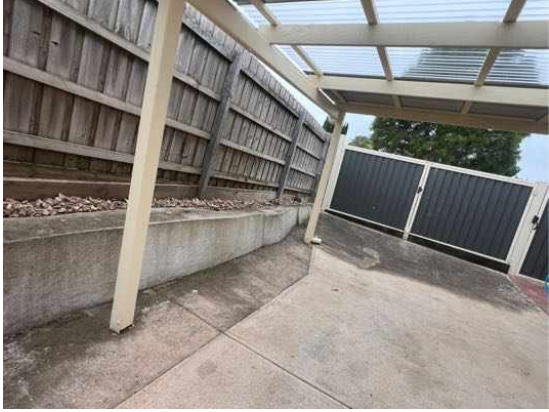
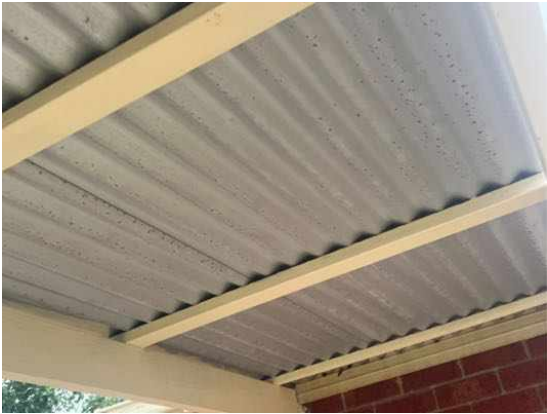
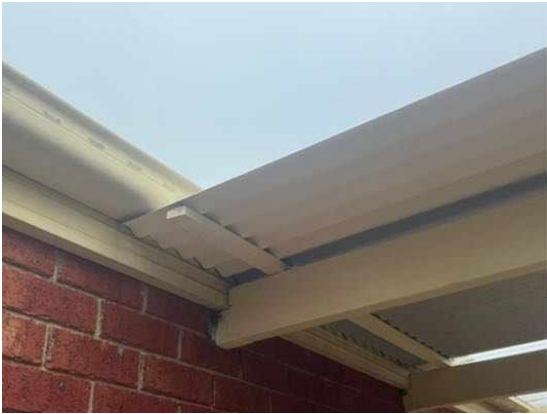
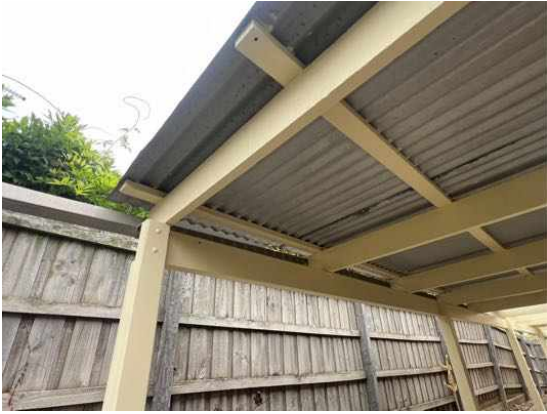
### Defects 3.11

Building:	Main Building
Location:	Pergola > Rear
Finding:	Unconventional handyman work
Information:	This handyman work appears to have been completed to a substandard level and does not comply with regular building practices. Where handyman work is not completed satisfactorily, accelerated deterioration of the associated building elements is likely to occur and secondary defects to surrounding structures may develop.

It is highly recommended that the substandard work be rectified by professional services. Works to improve this area are likely to increase the safety and the operation of the associated building elements.

The client should exercise care when coming into the immediate vicinity of the substandard works. Rectification works are advised as soon as possible by the appropriate trades.

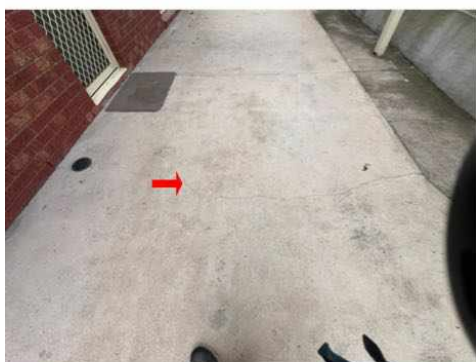
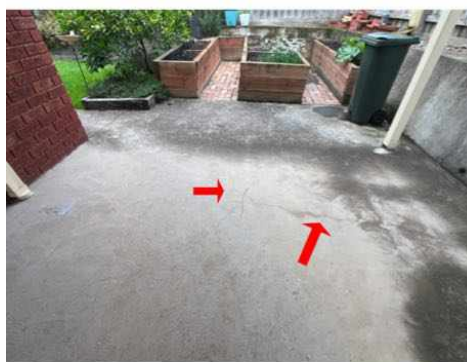
### Defects 3.12

Building:	Main Building
Location:	Pergola > Rear
Finding:	Cracking - Damage Category 0 - Hairline (less than 1mm)
Information:	Hairline cracks are very minor in nature and generally are only ever an appearance defect. While such cracking may be noticeable in some cases, it is quite common and does not indicate any structural damage.

Cracking of this nature can generally be repaired with minor sanding, filling and/or repainting. Such works should be performed by a qualified painter or a general handyman.

Monitoring of all cracking should be conducted frequently. Always contact a building inspector should cracks widen, lengthen, or become more numerous.

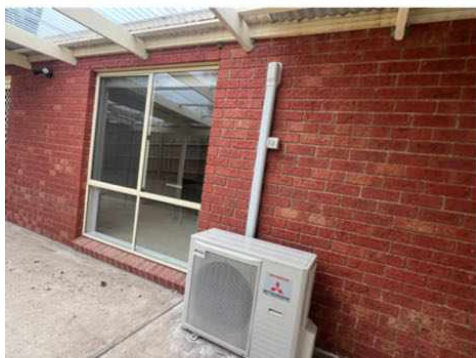
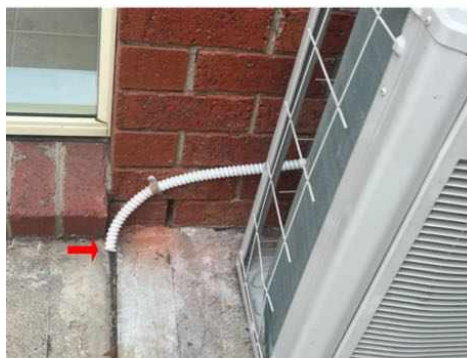
### Defects 3.13

Building:	Main Building
Location:	Rear Elevation > Centre
Finding:	Air conditioner - Disconnected overflow
Information:	The Air Conditioner (A/C) overflow was found to be disconnected from storm water drainage and is creating excessive moisture in the surrounding area.

Such leaking creates an environment which is conducive to an array of defects, including water damage to associated building elements and the attraction of termite or timber pest infestation.

It is highly recommended that a licensed plumber be appointed to connect the A/C overflow in order to prevent such an environment from being created. These minor works should be carried out as soon as possible.

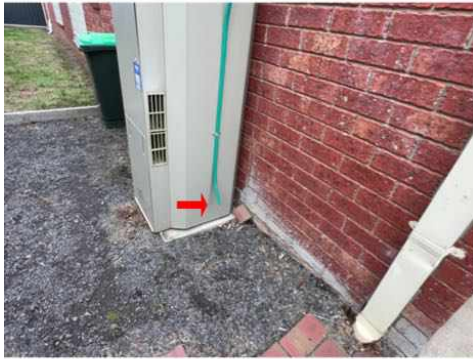
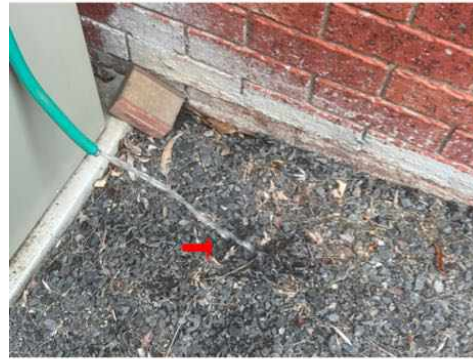
### Defects 3.14

Building:	Main Building
Location:	Exterior walls - right side > Rear
Finding:	HWS Overflow - Not Connected
Information:	The Hot Water System (HWS) overflow was found to be disconnected from storm water drainage and is creating excessive moisture in the surrounding area.

These damp conditions can lead to secondary defects such as rot, rust or corrosion of associated building elements, the formation of fungal decay, or even the creation of potential slip hazards. When coupled with poor site drainage, pooling of water may also attract termite activity to this area.

It is highly recommended that a licensed plumber be appointed to connect the HWS overflow in order to prevent such an environment from being created. These minor works should be carried out as soon as possible.

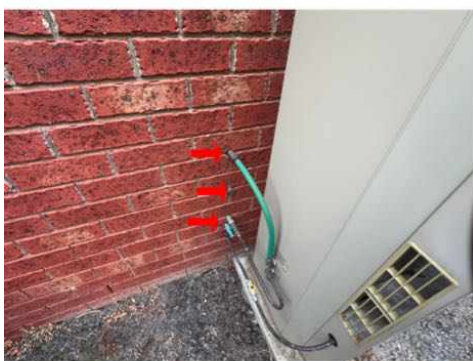
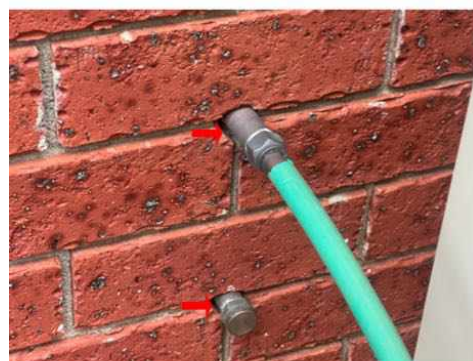
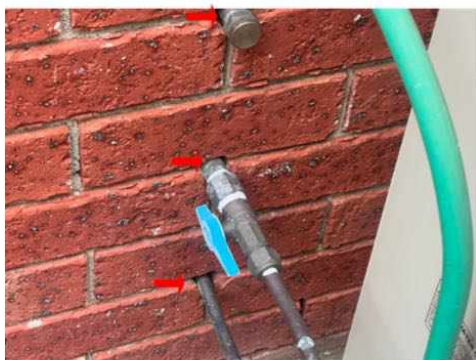
### Defects 3.15

Building:	Main Building
Location:	Exterior walls - right side > Rear
Finding:	External walls - Holes
Information:	Significant holes were identified around pipe penetrations in this wall section. It is suspected that the installation of this pipework was completed to a substandard level of workmanship or is incomplete.

Gaps and holes around pipework makes the area susceptible to insect and vermin ingress, as well as allowing water penetration to the cavity wall. As such, associated building elements are likely to deteriorate at an accelerated rate, and major implications are expected if holes around the pipework are left unmanaged.

All excessive holes, gaps or cracks should be adequately filled by a suitable sealant or trimmings as soon as possible to prevent any further damage. Such works may be conducted by a general handyperson or licensed plumber.

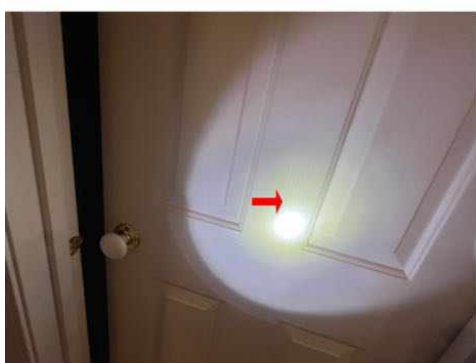
### Defects 3.16

Building: Main Building  
 Location: Bedroom - Master > Front Left  
 Finding: Door handle - Not latching-to WIR  
 Information: It was noted that the door in this area was not latching during operation at the time of inspection. Whilst detracting from the functionality of this building element, this minor defect may also be a security risk, and may therefore have serious implications if left unattended.

It is suspected that this defect has occurred due to minor issues with the associated hinges. Such damage is identified as general wear and tear, which is expected for building elements of this age.

A qualified carpenter or general handyperson may be appointed to perform rectification works as necessary, at client discretion. If left unattended, further functional impairment is likely to occur.

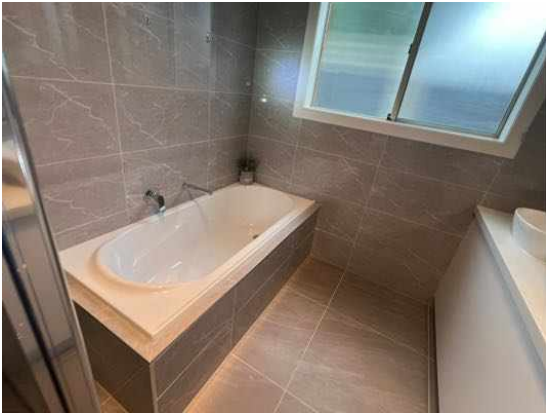
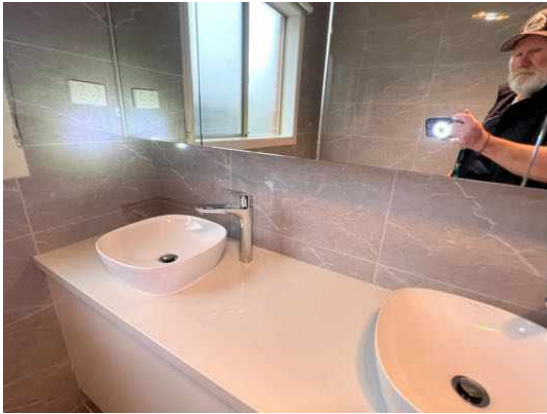
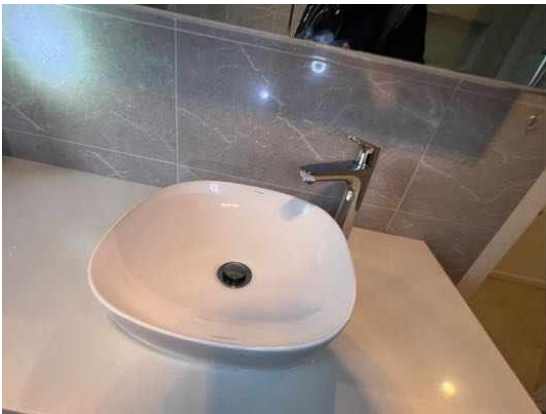
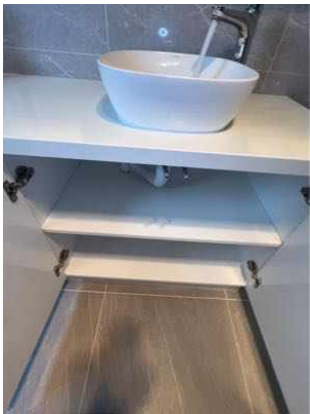
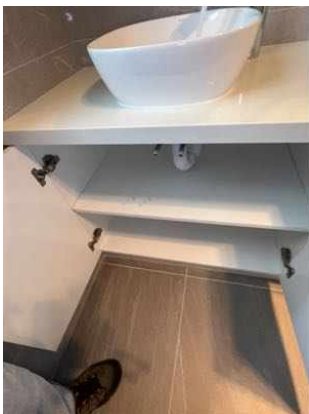
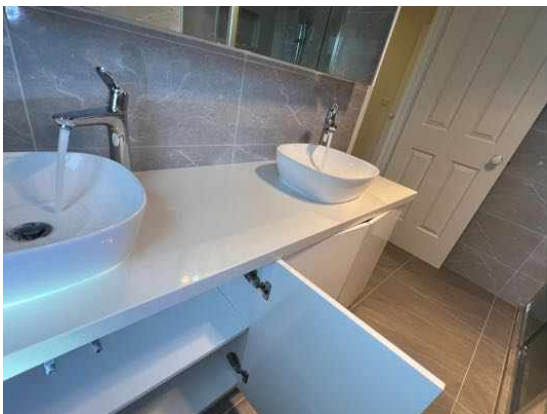
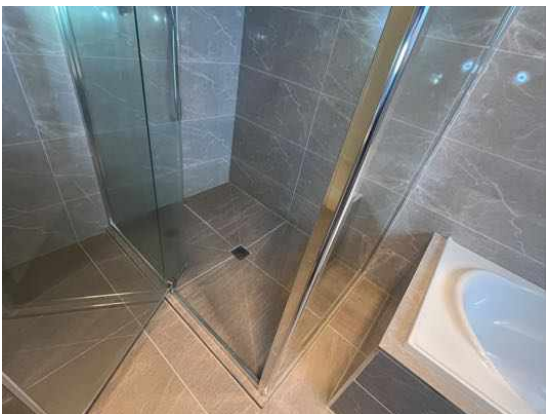
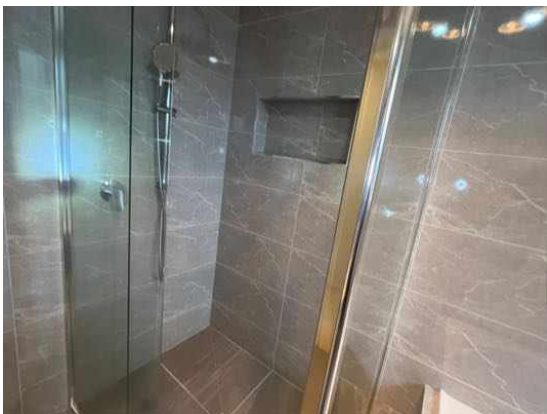
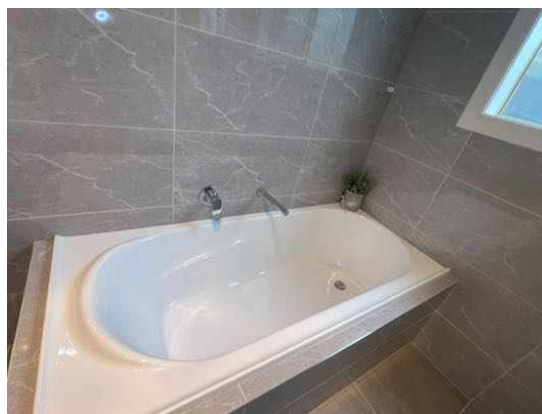
### Defects 3.17

Information: Additional photos are provided for your general reference

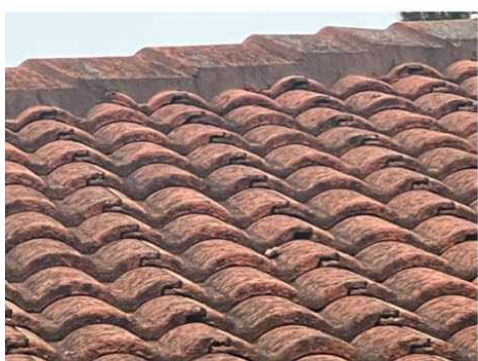
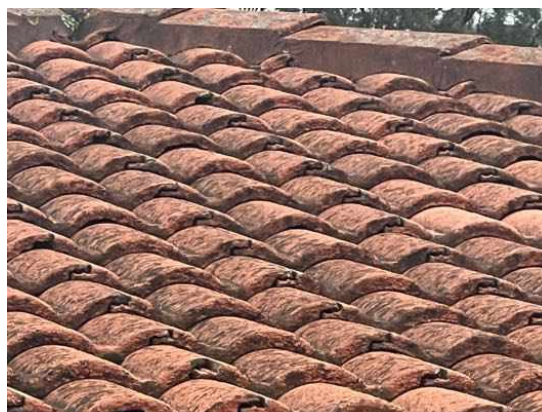
### Defects 3.18

Building:	Main Building
Location:	Front Elevation > All Areas
Finding:	Roof tiles - Weathered
Information:	Upon inspection of the exterior roofing, the majority of roof tiles were considered to be in a fair condition. While weathering of the tiles is consistent with the age of the property, maintenance works are required.

Isolated areas of mortar have come loose in the valleys and minor cracking is also present. Re-pointing and re-sealing the may be considered as an interim solution by the client to help preserve and extend the life span of the tiles.

Where left unmanaged, deteriorating roof tiles are likely to lead to a number of secondary defects, including minor water leaks and weather exposure to internal roofing structures.

Consultation with a roofing contractor is highly advised to gain advice on cost of remedial works that may be required in the short to medium term. Remedial works are likely to increase the longevity of the exterior roofing structure.

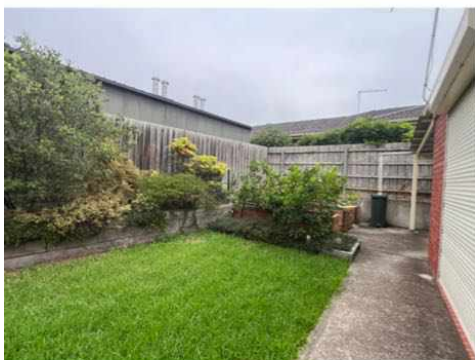
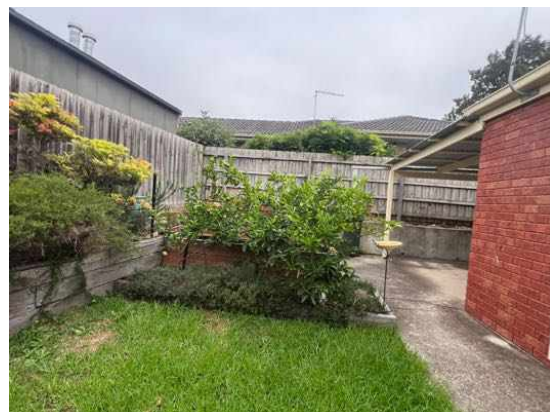
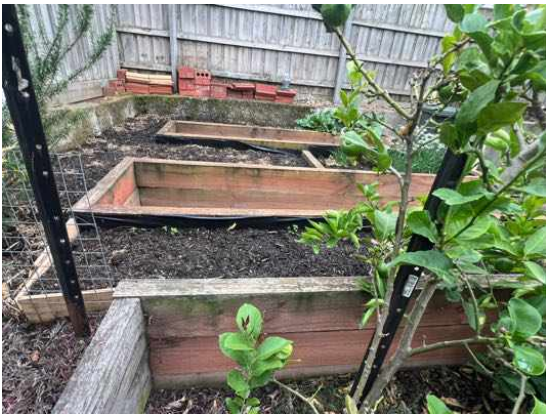
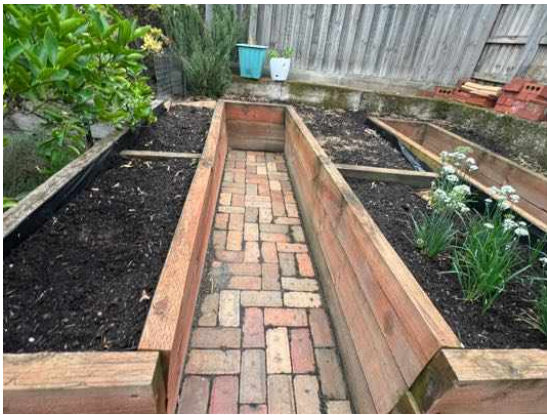
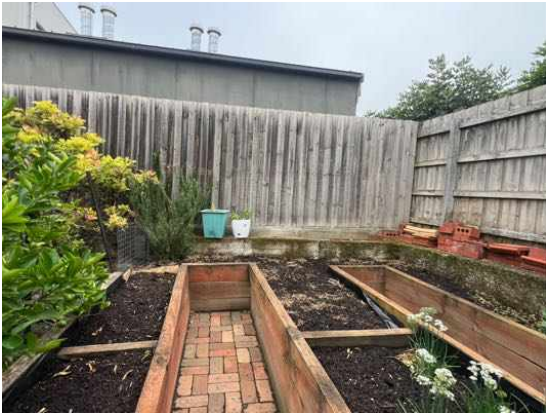
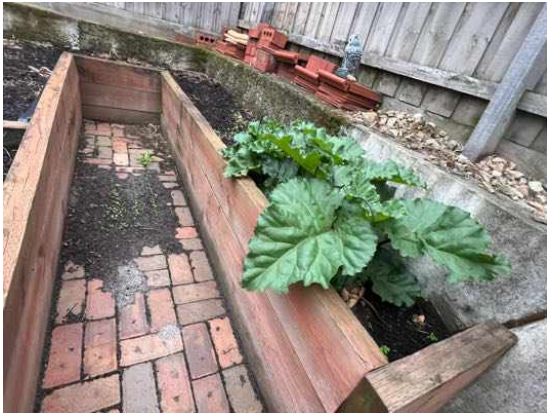
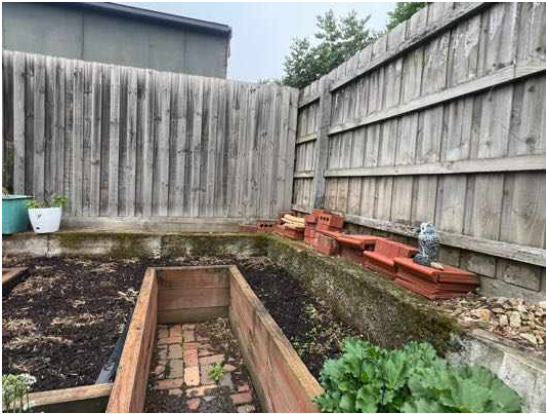
Building: Yard  
Location: Yard - Side > All Areas  
Finding: Additional Photos - Obstructions and Limitations  
Information: These photographs are an indication of the obstructions and limitations which impeded full inspection of the property at the time of inspection. These obstructions can hide an array of defects and should be removed to allow full inspection to be carried out. A re-inspection is recommended once the areas are made accessible.
