## Building Inspection Report

Inspection Date: Tue, 17 Mar 2026

Property Address: 6 Wyperfeld Ave, Taylors Lakes VIC 3038,  
Australia

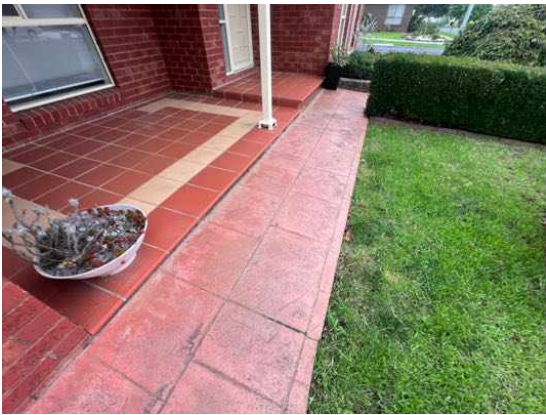
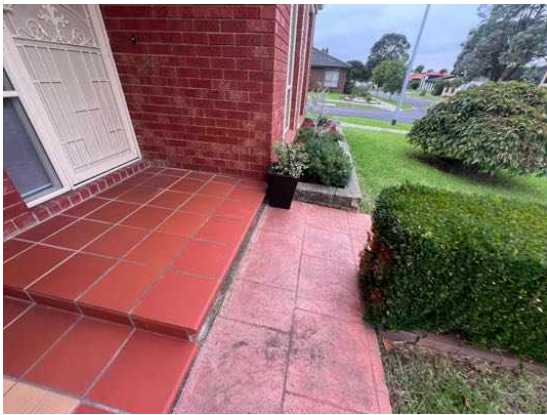
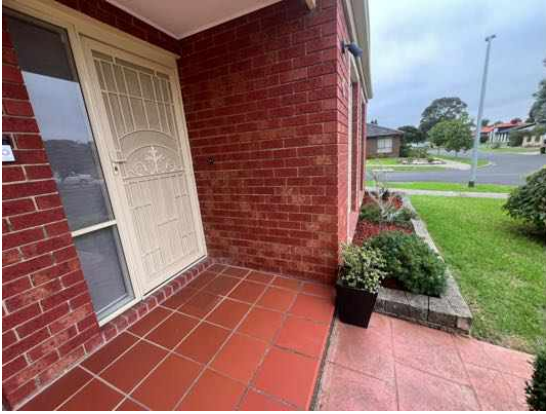
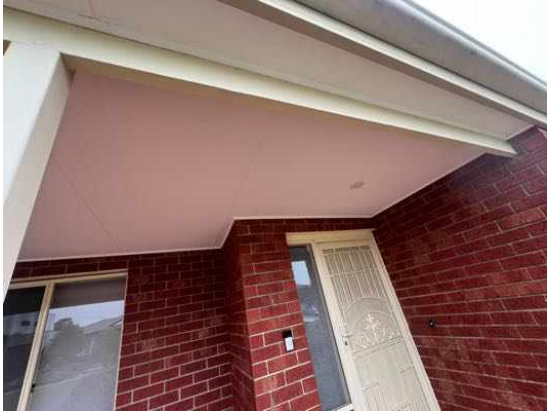
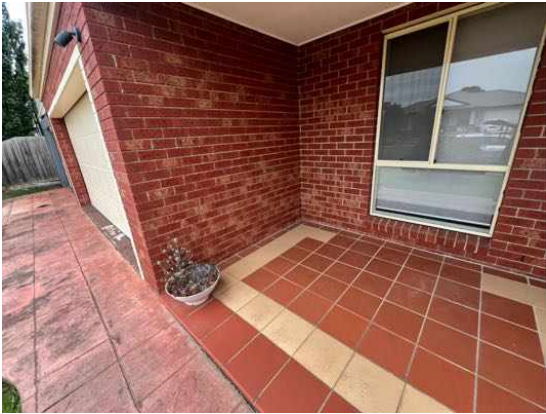
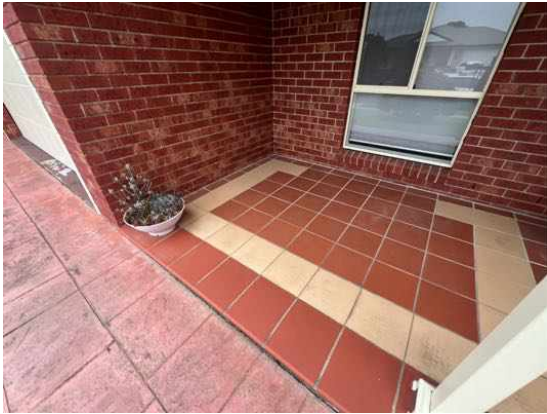
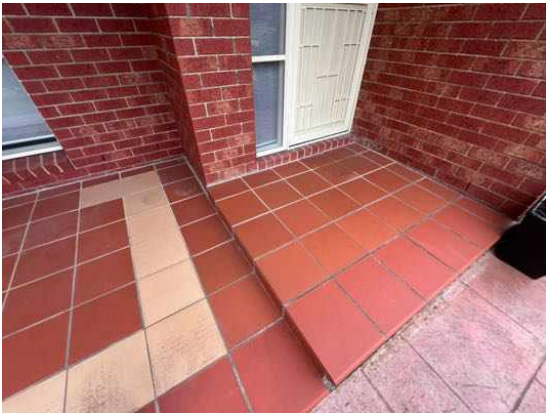
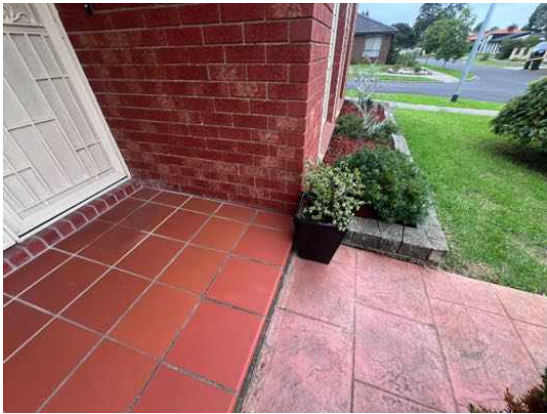
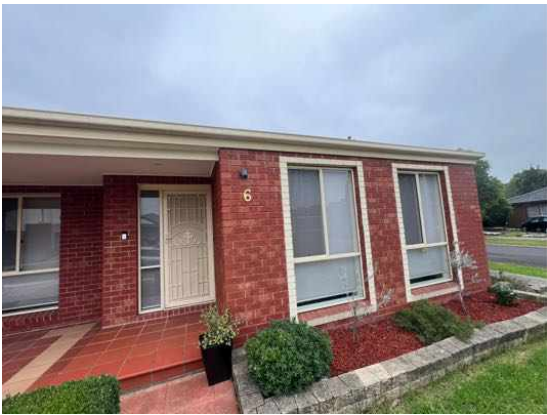
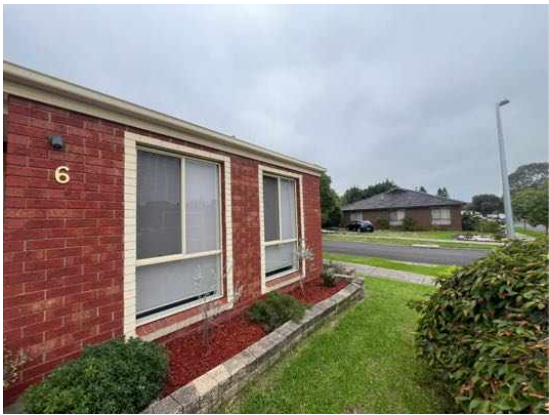
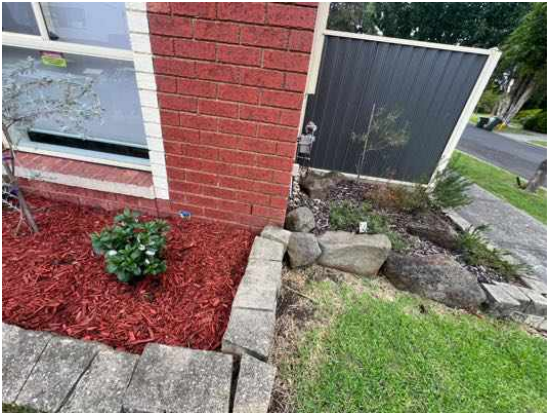
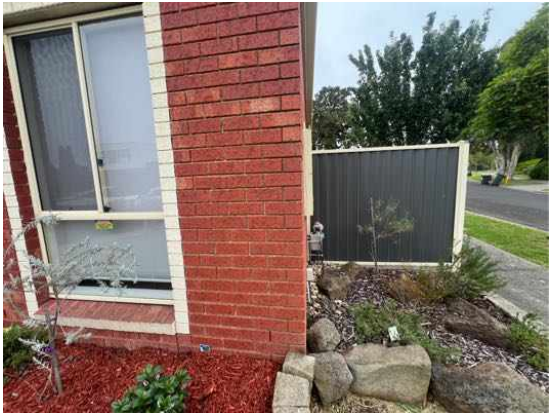
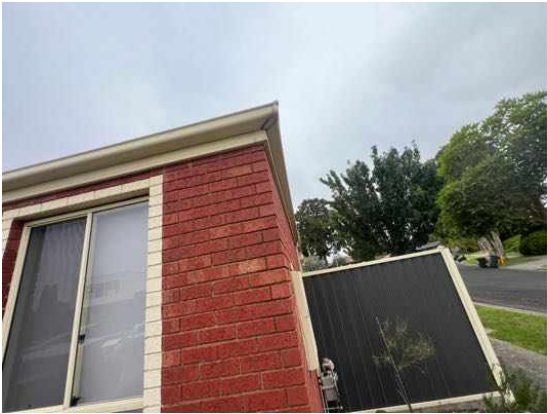
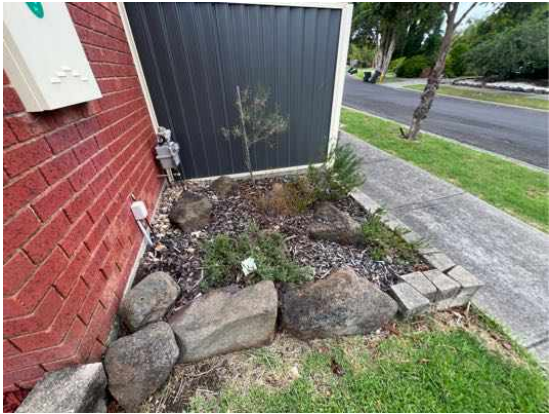
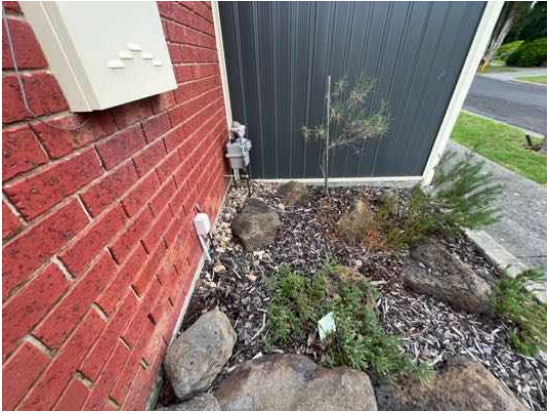
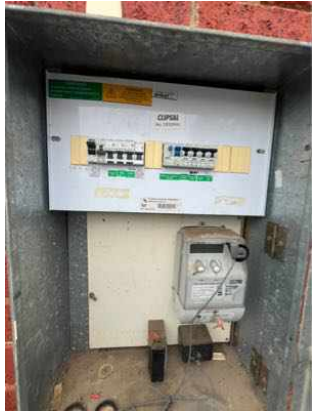
Building: Main Building  
Location: Front Elevation > All Areas  
Finding: Additional Photos  
Information: Additional photos are provided for your general reference

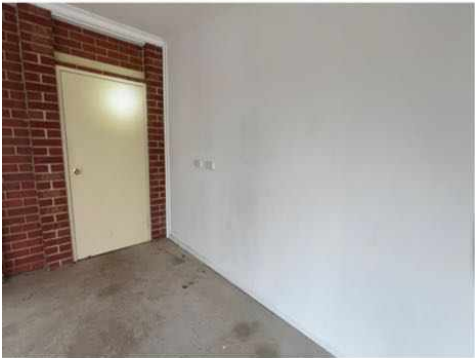
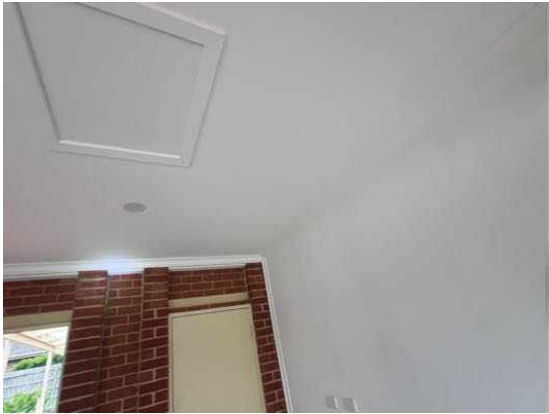
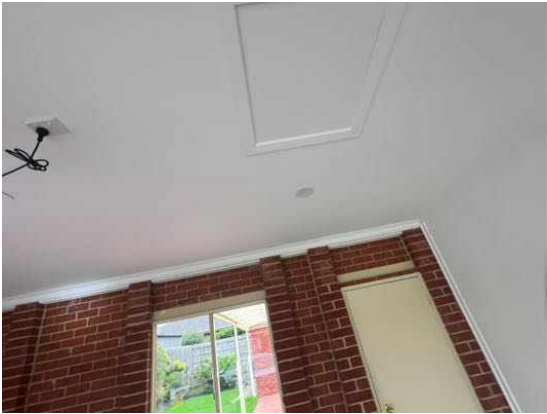
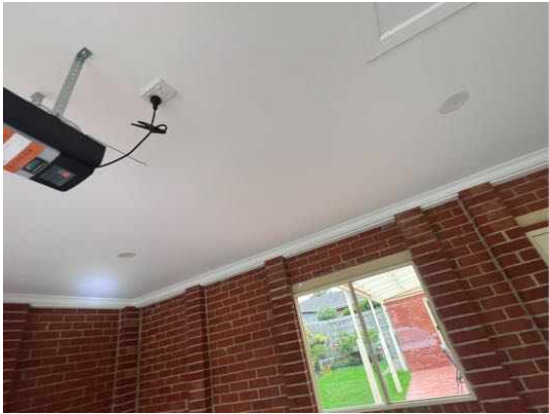
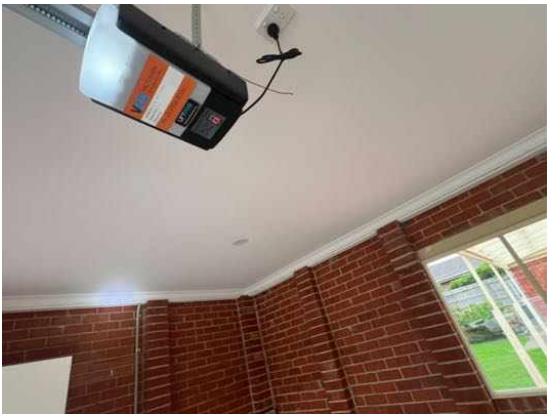
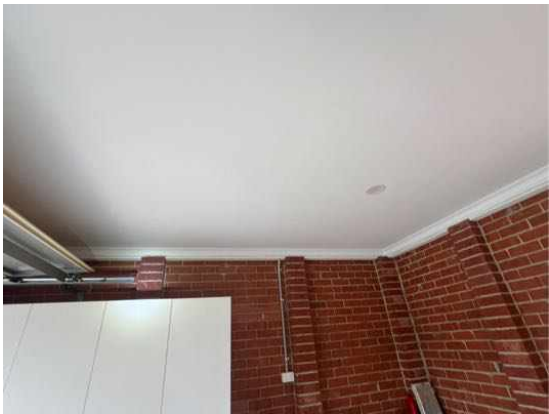
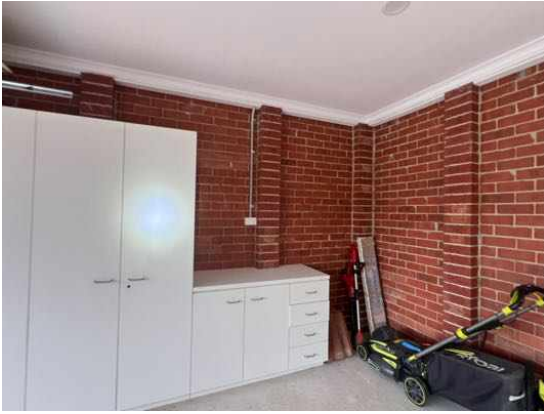
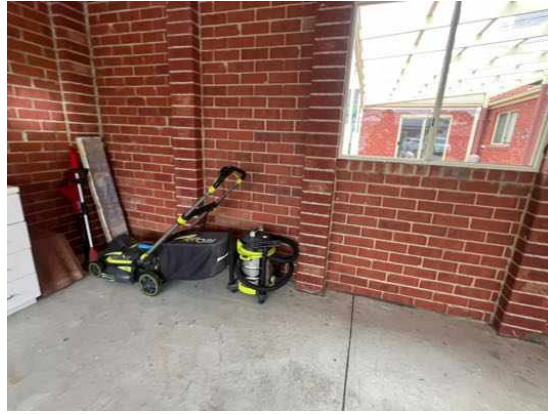
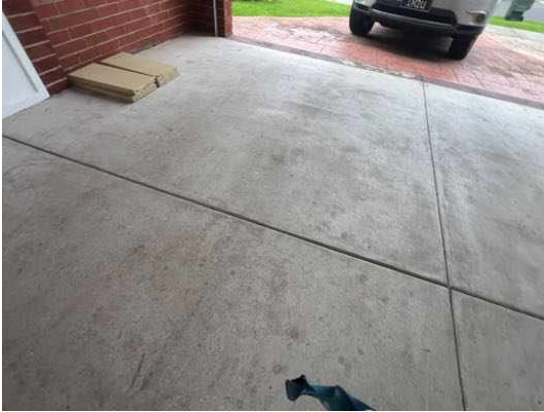
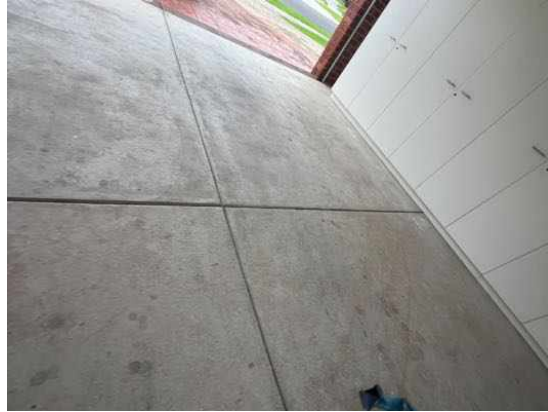
Building: Garage  
Location: All Areas > All Areas  
Finding: Additional Photos - Obstructions and Limitations  
Information: These photographs are an indication of the obstructions and limitations which impeded full inspection of the property at the time of inspection. These obstructions can hide an array of defects and should be removed to allow full inspection to be carried out. A re-inspection is recommended once the areas are made accessible.

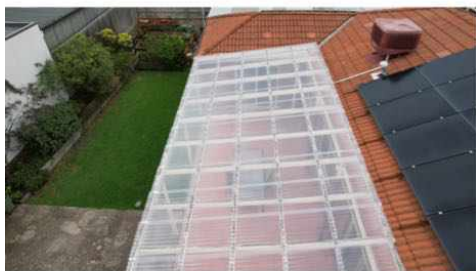
Building: Main Building  
 Location: Pergola > All Areas  
 Finding: Additional structure built without a permit (Suspected)  
 Information: The pergola structure on the left side of the house is suspected to have been constructed without a building permit. A building permit would be required for the structure.

It is highly advised to request that the current owner provide a Defect report (Owner Builder/Section 137b) for this structure. This would involve a structural engineer or a licenced building surveyor conducting an inspection of the structure and advising of any defects and/or areas of non-compliance in accordance with the current building codes. The current owner should then attend to any issues on this report prior to settlement.

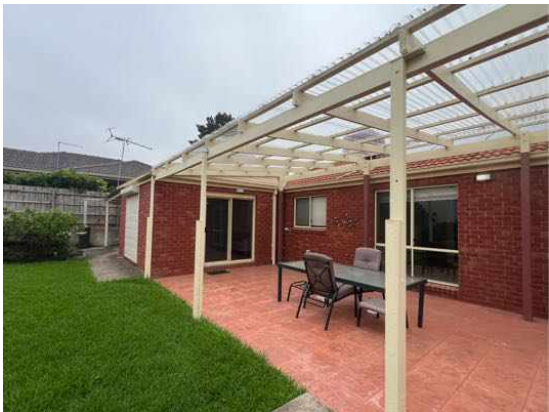
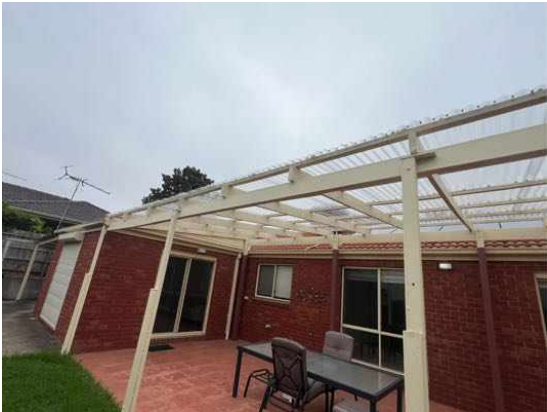
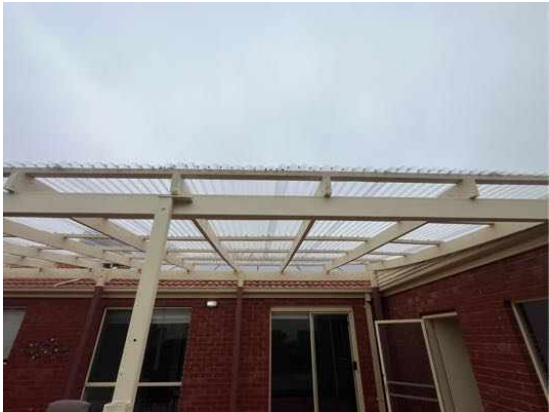
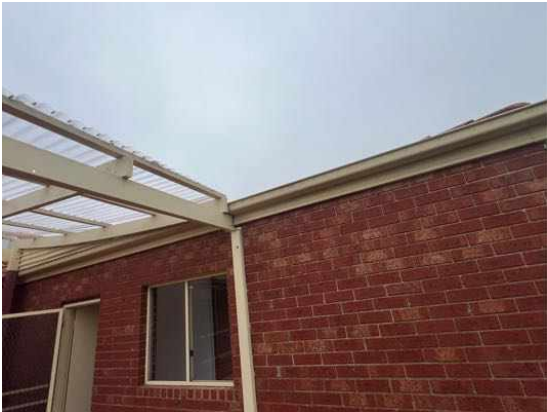
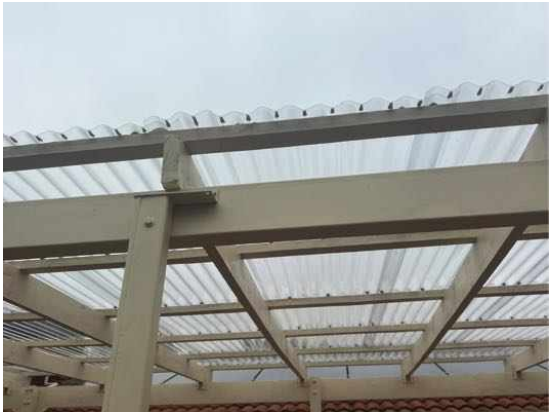
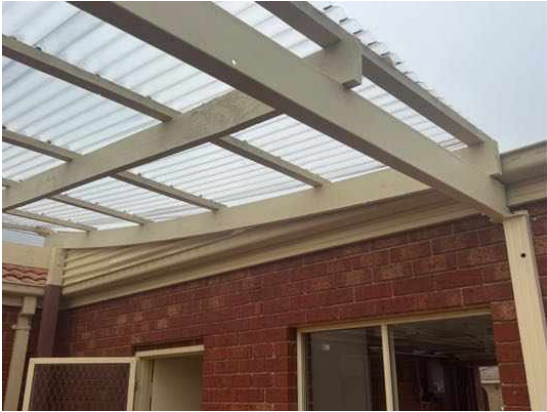
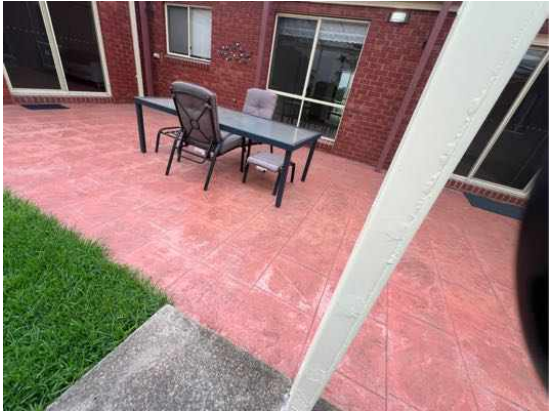
Building: Main Building  
Location: Exterior walls - left side > All Areas  
Finding: Additional Photos - Obstructions and Limitations  
Information: These photographs are an indication of the obstructions and limitations which impeded full inspection of the property at the time of inspection. These obstructions can hide an array of defects and should be removed to allow full inspection to be carried out. A re-inspection is recommended once the areas are made accessible.

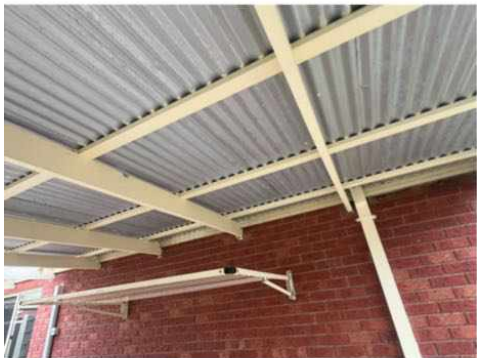
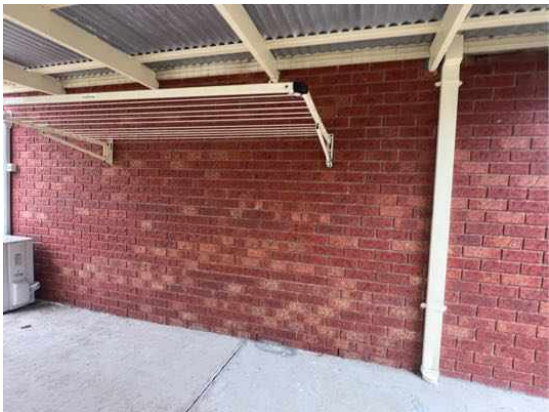
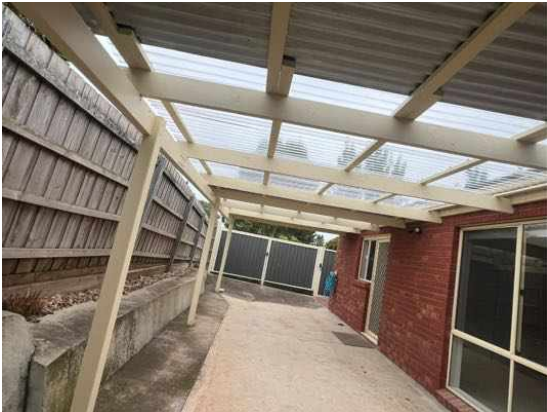
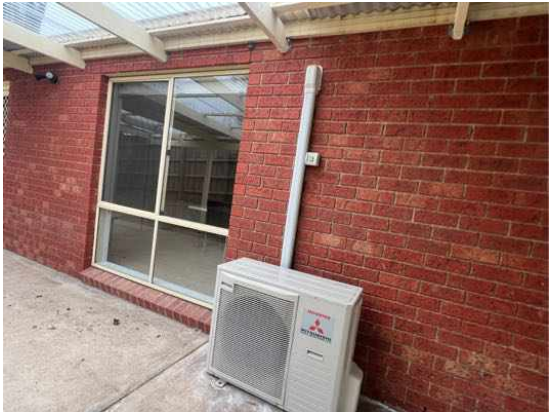
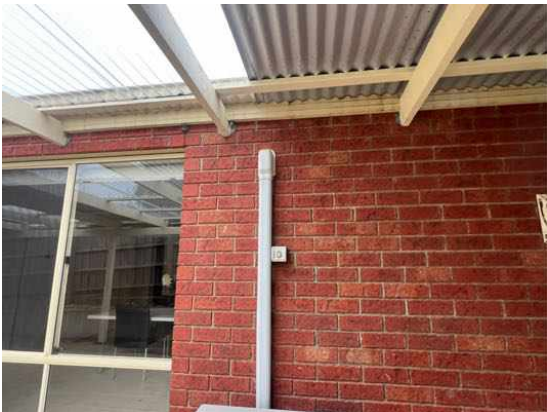
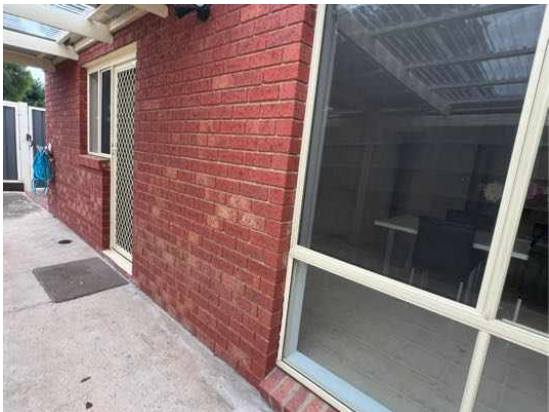
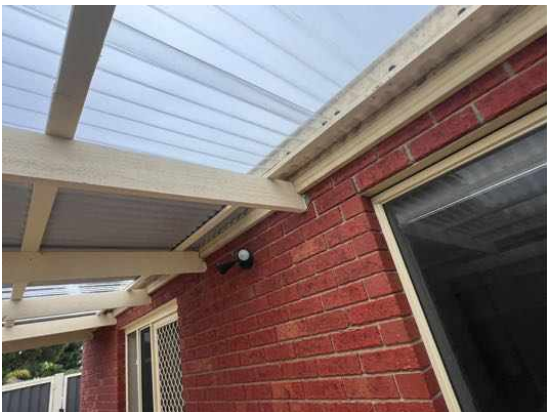
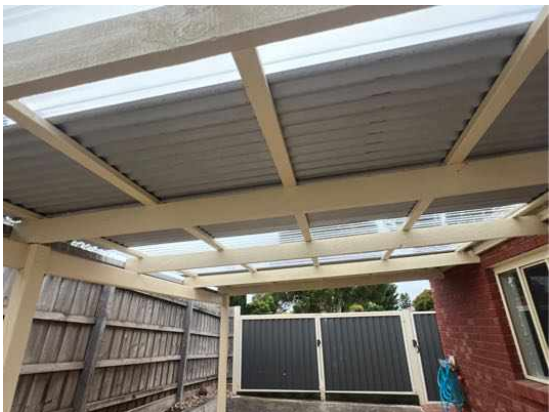
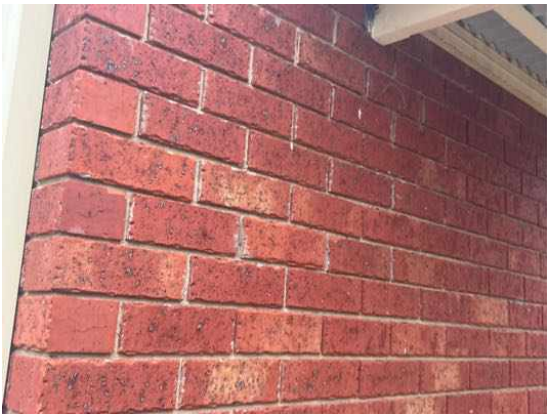
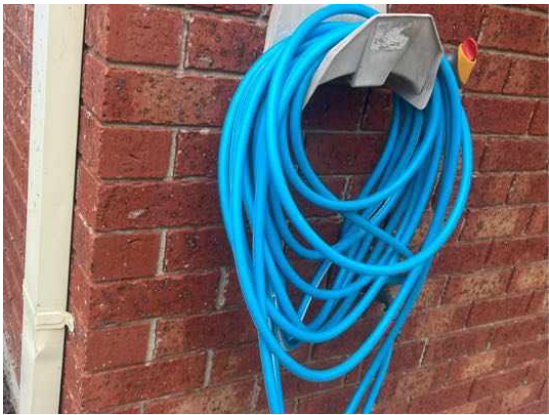
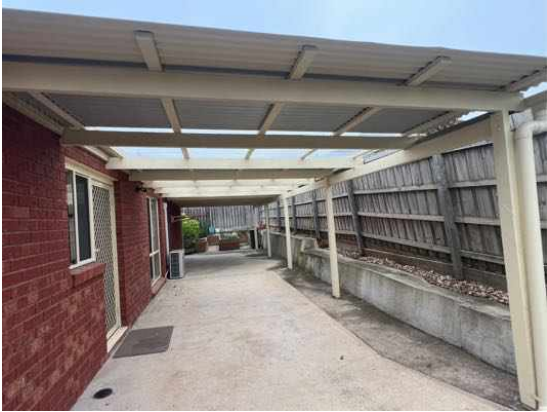
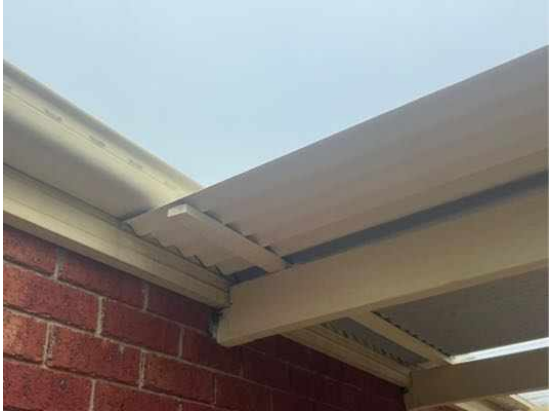
**Noted Item**

Building: Main Building  
Location: Rear Elevation > All Areas  
Finding: Additional Photos  
Information: Additional photos are provided for your general reference

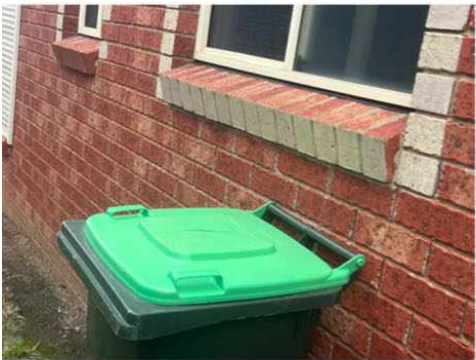
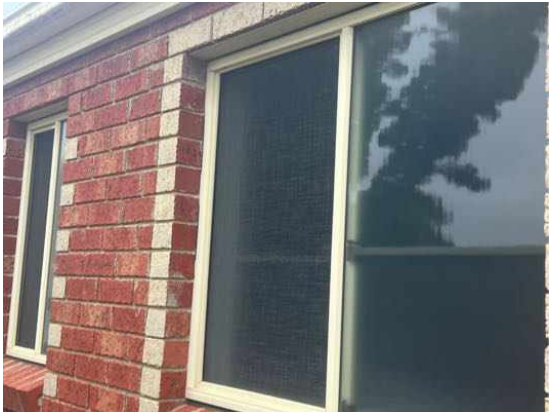
**Noted Item**

Building: Main Building  
Location: Exterior walls - right side > All Areas  
Finding: Additional Photos  
Information: Additional photos are provided for your general reference

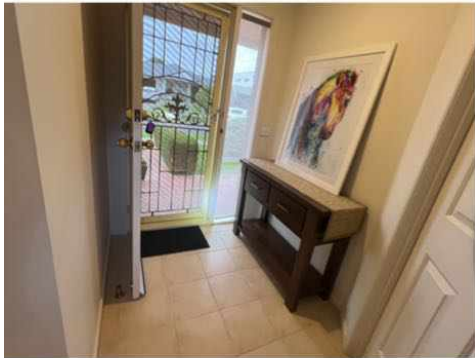
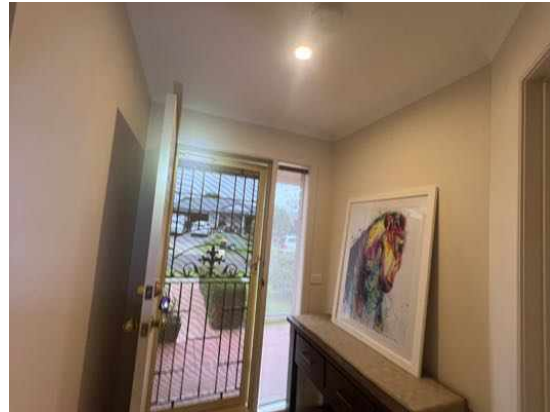
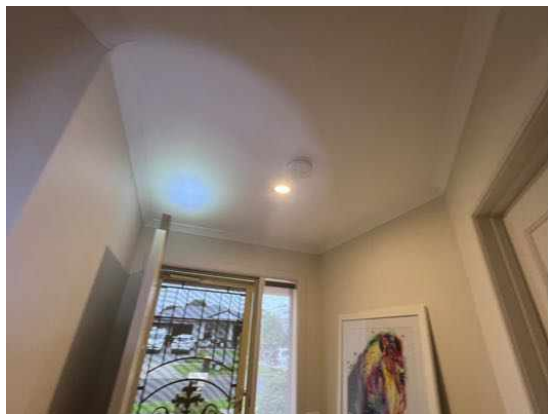
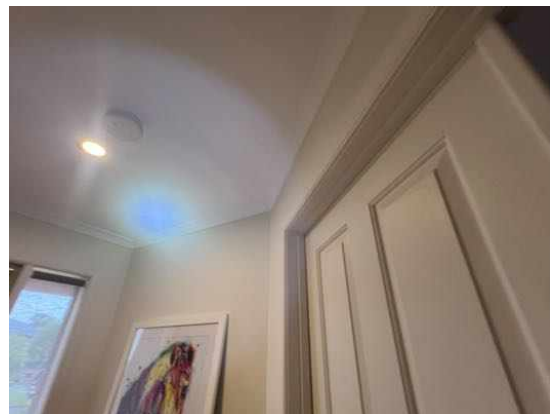
Building: Main Building  
 Location: Entry > All Areas  
 Finding: Additional Photos - Obstructions and Limitations  
 Information: These photographs are an indication of the obstructions and limitations which impeded full inspection of the property at the time of inspection. These obstructions can hide an array of defects and should be removed to allow full inspection to be carried out. A re-inspection is recommended once the areas are made accessible.

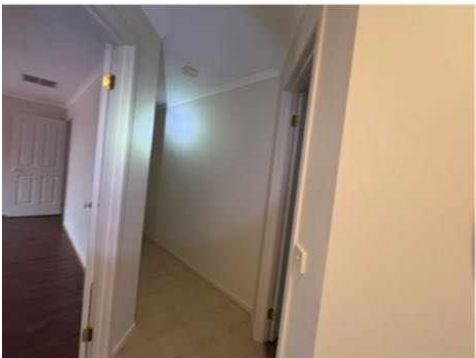
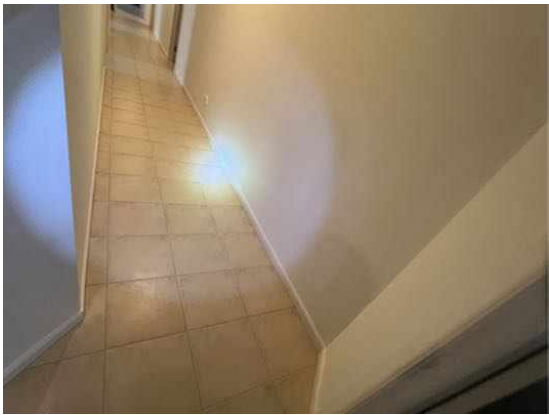
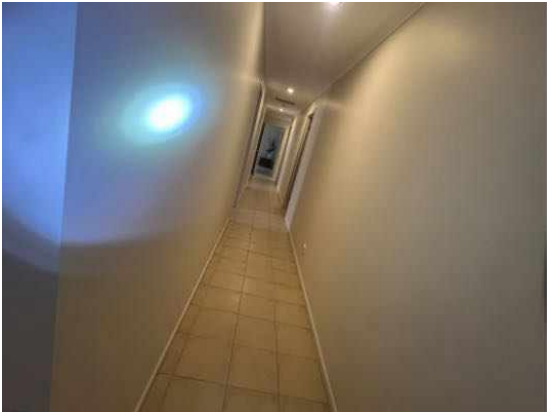
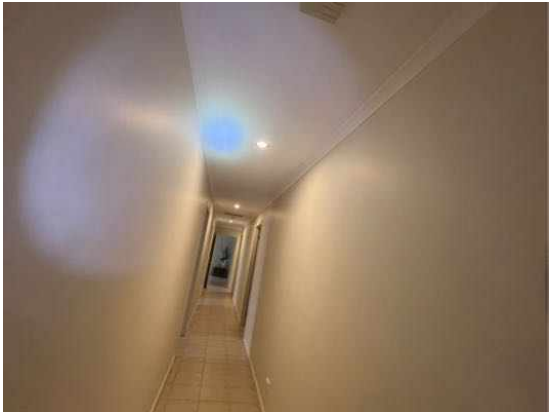
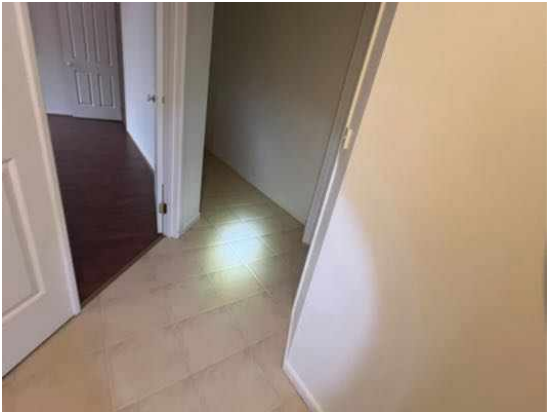
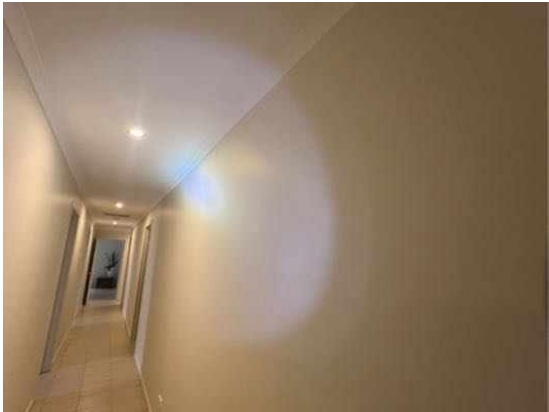
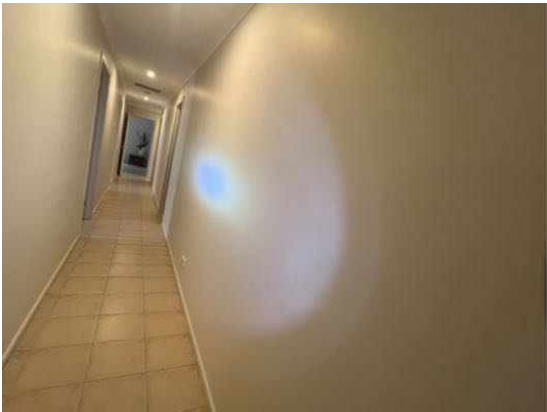
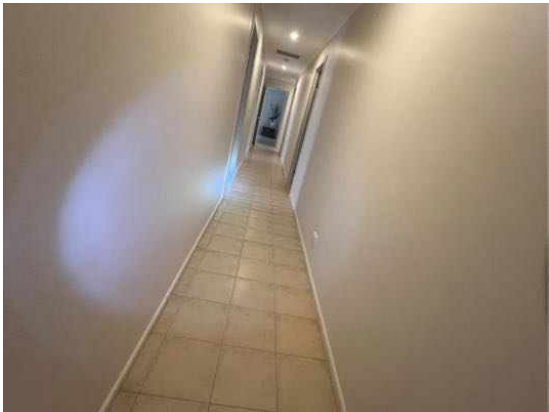
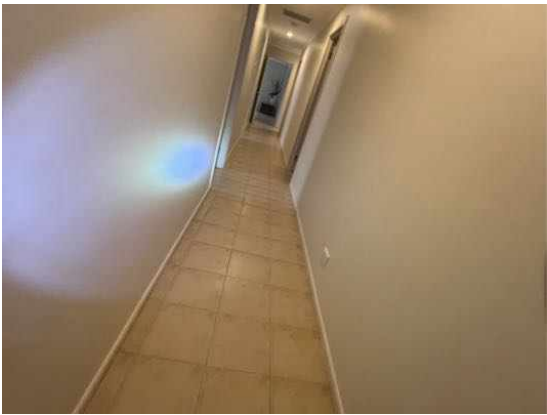
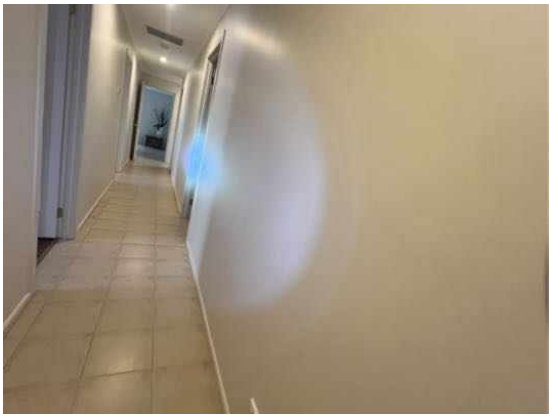
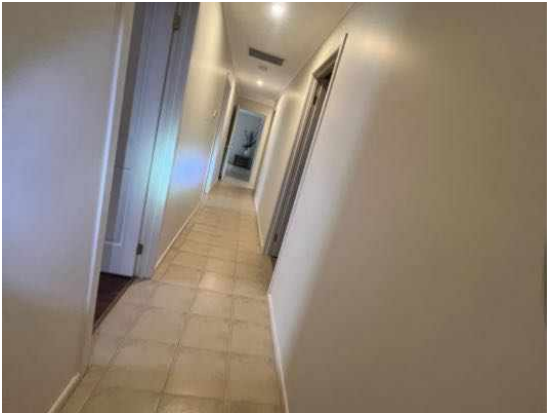
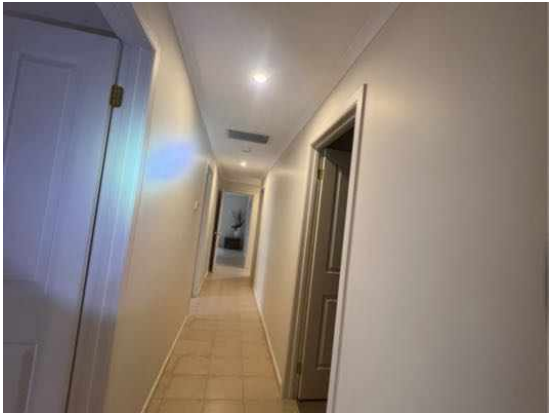
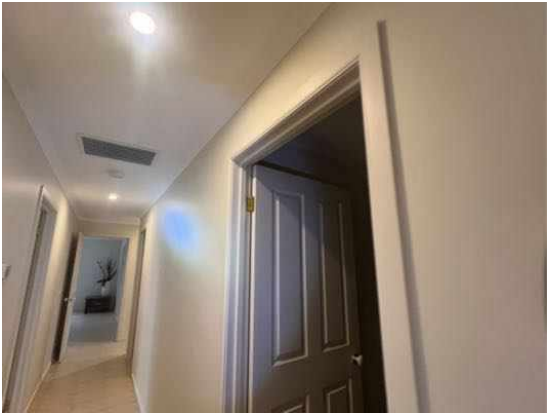
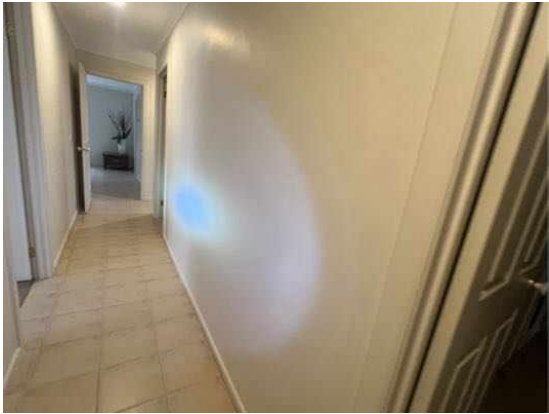
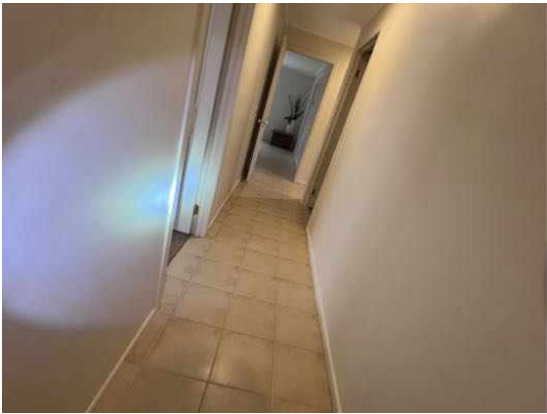
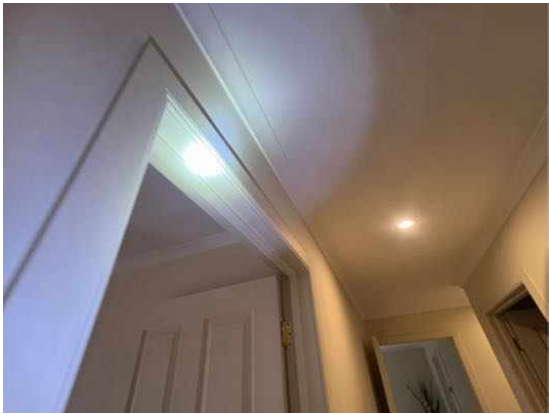
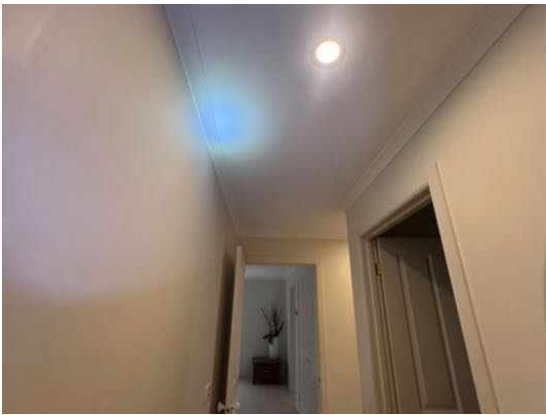
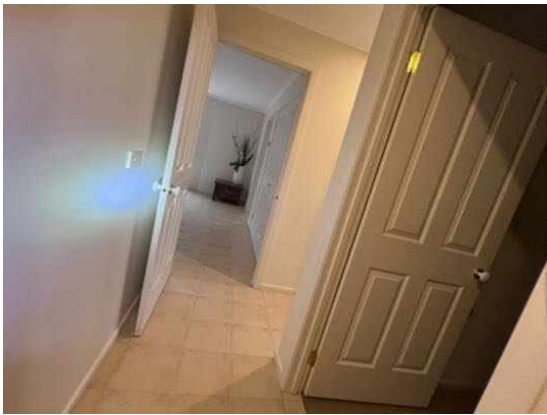
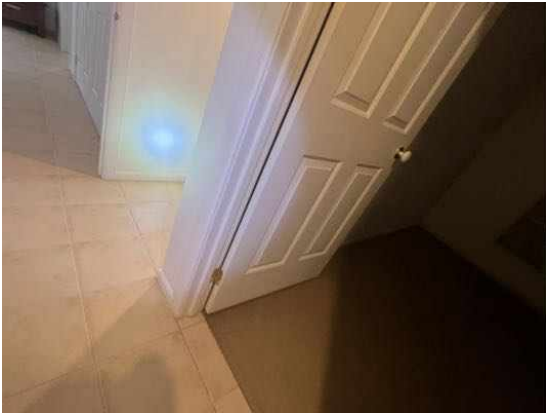
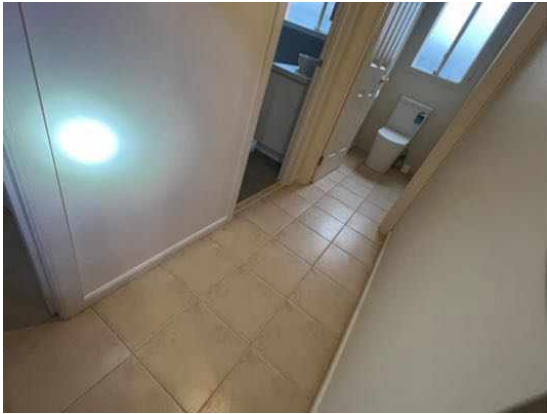
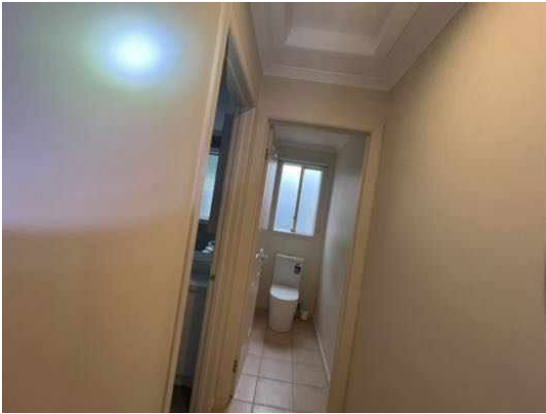
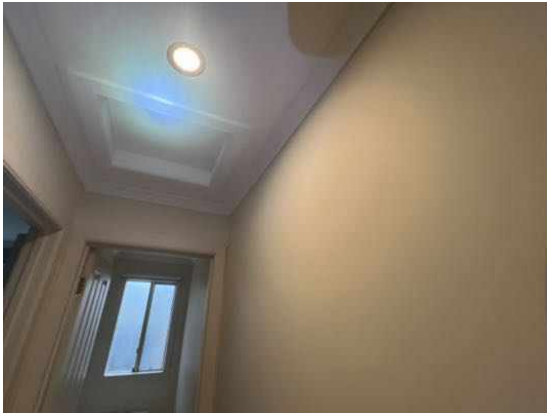
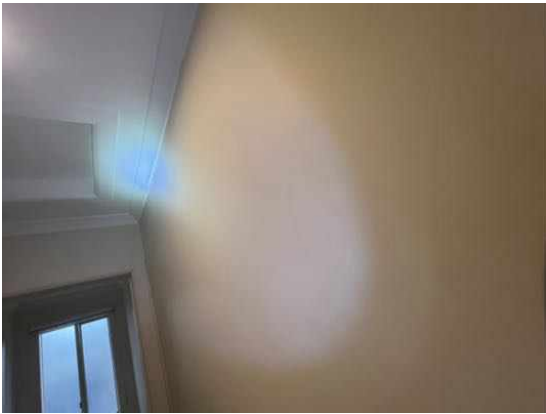
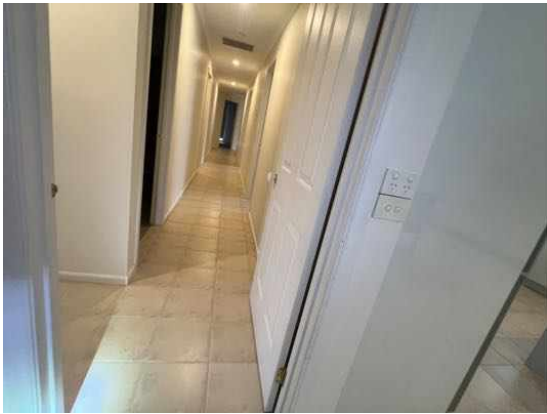
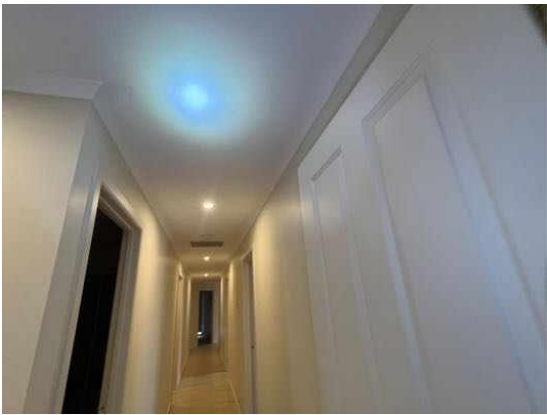
Building: Main Building  
 Location: Hallway > All Areas  
 Finding: Additional Photos - Obstructions and Limitations  
 Information: These photographs are an indication of the obstructions and limitations which impeded full inspection of the property at the time of inspection. These obstructions can hide an array of defects and should be removed to allow full inspection to be carried out. A re-inspection is recommended once the areas are made accessible.

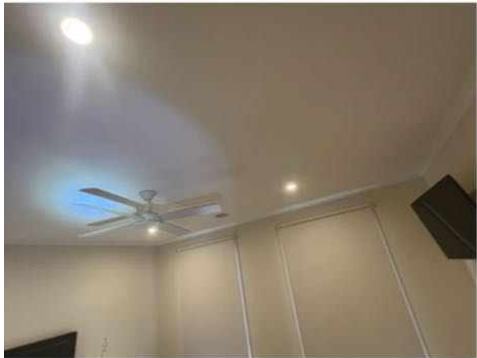
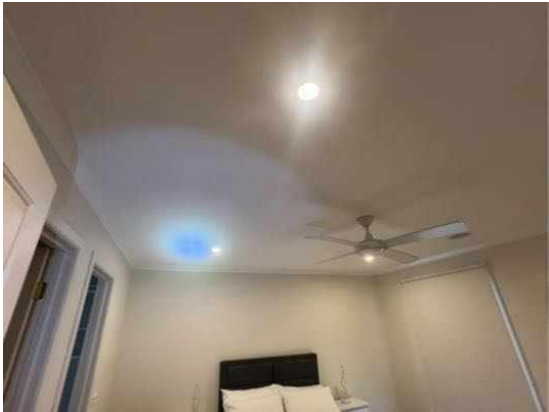
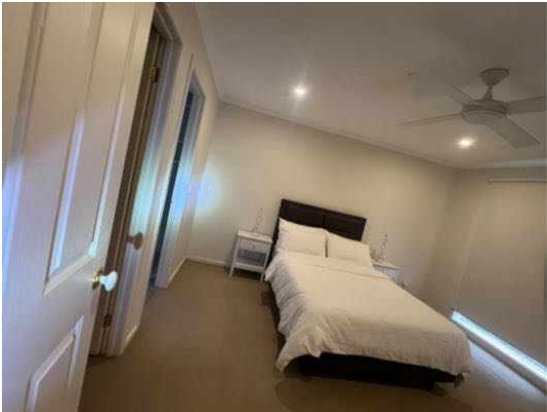
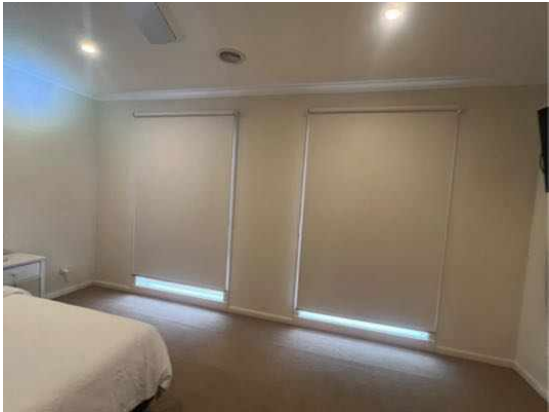
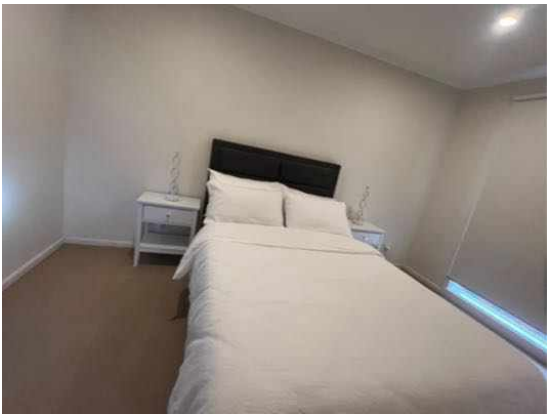
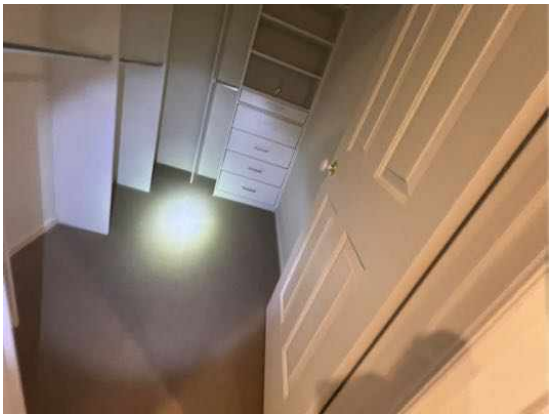
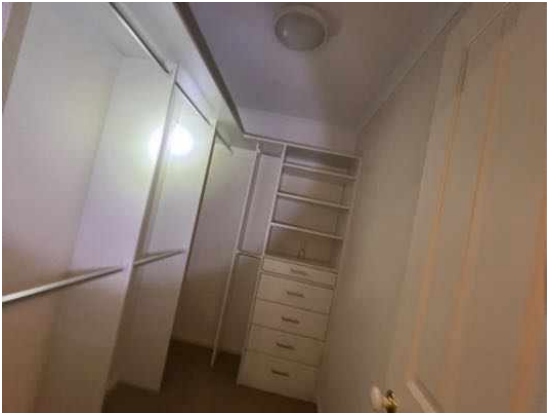
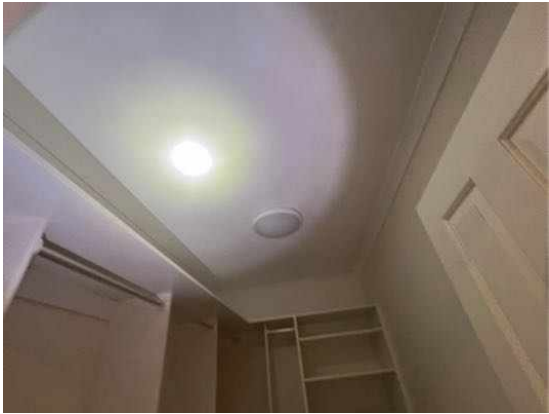
**Noted Item**

Building: Main Building  
Location: Bedroom - Master > All Areas  
Finding: Additional Photos  
Information: Additional photos are provided for your general reference

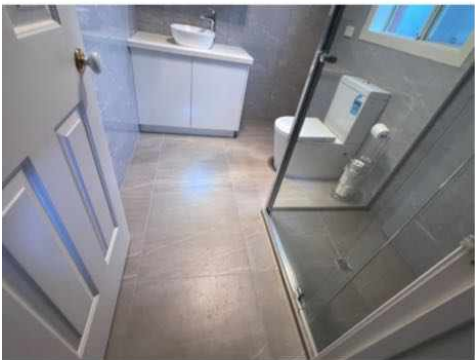
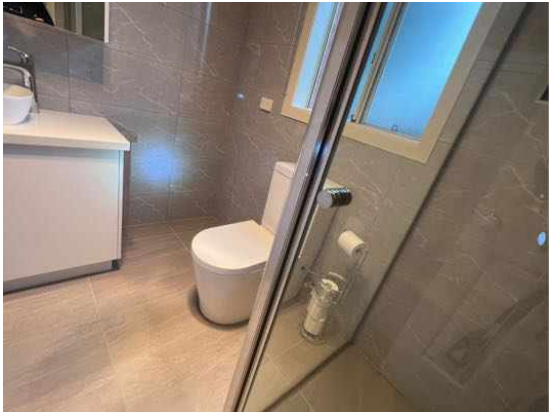
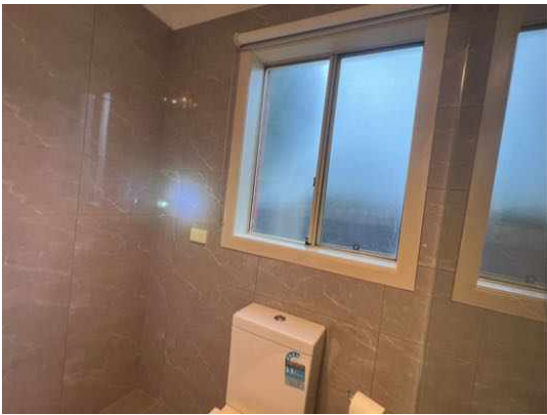
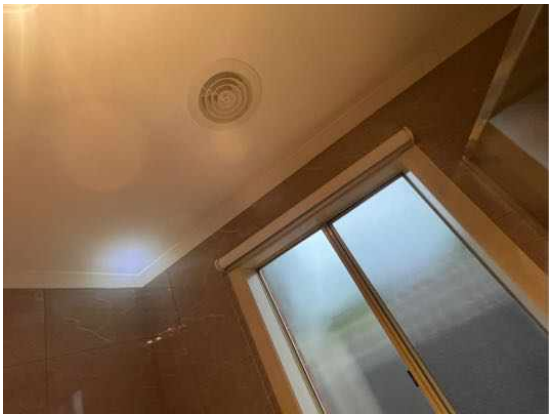
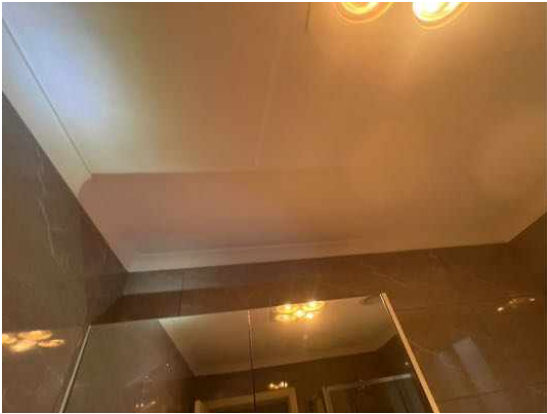
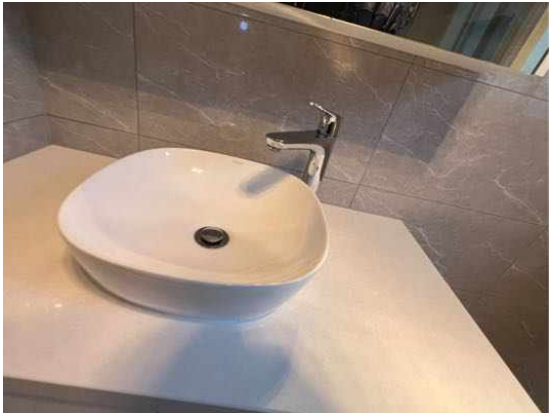
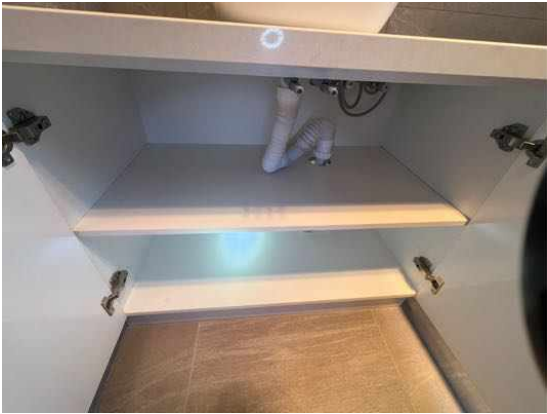
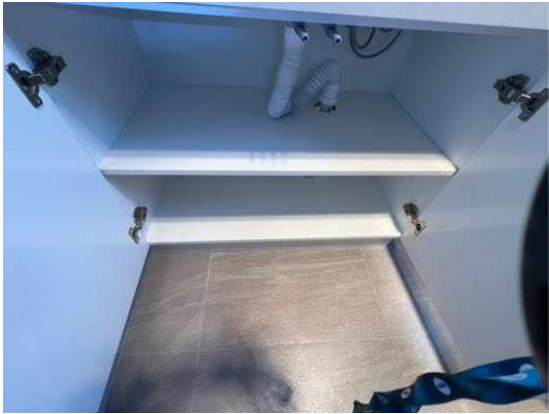
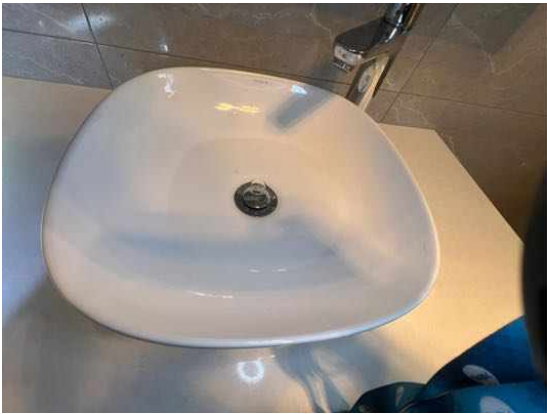
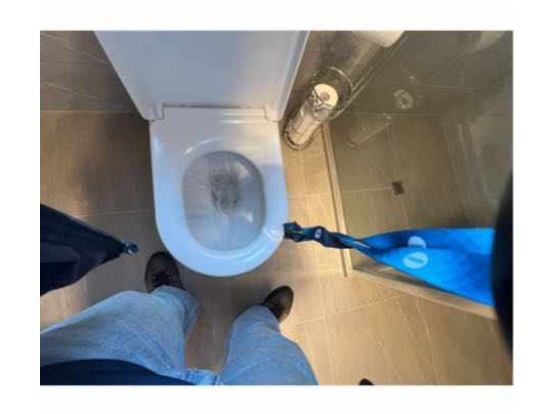
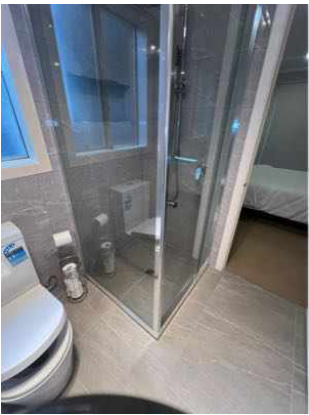
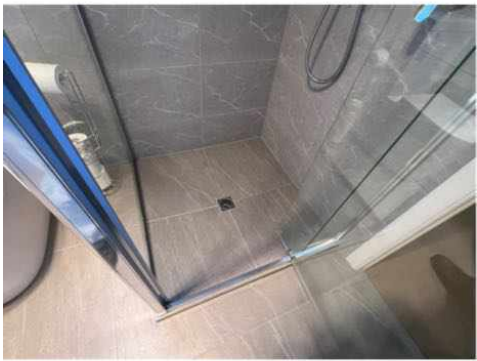
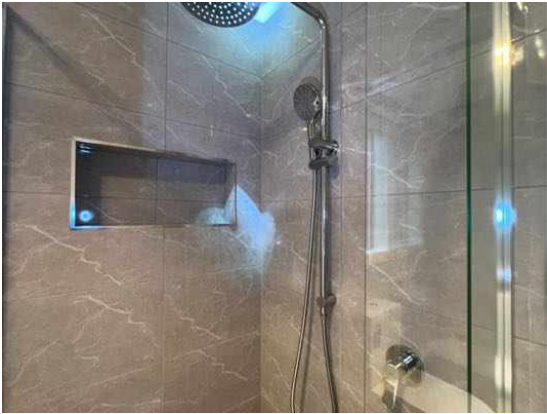
**Noted Item**

Building: Main Building  
Location: Ensuite - Master > All Areas  
Finding: Additional Photos  
Information: Additional photos are provided for your general reference

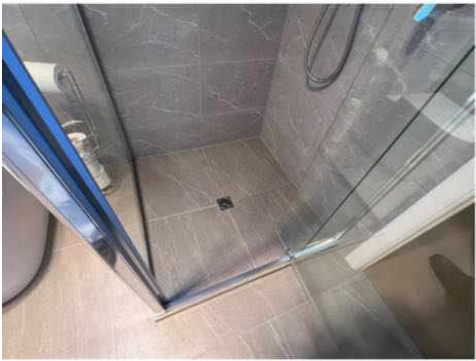
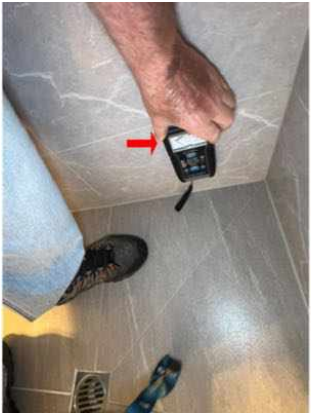
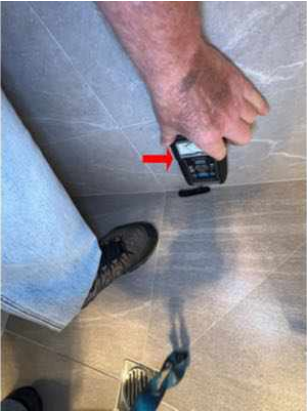
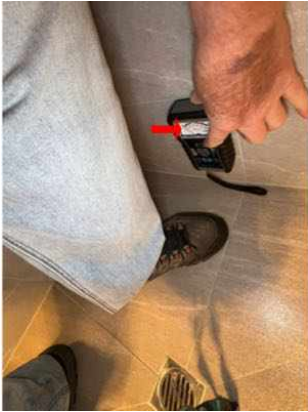
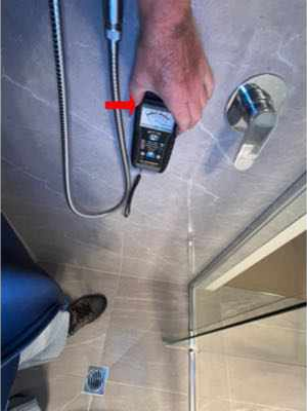
**Noted Item**

Building: Main Building  
 Location: Ensuite - Master > Rear Right  
 Finding: Additional Photos-moisture readings taken from all wet area walls & floors-and found to be within tolerance  
 Information: Additional photos are provided for your general reference. Arrows have been included to highlight areas of importance. Please discuss these photos with your building consultant for clarification.
