## Building Inspection Report

Inspection Date: Tue, 17 Mar 2026

Property Address: 6 Wyperfeld Ave, Taylors Lakes VIC 3038,  
Australia

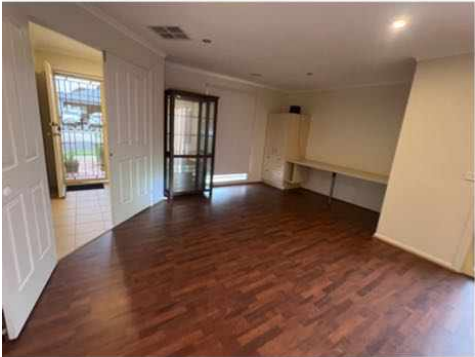
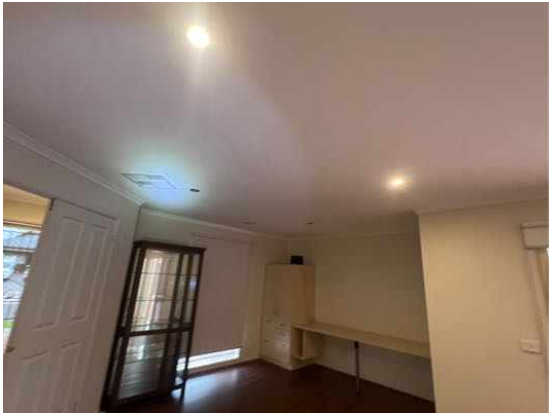
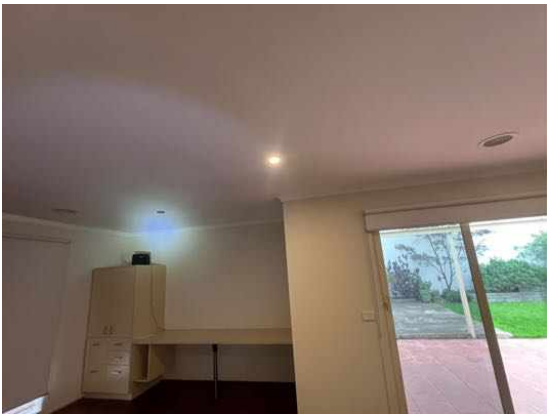
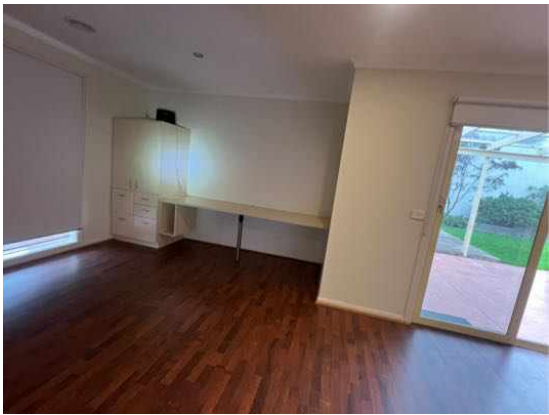
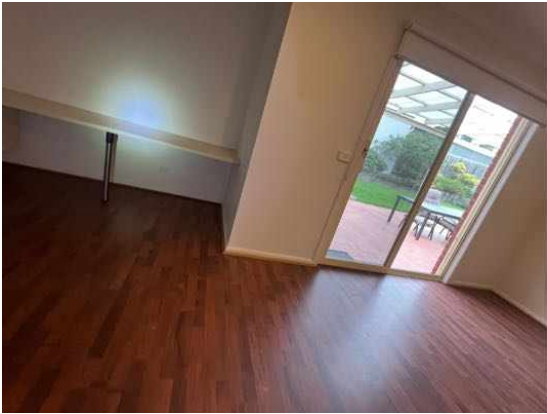
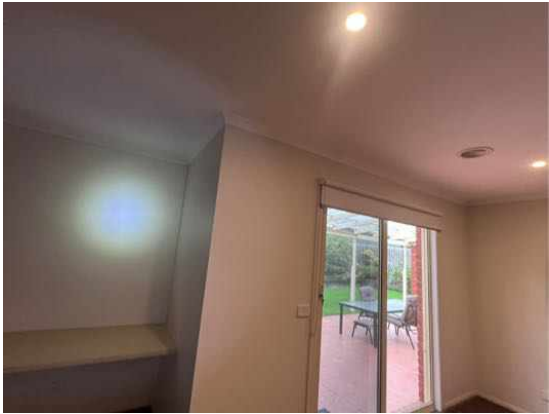
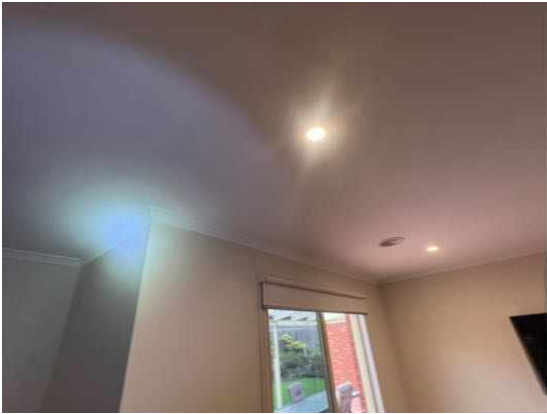
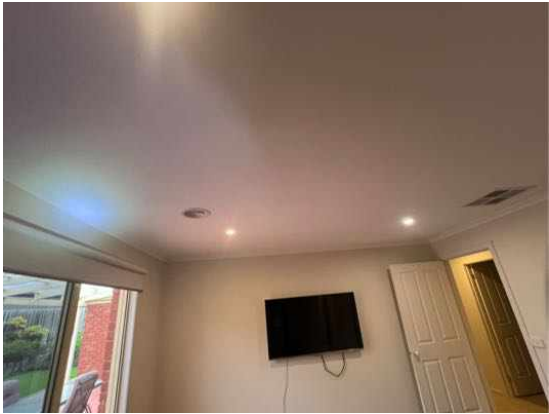
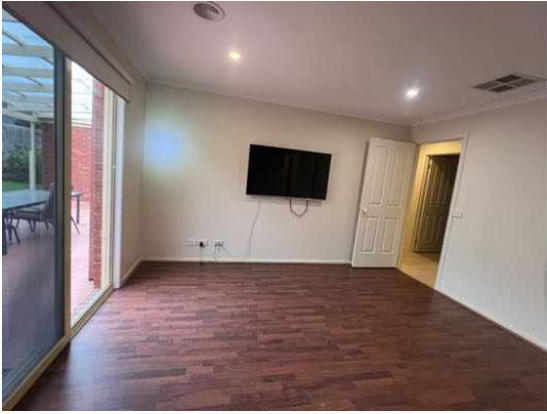
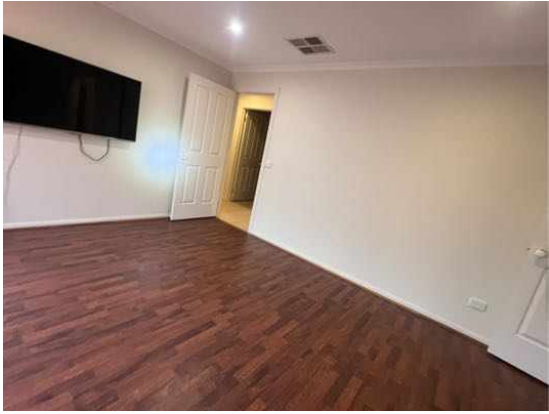
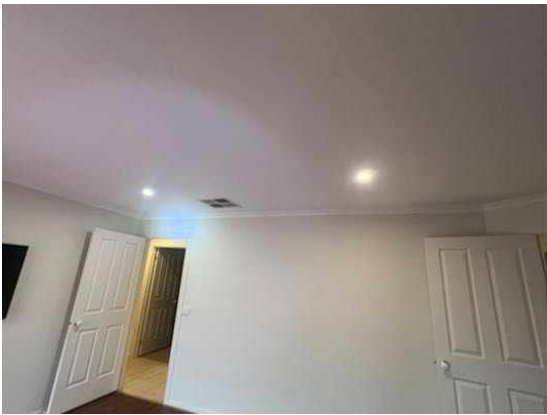
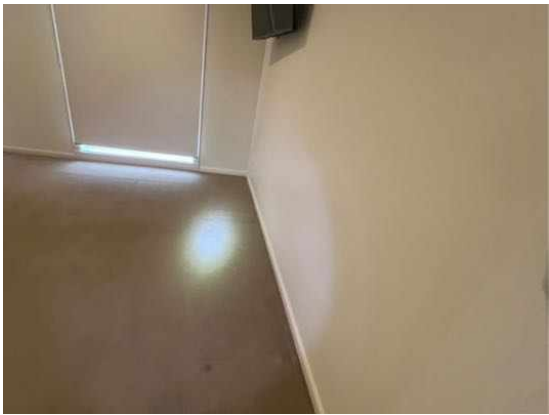
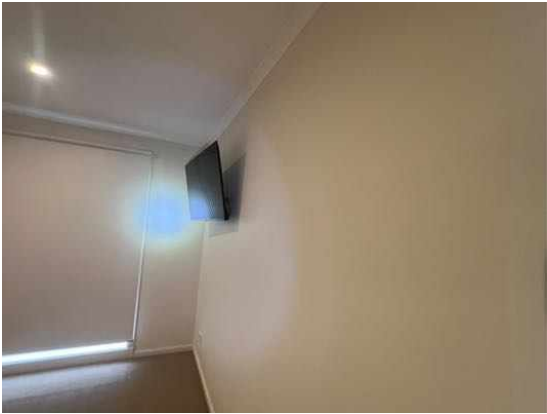
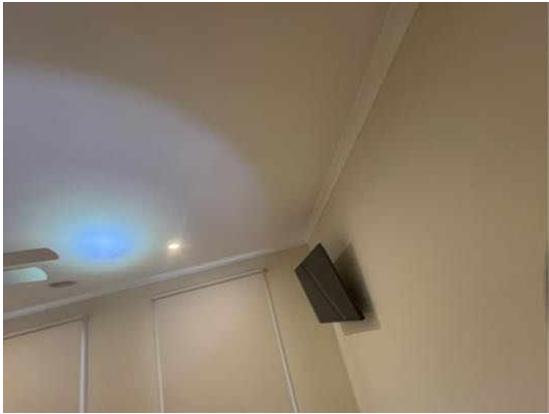
**Noted Item**

Building: Main Building  
Location: Living Room > All Areas  
Finding: Additional Photos - Obstructions and Limitations  
Information: These photographs are an indication of the obstructions and limitations which impeded full inspection of the property at the time of inspection. These obstructions can hide an array of defects and should be removed to allow full inspection to be carried out. A re-inspection is recommended once the areas are made accessible.

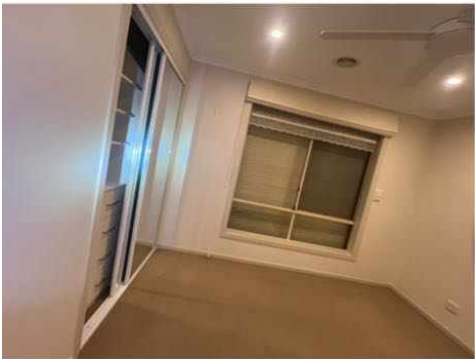
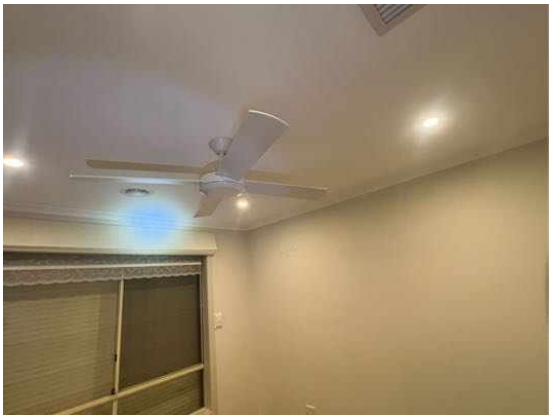
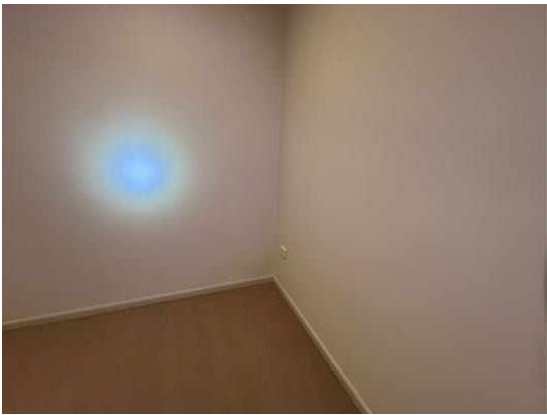
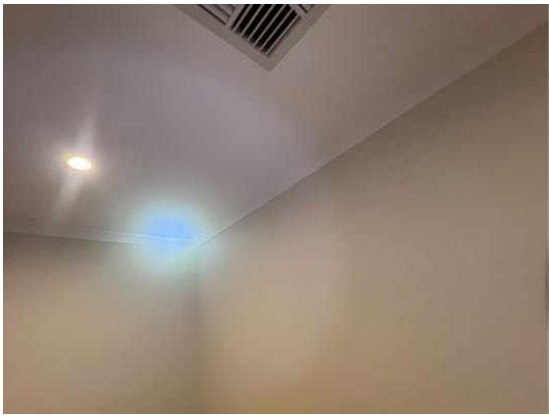
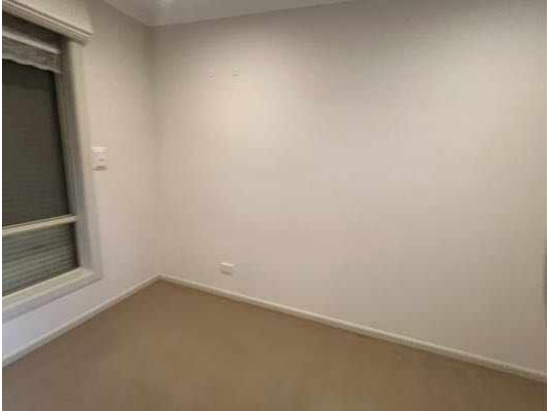
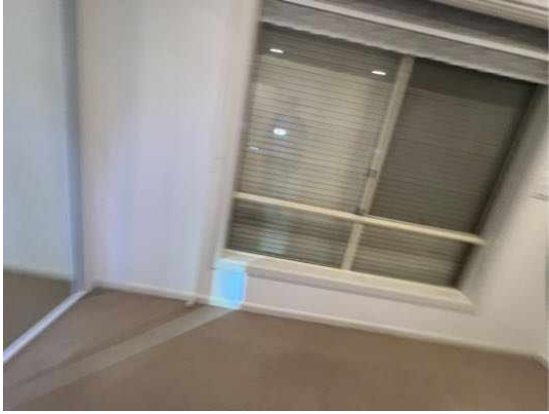
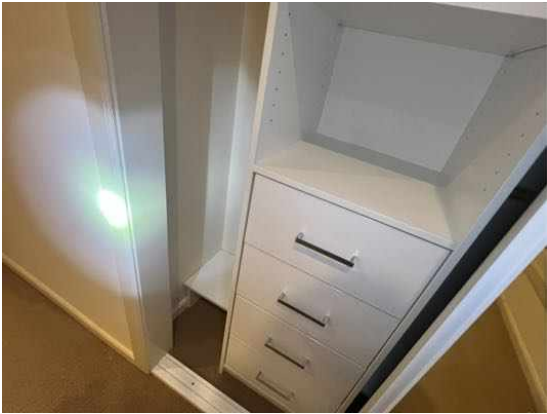
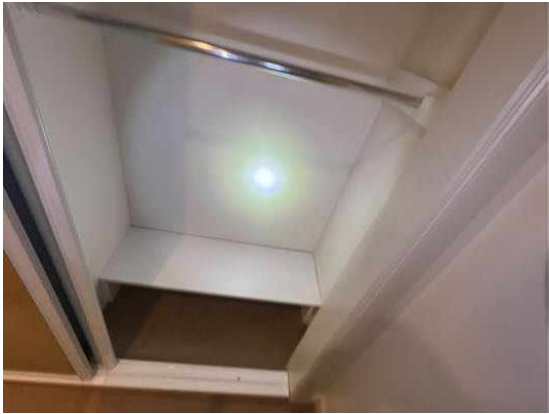
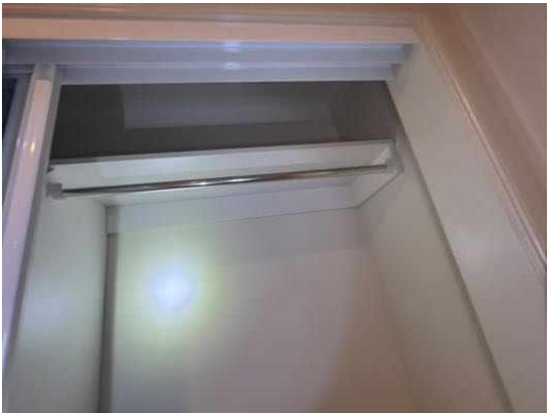
Building: Main Building  
Location: Bedroom 2 > All Areas  
Finding: Additional Photos - Obstructions and Limitations  
Information: These photographs are an indication of the obstructions and limitations which impeded full inspection of the property at the time of inspection. These obstructions can hide an array of defects and should be removed to allow full inspection to be carried out. A re-inspection is recommended once the areas are made accessible.

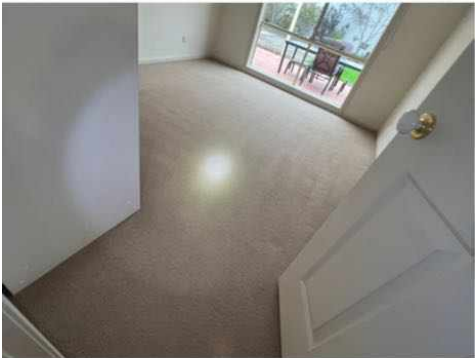
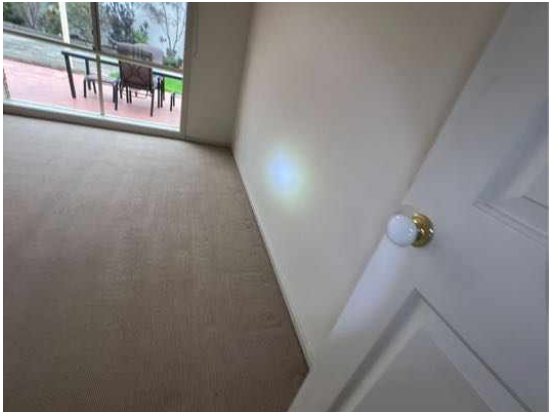
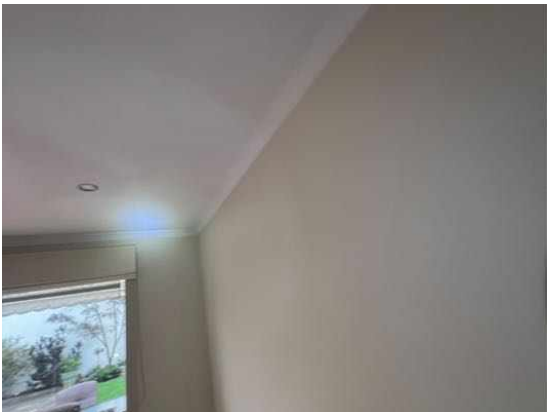
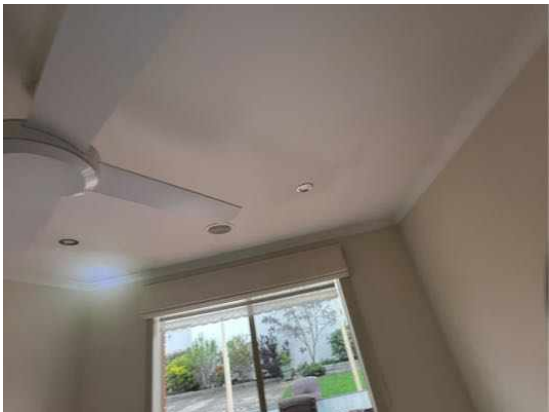
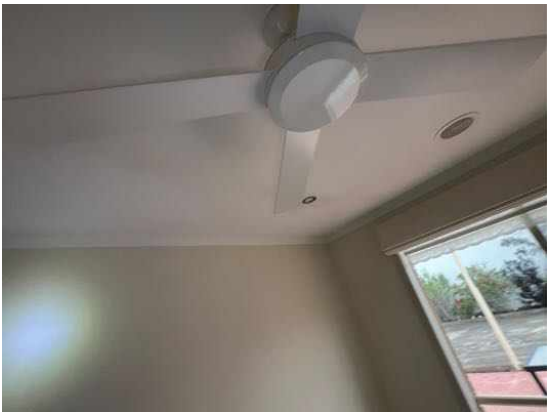
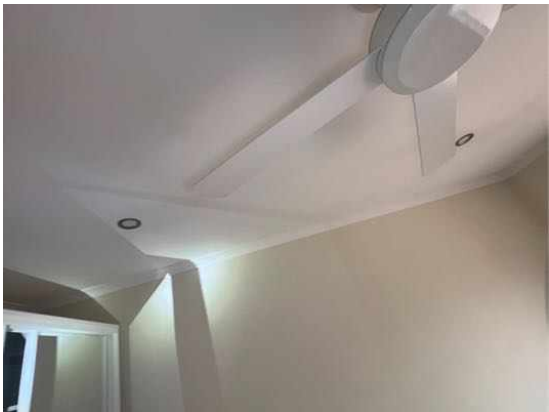
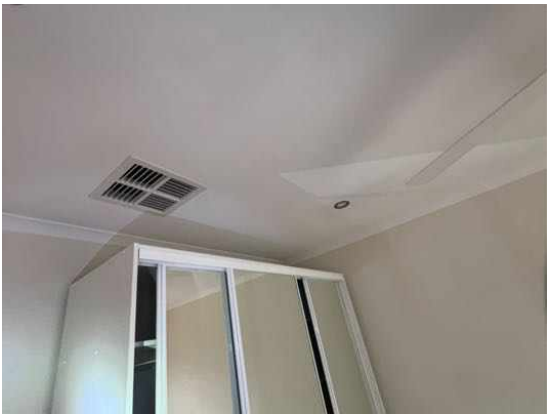
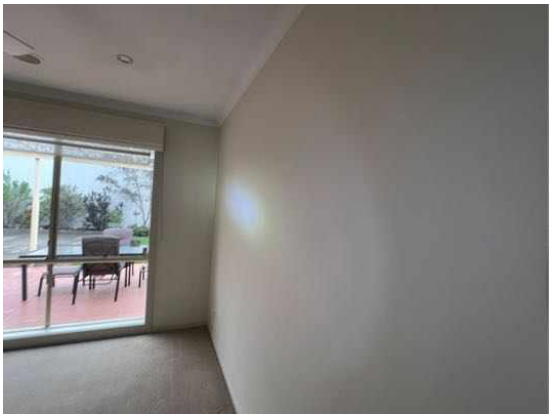
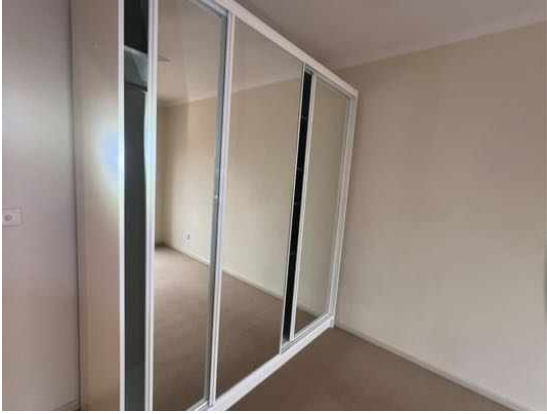
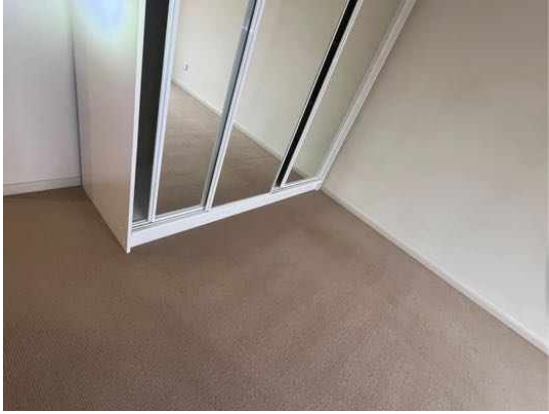
Building: Main Building  
Location: Bedroom 3 > All Areas  
Finding: Additional Photos - Obstructions and Limitations  
Information: These photographs are an indication of the obstructions and limitations which impeded full inspection of the property at the time of inspection. These obstructions can hide an array of defects and should be removed to allow full inspection to be carried out. A re-inspection is recommended once the areas are made accessible.

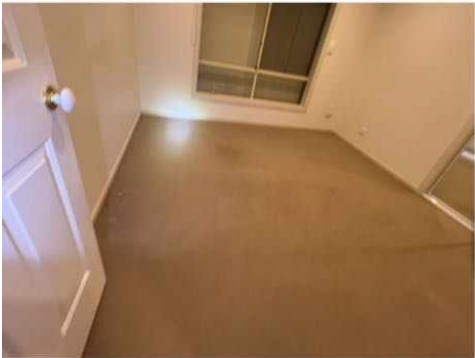
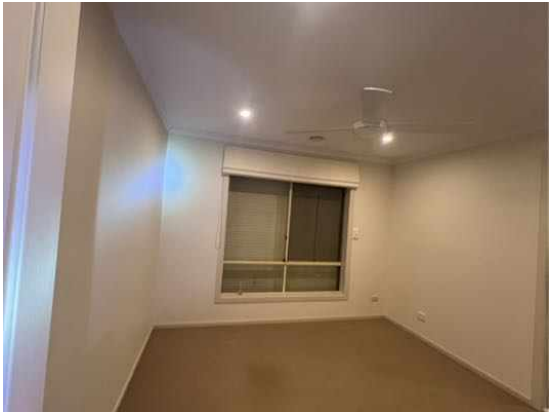
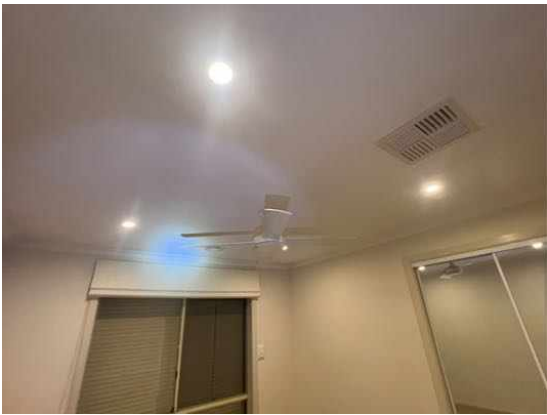
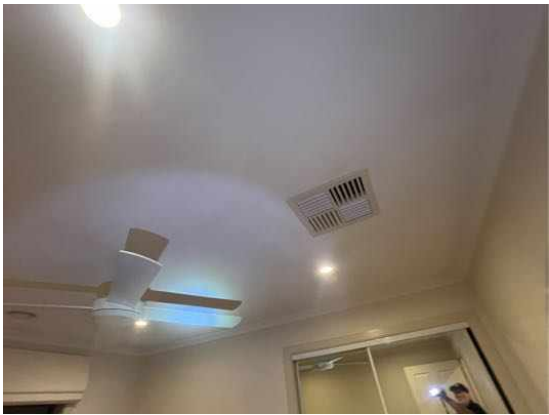
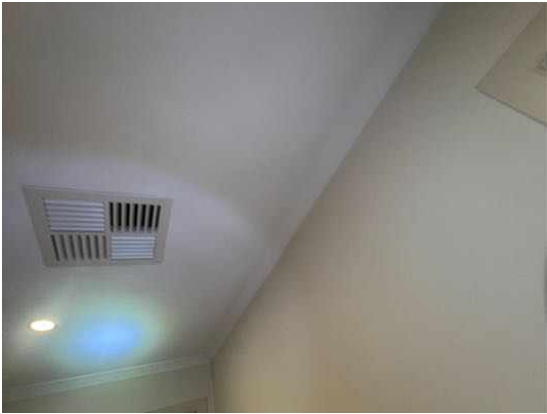
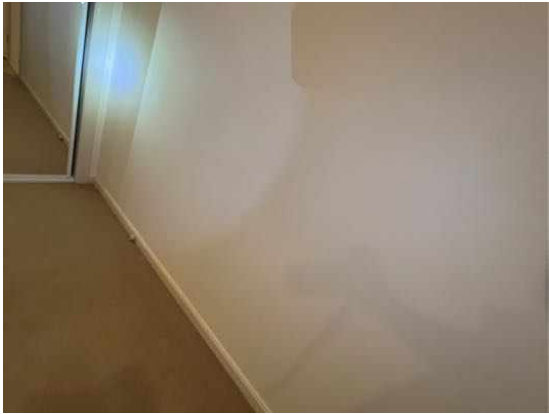
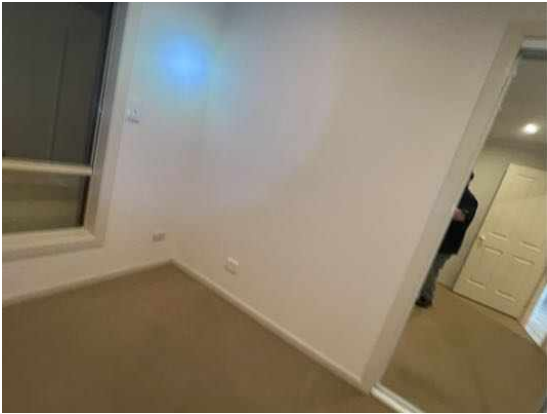
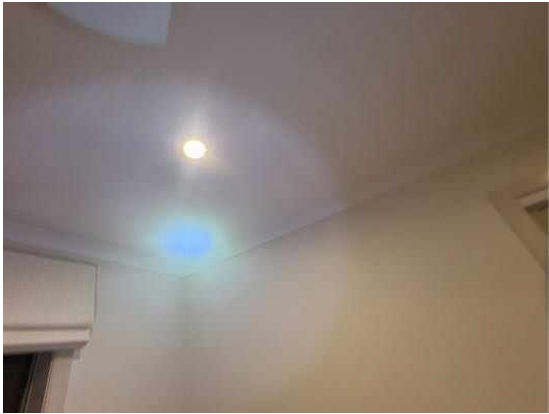
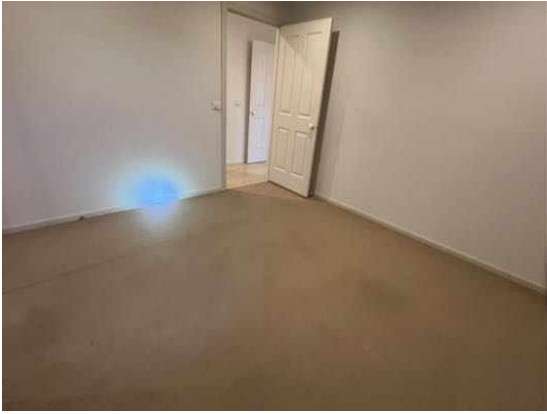
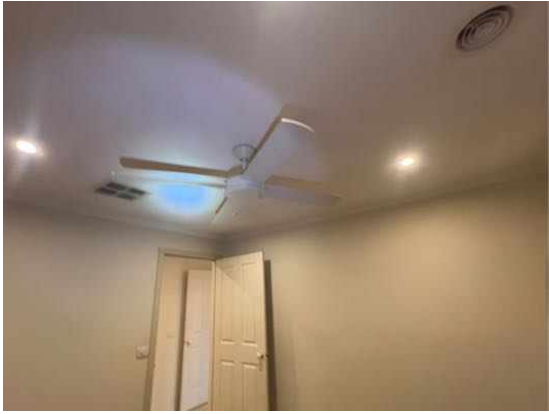
Building: Main Building  
Location: Bedroom 4 > All Areas  
Finding: Additional Photos  
Information: Additional photos are provided for your general reference

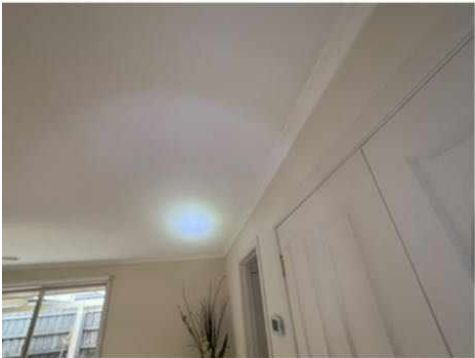
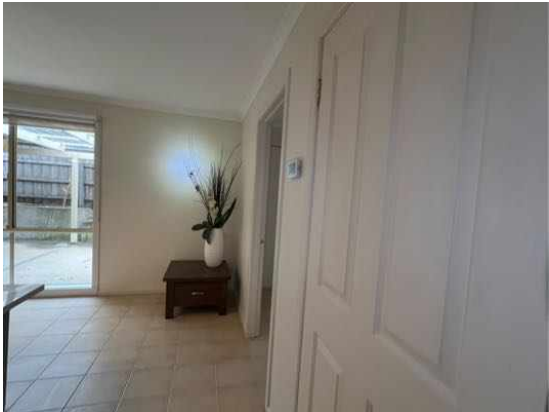
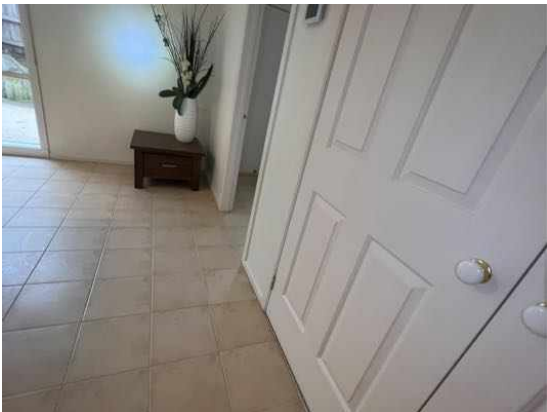
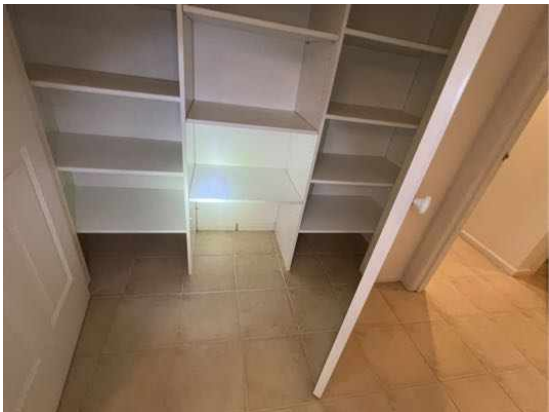
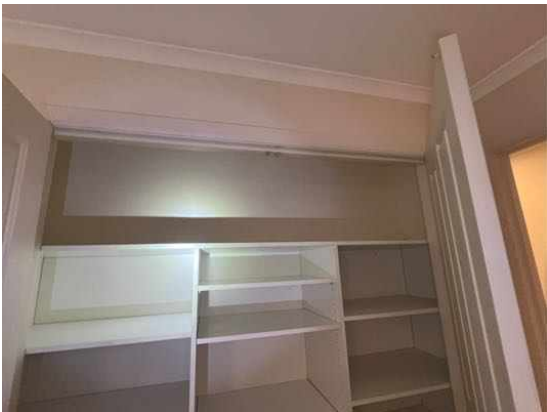
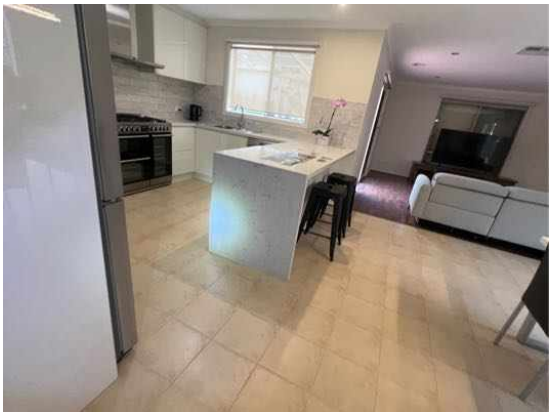
Building: Main Building  
Location: Kitchen > All Areas  
Finding: Additional Photos - Obstructions and Limitations  
Information: These photographs are an indication of the obstructions and limitations which impeded full inspection of the property at the time of inspection. These obstructions can hide an array of defects and should be removed to allow full inspection to be carried out. A re-inspection is recommended once the areas are made accessible.

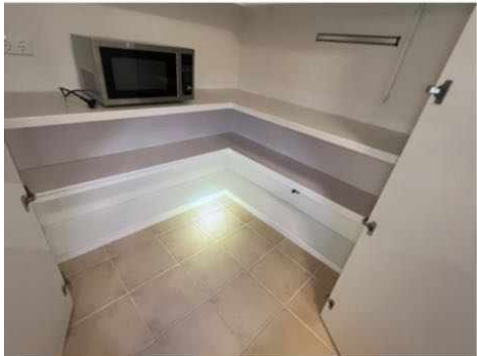
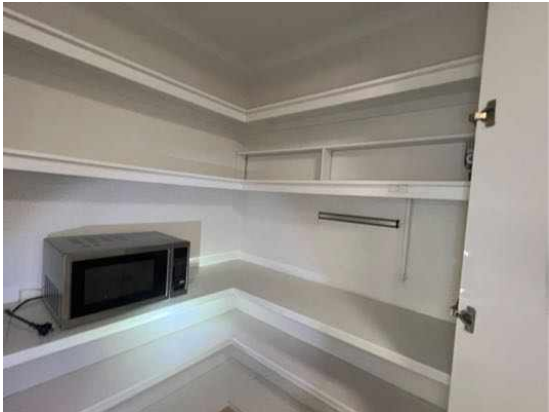
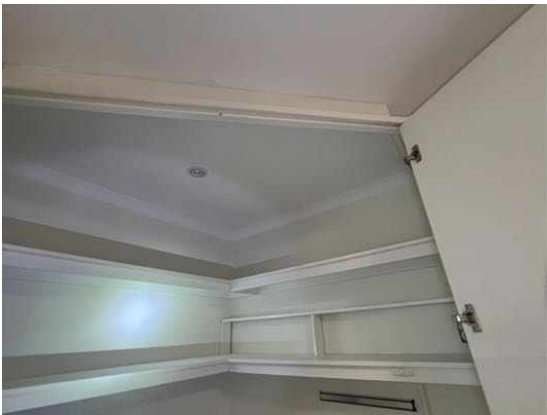
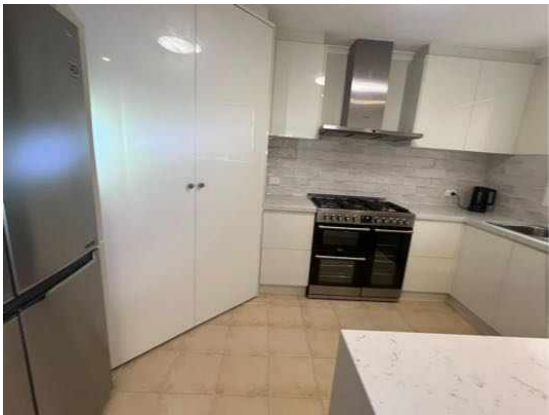
Building: Main Building  
 Location: Pantry - Walk In > All Areas  
 Finding: Additional Photos - Obstructions and Limitations  
 Information: These photographs are an indication of the obstructions and limitations which impeded full inspection of the property at the time of inspection. These obstructions can hide an array of defects and should be removed to allow full inspection to be carried out. A re-inspection is recommended once the areas are made accessible.

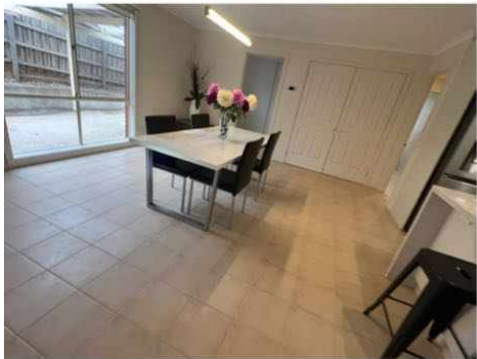
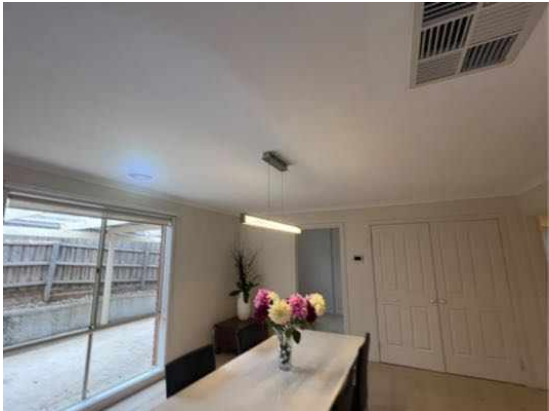
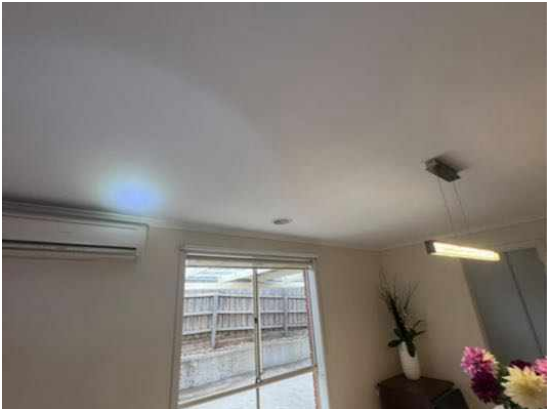
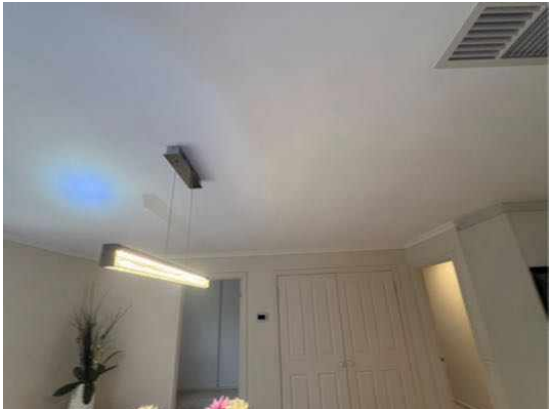
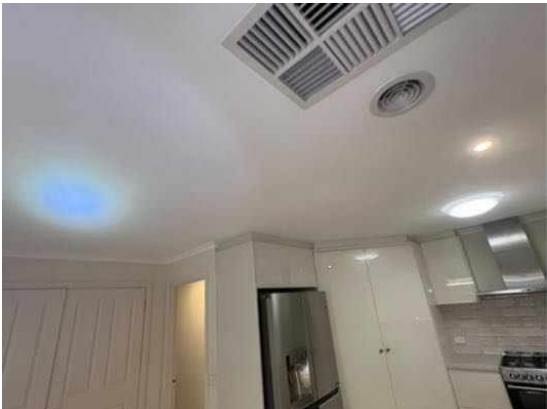
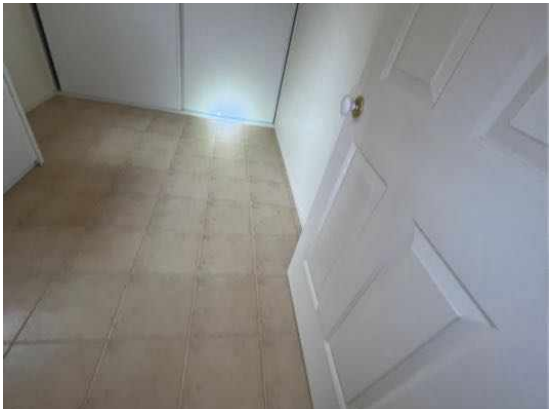
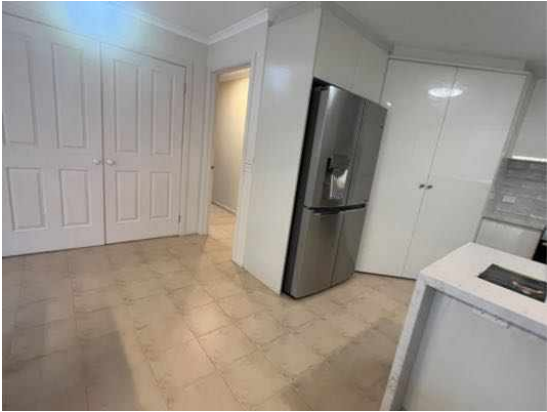
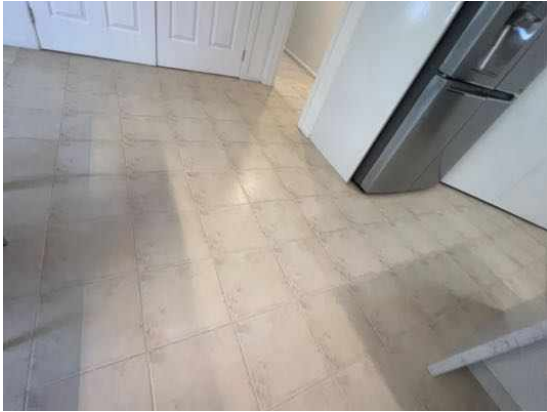
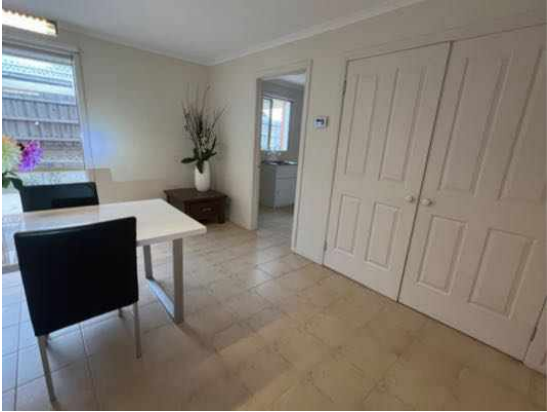
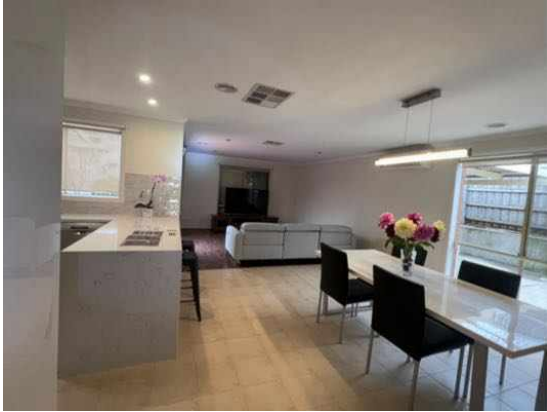
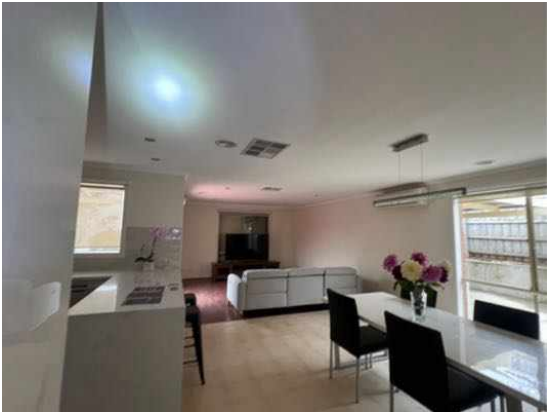
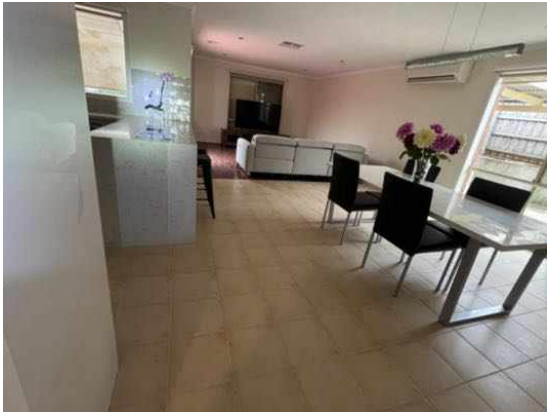
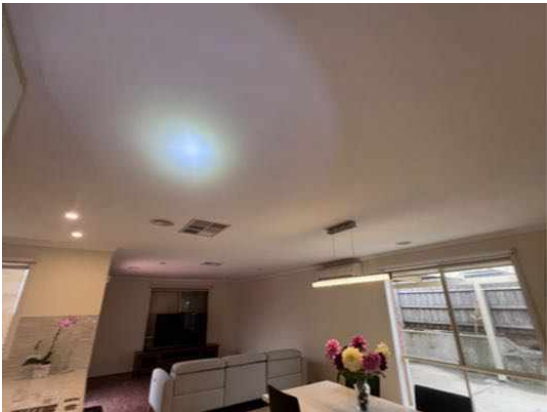
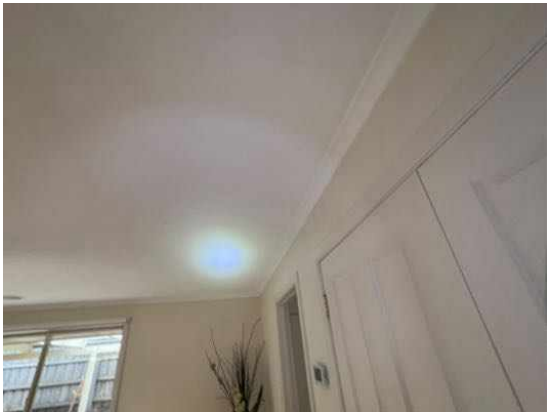
Building: Main Building  
Location: Dining Room > All Areas  
Finding: Additional Photos - Obstructions and Limitations  
Information: These photographs are an indication of the obstructions and limitations which impeded full inspection of the property at the time of inspection. These obstructions can hide an array of defects and should be removed to allow full inspection to be carried out. A re-inspection is recommended once the areas are made accessible.

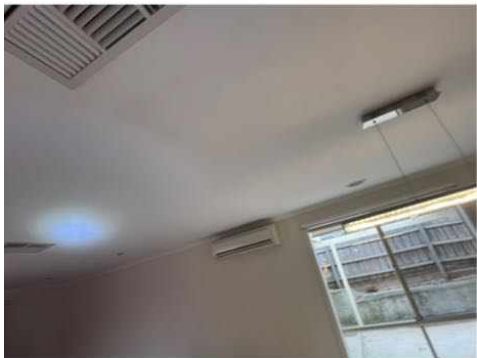
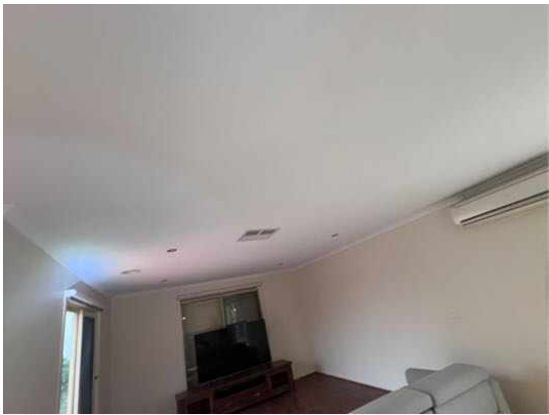
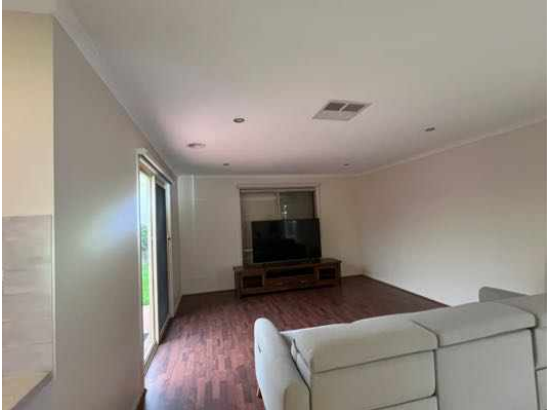
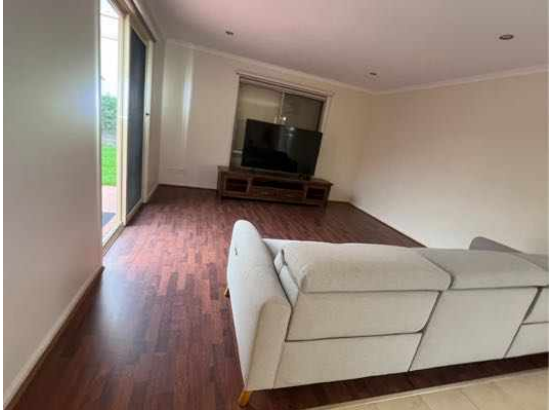
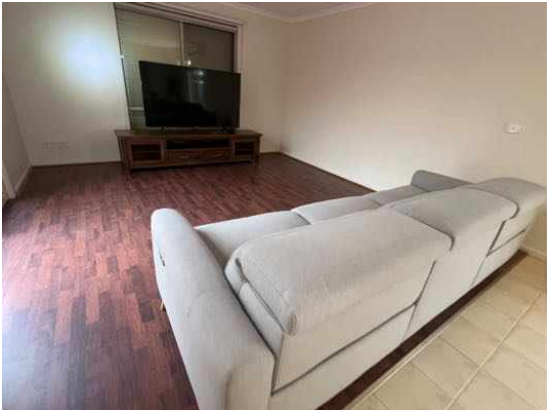
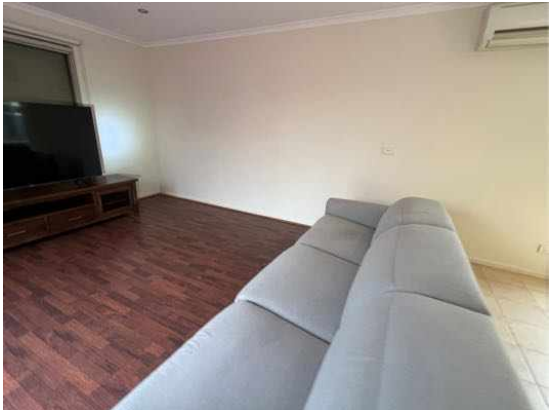
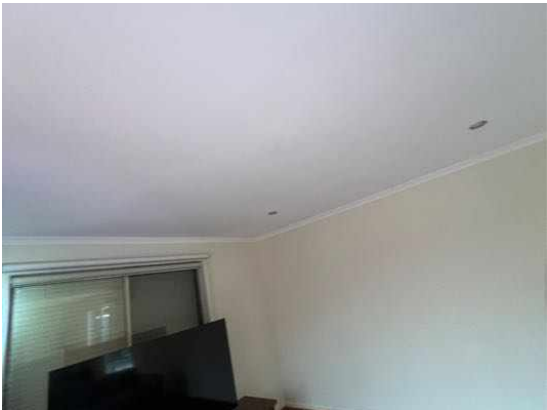
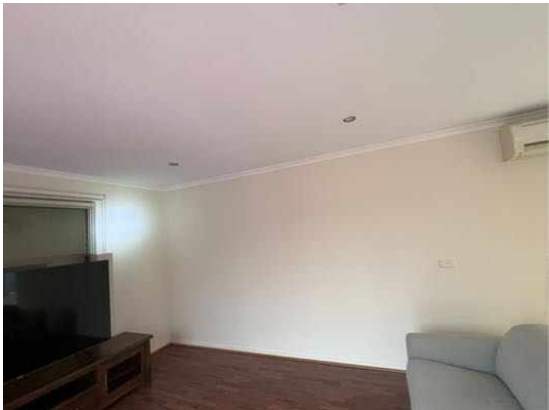
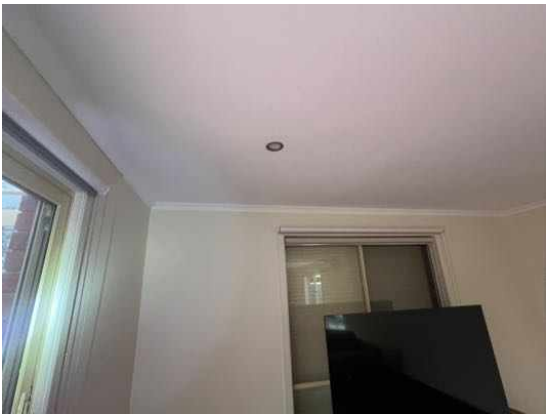
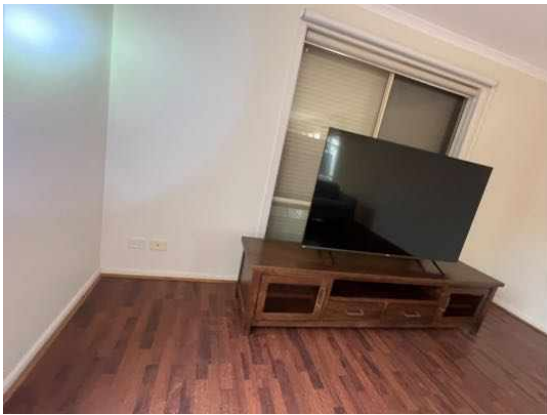
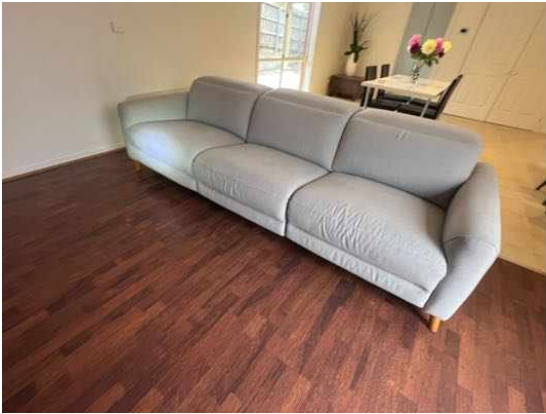
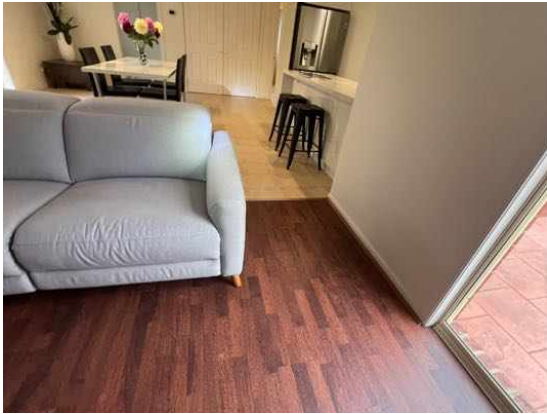
Building: Main Building  
 Location: Family Room > All Areas  
 Finding: Additional Photos - Obstructions and Limitations  
 Information: These photographs are an indication of the obstructions and limitations which impeded full inspection of the property at the time of inspection. These obstructions can hide an array of defects and should be removed to allow full inspection to be carried out. A re-inspection is recommended once the areas are made accessible.

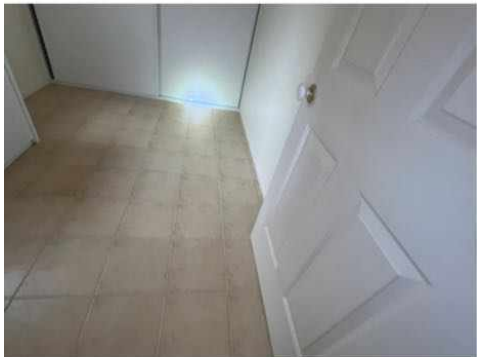
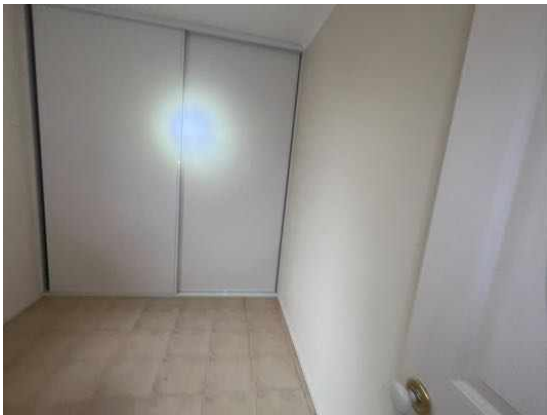
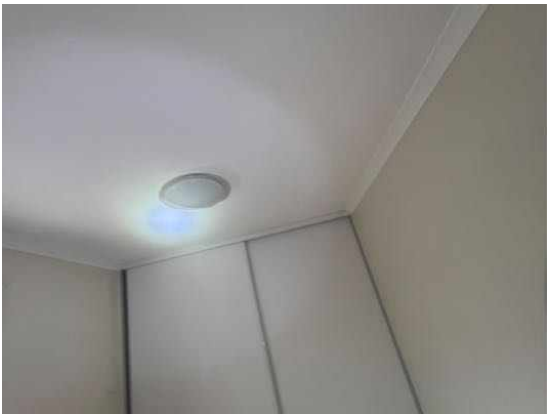
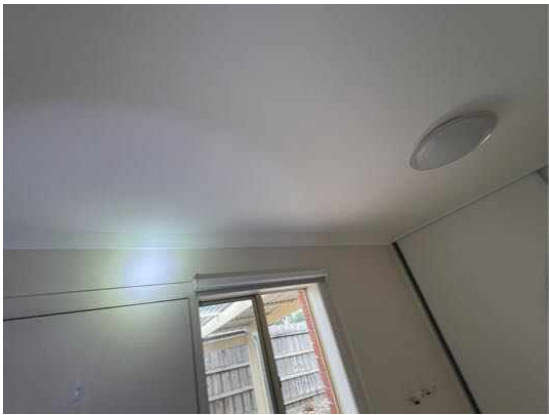
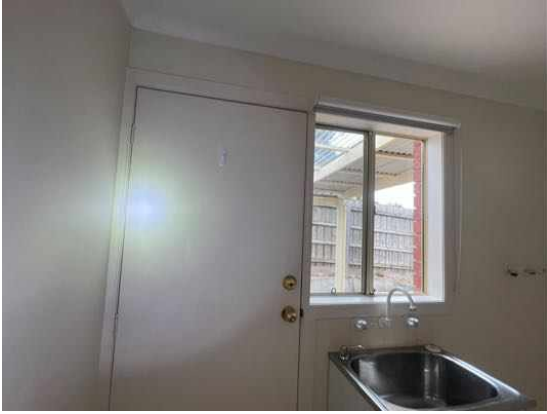
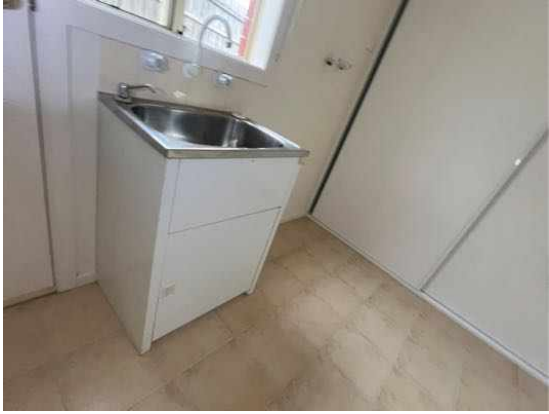
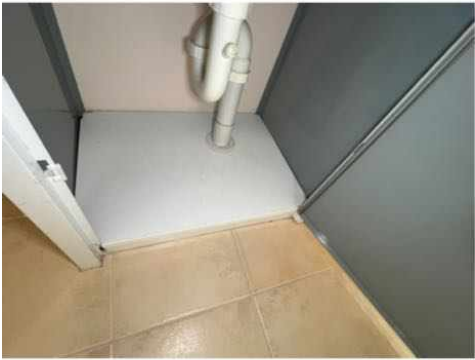
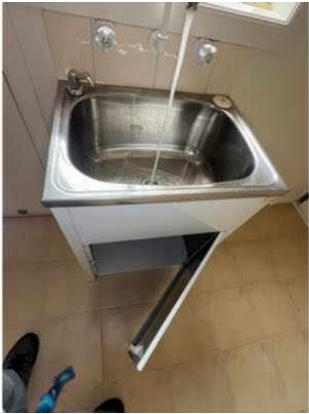
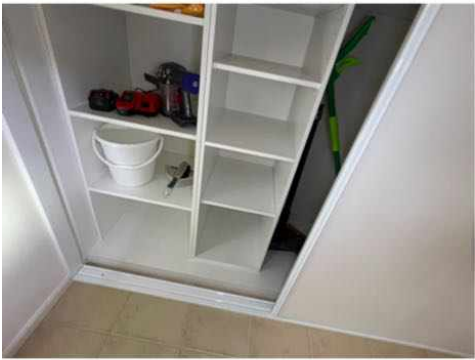
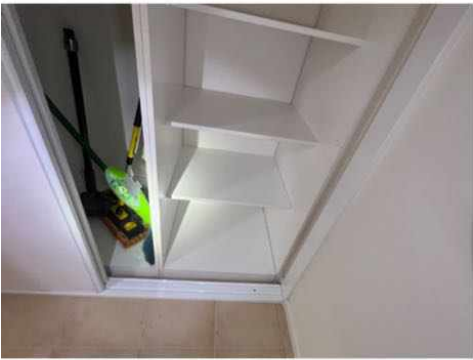
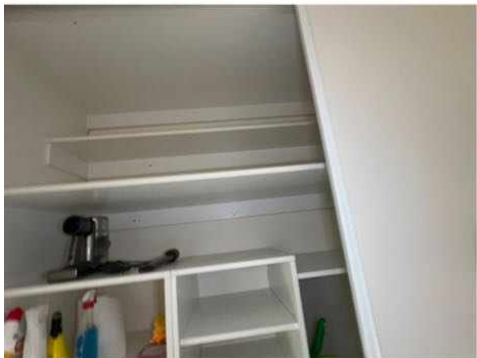
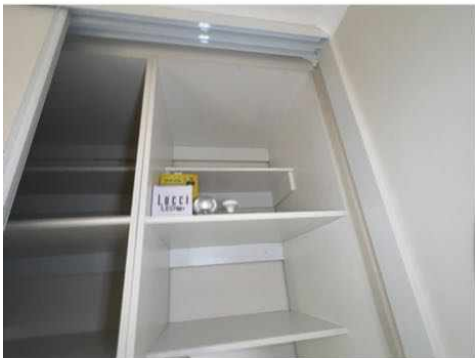
Building: Main Building  
Location: Laundry > All Areas  
Finding: Additional Photos - Obstructions and Limitations  
Information: These photographs are an indication of the obstructions and limitations which impeded full inspection of the property at the time of inspection. These obstructions can hide an array of defects and should be removed to allow full inspection to be carried out. A re-inspection is recommended once the areas are made accessible.

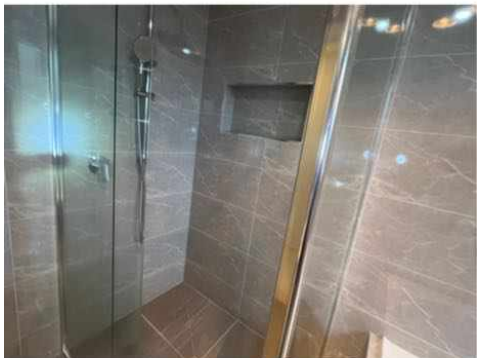
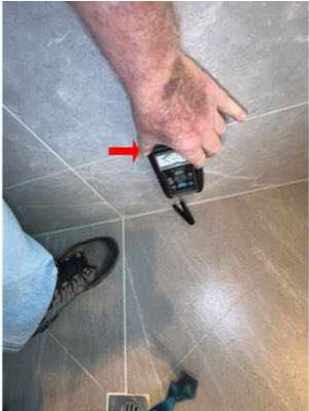
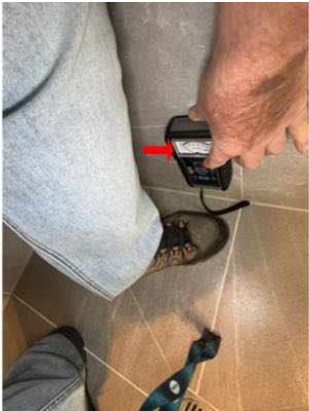
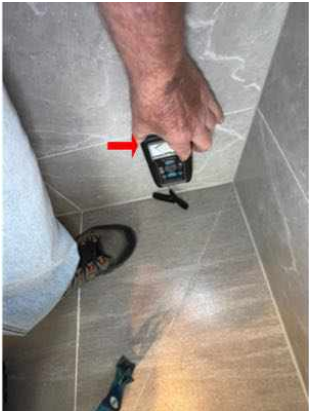
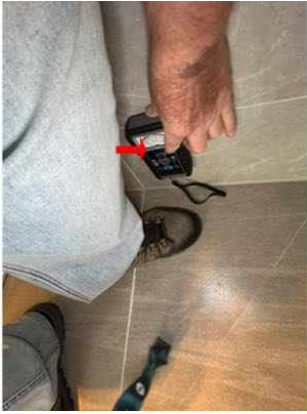
Building: Main Building  
Location: Bathroom > All Areas,Front Left  
Finding: Additional Photos-moisture readings taken from all wet area walls & floors-and found to be within tolerance  
Information: Additional photos are provided for your general reference. Arrows have been included to highlight areas of importance. Please discuss these photos with your building consultant for clarification.

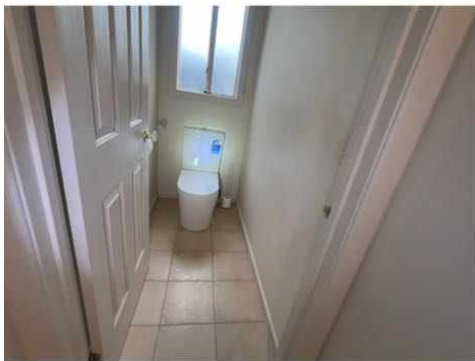
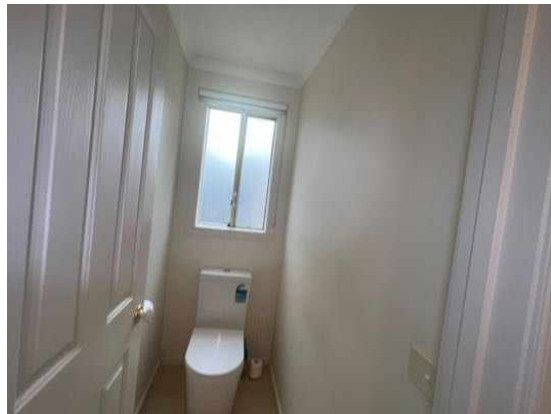
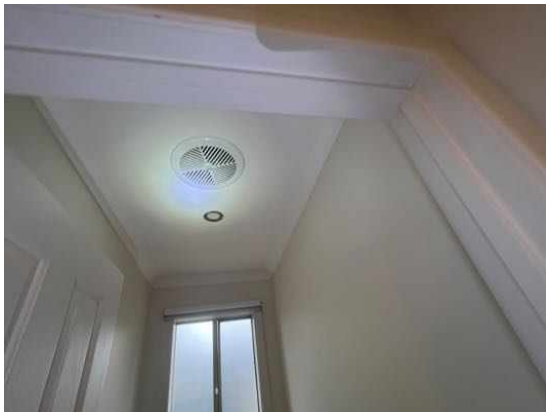
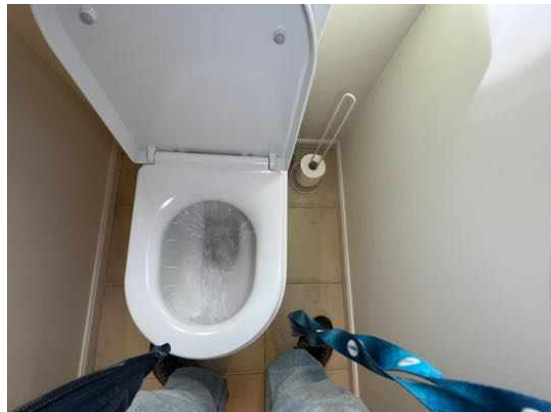
Building: Main Building  
Location: Toilet (WC) > All Areas  
Finding: Additional Photos  
Information: Additional photos are provided for your general reference
