## Building Inspection Report

Inspection Date: Tue, 17 Mar 2026

Property Address: 6 Wyperfeld Ave, Taylors Lakes VIC 3038,  
Australia

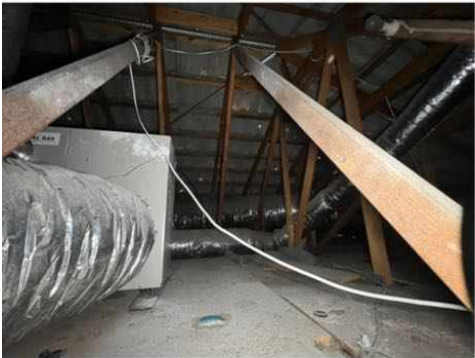
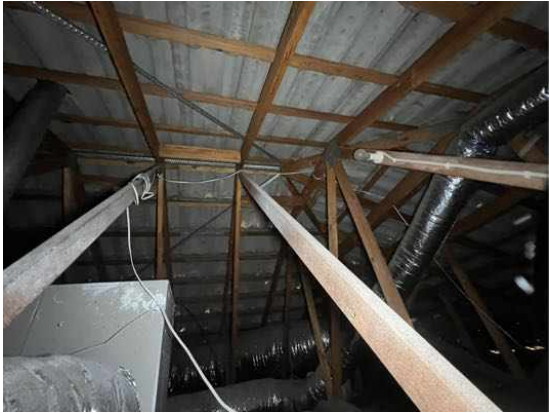
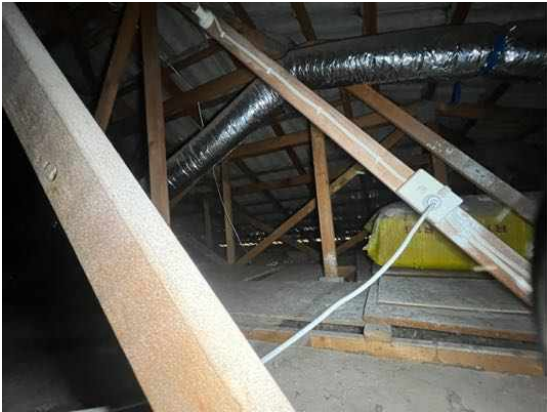
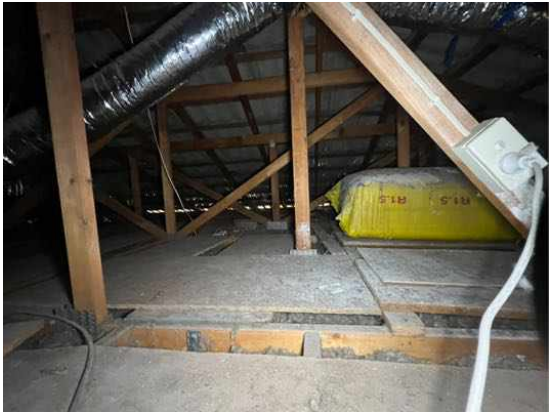
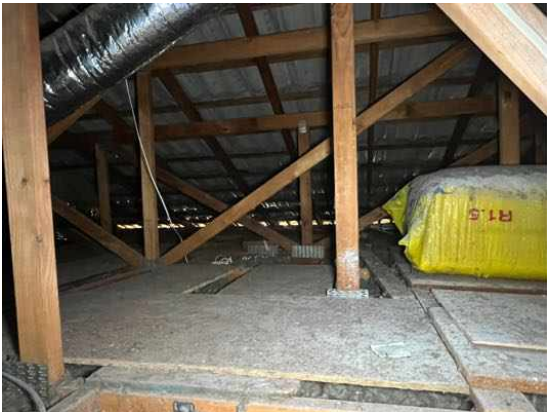
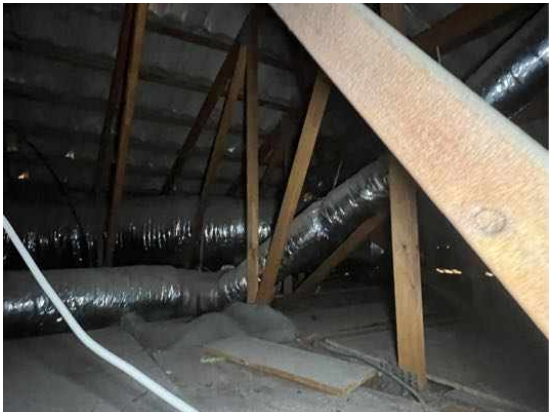
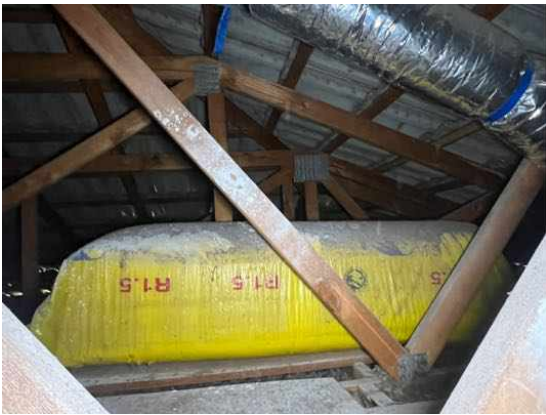
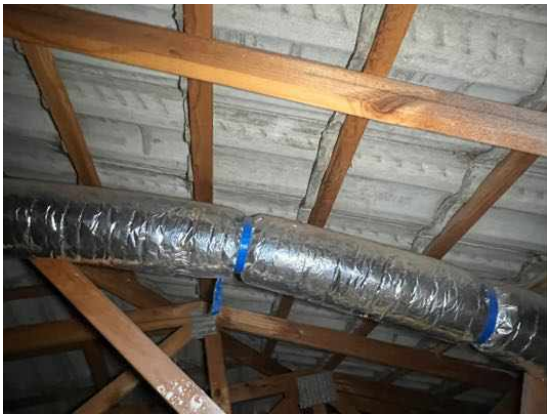
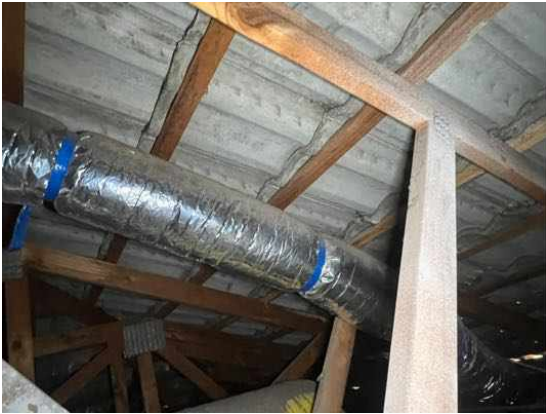
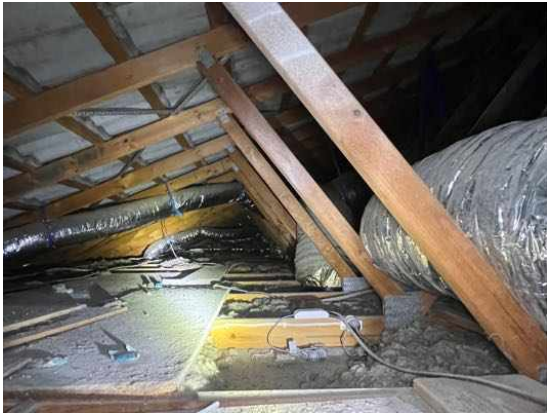
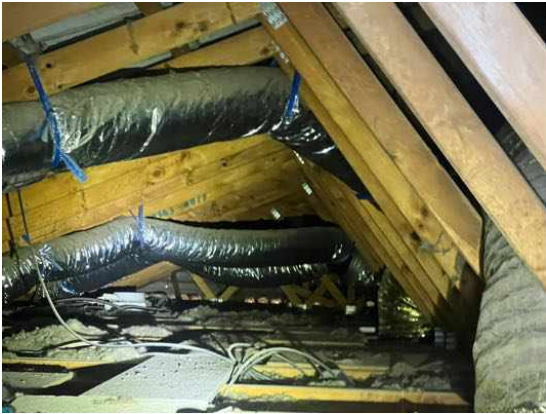
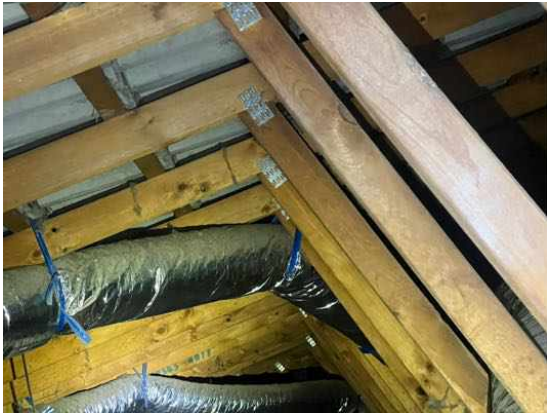
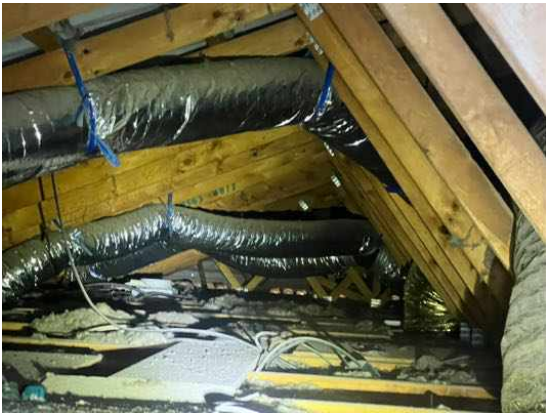
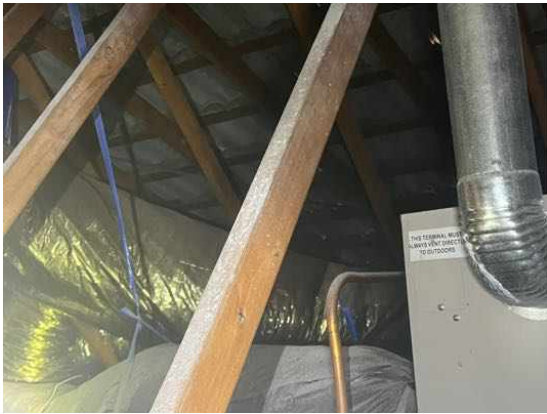
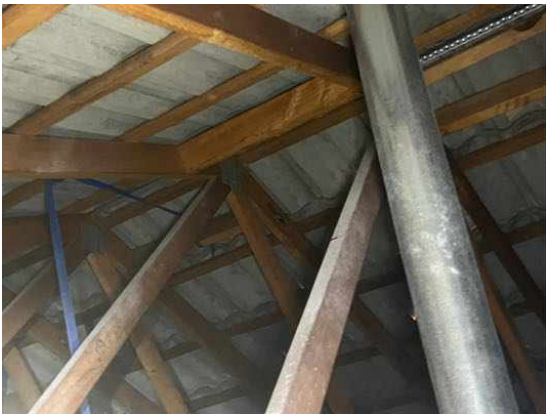
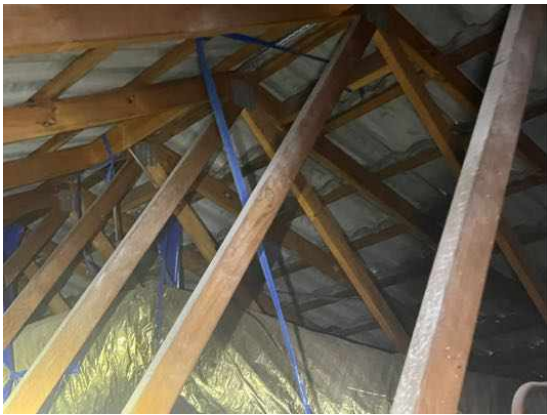
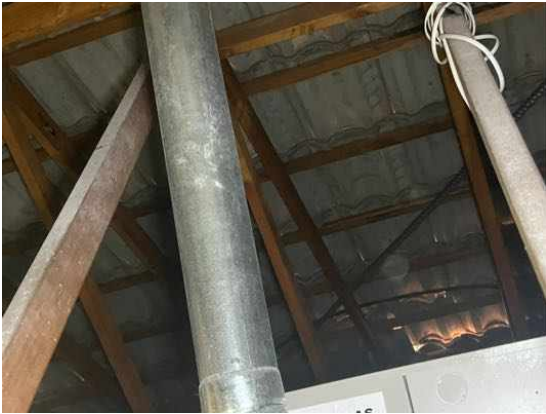
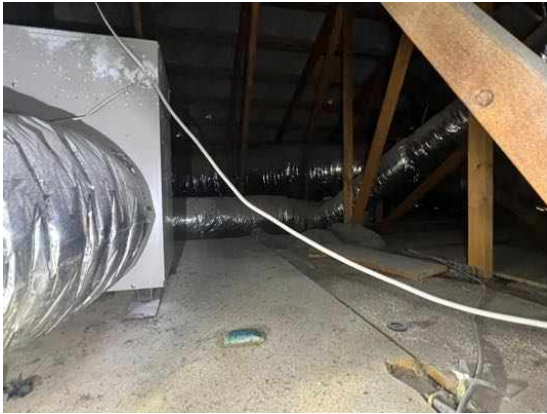
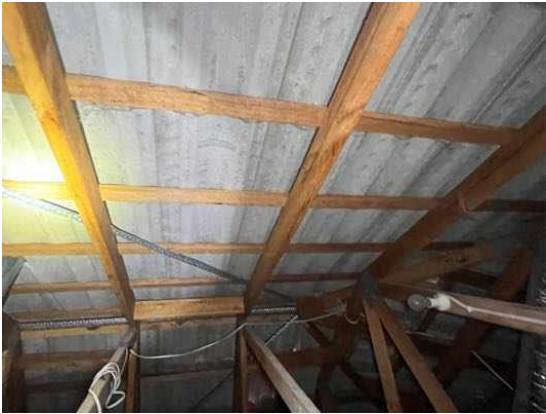
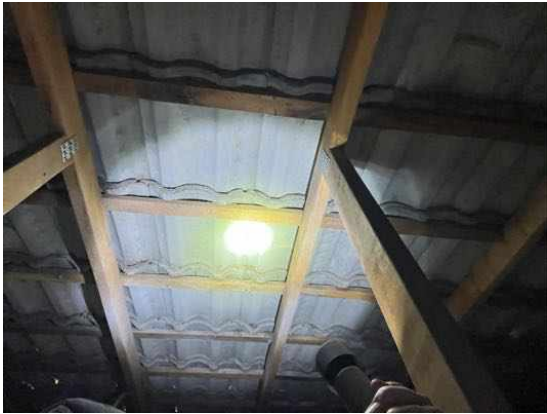
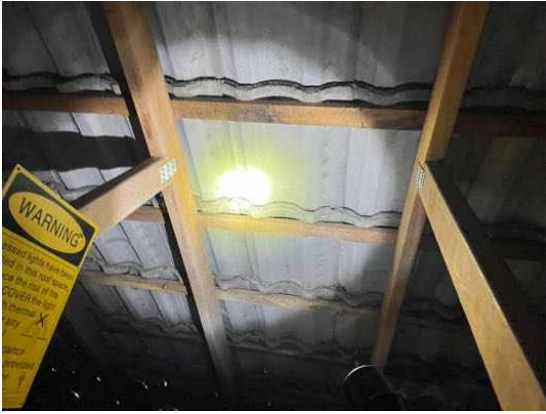
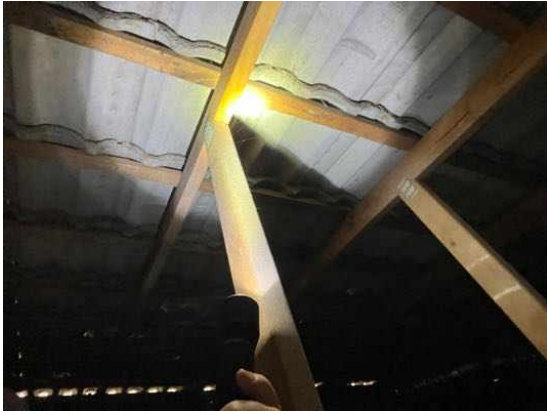
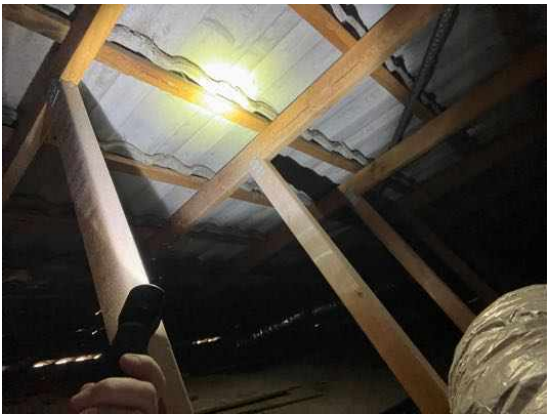
Information:

These photographs are an indication of the obstructions and limitations which impeded full inspection of the property at the time of inspection. These obstructions can hide an array of defects and should be removed to allow full inspection to be carried out. A re-inspection is recommended once the areas are made accessible.
