# Building and Timber Pest Inspection Report

Inspection Date: Mon, 2 Mar 2026

Property Address: 31 Brendan Ave Farmborough Heights  
NSW 2526, Australia

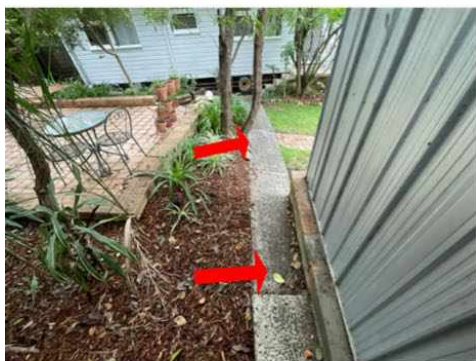
#### Finding 1.01

Building:	Building 1
Location:	Footpaths
Finding:	Trip safety hazards
Information:	A raised section of the left concrete paths, the rear angled path and minor areas of subsidence have created trip hazards. The uneven surface poses a risk to pedestrians, particularly the elderly, children, and individuals with mobility issues. It is recommended to repair these areas by a concreting contractor.

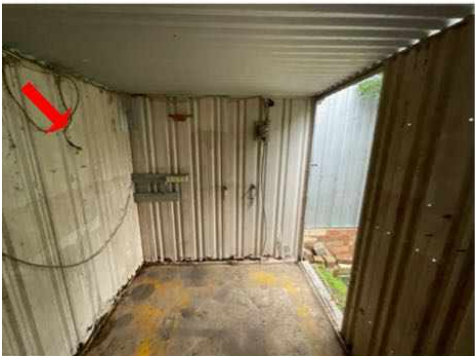
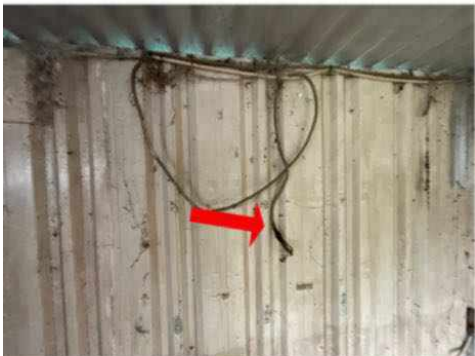
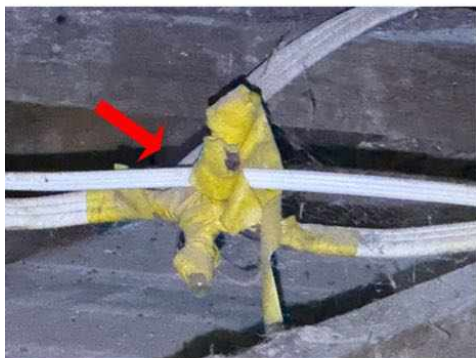
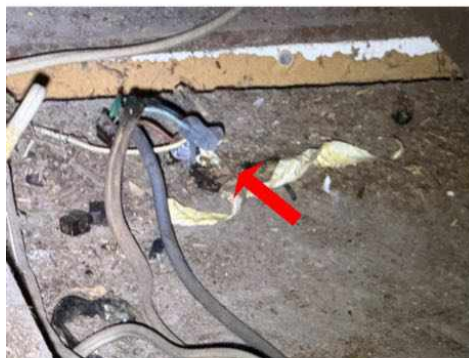
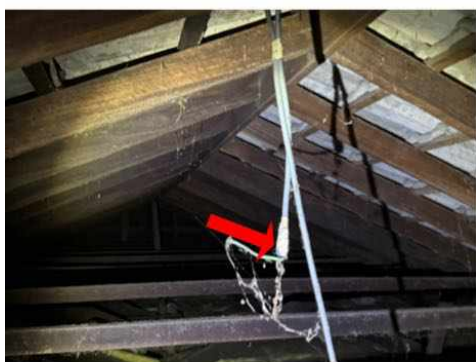
#### Finding 1.02

Building:	Building 1
Location:	Shed, right wall, roof cavity
Finding:	Electrical cables missing a junction box
Information:	Numerous electrical fitting in these areas were found to be missing a junction boxes at the time of inspection.

This missing fittings and loose cables does expose electrical works, and may create a

safety hazard if there is potential contact with persons in the area.

A Licensed electrician should be appointed to rectify these areas immediately.

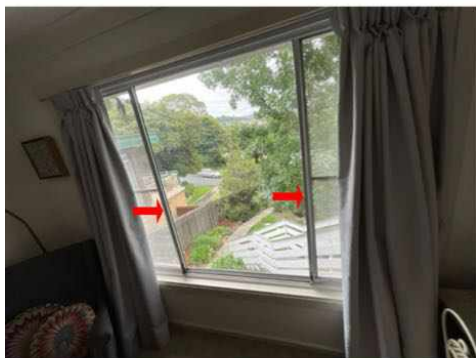
### Finding 1.03

Building:	Building 1
Location:	Bedroom - Master
Finding:	Window opening restrictors missing.
Information:	The Building Code of Australia rules require all openable windows (where the internal floor is more than 2m above the ground outside) in residential rooms to be fitted with a suitable screen or restrictor. Windows located 1.7m above the floor level do not require protection.

Window restrictors are required where people who are vulnerable to the risk of falling have access to windows. This means all windows above ground level which do not have another fall prevention safety measure in place, such as a balcony or balustrade should have a restrictor.

These need to be added urgently for the safety of all persons.

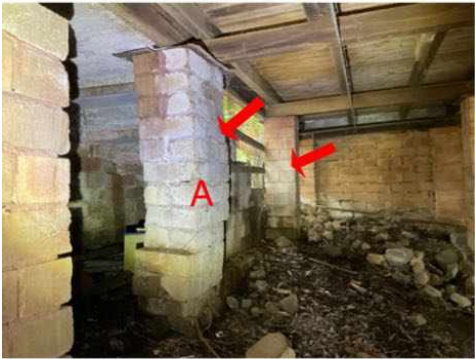
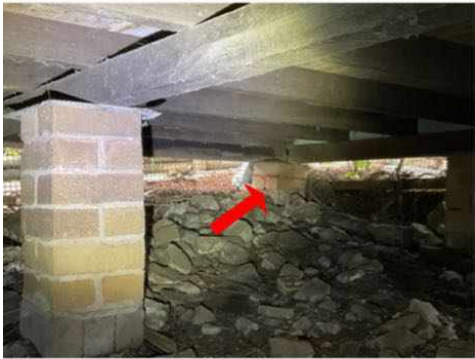
**Finding 3.02**

Building: Building 1  
Location: Subfloor  
Finding: Piers on a lean  
Information: Evidence of three rear brick piers leaning was identified. It is recommended to seek the expertise of pier repair specialists or licensed builder in the next year to assess your foundations and decide on the best course of action (possibly repair or replace pier A). It's essential that this remedial work is performed to prevent the problem becoming worse.

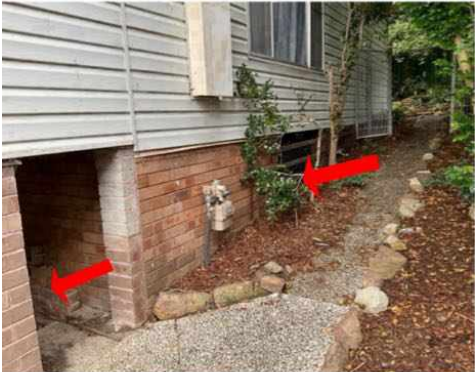
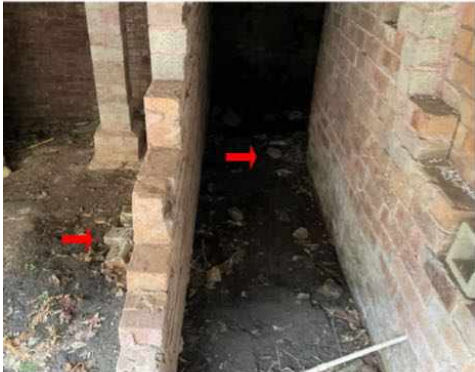
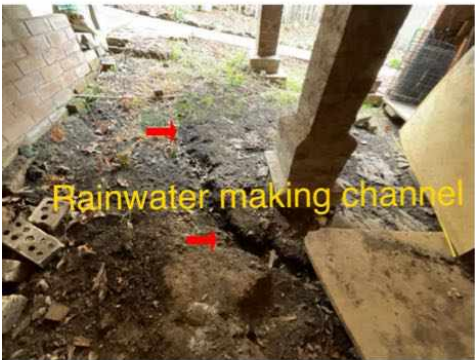
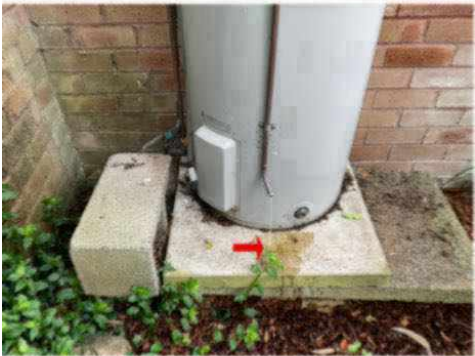
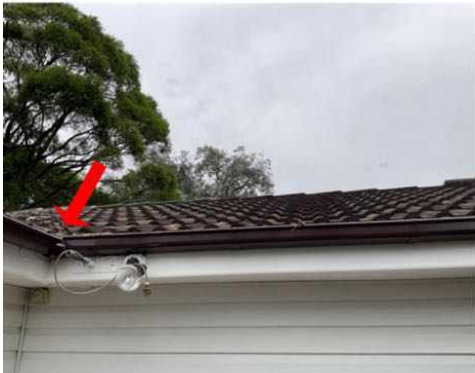
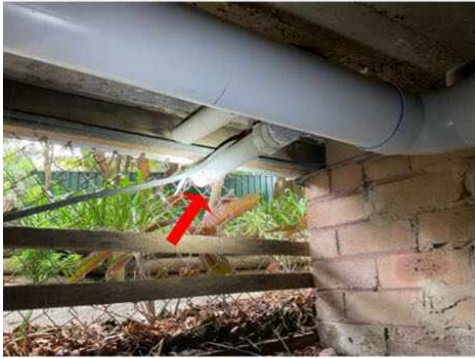
Finding: Site drainage - Inadequate  
Information: The site drainage in these areas was found to be inadequate at the time of inspection, creating potential for subsequent water damage to associated building elements.

The front deck gutter is loose. The laundry and bathroom floor wastes empty to the subfloor areas.

It is important that water does not lie against the base of walls; surrounding paths and ground levels should be sloped to drain water away from walls. Downpipes should not discharge stormwater onto lower walls or plinths. Stormwater should be carried away by large, regularly cleaned drains. Ground levels may need to be lowered to expose a buried DPC.

Where site drainage is inadequate, installation of an Agricultural (Aggie) Drain may be required. A qualified plumber should be appointed to further inspect the property and perform any remedial works as necessary. Secondary defects are likely to occur if left unmanaged.

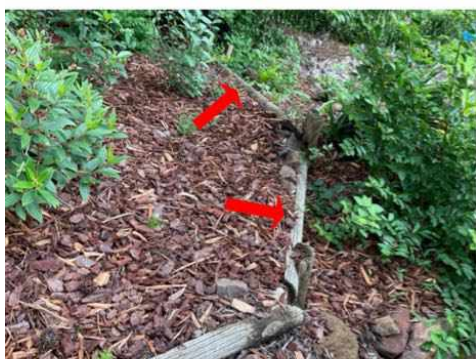
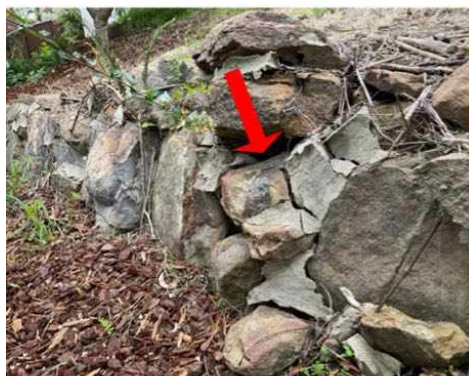
Finding 3.05

Building:	Building 1
Location:	Exterior stonework and pine walks
Finding:	Retaining walls - defective
Information:	Some retaining walls were found to be defective at the time of inspection. Generally, defective retaining walls are caused by poor original design or material use. However, deteriorated retaining walls may also be a result of substandard construction, poor site drainage or unmanaged stormwater flows. The pictured small timber retaining walls are leaning outward and many stone walls have collapsed inward (up the slope).  Due to the small size of these walls, a landscaper or retaining wall installer may be appointed to repair or replace these walls, at the discretion of the client.

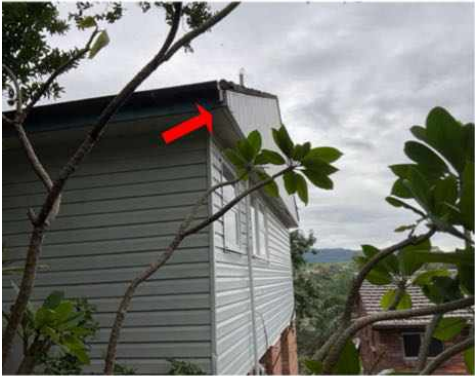
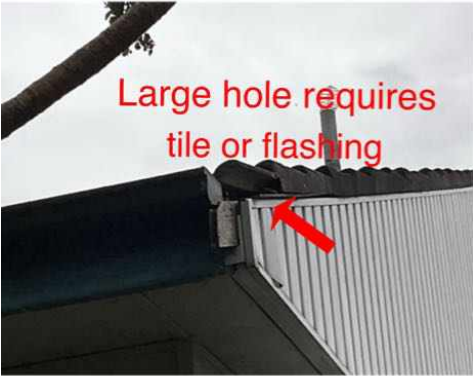
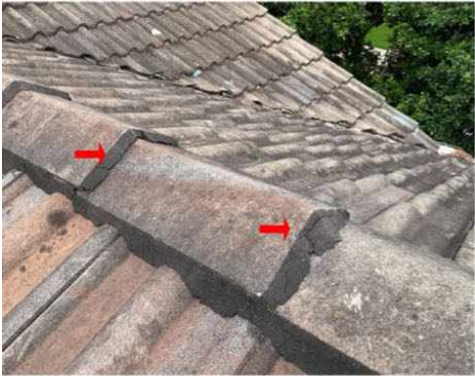
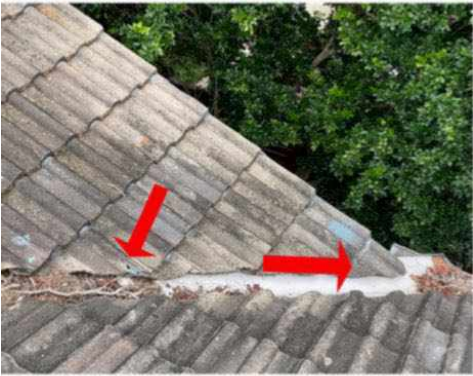
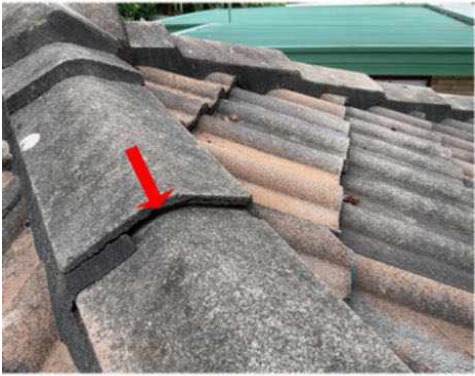
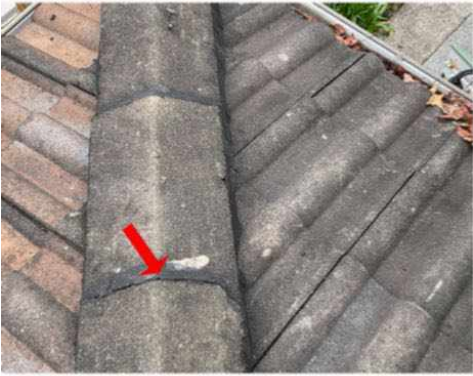
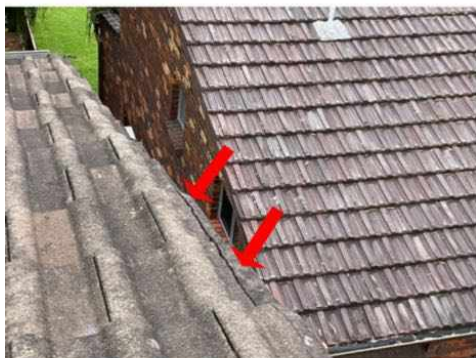
### Finding 3.06

Building:	Building 1
Location:	Roof Exterior
Finding:	Roofing areas - Weathered
Information:	Upon inspection of the exterior roofing, the majority of the roof areas were considered to be in a good condition. While weathering of these pictured areas is consistent with the age of the property, maintenance works are required.

roofing areas. Where left unmanaged, deteriorating roofing materials are likely to lead to a number of secondary defects, including minor water leaks and weather exposure to internal roofing structures.

Re-sealing and replacing small areas of gaps, damage or rust the may be considered as an interim solution by the client to help preserve and extend the life span of these

Consultation with a roofing contractor is highly advised to gain advice on cost of remedial works that may be required in the short to medium term.

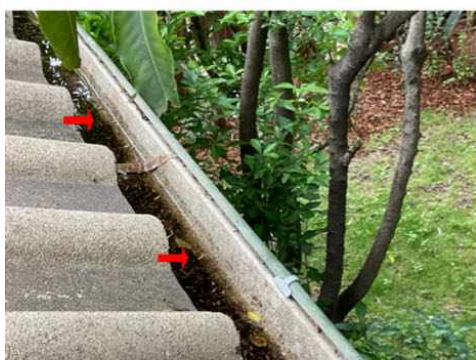
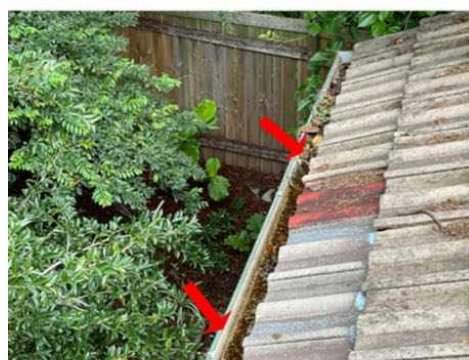
### Finding 3.07

Building:	Building 1
Location:	Roof exterior
Finding:	Roof plumbing - Insufficient fall
Information:	It appears there may be an insufficient fall in the rear roof drainage, which means that the angle is inadequate to facilitate movement of rainwater. This is resulting in pooling of water in the area, creating the potential for water damage to associated building elements.

Without adequate roof drainage, premature rust and decay of the roof plumbing structures is imminent. The development of such deterioration is likely to lead to the formation of secondary defects to adjoining wall sections and roofing elements.

Adjustment by a roofing plumber is required as soon as possible to prevent any further damage to the area.

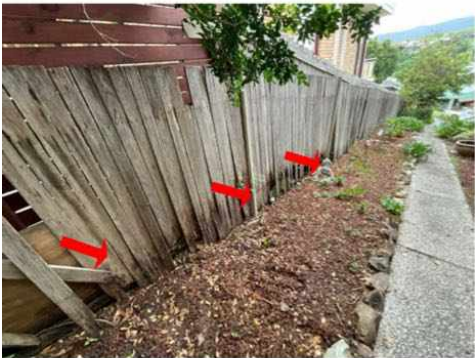
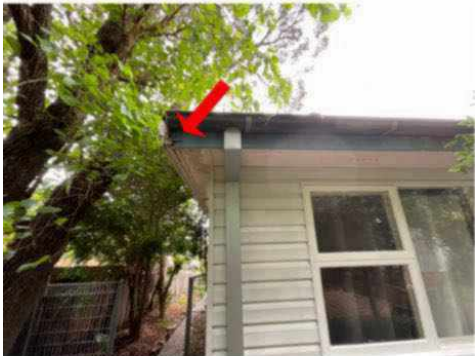
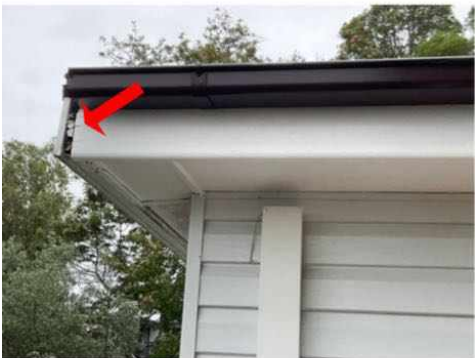
Building:	Building 1
Location:	Pictured areas
Finding:	Wood rot
Information:	The building and fence areas show evidence of wood rot. Wood rot, also known as Fungal Decay, occurs when timbers and other cellulose building materials are exposed to damp conditions on an ongoing basis. This could be the result of exposure to weathering over a prolonged period of time, or the attraction of excessive moisture from other abutting building materials.

Early intervention and regular maintenance, particularly of exterior timbers, will prolong the useful life of these building elements. Prior to any works being performed, the cause of the moisture that has created the visible wood rot should be identified and addressed in a suitable manner. Replacement of affected timbers may then be a necessary step in protecting surrounding building elements from such deterioration.

A qualified carpenter or registered builder may also be required to replace affected building materials.

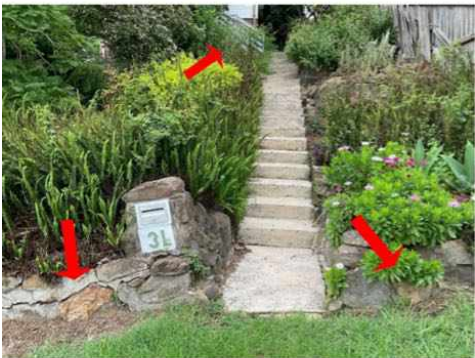
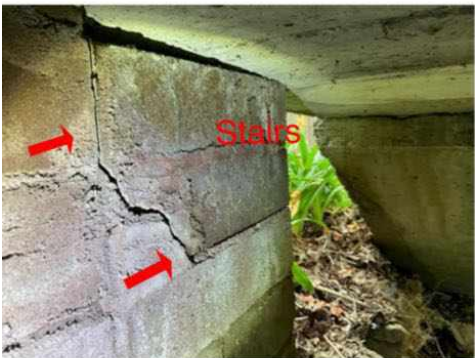
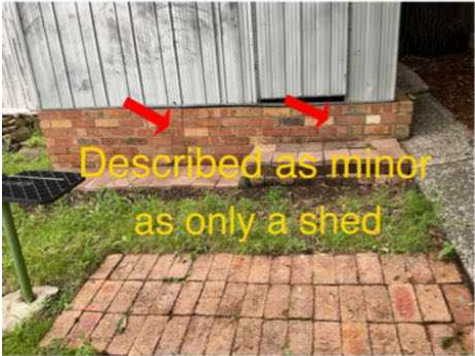
**Finding 3.10**

Building: Building 1  
Location: Exterior stonework  
Finding: Step cracking to brickwork  
Information: Minor step cracking was identified to the brickwork in these areas at the time of inspection. Step cracking, which is similar to other forms of cracking, has a variety of possible causes. However, the most common is the subsidence of adjacent footings.

Step cracking is a relatively common defect, and is most likely to occur adjacent to windows, doors and other openings. Mortar failure in the gaps between affected bricks indicates the stresses and tensions affecting the wall.

Where step cracking is extensive or severe, the client is advised to consult a structural engineer. Minor step cracking can be used as a warning sign to address factors causing stress to the wall, which can include the effect of surrounding trees, water leaks, soil erosion, or even the presence of reactive soils in the surrounding area.

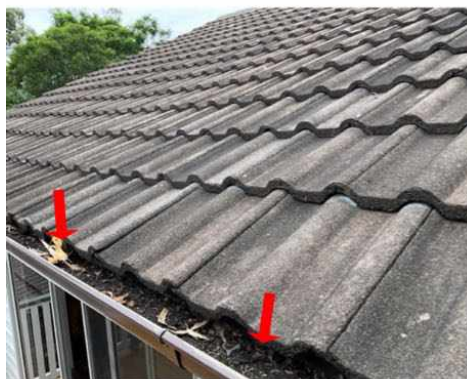
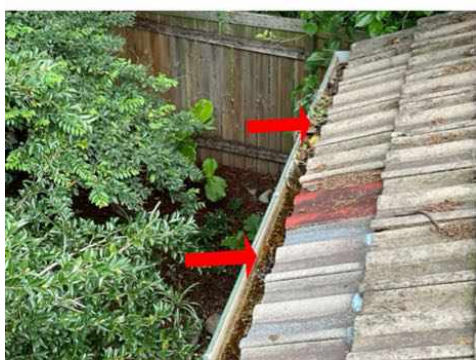
### Finding 3.12

Building: Building 1  
 Location: Roof exterior  
 Finding: Gutters - Full and blocked  
 Information: The guttering on around the roof was found to be blocked at the time of the inspection. Roof plumbing structures, such as guttering and downpipes, should be free of all debris to prevent blockages. Blockages of the guttering and downpipes will lead to pooling and accumulated water overflows, which is likely to subsequently flood eaves and exterior walls.

Blocked gutters are likely to lead to high levels of moisture in the affected areas which can cause rust and decay of the gutters and downpipes and wood rot to adjoining timber areas. Blockages in gutters should therefore be removed immediately to ensure dry conditions are maintained.

It is highly advised that gutters be cleaned by the homeowner or a general handyperson as a matter of urgency.

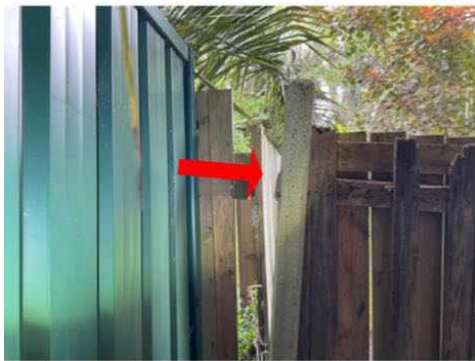
### Finding 3.13

Building:	Building 1
Location:	Pictured fences
Finding:	Fences damaged - leaning
Information:	Evidence of damage to many fences was identified at the time of the inspection. The likely cause of this fence leaning is not enough concrete used in the post footings, wood rot and wood borer damage. If left unmanaged these fences may deteriorate further. It is suggest a fencing contractor be engaged for rectification when convenient.

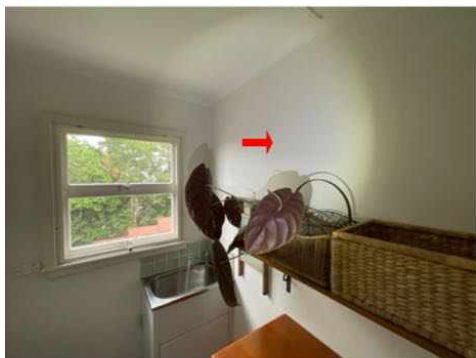
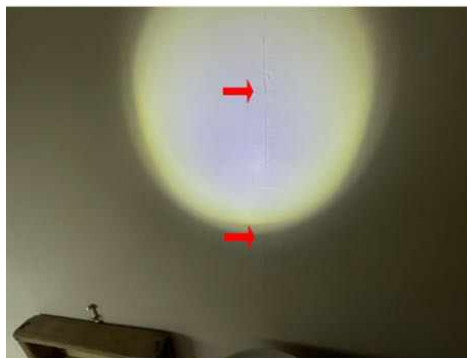
Building:	Building 1
Location:	Laundry
Finding:	Cracking - Damage Category 1 - Fine (up to 1mm)
Information:	Although fine cracks are quite noticeable, they are often only considered to be an appearance defect, and usually do not indicate any structural damage. Generally, the cause of a fine crack is indicative of a separation between building materials and finishes (e.g. paint, plaster, etc.) along joins.

Cracking of this nature can generally be repaired with minor sanding, filling and/or repainting. Such works should be performed by a qualified painter or a general handyman.

Monitoring of all cracking should be conducted frequently. Always contact a building inspector should cracks widen, lengthen, or become more numerous.

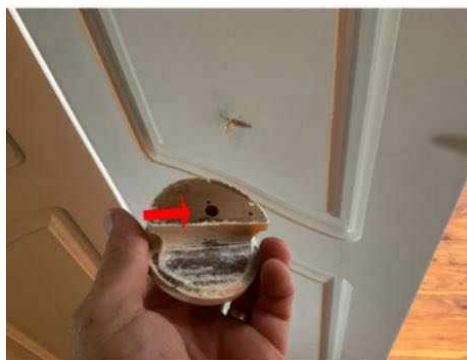
Building:	Building 1
Location:	Pictured areas
Finding:	Building elements damaged
Information:	Evidence of minor missing or damaged areas was identified at the time of the inspection. These include -

1. The rear subfloor door is damaged requiring repair.
2. Some door handles are damaged.

A carpenter would be the trade responsible for rectification of these areas when convenient.

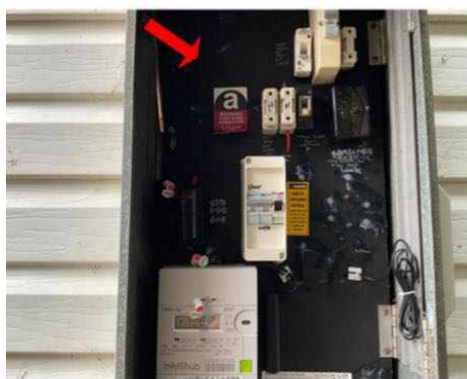
Building:	Building 1
Location:	Meter Box
Finding:	Termite Management System - no evidence of a chemical installation
Information:	The application of a post-construction chemical termite barrier is highly recommended for all properties. Such barriers are highly effective in preventing termite attack on any timber building elements throughout the property.

The client may consider gaining further advice from a pest controller as to the costs and procedures involved with a 'chemical' application. It is recommended that

obtaining such advice be a short-term priority.

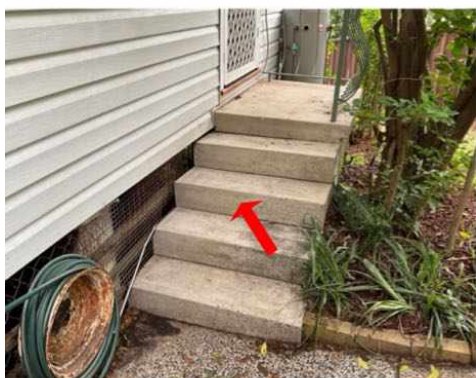
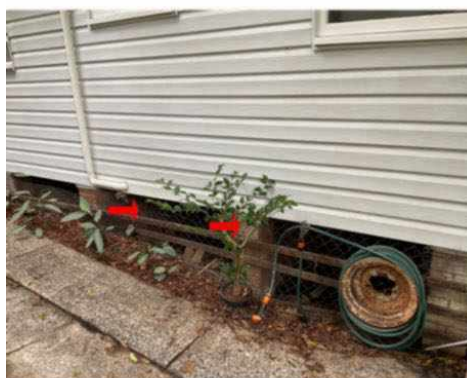
## Finding 6.02

Building:	Building 1
Location:	Many wall areas
Finding:	Bridging - Vegetation, decking, etc
Information:	Where vegetation and decking obstructs inspection of building elements, also known as bridging as it provides a bridging point for the access of termites, full inspection can not be achieved. Consequently moisture or dampness may be present and the areas becomes conducive to termite activity. Plants and decks against or very close to buildings provide cover, shade and can provide an environment that is attractive to termite infestation.

The removal and replanting of plant species that do not provide "cover" or cutting back of existing vegetation, leaving a small gap between decking and the building walls, removing rubbish etc will assist greatly in preventing Bridging from occurring.

The removal of any such stored building or plant materials that may be conducive to termite activity should be carried out as soon as possible and arrange re inspection to minimize the risk of termite attack.

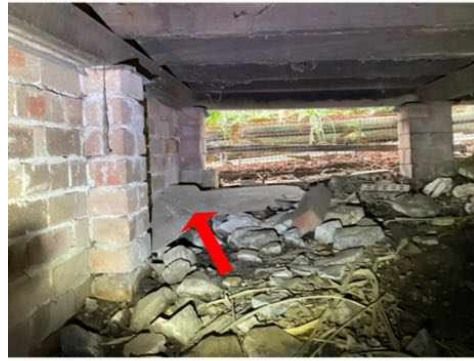
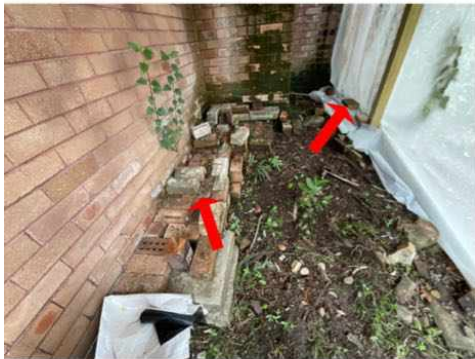
### Finding 6.03

Building:	Building 1
Location:	Yard & subfloor areas
Finding:	Timber in contact with the ground
Information:	Any timbers in direct ground contact provide opportunity for concealed termite entry and are likely to be subject to premature rot and decay as the soil retains moisture or damp conditions against the timbers.

Removal of all waste timber that is in direct contact with ground is highly advised. This timber is promoting mould and wood rot and is very attractive to termites.

Frequent pest inspections are advised to readily identify any termite activity in these areas.

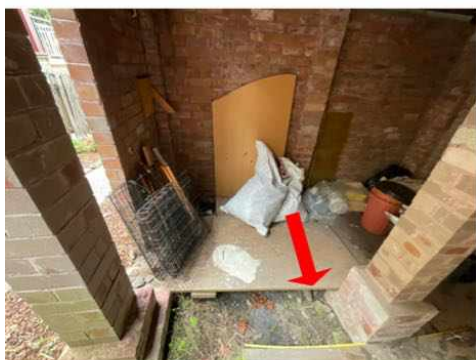
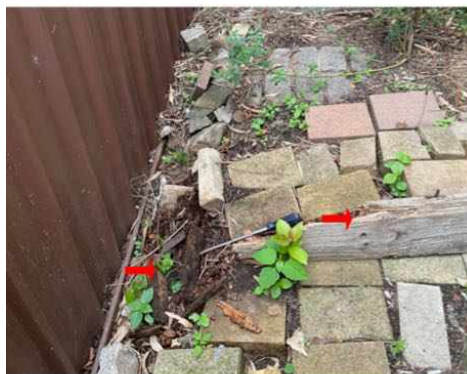
Building:	Building 1
Location:	Many areas
Finding:	Fungal decay - present (localised)
Information:	Fungal decay also known as wood decay or wood rot generally refers to the deterioration of timber elements when in contact with excessive levels of moisture for a prolonged period of time.

Note - See ALL wood rot photos, all these show fungal decay.

In this case, the affected timber element is in a decaying state and will need replacement by a carpenter or licensed builder.

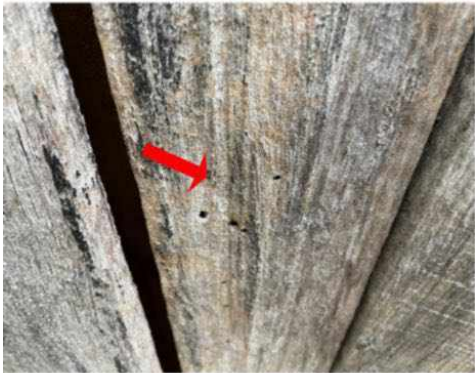
### Finding 8.01

Building:	Building 1
Location:	Pictured fences and some trees
Finding:	Evidence of wood borer activity identified
Information:	Wood borers small beetles that colonise in exposed timber elements are a common timber pest that are regularly mistaken for termites. Although wood borer activity is generally not detrimental to the affected timber they may lead to serious damage and necessitate replacement of certain building elements if left unattended.

As no live wood borer activity was identified treatment is not required at this time. Replacement of affected timbers may be considered by the client for superficial reasons.

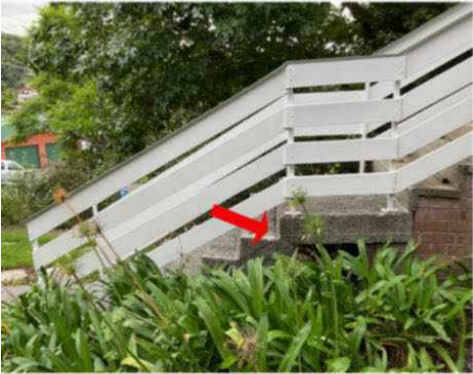
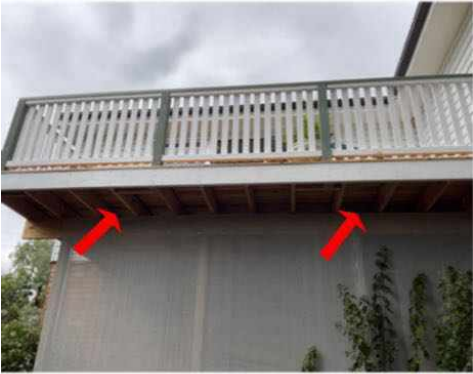
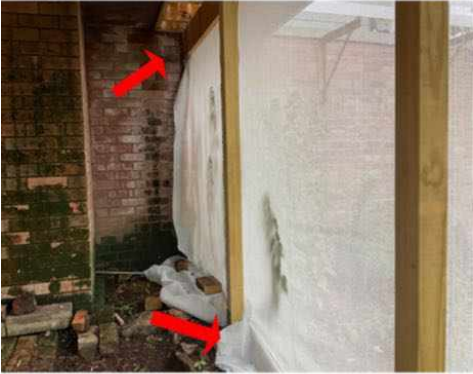
has been made, on any elevated structure, as suitable for any specific number of people or purpose. This can only be done by a qualified engineer. For the purpose of this report, the Structure includes the elevated front decks, handrails and stairs. The visible areas of the front steps show minor step cracking present in the lower steps (pictures 2 & 3).

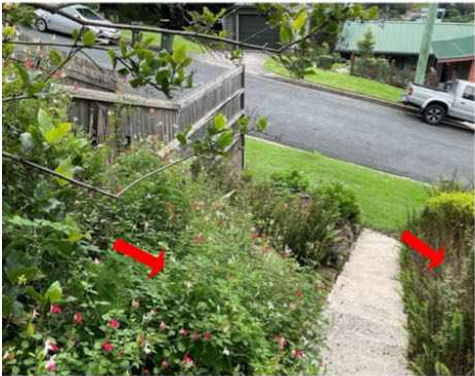
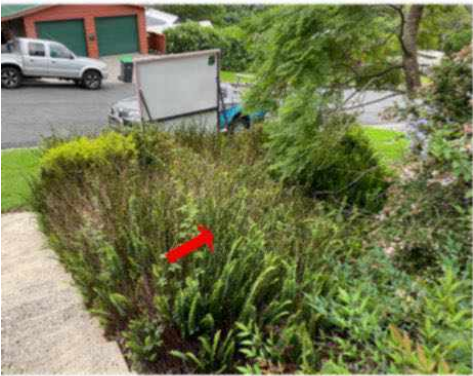
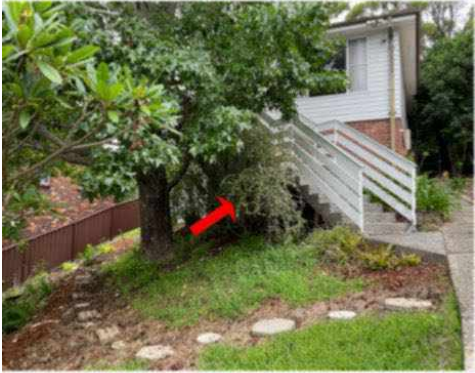
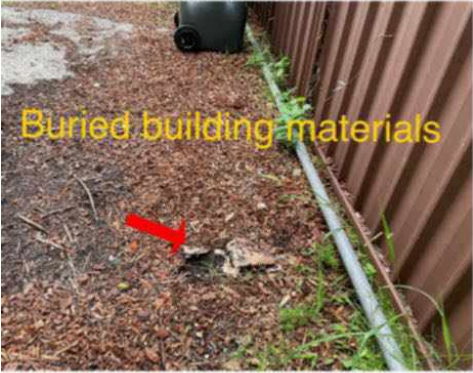
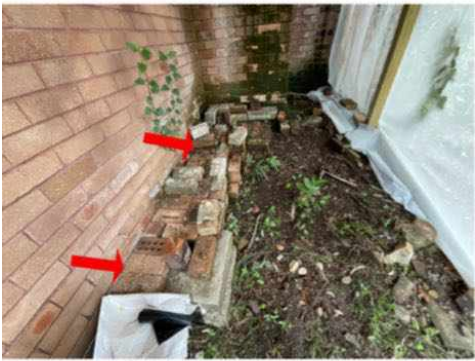
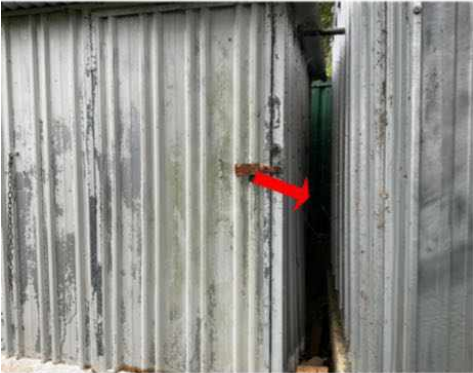
Building: Building 1  
 Location: Pictured fences

Finding: Additional Photos - Obstructions and Limitations of EXTERNAL AREAS  
Information: These photographs are an indication of the obstructions and limitations which impeded full inspection of external areas at the time of inspection. These obstructions can hide an array of defects and should be removed to allow full inspection to be carried out. A re-inspection is recommended once the areas are made accessible.

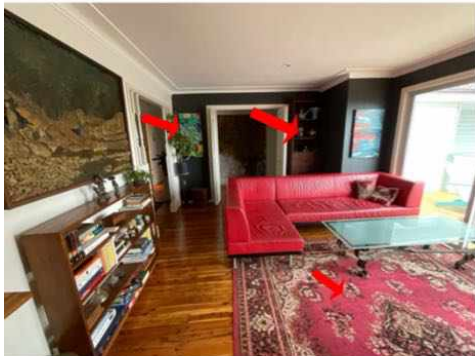
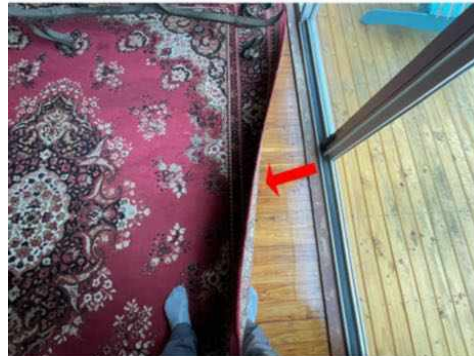
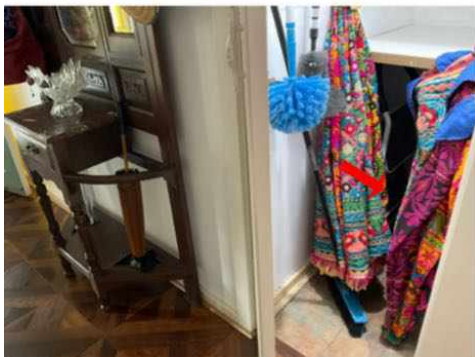
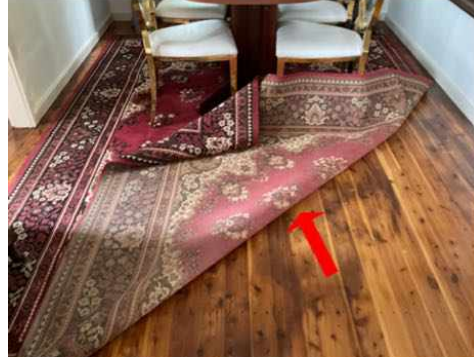
Building: Building 1  
Location: Pictured fences  
Finding: Additional Photos - Obstructions and Limitations of INTERNAL AREAS  
Information: These photographs are an indication of the obstructions and limitations which impeded full inspection of Internal areas at the time of inspection. These obstructions can hide an array of defects and should be removed to allow full inspection to be carried out. A re-inspection is recommended once the areas are made accessible.

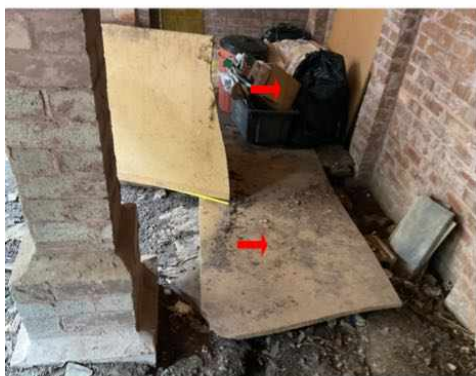
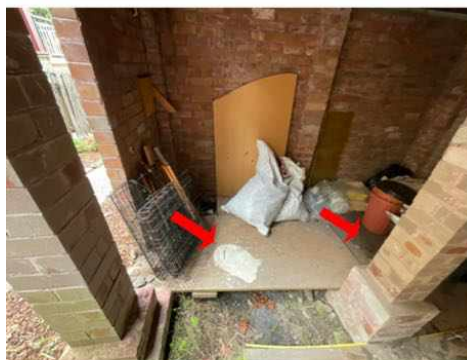
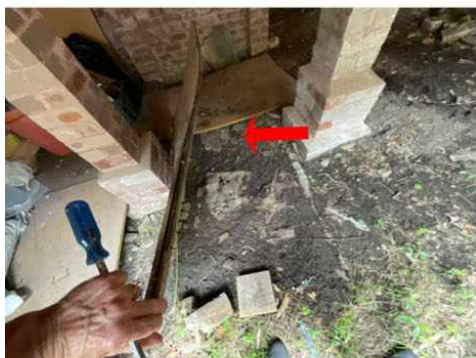
Building: Building 1  
 Location: Pictured fences  
 Finding: Additional Photos - Obstructions and Limitations of SUBFLOOR AREAS  
 Information: These photographs are an indication of the obstructions and limitations which impeded full inspection of subfloor areas at the time of inspection. These obstructions can hide an array of defects and should be removed to allow full inspection to be carried out. A re-inspection is recommended once the areas are made accessible.

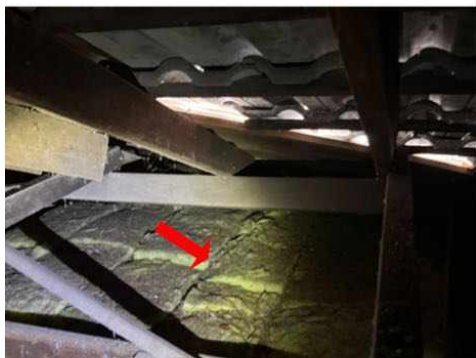
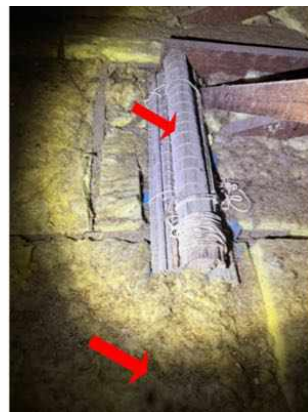
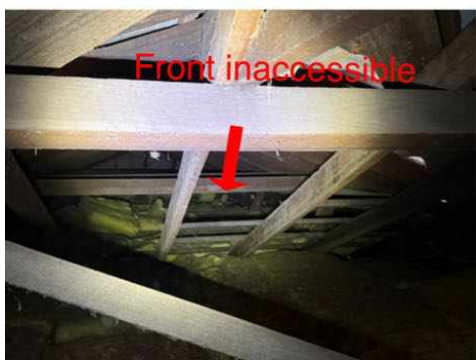
Building: Building 1  
 Location: Pictured fences  
 Finding: Additional Photos - Obstructions and Limitations of the ROOF CAVITY  
 Information: These photographs are an indication of the obstructions and limitations which impeded full inspection of roof cavity areas at the time of inspection. These obstructions can hide an array of defects and should be removed to allow full inspection to be carried out if applicable. A re-inspection is recommended once the areas are made accessible.

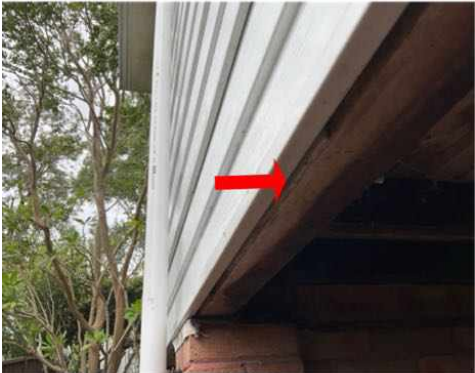
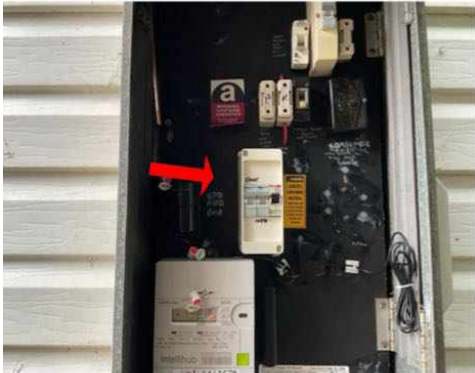
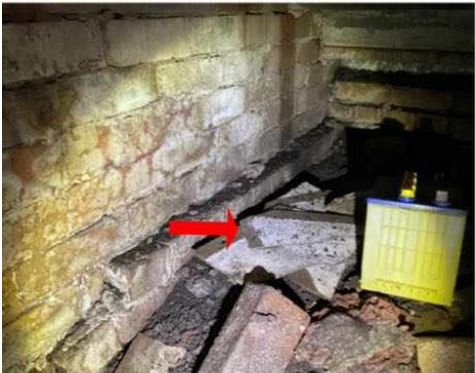
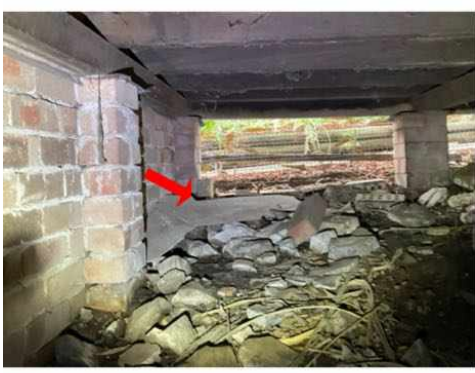
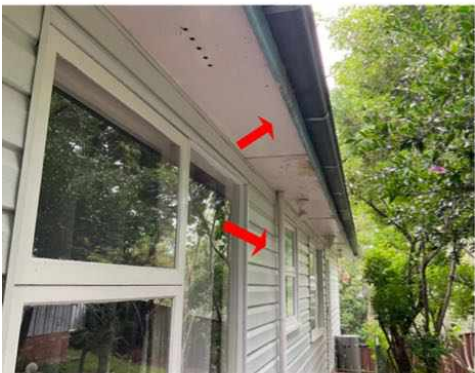
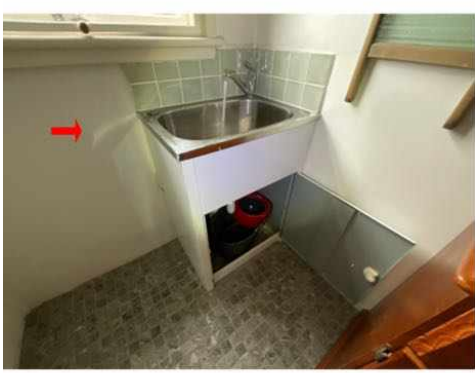
Building:	Building 1
Location:	Many areas
Finding:	Asbestos - Suspected ACM Identified on Site
Information:	Reporting on Asbestos is outside the Scope of this Report. This suspected defect is highlighted as a caution only. We suspect, based on our experience in the building industry, that there is a higher risk of the identified building element containing asbestos.

As Asbestos Reporting is outside the scope of this report, we advise that you consider a separate Asbestos Inspection and Condition Audit, which can include the taking of samples for definitive confirmation of the presence of Asbestos.

In the interim, the client is advised to act with caution, especially when considering any damage to building materials general wear and tear renovations extensions demolition and general maintenance activities due to the suspected presence of Asbestos.

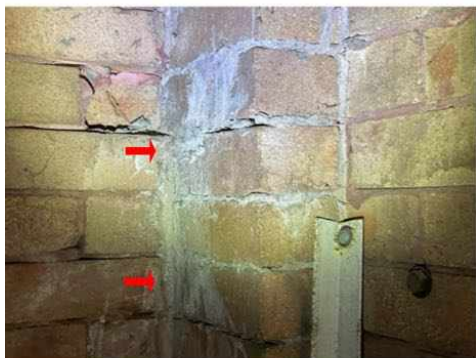
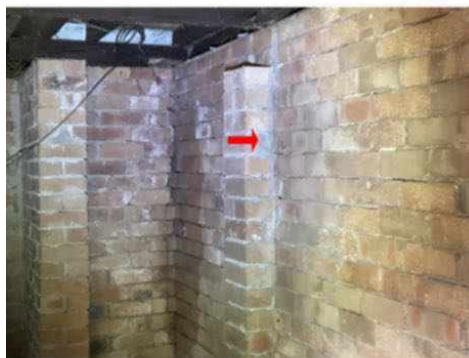
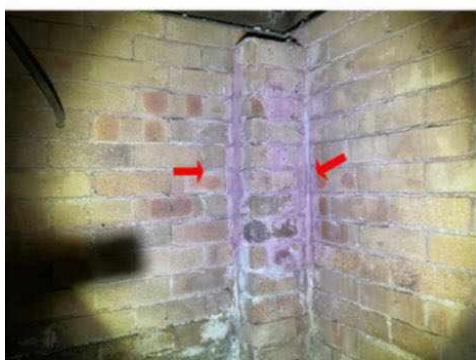
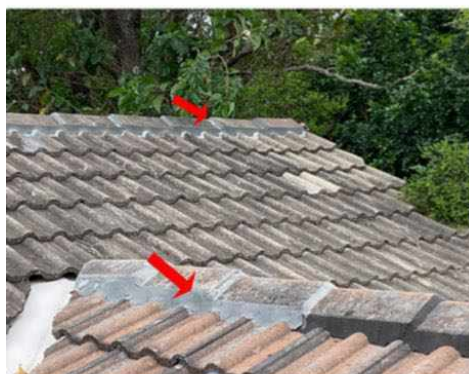
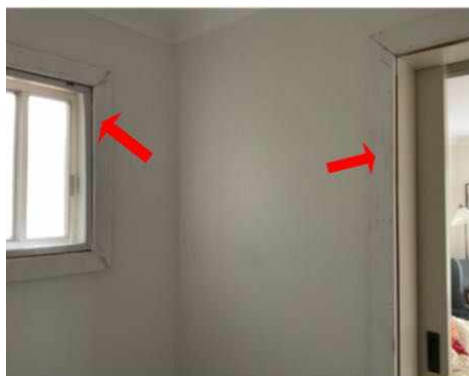
Building: Building 1  
Location: Many areas  
Finding: Repairs evident in many areas  
Information:

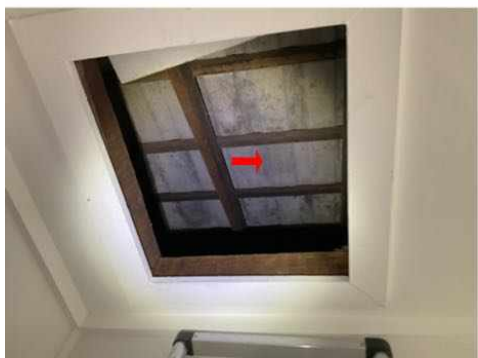
Building: Building 1  
 Location: Roof Void  
 Finding: Sarking - Missing  
 Information: Sarking is missing under the roof sheeting. Sarking acts as an insulator that helps with noise reduction and protects against water penetration. Sarking plays a key role in the operation and function of the overall roofing structure and its performance.

Although not a requirement at the time of construction, replacement of any missing building element is advisable (although this can be quite expensive to do after the time of construction). Where sarking is missing, regular inspections of the roof tiles for cracking and potential moisture penetration is required.

Sarking may be retrospectively fitted by a registered builder at the discretion of the client.
