Building and Timber Pest Inspection Report

Inspection Date: Fri, 16 Jan 2026

Property Address: 17 Price St, Bowral NSW 2576, Australia

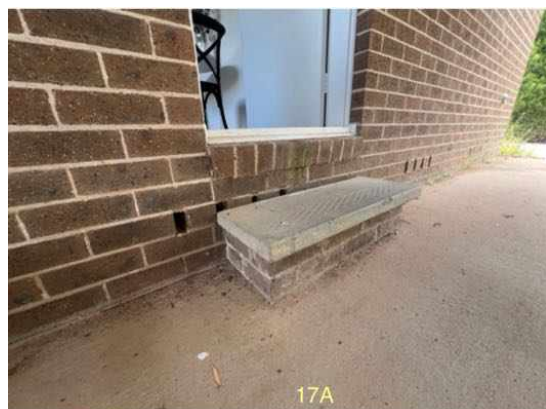
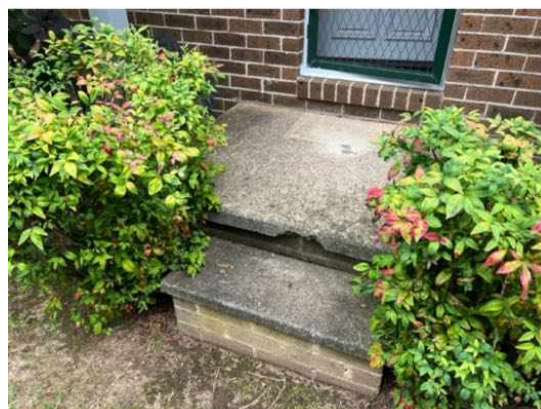
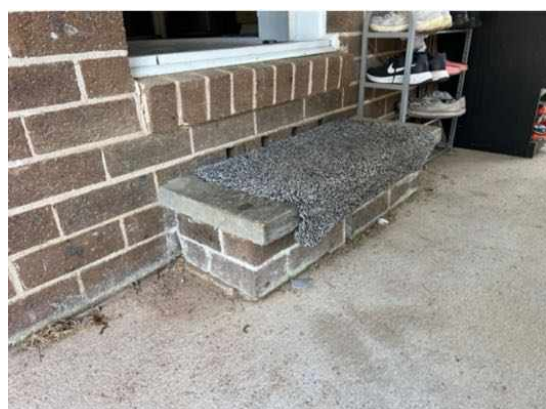
Building:	Not Applicable
Location:	17A - Carport, 17B - Carport, Porch
Finding:	Stairs - Uneven heights
Information:	The stairs were found to be of varying heights, creating a potential trip hazard for users of the staircase. According to normal building practices, all stairs should be measured and levelled to exact heights so as to prevent tripping.

Although retrospective works may not be relevant or cost-efficient, re-levelling of the uneven stairs is otherwise advisable. Consultation with a qualified carpenter as to the cost of potential solutions is recommended as soon as possible.

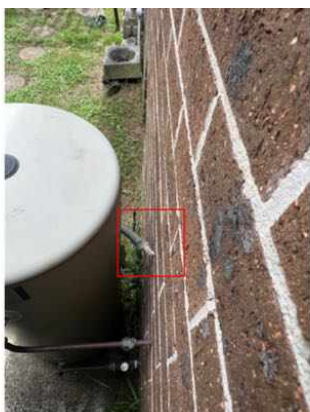
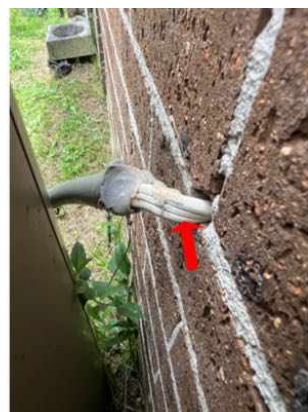
Finding 1.02

Building:	Building 2
Location:	Hot Water System
Finding:	Electrical wires exposed
Information:	Exposed electrical wiring was identified. Exposed electrical wiring represents a

potential safety hazard including for fire and personal contact. Contact a licensed electrician urgently for further inspection investigation and rectification.

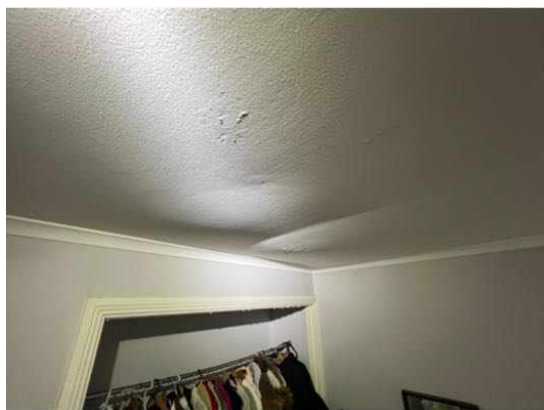
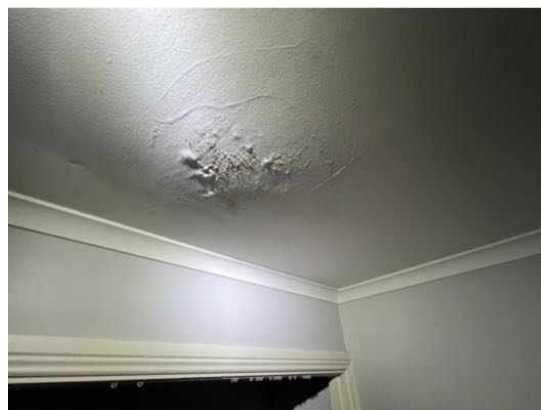
Finding 1.03

Building:	Building 2
Location:	Bedroom - Master
Finding:	Ceiling - Sagging
Information:	Sections of the ceiling were found to be sagging at the time of inspection. Sagging to the fixed ceiling structure generally indicates that the building materials have swollen, due to contact with water, or that fixings (e.g. nails or glue) have become loose and require reattachment.

In some cases, sagging ceiling linings may also indicate that there are structural issues, causing surfaces to warp, twist or sag. Where sagging appears to be major, appointment of a structural engineer is advised to further inspect the property and identify the source and rectification works required.

Where minor sagging is evident, comparatively minor works, such as re-gluing of ceiling sheets, may be required. Such works may be performed by relevant tradespeople, such as plasterers and painters. Where excessive moisture has caused the roofing structure to swell and sag, the source of the water leak should primarily be identified prior to any remedial works being performed.

The appropriate action should be taken by the client as soon as possible to ensure that any potential further damage is limited.

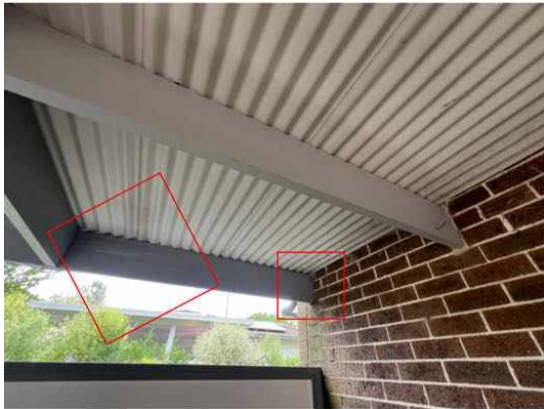
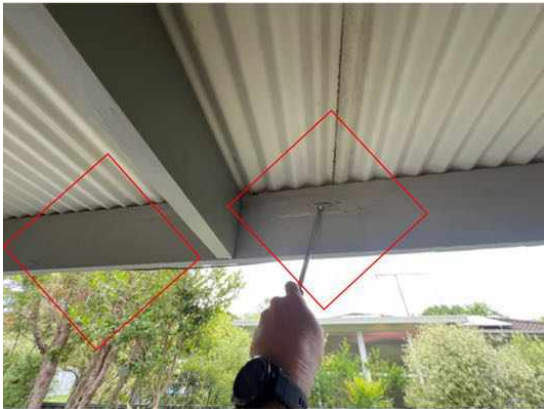
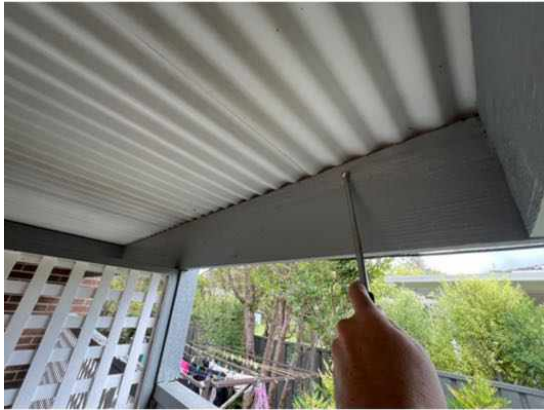
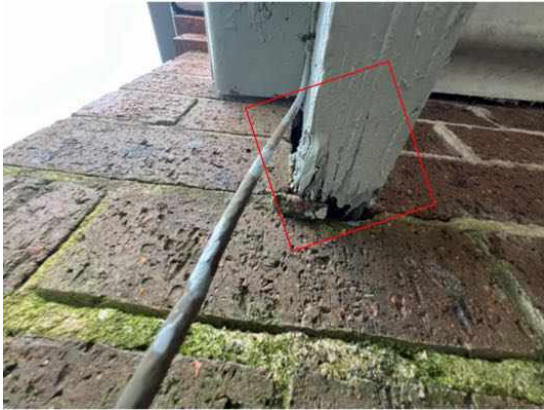
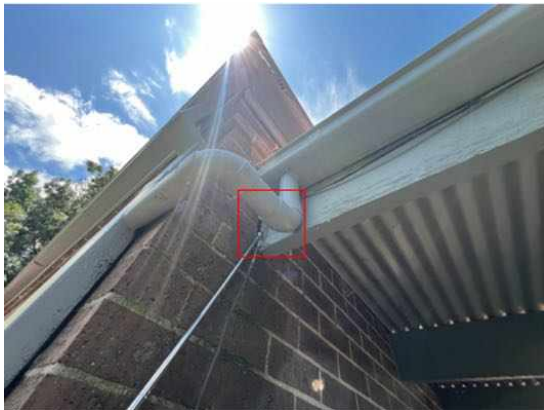
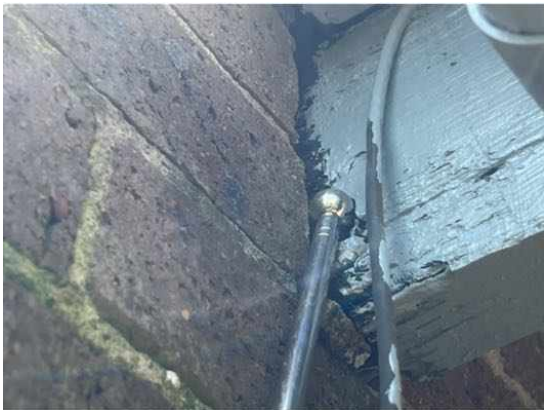
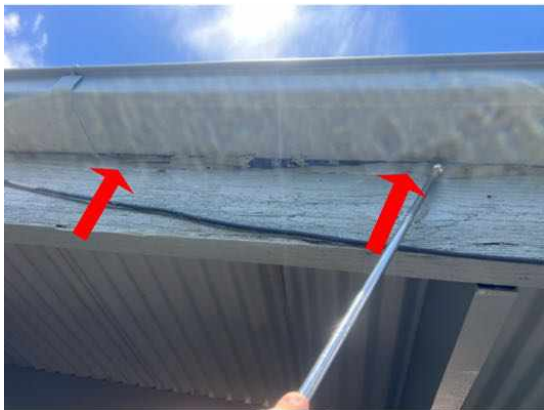
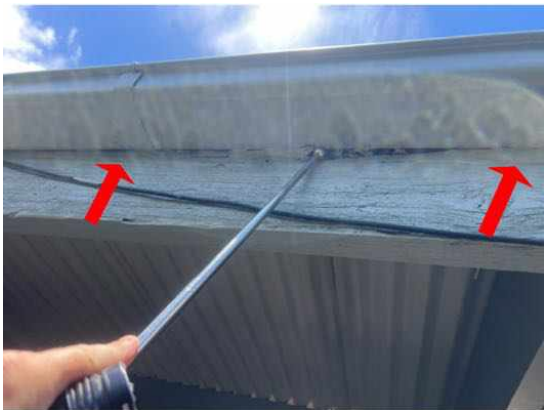
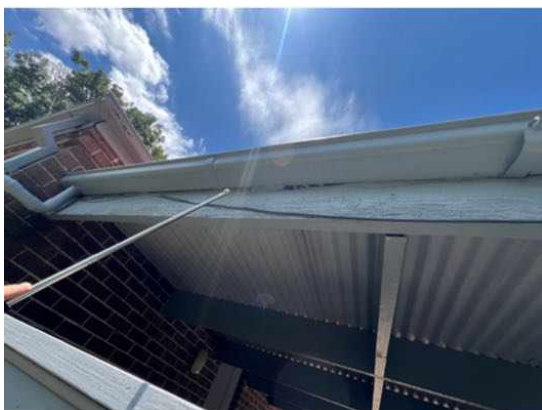
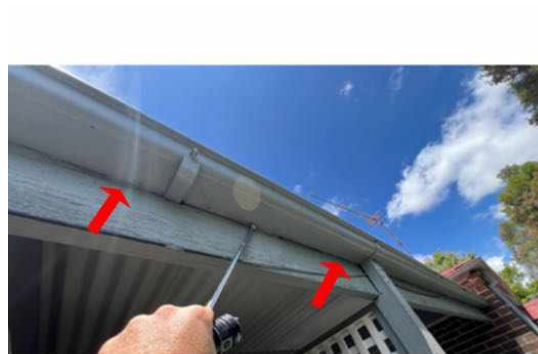
Finding 2.01

Building:	Building 1
Location:	Carport
Finding:	Supporting beam structure - Wood rot
Information:	The carport beam was observed to exhibit timber rot consistent with fungal decay. The affected timber shows signs of deterioration and loss of durability, likely associated with prolonged moisture exposure.

Timber rot of this nature reduces the load-bearing capacity of the beam and compromises its ability to perform as intended. If left unmanaged, continued deterioration is likely, which may lead to loss of structural integrity and increased risk of failure of the supported elements.

Deteriorated timber also provides conditions that are conducive to termite activity, as decayed timber is more readily penetrated and may allow concealed access if in contact with moisture or the ground.

Where timber rot is present to a structural beam, rectification or replacement of the affected timber element is required. The urgency and extent of works are dependent on the severity and spread of decay. Further assessment by a registered builder is recommended to determine the appropriate scope and timeframe for remedial works.

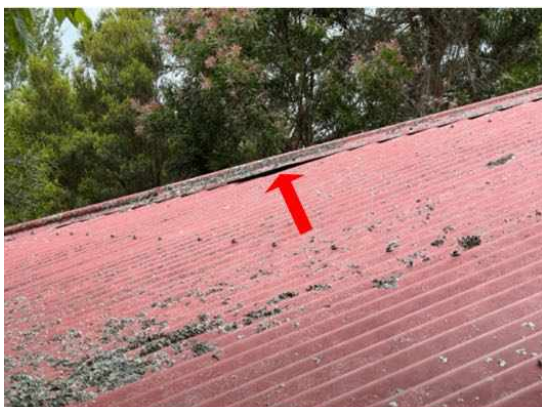
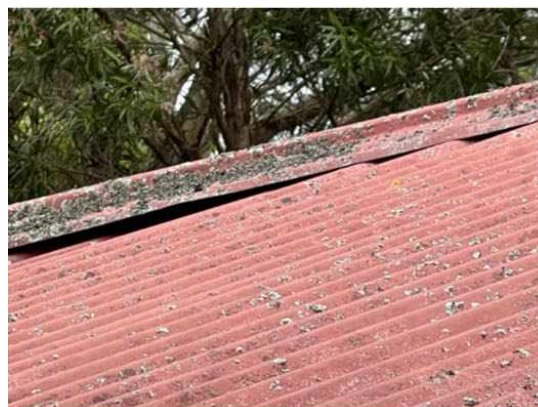
Finding 2.02

Building:	Building 2
Location:	Roof Exterior (above Bedroom - Master)
Finding:	Roof sheets - Sagging
Information:	Sections of the roof sheeting were identified as sagging during inspection of the exterior roof. Sagging roof sheets are likely a result of failures of fastenings or fixings, but may also indicate inadequate roof support.

Where roof sheeting is sagging, inadequate roof drainage is likely to occur. The presence of excessive moisture in these areas will lead to accelerated deterioration of the roof sheeting, and may detract from the structural integrity of the roof covering if left unmanaged for a prolonged period of time.

Appointment of a roofing restoration contractor is advised to address any underlying structural causes and ensure that the development of secondary building defects does not occur.

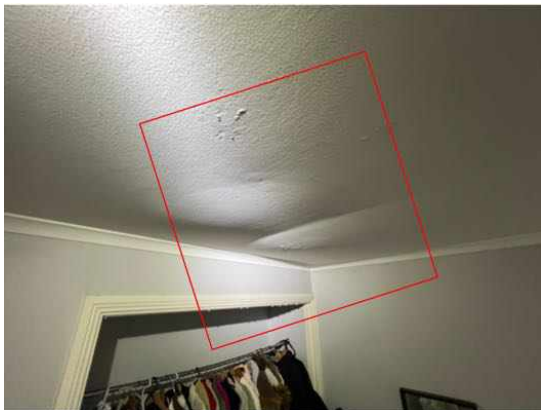
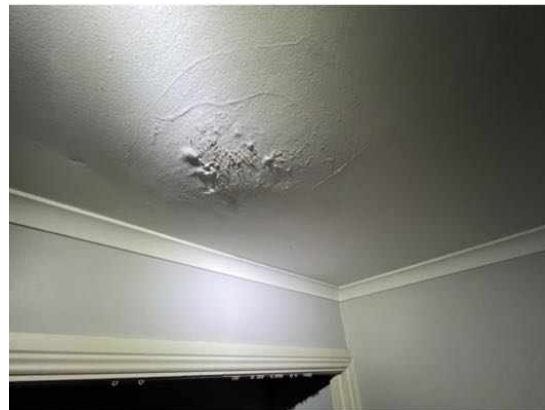
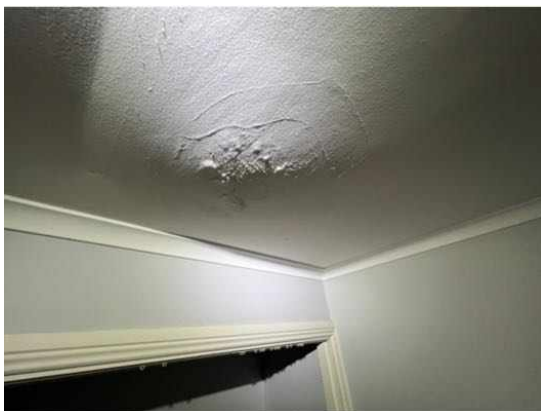
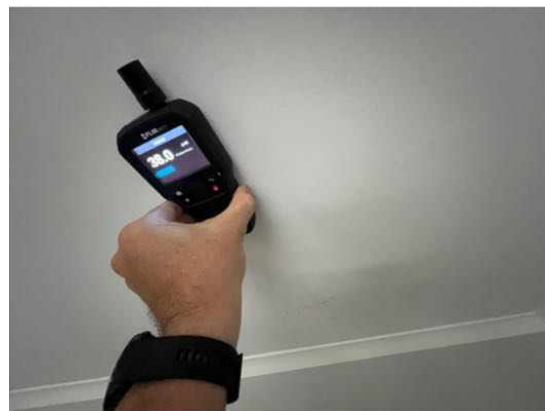
Finding 2.03

Building:	Building 2
Location:	Bedroom - Master
Finding:	Ceiling - Water damaged

Information: Water damage to the ceiling lining is generally an indication of excessive moisture being present in the roof void, usually via a leak to the roof covering.

Where water damage is evident to the ceiling, the primary requirement is to identify and rectify the source of the leak. A roofing plumber should be appointed as soon as possible to identify the leak and perform rectification works as necessary, ensuring the water damage is restricted.

Once the leak is repaired, consultation with relevant tradespeople, including plasterers and painters, is advised. Rectification works may include replacement of ceiling lining or minor repainting, depending on the extent of the damage.

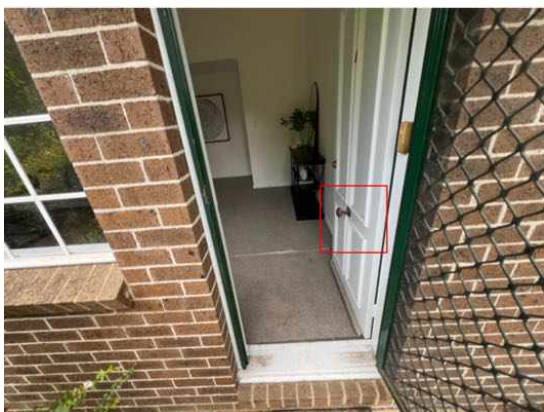
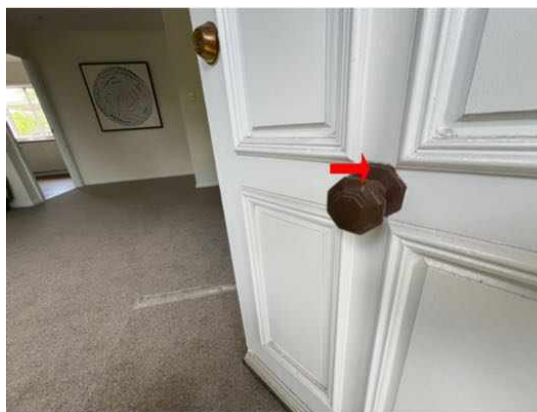
Finding 3.02

Finding: Door Handle - Loose

Information: The door handle in this area was identified as loose at the time of inspection. A loose door handle can impede the proper operation of the door and, if left unattended, may lead to further deterioration or damage to the associated door structure.

This defect is typically caused by wear and tear, insufficient fixing, or deterioration of the handle's components.

It is recommended that a qualified carpenter or general handyperson be appointed to secure or replace the handle to restore its functionality and ensure proper operation.

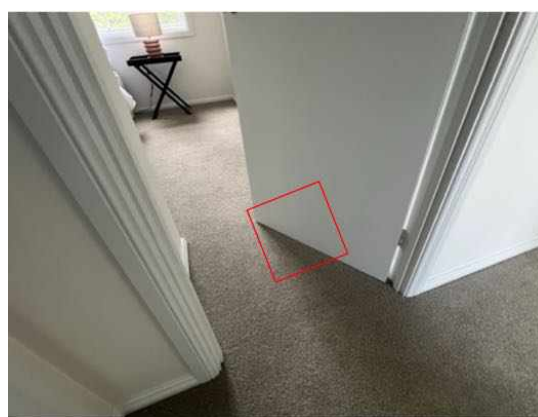
Finding 3.03

Information: Binding and/or jamming of several doors throughout the property were evident during standard operation. This defect inhibits the functionality of affected doors as well as creating potential for secondary defects to associated building elements, such as

damage to the floor covering.

A door that binds to flooring or to the associated door frame may have several causes, ranging from minor defects, such as poor installation of the door or deteriorated hinges, through to major structural issues, such as damage to subfloor structures.

Where door binding/jamming appears to indicate major structural issues, a registered builder specialising in re-stumping should be appointed to provide an estimate on the cost of rectification.

For minor causes, a qualified carpenter or general handyman should be appointed to perform minor rectification works at client discretion.

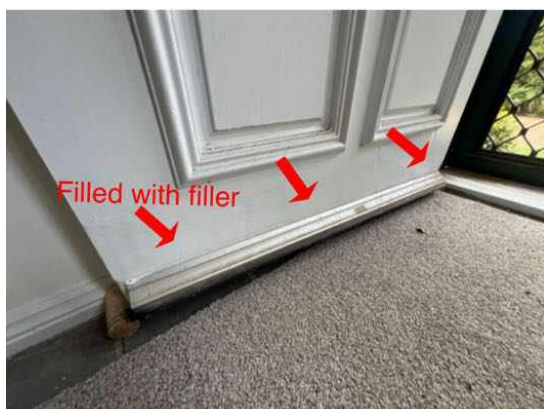
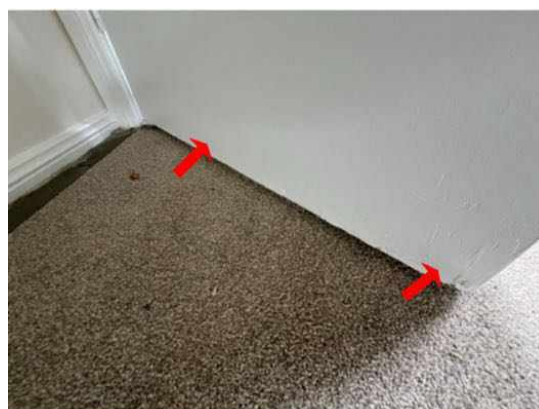
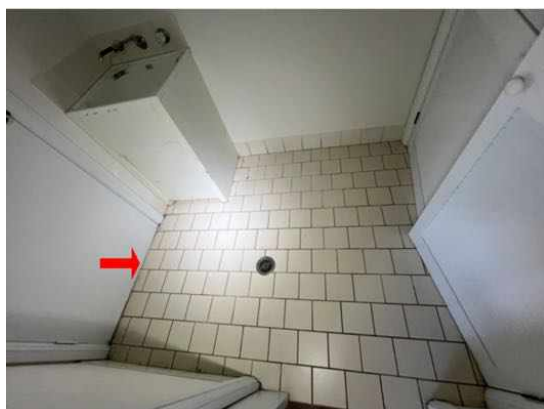
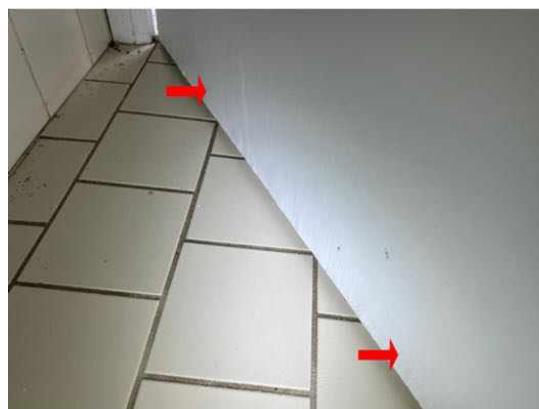
Finding 3.04

Building:	Building 1
Location:	Entry. Laundry
Finding:	Door - Wood rot
Information:	This door shows evidence of wood rot. Wood rot, also known as Fungal Decay, occurs when timbers and other cellulose building materials are exposed to damp conditions on an ongoing basis. This could be the result of exposure to weathering over a prolonged period of time, or the attraction of excessive moisture from other abutting building materials. Contributing factors also include poor air ventilation in the area.

Wood rot is often associated with general damp problems and is evidenced by a 'musty' smell or mould and mildew occurring on surfaces. If left unmanaged, damp conditions can lead to further health problems and the decay of timbers will continue.

Early intervention and regular maintenance, particularly of exterior timbers, will prolong the useful life of these building elements. Prior to any works being performed, the cause of the moisture that has created the visible wood rot should be identified and addressed in a suitable manner. Replacement of affected timbers may then be a necessary step in protecting surrounding building elements from such deterioration.

A qualified plumber may be appointed to assess the cause of excessive moisture and to provide advice on any remedial works as required. A qualified carpenter or registered builder may also be required to replace affected building materials.

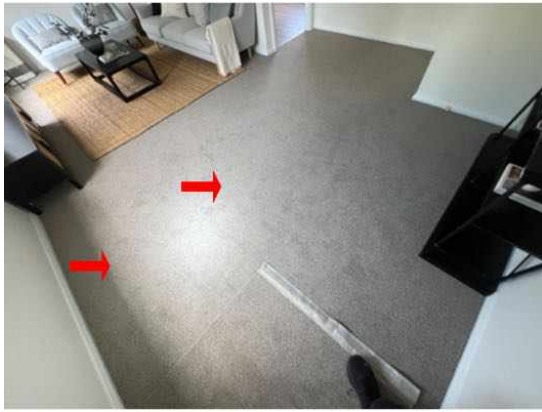
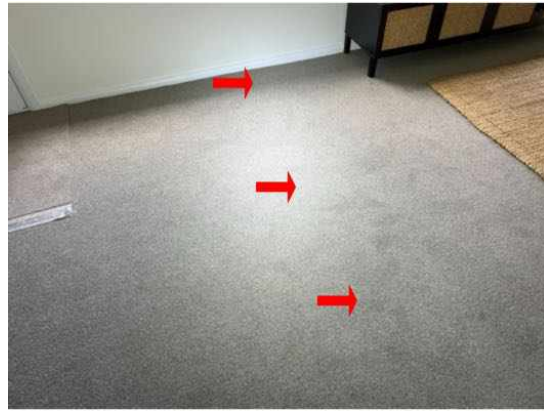
Finding 3.05

Information: The internal flooring in this area is out of level and uneven. Uneven flooring is likely to indicate minor defects such as expected movement of the foundations of the property, but may also indicate subsidence of the associated subfloor stumps.

It is advised that the flooring be closely monitored to identify any further movement. Where flooring remains relatively unchanged for an extended period of time (i.e. several months), it is likely that this defect has been caused by expected movement of the foundations of the property.

However, where flooring is uneven further, potentially invasive inspection of the subfloor structures and stumps in this area is required. In this case, works to repair are likely to be required, and would be carried out by a registered builder specialising in re-stumping.

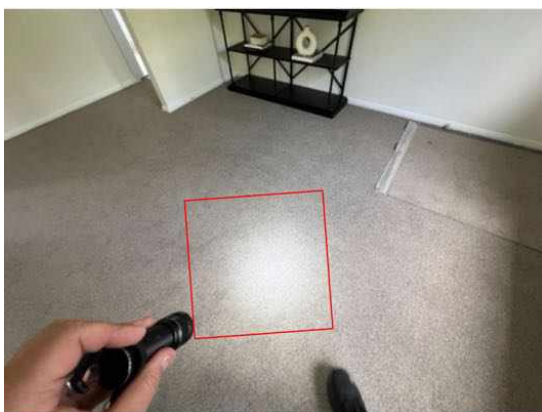
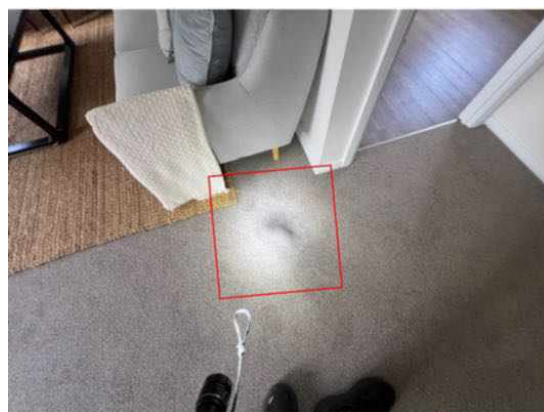
Finding 3.06

Building:	Building 1
Location:	Dining Room, Hallway, Bedroom 2
Finding:	Floors - bouncy
Information:	The internal flooring in this area was identified as being bouncy at the time of inspection. A bouncy floor surface generally presents as a discernible change in level as they are walked across, in noisy or creaking flooring, or in consequent movement of surrounding furniture and fixtures.

Bouncy floors generally indicate that the floorboards or the subfloor structures are coming loose from the joists that they are installed on. Bouncy flooring may also be the result of gaps between flooring and stumps or joist structures, which require packing.

The client is advised to seek quotations for required repairs from a Registered Builder specialising in re-stumping. The potential resolution may range from packing gaps in subfloor structures through to replacement of subfloors stumps and refixing of flooring.

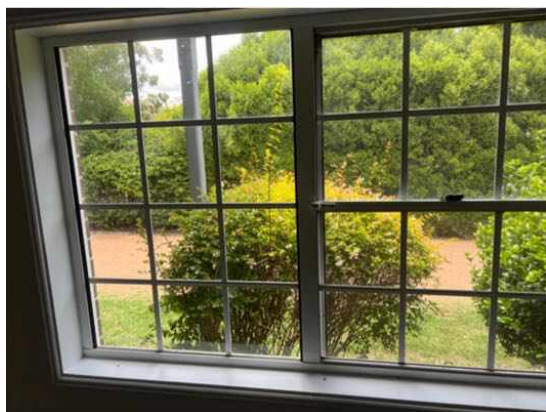
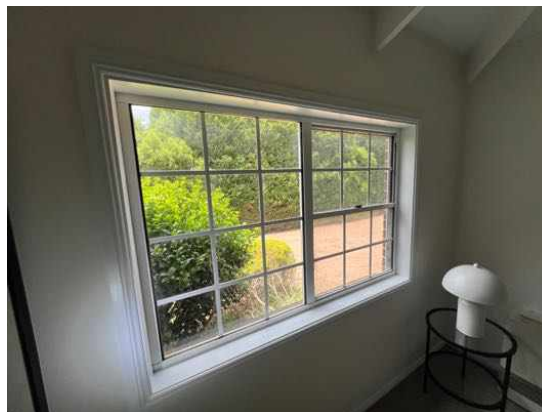
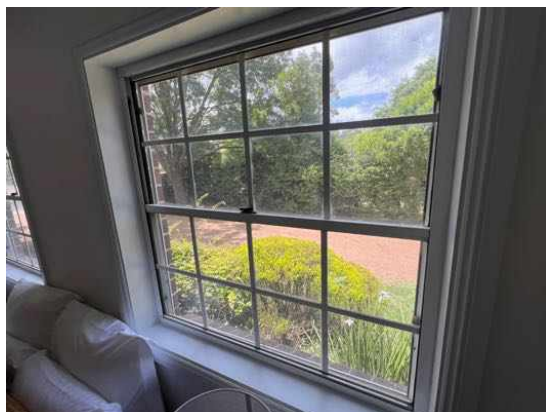
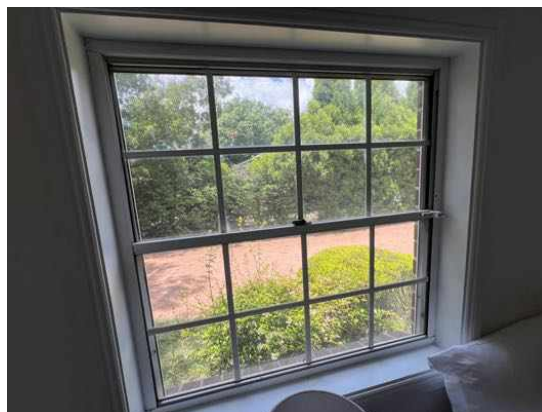
Finding 3.07

Building:	Building 1
Location:	Dining Room, Living Room, Bedroom 2
Finding:	Window service recommended
Information:	Some windows throughout the property were found not to be fully operational. This may be due to the fact that they did not open, stiff to open, did not stay open or were binding at time of inspection. A window service is recommended.

Windows provide ventilation to the adjoining area and should be at a fully operational level to ensure user comfort.

A competent general handyman or carpenter may be engaged at the clients discretion.

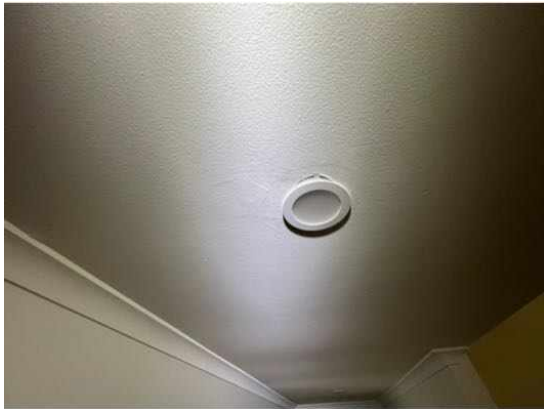
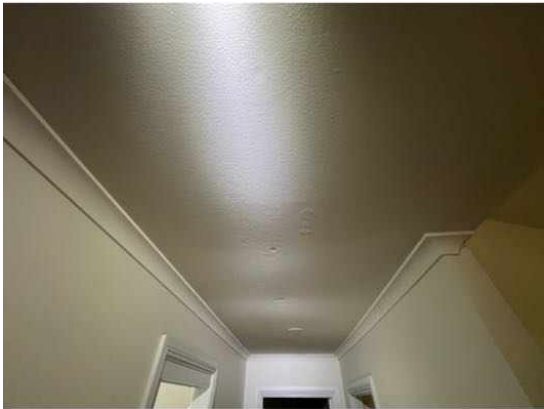
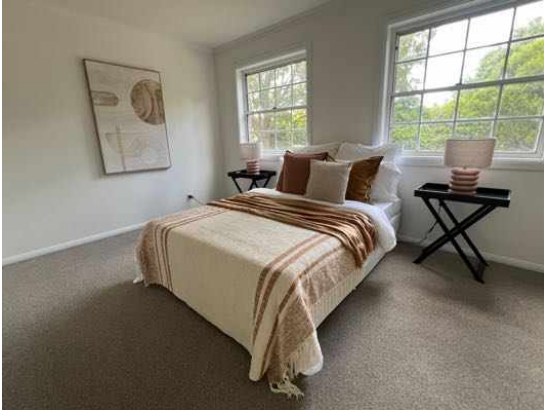
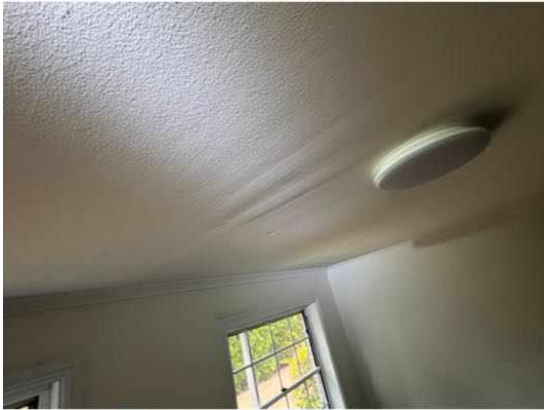
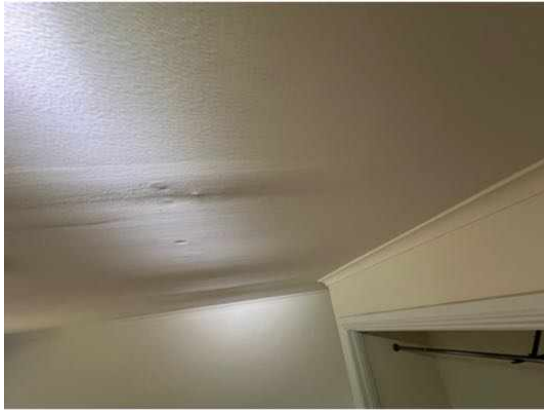
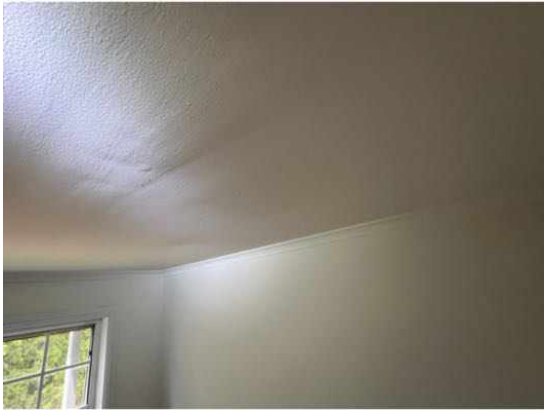
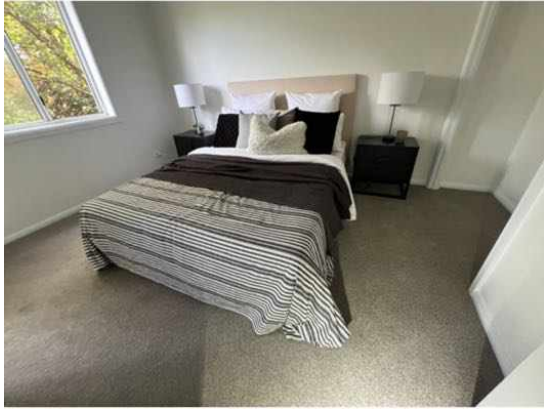
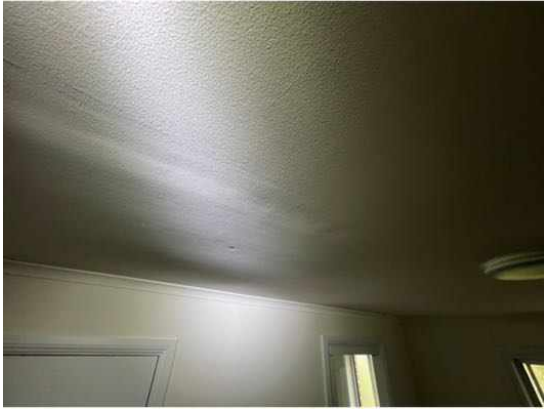
Finding 3.08

Building:	Building 1
Location:	Hallway, Bedroom 2, Bedroom - Master
Finding:	Ceiling Defects - Poor Finishing and nail popping.
Information:	Visual inspection revealed ceiling defects, nail popping, and inconsistent flushing of join lines. Additionally, evidence of substandard patching and finishing was noted in areas where previous defects have been addressed, but not to an acceptable visual standard.

Nail popping and poor join treatment, while generally not structural, can lead to further deterioration of ceiling linings if left unmanaged. These issues detract from the ceiling's appearance and may compromise the long-term durability of the plasterboard fixing.

Rectification by a qualified plasterer is recommended. Works should include securing loose fixings, re-flushing affected joints, and applying back-blocking where necessary to stabilise the ceiling structure and improve the visual condition.

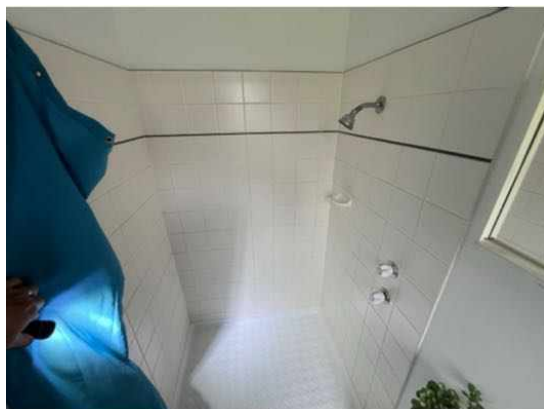
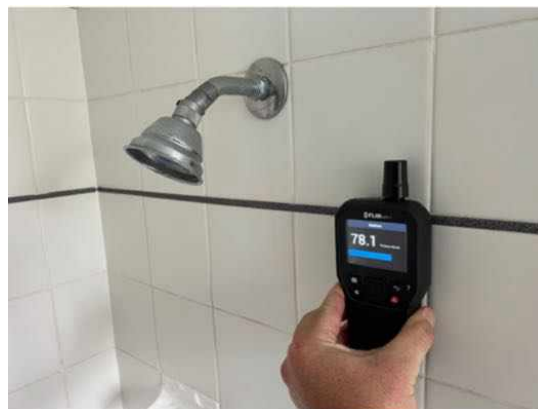
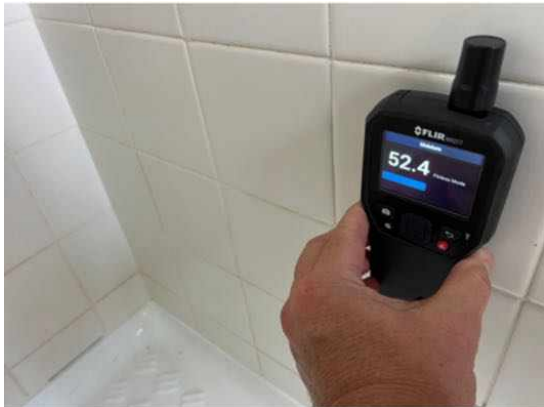
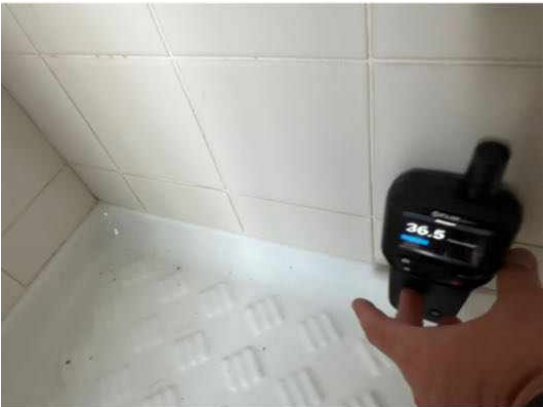
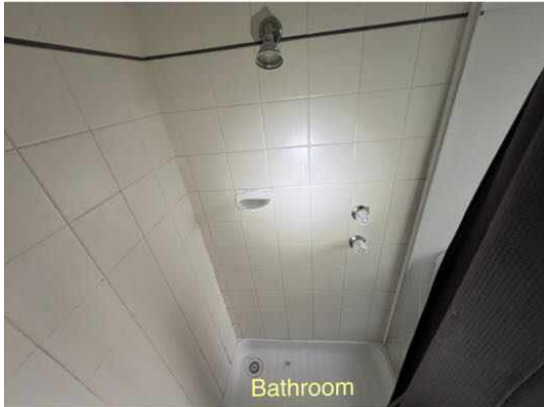
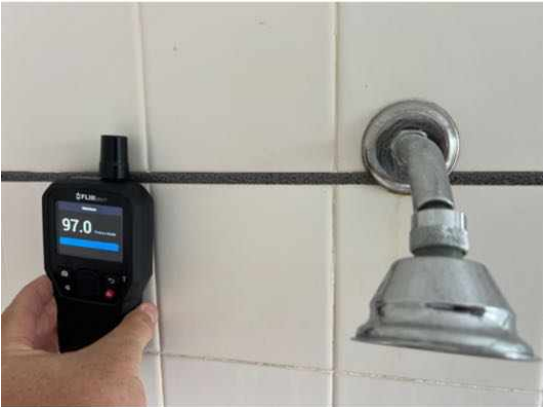
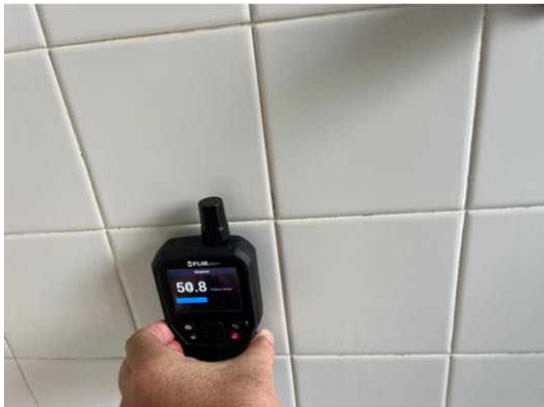
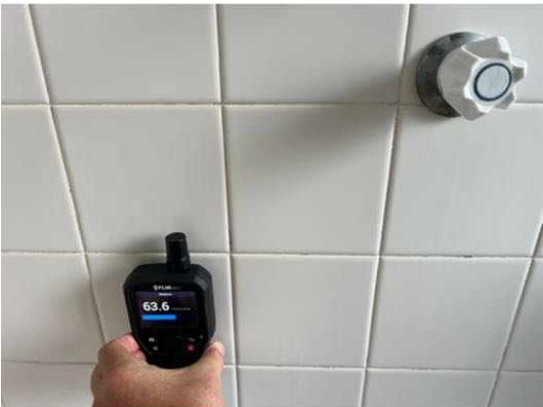
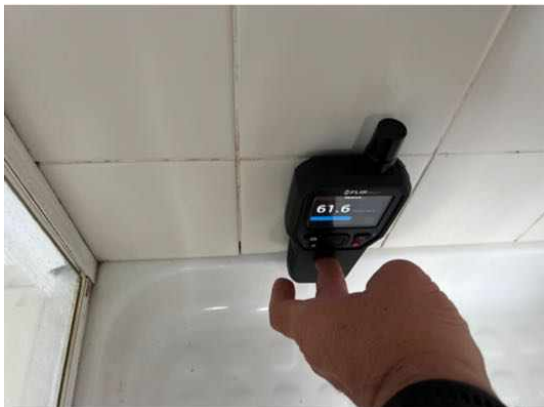
Finding 3.17

Building:	Building 1
Location:	Ensuite, Bathroom
Finding:	Moisture in Shower
Information:	Moisture is evident behind the tiles to the shower alcove. This defect is quite common, and is suspected to have been caused by moisture permeating through the grouting in this area. Leaking pipes within the adjoining wall is also a possible cause.

Damp (or structural damp) refers to the presence of unwanted moisture in the structure of a building, either as the result of intrusion from outside, or condensation from within the structure. In the shower area, internal water leaks or other sources of excessive moisture are generally the cause of damp. Always ensure that sealant and grout is in good condition to prevent any moisture issues occurring in the future.

Please note, the moisture meter used operates on the principle of electrical impedance, generating a low-frequency alternating electric field between its electrodes. The instrument measures moisture content within the material at a maximum depth of 19mm below the surface, rather than on the surface itself.

As a result, surface moisture such as residual water on shower tiles does not influence the reading, ensuring that the measurement reflects subsurface moisture levels within the building material, not superficial wetness.

Consultation with a qualified plumber or bathroom specialist is advised to identify the cause of damp and to perform remedial works as required.

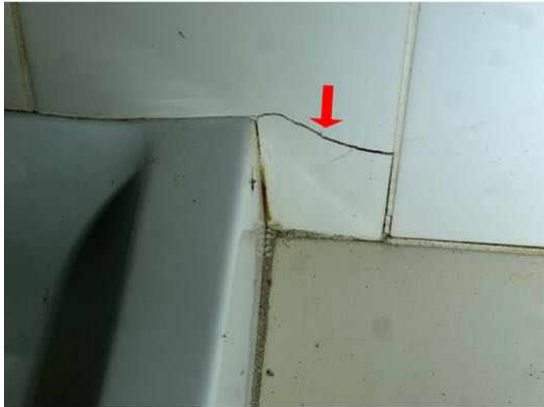
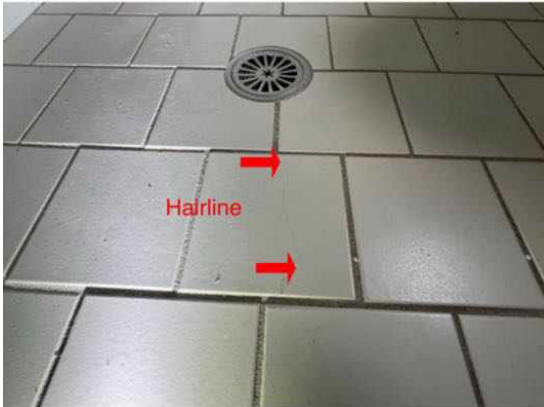
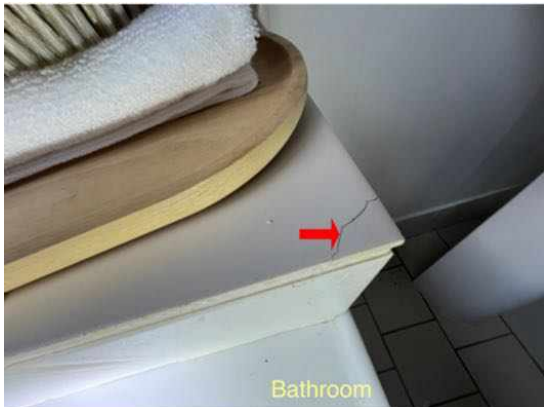
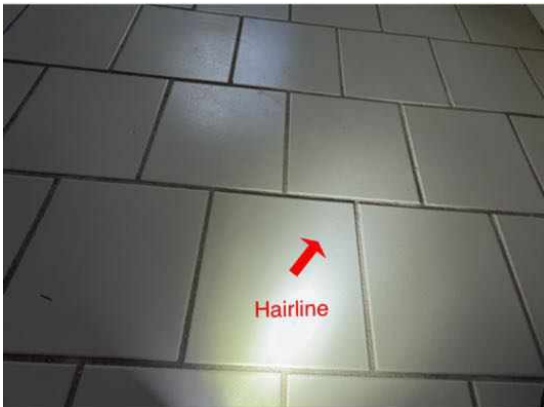
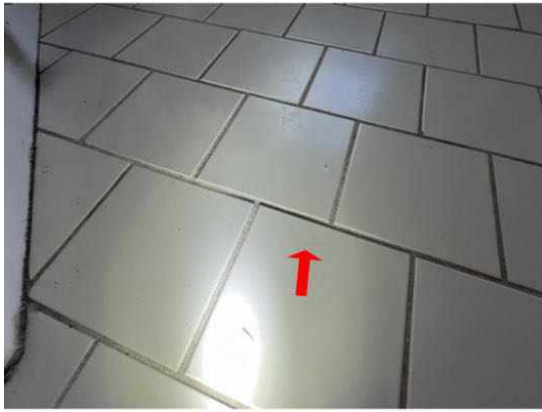
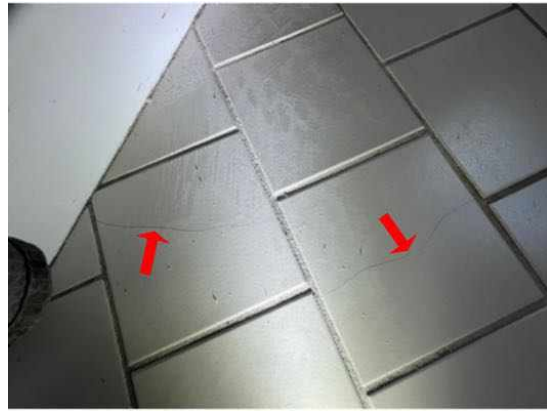
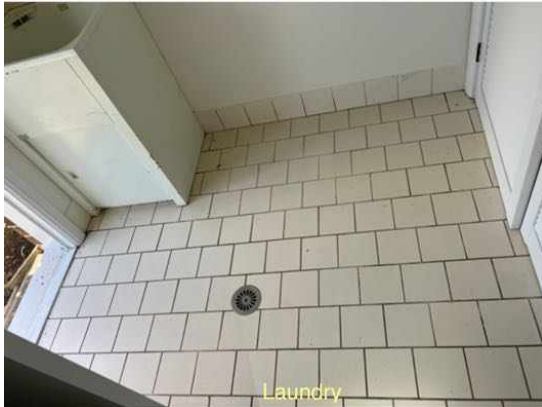
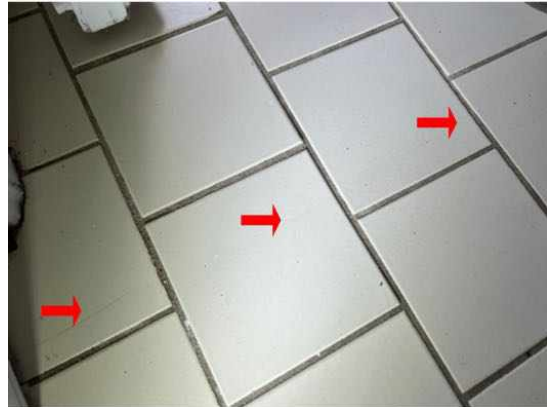
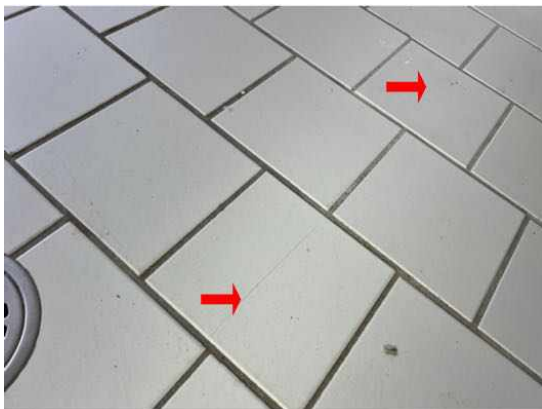
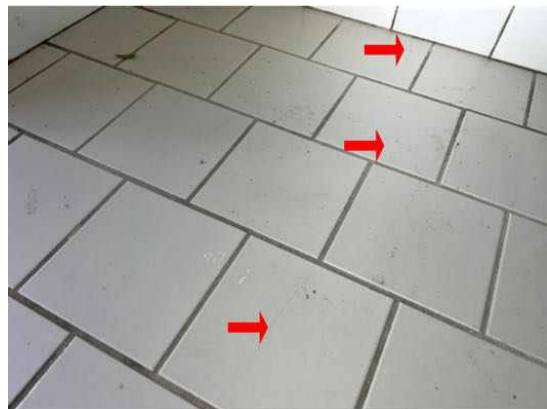
Finding 3.18

Building: Building 1
Location: Ensuite, Bathroom, Laundry
Finding: Tiles - Cracked or damaged
Information: Cracking was evident to the tiling in this area at the time of inspection. While the cracking appears to be minor, this area is frequently exposed to water, allowing potential for water penetration into adjoining sections of walls or flooring.

If left unmanaged, water penetration to these areas may lead to subsequent water damage, which is likely necessitate repair work to affected building elements.

A tiling contractor should be appointed to ensure that no further water damage occurs. The re-application of silicone and grouting throughout remaining tile work is also advised, to further protect the area against water penetration.

Where water penetration has led to water damage, appointment of a relevant tradesperson may be required to repair damaged building elements.

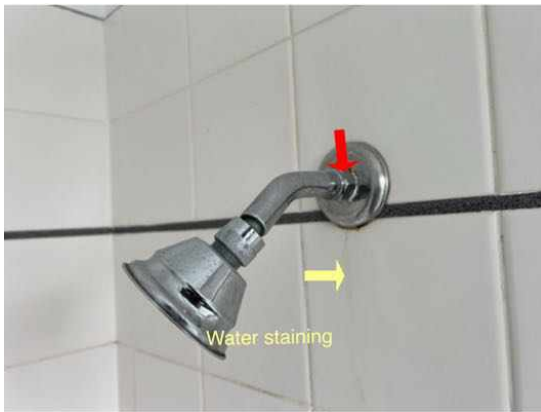
Finding 3.19

Building:	Building 1
Location:	Bathroom
Finding:	Shower head - Loose
Information:	The shower head at the wall connection in this area has not been installed correctly, or has deteriorated with age, and is consequently loose. This shower head being loose creates potential for water leaks and subsequent water damage to the surrounding area.

Where taps or spouts are loose, a qualified plumber should be appointed to re-fix the plumbing fitting.

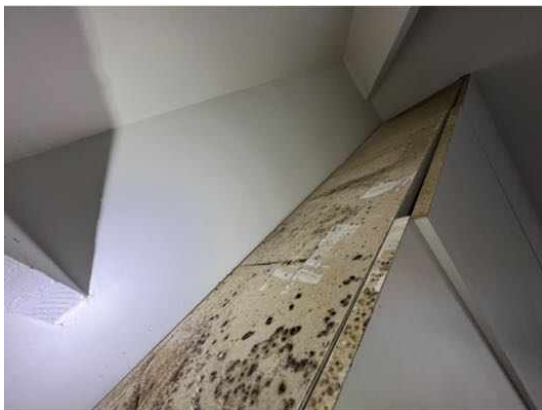
Finding 3.20

Building:	Building 1
Location:	Kitchen
Finding:	Surface - Requires cleaning
Information:	Regular cleaning and maintenance improves the longevity of all building elements. A build up of dirt and debris can reduce the useful life of building materials and may result in earlier replacement of items being required.

Excessive dirt is also likely to lead to secondary hazards, including potential health hazards, as the building elements begin to harbour bacteria and/or mould.

Remedial cleaning is recommended in order to improve the appearance of this area as well as to counteract the development of bacteria. Such works can be performed by a cleaning contractor and should be completed at the discretion of the client.

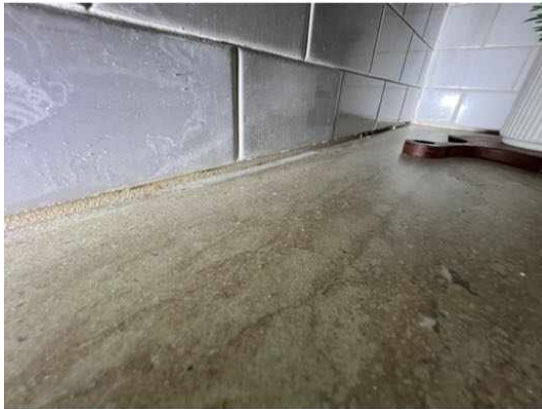
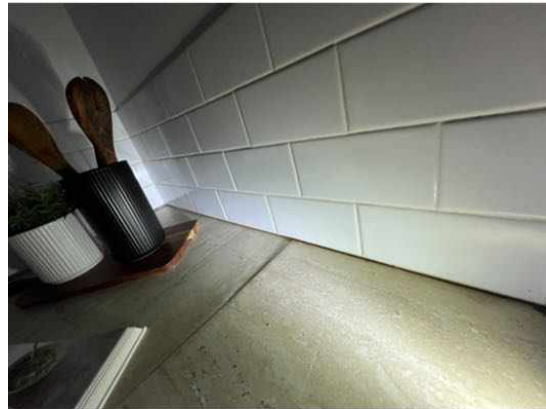
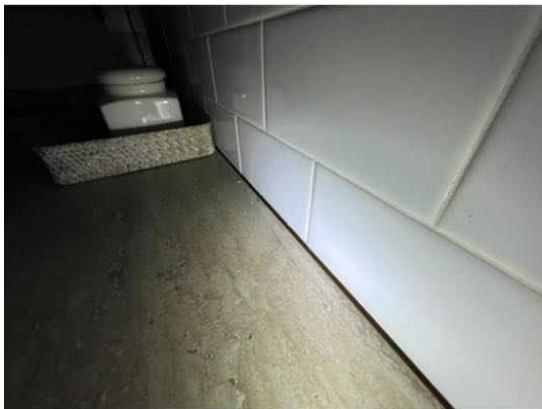
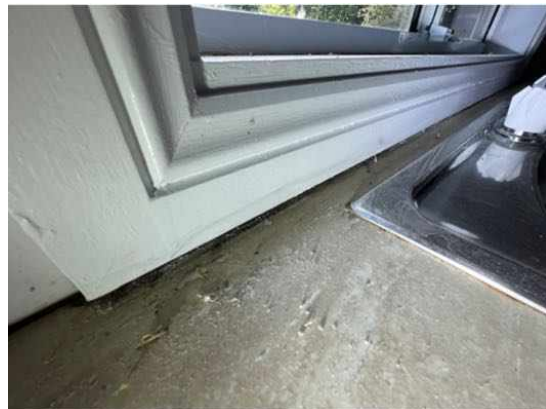
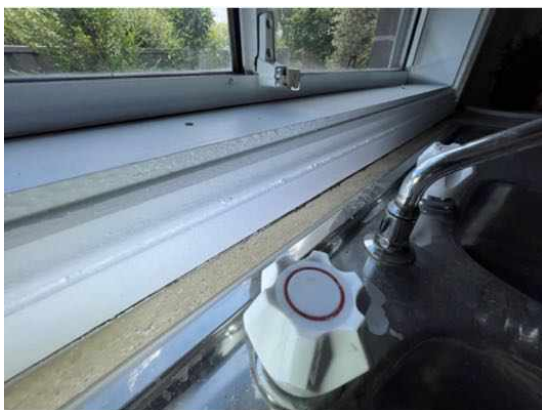
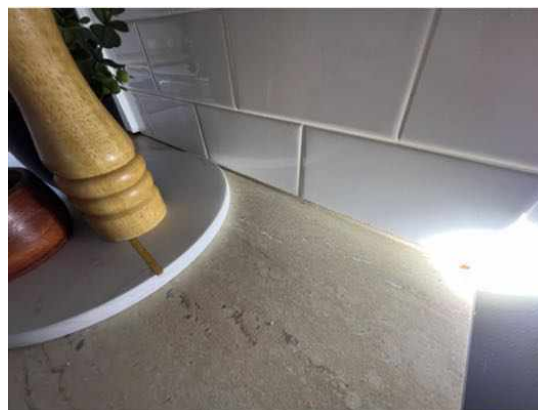
Building:	Building 1
Location:	Kitchen
Finding:	Kitchen Sealant - Missing
Information:	It was noted on inspection that sealant or grout is missing to the kitchen splashback.

Different materials move at different rates, generally causing cracking to grout or sealant at this point. A flexible sealant is required to allow for expected expansion and contraction, while keeping the joint water tight and protective of all associated building materials.

Flexible and mould resistant materials should be applied to affected areas to prevent any subsequent water damage that is likely to occur. Regular maintenance and replacement of damage or missing sealant and grout is highly recommended to the wet areas, as this is a regular wear and tear defect. Sealant and grouting in areas that come into regular contact with water should be maintained for the long term care of your property.

A sealant specialist or tiling contractor should be appointed to complete these works as soon as possible

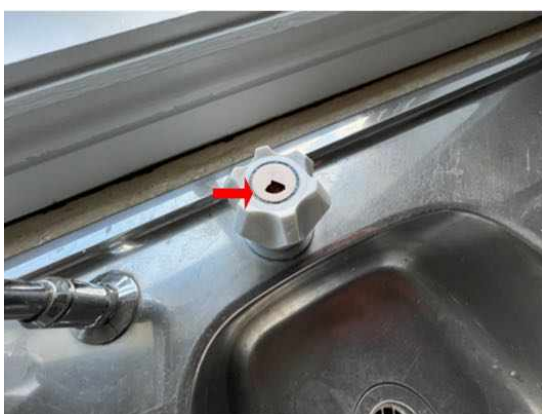
Finding 3.22

Building:	Building 1
Location:	Kitchen
Finding:	Tap - damage
Information:	The tap was identified as damaged at the time of inspection. Damage to the mixer tap may impair its functionality, including water flow control, and may result in leaks over time, leading to potential water damage to surrounding cabinetry and building elements.

It is recommended that a licensed plumber be appointed to inspect the mixer tap and undertake necessary repairs or replacement to ensure the fixture operates as intended.

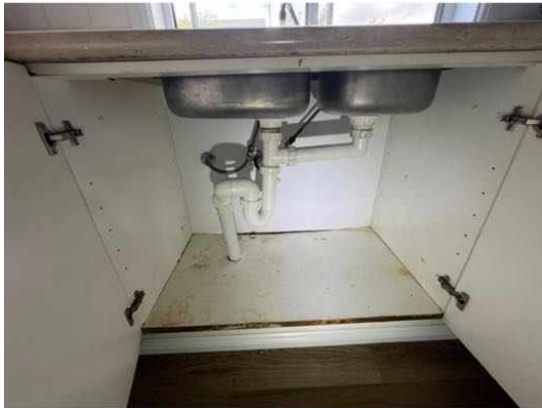
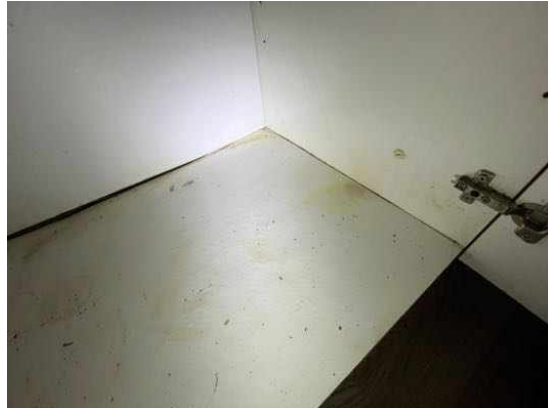
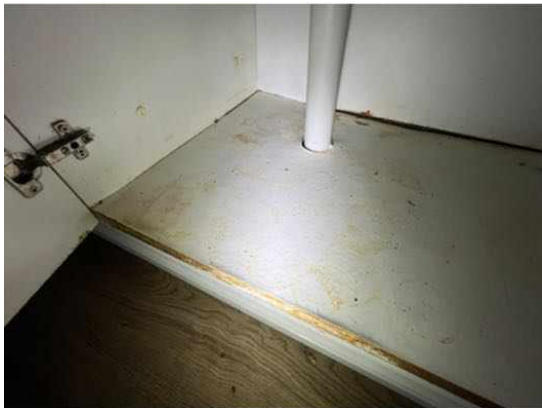
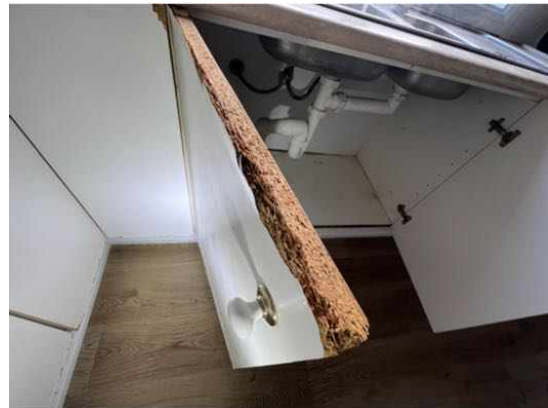
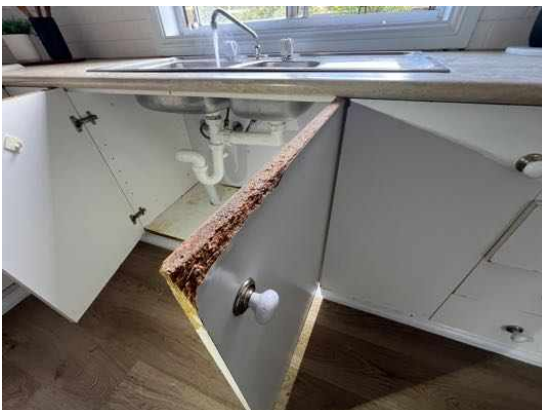
Finding 3.23

Building:	Building 1
Location:	Kitchen
Finding:	Water damage - joinery
Information:	Water damage was observed to joinery within the sink cabinet. This type of defect is typically caused by prolonged moisture exposure from minor plumbing leaks, condensation, or poor sealing around fixtures and fittings.

If left unmanaged, water ingress can lead to swelling, delamination, or deterioration of the joinery, potentially compromising its functionality and hygiene. Moist conditions in enclosed cabinetry may also create an environment conducive to mould or timber pest activity.

It is recommended that a licensed plumber be engaged to inspect the sink plumbing for leaks or seepage. A cabinetmaker or qualified joiner may also be required to replace the affected shelving or restore the unit where practical.

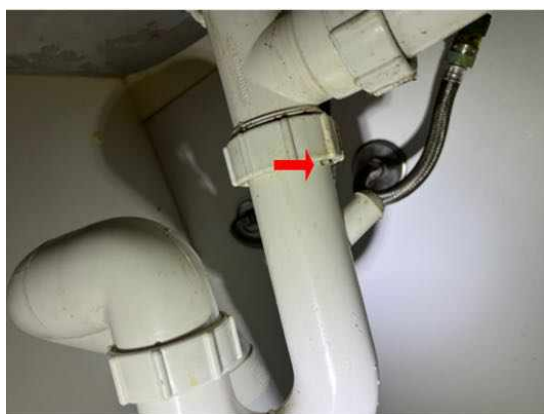
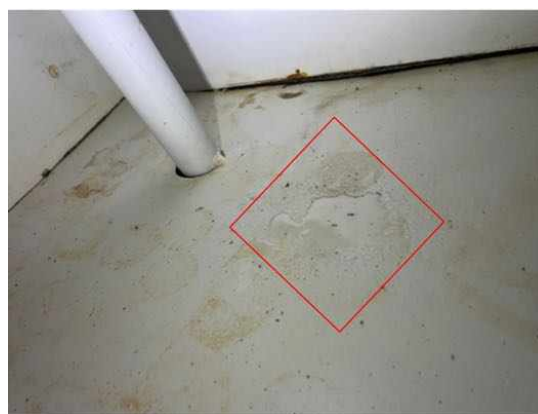
Finding 3.24

Location: Kitchen
Finding: Water leak - Active
Information: Generally, water leaks occur when a particular area of the property is not weather or water tight. As the surrounding area was found to be damp at the time of inspection, the leak is considered ongoing and hence requires urgent action.

Regardless of the location, even minor leaks that are left unmanaged can lead to serious damage of associated building elements and result in the need for replacement of building materials. Mould and other hazards such as electrical hazards may also arise if the leak is left to develop.

It is highly advised that the cause of the leak be identified and resolved immediately by a licensed plumber to prevent any further damage. Depending on the extent of the damage previously sustained, repair and/or replacement of any affected building materials may be required.
