Building and Timber Pest Inspection Report

Inspection Date: Fri, 16 Jan 2026

Property Address: 17 Price St, Bowral NSW 2576, Australia

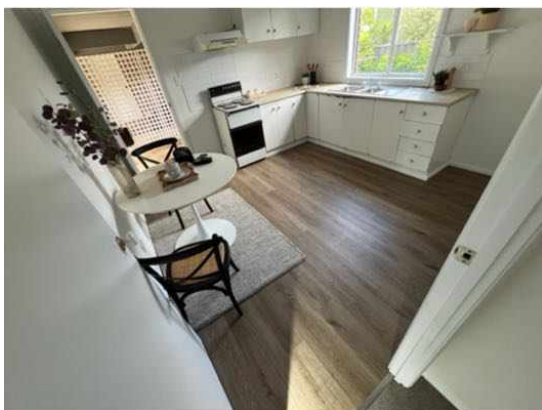
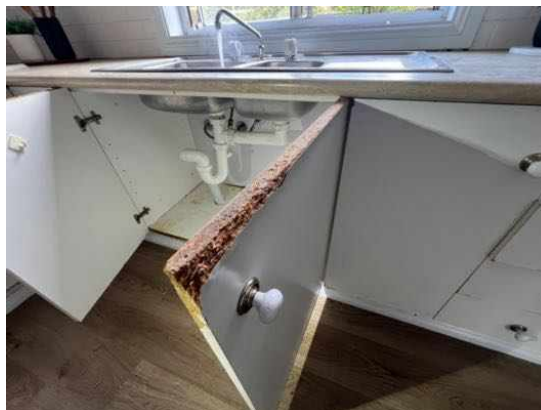
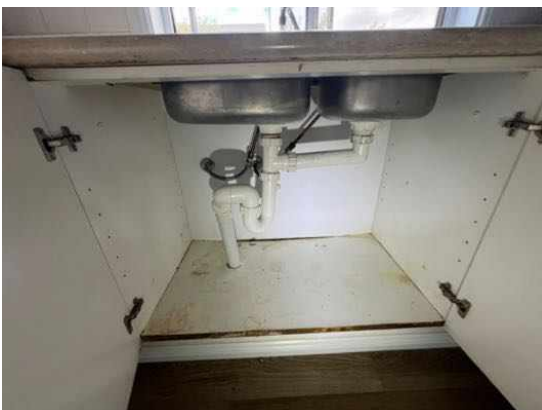
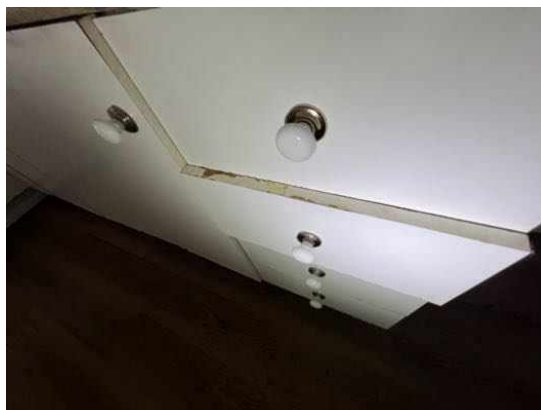
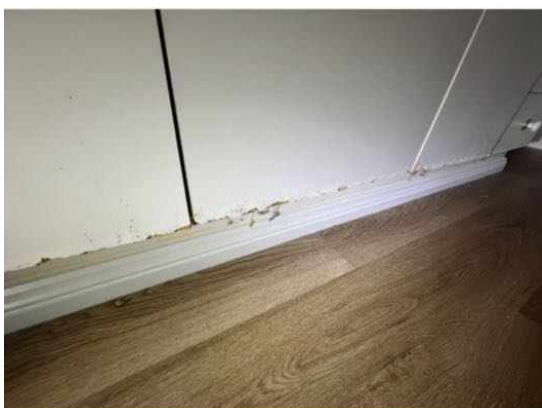
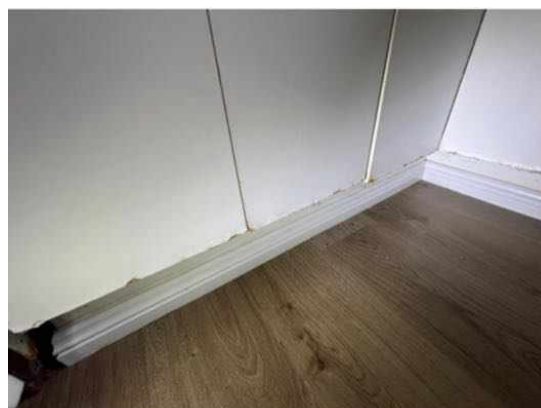
Finding 3.25

Building: Building 1
Location: Kitchen
Finding: Cabinetry - signs of wear and tear
Information: The cabinetry in the property displays signs of wear and tear, indicating that they are nearing the end of their lifespan.

It is likely that maintenance or replacement will be necessary in the near future.

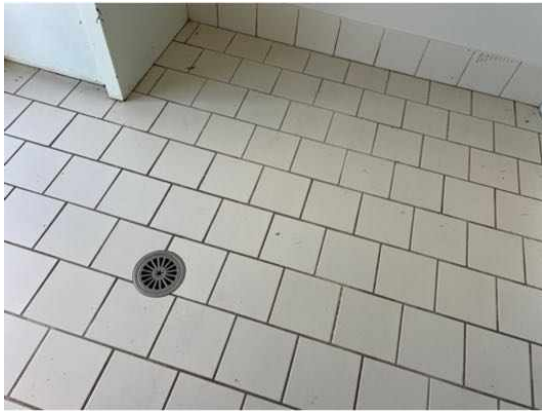
Finding 3.26

Building: Building 1
 Location: Laundry
 Finding: Floor tiles - Uneven
 Information: The tiled flooring area appears to be uneven in this area. While this may indicate a failure of the subfloor structure, it is suspected, in this case, that the area has been subjected to poor tiling workmanship at the time of installation.

Where poor workmanship is the cause of uneven tiling, the tiled surface level is unlikely to decrease further. If unevenness does increase over time, this may indicate issues with the associated flooring structure.

Where uneven tiled flooring appears to be a result of poor tiling work, a tiling contractor should be appointed to re-instate the flooring at the discretion of the client. Where flooring remains uneven, further inspection of the flooring structure may be required.

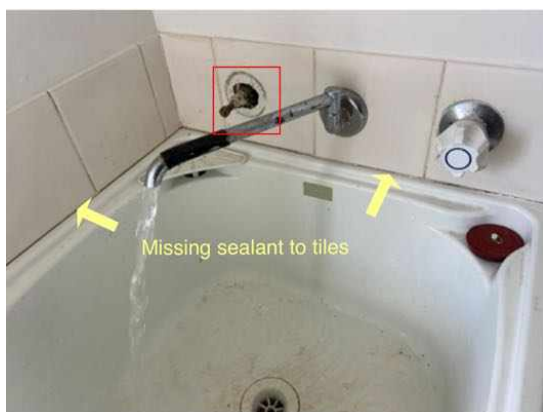
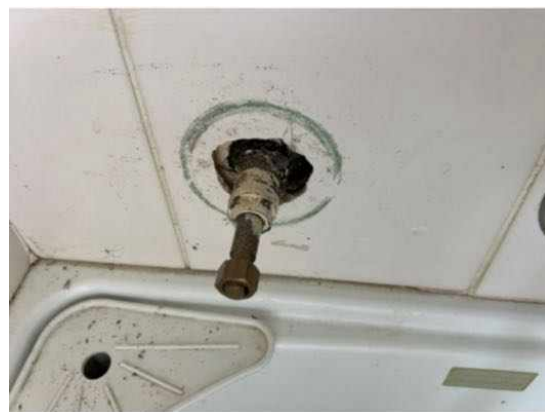
Finding 3.27

Building: Building 1
 Location: Laundry
 Finding: Tapware - Missing
 Information: Although some building elements may seem irrelevant or unnecessary, all building elements play a key role in the operation and function of the overall structure and its performance.

Replacement of any missing building element should be conducted as soon as possible to ensure that no damage or functional issues occur to associated building materials.

A licensed plumber should be appointed as soon as possible to replace the missing building element. Depending on the extent of the damage, repair and/or replacement of damaged building elements may be required.

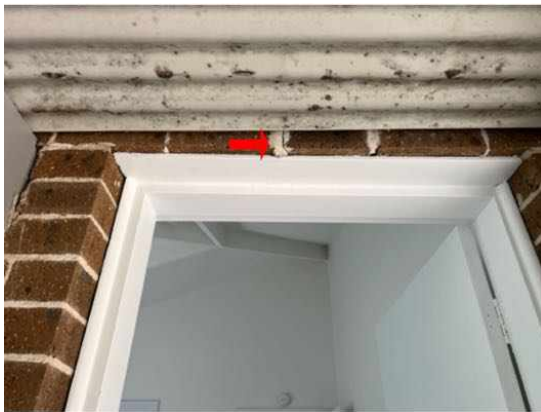
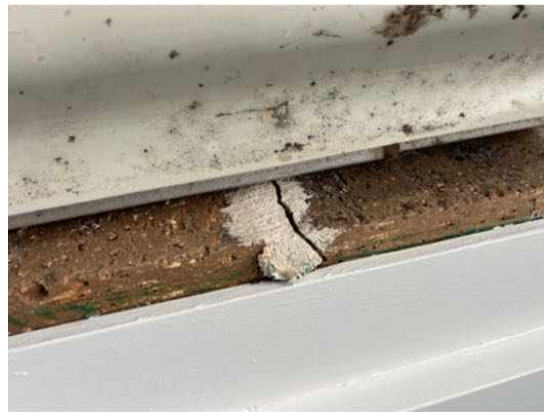
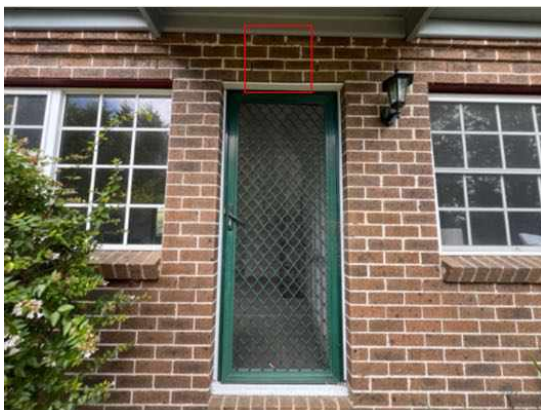
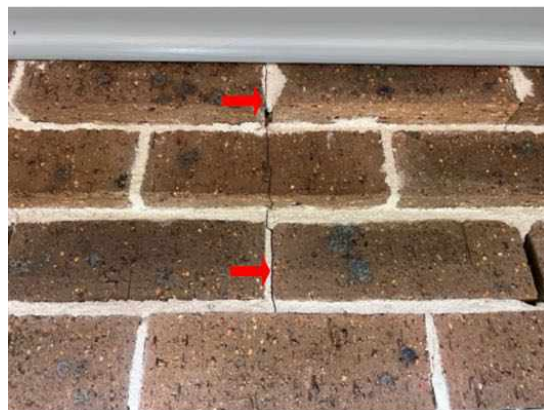
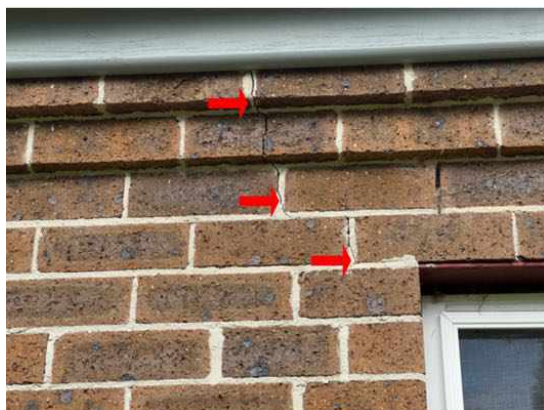
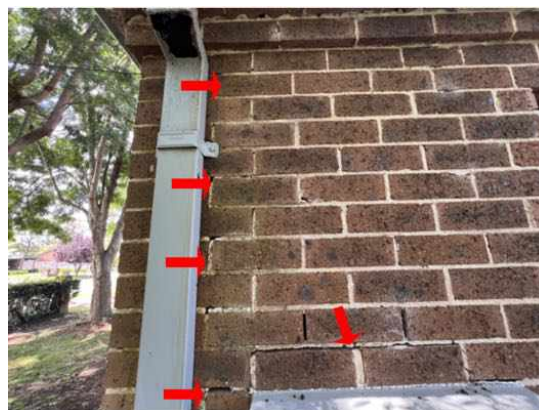
Finding 3.28

Building: Building 1
Location: Exterior walls - front and rear, Carport,
Finding: Brickwork - Cracking noticeable
Information: There were several cracks and or crack repairs evident to external brickwork.

Noticeable cracks are a common occurrence in external brickwork and are a likely result of age expected building movement, general expansion, and/or contraction of building materials in different weather conditions. Noticeable cracks in brickwork may develop if left unattended, with potential for necessitating major remedial works or replacement of the brickwork.

It is highly advised that a qualified bricklayer be appointed to provide necessary works to cracked brickwork to prevent any further damage. Such works should be conducted as soon as possible.

Always monitor these cracks and contact a building inspector should cracks widen, lengthen, or become more numerous.

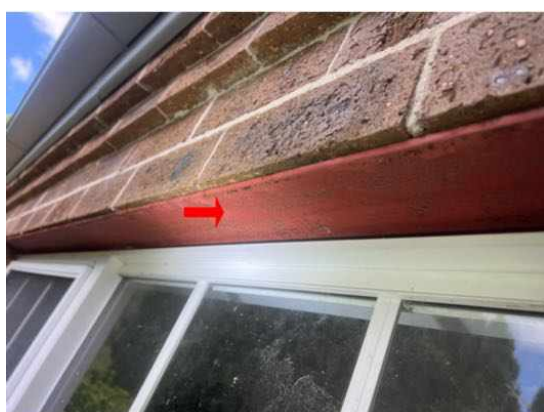
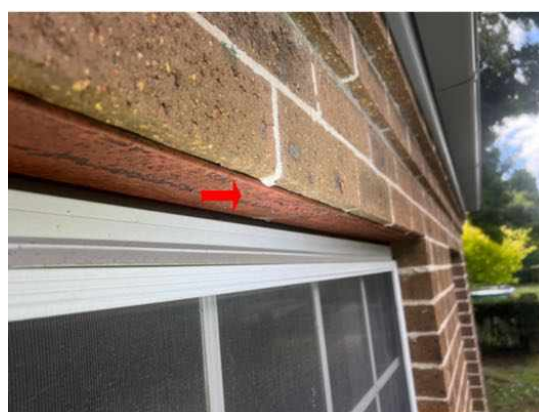
Finding 3.29

Building:	Building 1
Location:	All External Areas - all window lintels
Finding:	Lintel - Rusted or corroded
Information:	The steel lintel was observed to exhibit visible signs of rust and corrosion. Corrosion of lintels is commonly associated with prolonged moisture exposure and breakdown of protective coatings, particularly at external openings.

If left unmanaged, corrosion may continue to progress and can lead to expansion of the steel, deterioration of surrounding masonry, cracking to finishes, and potential reduction in the lintel's long-term performance.

Further assessment and ongoing monitoring are recommended to determine the extent of corrosion and whether maintenance or replacement may be required to limit further deterioration.

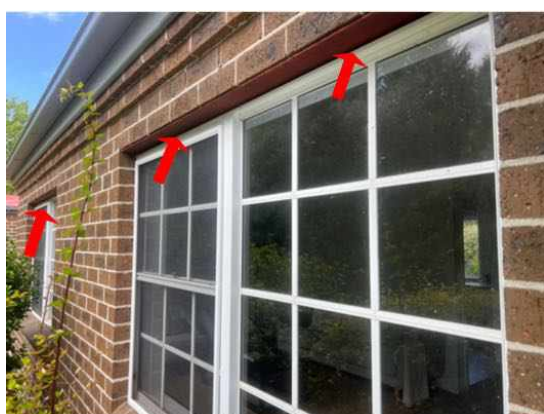
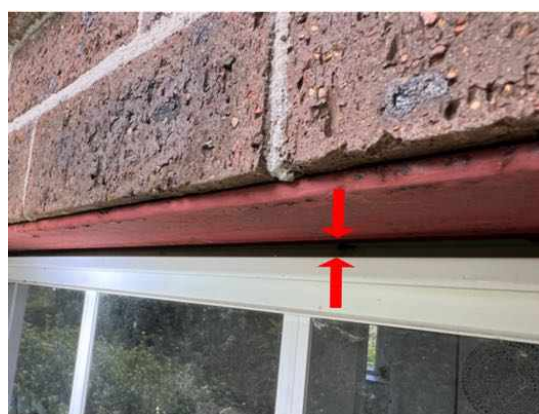
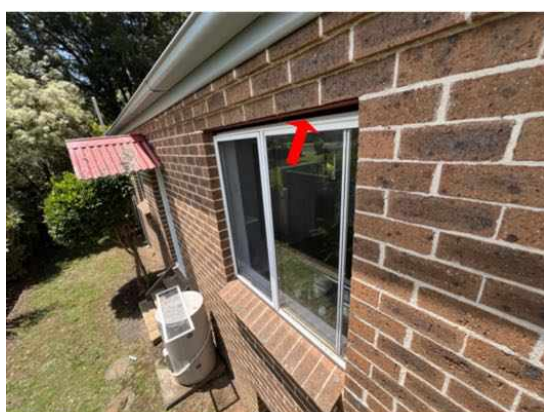
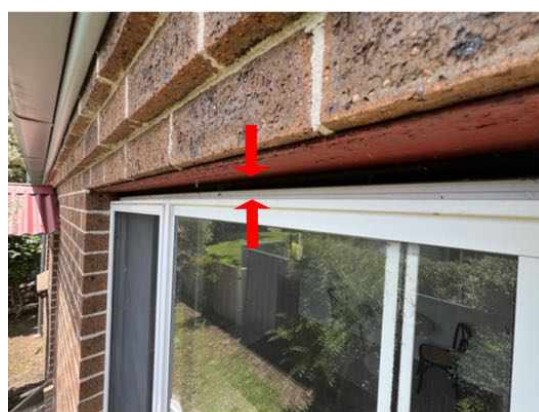
Finding 3.30

Building:	Building 1
Location:	All External Areas - all windows
Finding:	Window - gaps
Information:	Large gaps was observed between the aluminium window - lintel and/or reveals. It is

Gaps and holes makes the area susceptible to insect and vermin ingress, as well as allowing water penetration. As such, associated building elements are likely to deteriorate at an accelerated rate, and major implications are expected if Gaps are left unmanaged.

All excessive holes, gaps or cracks should be adequately filled by a suitable sealant or trimmings as soon as possible to prevent any further damage. Such works may be conducted by a general handyman or licensed carpenter.

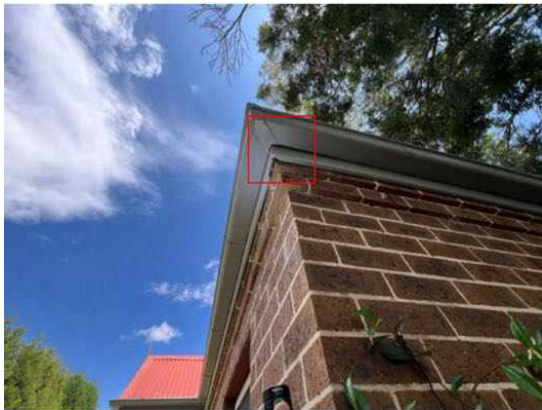
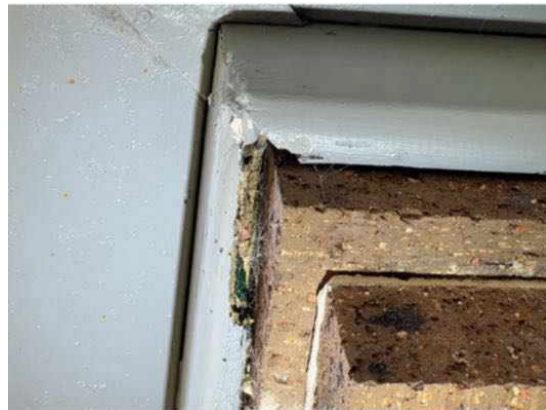
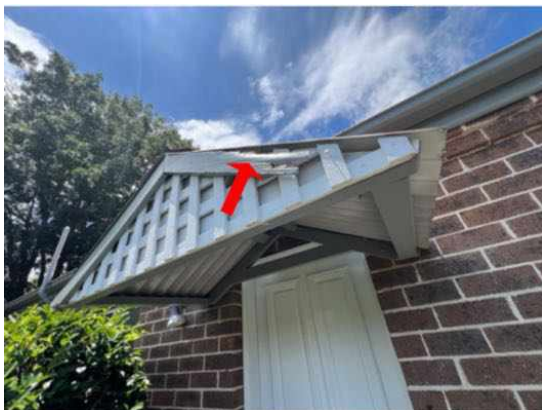
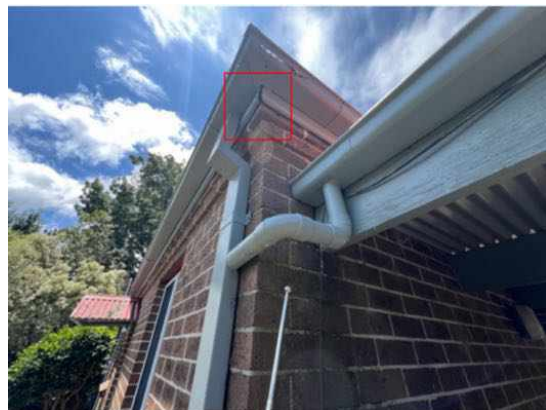
Finding 3.31

Building:	Building 1
Location:	Exterior walls - right side and rear side
Finding:	Fascias - Wood rot
Information:	Wood rot was found to be affecting fascias and barges in this area, evidenced by the presence of mould on the surface in some areas. Wood rot, also known as Fungal Decay, occurs when timbers and other cellulose building materials are exposed to damp conditions on an ongoing basis.

It is likely that this wood rot has developed as a result of faults in the roof plumbing, creating excessive moisture in this areas. Frequent exposure to rain and other weather

conditions also make fascias and bargeboards susceptible to accelerated deterioration.

Early intervention and regular maintenance will prolong the useful life of these building elements. Prior to any works being performed, the cause of the moisture that has created the visible wood rot should be identified and addressed in a suitable manner.

It is advised that a roof plumber be appointed to inspect all roof plumbing and subsequently identify the cause of the wood rot. Replacement of affected fascias and bargeboards may then be a necessary step in protecting surrounding building elements from such deterioration.

A qualified plumber may be appointed to assess the cause of excessive moisture and to provide advice on any remedial works as required. A qualified carpenter or registered builder may also be required to replace affected building materials.

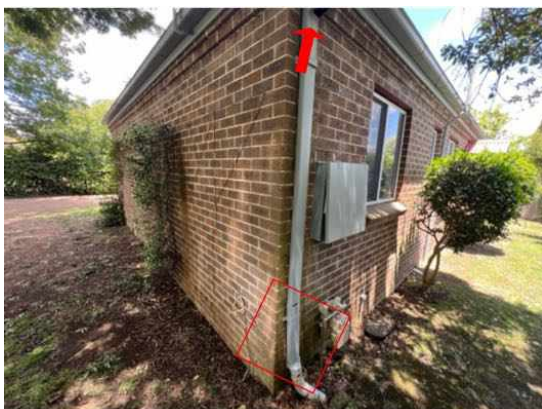
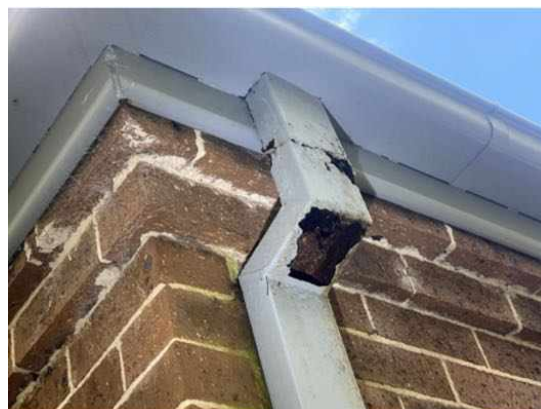
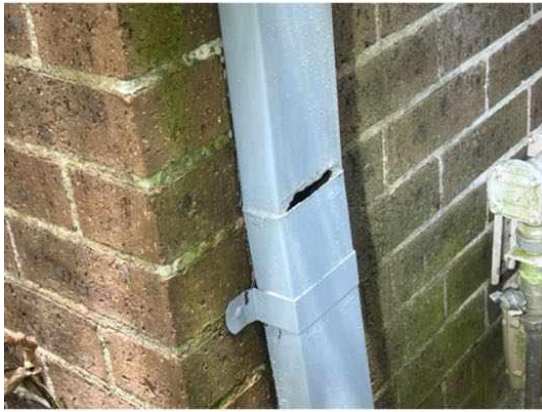
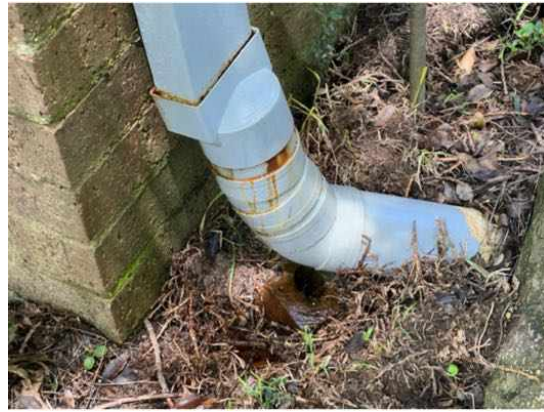
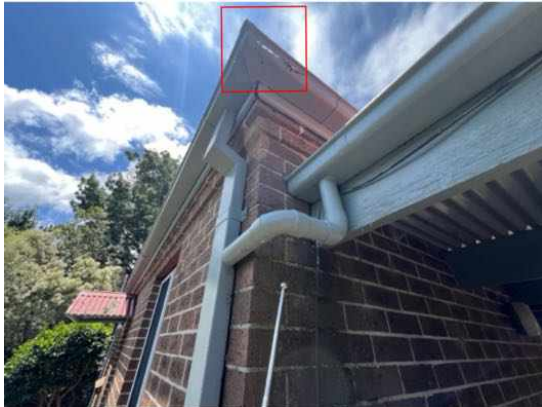
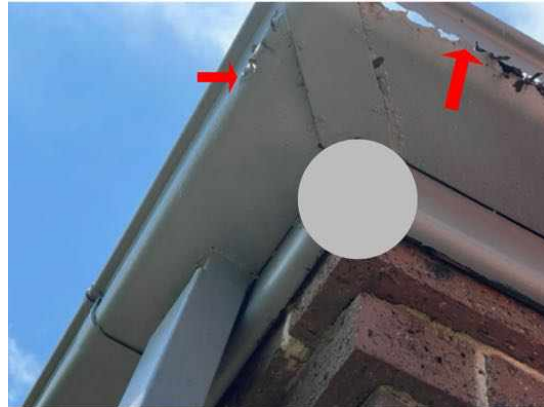
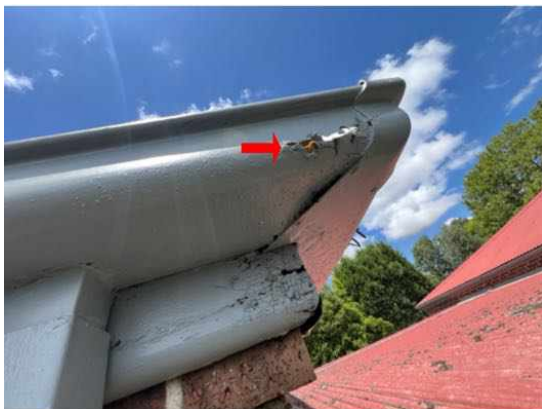
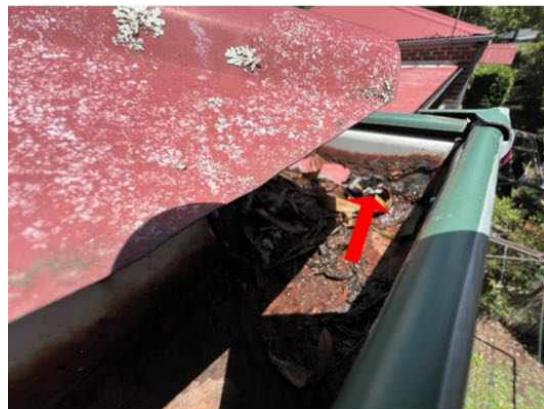
Finding 3.32

Building:	Building 1
Location:	Exterior walls - rear
Finding:	Roof plumbing - Rusted or corroded
Information:	The roof plumbing has areas of rust and corrosion. It is suspected that this has been caused by blockages, resulting in pooling or standing water, that have prematurely rusted elements of the roof plumbing.

Rusted roof plumbing will generally develop holes and leaks that can affect other building elements with poor drainage of storm water. Poorly drained roof areas will also lead to damp conditions surrounding the base perimeter of the building which, if left unmanaged, can lead to a range of secondary building defects.

Repair and/or replacement of rusted roof plumbing is highly required in order to reinstate the roof drainage system to a fully operational level. To further maintain these areas, gutters should be cleaned frequently, allowing the avoidance of any partial blockages.

A licensed plumber or specialist roof restoration company should be appointed to undertake these works. It is advised that such works be completed as soon as possible to prevent any further damage and deterioration.

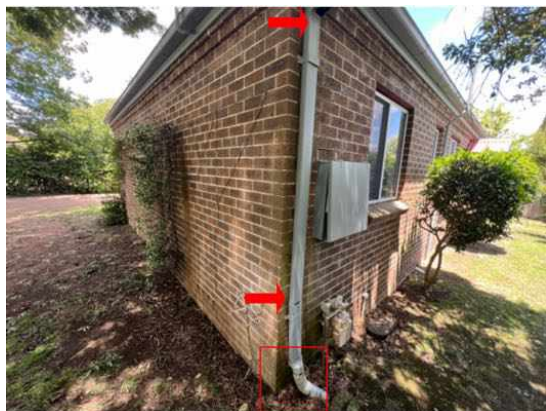
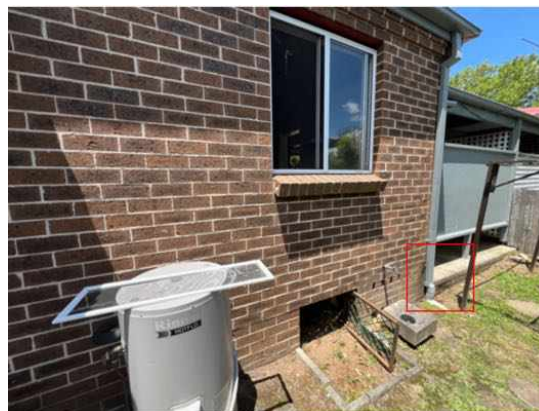
Finding 3.33

Building:	Building 1
Location:	Exterior walls - rear
Finding:	Water leak - External
Information:	Water leaks were found to be present to exterior plumbing work. Leaks are generally caused by deterioration of the plumbing elements over time, due to exposure to weather conditions, but may have also been caused by minor impact damage.

Such leaking creates damp conditions in the affected area, causing potential for water pooling and subsequent water damage if left unattended. These conditions may also attract termite attack, particularly if the area is subject to minimal levels of sun throughout daylight hours.

It is highly advised that a licensed plumber be appointed to rectify any water leaks that may be present. Areas of repair and replacement of plumbing fittings and fixtures may be required and, as such, a quotation should be sought.

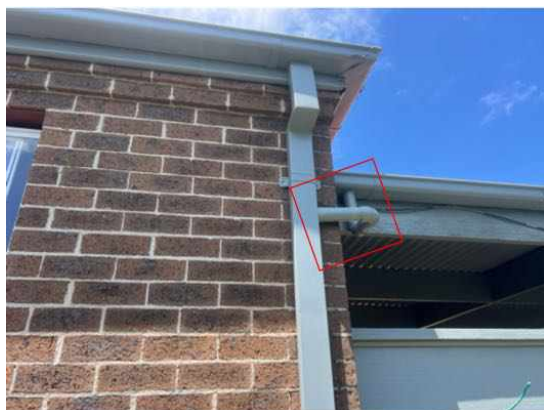
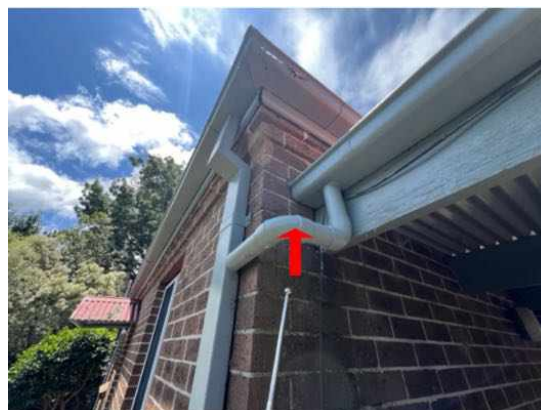
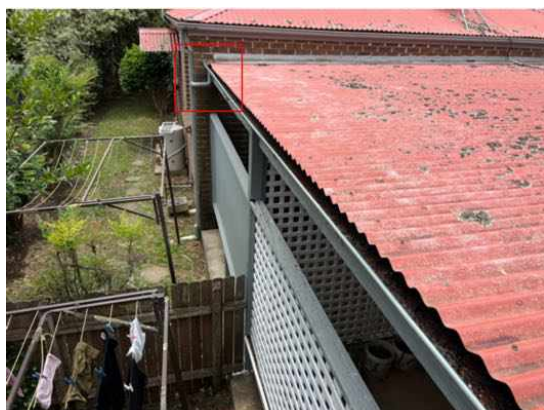
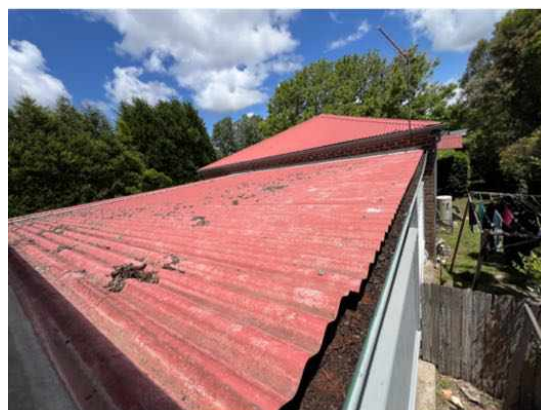
Finding 3.34

Building:	Building 1
Location:	Carport
Finding:	Roof plumbing - Insufficient capacity
Information:	It is suspected that the roof plumbing to the exterior roof is insufficient in capacity and is not adequately managing the volume of rainwater that it is required to drain. The result is generally that the plumbing overflows during periods of heavy rainfall, creating damp conditions against external surfaces and the base of the building perimeter.

If left unmanaged, the excess moisture in this areas may allow the formation and development of an environment that is conducive to rust, corrosion and rot, creating potential for secondary defects to all associated building elements. Damp conditions are also conducive to termite and pest activity, further exacerbating the risk of the environment.

Appointment of a roofing plumber is recommended to replace any inadequate drainage systems to ensure proper drainage to this area. In the interim, it is important to ensure that all roof plumbing is free of any debris or blockages.

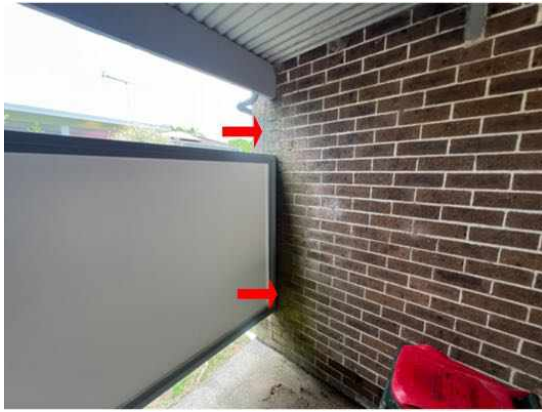
Finding 3.35

Building:	Building 1
Location:	Carport
Finding:	Walls - Water stained
Information:	Water staining to sections of the walls in this area was evident at the time of inspection. Water staining indicates that surfaces have been exposed to excessive moisture over time. The minerals and other elements in the water lead to staining, which may graduate to corrosion and deterioration if left unmanaged.

While mostly an appearance defect, water staining can be indicative of more serious defects, which may be currently concealed by wall linings.

Where water staining is active, a licensed plumber must be consulted to identify the cause of the staining and to provide advice on any reparation works that may be required. Replacement of any broken or damaged structures is advised.

Conversely, where water staining is old and inactive, affected building materials may be repaired or replaced at client discretion.

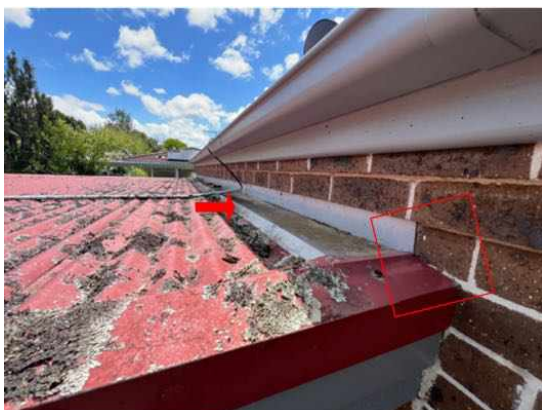
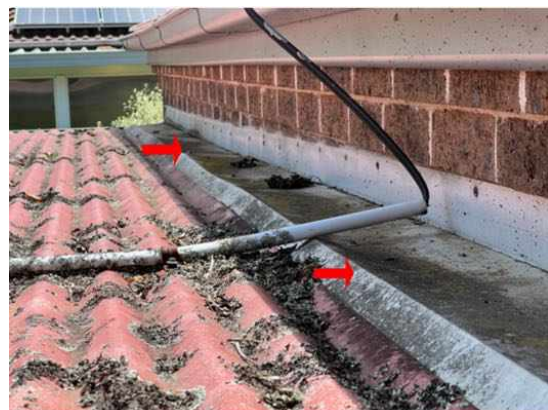
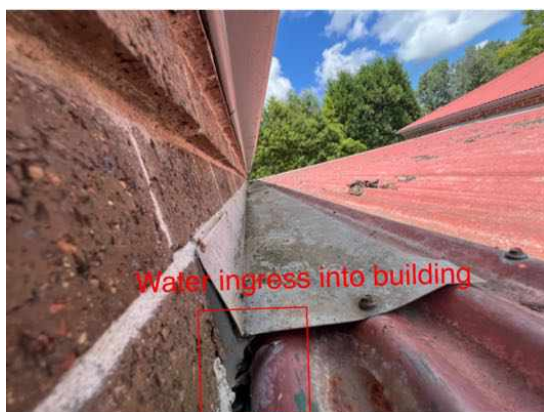
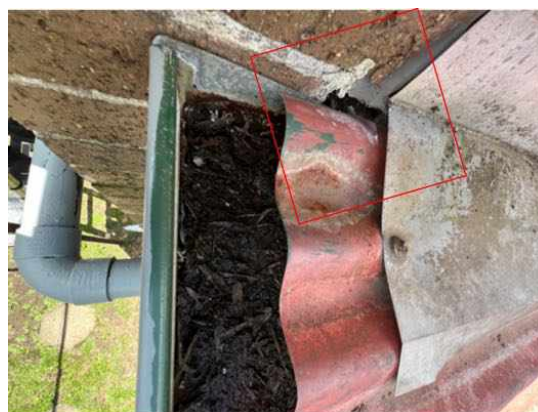
Finding 3.36

Building:	Building 1
Location:	Roof Exterior (carport)
Finding:	Roof plumbing - Flashing inadequate
Information:	Some sections of the roof are missing or have inadequate roof flashings. Flashings are metal and other materials which are applied to seals and intersections between roof coverings and building elements. They are designed to aid in weatherproofing of roof joins.

Flashings that are not installed adequately or are missing are likely to result in water penetration to the interior of the property, as well as creating excessively damp conditions against the exterior surfaces and around the base perimeter of the building.

Premature ageing and secondary building defects are imminent where roof plumbing is missing or inadequately installed. Additionally, water pooling also creates an environment that is susceptible to termite and pest infestation.

A roofing plumber should be appointed as soon as possible to install relevant roof plumbing materials, ensuring that no further damage is sustained.

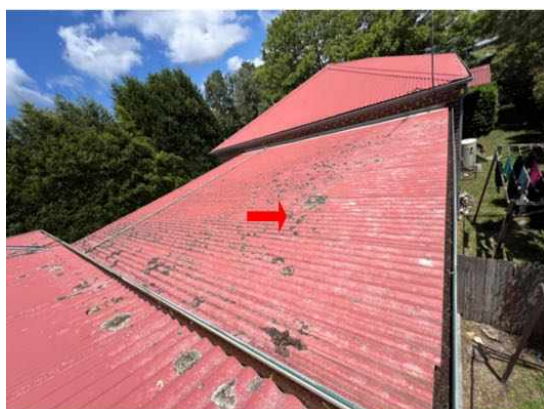
Finding 3.37

Building:	Building 1
Location:	Roof Exterior (carport)
Finding:	Exterior roof - Insufficient fall
Information:	It was identified that there is insufficient fall or angle in the roofing structure, which is leading to pooling of water and an array of secondary related building defects. Such defects are likely to include material deterioration, leaks and/or corrosion of associated building materials.

The angle of the roof is insufficient to facilitate the effective drainage of rain water to the roof plumbing systems. Over time, if this defect is not addressed (potentially including structural changes to the roof), further building defects will develop.

Consultation with a roofing plumber or roofing restoration contractor is required for quotations regarding these works. Where water pooling is quite significant, structural alterations to the roof may potentially be expensive and time-consuming.

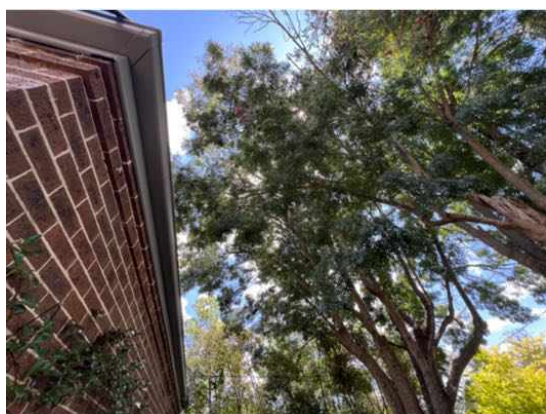
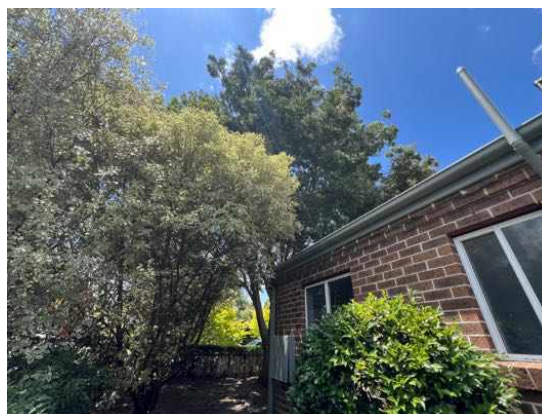
Finding 3.38

Building:	Building 1
Location:	Roof Exterior
Finding:	Trees - Overhanging and filling gutters

Gutters are a critical part of the building's management of storm water and rain. It is therefore important that they be kept clear to prevent secondary damage to associated building elements, including exterior and interior walls, ceiling linings and any adjoining building elements. Where gutters are blocked, pooling of rainwater is likely to occur, fast-tracking rust and corrosion of the roof plumbing elements.

It is highly advised that all overhanging tree branches be removed as soon as possible to prevent any further damage. Repair and/or replacement of sections of damaged guttering may also be required where the extent of the damage necessitates.

Such works should be performed by the homeowner; however, appointment of a landscape contractor or an arborist may be required. Consultation with a licensed roof plumber is required where guttering has been damaged.

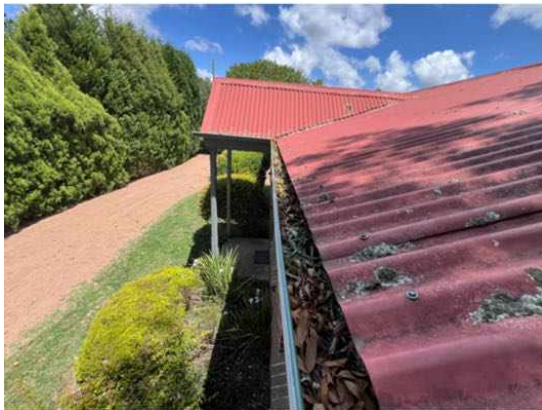
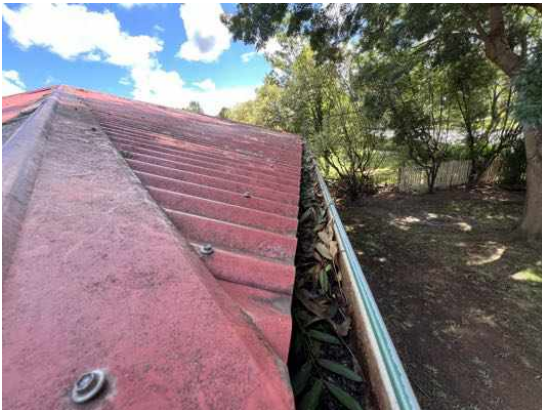
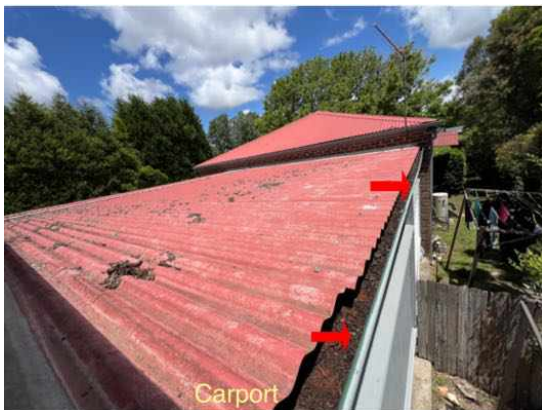
Finding 3.39

Blocked gutters are likely to lead to high levels of moisture in the affected areas. Such moisture will not only cause rust and decay of the associated building materials, but can also provide conditions that are conducive to termite and timber pest activity. Blockages in gutters should therefore be removed immediately to ensure dry conditions are maintained.

Consult a Licensed Plumber for further specific advice on remedial works that may be required. In the interim, it is highly advised that blocked gutters be removed by the homeowner or a general handyperson as a matter of urgency.

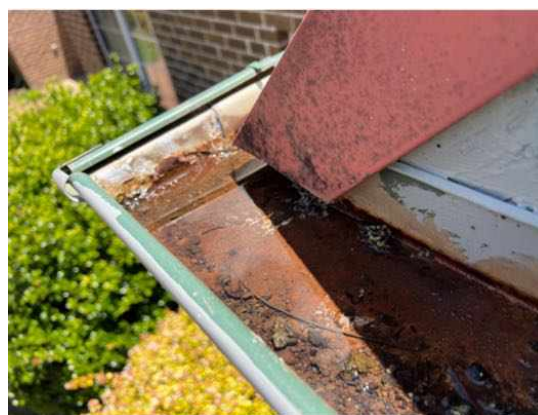
Finding 3.40

Building:	Building 1
Location:	Roof Exterior (porch)
Finding:	Gutters - Water pooling
Information:	Water was found to be pooling in sections of the roof guttering. This is generally a secondary defect caused by blocked or partially blocked gutters. Such blockages and subsequent water pooling are likely to lead to rust and water damage to associated

Any areas of guttering that shows evidence of water pooling should be checked for partial or full blockages and any secondary damage that may have occurred as a result. Depending on the extent of the damage, building elements may require repair and/or replacement to ensure adequate roof drainage and function of exterior plumbing system.

A roofing plumber should be appointed as soon as possible to rectify this issue. It is highly advised that all gutters be maintained on a frequent basis to ensure the condition of roof plumbing.

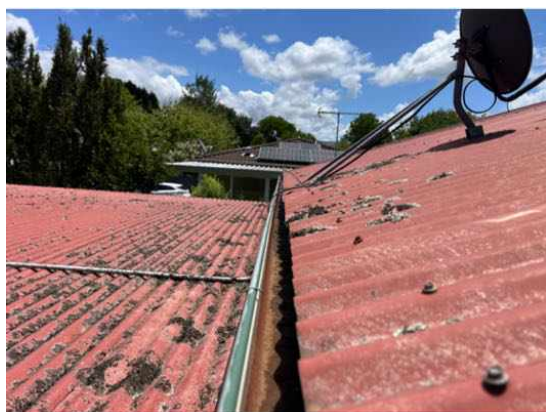
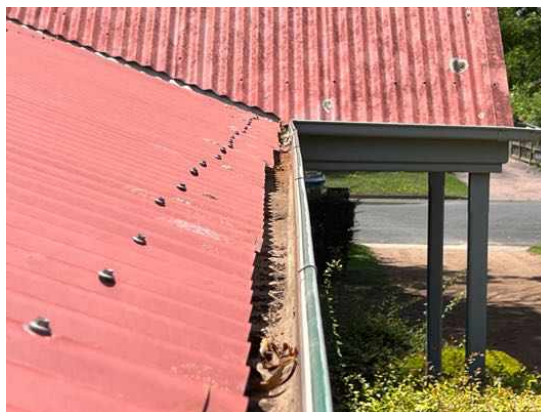
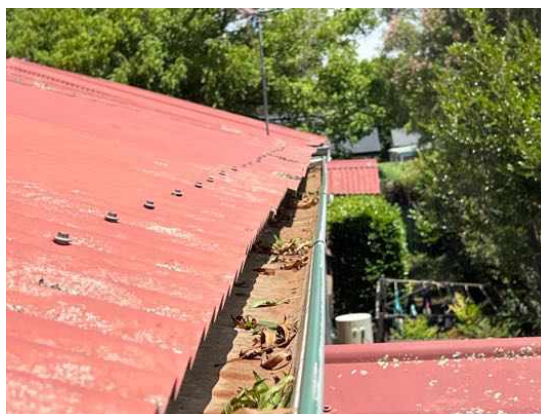
Finding 3.41

Building:	Building 1
Location:	Roof Exterior
Finding:	Roof plumbing - Rusted or corroded
Information:	The roof plumbing has areas of rust and corrosion. It is suspected that this has been caused by blockages, resulting in pooling or standing water, that have prematurely rusted elements of the roof plumbing.

Rusted roof plumbing will generally develop holes and leaks that can affect other building elements with poor drainage of storm water. Poorly drained roof areas will also lead to damp conditions surrounding the base perimeter of the building which, if left unmanaged, can lead to a range of secondary building defects.

Repair and/or replacement of rusted roof plumbing is highly required in order to reinstate the roof drainage system to a fully operational level. To further maintain these areas, gutters should be cleaned frequently, allowing the avoidance of any partial blockages.

A licensed plumber or specialist roof restoration company should be appointed to undertake these works. It is advised that such works be completed as soon as possible to prevent any further damage and deterioration.

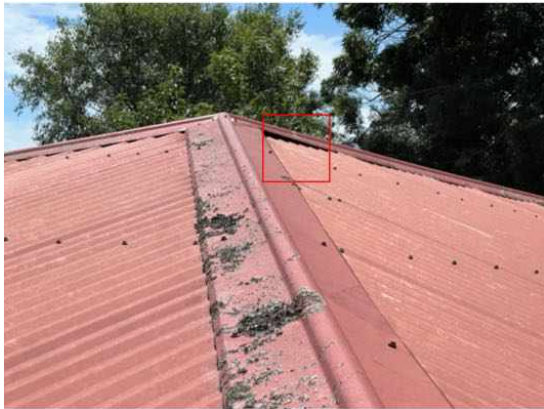
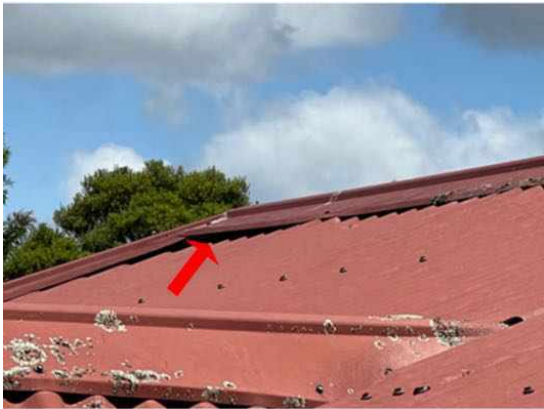
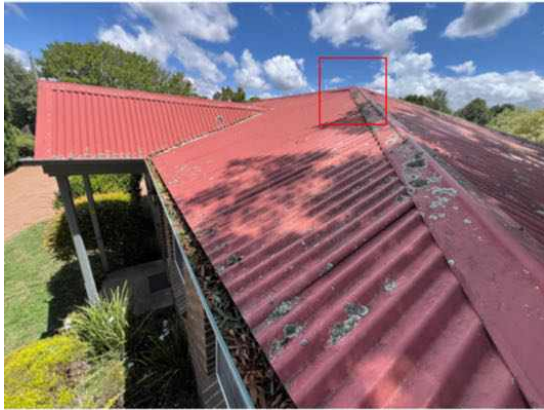
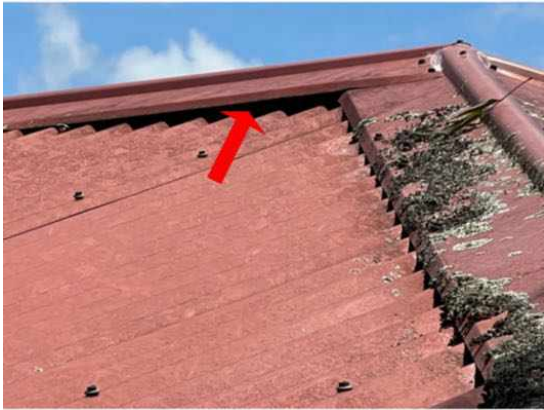
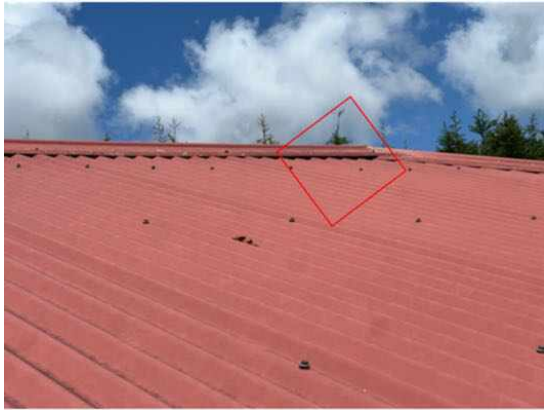
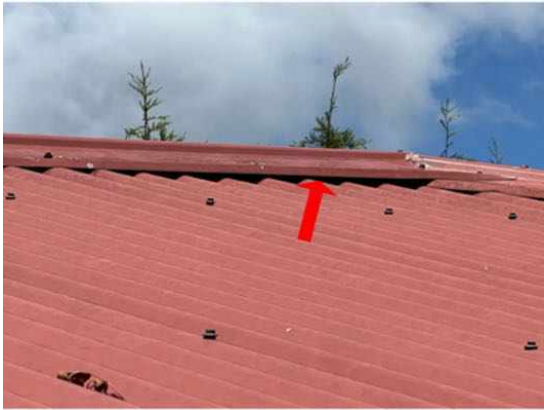
Finding 3.42

Building:	Building 1
Location:	Roof Exterior
Finding:	Roof plumbing - Flashing inadequate
Information:	Some sections of the roof are missing or have inadequate roof flashings. Flashings are metal and other materials which are applied to seals and intersections between roof coverings and building elements. They are designed to aid in weatherproofing of roof joins.

Flashings that are not installed adequately or are missing are likely to result in water penetration to the interior of the property, as well as creating excessively damp conditions against the exterior surfaces and around the base perimeter of the building.

Premature ageing and secondary building defects are imminent where roof plumbing is missing or inadequately installed. Additionally, water pooling also creates an environment that is susceptible to termite and pest infestation.

A roofing plumber should be appointed as soon as possible to install relevant roof plumbing materials, ensuring that no further damage is sustained.

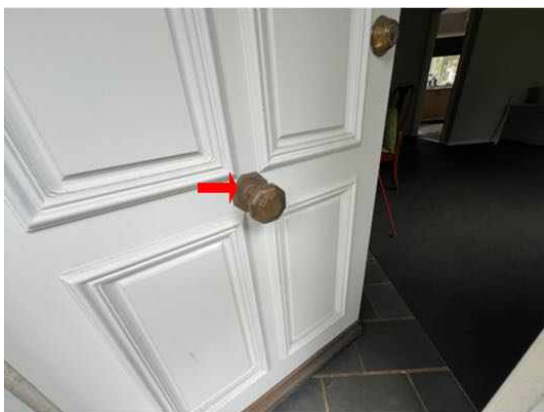
Finding 3.44

Building:	Building 2
Location:	Entry
Finding:	Door Handle - Loose
Information:	The door handle in this area was identified as loose at the time of inspection. A loose door handle can impede the proper operation of the door and, if left unattended, may lead to further deterioration or damage to the associated door structure.

This defect is typically caused by wear and tear, insufficient fixing, or deterioration of the handle's components.

It is recommended that a qualified carpenter or general handyperson be appointed to secure or replace the handle to restore its functionality and ensure proper operation.

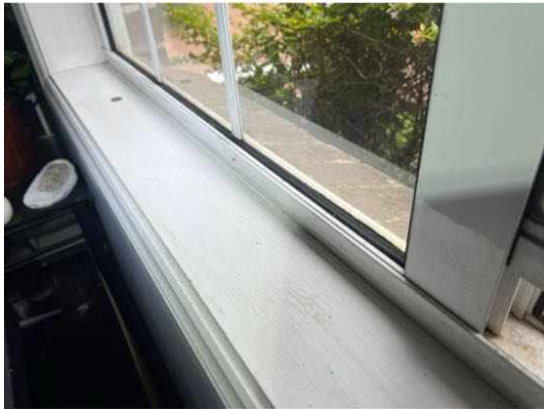
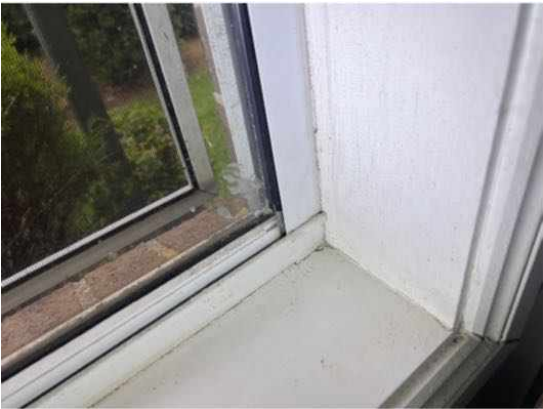
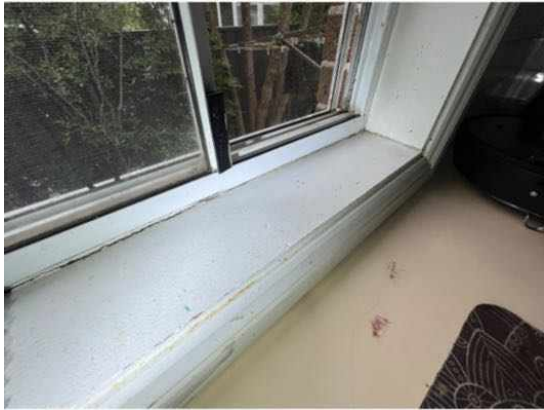
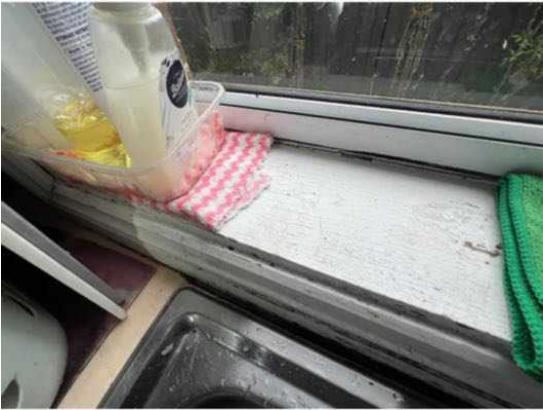
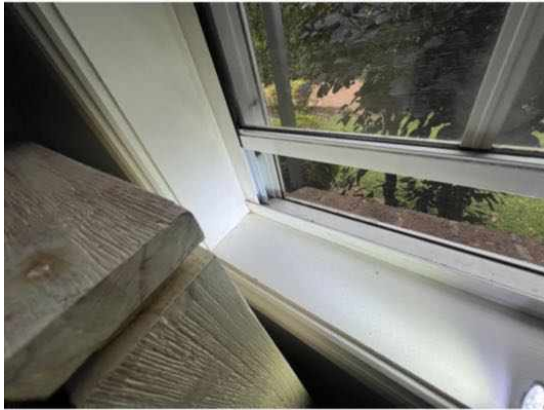
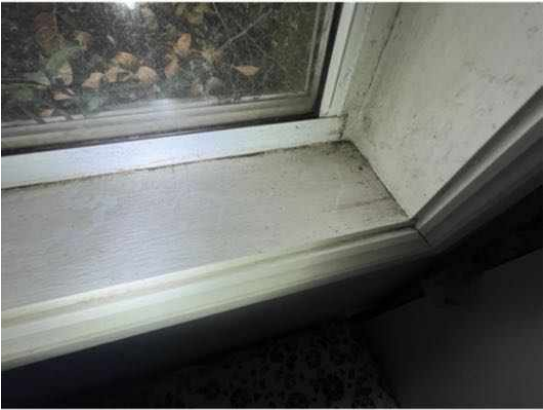
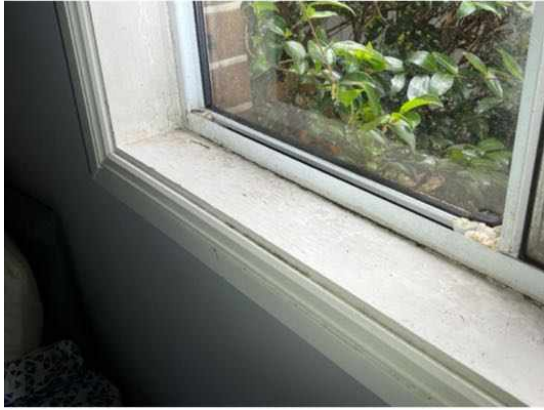
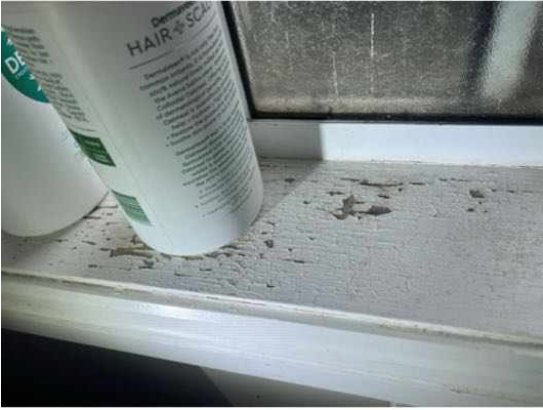
Finding 3.47

Building:	Building 2
Location:	All Internal Areas
Finding:	Painting deteriorated
Information:	The paint work in these areas of the property require attention to prepare and re paint. Whilst incomplete or missing paint finish is generally an appearance defect, it can also lead to the development of secondary building defects over time. Incomplete areas of paint finish exposes the area to moisture, potentially accelerating the deterioration of underlying building materials.

Degraded paint finishes should be sanded back, filled, leveled and painted, as applicable. Where inadequate or missing paint protection has led to the deterioration of the associated building element, repair and/or replacement of this building element may be required.

A painting contractor should be appointed at the clients discretion to perform necessary works to aid the appearance of the affected area and to ensure the area is protected against further deterioration. Alternatively, the homeowner following manufacturer instructions may perform these works

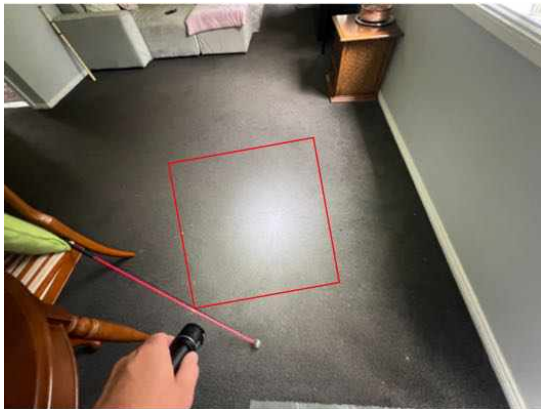
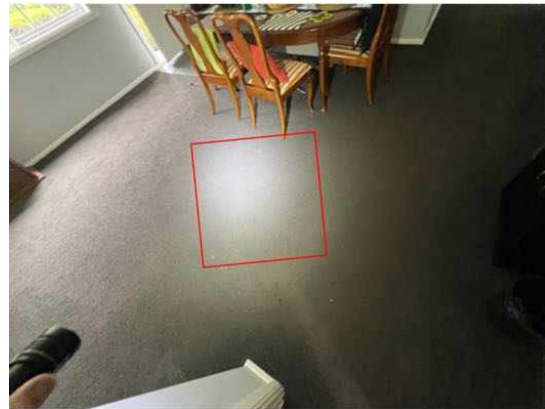
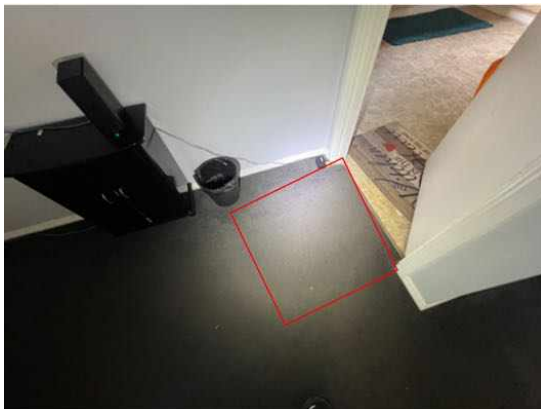
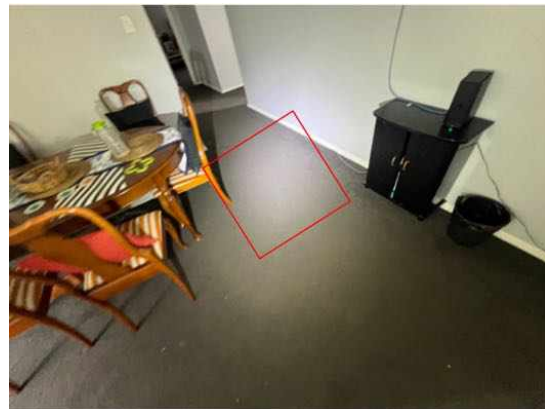
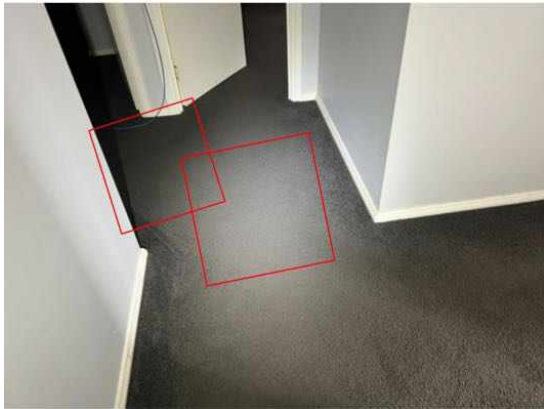
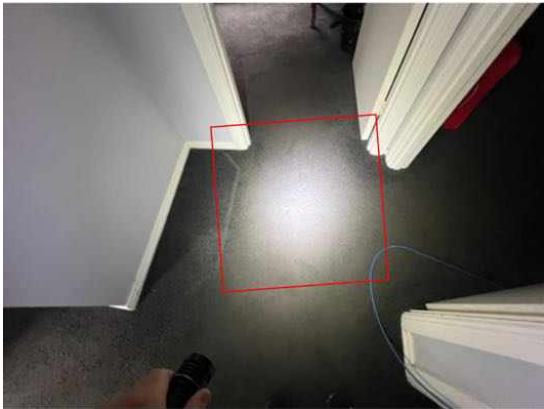
Finding 3.48

Bouncy floors generally indicate that the floorboards or the subfloor structures are coming loose from the joists that they are installed on. Bouncy flooring may also be the result of gaps between flooring and stumps or joist structures, which require packing.

The client is advised to seek quotations for required repairs from a Registered Builder specialising in re-stumping. The potential resolution may range from packing gaps in subfloor structures through to replacement of subfloors stumps and refixing of flooring.
