Building and Timber Pest Inspection Report

Inspection Date: Fri, 16 Jan 2026

Property Address: 17 Price St, Bowral NSW 2576, Australia

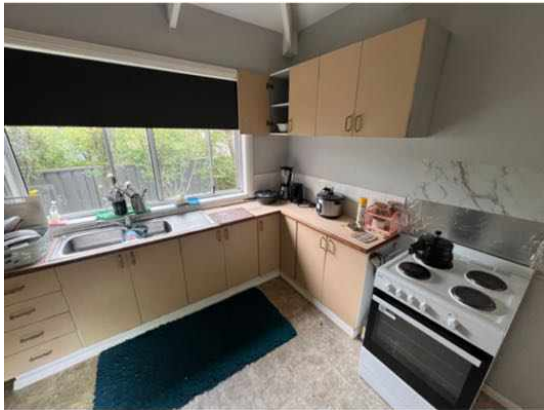
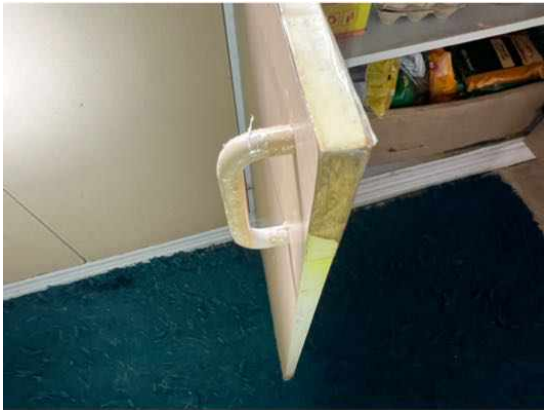
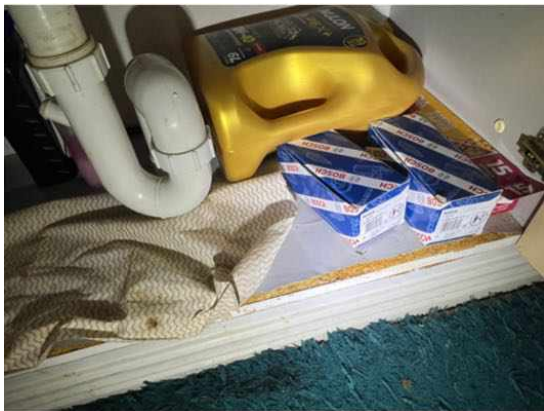
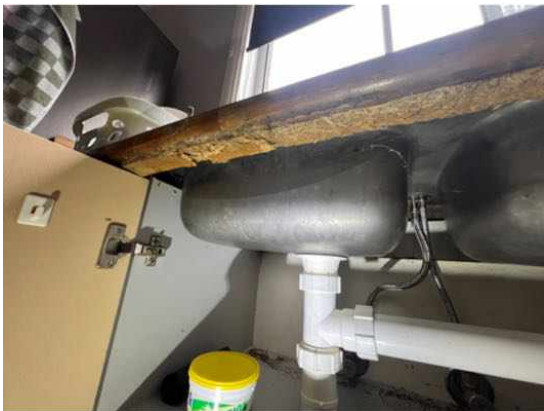
Finding 3.49

Building: Building 2
 Location: Kitchen
 Finding: Cabinetry - signs of wear and tear
 Information: The cabinetry in the property displays signs of wear and tear, indicating that they are nearing the end of their lifespan.

It is likely that maintenance or replacement will be necessary in the near future.

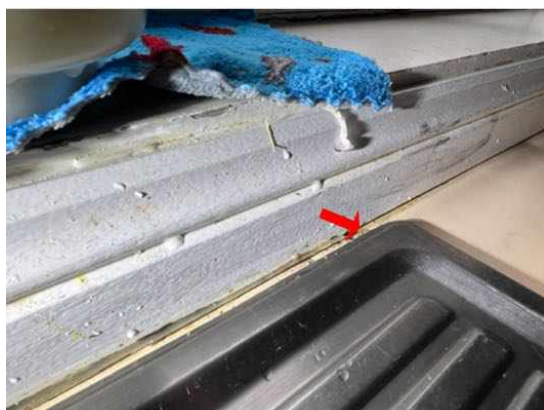
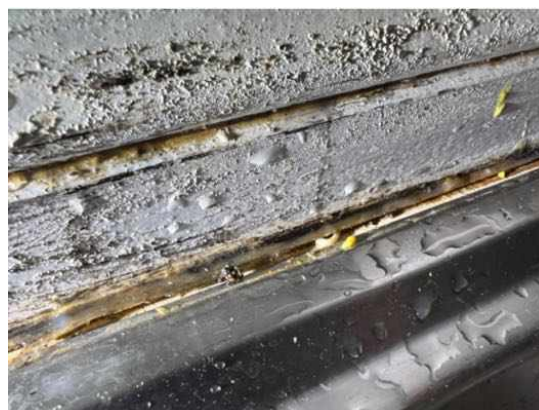
Finding 3.50

Building:	Building 2
Location:	Kitchen
Finding:	Kitchen Sealant - degraded.
Information:	It was noted on inspection that sealant or grout is degraded to the kitchen sink.

Different materials move at different rates, generally causing cracking to grout or sealant at this point. A flexible sealant is required to allow for expected expansion and contraction, while keeping the joint water tight and protective of all associated building materials.

Flexible and mould resistant materials should be applied to affected areas to prevent any subsequent water damage that is likely to occur. Regular maintenance and replacement of damage or missing or damaged sealant and grout is highly recommended to the wet areas, as this is a regular wear and tear defect. Sealant and grouting in areas that come into regular contact with water should be maintained for the long term care of your property.

A sealant specialist or tiling contractor should be appointed to complete these works as soon as possible

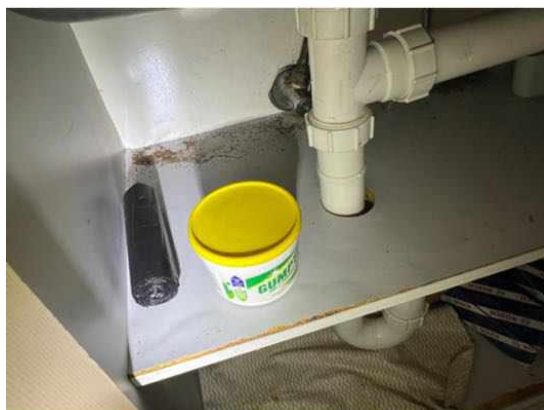
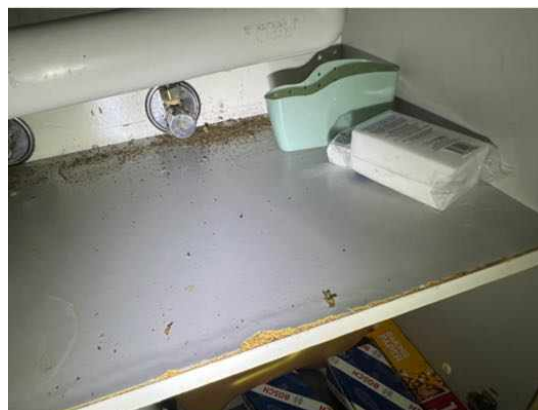
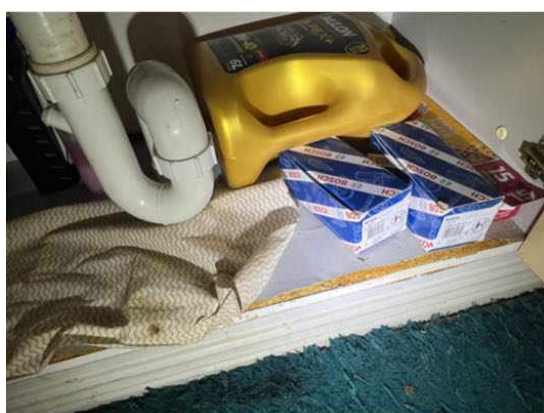
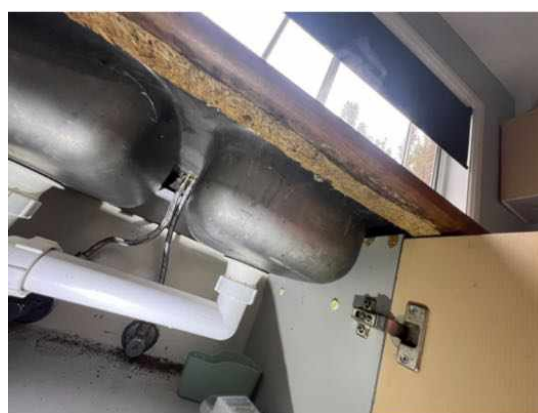
Finding 3.51

Building:	Building 2
Location:	Kitchen
Finding:	Water damage - joinery
Information:	Water damage was observed to joinery within the sink cabinet. This type of defect is typically caused by prolonged moisture exposure from minor plumbing leaks, condensation, or poor sealing around fixtures and fittings.

If left unmanaged, water ingress can lead to swelling, delamination, or deterioration of the joinery, potentially compromising its functionality and hygiene. Moist conditions in enclosed cabinetry may also create an environment conducive to mould or timber pest activity.

It is recommended that a licensed plumber be engaged to inspect the sink plumbing

for leaks or seepage. A cabinetmaker or qualified joiner may also be required to replace the affected shelving or restore the unit where practical.

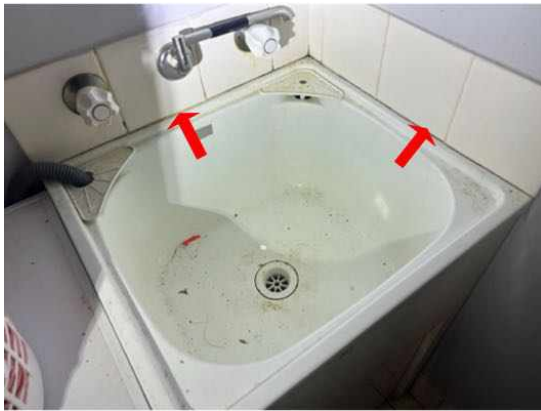
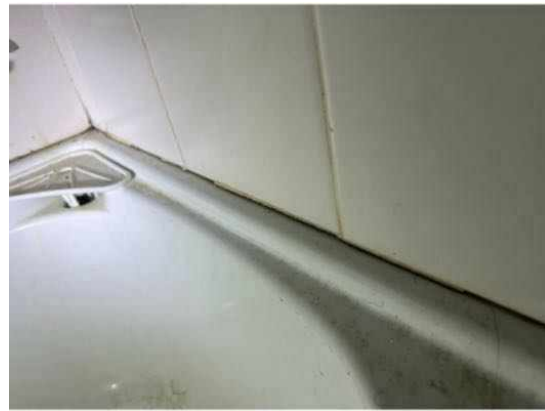
Finding 3.52

Building:	Building 2
Location:	Laundry
Finding:	Laundry Sealant - Missing
Information:	It was noted on inspection that sealant or grout is missing to the laundry splashback.

Different materials move at different rates, generally causing cracking to grout or sealant at this point. A flexible sealant is required to allow for expected expansion and contraction, while keeping the joint water tight and protective of all associated building materials.

There appears to be excessive mould to the sealant and grout which will likely require scraping out and replacement.

Flexible and mould resistant materials should be applied to affected areas to prevent any subsequent water damage that is likely to occur. Regular maintenance and replacement of damage or missing or damaged sealant and grout is highly recommended to the wet areas, as this is a regular wear and tear defect. Sealant and grouting in areas that come into regular contact with water should be maintained for

the long term care of your property.

A sealant specialist or tiling contractor should be appointed to complete these works as soon as possible

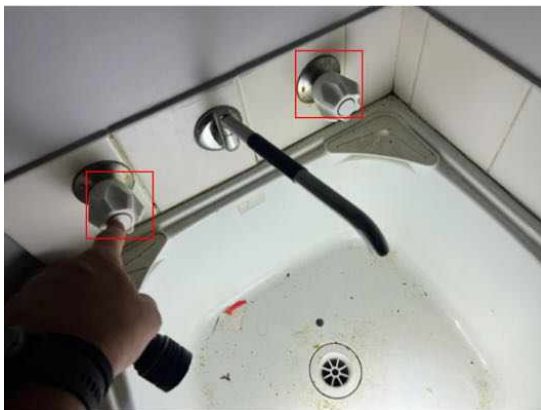
Finding 3.53

Information: A plumbing fixture was identified as inoperable, with the tap unable to be turned on or off at the time of inspection. This condition may result from internal deterioration, corrosion, or prolonged lack of use.

It is recommended that a licensed plumber be appointed to assess the fixture and carry out any necessary repairs or replacement to restore proper function.

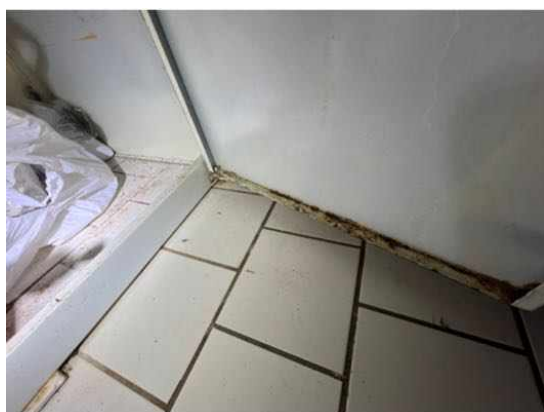
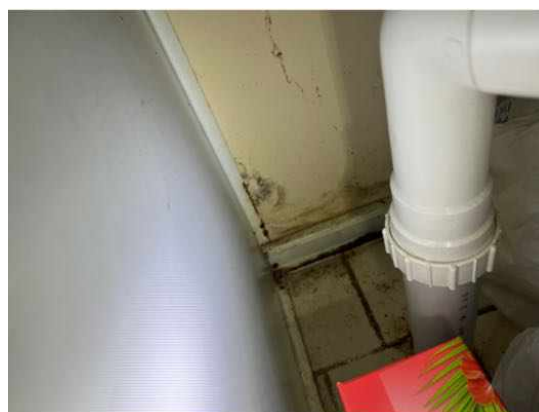
Finding 3.54

Finding: Trough - Rusted or corroded.

Information: This laundry trough shows evidence of rusting and corrosion, which is likely to have

developed as a result of excessive exposure to moisture and or inadequate coatings.

As surface rust provides no protection to the underlying iron, the deteriorating condition is likely to worsen if not addressed in the short-term future.

Rusting and corrosion should be managed by ideally removing or limiting the affected surface from exposure to moisture. A licensed plumber may be appointed to replace any building elements that have been severely affected by rust or water damage.

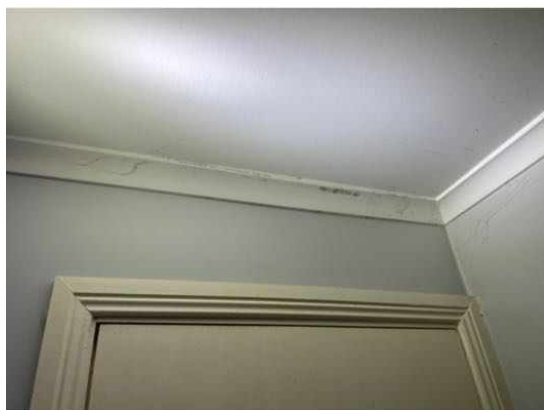
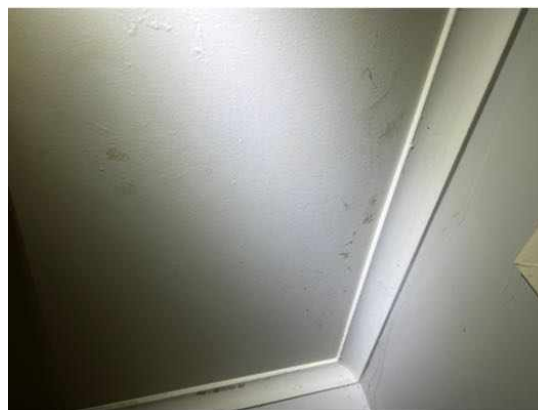
Finding 3.55

Building:	Building 2
Location:	Laundry
Finding:	Mould - ceiling
Information:	Mould spotting was observed on the ceiling at the time of inspection. This condition is typically indicative of prolonged moisture exposure, which may be caused by water ingress, inadequate ventilation, or condensation buildup.

If left unmanaged, persistent moisture can lead to further mould growth, deterioration of building materials, and potential health concerns.

It is recommended that a licensed plumber or building professional be engaged to investigate the source of moisture and undertake any necessary remedial works. Remediation of the mould-affected areas should also be carried out to prevent further deterioration.

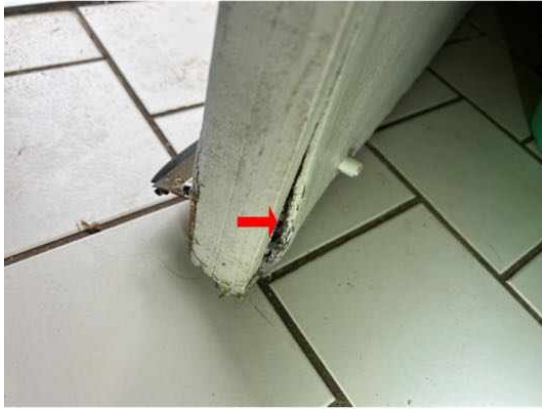
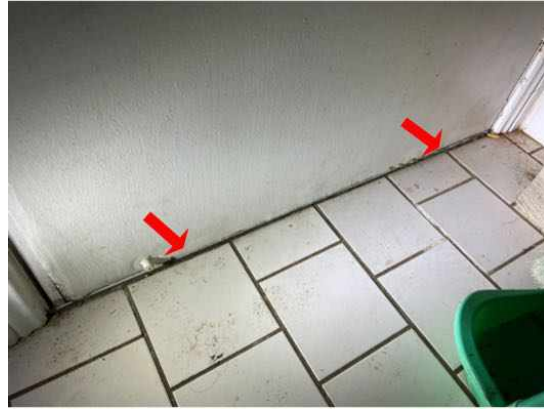
Finding 3.56

Finding: Door - Wood rot

Information: This door shows evidence of wood rot. Wood rot, also known as Fungal Decay, occurs when timbers and other cellulose building materials are exposed to damp conditions on an ongoing basis. This could be the result of exposure to weathering over a prolonged period of time, or the attraction of excessive moisture from other abutting building materials. Contributing factors also include poor air ventilation in the area.

Wood rot is often associated with general damp problems and is evidenced by a 'musty' smell or mould and mildew occurring on surfaces. If left unmanaged, damp conditions can lead to further health problems and the decay of timbers will continue.

Early intervention and regular maintenance, particularly of exterior timbers, will prolong the useful life of these building elements. Prior to any works being performed, the cause of the moisture that has created the visible wood rot should be identified and addressed in a suitable manner. Replacement of affected timbers may then be a necessary step in protecting surrounding building elements from such deterioration.

A qualified plumber may be appointed to assess the cause of excessive moisture and to provide advice on any remedial works as required. A qualified carpenter or registered builder may also be required to replace affected building materials.

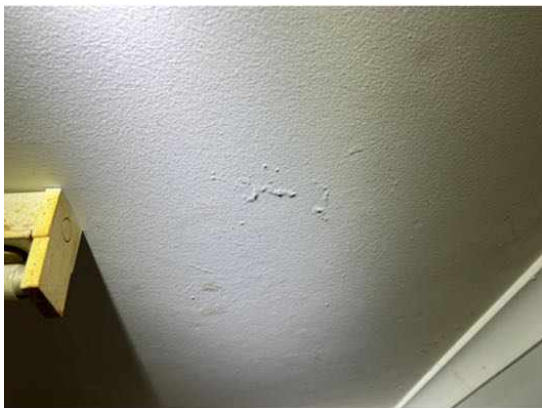
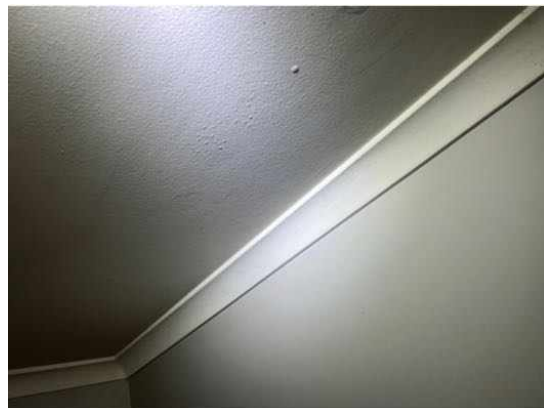
Finding 3.57

Building:	Building 2
Location:	Laundry
Finding:	Painted surface - Bubbling
Information:	Sections of paint in this area was found to have bubbled and deteriorated. Paint bubbling is generally an indication of excessive moisture in the area, that is currently hidden by the painted surface.

The presence of excessive moisture can have major implications on associated building elements if left unattended. While only seemingly minor at this stage, the damage cannot be determined due to the paint obstructing any further inspection of the damage.

It is highly advised that the affected paint be cleaned to allow a further, more invasive inspection by a licensed plumber. Failure to act on this defect may necessitate major works in the future.

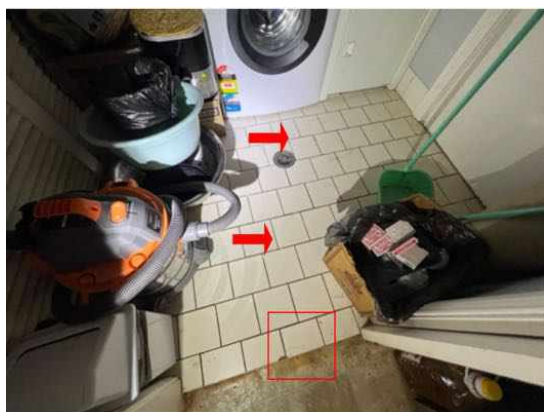
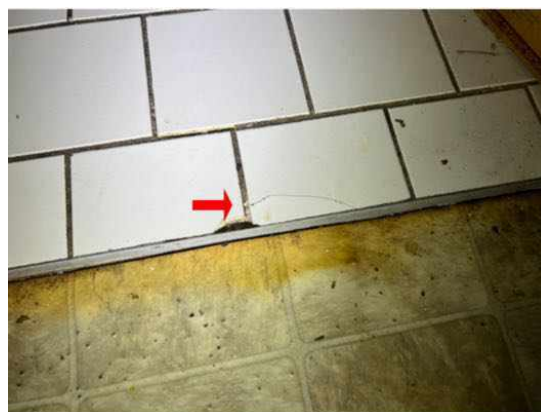
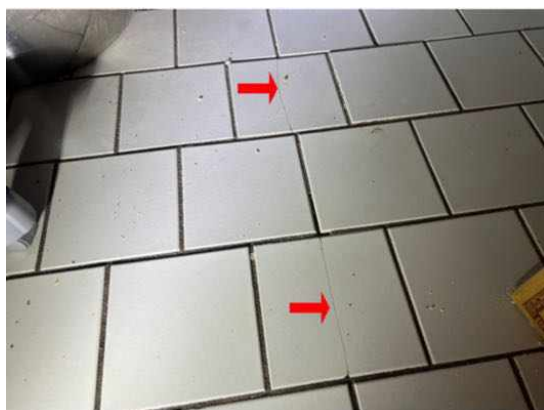
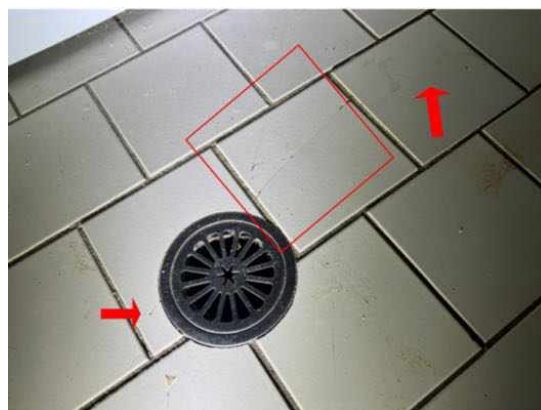
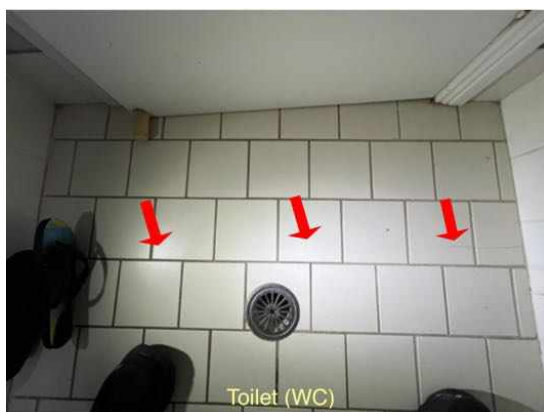
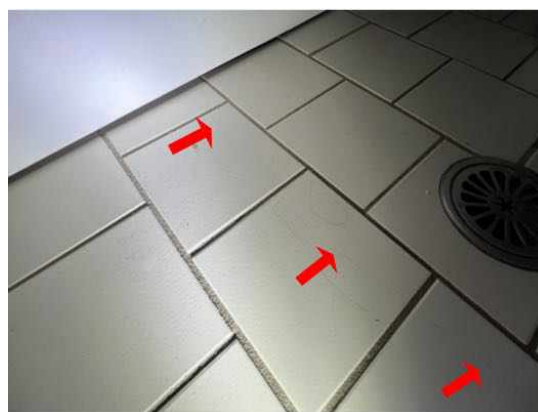
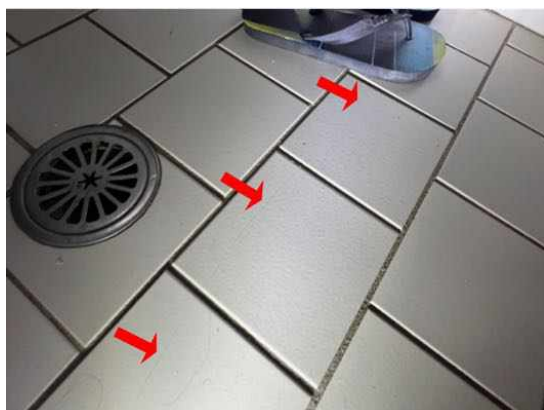
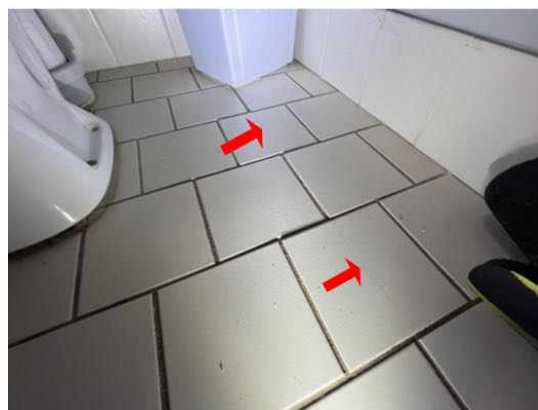
Building:	Building 2
Location:	Laundry, Toilet (WC)
Finding:	Tiles - (hairline)Cracked or damaged

Cracking was evident to the tiling in this area at the time of inspection. While the cracking appears to be a very minor hairline crack, this area is frequently exposed to water, allowing potential for water penetration into adjoining sections of walls or flooring.

If left unmanaged, water penetration to these areas may lead to subsequent water damage, which is likely necessitate repair work to affected building elements.

A tiling contractor should be appointed to ensure that no further water damage occurs. The re-application of silicone and grouting throughout remaining tile work is also advised, to further protect the area against water penetration.

Where water penetration has led to water damage, appointment of a relevant tradesperson may be required to repair damaged building elements.

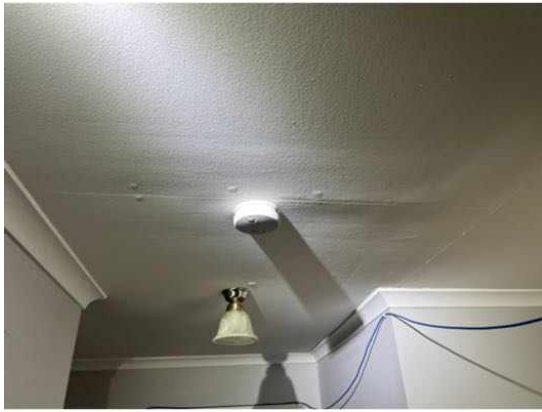
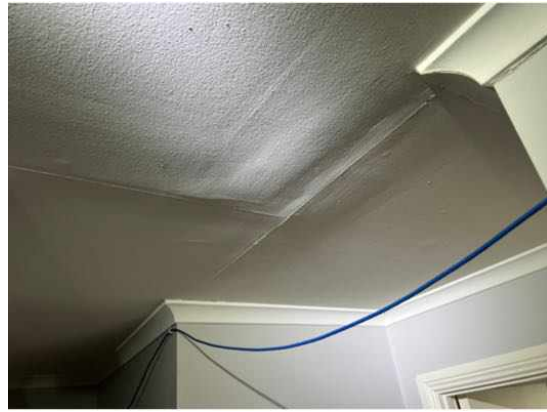
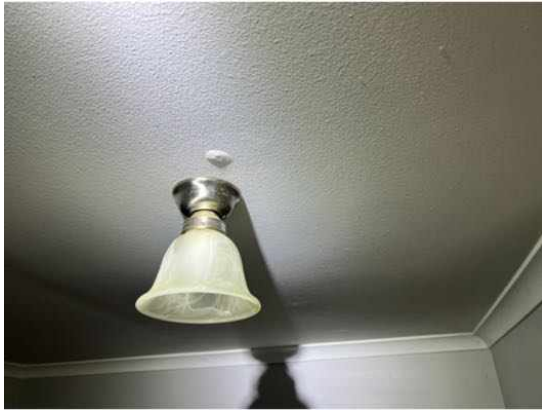
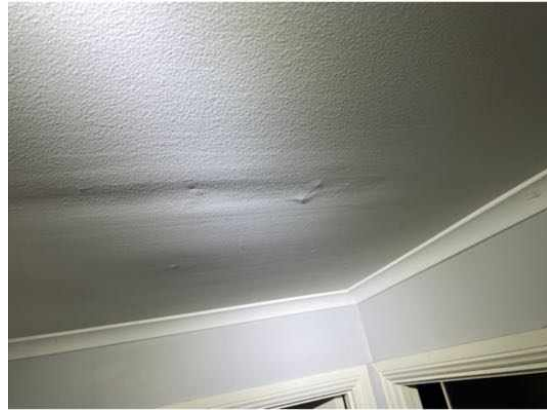
Finding 3.59

Building:	Building 2
Location:	Hallway
Finding:	Ceiling – Popped Nails and Hairline Cracks.
Information:	Popped nails were identified to the ceiling lining, with multiple visible patch repairs evident across the surface. The patchwork is considered substandard, with uneven finishes and incomplete blending, suggesting that previous repair attempts were cosmetic in nature and did not involve re-fixing the underlying ceiling sheets.

Additionally, hairline linear cracking was observed at several butt joints between ceiling sheets. This type of cracking is commonly caused by minor structural movement, material shrinkage, or flexing along joint lines over time.

While these issues are largely cosmetic at this stage, they indicate a history of movement and poor-quality repair work. If left unmanaged, further deterioration or more noticeable ceiling deformation may occur.

It is recommended that a qualified plasterer or painter be engaged to assess and undertake remedial works to ensure the ceiling is properly prepared and refinished to an acceptable standard.

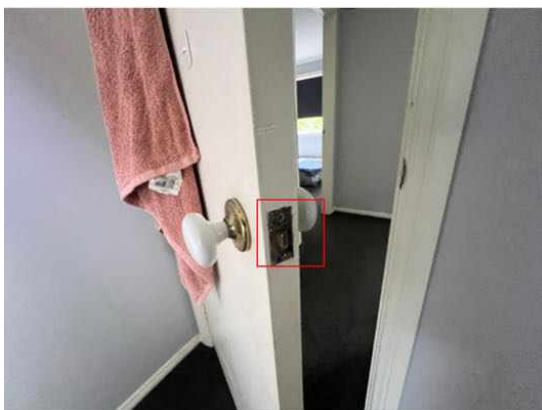
Finding 3.60

Building:	Building 2
Location:	Bedroom 3
Finding:	Door handle - Not latching
Information:	It was noted that the door in this area was not latching during operation at the time of inspection. Whilst detracting from the functionality of this building element, this minor defect may also be a security risk, and may therefore have serious implications if left unattended.

It is suspected that this defect has occurred due to minor issues with the associated hinges. Such damage is identified as general wear and tear, which is expected for building elements of this age.

A qualified carpenter or general handyperson may be appointed to perform rectification works as necessary, at client discretion. If left unattended, further functional impairment is likely to occur.

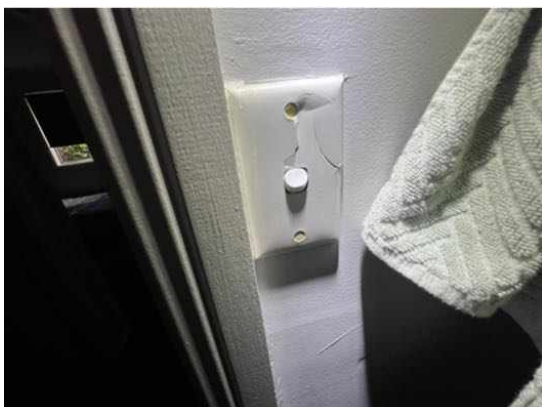
Finding 3.61

Building: Building 2
 Location: Bedroom 3
 Finding: Switches - Damaged/Faulty
 Information: The switches in this area was found to be damaged or faulty at the time of inspection. This occurs generally when the building materials have either aged and decayed or as a result of impact damage (accidental or deliberate). This damage may also have occurred during installation.

Repair and/or replacement of the switches is advised to ensure the fixture and it's associated structures are safe and fully operational. A licensed electrician should be appointed to repair/replace the light switch as soon as possible.

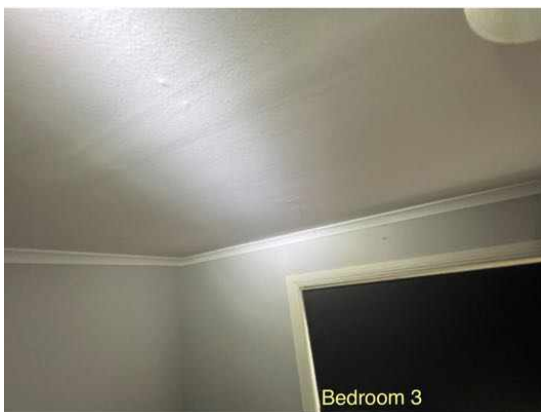
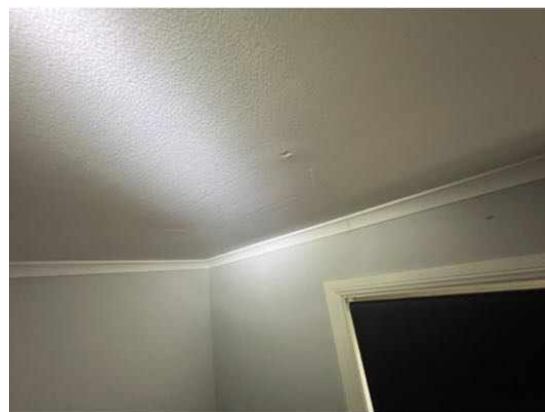
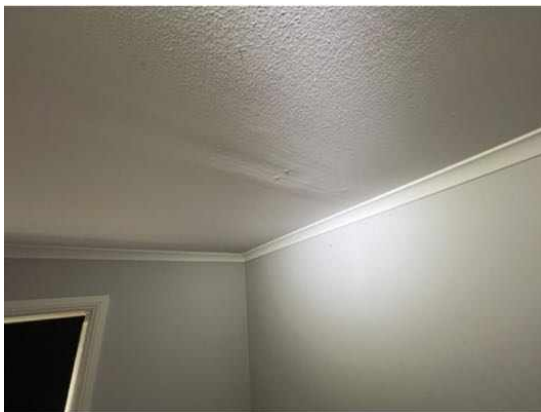
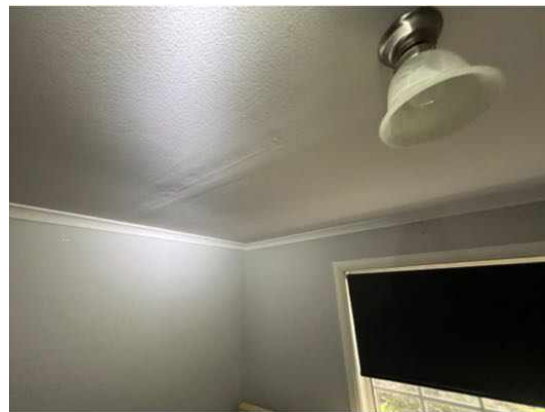
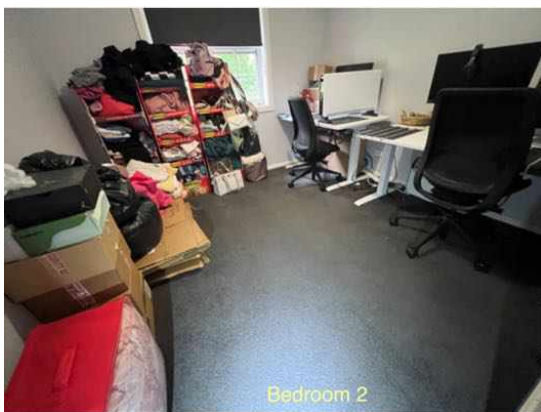
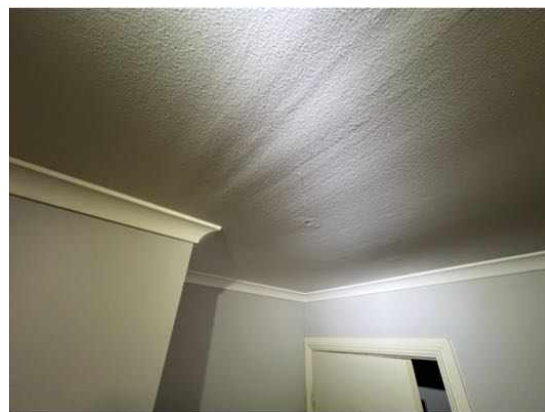
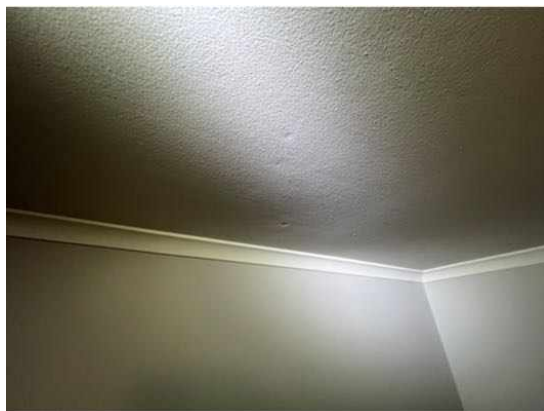
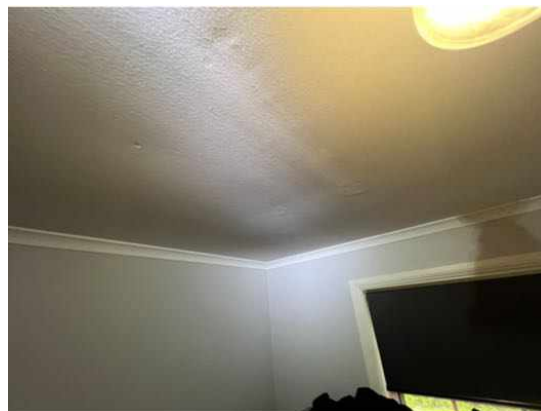
Finding 3.62

Building: Building 2
 Location: Bedroom 3, Bedroom 2
 Finding: Ceiling Defects - Poor Finishing and nail popping.

Visual inspection revealed ceiling defects, nail popping, and inconsistent flushing of join lines. Additionally, evidence of substandard patching and finishing was noted in areas where previous defects have been addressed, but not to an acceptable visual standard.

Nail popping and poor join treatment, while generally not structural, can lead to further deterioration of ceiling linings if left unmanaged. These issues detract from the ceiling's appearance and may compromise the long-term durability of the plasterboard fixing.

Rectification by a qualified plasterer is recommended. Works should include securing loose fixings, re-flushing affected joints, and applying back-blocking where necessary to stabilise the ceiling structure and improve the visual condition.

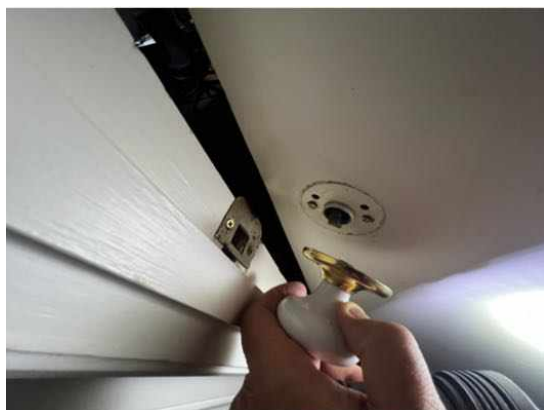
Finding 3.63

Building: Building 2
 Location: Bedroom 2
 Finding: Door - damage handle
 Information: The door handle in this area was found to be damaged at the time of inspection. Breakage occurs generally when the building materials have aged and decayed, but may be indicative of impact damage (accidental or deliberate).

Repair and/or replacement of the broken door handle is advised to improve the operational state of the associated door.

A qualified carpenter or general handyman should be appointed to repair/replace the door handle at the client's discretion.

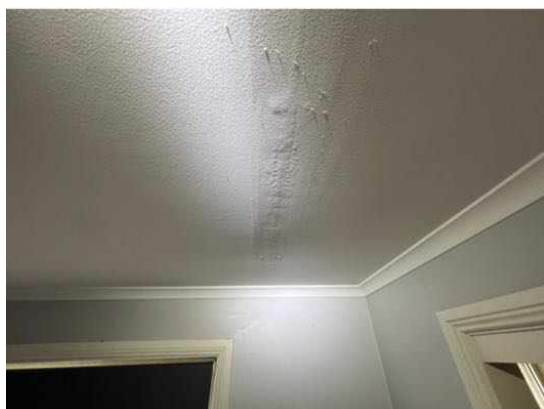
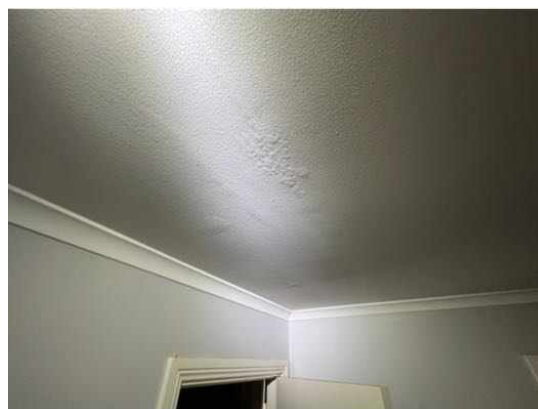
Finding 3.64

Building: Building 2
 Location: Bedroom - Master
 Finding: Painted surface - Bubbling
 Information: Sections of paint in this area was found to have bubbled and deteriorated. Paint bubbling is generally an indication of excessive moisture in the area, that is currently hidden by the painted surface.

The presence of excessive moisture can have major implications on associated building elements if left unattended. While only seemingly minor at this stage, the damage cannot be determined due to the paint obstructing any further inspection of the damage.

It is highly advised that the affected paint be cleaned to allow a further, more invasive inspection by a licensed plumber. Failure to act on this defect may necessitate major works in the future.

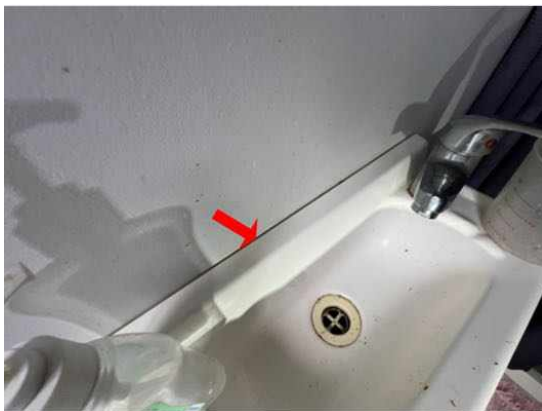
Finding 3.65

Building:	Building 2
Location:	Ensuite
Finding:	Vanity Sealant - degraded/missing
Information:	It was noted on inspection that sealant or grout is degraded/ missing to the vanity splashback.

Different materials move at different rates, generally causing cracking to grout or sealant at this point. A flexible sealant is required to allow for expected expansion and contraction, while keeping the joint water tight and protective of all associated building materials.

There appears to be excessive mould to the sealant and grout which will likely require scraping out and replacement.

Flexible and mould resistant materials should be applied to affected areas to prevent any subsequent water damage that is likely to occur. Regular maintenance and replacement of damage or missing sealant and grout is highly recommended to the wet areas, as this is a regular wear and tear defect. Sealant and grouting in areas that come into regular contact with water should be maintained for the long term care of your property.

A sealant specialist or tiling contractor should be appointed to complete these works as soon as possible

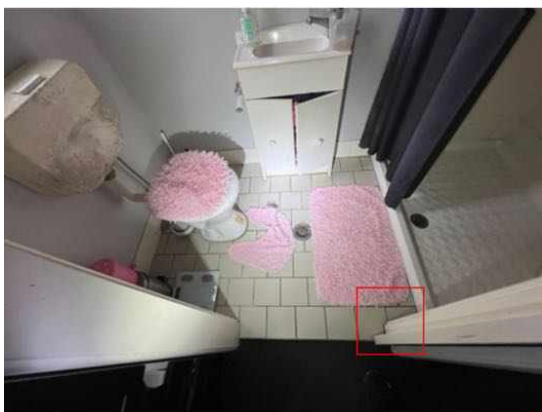
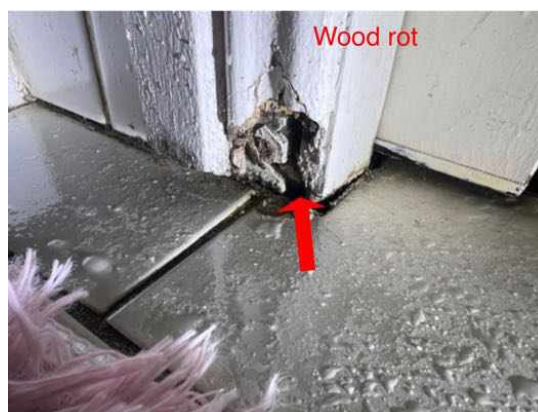
Finding 3.66

Building:	Building 2
Location:	Ensuite
Finding:	Door Jamb – Water Damage
Information:	Water damage was observed to the base of the door jamb in this area. This type of defect is typically caused by moisture exposure from wet areas, inadequate sealing, or failed waterproofing at adjoining tiled surfaces.

If left unmanaged, water ingress may result in swelling, decay, or deterioration of the timber, potentially affecting the operation of the door and compromising surrounding finishes.

It is recommended that a qualified carpenter or builder assess the extent of damage and carry out repairs or replacement of the affected section as required. Improved sealing or waterproofing should also be considered to minimise recurrence.

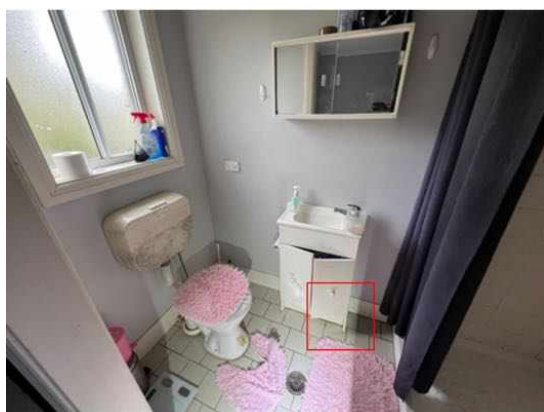
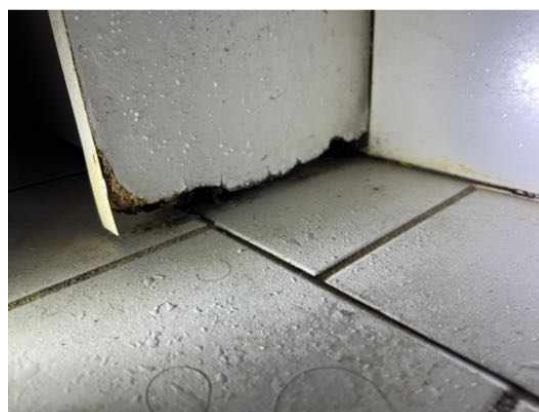
Finding 3.67

Building:	Building 2
Location:	Ensuite
Finding:	Vanity - water damage
Information:	Water damage was observed to the vanity. This type of defect is typically caused by

prolonged moisture exposure from minor plumbing leaks, condensation, or poor sealing around fixtures and fittings.

If left unmanaged, water ingress can lead to swelling, delamination, or deterioration of the joinery, potentially compromising its functionality and hygiene. Moist conditions in enclosed cabinetry may also create an environment conducive to mould or timber pest activity.

It is recommended that a licensed plumber be engaged to inspect the sink plumbing for leaks or seepage. A cabinetmaker or qualified joiner may also be required to replace the affected shelving or restore the unit where practical.

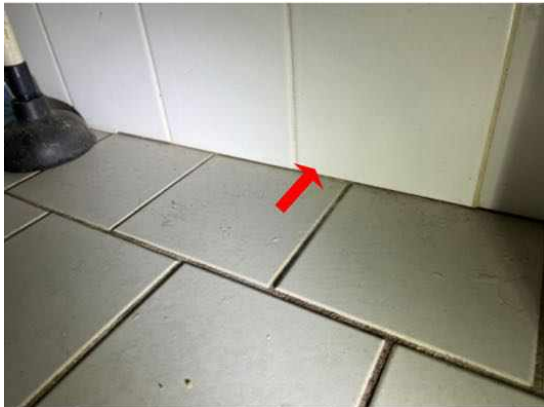
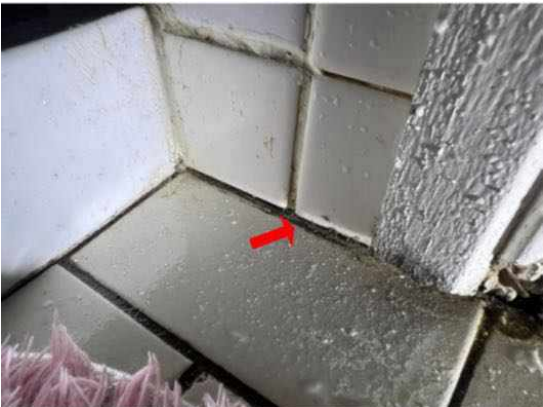
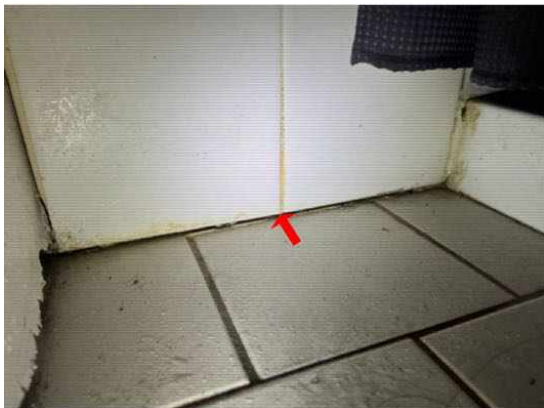
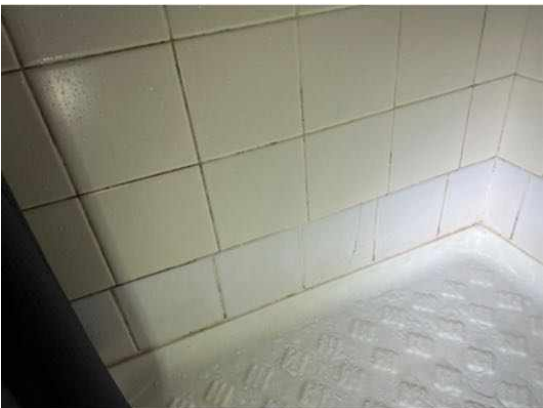
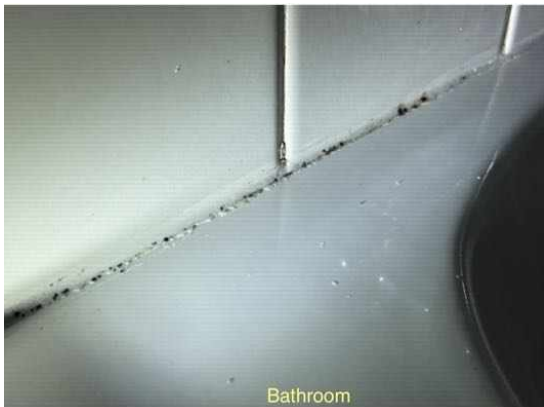
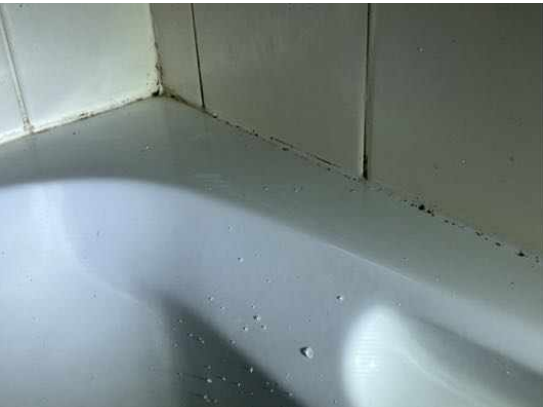
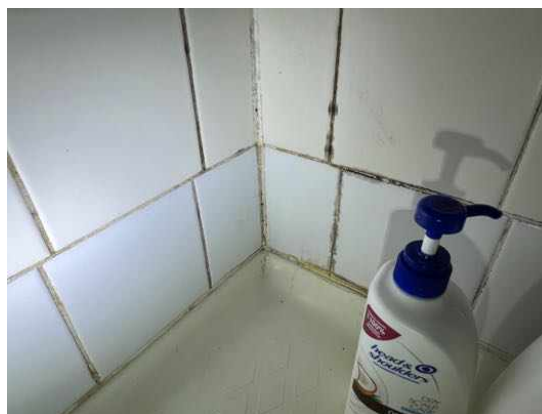
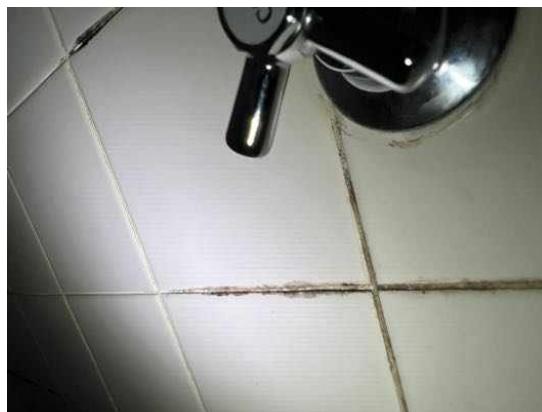
Finding 3.68

Building:	Building 2
Location:	Ensuite, Bathroom
Finding:	Sealant and grouting - Missing or damaged
Information:	It was noted on inspection that sealant or grout is degraded to the tiled shower alcove and or other areas of the bathroom.

Different materials and floor areas move at different rates, generally causing cracking to grout or sealant at this point. A flexible sealant is required to allow for expected expansion and contraction, while keeping the joint water tight and protective of all associated building materials.

There appears to be excessive mould to the sealant and grout which will likely require scraping out and replacement.

Flexible and mould resistant materials should be applied to affected areas to prevent any subsequent water damage that is likely to occur. Regular maintenance and replacement of damage or missing or damaged sealant and grout is highly recommended to the wet areas, as this is a regular wear and tear defect. Sealant and grouting in areas that come into regular contact with water should be maintained for the long term care of your property.

A sealant specialist or tiling contractor should be appointed to complete these works as soon as possible

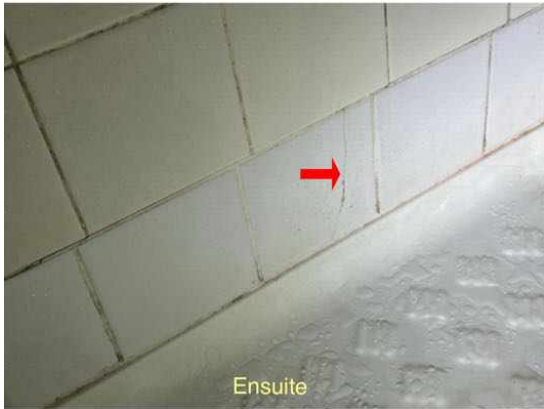
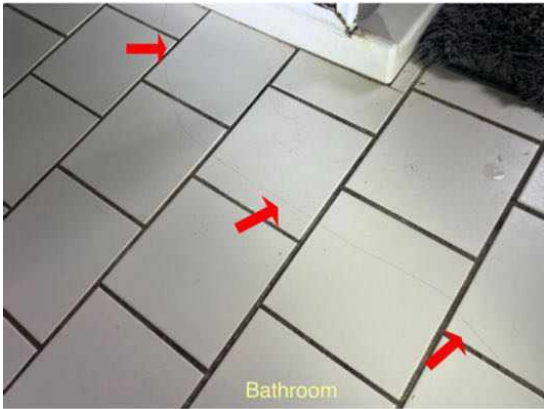
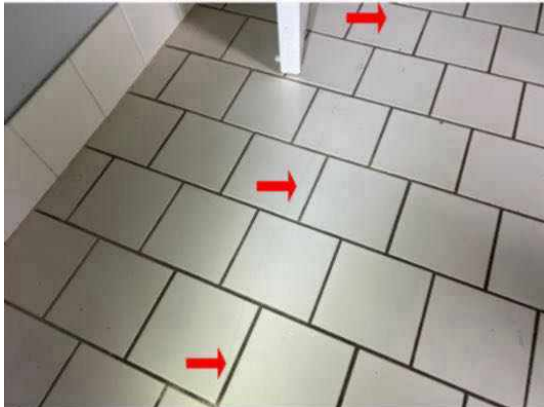
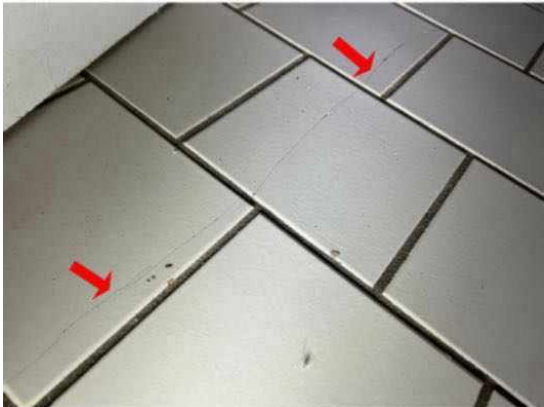
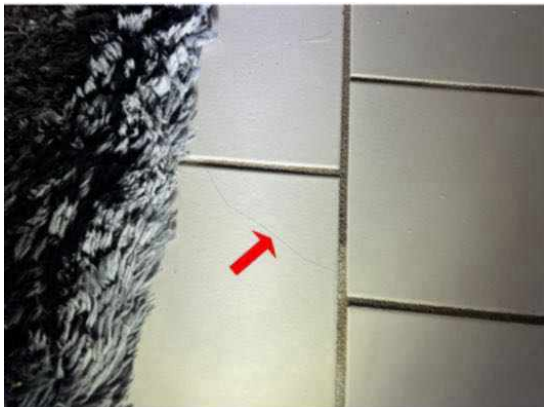
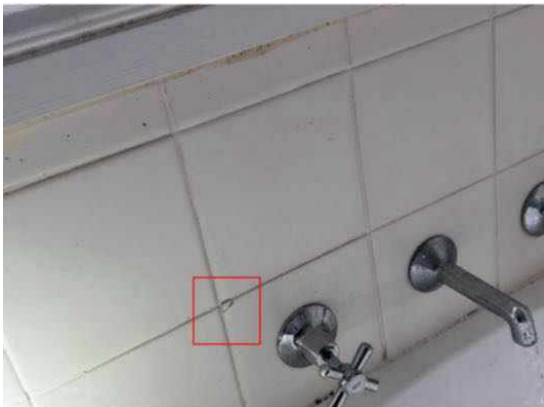
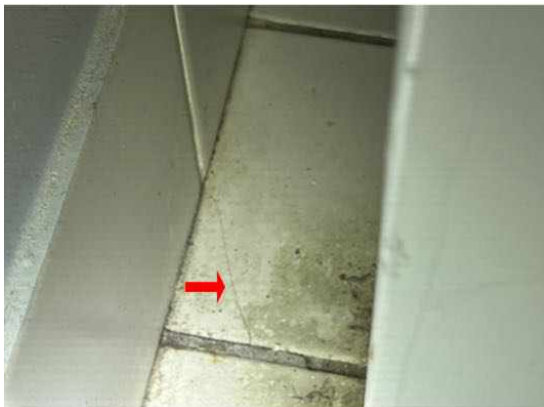
Building:	Building 2
Location:	Ensuite, Bathroom
Finding:	Tiles - Cracked or damaged
Information:	Cracking was evident to the tiling in this area at the time of inspection. While the cracking appears to be minor, this area is frequently exposed to water, allowing potential for water penetration into adjoining sections of walls or flooring.

If left unmanaged, water penetration to these areas may lead to subsequent water damage, which is likely necessitate repair work to affected building elements.

A tiling contractor should be appointed to ensure that no further water damage occurs. The re-application of silicone and grouting throughout remaining tile work is also advised, to further protect the area against water penetration.

Where water penetration has led to water damage, appointment of a relevant tradesperson may be required to repair damaged building elements.

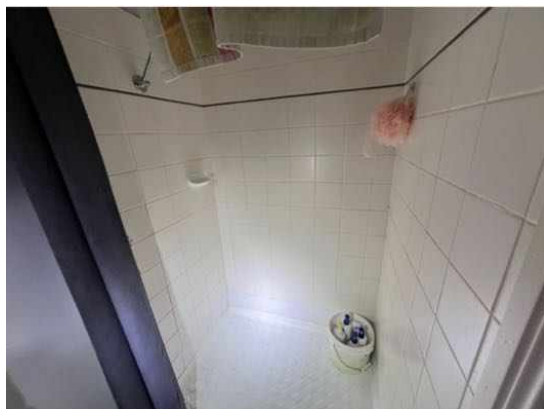
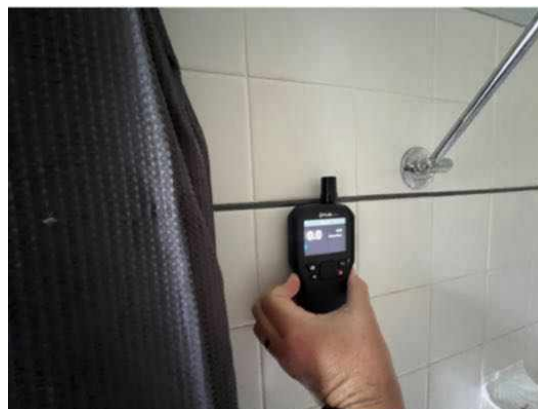
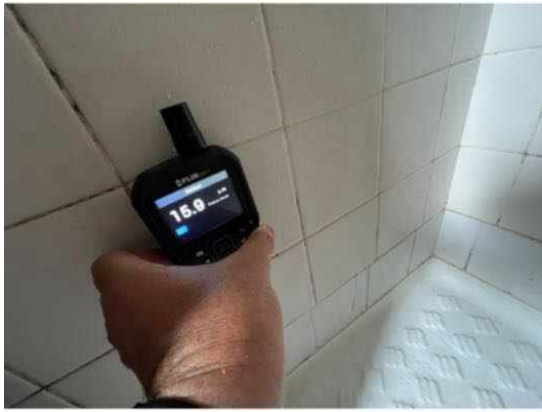
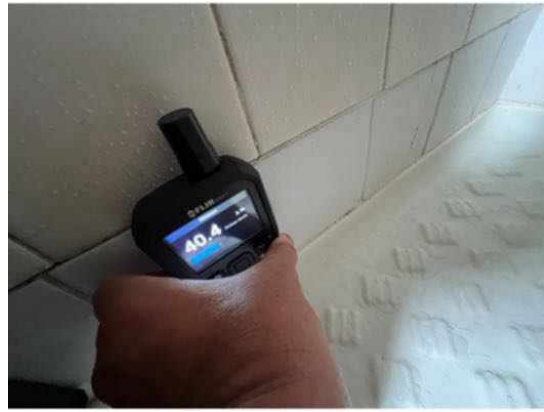
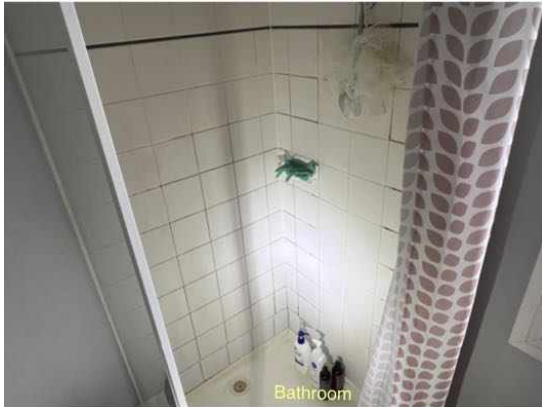
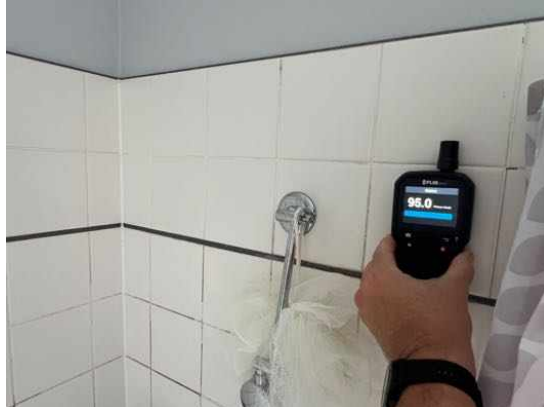
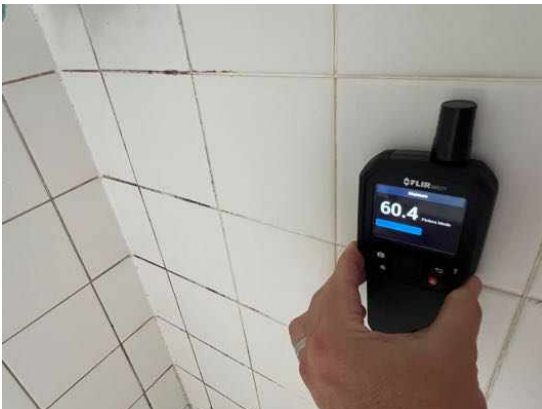
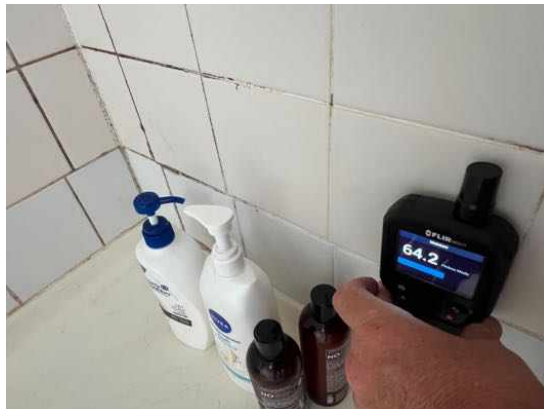
Finding 3.70

Building: Building 2
Location: Ensuite, Bathroom
Finding: Moisture in Shower
Information: Moisture is evident behind the tiles to the shower alcove. This defect is quite common, and is suspected to have been caused by moisture permeating through the grouting in this area. Leaking pipes within the adjoining wall is also a possible cause.

Damp (or structural damp) refers to the presence of unwanted moisture in the structure of a building, either as the result of intrusion from outside, or condensation from within the structure. In the shower area, internal water leaks or other sources of excessive moisture are generally the cause of damp. Always ensure that sealant and grout is in good condition to prevent any moisture issues occurring in the future.

Consultation with a qualified plumber or bathroom specialist is advised to identify the cause of damp and to perform remedial works as required.
