Building and Timber Pest Inspection Report

Inspection Date: Fri, 16 Jan 2026

Property Address: 17 Price St, Bowral NSW 2576, Australia

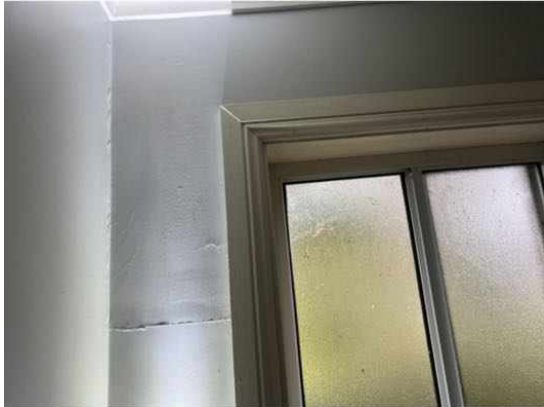
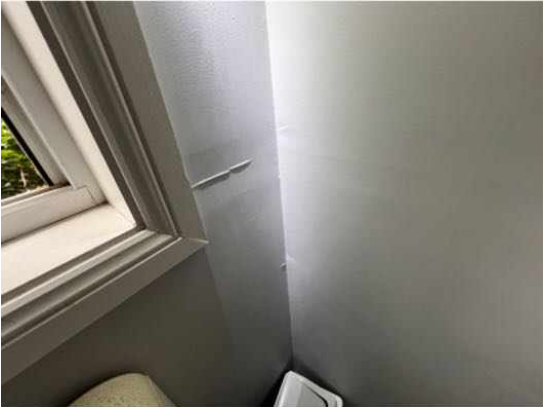
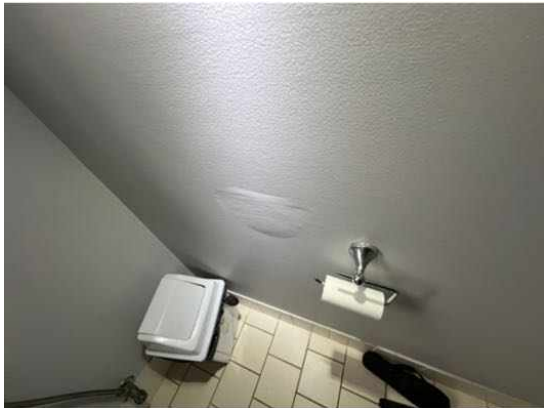
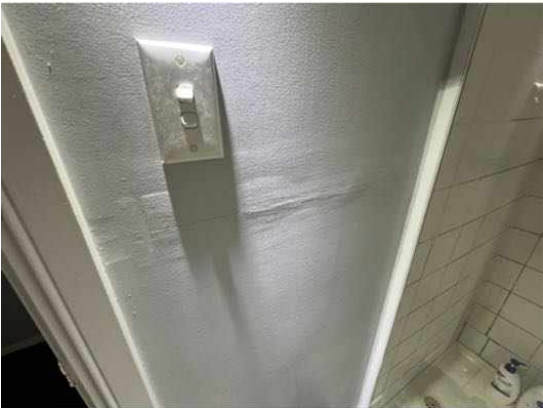
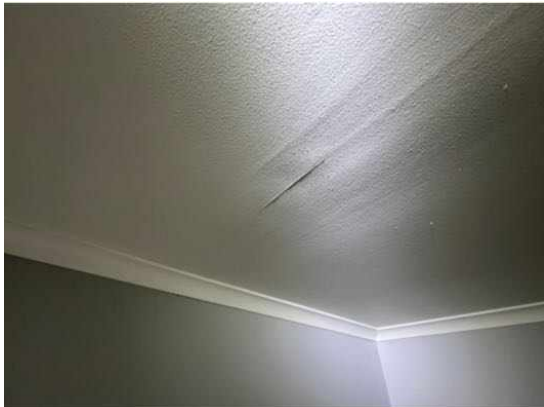
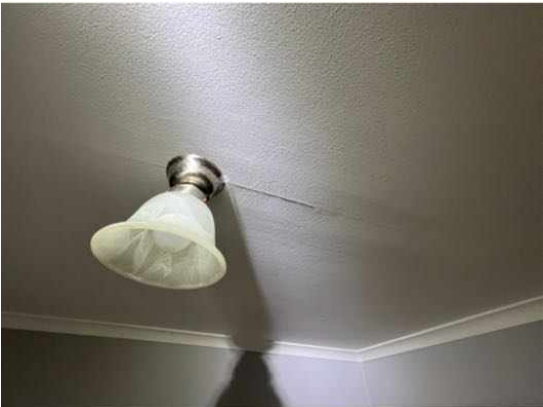
Finding 3.71

Building:	Building 2
Location:	Ensuite, Toilet (WC), Bathroom
Finding:	Plasterboard - Incomplete or substandard works
Information:	The works to this area appear to be incomplete or have been completed to a substandard level.

Works that have not been completed to a satisfactory level create potential for the development of building defects and may impede on the safety and integrity of the overall structure.

It is highly recommended that a plasterer or painter be appointed to complete these

works and ensure the safety of the area and the longevity of all associated building elements.

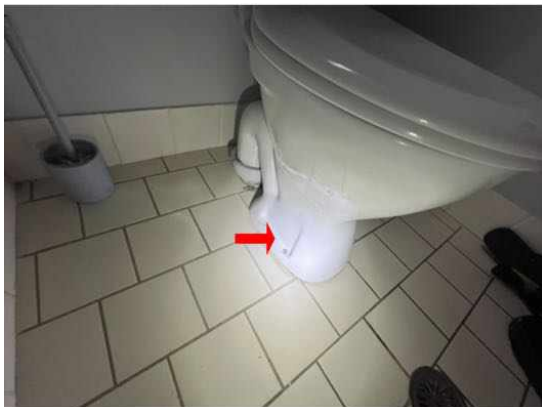
Finding 3.72

Building: Building 2
Location: Toilet (WC)
Finding: Toilet pan - Loose
Information: The toilet pan was found to be loose and relatively unstable at the time of inspection. It is suspected that this defect has developed due to general aging of the toilet pan and associated materials. However, the loose fixing may also be a result of impact damage.

If left unmanaged, the toilet pan could deteriorate further, leading to greater destabilisation and the potential for water leaks to surrounding building elements.

It is recommended that the pan be refixed to the floor with concrete or silicone by a licensed plumbing contractor.

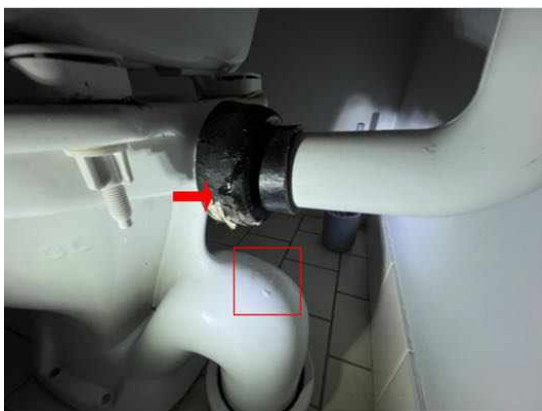
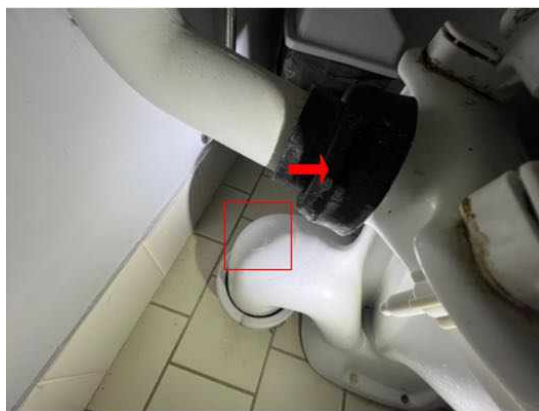
Finding 3.73

Building: Building 2
 Location: Toilet (WC)
 Finding: Toilet - Leaking
 Information: At the time of inspection, the toilet showed evidence of leaking during operation.

Although common, internal water leaks can be detrimental to surrounding building elements. Rust, corrosion, decay and water damage are all potential outcomes of a water leak that is left unattended, which are then likely to develop into more serious defects and may necessitate major repair works. Additionally, internal water leaks may significantly increase the water usage within the property.

It is highly advised that internal water leak be addressed by a licensed plumber as soon as possible. Use of the leaking toilet should be minimised until such time.

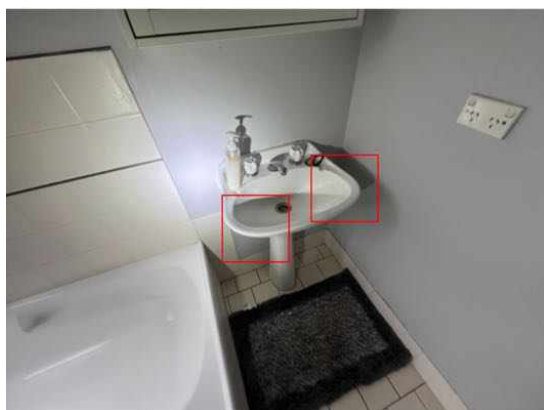
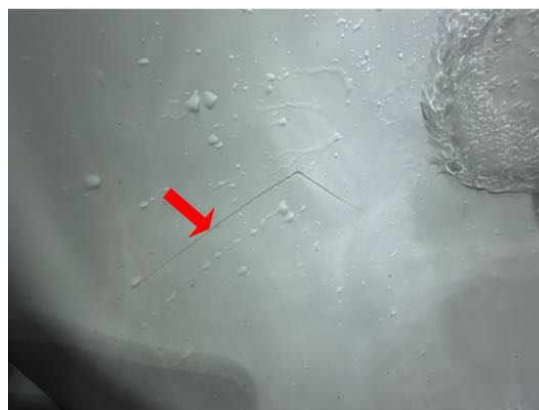
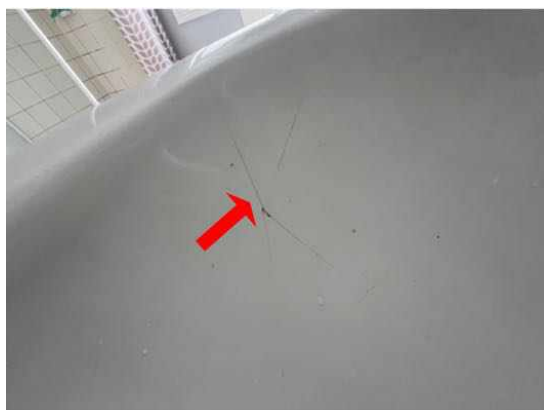
Finding 3.74

Building: Building 2
 Location: Bathroom
 Finding: Basin - Cracked
 Information: Cracking was evident to the basin at the time of inspection, which is suspected to have been by minor impact damage. While the cracking appears to be minor, any further impact damage sustained by the basin may lead to additional cracking.

As the cracking provides potential ingress for water, secondary water damage may occur to associated cabinetry, walls or flooring, if the cracking is left unmanaged.

Consultation with a plumber regarding basin repair or replacement is required. Remedial works may be required to protect against any further damage.

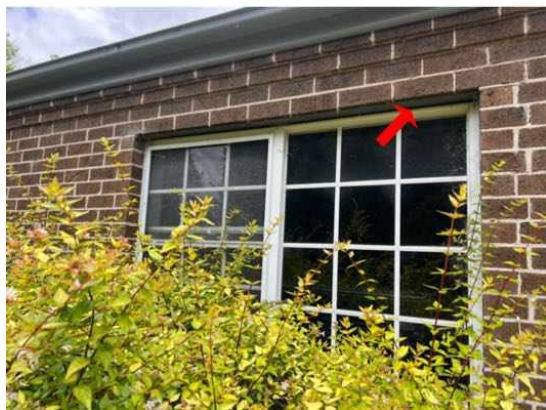
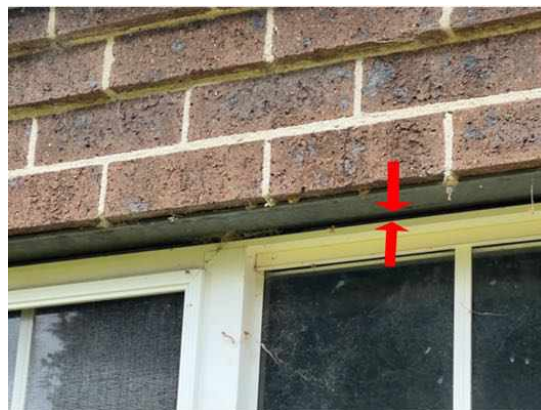
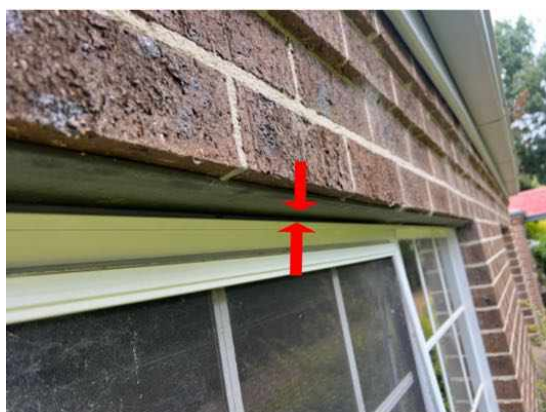
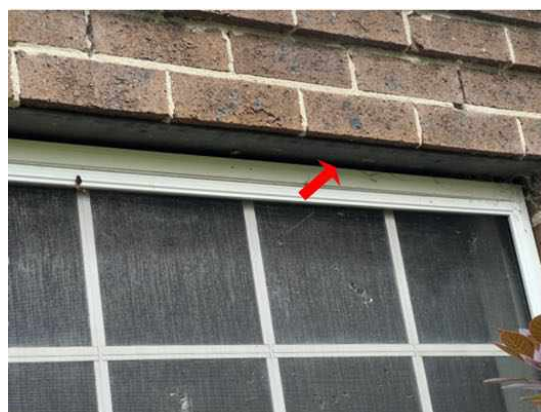
Finding 3.75

Building: Building 2
 Location: All External Areas - all windows
 Finding: Window - gaps
 Information: Large gaps were observed between the aluminium window - lintel and/or reveals. It is suspected that the installation of sealant was completed to a substandard level of workmanship or is incomplete.

allowing water penetration. As such, associated building elements are likely to deteriorate at an accelerated rate, and major implications are expected if Gaps are left unmanaged.

All excessive holes, gaps or cracks should be adequately filled by a suitable sealant or trimmings as soon as possible to prevent any further damage. Such works may be conducted by a general handyperson or licensed carpenter.

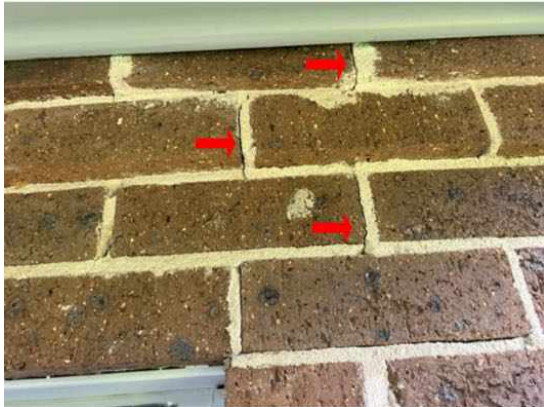
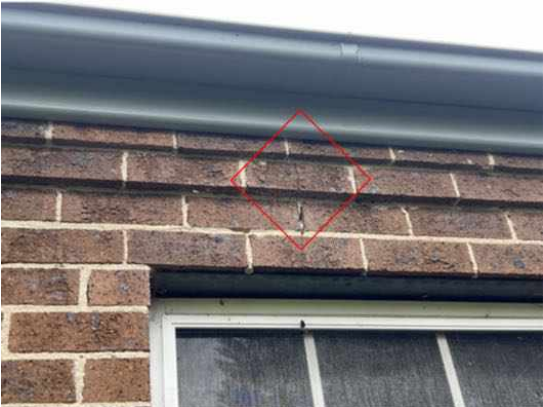
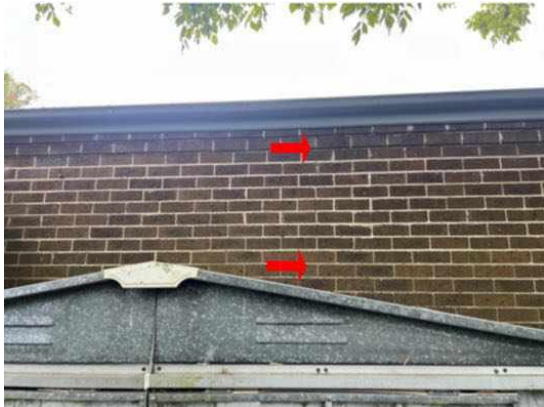
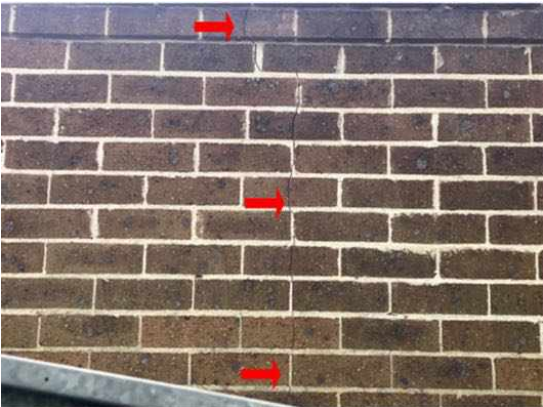
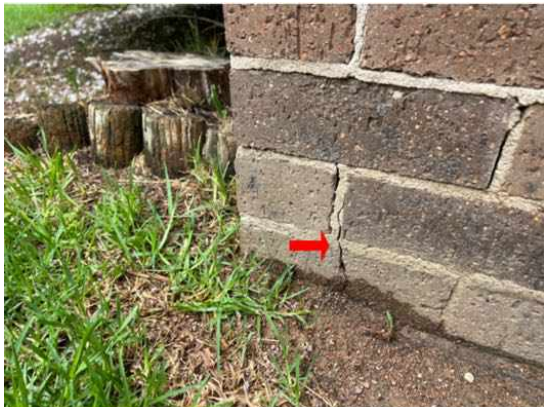
Finding 3.76

Building:	Building 2
Location:	Exterior walls - front, left side.
Finding:	Brickwork - Cracking noticeable
Information:	There were several cracks and or crack repairs evident to external brickwork.

Noticeable cracks are a common occurrence in external brickwork and are a likely result of age expected building movement, general expansion, and/or contraction of building materials in different weather conditions. Noticeable cracks in brickwork may develop if left unattended, with potential for necessitating major remedial works or replacement of the brickwork.

It is highly advised that a qualified bricklayer be appointed to provide necessary works to cracked brickwork to prevent any further damage. Such works should be conducted as soon as possible.

Always monitor these cracks and contact a building inspector should cracks widen, lengthen, or become more numerous.

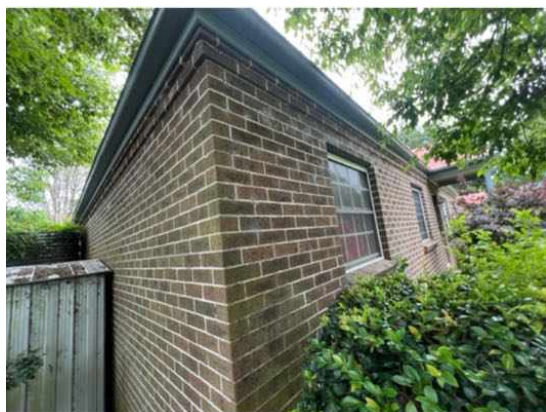
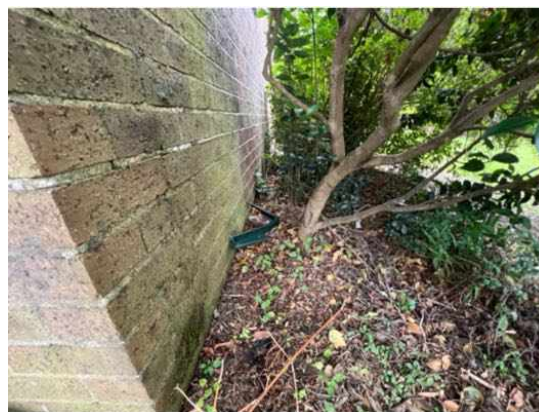
Finding 3.77

Building: Building 2
Location: Exterior walls - front
Finding: Walls - Water stained
Information: Water staining to sections of the walls in this area was evident at the time of inspection. Water staining indicates that surfaces have been exposed to excessive moisture over time. The minerals and other elements in the water lead to staining,

which may graduate to corrosion and deterioration if left unmanaged.

While mostly an appearance defect, water staining can be indicative of more serious defects, which may be currently concealed by wall linings.

Where water staining is active, a licensed plumber must be consulted to identify the cause of the staining and to provide advice on any reparation works that may be required. Replacement of any broken or damaged structures is advised.

Conversely, where water staining is old and inactive, affected building materials may be repaired or replaced at client discretion.

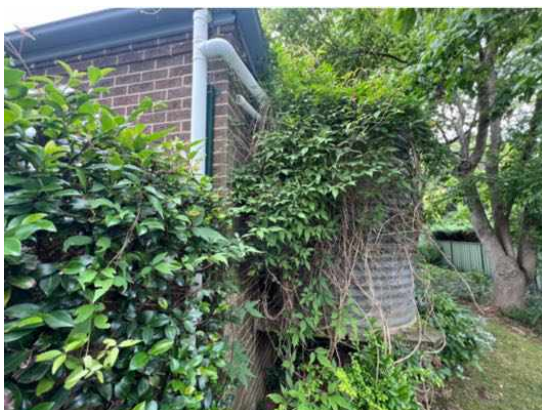
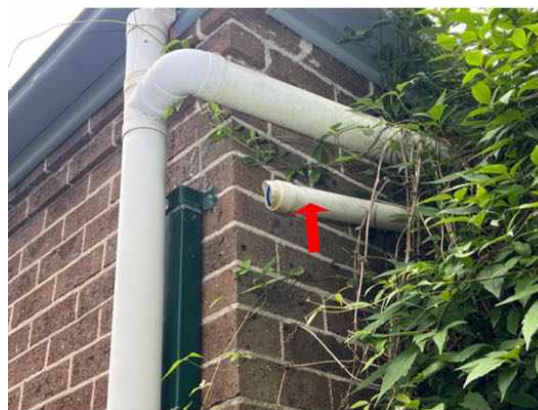
Finding 3.78

Building:	Building 2
Location:	Exterior walls - left side
Finding:	Water tank overflow - Not connected
Information:	The plumbing is not adequately connected to stormwater drainage on the site. This disconnection negatively impacts the functional capacity of the tanks plumbing.

Where water tank doesn't drain adequately, the area at the base perimeter can become excessively damp, potentially creating an environment that is susceptible to rust and corrosion of surrounding building elements, as well as attracting termites and other pests.

It is highly recommended that a plumber be appointed to further inspect the area and to install adequate drainage equipment where necessary.

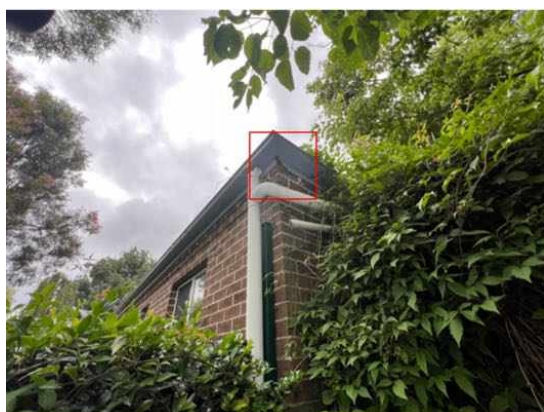
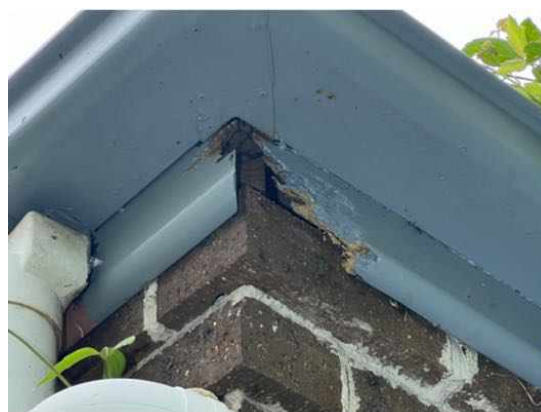
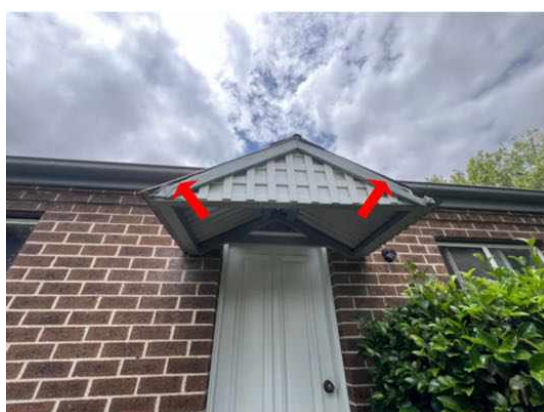
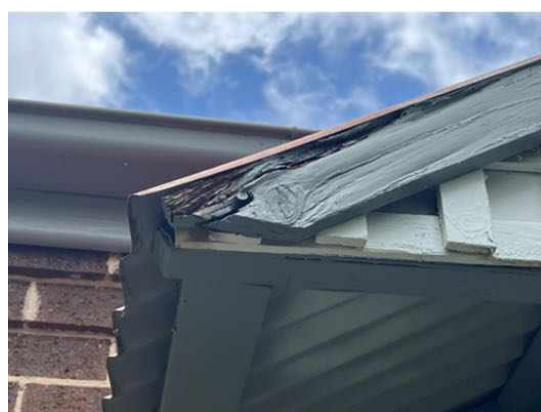
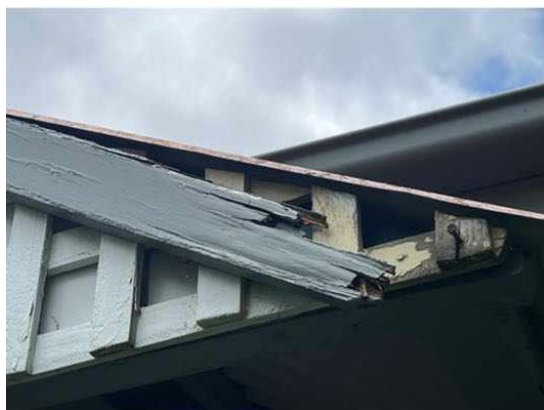
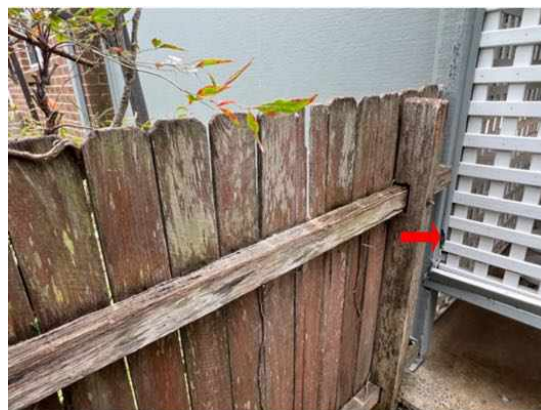
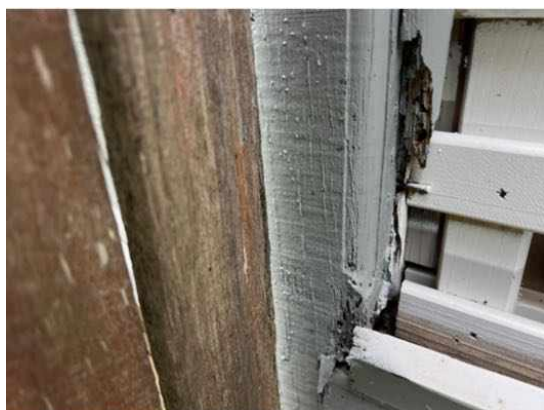
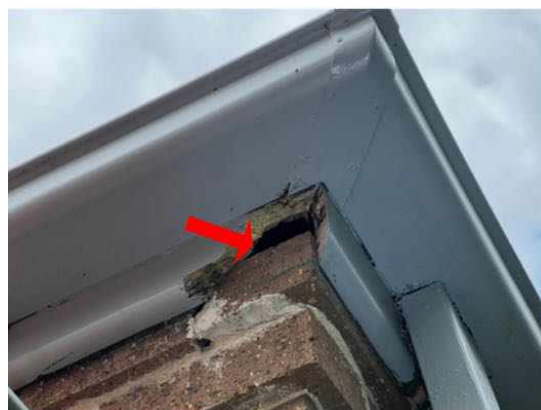
Finding 3.80

Building:	Building 2
Location:	Exterior walls - rear
Finding:	Wood rot
Information:	This building element shows evidence of wood rot. Wood rot, also known as Fungal Decay, occurs when timbers and other cellulose building materials are exposed to

damp conditions on an ongoing basis. This could be the result of exposure to weathering over a prolonged period of time, or the attraction of excessive moisture from other abutting building materials. Contributing factors also include poor air ventilation in the area.

Wood rot is often associated with general damp problems and is evidenced by a 'musty' smell or mould and mildew occurring on surfaces. If left unmanaged, damp conditions can lead to further health problems and the decay of timbers will continue.

Early intervention and regular maintenance, particularly of exterior timbers, will prolong the useful life of these building elements. Prior to any works being performed, the cause of the moisture that has created the visible wood rot should be identified and addressed in a suitable manner. Replacement of affected timbers may then be a necessary step in protecting surrounding building elements from such deterioration.

A qualified plumber may be appointed to assess the cause of excessive moisture and to provide advice on any remedial works as required. A qualified carpenter or registered builder may also be required to replace affected building materials.

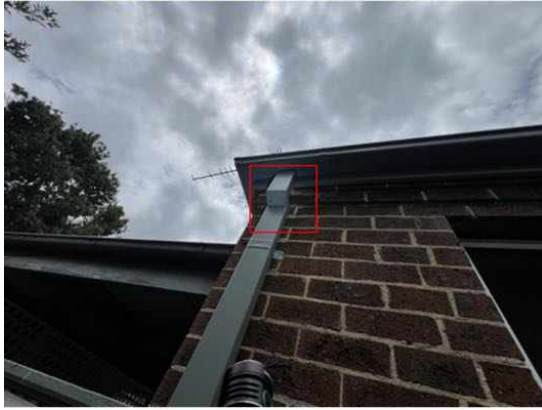
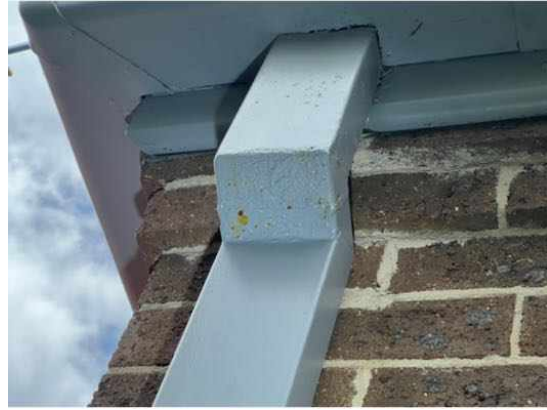
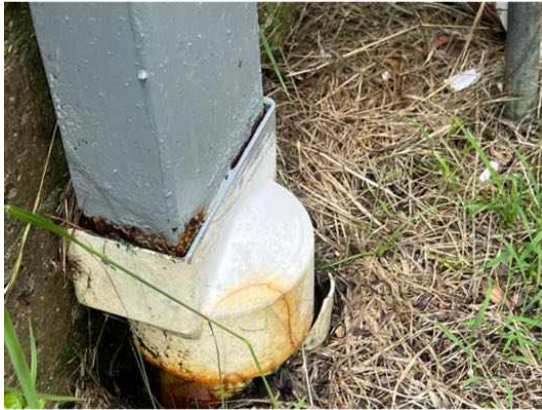
Finding 3.81

Building:	Building 2
Location:	Exterior walls - rear
Finding:	Building element - Rusted or corroded
Information:	This building element shows evidence of rusting and corrosion, which is likely to have developed as a result of excessive exposure to moisture and or inadequate coatings.

As surface rust provides no protection to the underlying iron, the deteriorating condition is likely to worsen if not addressed in the short-term future.

Where possible, the use of galvanized (treated) metals or aluminium coated metals aid in rust prevention, as does regular general maintenance. Rust formation can be controlled with coatings, such as paint, that isolate the iron from the environment.

Rusting and corrosion should be managed by ideally removing or limiting the affected surface from exposure to moisture. A registered builder may be appointed to replace any building elements that have been severely affected by rust or water damage.

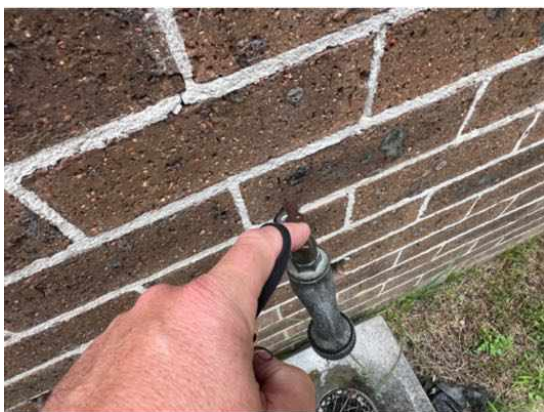
Finding 3.82

Building: Building 2
 Location: Exterior walls - rear
 Finding: Tap - Stiff to operate
 Information: The Tap was observed to be stiff and difficult to operate at the time of inspection. This issue is commonly caused by internal component wear, mineral buildup, or lack of maintenance.

If left unmanaged, further deterioration may occur, potentially leading to reduced functionality, leaks, or failure of the fixture.

It is recommended that a licensed plumber be engaged to assess and rectify the issue to ensure smooth operation and prevent further deterioration.

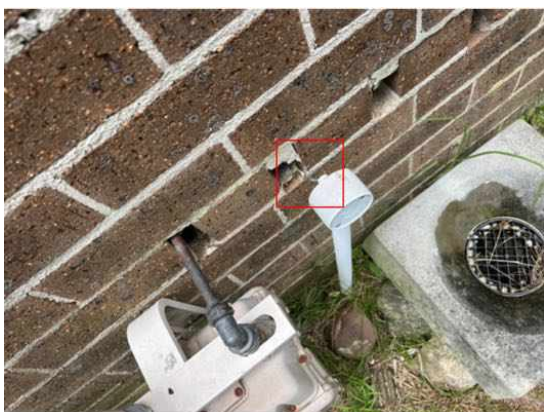
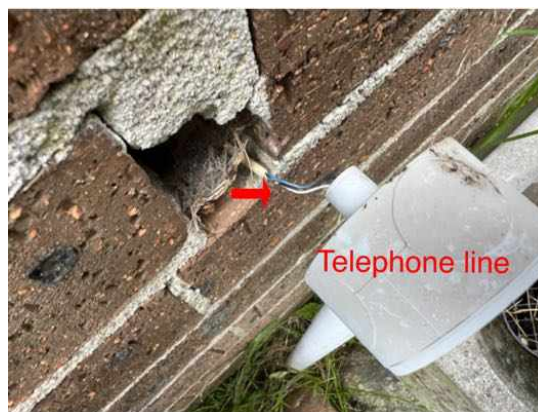
Finding 3.83

Building:	Building 2
Location:	Exterior walls - rear
Finding:	Additional Photos. Minor defects.
Information:	Additional photos are provided for your general reference. Where arrows have been provided, please discuss these items with the building inspector.

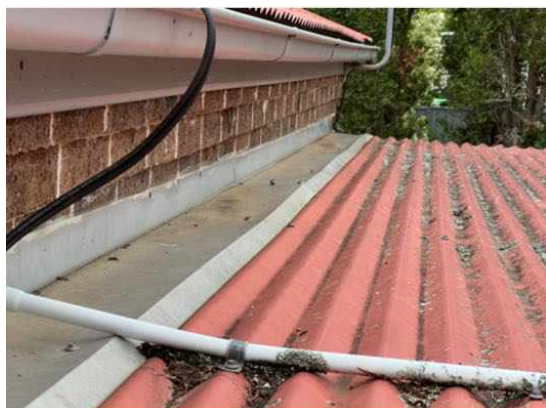
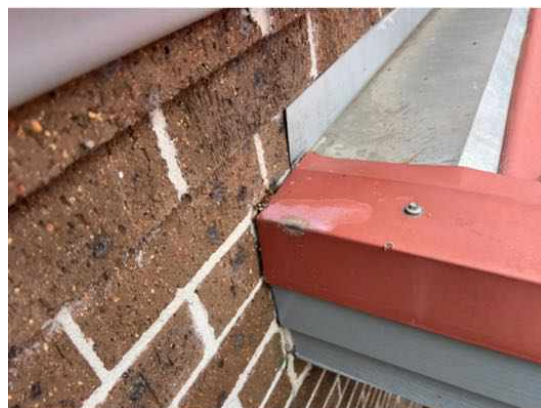
Finding 3.84

Building:	Building 2
Location:	Roof Exterior (carport)
Finding:	Roof plumbing - Flashing inadequate
Information:	Some sections of the roof are missing or have inadequate roof flashings. Flashings are metal and other materials which are applied to seals and intersections between roof coverings and building elements. They are designed to aid in weatherproofing of roof joins.

Flashings that are not installed adequately or are missing are likely to result in water penetration to the interior of the property, as well as creating excessively damp conditions against the exterior surfaces and around the base perimeter of the building.

Premature ageing and secondary building defects are imminent where roof plumbing

is missing or inadequately installed. Additionally, water pooling also creates an environment that is susceptible to termite and pest infestation.

A roofing plumber should be appointed as soon as possible to install relevant roof plumbing materials, ensuring that no further damage is sustained.

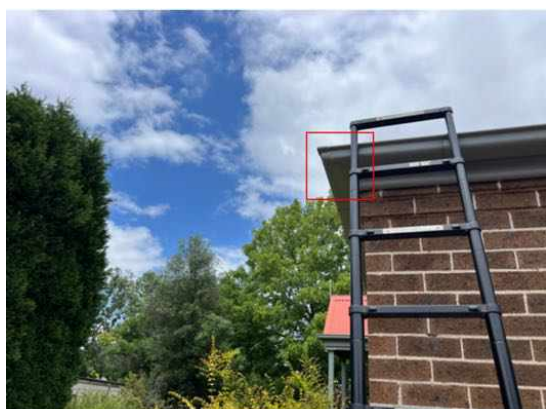
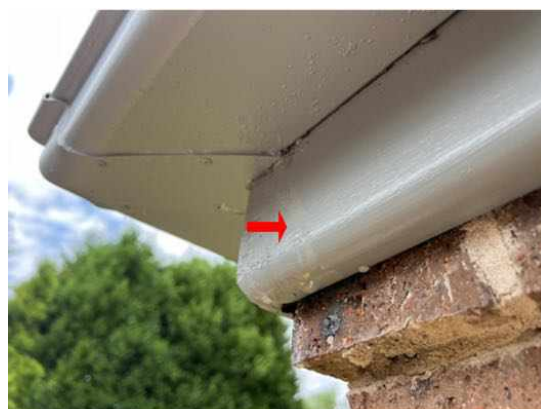
Finding 3.85

Building:	Building 2
Location:	Roof Exterior
Finding:	Guttering - Active Leak
Information:	An active leak was identified in the guttering during the inspection. This issue is likely caused by damage, corrosion, or substandard installation. The leak allows water to escape improperly, increasing the risk of water pooling around the building's foundation. Prolonged moisture exposure can create conditions conducive to termite activity and may also lead to soil erosion, water ingress into lower areas, or damage to associated building elements.

A licensed roof plumber should assess the guttering to identify the exact cause of the leak and carry out necessary repairs or replacements as a priority to prevent further damage and mitigate the risk of termite infestation.

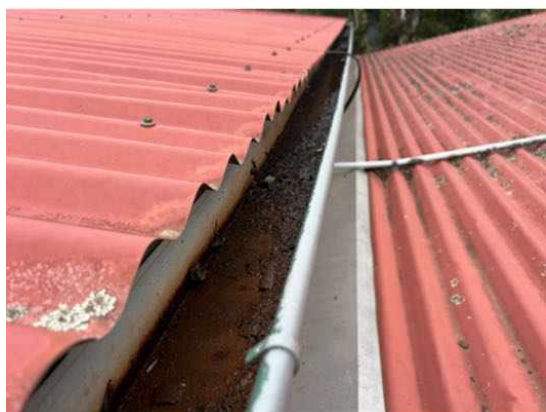
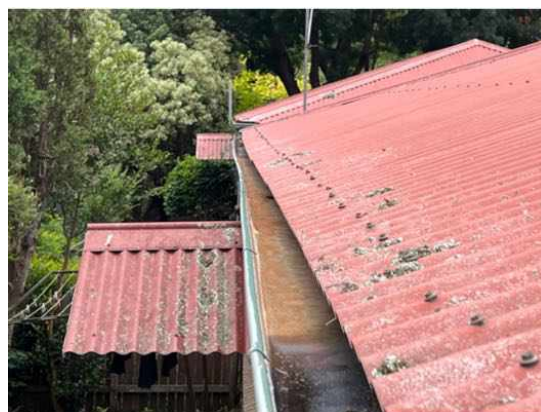
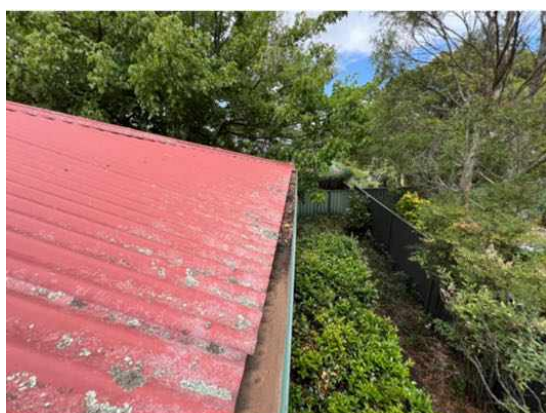
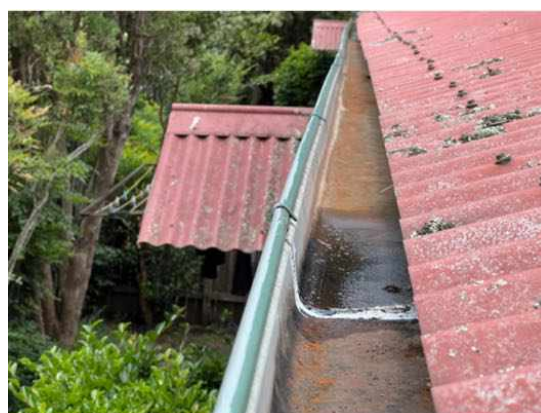
Finding 3.86

Building:	Building 2
Location:	Roof Exterior
Finding:	Roof plumbing - Rusted or corroded
Information:	The roof plumbing has areas of rust and corrosion. It is suspected that this has been caused by blockages, resulting in pooling or standing water, that have prematurely rusted elements of the roof plumbing.

Rusted roof plumbing will generally develop holes and leaks that can affect other building elements with poor drainage of storm water. Poorly drained roof areas will also lead to damp conditions surrounding the base perimeter of the building which, if left unmanaged, can lead to a range of secondary building defects.

Repair and/or replacement of rusted roof plumbing is highly required in order to reinstate the roof drainage system to a fully operational level. To further maintain these areas, gutters should be cleaned frequently, allowing the avoidance of any partial blockages.

A licensed plumber or specialist roof restoration company should be appointed to undertake these works. It is advised that such works be completed as soon as possible to prevent any further damage and deterioration.

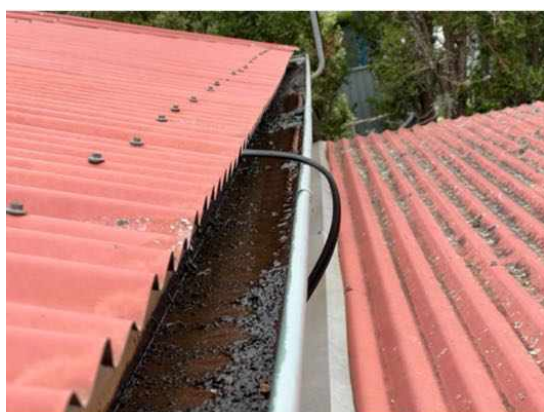
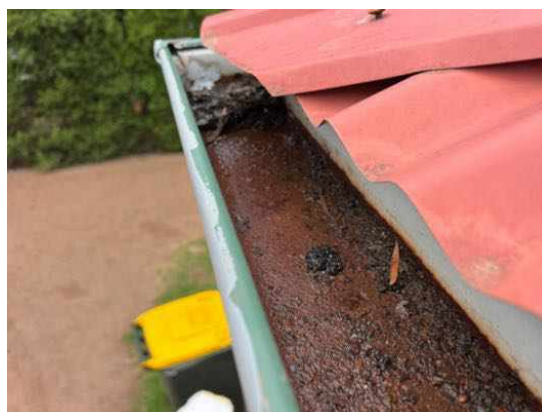
Finding 3.87

Building:	Building 2
Location:	Roof Exterior
Finding:	Gutters - Water pooling
Information:	Water was found to be pooling in sections of the roof guttering. This is generally a secondary defect caused by blocked or partially blocked gutters. Such blockages and subsequent water pooling are likely to lead to rust and water damage to associated structures if left unattended.

Any areas of guttering that shows evidence of water pooling should be checked for partial or full blockages and any secondary damage that may have occurred as a result. Depending on the extent of the damage, building elements may require repair and/or replacement to ensure adequate roof drainage and function of exterior plumbing system.

A roofing plumber should be appointed as soon as possible to rectify this issue. It is highly advised that all gutters be maintained on a frequent basis to ensure the condition of roof plumbing.

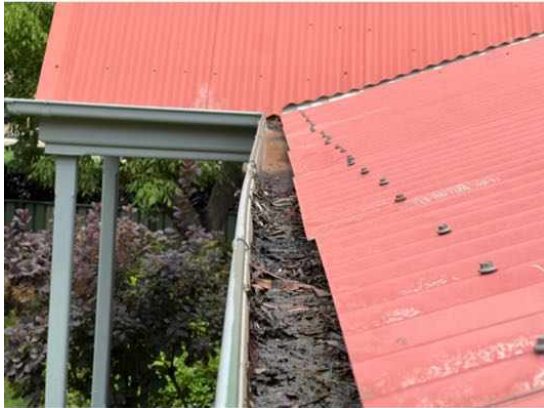
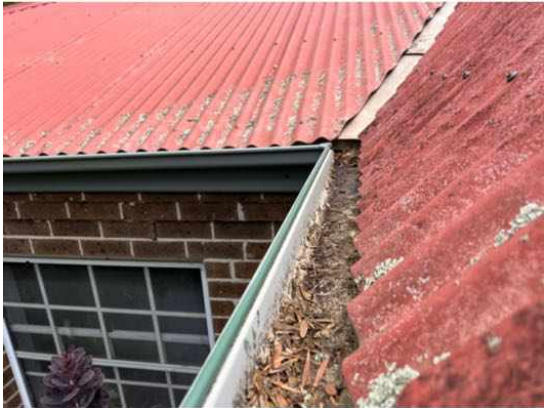
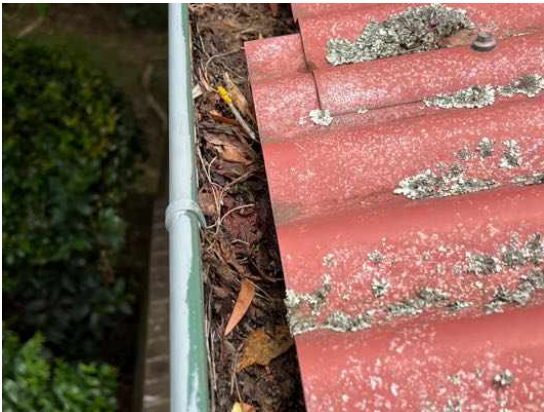
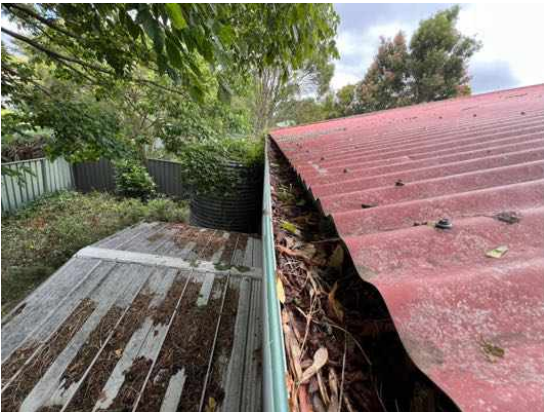
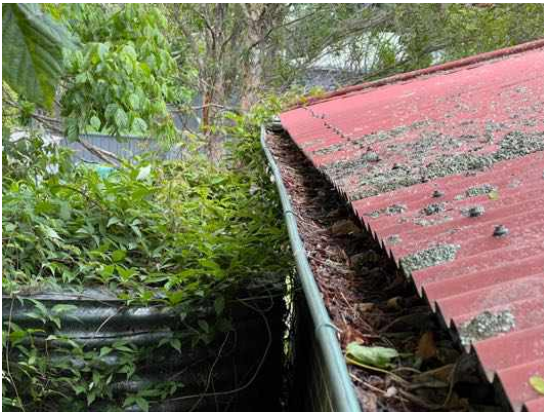
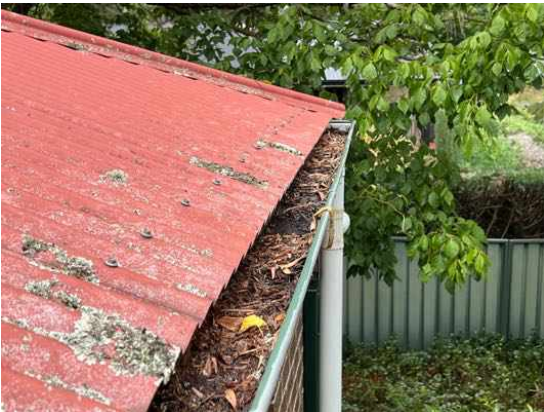
Finding 3.88

Building:	Building 2
Location:	Roof Exterior
Finding:	Gutters - Blocked
Information:	Roof plumbing structures, such as guttering and downpipes, should be free of all debris to prevent blockages. Blockages of the guttering and downpipes will lead to pooling and accumulated water overflows, which is likely to subsequently flood eaves and exterior walls.

Blocked gutters are likely to lead to high levels of moisture in the affected areas. Such moisture will not only cause rust and decay of the associated building materials, but can also provide conditions that are conducive to termite and timber pest activity.

Blockages in gutters should therefore be removed immediately to ensure dry conditions are maintained.

Consult a Licensed Plumber for further specific advice on remedial works that may be required. In the interim, it is highly advised that blocked gutters be removed by the homeowner or a general handyperson as a matter of urgency.

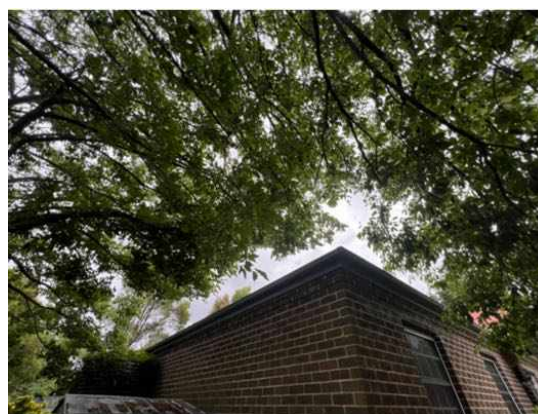
Finding 3.89

Building: Building 2
Location: Roof Exterior
Finding: Trees - Overhanging and filling gutters

Gutters are a critical part of the building's management of storm water and rain. It is therefore important that they be kept clear to prevent secondary damage to associated building elements, including exterior and interior walls, ceiling linings and any adjoining building elements. Where gutters are blocked, pooling of rainwater is likely to occur, fast-tracking rust and corrosion of the roof plumbing elements.

It is highly advised that all overhanging tree branches be removed as soon as possible to prevent any further damage. Repair and/or replacement of sections of damaged guttering may also be required where the extent of the damage necessitates.

Such works should be performed by the homeowner; however, appointment of a landscape contractor or an arborist may be required. Consultation with a licensed roof plumber is required where guttering has been damaged.

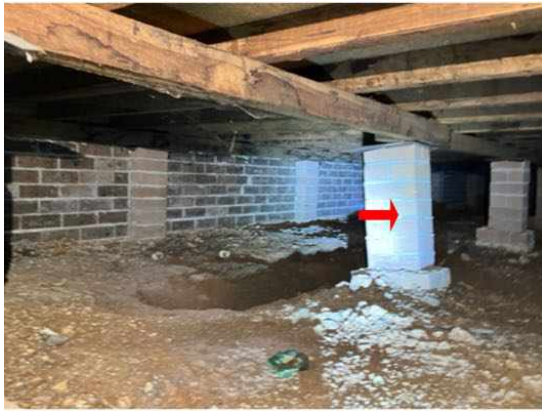
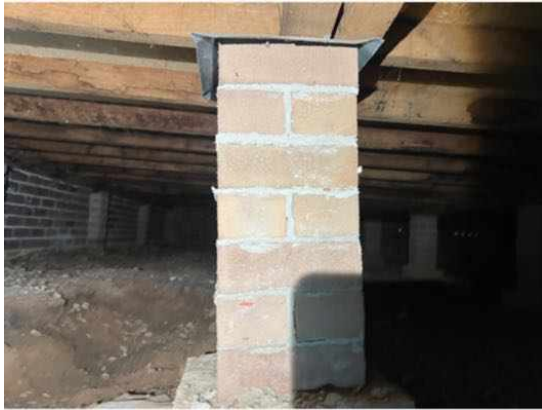
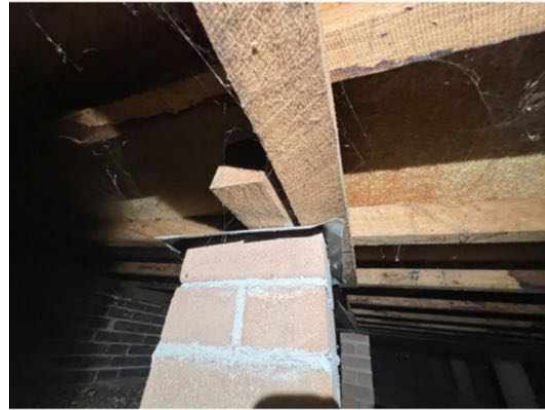
Finding 3.90

Information: The brick pier in the subfloor structure is not plumb and is failing to provide adequate support to the bearer. This misalignment compromises the pier's structural integrity and may lead to uneven load distribution, which can cause further structural issues within the floor system.

If left unattended, this lack of support is likely to result in increased movement, potential sagging of the floor, and further degradation of both the pier and the bearer.

Immediate assessment by a Registered Builder or Structural Engineer is required to realign and secure the pier, ensuring it provides adequate support to the bearer. This defect should be addressed as a priority to maintain structural stability.

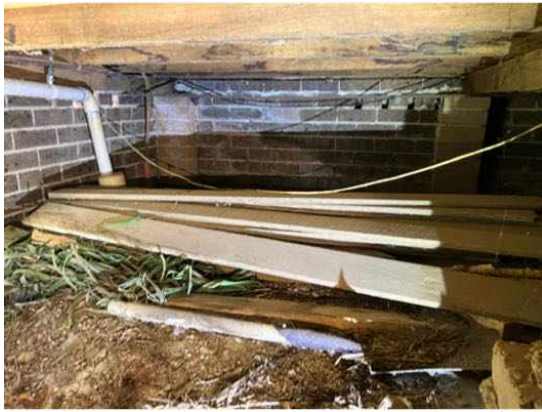
Finding 3.91

Building:	Building 2
Location:	Subfloor
Finding:	Stored timbers - subfloor space or external area
Information:	The storing of timbers in the subfloor space or around the external property increases the risk of termite activity being present. As they are likely to come into contact with weather conditions or excessive moisture wood rot is likely to develop on timbers that are not treated.

It is highly recommended that any stored timbers be immediately removed from areas in which they may attract any termite / timber pest attack. Minimisation of risk / prevention of termite attack is far more adequate than dealing with the presence of termite activity.

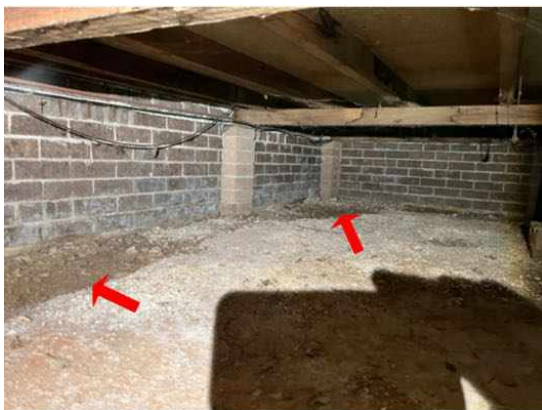
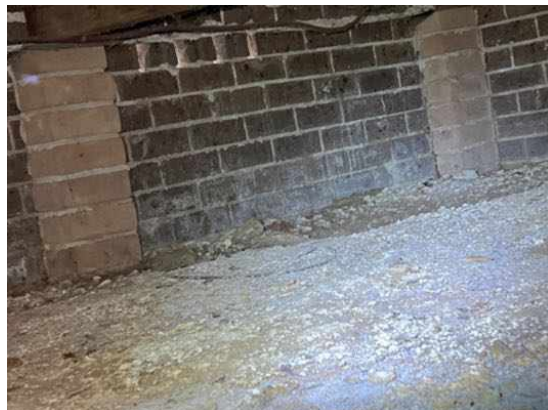
Finding 3.92

Building:	Building 2
Location:	Subfloor
Finding:	Water pooling - against property
Information:	Water appears to be pooling against the house. It is suspected that this is a result of poor site drainage but may also be due to excessive moisture from an unidentified source.

Where water is pooling against the house water damage to the external wall cladding is imminent.

Such water pooling also increases the risk of termite activity and the development of fungal decay in the area.

Consult a Licensed Plumber regarding the cost of potential site drainage rectification works.

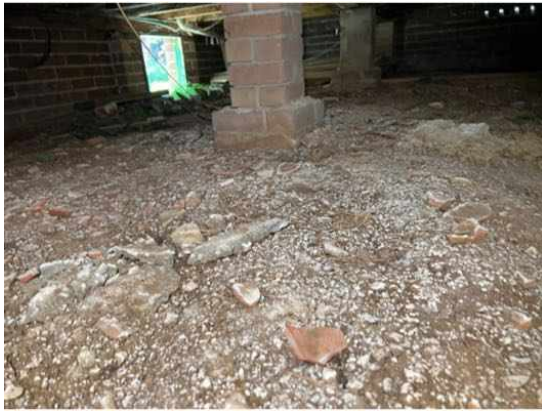
Finding 3.93

Information: Where evidence of mould growth was noted, there may be environmental, biological or health issues associated with the report. A specialist inspection by a suitably qualified environmental health inspector is warranted, where mould is extensive or where any queries regarding air quality spores or other related issues apply.

Generally, the client is advised to ensure that the general environment is free of moisture and humidity to aid in the prevention of mould formation and development. Any mould found during the inspection should be cleaned immediately by a cleaning contractor or the homeowner as applicable.

Please note that severely affected building elements may require replacement by a registered builder or qualified carpenter.

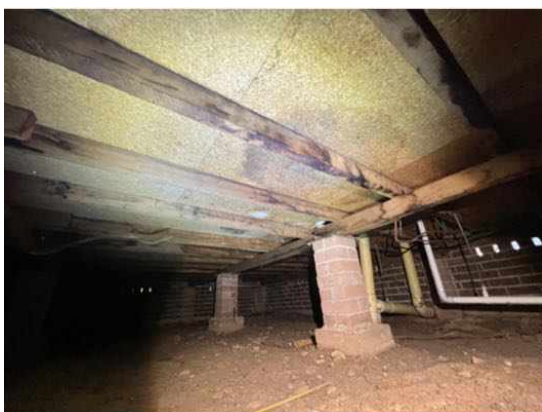
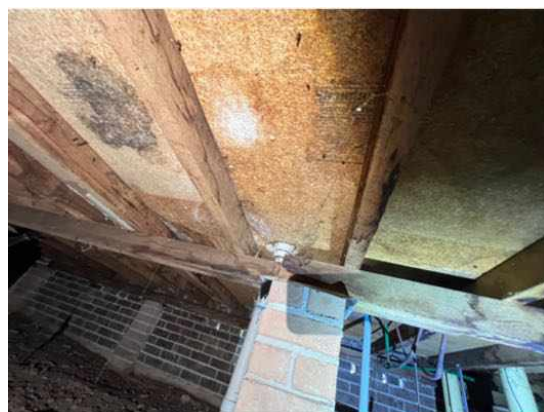
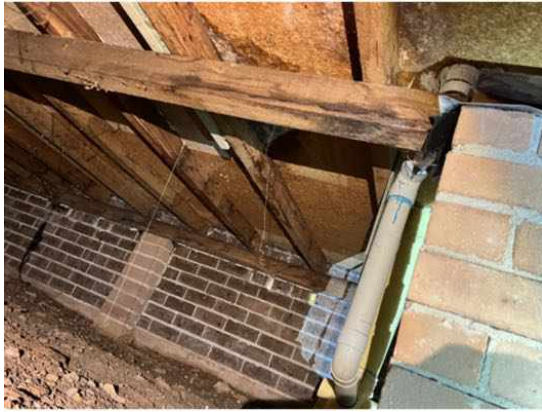
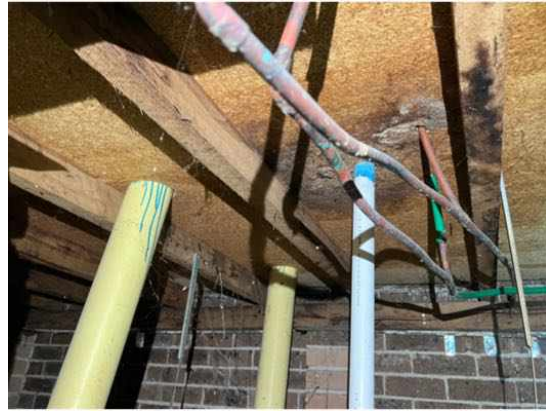
Finding 4.01

Building:	Building 2
Location:	Subfloor
Finding:	Water staining
Information:	Water staining was evident in this area at the time of inspection. Water staining indicates that surfaces have been exposed to excessive moisture over time. The minerals and other elements in the water lead to staining, which may graduate to corrosion and deterioration if left unmanaged.

While mostly an appearance defect, water staining can be indicative of more serious defects, which may be currently concealed by other building elements.

Where water staining is active, a licensed plumber must be consulted to identify the cause of the staining and to provide advice on any reparation works that may be required. Replacement of any broken or damaged structures is advised.

Conversely, where water staining is old and inactive, affected building materials may be repaired or replaced at client discretion. A qualified carpenter or registered builder may be appointed to perform these works.

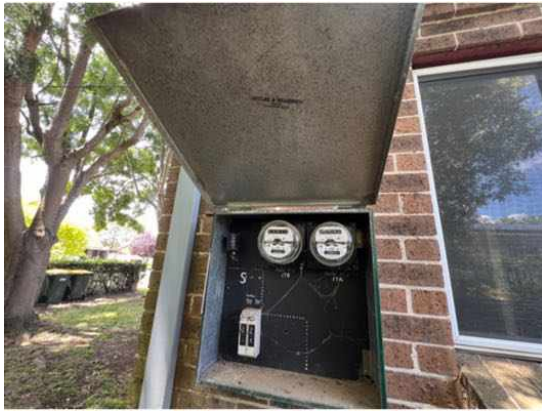
At the time of inspection, no Durable Notice was identified, and there was no evidence to suggest that a termite management system had been installed or that preventative treatments had taken place. In the absence of a recorded termite barrier, the property remains susceptible to potential termite attack on timber building elements.

It is recommended that the purchaser make further inquiries with the vendor regarding any past termite treatments or history of termite activity at the property, including any treatments applied to trees on-site. Additionally, consultation with a licensed pest controller is advised to assess the feasibility and cost of installing a post-construction chemical termite barrier. If a termite management system is installed, a Durable Notice should be placed in the switchboard unit or another accessible location to indicate the type of barrier in place and its maintenance requirements.

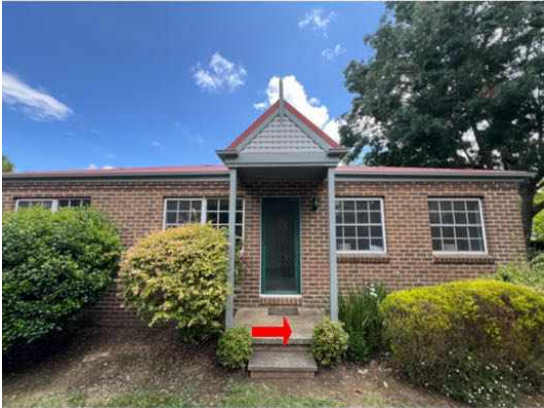
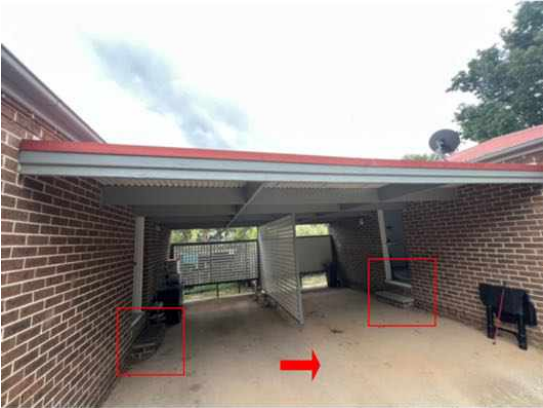
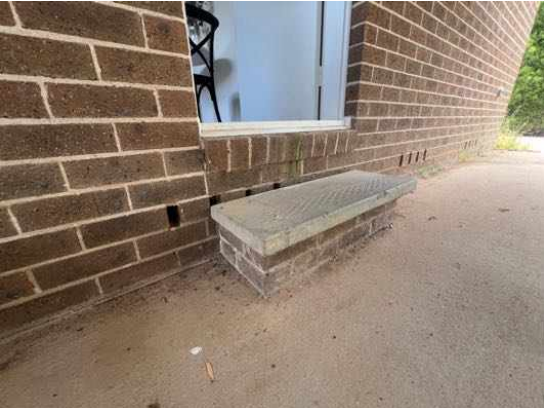
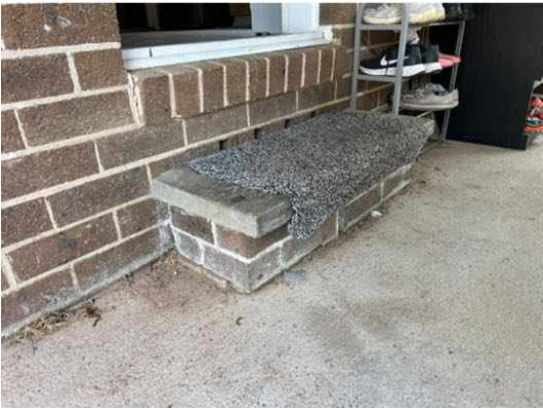
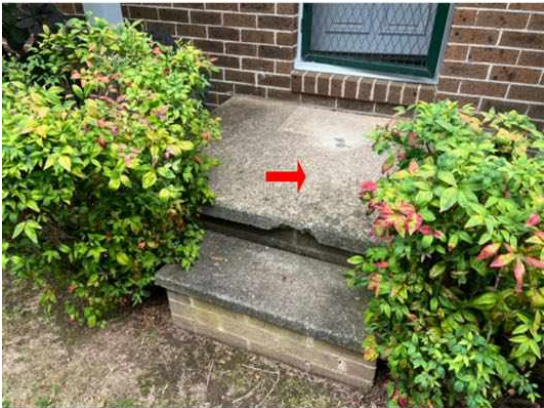
Where a concrete patio is retrospectively installed against an external wall, this provides a concealed entry point for termites.

The client should consider obtaining further advice from a timber pest technician regarding treatments required in this area. It is recommended that obtaining such advice be a short-term priority.
