Building and Timber Pest Inspection Report

Inspection Date: Fri, 16 Jan 2026

Property Address: 17 Price St, Bowral NSW 2576, Australia

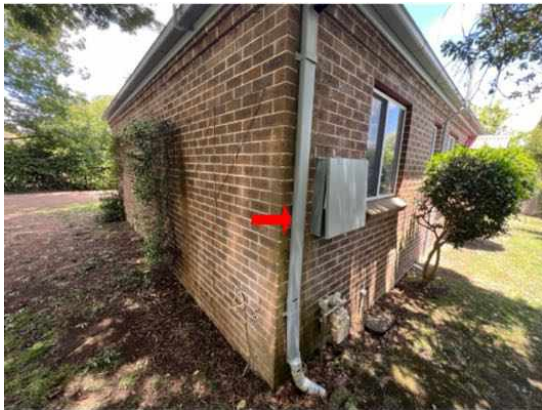
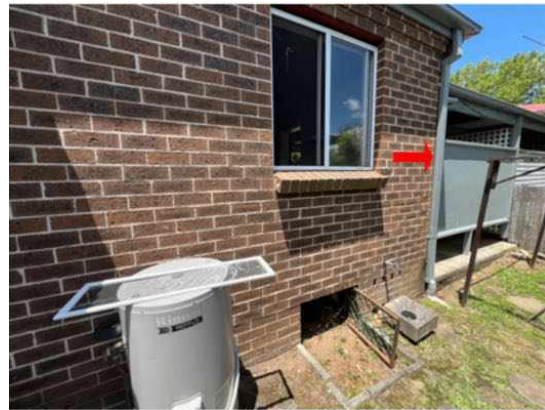
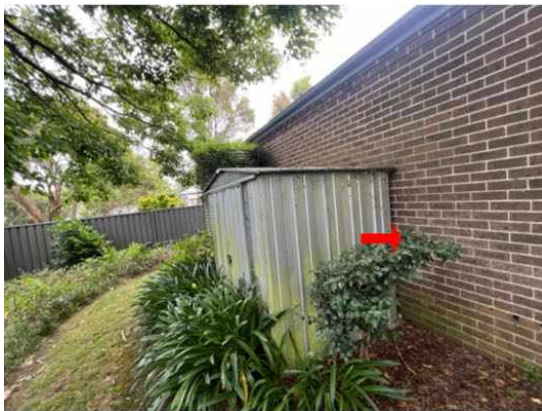
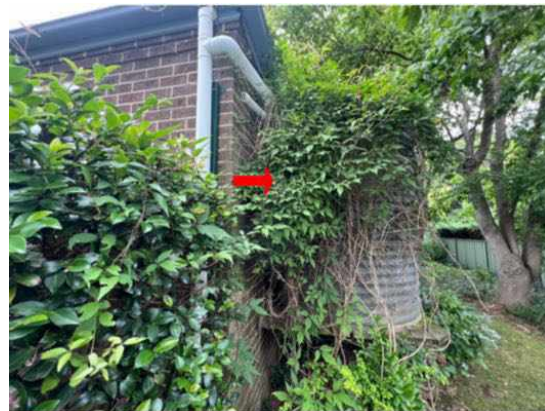
Finding 6.04

Building: Not Applicable
Location: All External Areas

Where any part of an attachment to a building is not isolated and is not provided with a clear gap of not less than 25mm from the building, bridging occurs. Attachments to buildings such as hot water services, downpipes, verandahs, decks, steps, fences, service conduits and the like provide the opportunity for concealed entry.

Building attachments of this nature need to be frequently inspected for termite activity by a qualified inspector

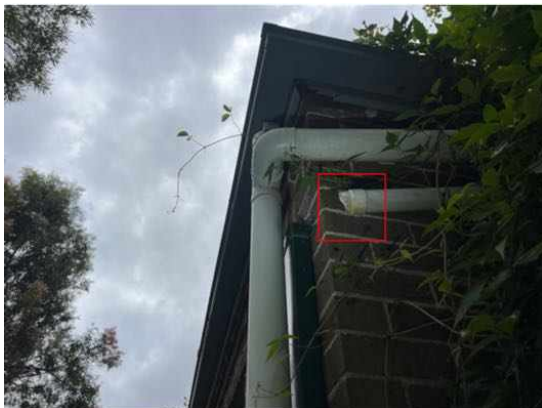
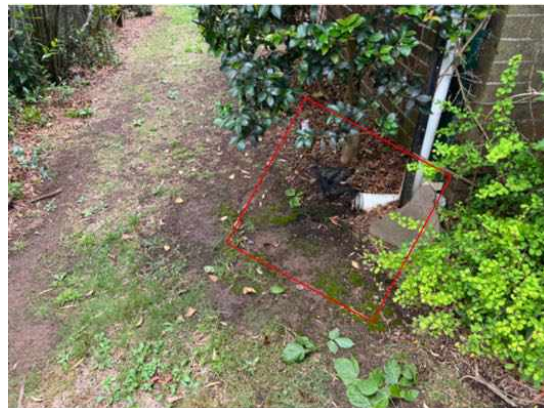
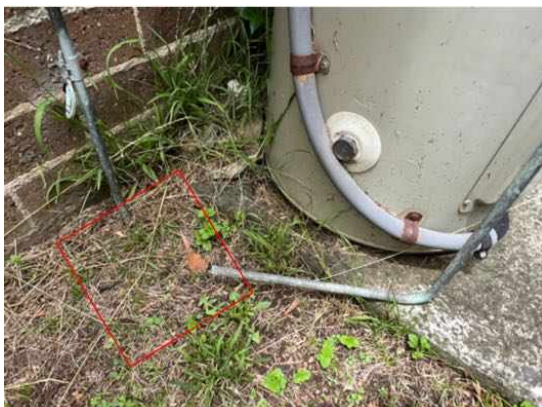
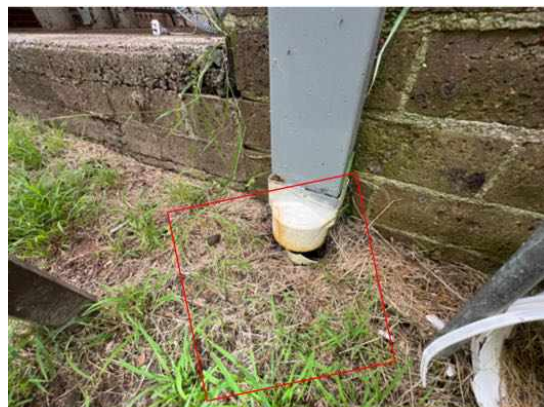
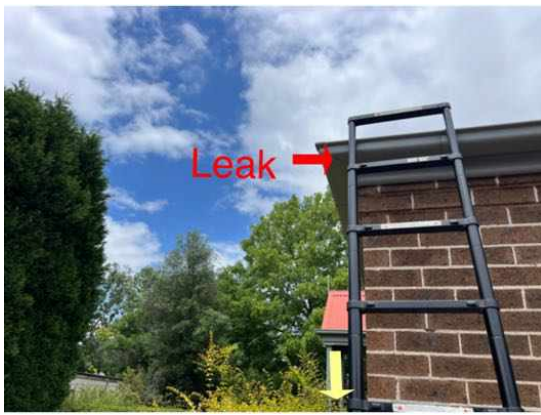
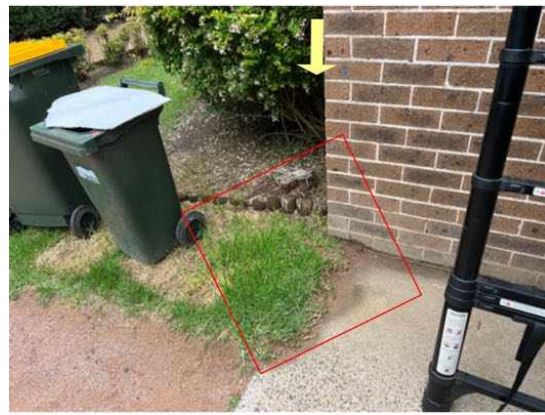
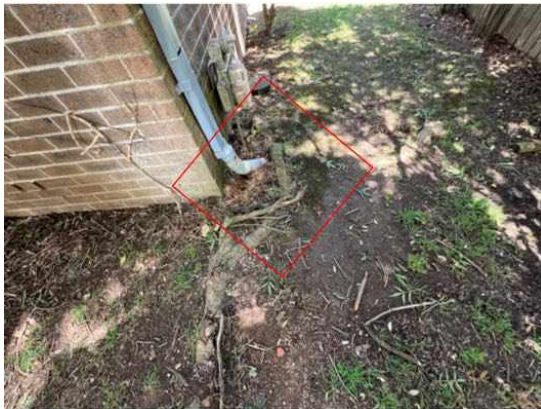
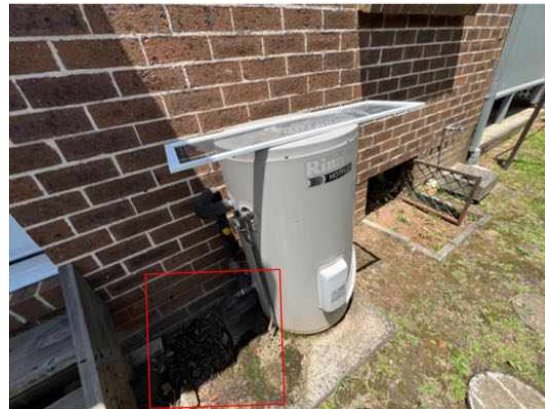
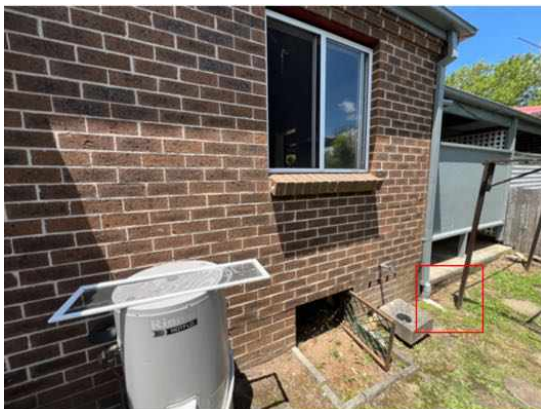
Finding 6.06

Building:	Not Applicable
Location:	All External Areas
Finding:	Evidence of excessive moisture was present at the time of inspection
Information:	Excessive moisture can attract termites and produce conditions that promote termite attack, fungal growth and wood decay. Excessive moisture is generally caused by deteriorated, inadequate or missing roof drainage, leaking plumbing pipes or fixtures, poorly plumbed HWS overflows or condenser units and poor site drainage. It is highly recommended that all plumbing and drainage fixtures and fittings be maintained regularly in order to prevent excessive moisture being present in the external / internal property.

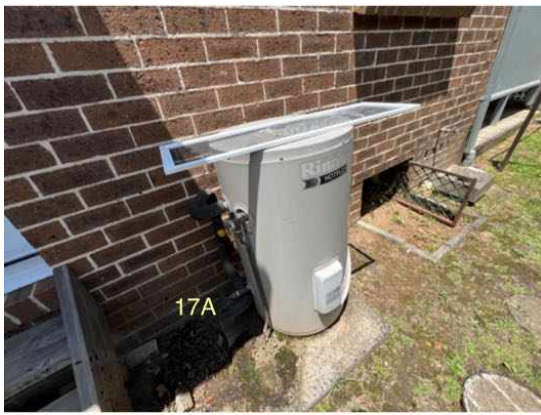
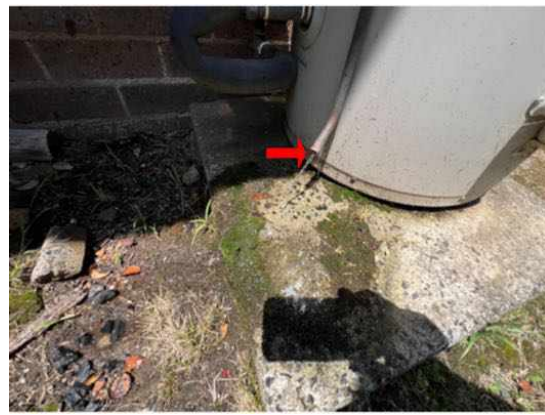
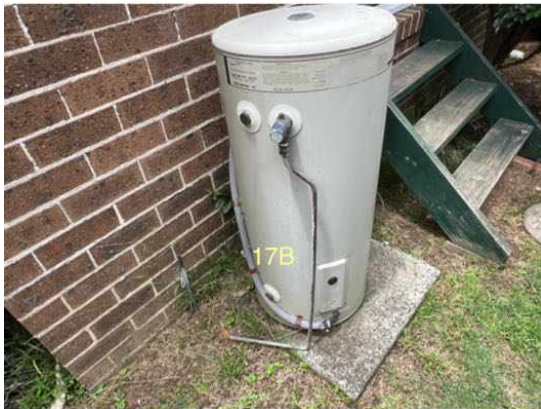
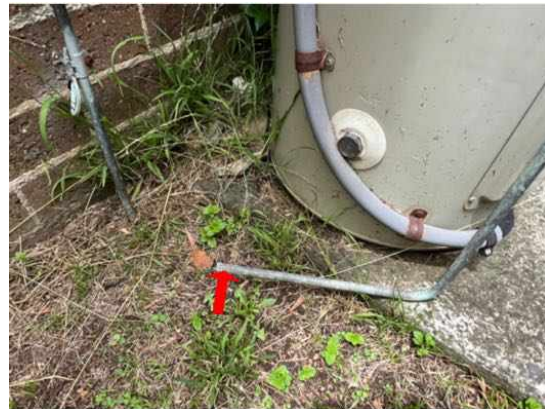
Building:	Not Applicable
Location:	Exterior walls - rear
Finding:	HWS Overflow - Not Connected
Information:	The Hot Water System (HWS) overflow was found to be disconnected from storm water drainage and is creating excessive moisture in the surrounding area.

These damp conditions can lead to secondary defects such as rot, rust or corrosion of associated building elements, the formation of fungal decay, or even the creation of potential slip hazards. When coupled with poor site drainage, pooling of water may also attract termite activity to this area.

It is highly recommended that a licensed plumber be appointed to connect the HWS overflow in order to prevent such an environment from being created. These minor works should be carried out as soon as possible.

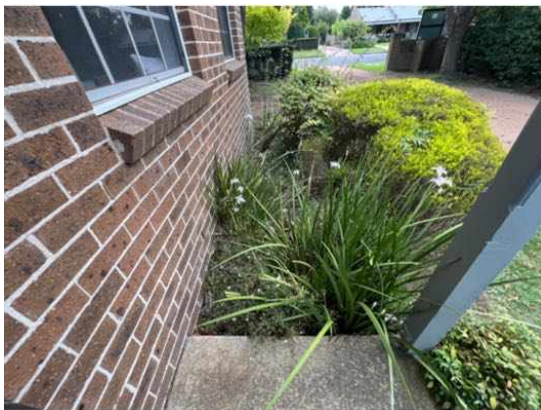
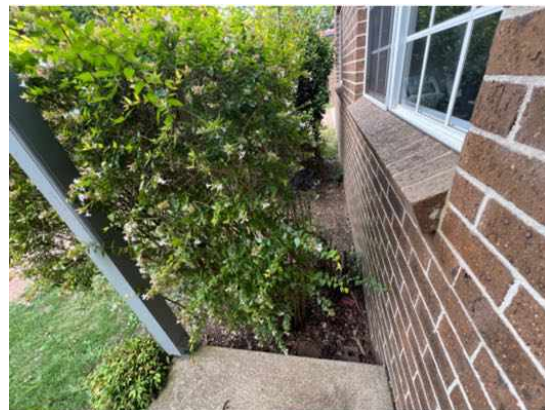
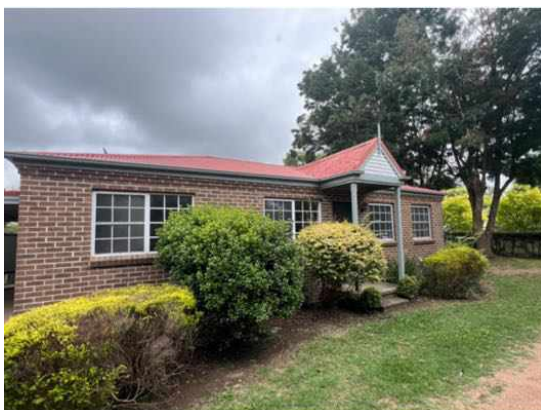
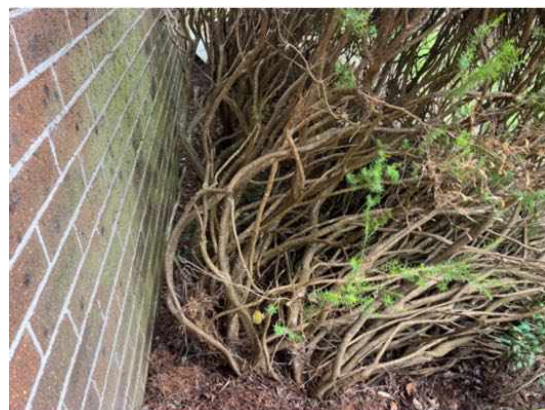
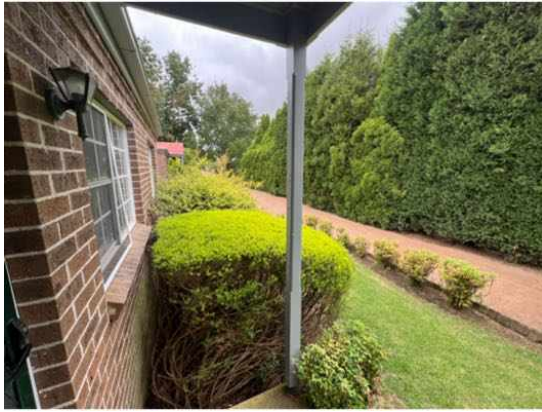
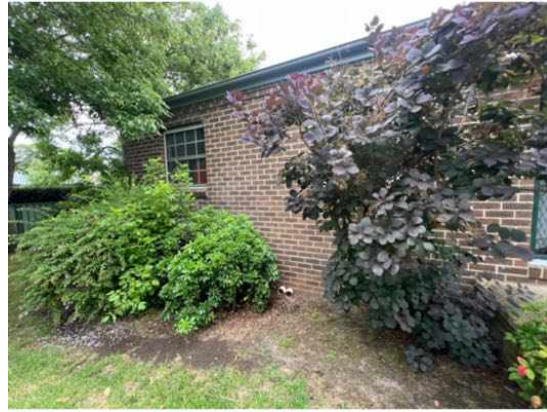
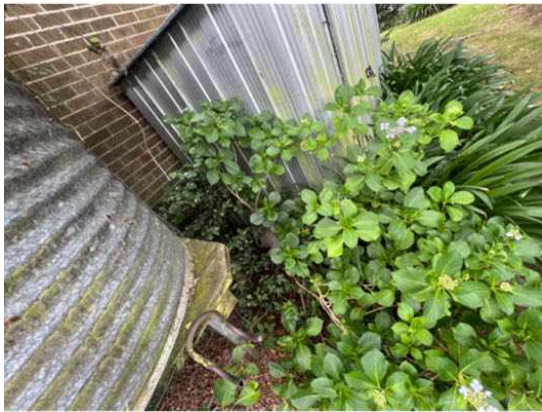
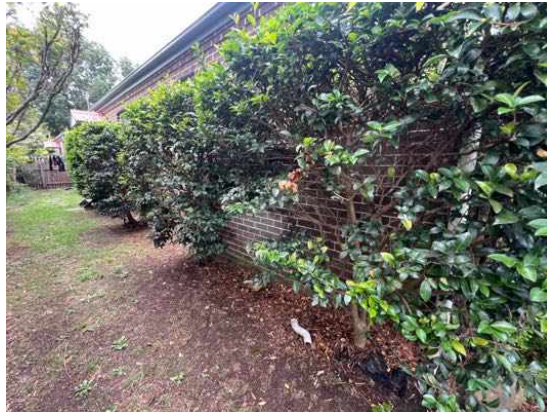
Building:	Not Applicable
Location:	All External Areas
Finding:	Garden Beds - Conditions Conducive to Termites
Information:	Garden beds were observed around the perimeter of the building, obstructing visual inspection of lower wall areas and providing potential concealed termite entry points.

Raised soil levels and retained moisture from watering can allow termites to access wall cavities or weep holes undetected, while timber edging materials may further encourage activity.

It is recommended that garden beds be reduced or cleared from the building perimeter, or that regular timber pest inspections be carried out in accordance with AS 4349.3 or AS 3660.2 to monitor risk.

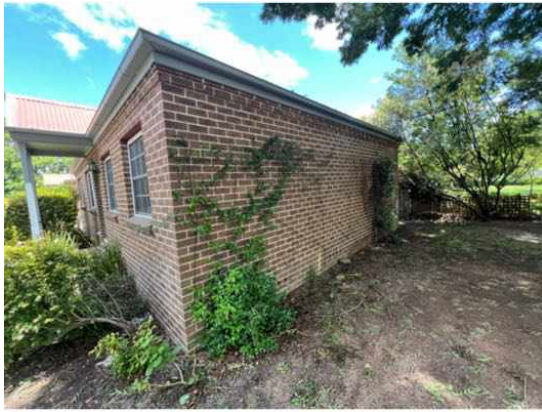
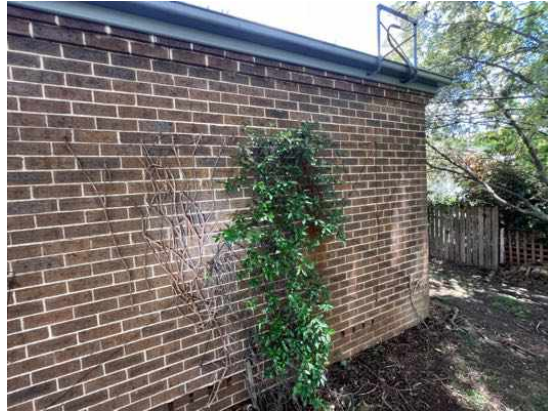
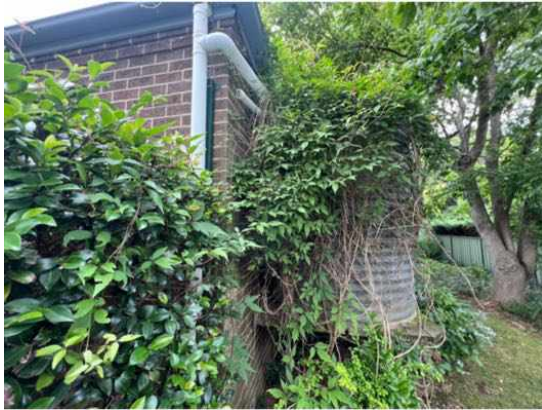
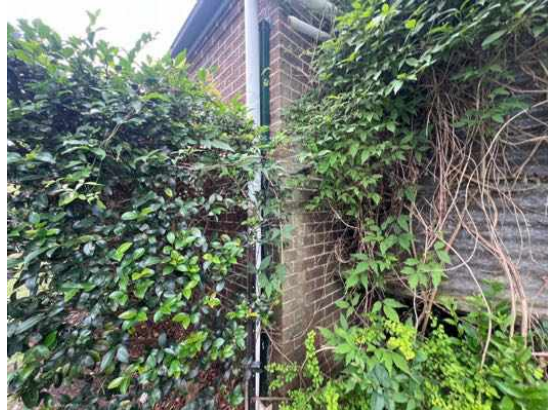
Building:	Not Applicable
Location:	All External Areas
Finding:	Vegetation Against Building - Conducive to Termite Activity
Information:	Vegetation and trees were observed in direct contact or in close proximity to the building at the time of inspection. This condition creates a conducive environment for termite activity by providing concealed access points, retaining moisture against the structure, and reducing ventilation. Additionally, vegetation can contribute to organic debris buildup, further increasing the risk of pest infestation.

It is recommended that all vegetation be trimmed back to allow adequate clearance from the building. Ongoing maintenance is advised to reduce the risk of termite activity and improve ventilation around the structure. Regular termite inspections should also be conducted to monitor for any signs of infestation.

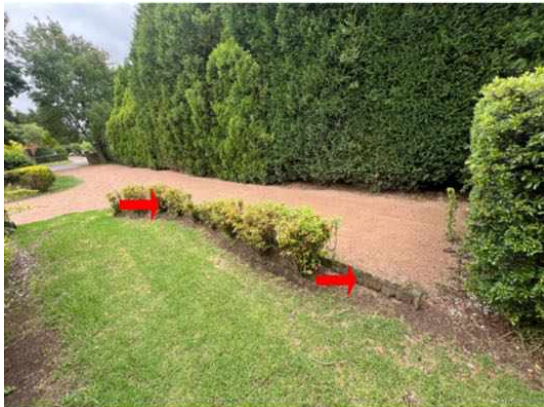
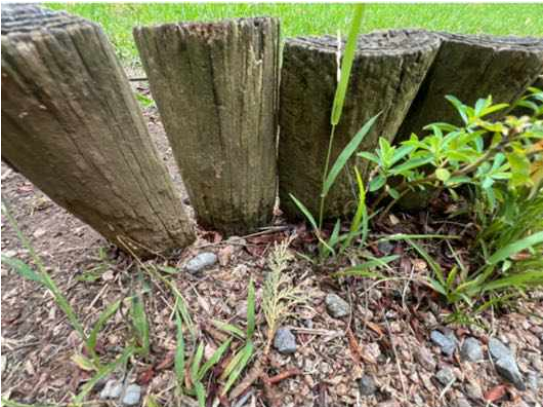
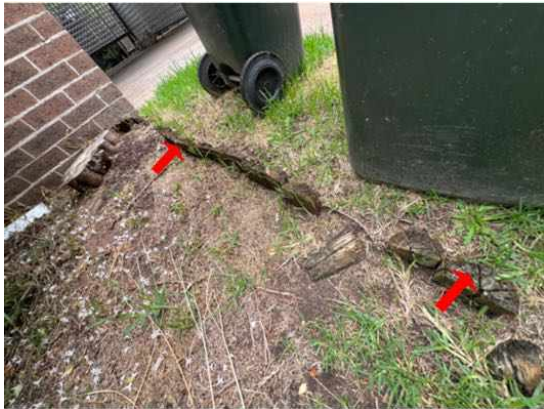
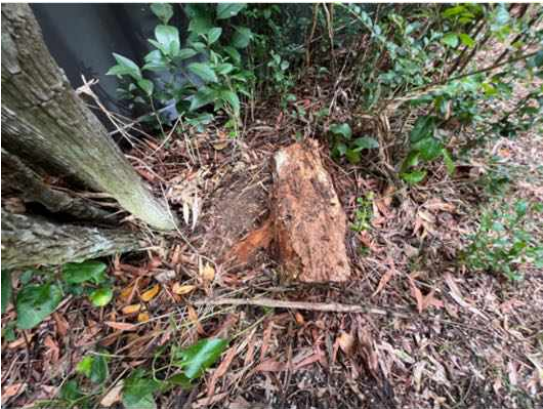
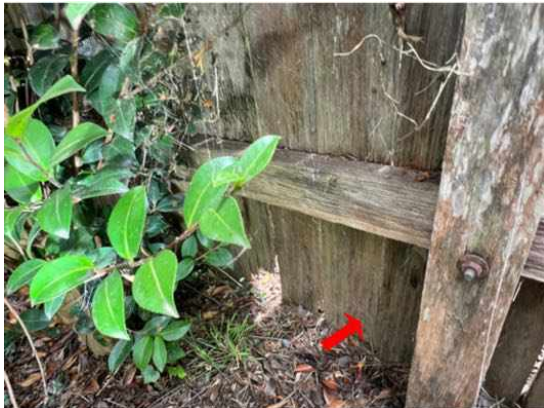
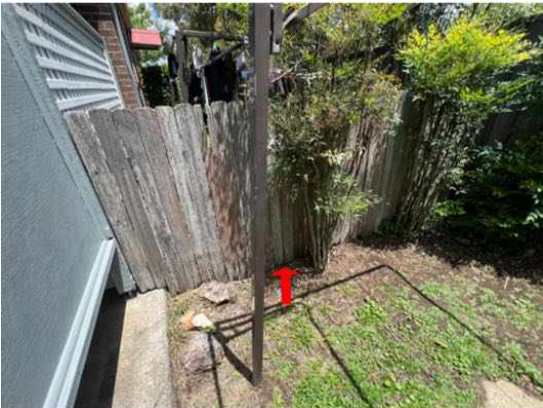
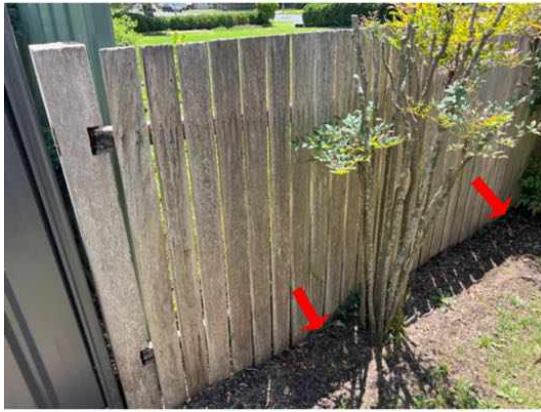
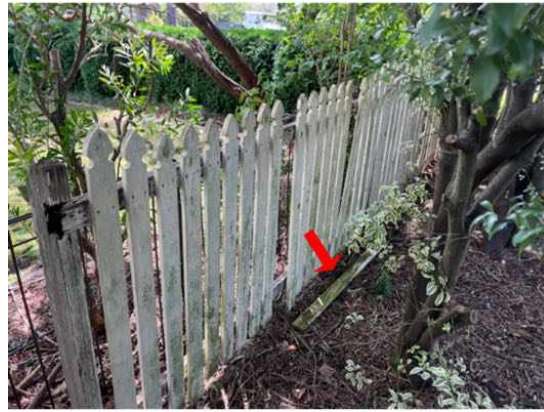
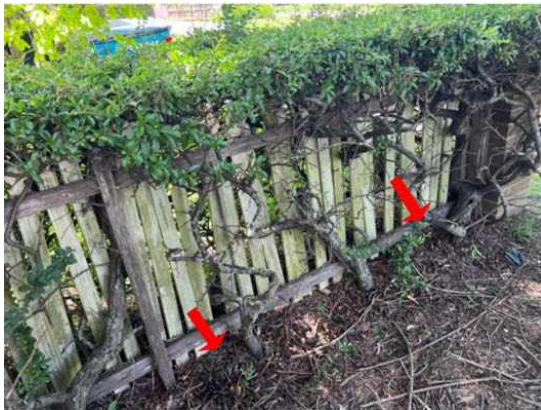
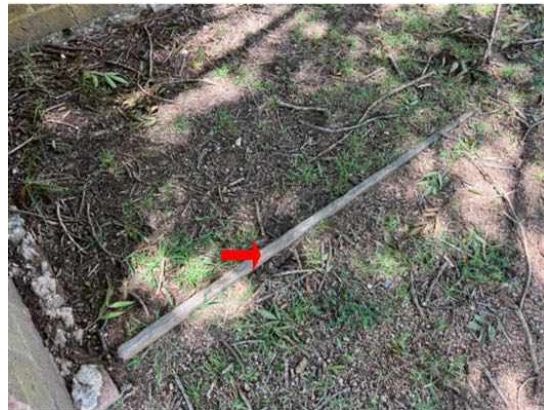
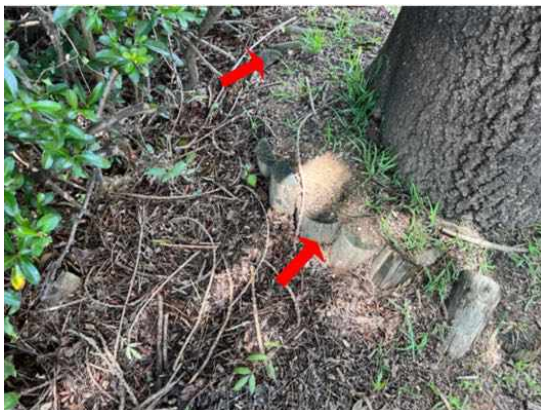
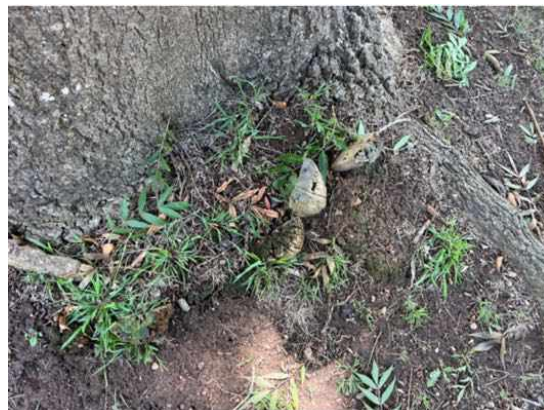
Building: Yard
Location: All External Areas
Finding: In ground contact
Information: Any timbers in direct ground contact provide opportunity for concealed termite entry and are likely to be subject to premature rot and decay as the soil retains moisture or damp conditions against the timbers.

Remove untreated timber that is in direct contact with external grounds. Consider replacement with more durable materials i.e. treated timber or non timber elements. Frequent pest inspections are advised to readily identify any termite activity in these areas.

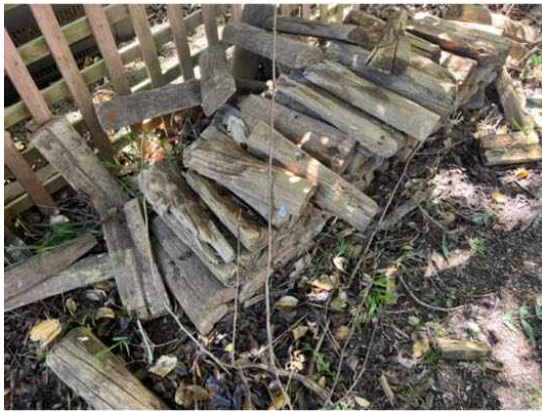
Finding 6.16

Building:	Yard
Location:	Yard - Back
Finding:	Building materials in direct ground contact - conducive to termites
Information:	Where timber elements are in direct contact with the ground and consequently moisture or dampness they become conducive to termite activity. Whether timber is used as a building element part of a fencing structure or stored as an unused item they can provide an environment that is attractive to termite infestation.

When met with excessive moisture timber begins to decay and develop wood rot. Any timbers that are in direct contact with external grounds especially if left untreated or

non-durable also provide ingress for subterranean termites into that particular element.

The removal of any such materials that may be conducive to termite activity should be removed as soon as possible to minimise the risk of termite attack.

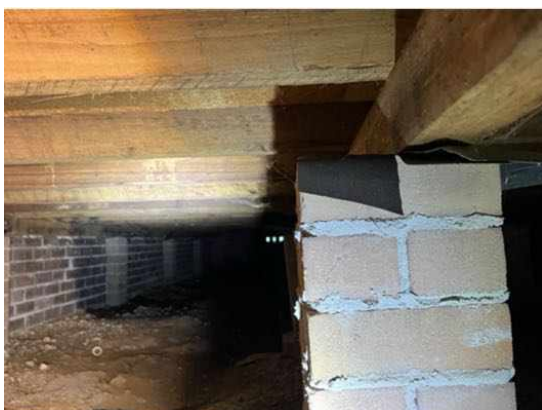
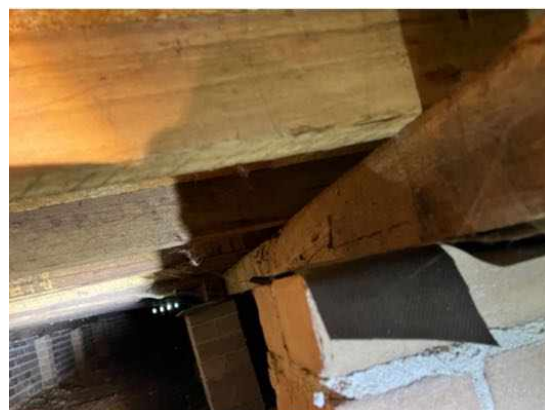
Finding 6.17

Building:	Building 2
Location:	Subfloor
Finding:	Ant caps - Not installed
Information:	Ant caps have not been installed to the subfloor structure at the time of inspection. Generally, ant caps are installed to the intersection between the top of the stumps (or piers) and the subfloor structures.

Installed during the construction process, ant caps are designed to easily identify termite or pest ingress from stumps to the adjoining bearers.

Where ant caps have not been installed, frequent monitoring of these areas should be carried out in order to identify any signs of termite or timber pest workings.

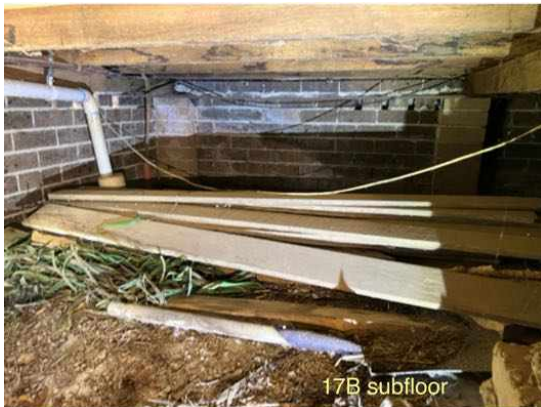
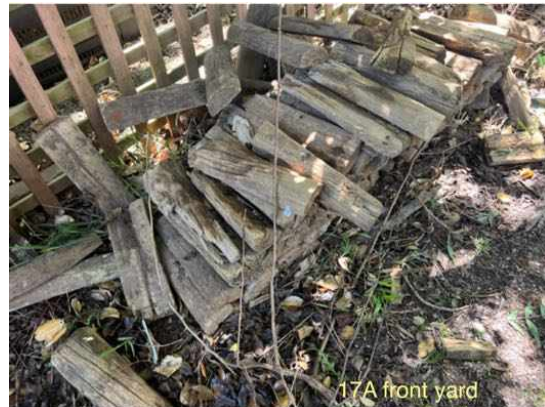
Finding 6.18

Building:	Building 2
-----------	------------

Location: Subfloor
 Finding: Stored timbers - subfloor space or external area
 Information: The storing of timbers in the subfloor space or around the external property increases the risk of termite activity being present. As they are likely to come into contact with weather conditions or excessive moisture wood rot is likely to develop on timbers that are not treated.

It is highly recommended that any stored timbers be immediately removed from areas in which they may attract any termite / timber pest attack. Minimisation of risk / prevention of termite attack is far more adequate than dealing with the presence of termite activity.

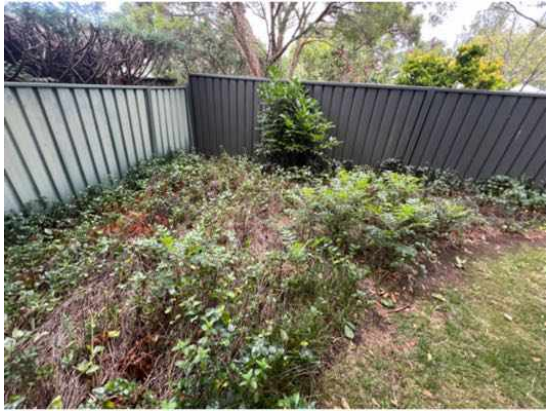
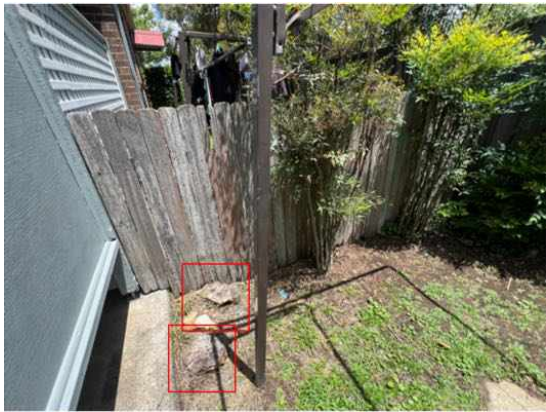
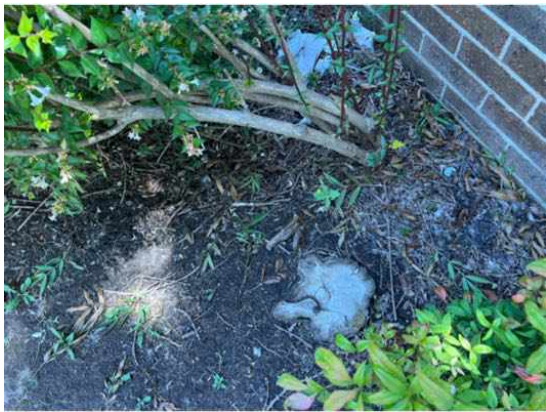
Finding 6.19

Building: Yard
 Location: The Site
 Finding: Stumps, Dead or Decayed Trees - conducive conditions
 Information: Stumps and/or dead or decaying trees were observed within the property boundary during the inspection. These elements are recognised as significant conducive conditions, as they retain moisture and provide a cellulose-rich environment ideal for sustaining termite activity.

Even in the absence of visible termite workings at the time of inspection, decayed timber material can support undetected subterranean termite harbourage, particularly when located in close proximity to the dwelling. The risk of concealed termite ingress into structural timbers is increased when such materials are not removed or managed appropriately.

The client is advised to consult a licensed pest management professional to assess the site and determine whether treatment or removal of the stumps or trees is required. Ongoing timber pest inspections should be maintained at regular intervals to monitor for any future activity.

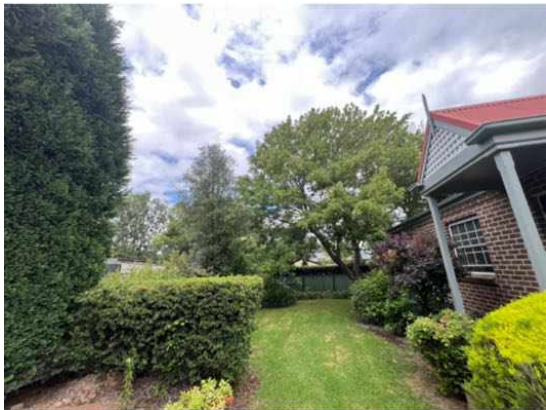
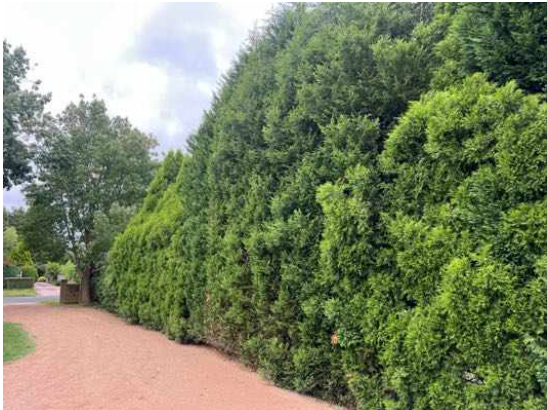
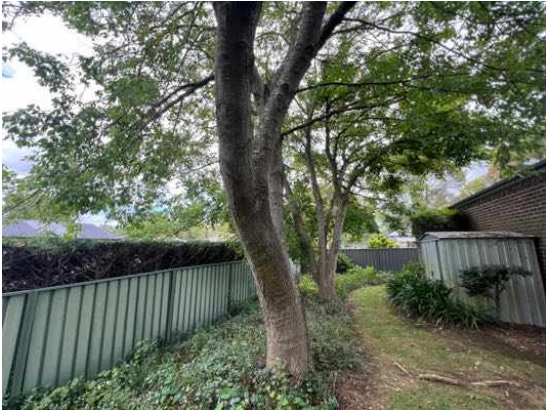
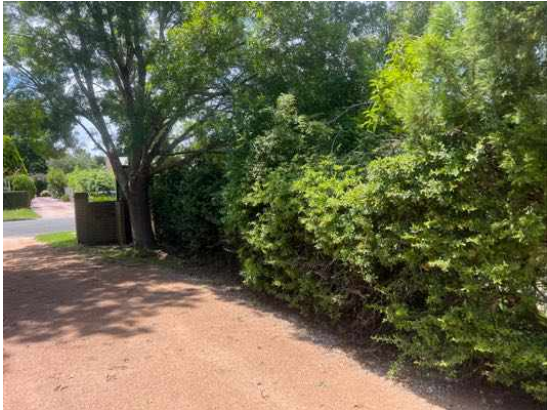
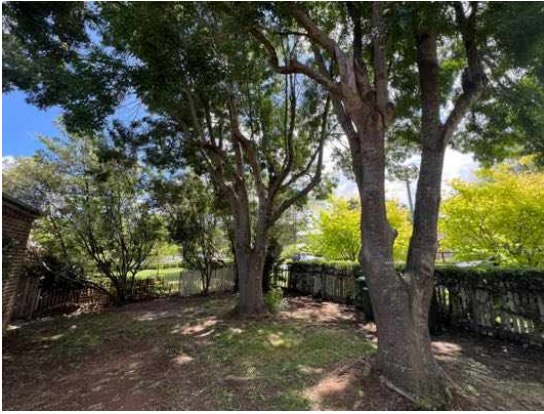
Finding 6.20

Building: Yard
Location: The Site
Finding: Timber Pest Risk – Trees Within 50m of Dwelling
Information: Mature trees were identified within 50 metres of the dwelling. The presence of trees in close proximity to the structure increases the risk of termite activity, as trees provide a natural food source and nesting environment for termites. Tree roots can also contribute to excessive moisture retention in the soil, creating conducive conditions for timber pest activity.

Regular monitoring for signs of termite activity is advised. A licensed pest inspector should be engaged to assess the area and provide further recommendations on risk mitigation and management.

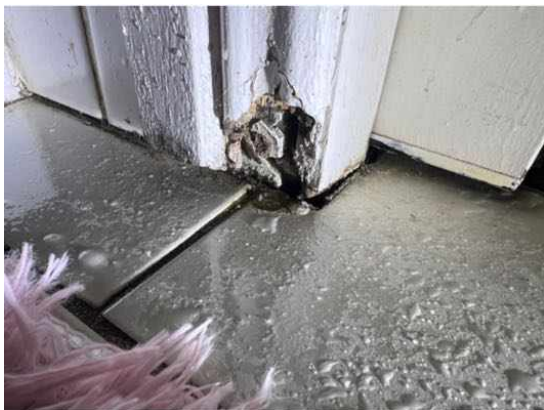
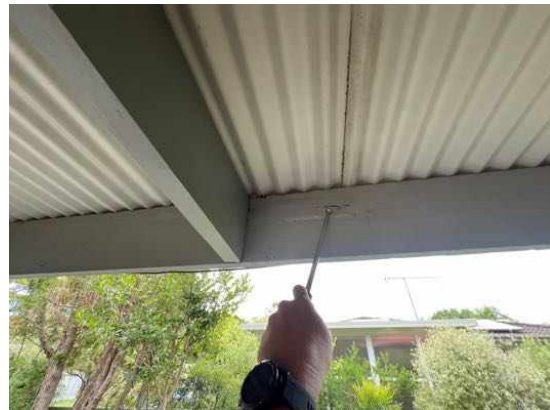
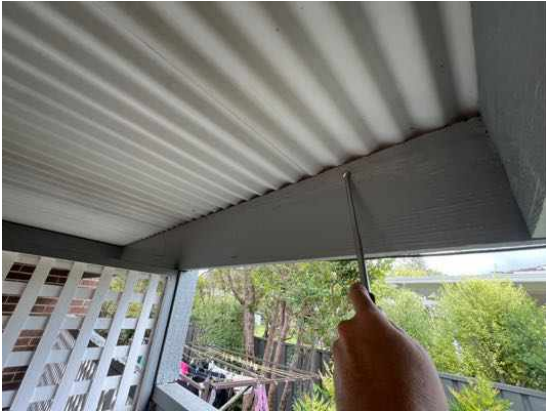
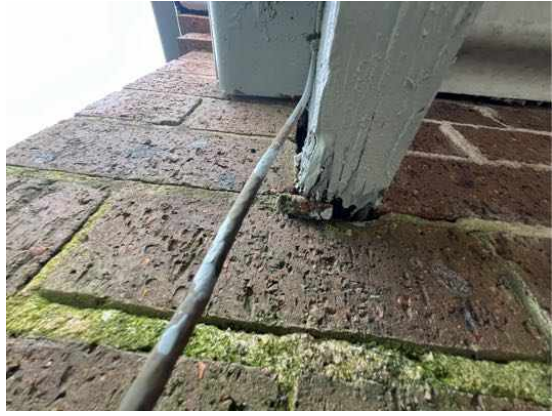
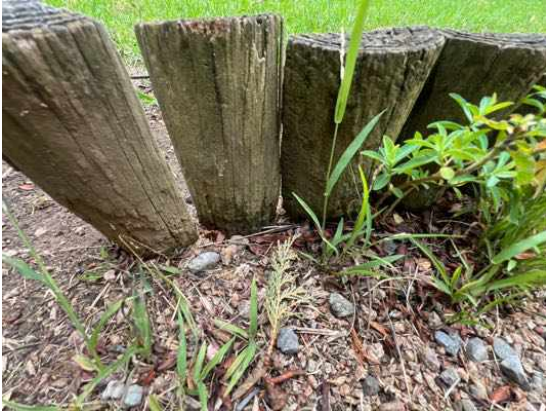
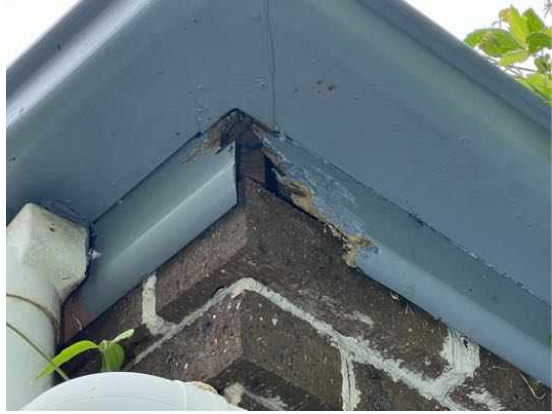
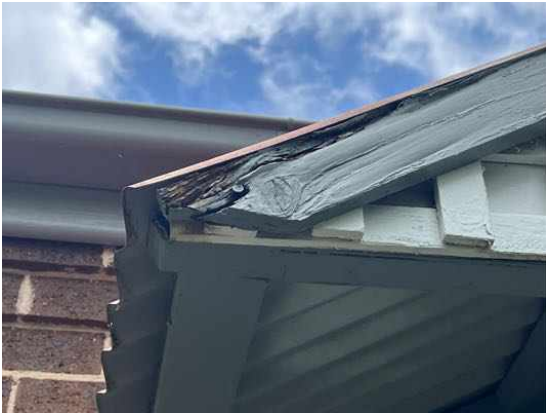
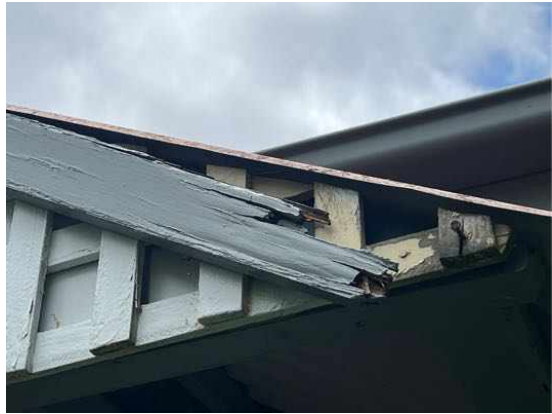
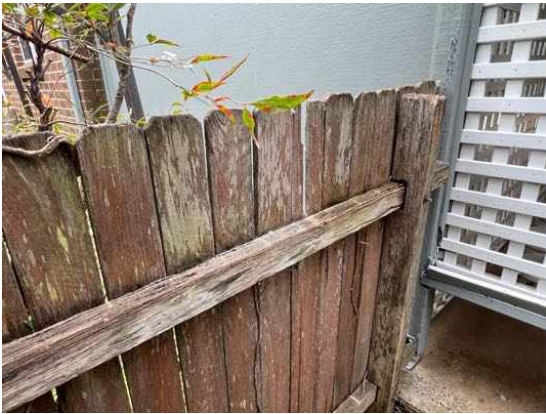
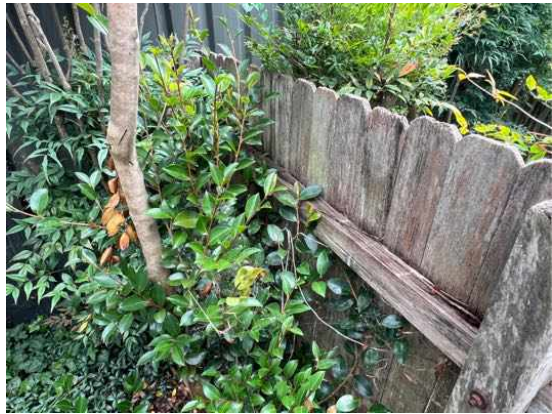
Finding 7.01

Building:	Not Applicable
Location:	All External Areas
Finding:	Fungal decay - present (localised)
Information:	Fungal decay also known as wood decay or wood rot generally refers to the deterioration of timber elements when in contact with excessive levels of moisture for a prolonged period of time.

The development of fungal decay is accelerated by temperatures in the range of 5degreeC to 40degreeC as well as the presence of oxygen. Generally fungal decay develops on timber elements that are in use in an external environment which are exposed to rain penetration.

In this case although the affected timber element is in a decaying state the extent of any visible damage appears to be localised to a specific area and is yet to spread to other parts of the building element or affect adjoining structures. The fungal decay is therefore likely to be of a relatively superficial nature with minimal impact on the structural integrity or tensile strength of the timber element.

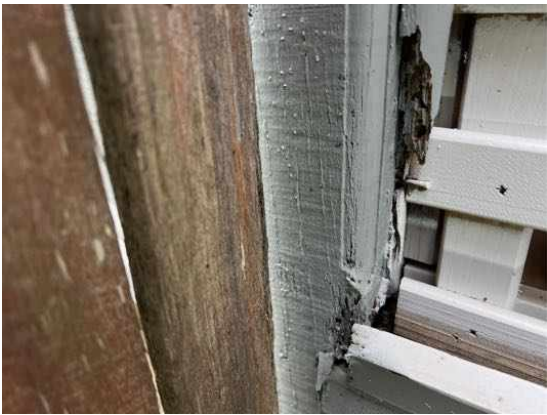
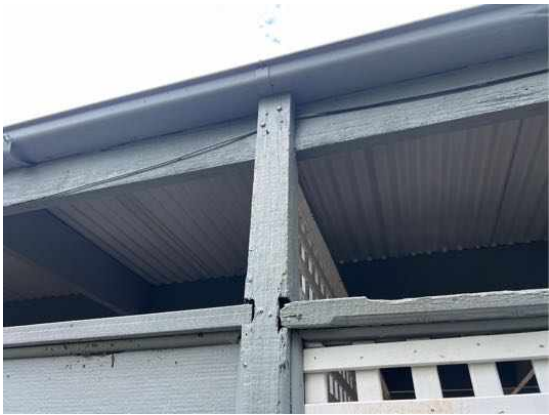
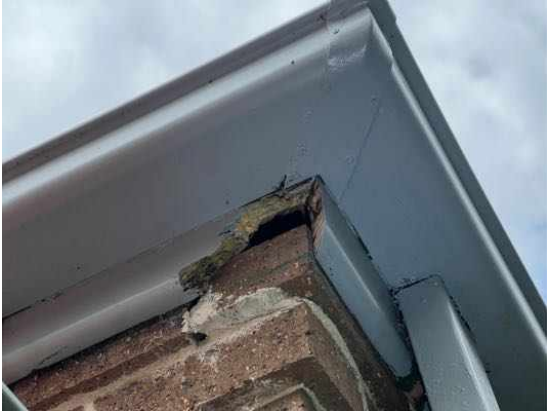
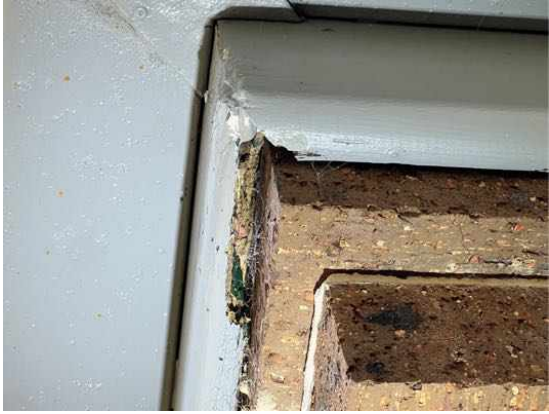
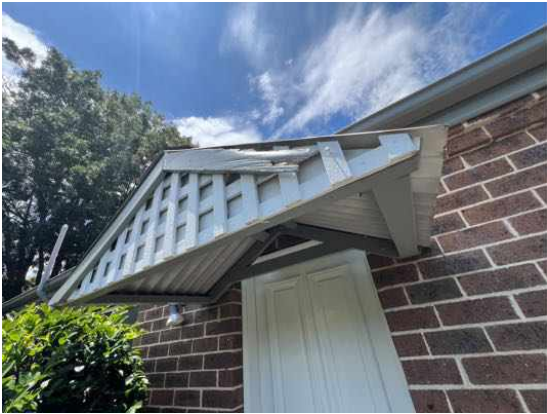
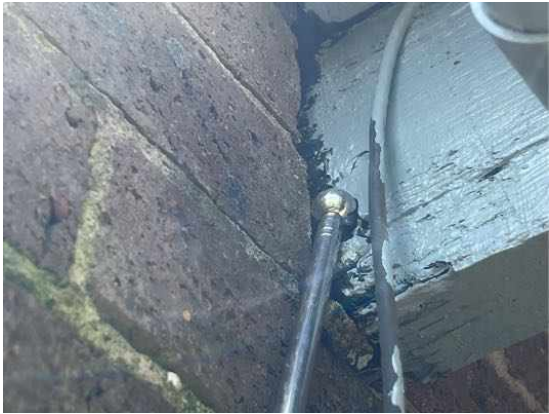
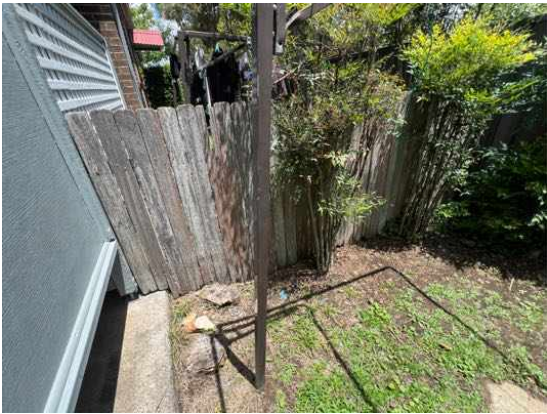
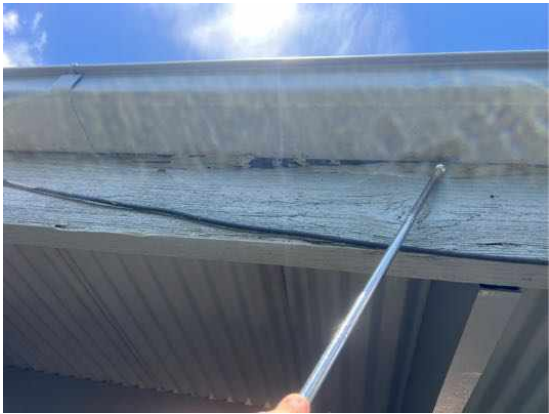
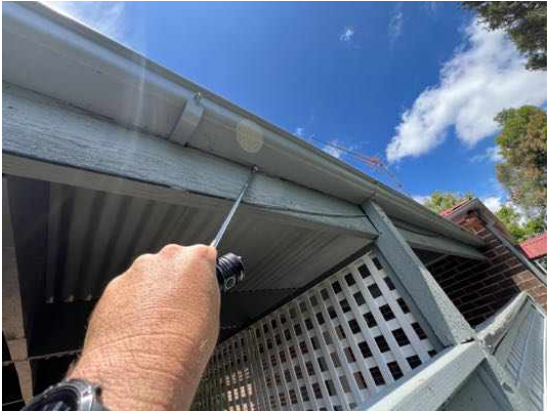
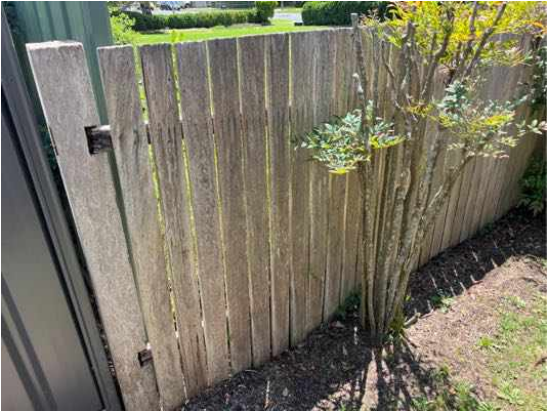
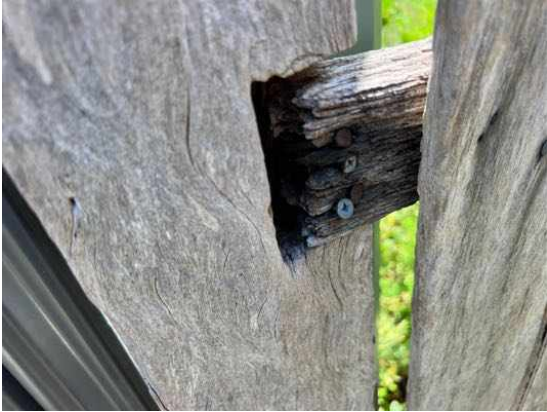
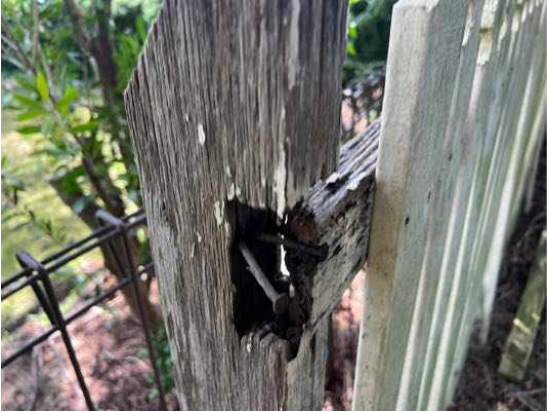
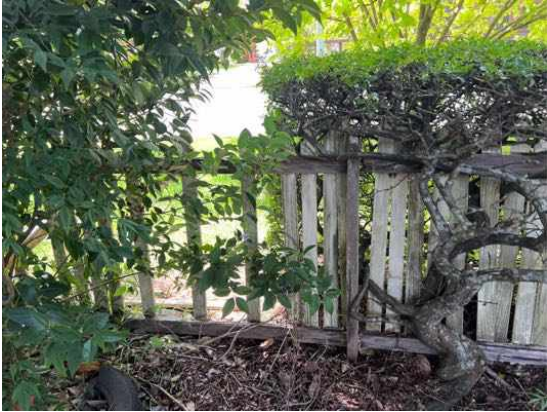
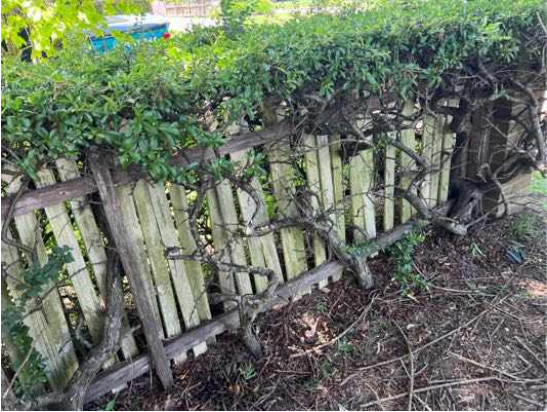
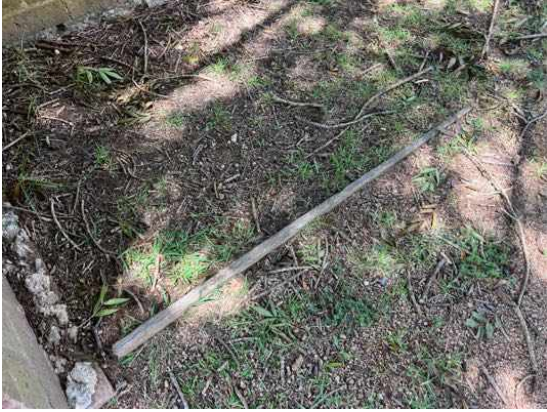
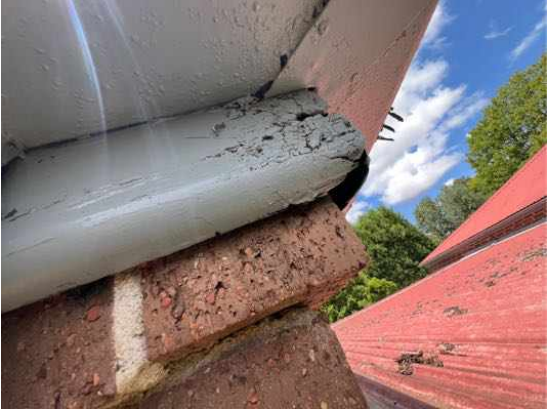
Finding 8.01

Evidence of wood borer activity and/or damage

Building: Yard
 Location: The Site
 Finding: Evidence of wood borer activity identified
 Information: Wood borers small beetles that colonise in exposed timber elements are a common timber pest that are regularly mistaken for termites. Although wood borer activity is generally not detrimental to the affected timber they may lead to serious damage and necessitate replacement of certain building elements if left unattended.

As no live wood borer activity was identified treatment is not required at this time. Replacement of affected timbers may be considered by the client for superficial reasons.

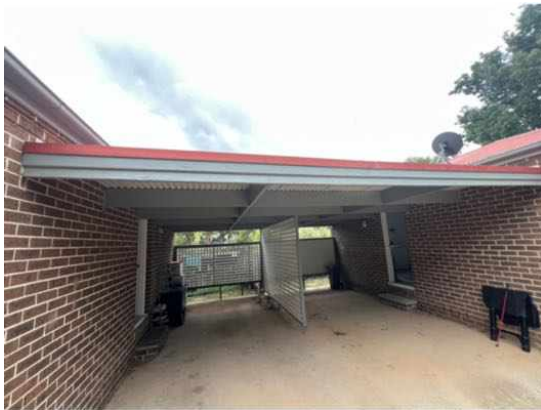
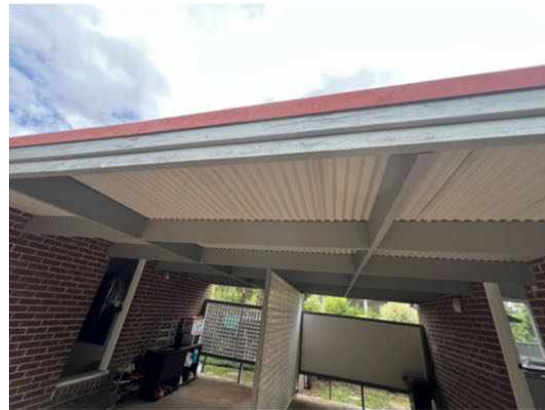
It is strongly recommended that the purchaser request formal documentation from the vendor confirming whether the pergola structure has been approved. If no approval can be produced, the current owner should be asked to obtain a Building Information Certificate and provide a structural assessment confirming that the structure is safe and built in accordance with current building standards.

This inspection report does not constitute formal approval, and any informal assessment should not be relied upon to confirm compliance. Further enquiries with the local council or an accredited certifier are strongly recommended prior to settlement.

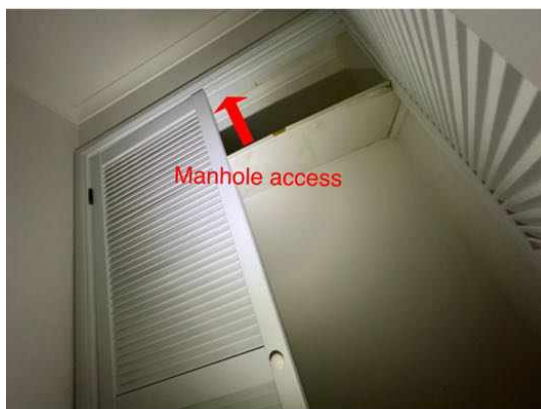
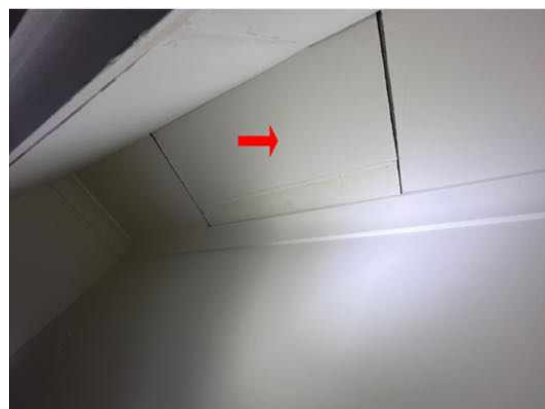
Building: Building 1
 Location: Laundry (linen)
 Finding: No Access - Roof Void 17A
 Information: Access to this area was restricted at the time of inspection, preventing a full assessment. The condition of any concealed elements could not be determined, and defects may exist that were not visible during the inspection.

Further inspection is recommended once access is made available.
